CHLORIDE INTRUSION INTO BRIDGE DECKS OVERLAID WITH LATEX MODIFIED CONCRETE

March 1996

RHODE ISLAND DEPARTMENT OF TRANSPORTATION

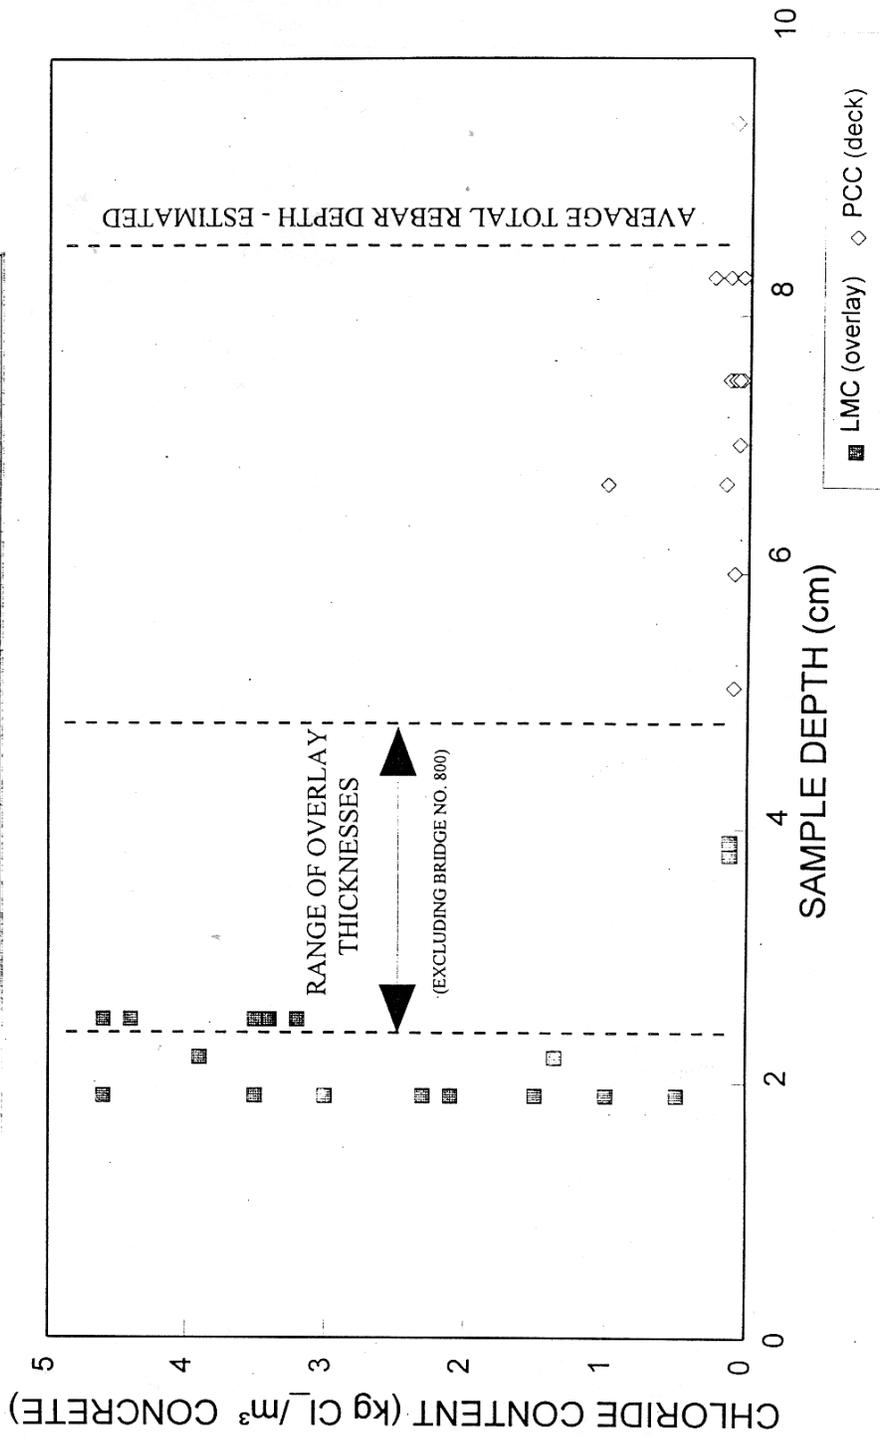
Figure 1 - Chloride Intrusion in LMC Overlaid Bridges

Bridge #250 was not included because of the condition of the overlay and the potential impact on the chloride levels
 Bridge #800 was not included to show the range of overlay thicknesses because of the substantially higher thickness

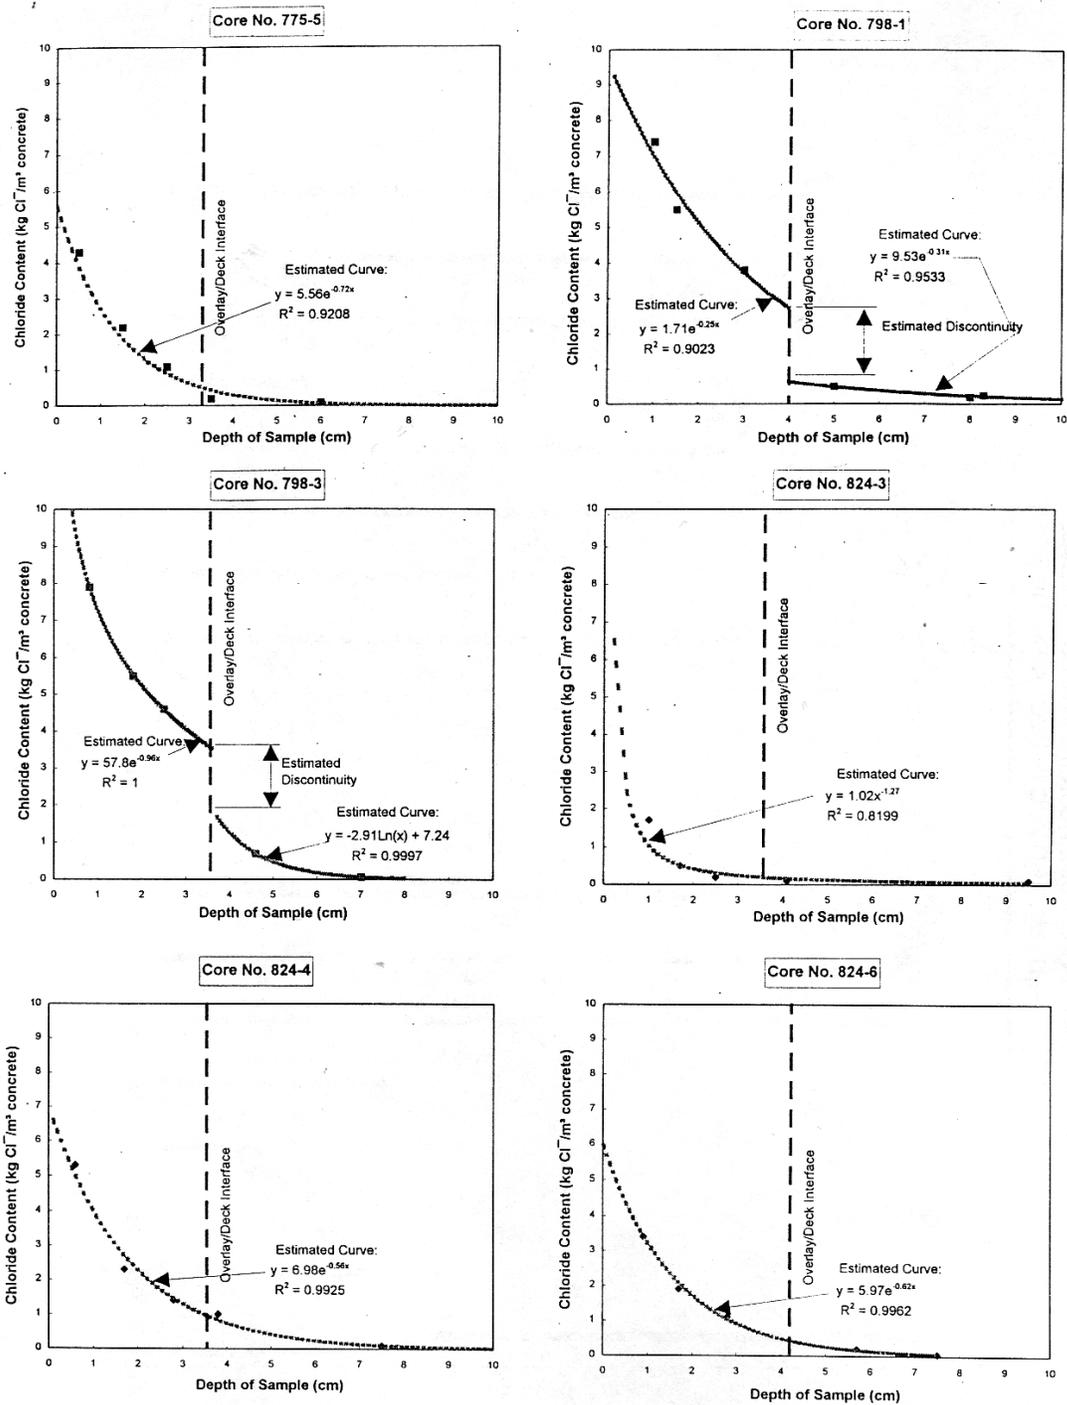
Figure 4 - Profile of Chloride Intrusion in LMC Overlaid Bridge Decks

The profiling that was performed on selected cores (see figure 4) from LMC overlaid decks indicates that depending on the way the overlay was placed, either case noted above¹³ may occur. Bridges number 775 and 824 appear to have had the chloride intrusion reduced steadily through the overlay, implying the trap effect. Bridge number 798 shows a sharp drop at the level of the LMC/PCC interface, implying a barrier effect¹⁴. Based on the chloride levels from number 798, it is possible that both effects are occurring. The other cores show that the LMC can cause a drop of at least $4 \text{ kg Cl}^-/\text{m}^3$ of concrete through three to four centimeters of an LMC overlay. If this is a limit to the inhibiting (trap) effect of the LMC, any additional protection may be caused by a barrier effect when the chloride levels in the top of the overlay are higher than $4 \text{ kg Cl}^-/\text{m}^3$ of concrete¹⁵. The analysis of the area under the estimated chloride intrusion curves confirm that although the amount of chloride in the LMC is often comparable with that in the PCC at the same depth, the LMC provides better protection at the rebar level. The chloride contents average one-fourth as much for the decks with a LMC overlay compared to the full depth PCC decks.¹⁶ A comparison of the ratios of chloride content in the first depth range to that of the second depth range shows that, on average, the ratio between the two for the LMC cores is double that of the PCC.¹⁷ This indicates a much higher percentage of the chlorides entering the concrete are passing through towards the rebar level in the full depth PCC.
