BRIDGE NO. 070001

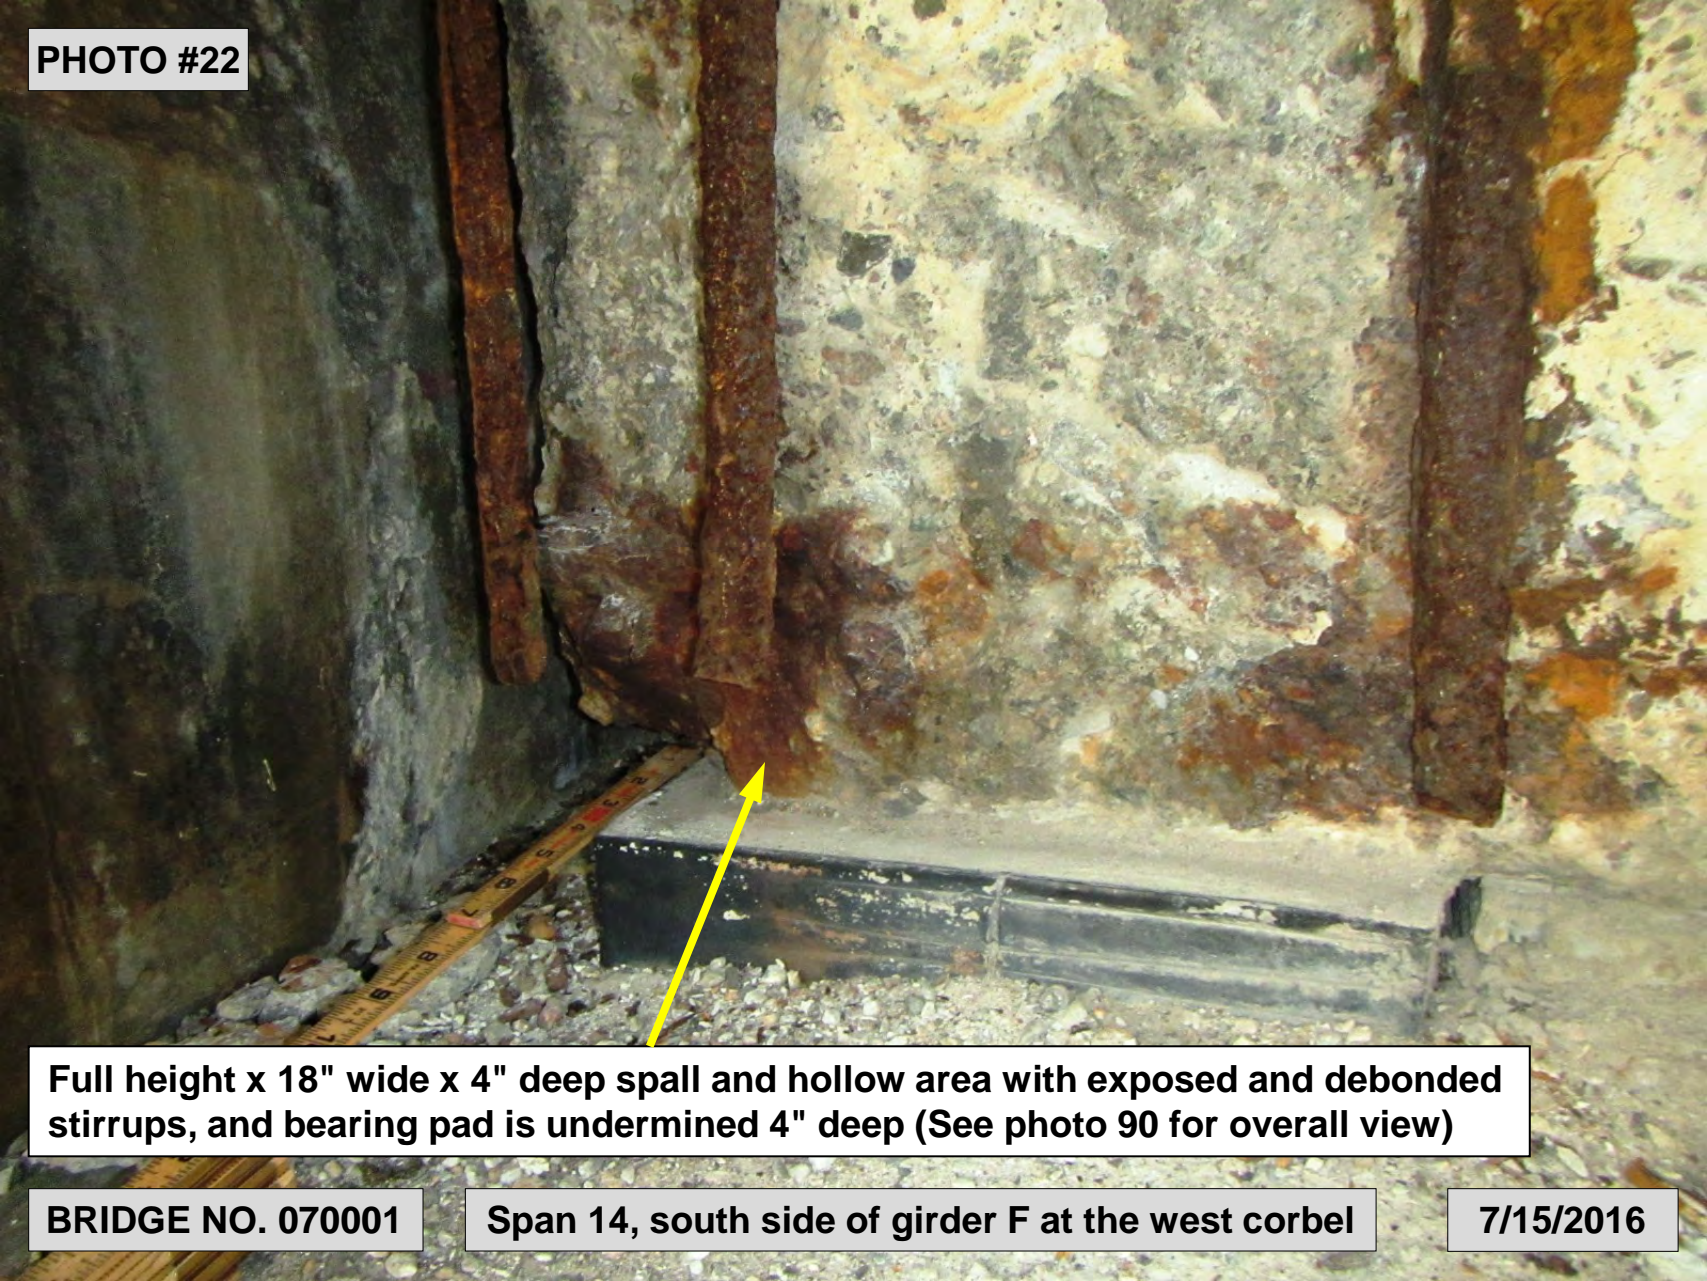
PHOTO #22

Full height x 18" wide x 4" deep spall and hollow area with exposed and debonded stirrups, and bearing pad is undermined 4" deep (See photo 90 for overall view)

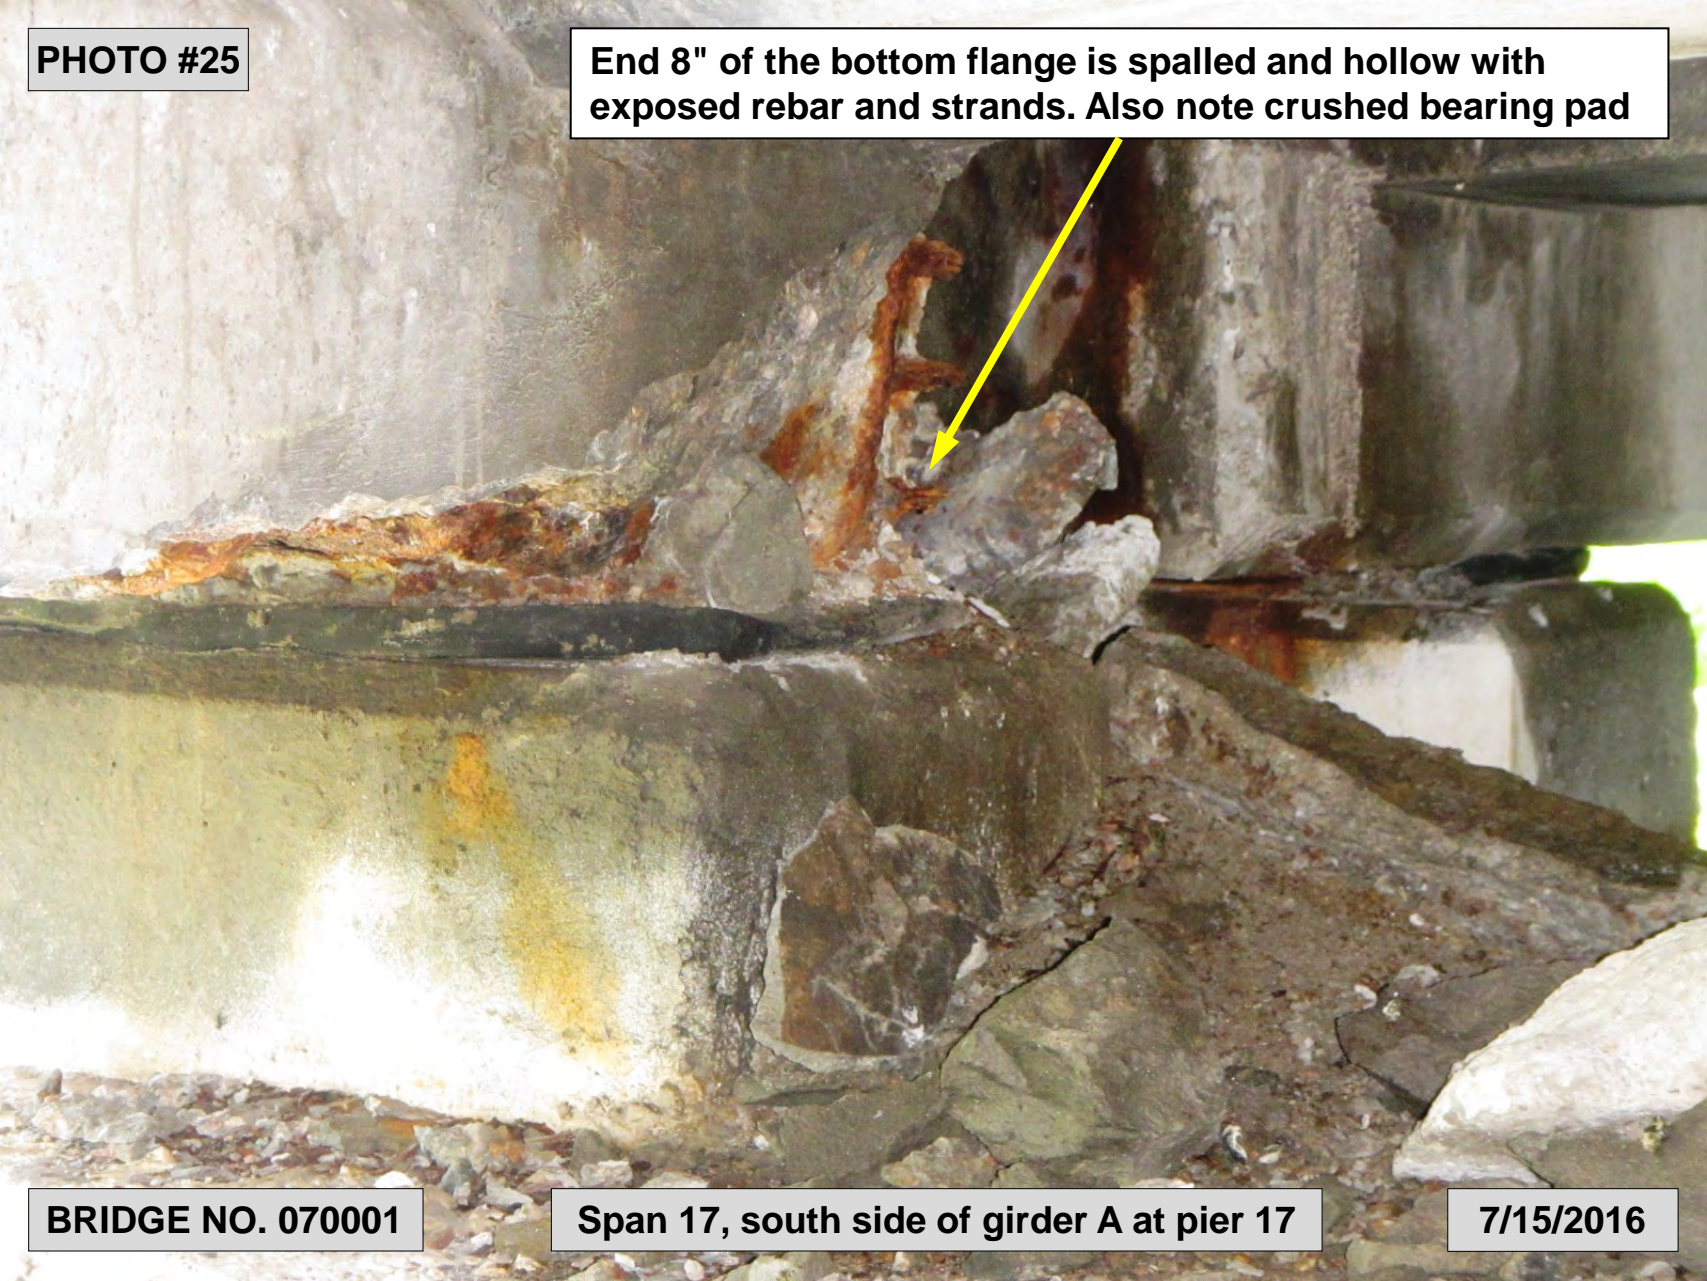
PHOTO #25

End 8" of the bottom flange is spalled and hollow with exposed rebar and strands. Also note crushed bearing pad

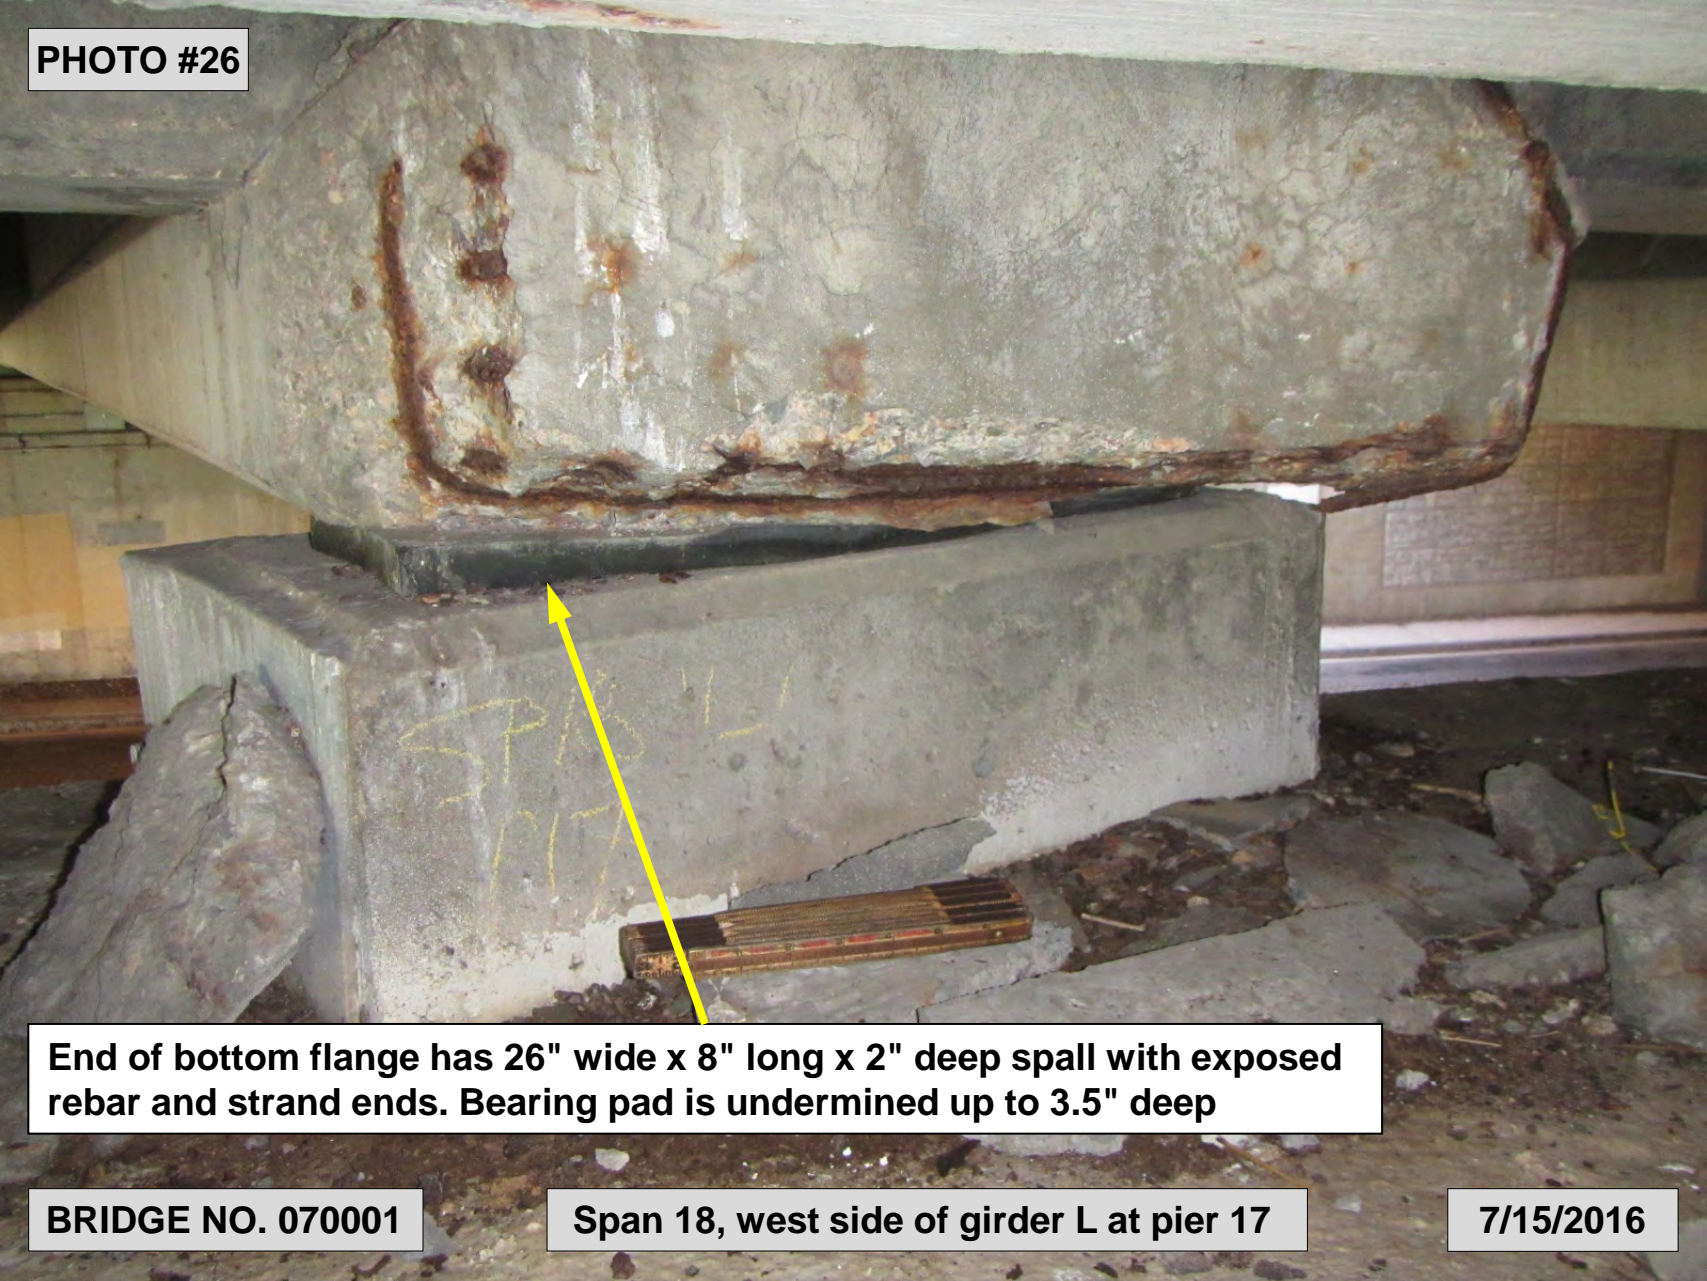
PHOTO #26

End of bottom flange has 26" wide x 8" long x 2" deep spall with exposed rebar and strand ends. Bearing pad is undermined up to 3.5" deep

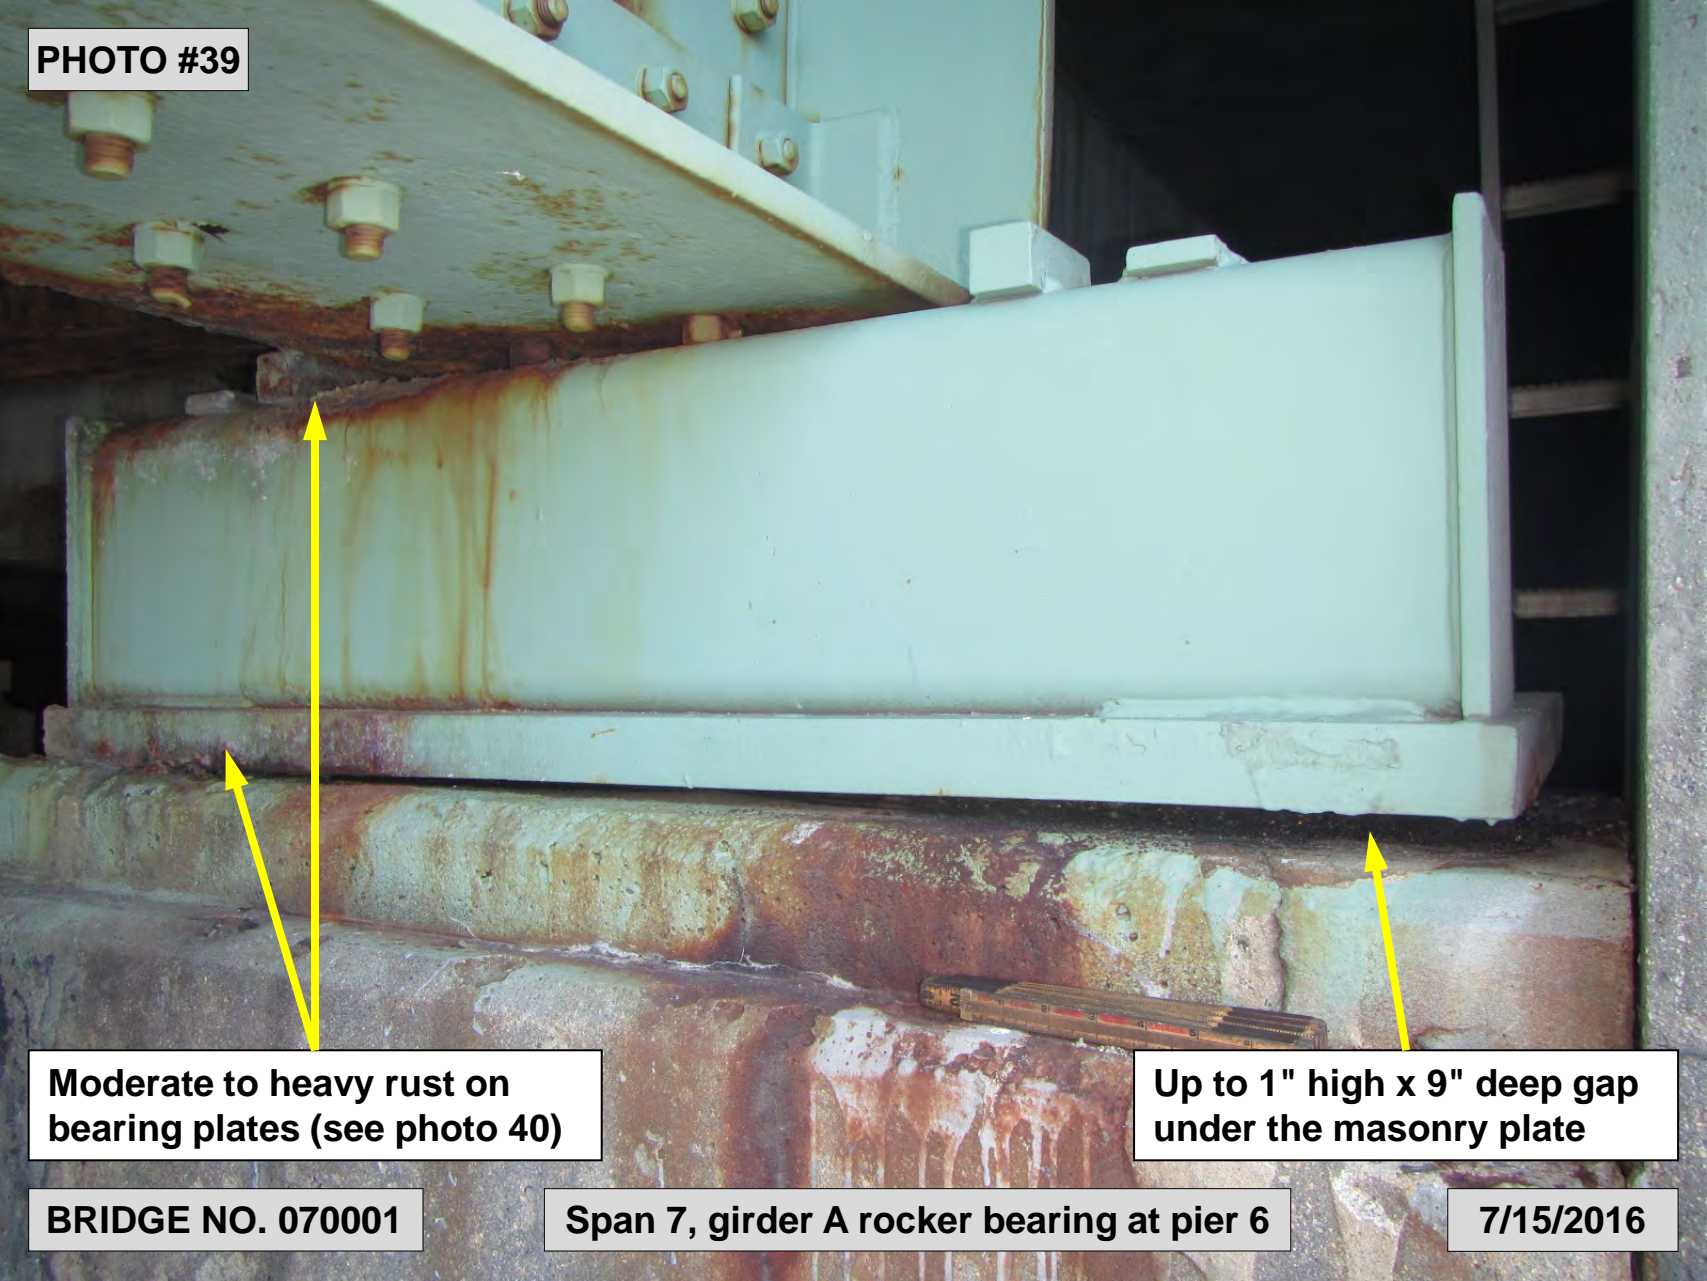
PHOTO #39

Moderate to heavy rust on bearing plates (see photo 40)

Up to 1" high x 9" deep gap under the masonry plate

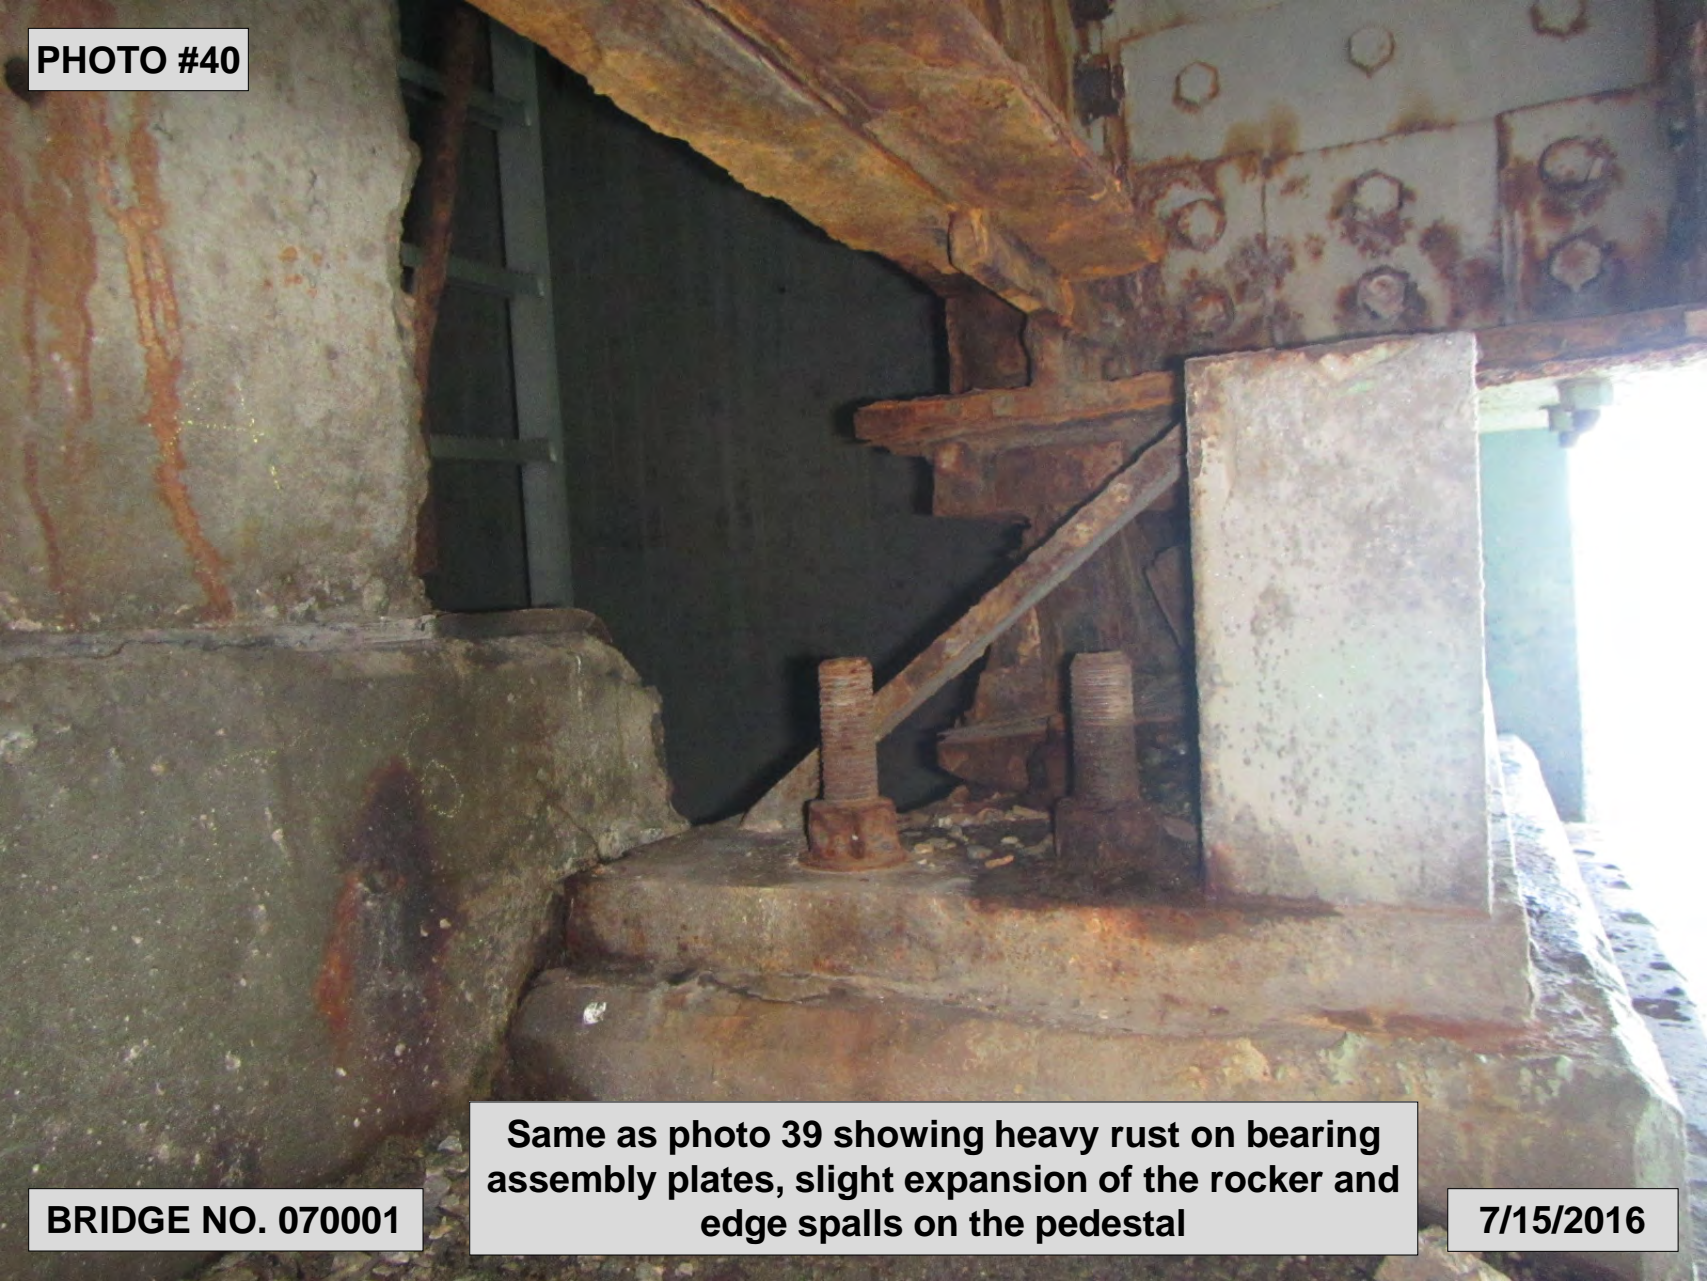
PHOTO #40

Same as photo 39 showing heavy rust on bearing assembly plates, slight expansion of the rocker and edge spalls on the pedestal

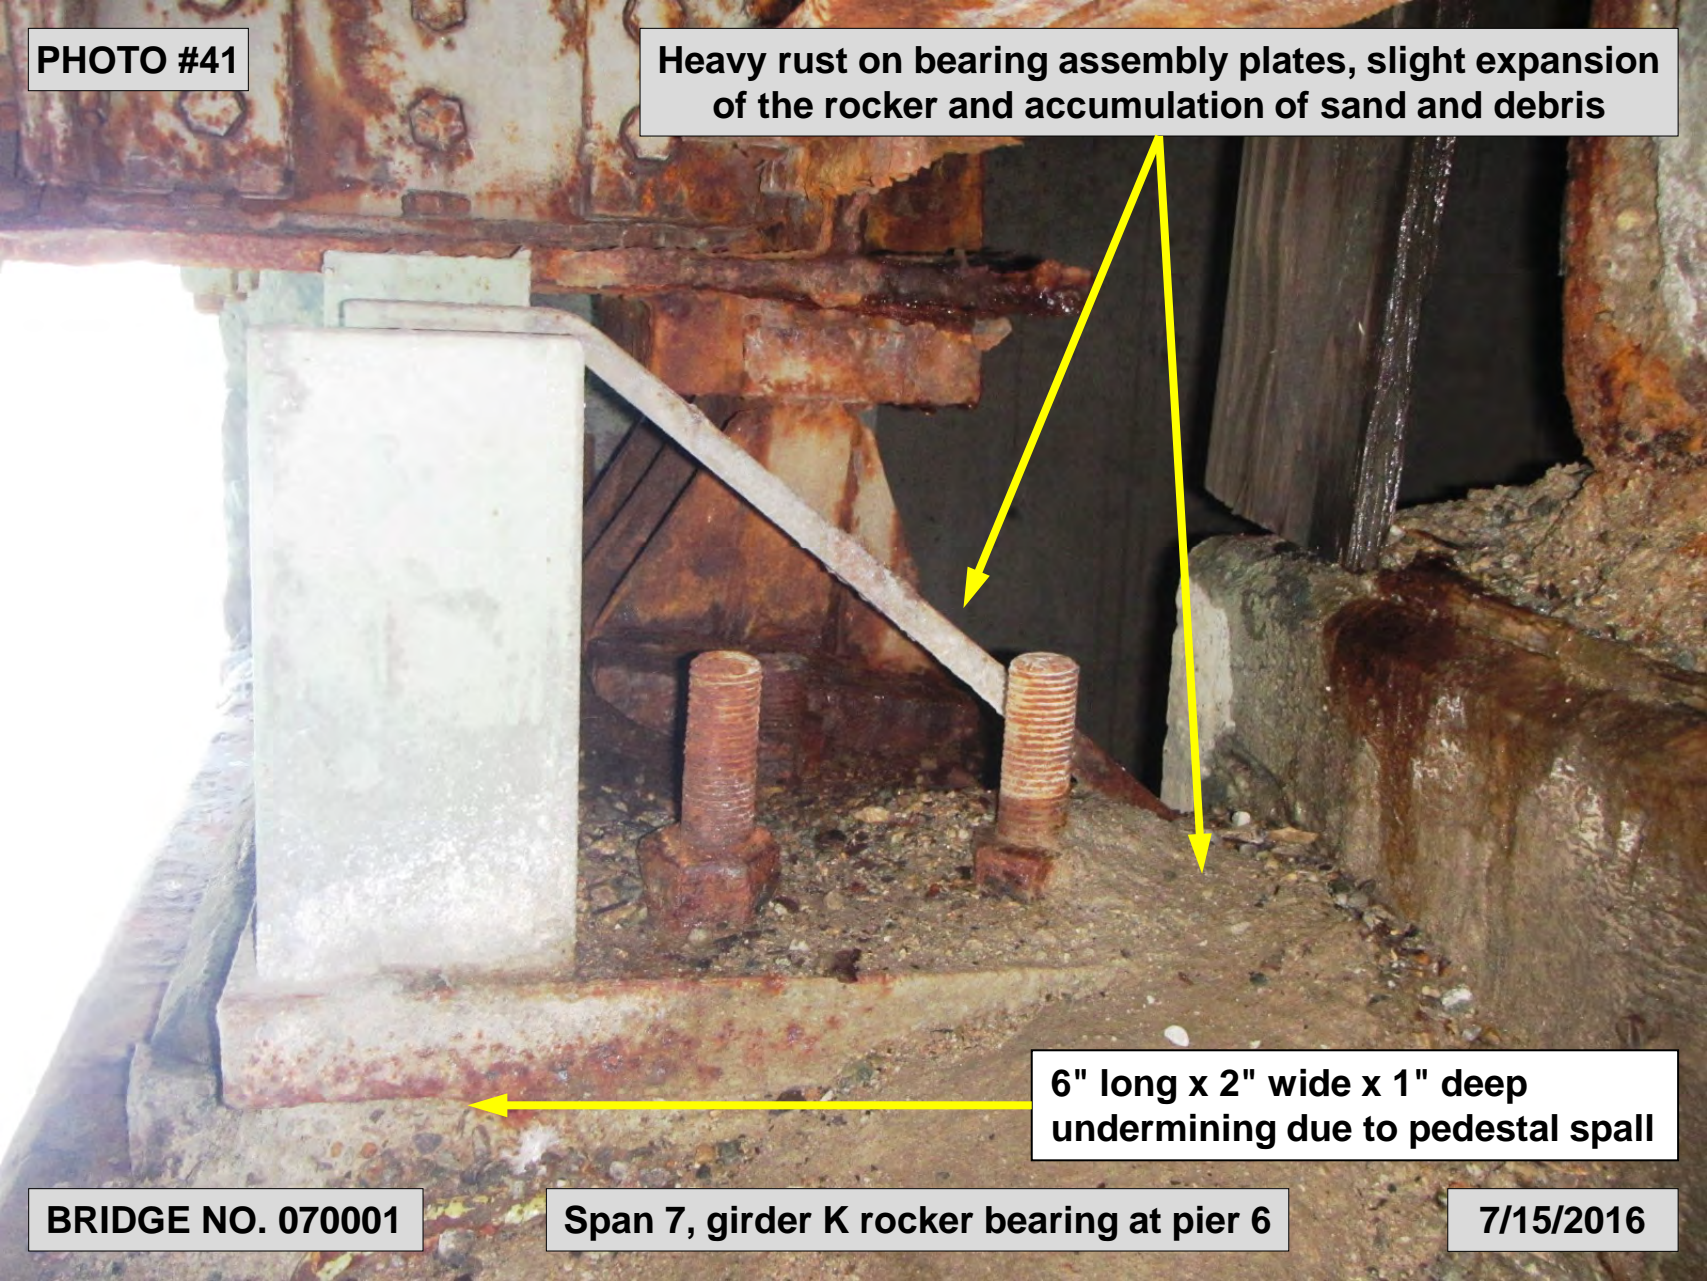
PHOTO #41

Heavy rust on bearing assembly plates, slight expansion of the rocker and accumulation of sand and debris

6" long x 2" wide x 1" deep
undermining due to pedestal spall

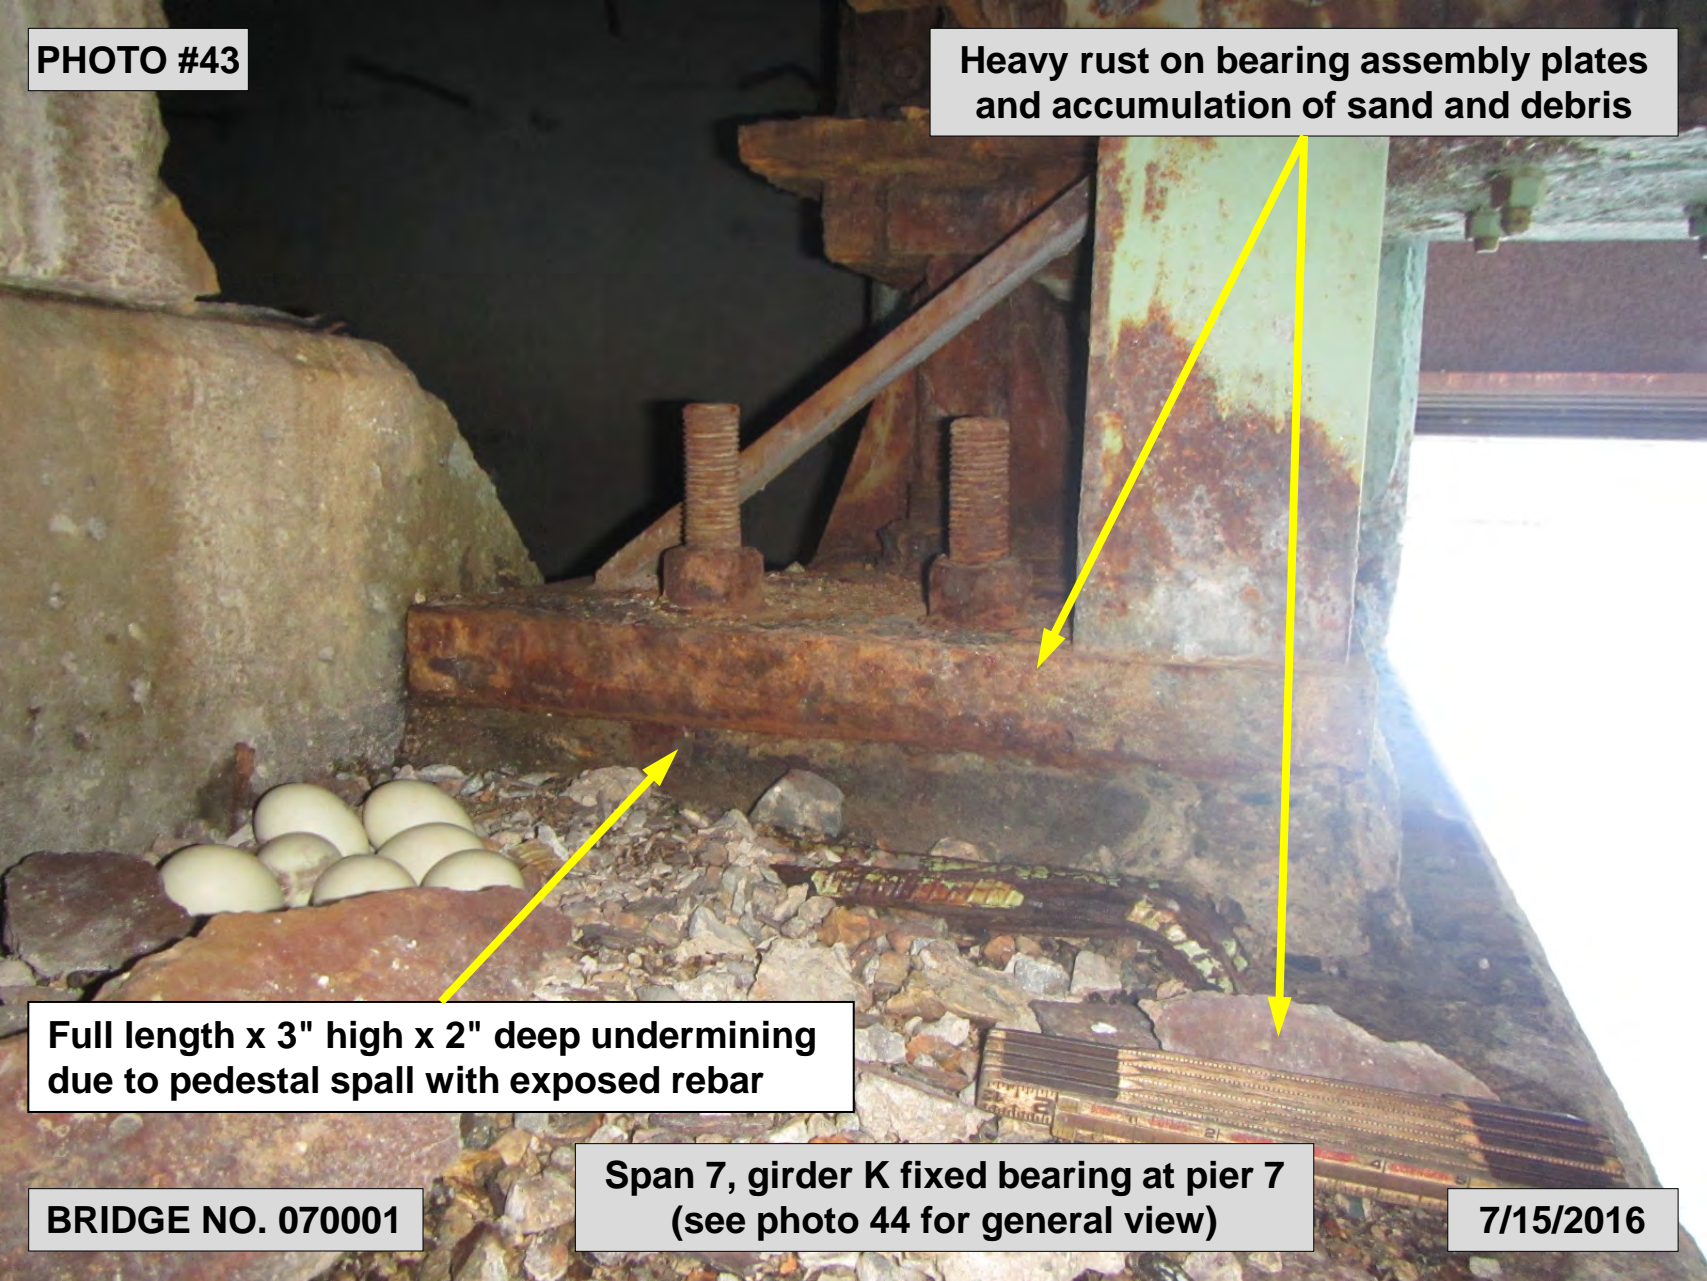
PHOTO #43

Heavy rust on bearing assembly plates and accumulation of sand and debris

Full length x 3" high x 2" deep undermining due to pedestal spall with exposed rebar

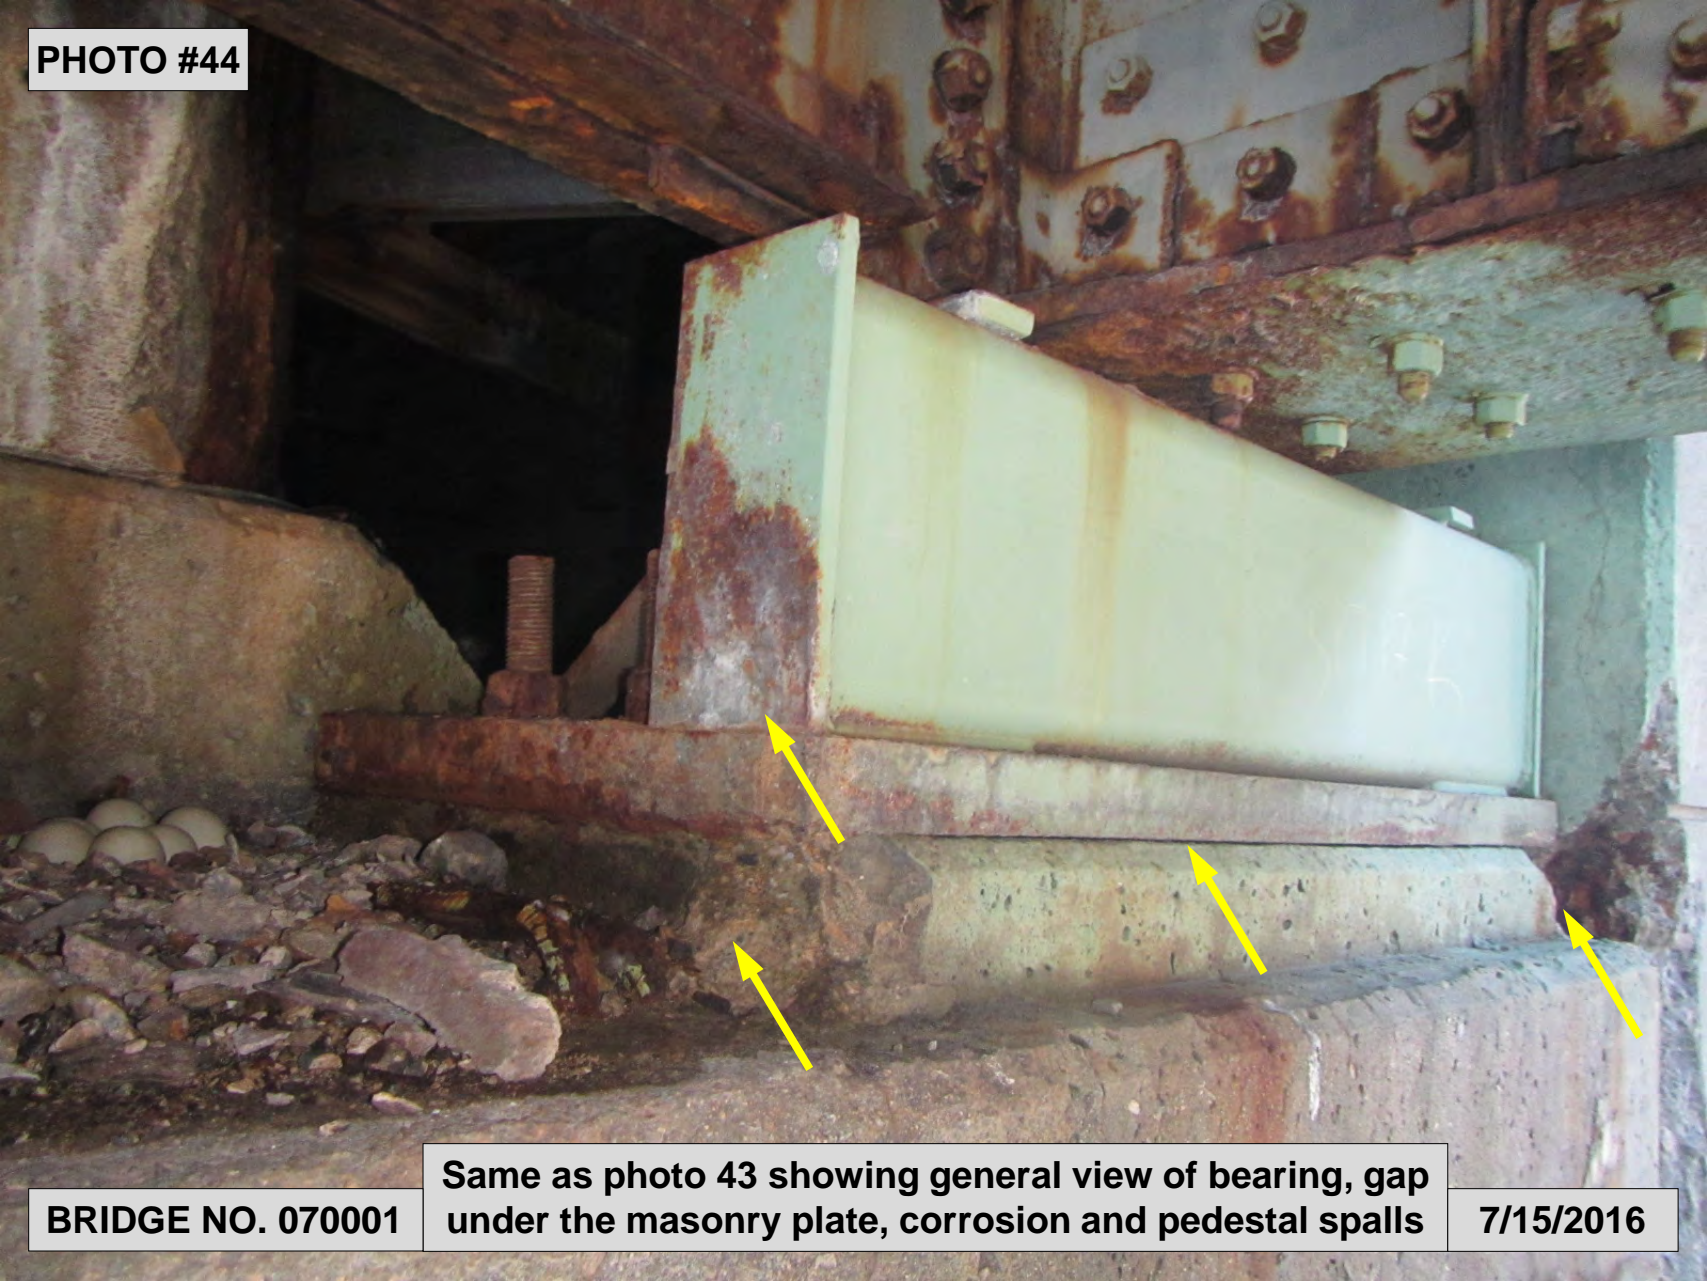
PHOTO #44

Same as photo 43 showing general view of bearing, gap under the masonry plate, corrosion and pedestal spalls

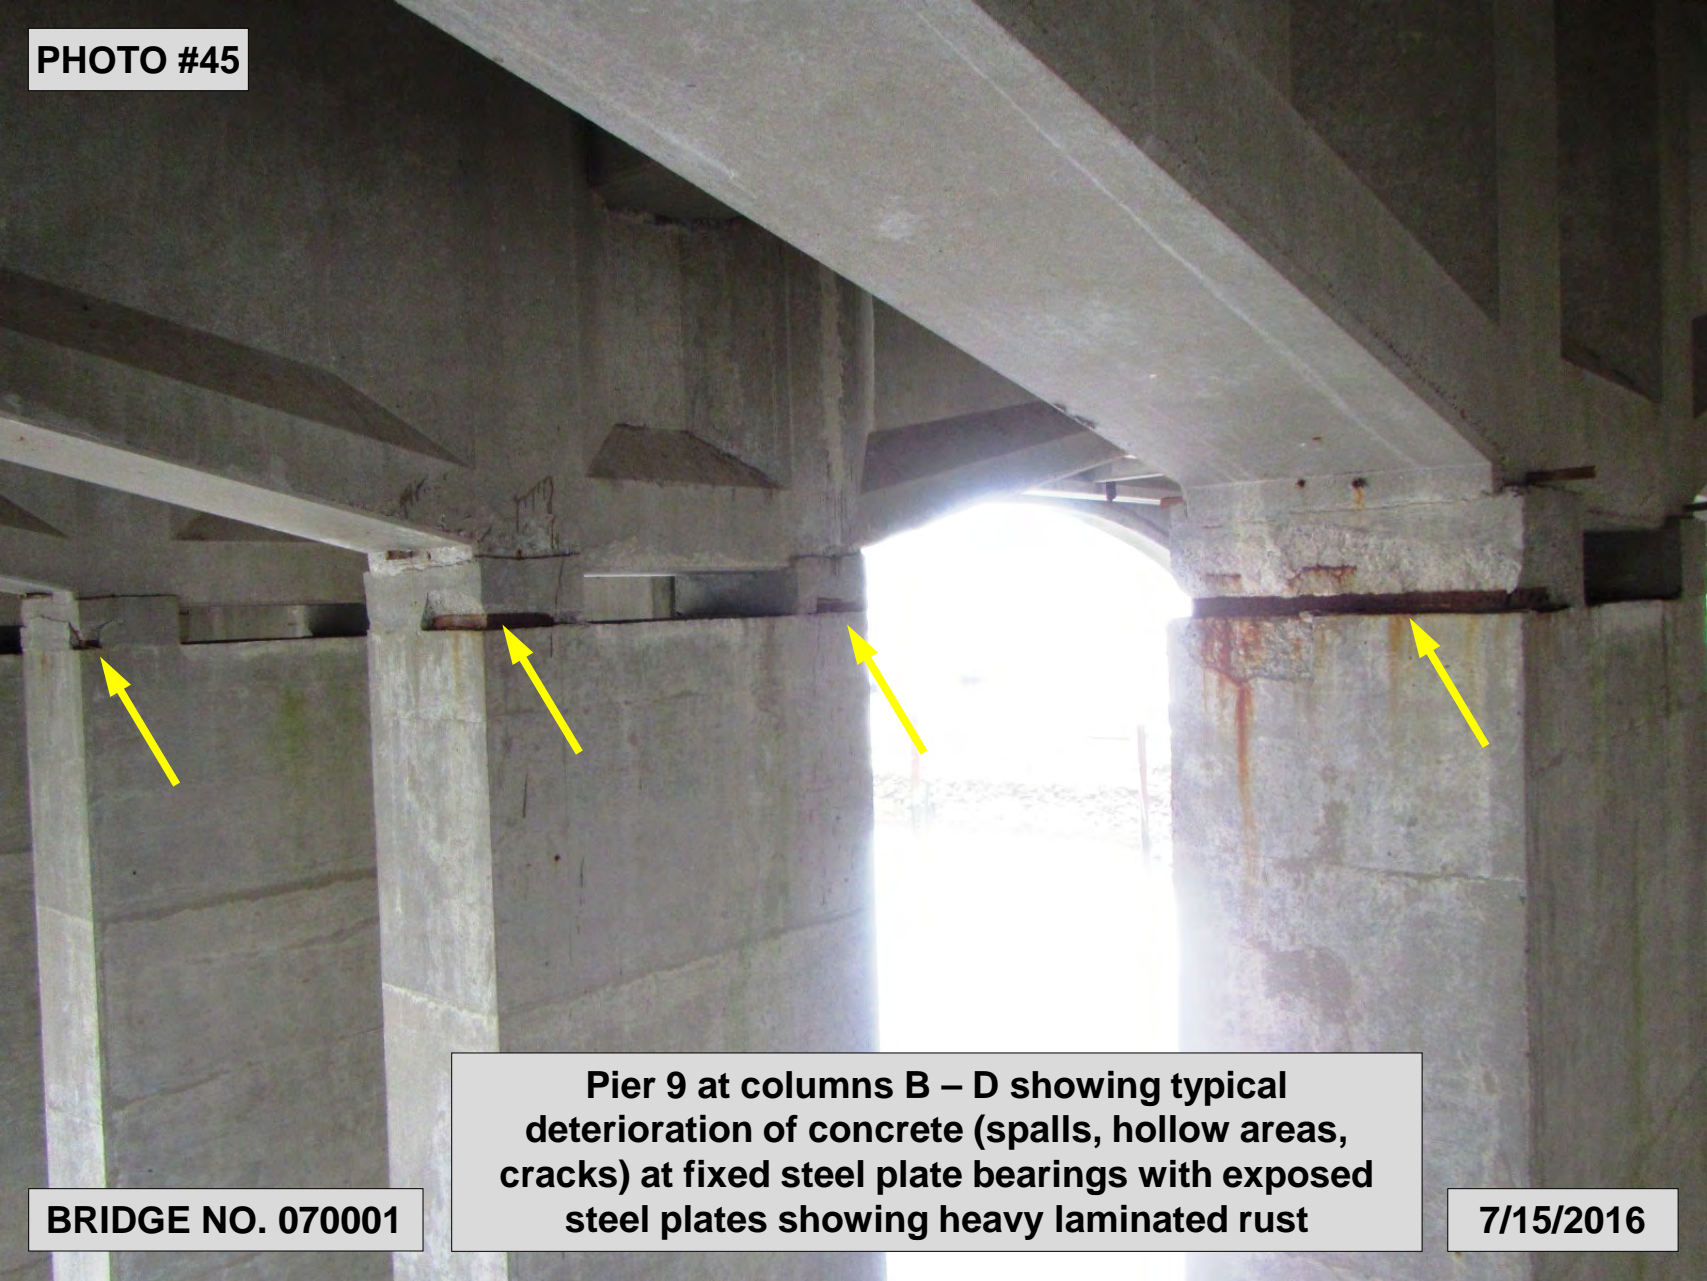
PHOTO #45

Pier 9 at columns B – D showing typical deterioration of concrete (spalls, hollow areas, cracks) at fixed steel plate bearings with exposed steel plates showing heavy laminated rust

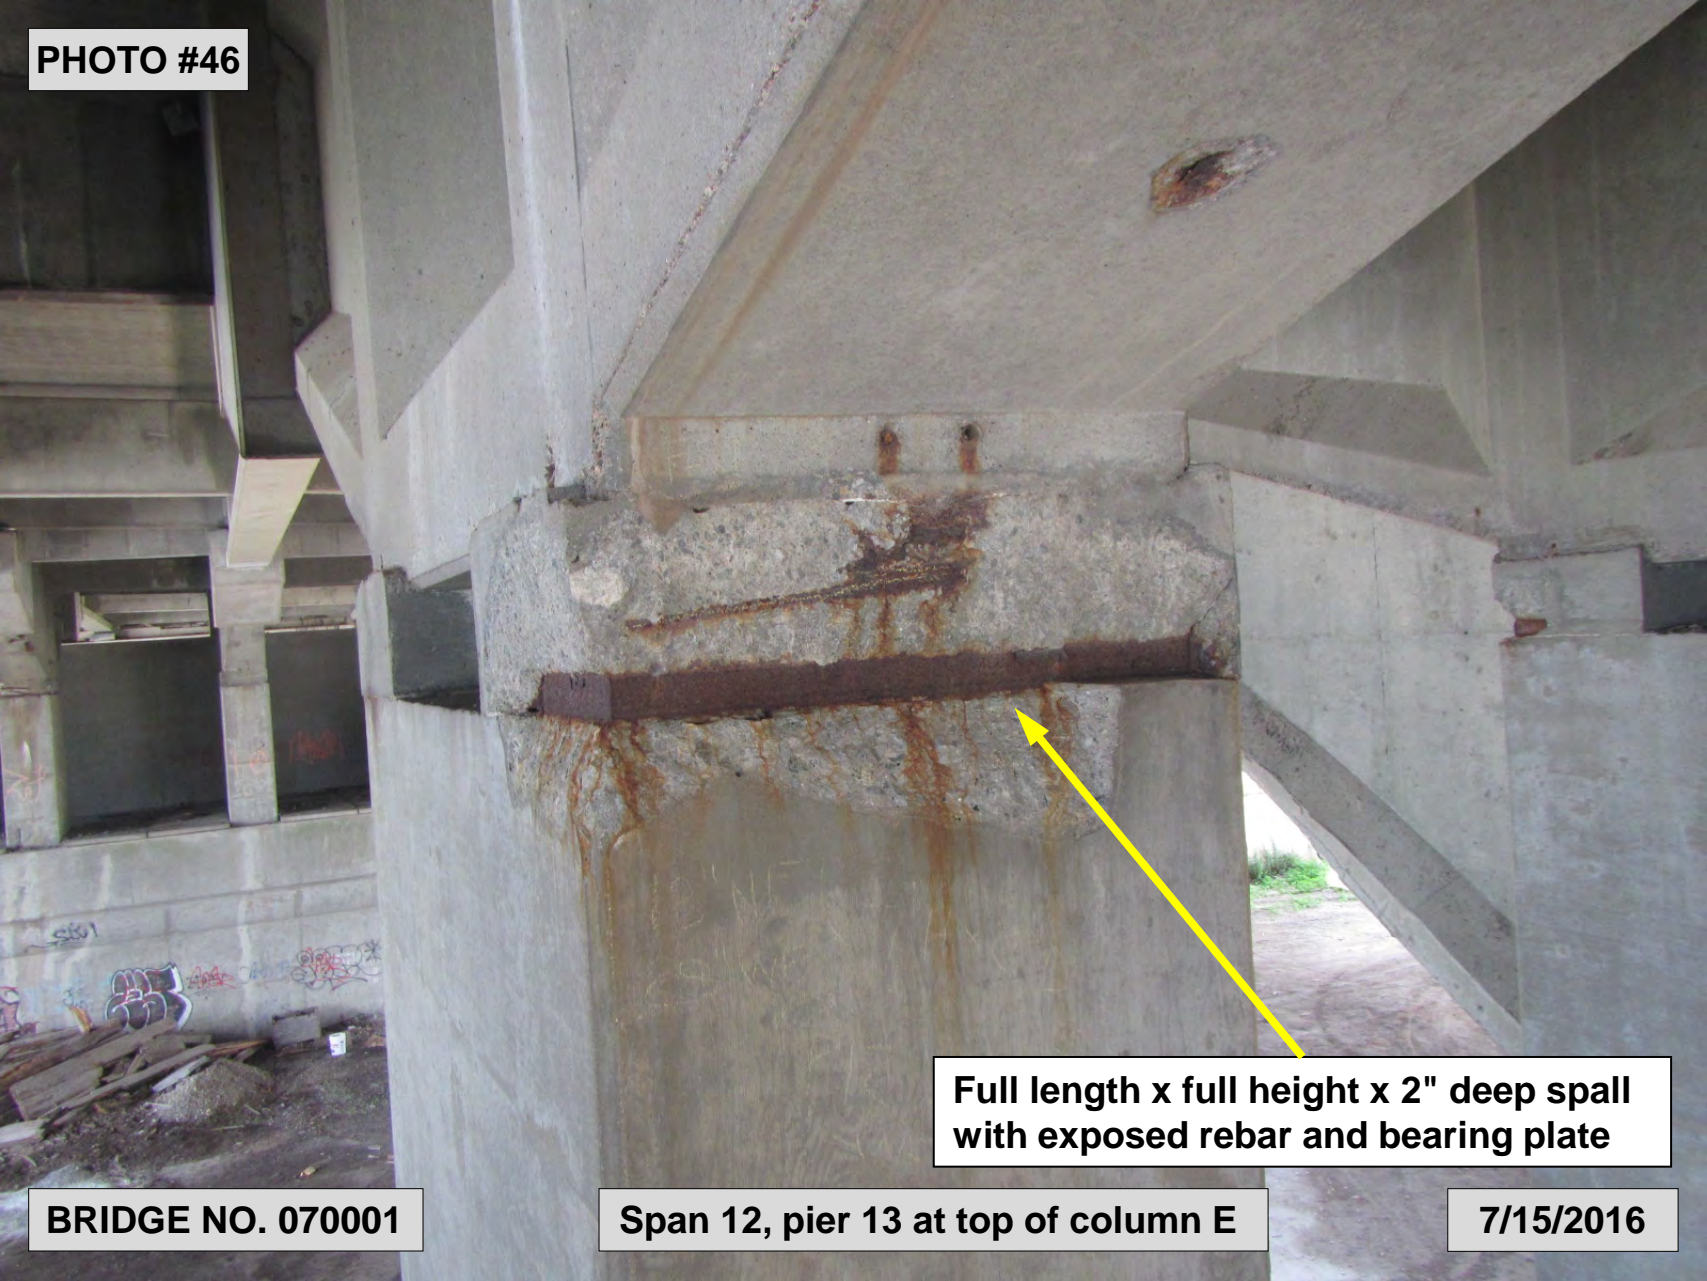
PHOTO #46

**Full length x full height x 2" deep spall
with exposed rebar and bearing plate**
