BRIDGE NO. 070001

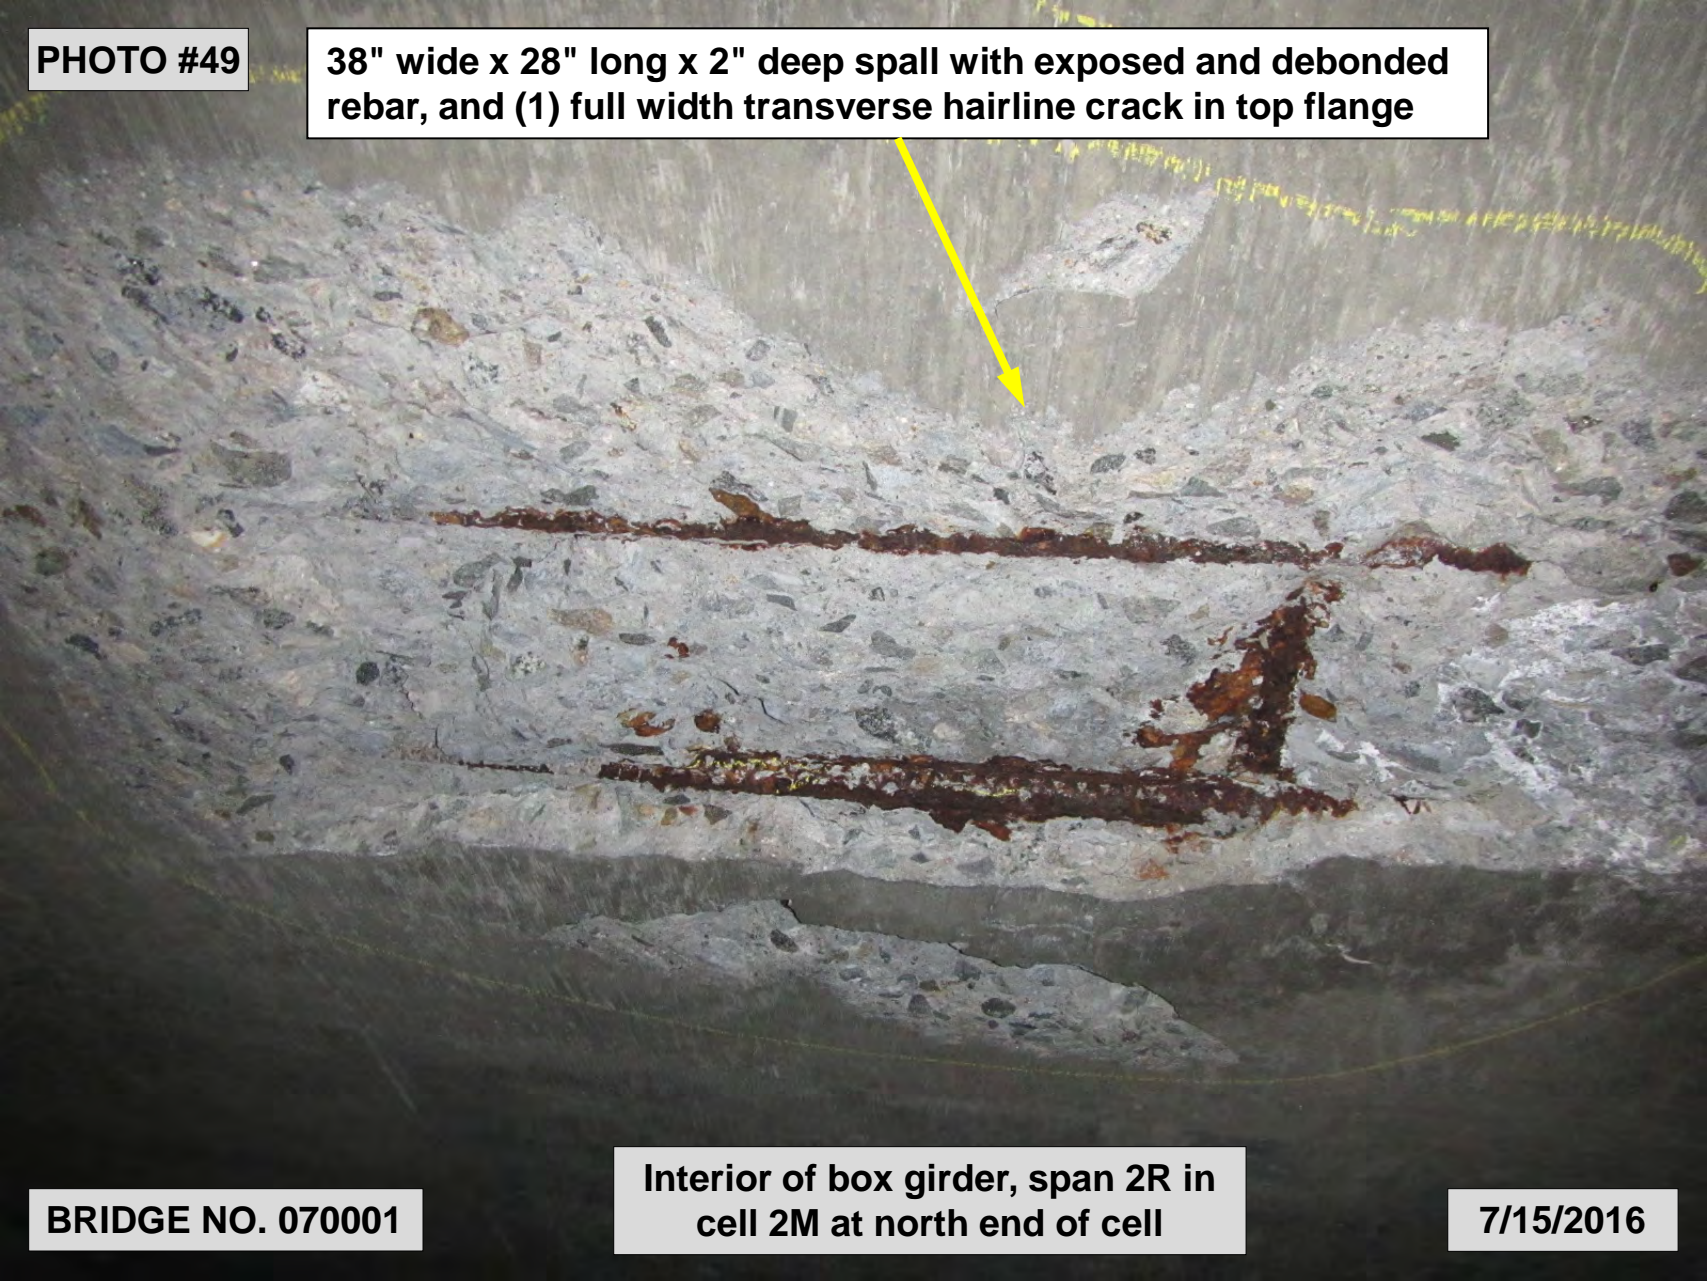
PHOTO #49

38" wide x 28" long x 2" deep spall with exposed and debonded rebar, and (1) full width transverse hairline crack in top flange

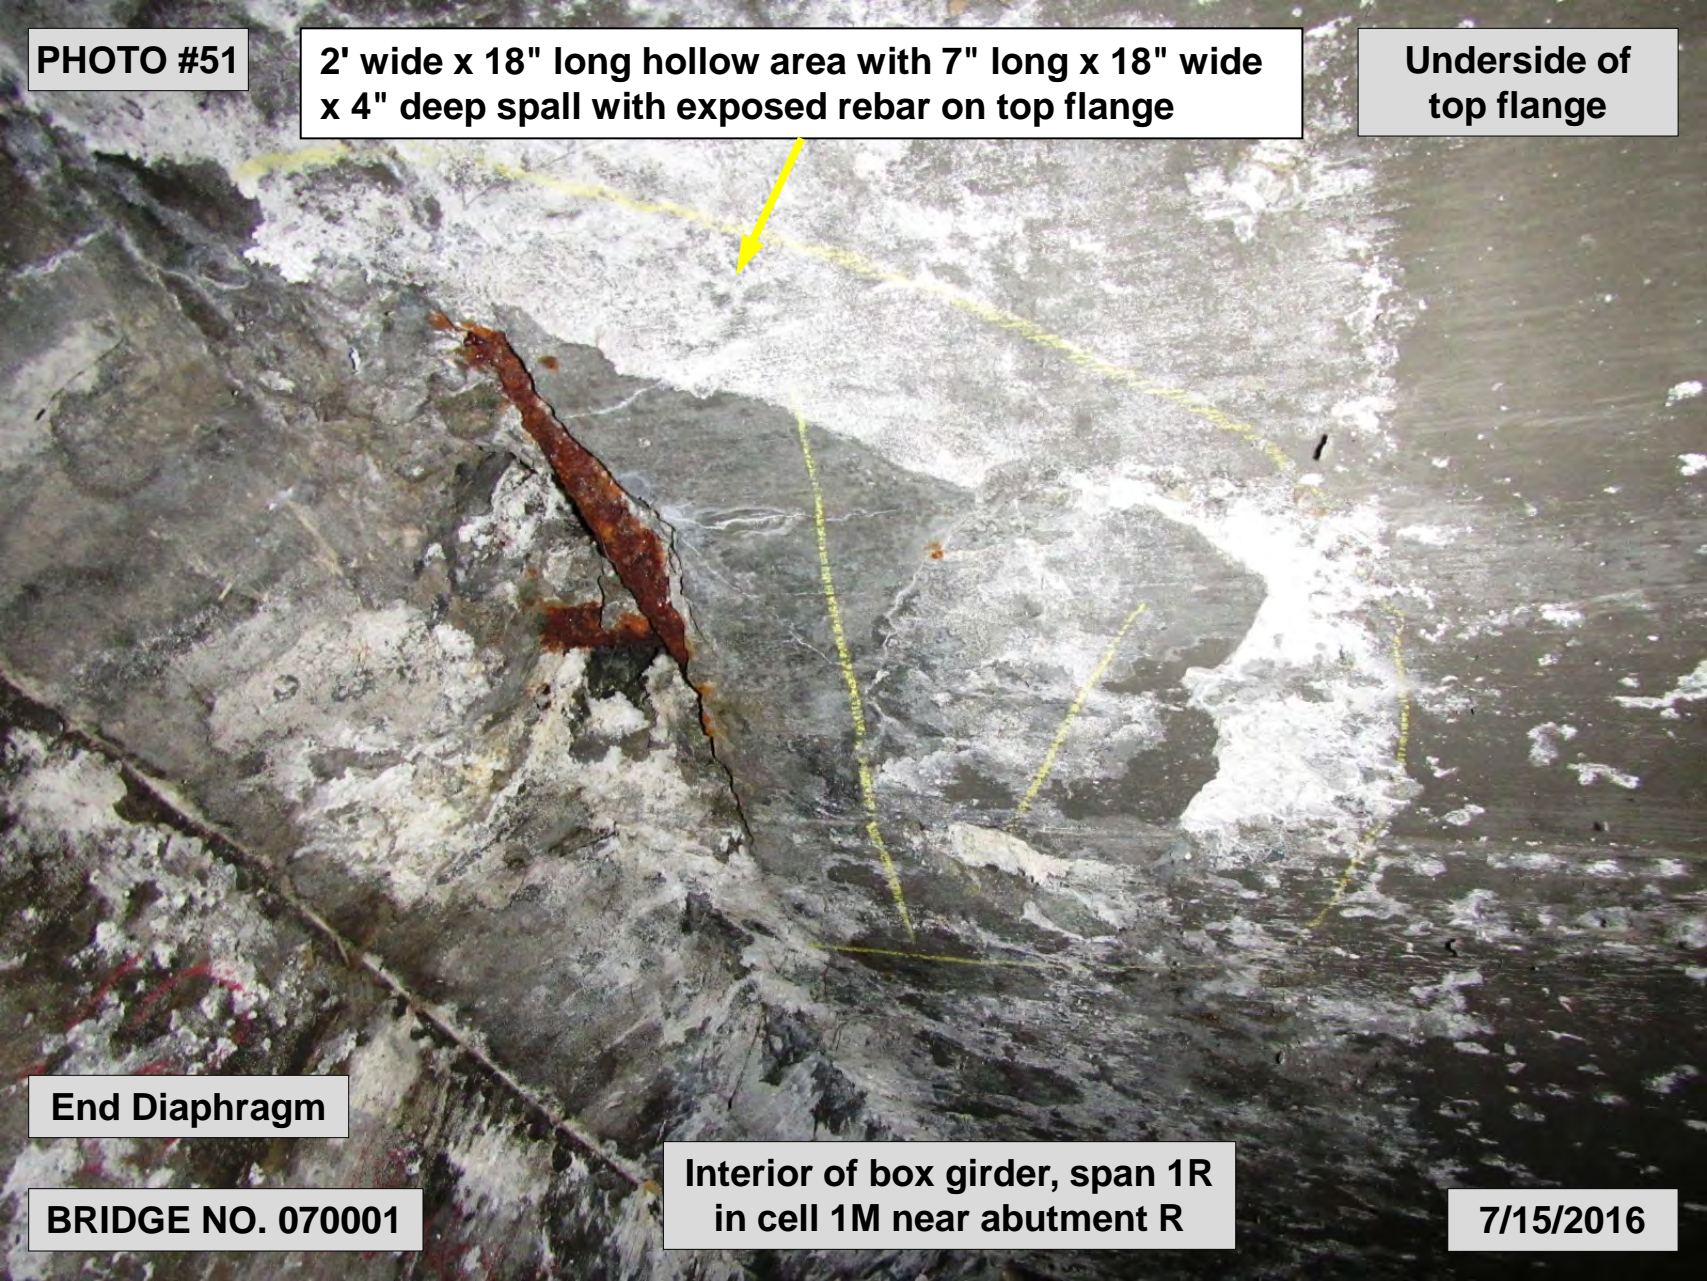
PHOTO #51

2' wide x 18" long hollow area with 7" long x 18" wide x 4" deep spall with exposed rebar on top flange

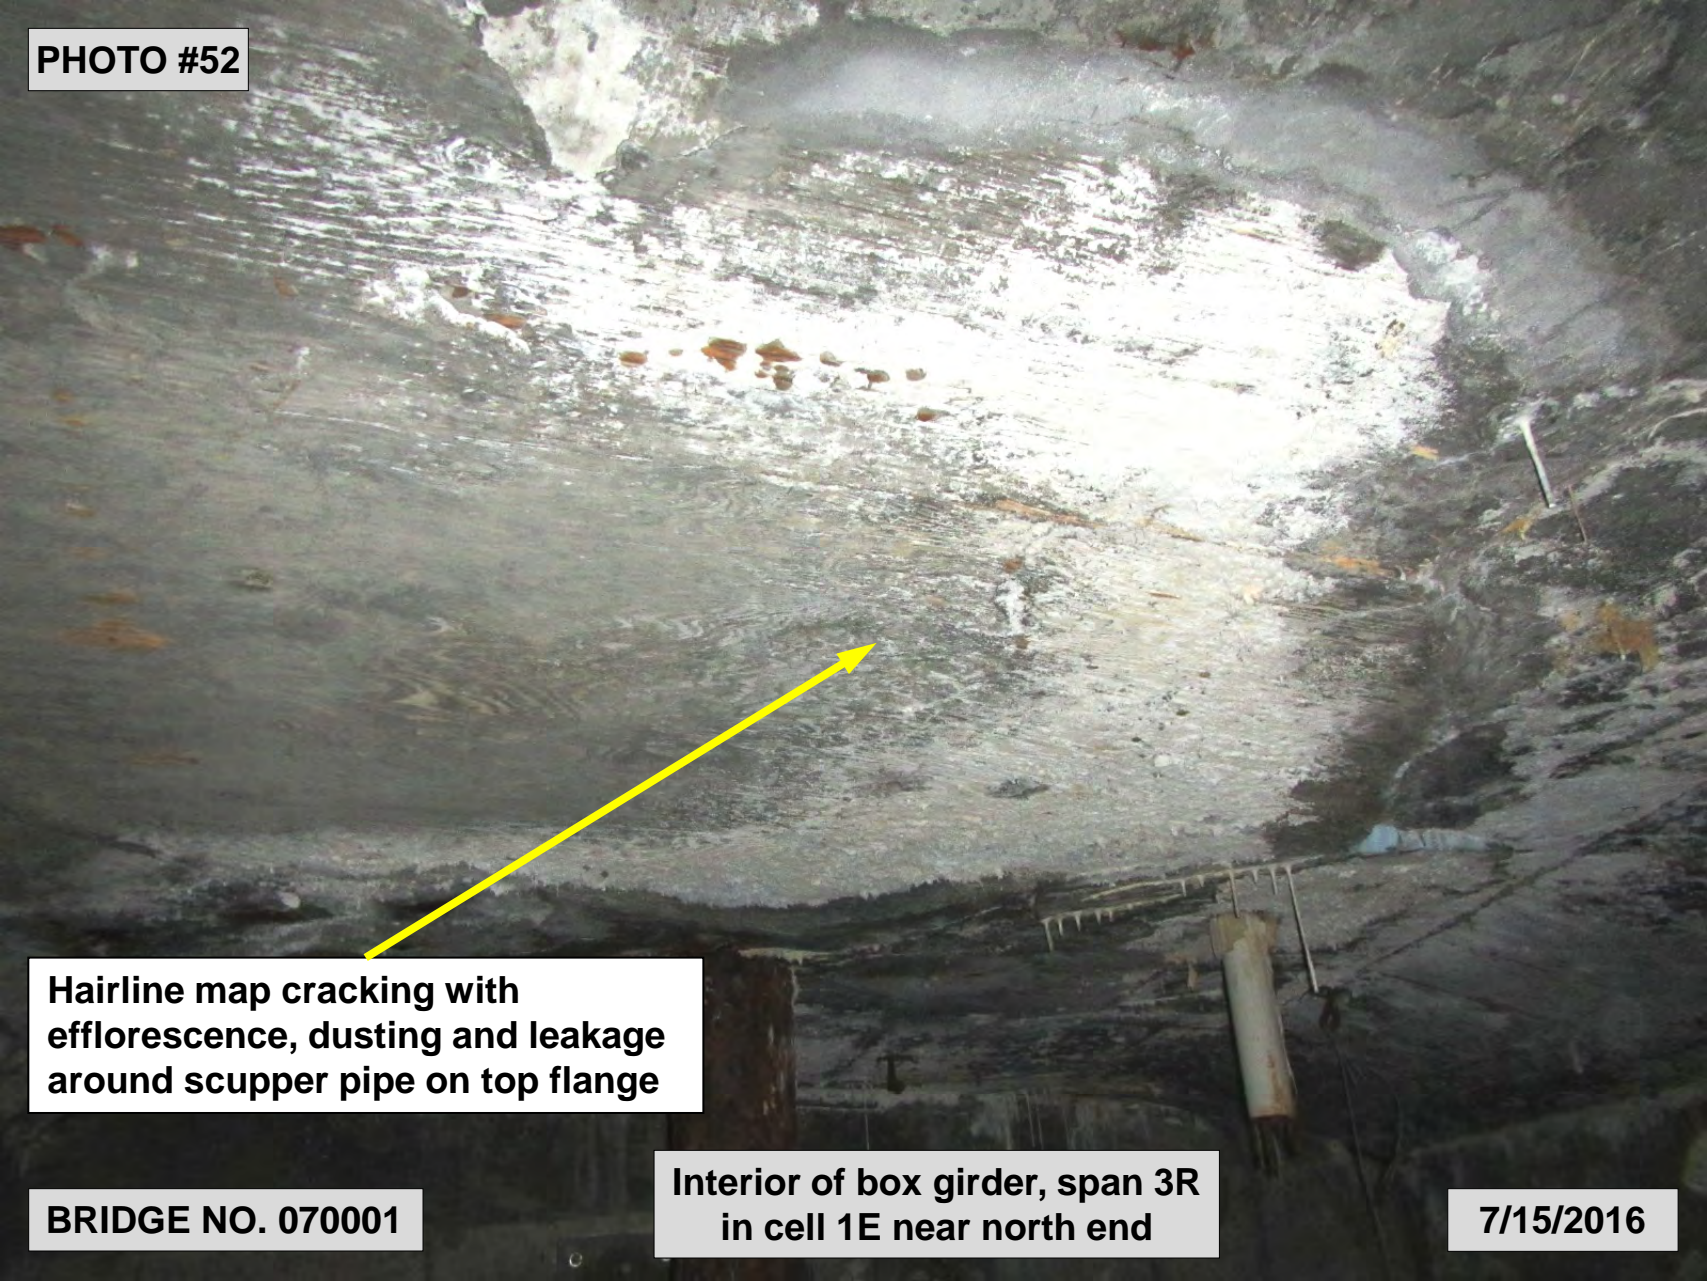
PHOTO #52

Hairline map cracking with efflorescence, dusting and leakage around scupper pipe on top flange

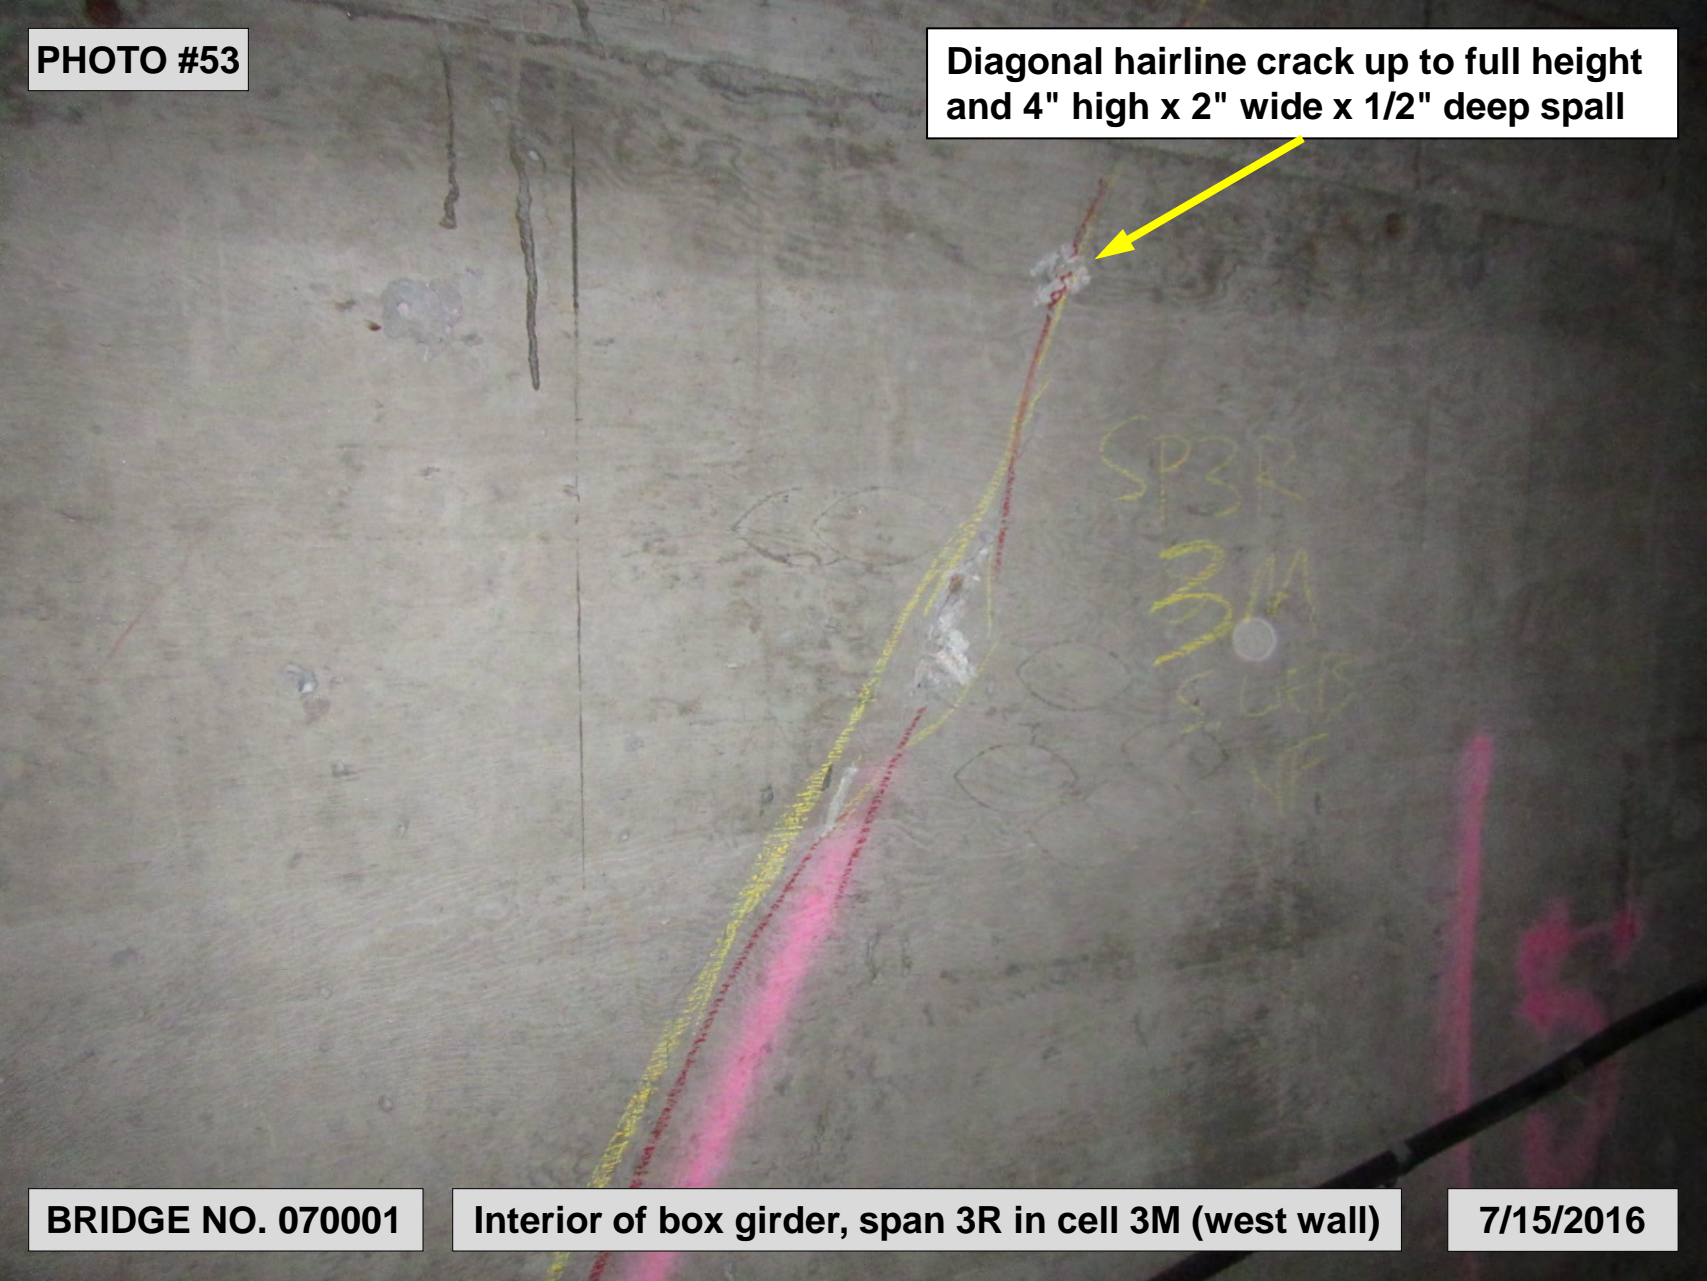
PHOTO #53

Diagonal hairline crack up to full height and 4" high x 2" wide x 1/2" deep spall

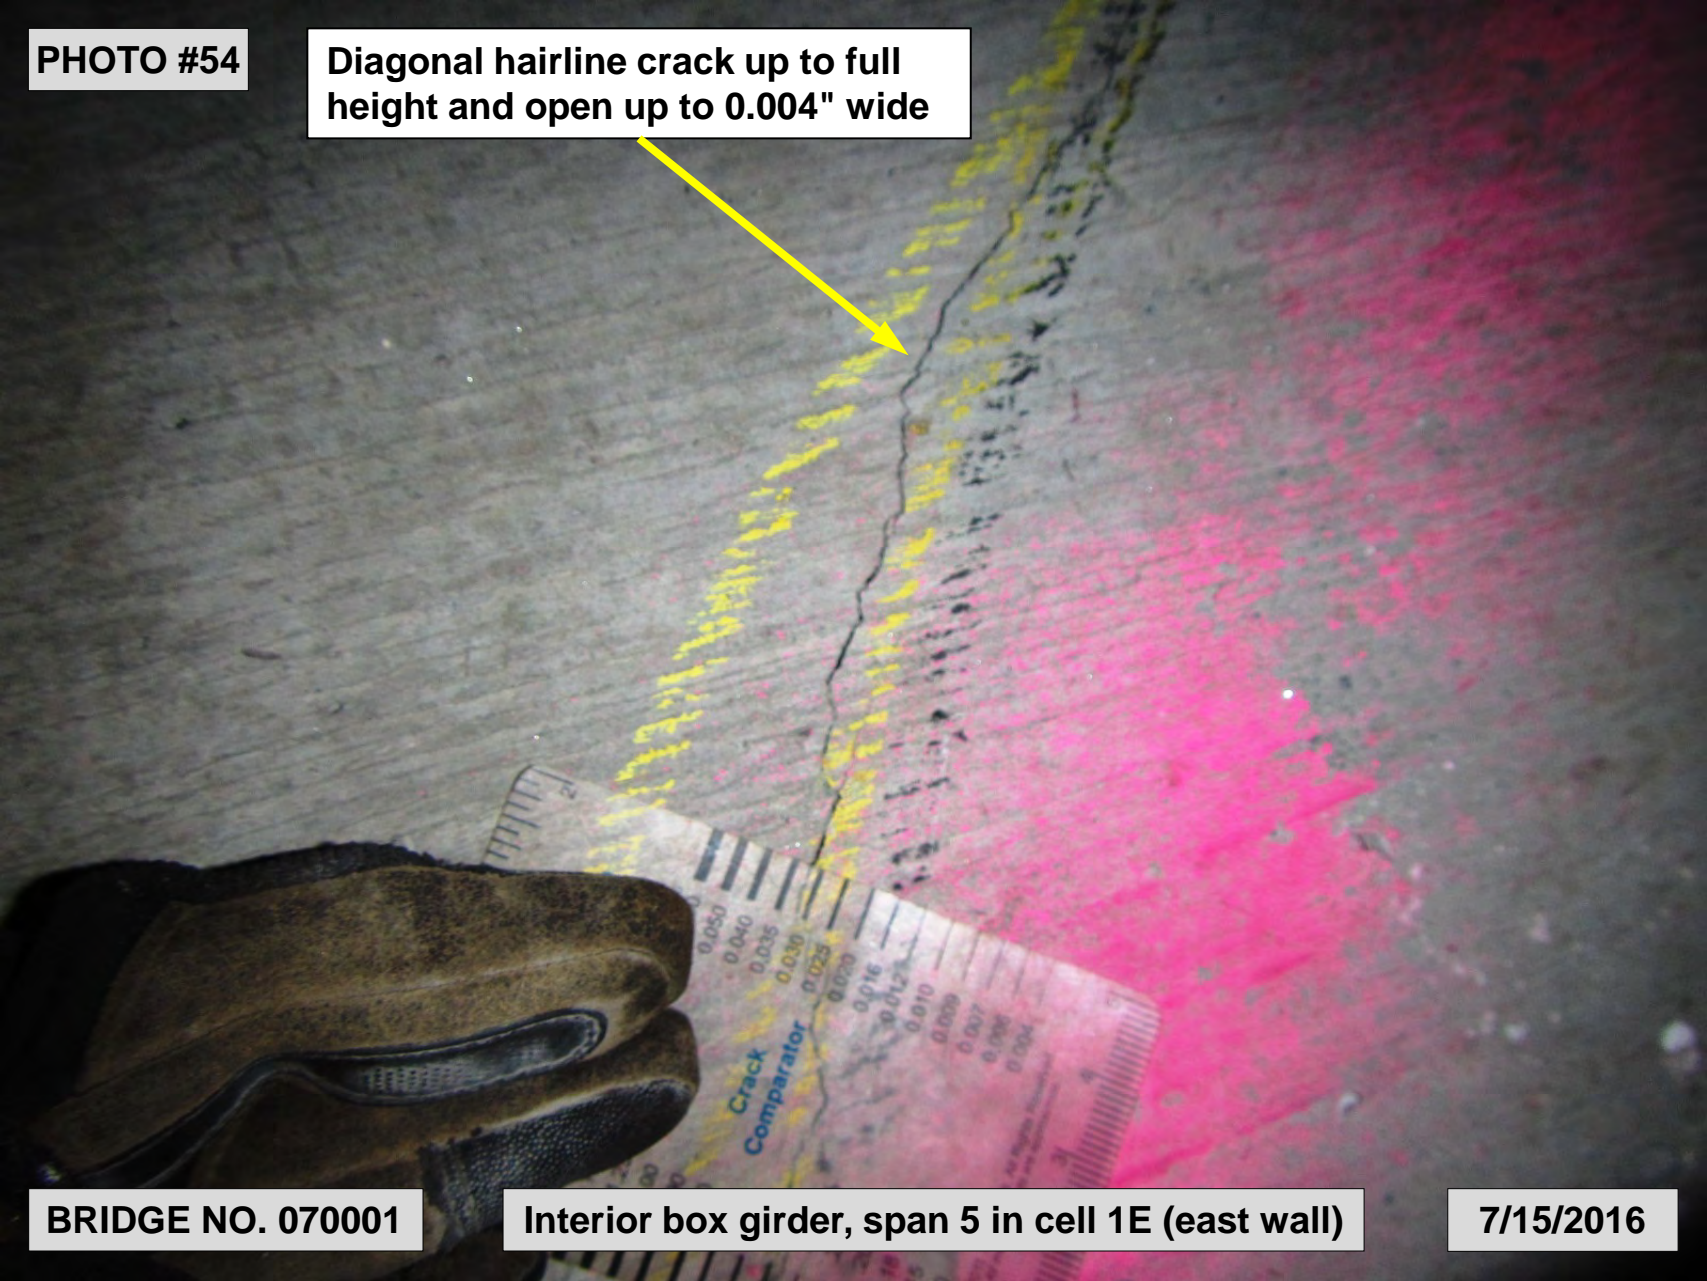
PHOTO #54

Diagonal hairline crack up to full height and open up to 0.004" wide

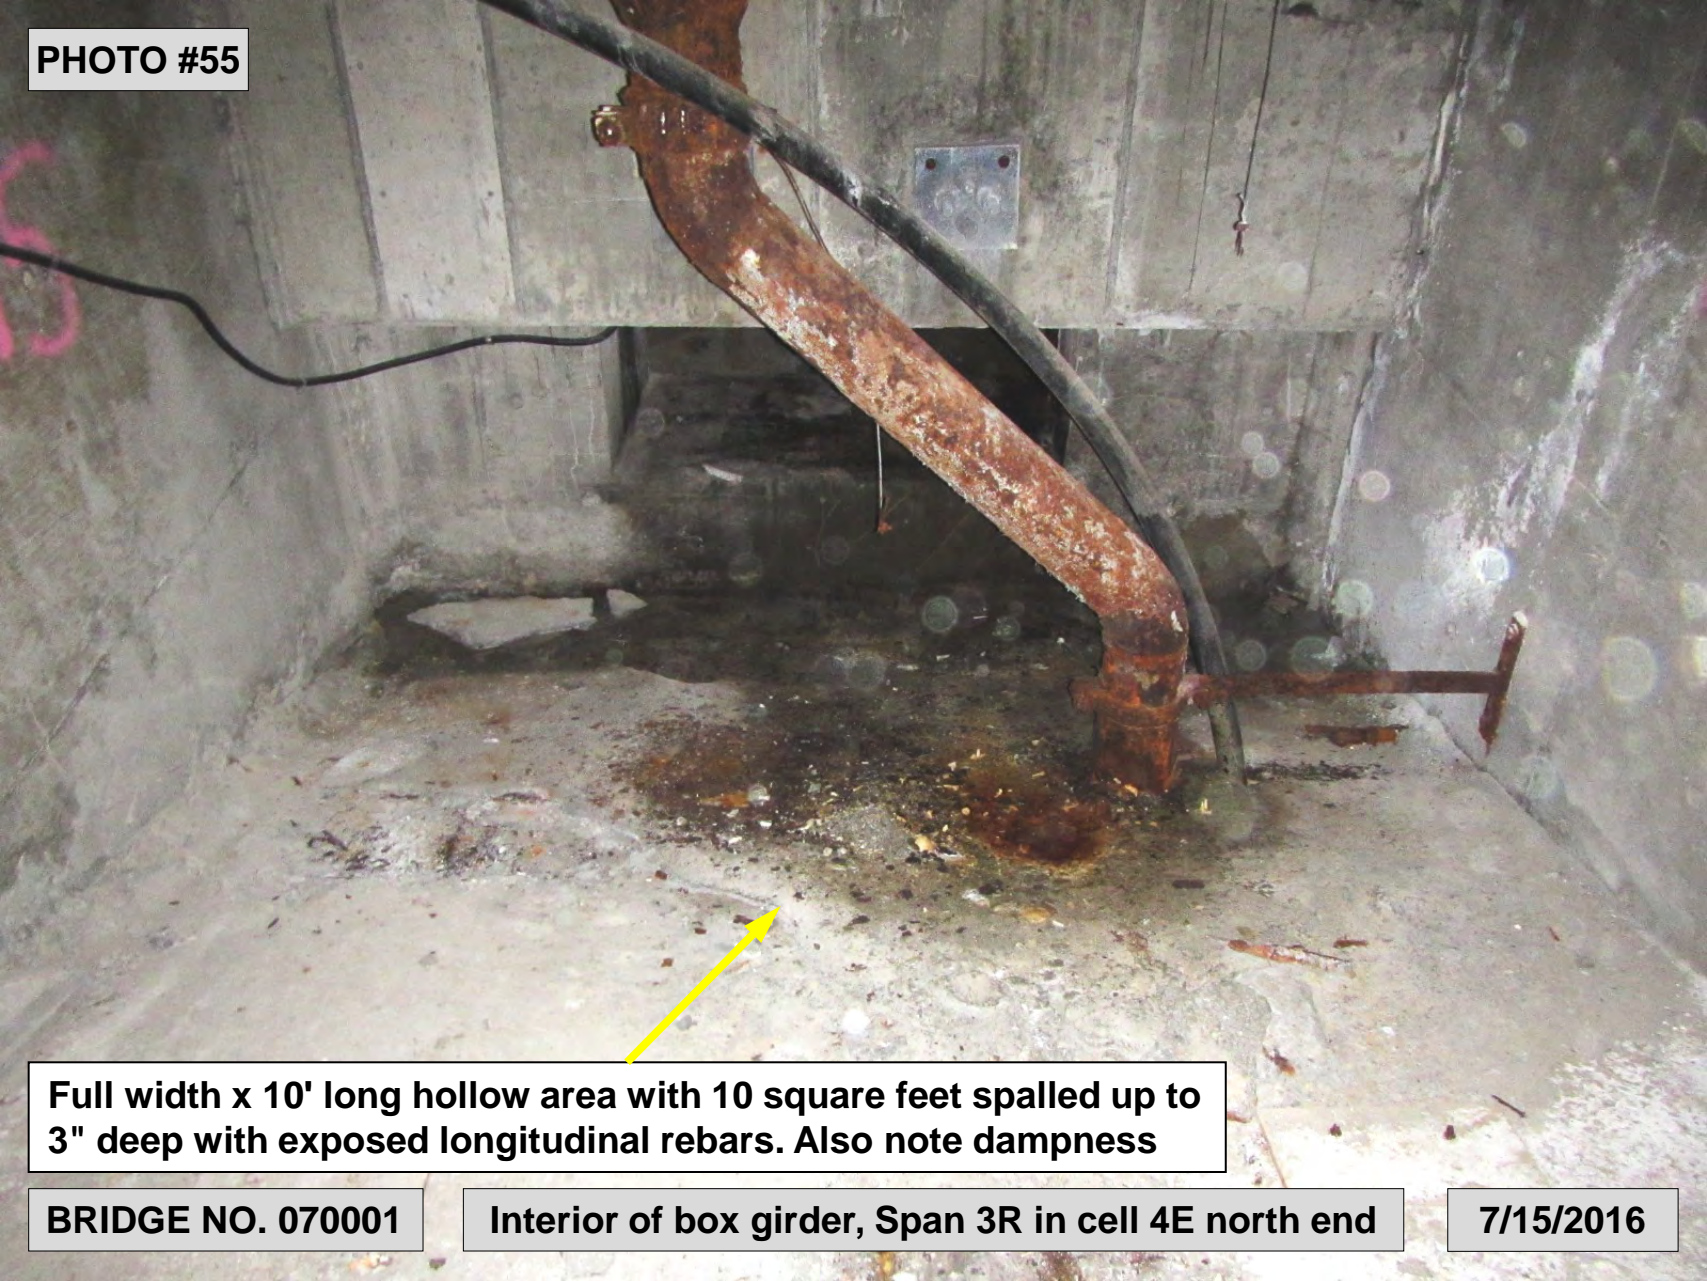
PHOTO #55

Full width x 10' long hollow area with 10 square feet spalled up to 3" deep with exposed longitudinal rebar. Also note dampness

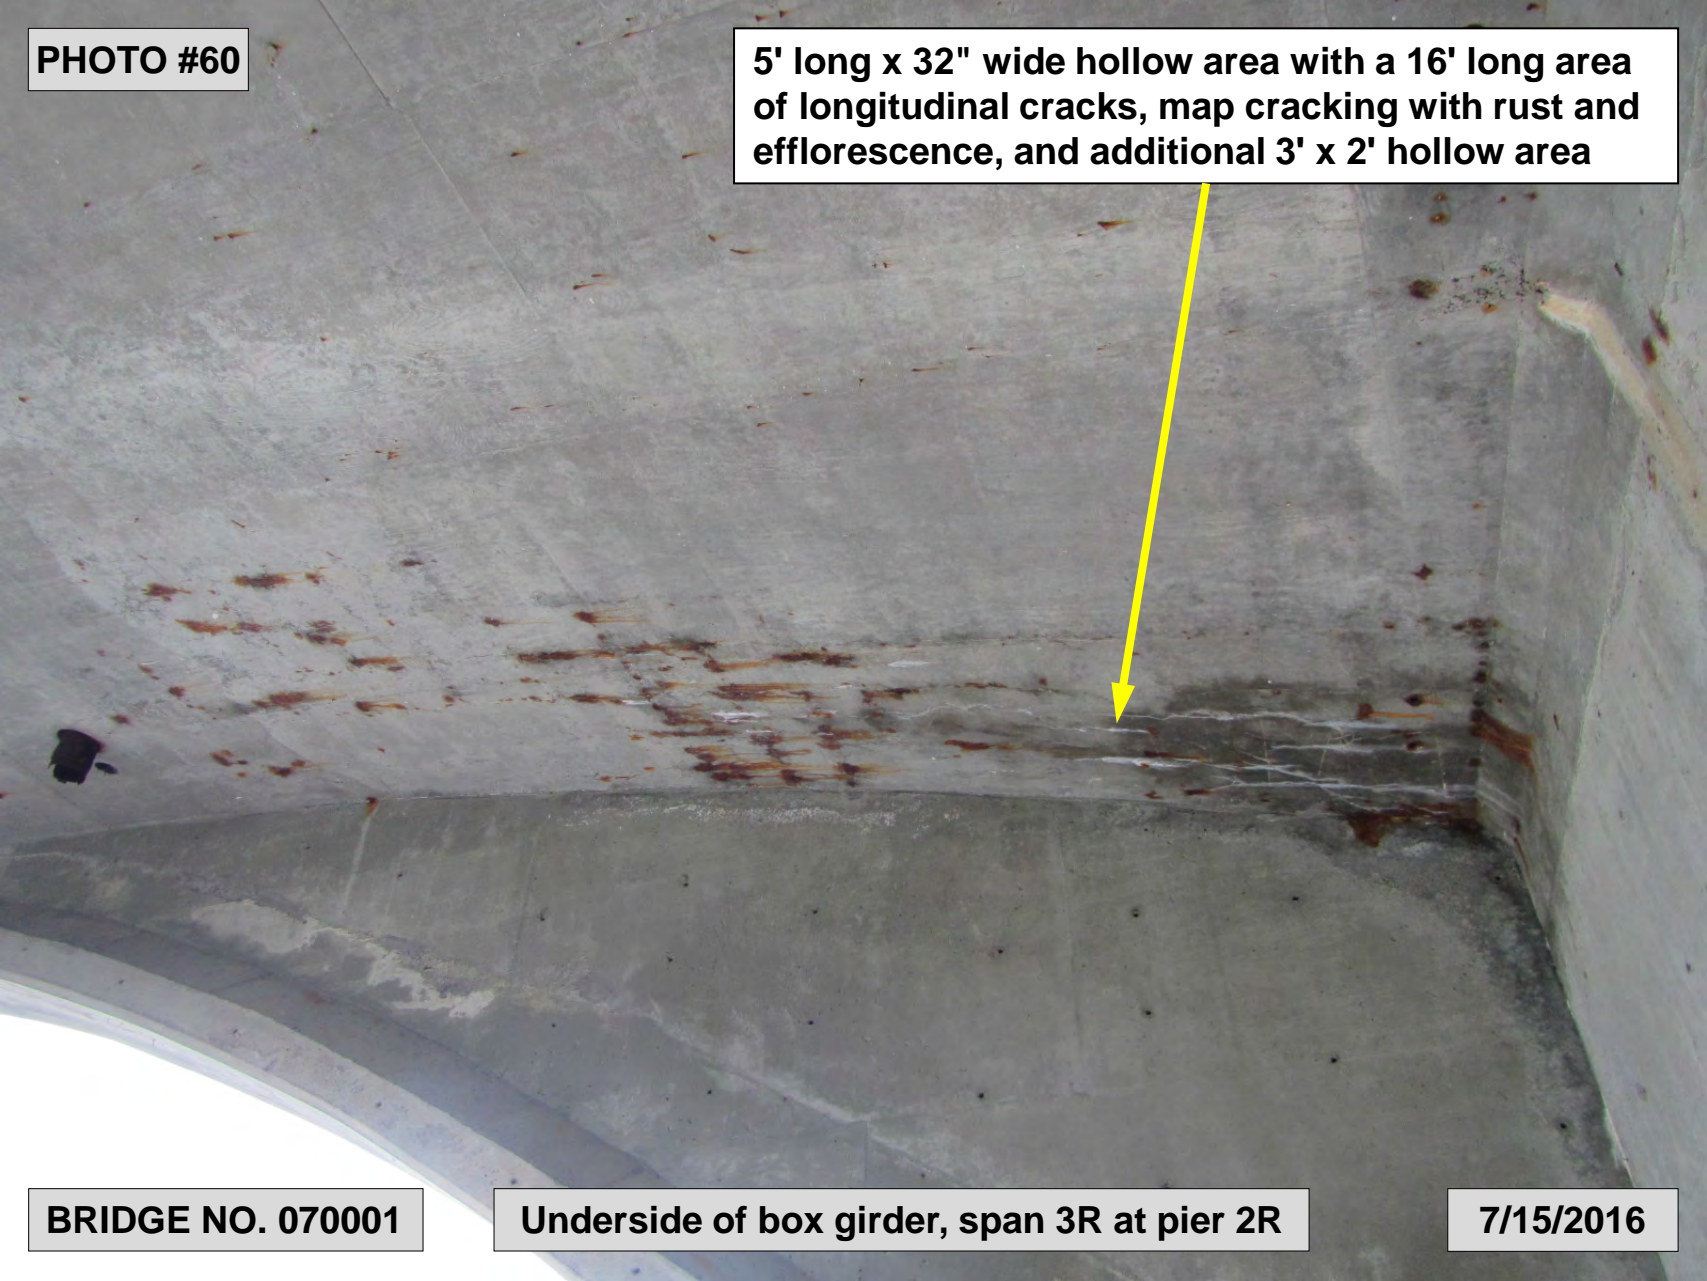
PHOTO #60

5' long x 32" wide hollow area with a 16' long area of longitudinal cracks, map cracking with rust and efflorescence, and additional 3' x 2' hollow area

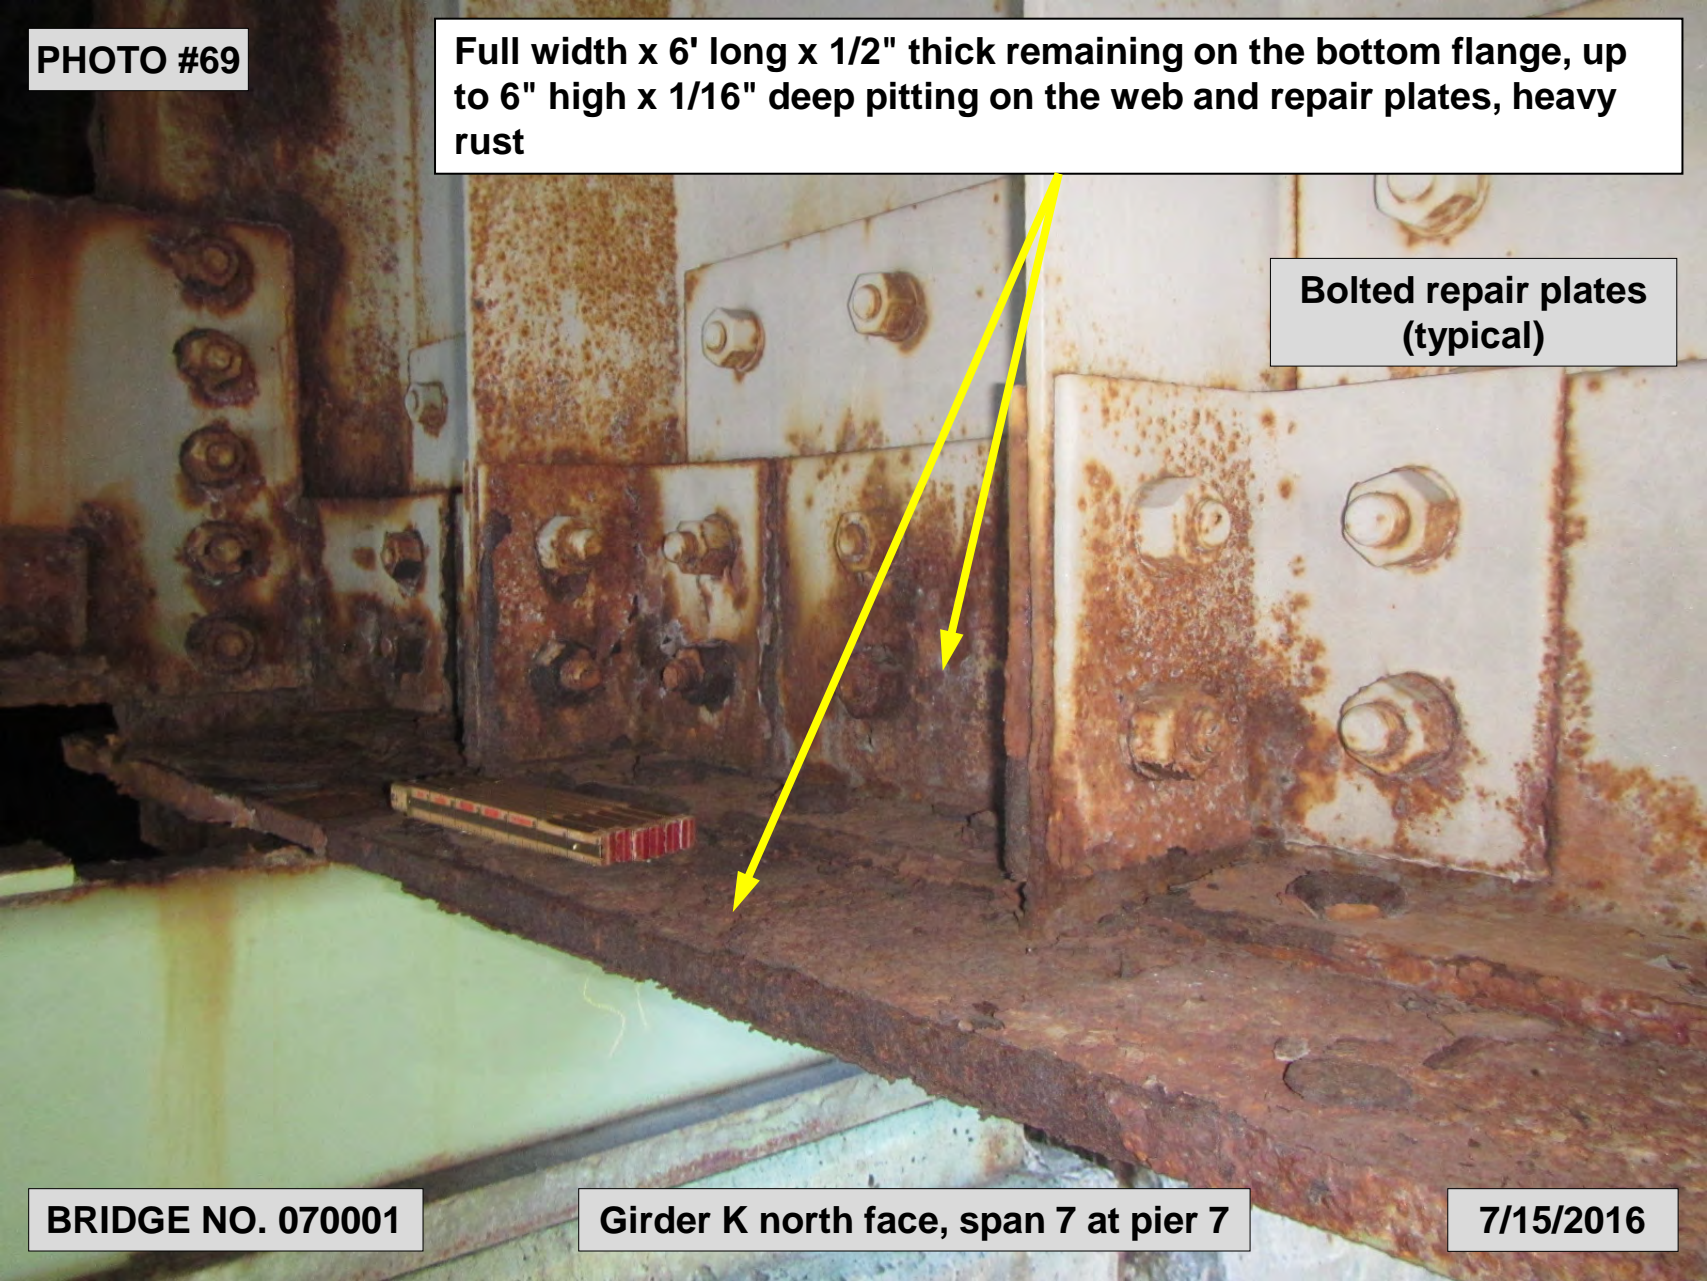
PHOTO #69

Full width x 6' long x 1/2" thick remaining on the bottom flange, up to 6" high x 1/16" deep pitting on the web and repair plates, heavy rust

**Bolted repair plates
(typical)**

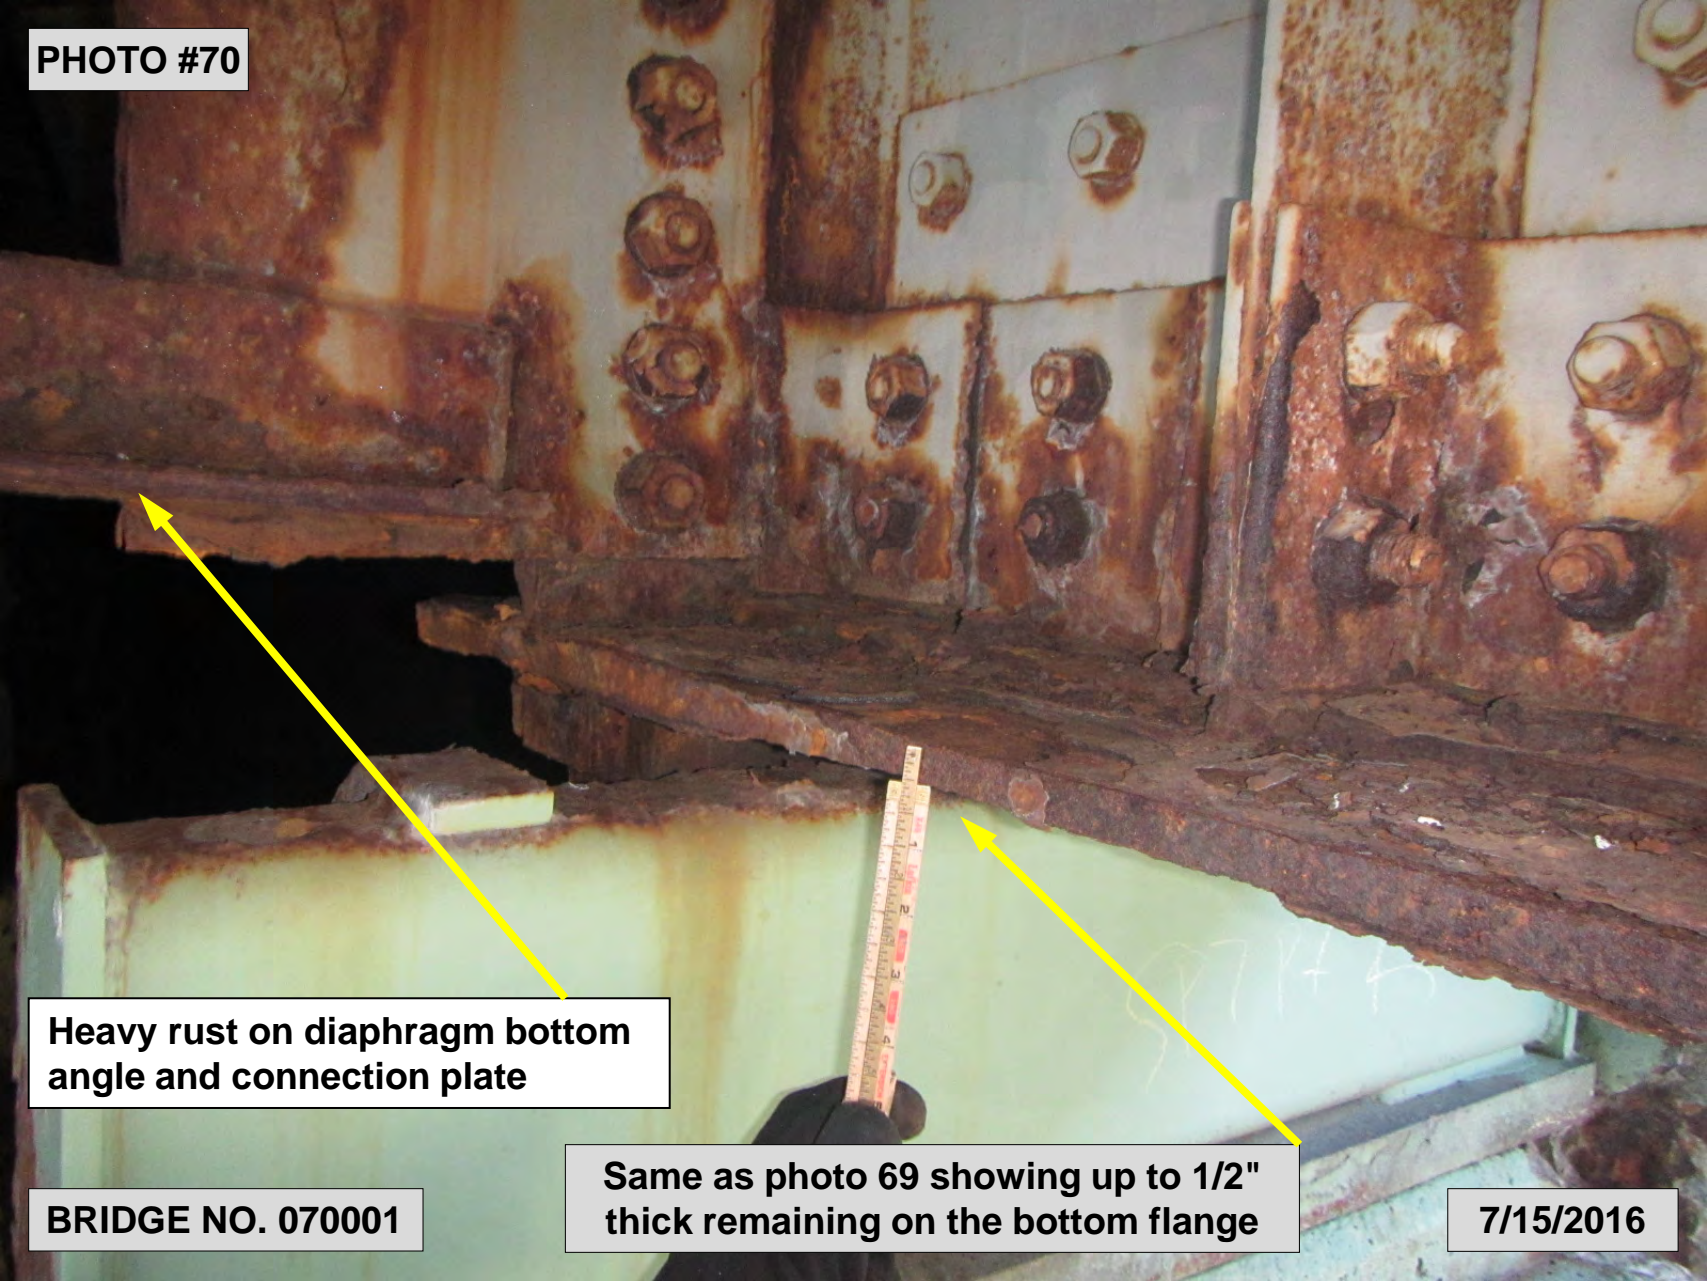
PHOTO #70

Heavy rust on diaphragm bottom angle and connection plate

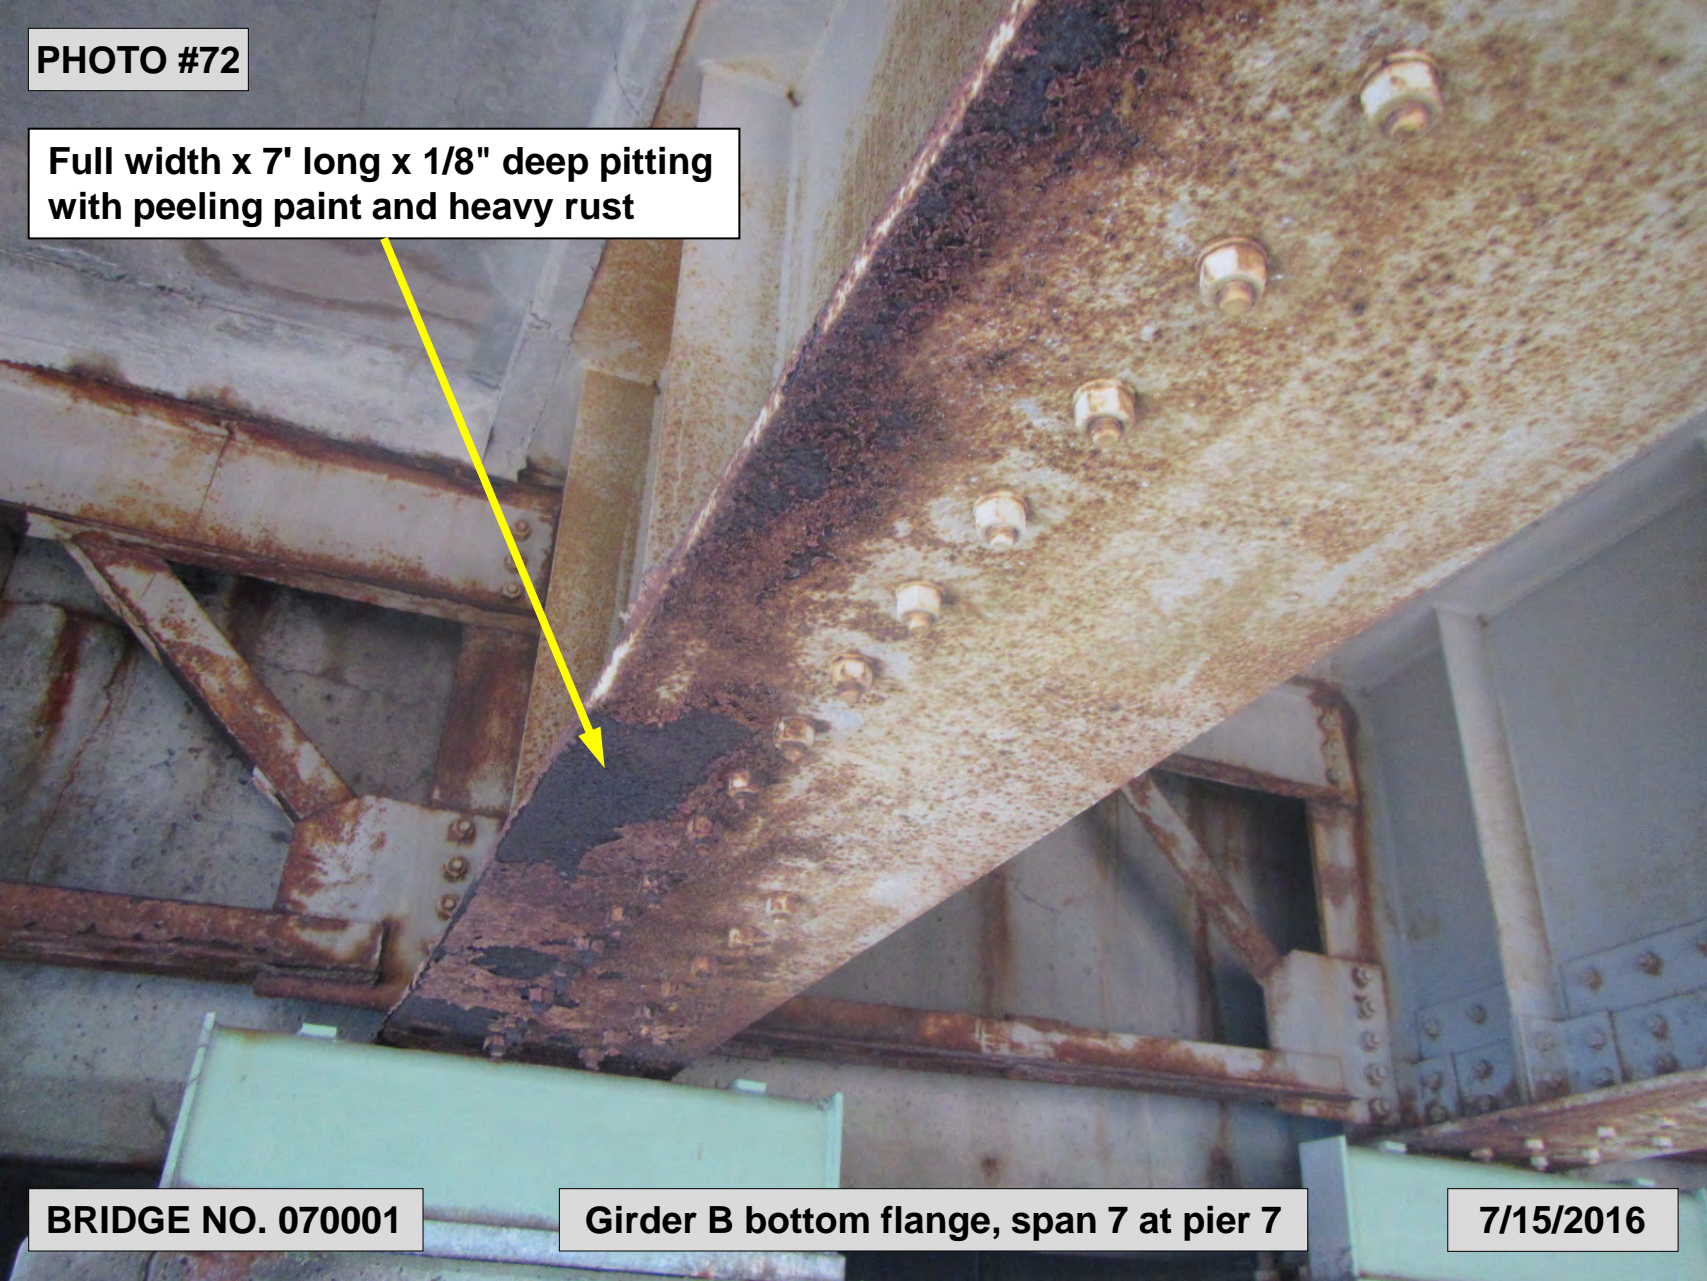
PHOTO #72

**Full width x 7' long x 1/8" deep pitting
with peeling paint and heavy rust**
