BRIDGE NO. 070001

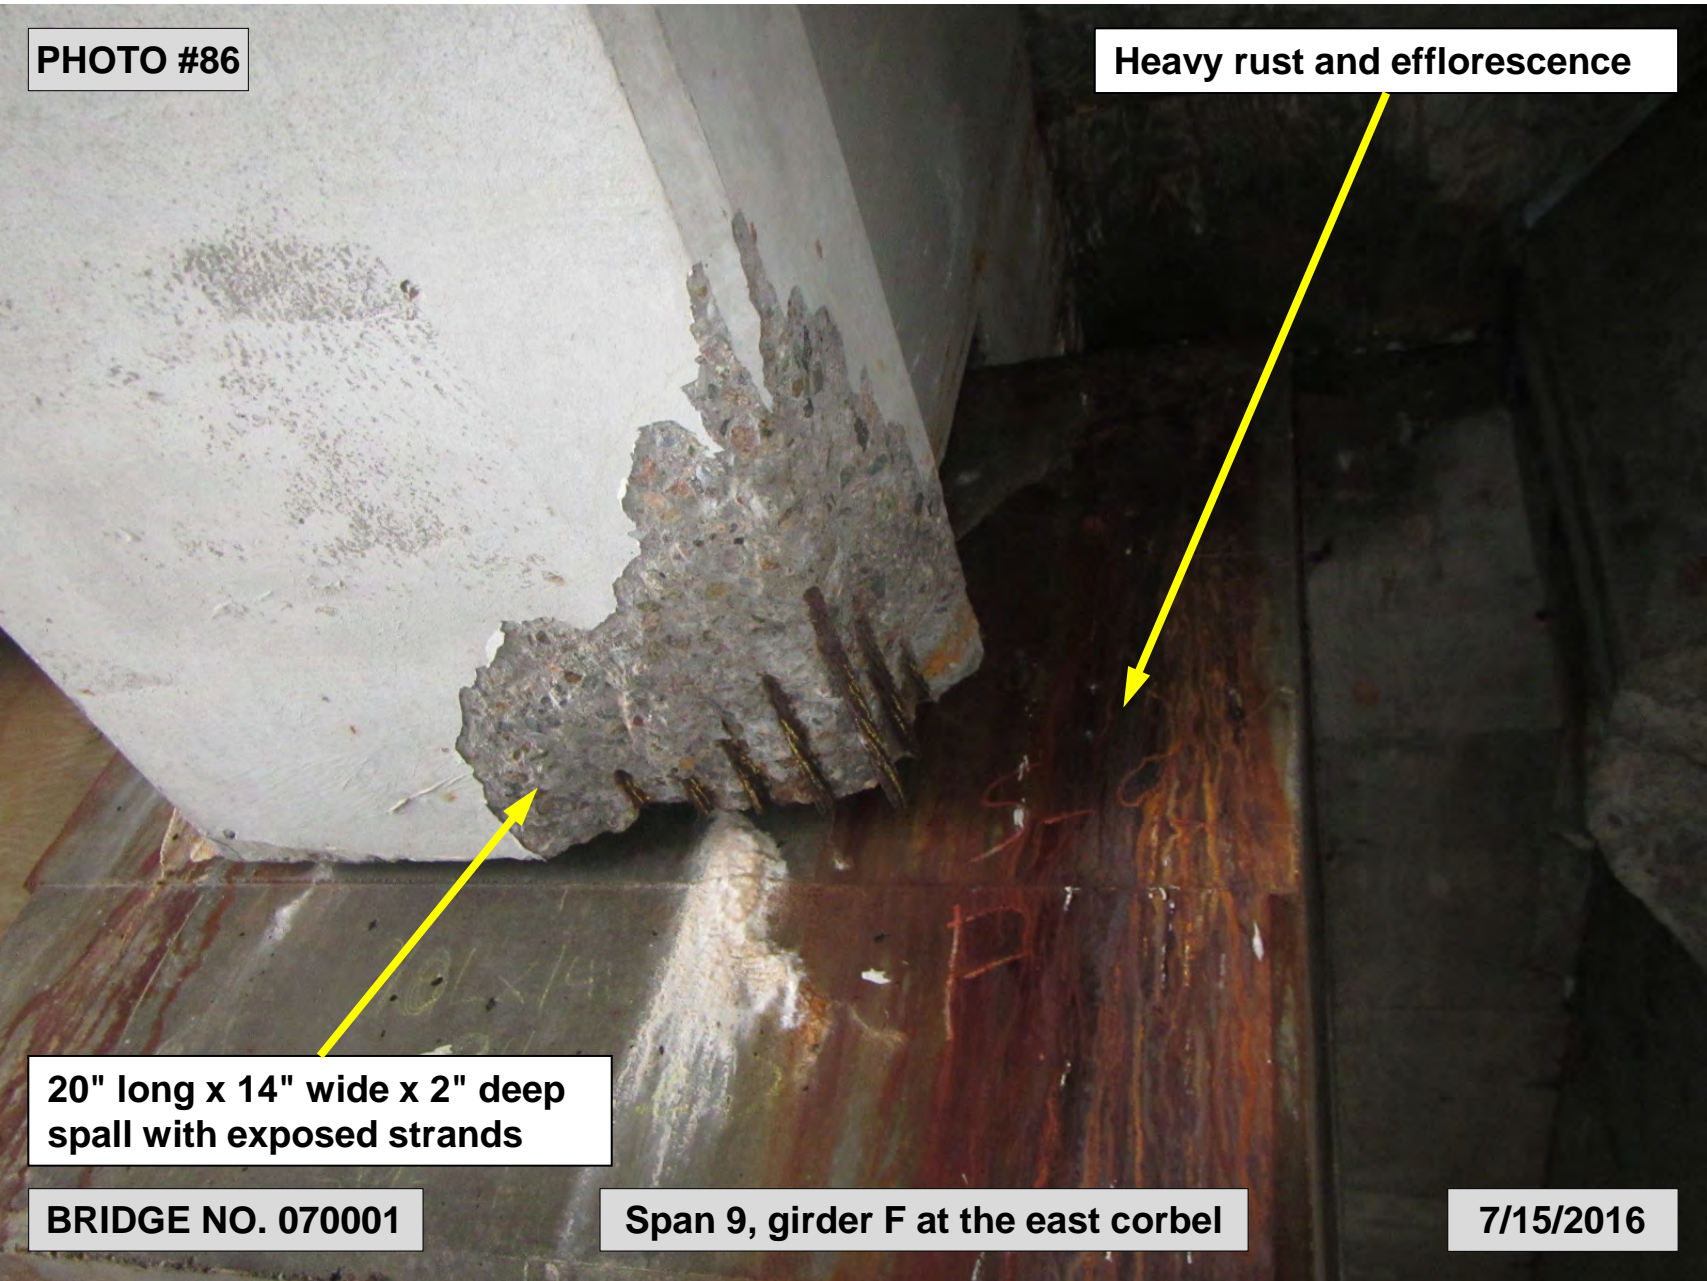
PHOTO #86

Heavy rust and efflorescence

**20" long x 14" wide x 2" deep
spall with exposed strands**

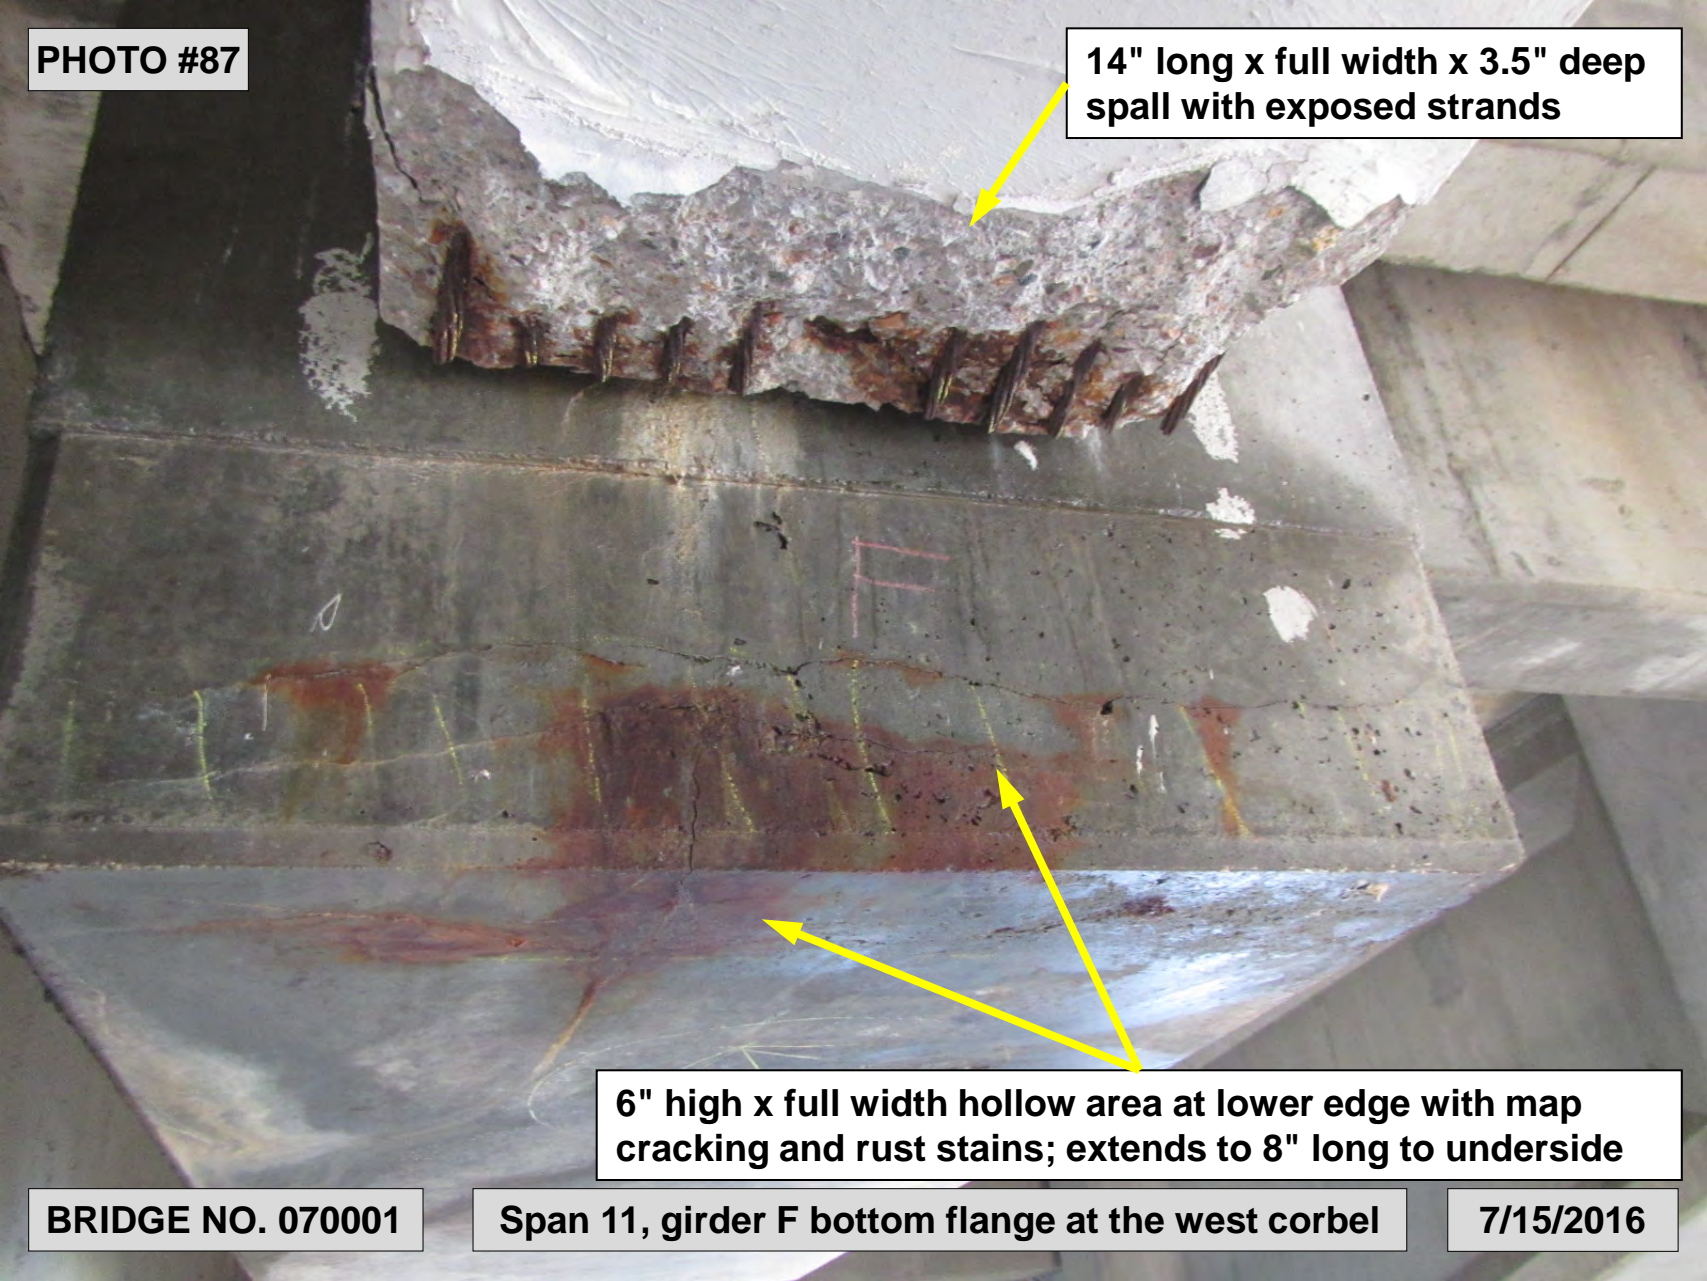
PHOTO #87

**14" long x full width x 3.5" deep
spall with exposed strands**

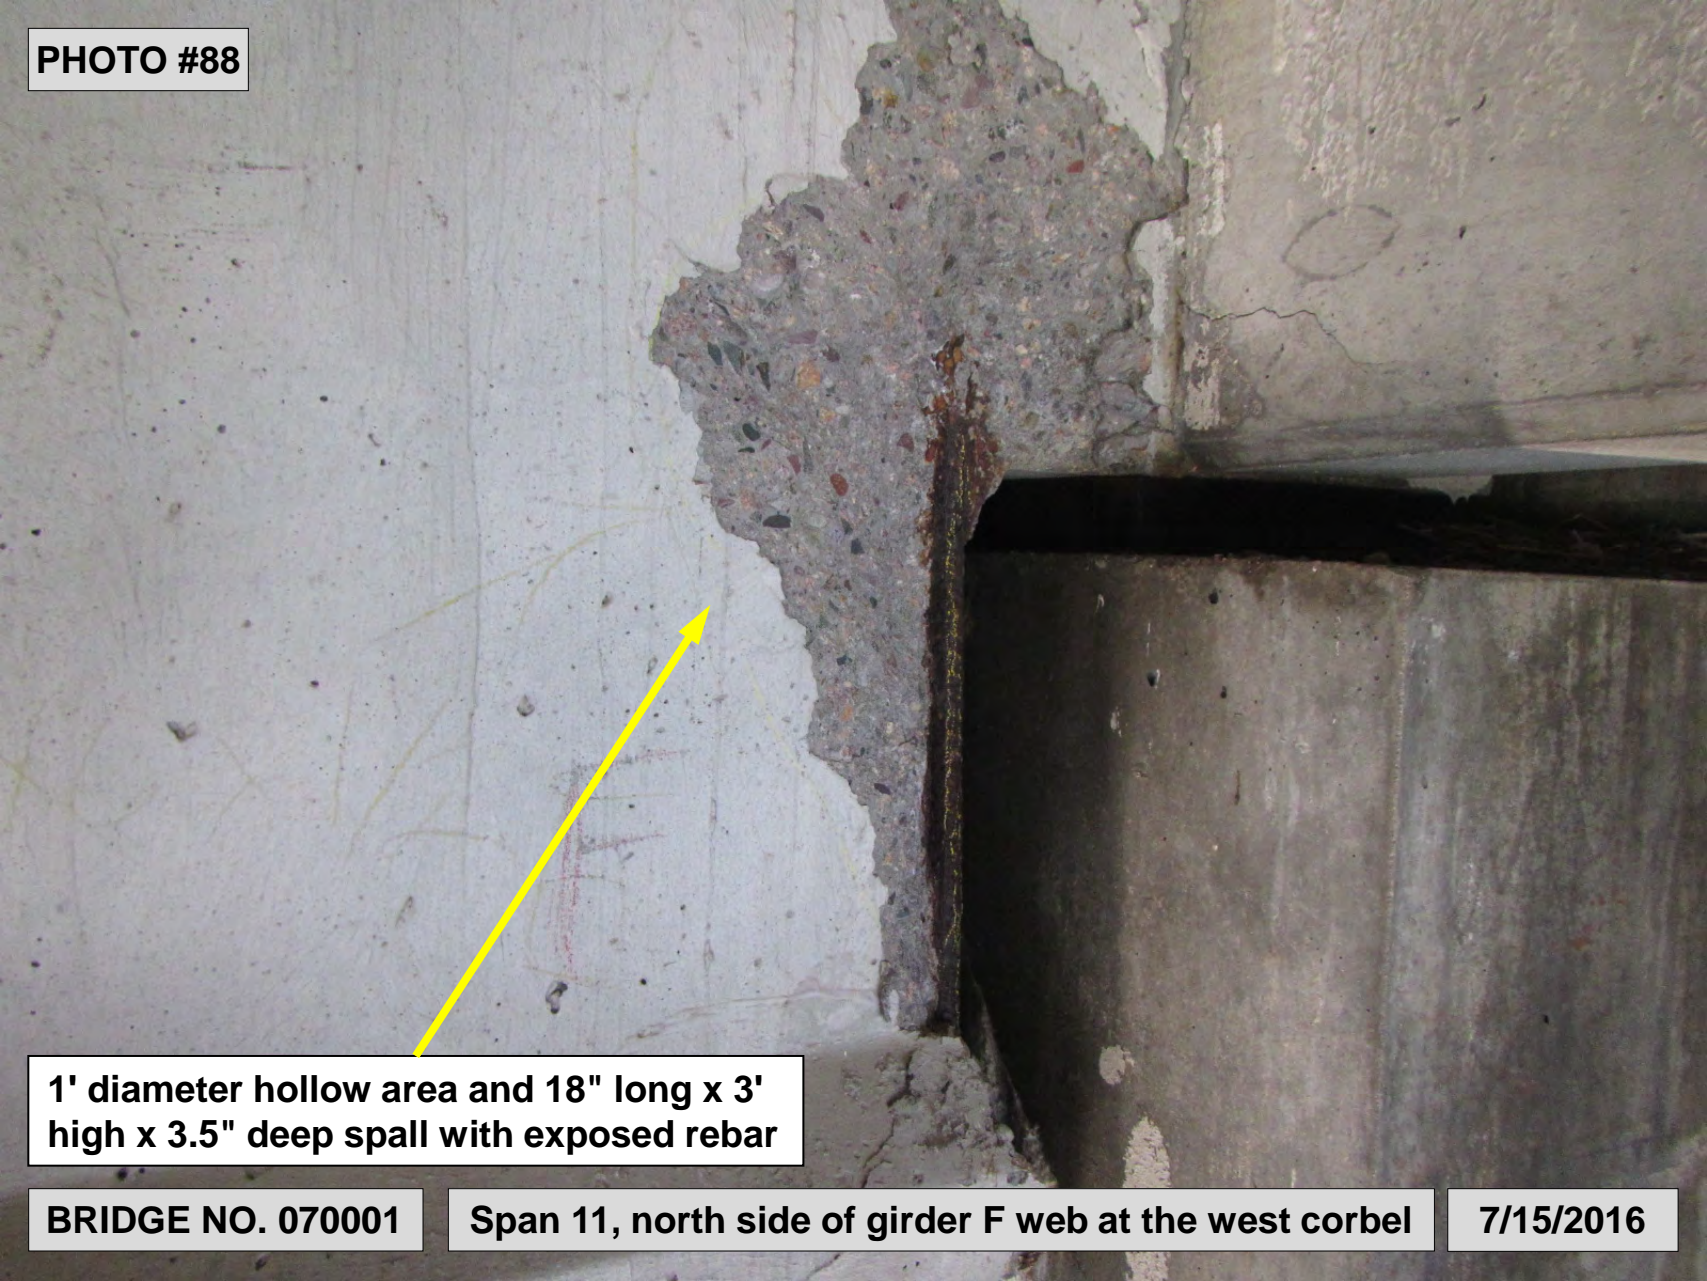
PHOTO #88

1' diameter hollow area and 18" long x 3' high x 3.5" deep spall with exposed rebar

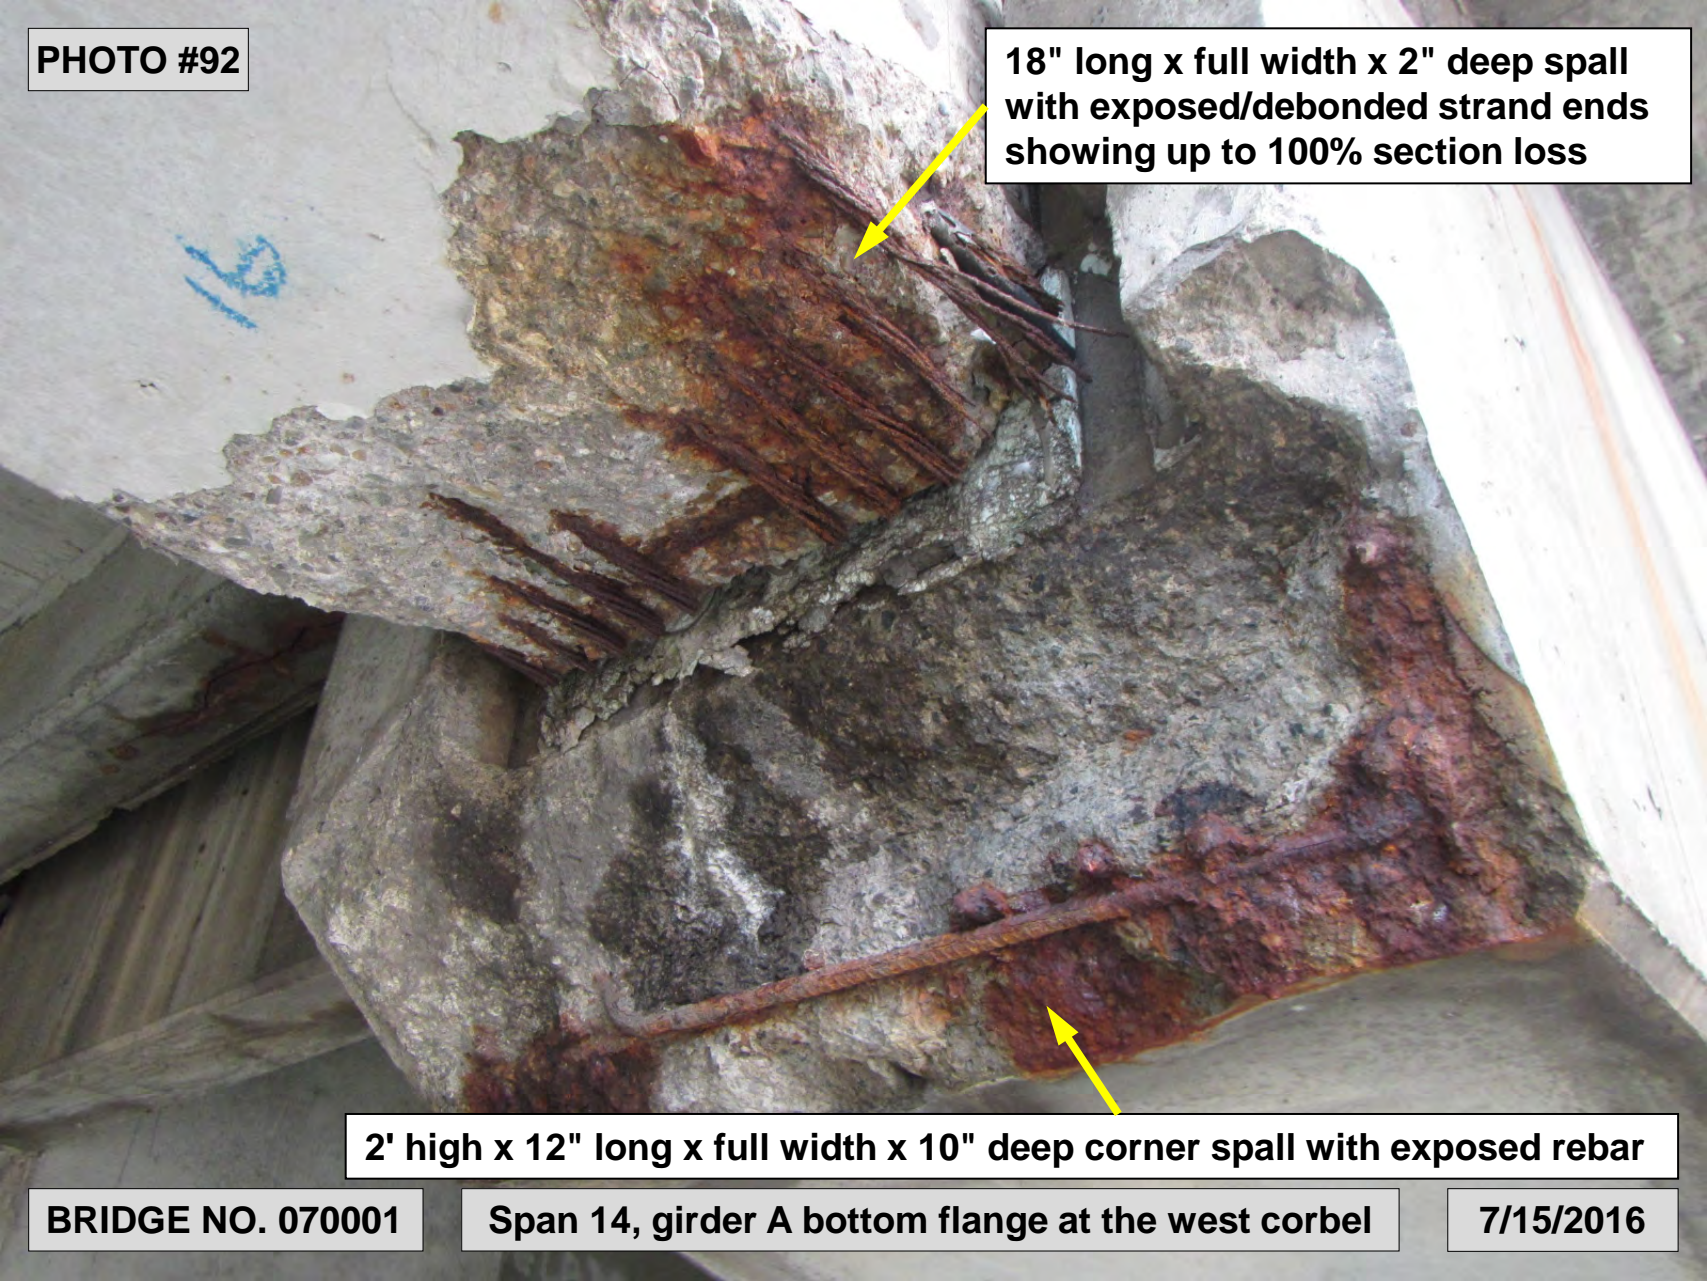
PHOTO #92

18" long x full width x 2" deep spall with exposed/debonded strand ends showing up to 100% section loss

2' high x 12" long x full width x 10" deep corner spall with exposed rebar

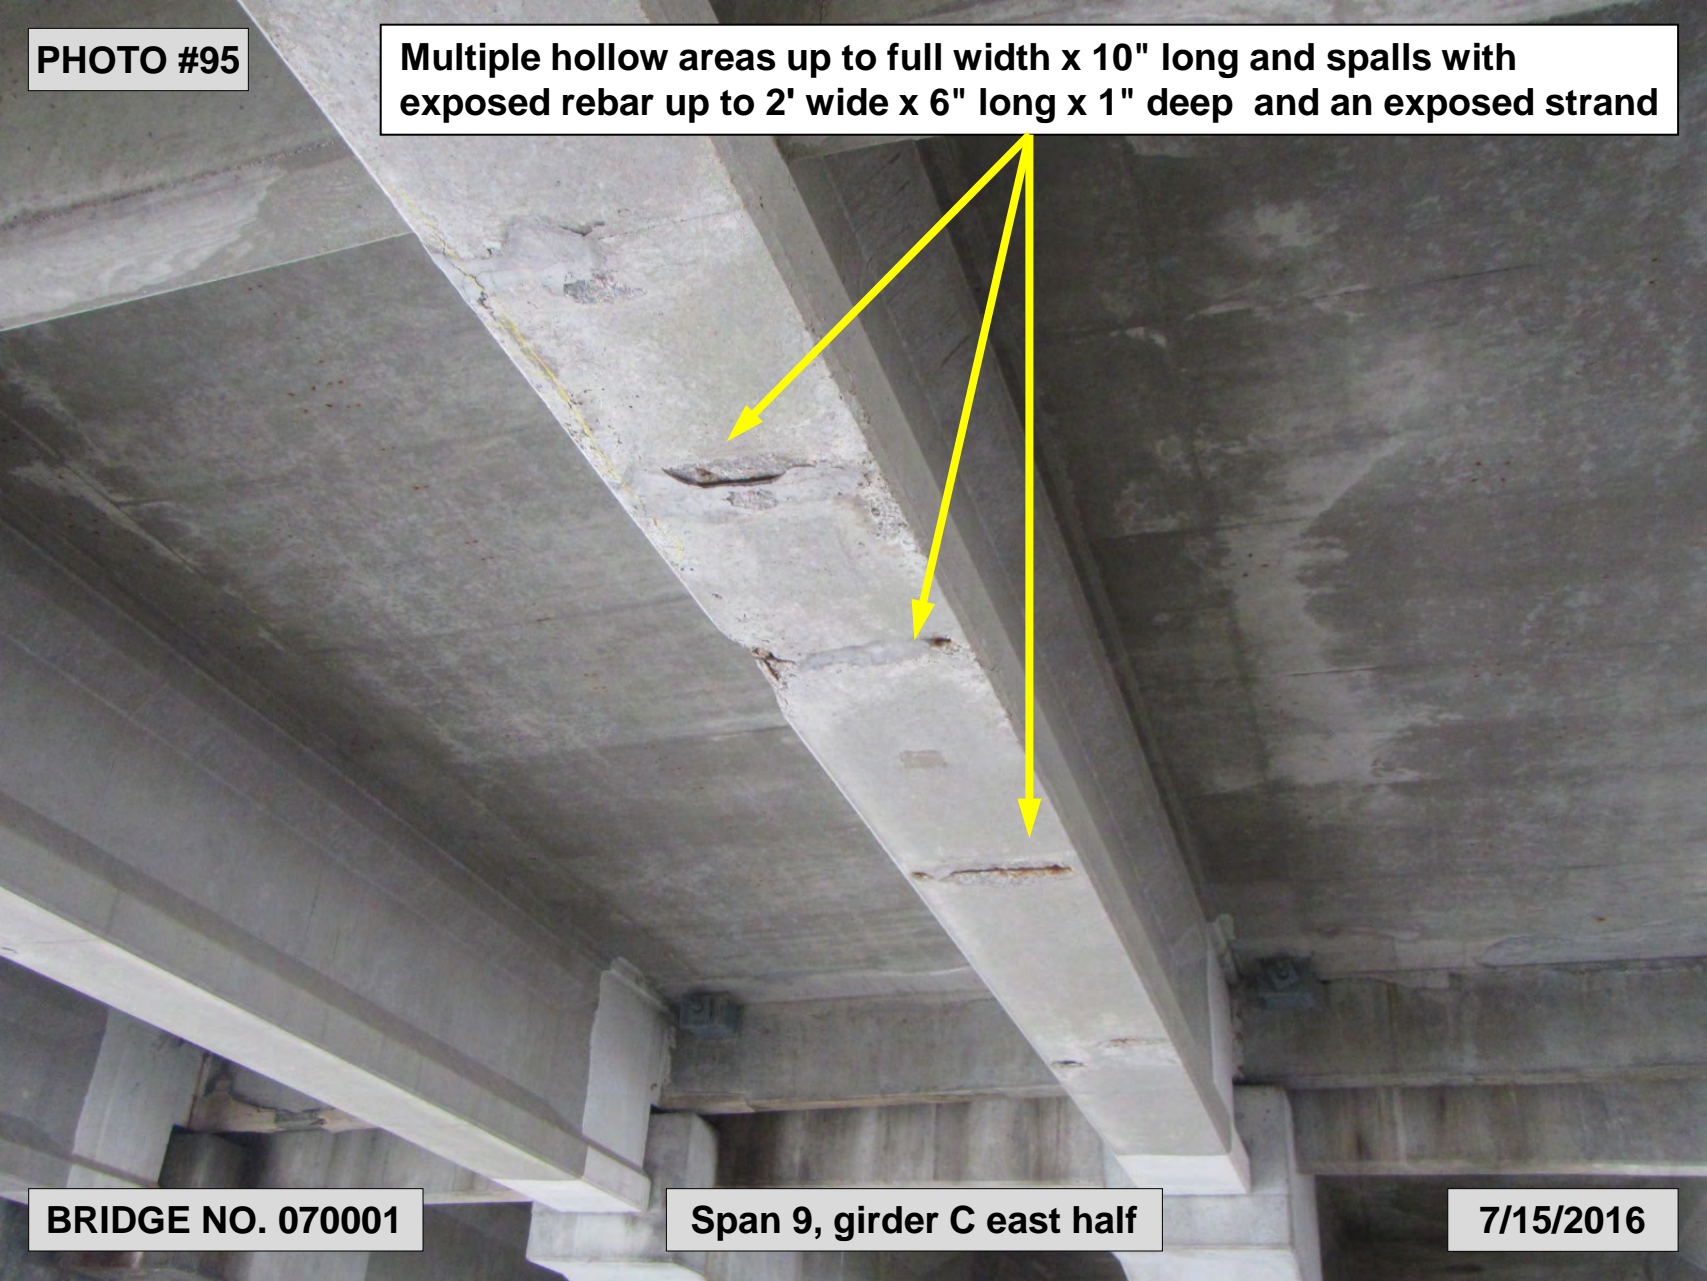
PHOTO #95

Multiple hollow areas up to full width x 10" long and spalls with exposed rebar up to 2' wide x 6" long x 1" deep and an exposed strand

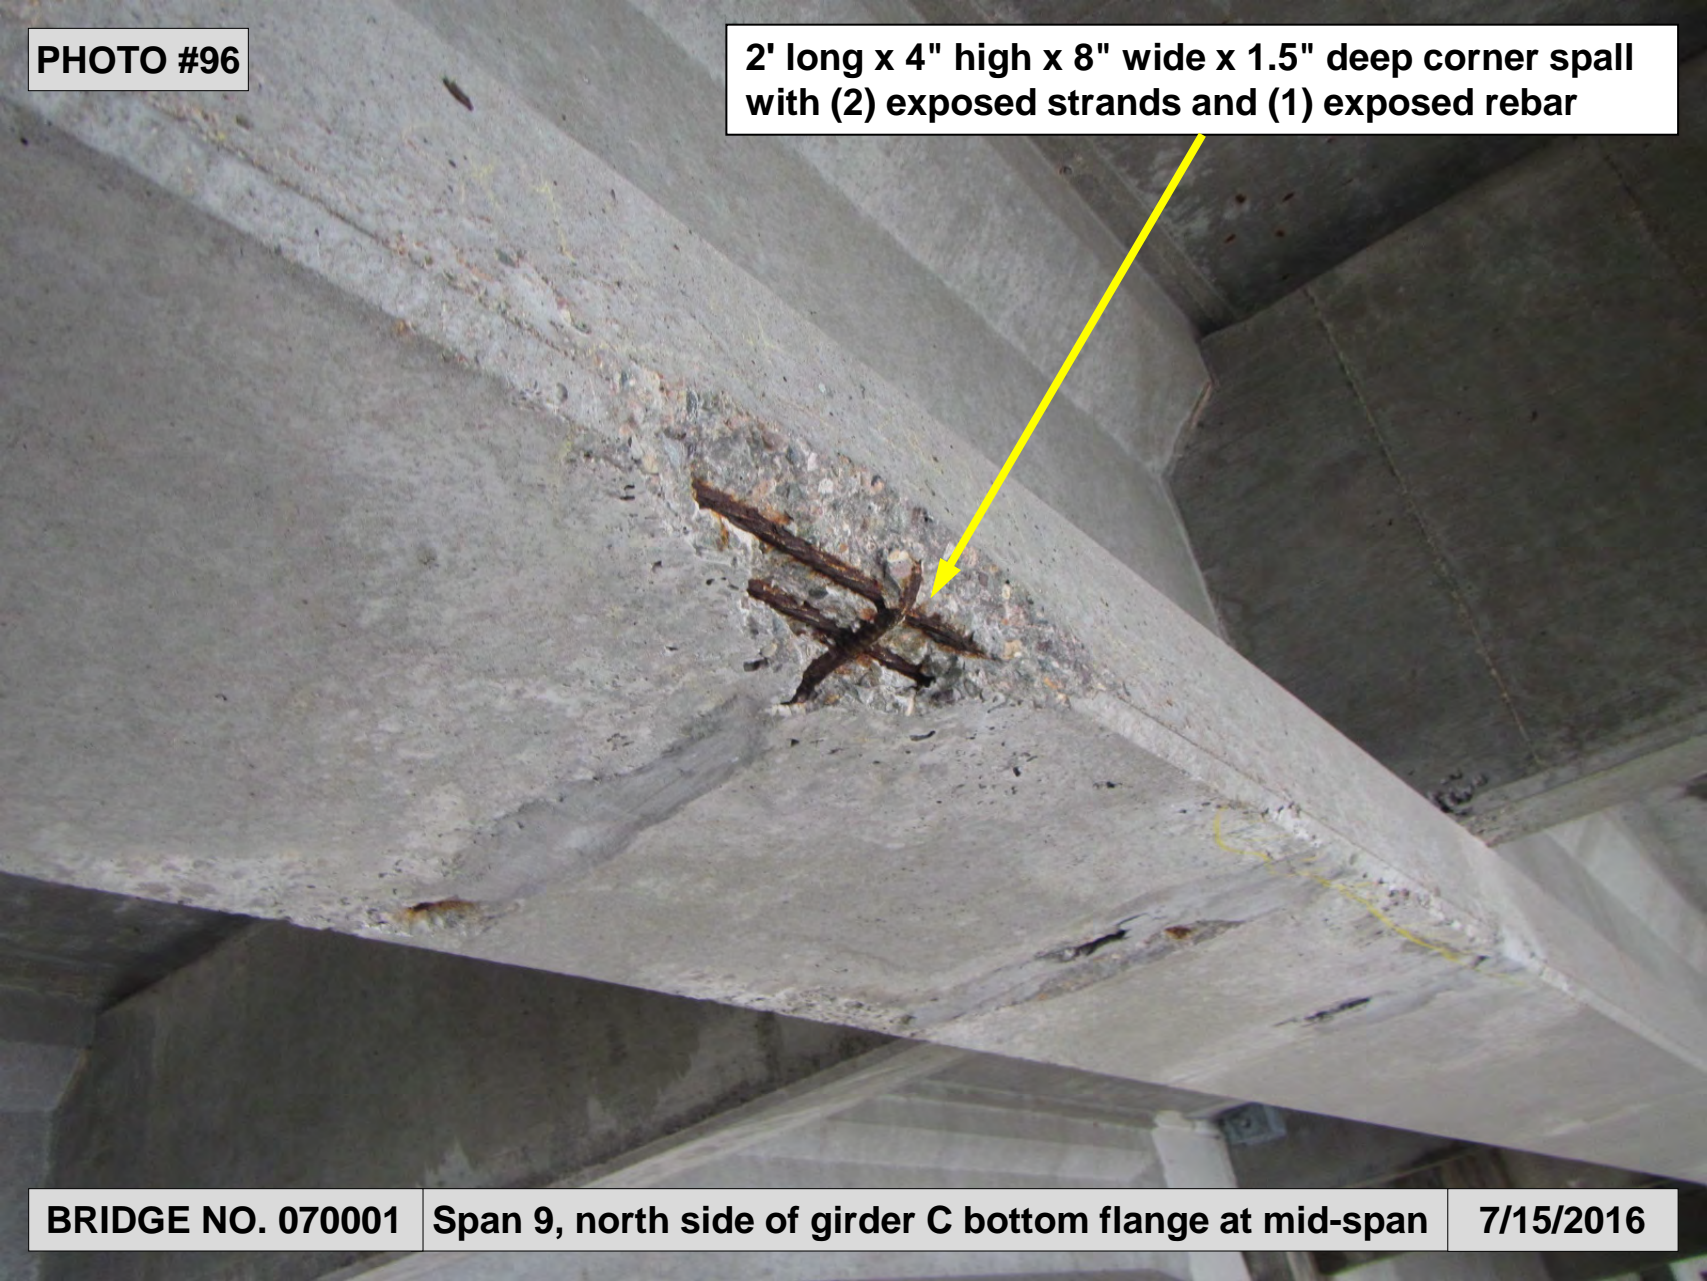
PHOTO #96

2' long x 4" high x 8" wide x 1.5" deep corner spall with (2) exposed strands and (1) exposed rebar

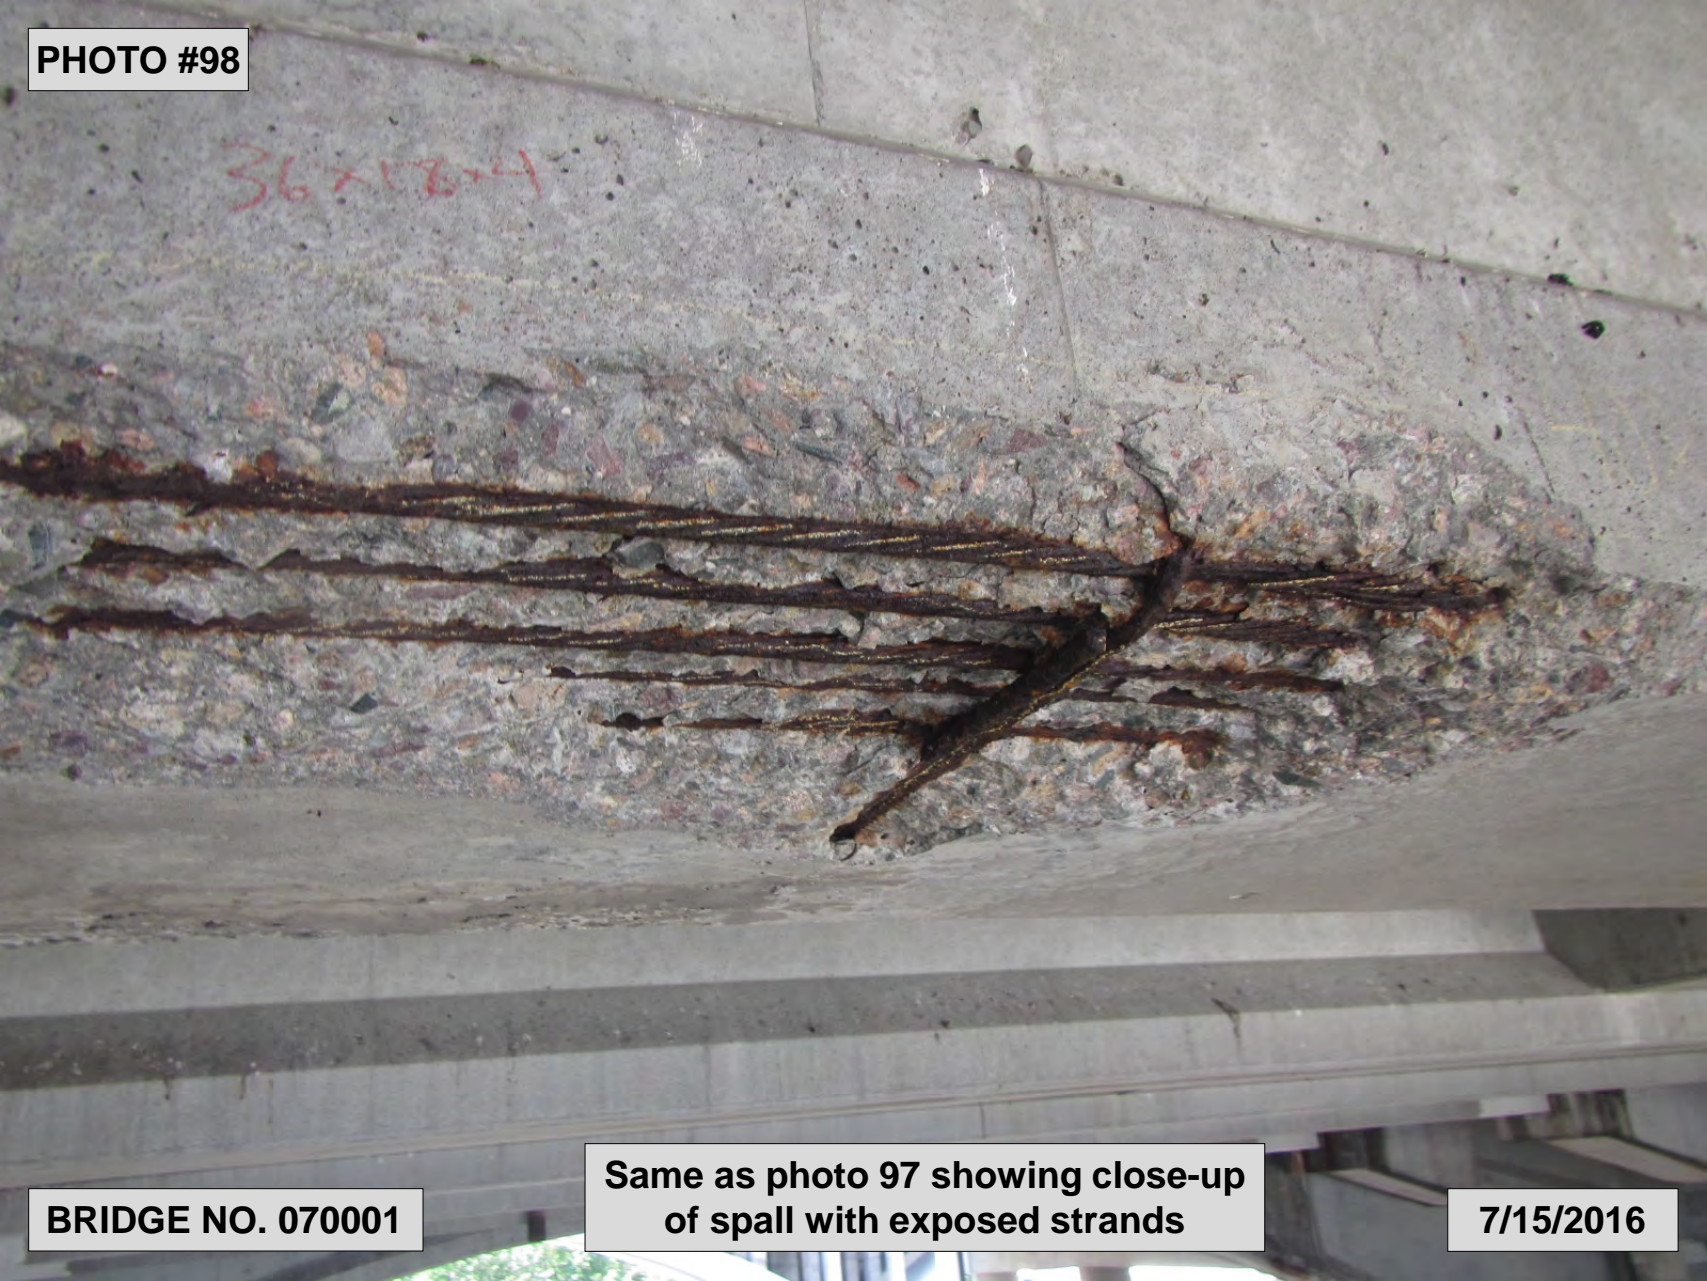
PHOTO #98

Same as photo 97 showing close-up
of spall with exposed strands

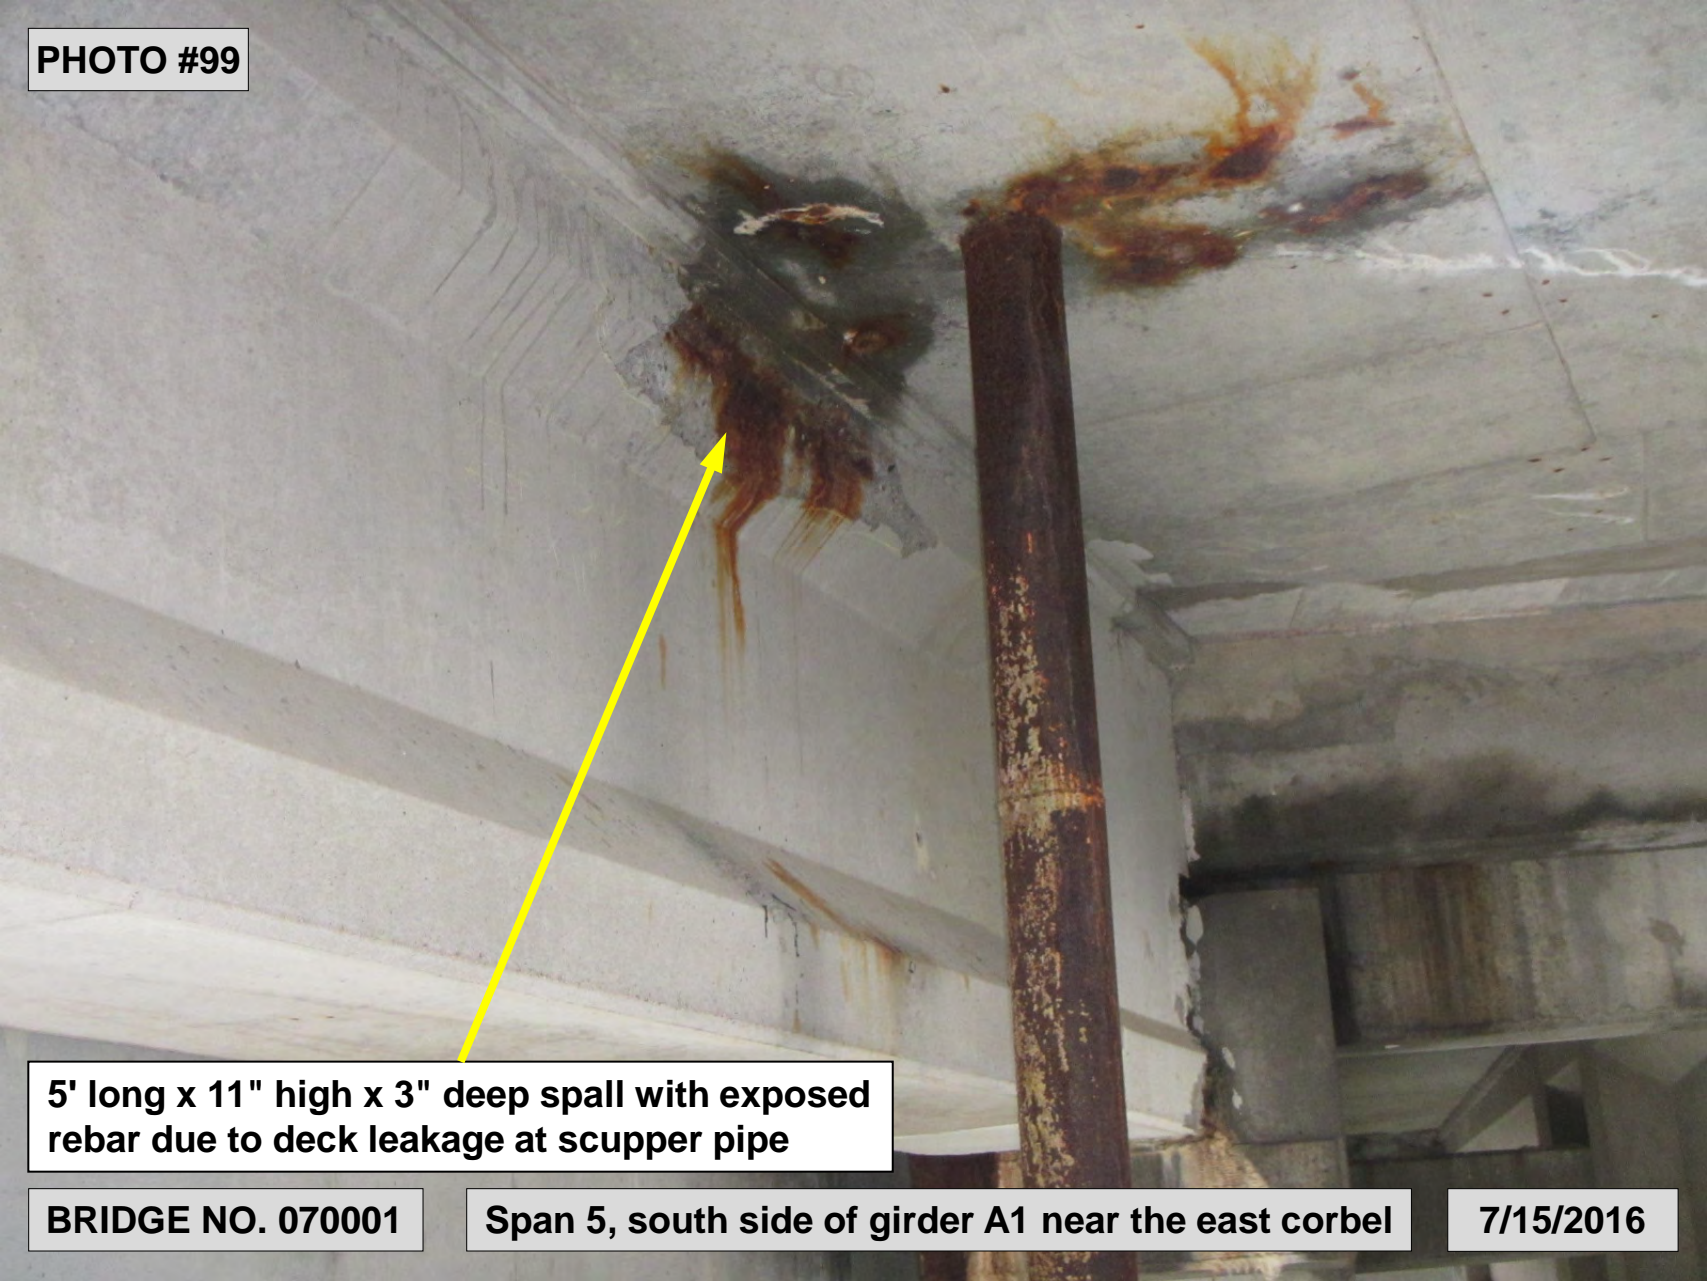
PHOTO #99

5' long x 11" high x 3" deep spall with exposed rebar due to deck leakage at scupper pipe

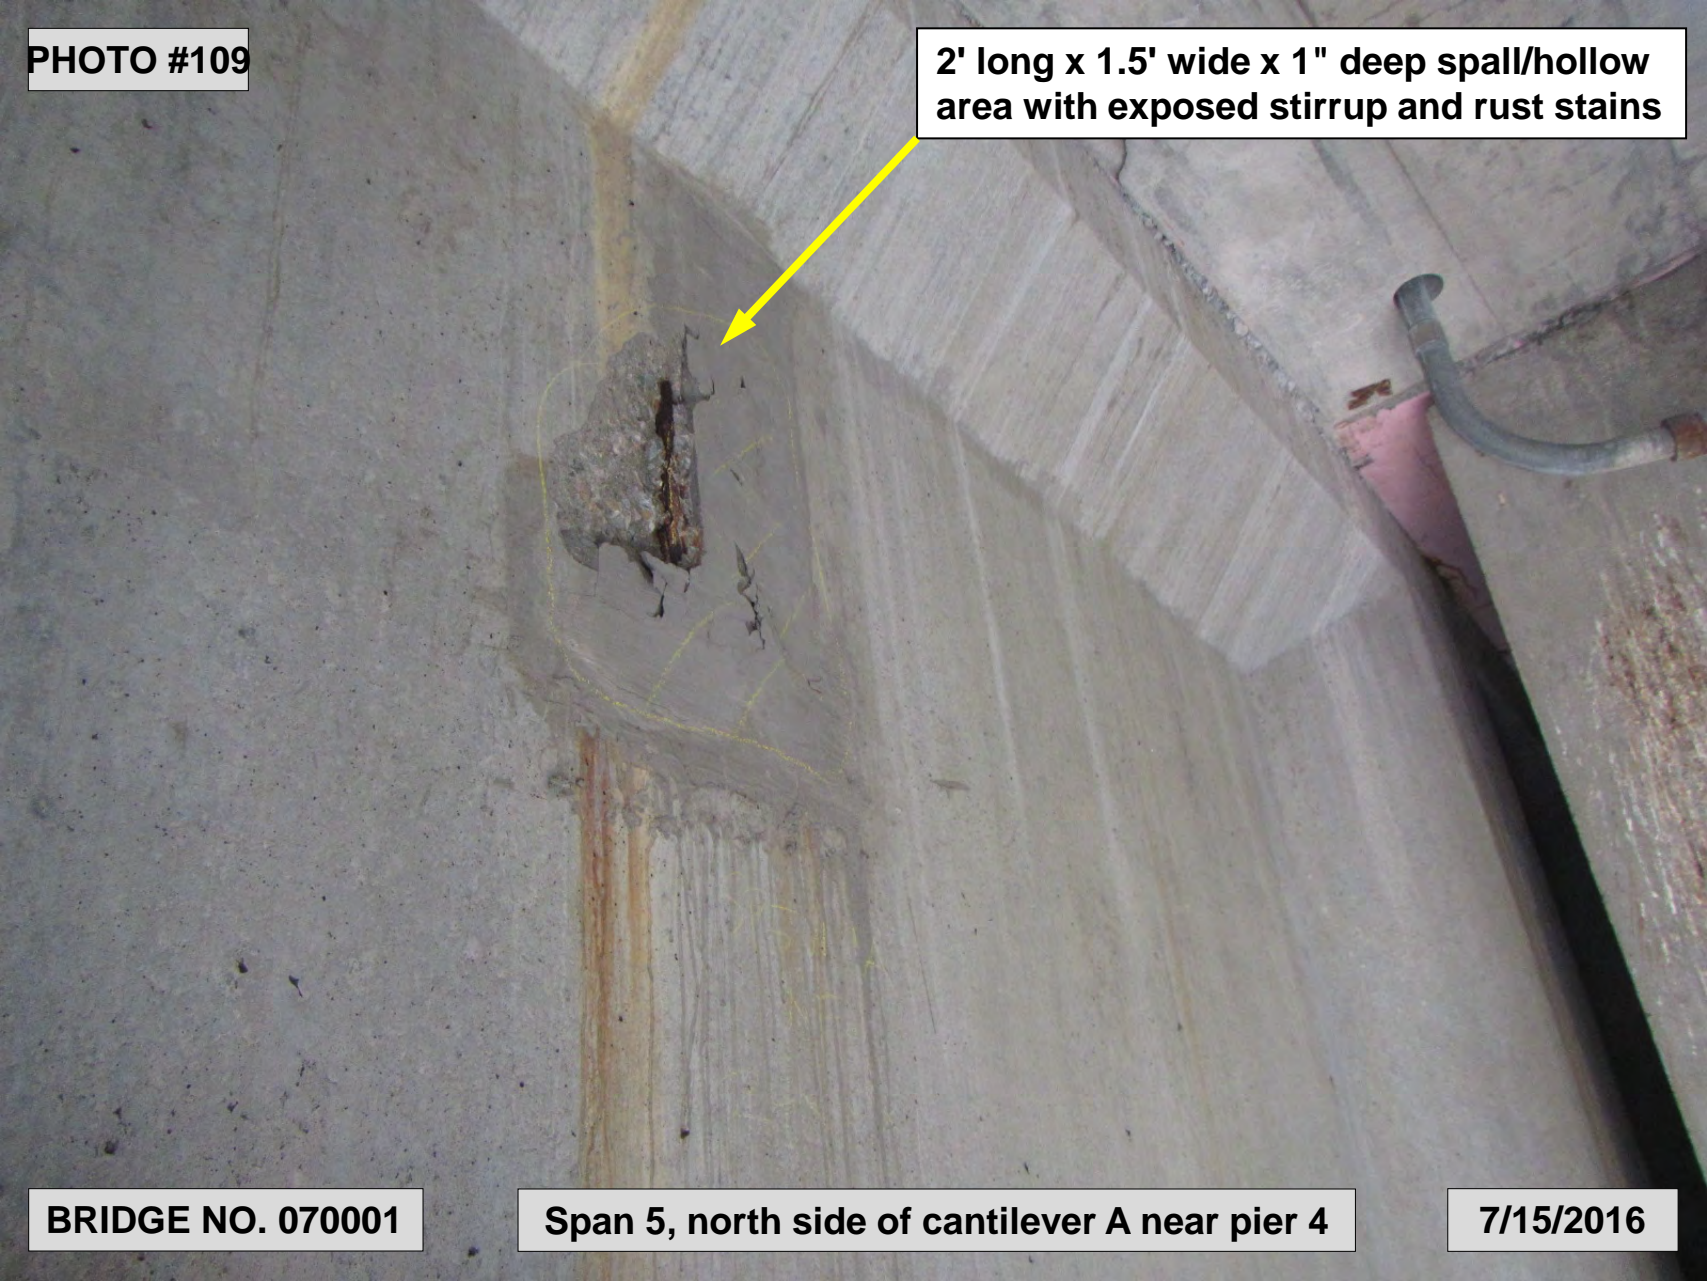
PHOTO #109

2' long x 1.5' wide x 1" deep spall/hollow area with exposed stirrup and rust stains

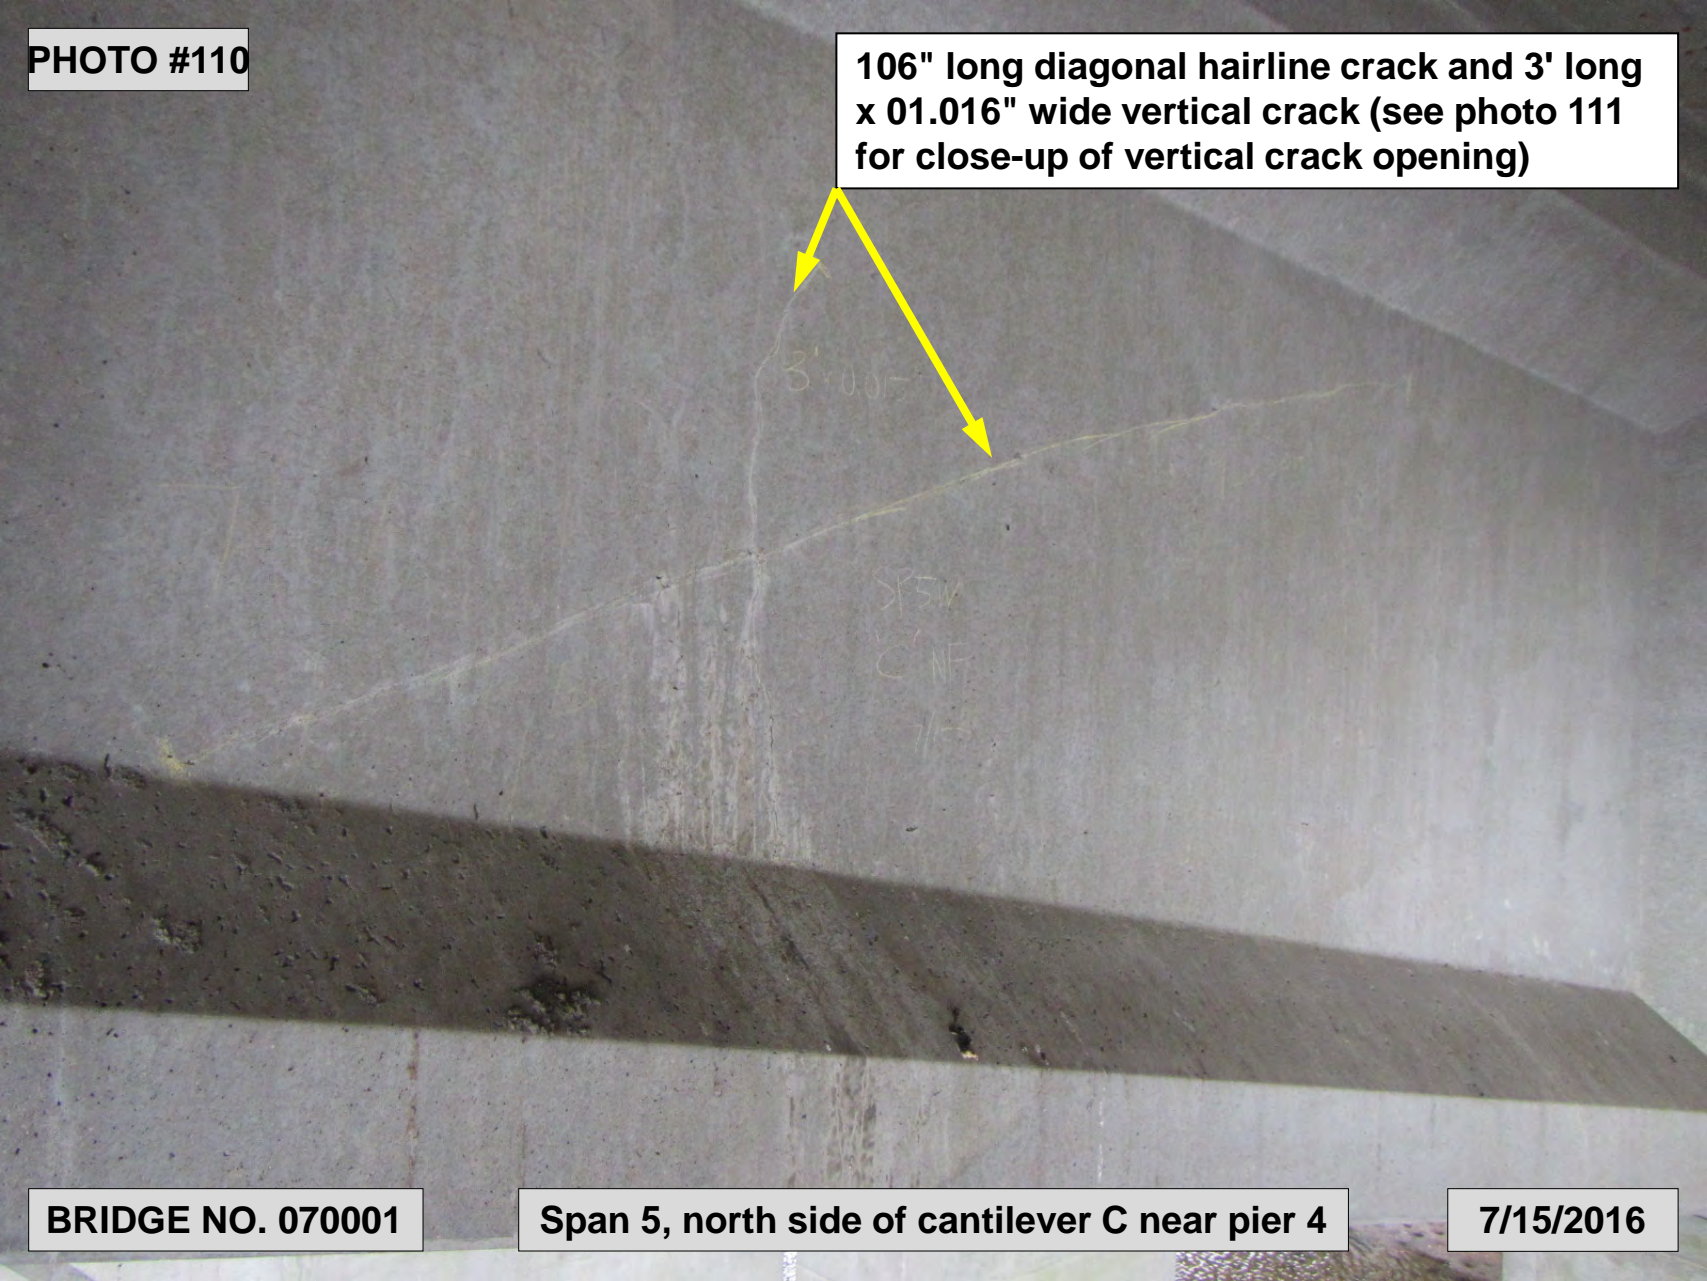
PHOTO #110

106" long diagonal hairline crack and 3' long x 01.016" wide vertical crack (see photo 111 for close-up of vertical crack opening)
