BRIDGE NO. 070001

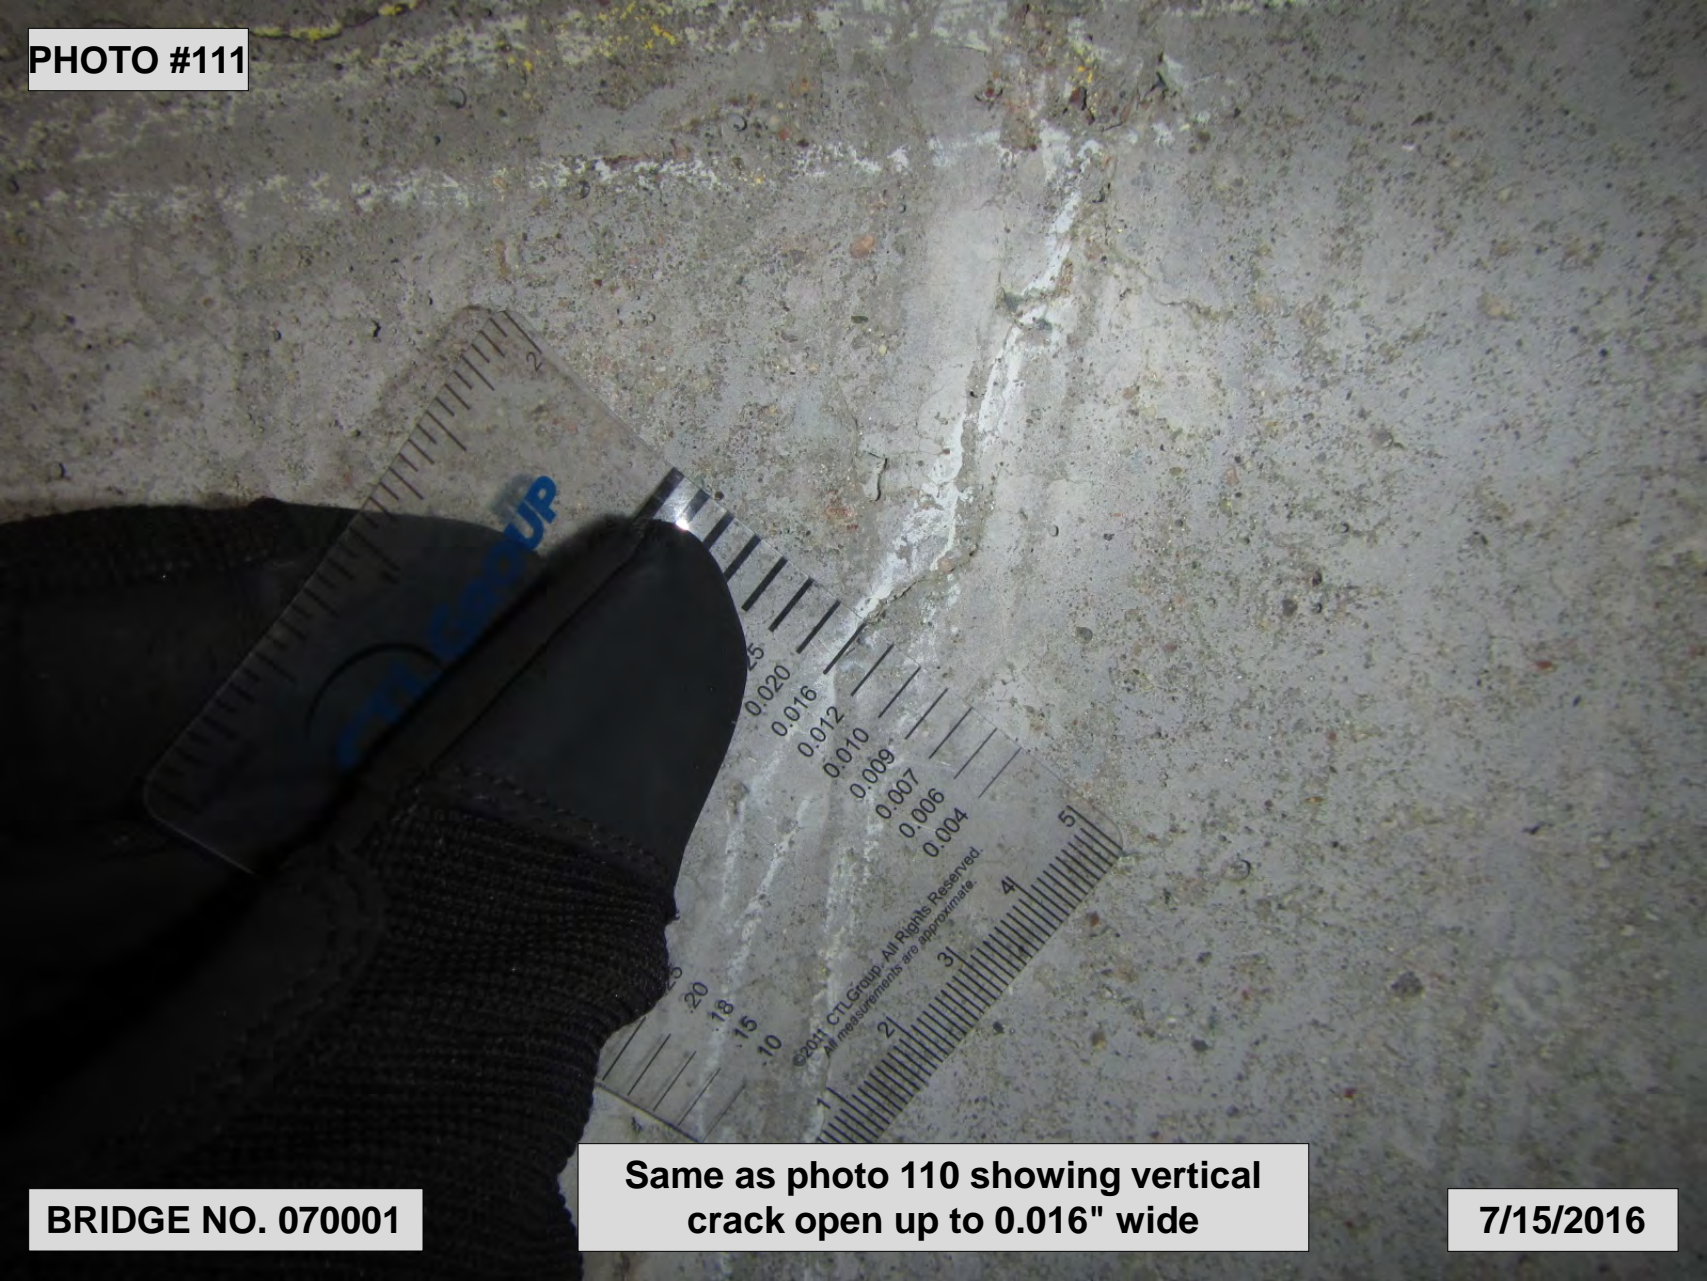
PHOTO #111

Same as photo 110 showing vertical crack open up to 0.016" wide

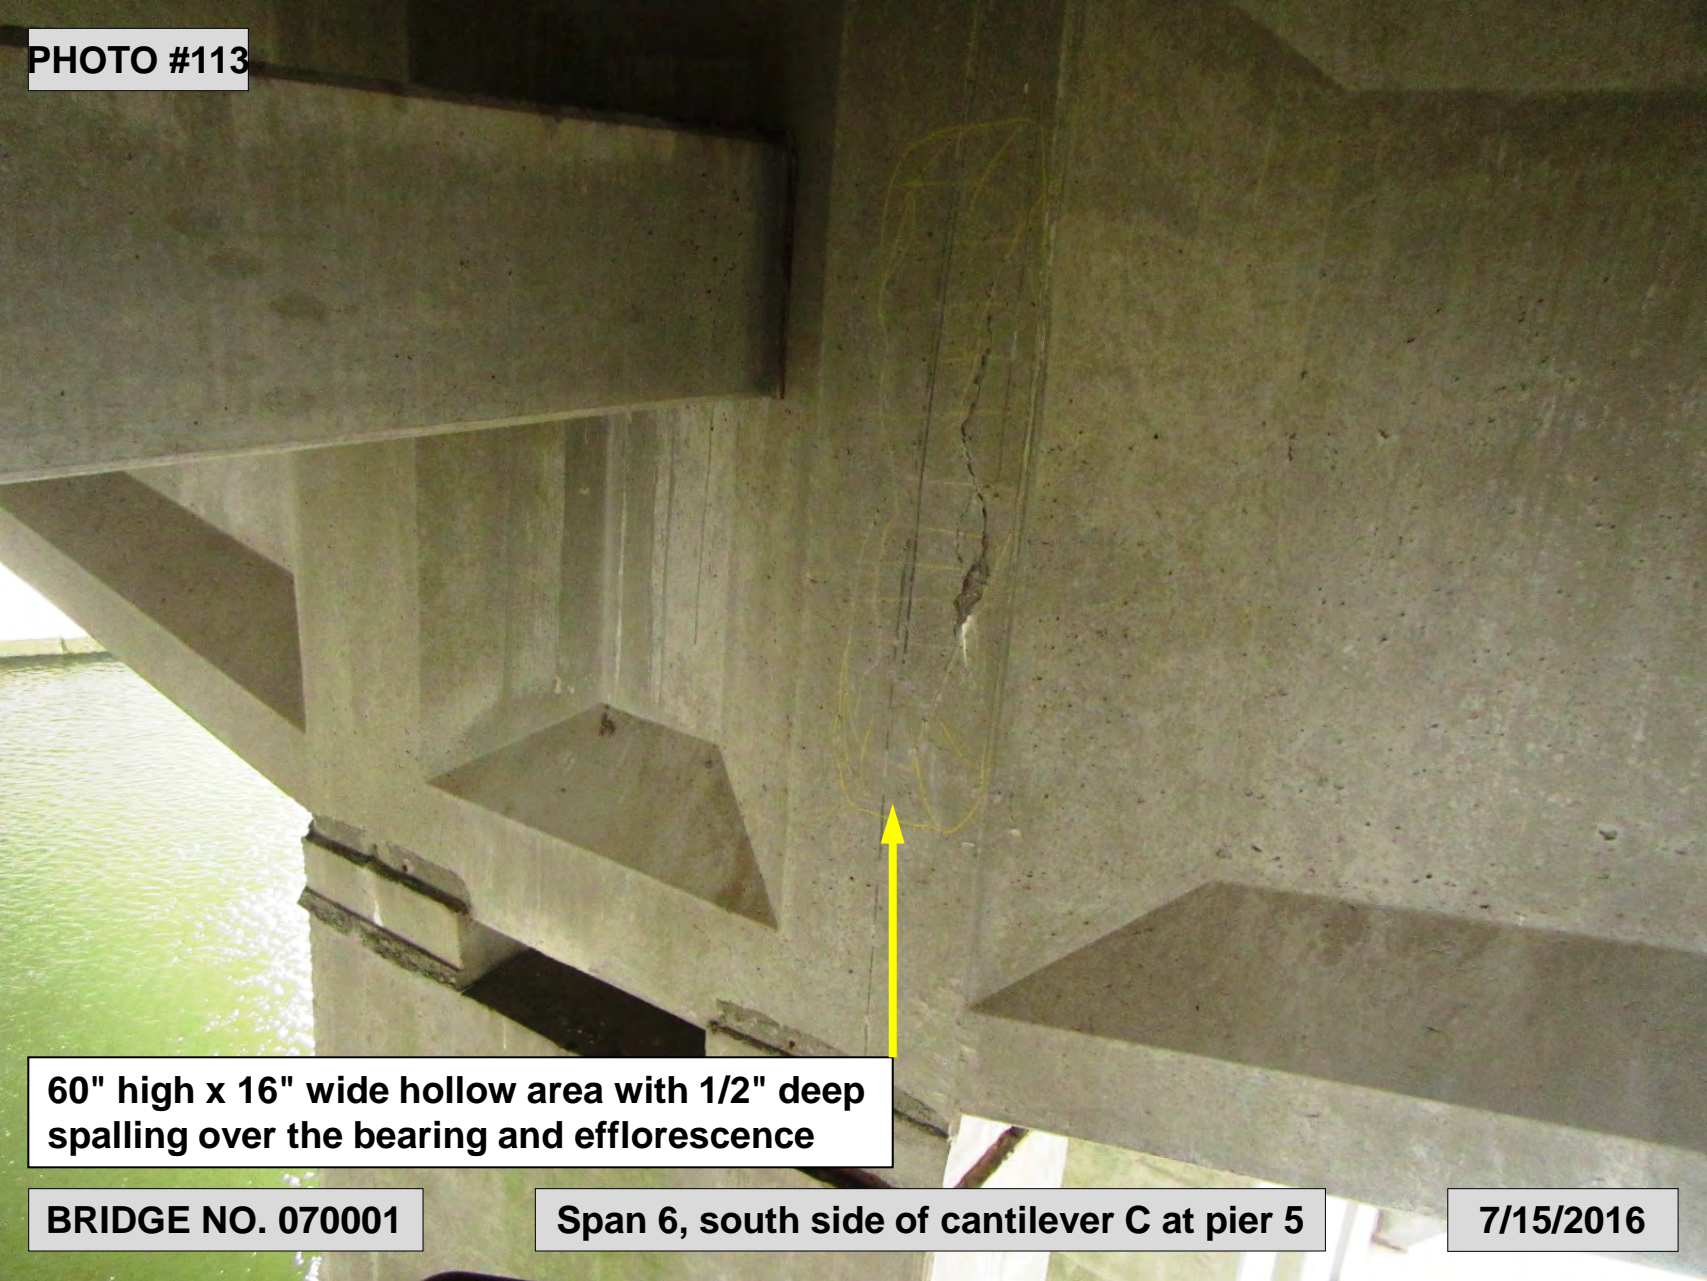
PHOTO #113

60" high x 16" wide hollow area with 1/2" deep spalling over the bearing and efflorescence

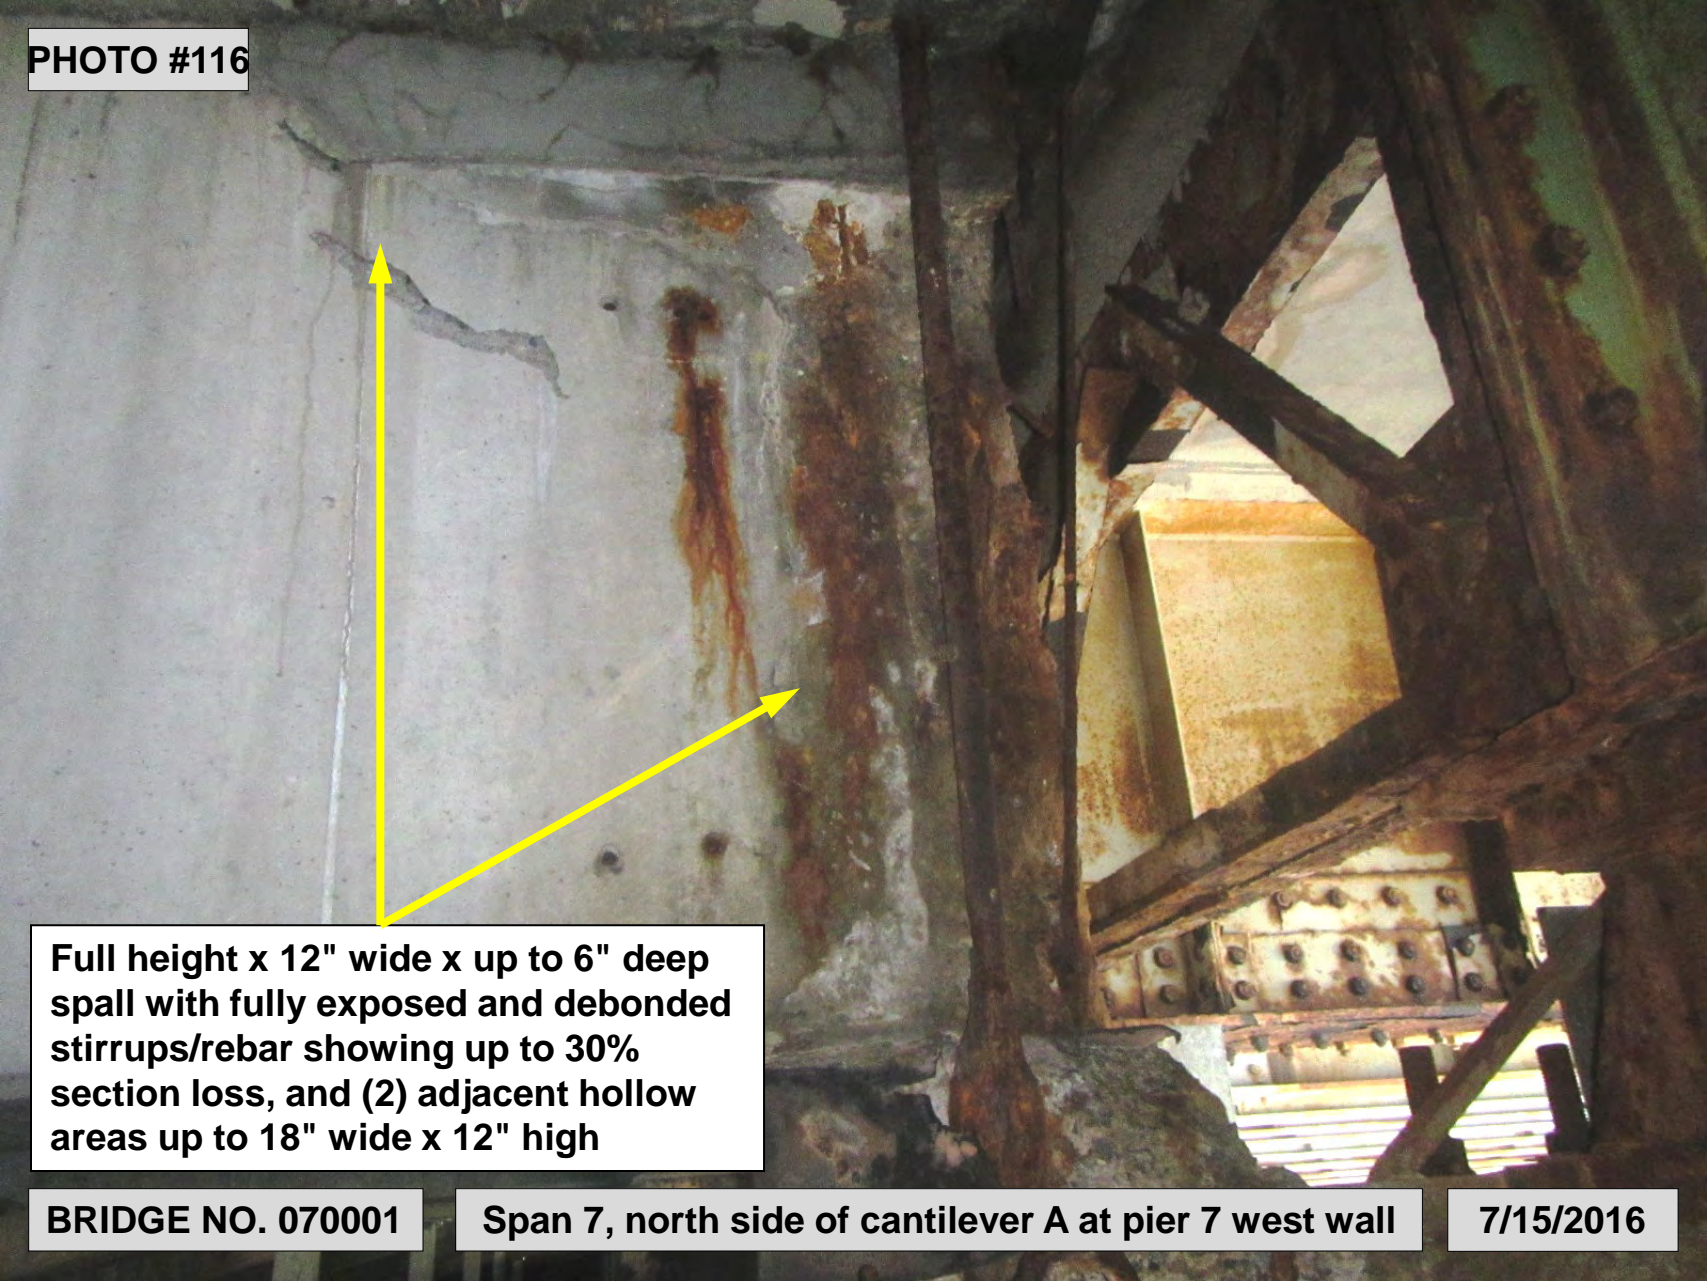
PHOTO #116

Full height x 12" wide x up to 6" deep spall with fully exposed and debonded stirrups/rebar showing up to 30% section loss, and (2) adjacent hollow areas up to 18" wide x 12" high

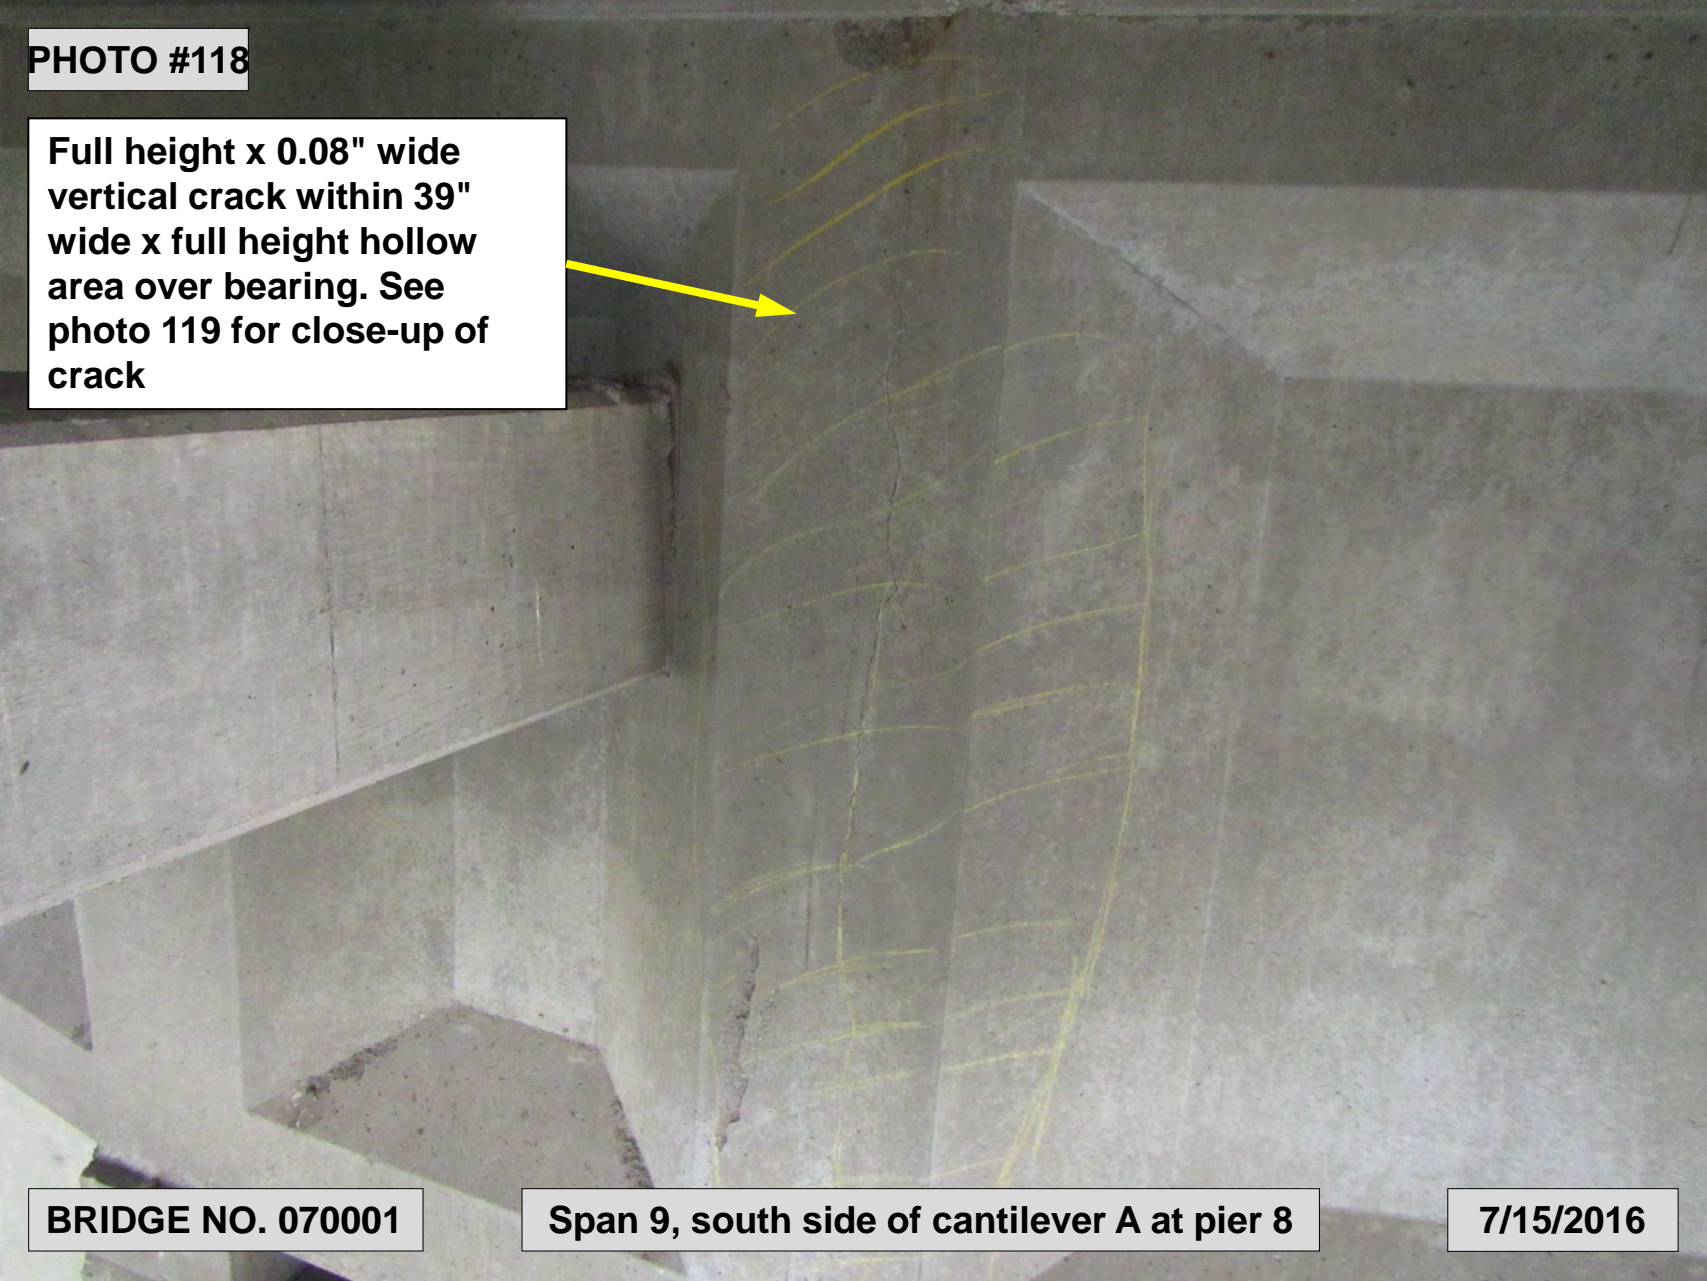
PHOTO #118

Full height x 0.08" wide vertical crack within 39" wide x full height hollow area over bearing. See photo 119 for close-up of crack

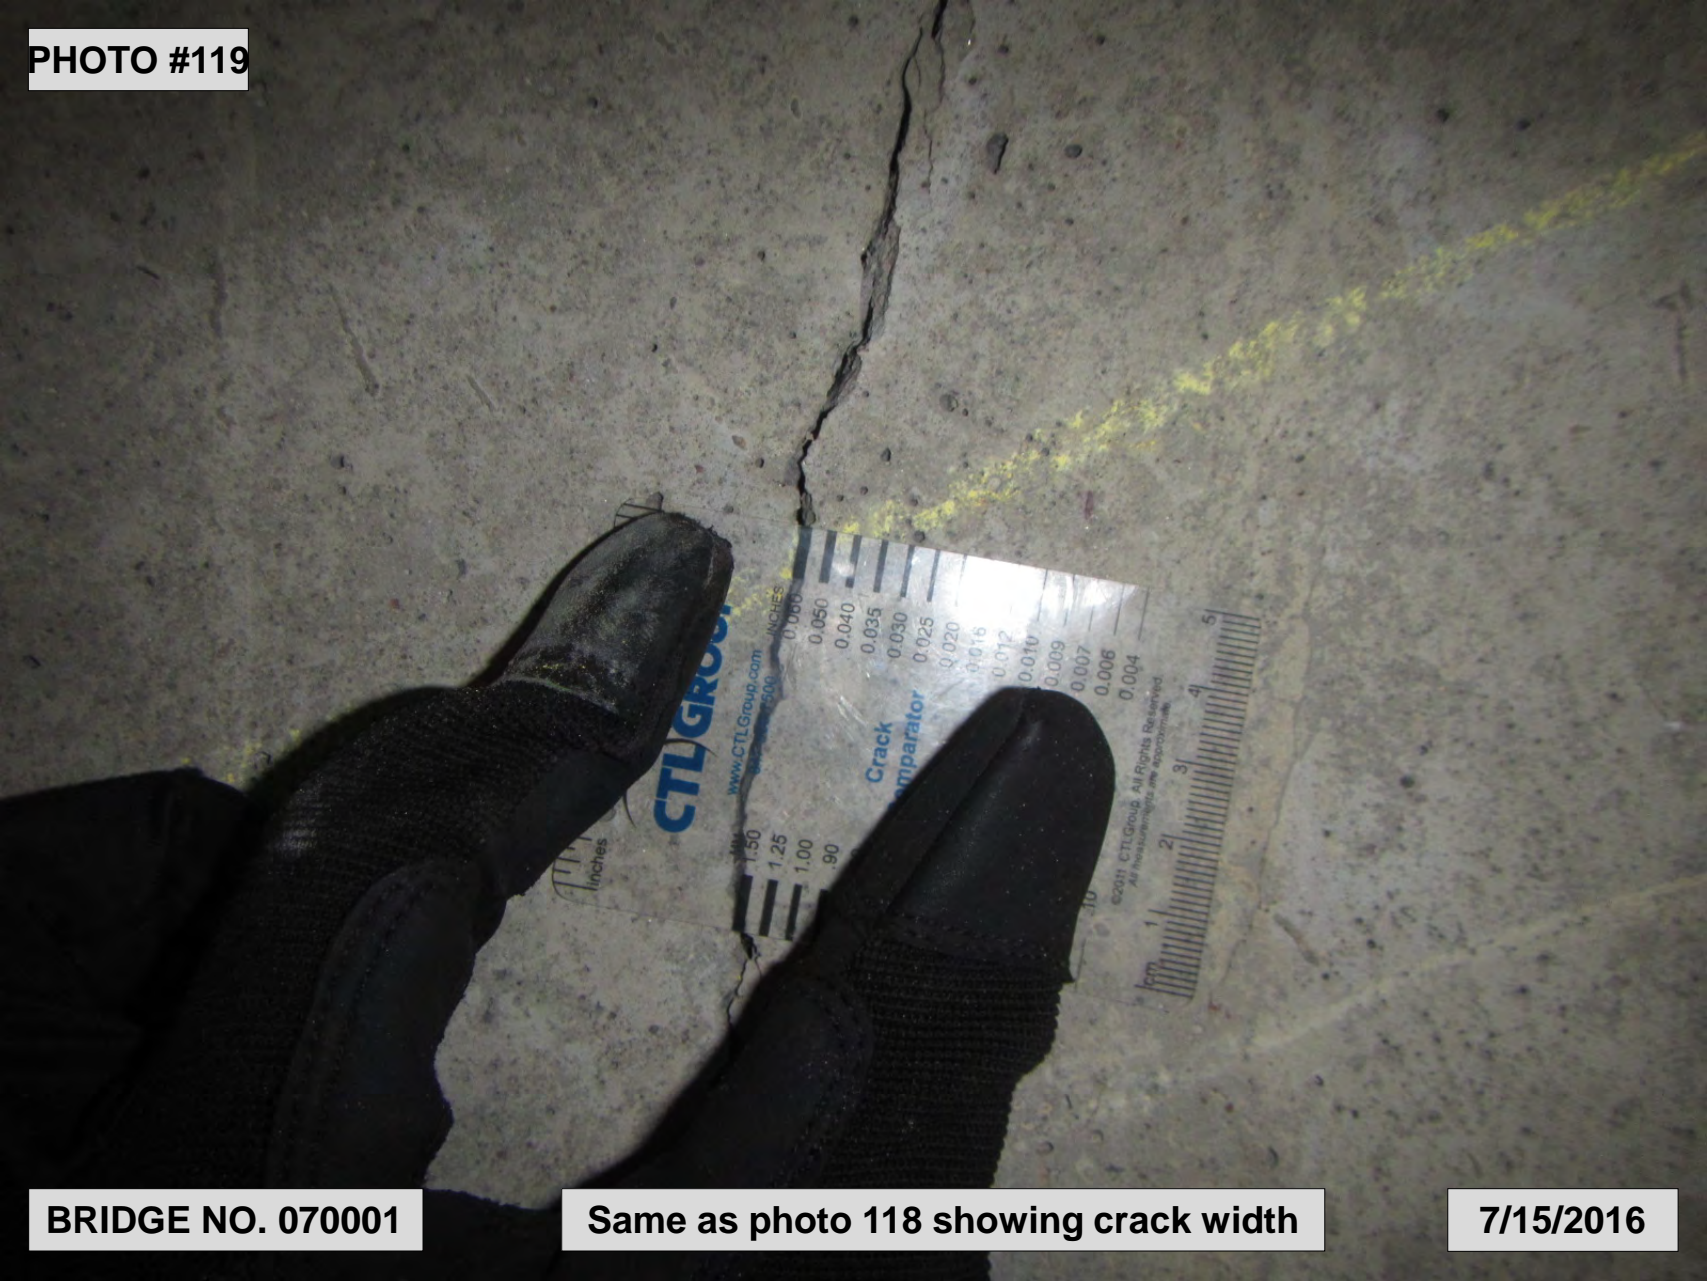
PHOTO #119

Same as photo 118 showing crack width

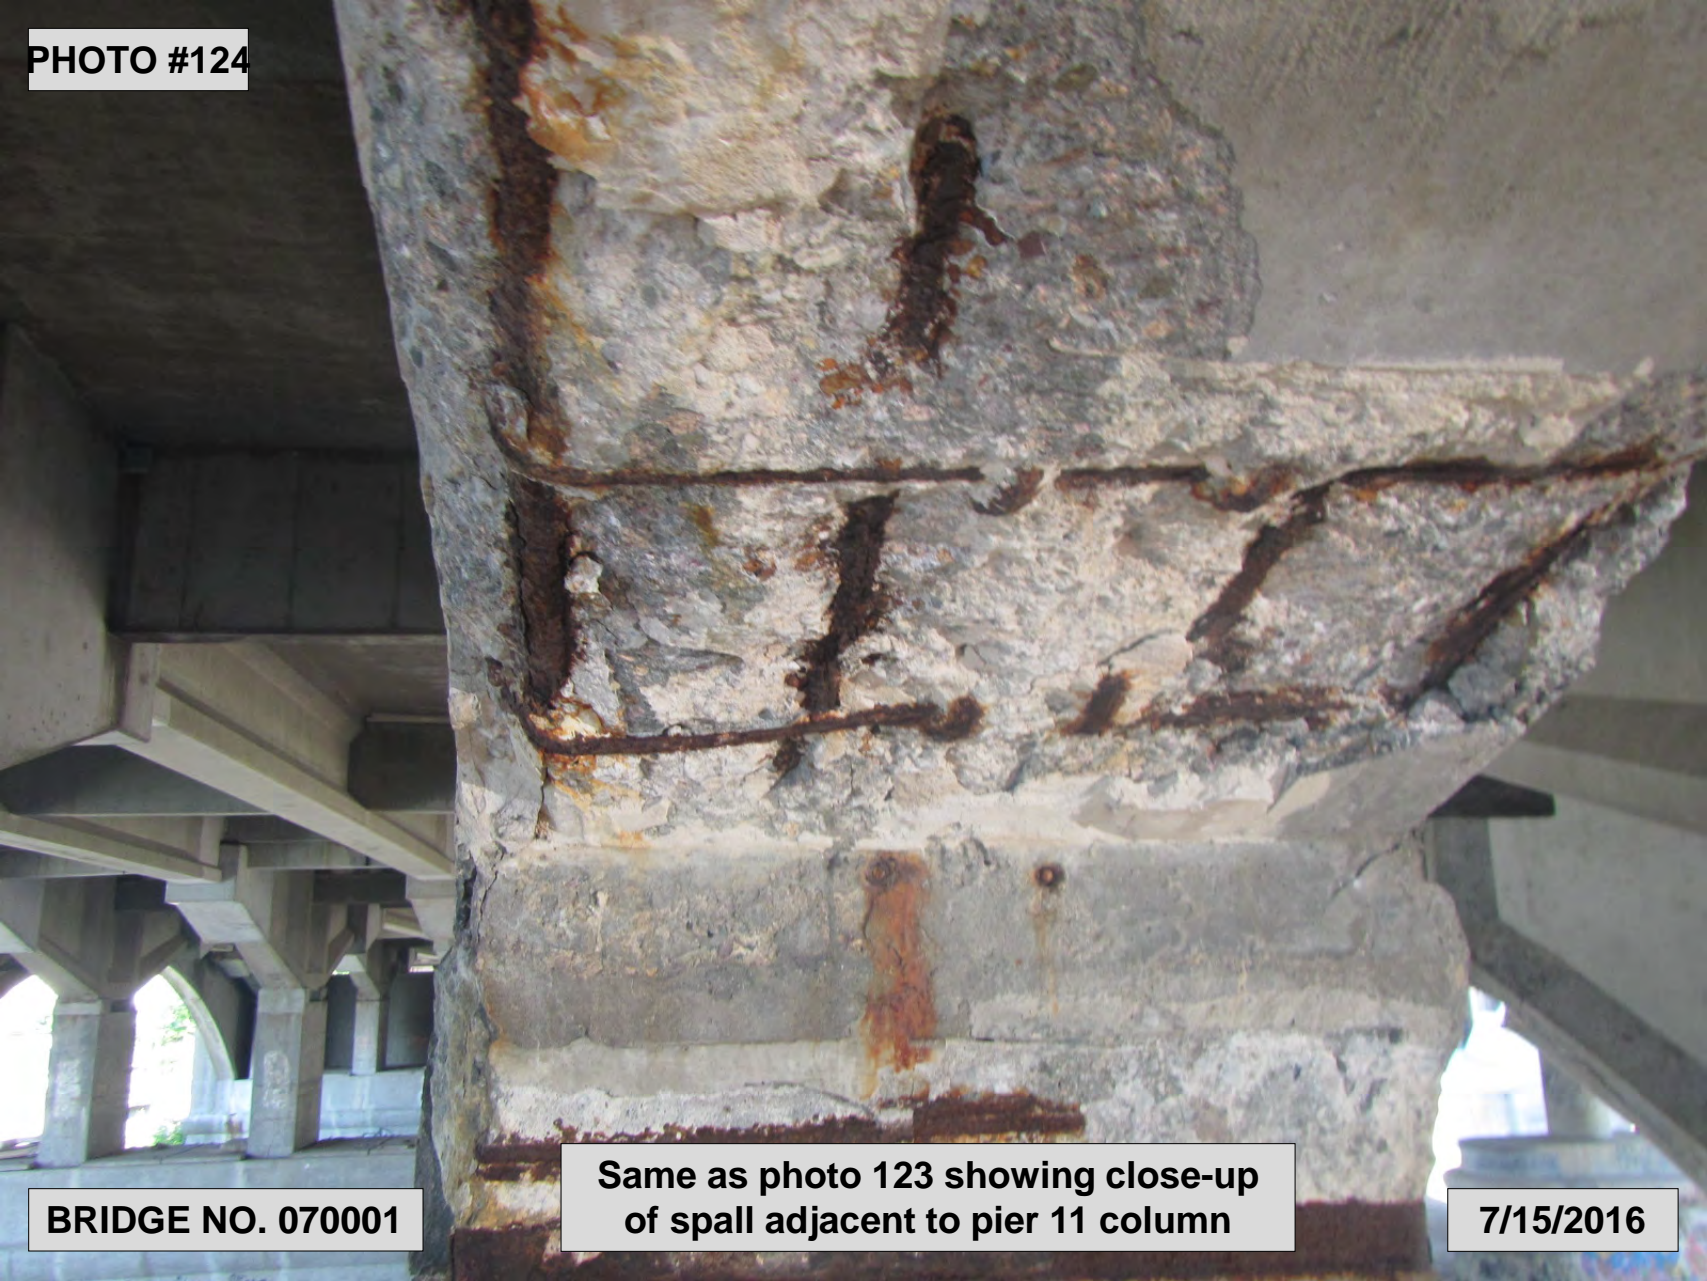
PHOTO #124

**Same as photo 123 showing close-up
of spall adjacent to pier 11 column**

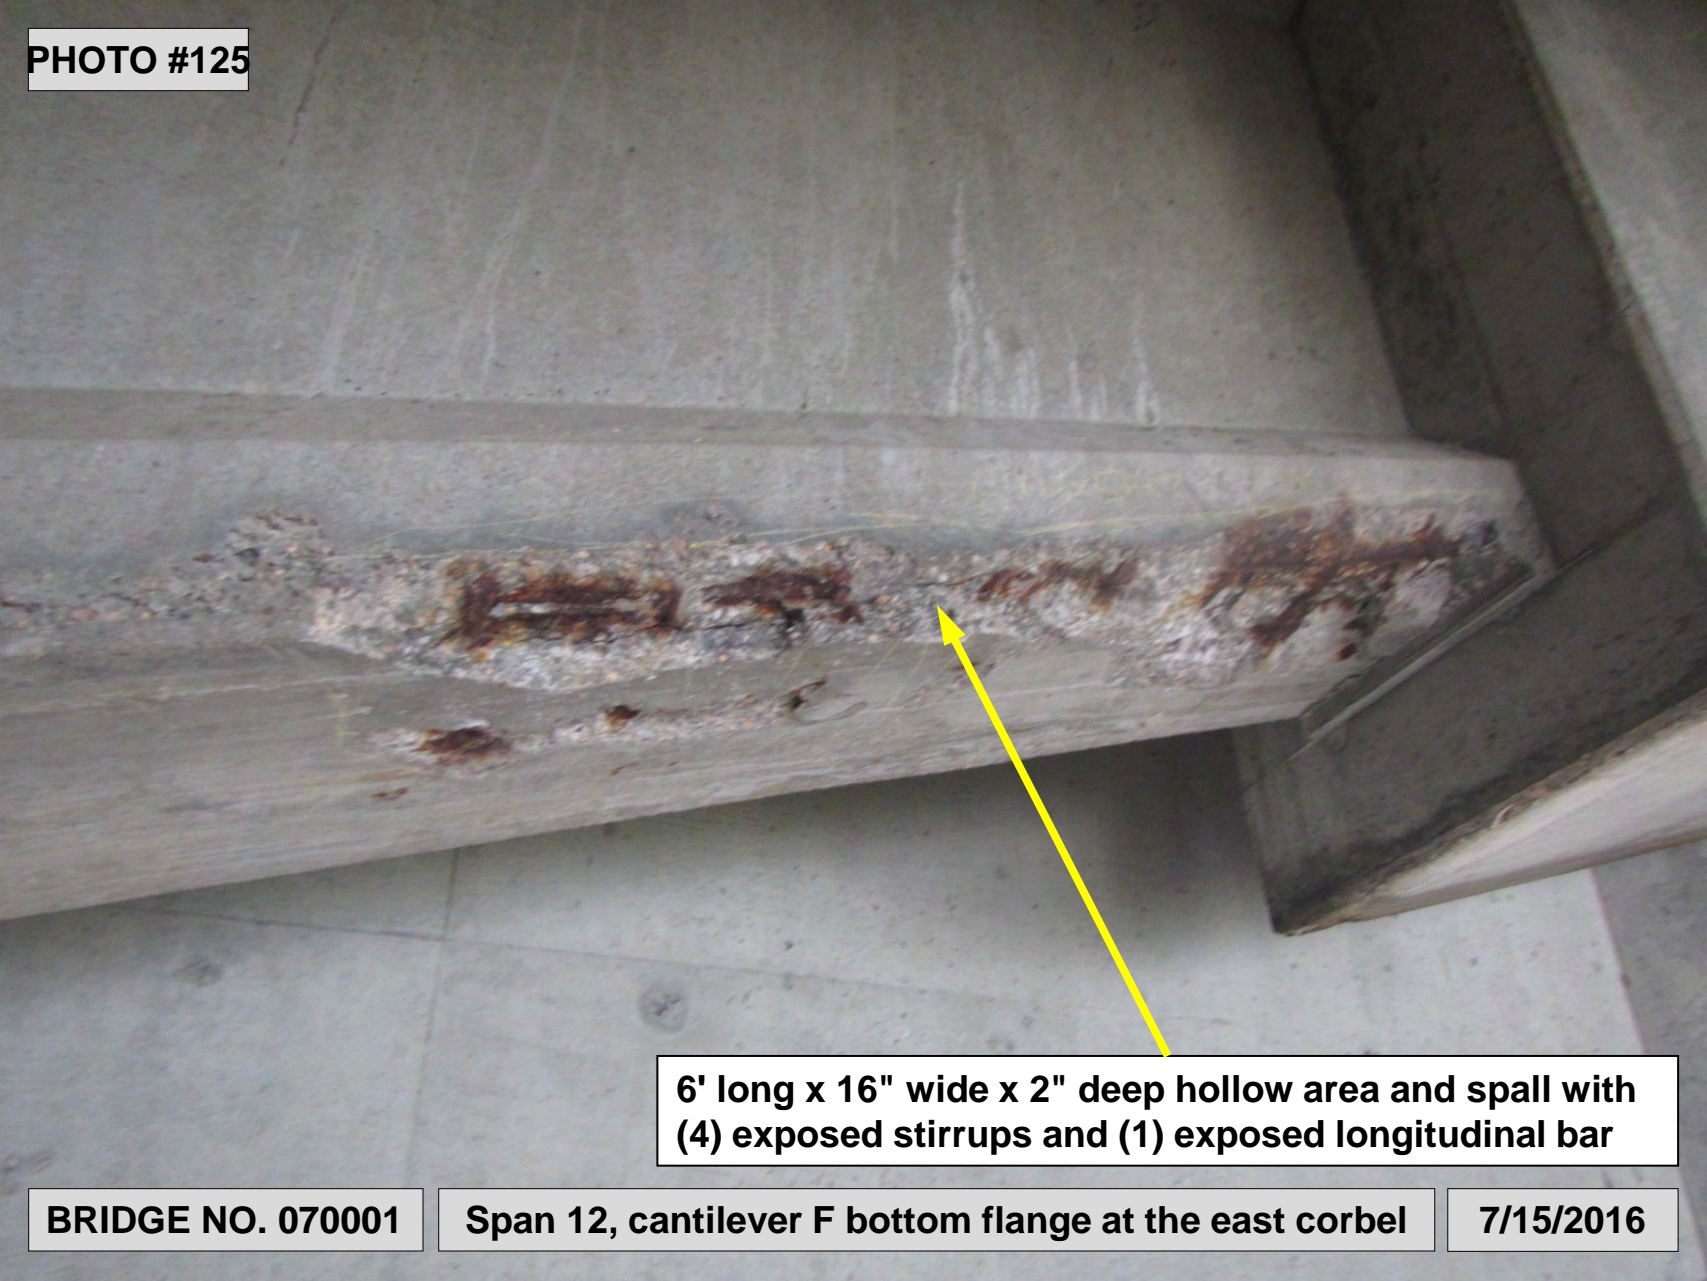
PHOTO #125

6' long x 16" wide x 2" deep hollow area and spall with (4) exposed stirrups and (1) exposed longitudinal bar
