PHOTO NO. 1

BRIDGE NO. 070001

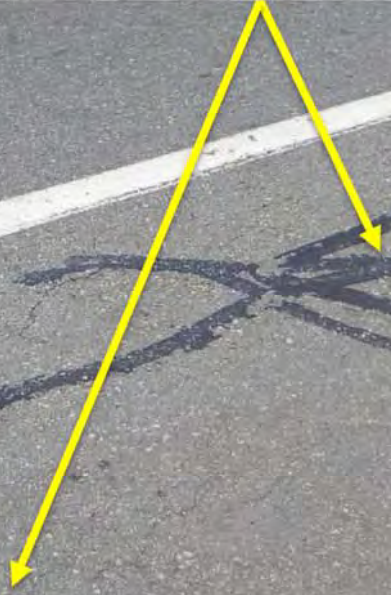
RANDOM SEALED AND
UNSEALED LONGITUDINAL
AND TRANSVERSE CRACKS

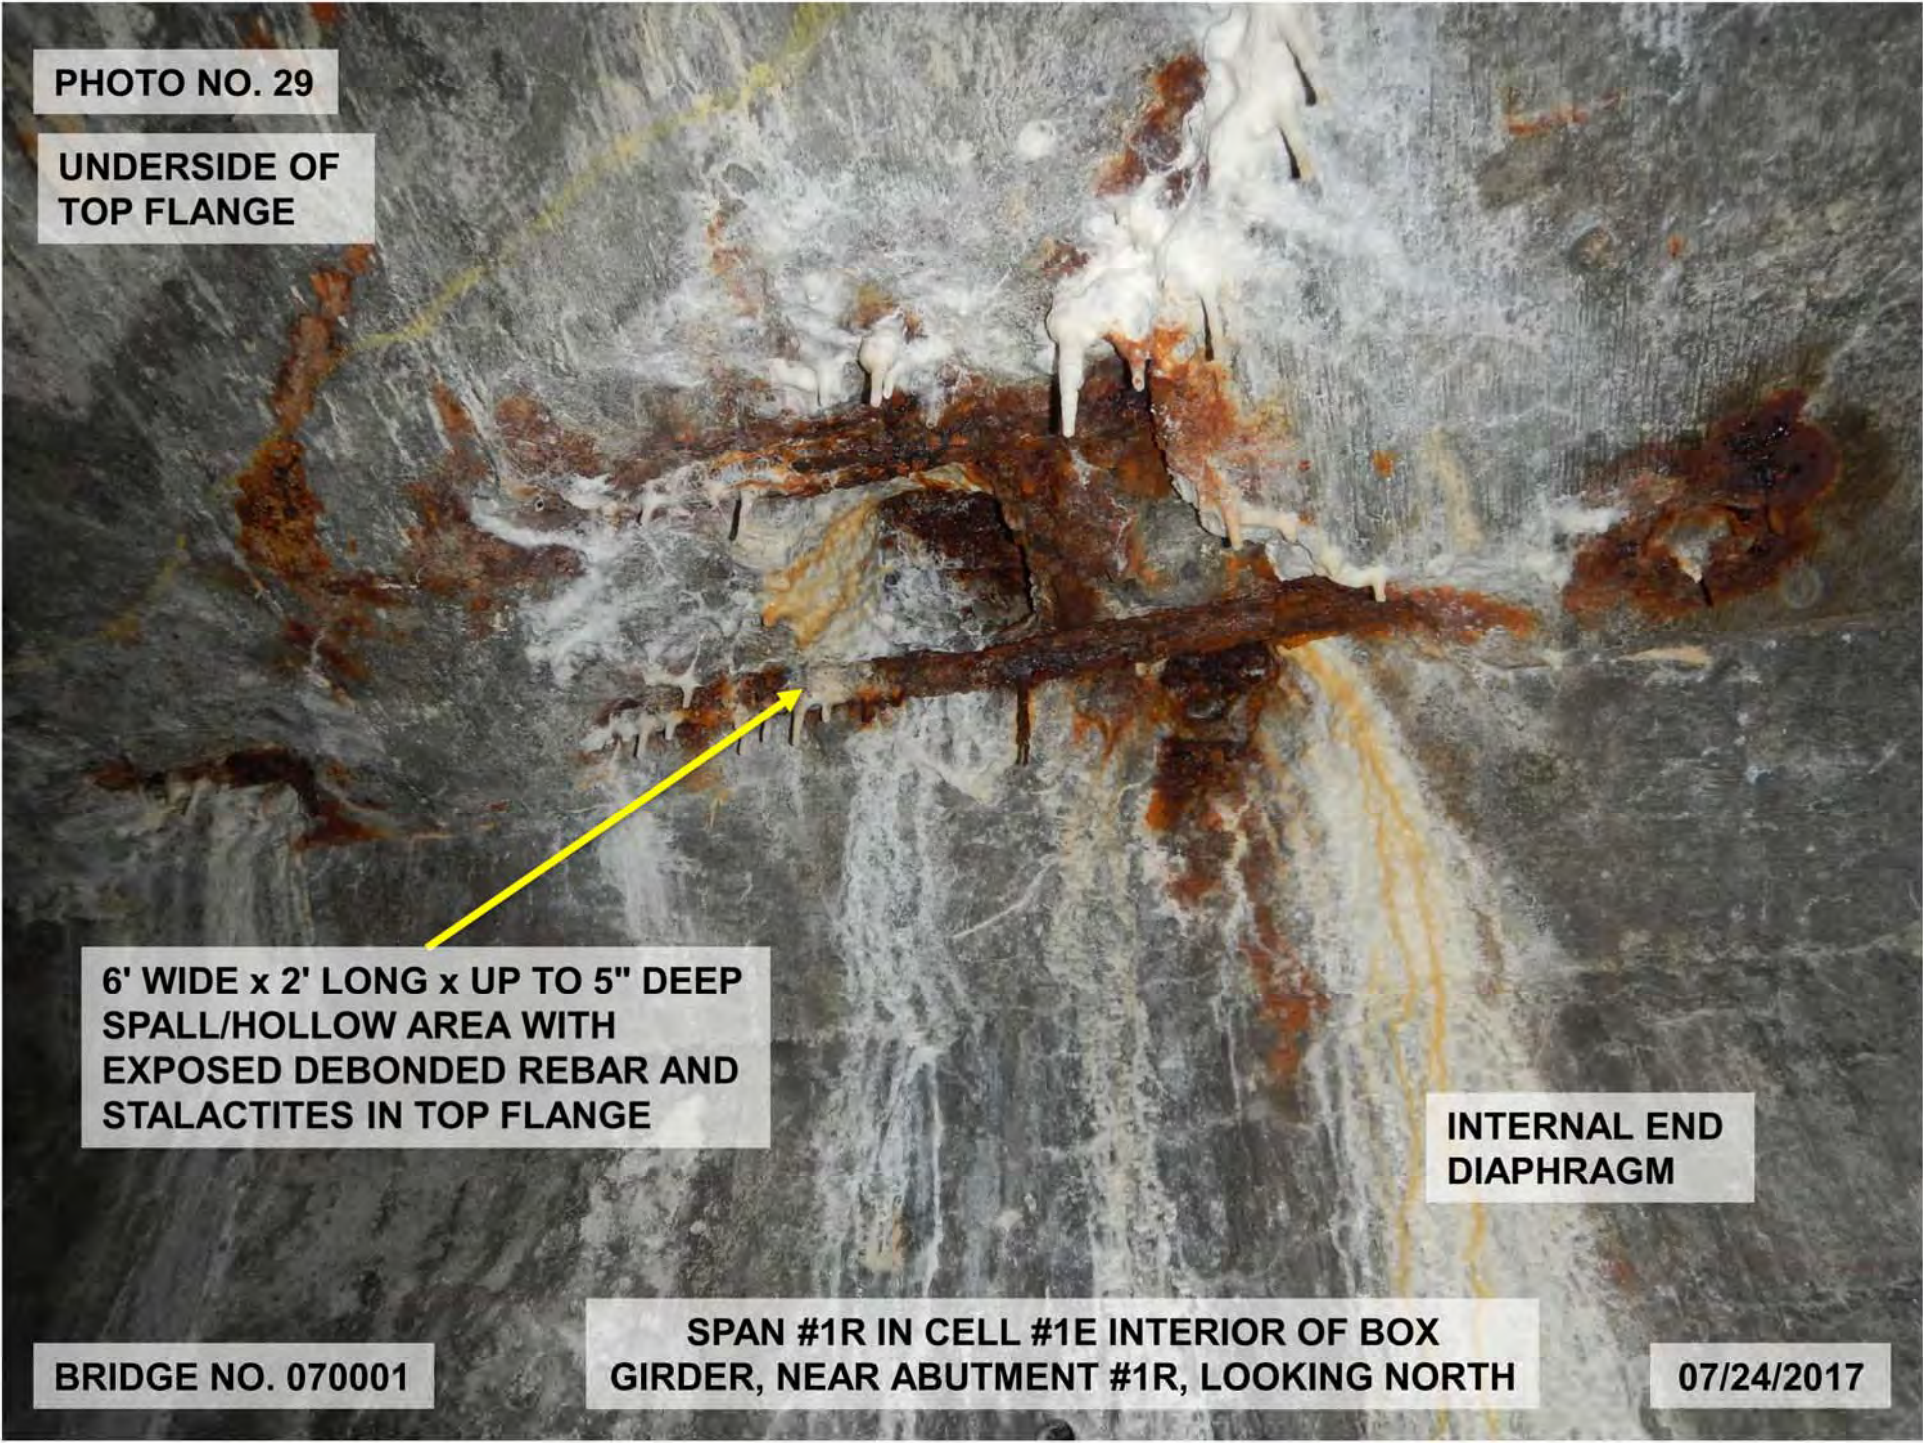
**6' WIDE x 2' LONG x UP TO 5" DEEP
SPALL/HOLLOW AREA WITH
EXPOSED DEBONDED REBAR AND
STALACTITES IN TOP FLANGE**

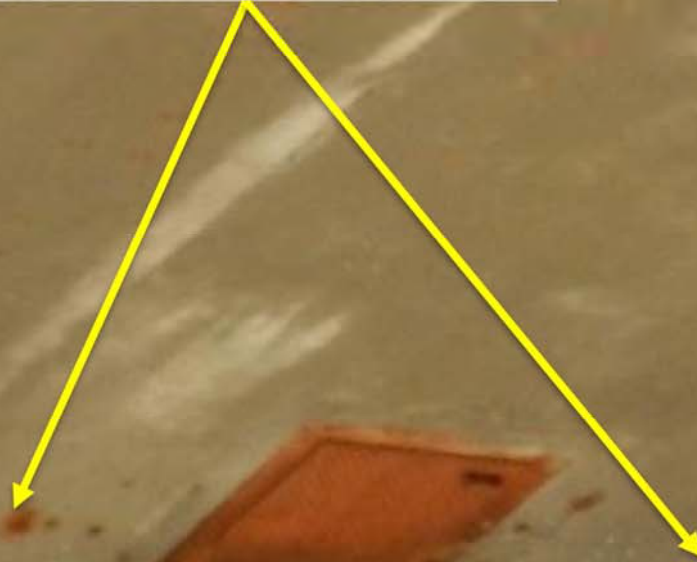
**MINOR MOISTURE, RUST
STAINS ANDHAIRLINE CRACKS
WITH EFFLORESCENCE**

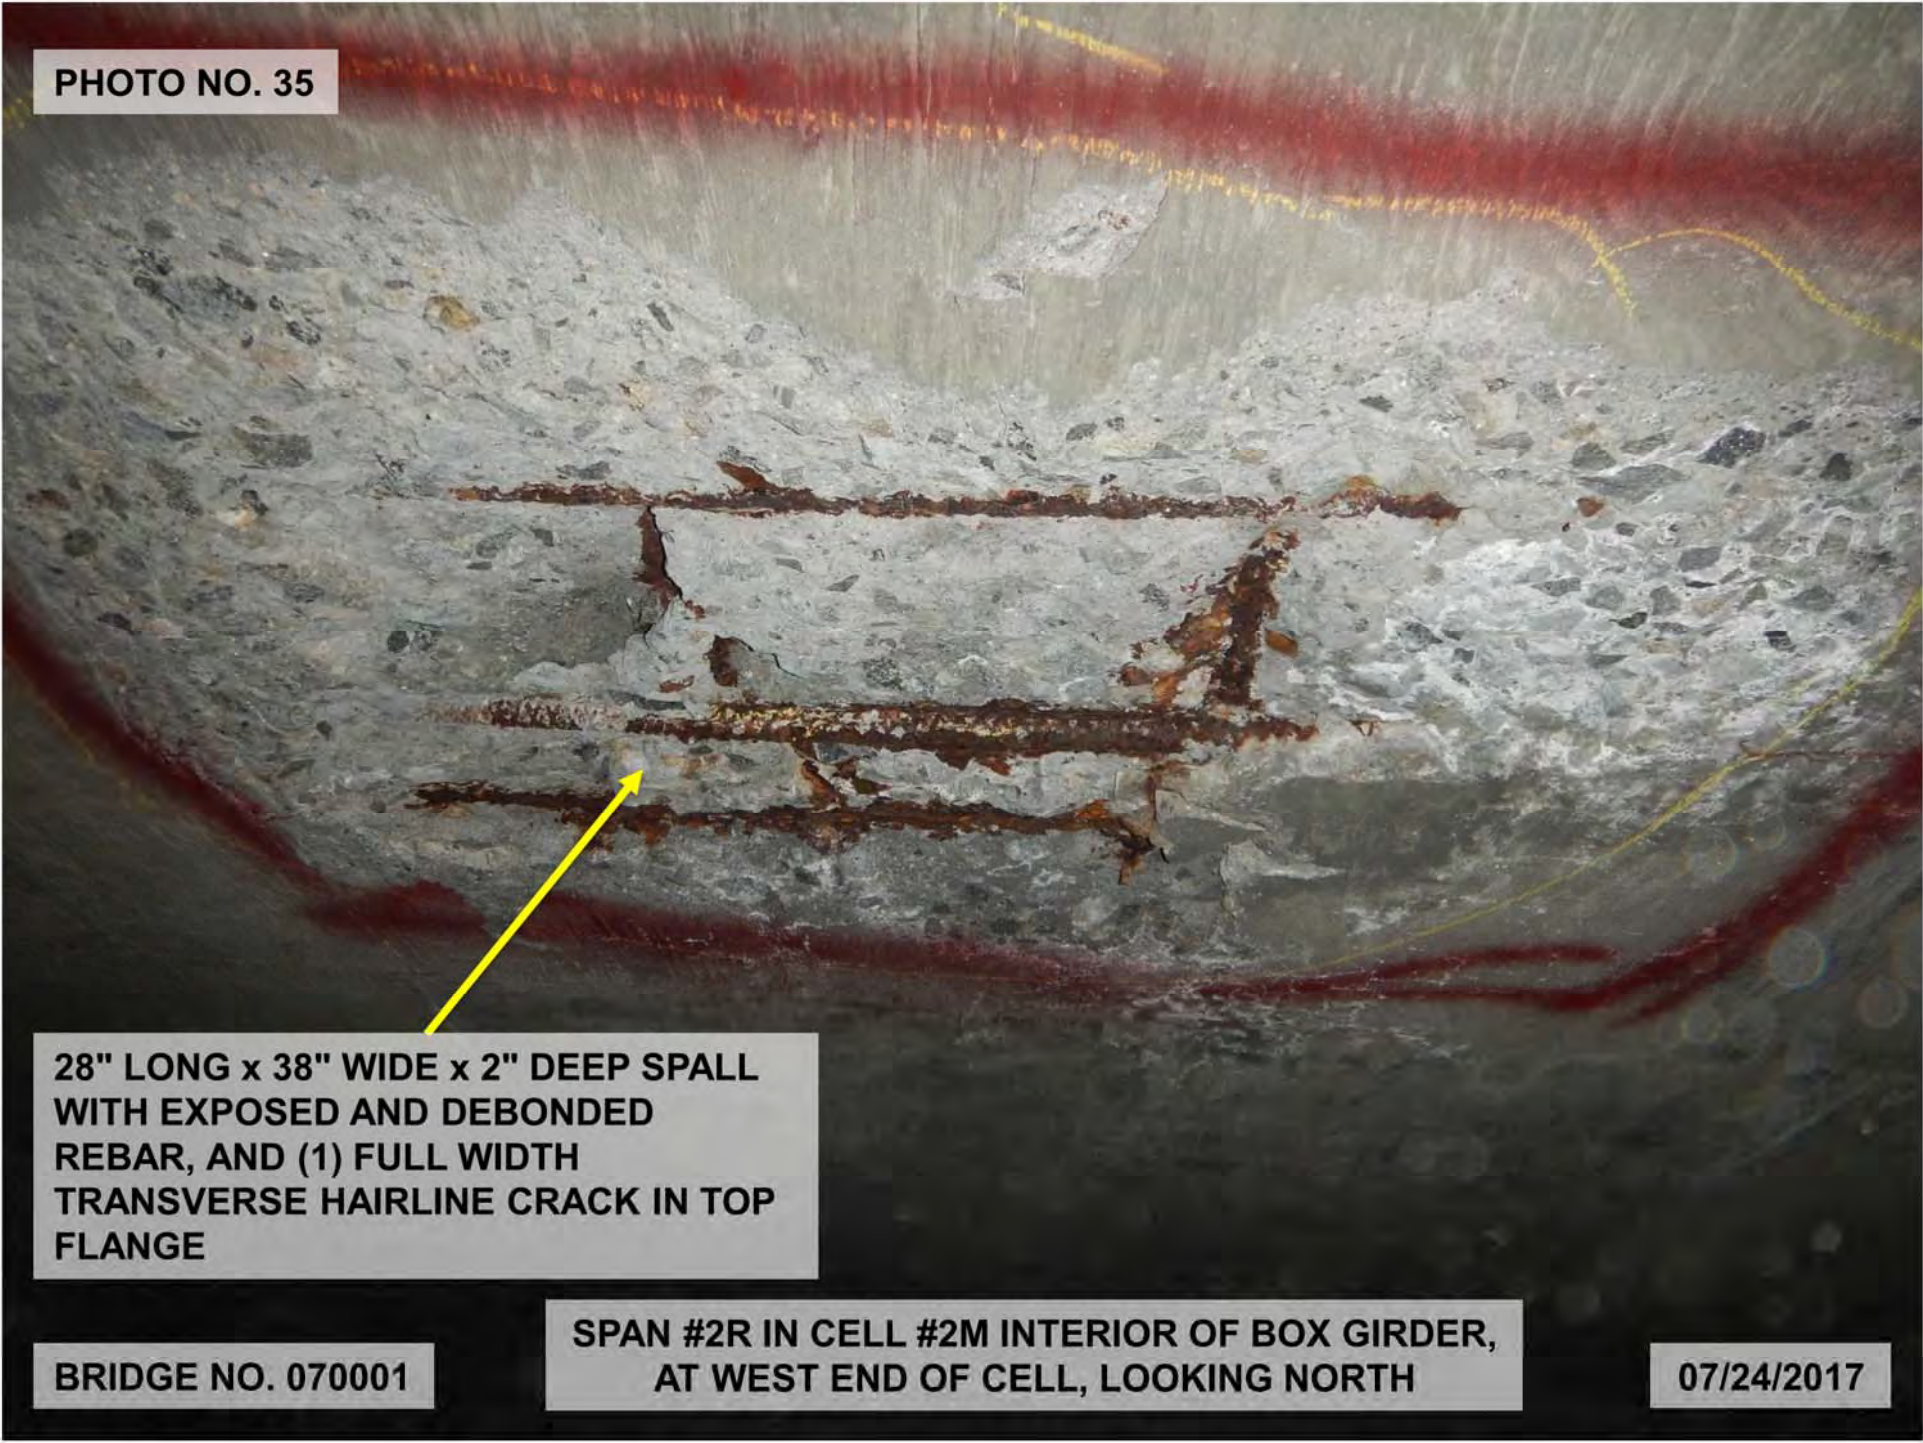
28" LONG x 38" WIDE x 2" DEEP SPALL
WITH EXPOSED AND DEBONDED
REBAR, AND (1) FULL WIDTH
TRANSVERSE HAIRLINE CRACK IN TOP
FLANGE

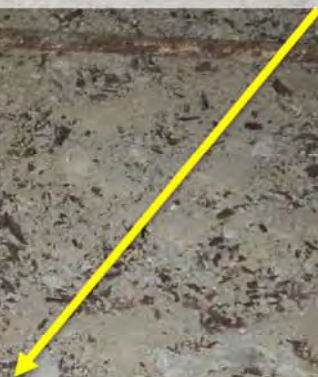
**5' LONG x FULL WIDTH x 2" DEEP
SPALL WITH EXPOSED DEBONDED
REBAR WITH UP TO 90% SECTION
LOSS**

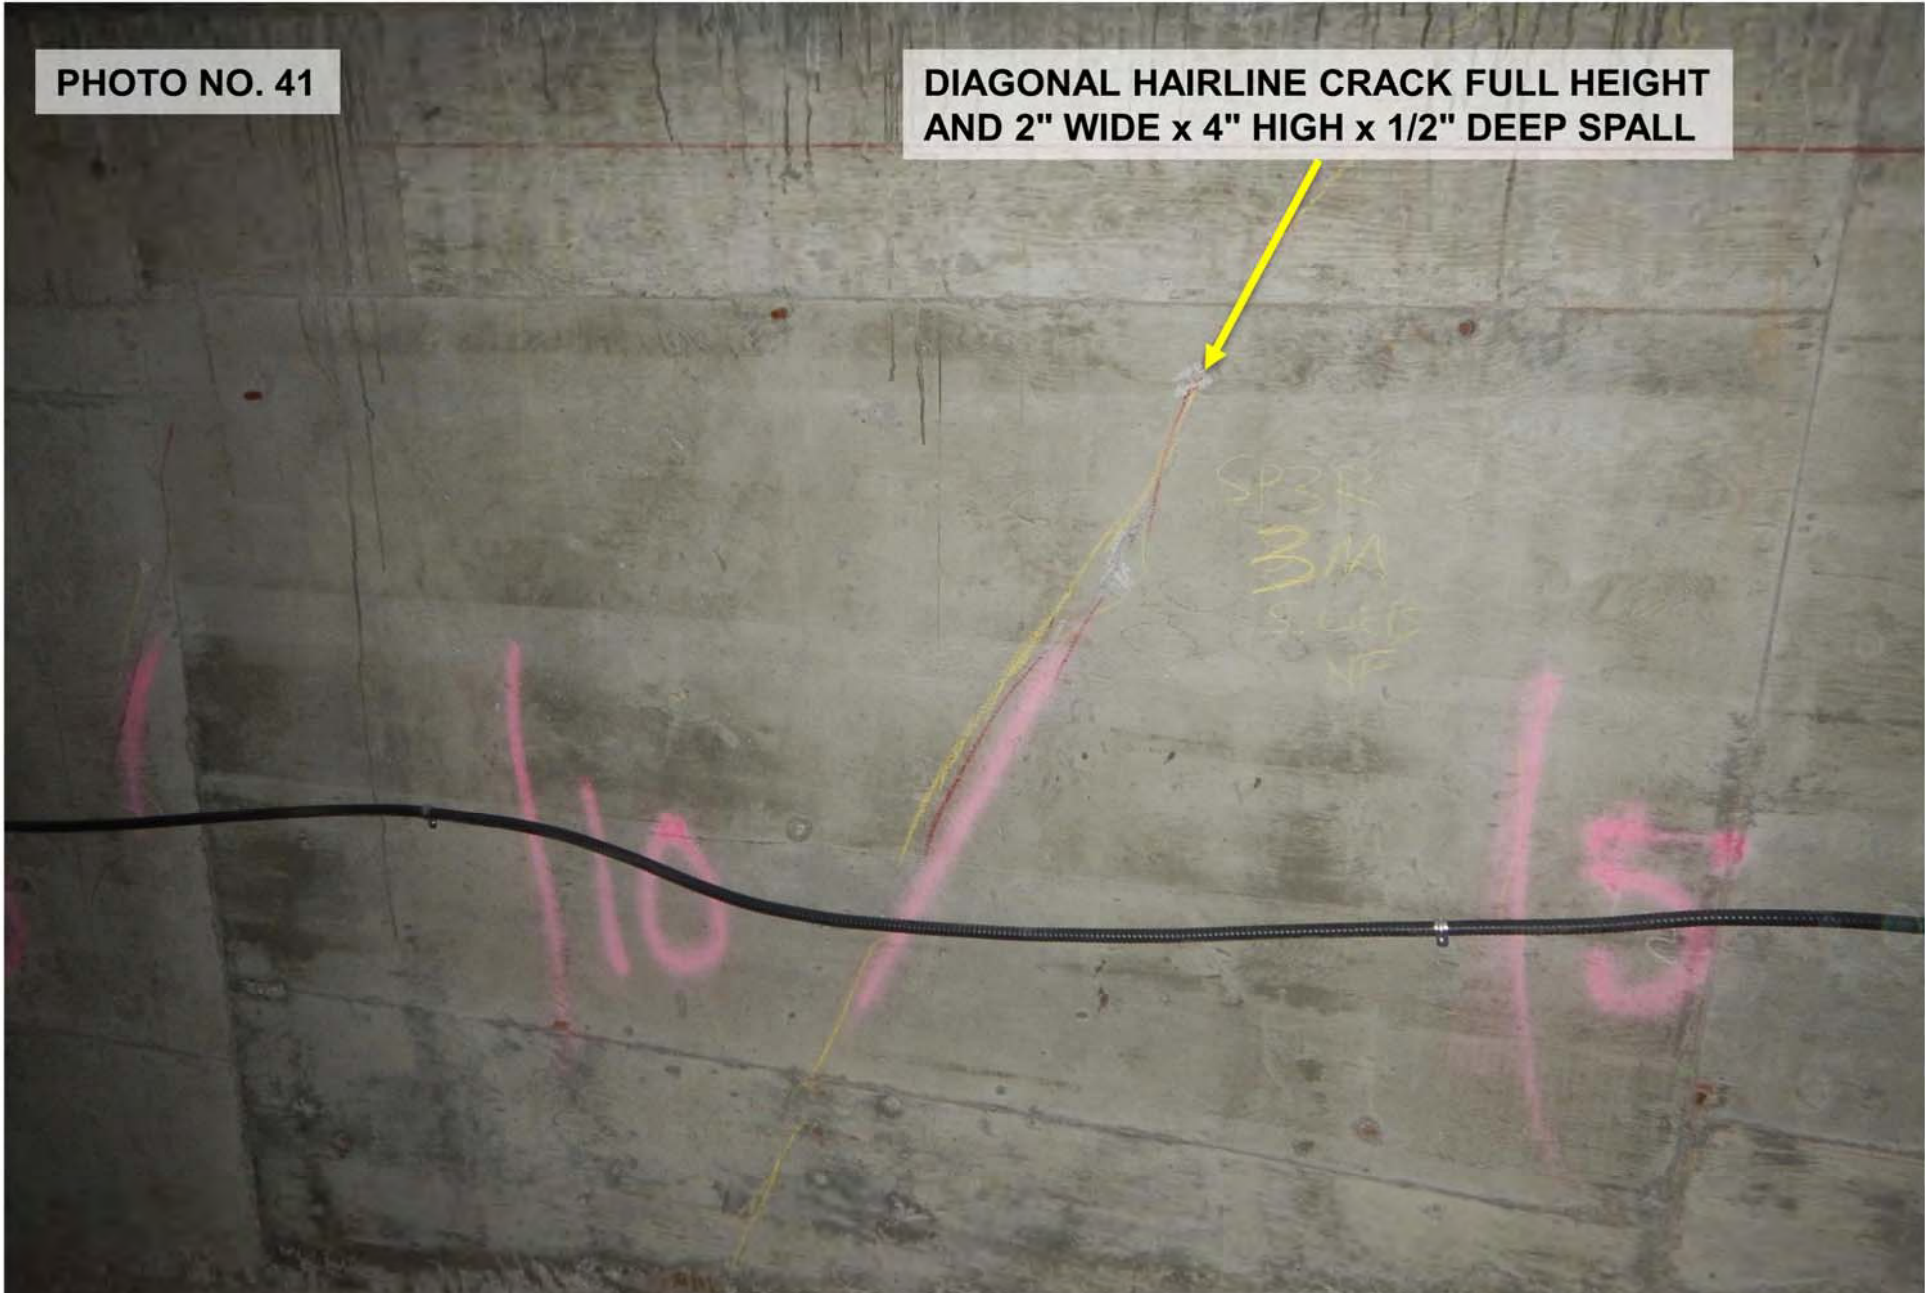
DIAGONAL HAIRLINE CRACK FULL HEIGHT
AND 2" WIDE x 4" HIGH x 1/2" DEEP SPALL

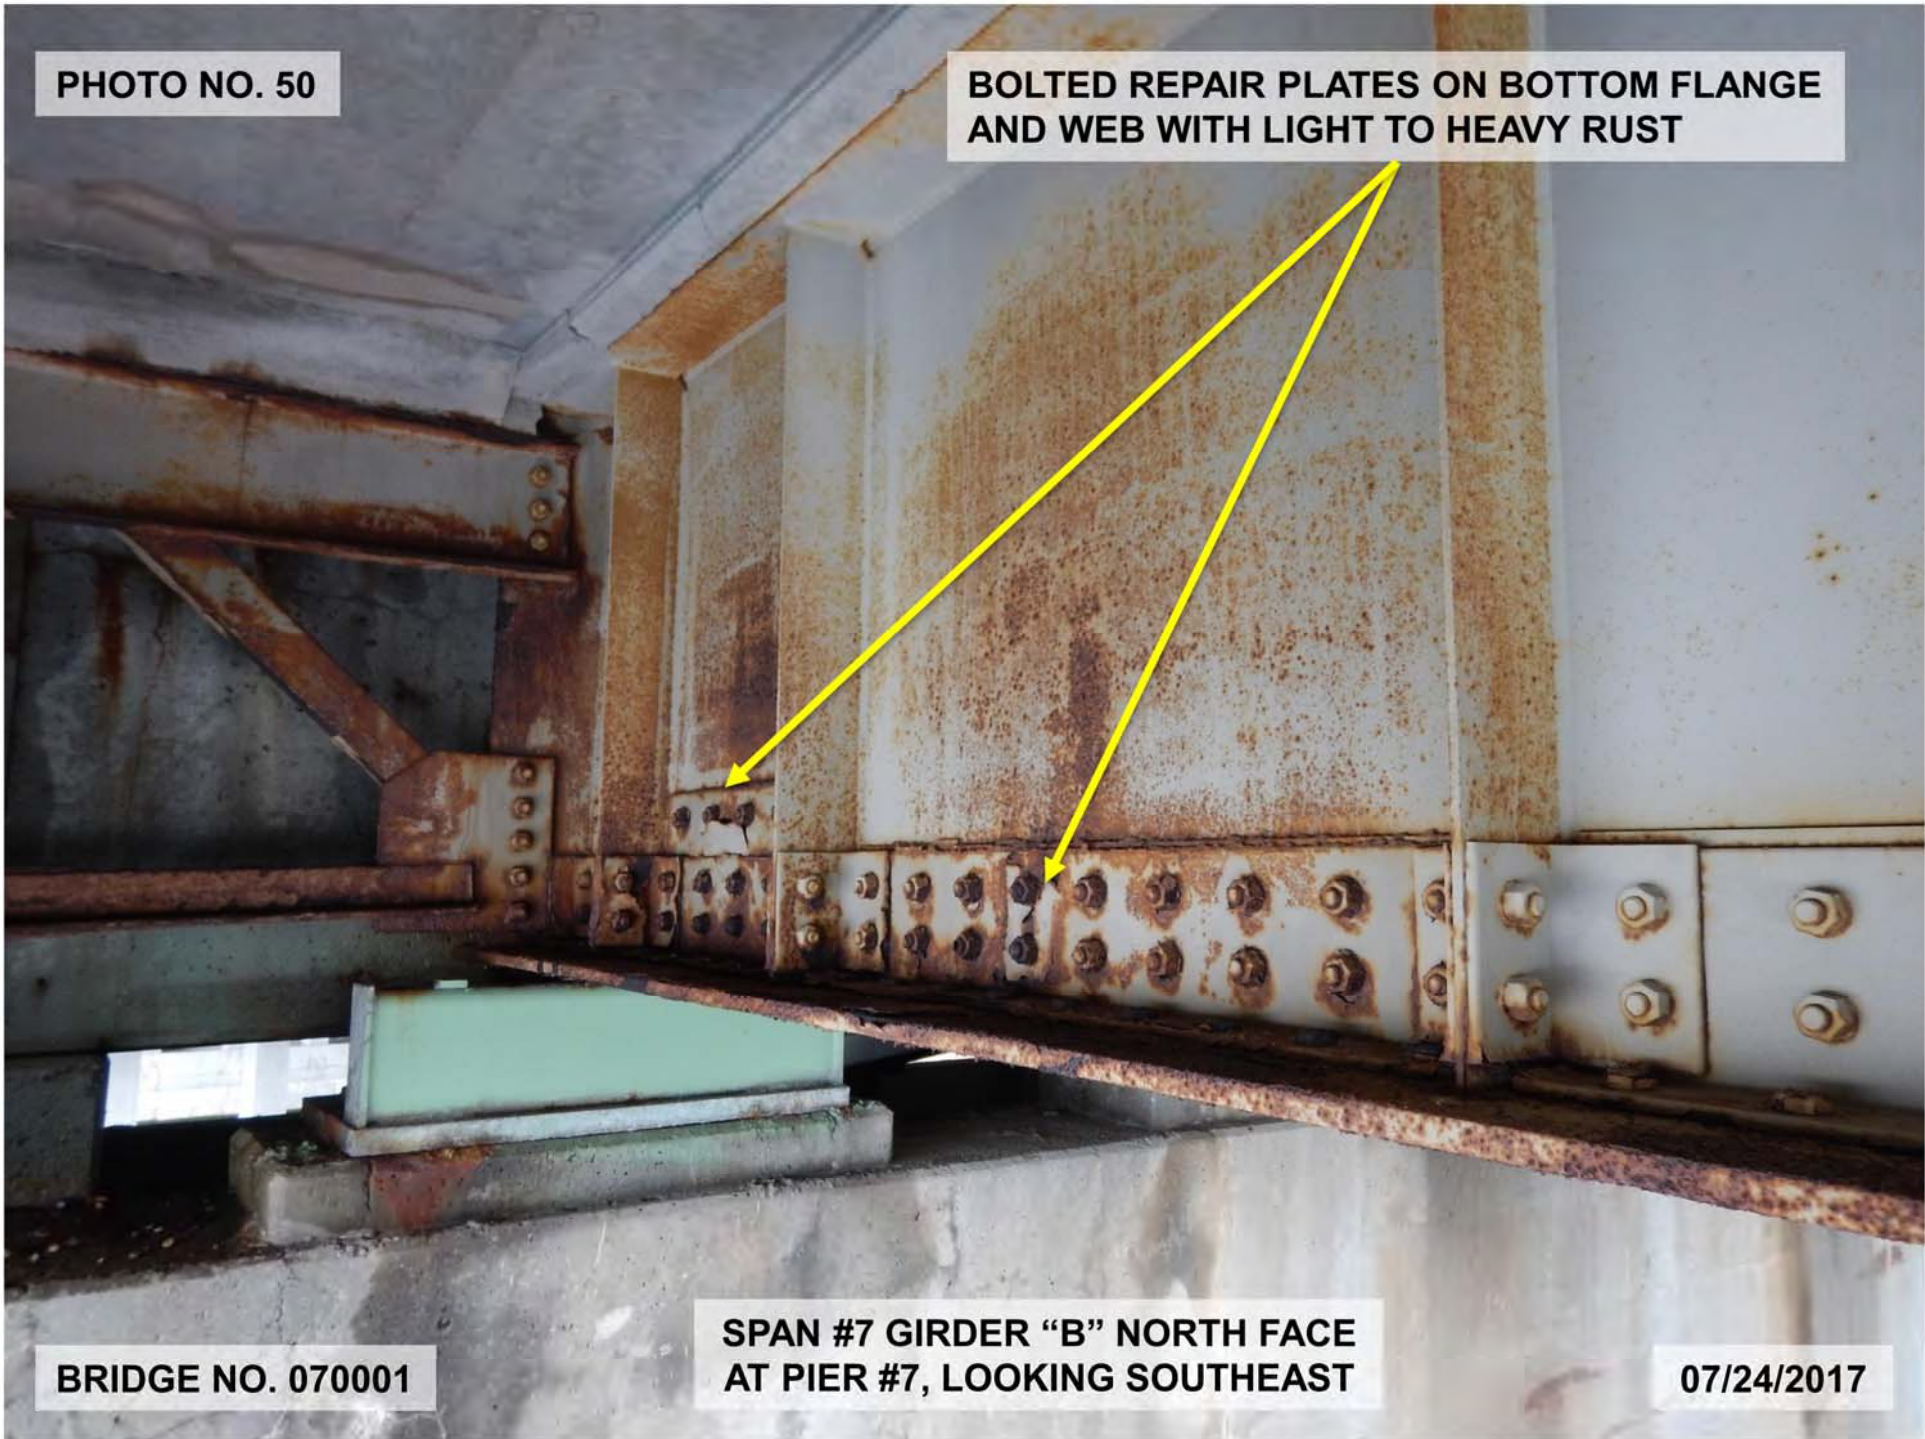
BOLTED REPAIR PLATES ON BOTTOM FLANGE
AND WEB WITH LIGHT TO HEAVY RUST

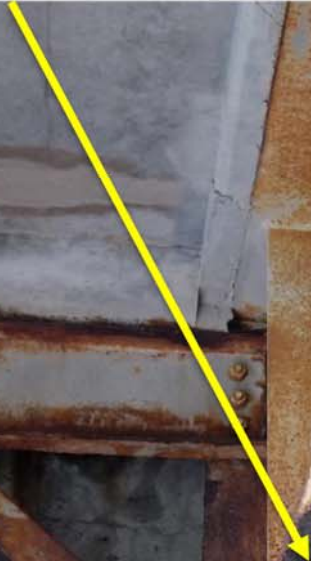
**7' LONG x FULL WIDTH x 1/8" DEEP PITTING
WITH PEELING PAINT AND HEAVY RUST**

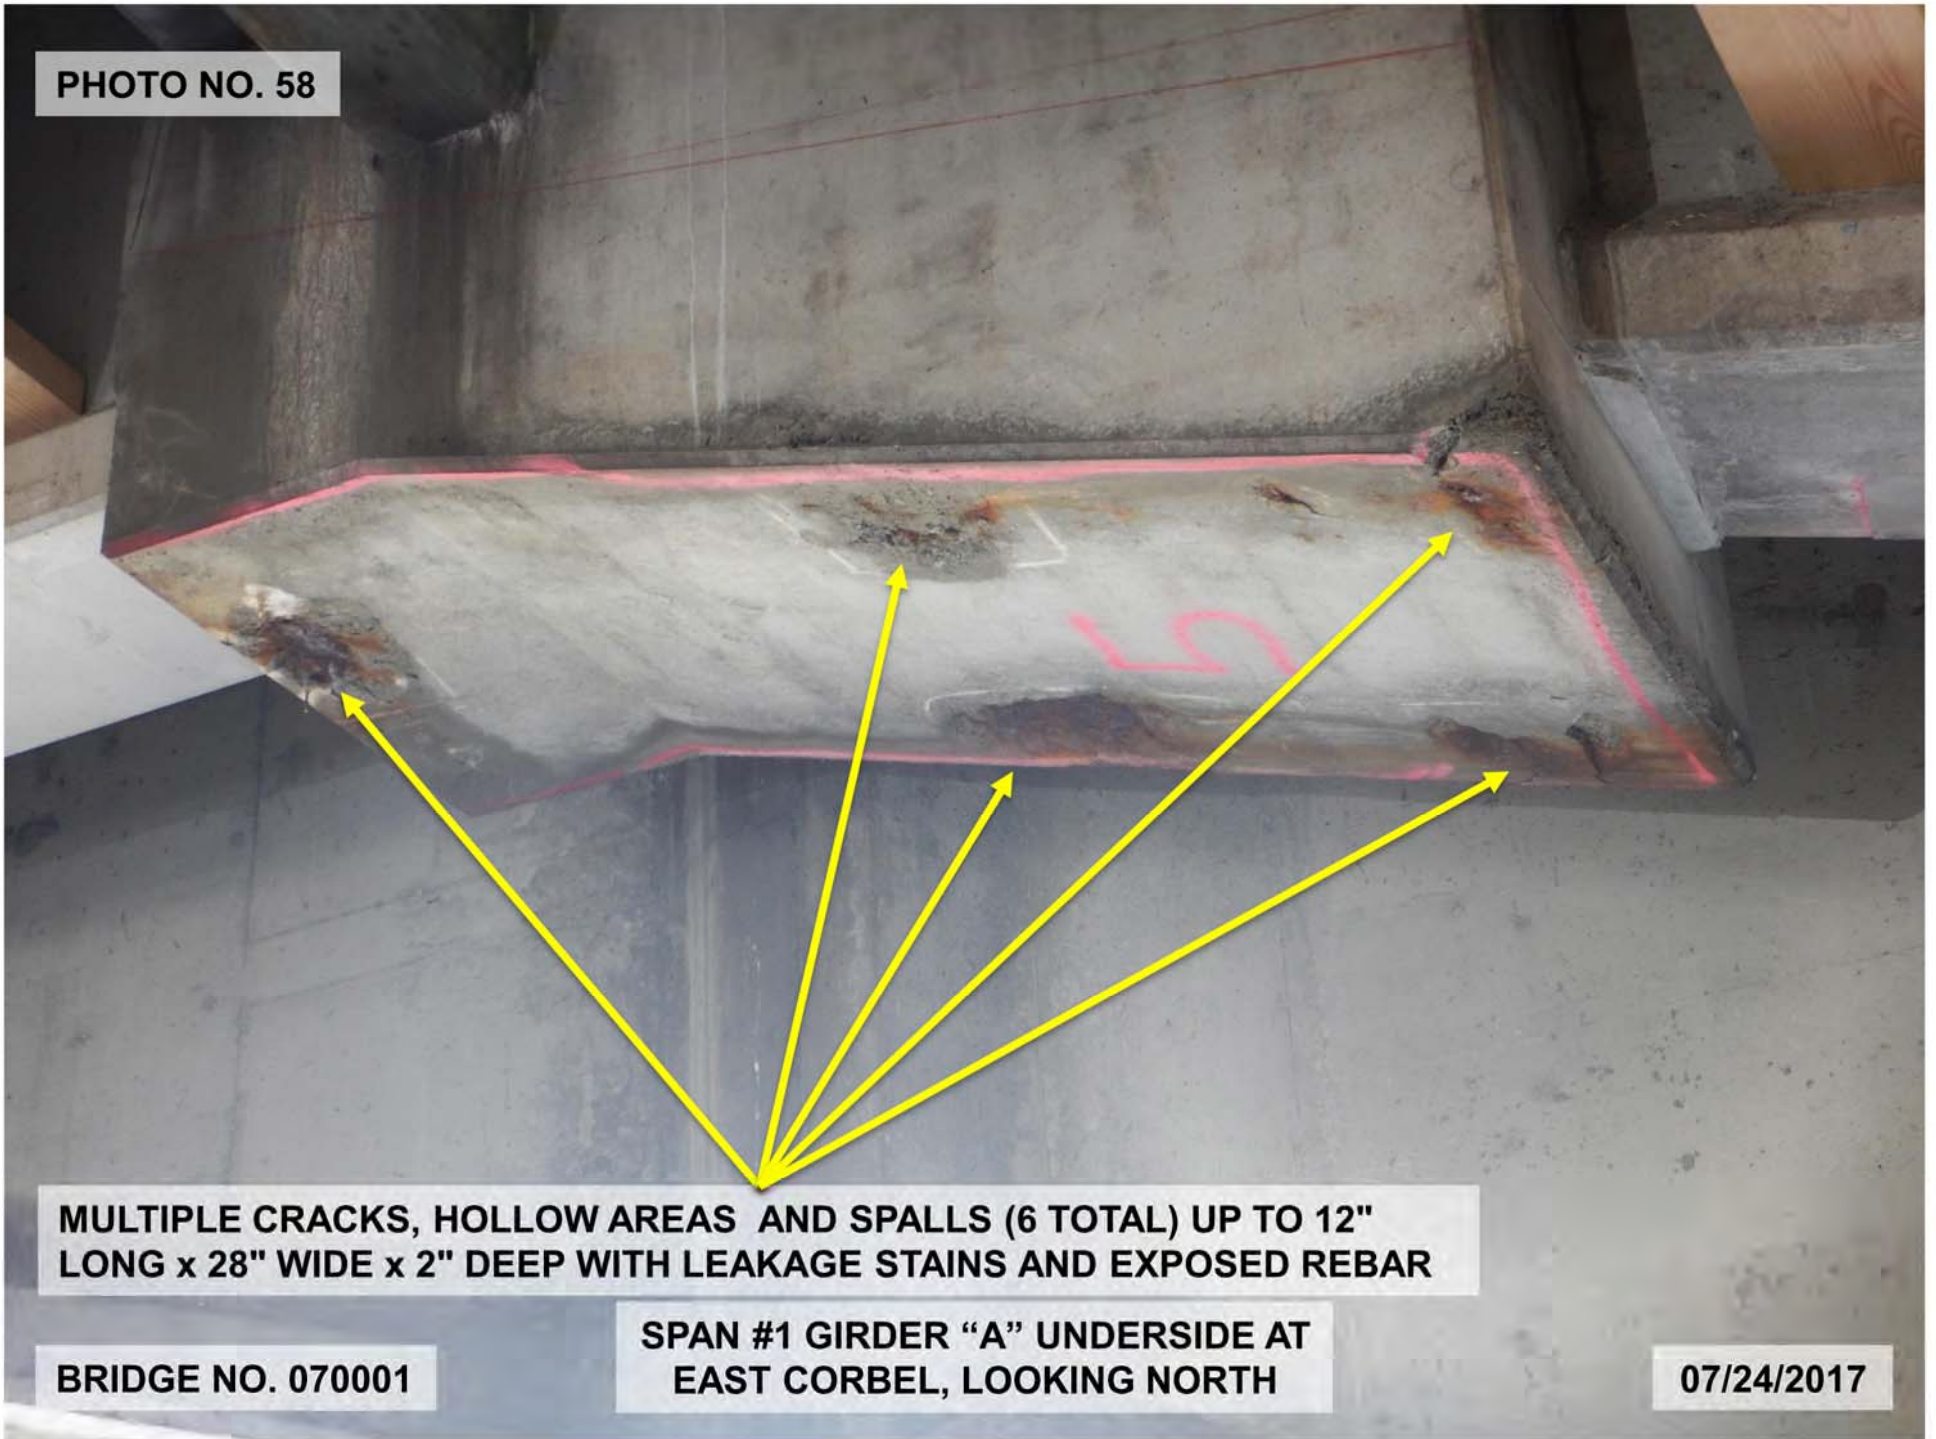
**MULTIPLE CRACKS, HOLLOW AREAS AND SPALLS (6 TOTAL) UP TO 12"
LONG x 28" WIDE x 2" DEEP WITH LEAKAGE STAINS AND EXPOSED REBAR**

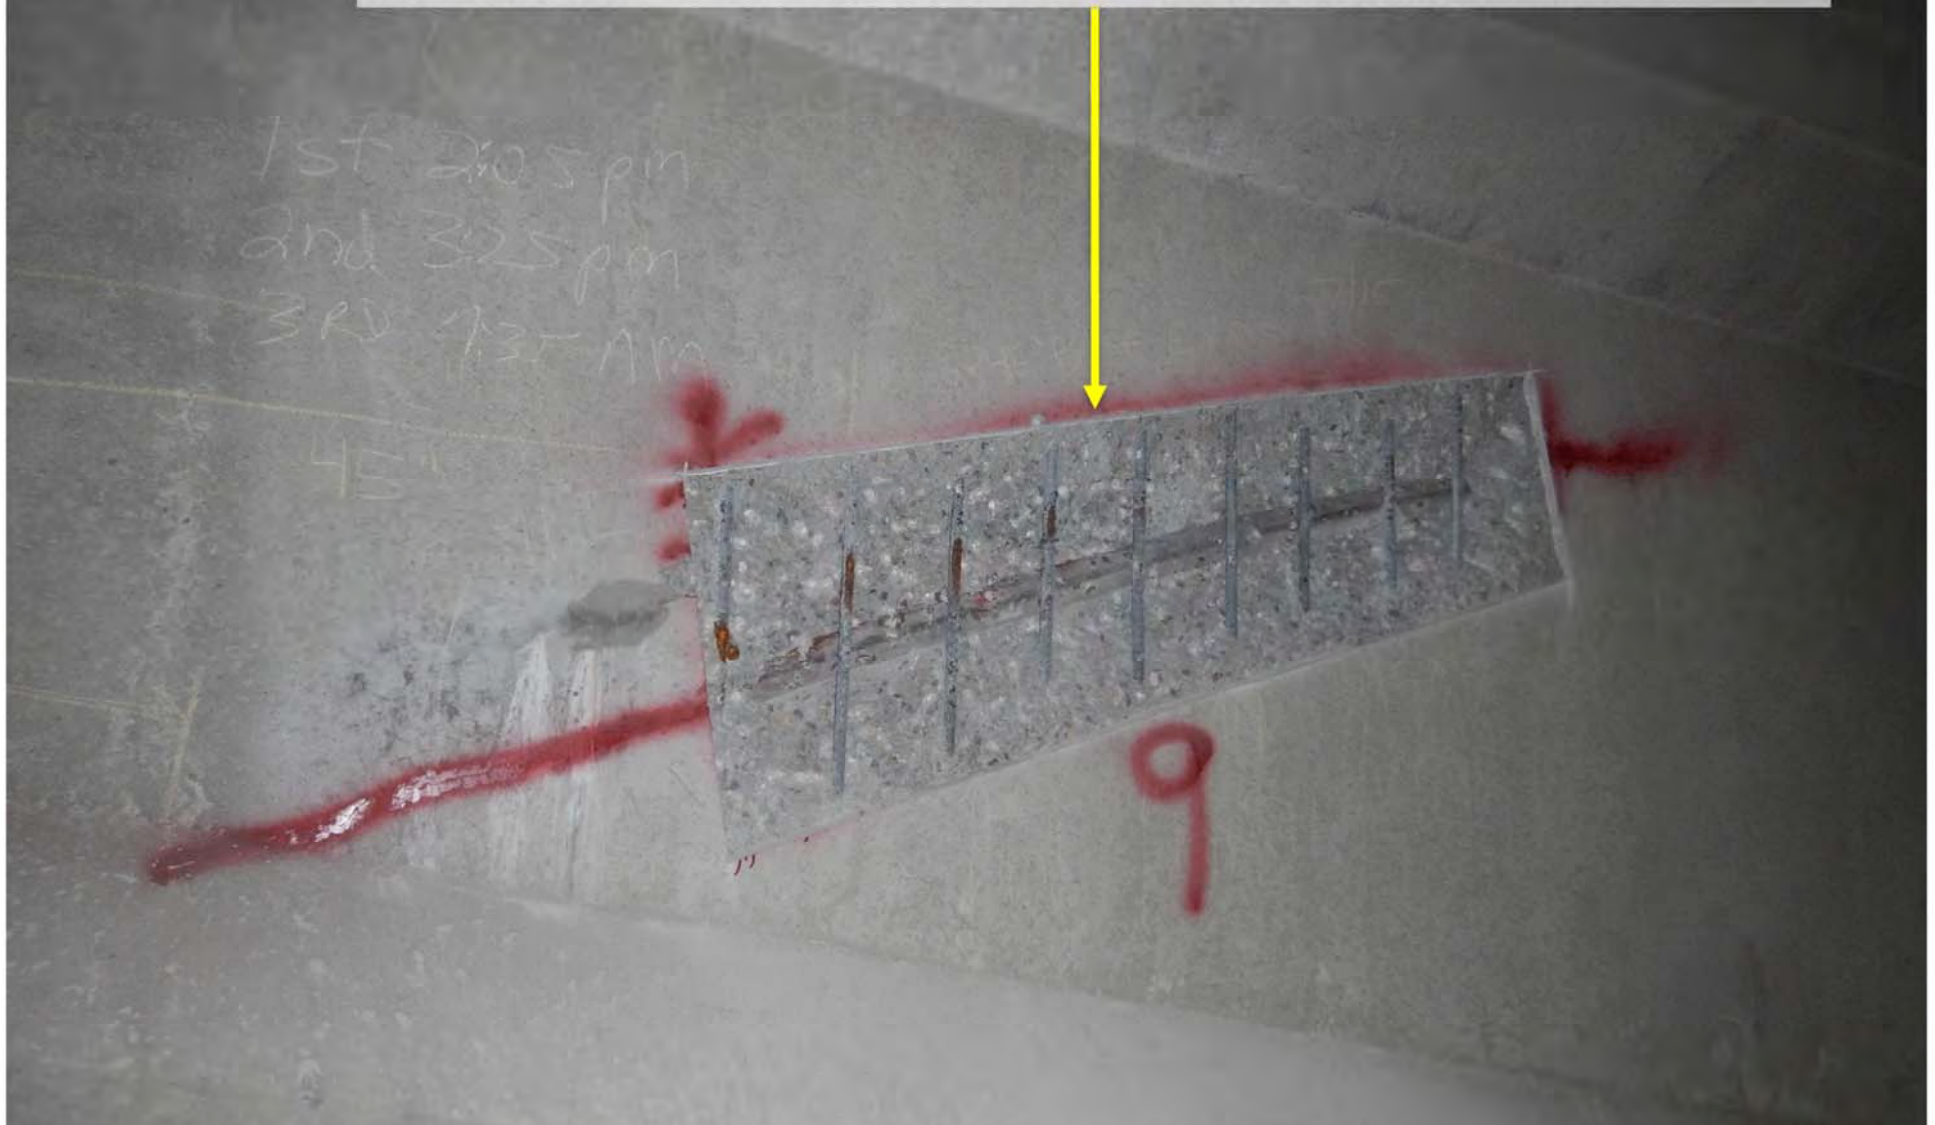
114" LONG DIAGONAL HAIRLINE CRACK WITHIN 5' LONG x 15" HIGH HOLLOW AREA WITH EDGE SPALLING UP TO 1/2" DEEP AND EFFLORESCENCE

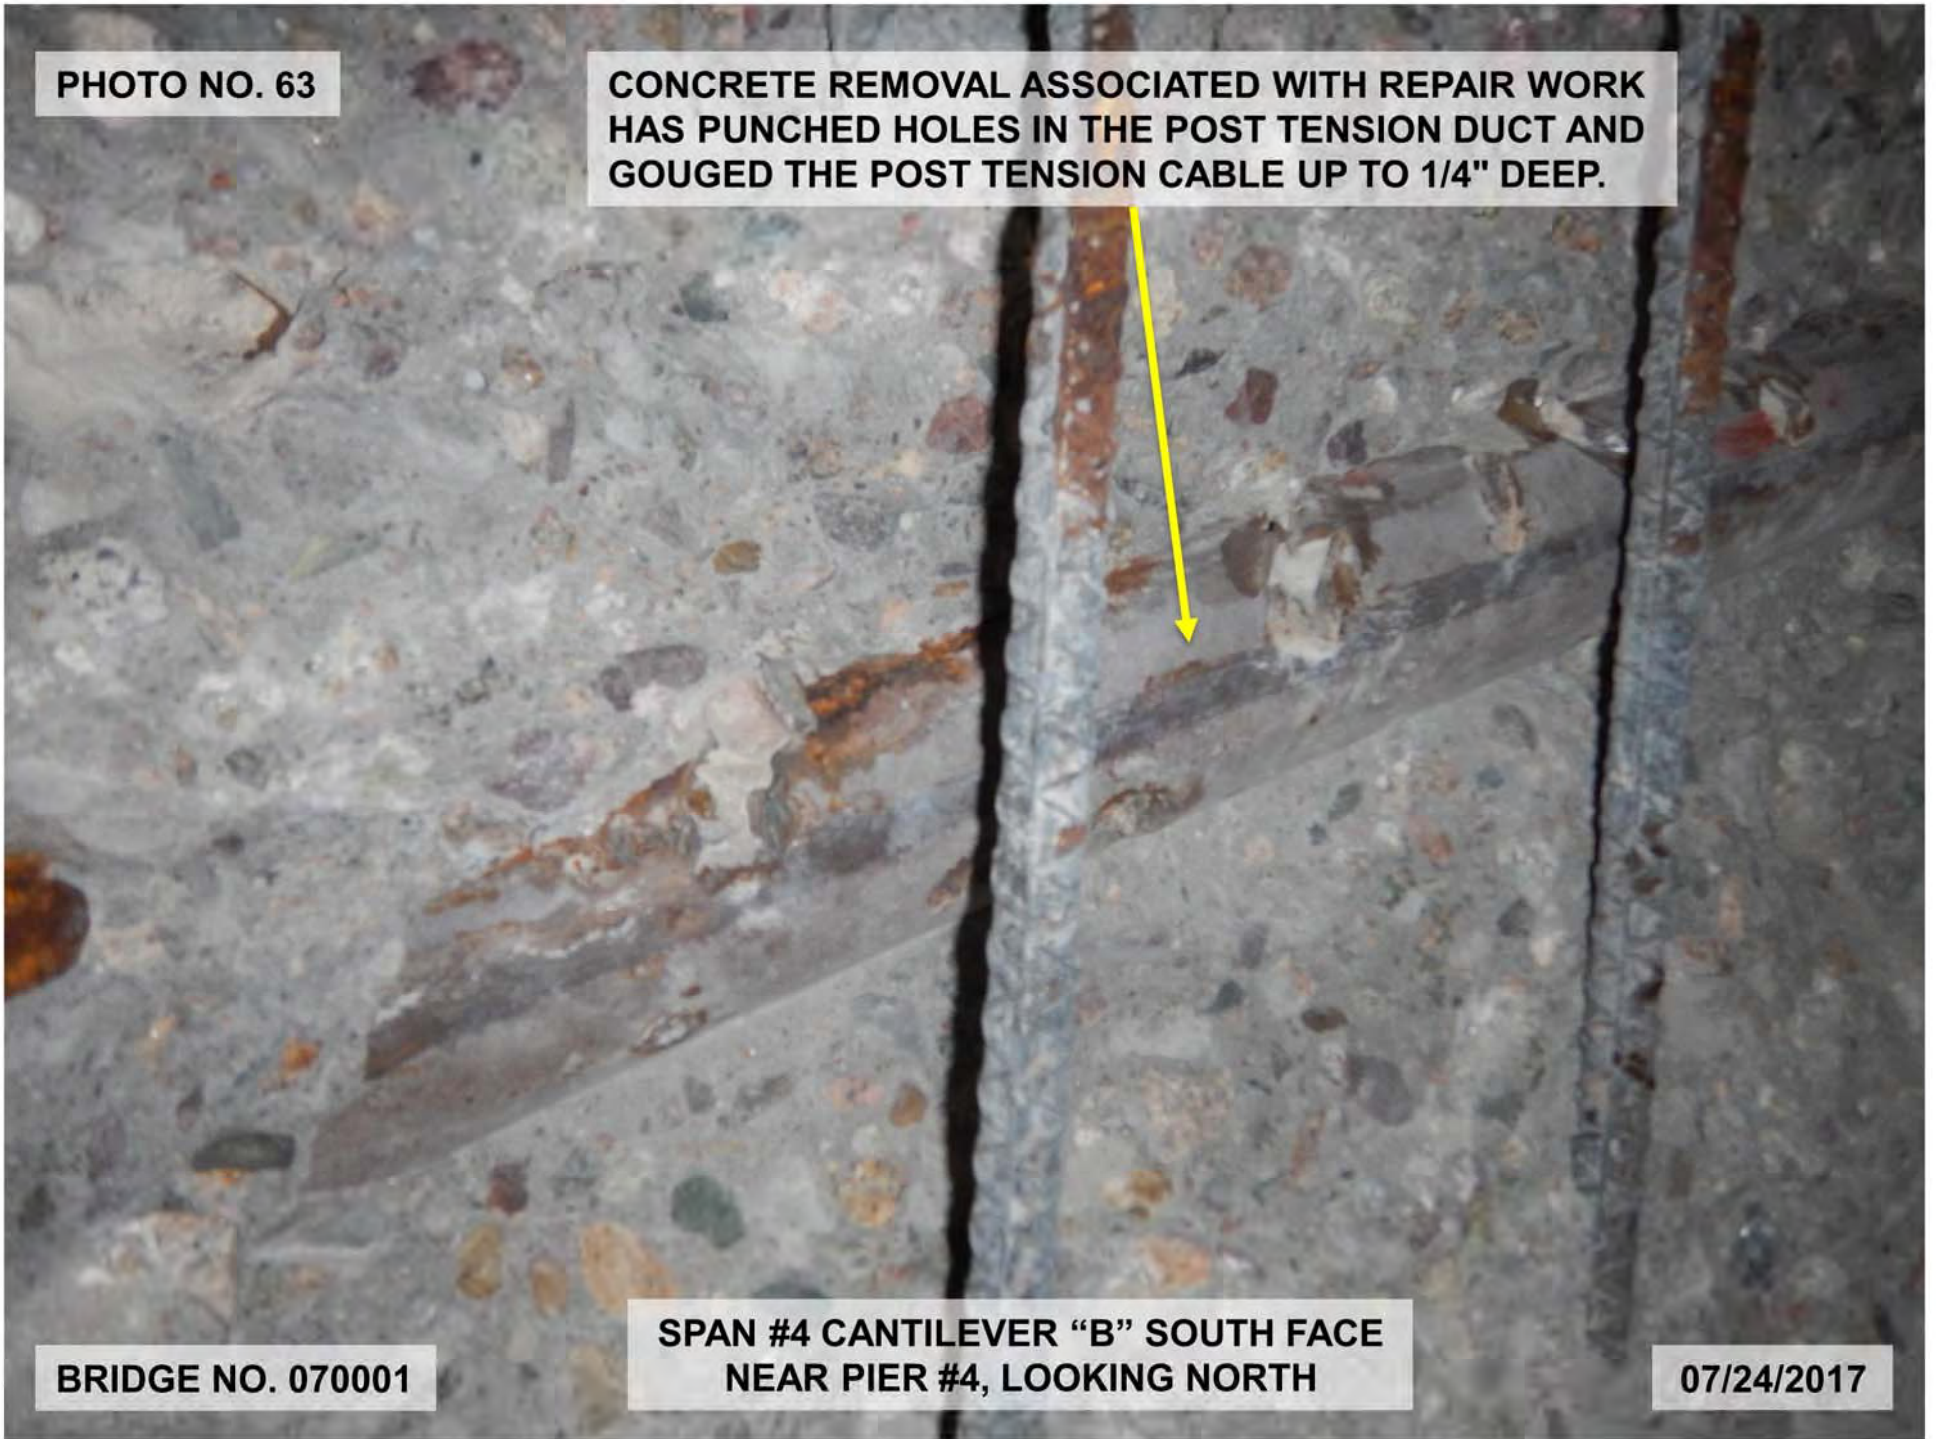
**CONCRETE REMOVAL ASSOCIATED WITH REPAIR WORK
HAS PUNCHED HOLES IN THE POST TENSION DUCT AND
GOUGED THE POST TENSION CABLE UP TO 1/4" DEEP.**

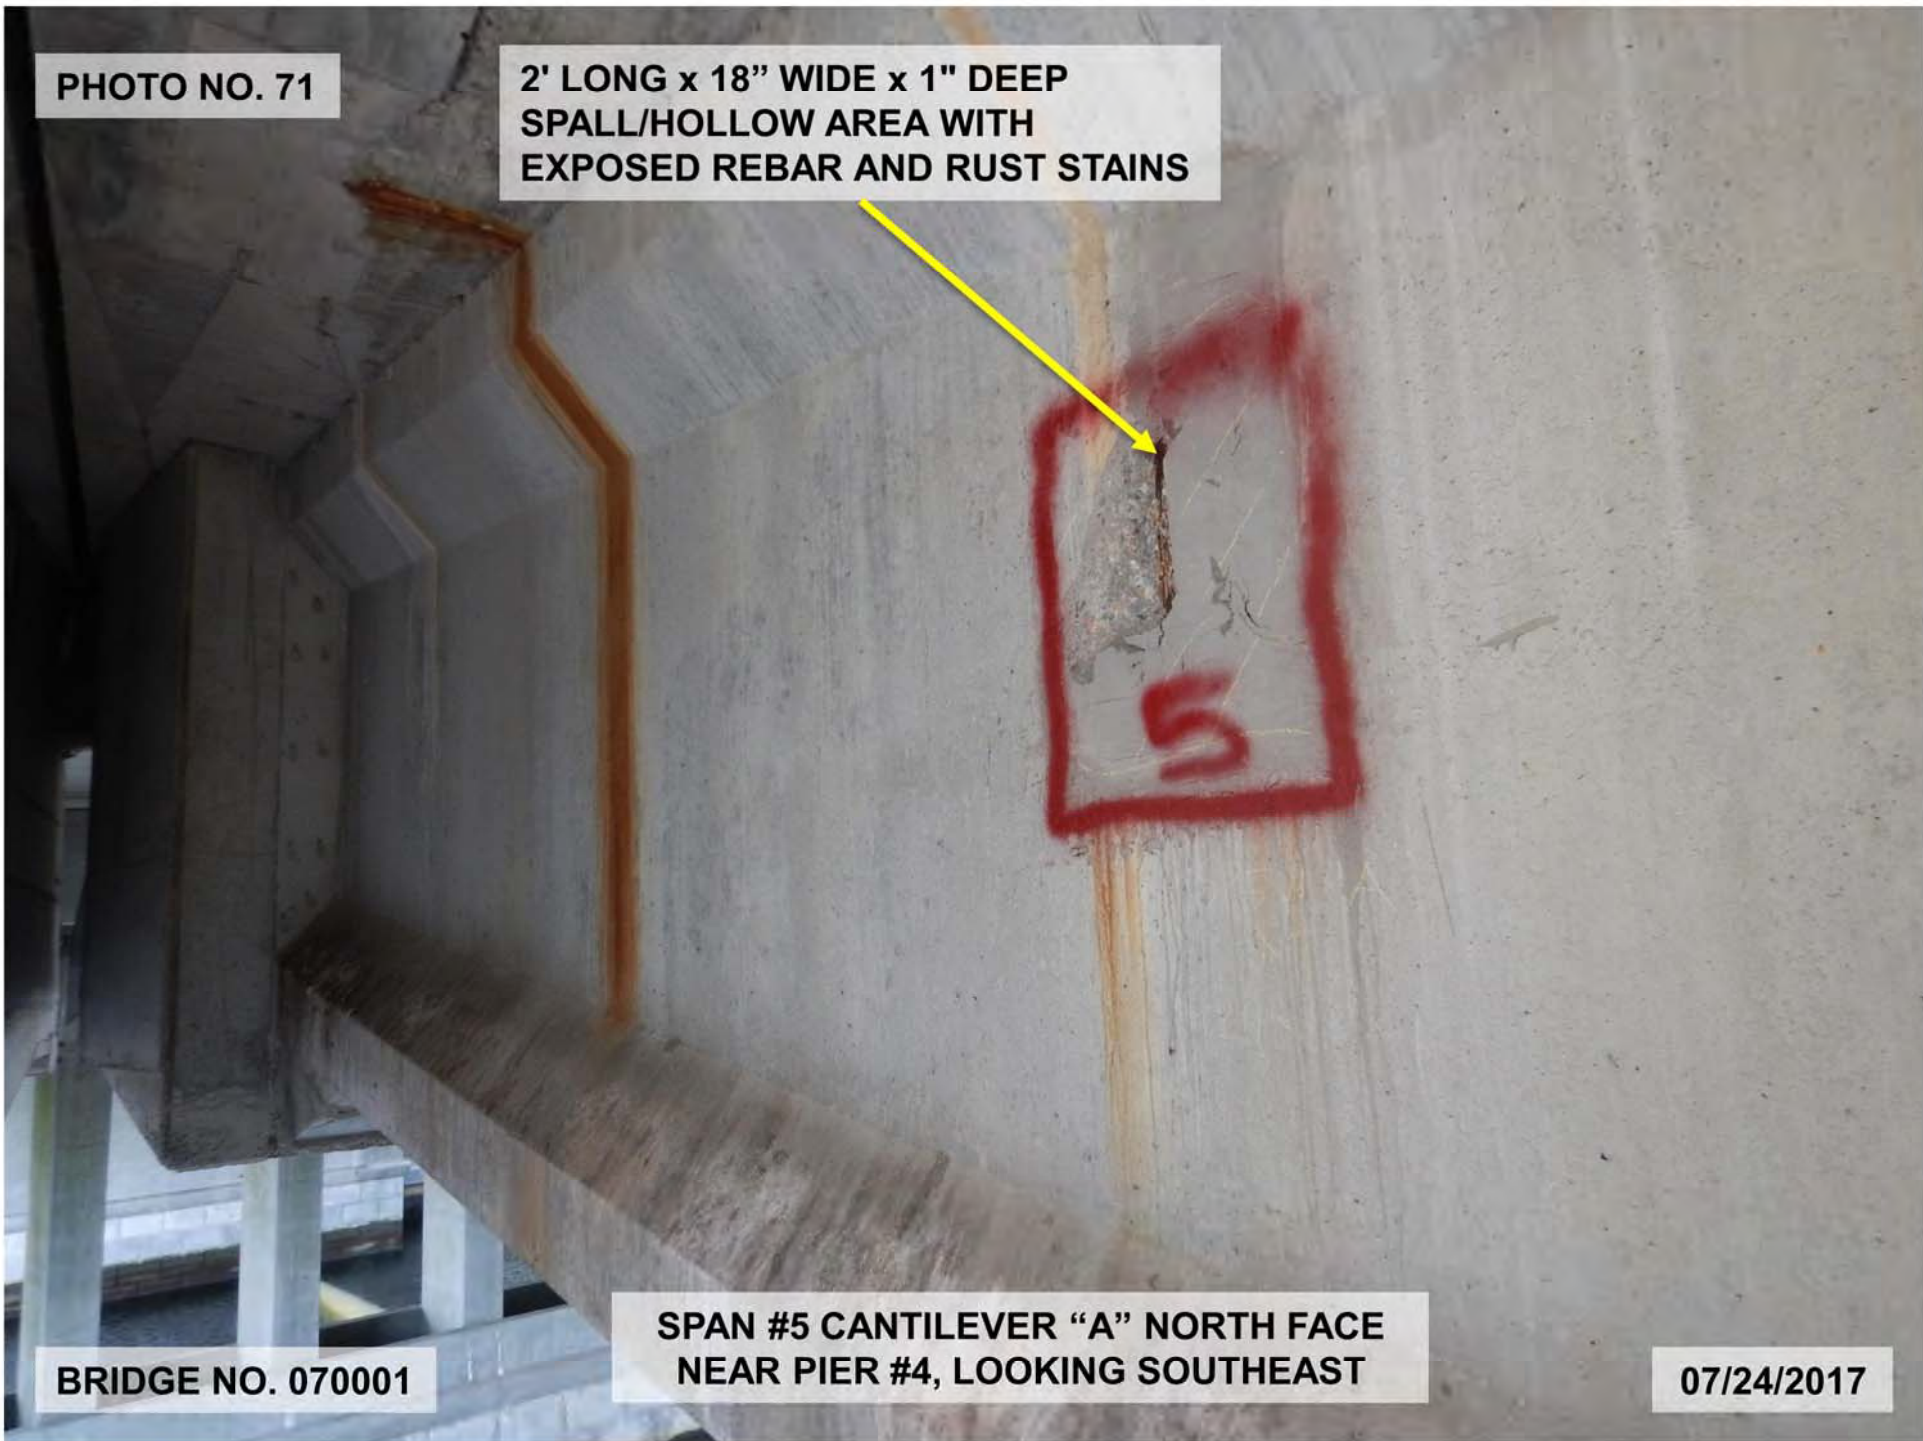
2' LONG x 18" WIDE x 1" DEEP
SPALL/HOLLOW AREA WITH
EXPOSED REBAR AND RUST STAINS

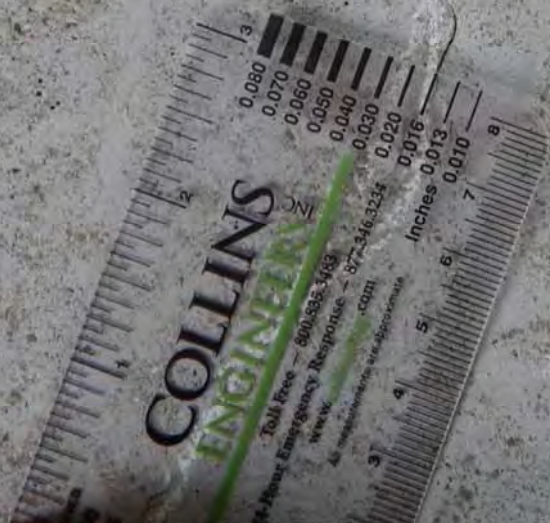
3' LONG HAIRLINE
VERTICAL CRACK

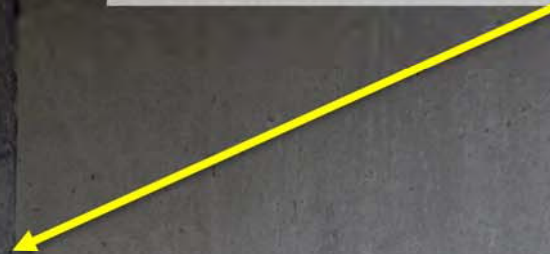
16" LONG x 60" HIGH HOLLOW AREA WITH 1/2" DEEP SPALLING OVER THE PEDESTAL AND EFFLORESCENCE
