PHOTO NO. 1

BRIDGE NO. 070001

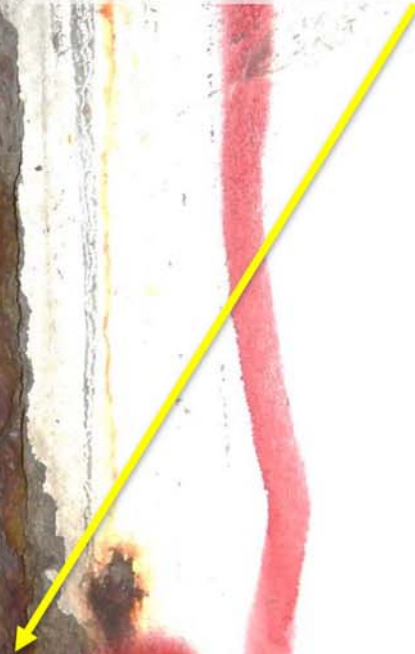
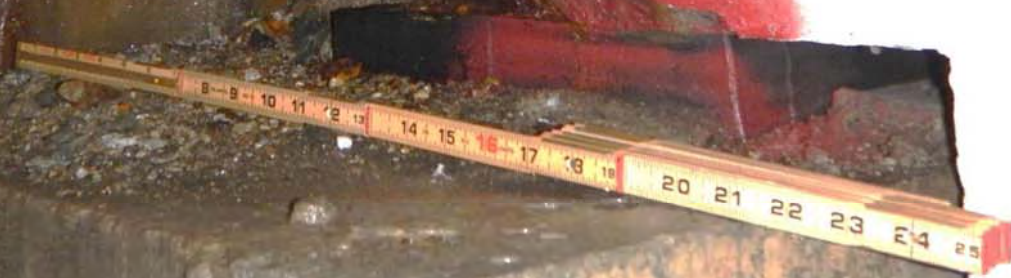
12" LONG x FULL HEIGHT x 7" DEEP
SPALL WITH EXPOSED AND
DEBONDED REBAR. LOSS OF BEARING
UP TO 10" LONG x 5" WIDE

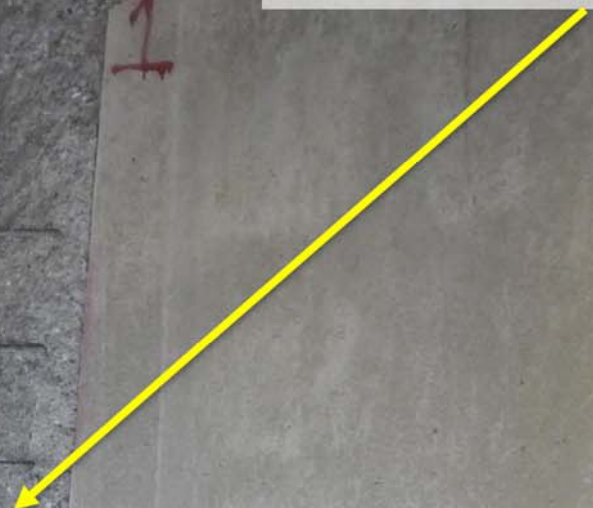
**SPAN #9 CANTILEVER "A" SOUTH FACE AT
PIER #8, LOOKING NORTHWEST**

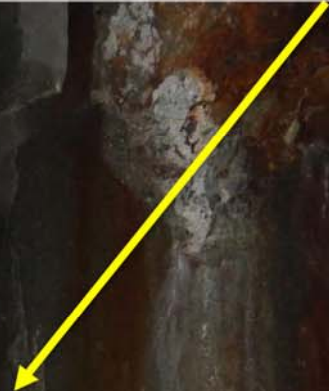
12" LONG x FULL HEIGHT x 3" DEEP SPALL WITH
EXPOSED AND DEBONDED REBAR AND LOSS OF
BEARING 7" LONG x 2" WIDE

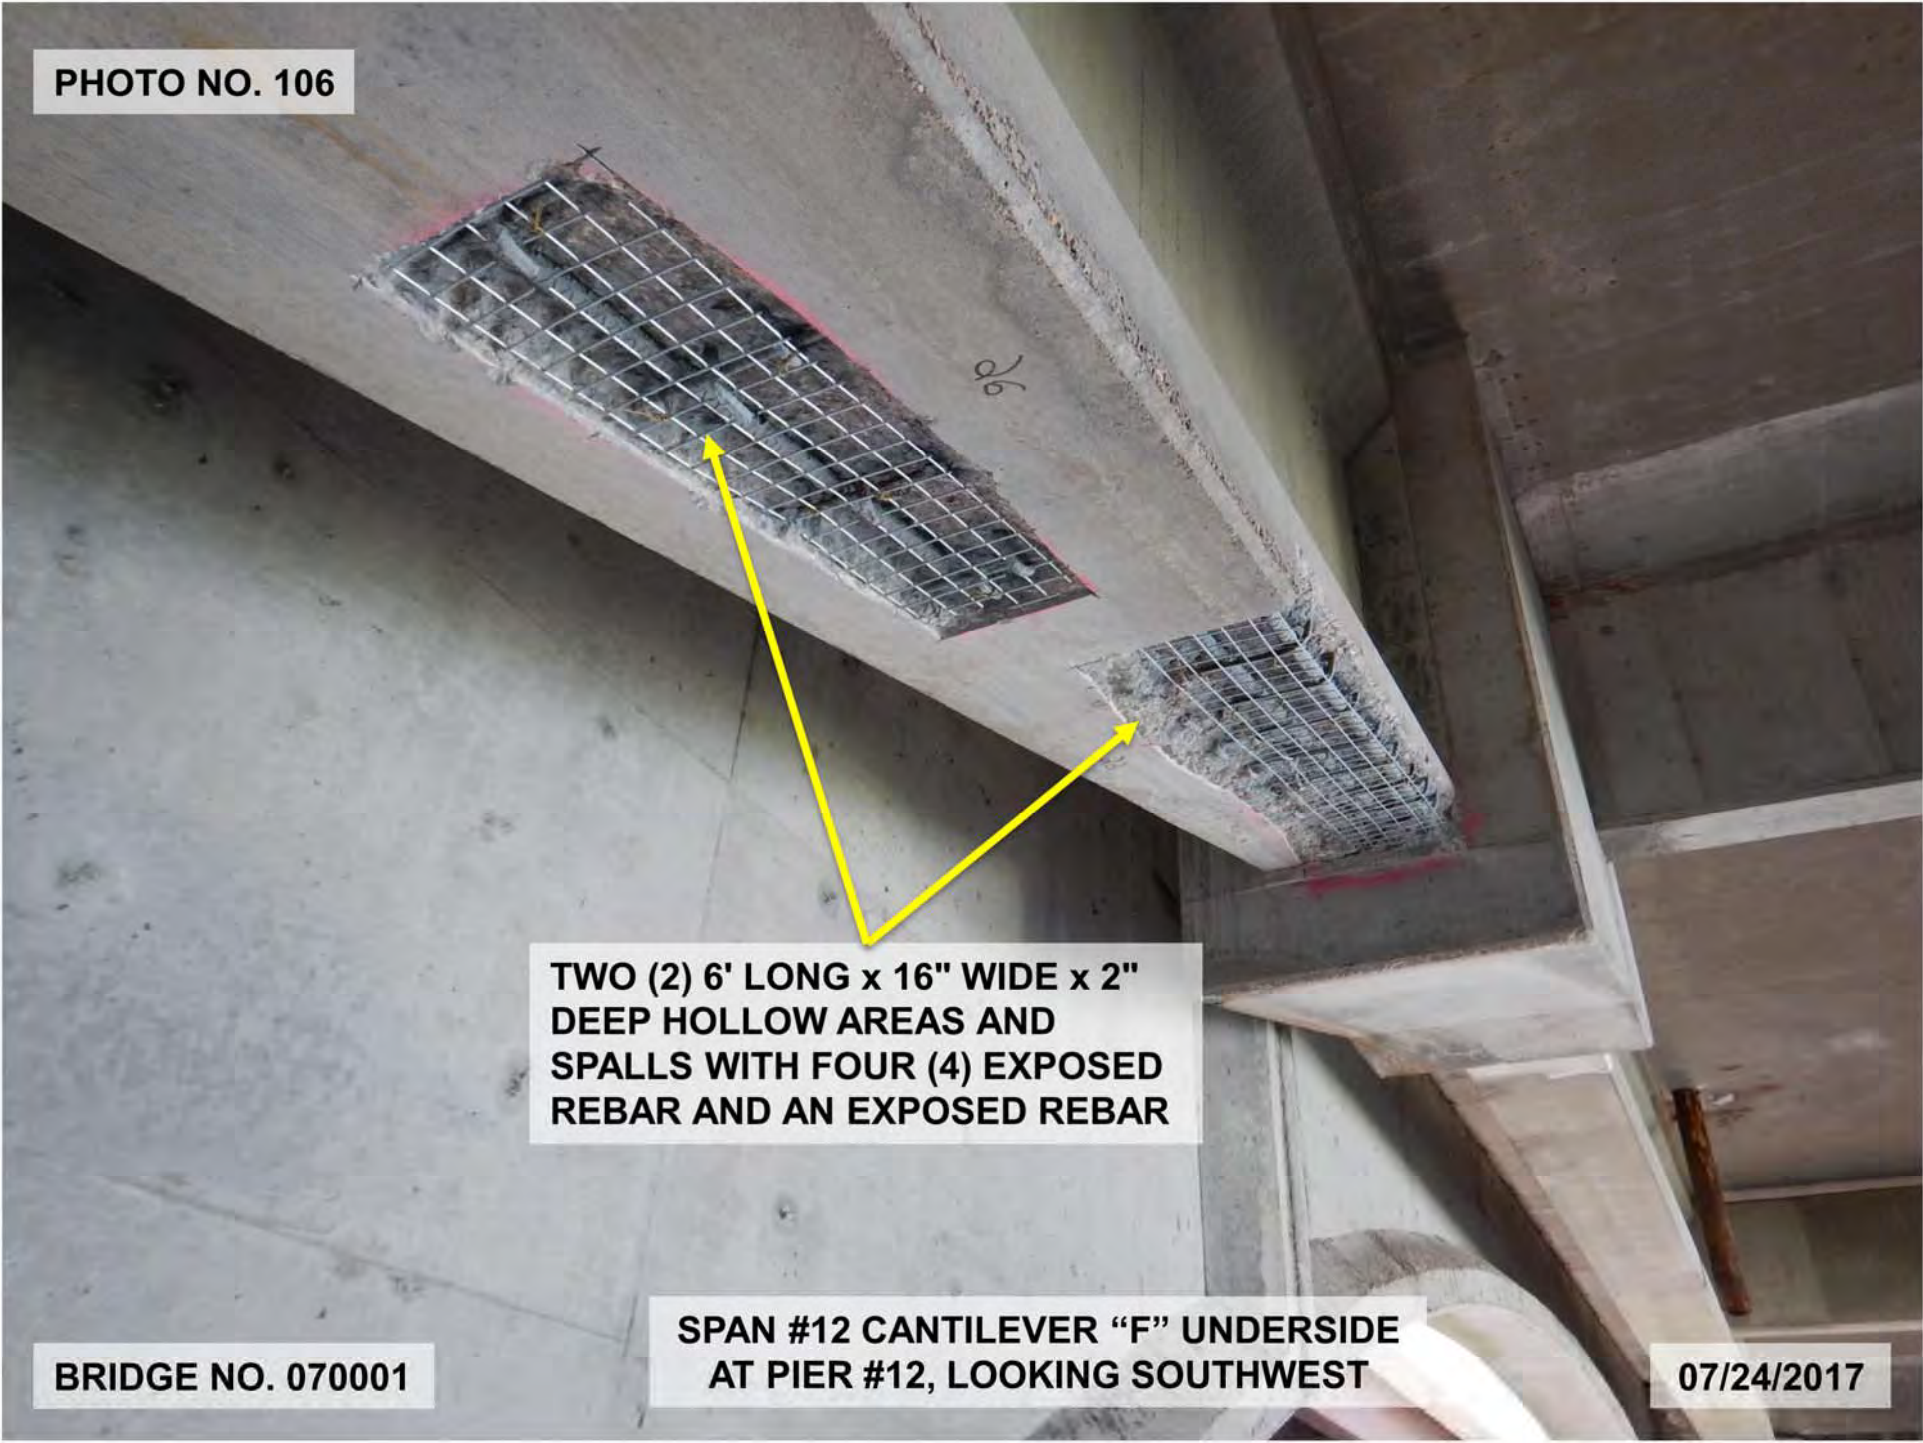
TWO (2) 6' LONG x 16" WIDE x 2"
DEEP HOLLOW AREAS AND
SPALLS WITH FOUR (4) EXPOSED
REBAR AND AN EXPOSED REBAR

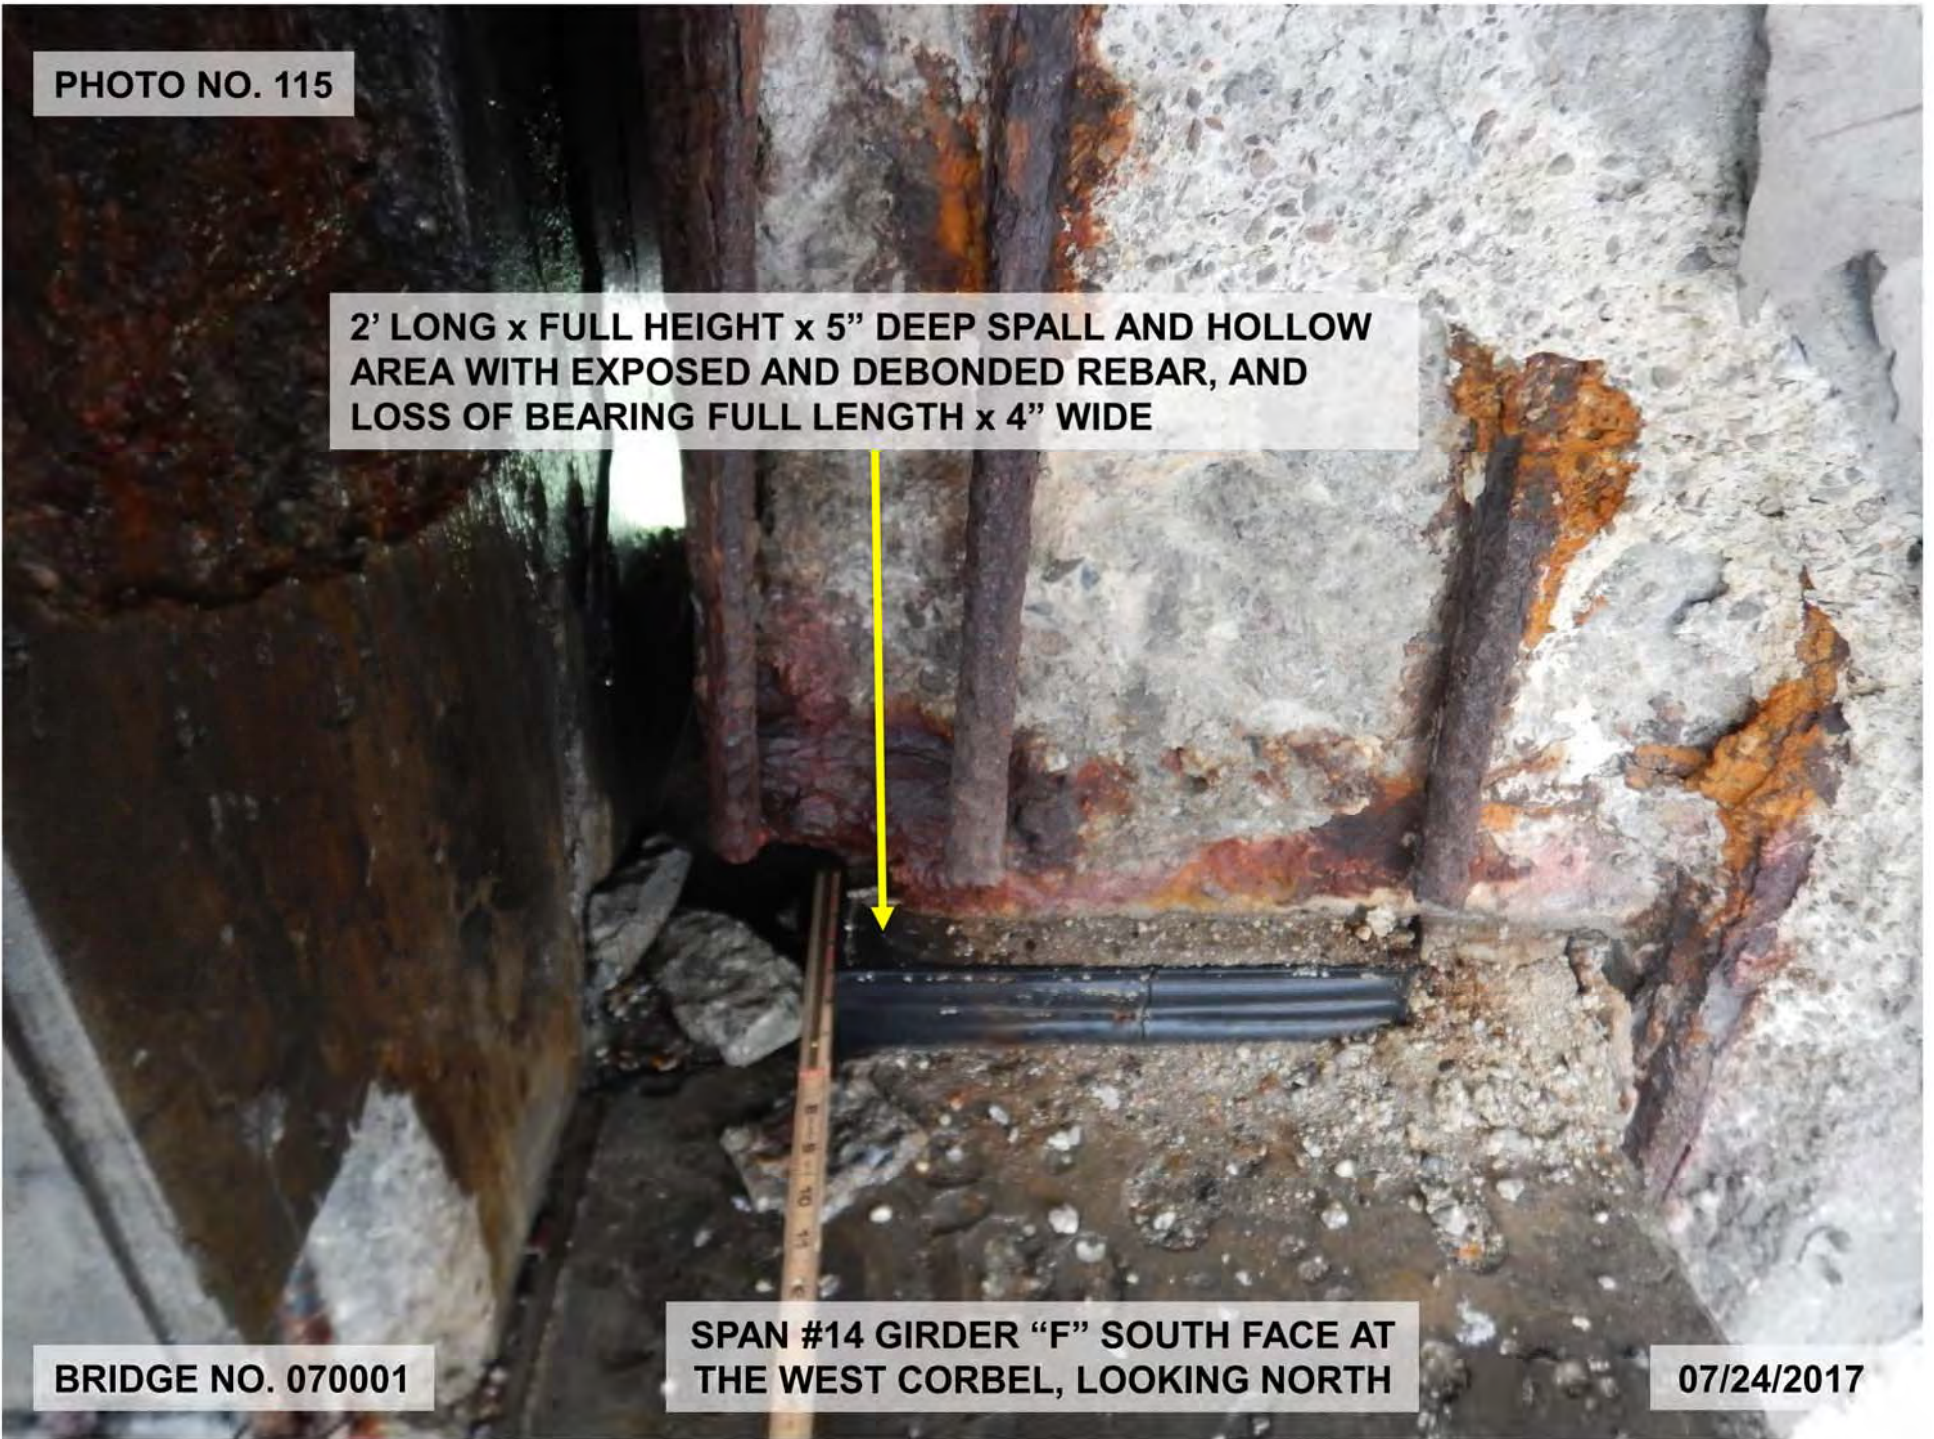
**2' LONG x FULL HEIGHT x 5" DEEP SPALL AND HOLLOW
AREA WITH EXPOSED AND DEBONDED REBAR, AND
LOSS OF BEARING FULL LENGTH x 4" WIDE**

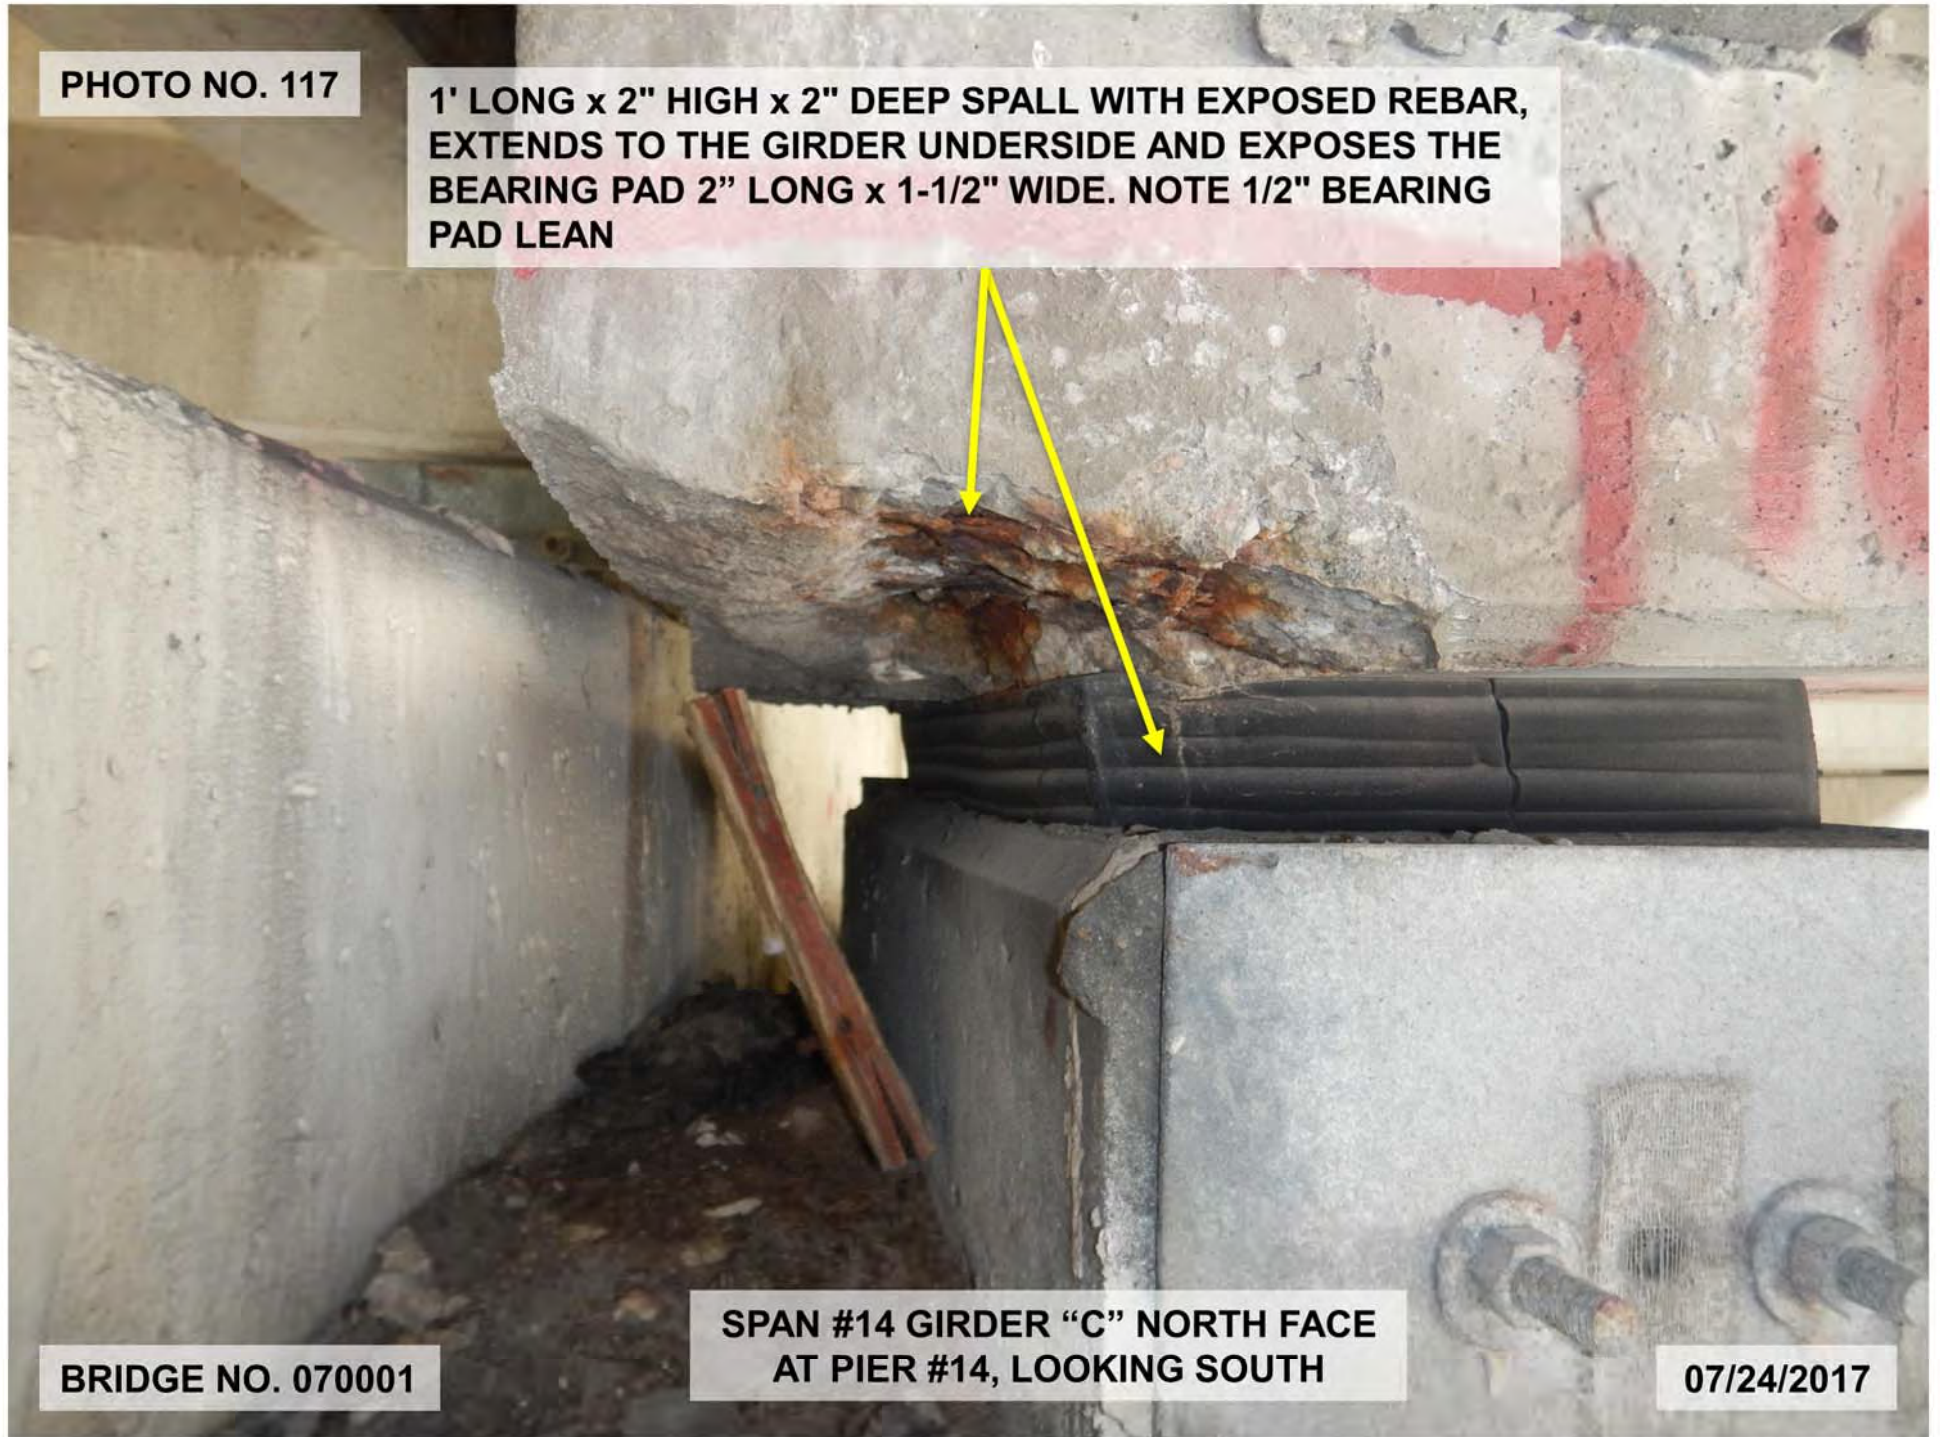
1' LONG x 2" HIGH x 2" DEEP SPALL WITH EXPOSED REBAR, EXTENDS TO THE GIRDER UNDERSIDE AND EXPOSES THE BEARING PAD 2" LONG x 1-1/2" WIDE. NOTE 1/2" BEARING PAD LEAN

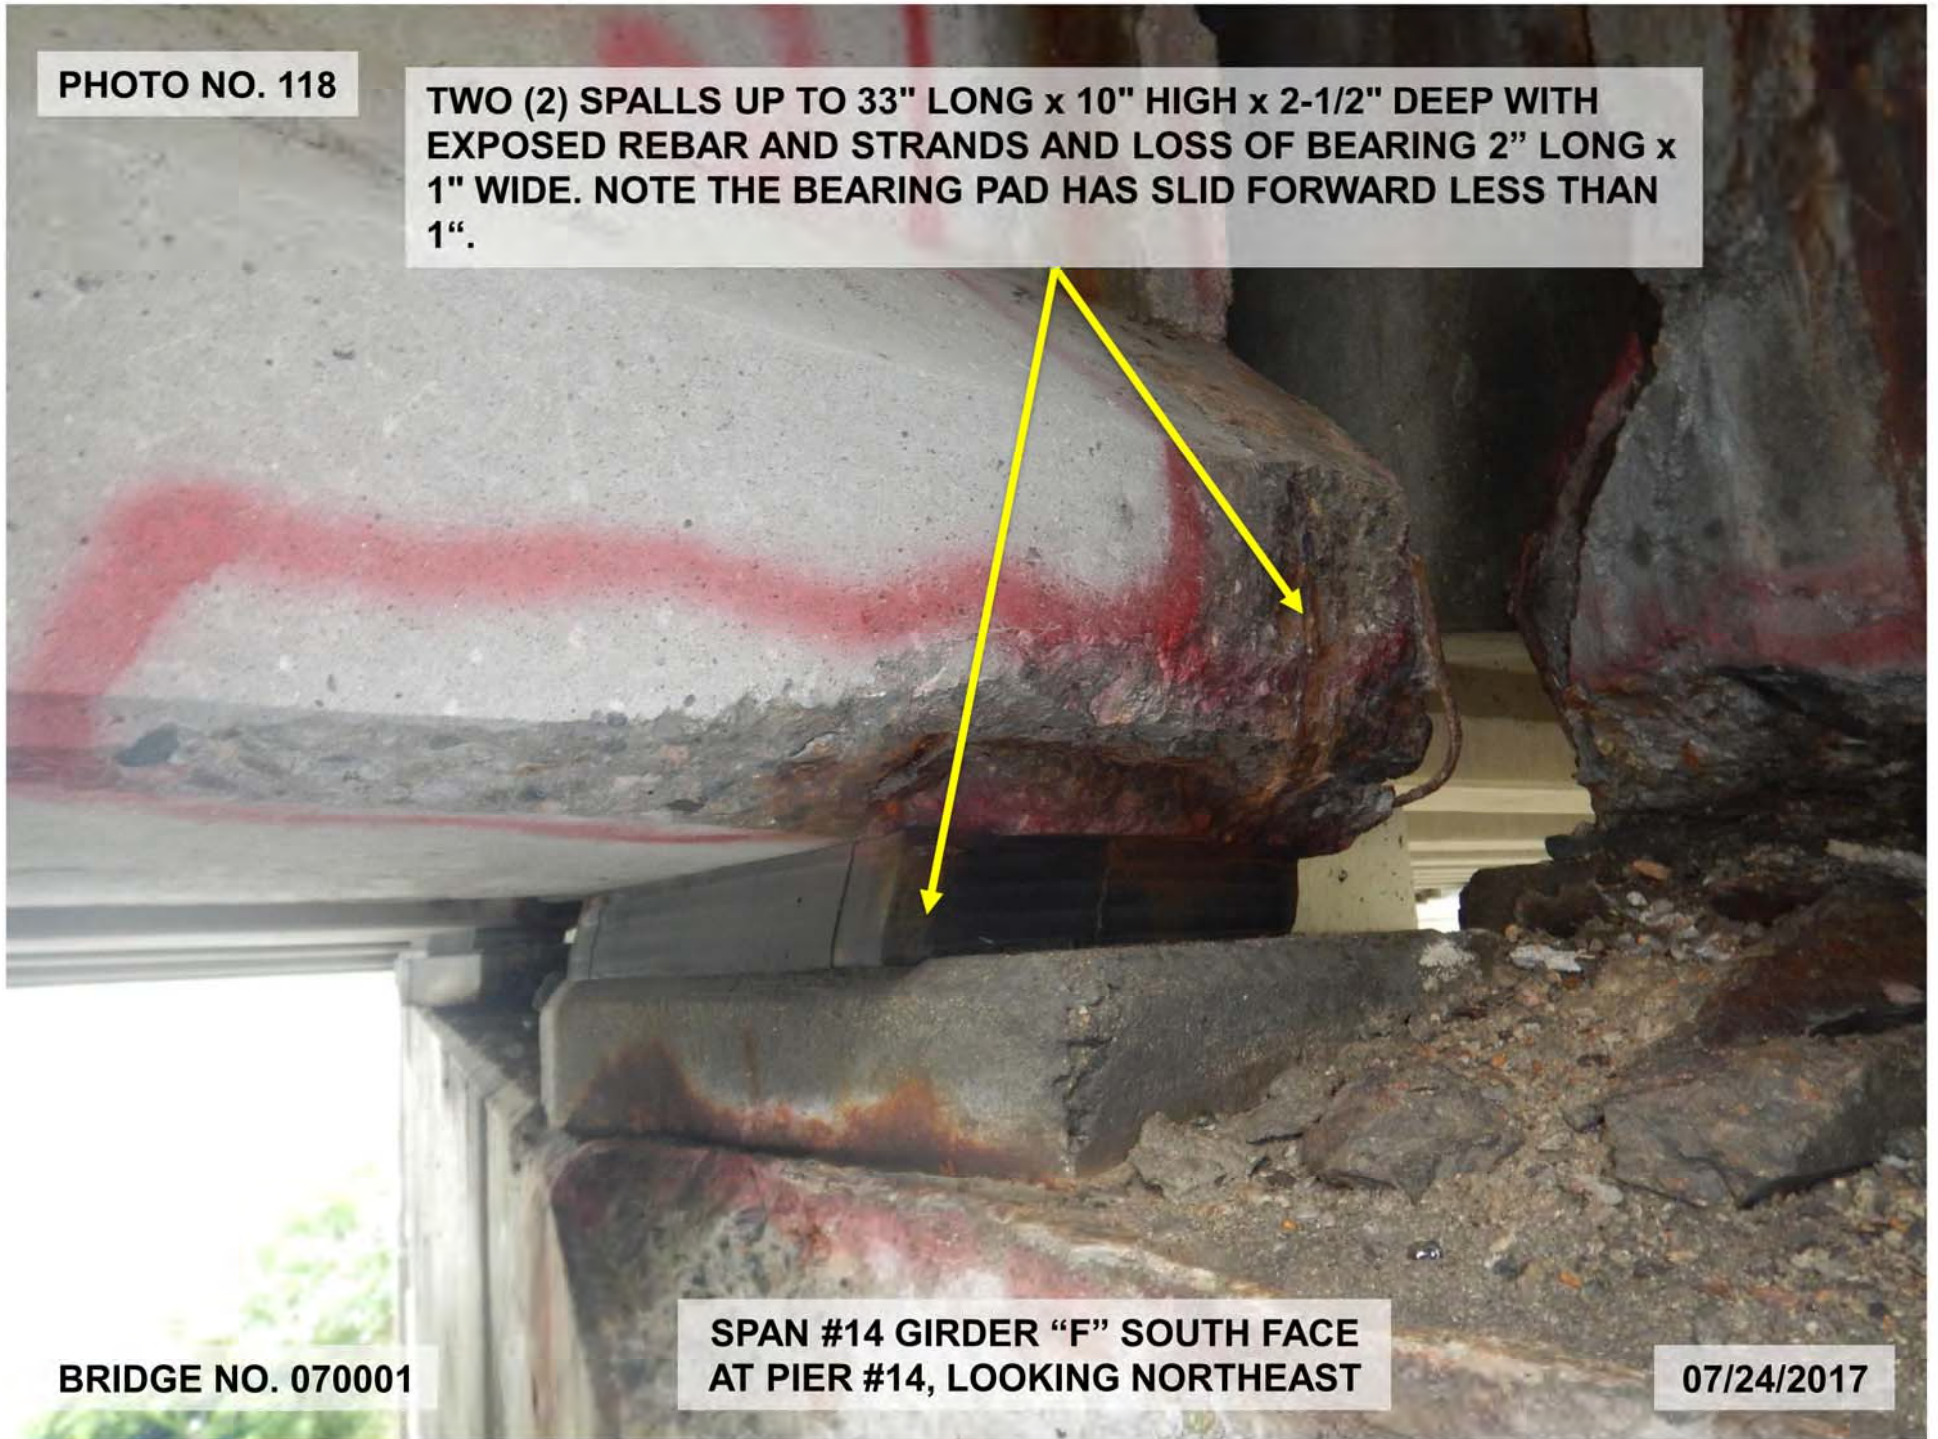
TWO (2) SPALLS UP TO 33" LONG x 10" HIGH x 2-1/2" DEEP WITH EXPOSED REBAR AND STRANDS AND LOSS OF BEARING 2" LONG x 1" WIDE. NOTE THE BEARING PAD HAS SLID FORWARD LESS THAN 1".

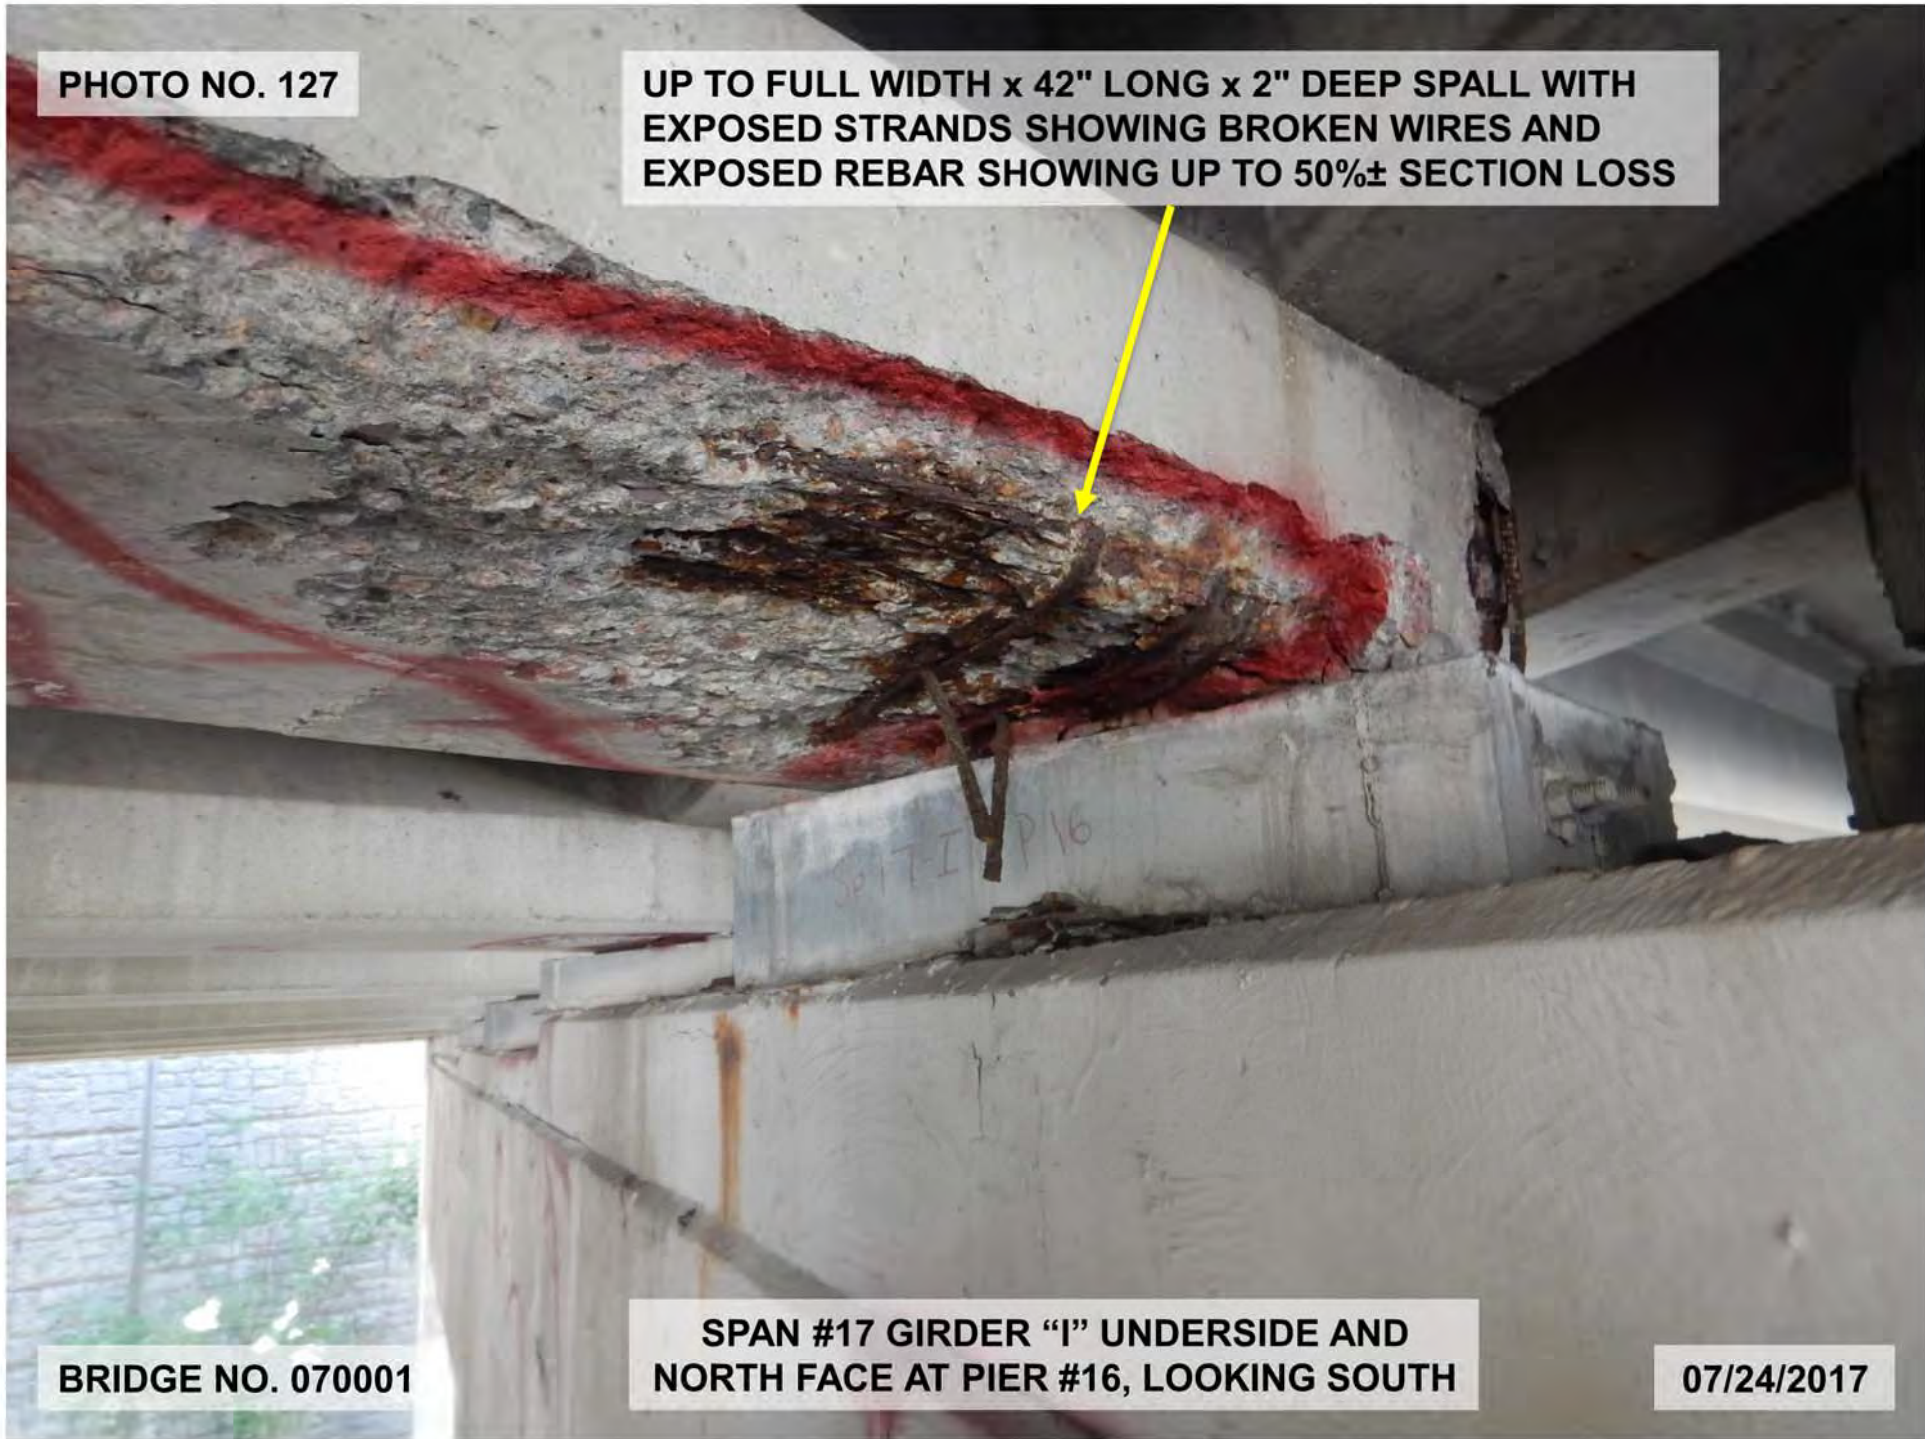
UP TO FULL WIDTH x 42" LONG x 2" DEEP SPALL WITH EXPOSED STRANDS SHOWING BROKEN WIRES AND EXPOSED REBAR SHOWING UP TO 50%± SECTION LOSS

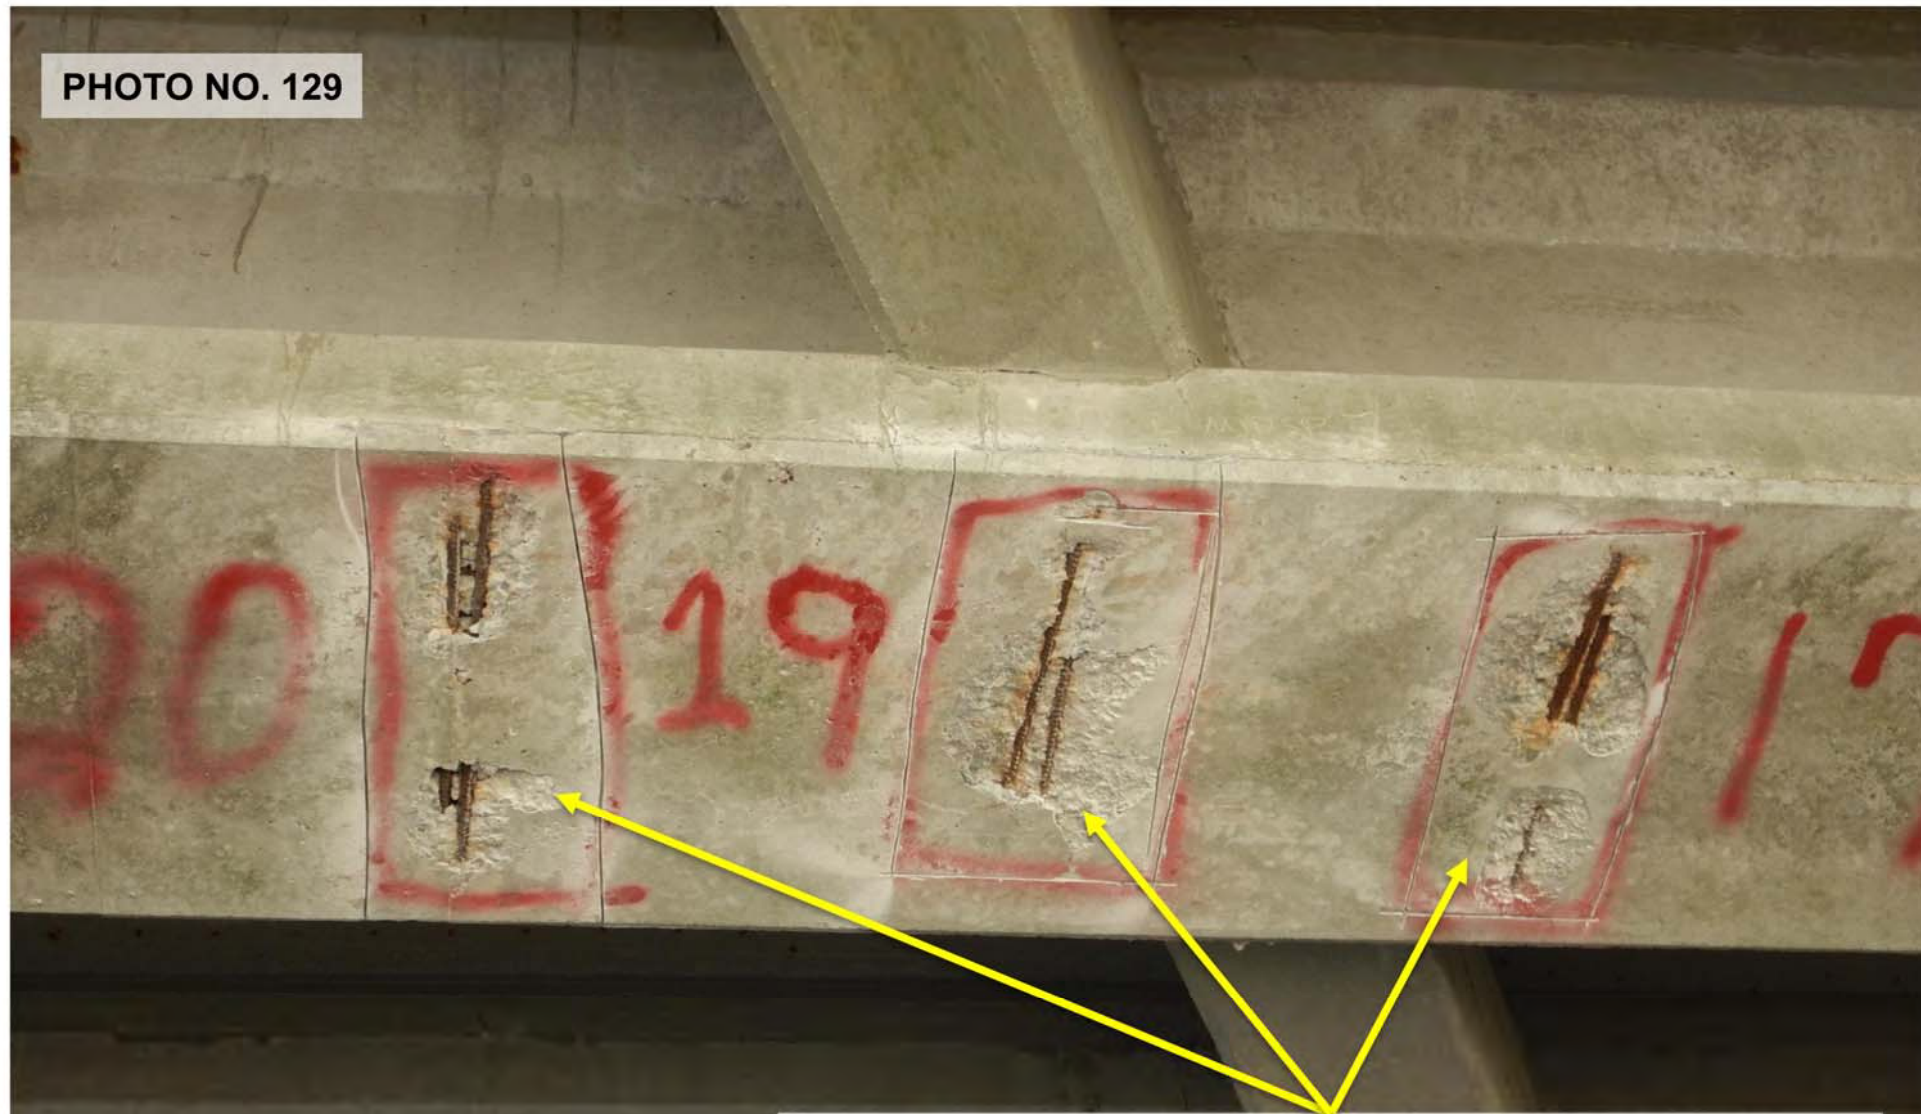
THREE (3) SPALLS WITH EXPOSED REBAR UP TO 10"
LONG x FULL WIDTH x 1/2" DEEP

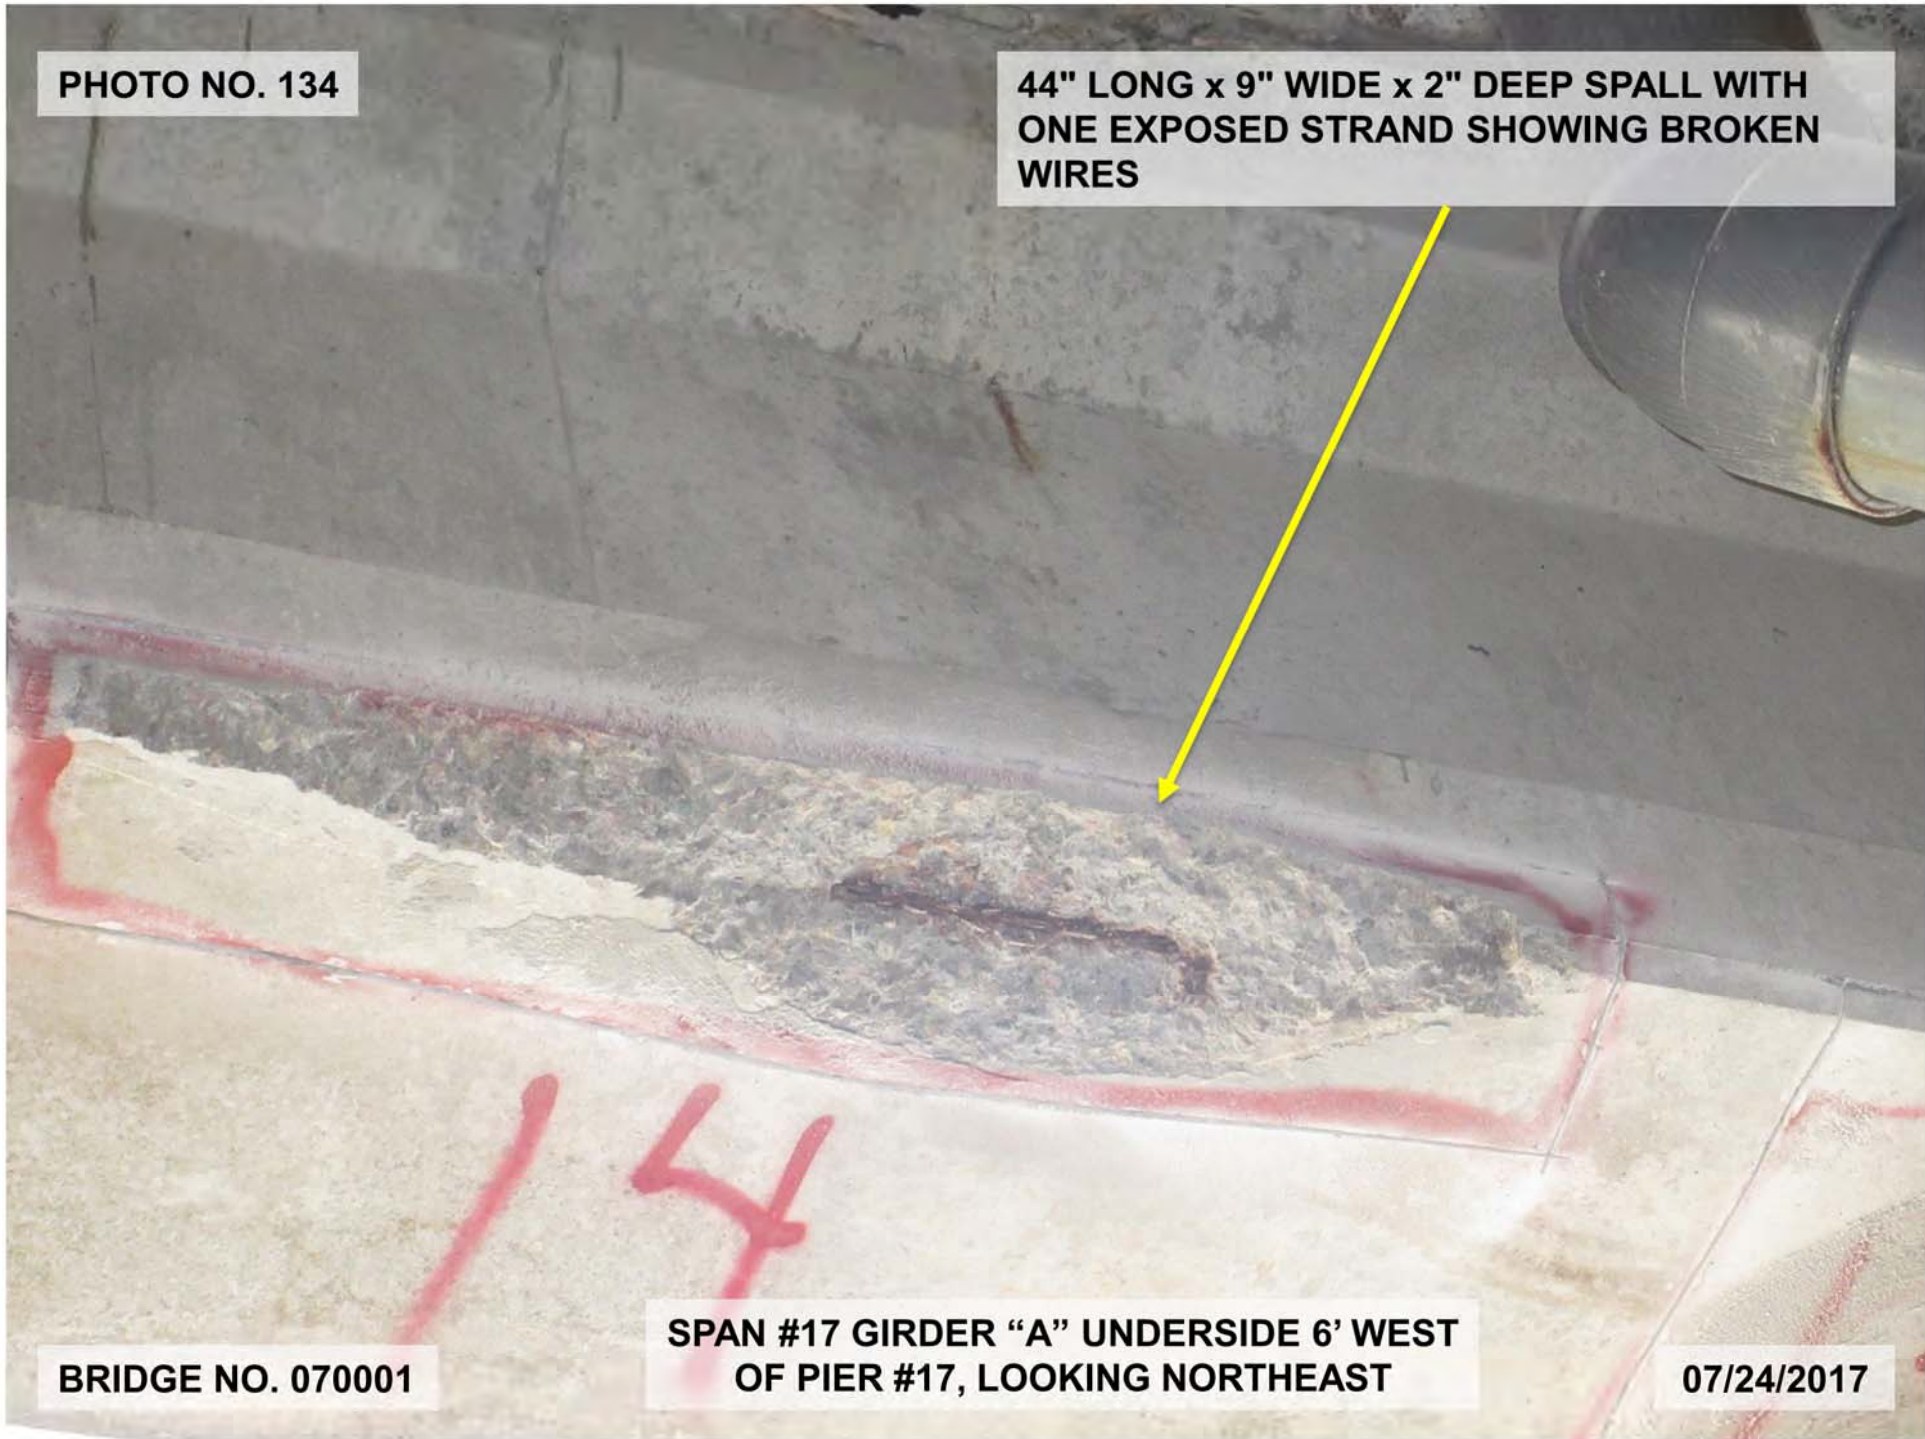
**44" LONG x 9" WIDE x 2" DEEP SPALL WITH
ONE EXPOSED STRAND SHOWING BROKEN
WIRES**

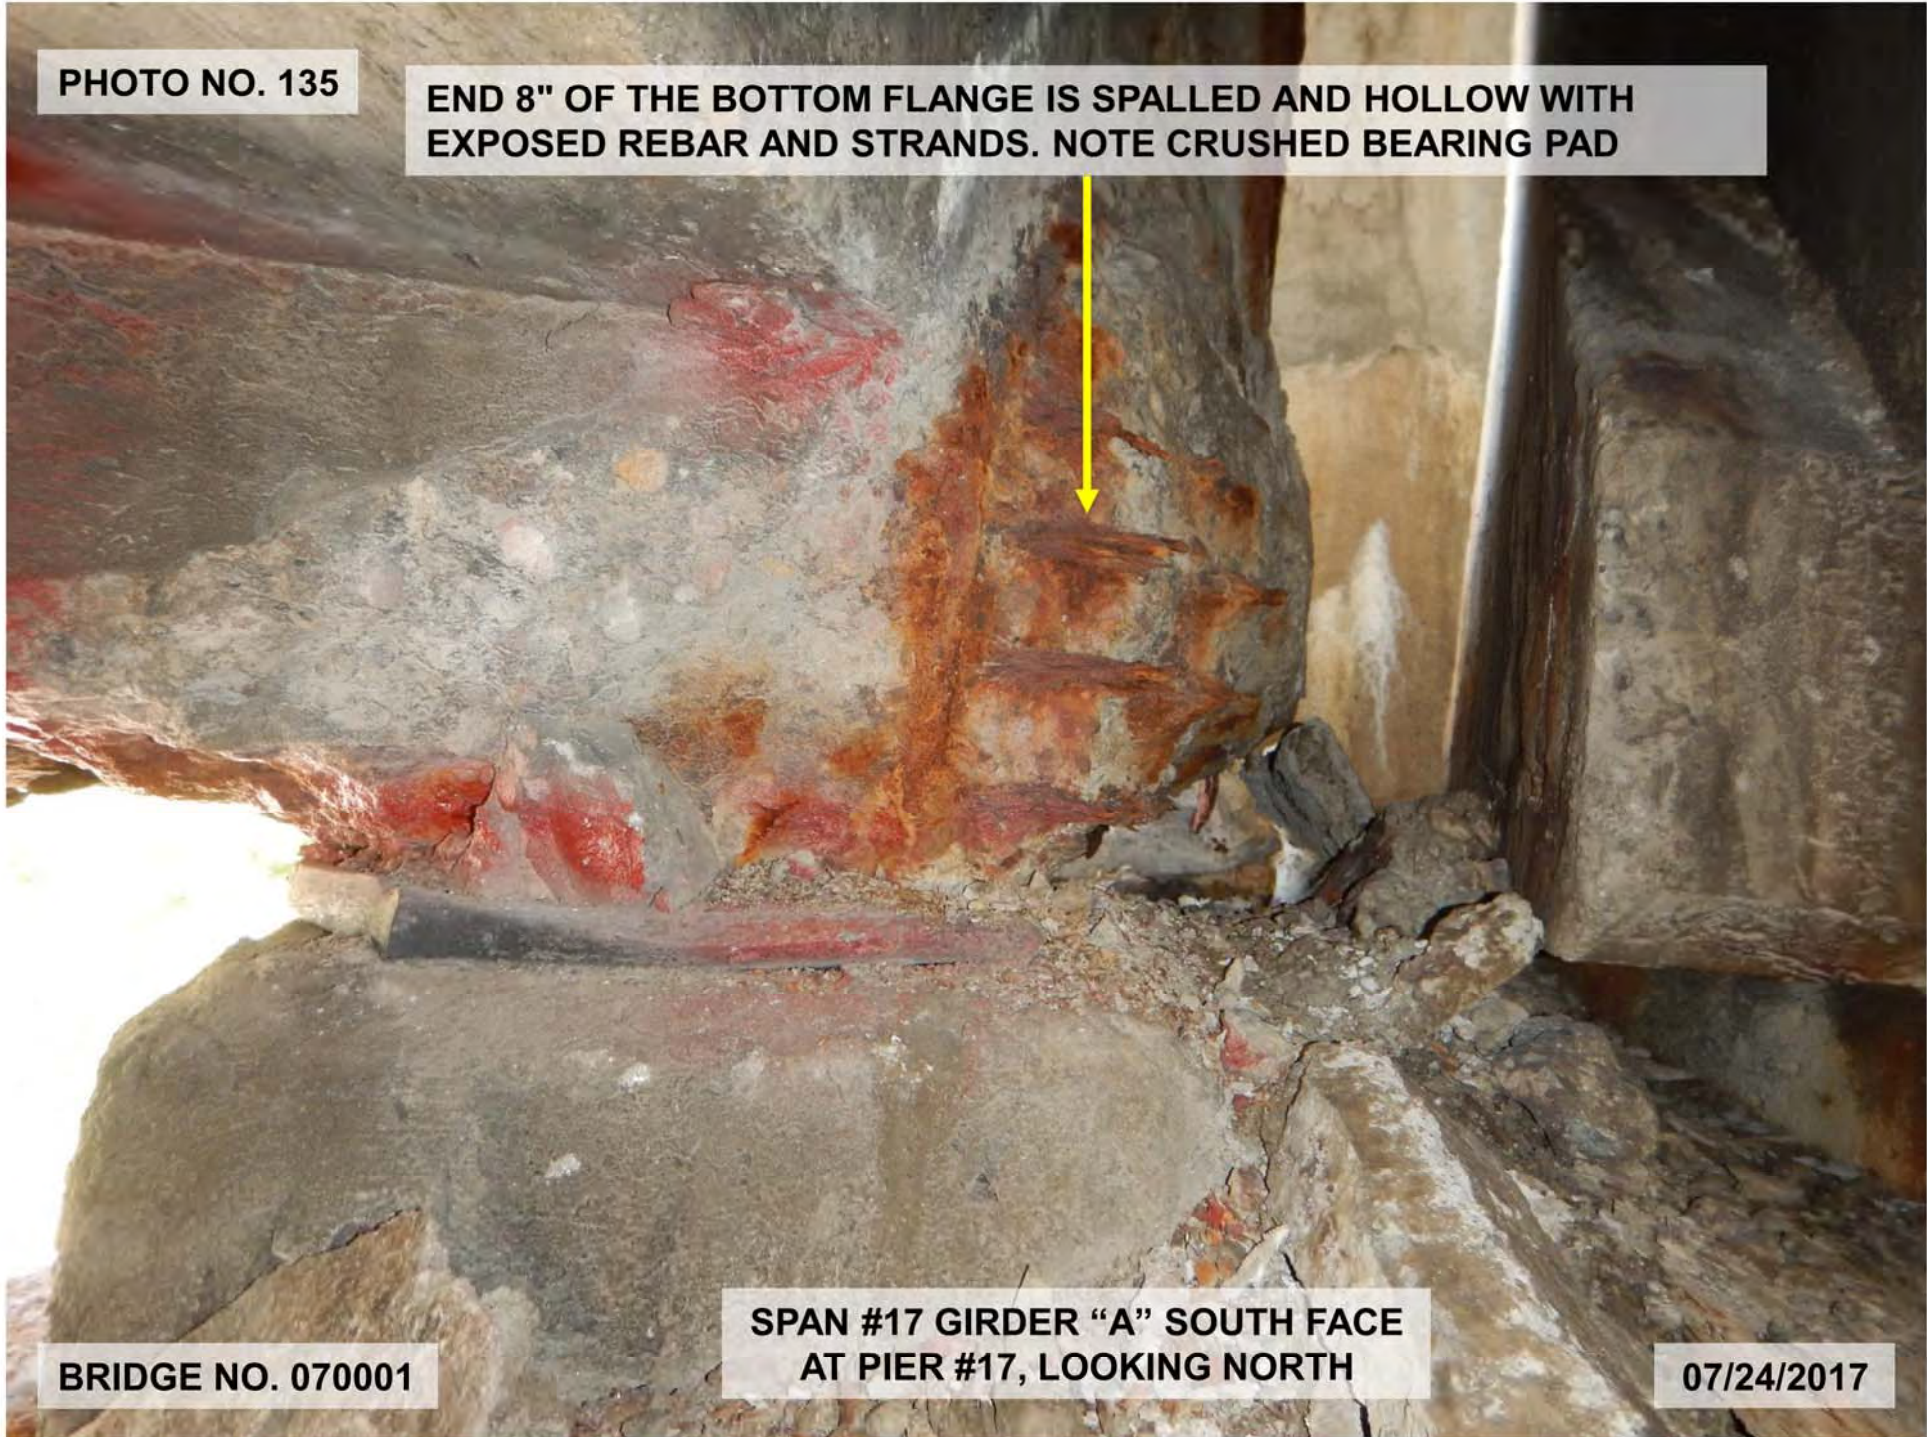
END 8" OF THE BOTTOM FLANGE IS SPALLED AND HOLLOW WITH EXPOSED REBAR AND STRANDS. NOTE CRUSHED BEARING PAD
