PHOTO NO. 1

BRIDGE NO. 070001

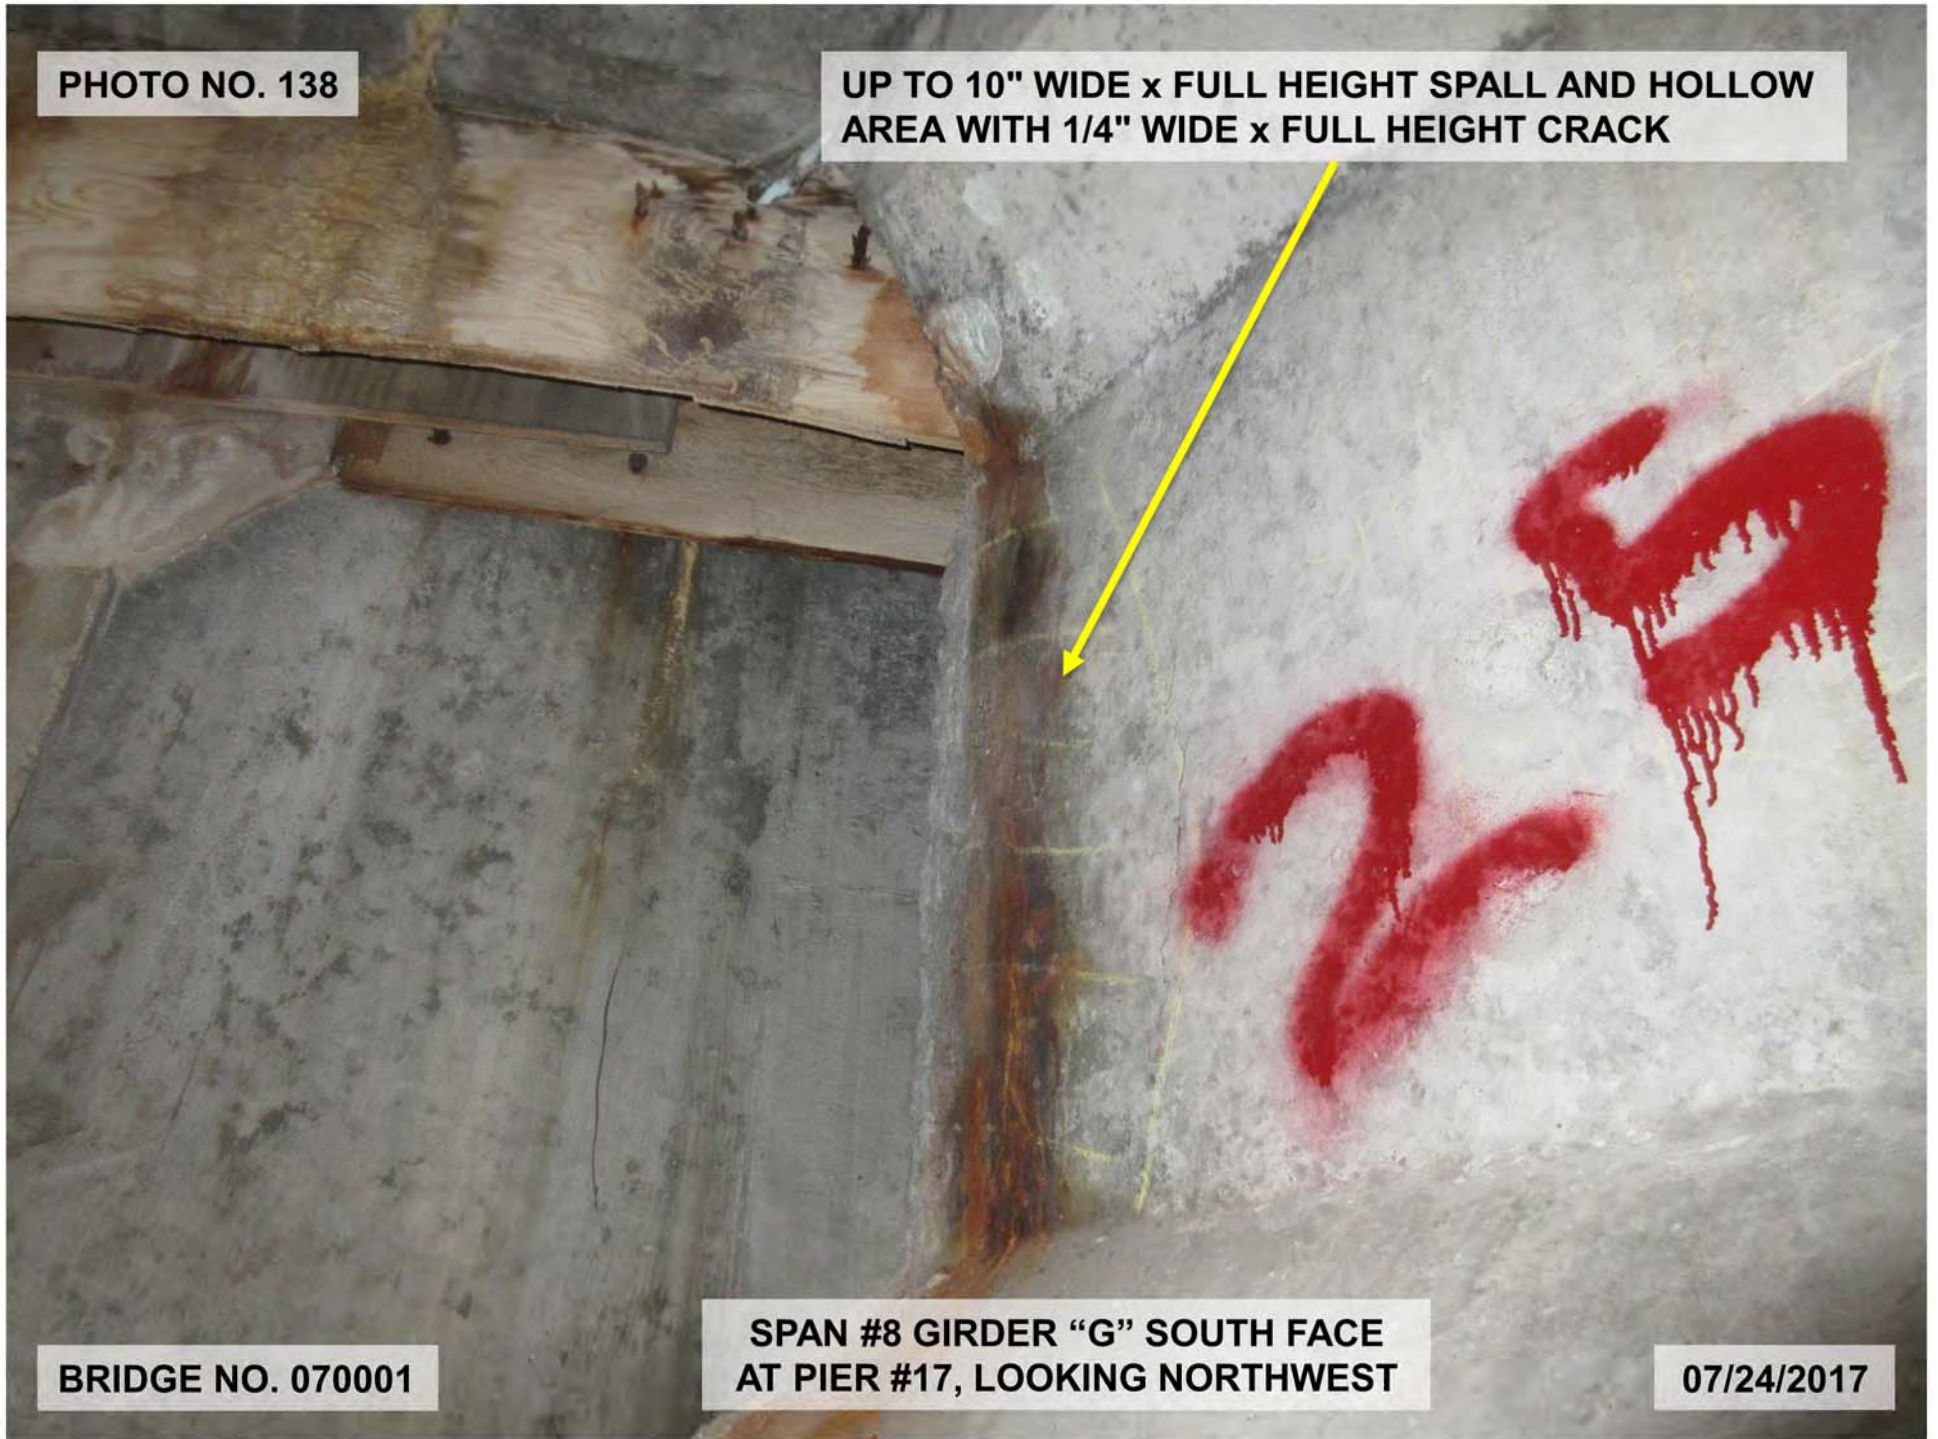
UP TO 10" WIDE x FULL HEIGHT SPALL AND HOLLOW
AREA WITH 1/4" WIDE x FULL HEIGHT CRACK

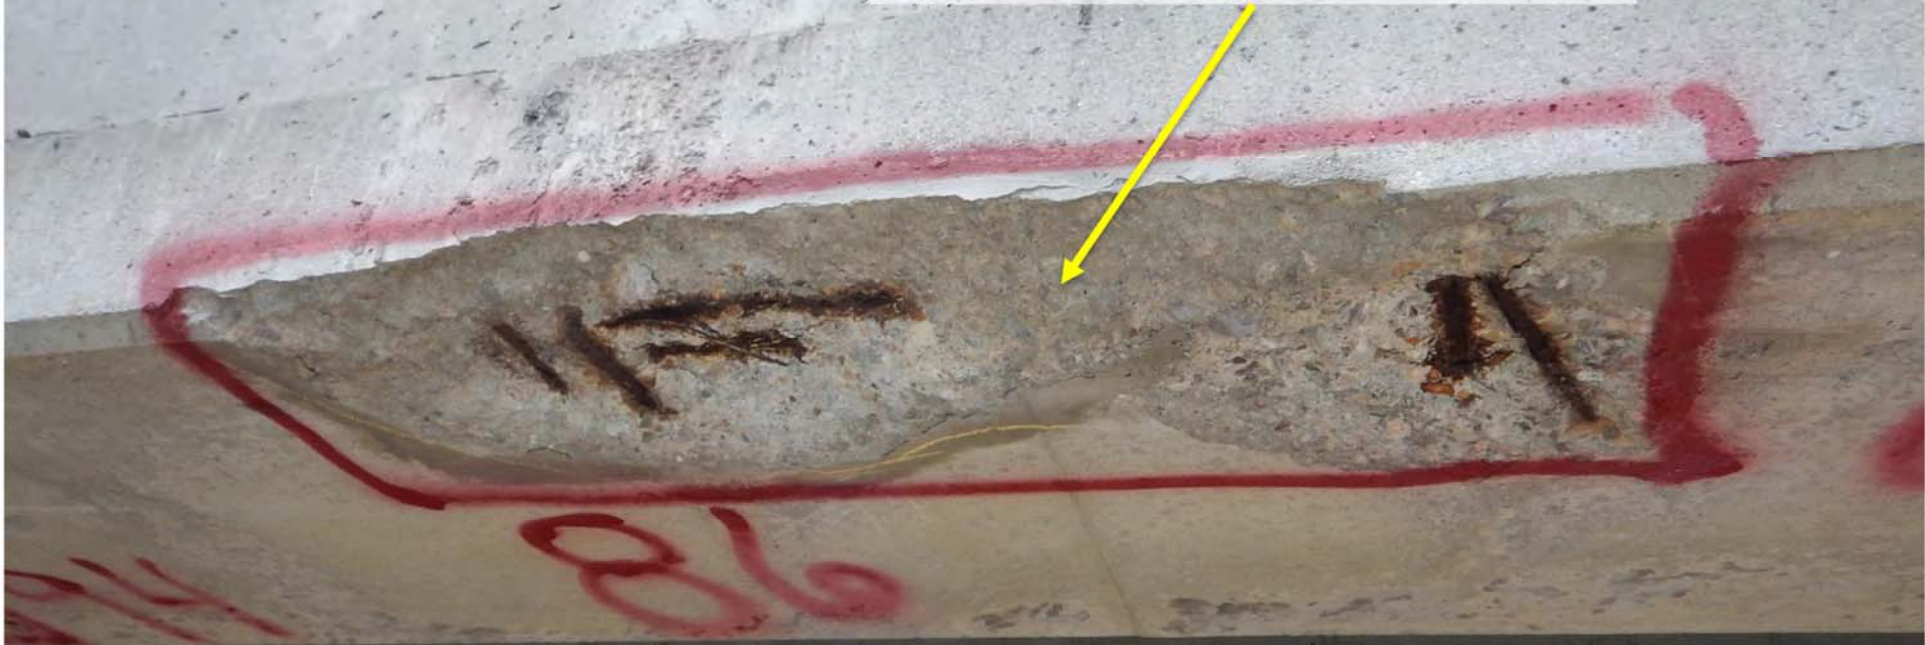
39" LONG x 1' WIDE x 2-1/2" DEEP
SPALL WITH EXPOSED RUSTED REBAR
AND EXPOSED STRANDS; EXPOSED
STRANDS HAVE A FEW BROKEN WIRES

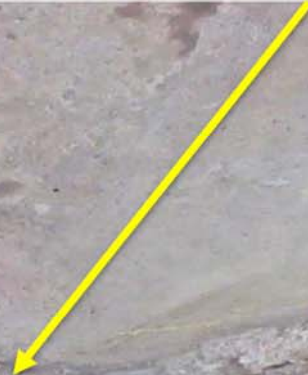
52" LONG x FULL WIDTH x UP TO 3" DEEP
SPALL WITH EXPOSED REBAR AND EXPOSED
STRANDS CONTINUOUS OVER THE BEARING.

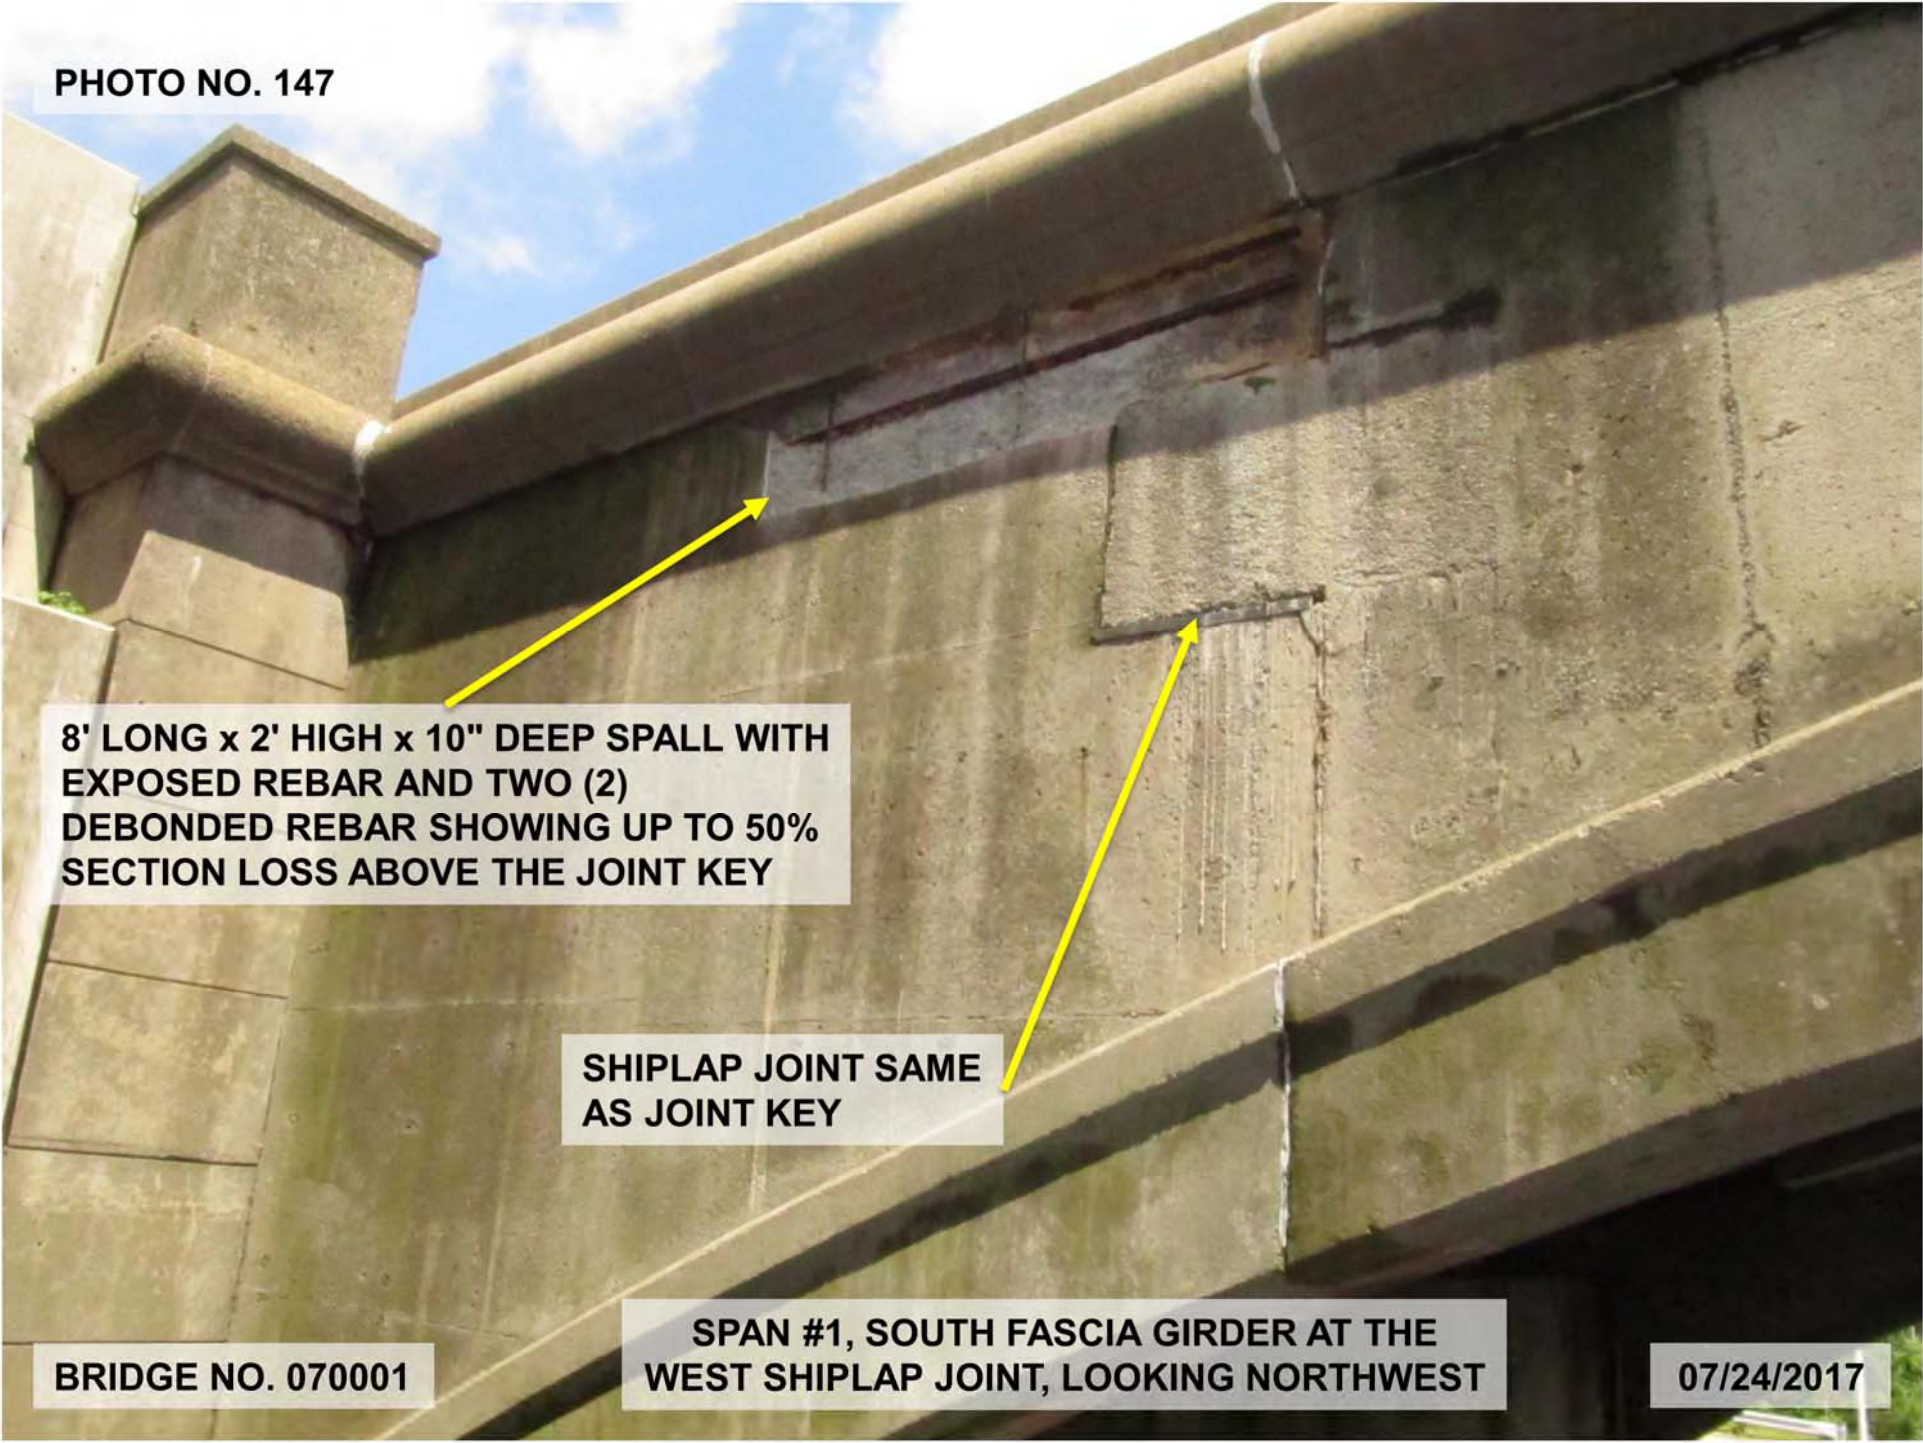
8' LONG x 2' HIGH x 10" DEEP SPALL WITH EXPOSED REBAR AND TWO (2) DEBONDED REBAR SHOWING UP TO 50% SECTION LOSS ABOVE THE JOINT KEY

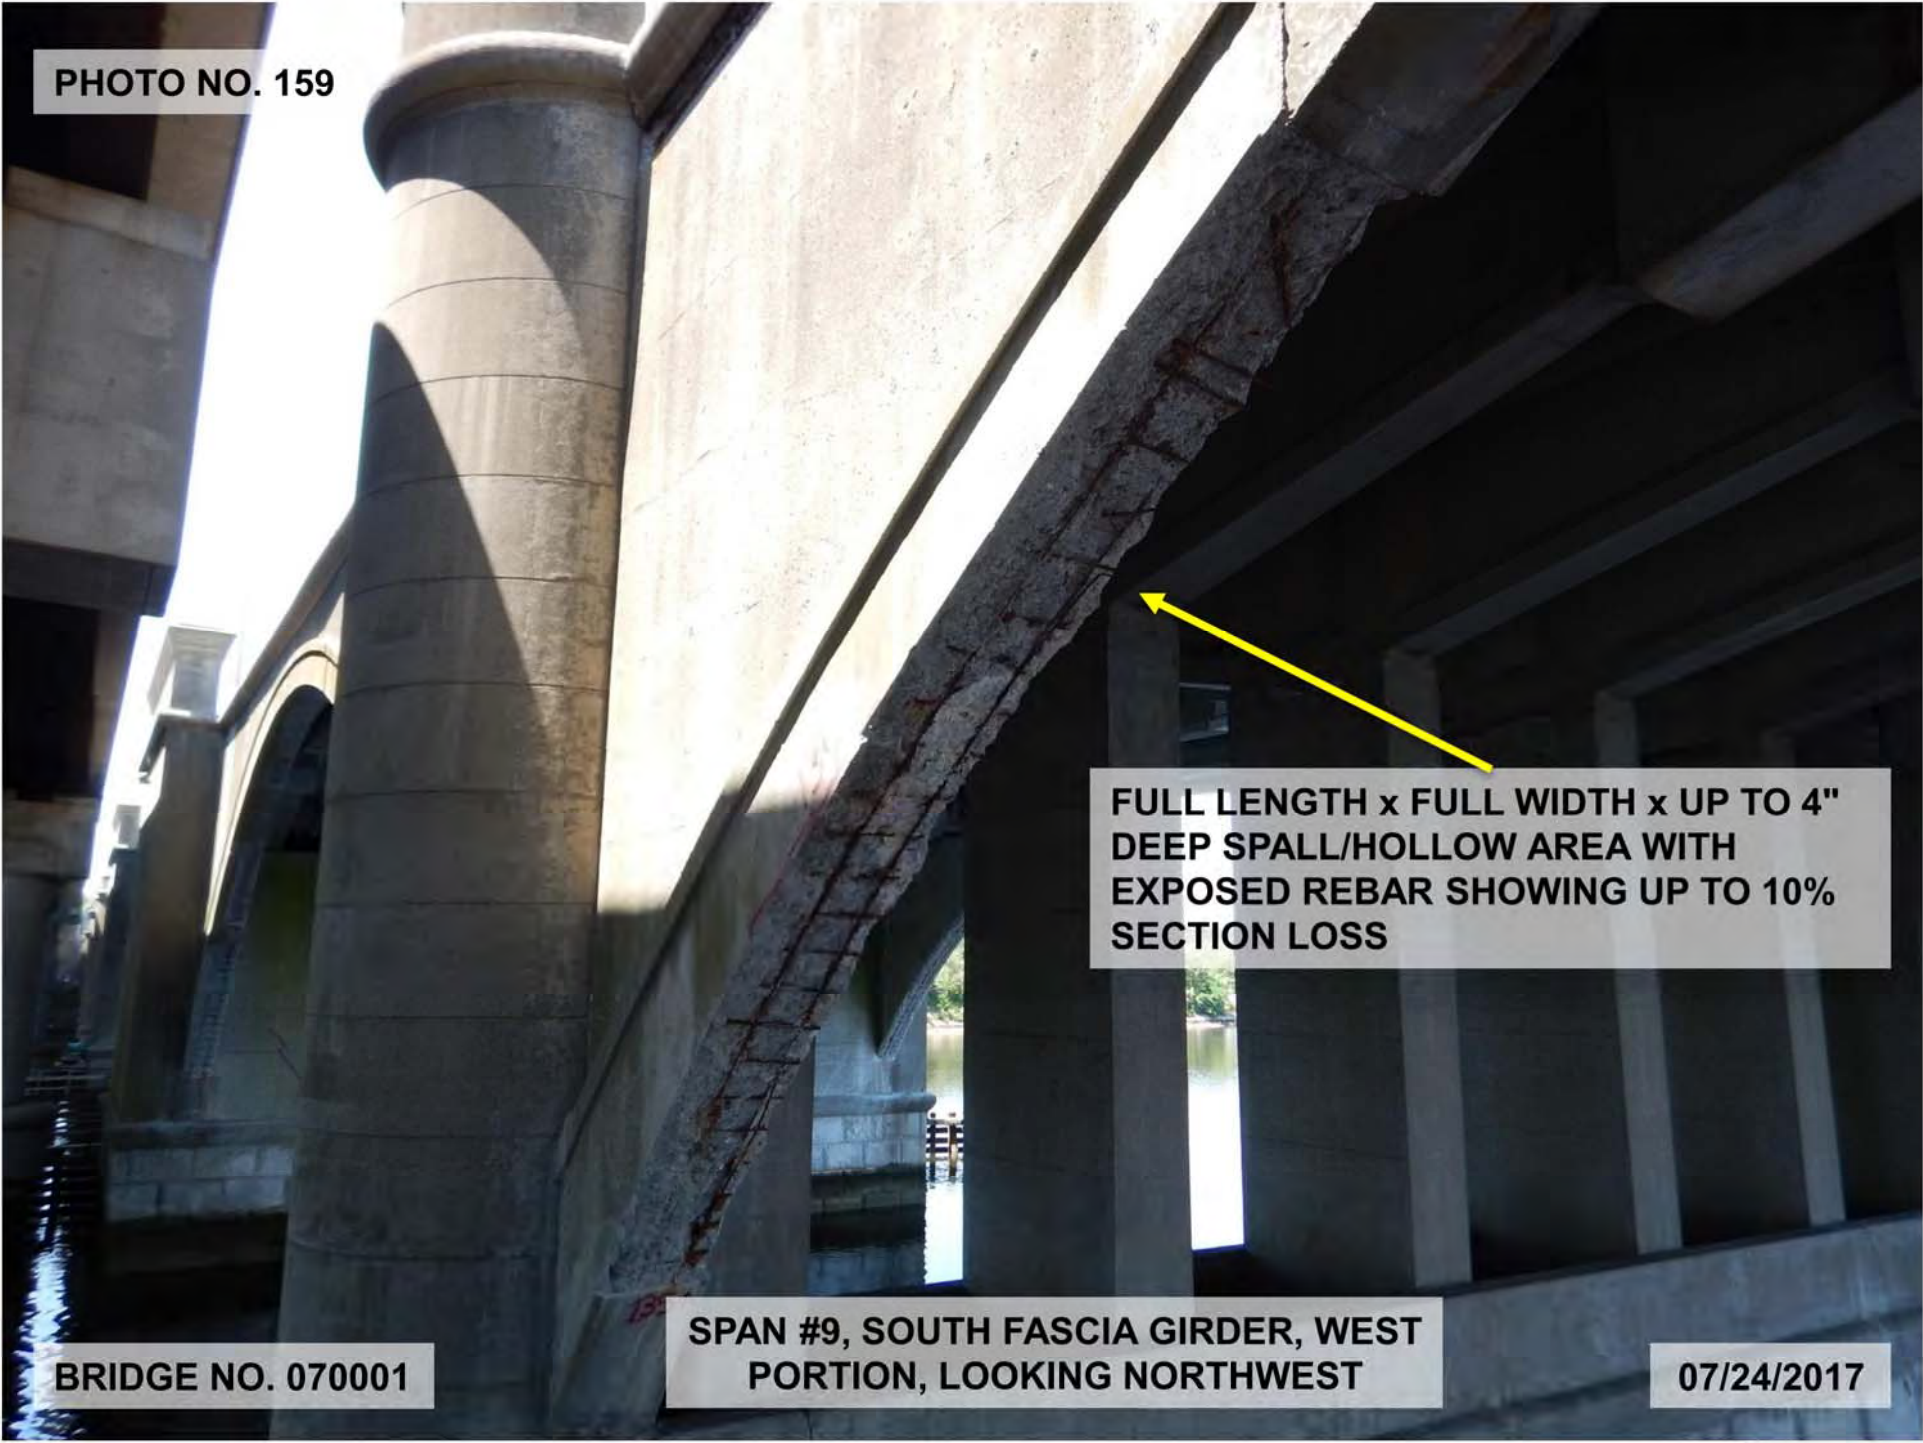
FULL LENGTH x FULL WIDTH x UP TO 4"
DEEP SPALL/HOLLOW AREA WITH
EXPOSED REBAR SHOWING UP TO 10%
SECTION LOSS

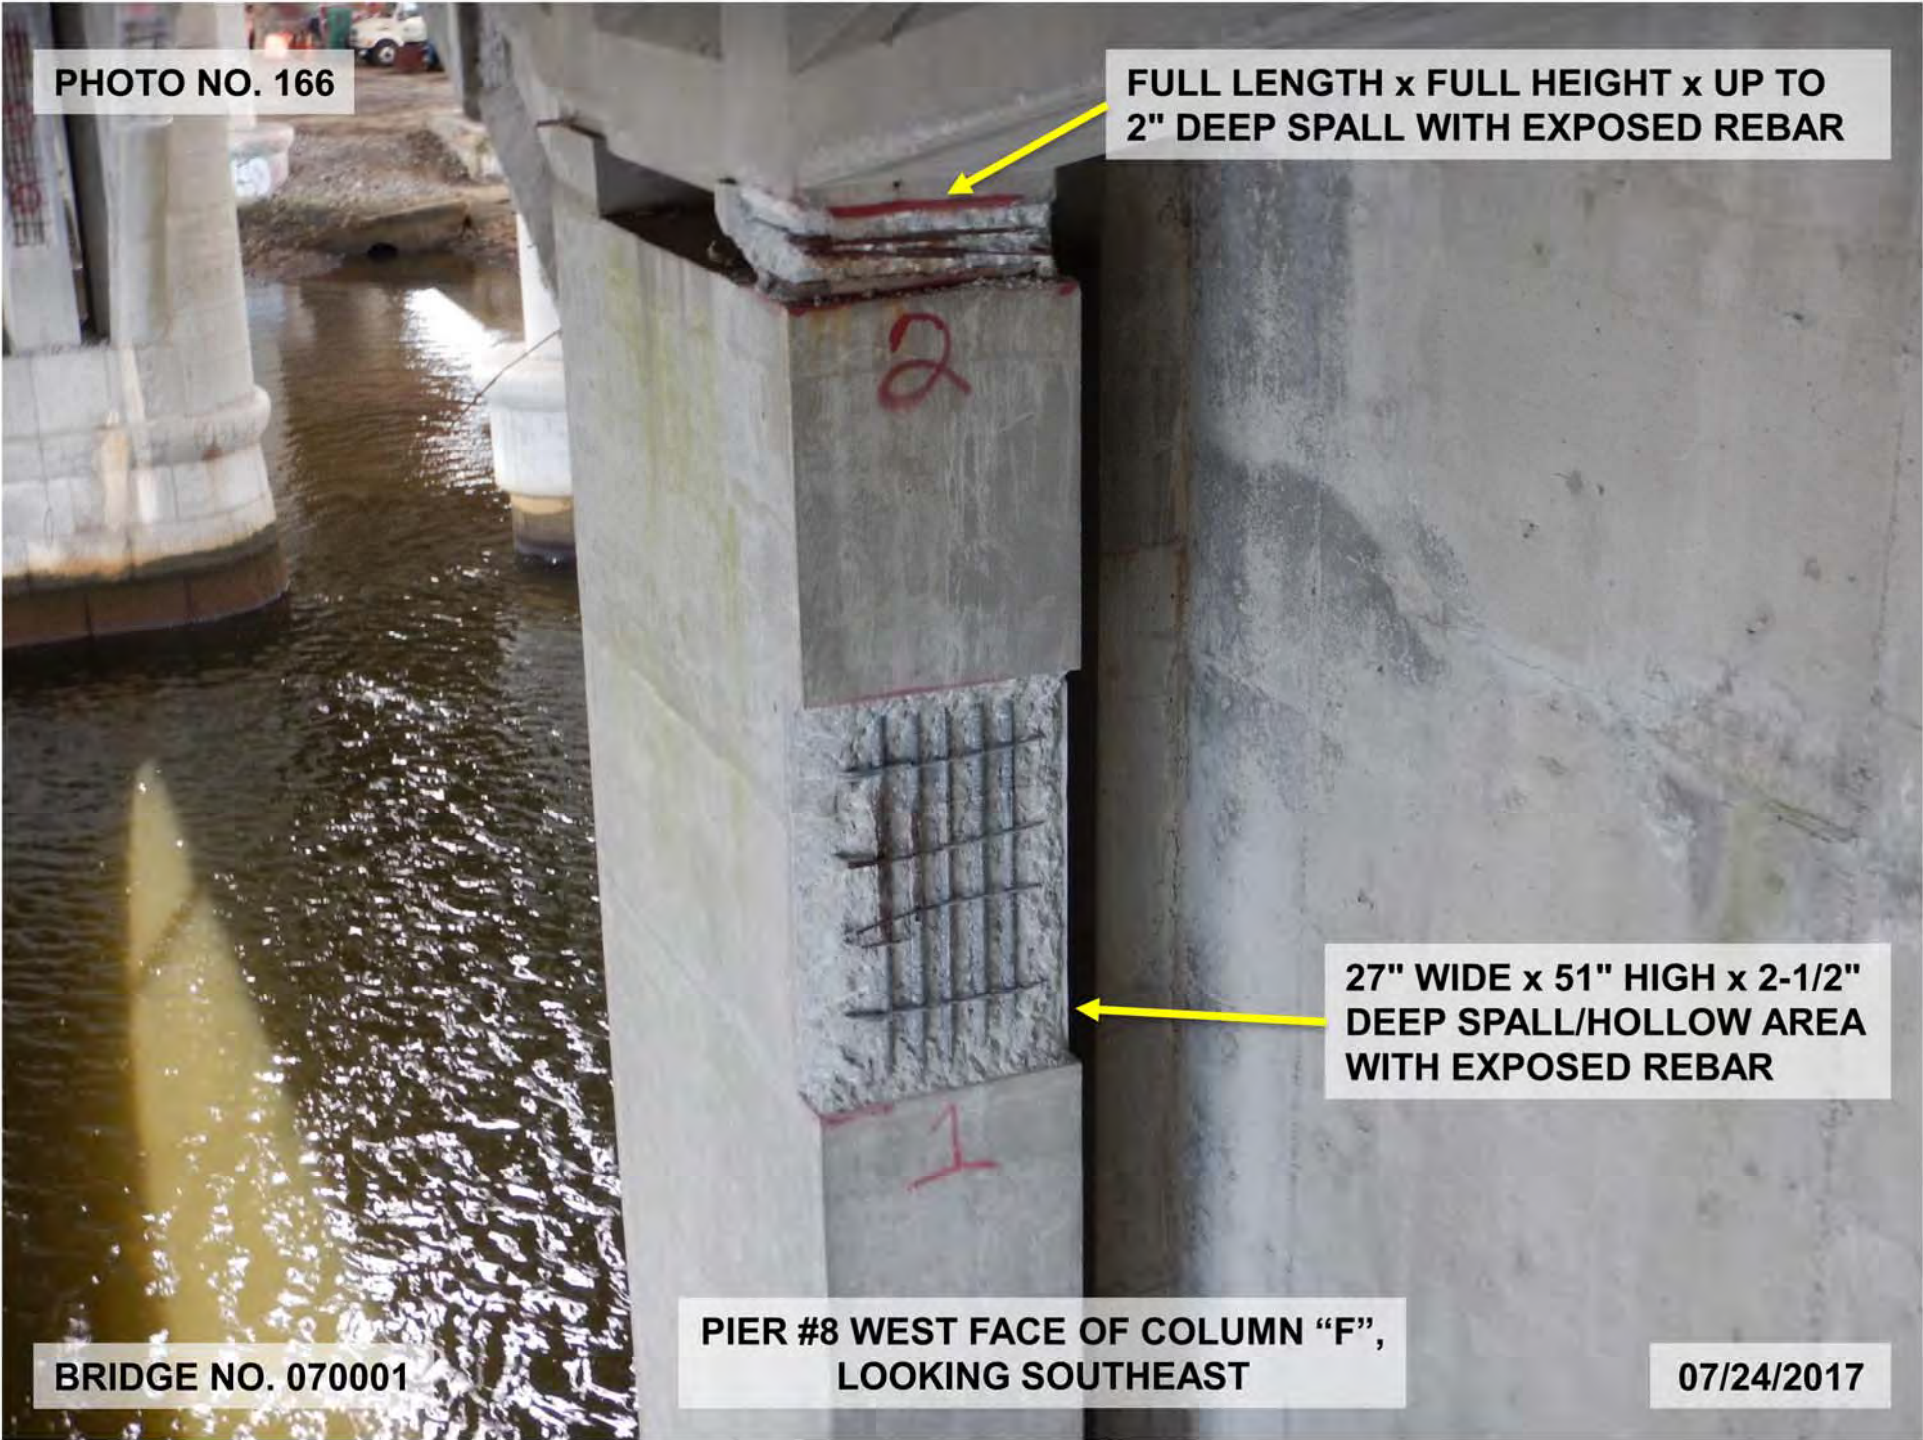
27" WIDE x 51" HIGH x 2-1/2" DEEP SPALL/HOLLOW AREA WITH EXPOSED REBAR

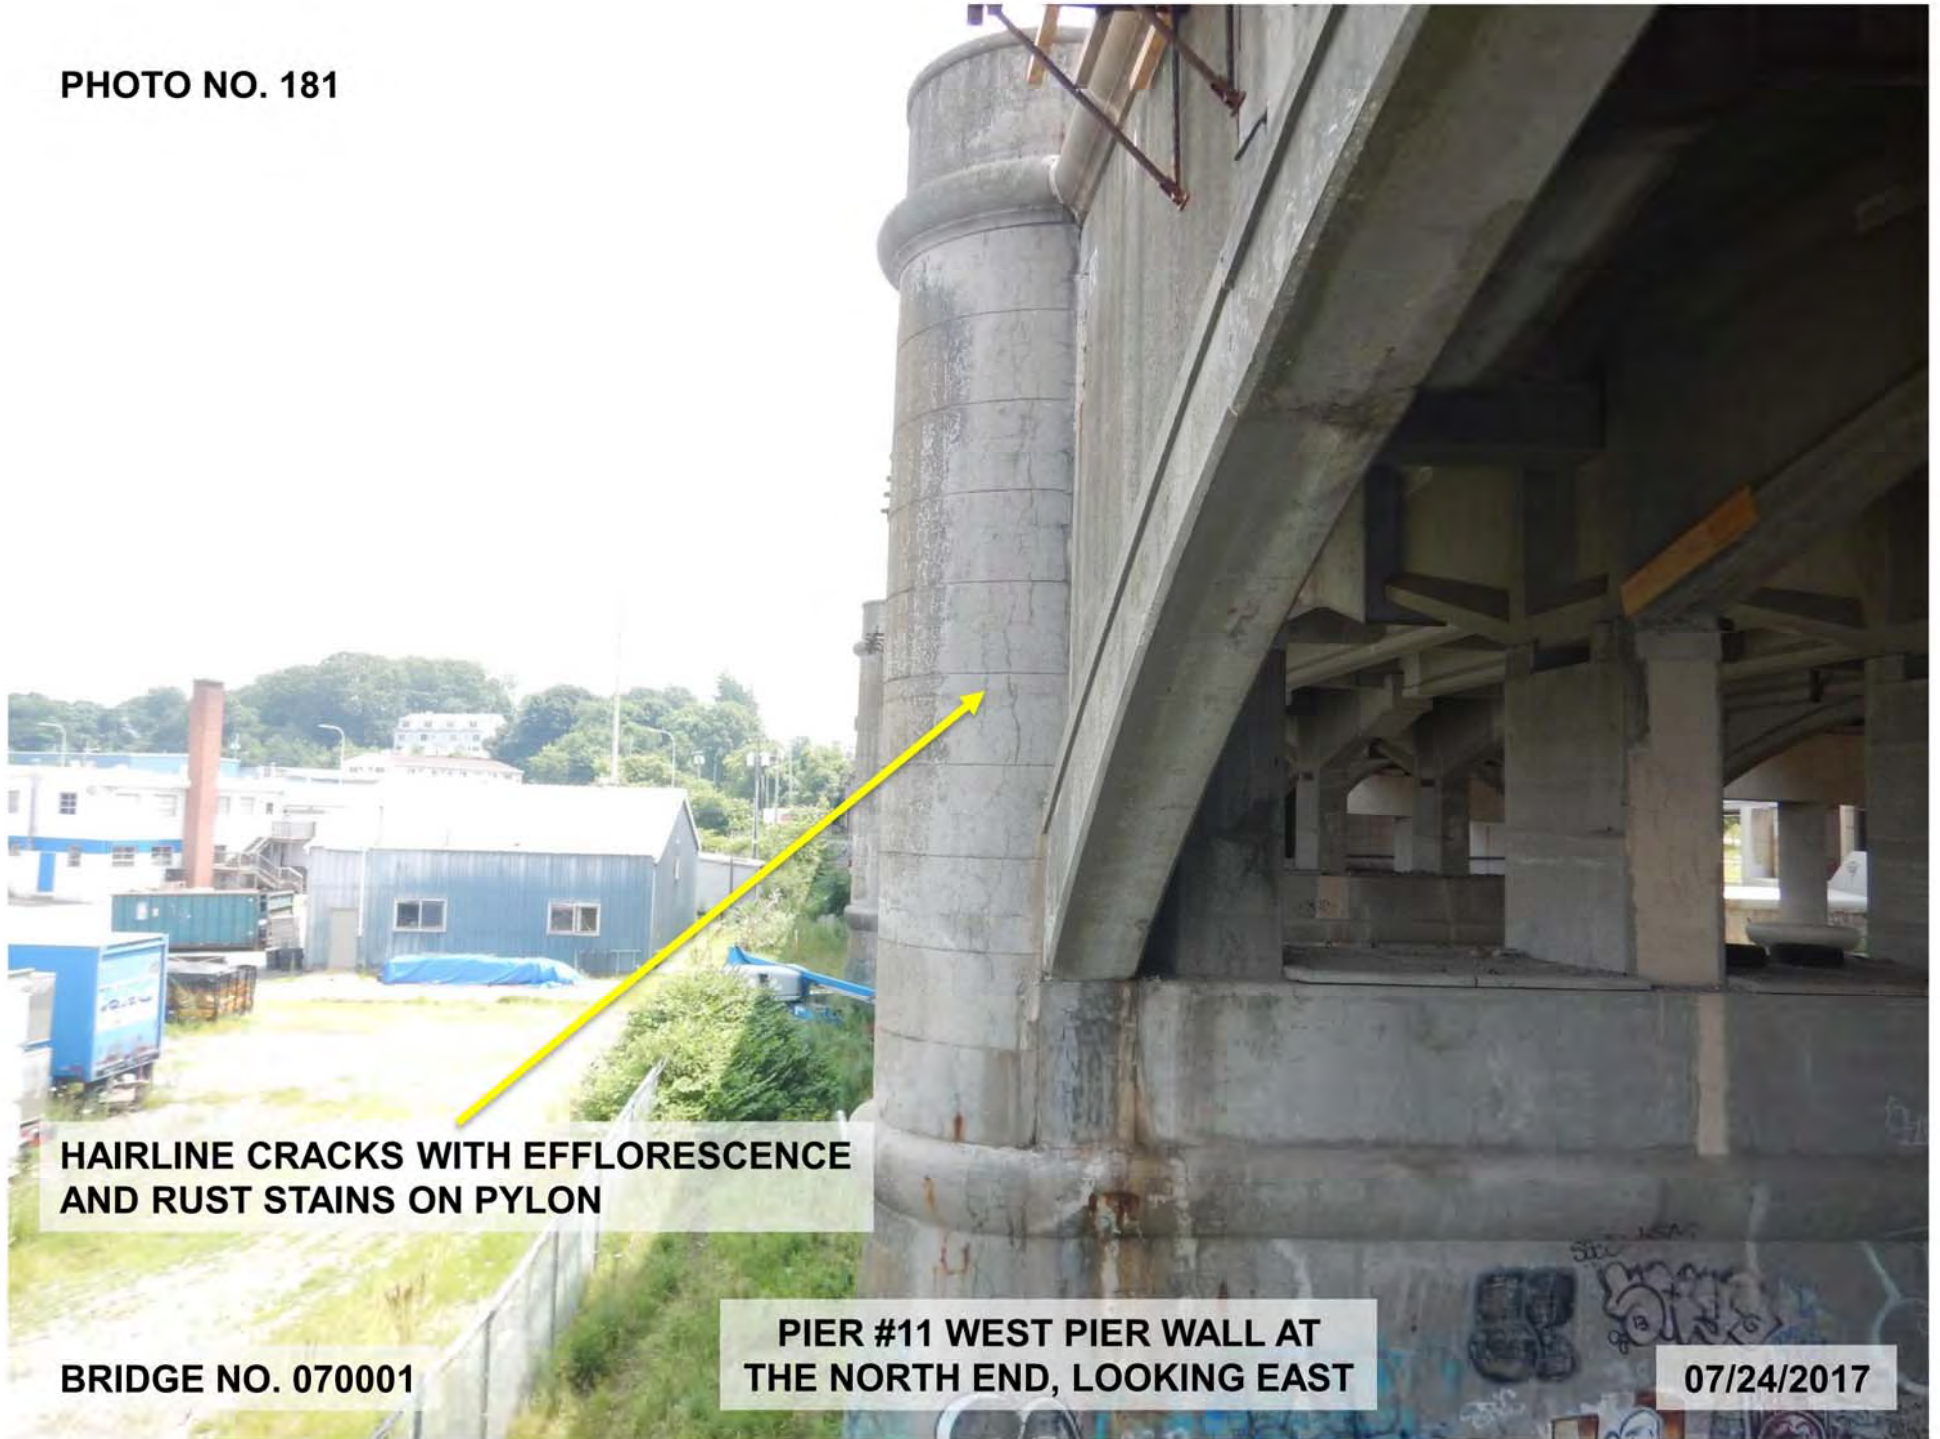
**HAIRLINE CRACKS WITH EFFLORESCENCE
AND RUST STAINS ON PYLON**

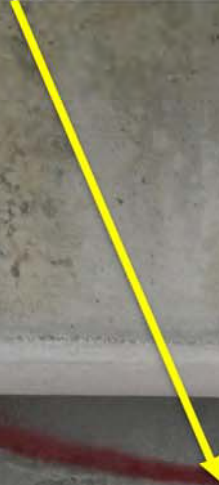
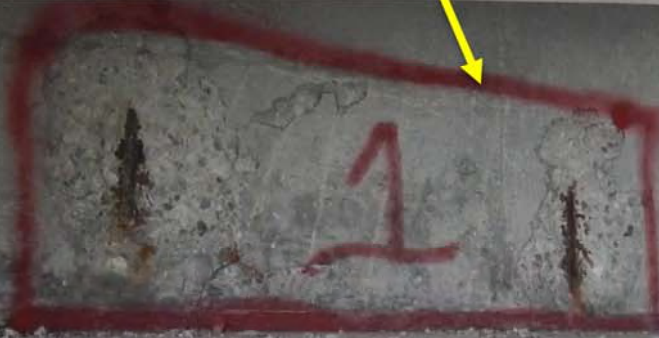
54" LONG x 2' HIGH HOLLOW AREA WITH SPALLING
UP TO 1-1/2" DEEP AND EXPOSED REBAR

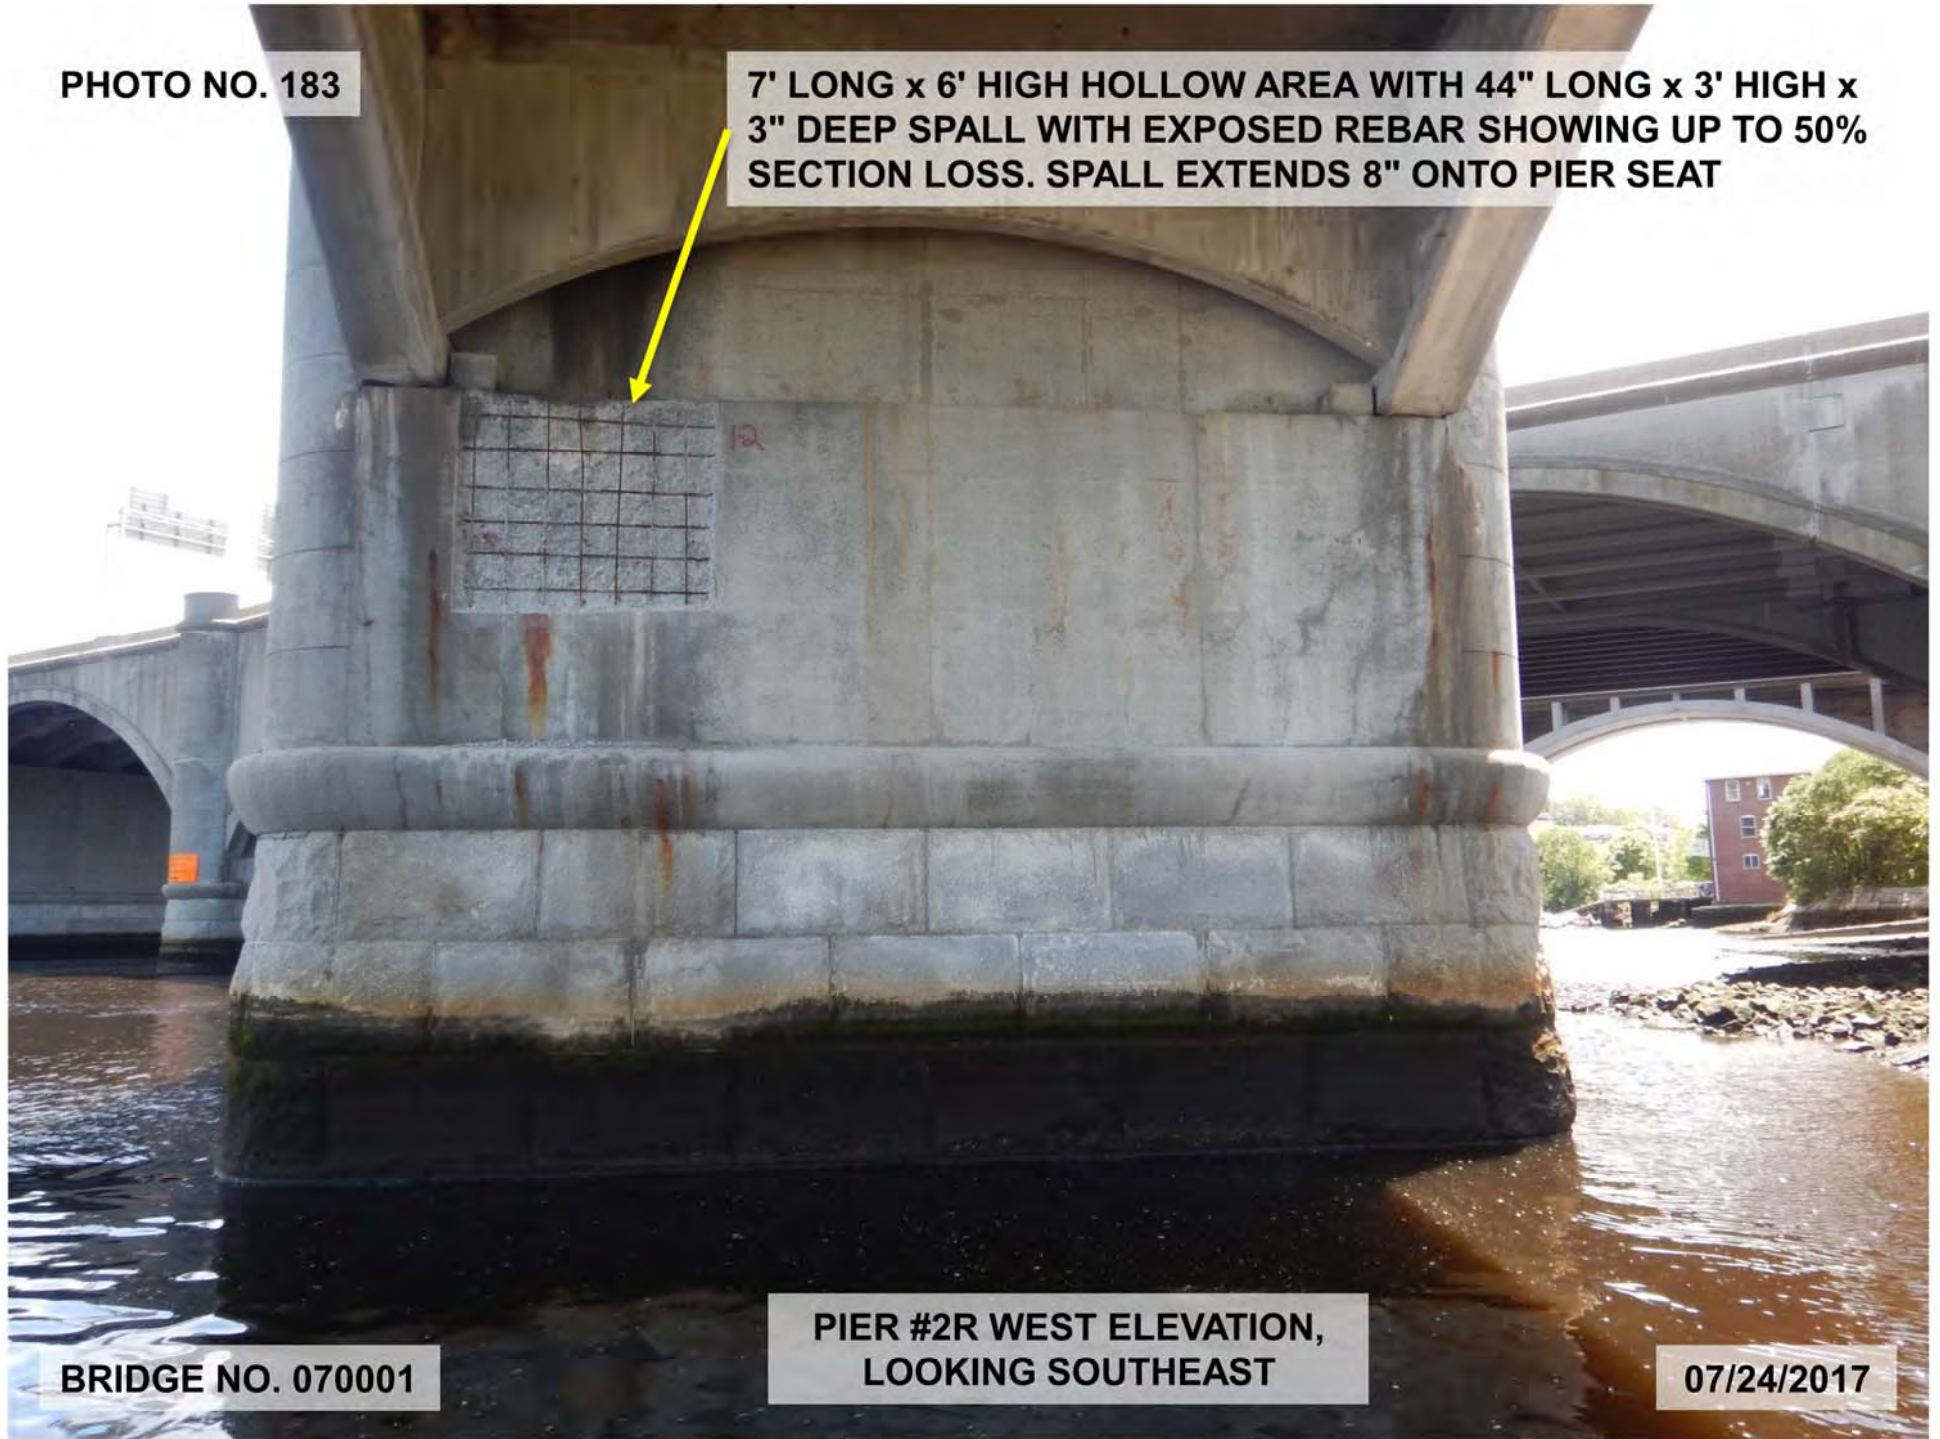
7' LONG x 6' HIGH HOLLOW AREA WITH 44" LONG x 3' HIGH x 3" DEEP SPALL WITH EXPOSED REBAR SHOWING UP TO 50% SECTION LOSS. SPALL EXTENDS 8" ONTO PIER SEAT

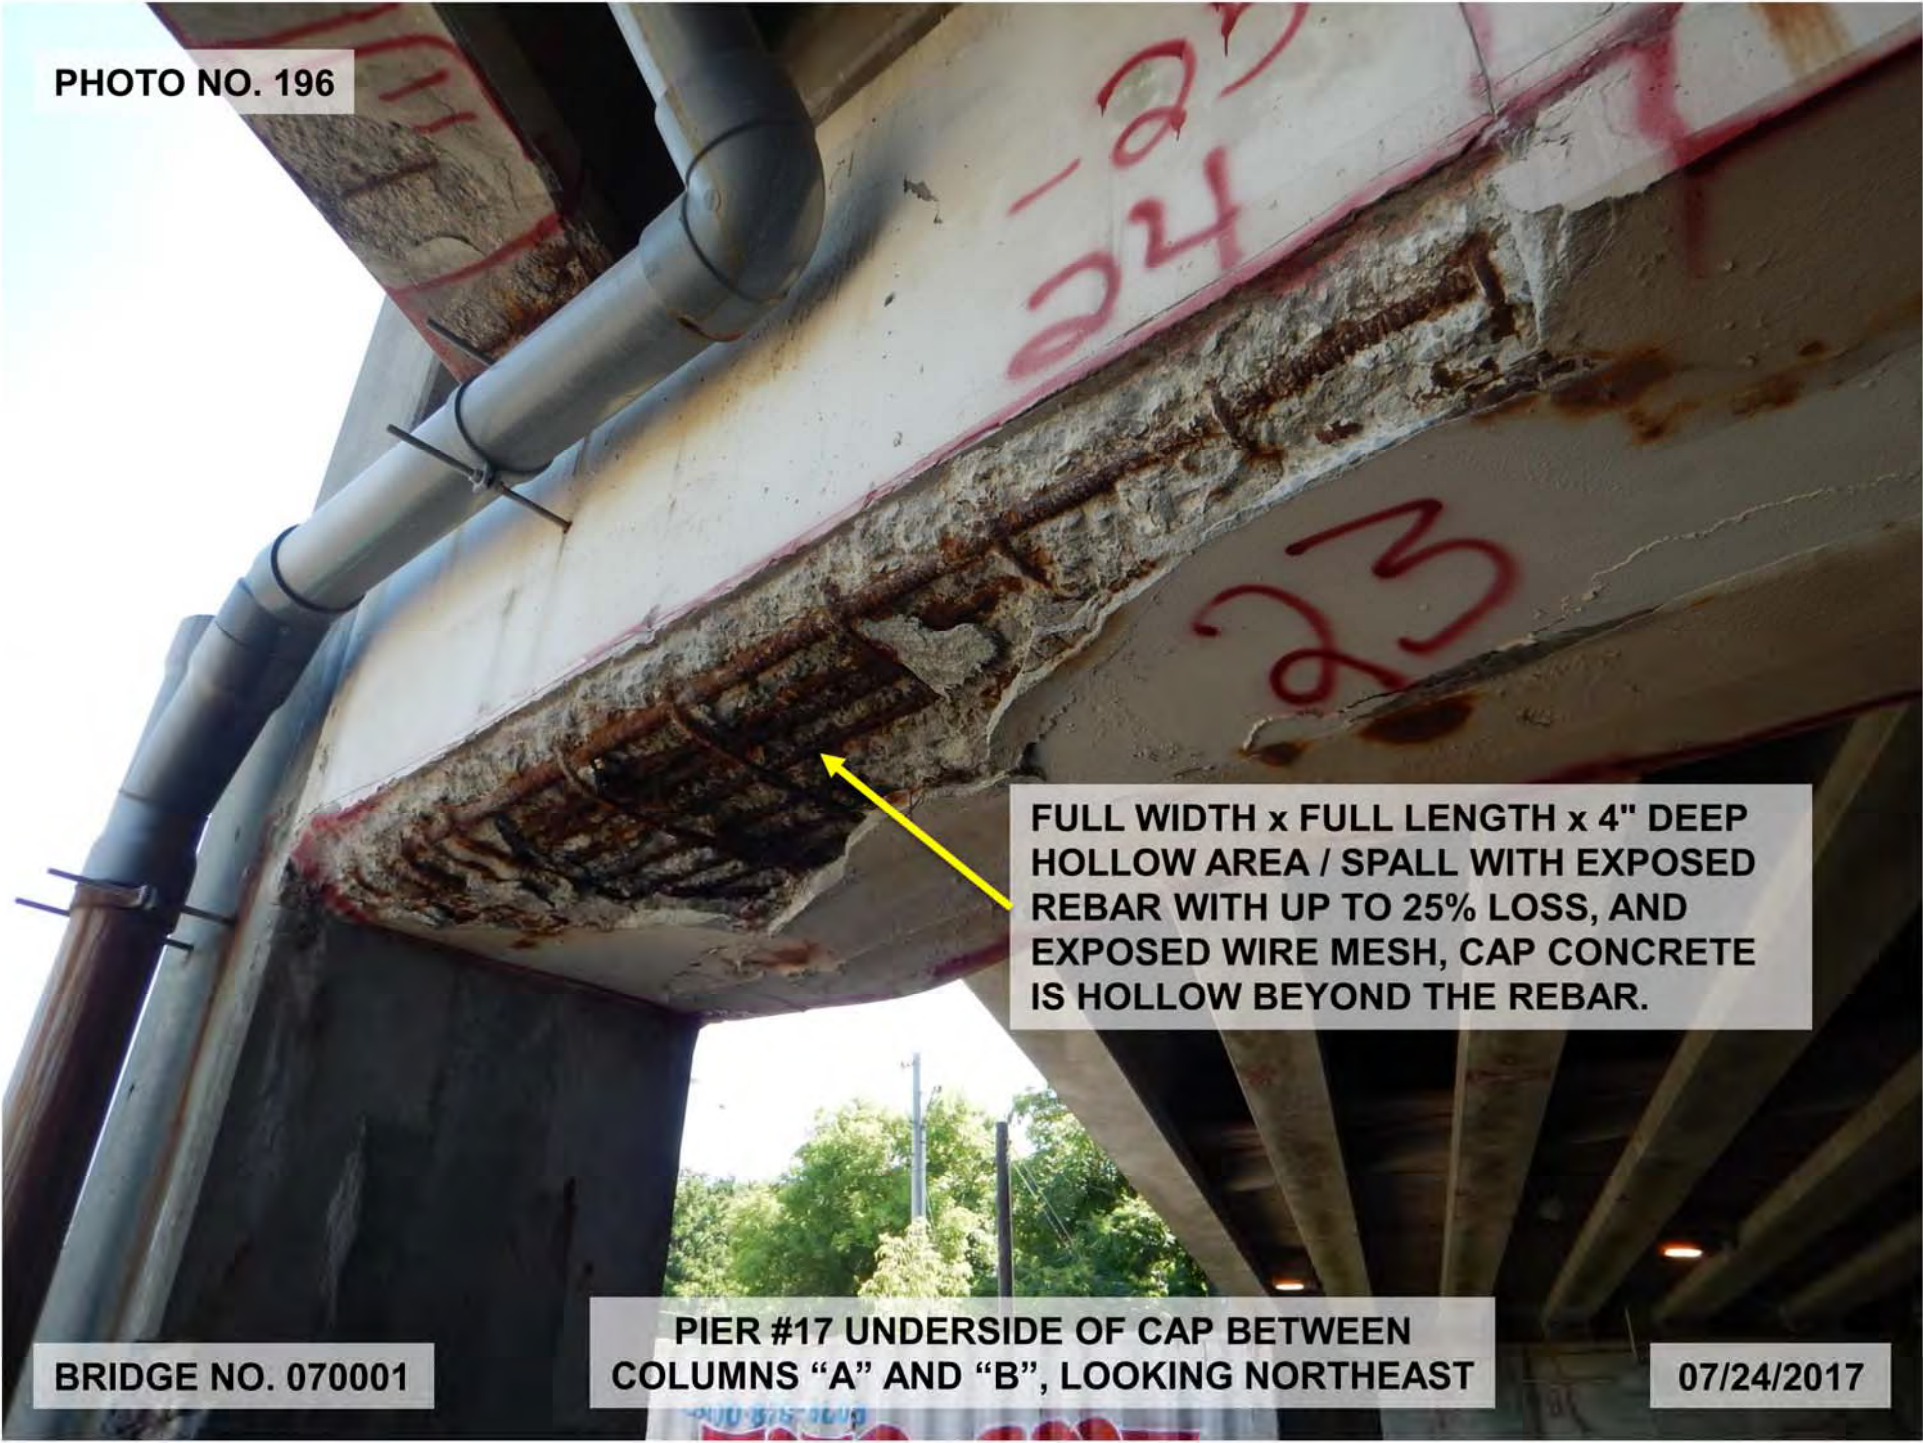
FULL WIDTH x FULL LENGTH x 4" DEEP HOLLOW AREA / SPALL WITH EXPOSED REBAR WITH UP TO 25% LOSS, AND EXPOSED WIRE MESH, CAP CONCRETE IS HOLLOW BEYOND THE REBAR.

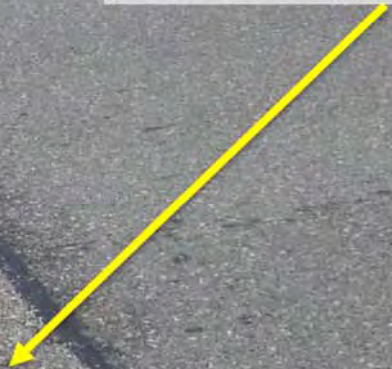
POURABLE JOINT SEAL
WITH ADHESION CRACKING

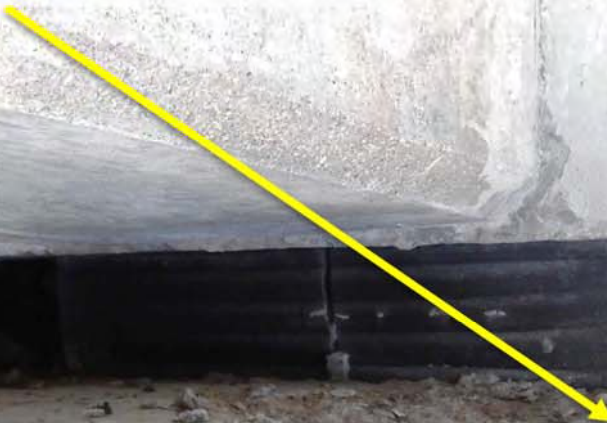
**BEARING PAD IS UNDERMINED 1" DEEP
DUE TO SPALL 1' WIDE x 1' HIGH x 1-
1/2" DEEP WITH EXPOSED ANCHOR
PLATE ON THE CORBEL. NOTE
MODERATE TO SEVEERE BULGING ON
THE BEARING PAD**
