PHOTO NO. 1

BRIDGE NO. 070001

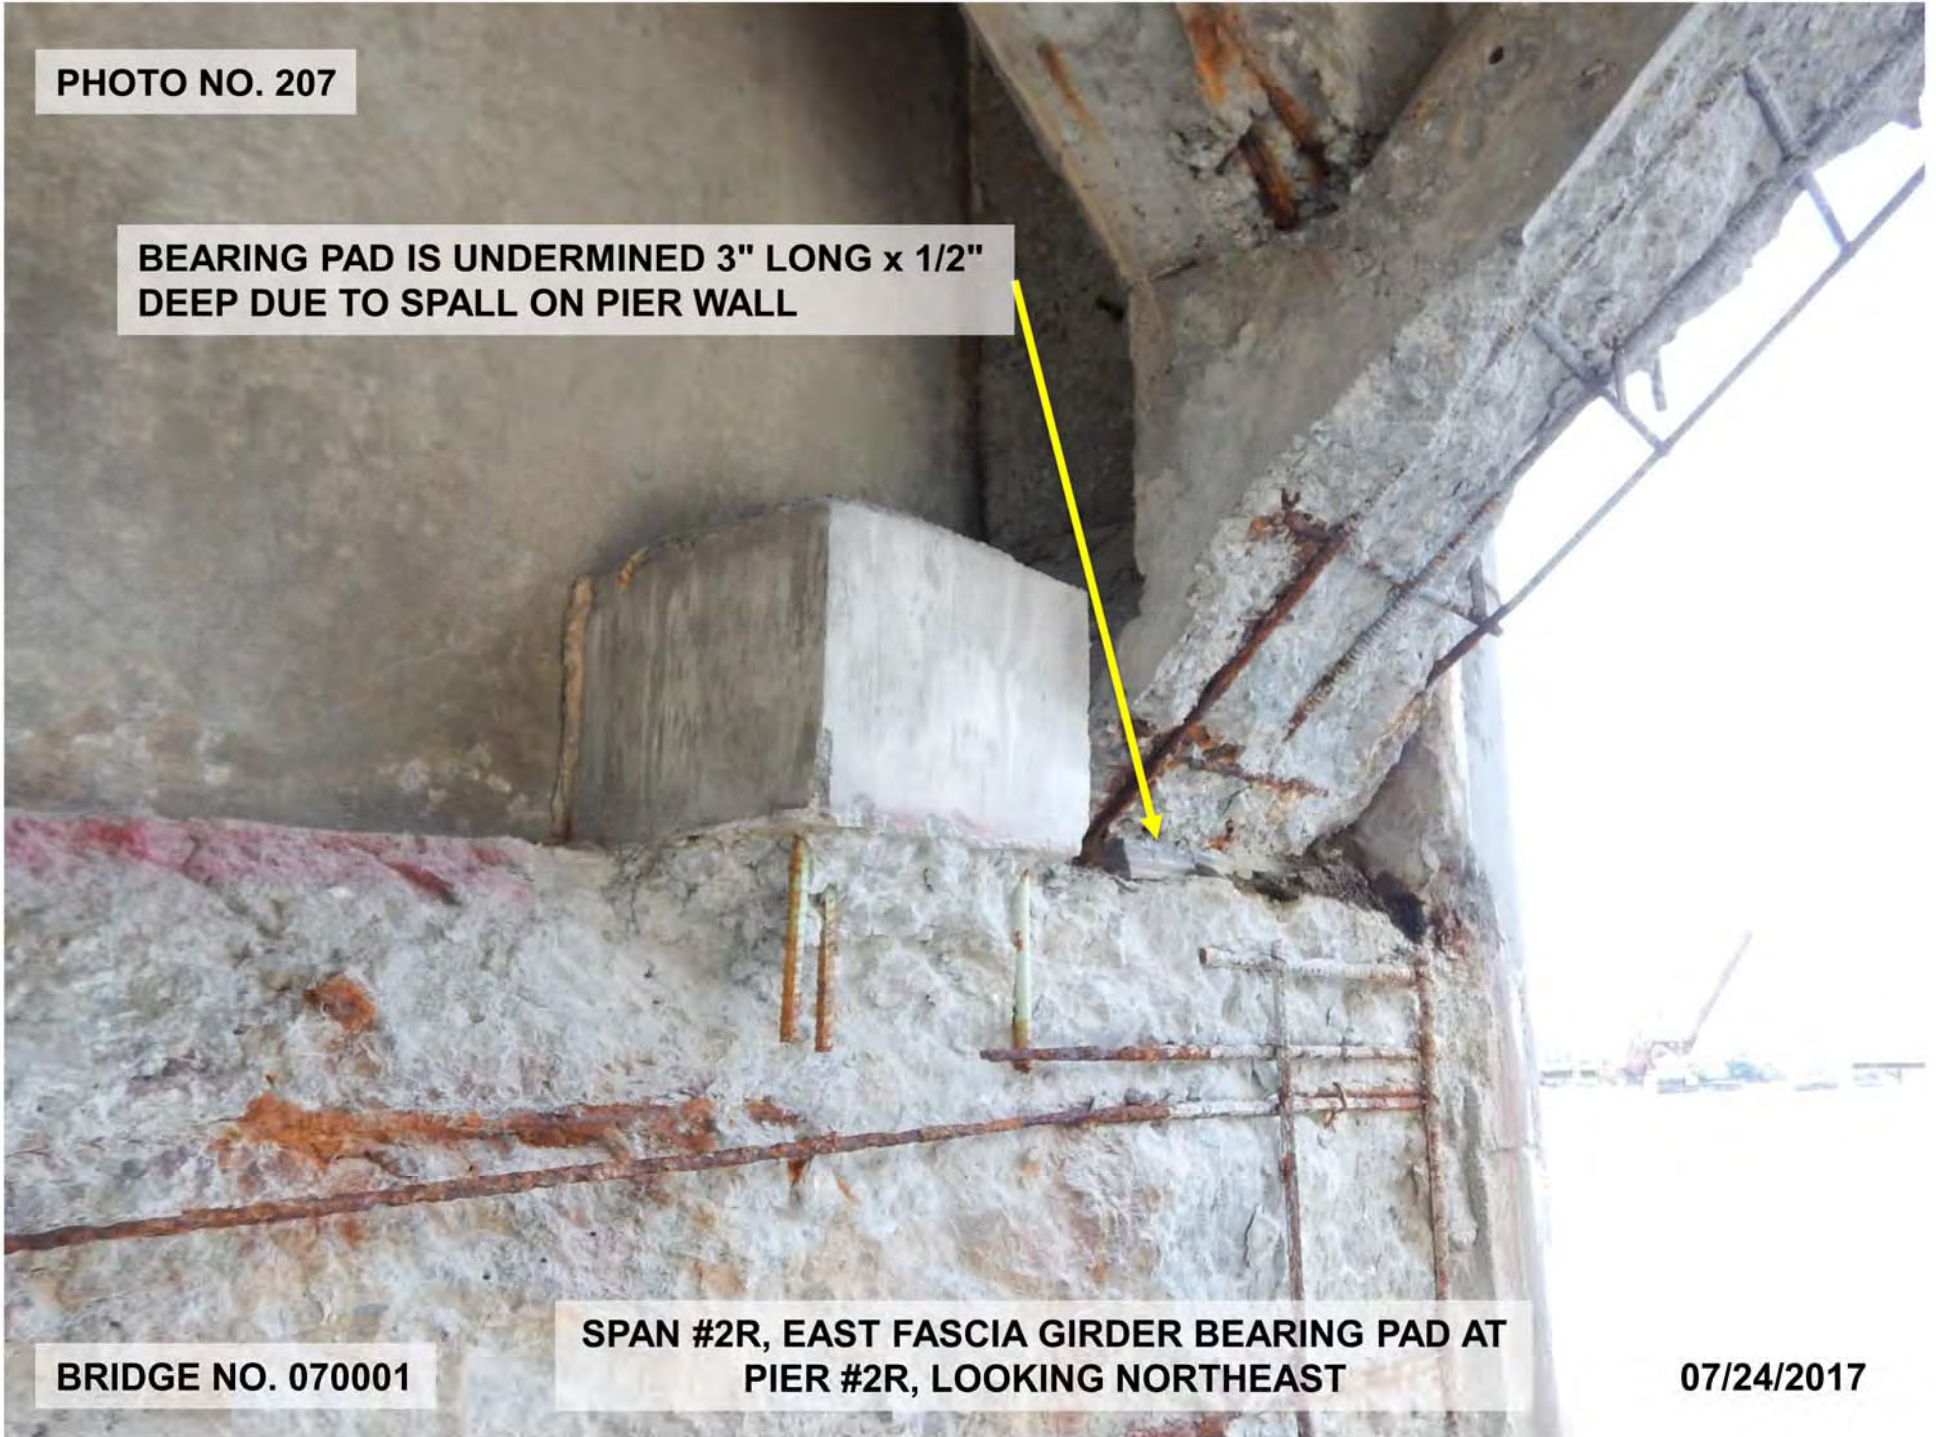
**BEARING PAD IS UNDERMINED 3" LONG x 1/2"
DEEP DUE TO SPALL ON PIER WALL**

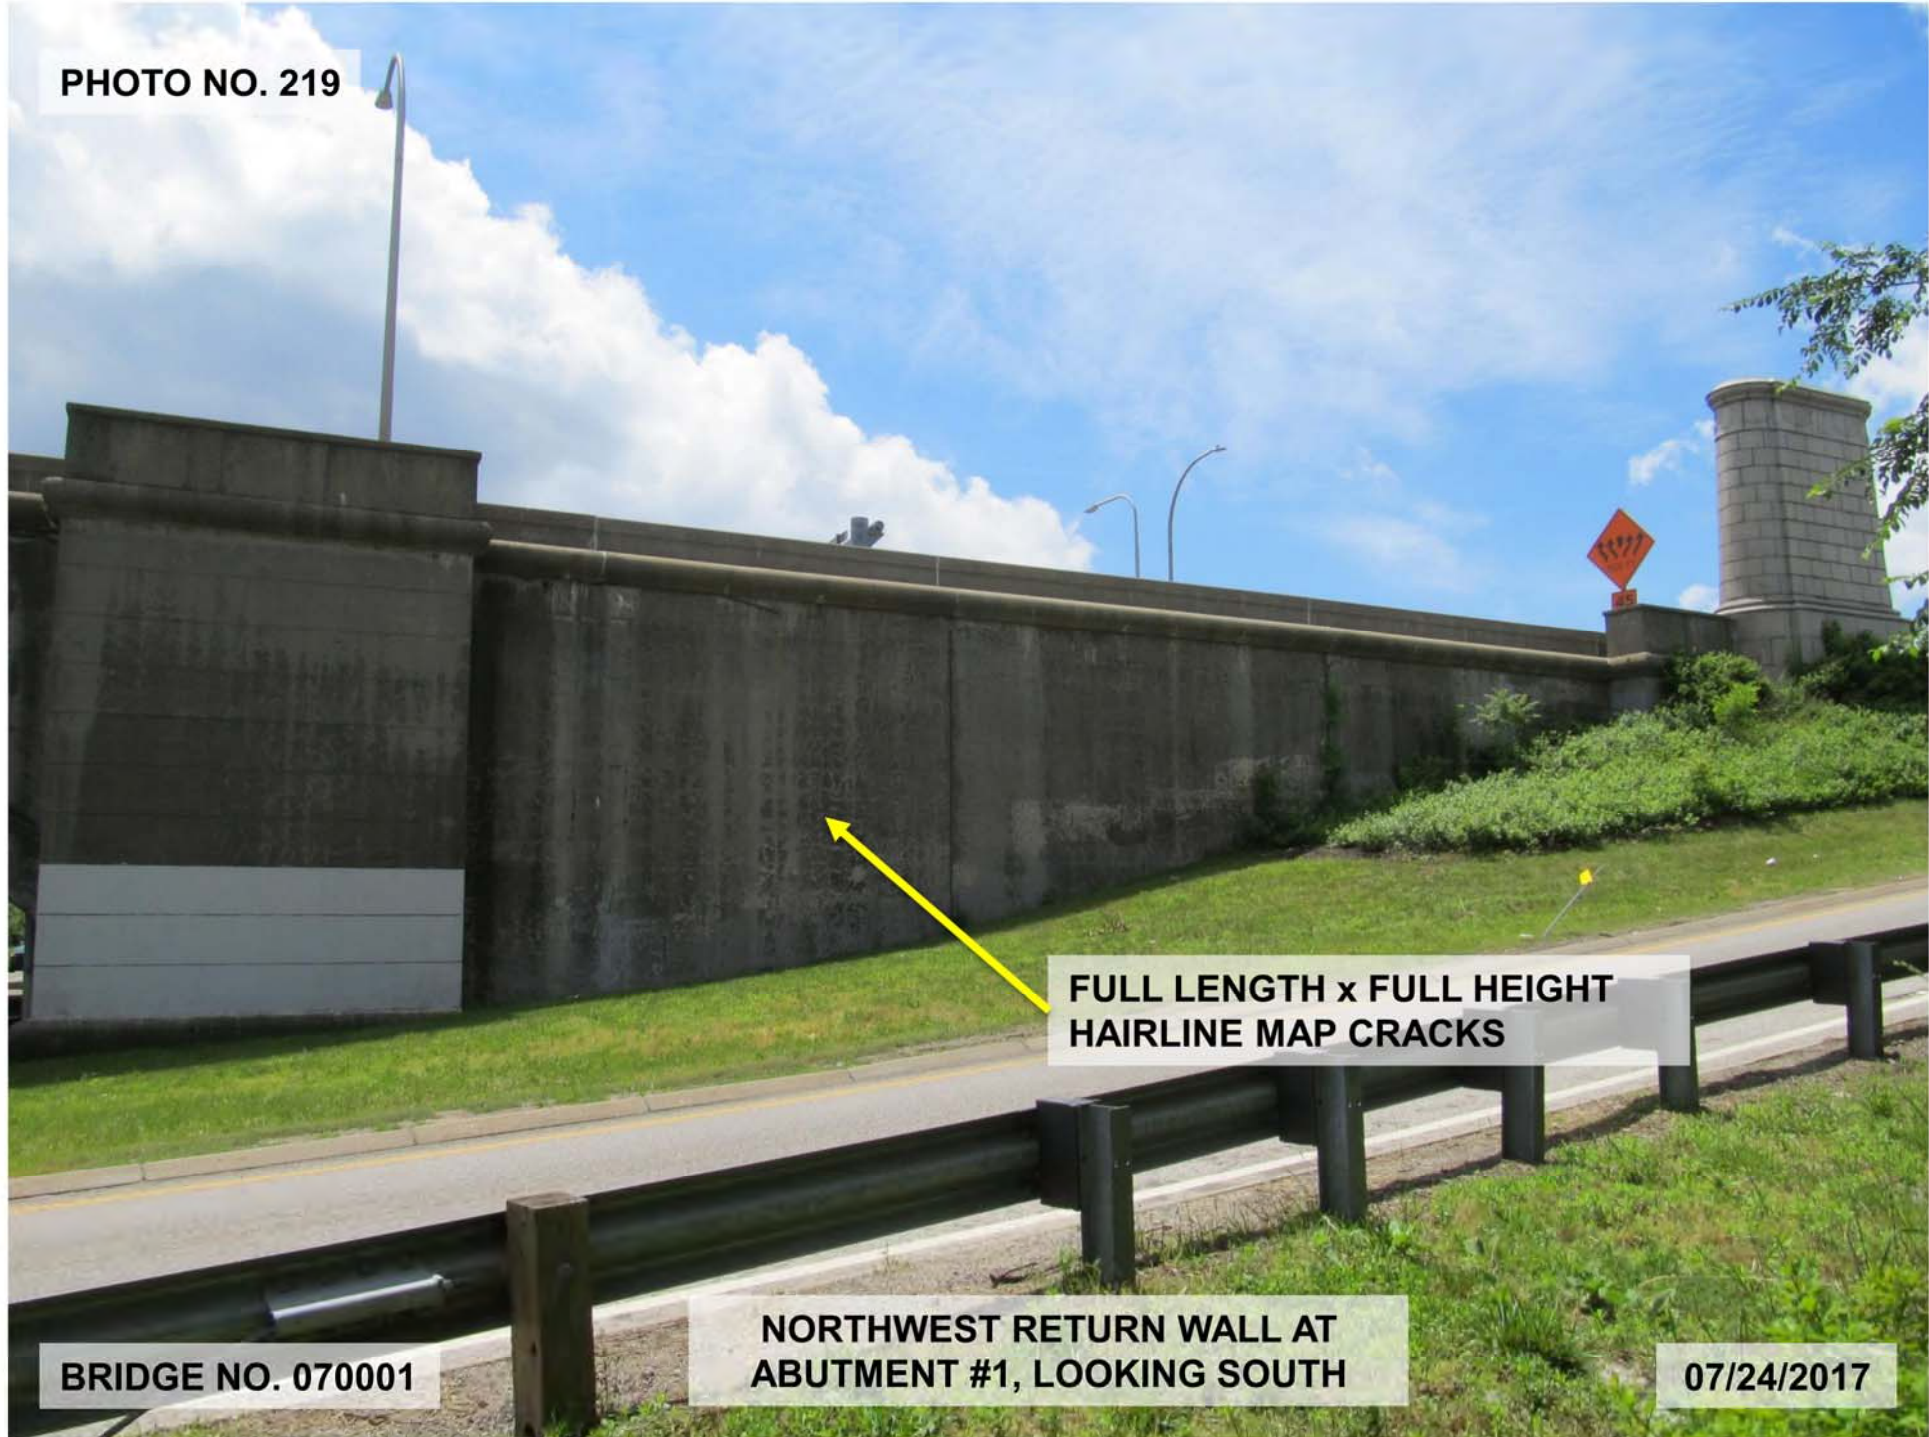
**FULL LENGTH x FULL HEIGHT
HAIRLINE MAP CRACKS**

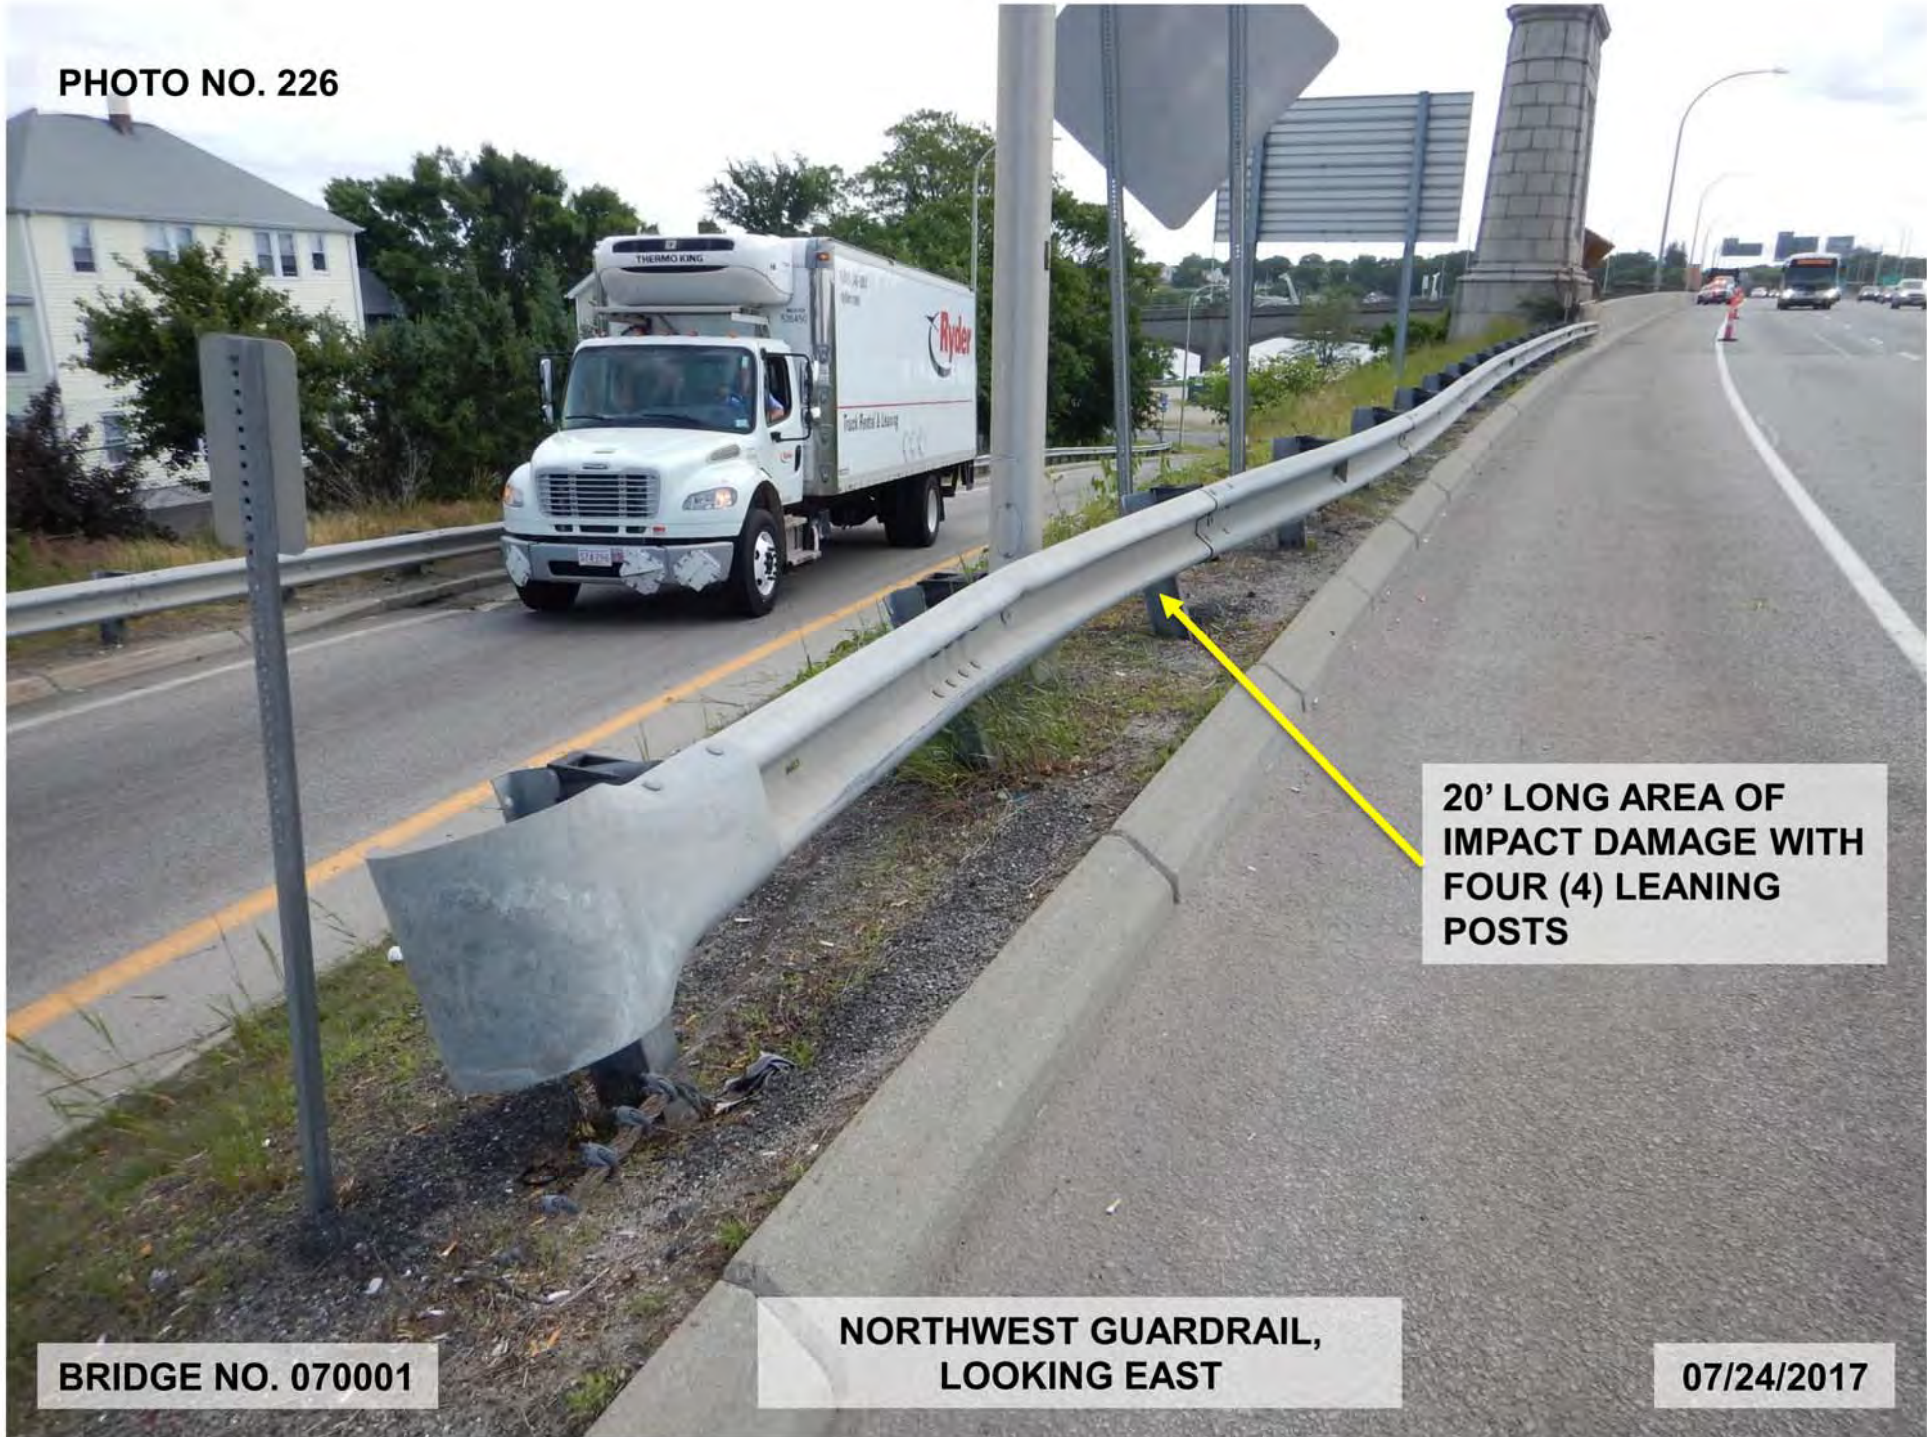
20' LONG AREA OF
IMPACT DAMAGE WITH
FOUR (4) LEANING
POSTS

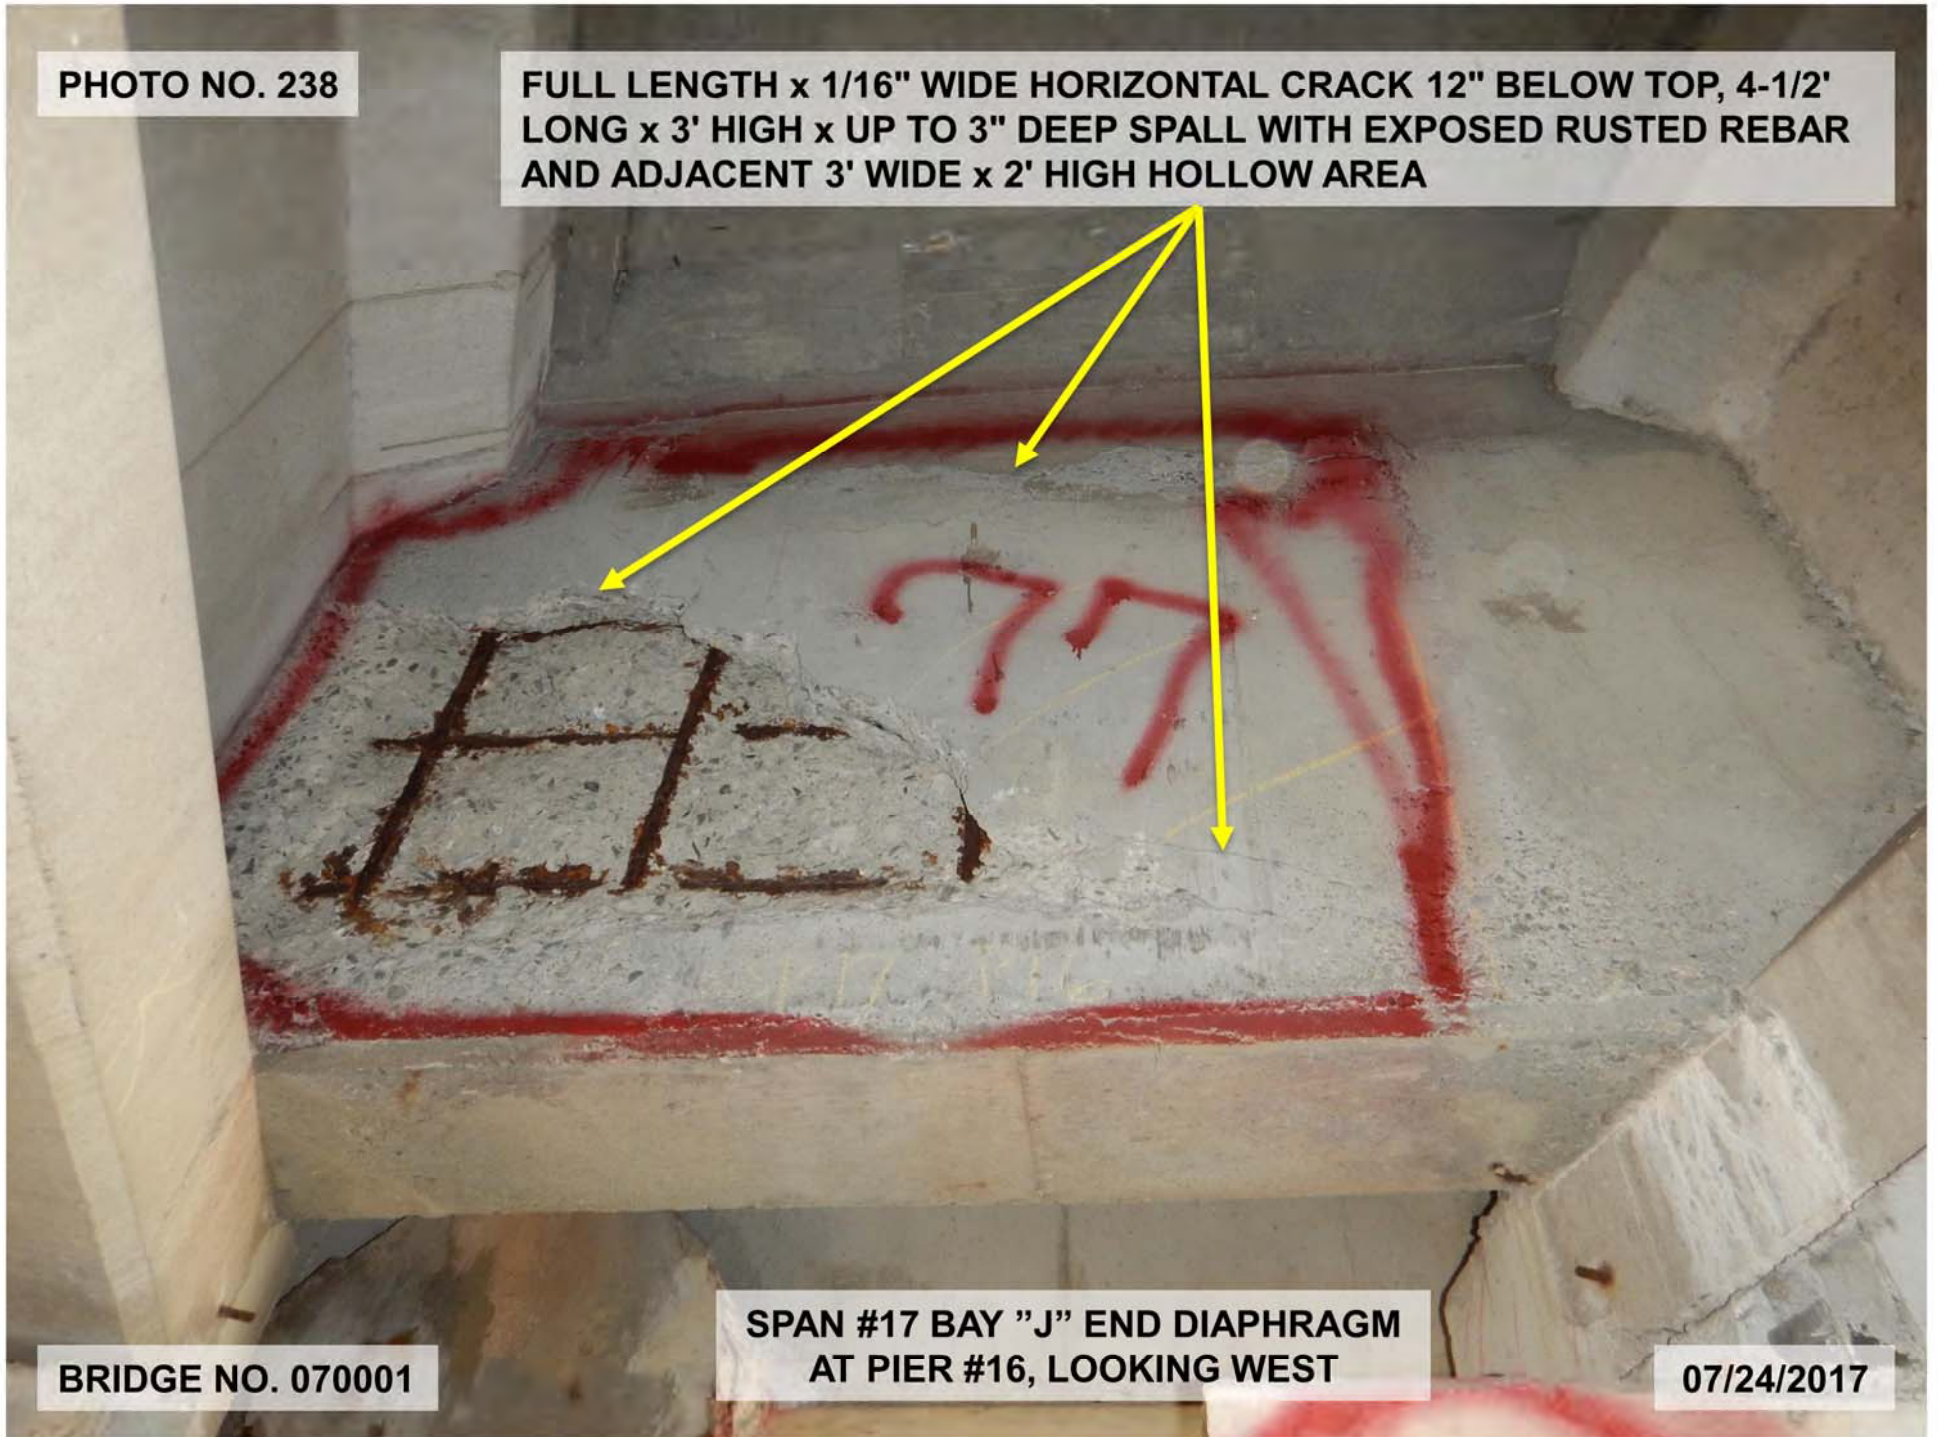
FULL LENGTH x 1/16" WIDE HORIZONTAL CRACK 12" BELOW TOP, 4-1/2' LONG x 3' HIGH x UP TO 3" DEEP SPALL WITH EXPOSED RUSTED REBAR AND ADJACENT 3' WIDE x 2' HIGH HOLLOW AREA

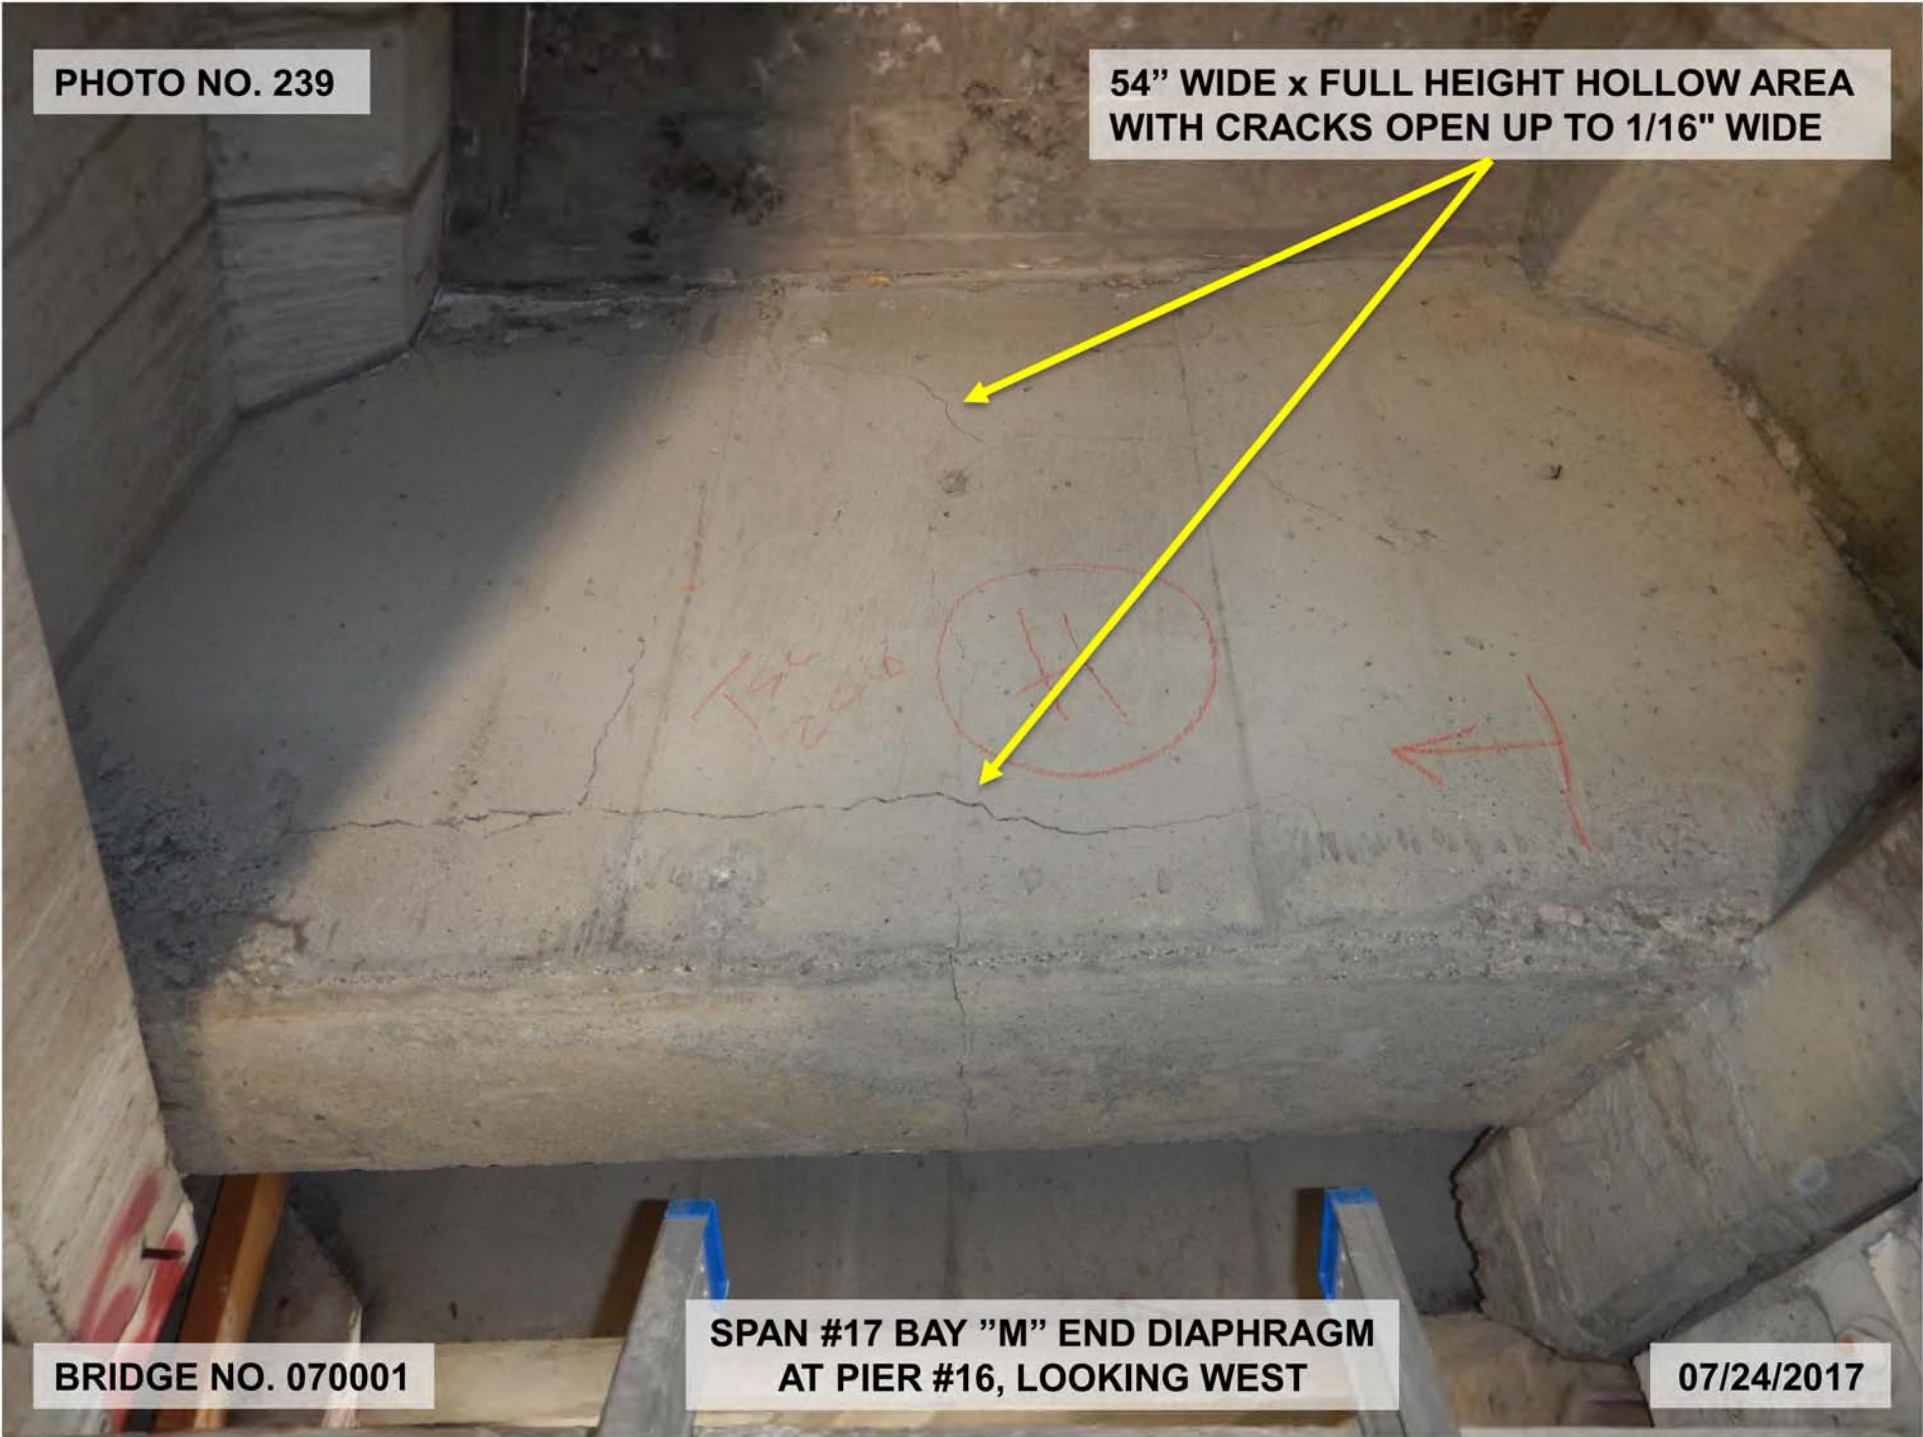
54" WIDE x FULL HEIGHT HOLLOW AREA
WITH CRACKS OPEN UP TO 1/16" WIDE

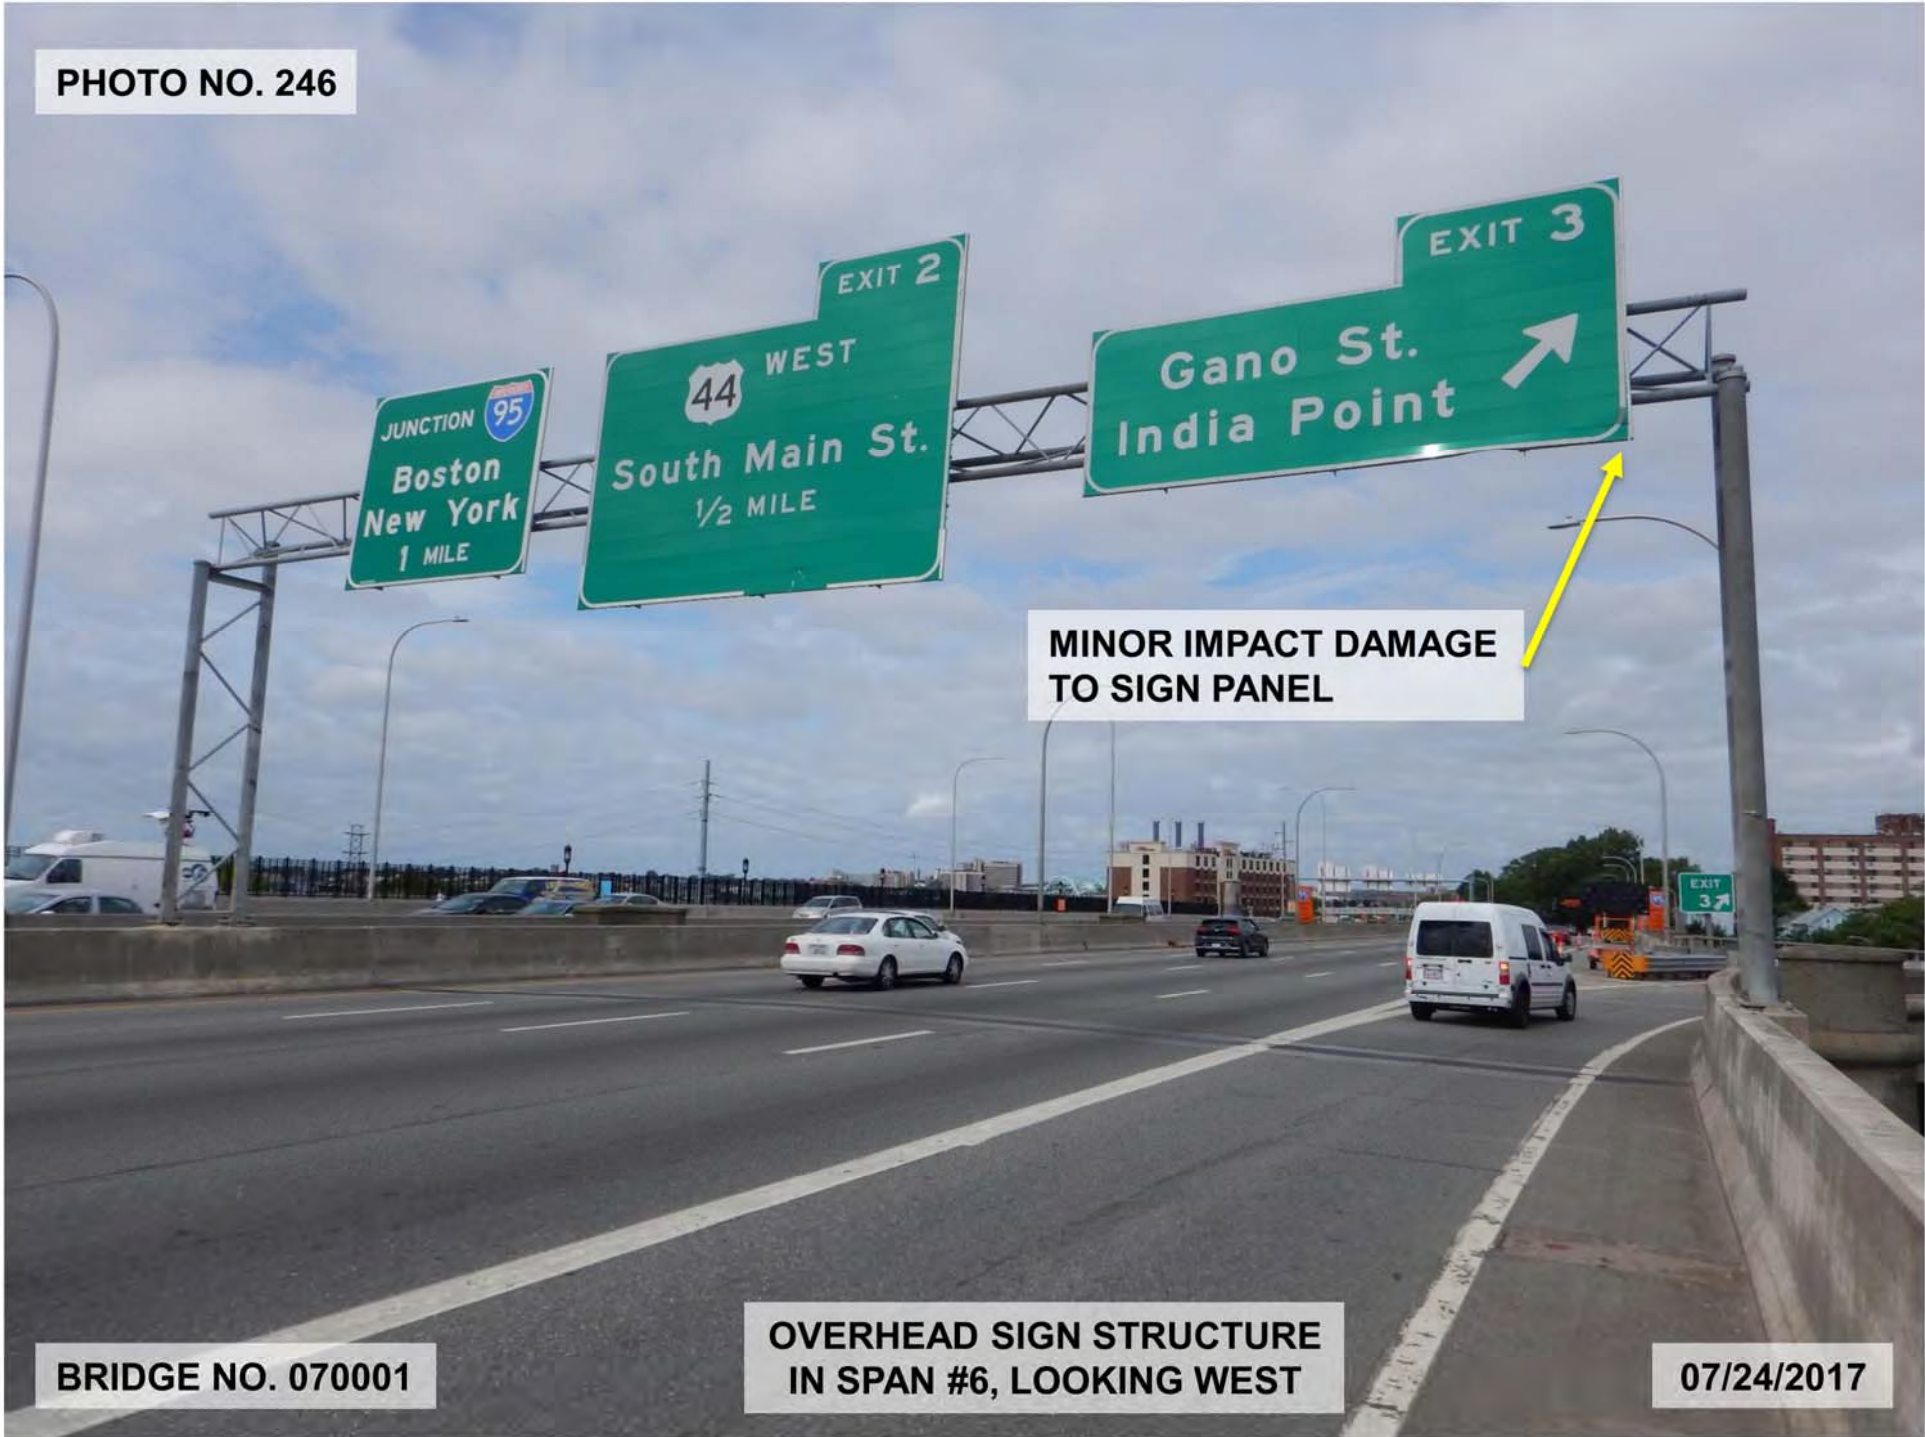
MINOR IMPACT DAMAGE TO SIGN PANEL
