12-MONTH SPECIAL INSPECTION

BRIDGE #070001

07/22/2020

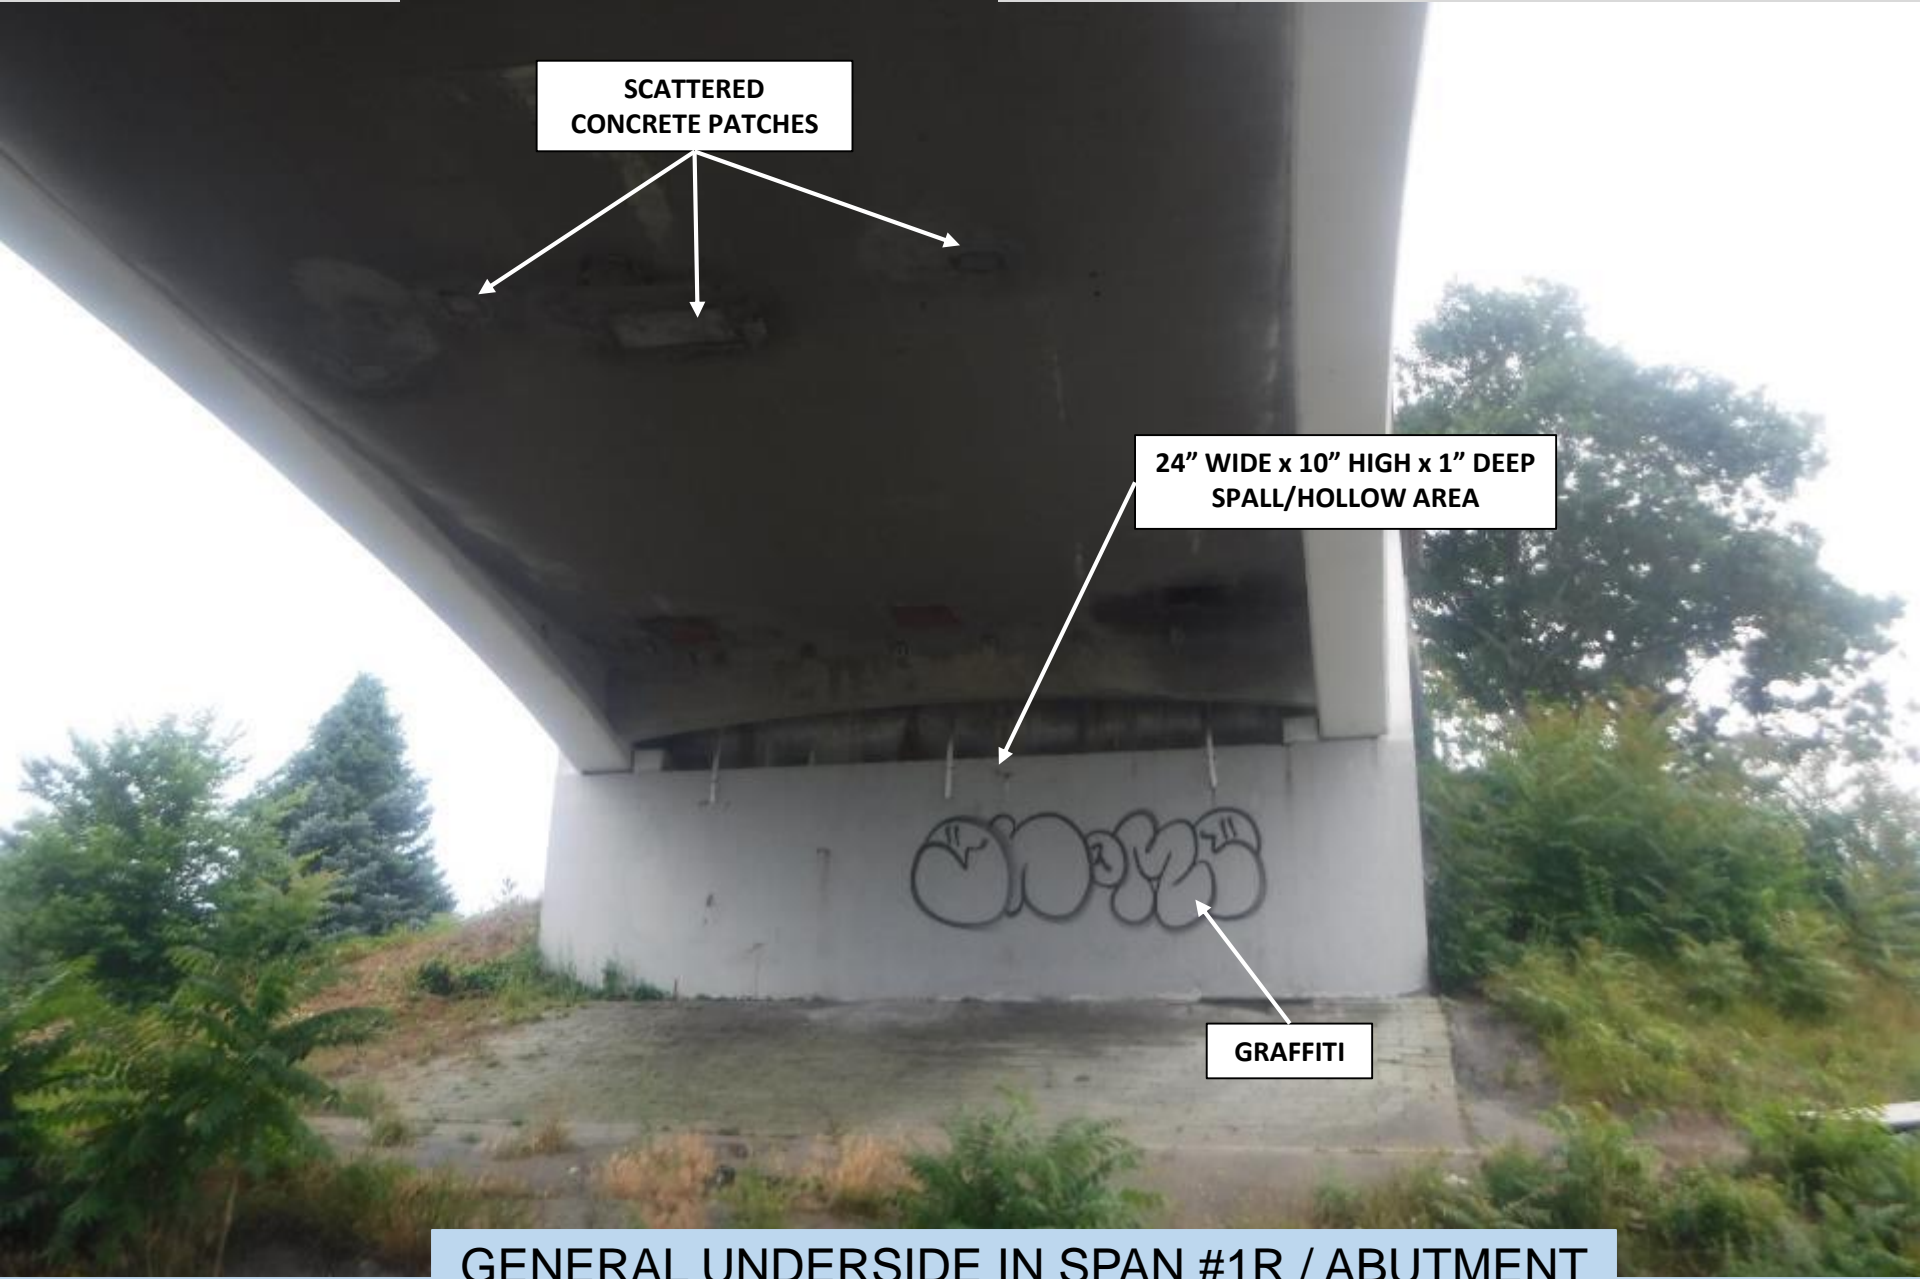
**SCATTERED
CONCRETE PATCHES**

**24" WIDE x 10" HIGH x 1" DEEP
SPALL/HOLLOW AREA**

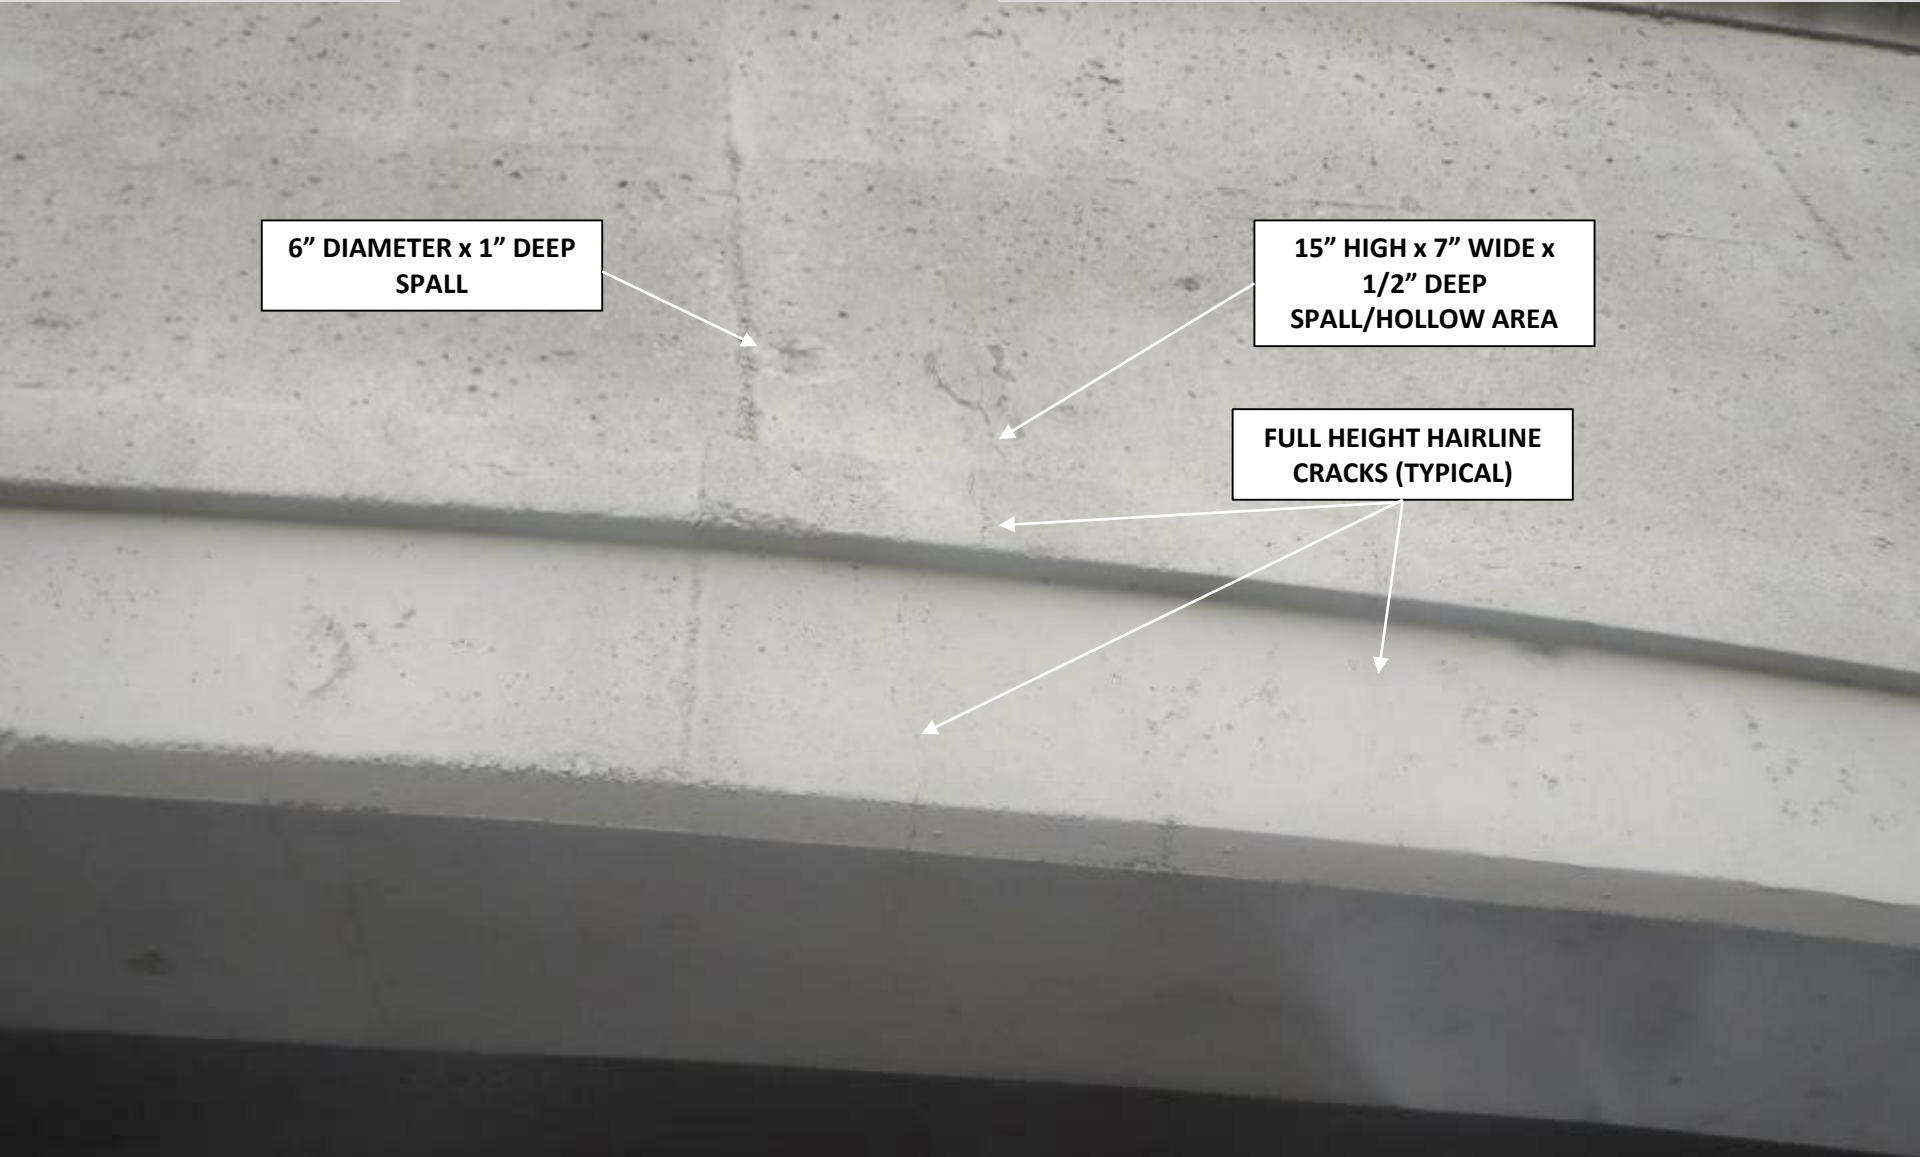
**SOUTH ARCH – SOUTH FACE
AT EAST 1/3 POINT IN SPAN #2R
(LOOKING NORTH)**

**6" DIAMETER x 1" DEEP
SPALL**

**15" HIGH x 7" WIDE x
1/2" DEEP
SPALL/HOLLOW AREA**

**FULL HEIGHT HAIRLINE
CRACKS (TYPICAL)**

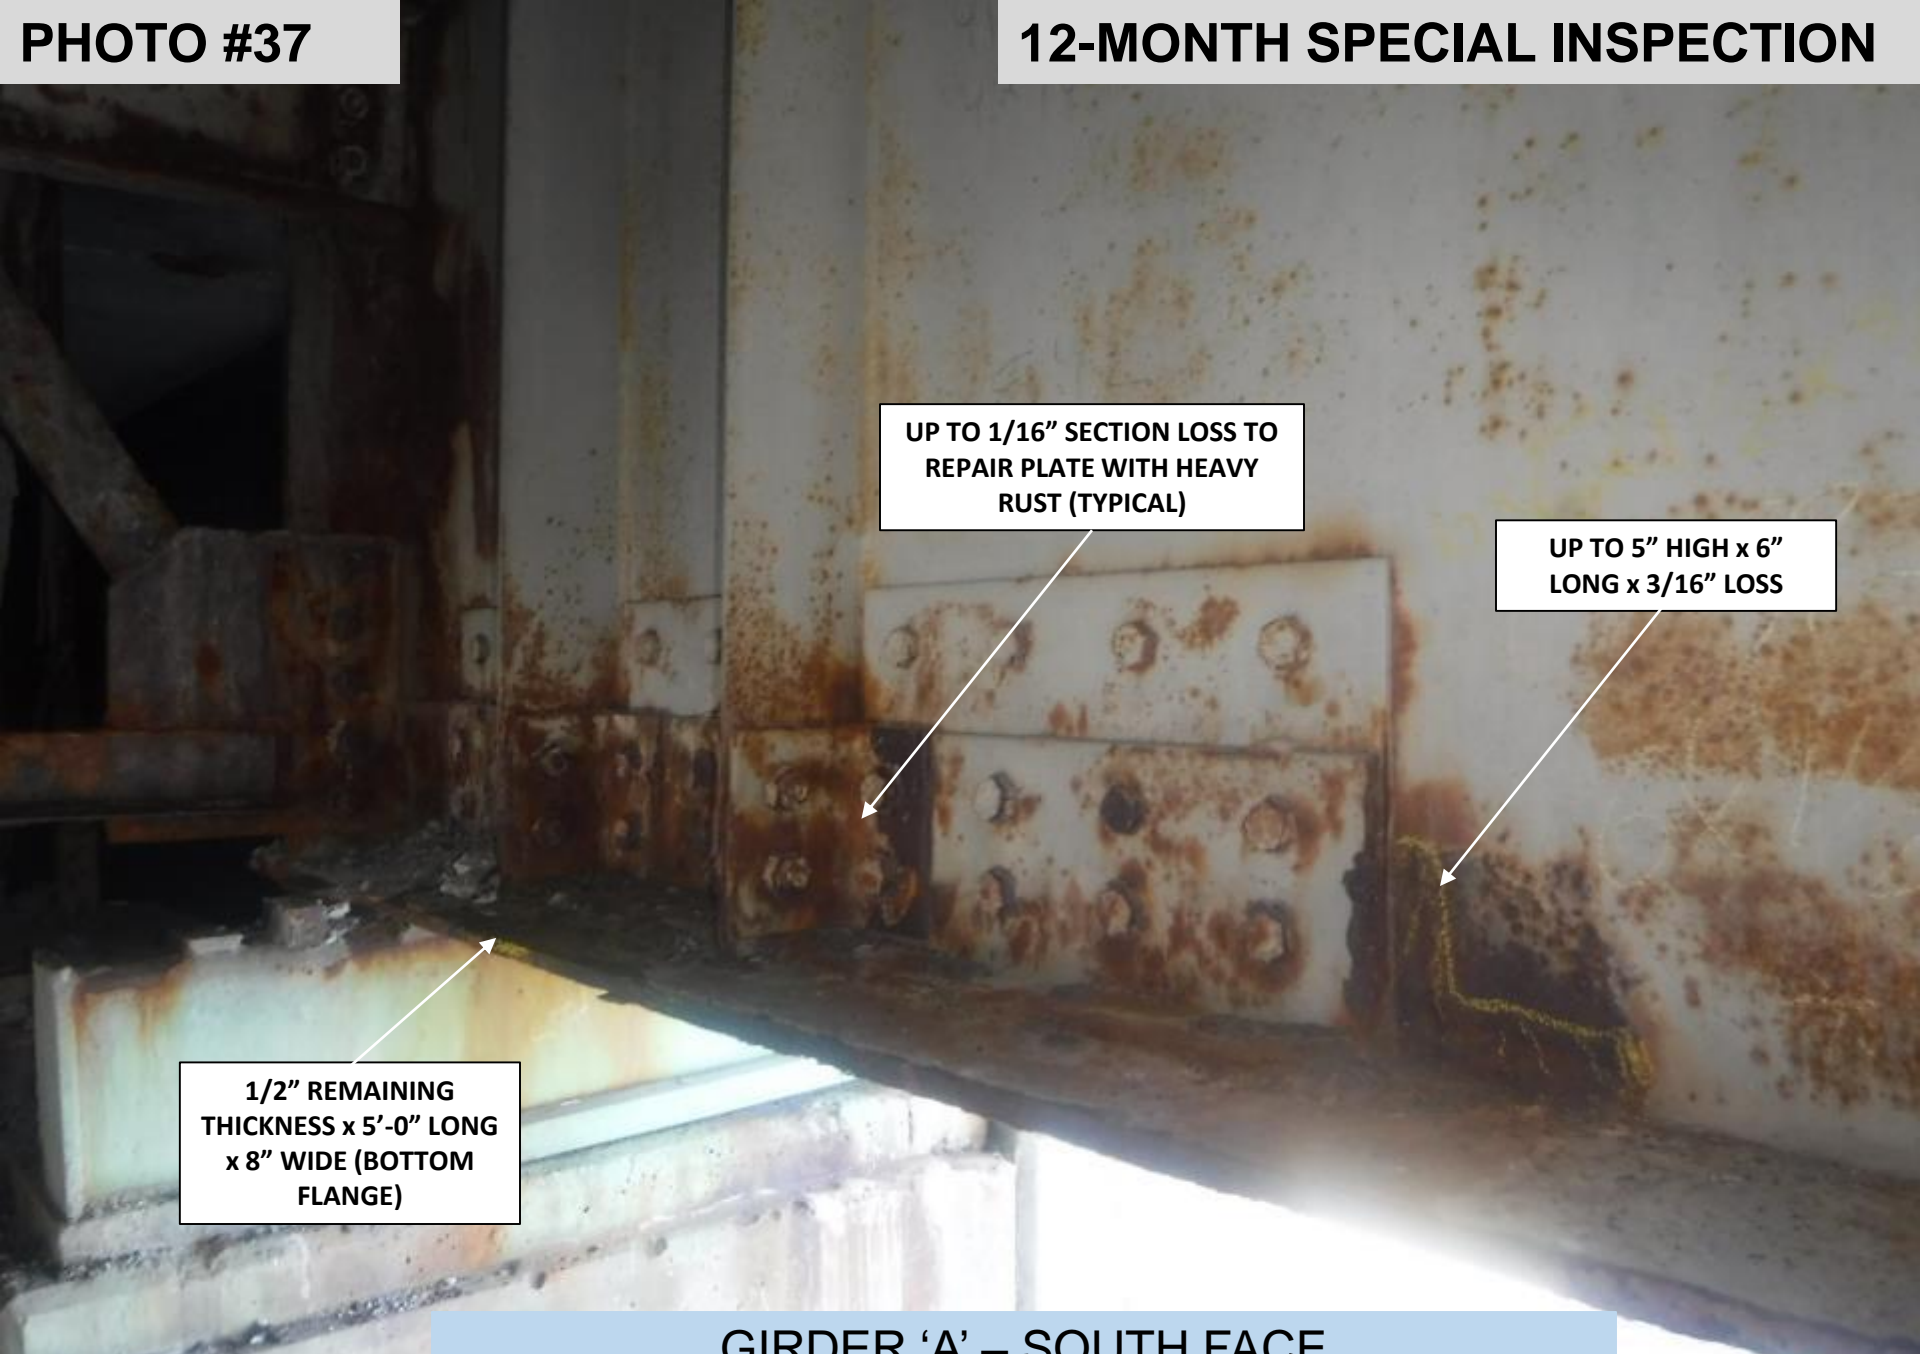
1/2" REMAINING THICKNESS x 5'-0" LONG x 8" WIDE (BOTTOM FLANGE)

UP TO 1/16" SECTION LOSS TO REPAIR PLATE WITH HEAVY RUST (TYPICAL)

UP TO 5" HIGH x 6" LONG x 3/16" LOSS

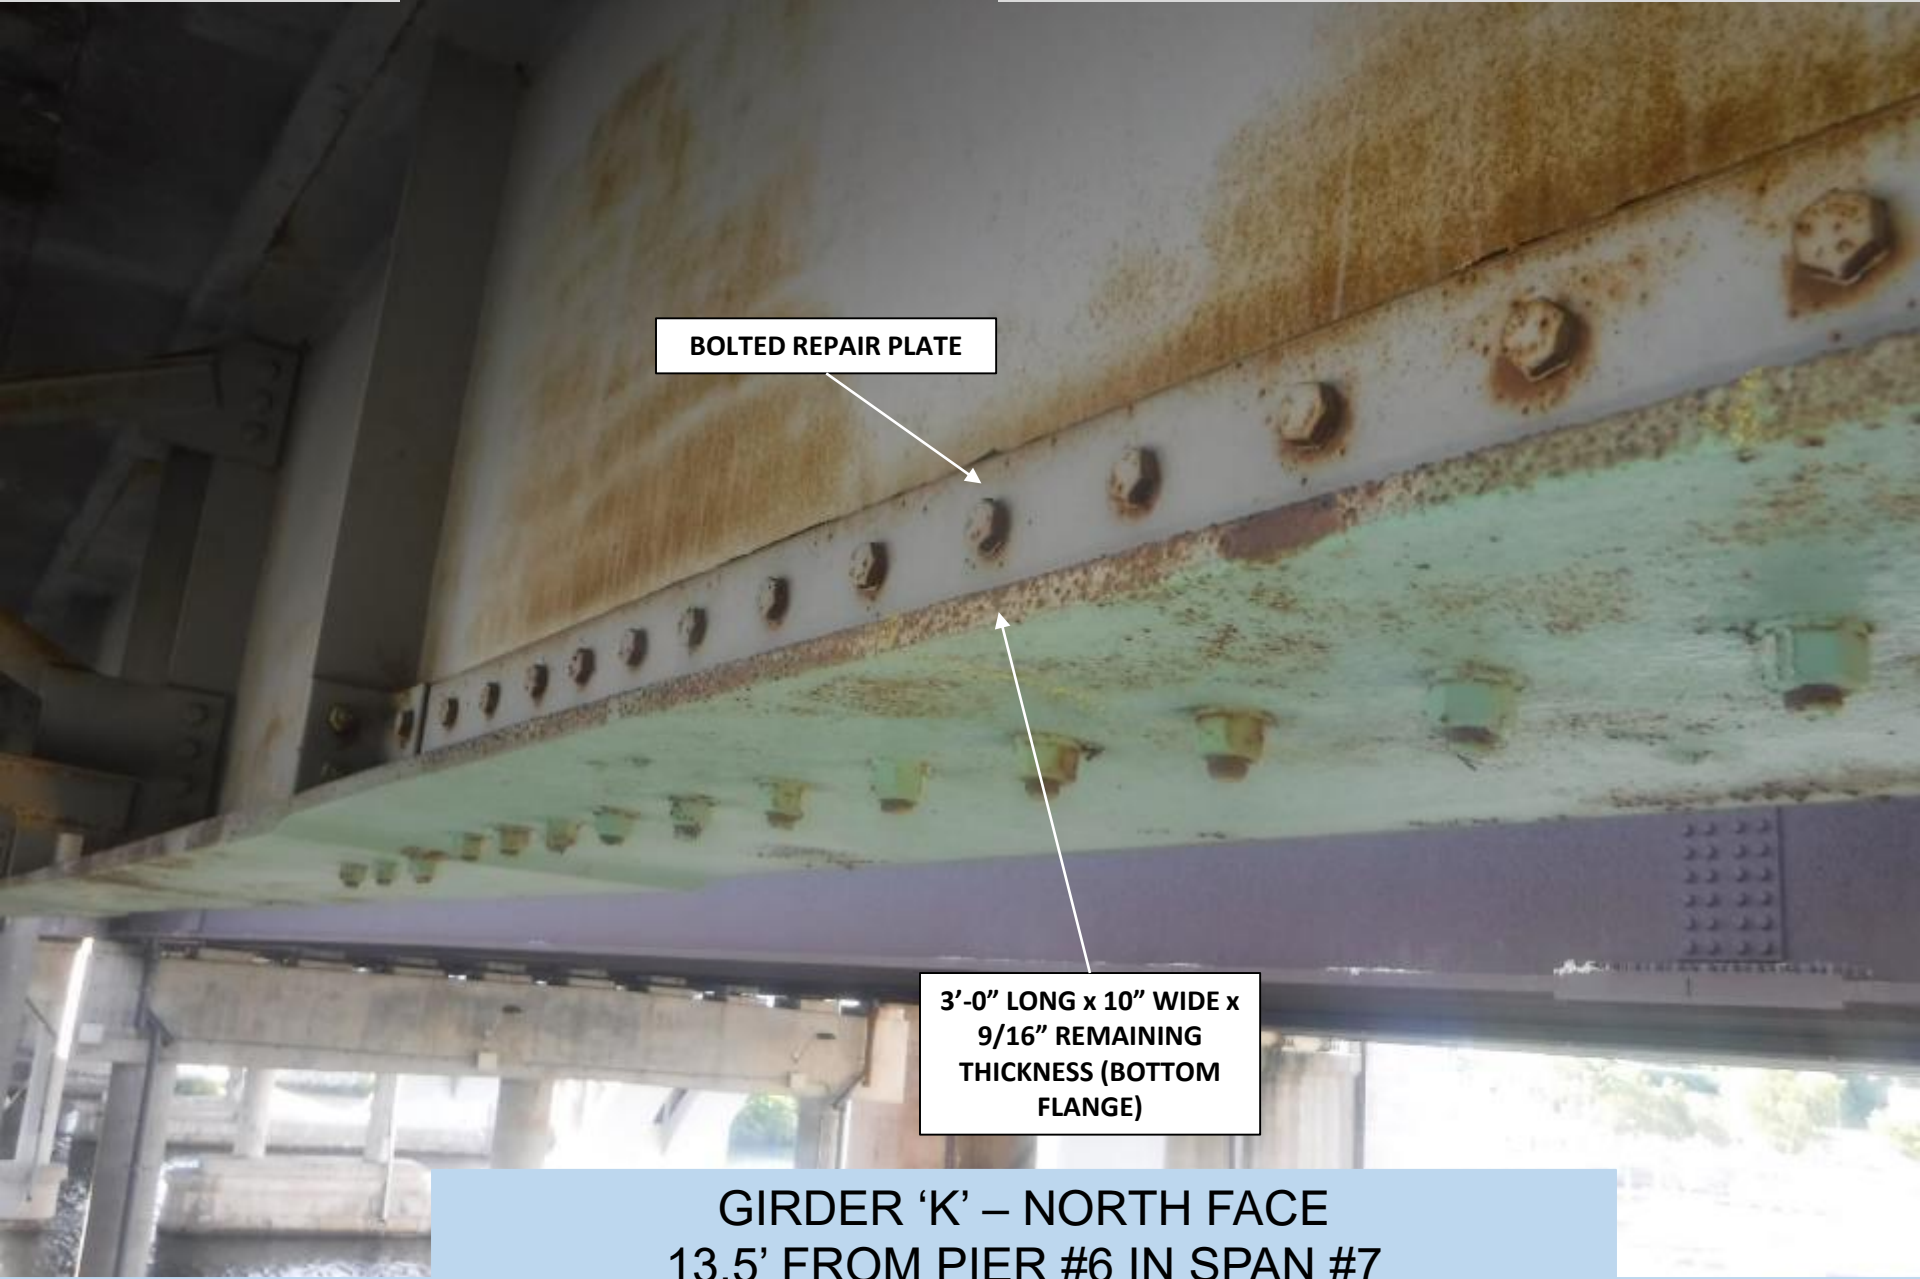
**GIRDER 'K' – NORTH FACE
13.5' FROM PIER #6 IN SPAN #7
(LOOKING SOUTHEAST)**

BOLTED REPAIR PLATE

**3'-0" LONG x 10" WIDE x
9/16" REMAINING
THICKNESS (BOTTOM
FLANGE)**

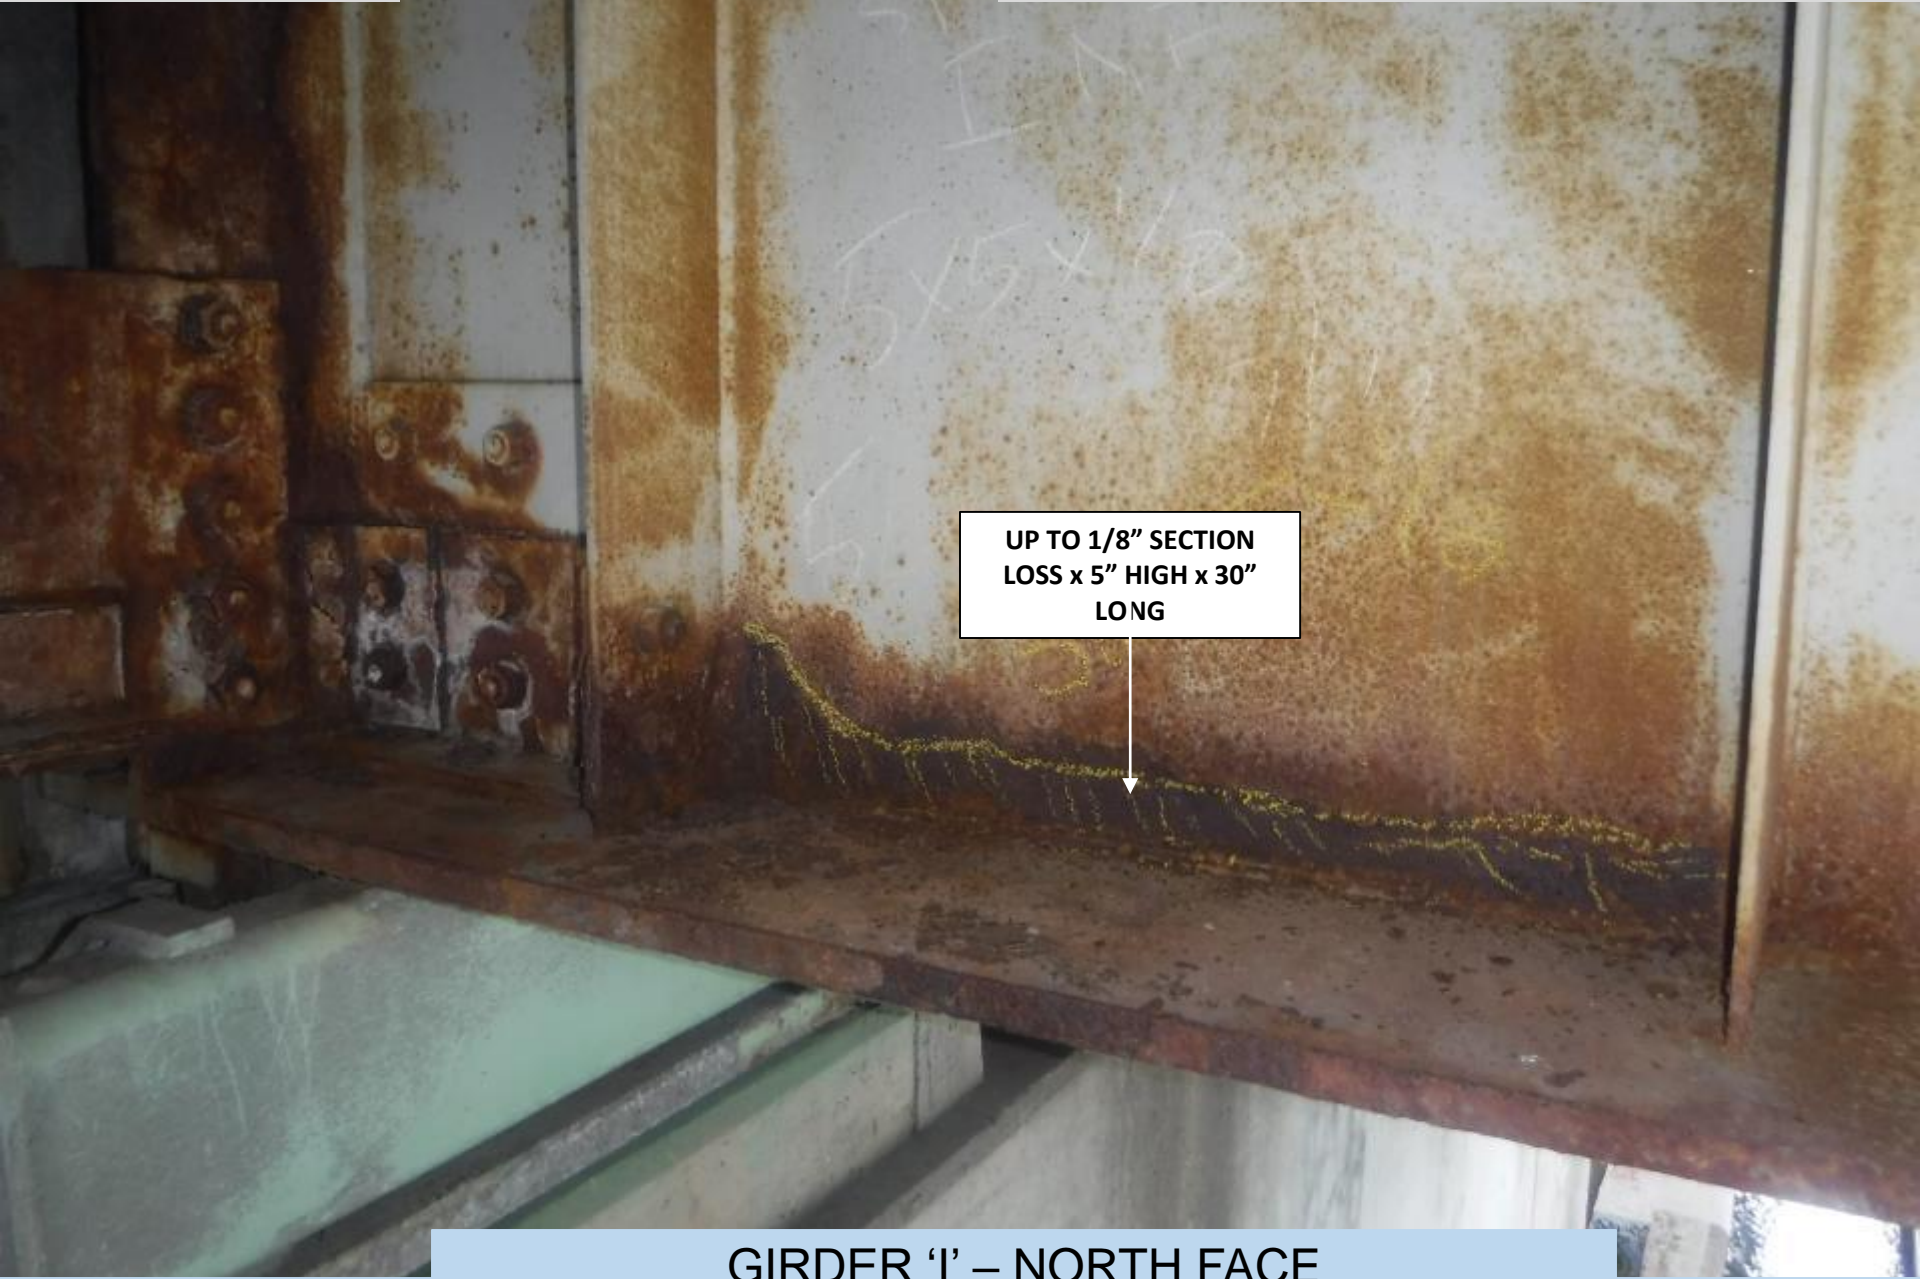
**UP TO 1/8" SECTION
LOSS x 5" HIGH x 30"
LONG**

**0.012" WIDE x 17" LONG
SHEAR CRACK**

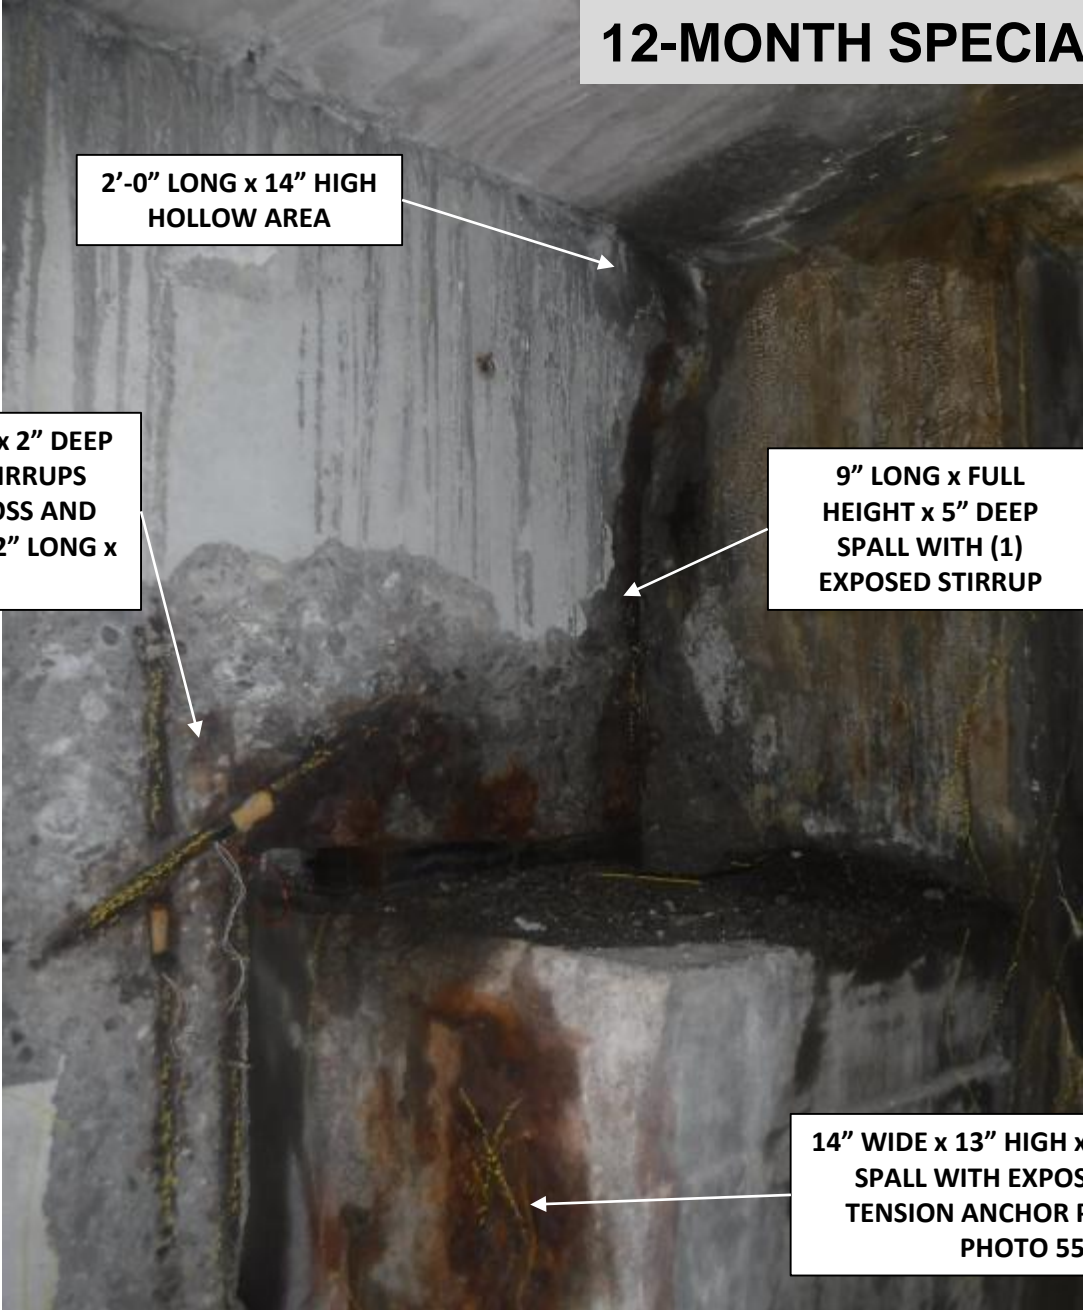
**2'-0" LONG x 14" HIGH
HOLLOW AREA**

**27" LONG x UP TO 2'-0" HIGH x 2" DEEP
SPALL WITH (3) EXPOSED STIRRUPS
WITH UP TO 50% SECTION LOSS AND
BEARING AREA REDUCED BY 12" LONG x
1" WIDE**

**9" LONG x FULL
HEIGHT x 5" DEEP
SPALL WITH (1)
EXPOSED STIRRUP**

**14" WIDE x 13" HIGH x 1-1/2" DEEP
SPALL WITH EXPOSED POST-
TENSION ANCHOR PLATE (SEE
PHOTO 55)**

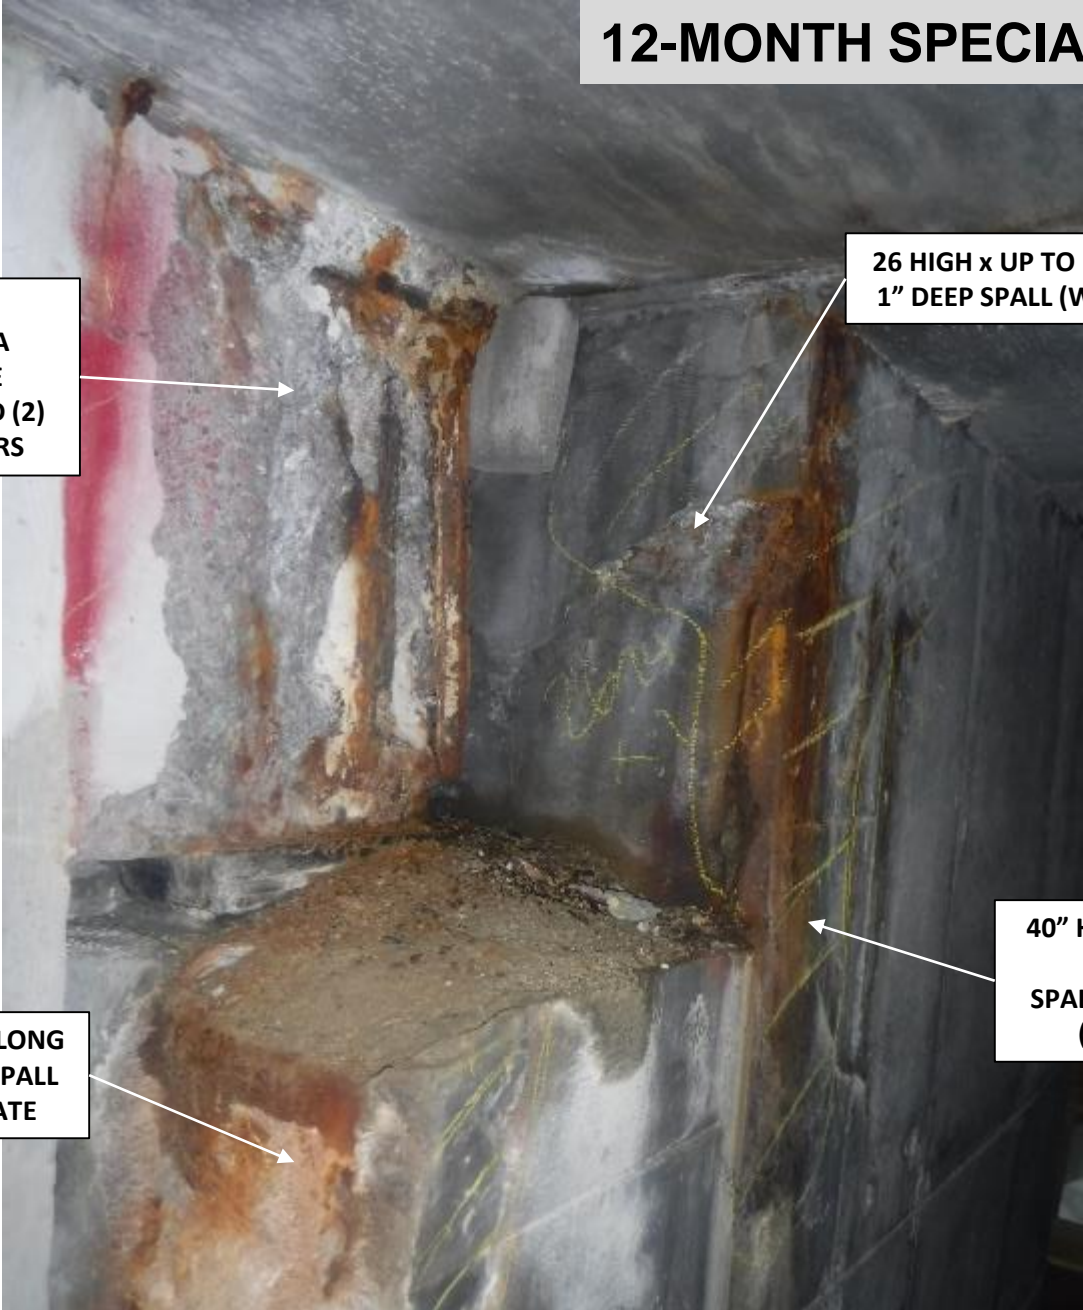
30" LONG x 28" HIGH x 3" DEEP SPALL/HOLLOW AREA WITH 12" LONG X 2" WIDE REDUCED BEARING AREA AND (2) EXPOSED/DEBONDED REBARS

26 HIGH x UP TO 14" WIDE x 1" DEEP SPALL (WEST FACE)

14" HIGH x 12" WIDE x 7-1/2" LONG (SOUTH FACE) x 1-1/2" DEEP SPALL WITH EXPOSED ANCHOR PLATE

40" HIGH x 22" WIDE x 1/2" DEEP SPALL/HOLLOW AREA (SOUTH FACE)

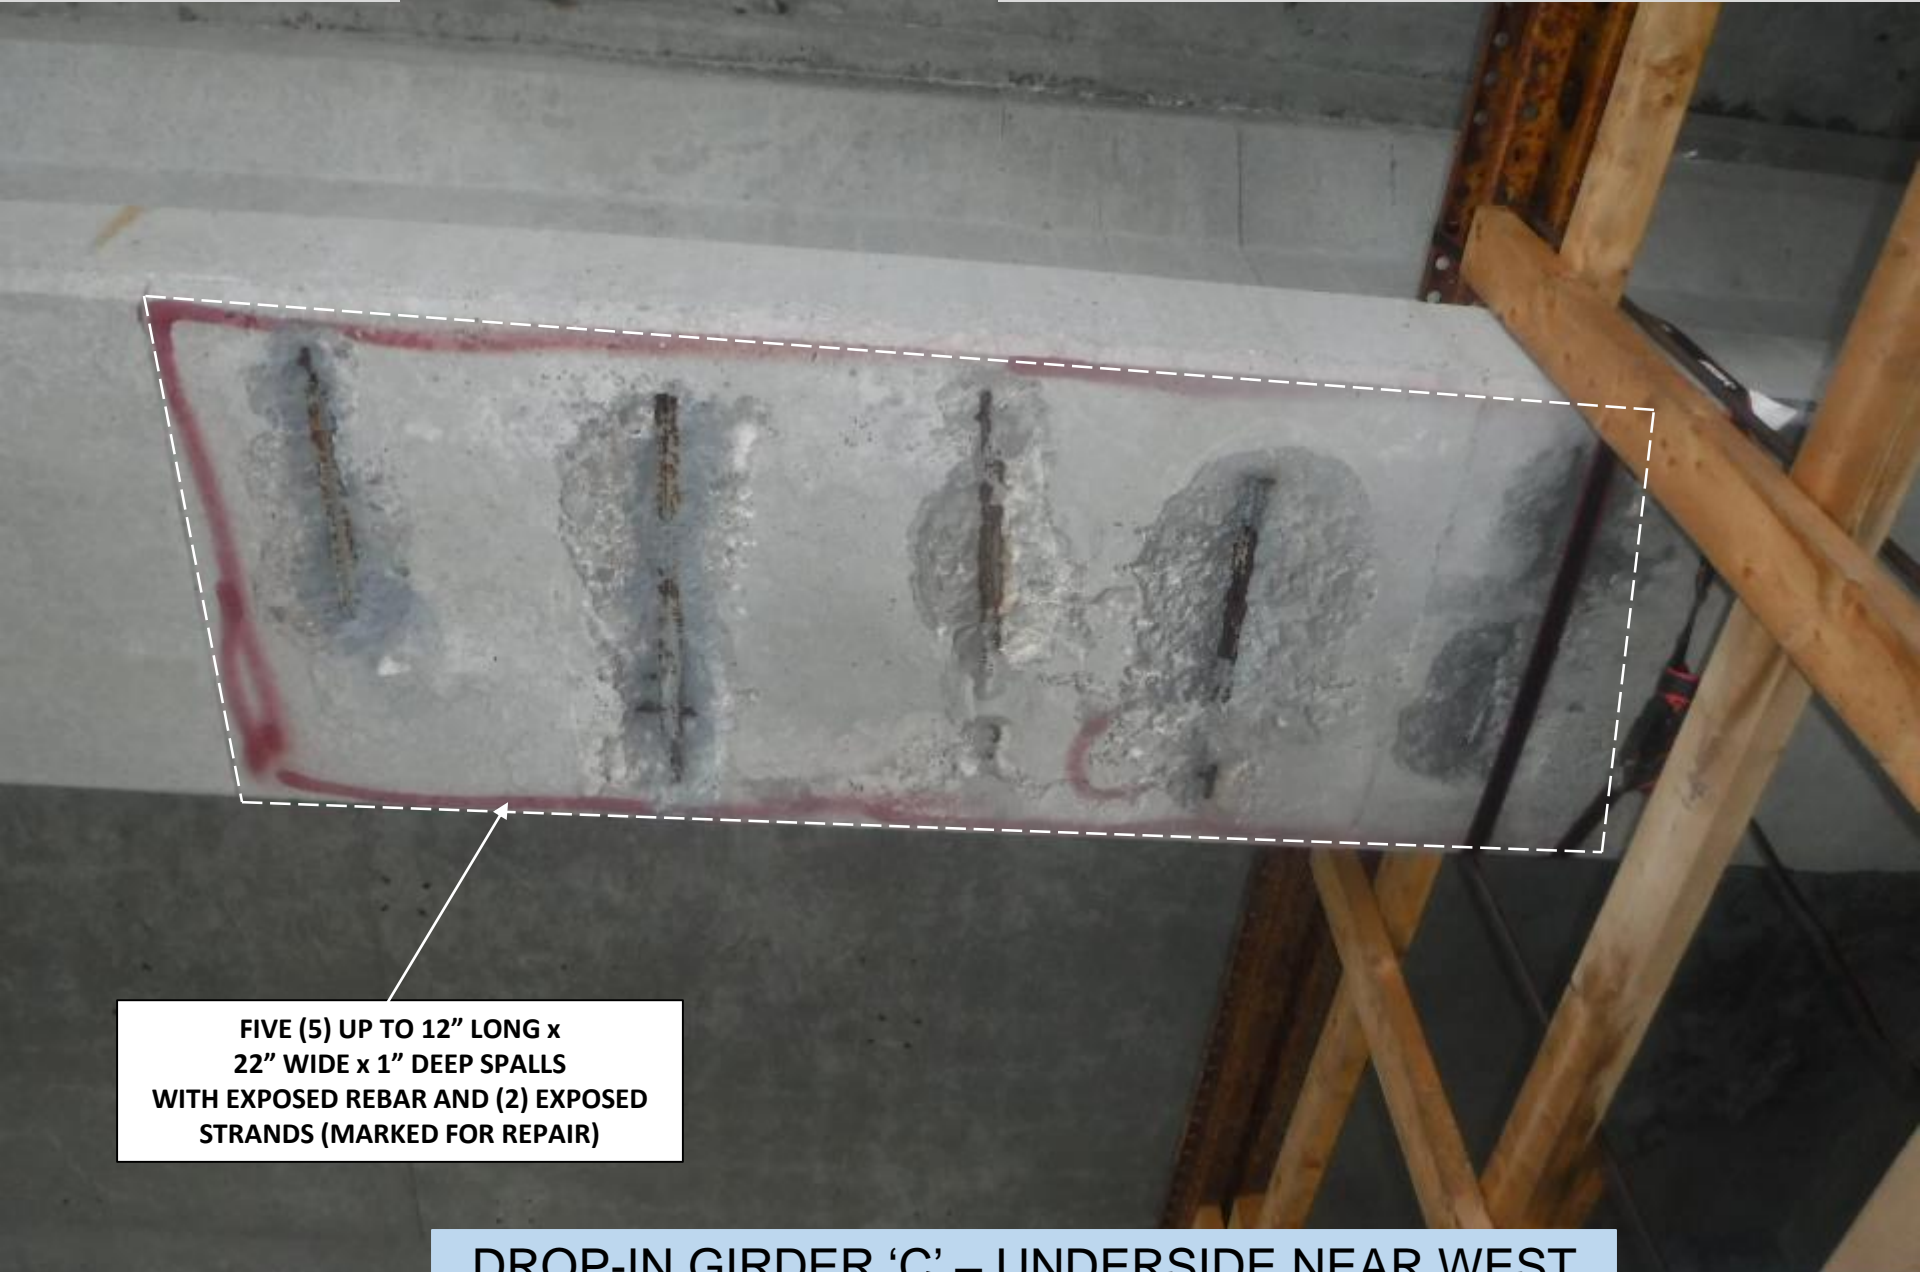
DROP-IN GIRDER 'C' – UNDERSIDE NEAR WEST

**FIVE (5) UP TO 12" LONG x
22" WIDE x 1" DEEP SPALLS
WITH EXPOSED REBAR AND (2) EXPOSED
STRANDS (MARKED FOR REPAIR)**

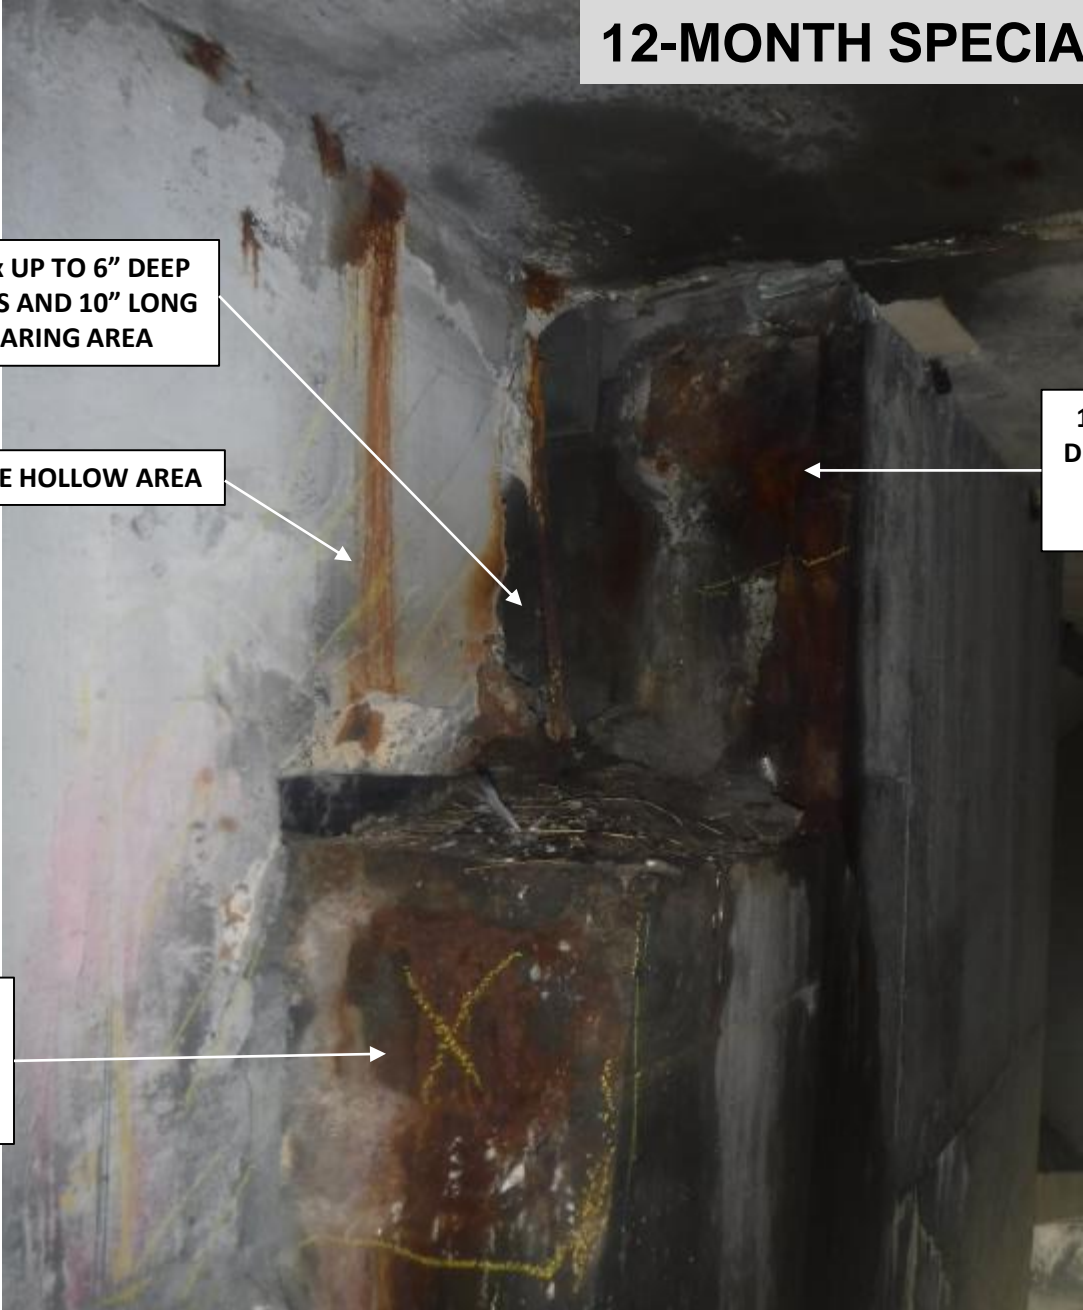
10" LONG x FULL HEIGHT x UP TO 6" DEEP SPALL WITH EXPOSED BARS AND 10" LONG x 2" WIDE REDUCED BEARING AREA

40" HIGH x 7" TO 20" WIDE HOLLOW AREA

12" HIGH x 12" WIDE x 1" DEEP SPALL WITH EXPOSED POST-TENSION ANCHOR PLATE (WEST FACE)

14" HIGH x 16" WIDE x 1" DEEP SPALL WITH EXPOSED POST-TENSION ANCHOR PLATE (WEST FACE)

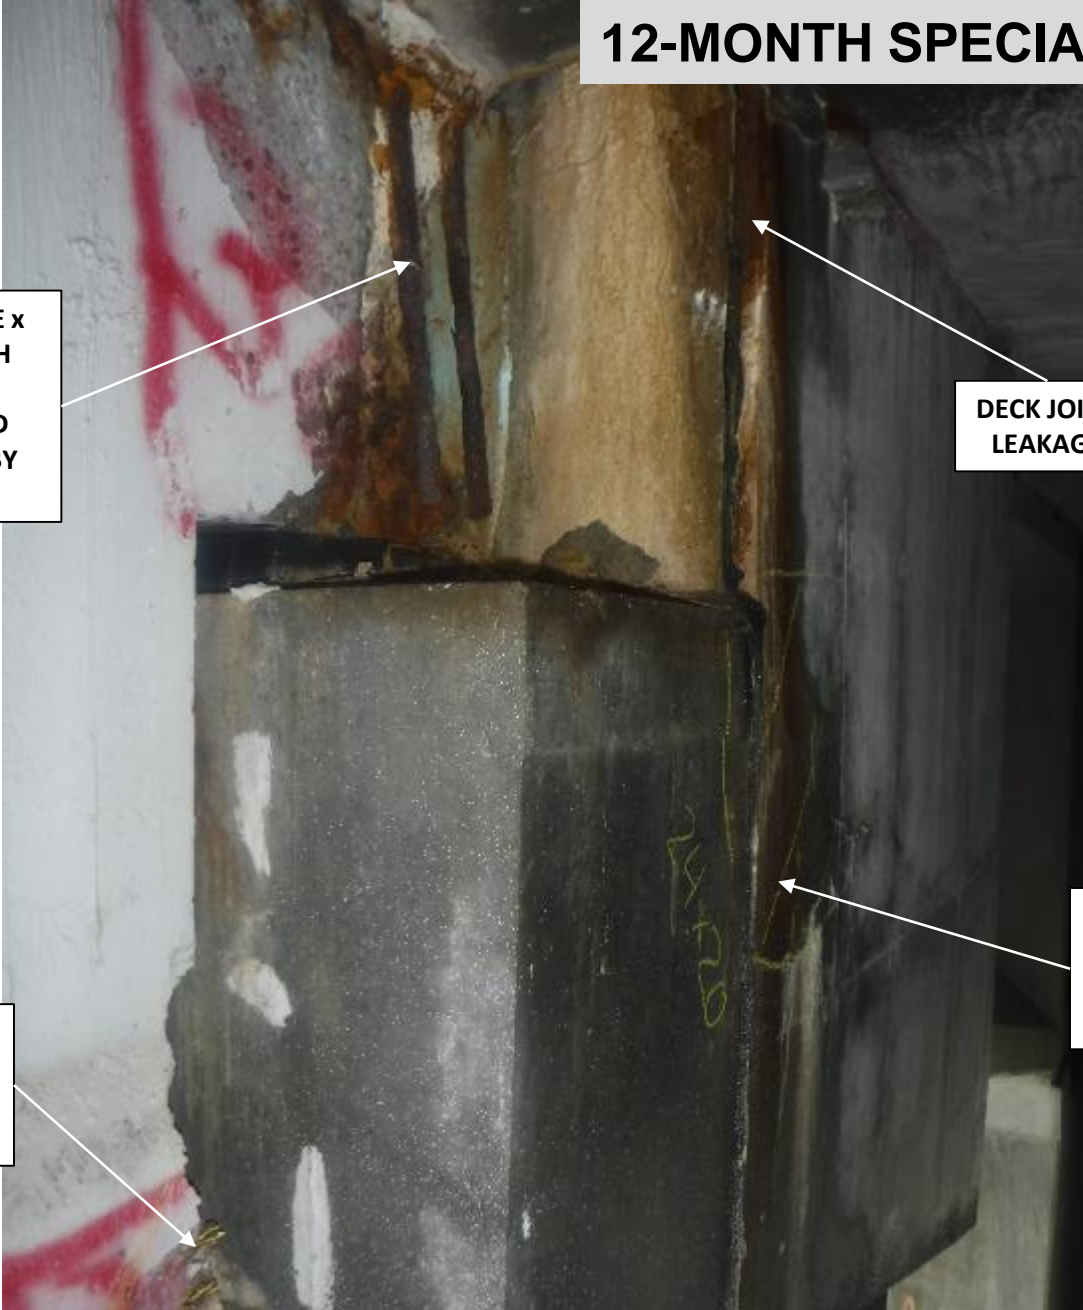
DROP-IN GIRDER 'F' – SOUTH FACE AT EAST CORBEL IN SPAN #13 (LOOKING NORTH)

24" HIGH x UP TO 24" WIDE x UP TO 5" DEEP SPALL WITH (2) EXPOSED AND DEBONDED STIRRUPS AND BEARING AREA REDUCED BY 12" LONG x 2" WIDE

DECK JOINT LEAKAGE

20" HIGH x 24" WIDE HOLLOW AREA WITH CRACKS, EFFLORESCENCE, AND RUST STAINING

9" LONG x 14" HIGH x 2-1/2" DEEP SPALL WITH (2) EXPOSED STRANDS x 3" LONG (BOTTOM FLANGE)
