12-MONTH SPECIAL INSPECTION

BRIDGE #070001

07/22/2020

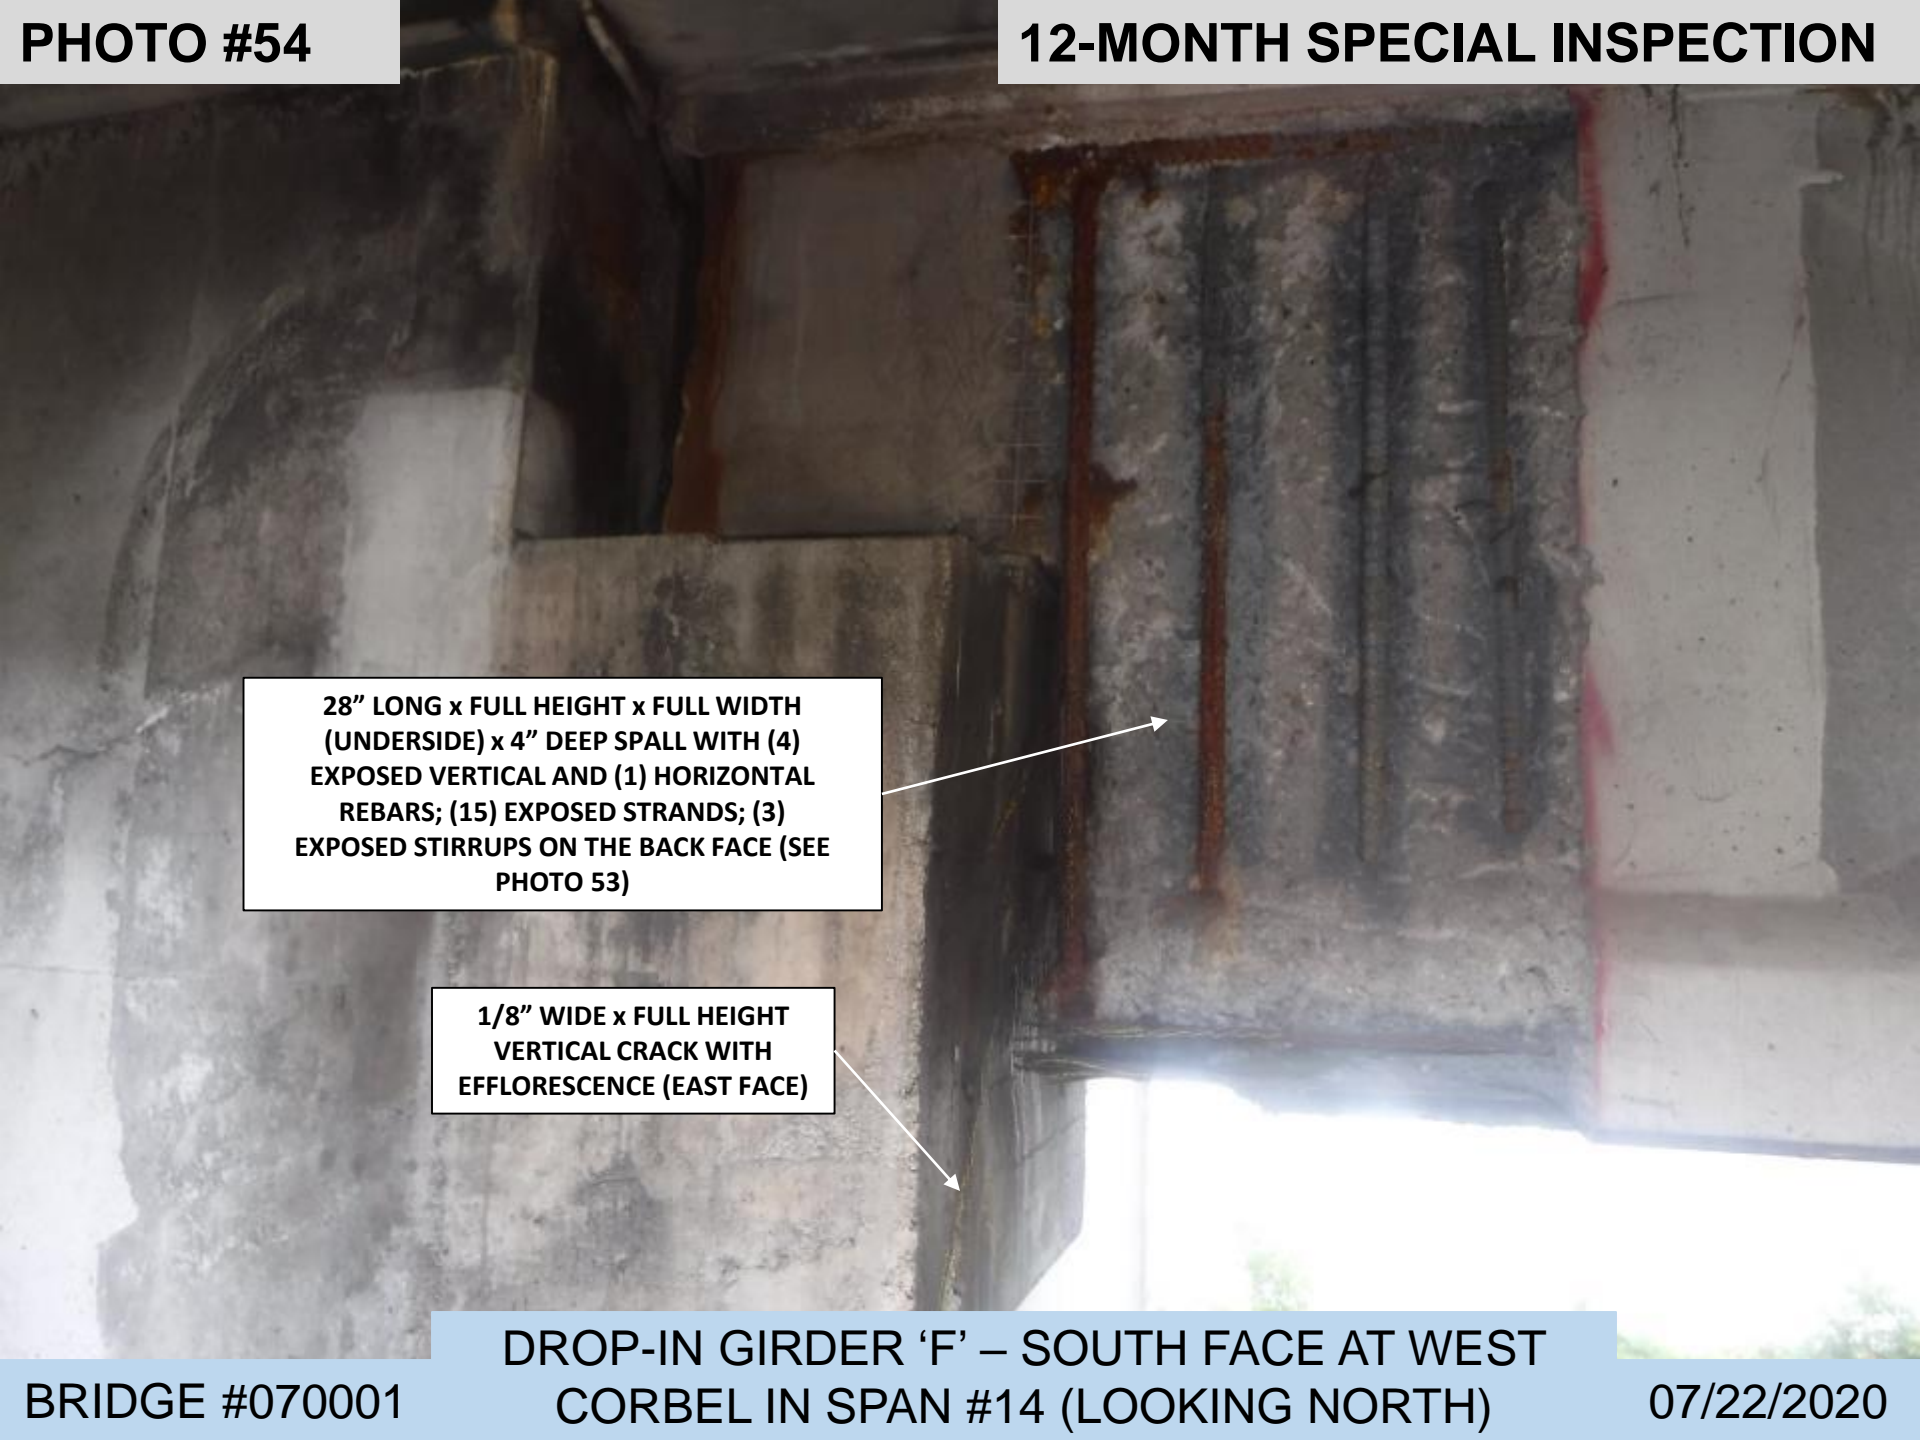
28" LONG x FULL HEIGHT x FULL WIDTH (UNDERSIDE) x 4" DEEP SPALL WITH (4) EXPOSED VERTICAL AND (1) HORIZONTAL REBARS; (15) EXPOSED STRANDS; (3) EXPOSED STIRRUPS ON THE BACK FACE (SEE PHOTO 53)

1/8" WIDE x FULL HEIGHT VERTICAL CRACK WITH EFFLORESCENCE (EAST FACE)

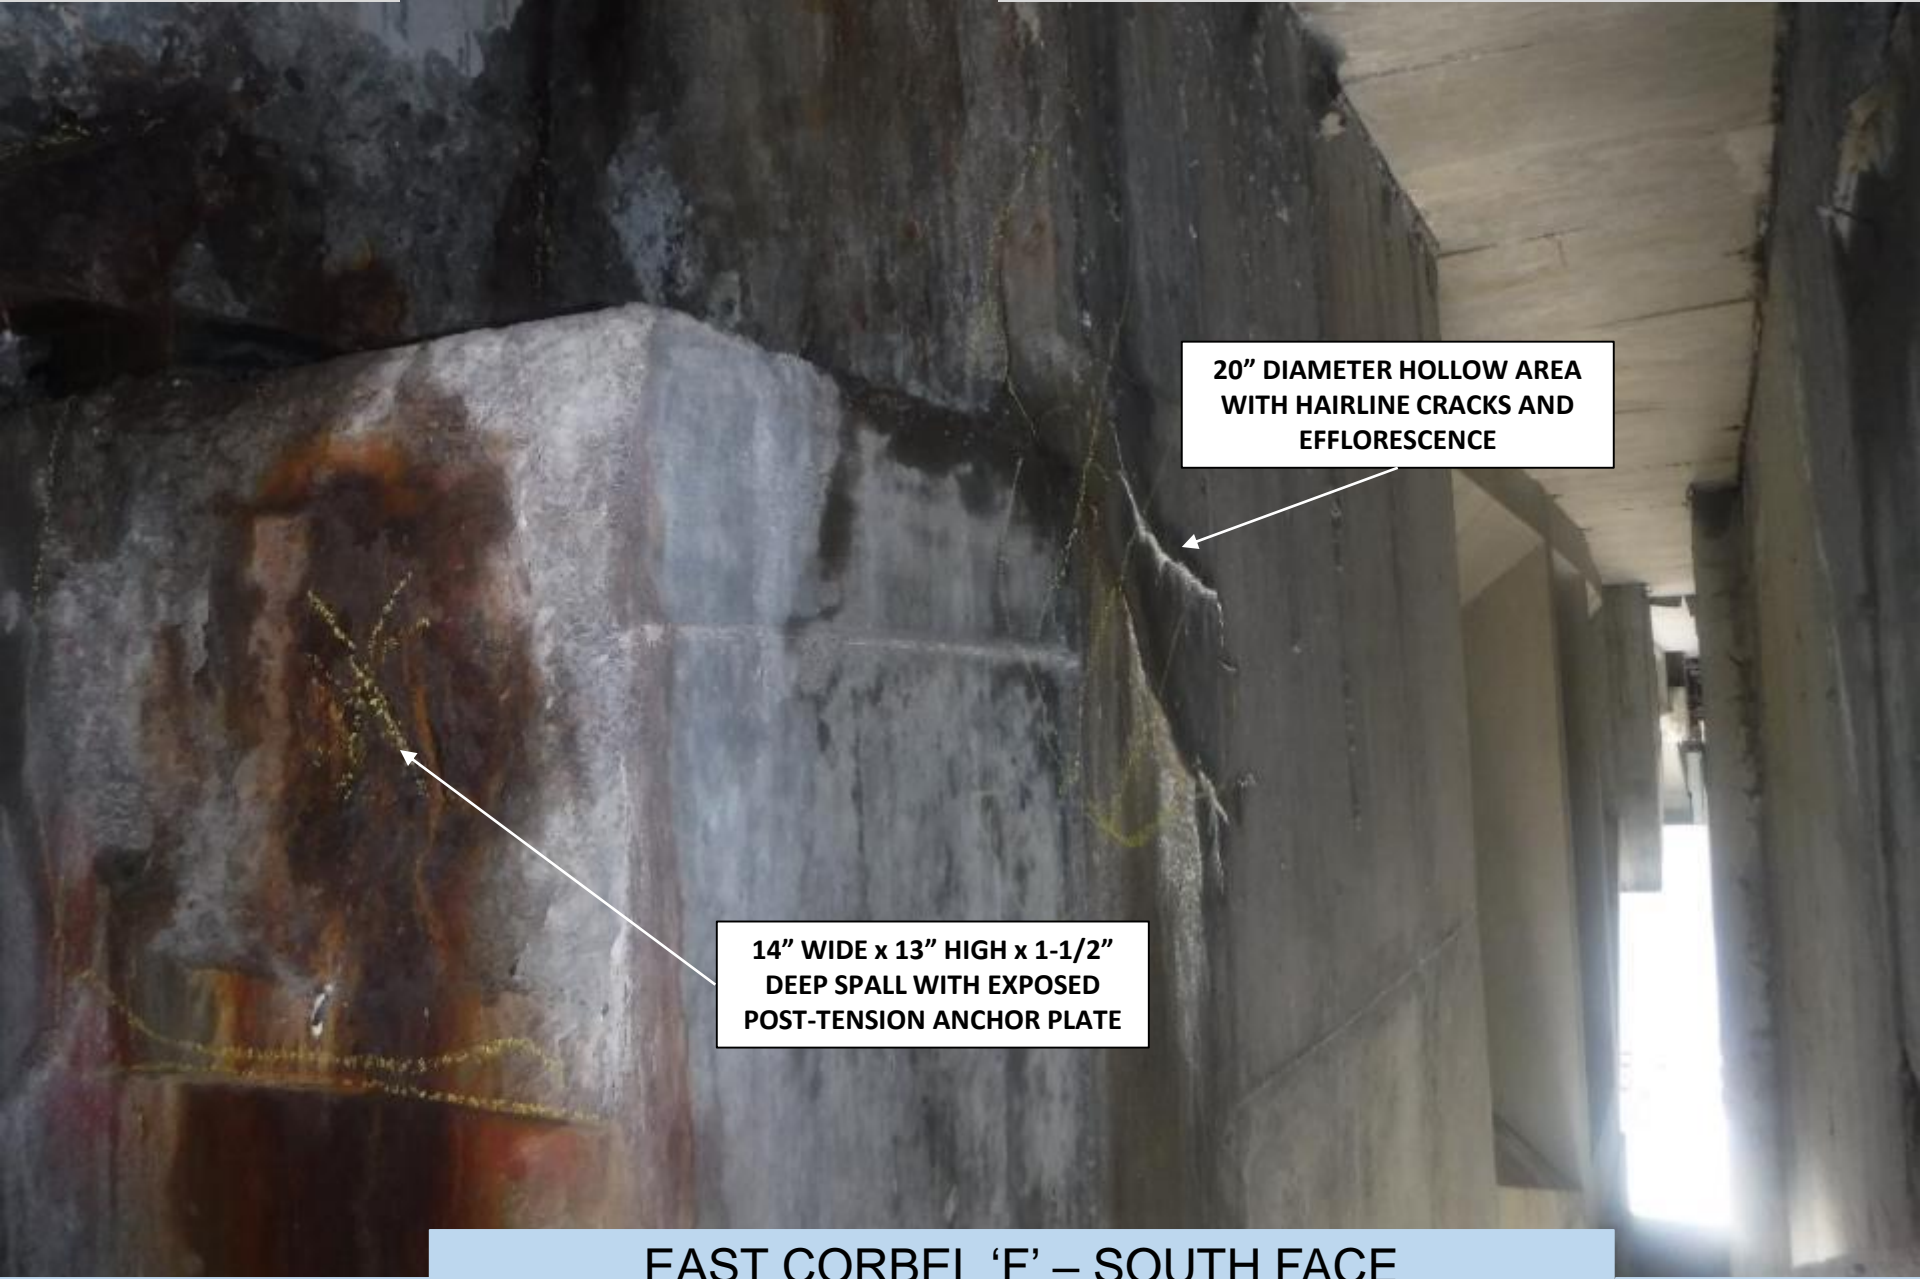
**20" DIAMETER HOLLOW AREA
WITH HAIRLINE CRACKS AND
EFFLORESCENCE**

**14" WIDE x 13" HIGH x 1-1/2"
DEEP SPALL WITH EXPOSED
POST-TENSION ANCHOR PLATE**

14" HIGH x 10" WIDE x 1" DEEP SPALL WITH EXPOSED REBAR AND (1) EXPOSED STIRRUP

1-1/2" WIDE x 1" LONG BEARING UNDERMINING

15" WIDE x 18" HIGH x UP TO 5" DEEP SPALL WITH EXPOSED POST-TENSION ANCHOR PLATE

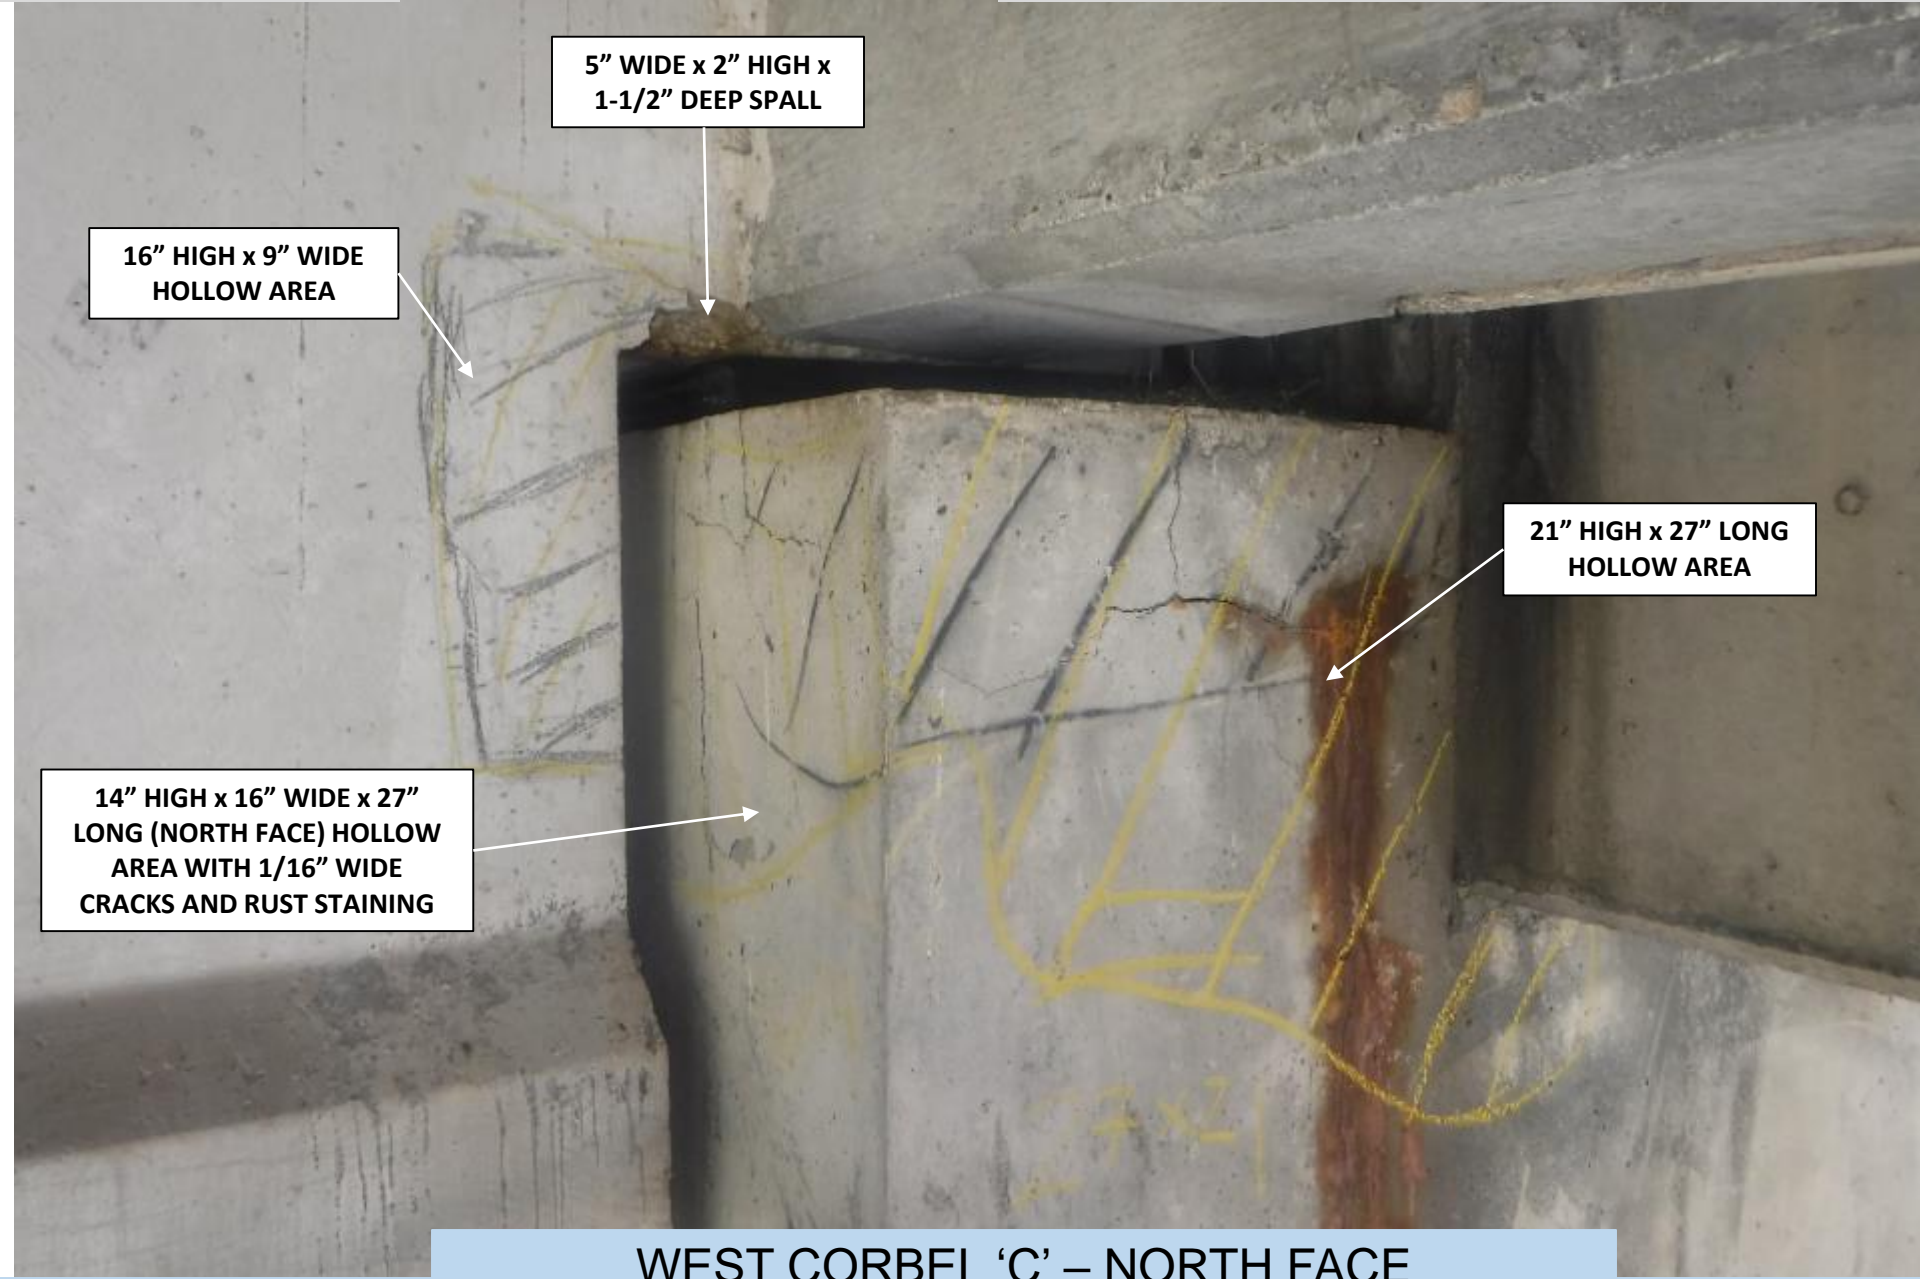
BRIDGE #070001 **WEST CORBEL 'C' – NORTH FACE
IN SPAN #11 (LOOKING SOUTH)** **07/22/2020**

**5" WIDE x 2" HIGH x
1-1/2" DEEP SPALL**

**16" HIGH x 9" WIDE
HOLLOW AREA**

**21" HIGH x 27" LONG
HOLLOW AREA**

**14" HIGH x 16" WIDE x 27"
LONG (NORTH FACE) HOLLOW
AREA WITH 1/16" WIDE
CRACKS AND RUST STAINING**

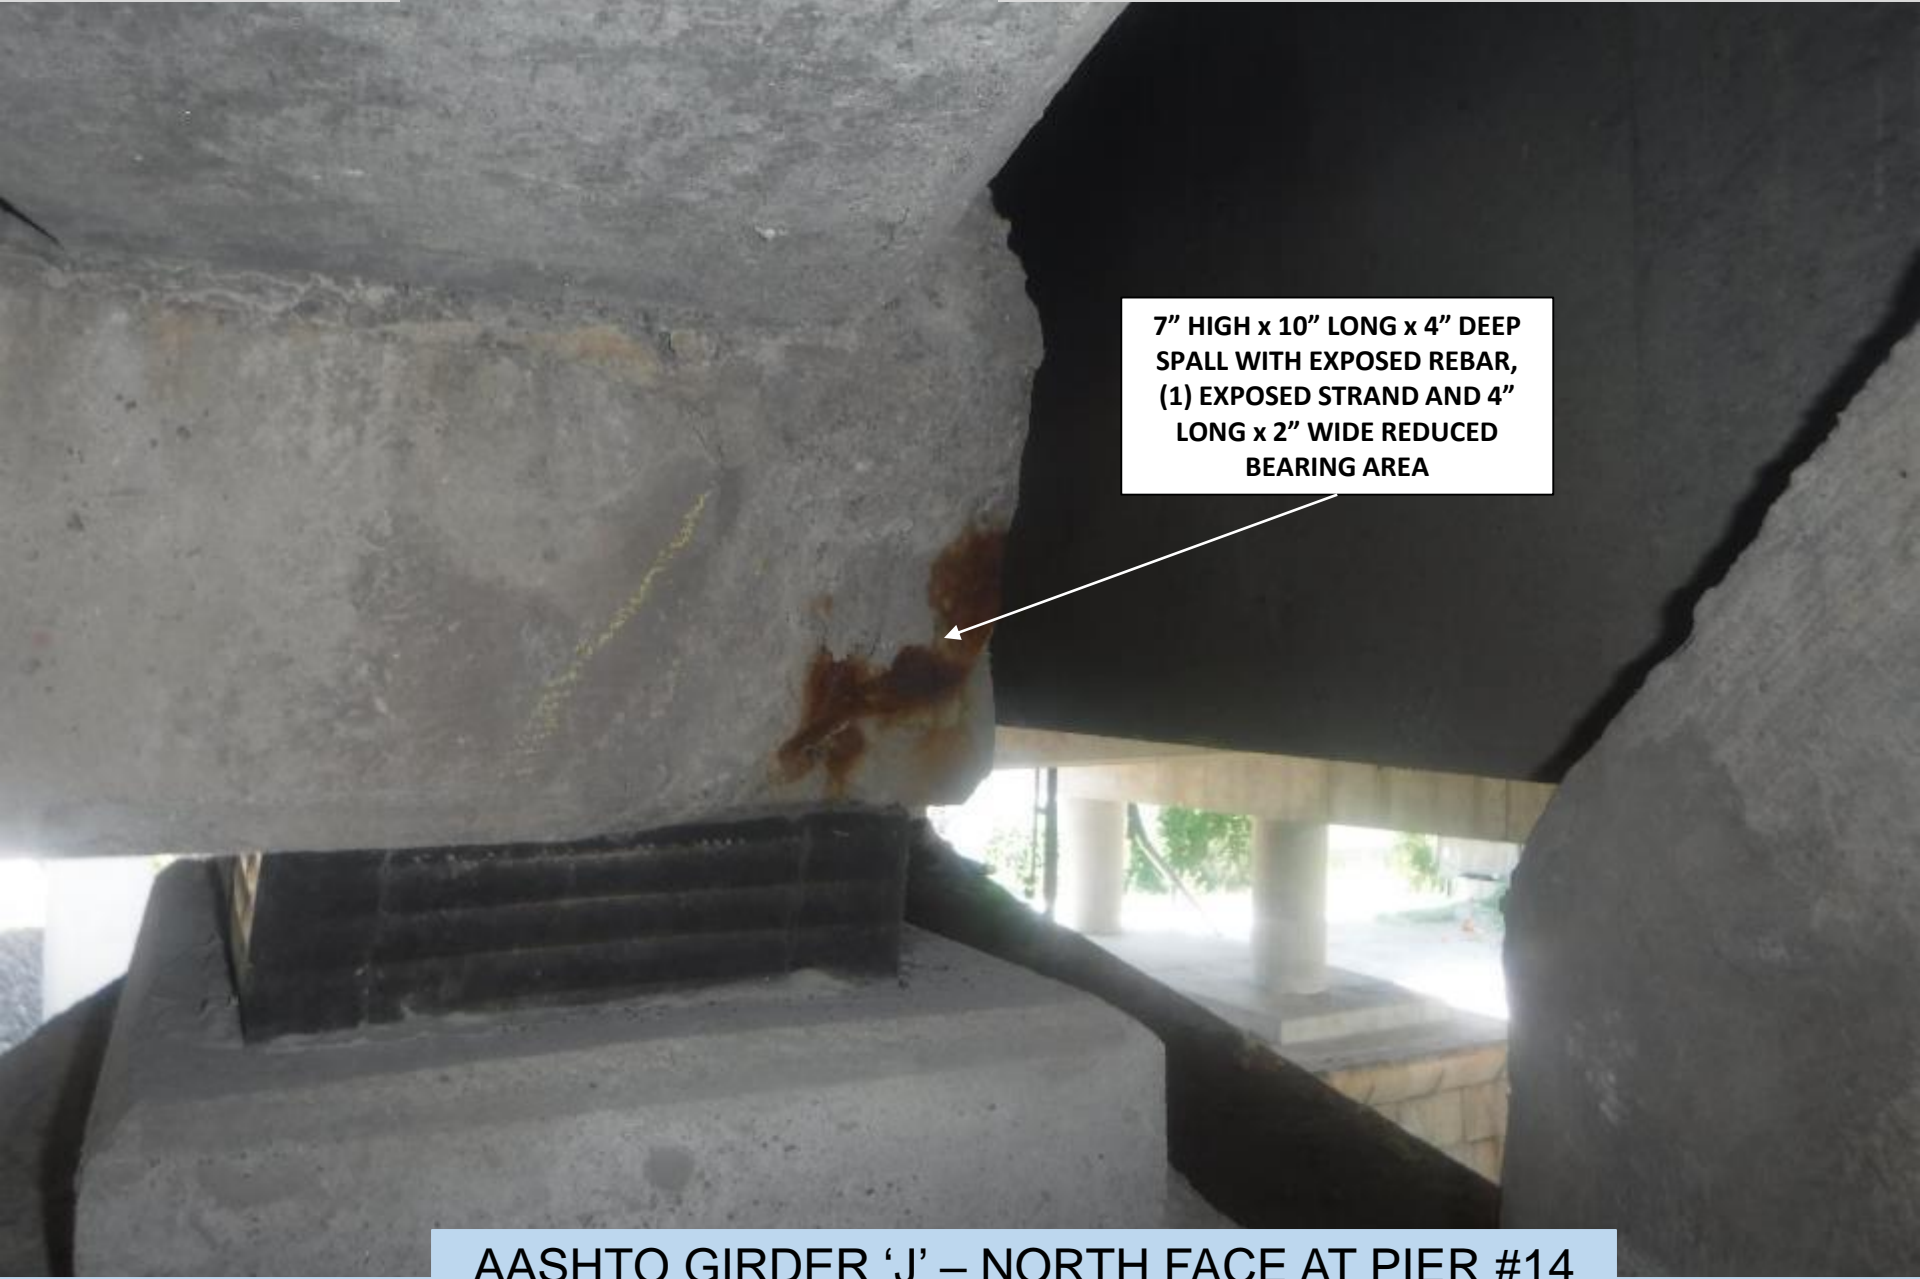
**7" HIGH x 10" LONG x 4" DEEP
SPALL WITH EXPOSED REBAR,
(1) EXPOSED STRAND AND 4"
LONG x 2" WIDE REDUCED
BEARING AREA**

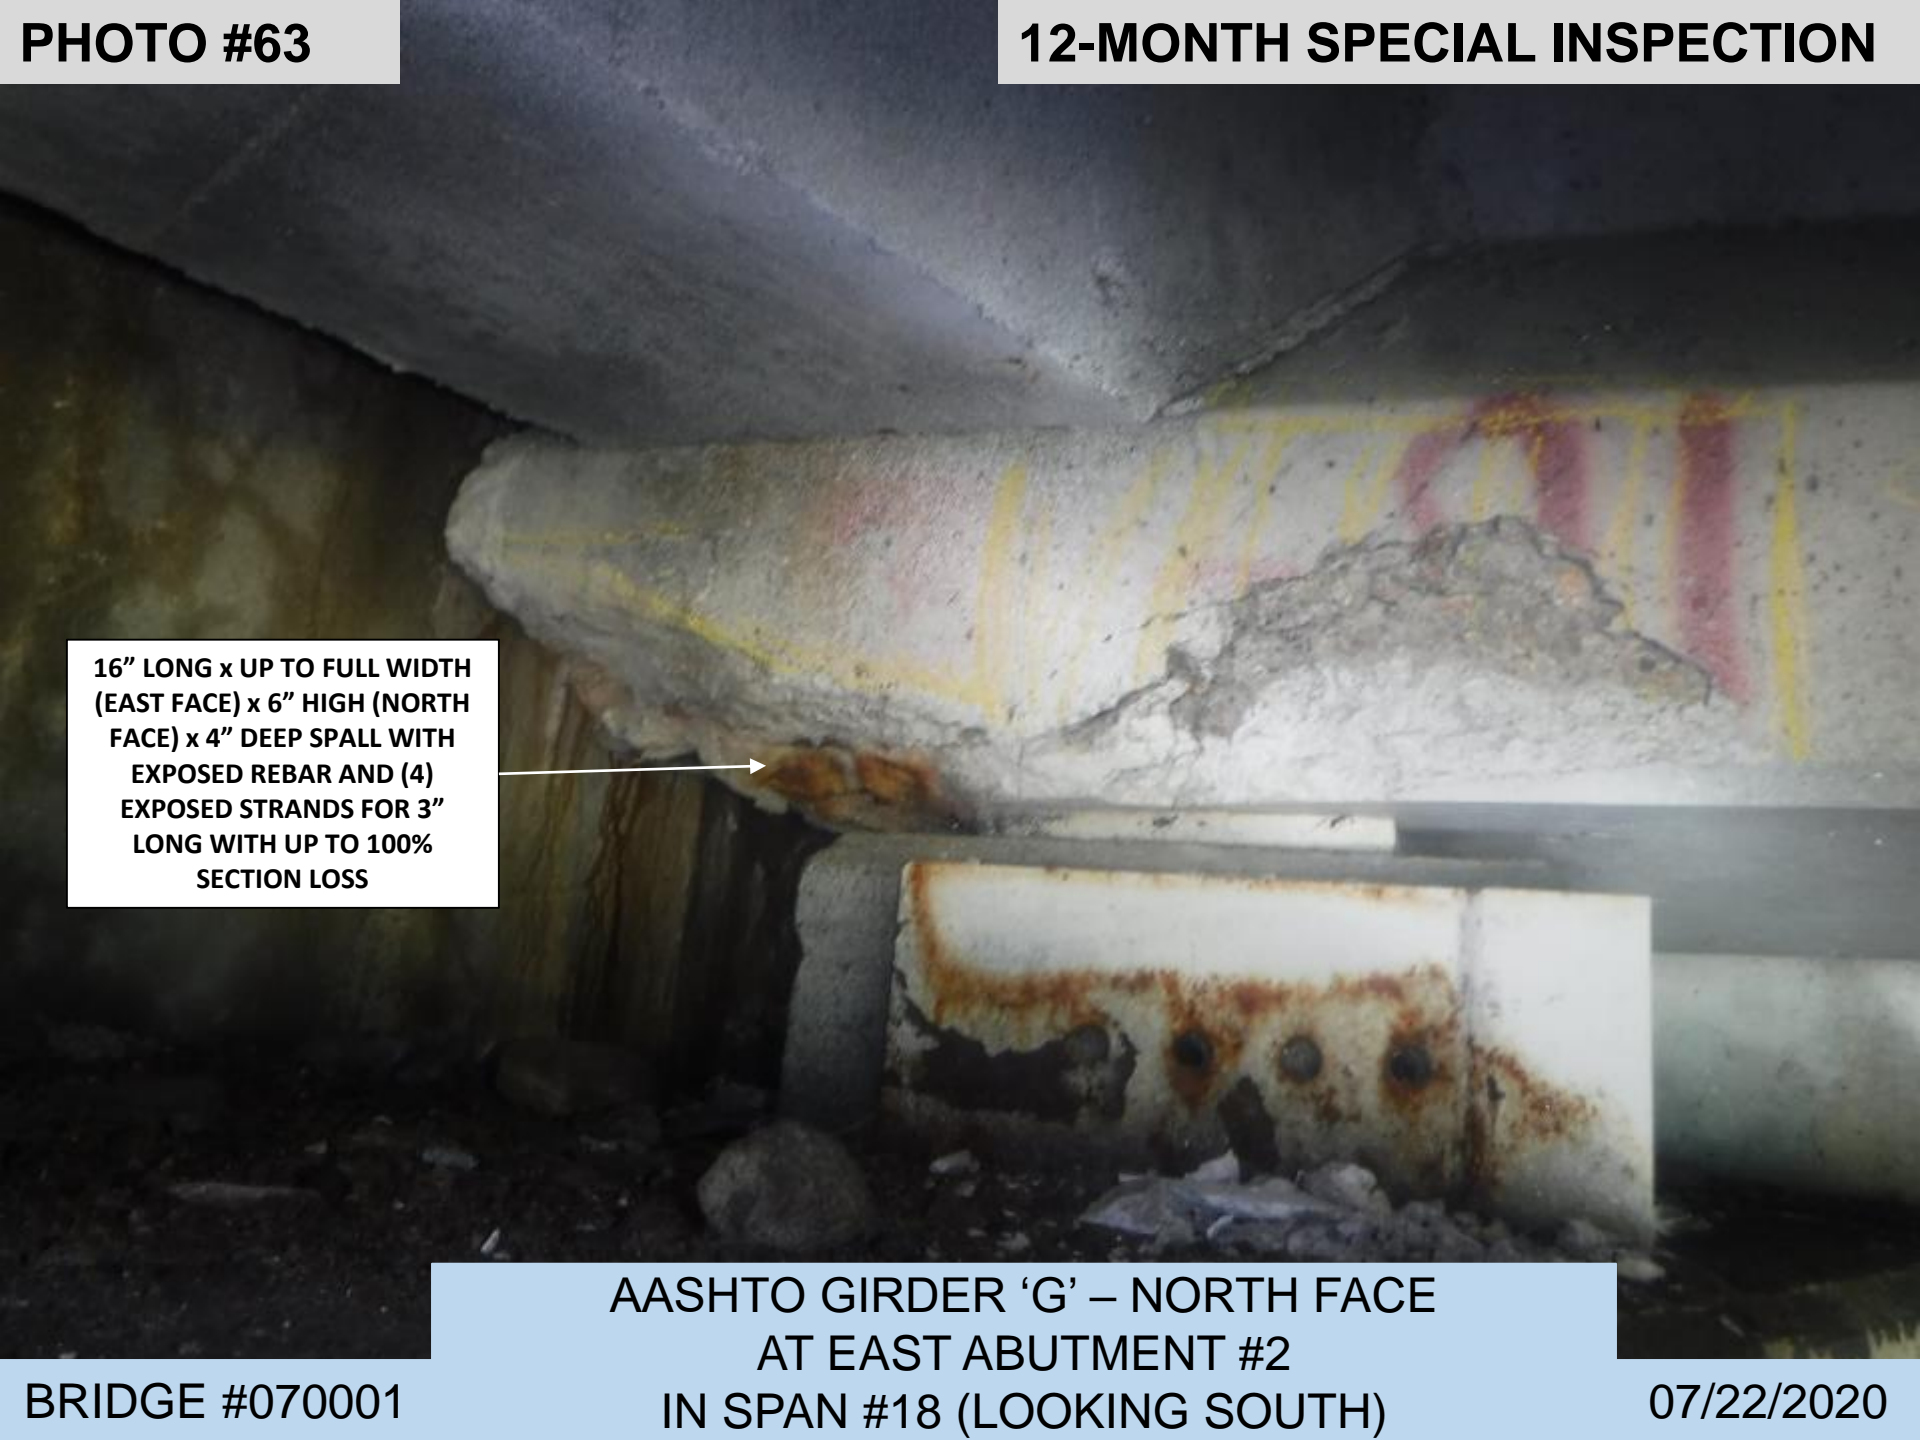
**AASHTO GIRDER 'G' – NORTH FACE
AT EAST ABUTMENT #2
IN SPAN #18 (LOOKING SOUTH)**

16" LONG x UP TO FULL WIDTH (EAST FACE) x 6" HIGH (NORTH FACE) x 4" DEEP SPALL WITH EXPOSED REBAR AND (4) EXPOSED STRANDS FOR 3" LONG WITH UP TO 100% SECTION LOSS

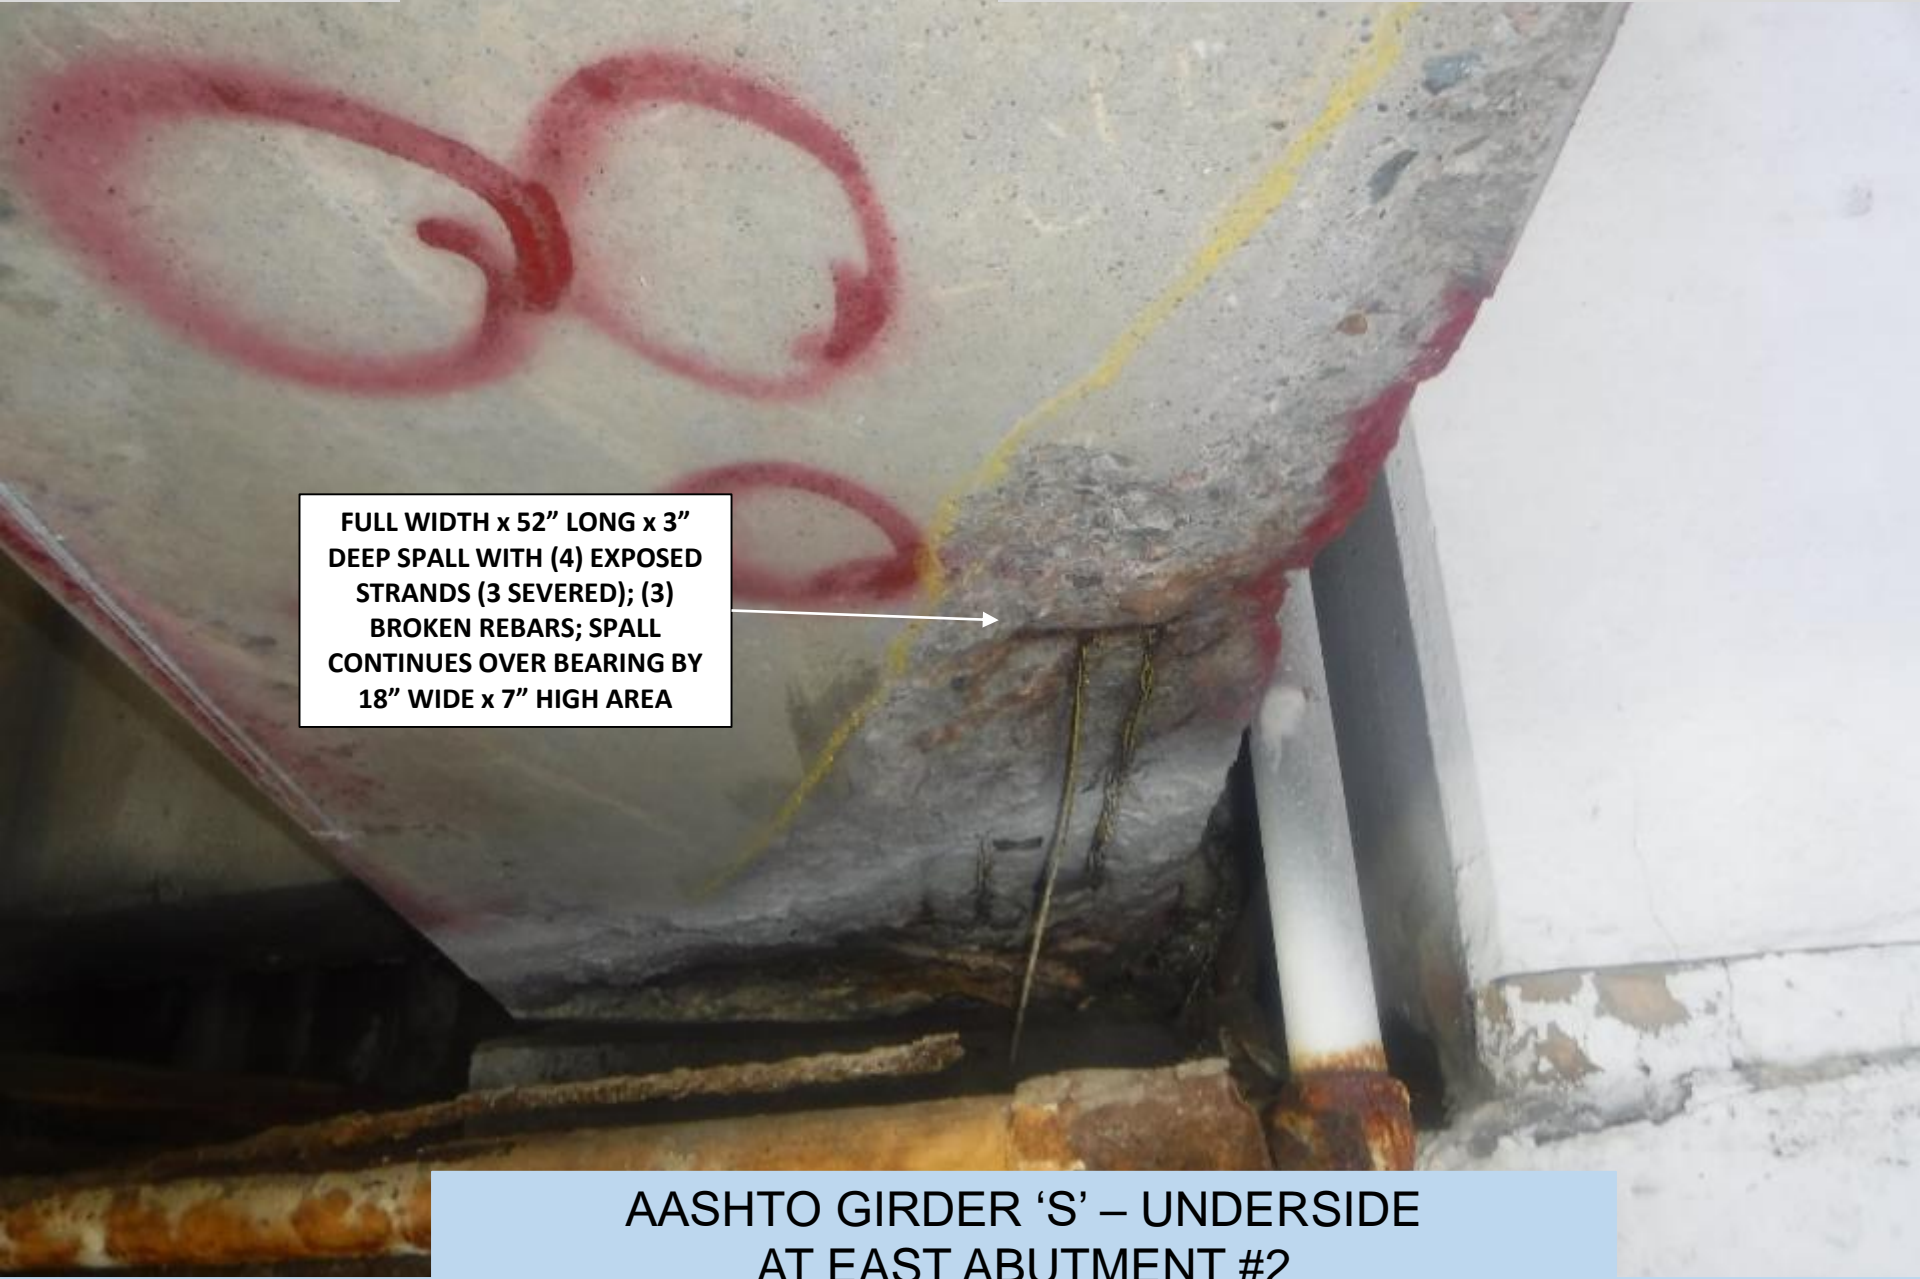
**AASHTO GIRDER 'S' – UNDERSIDE
AT EAST ABUTMENT #2
IN SPAN #18 (LOOKING EAST)**

**FULL WIDTH x 52" LONG x 3"
DEEP SPALL WITH (4) EXPOSED
STRANDS (3 SEVERED); (3)
BROKEN REBARS; SPALL
CONTINUES OVER BEARING BY
18" WIDE x 7" HIGH AREA**

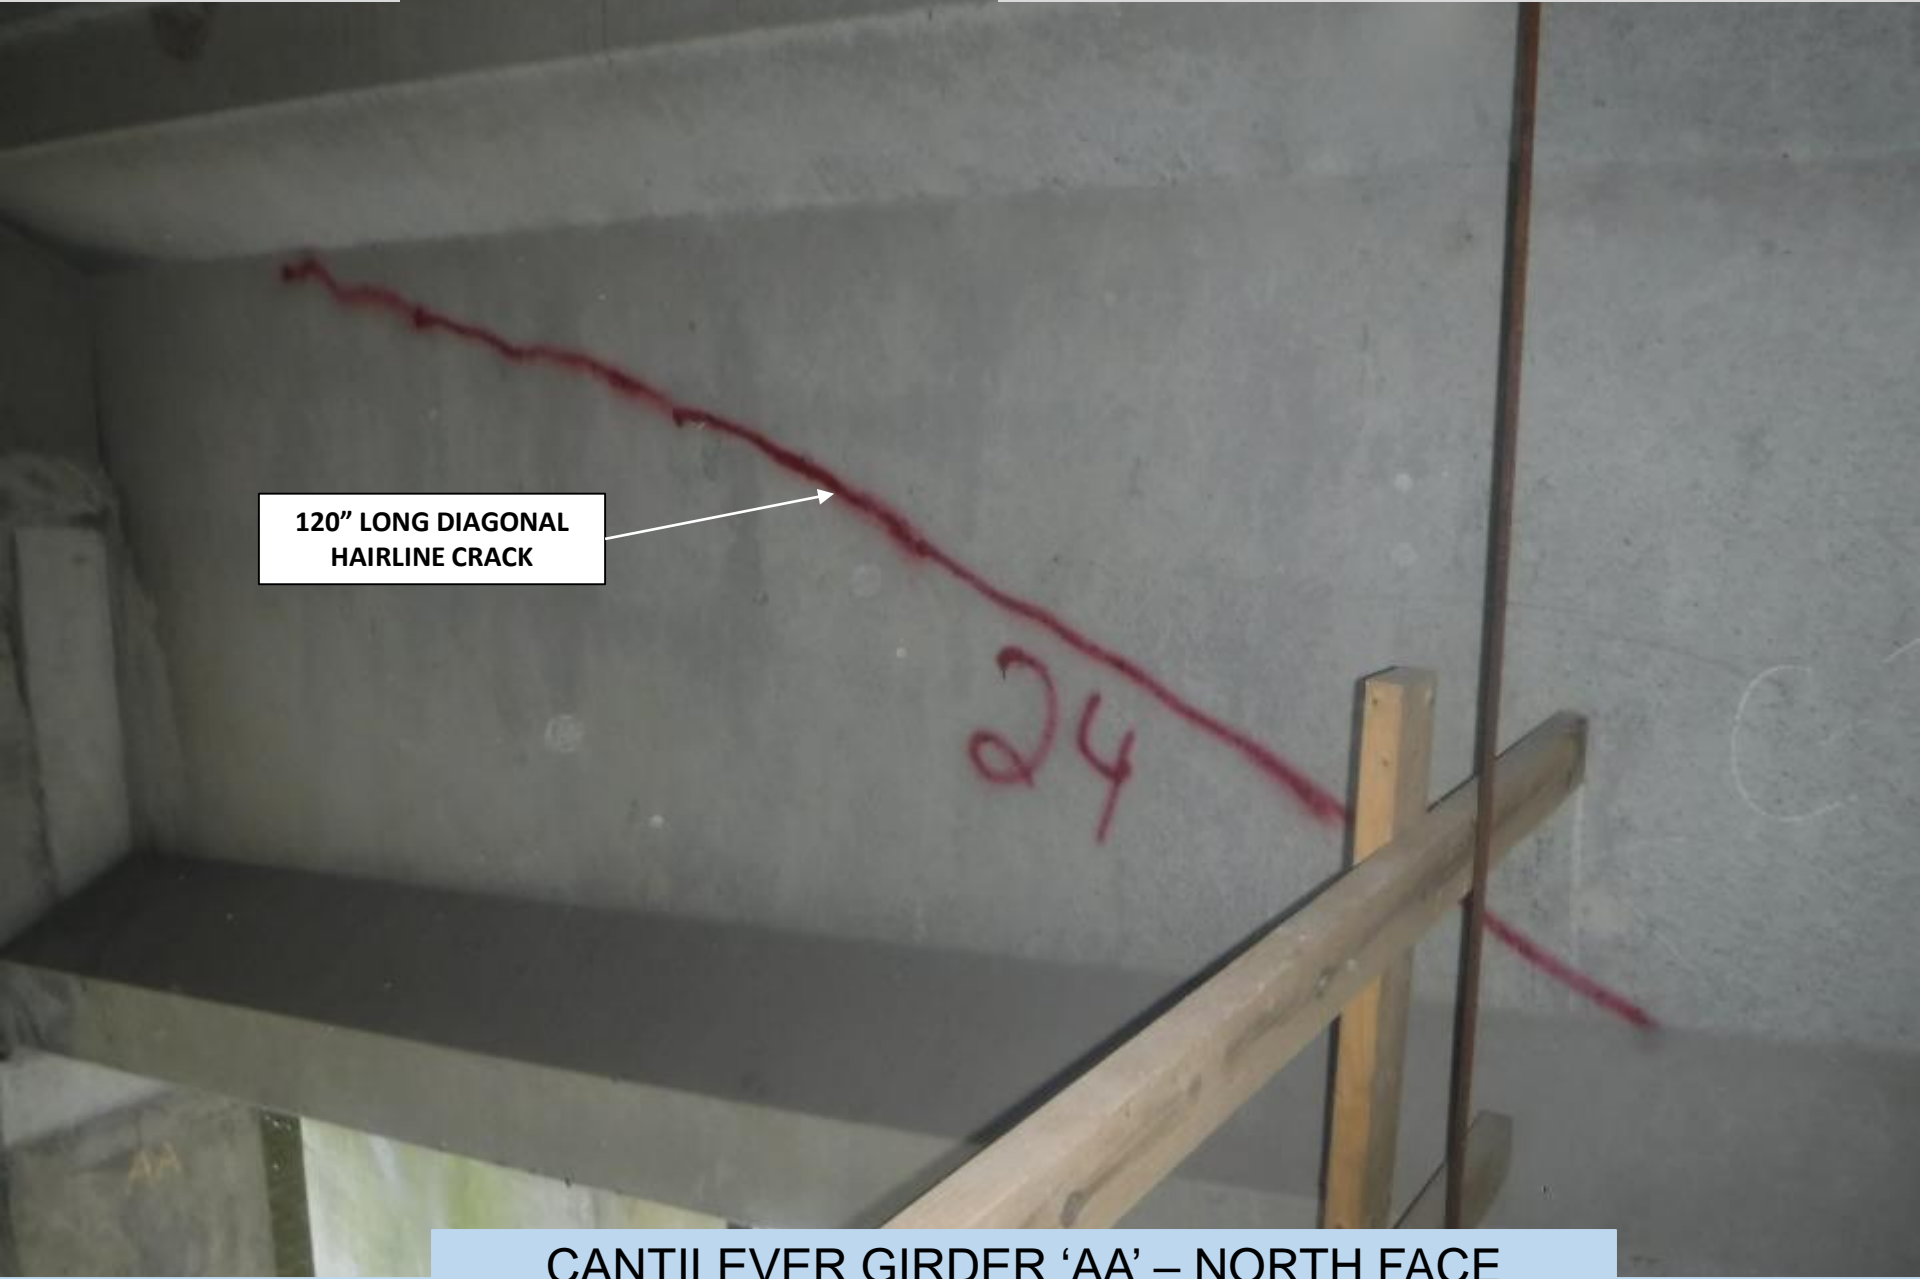
**120" LONG DIAGONAL
HAIRLINE CRACK**

**0.05" WIDE x FULL HEIGHT
VERTICAL HAIRLINE CRACK
WITH EFFLORESCENCE**

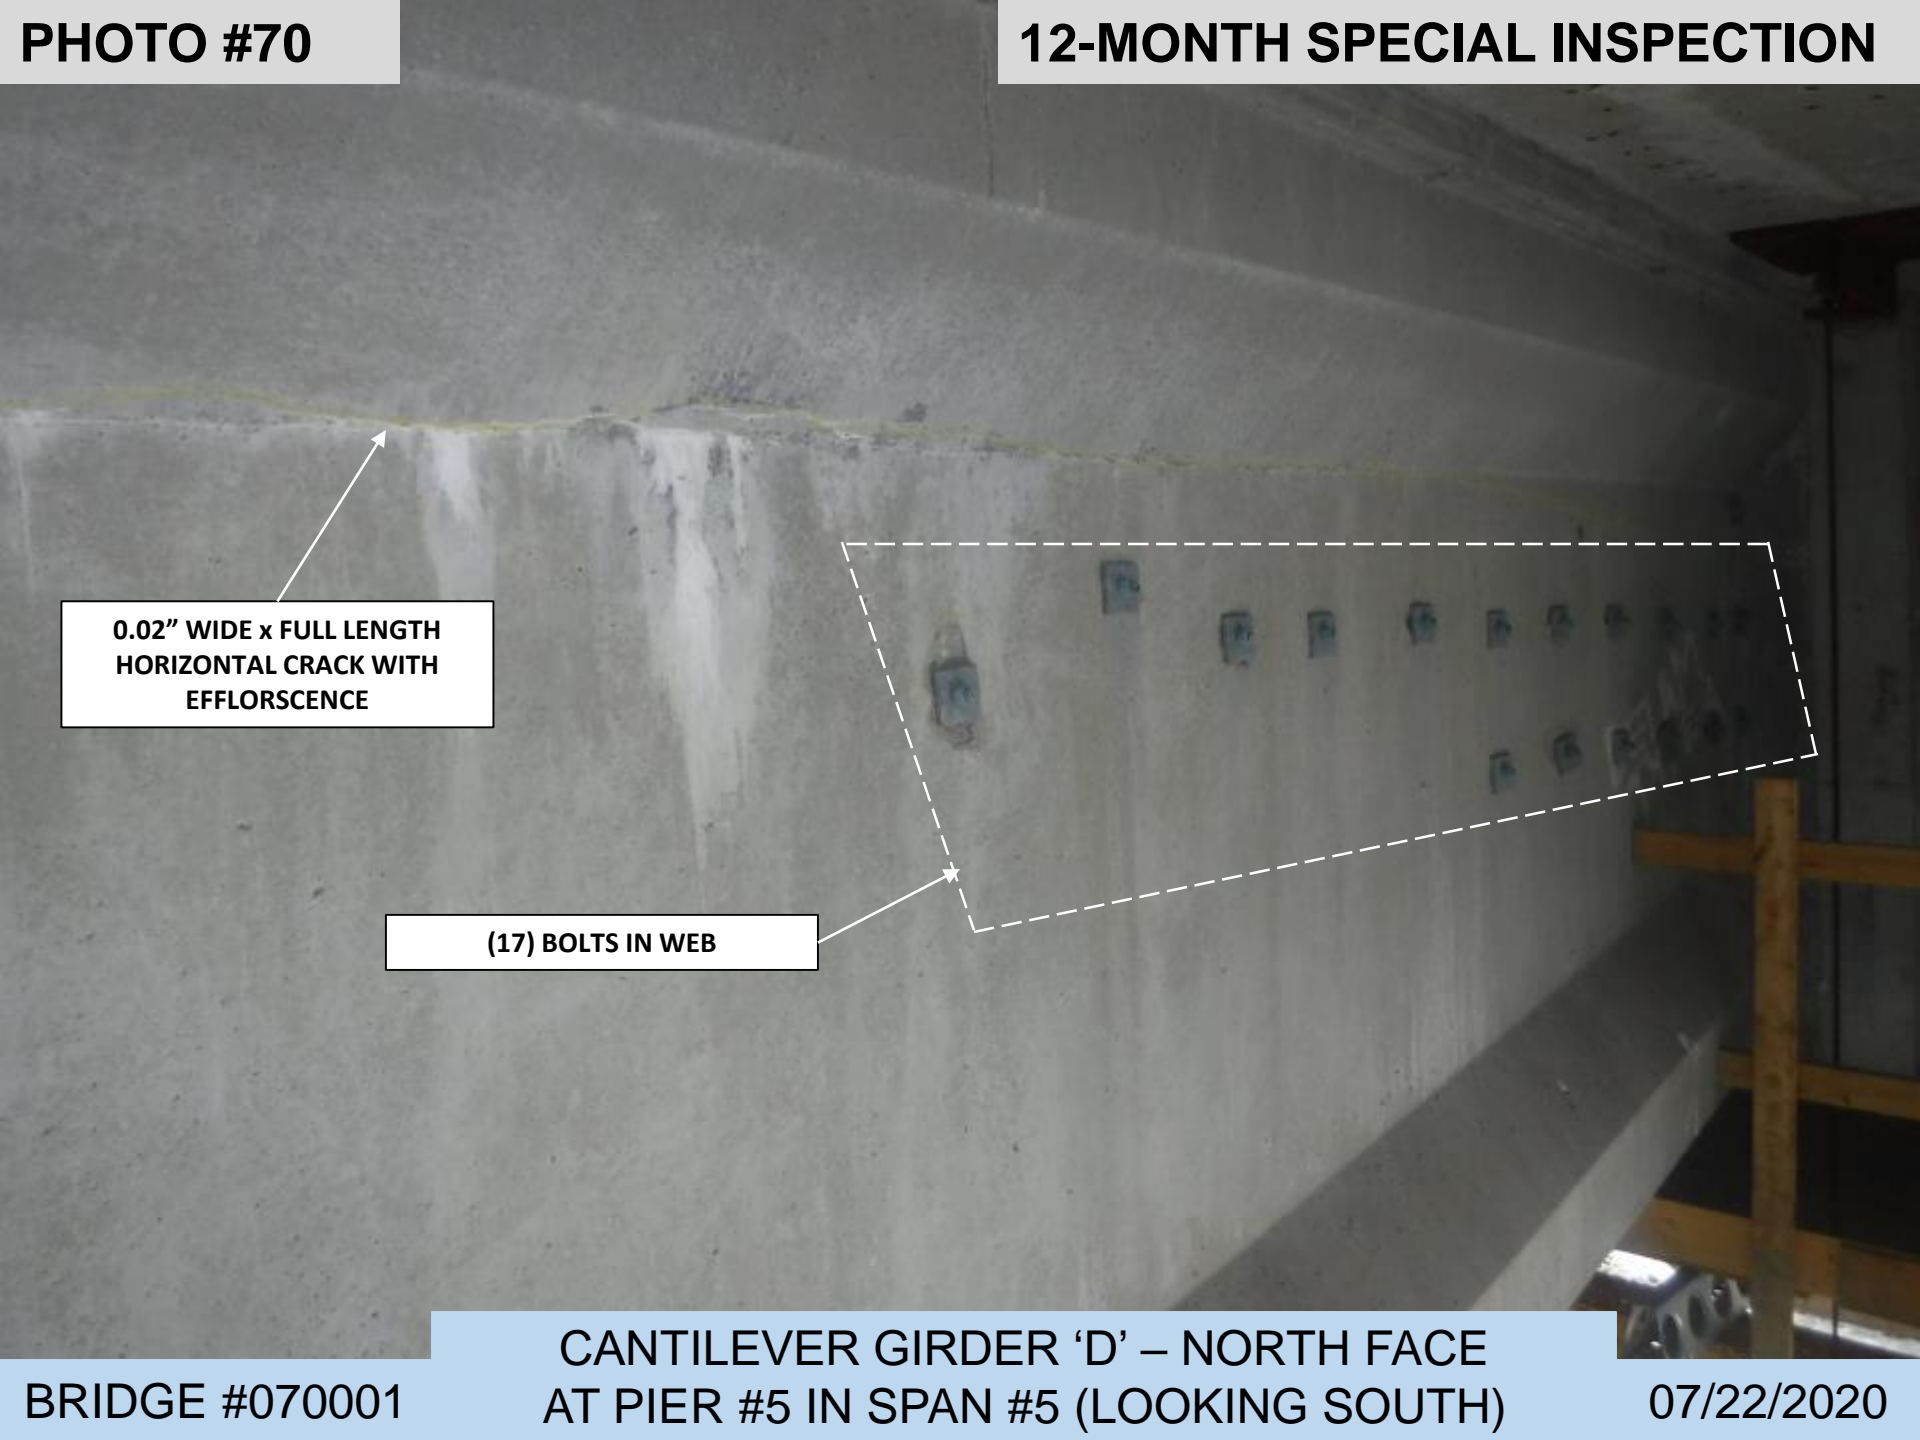
0.02" WIDE x FULL LENGTH
HORIZONTAL CRACK WITH
EFFLORSCENCE

(17) BOLTS IN WEB
