12-MONTH SPECIAL INSPECTION

BRIDGE #070001

07/22/2020

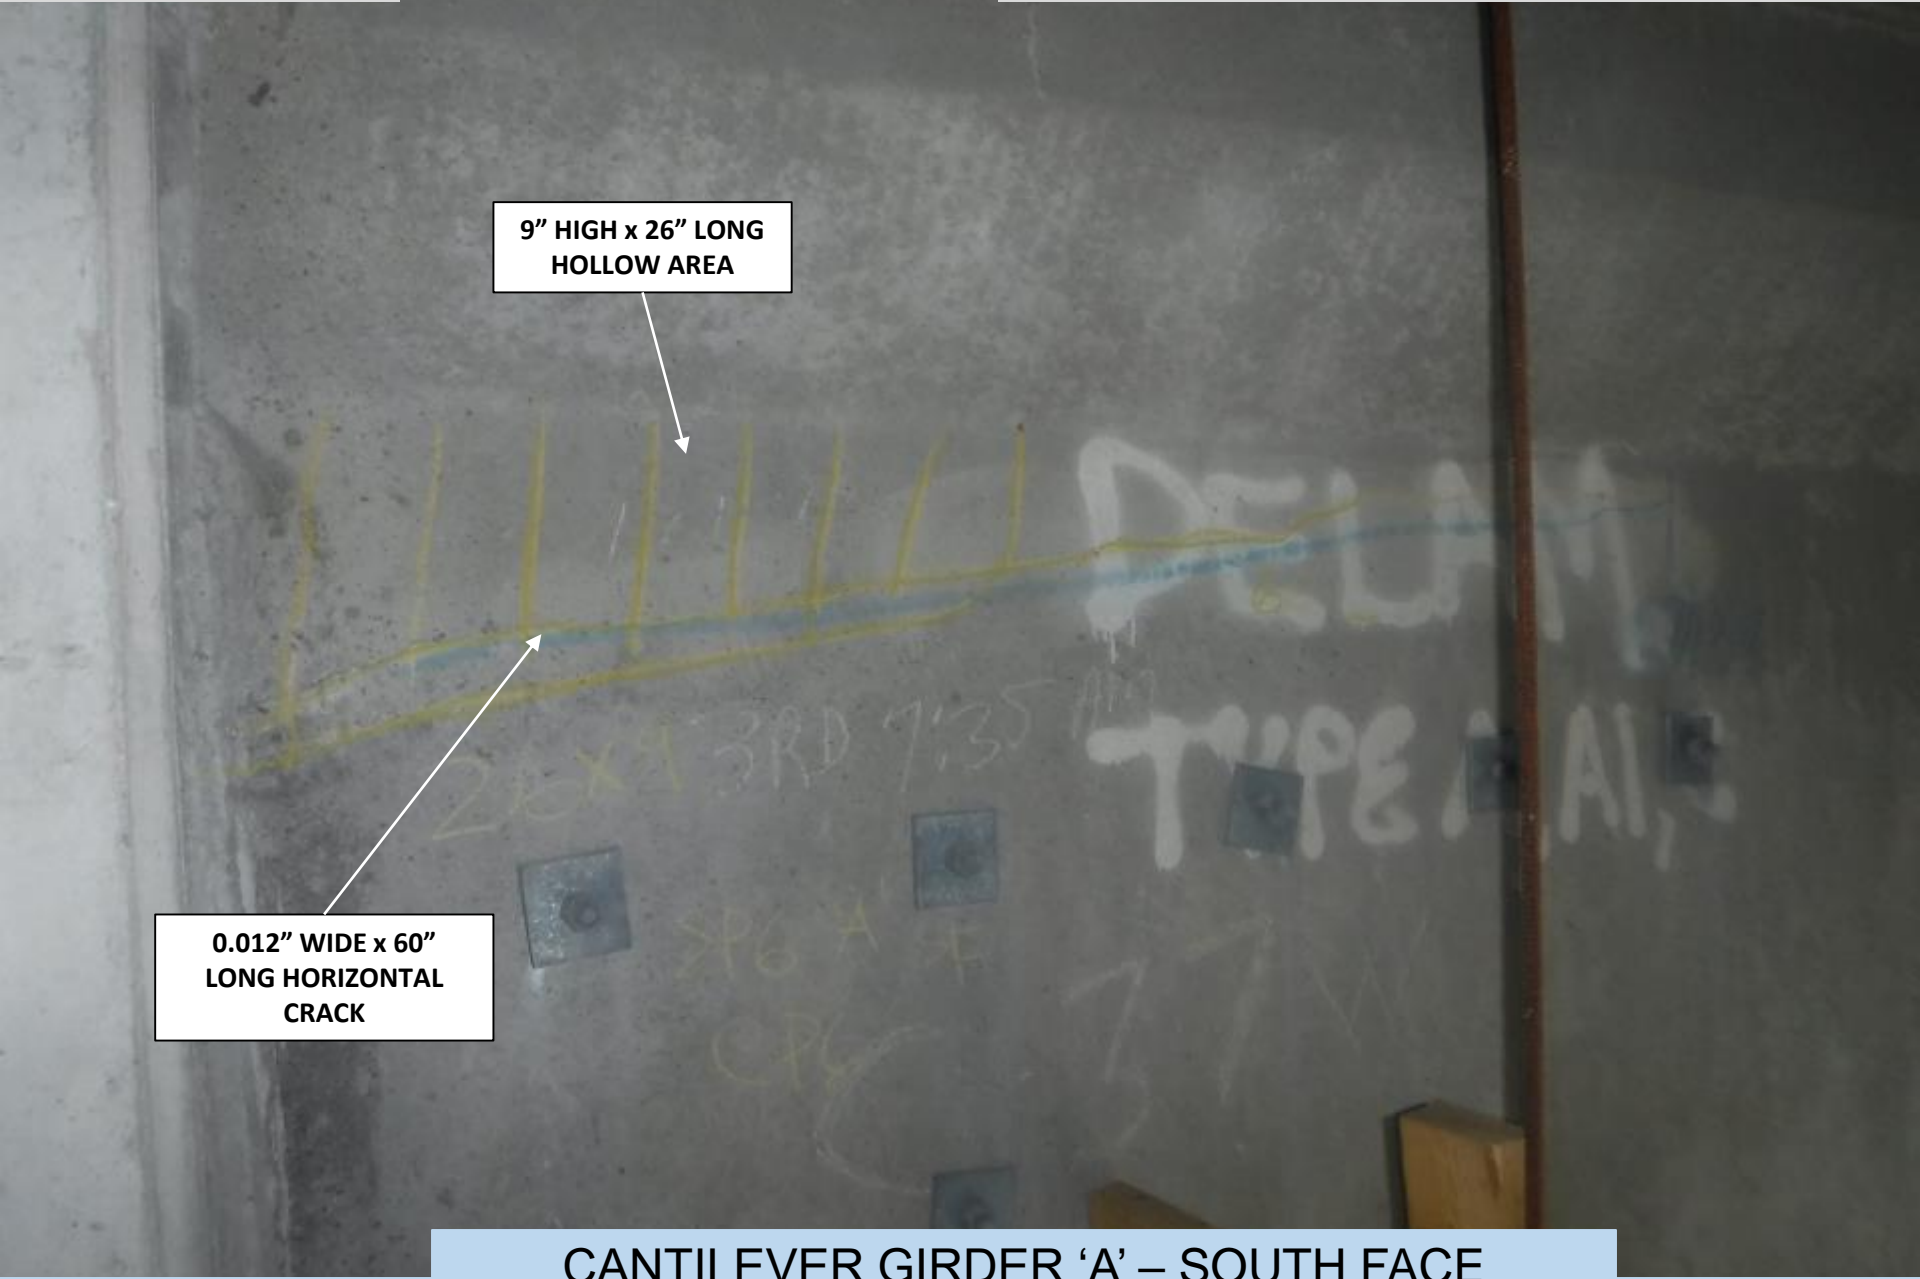
**9" HIGH x 26" LONG
HOLLOW AREA**

**0.012" WIDE x 60"
LONG HORIZONTAL
CRACK**

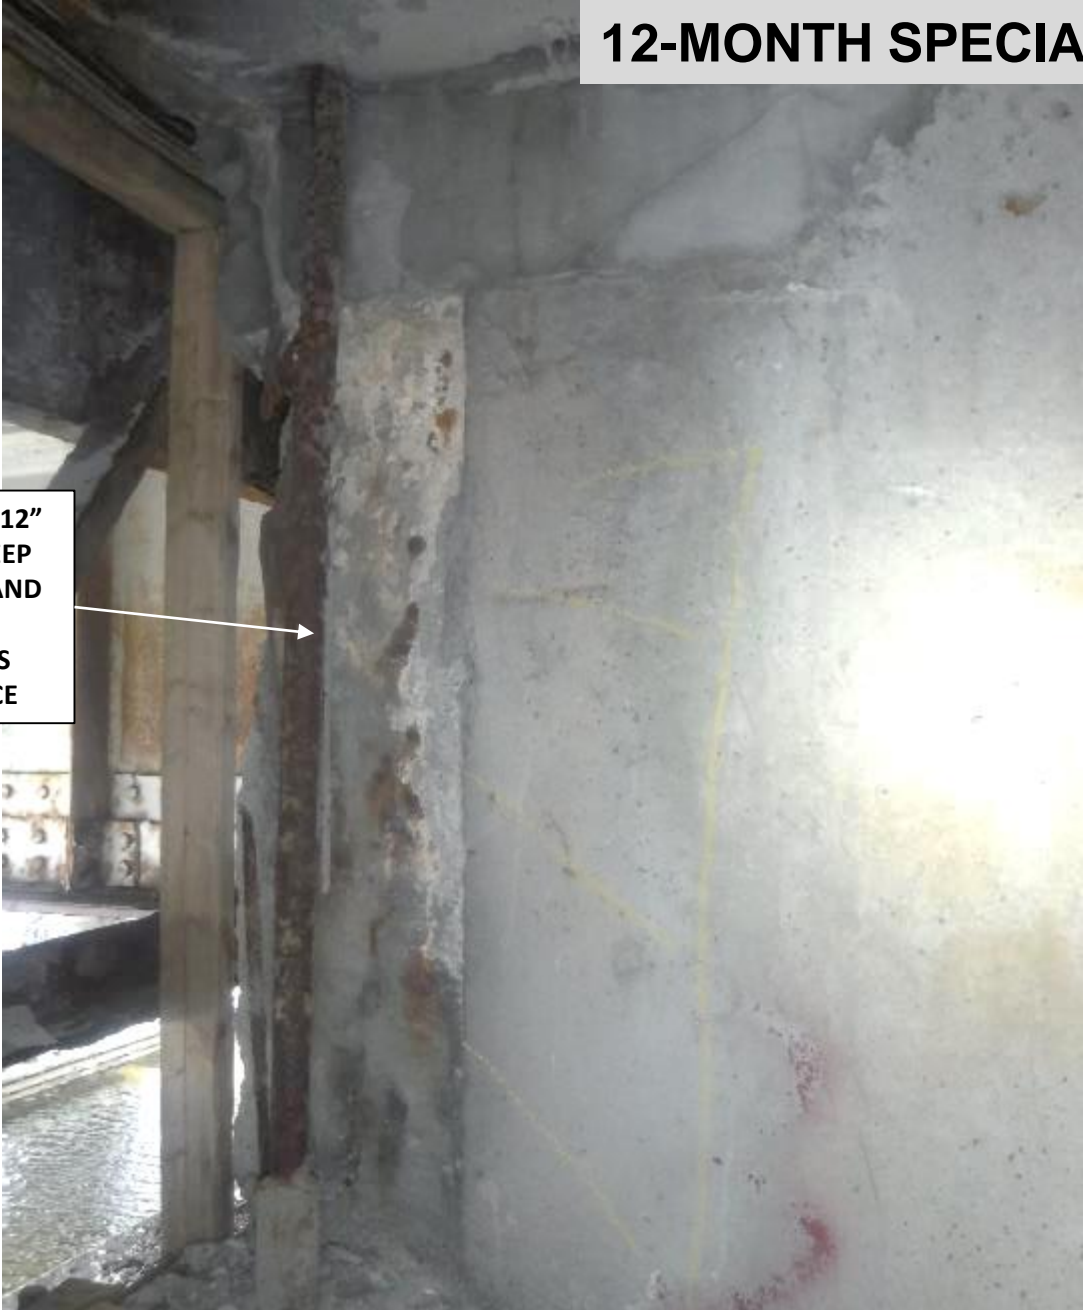
FULL HEIGHT x 16" WIDE x 12" LONG (EAST FACE) x 8" DEEP SPALL WITH (1) EXPOSED AND DEBONDED REBAR; ADDITIONAL 12" WIDE IS HOLLOW ON NORTH FACE

FULL HEIGHT x 2'-0" LONG x 16" WIDE (EAST FACE) x 5" DEEP SPALL WITH EXPOSED REBAR; UP TO 75% SECTION LOSS AND EXPOSED ANCHOR PLATE

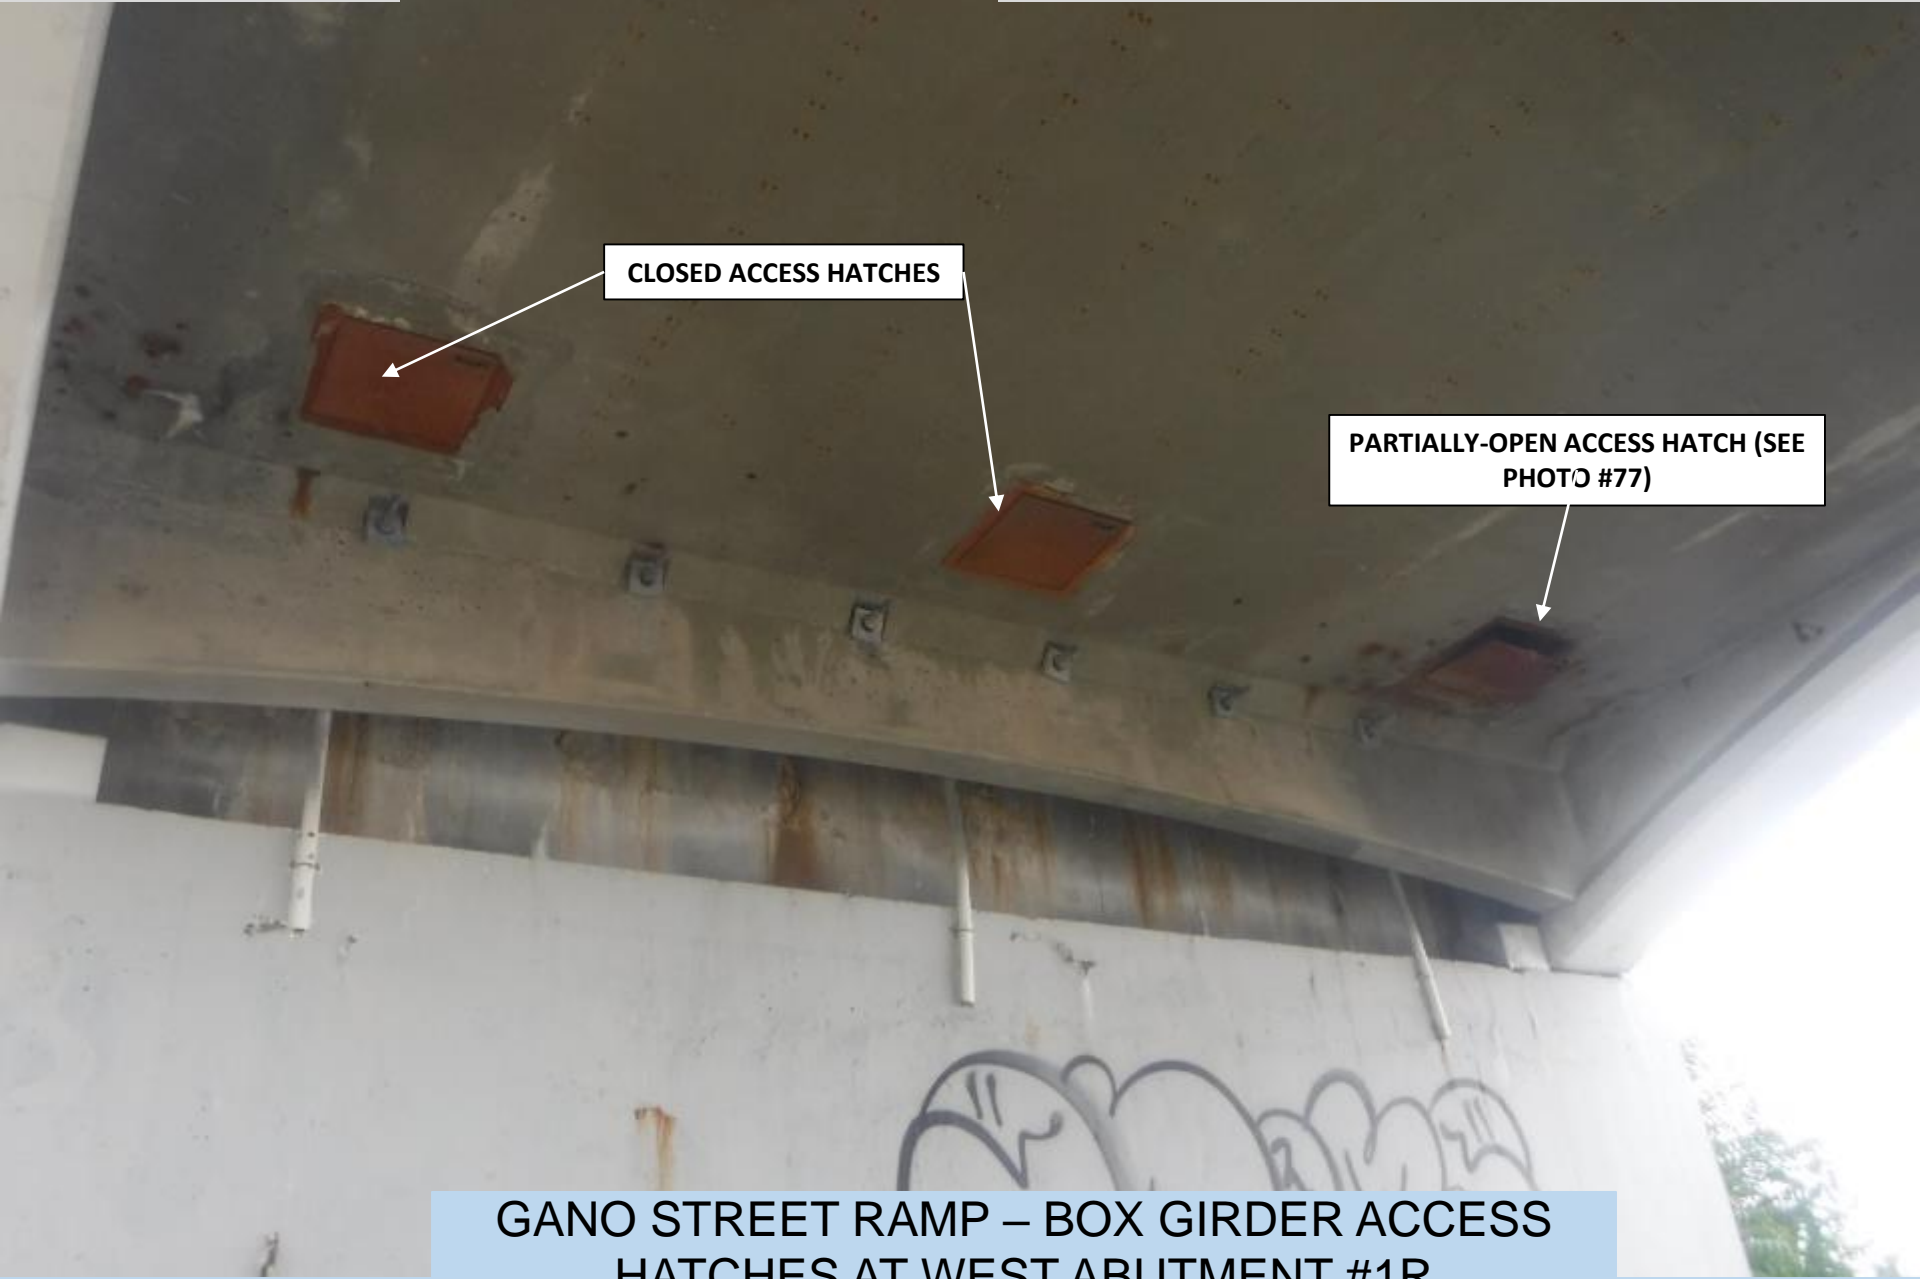
GANO STREET RAMP – BOX GIRDER ACCESS HATCHES AT WEST ABUTMENT #1R

CLOSED ACCESS HATCHES

PARTIALLY-OPEN ACCESS HATCH (SEE PHOTO #77)

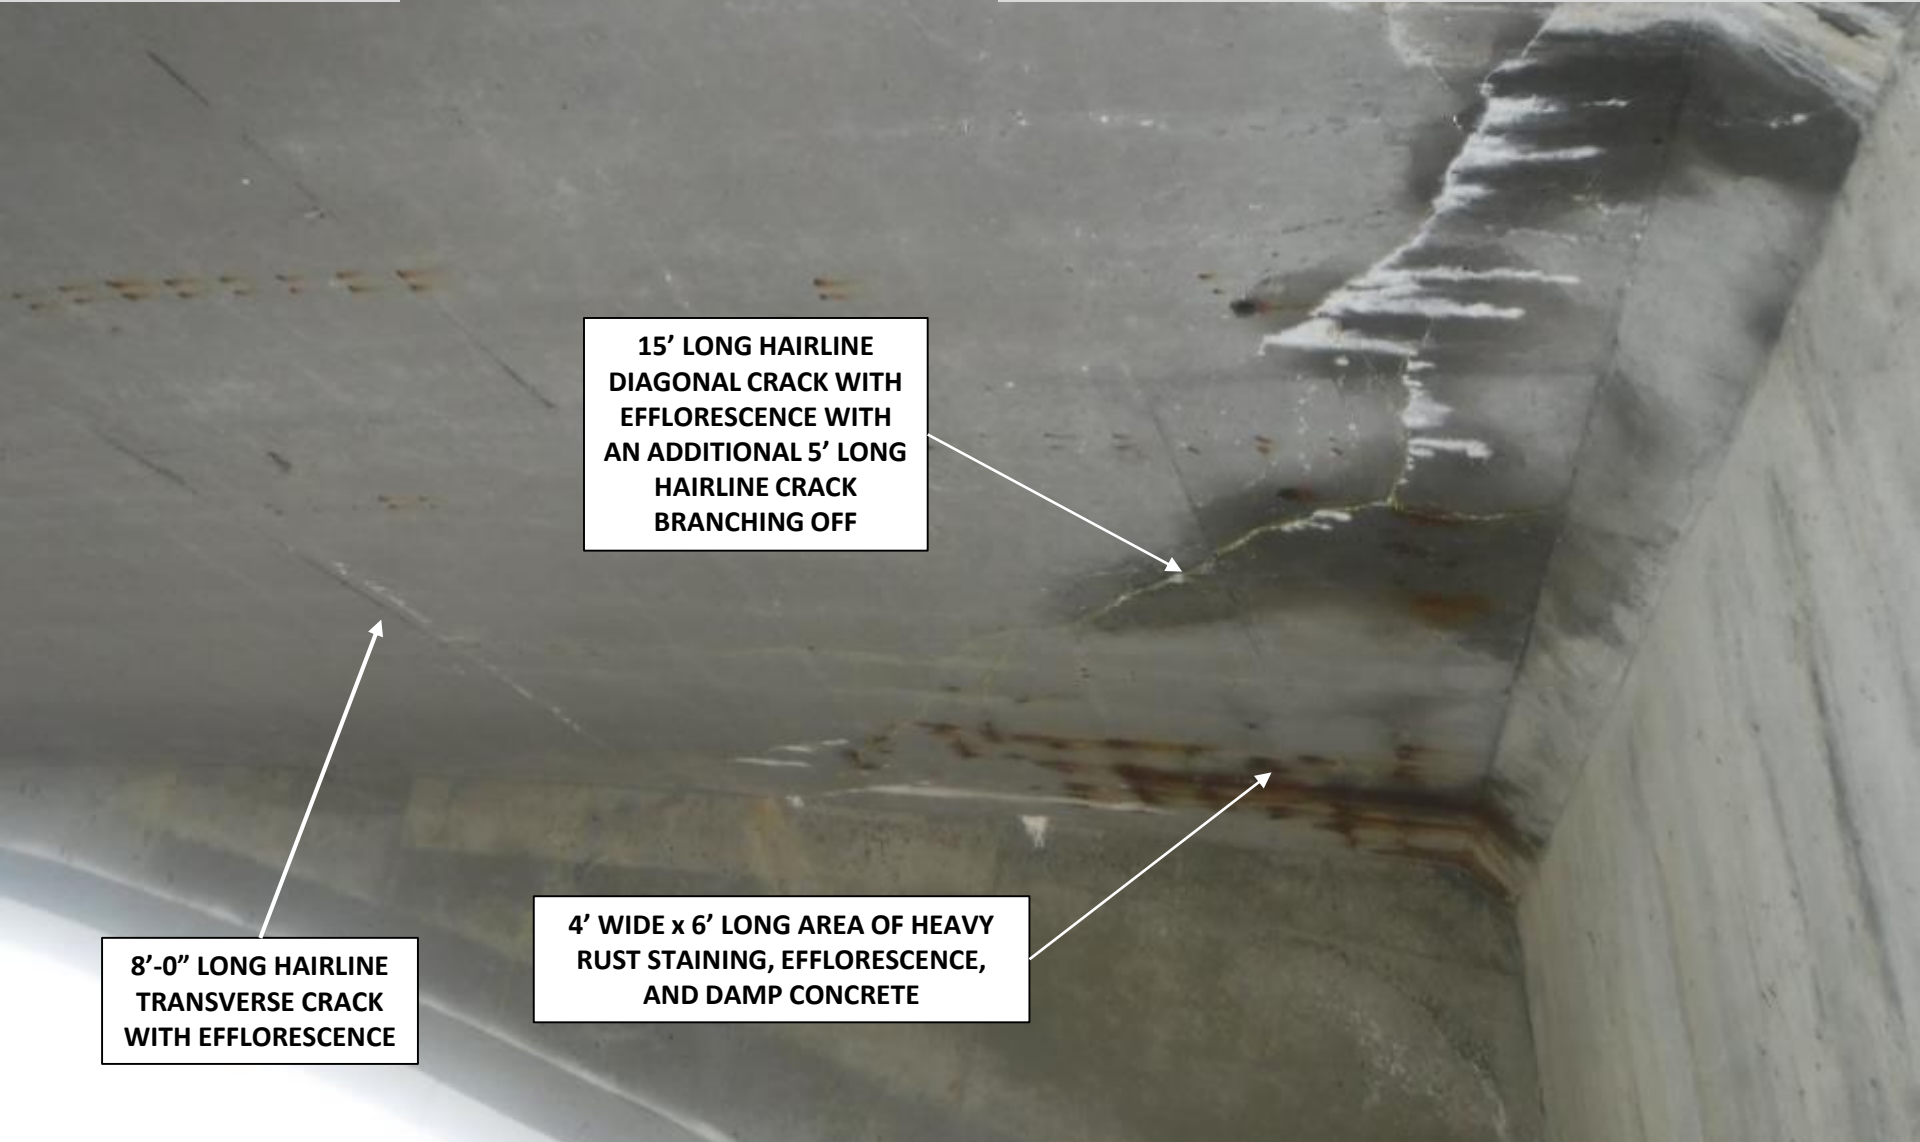
**BOX GIRDER EXTERIOR – UNDERSIDE
AT NORTH END NEAR PIER #2R IN SPAN #2R**

**15' LONG HAIRLINE
DIAGONAL CRACK WITH
EFFLORESCENCE WITH
AN ADDITIONAL 5' LONG
HAIRLINE CRACK
BRANCHING OFF**

**8'-0" LONG HAIRLINE
TRANSVERSE CRACK
WITH EFFLORESCENCE**

**4' WIDE x 6' LONG AREA OF HEAVY
RUST STAINING, EFFLORESCENCE,
AND DAMP CONCRETE**

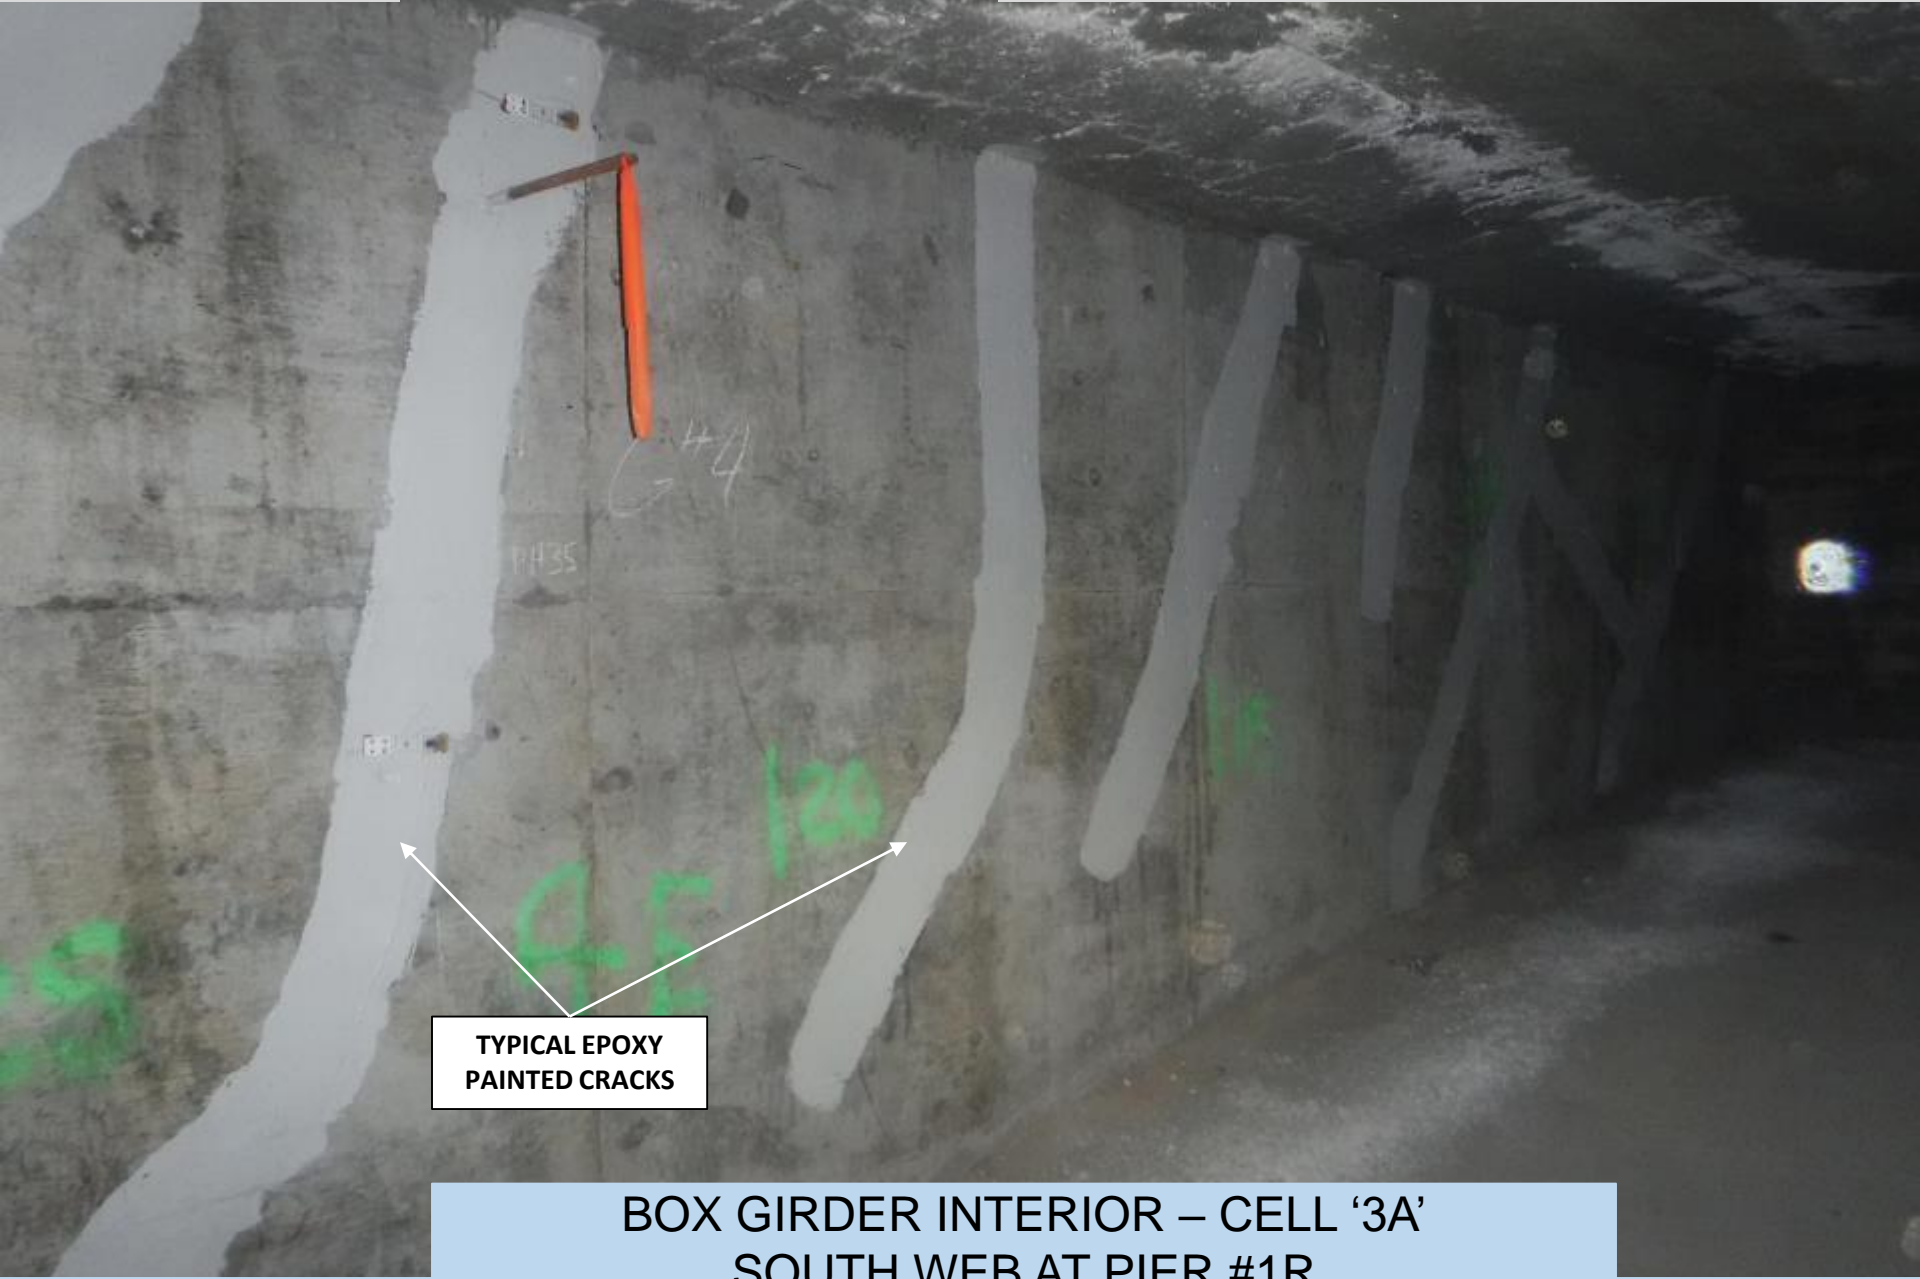
**BOX GIRDER INTERIOR – CELL '3A'
SOUTH WEB AT PIER #1R
IN SPAN #1R (LOOKING SOUTH)**

**TYPICAL EPOXY
PAINTED CRACKS**

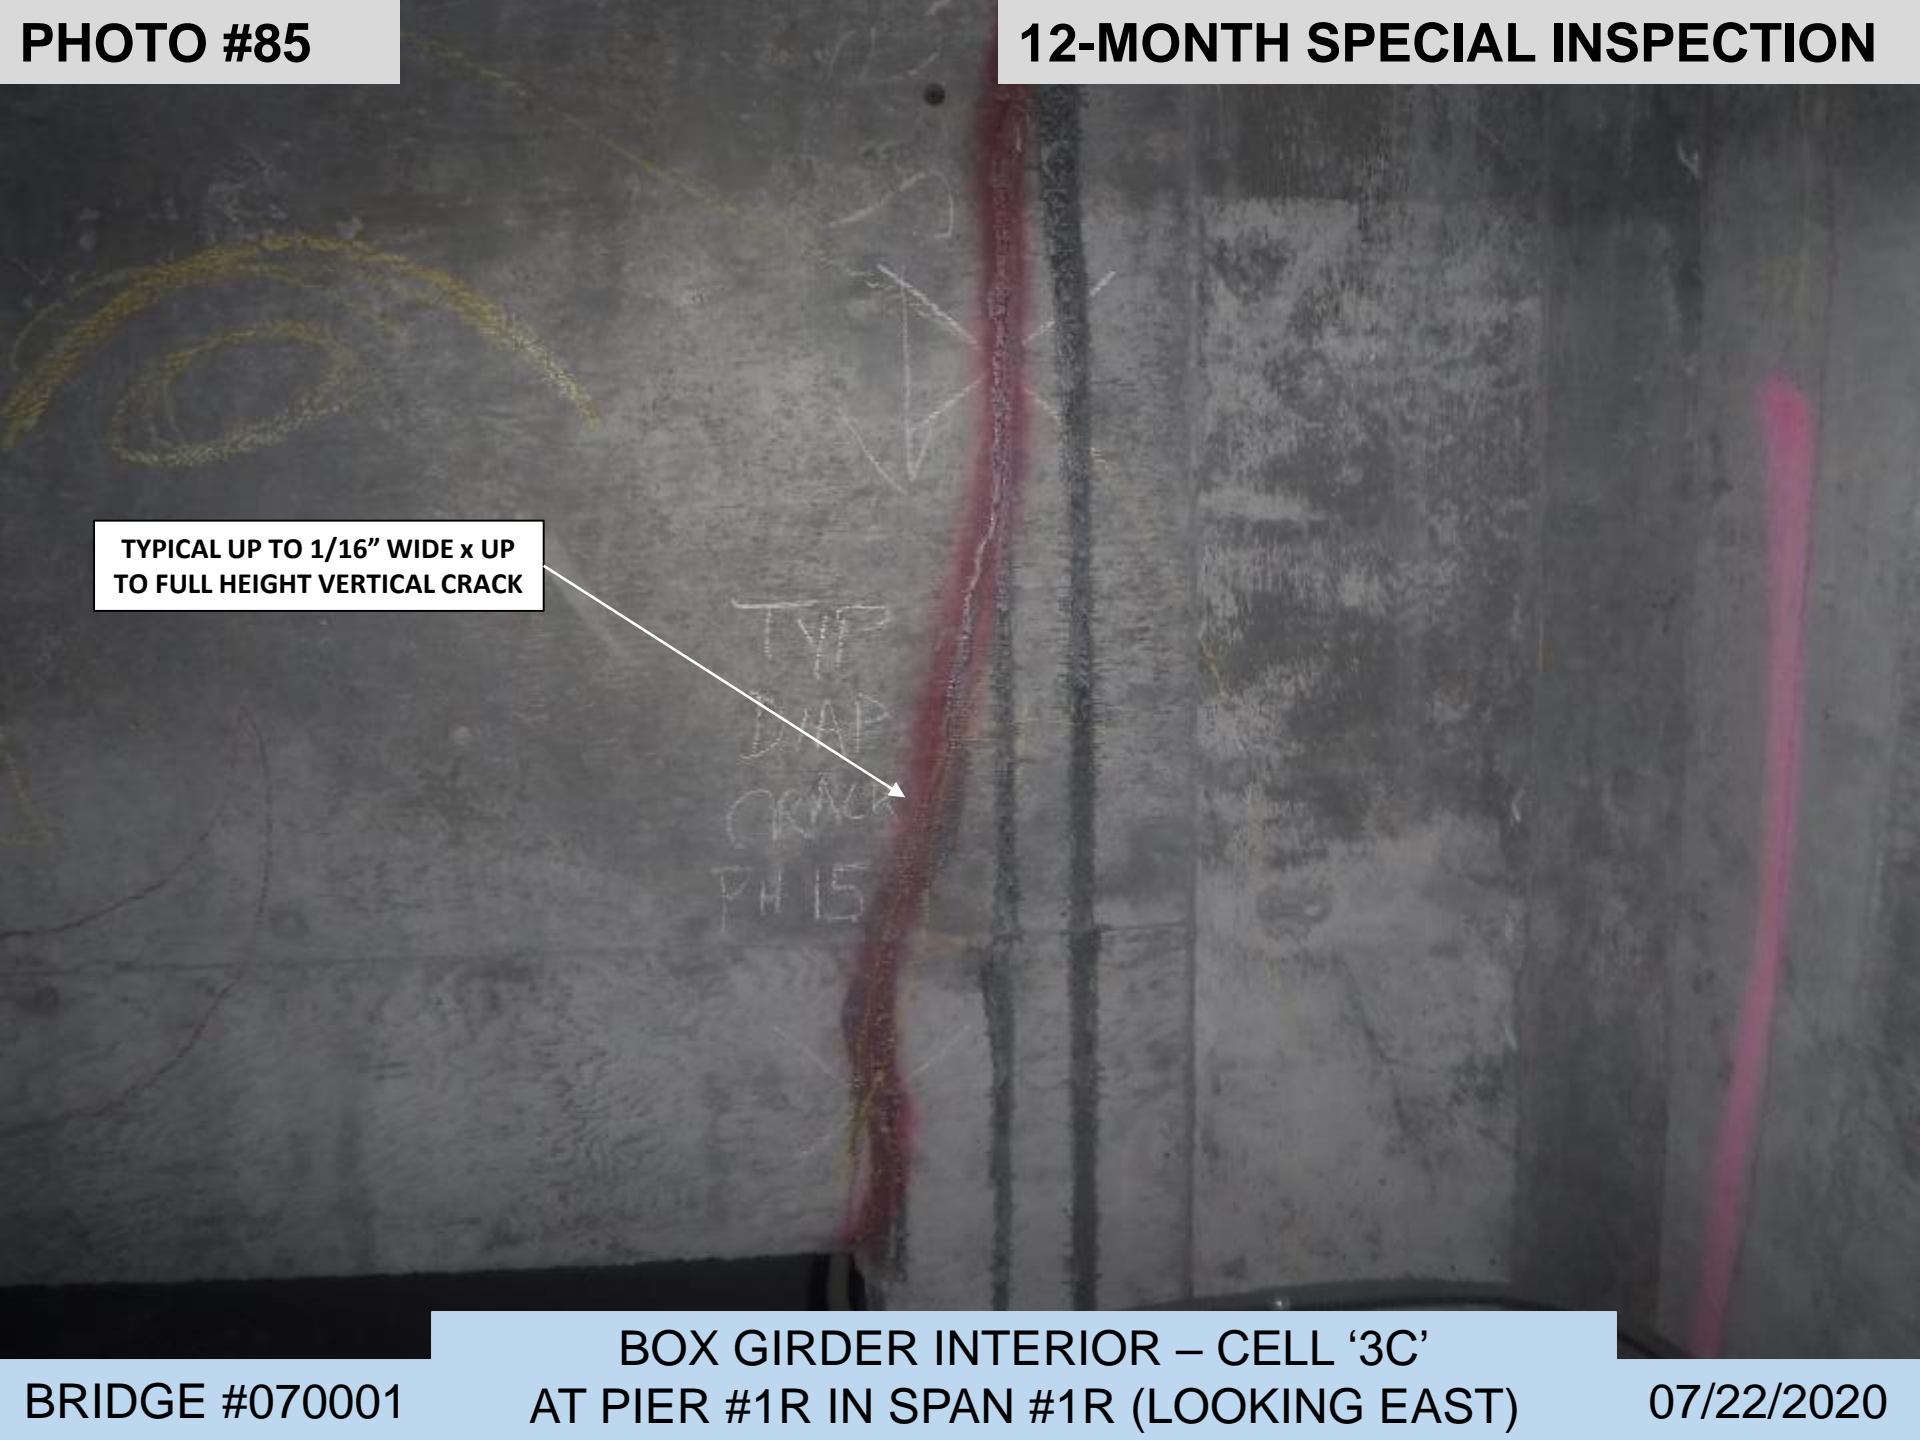
TYPICAL UP TO 1/16" WIDE x UP TO FULL HEIGHT VERTICAL CRACK

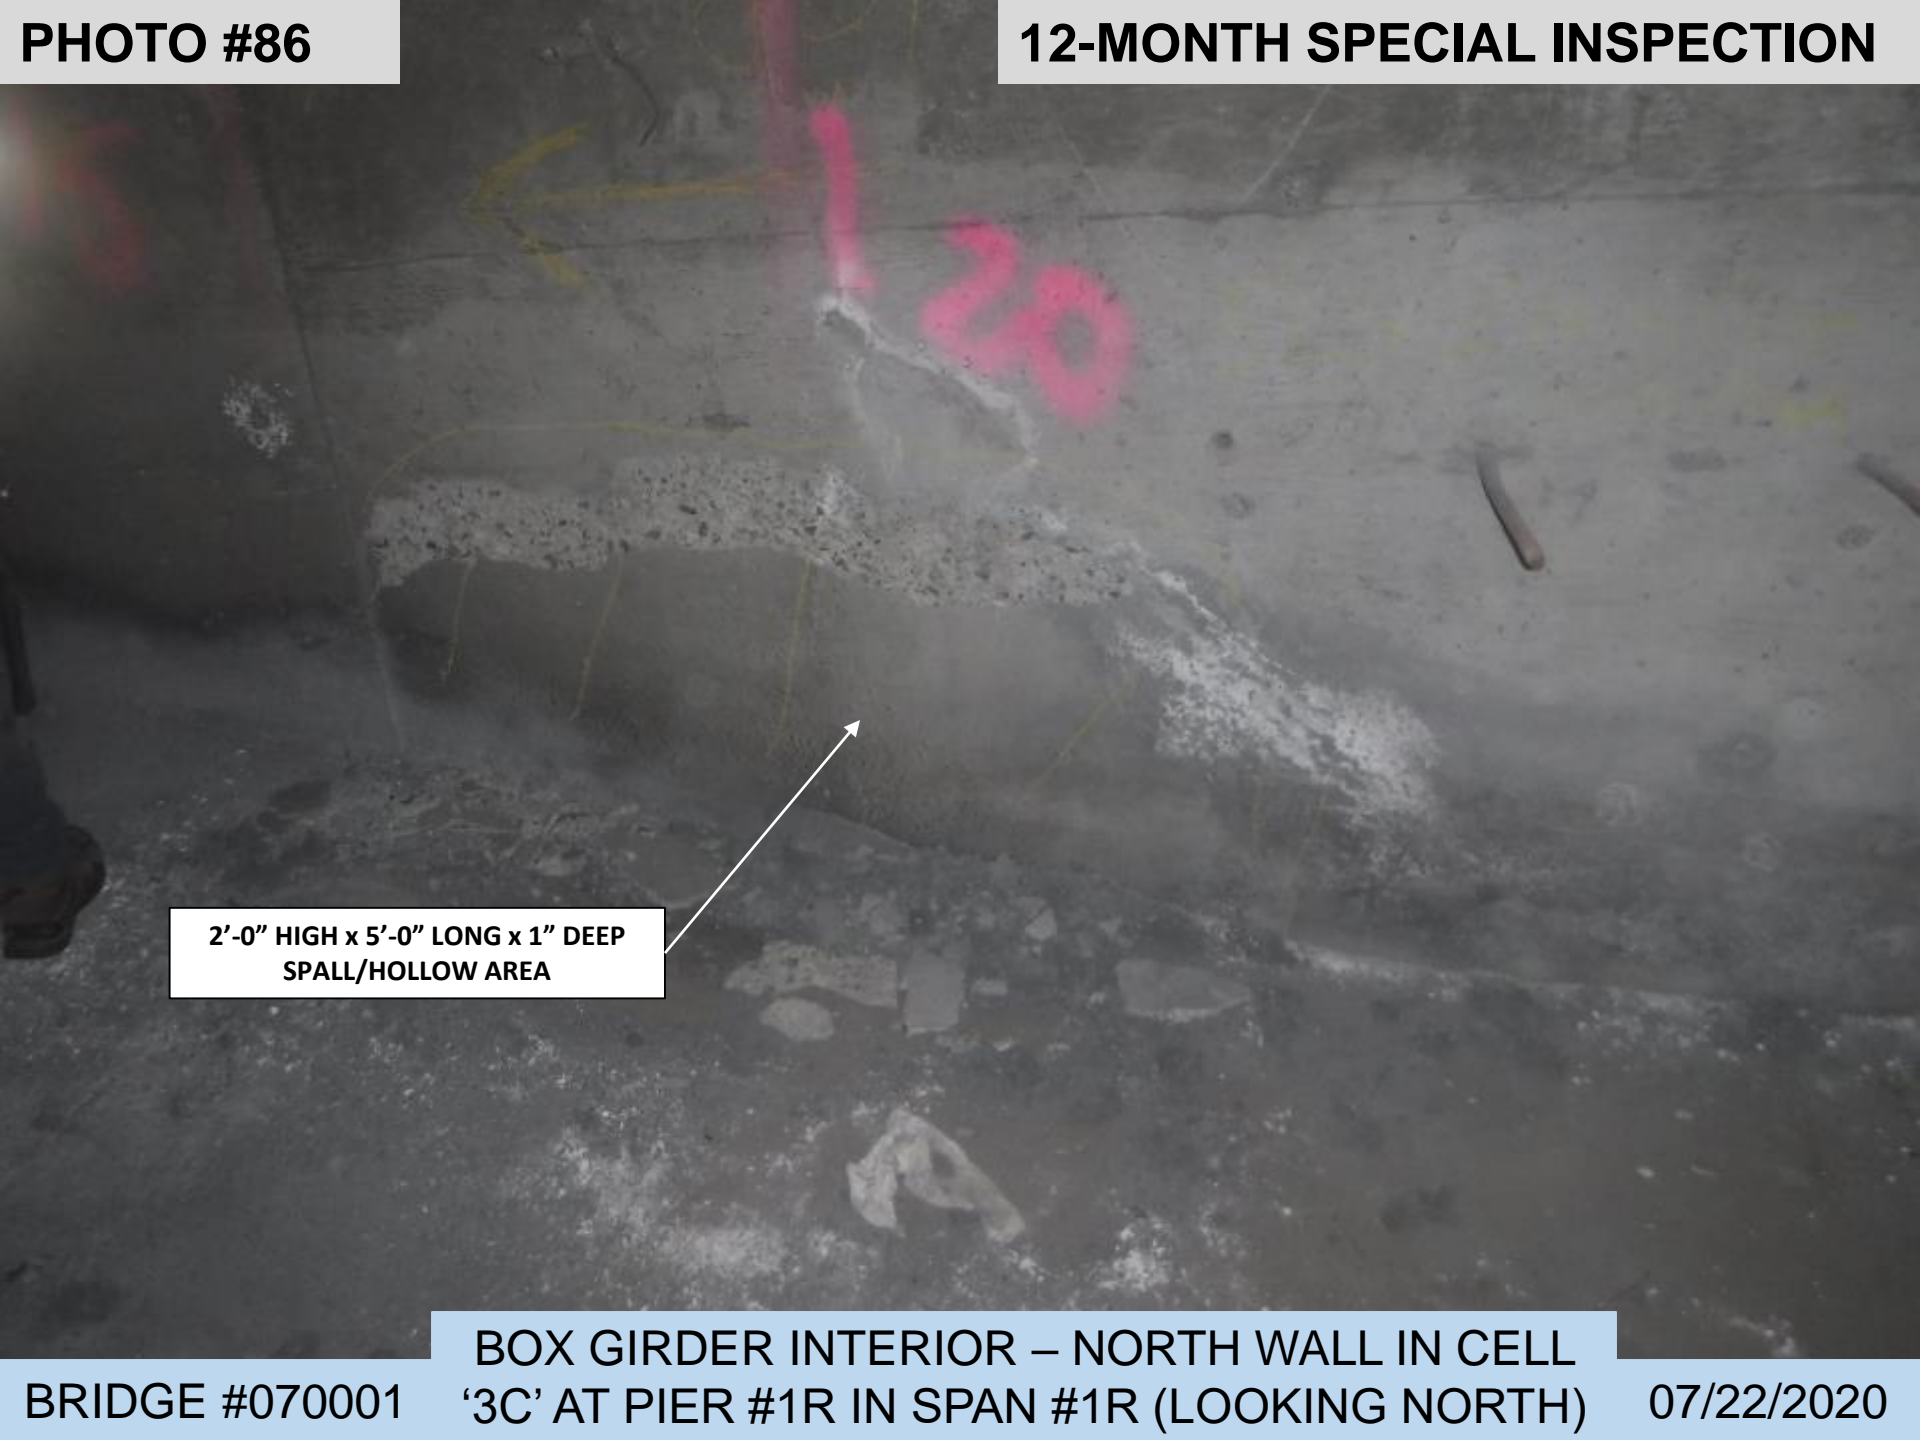
**2'-0" HIGH x 5'-0" LONG x 1" DEEP
SPALL/HOLLOW AREA**

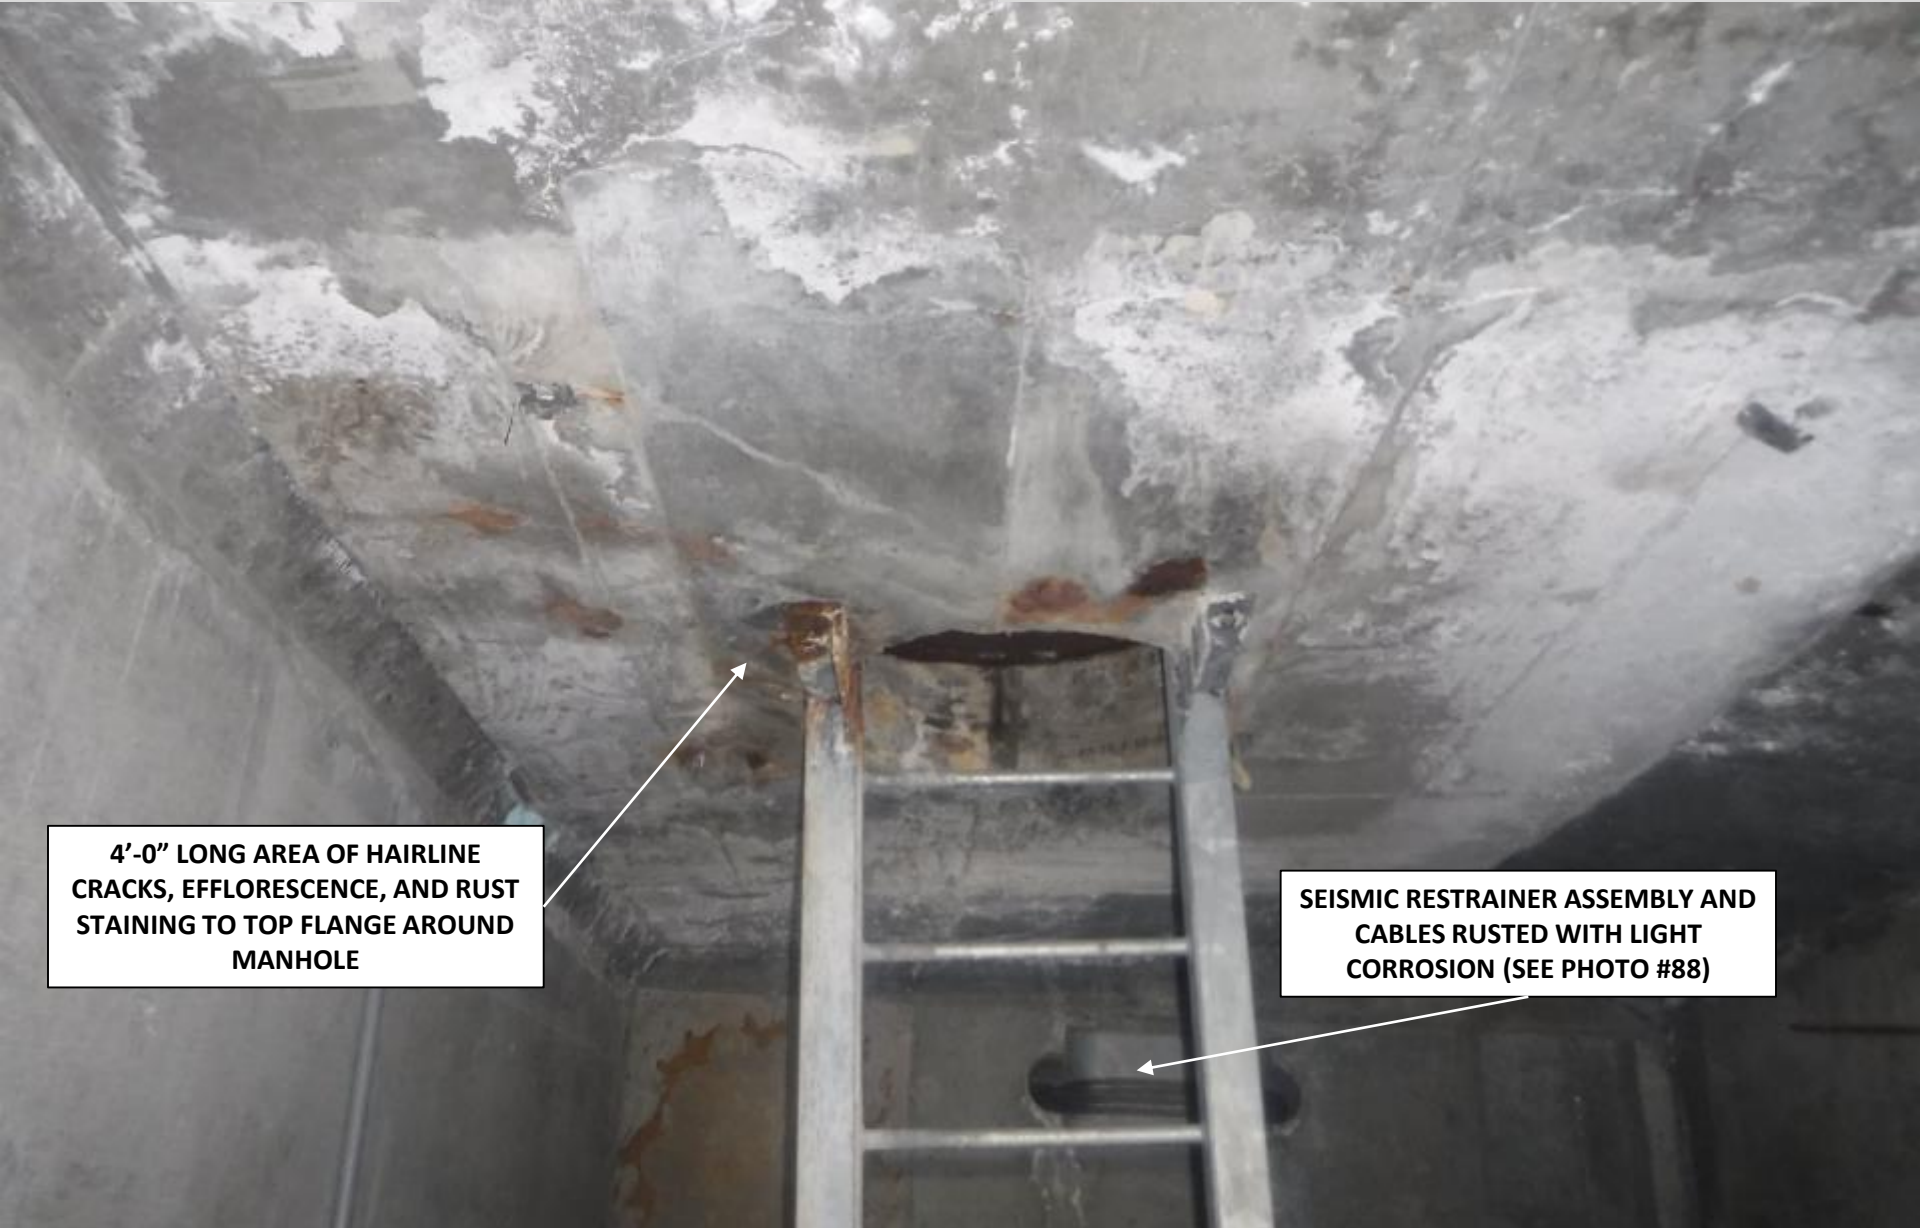
**4'-0" LONG AREA OF HAIRLINE
CRACKS, EFFLORESCENCE, AND RUST
STAINING TO TOP FLANGE AROUND
MANHOLE**

**SEISMIC RESTRAINER ASSEMBLY AND
CABLES RUSTED WITH LIGHT
CORROSION (SEE PHOTO #88)**

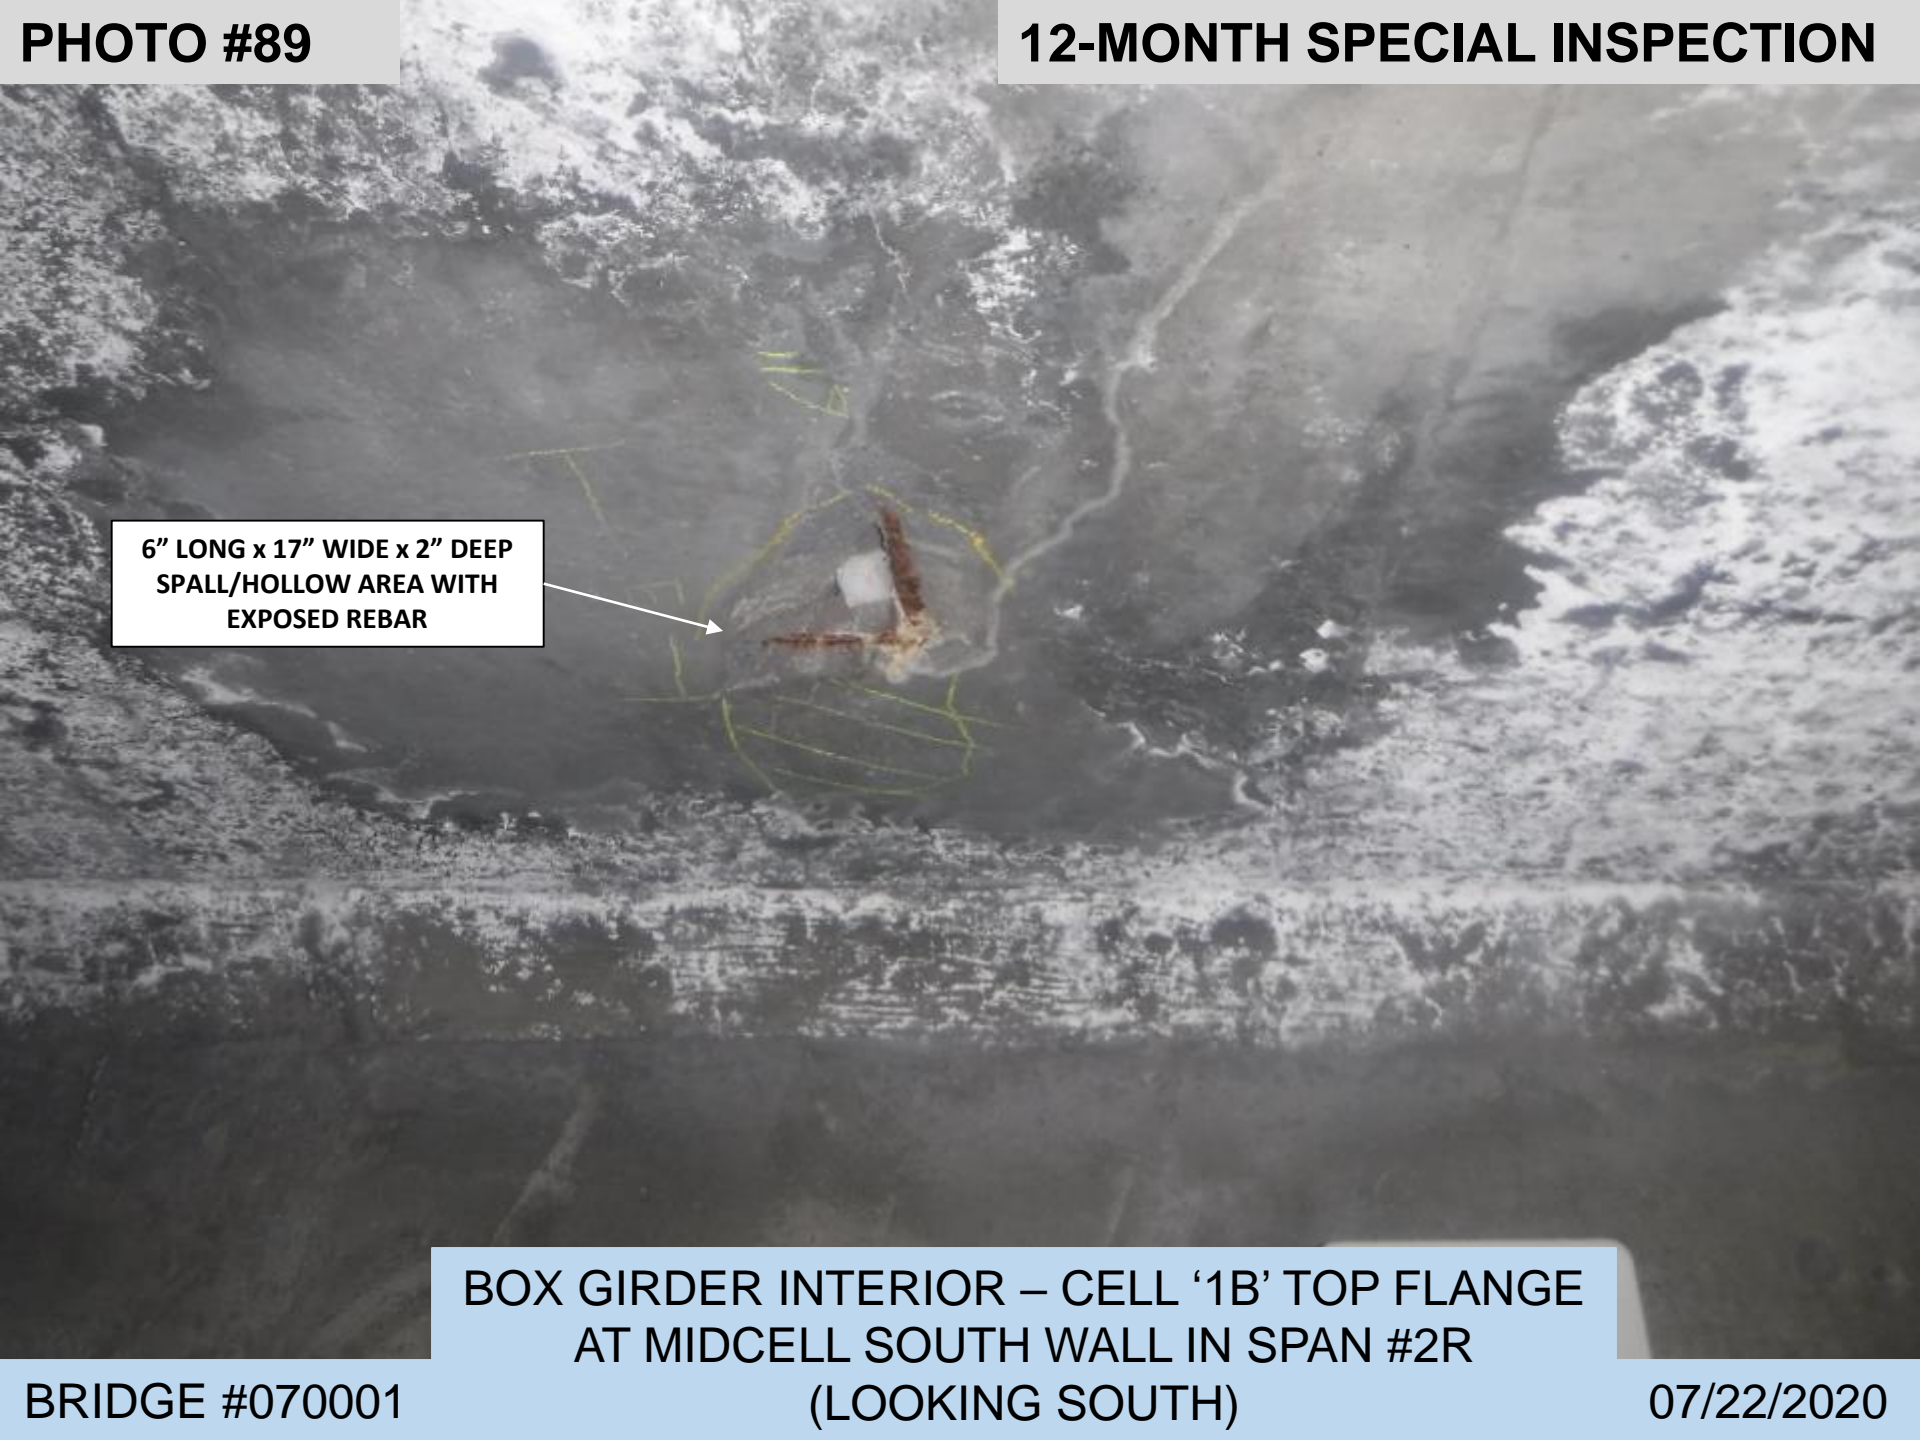
**BOX GIRDER INTERIOR – CELL '1B' TOP FLANGE
AT MIDCELL SOUTH WALL IN SPAN #2R**

**6" LONG x 17" WIDE x 2" DEEP
SPALL/HOLLOW AREA WITH
EXPOSED REBAR**
