12-MONTH SPECIAL INSPECTION

BRIDGE #070001

07/22/2020

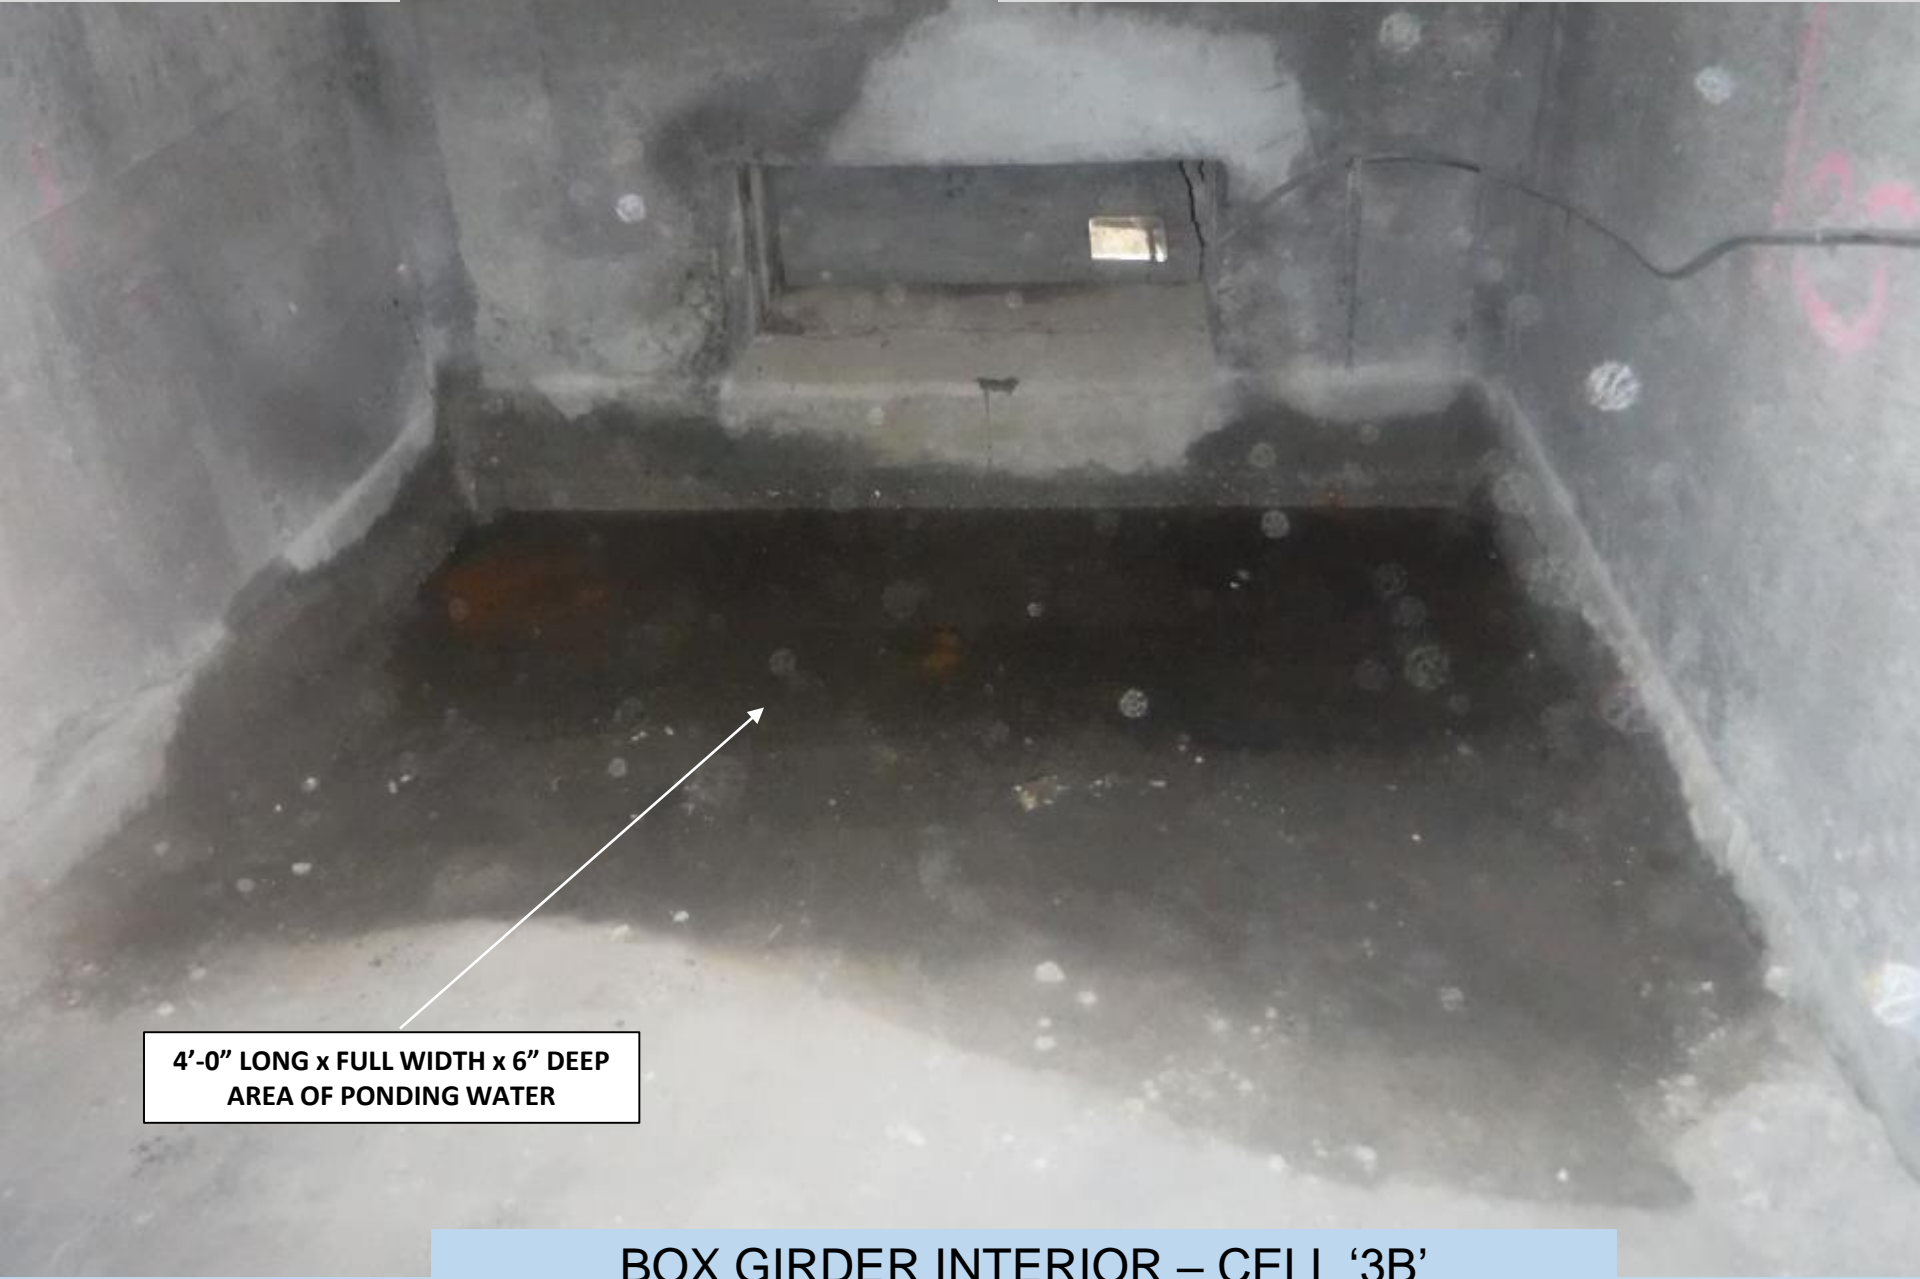
**4'-0" LONG x FULL WIDTH x 6" DEEP
AREA OF PONDING WATER**

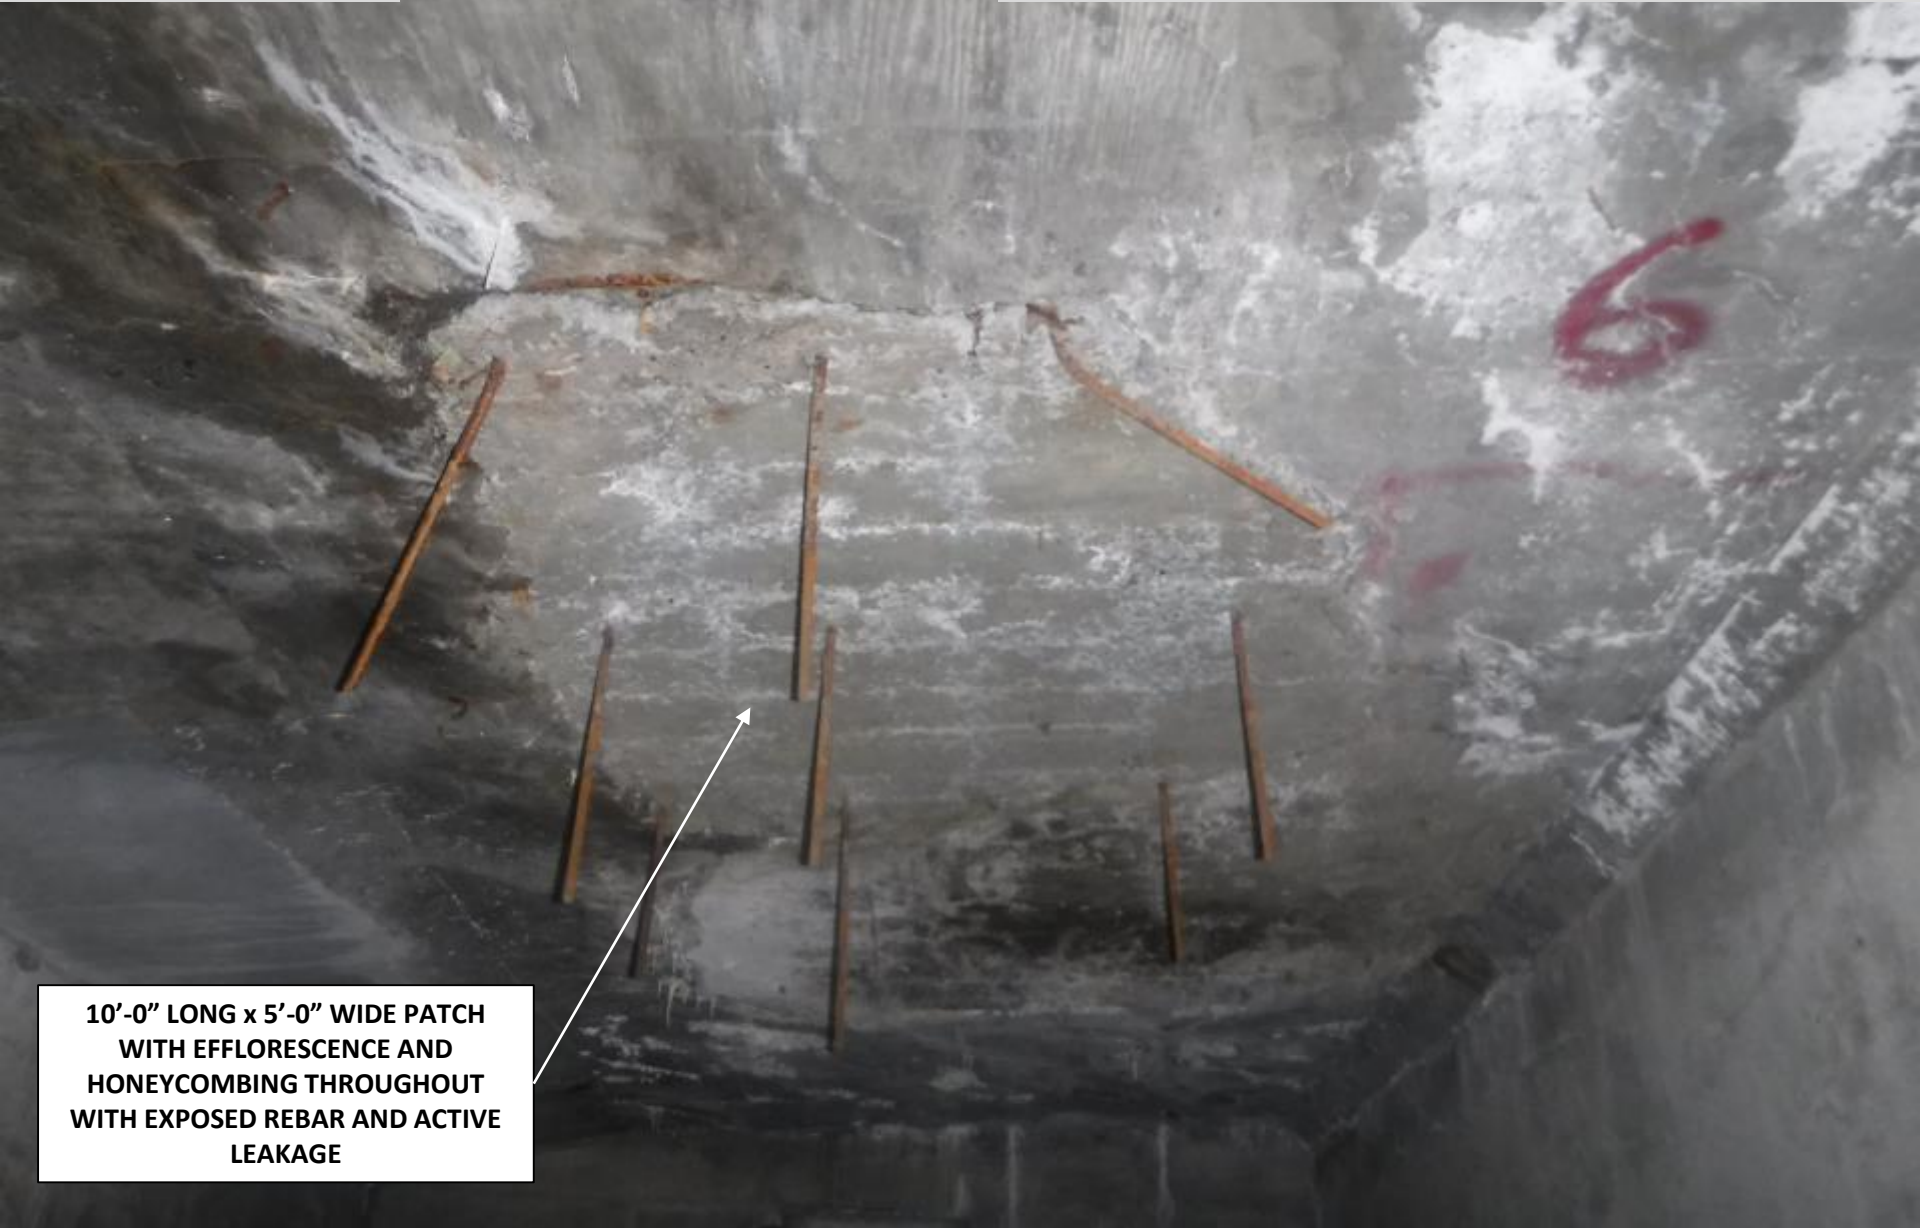
**BOX GIRDER INTERIOR – TOP FLANGE IN CELL
'3C' AT PIER #2R IN SPAN #2R (LOOKING EAST)**

**10'-0" LONG x 5'-0" WIDE PATCH
WITH EFFLORESCENCE AND
HONEYCOMBING THROUGHOUT
WITH EXPOSED REBAR AND ACTIVE
LEAKAGE**

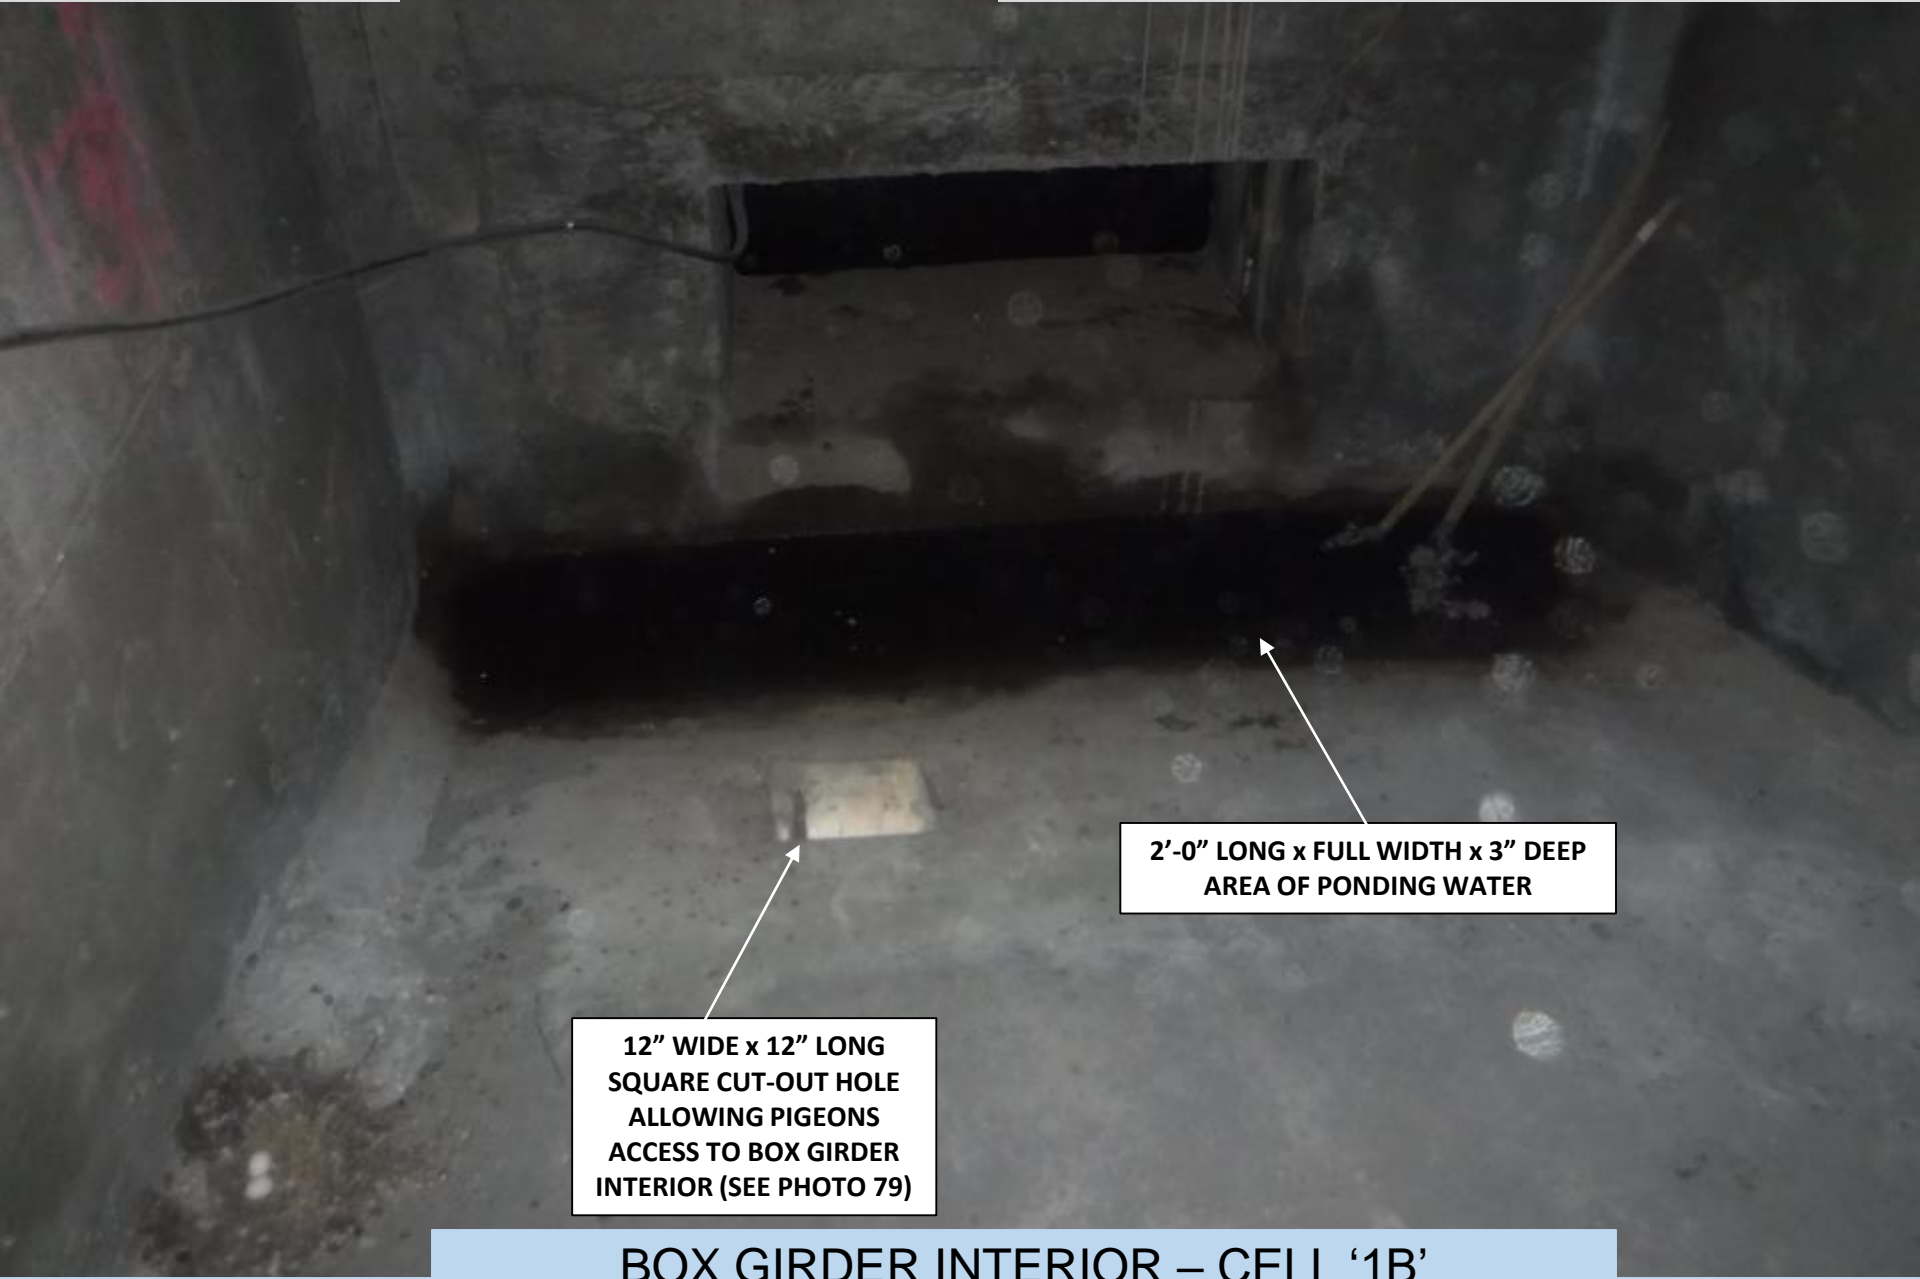
BRIDGE #070001 **BOX GIRDER INTERIOR – CELL '1B'** **07/22/2020**
AT PIER #2R IN SPAN #3R (LOOKING WEST)

12" WIDE x 12" LONG
SQUARE CUT-OUT HOLE
ALLOWING PIGEONS
ACCESS TO BOX GIRDER
INTERIOR (SEE PHOTO 79)

2'-0" LONG x FULL WIDTH x 3" DEEP
AREA OF PONDING WATER

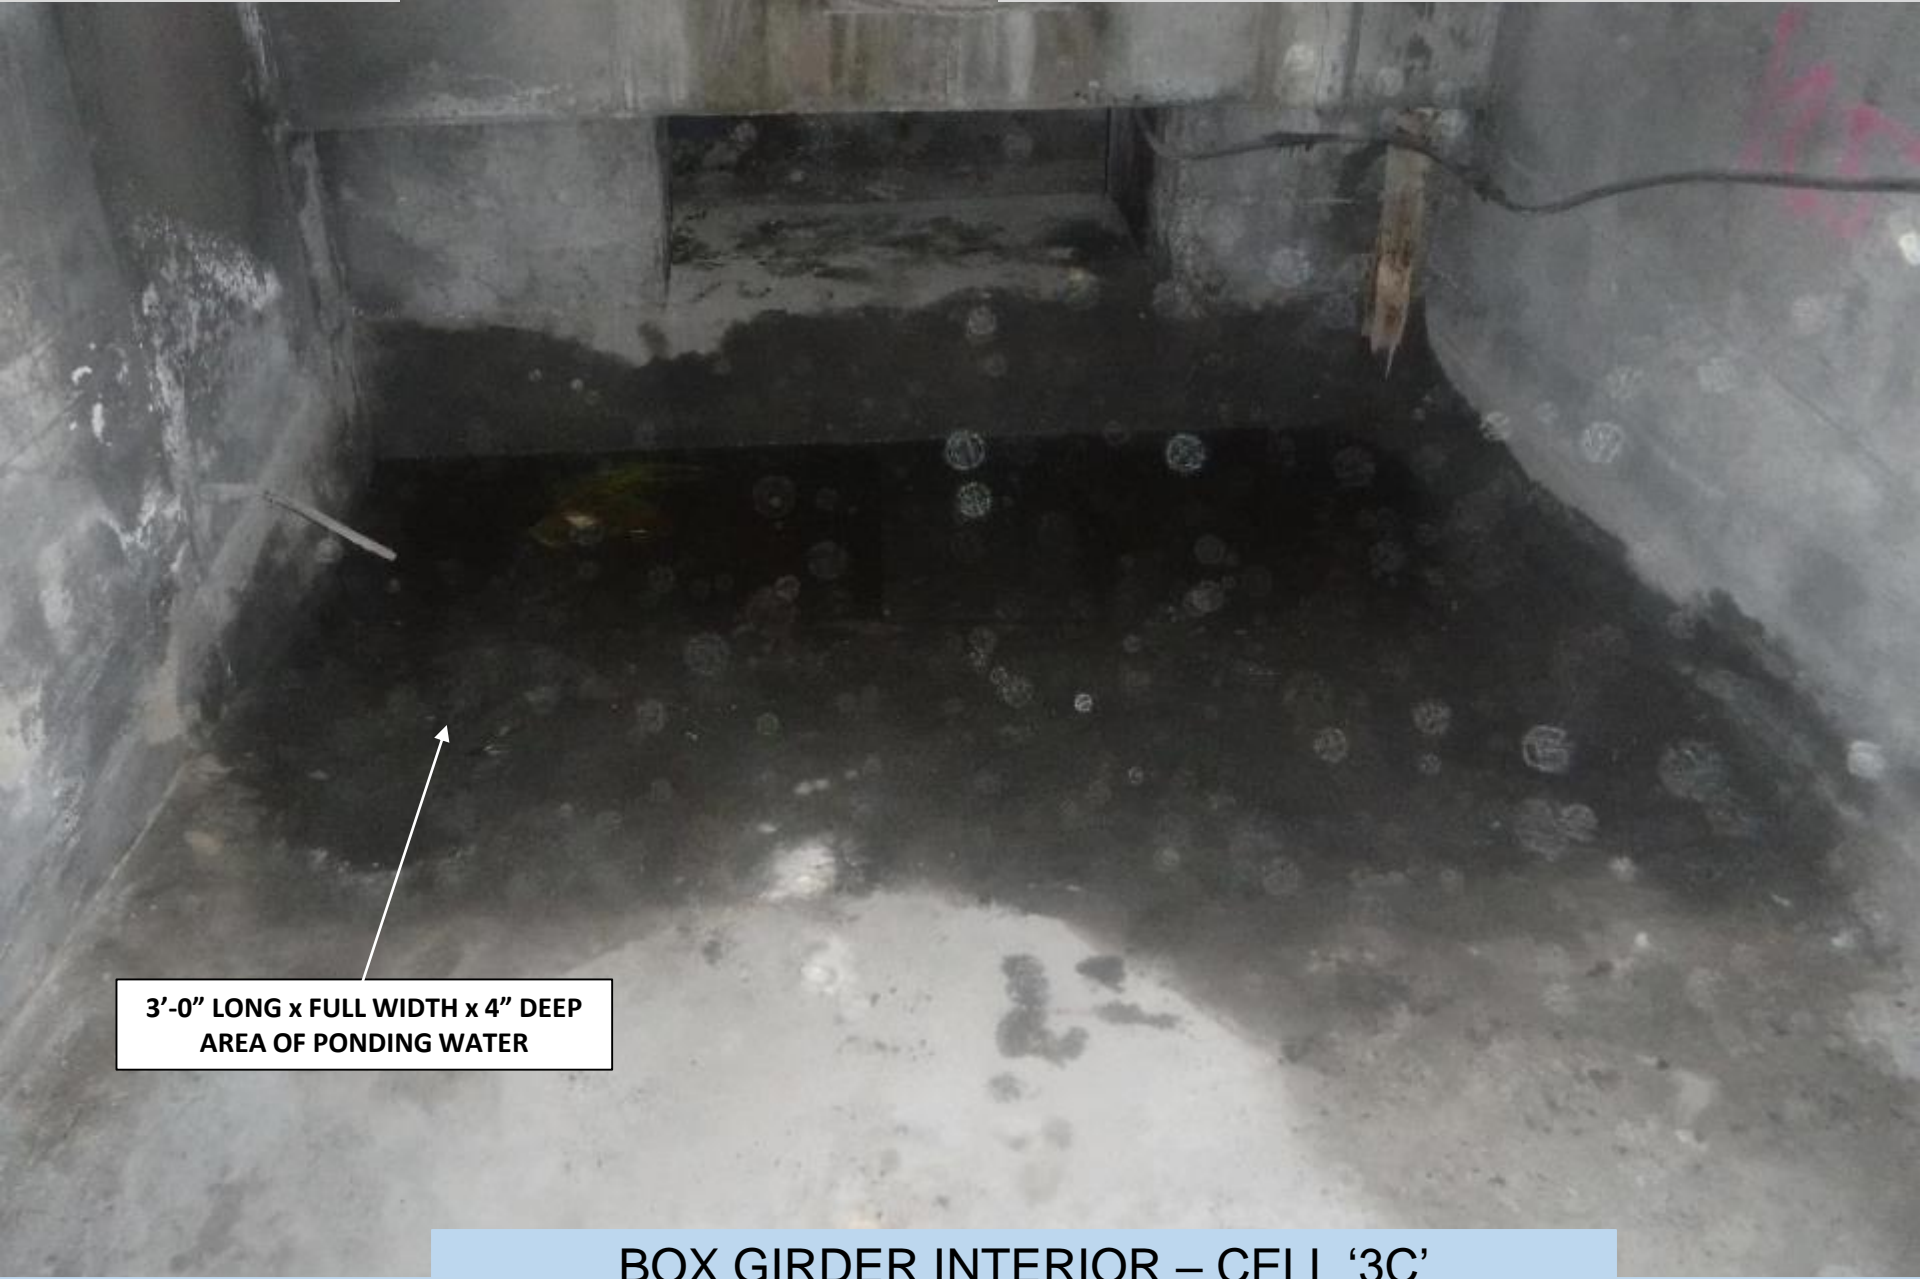
**3'-0" LONG x FULL WIDTH x 4" DEEP
AREA OF PONDING WATER**

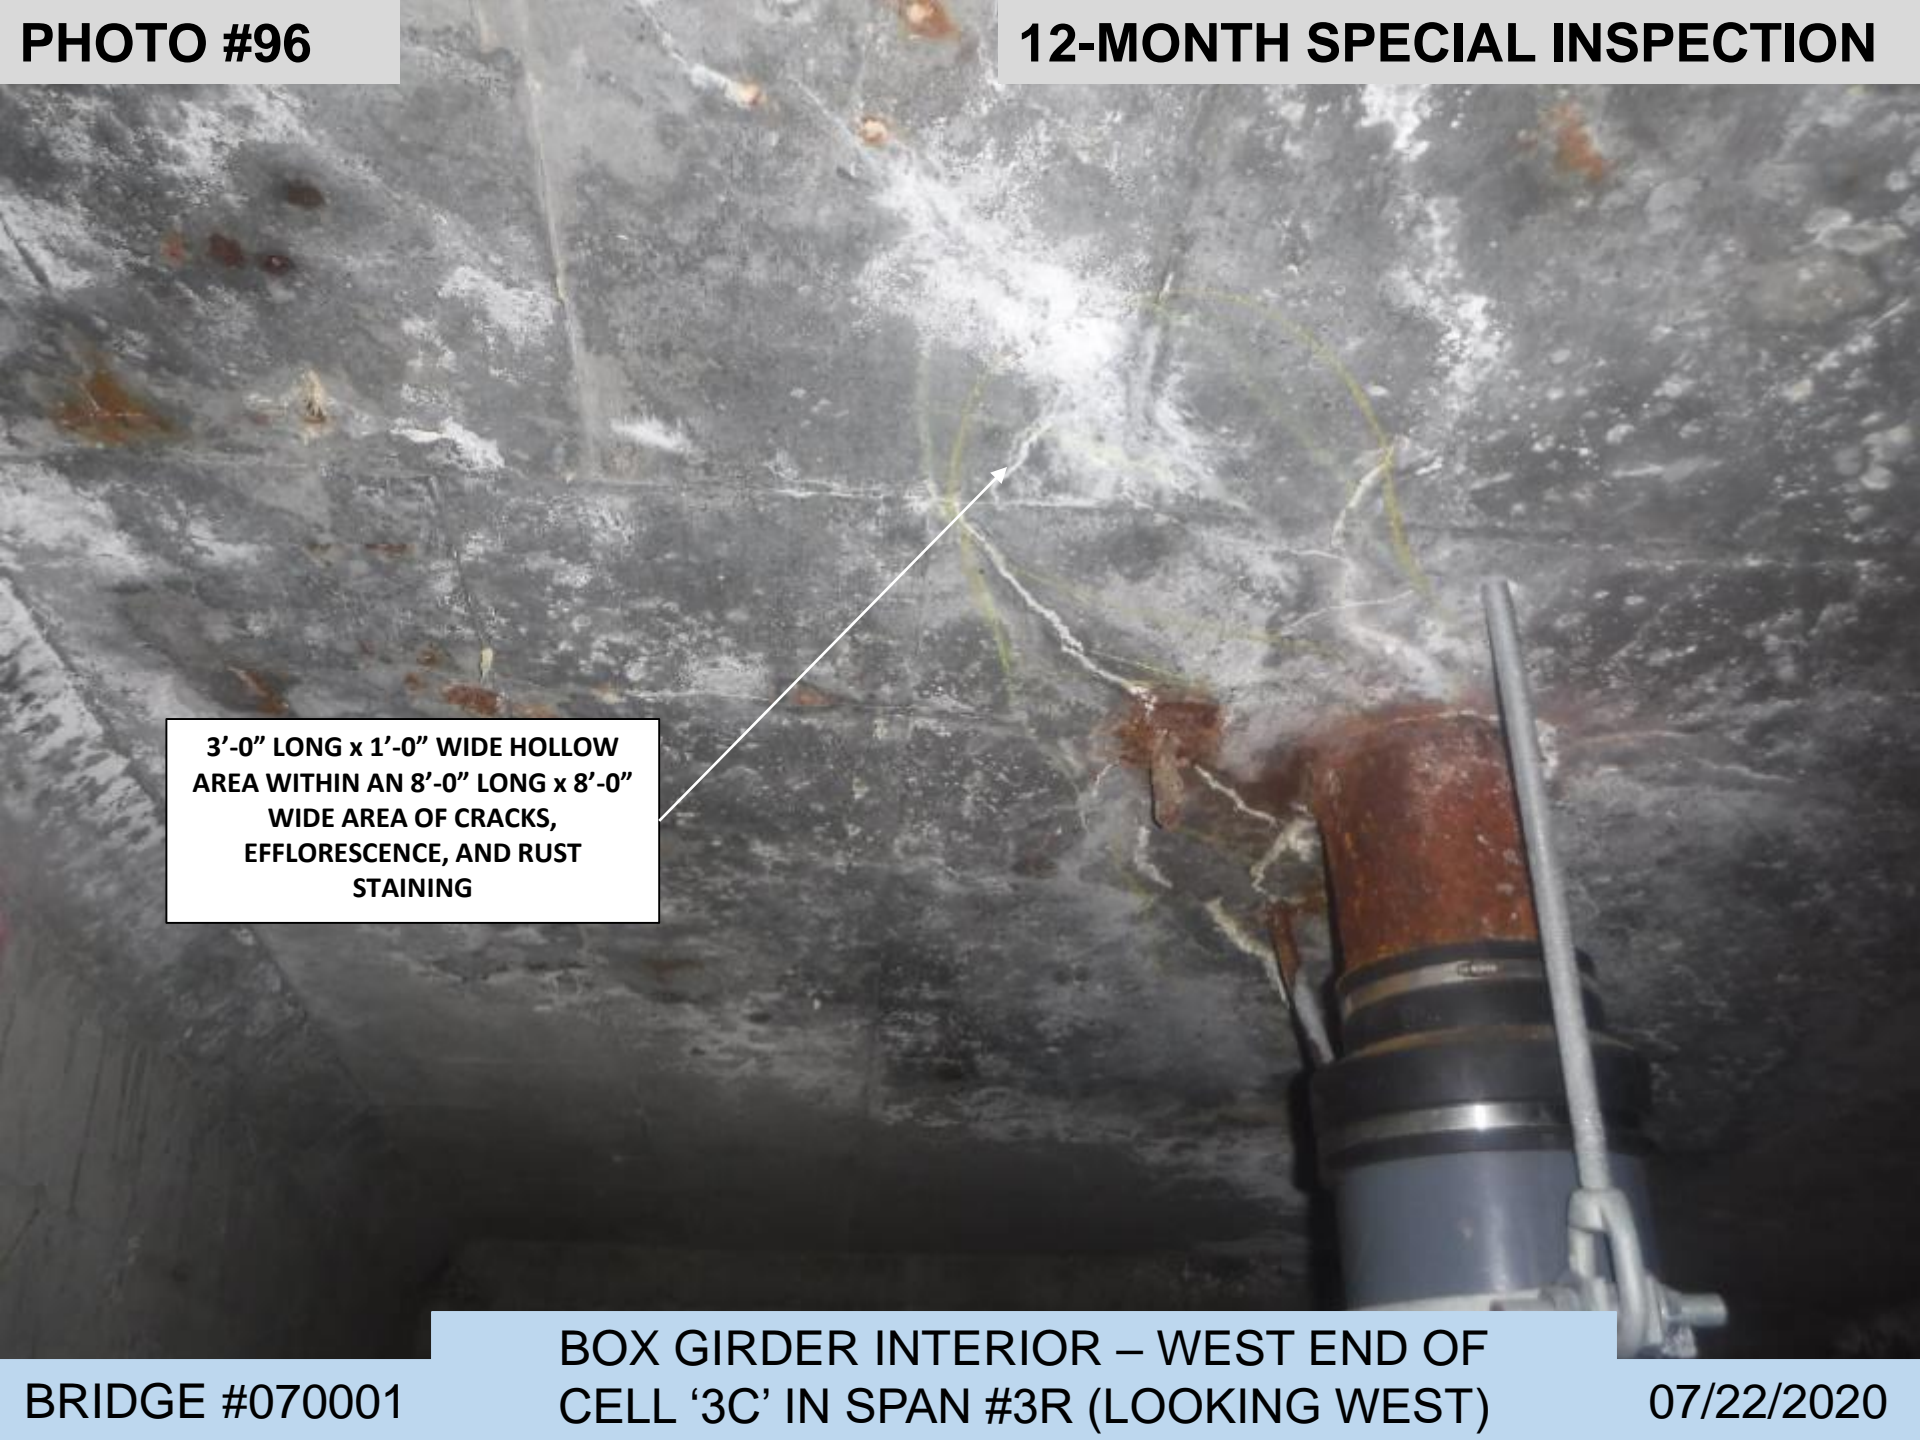
**3'-0" LONG x 1'-0" WIDE HOLLOW
AREA WITHIN AN 8'-0" LONG x 8'-0"
WIDE AREA OF CRACKS,
EFFLORESCENCE, AND RUST
STAINING**

**METAL MESH SCREEN AT
ACCESS HOLE IS PARTIALLY
OPEN AND ACCESSIBLE TO
PIGEONS (SEE PHOTO 83)**

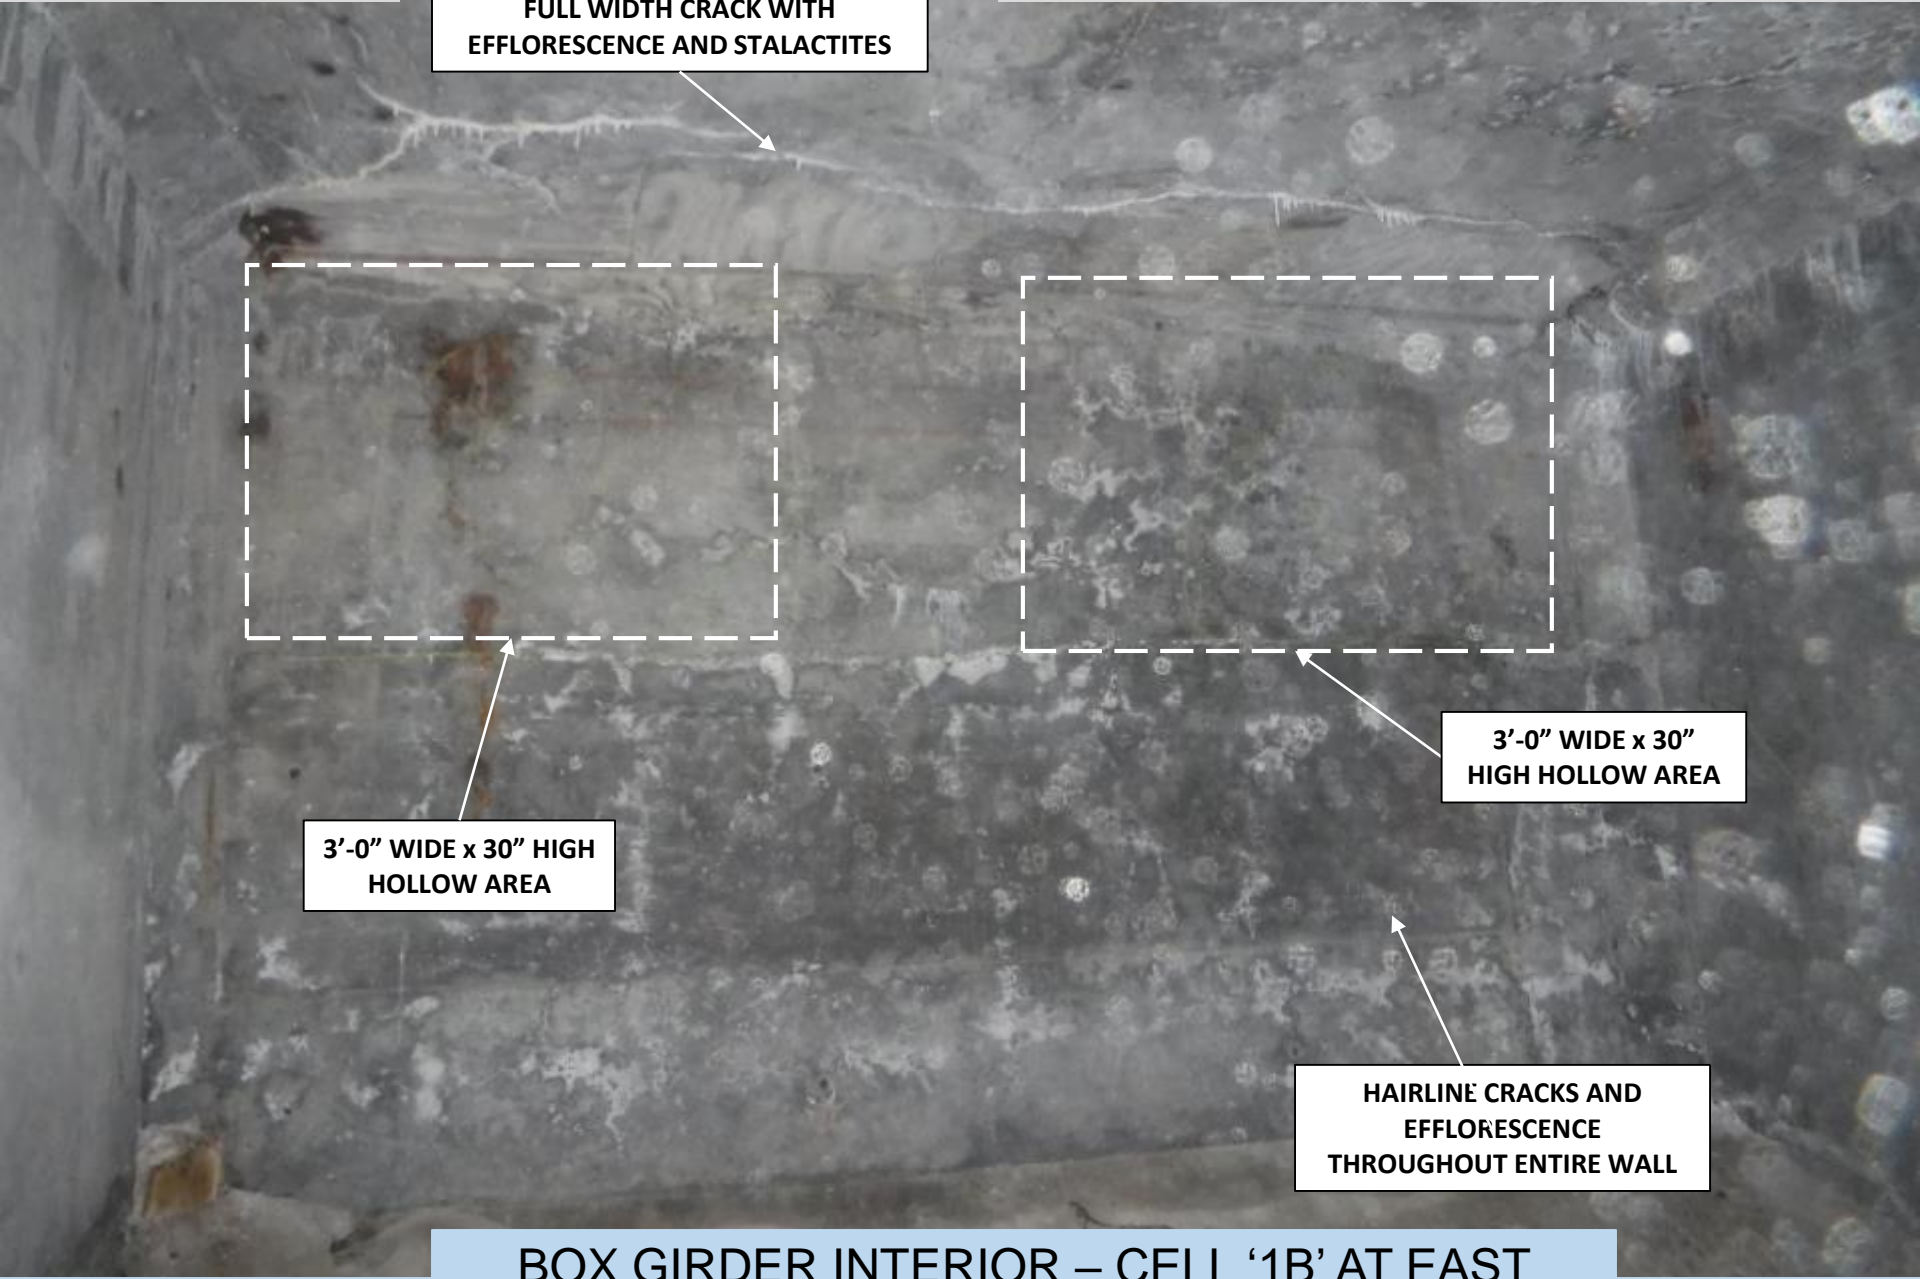
**FULL WIDTH CRACK WITH
EFFLORESCENCE AND STALACTITES**

**3'-0" WIDE x 30" HIGH
HOLLOW AREA**

**3'-0" WIDE x 30"
HIGH HOLLOW AREA**

**HAIRLINE CRACKS AND
EFFLORESCENCE
THROUGHOUT ENTIRE WALL**

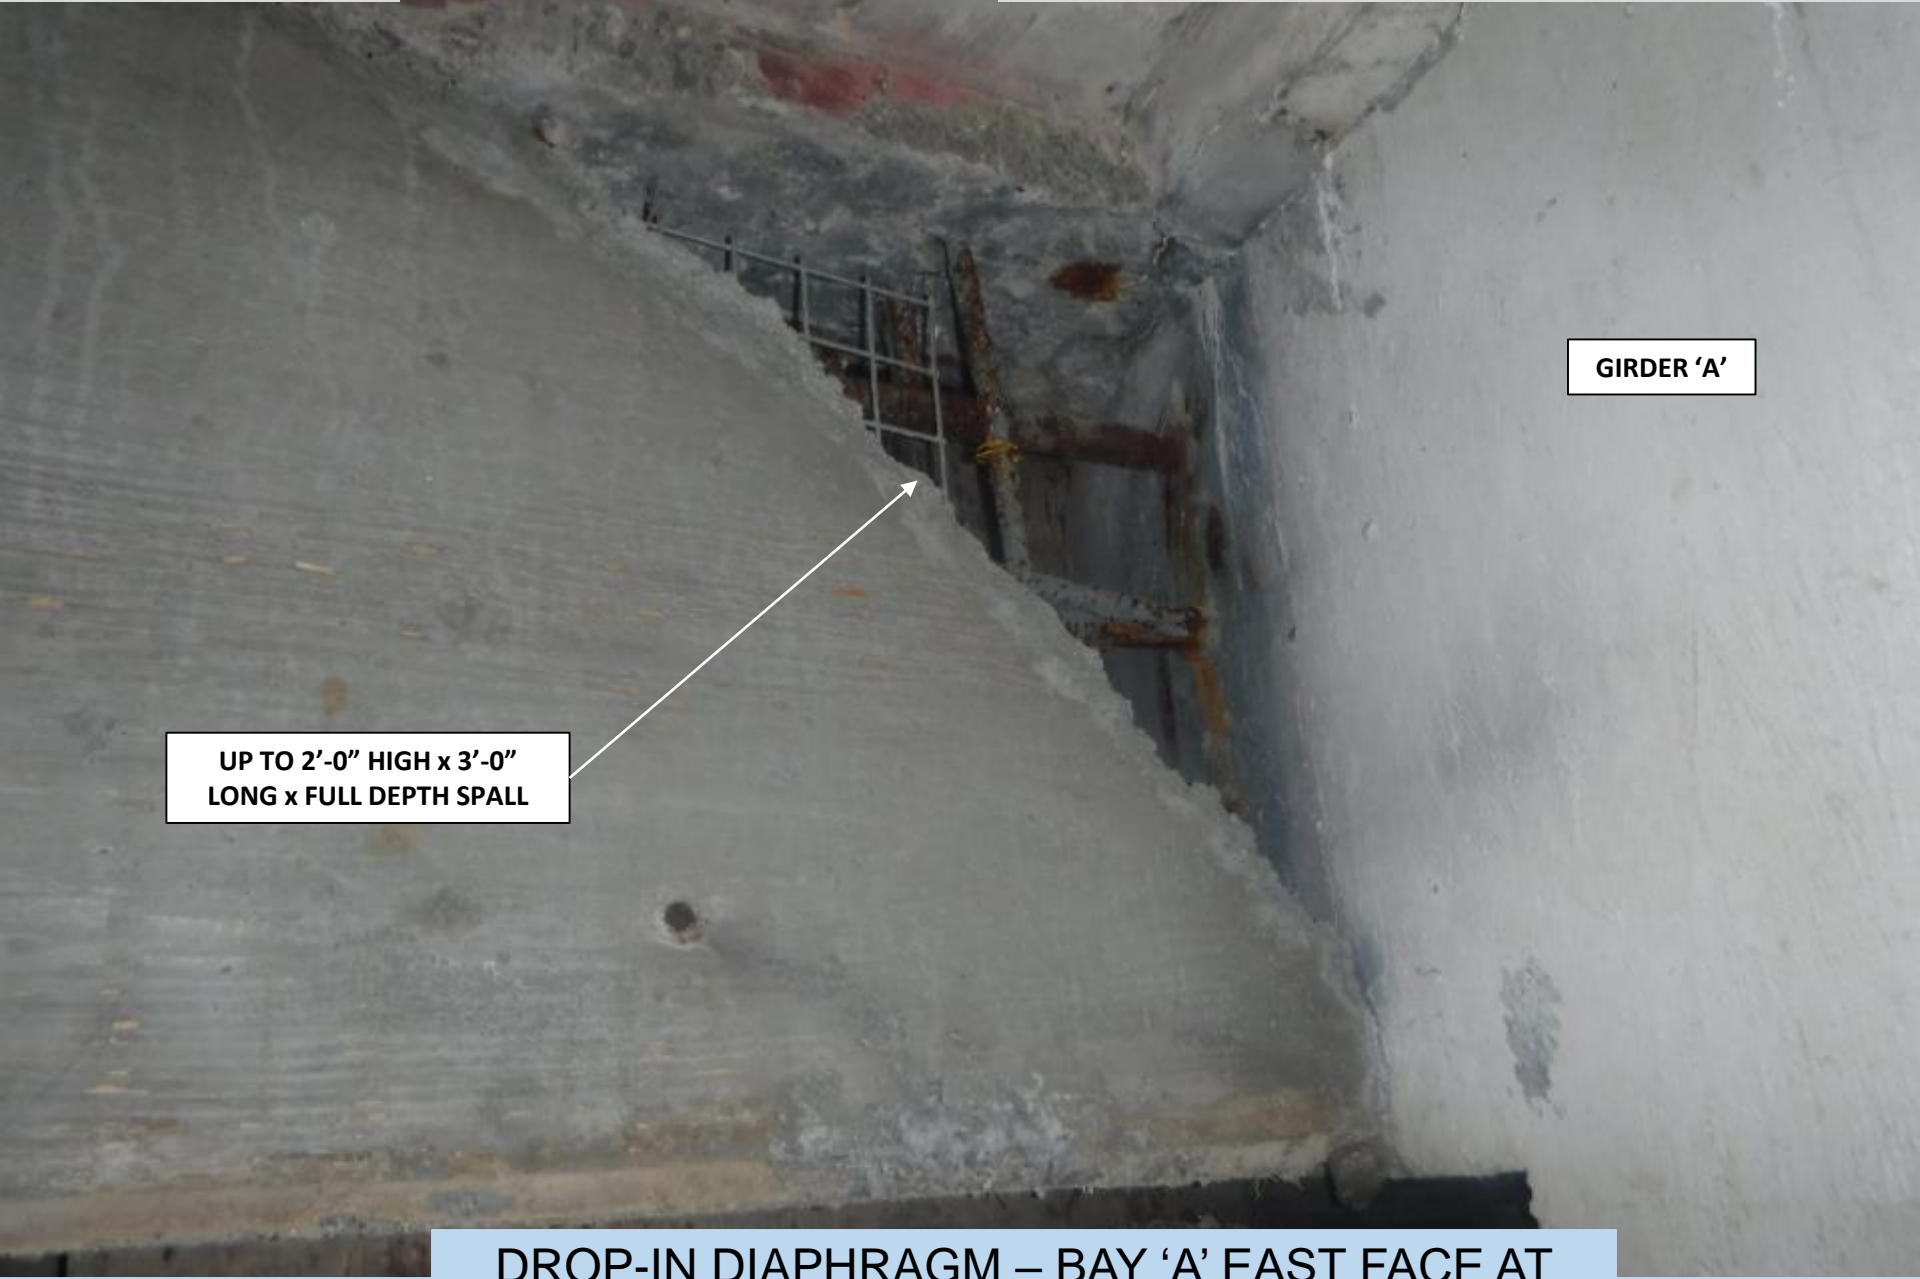
**UP TO 2'-0" HIGH x 3'-0"
LONG x FULL DEPTH SPALL**

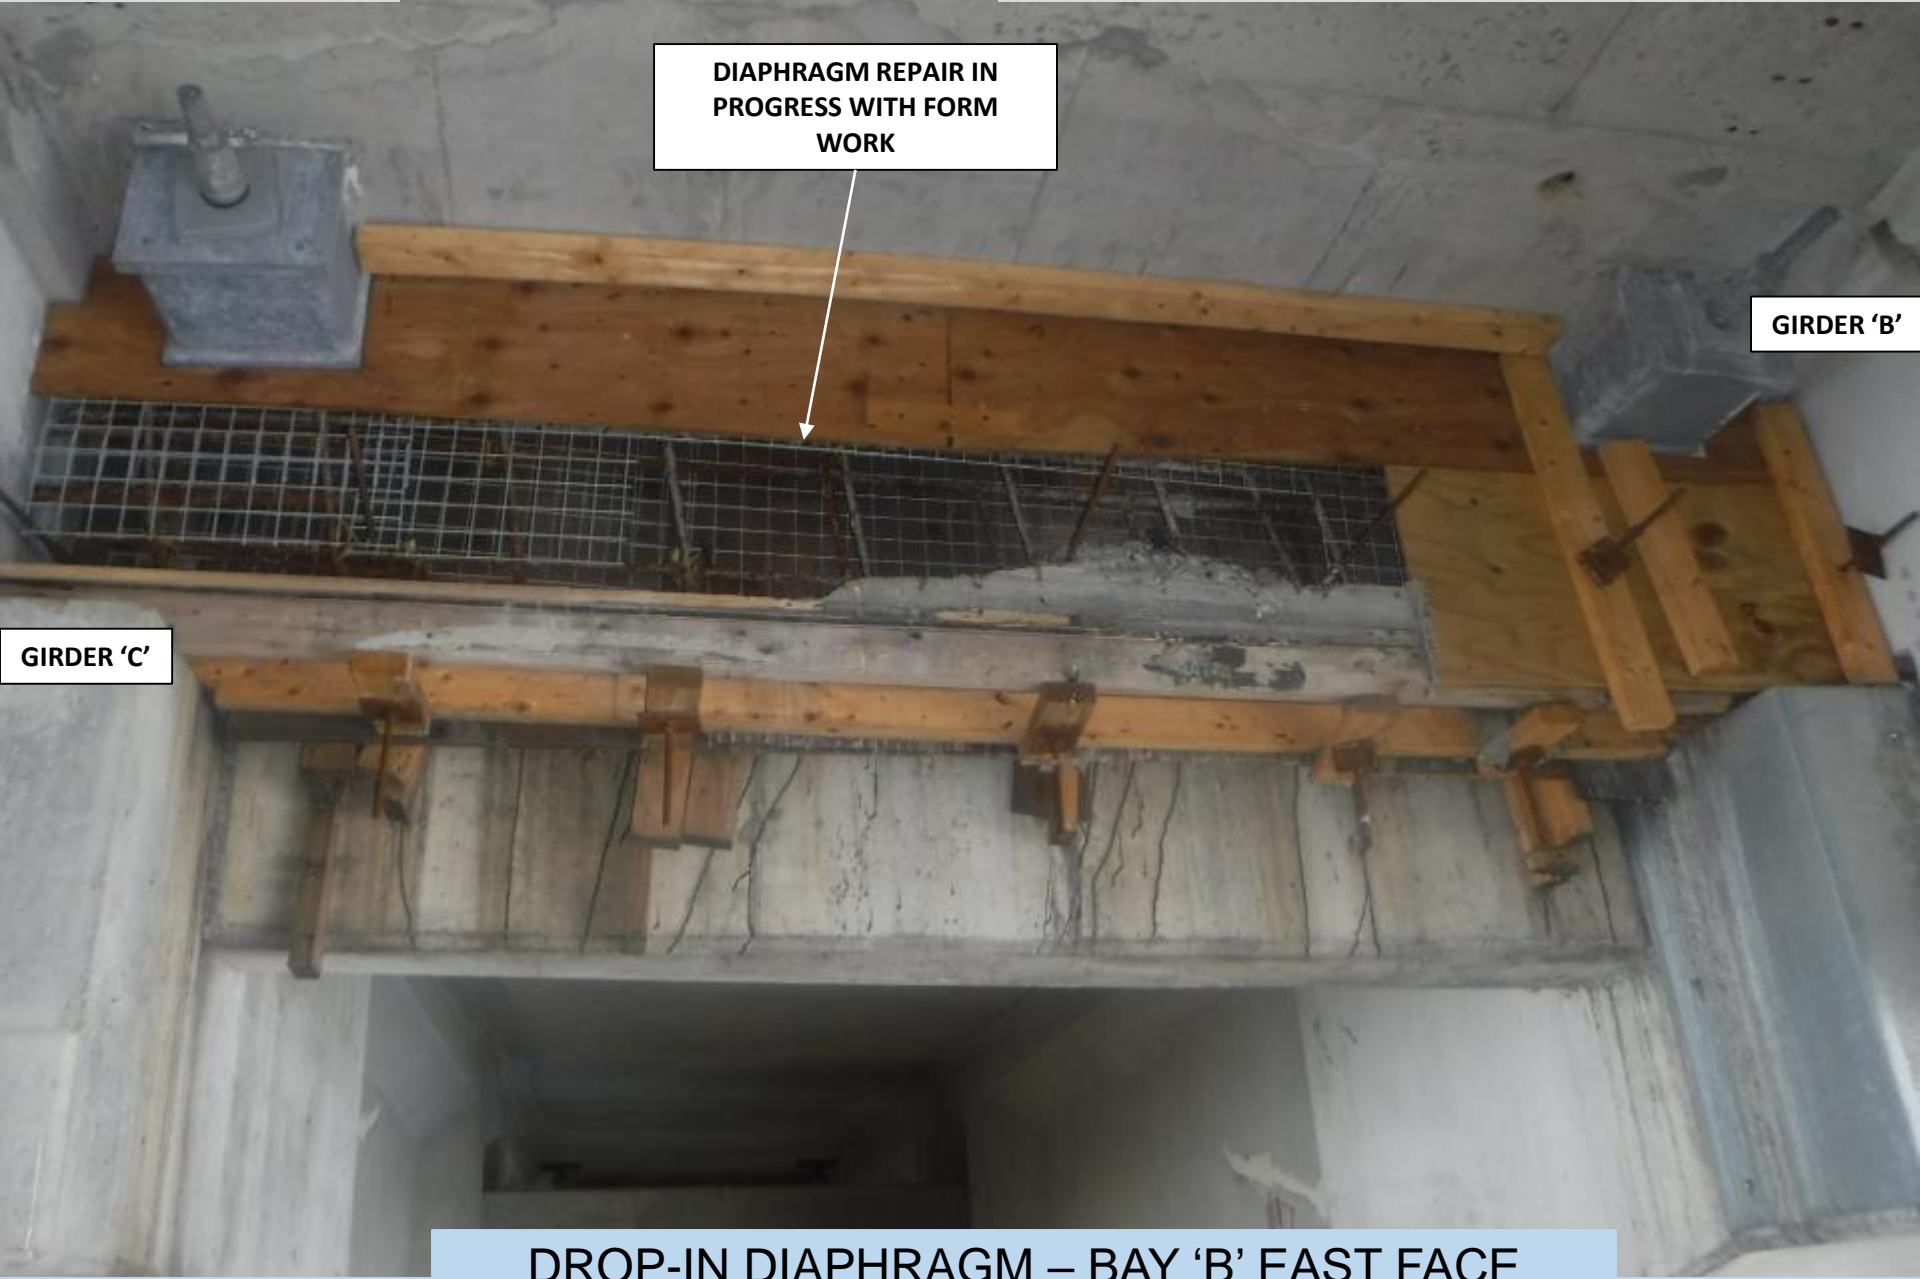
**DROP-IN DIAPHRAGM – BAY 'B' EAST FACE
AT PIER #4 IN SPAN #5 (LOOKING WEST)**

**DIAPHRAGM REPAIR IN
PROGRESS WITH FORM
WORK**

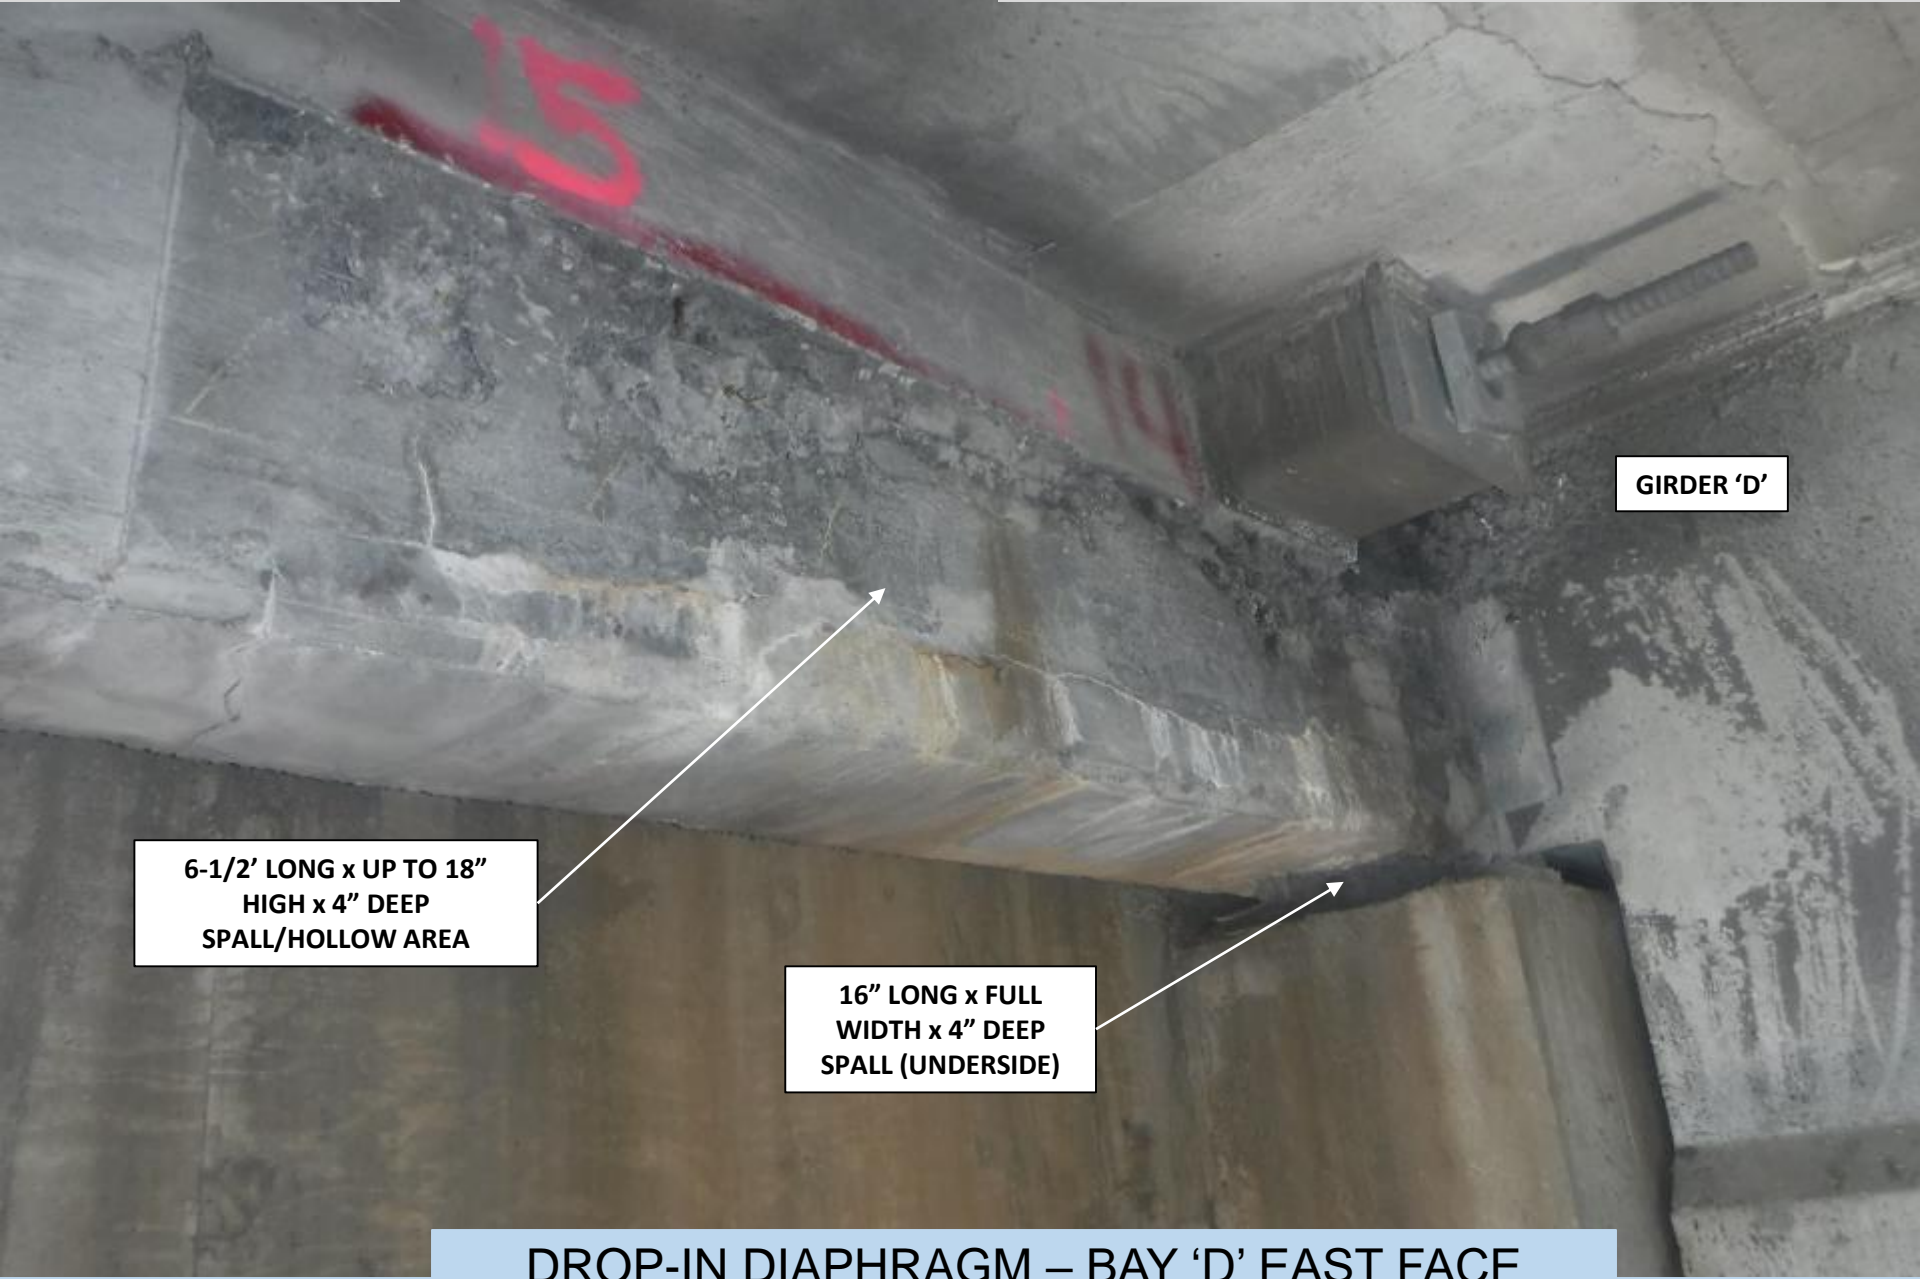
**6-1/2' LONG x UP TO 18"
HIGH x 4" DEEP
SPALL/HOLLOW AREA**

**16" LONG x FULL
WIDTH x 4" DEEP
SPALL (UNDERSIDE)**

**DIAPHRAGM CONCRETE HAS BEEN
REMOVED WITH ONLY REBAR LEFT
(REPAIR IN PROGRESS)**
