12-MONTH SPECIAL INSPECTION

BRIDGE #070001

07/22/2020

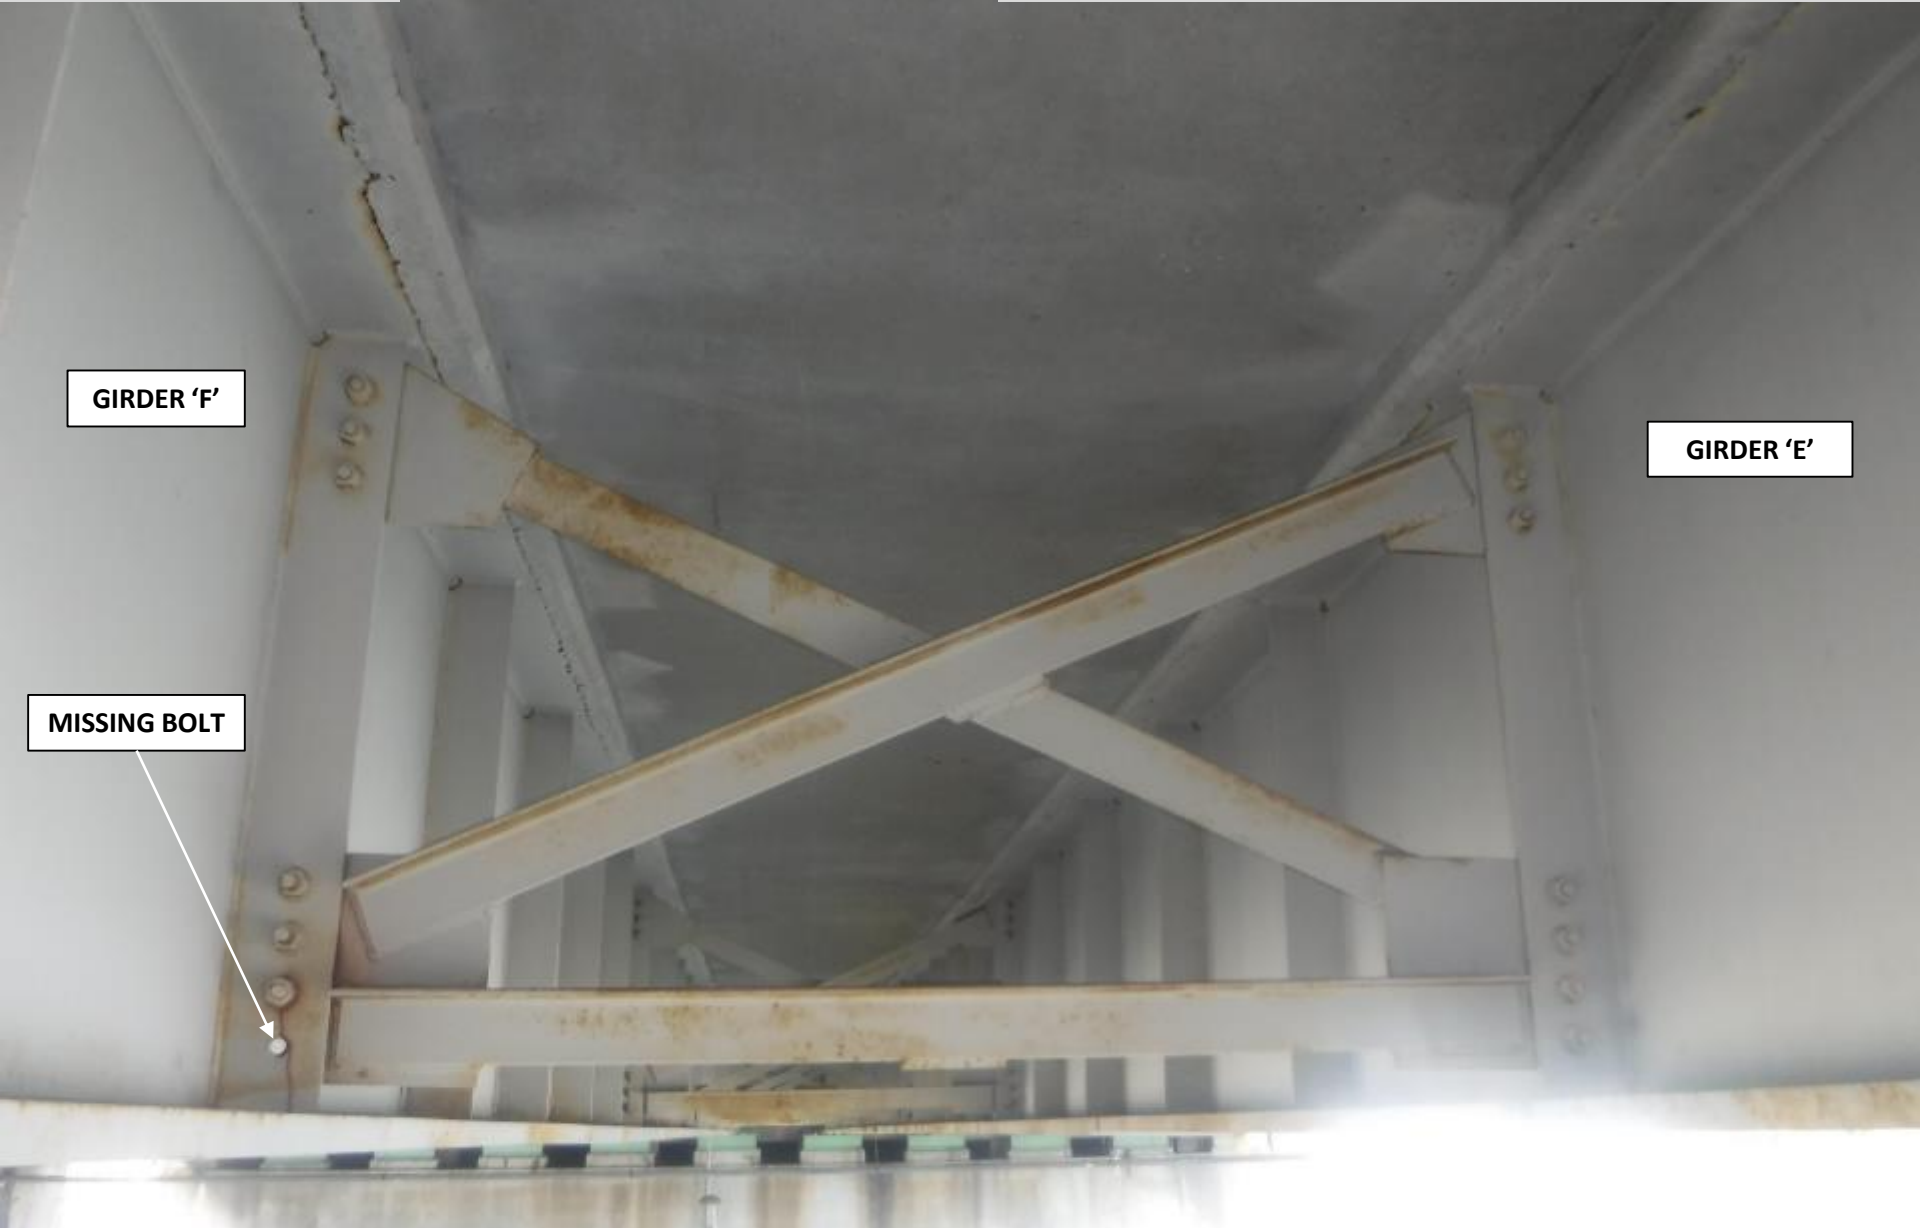
MISSING BOLT

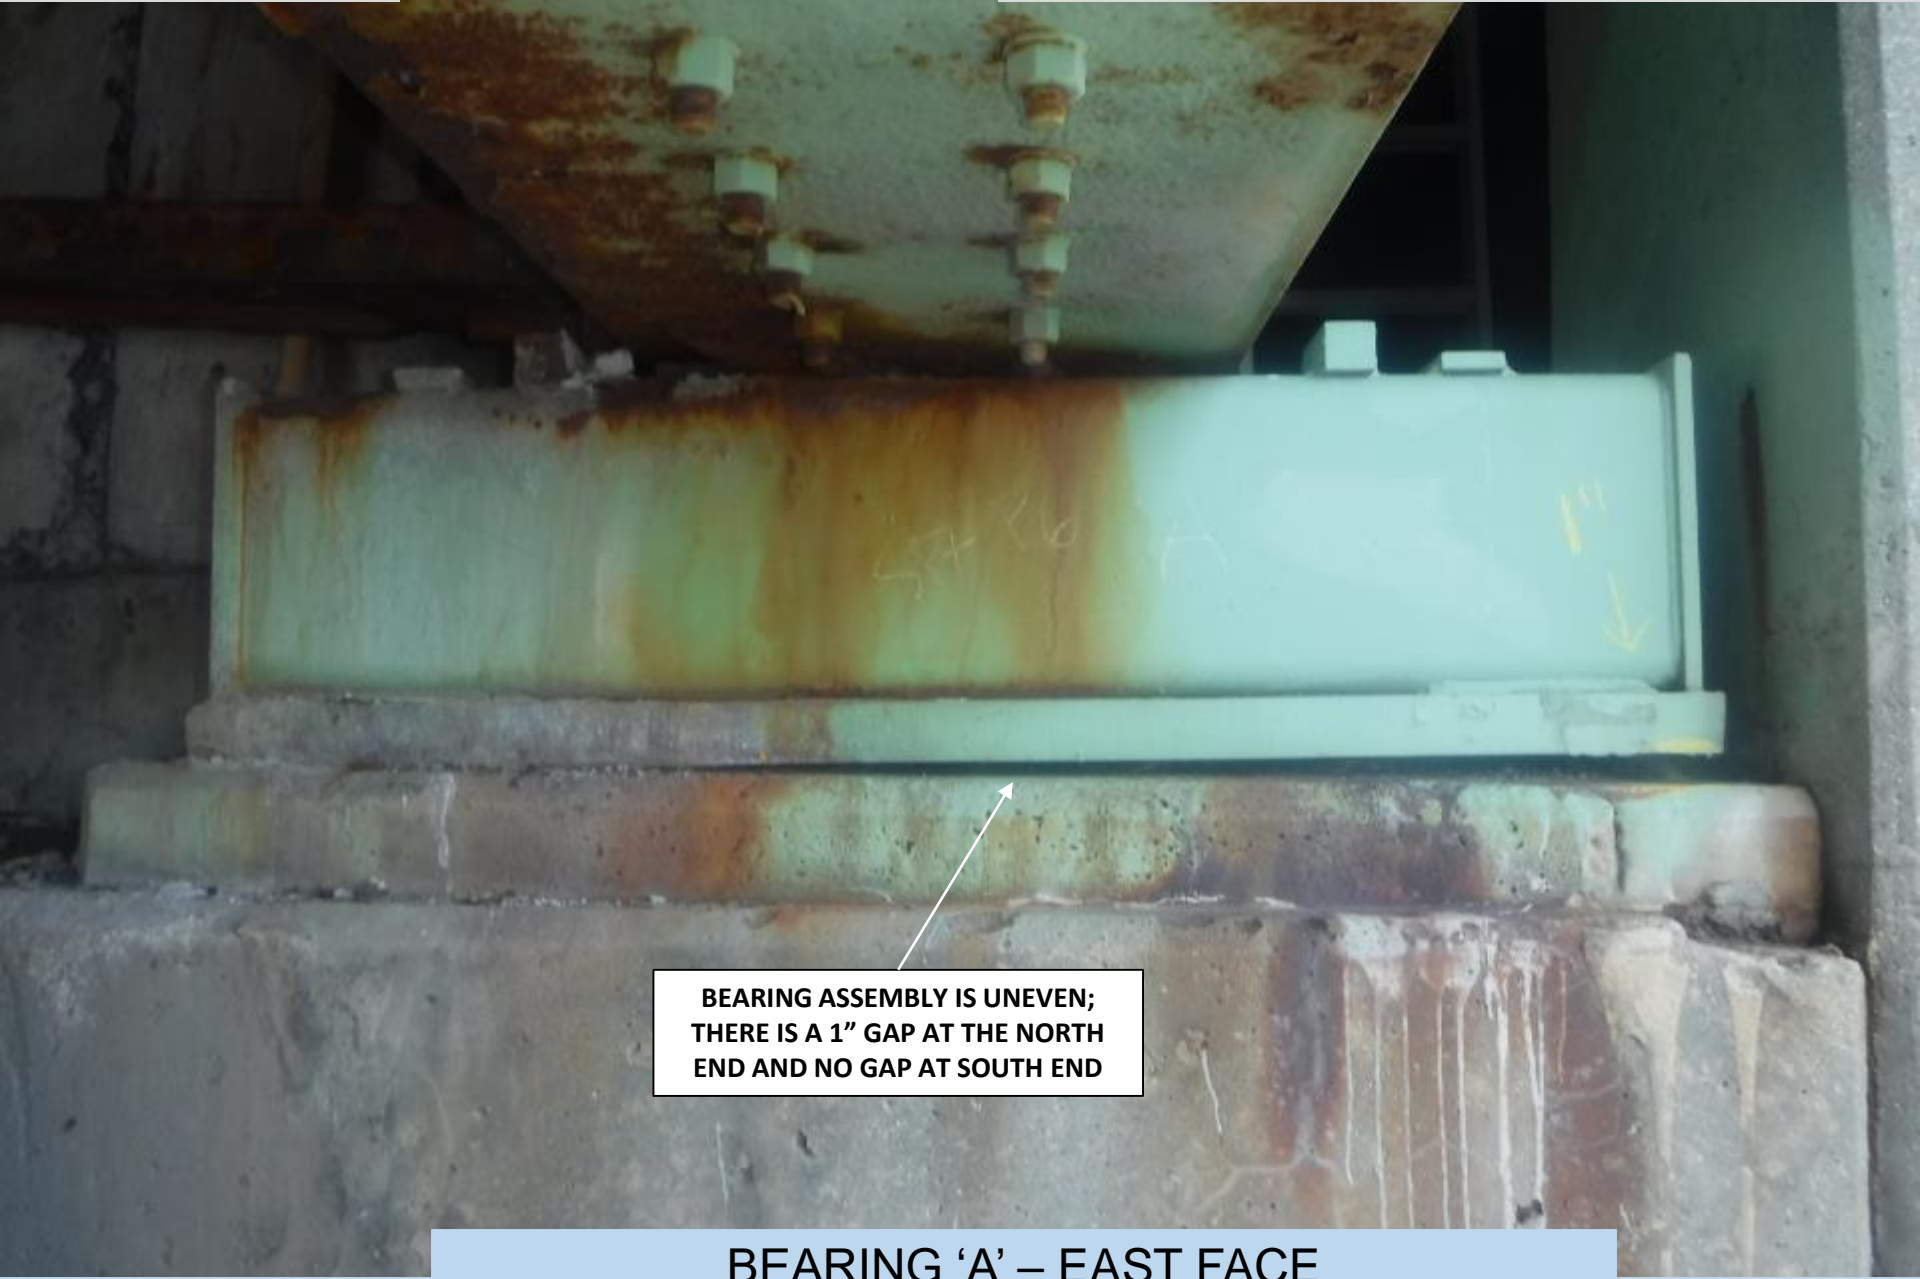
**BEARING 'A' – EAST FACE
AT PIER #6 IN SPAN #7 (LOOKING WEST)**

**BEARING ASSEMBLY IS UNEVEN;
THERE IS A 1" GAP AT THE NORTH
END AND NO GAP AT SOUTH END**

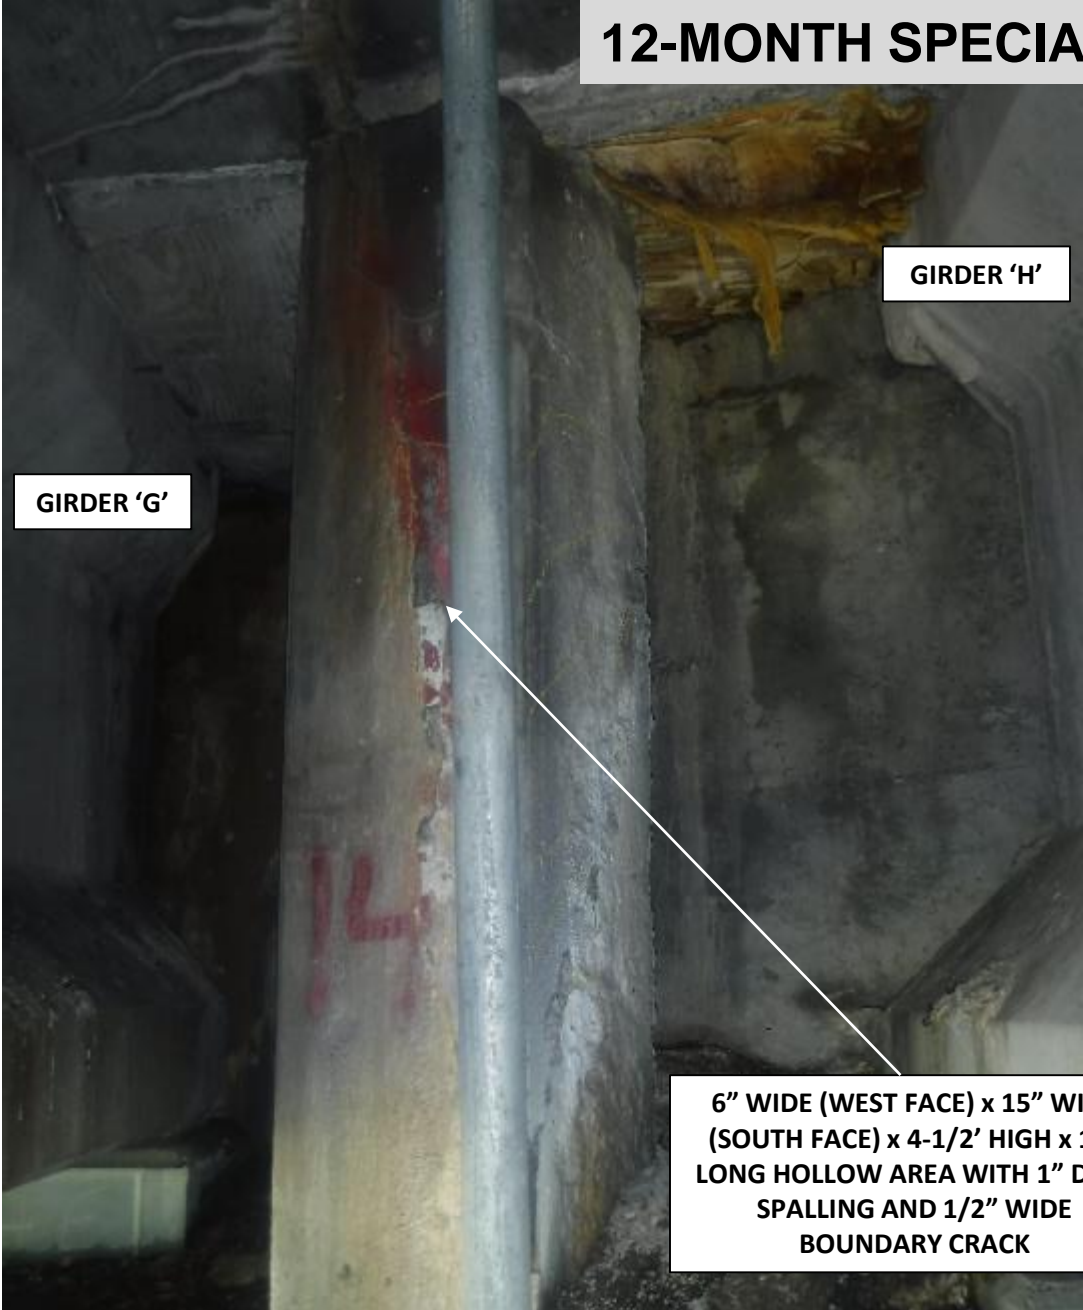
**6" WIDE (WEST FACE) x 15" WIDE
(SOUTH FACE) x 4-1/2' HIGH x 12"
LONG HOLLOW AREA WITH 1" DEEP
SPALLING AND 1/2" WIDE
BOUNDARY CRACK**

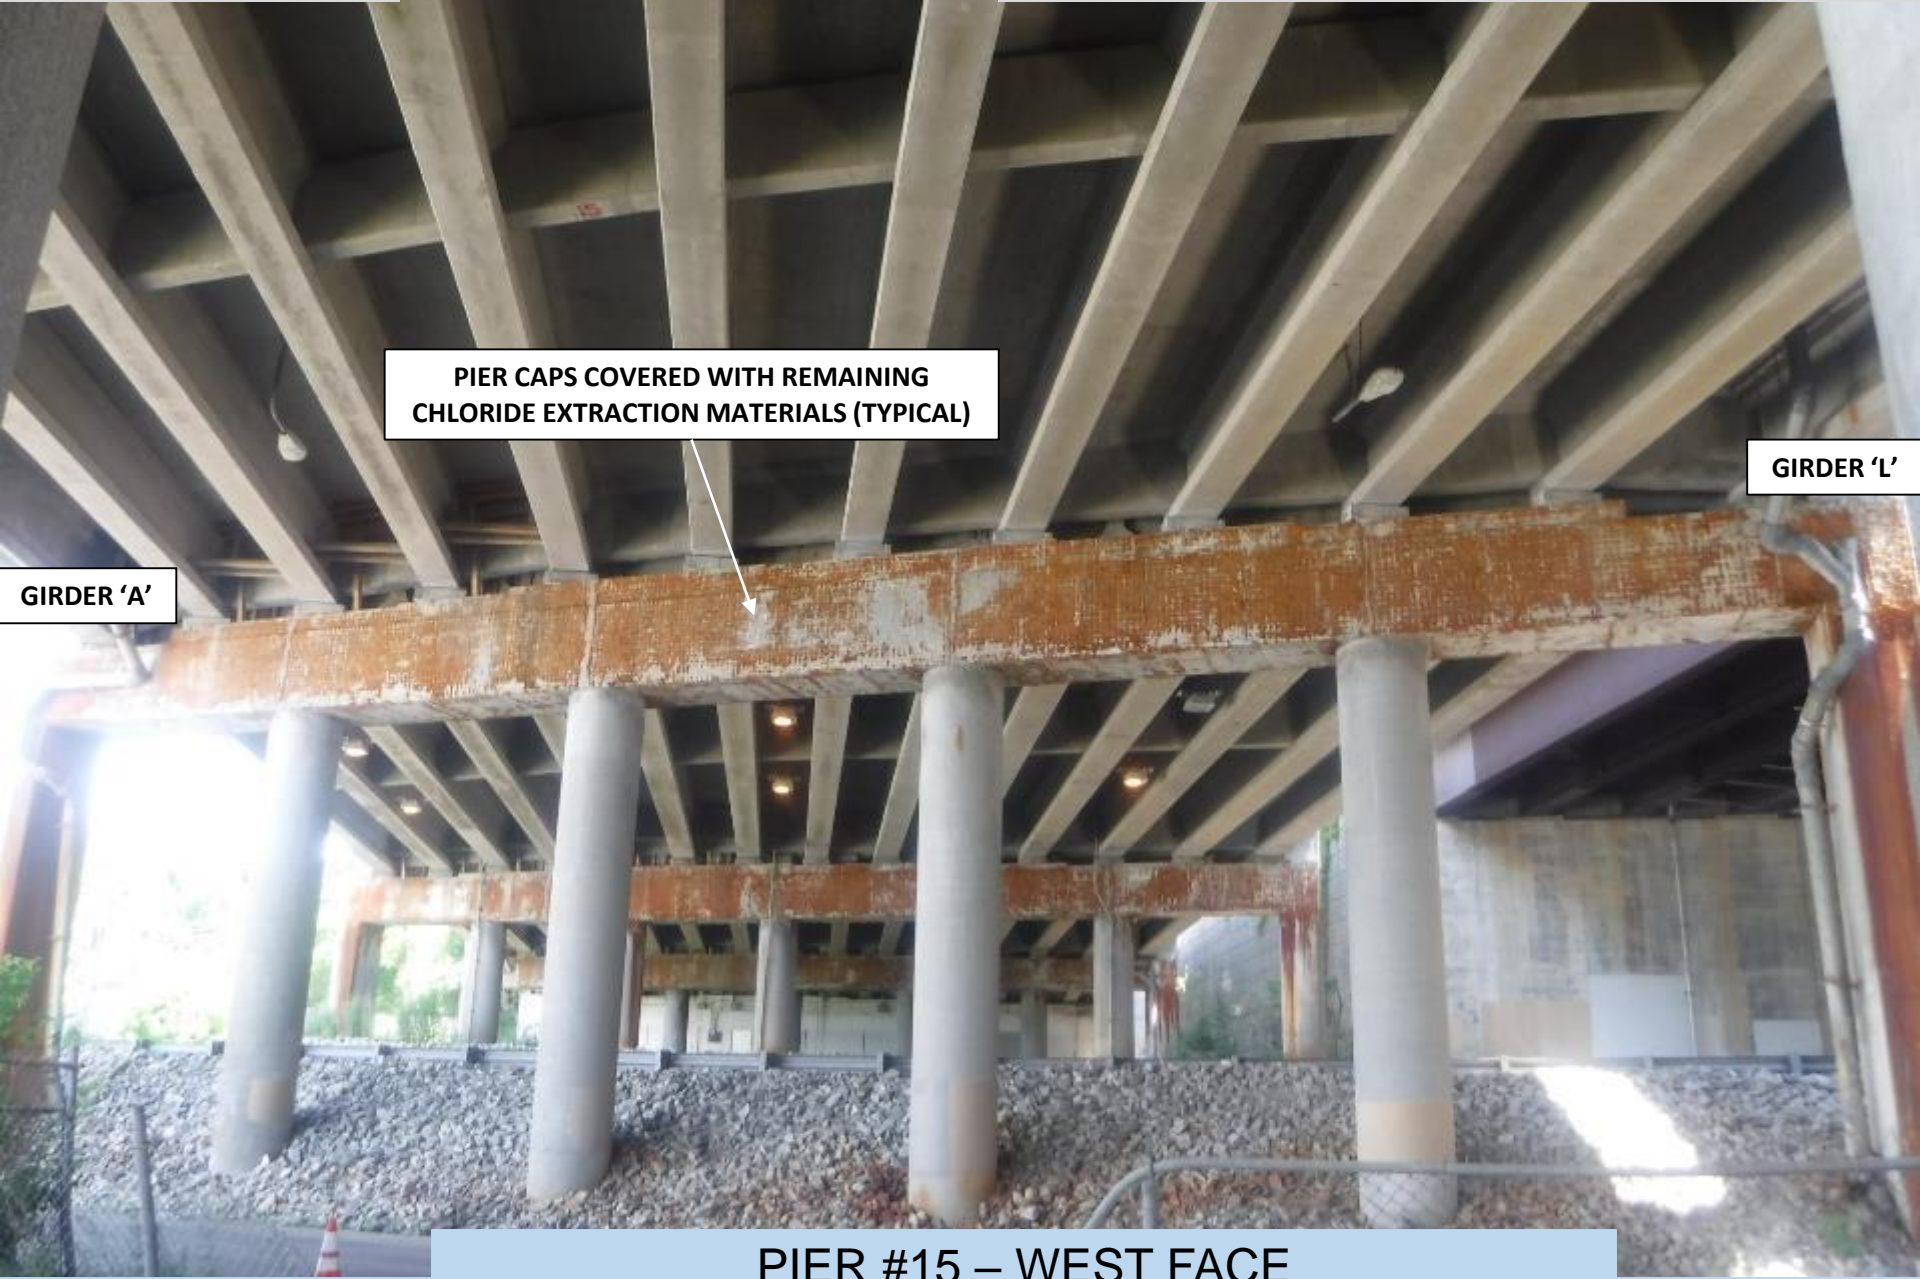
**PIER CAPS COVERED WITH REMAINING
CHLORIDE EXTRACTION MATERIALS (TYPICAL)**

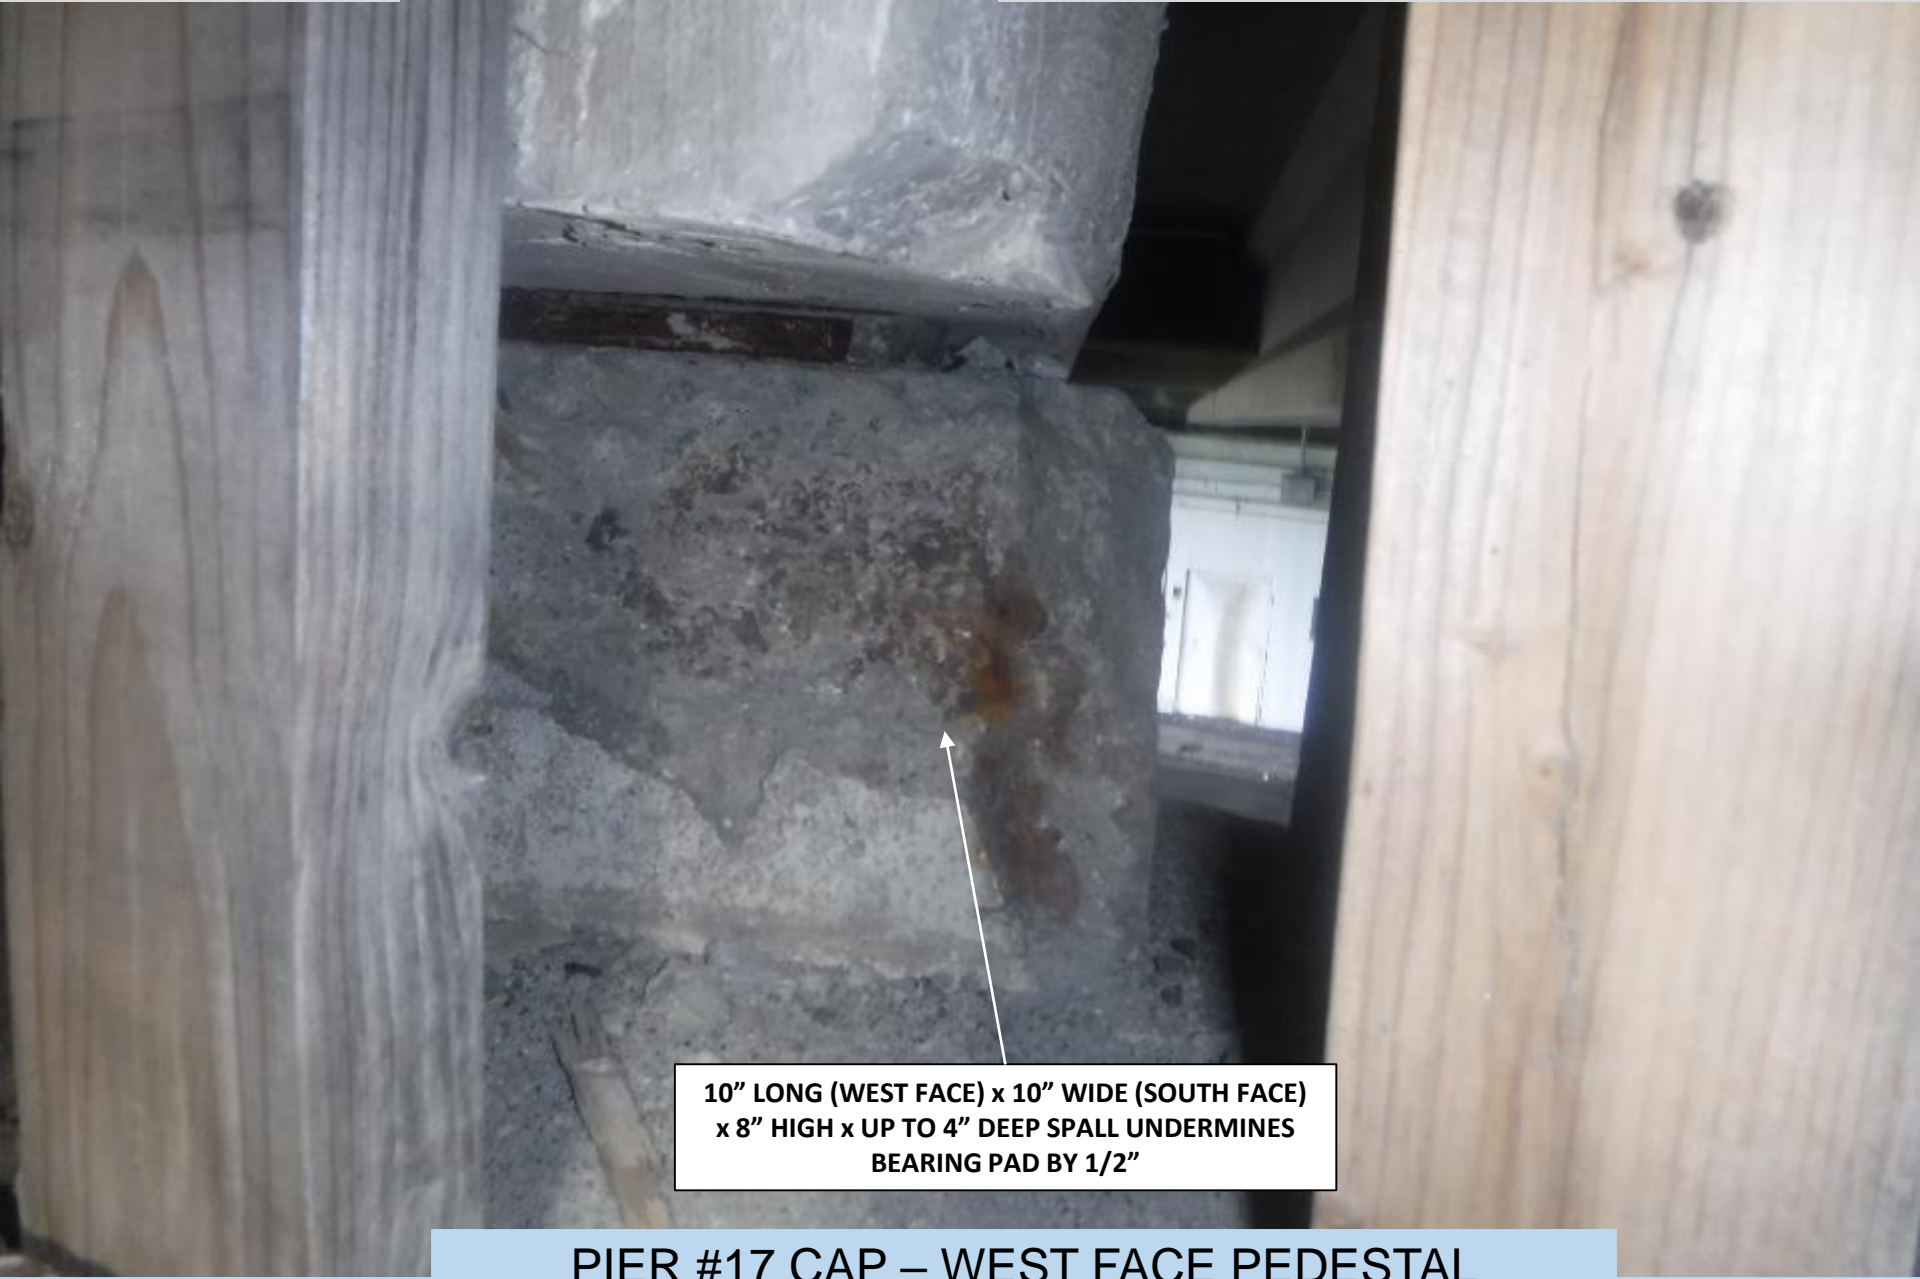
**10" LONG (WEST FACE) x 10" WIDE (SOUTH FACE)
x 8" HIGH x UP TO 4" DEEP SPALL UNDERMINES
BEARING PAD BY 1/2"**

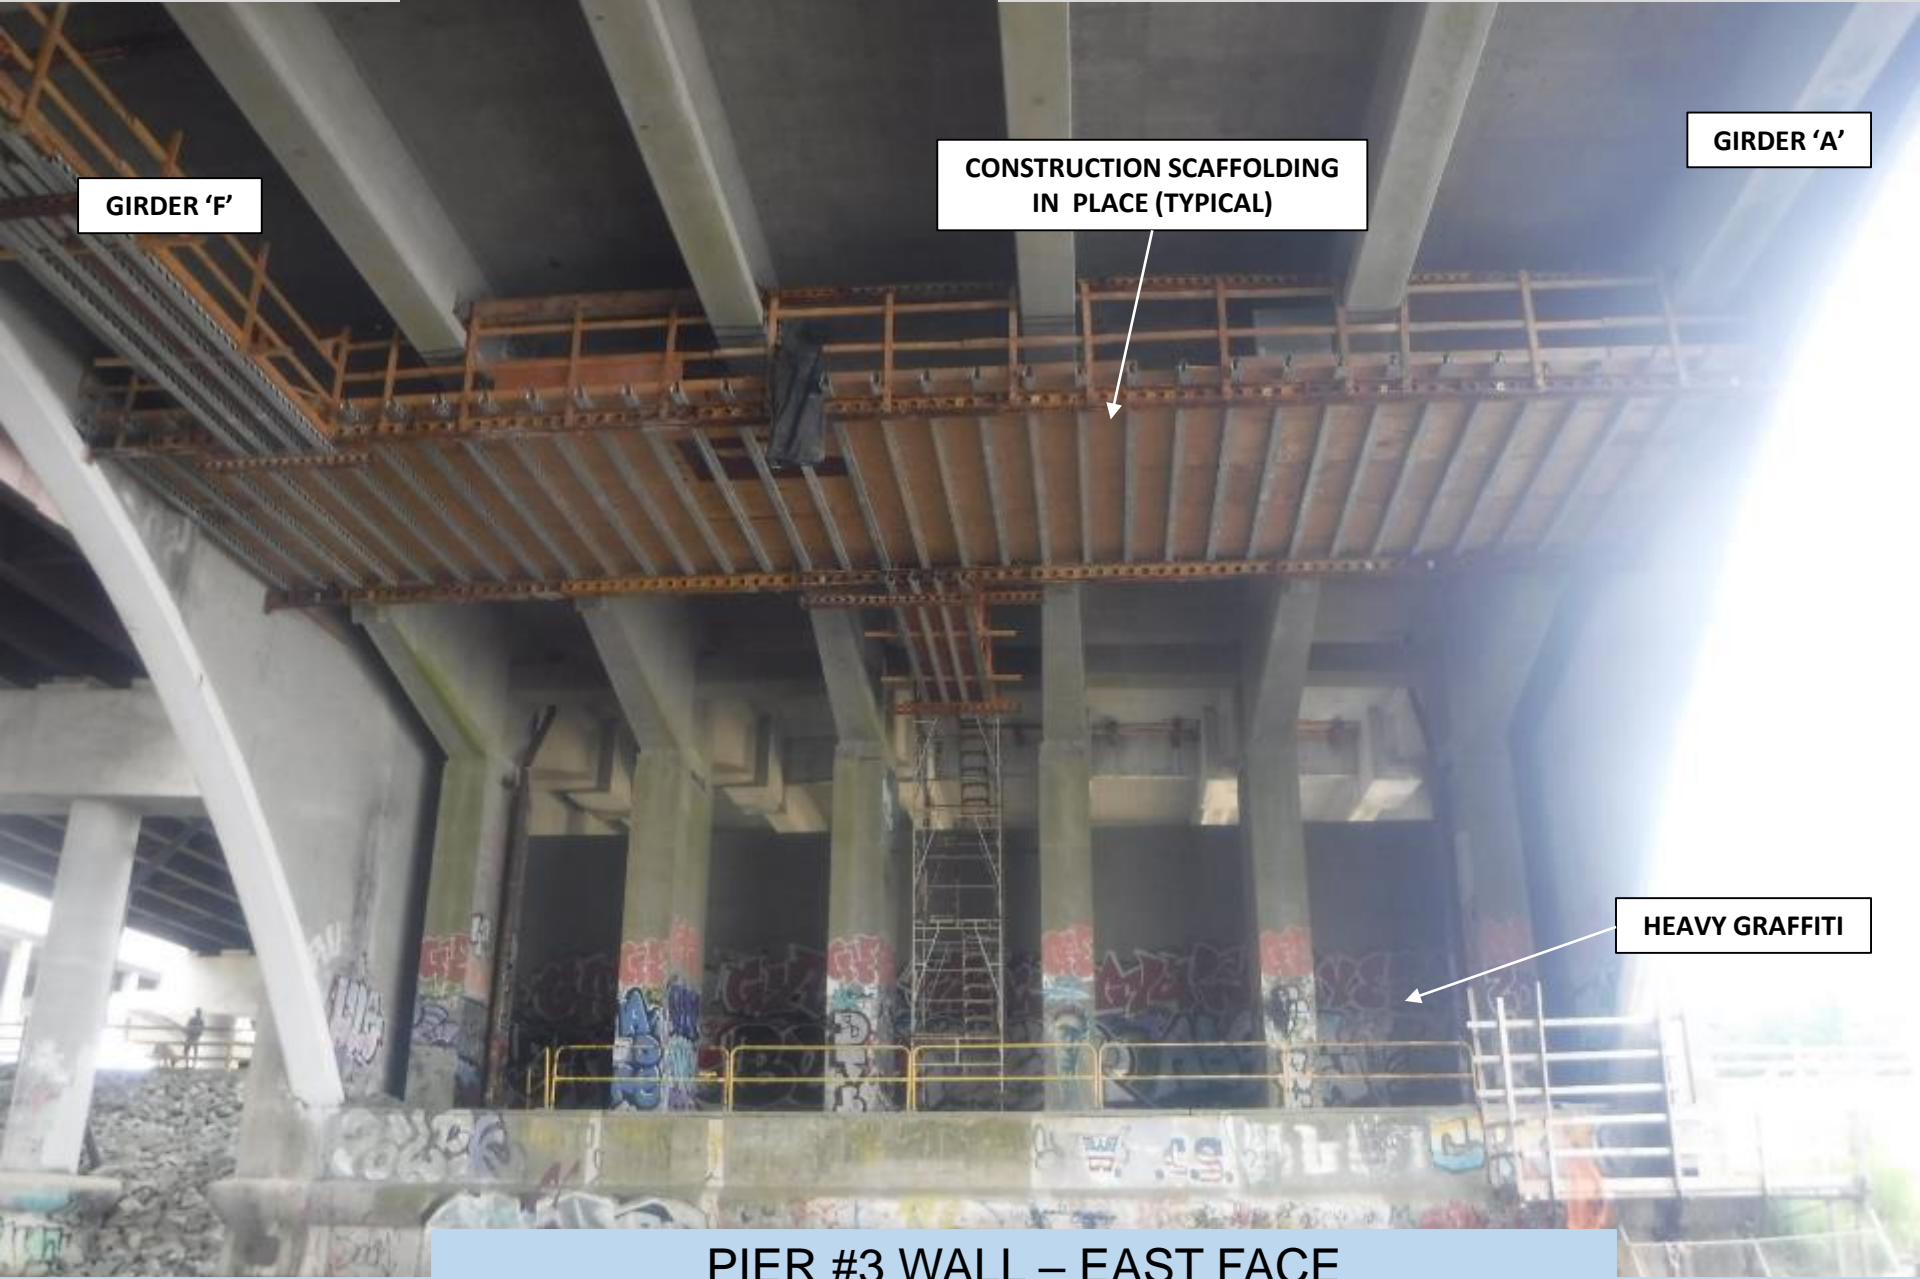
**CONSTRUCTION SCAFFOLDING
IN PLACE (TYPICAL)**

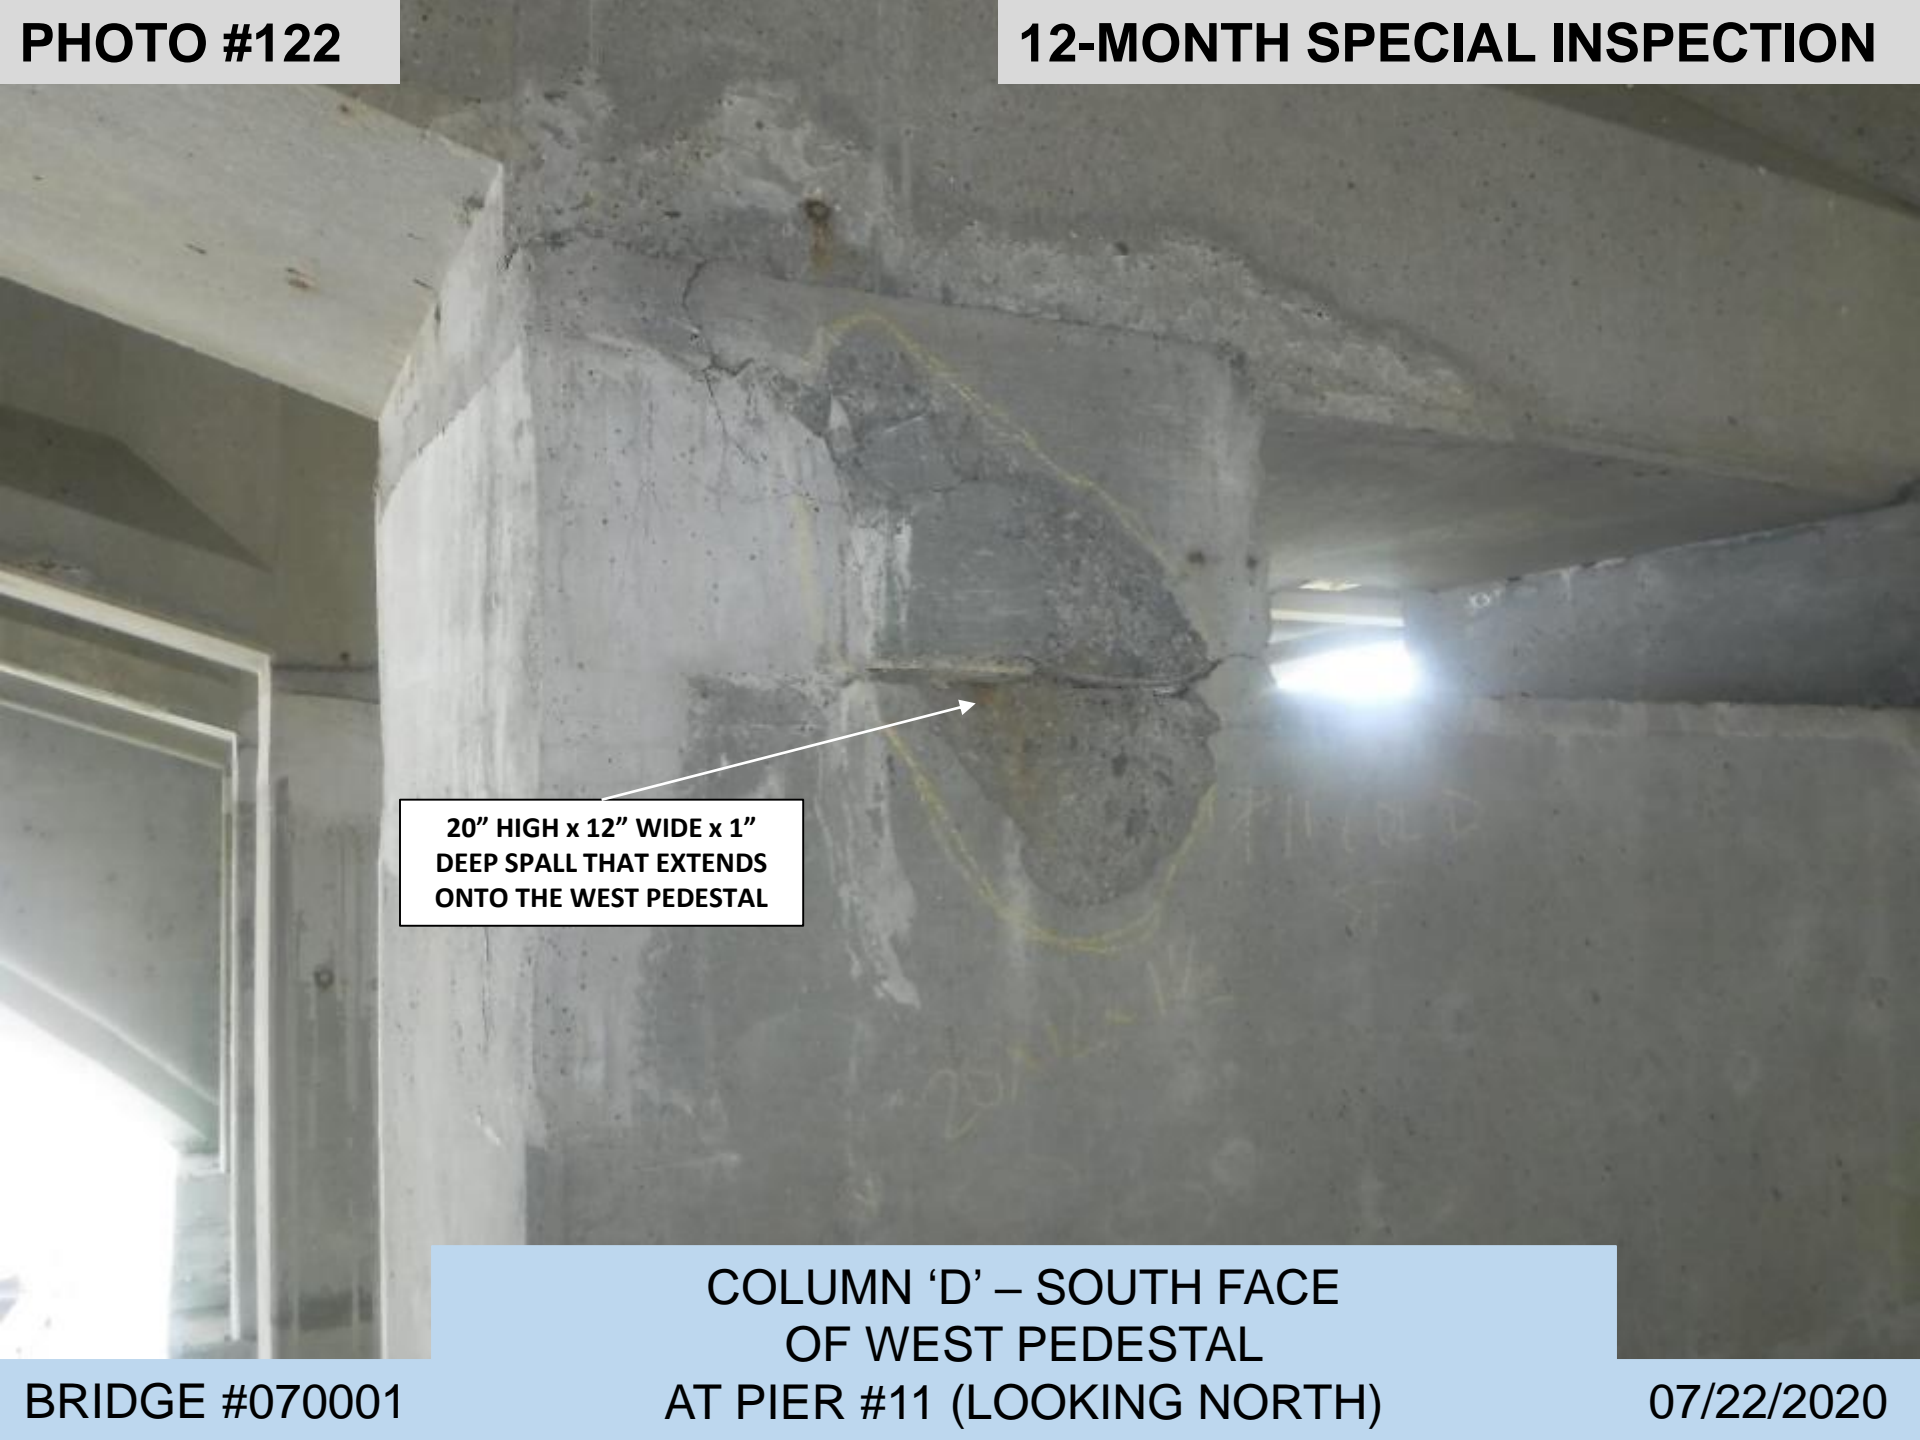
**COLUMN 'D' – SOUTH FACE
OF WEST PEDESTAL**

**20" HIGH x 12" WIDE x 1"
DEEP SPALL THAT EXTENDS
ONTO THE WEST PEDESTAL**

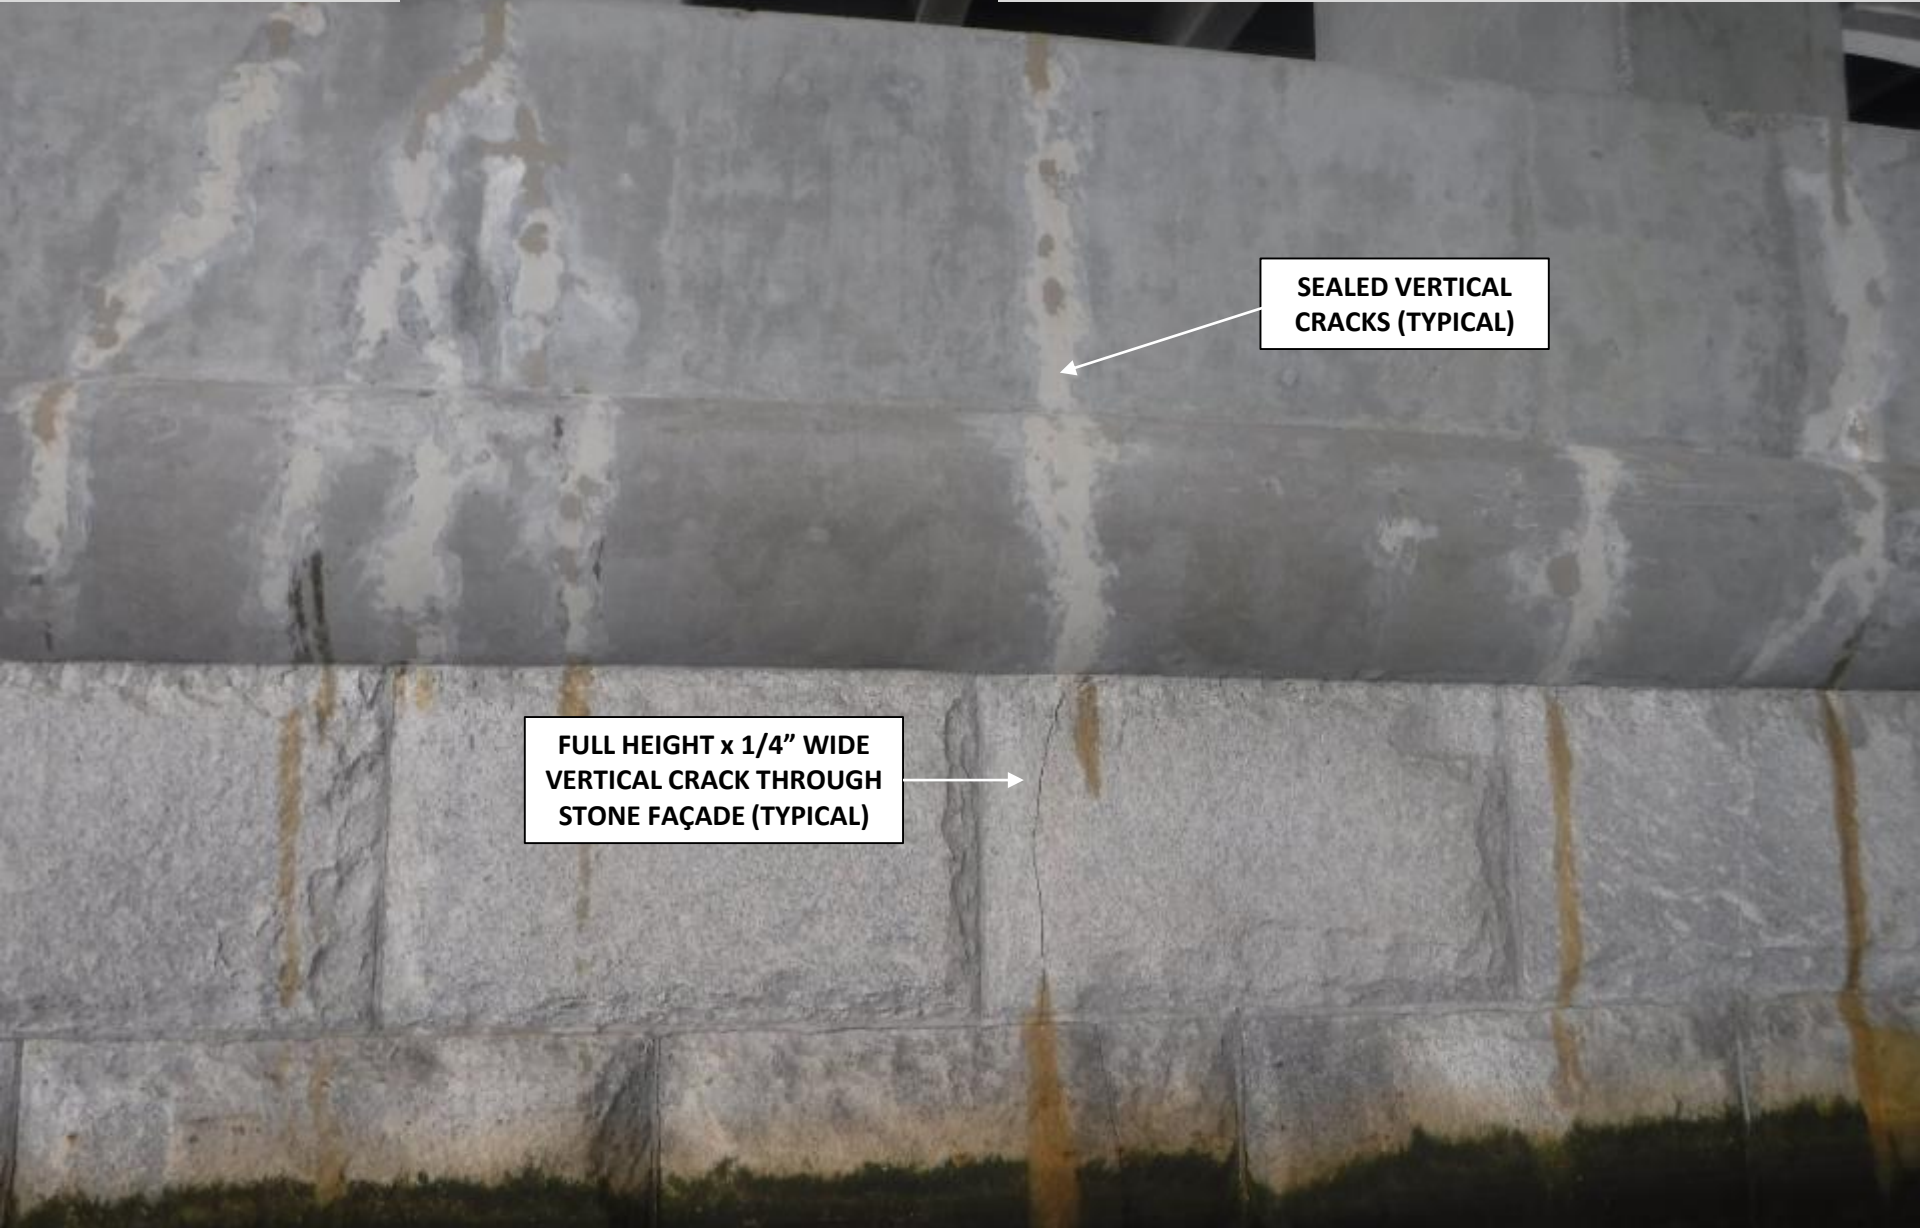
**SEALED VERTICAL
CRACKS (TYPICAL)**

**FULL HEIGHT x 1/4" WIDE
VERTICAL CRACK THROUGH
STONE FAÇADE (TYPICAL)**

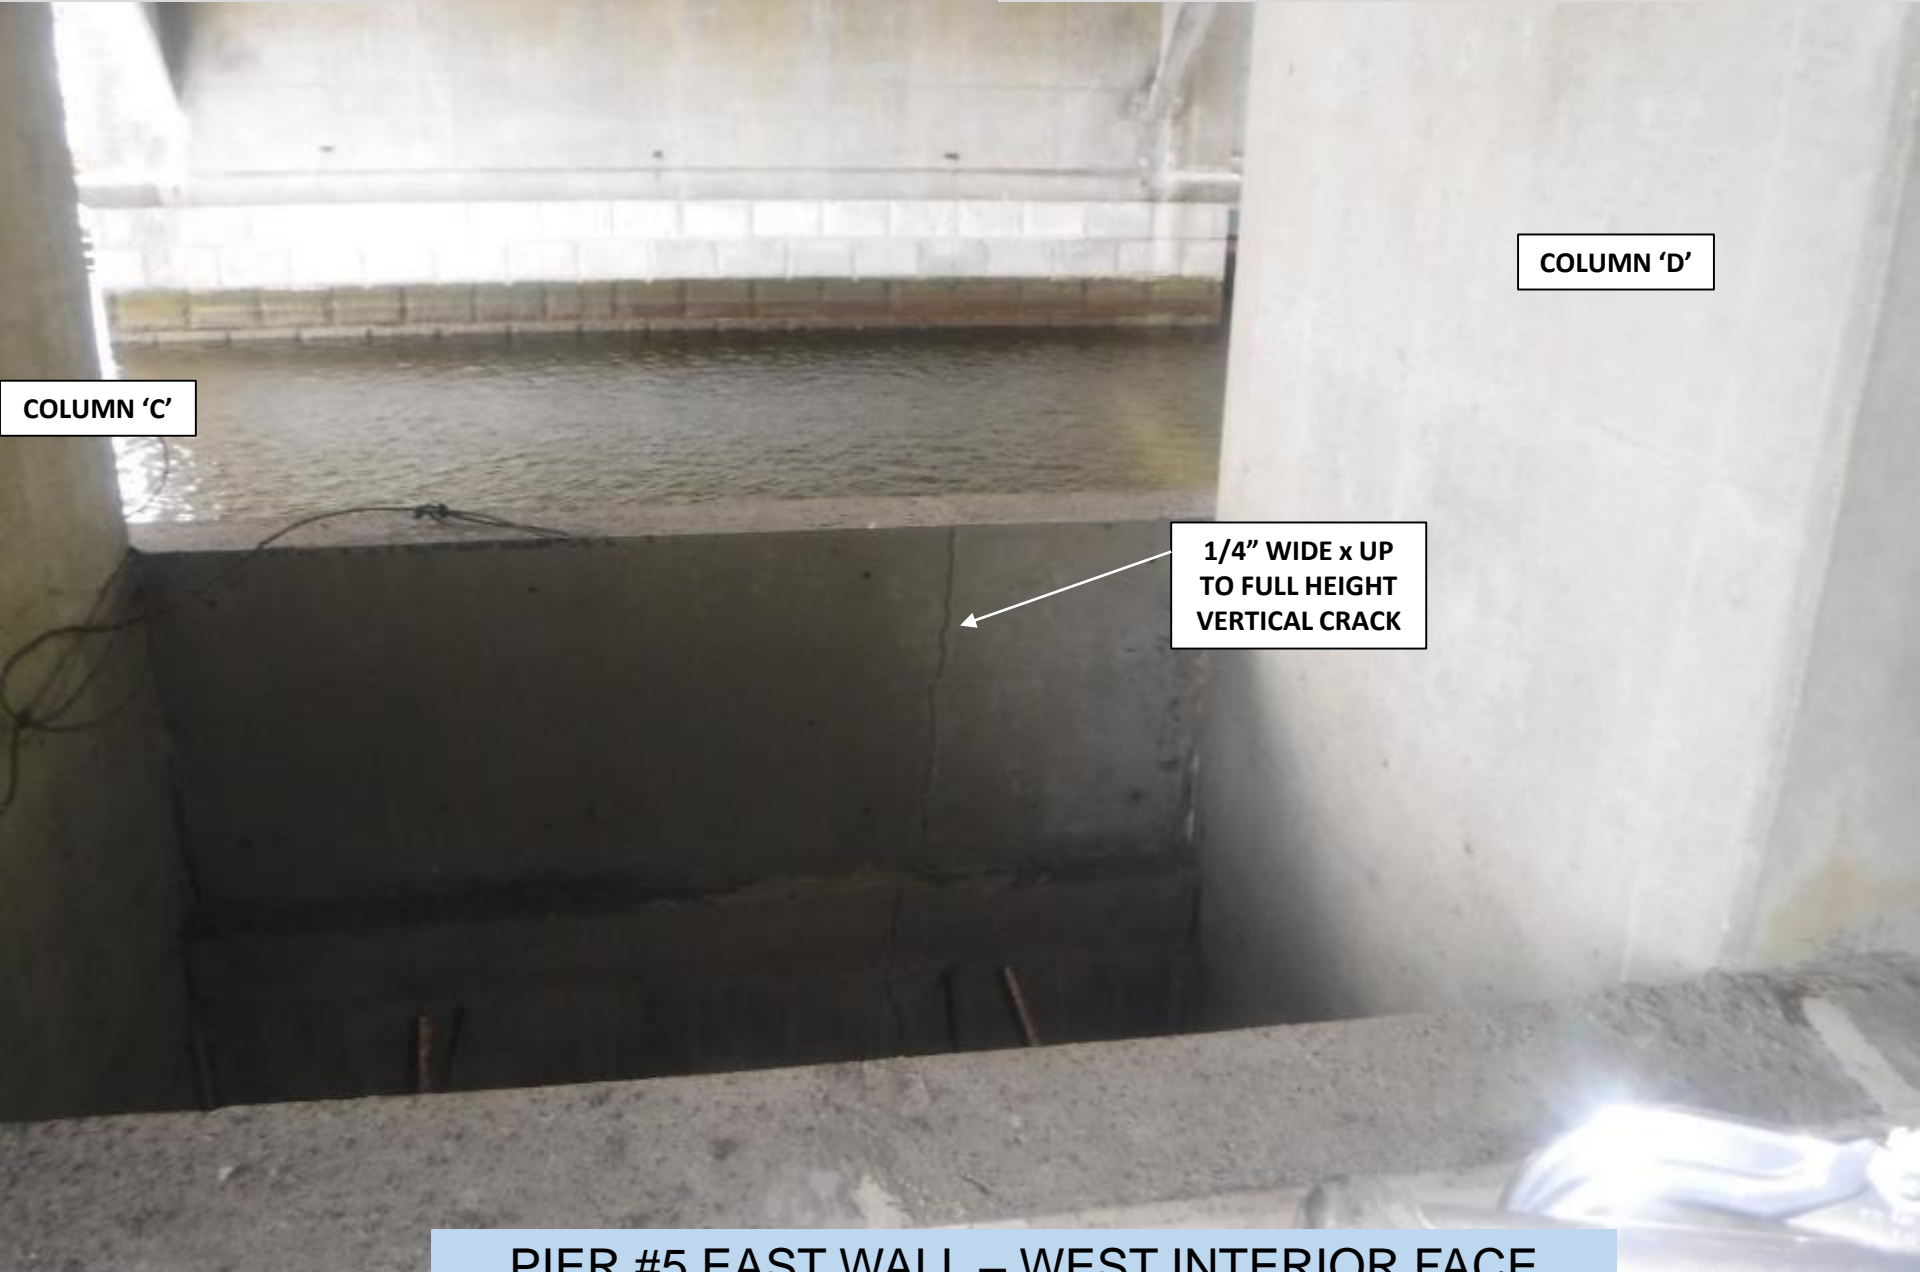
**1/4" WIDE x UP
TO FULL HEIGHT
VERTICAL CRACK**
