12-MONTH SPECIAL INSPECTION

BRIDGE #070001

07/22/2020

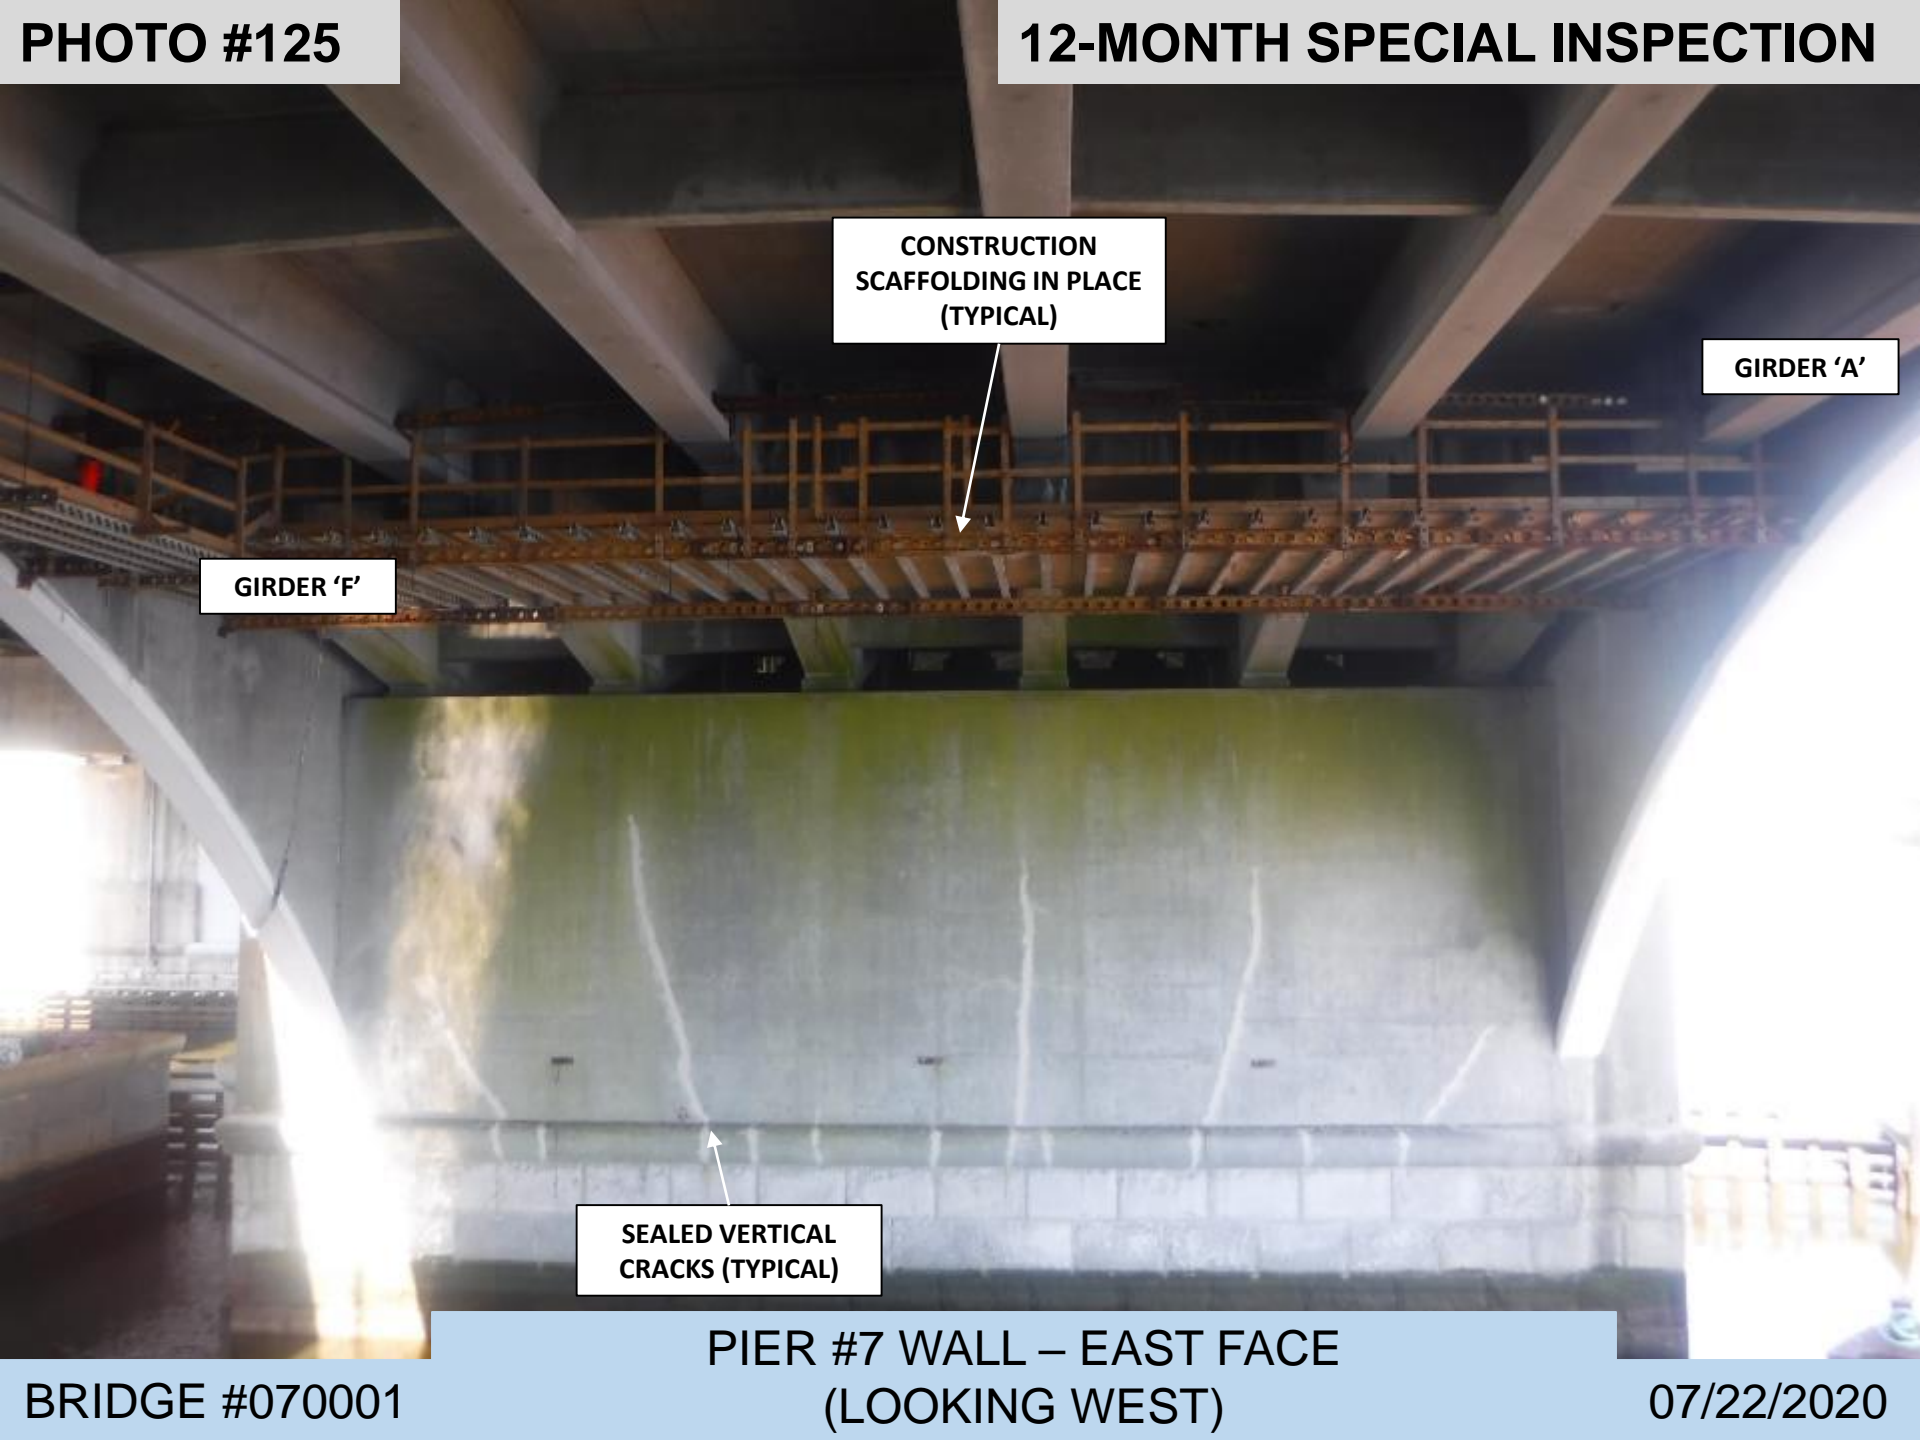
PIER #7 WALL – EAST FACE

**CONSTRUCTION
SCAFFOLDING IN PLACE
(TYPICAL)**

**SEALED VERTICAL
CRACKS (TYPICAL)**

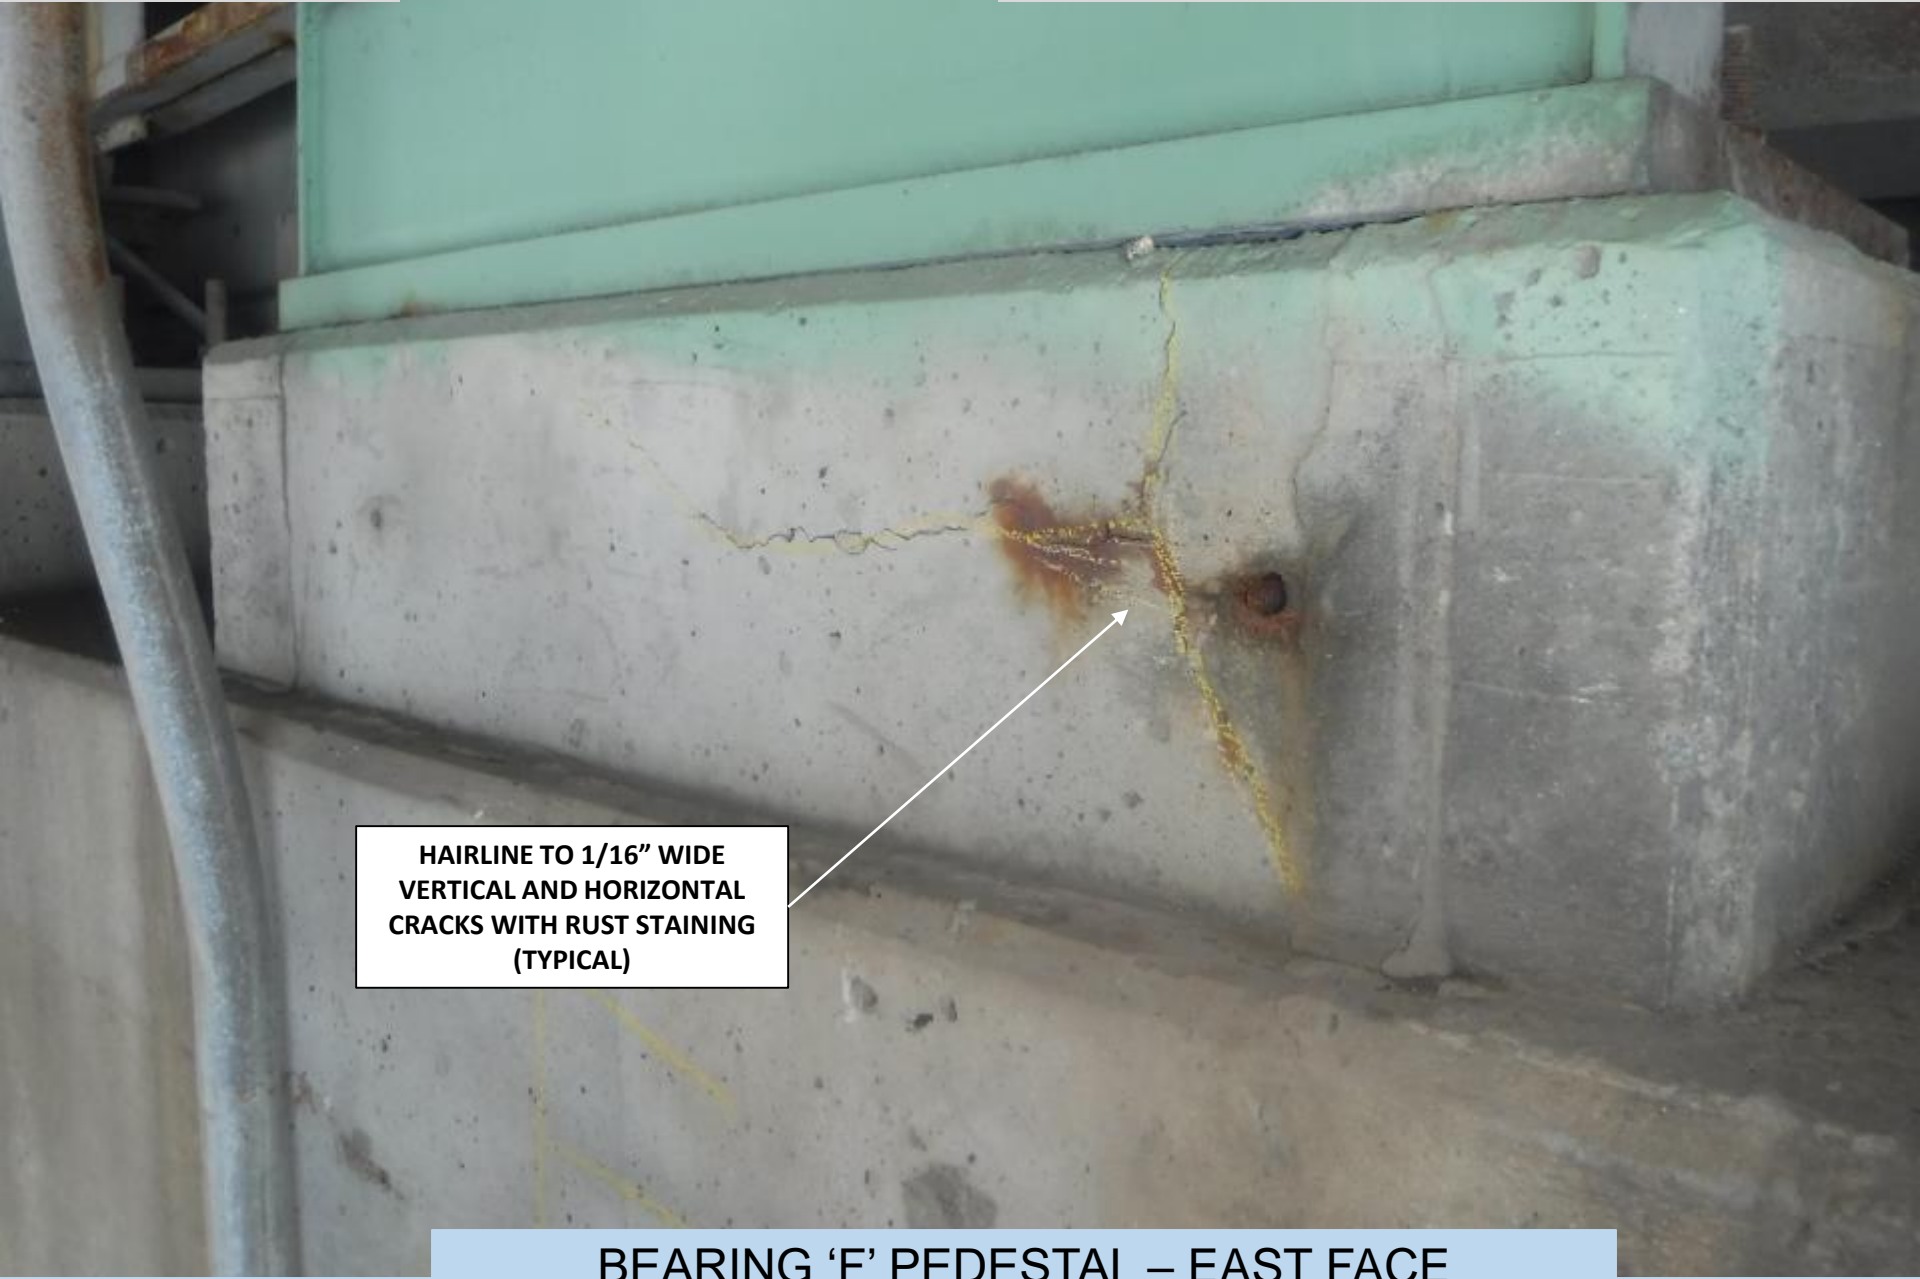
**HAIRLINE TO 1/16" WIDE
VERTICAL AND HORIZONTAL
CRACKS WITH RUST STAINING
(TYPICAL)**

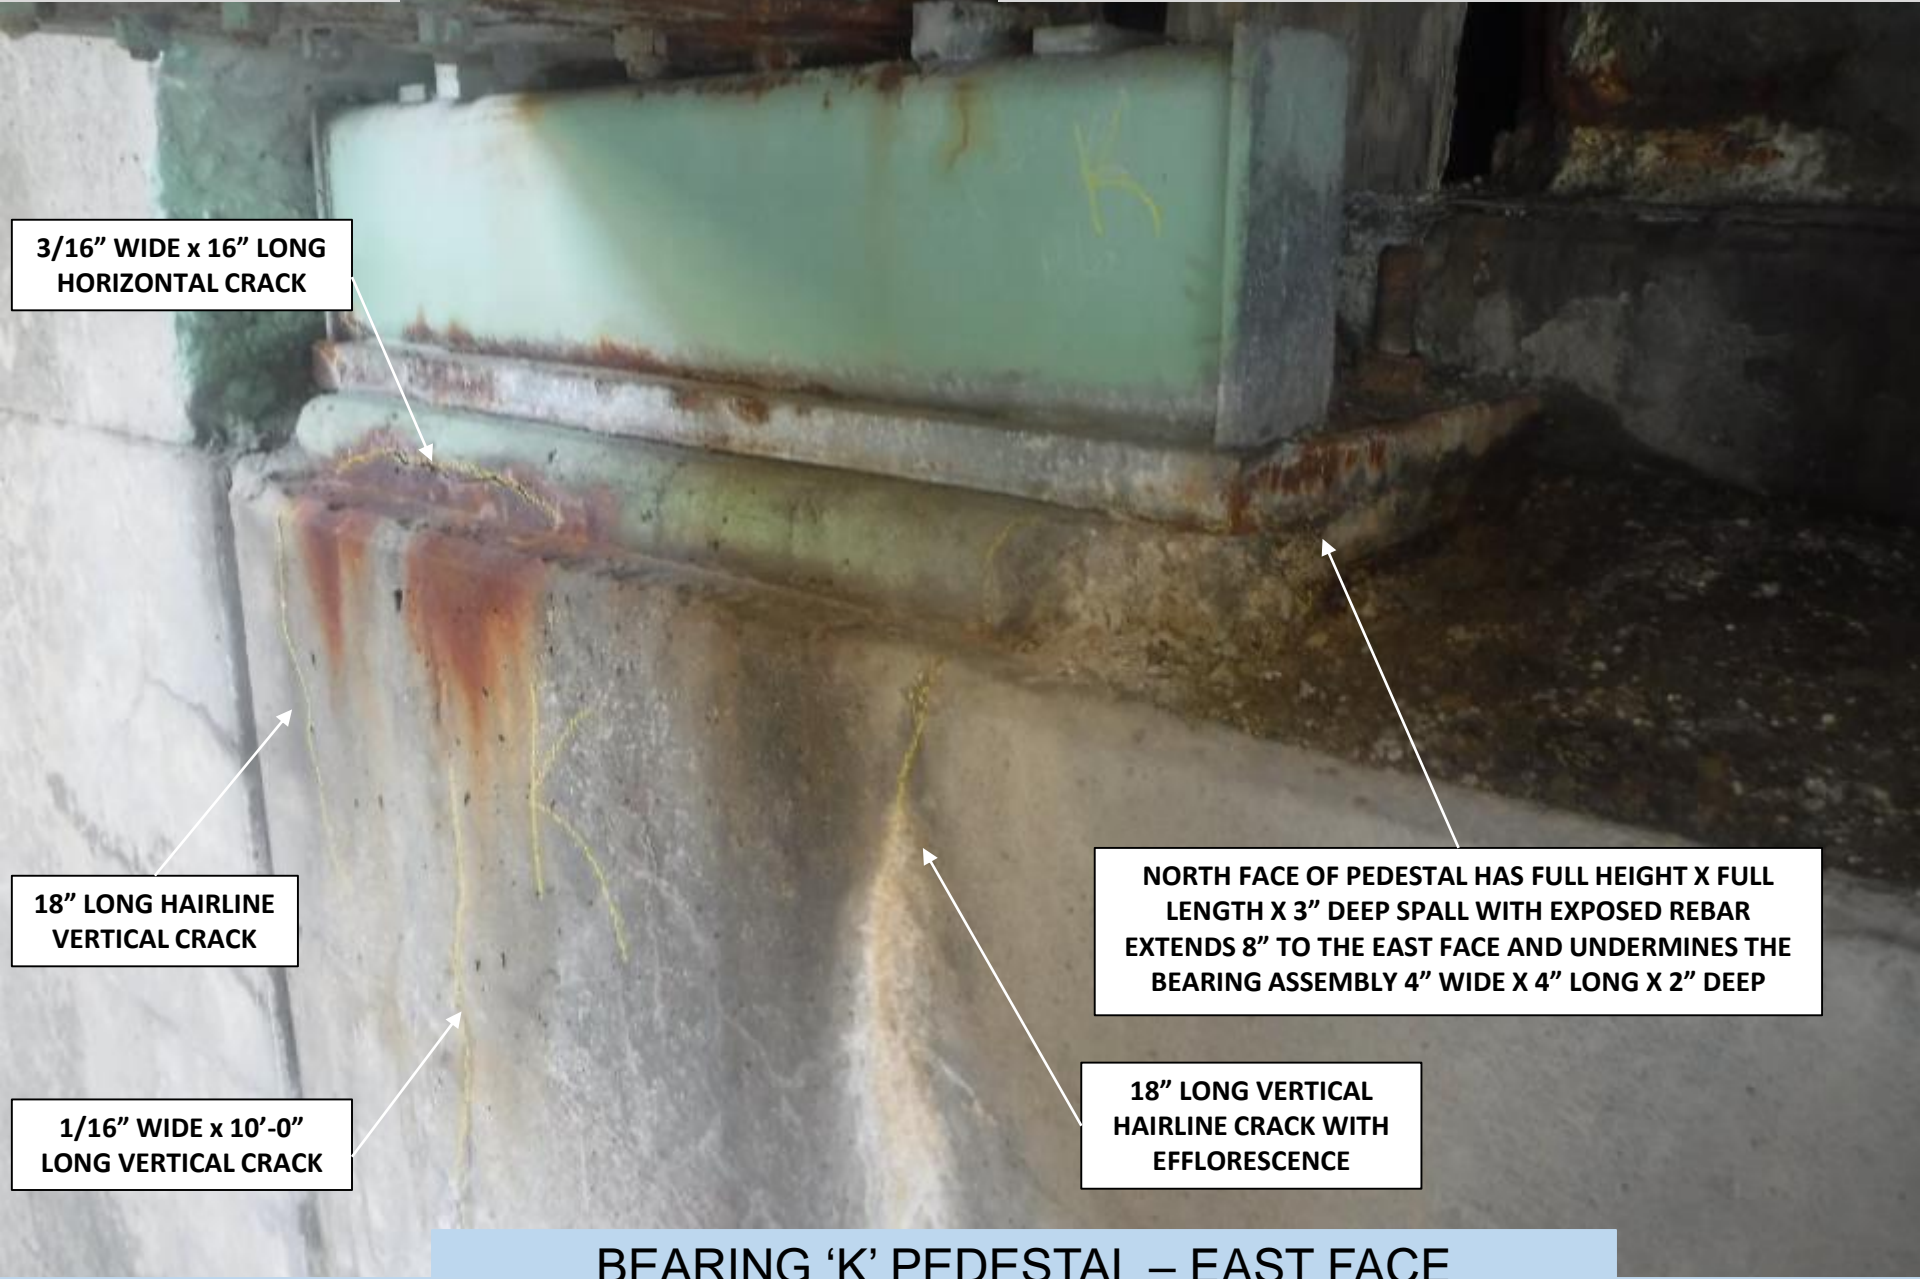
**3/16" WIDE x 16" LONG
HORIZONTAL CRACK**

**18" LONG HAIRLINE
VERTICAL CRACK**

**1/16" WIDE x 10'-0"
LONG VERTICAL CRACK**

**NORTH FACE OF PEDESTAL HAS FULL HEIGHT X FULL
LENGTH X 3" DEEP SPALL WITH EXPOSED REBAR
EXTENDS 8" TO THE EAST FACE AND UNDERMINES THE
BEARING ASSEMBLY 4" WIDE X 4" LONG X 2" DEEP**

**18" LONG VERTICAL
HAIRLINE CRACK WITH
EFFLORESCENCE**

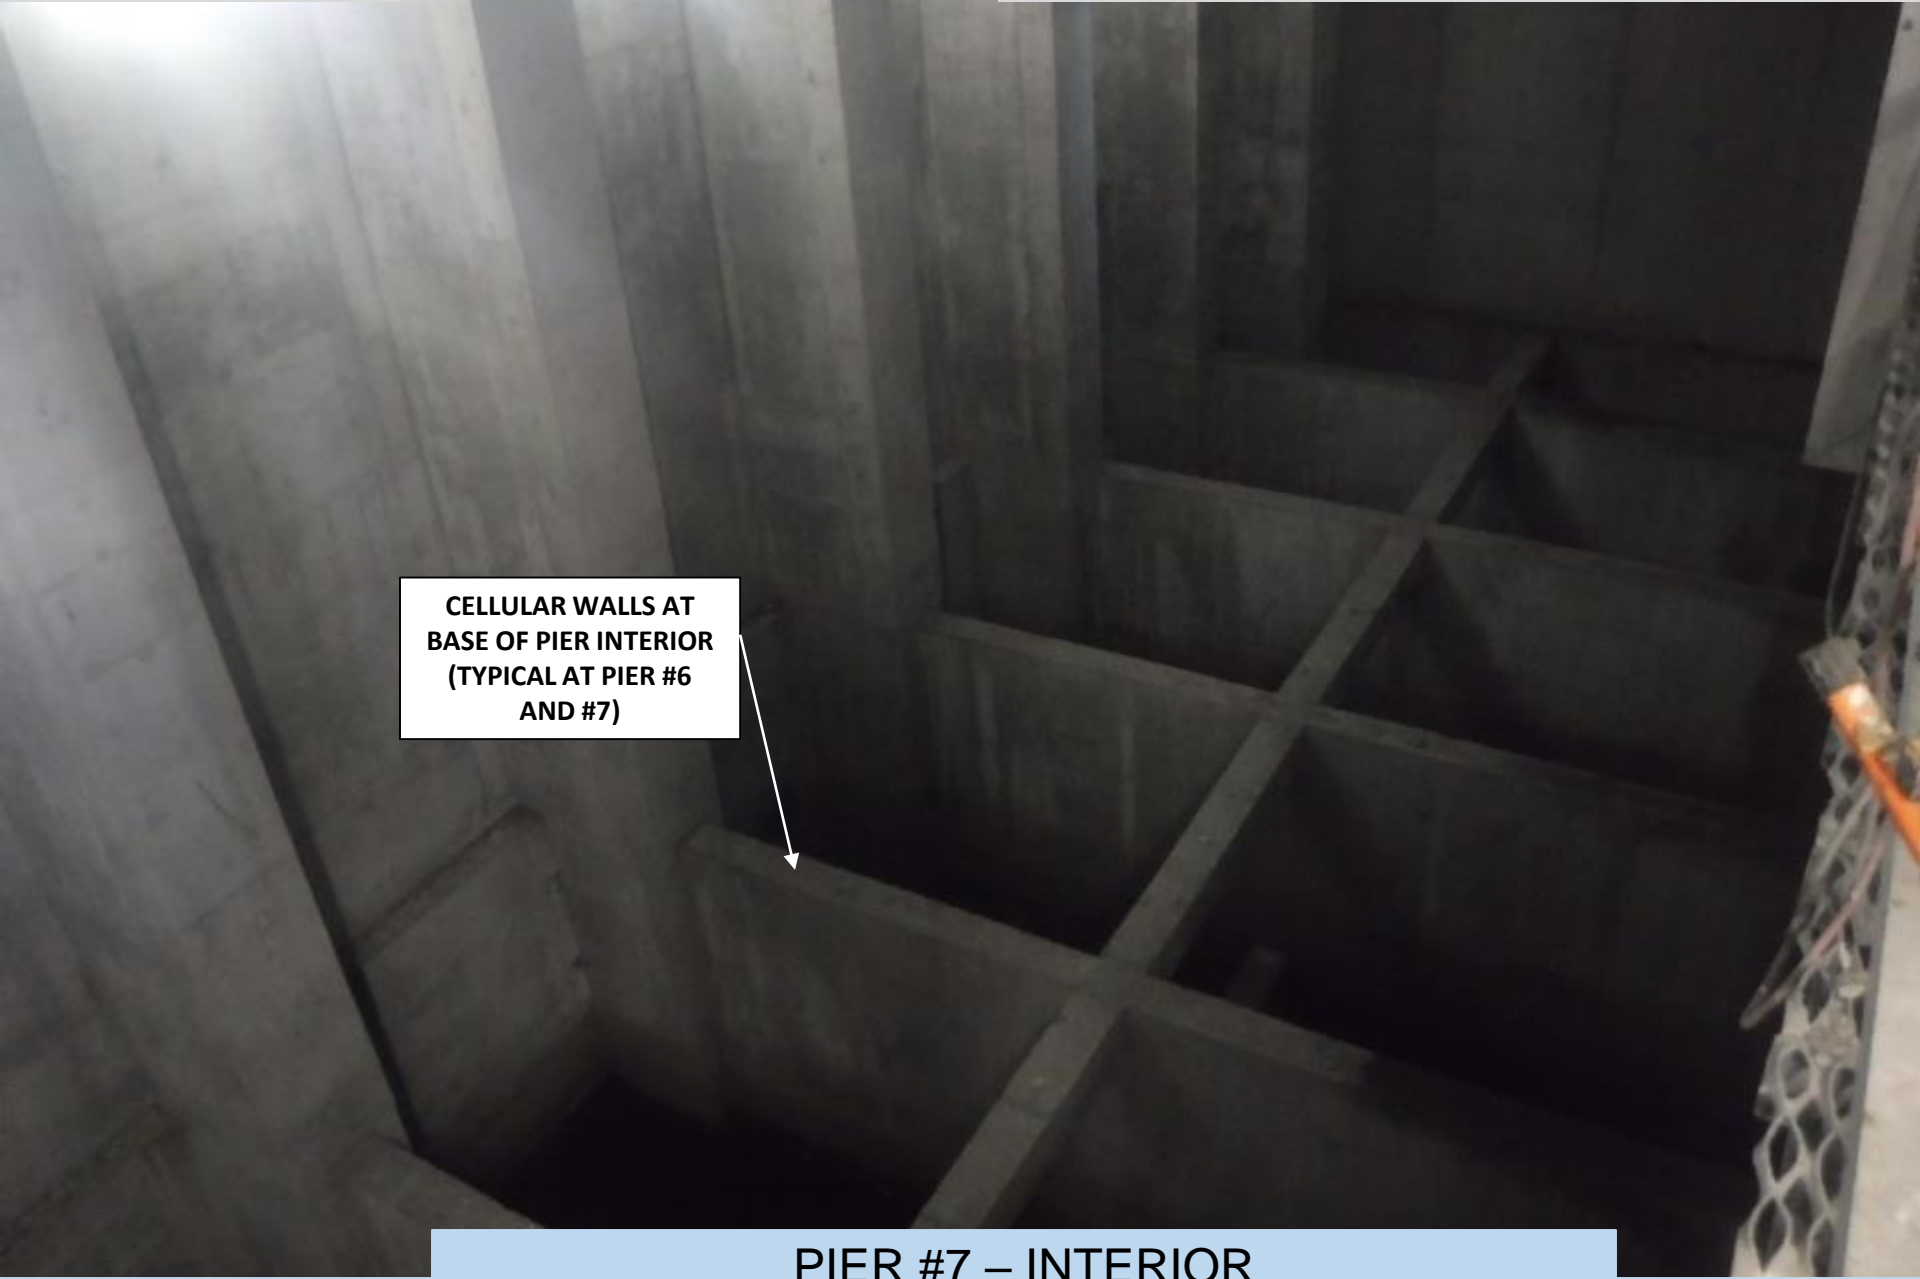
**CELLULAR WALLS AT
BASE OF PIER INTERIOR
(TYPICAL AT PIER #6
AND #7)**

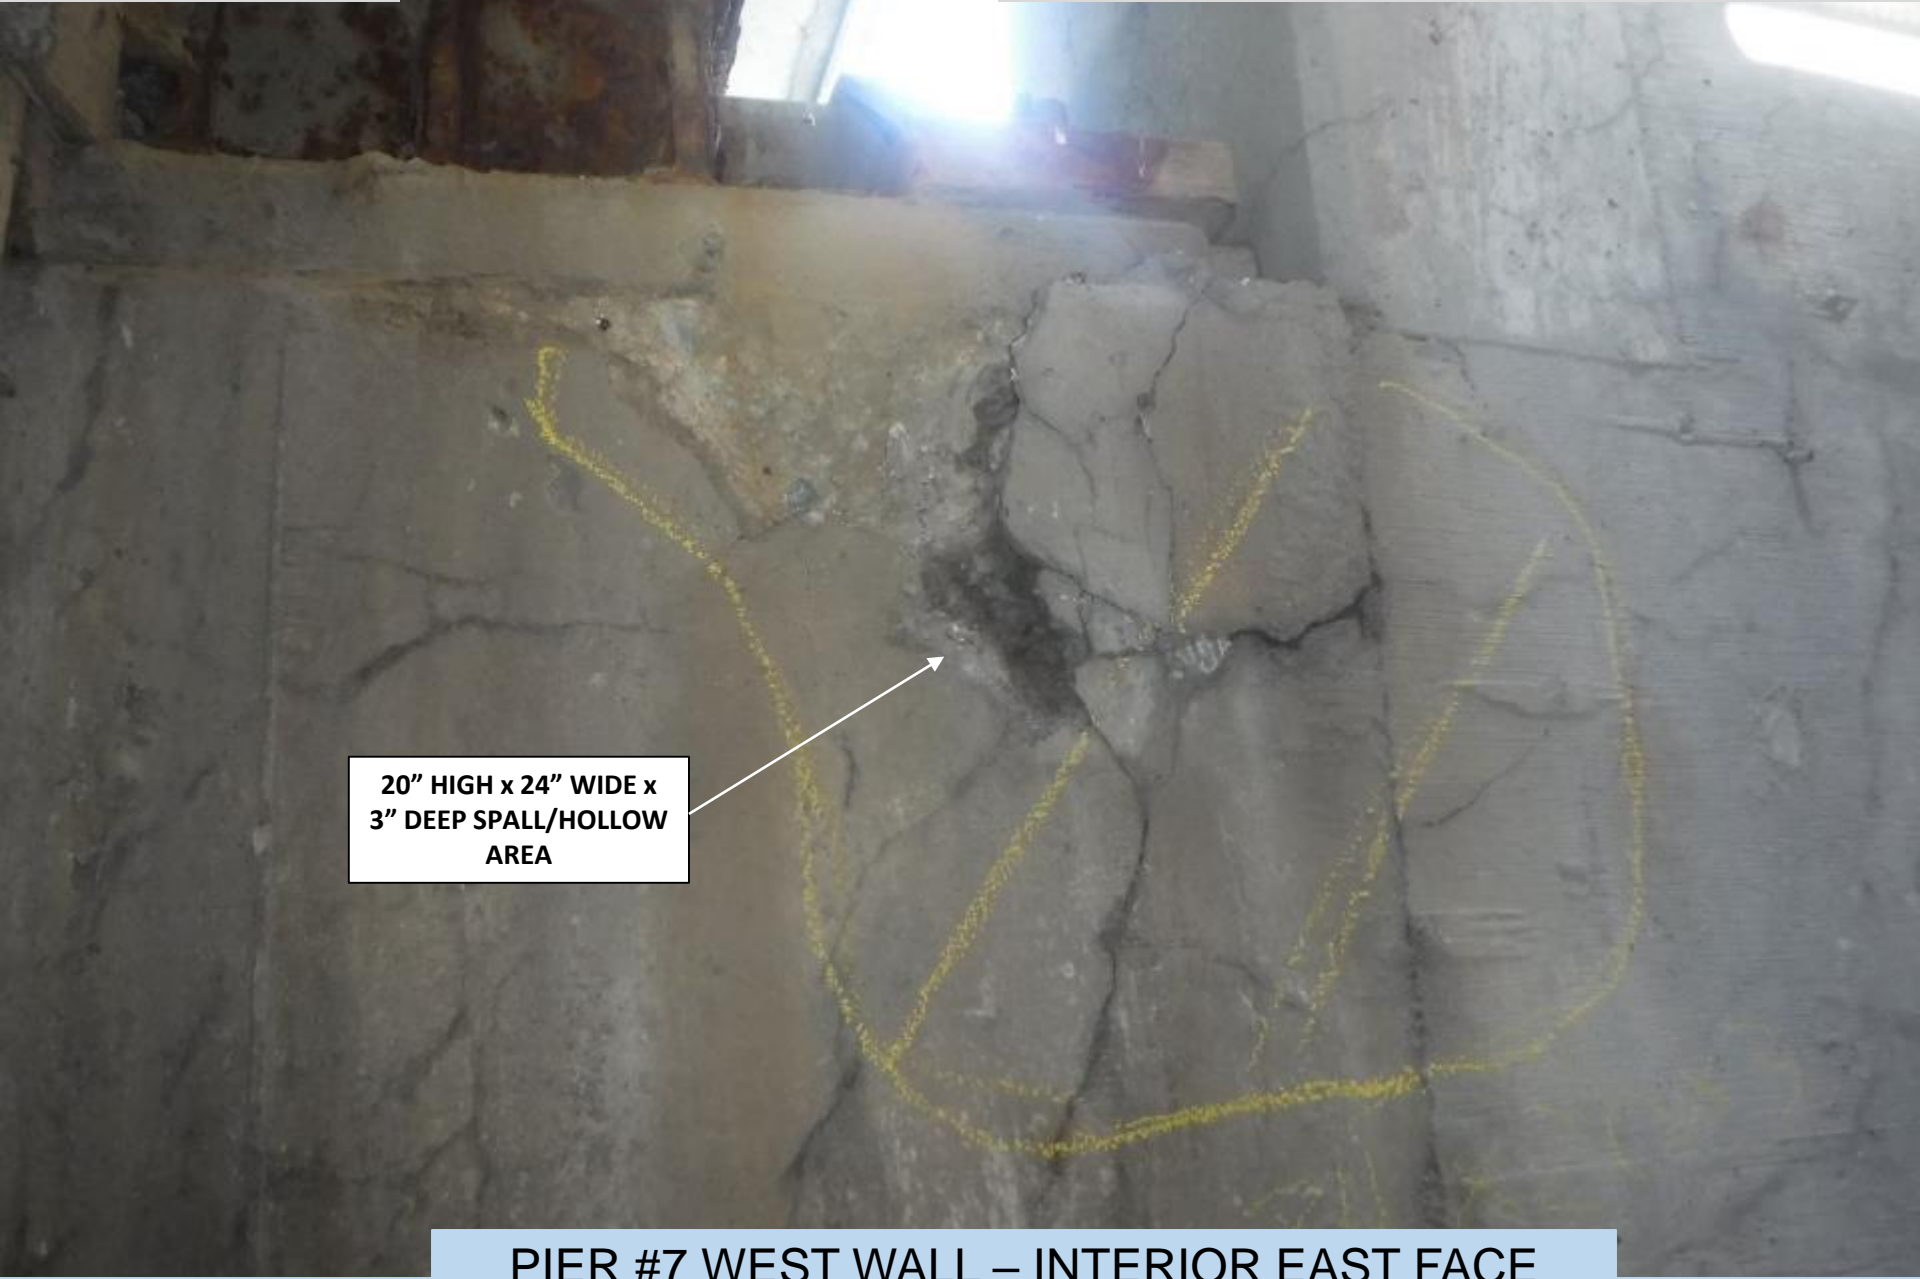
**20" HIGH x 24" WIDE x
3" DEEP SPALL/HOLLOW
AREA**

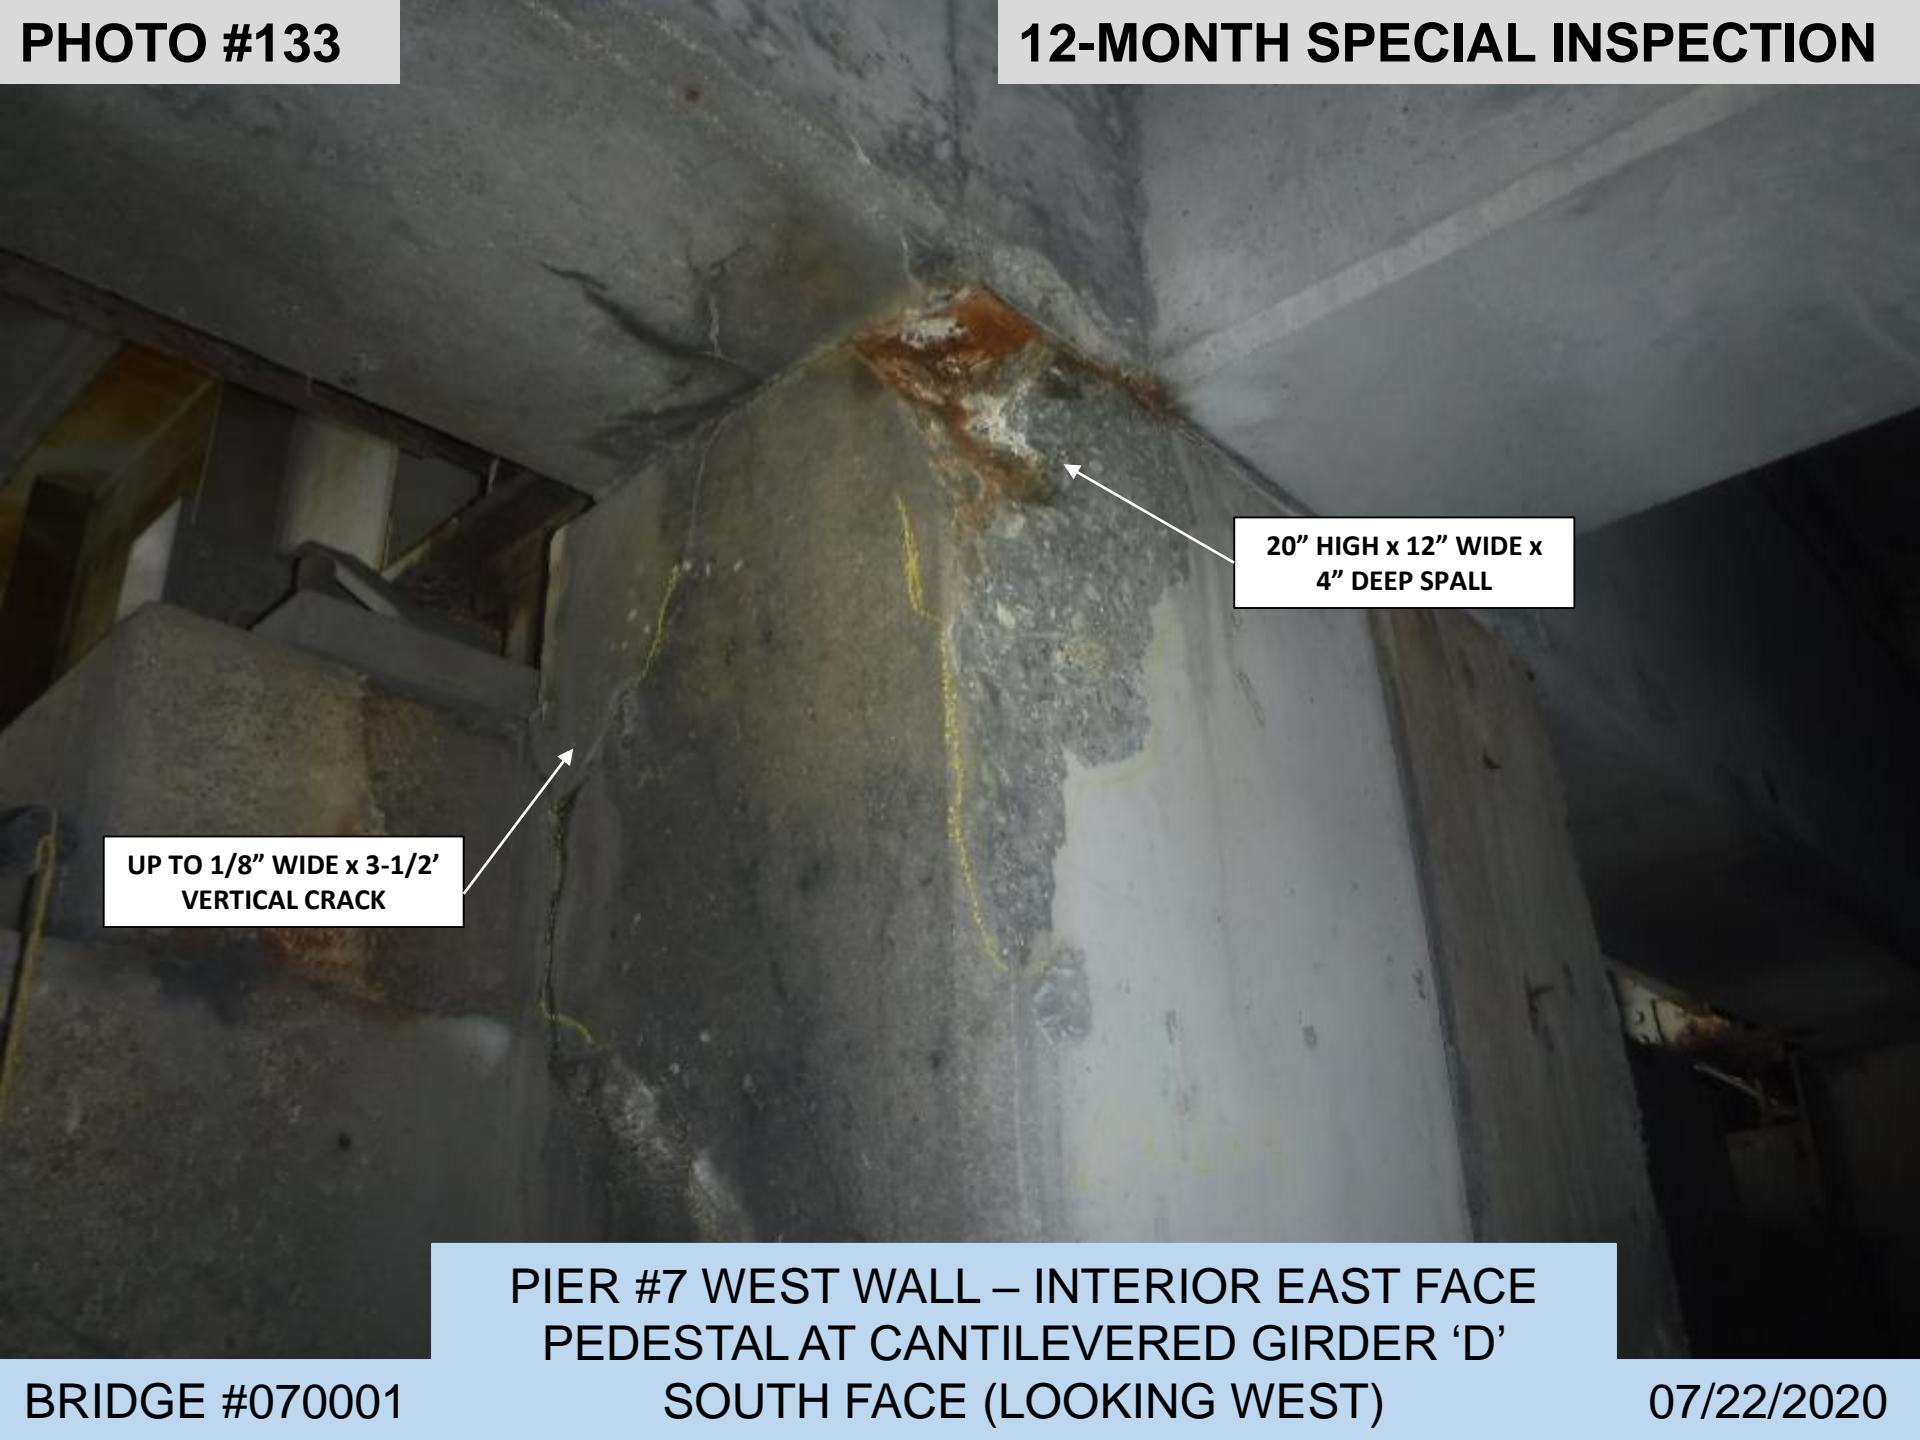
**PIER #7 WEST WALL – INTERIOR EAST FACE
PEDESTAL AT CANTILEVERED GIRDER 'D'
SOUTH FACE (LOOKING WEST)**

**UP TO 1/8" WIDE x 3-1/2'
VERTICAL CRACK**

**20" HIGH x 12" WIDE x
4" DEEP SPALL**

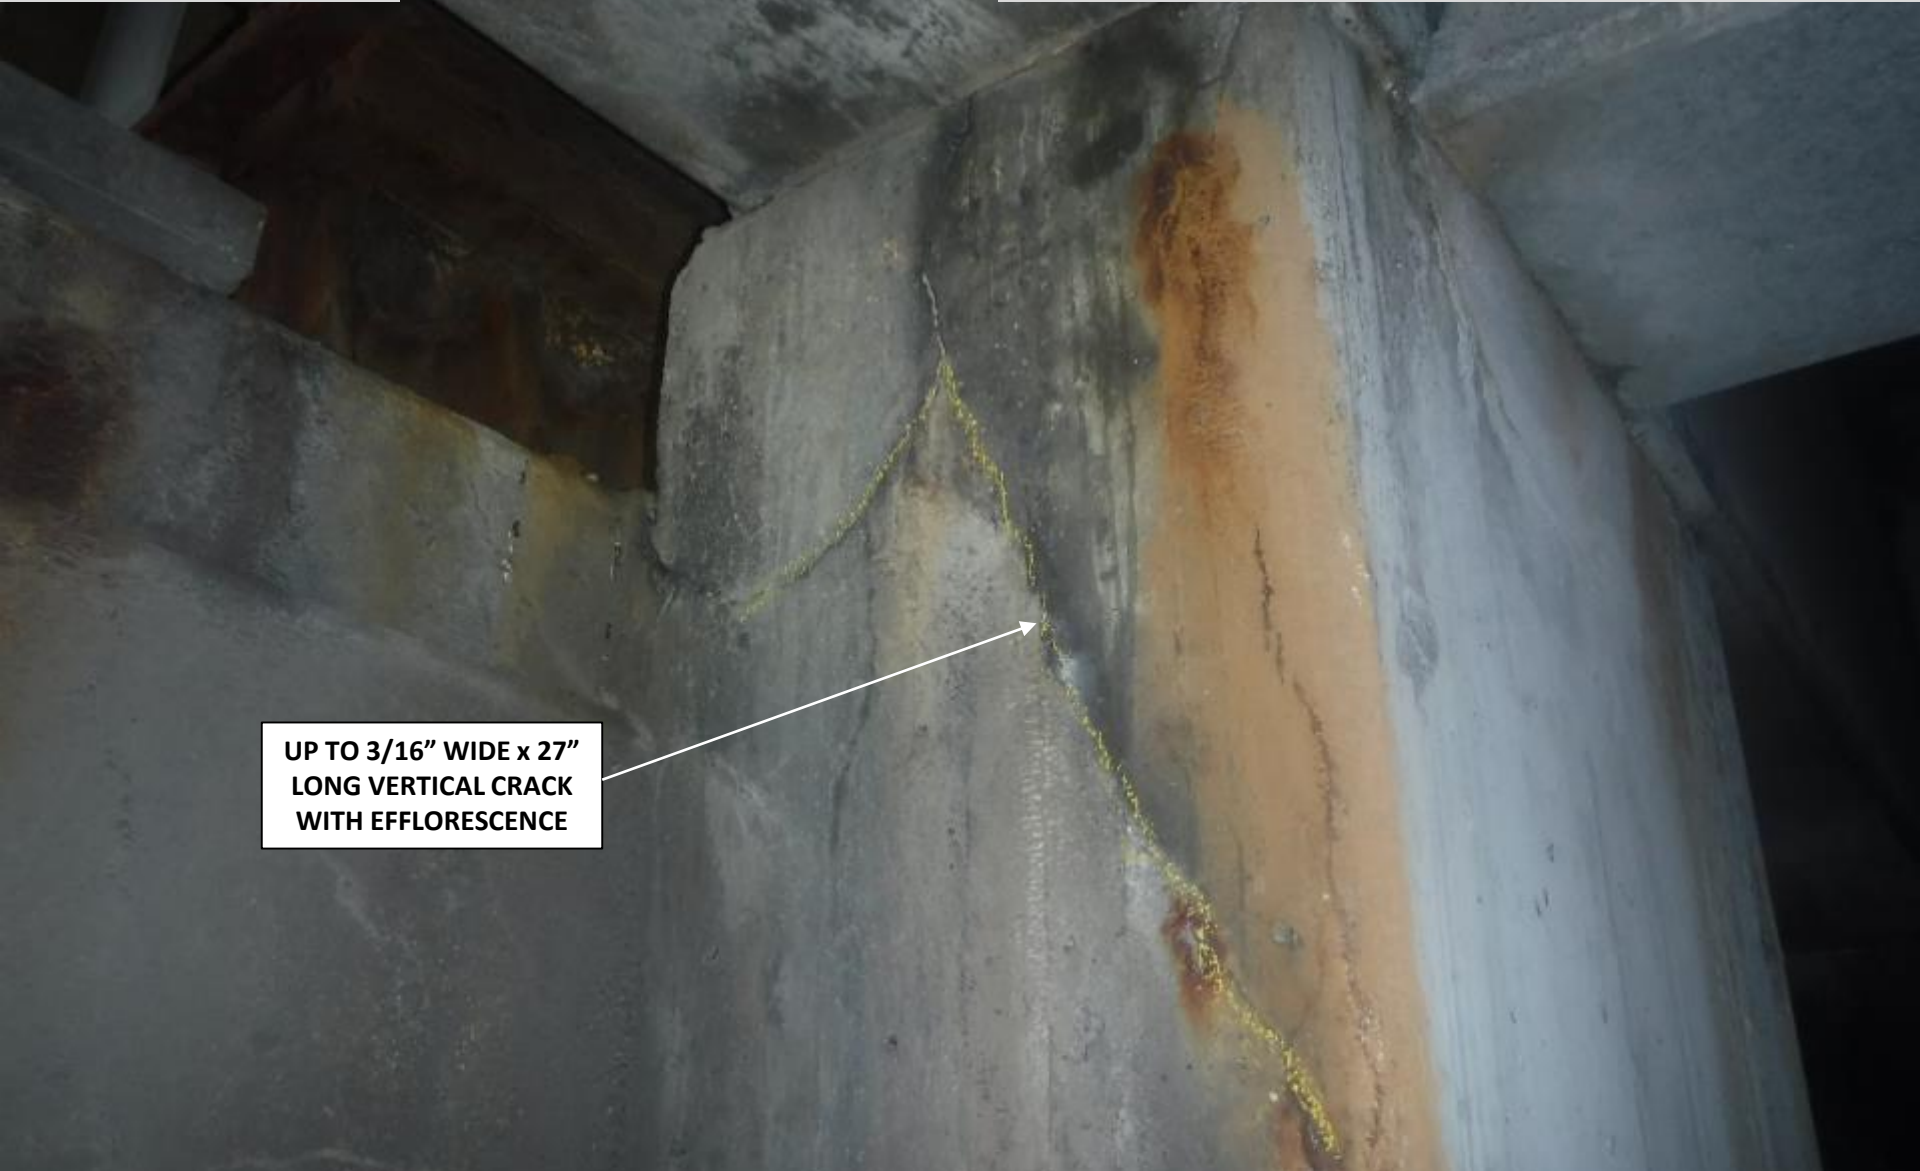
**PIER #7 WEST WALL – INTERIOR EAST FACE
PEDESTAL AT CANTILEVERED GIRDER 'E'**

**UP TO 3/16" WIDE x 27"
LONG VERTICAL CRACK
WITH EFFLORESCENCE**

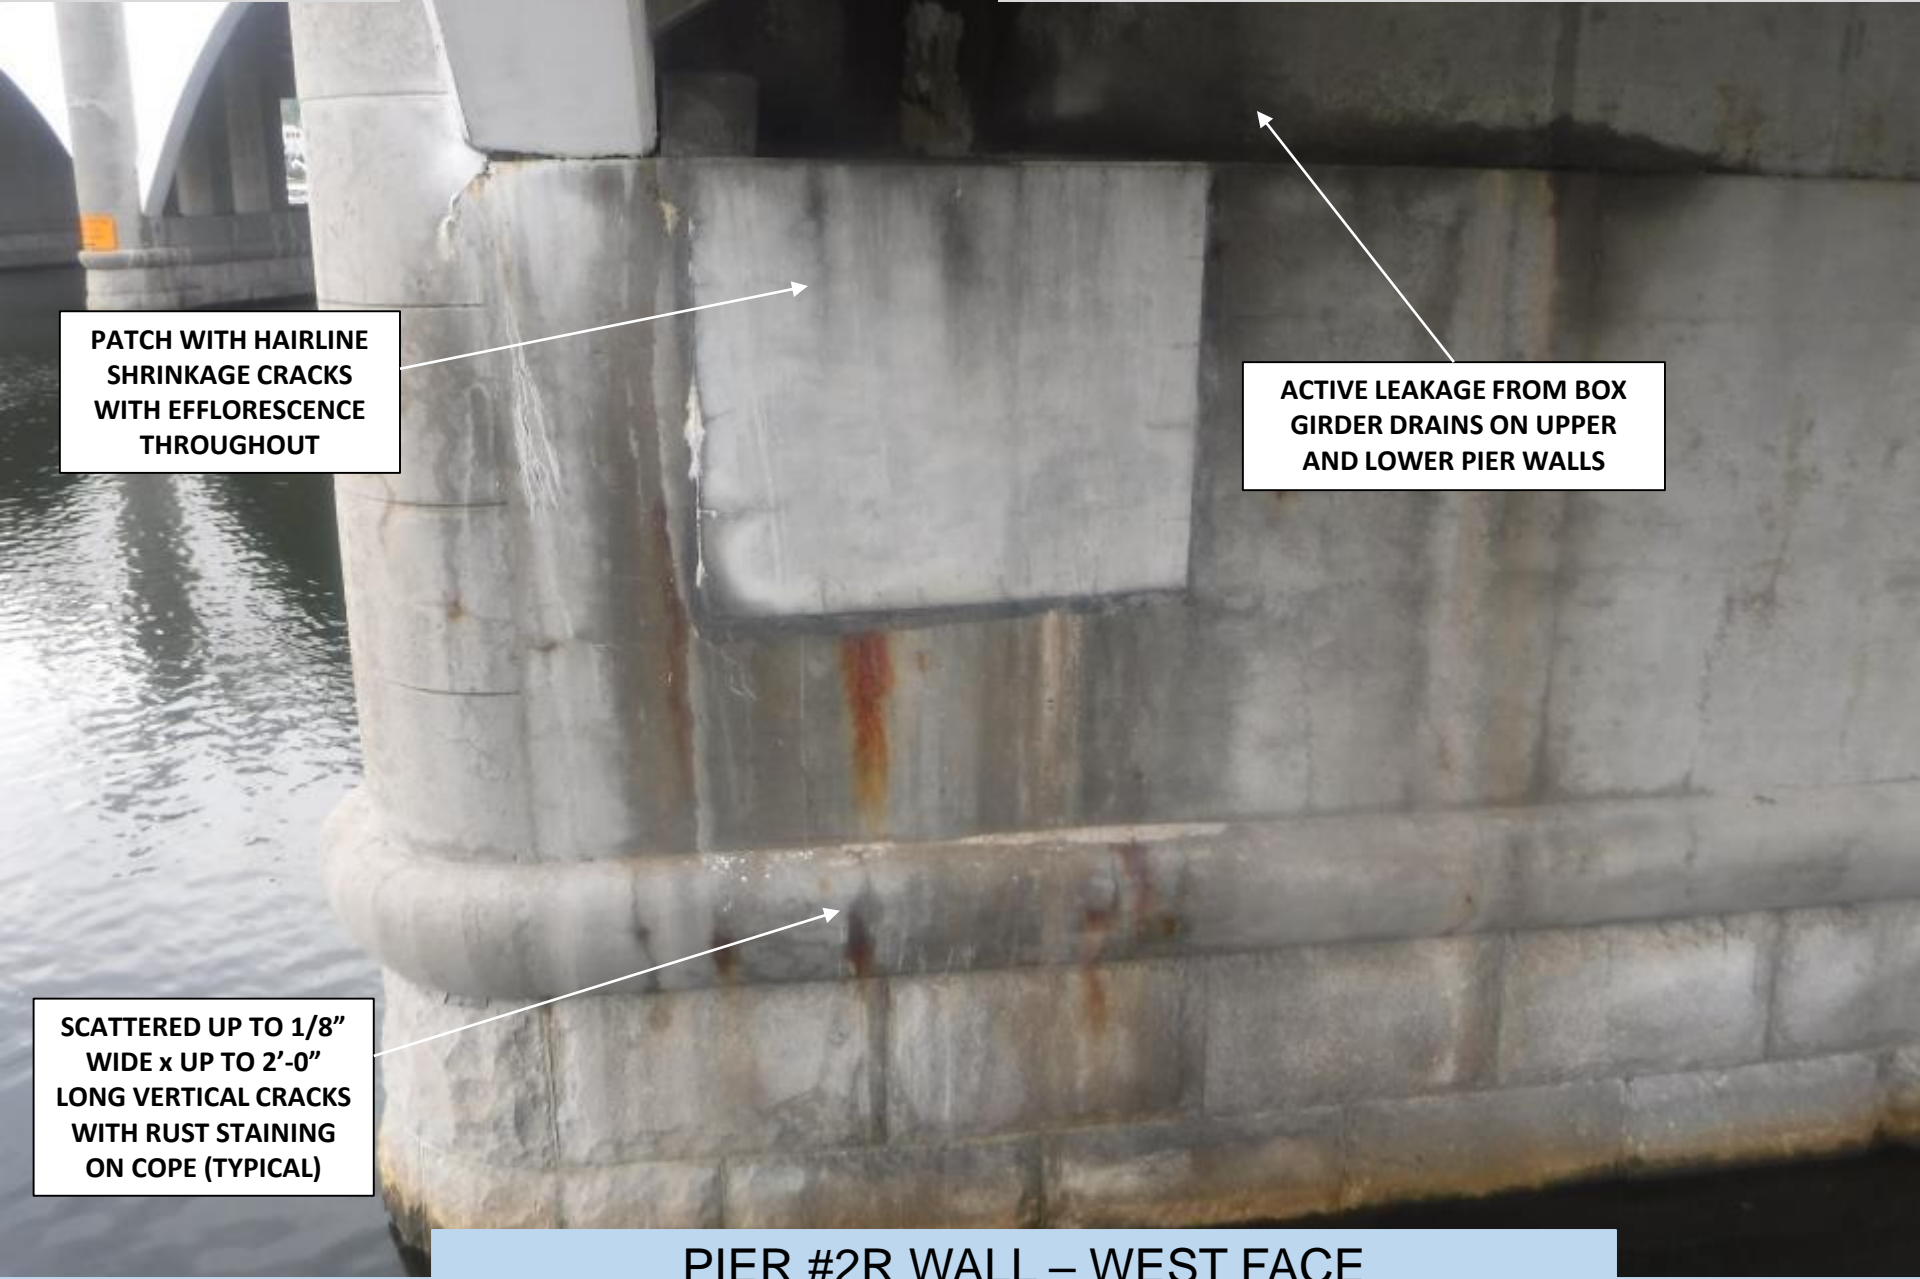
PATCH WITH HAIRLINE SHRINKAGE CRACKS WITH EFFLORESCENCE THROUGHOUT

ACTIVE LEAKAGE FROM BOX GIRDER DRAINS ON UPPER AND LOWER PIER WALLS

SCATTERED UP TO 1/8" WIDE x UP TO 2'-0" LONG VERTICAL CRACKS WITH RUST STAINING ON COPE (TYPICAL)

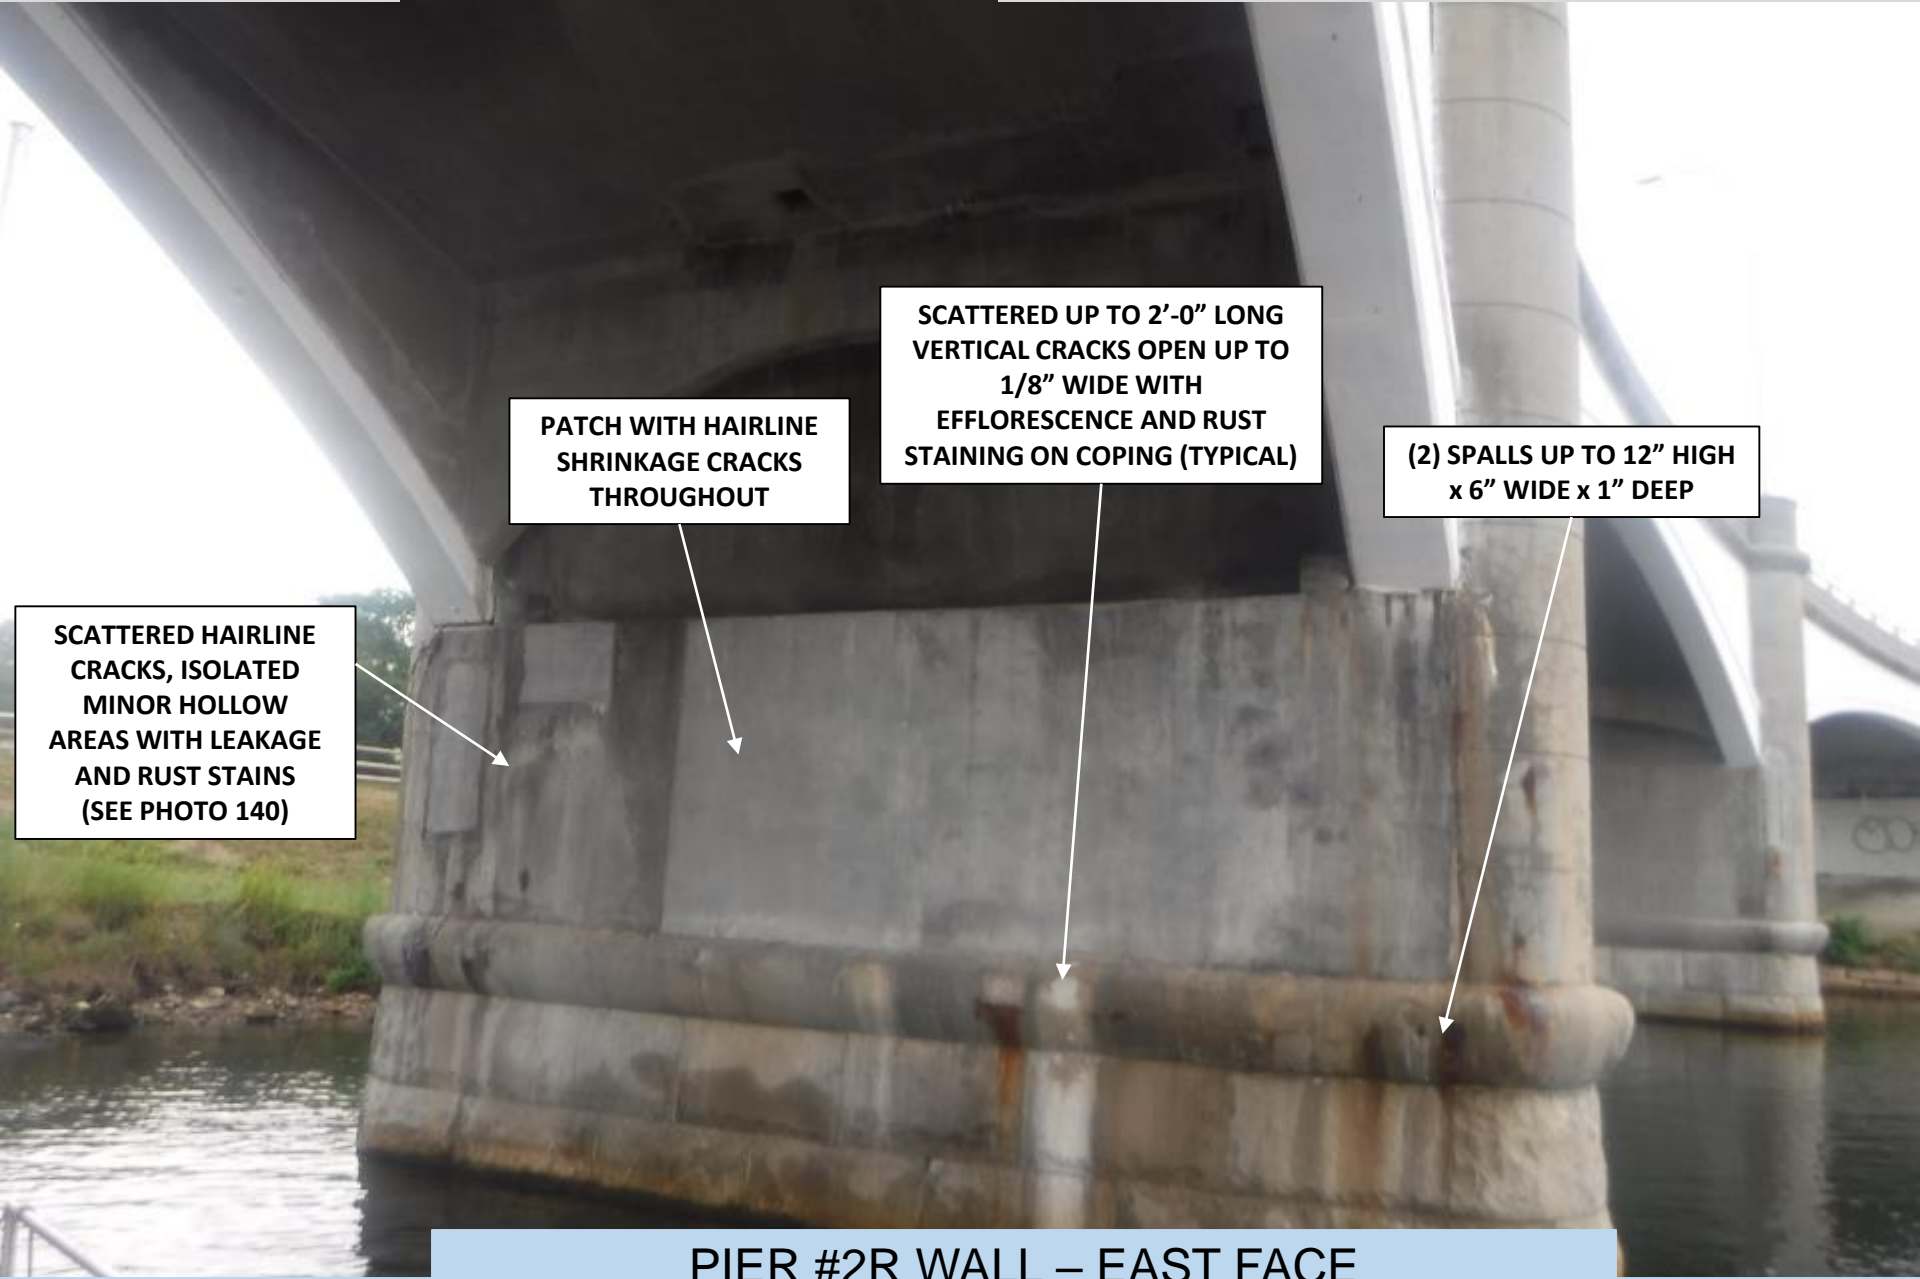
PIER #2R WALL – EAST FACE

PATCH WITH HAIRLINE SHRINKAGE CRACKS THROUGHOUT

SCATTERED UP TO 2'-0" LONG VERTICAL CRACKS OPEN UP TO 1/8" WIDE WITH EFFLORESCENCE AND RUST STAINING ON COPING (TYPICAL)

(2) SPALLS UP TO 12" HIGH x 6" WIDE x 1" DEEP

SCATTERED HAIRLINE CRACKS, ISOLATED MINOR HOLLOW AREAS WITH LEAKAGE AND RUST STAINS (SEE PHOTO 140)
