ROUTINE INSPECTION

BRIDGE #070001

**DECEMBER**  
Inspection

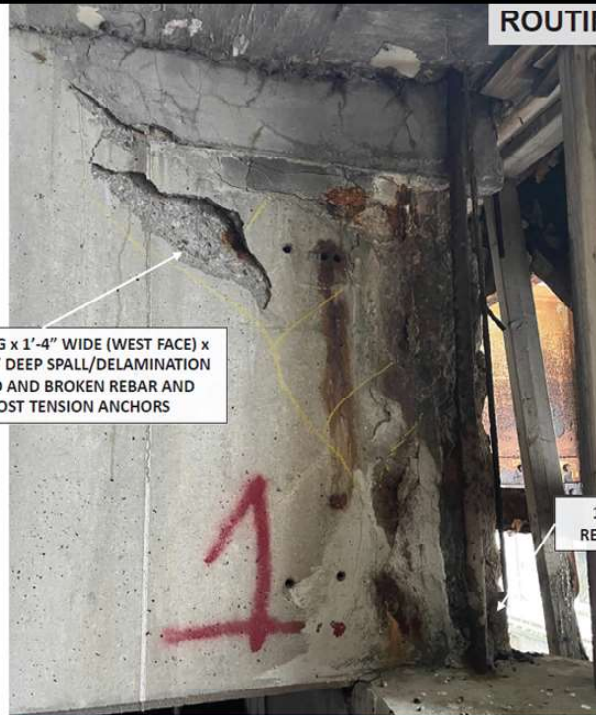
PHOTO #151

UP TO 3'-0" LONG x 1'-4" WIDE (WEST FACE) x FULL HEIGHT x 6" DEEP SPALL/DELAMINATION WITH EXPOSED AND BROKEN REBAR AND EXPOSED POST TENSION ANCHORS

1'-0" WIDE x 7" LONG REDUCED BEARING AREA

CANTILEVER GIRDER 'A' - NORTH FACE AT PIER #7 IN SPAN #7 (LOOKING SOUTH)

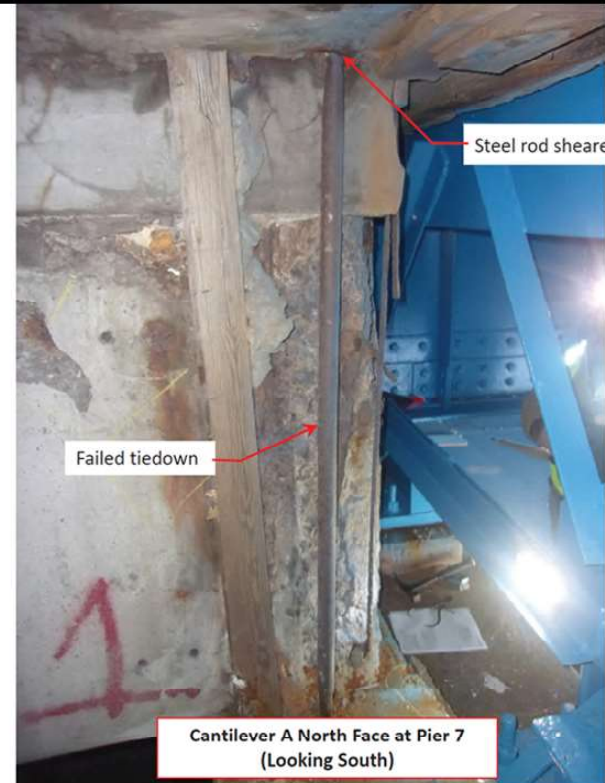
Photo #3

Failed tiedown

Steel rod sheared at top

Cantilever A North Face at Pier 7 (Looking South)

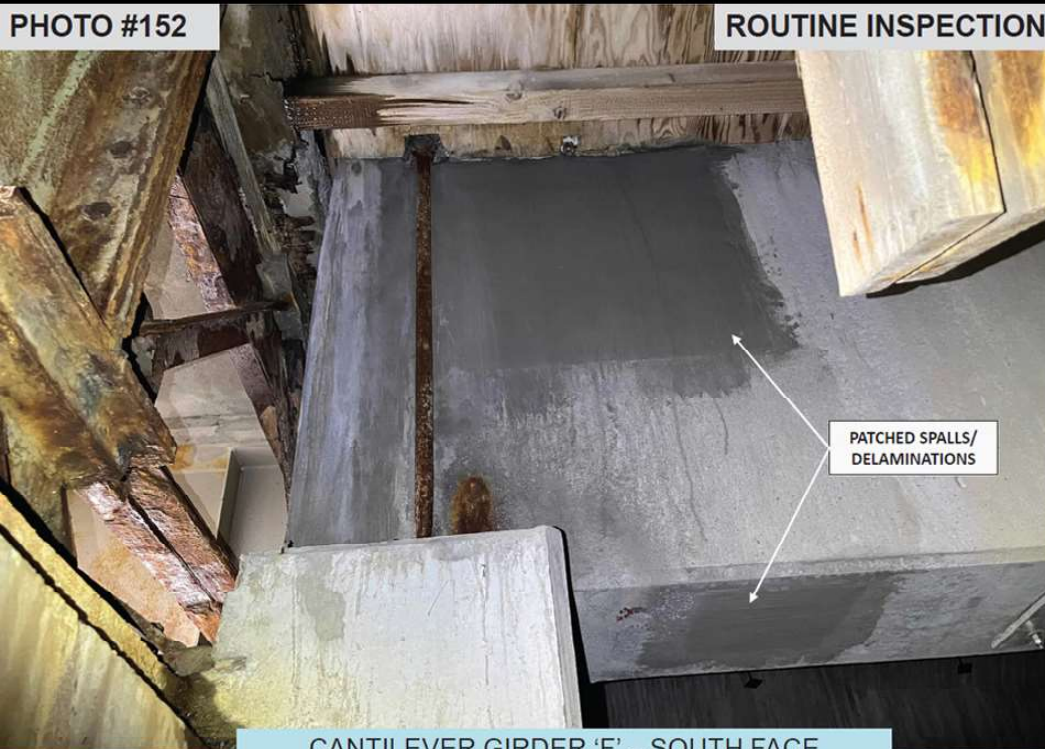
PHOTO #152

CANTILEVER GIRDER 'F' – SOUTH FACE AT PIER #7 IN SPAN #7 (LOOKING NORTH)

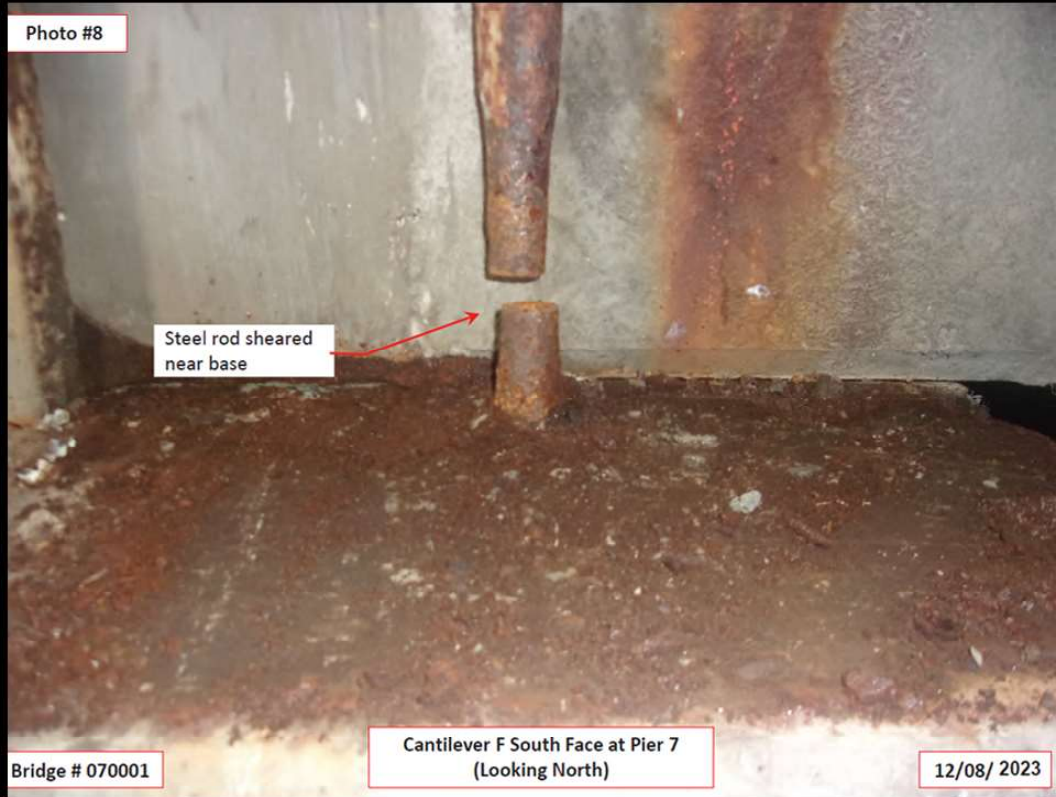
Photo #8

Cantilever F South Face at Pier 7 (Looking North)
