RIDOT

IDDE Compliance Update Report No. 1

January 1 – June 30, 2016
Submitted August 1, 2016

**2016 IDDE Compliance Update Report No. 1
January 1 – June 30, 2016
Submitted August 1, 2016**

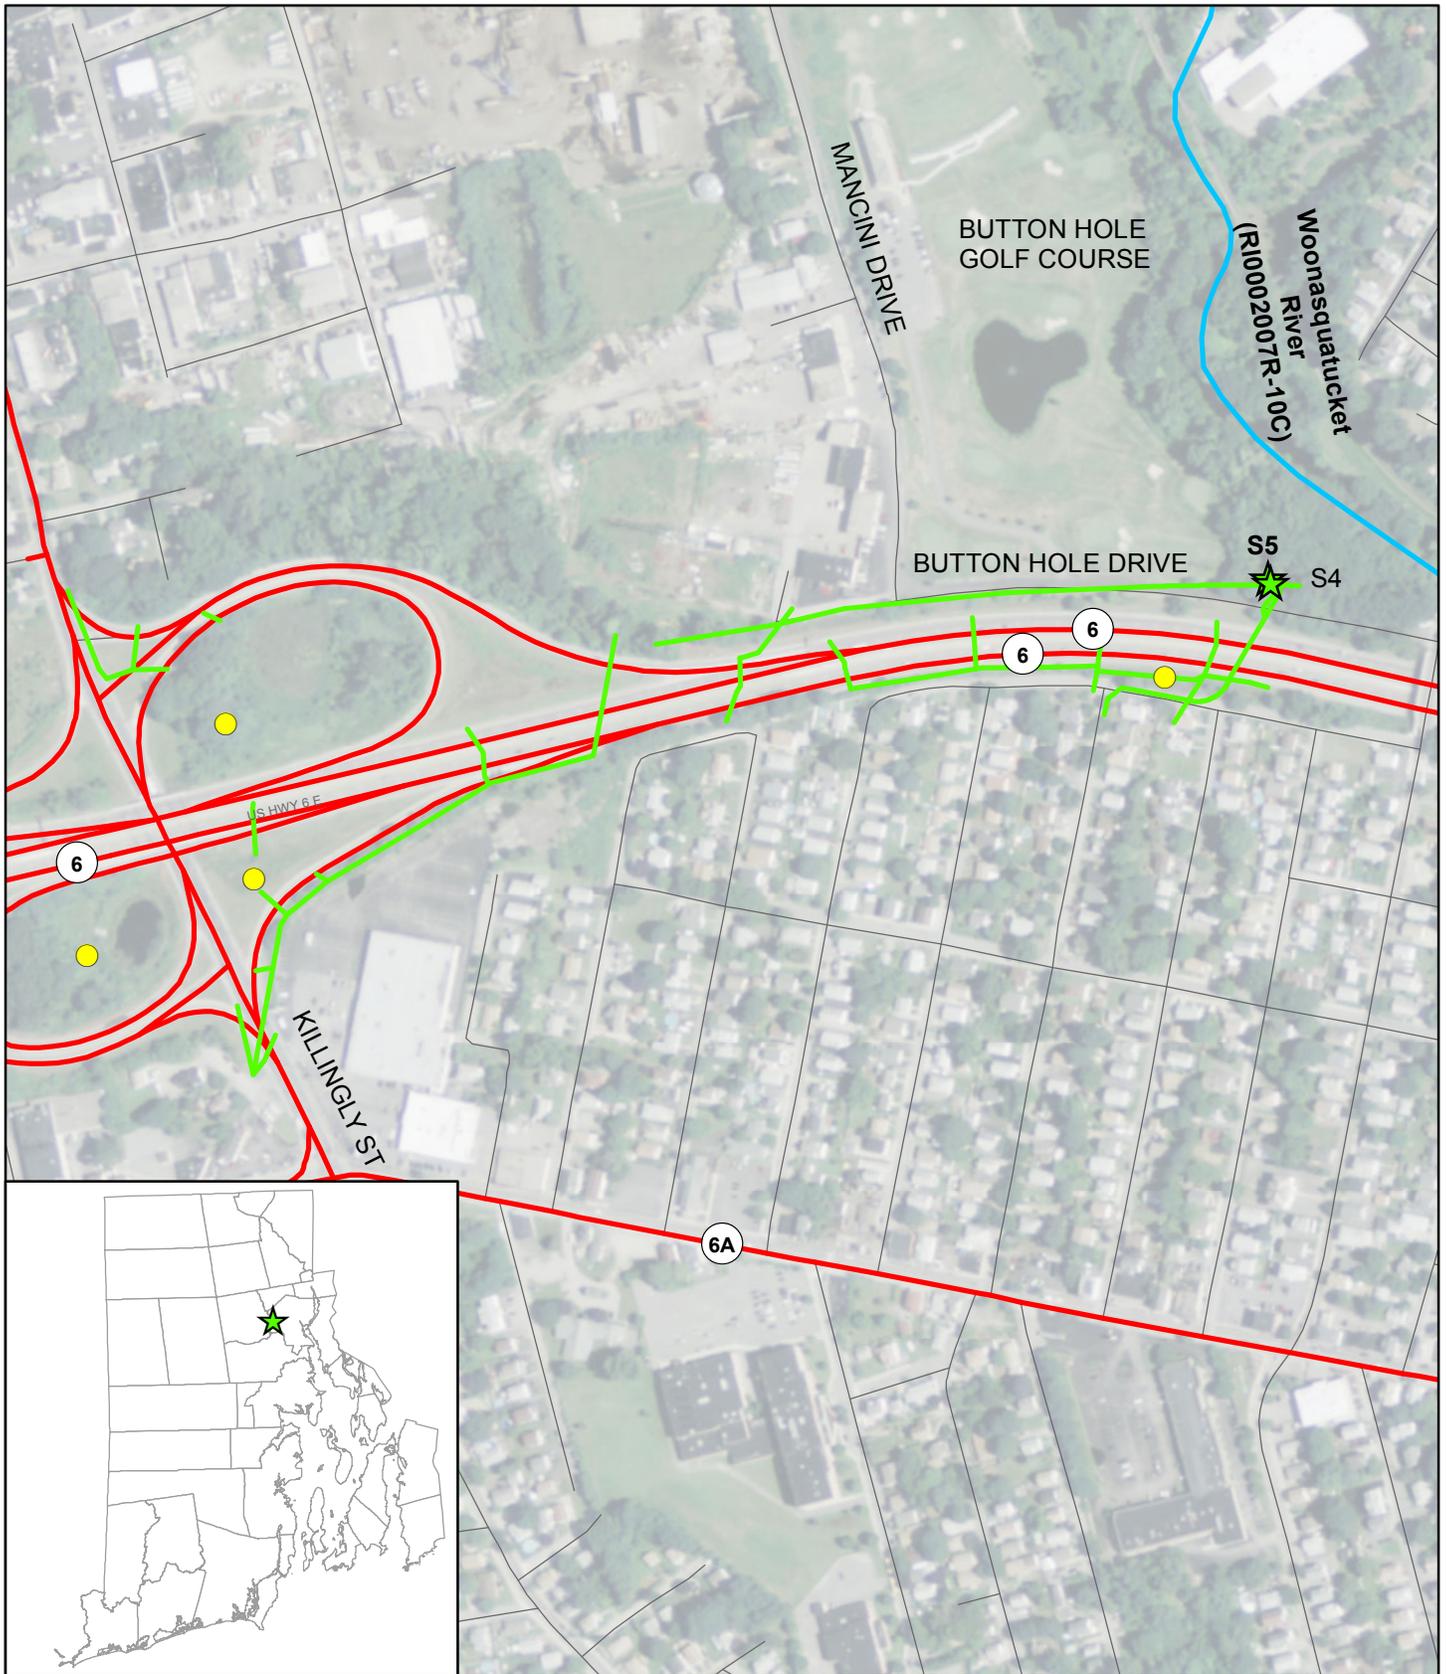
Figure 1
Appendix 8 Outfall S5

Outfall S5 is a 60-inch diameter outfall located off of Buttonhole Drive along the Woonasquatucket River in Providence and receives flows from a piped drainage trunkline located adjacent to Route 6. Smaller stormwater pipes drain into the trunkline from Route 6 and municipal roads such as Mancini Drive. At the Route 6 exit to Killingly Street (Route 128), three water quality ponds treat stormwater from Route 6 before discharging into the main trunkline. The main trunkline also receives drainage from Killingly Street and potentially more municipal roads. The landuse directly upstream of Outfall S5 is mainly recreational and industrial, with Button Hole Golf Course located adjacent to the outfall. See the attached figure for the location of Outfall S5.

The field staff noted the light blue color of the water and suds during the wet weather survey but the field staff were not able to identify the source from the immediate area around the outfall, and access to the trunkline to

follow the flow upstream was not possible without traffic control. Because staff observed a light blue, opaque, and sudsy characteristic to the water, RIDOT will move forward with an investigation into the drainage system. Additionally, the wet weather sample results exceeded thresholds set in the Consent Decree (e.g. surfactants or ammonia exceed thresholds and have detectable levels of chlorine), so even with no potential illicit discharge visual observations, the sampling results would have triggered further investigation.

The next recommended steps to initiate a potential illicit discharge investigation for outfall S5 include the following:

- Determine if investigation should occur during both dry and wet weather or only during wet weather since that is when the blue sudsy water was observed.

- Gather RIDOT drainage plans to identify the entire drainage system to the outfall.
- Identify locations on the plans where drainage from RIDOT roadways contribute to the flow and/or where non-RIDOT road drainage enters the RIDOT drainage system.

- Perform an initial site reconnaissance once the plans have been reviewed to identify where samples would be taken during the survey. This step may not always be necessary but due to the extensiveness of the contributing system, it is likely helpful for this outfall review.

- Perform sampling and observation as necessary to identify the source and/ or rule out that the source is from RIDOT roads. A sample should be taken at the outlet to document the parameter values at the outfall on the day of sampling the overall system.

- Document all steps in VueWorks.
- RIDOT Office of Storm Water Management to send notices to non-RIDOT entities connected to the stormwater system including private properties and municipalities, RIDEM and EPA, as necessary.
