# MONITORING OF LONG-TERM CREEP AND TEMPERATURE BEHAVIOR OF THE JAMESTOWN-VERRAZZANO BRIDGE

FHWA-RIDOT-RTD-02-1  
JUNE 2002

George Tsiatas  
Everett E. McEwen  
Hong Chen

University of Rhode Island

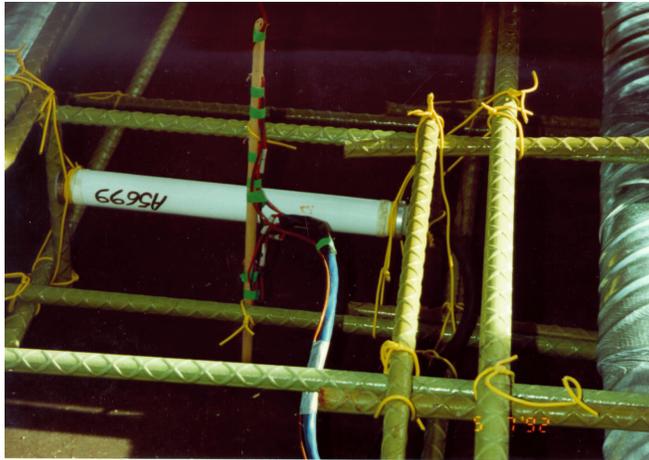
Fig. 1.5 Embedded Carlson Strain Meter (A5699)

segment P14MS1 were all retrofitted since the installation occurred after the concrete had been placed and cured. Fig. 1.4 shows the exact locations of the gages in P14MS1. Figures 1.5 and 1.6 show a typical embedded strain gage and a typical retrofitted strain gage respectively.

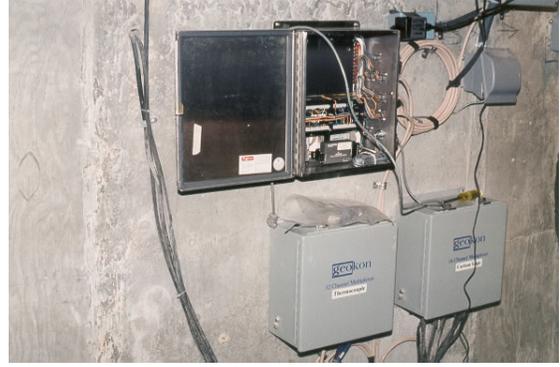
Fig. 1.9 ADAS System

In the week of September 15, 1997, CTL installed the ADAS inside the Jamestown-Verrazano bridge. This allowed for automated acquisition of the data via modem. The ADAS station is located in the main span closure segment and consists of a Data-Logger and three Multiplexers, Figs. 1.9 and 1.10. Multiplexer1 connects the eight Carlson strain meters in the main span closure segment. Multiplexer2 registers the eleven Carlson strain meters in segment P14MS1 and Multiplexer3 connects the nine thermocouples in the main span closure segment.

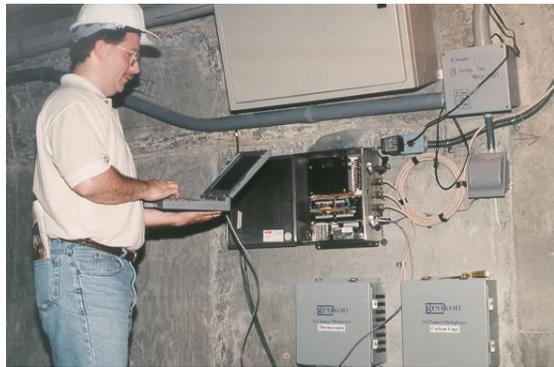
Fig. 1.10 J. Bak from RIDOT checks System
