Rhode Island Strategically Targeted Affordable Roadway Solutions

Aquidneck Island 2010-2011

Aquidneck Island
Transportation Study
On the move...connecting our communities

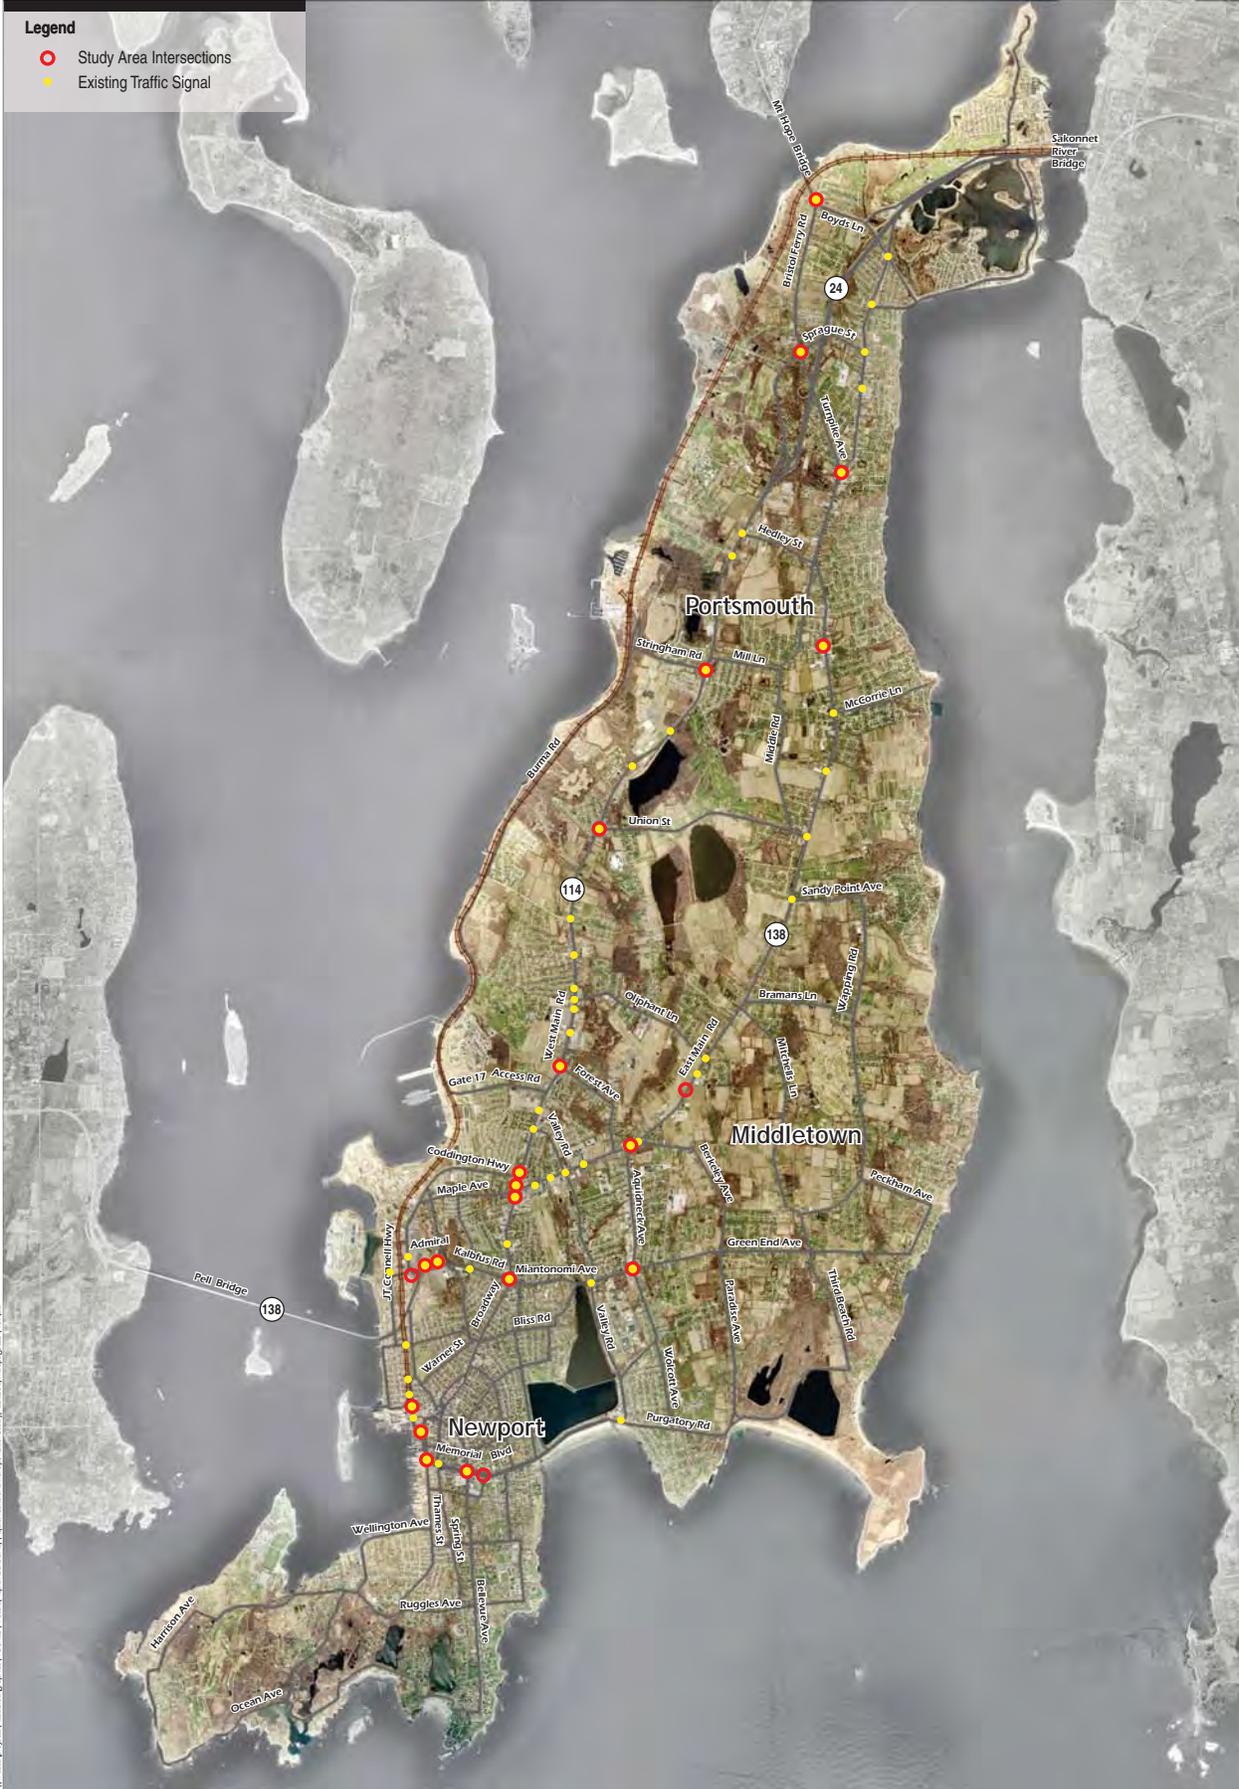
Figure 1-1

The general locations of the study intersections are shown in **Figure 1-1**.

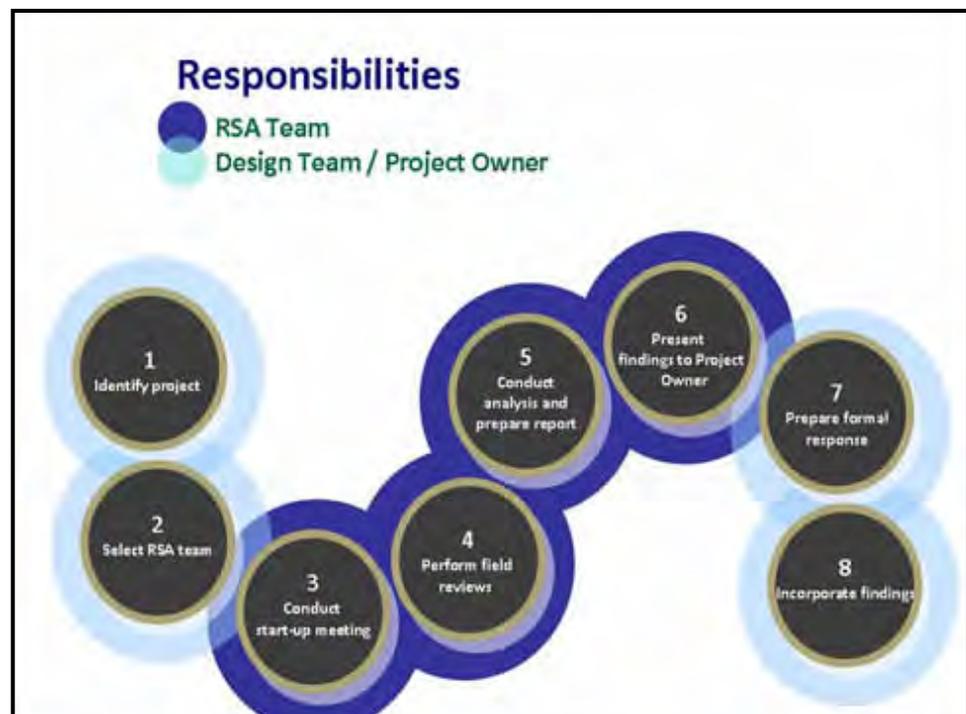
Figure 1-3 RSA 8 Step Process

1. Identify RSA project (design-stage) or existing road (in-service).
2. Select an independent, multi-disciplinary RSA team.
3. Conduct a start-up meeting to review project information and drawings.
4. Perform field reviews in various conditions.
5. Conduct the RSA analysis and prepare preliminary findings presentation.
6. Present preliminary RSA findings to project owner/design team.
7. Prepare formal response.
8. Incorporate findings into the project when appropriate.

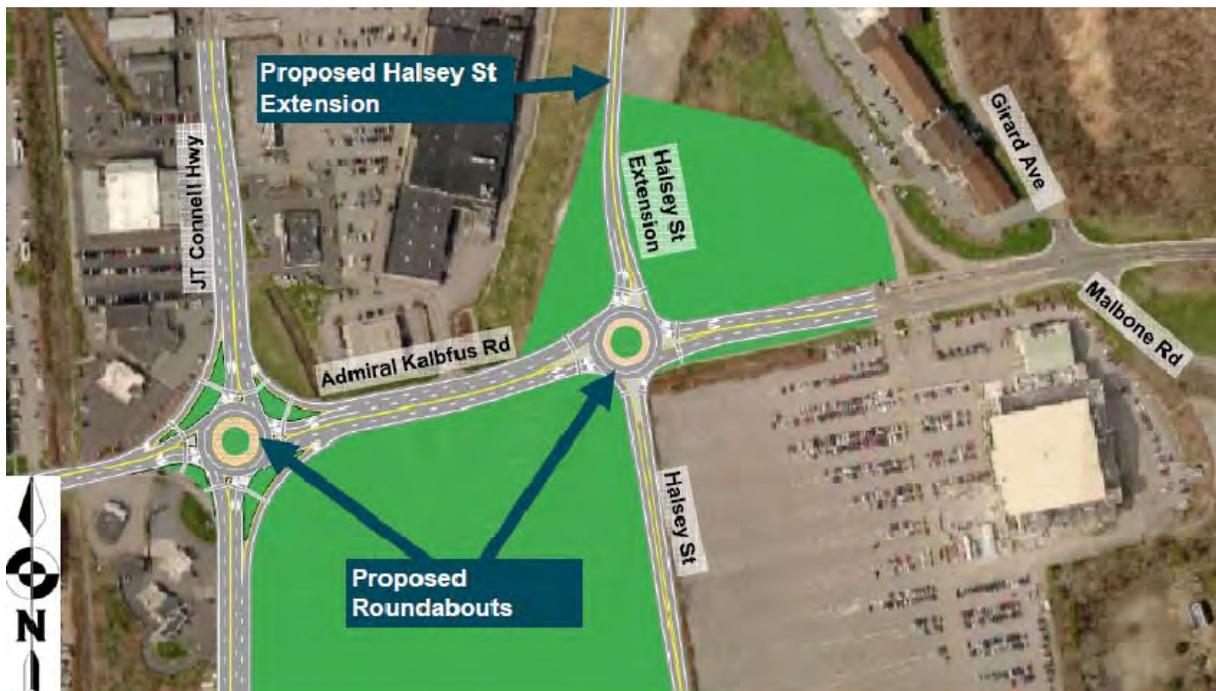
Figure 2-4 Proposed Conceptual Improvements – Admiral Kalbfus Road Corridor

Currently on RIDOT's Transportation Improvement Program is the Pell Bridge Access Improvements project. Numerous alternatives have been developed over the past 10 years. As part of the Aquidneck Island Transportation Study (AITS), an additional concept has been developed as shown below. This concept, as shown in **Figure 2-4**, involves the removal and relocation of the Pell Bridge Ramps. Modern roundabouts are also proposed at the Admiral Kabfus Road intersections with JT Connell Highway and Halsey Street.

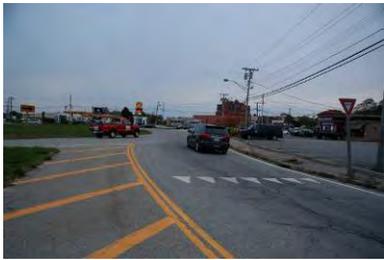
SPECIFIC NEAR TERM IMPROVEMENTS			POTENTIAL INTERMEDIATE IMPROVEMENTS	POTENTIAL LONG TERM IMPROVEMENTS
			(1-6 MONTHS)			(6 MONTHS - 2 YEARS)	(2 OR MORE YEARS)
NO.	ISSUES/CONCERNS	EXAMPLE OF ISSUES	ENGINEERING	ENFORCEMENT	EDUCATION & ENCOURAGEMENT	ENGINEERING	ENGINEERING
1	<p>Speed approaching, entering, and within the Newport Rotary</p> <p>- There are no posted speed limit signs on the approaches to the rotary. The existing geometry of the rotary (large radius, poor deflection on the approaches) results in higher speeds entering, within, and exiting.</p>

<p><i>Photo shows the wide entering approach to the rotary with poor deflection, entering from JT Connell Hwy from the north. As a result, drivers enter the rotary at higher speeds than with modern roundabouts.</i></p>	<ul style="list-style-type: none"> - Install speed limit signs on all approaches to the rotary. Use portable speed feedback signs to alert motorists of their travel speeds. Increase police enforcement of speed limits. - Consider retrofitting the existing rotary with modern roundabout features using striping and signage. 	<ul style="list-style-type: none"> - Increase police enforcement of speed limits. 	<ul style="list-style-type: none"> - If the rotary is retrofitted to a modern roundabout or a new modern roundabout is constructed, educate or remind drivers about the basic principles of roundabout functionality. 	<ul style="list-style-type: none"> - Consider retrofitting the existing rotary with modern roundabout features using striping and signage. 	<ul style="list-style-type: none"> - Consider constructing a new modern roundabout to replace the existing rotary.

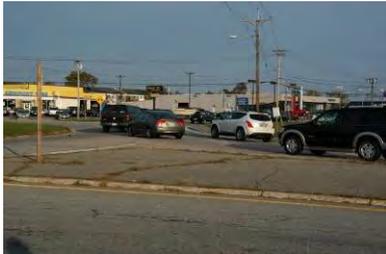
SPECIFIC NEAR TERM IMPROVEMENTS			POTENTIAL INTERMEDIATE IMPROVEMENTS	POTENTIAL LONG TERM IMPROVEMENTS
			(1-6 MONTHS)			(6 MONTHS - 2 YEARS)	(2 OR MORE YEARS)
NO.	ISSUES/CONCERNS	EXAMPLE OF ISSUES	ENGINEERING	ENFORCEMENT	EDUCATION & ENCOURAGEMENT	ENGINEERING	ENGINEERING
2	<p>Poorly delineated rotary</p> <p>- The rotary is poorly delineated and sometimes operates as two lanes.</p>

<p><i>Photo shows the confusion motorists find when driving the rotary due to wide lanes with no delineation.</i></p>	<ul style="list-style-type: none"> - Re-stripe the existing pavement to clearly delineate the rotary. Relocate the yield lines (shark teeth) to the correct location, closer to the entrance point of the rotary. - Consider retrofitting the existing rotary with modern roundabout features using striping and signage. 		<ul style="list-style-type: none"> - If a new modern roundabout is constructed, educate or remind drivers about the basic principles of roundabout functionality. 	<ul style="list-style-type: none"> - Consider retrofitting the existing rotary with modern roundabout features using striping and signage. 	<ul style="list-style-type: none"> - Consider constructing a new modern roundabout to replace the existing rotary.

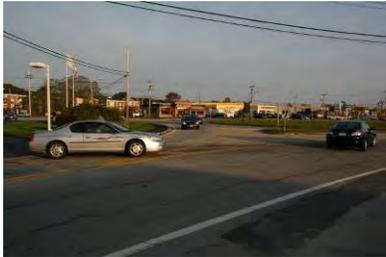
SPECIFIC NEAR TERM IMPROVEMENTS			POTENTIAL INTERMEDIATE IMPROVEMENTS	POTENTIAL LONG TERM IMPROVEMENTS
			(1-6 MONTHS)			(6 MONTHS - 2 YEARS)	(2 OR MORE YEARS)
NO.	ISSUES/CONCERNS	EXAMPLE OF ISSUES	ENGINEERING	ENFORCEMENT	EDUCATION & ENCOURAGEMENT	ENGINEERING	ENGINEERING
3	<p>Access points to adjacent properties are inside and too close to the rotary</p> <p>- There are access driveways inside of the rotary and too close to the approaches/ departures to the rotary.</p>

<p><i>Photo shows a vehicle exiting a driveway close to the rotary departure, causing potential conflicts.</i></p>				<p>– Extend splitter islands on all approaches to the rotary to make adjacent access points right-in, right-out only.</p> <p>Intermediate – Consider closing the Shell gas station driveway located along the rotary for the southwest parcel. The parcel has two other driveways that can be accessed from both Training Station Road and JT Connell Highway.</p>	<p>– Consider constructing a new modern roundabout to replace the existing rotary and modifying/relocating access driveways.</p>

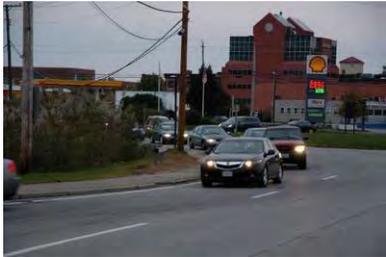
SPECIFIC NEAR TERM IMPROVEMENTS			POTENTIAL INTERMEDIATE IMPROVEMENTS	POTENTIAL LONG TERM IMPROVEMENTS
			(1-6 MONTHS)			(6 MONTHS - 2 YEARS)	(2 OR MORE YEARS)
NO.	ISSUES/CONCERNS	EXAMPLE OF ISSUES	ENGINEERING	ENFORCEMENT	EDUCATION & ENCOURAGEMENT	ENGINEERING	ENGINEERING
4	<p>Queues from traffic signals extending into the rotary</p> <p>- There are traffic signals at adjacent intersections to the north, west, and east of the rotary that have queues that extend into the rotary during peak hour traffic conditions.</p>

<p><i>Photo shows vehicle queues extending into the rotary, caused by the Pell Bridge On-Ramp intersection.</i></p>	<p>- Optimize the traffic signal timings at adjacent signals to minimize the queues that extend into the rotary.</p>				<p>- Increase capacity by adding lanes on the departure of the rotary and at adjacent signalized intersections to increase capacity and consider construction of alternate routes such as the Halsey Street extension to reduce volume of traffic traveling through the study area.</p>

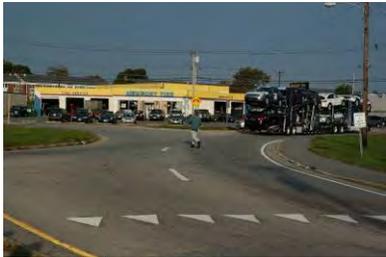
5	<p>No delineated crosswalks</p> <p>- There are currently no delineated pedestrian crosswalks on the approaches to the rotary; therefore, pedestrians were observed crossing in undesirable locations.</p>

<p><i>Photo illustrates a pedestrian crossing the rotary with no delineated crosswalks.</i></p>				<p>- Delineate crosswalks on all approaches including the installation of ADA compliant ramps.</p>	<p>- Consider constructing a new modern roundabout to replace the existing rotary and incorporating delineated crosswalks and ADA compliant ramps.</p>

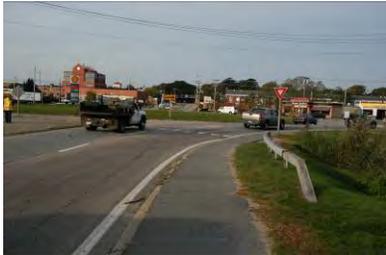
SPECIFIC NEAR TERM IMPROVEMENTS			POTENTIAL INTERMEDIATE IMPROVEMENTS	POTENTIAL LONG TERM IMPROVEMENTS
			(1-6 MONTHS)			(6 MONTHS - 2 YEARS)	(2 OR MORE YEARS)
NO.	ISSUES/CONCERNS	EXAMPLE OF ISSUES	ENGINEERING	ENFORCEMENT	EDUCATION & ENCOURAGEMENT	ENGINEERING	ENGINEERING
6	<p>Replace old/substandard guardrail on east leg of rotary</p> <p>– There is guardrail adjacent to the rotary that is old and does not meet current standards.</p>

<p><i>Photo illustrates the non-standard guardrail on the east leg of the rotary.</i></p>	<p>– Replace old guardrail with guardrail that meets current standards.</p>

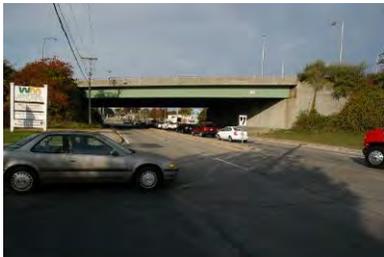
SPECIFIC NEAR TERM IMPROVEMENTS			POTENTIAL INTERMEDIATE IMPROVEMENTS	POTENTIAL LONG TERM IMPROVEMENTS
			(1-6 MONTHS)			(6 MONTHS - 2 YEARS)	(2 OR MORE YEARS)
NO.	ISSUES/CONCERNS	EXAMPLE OF ISSUES	ENGINEERING	ENFORCEMENT	EDUCATION & ENCOURAGEMENT	ENGINEERING	ENGINEERING
1	<p>Queue lengths in the westbound left-turn lane, southbound approach, and eastbound approach</p> <p>- The queues in the westbound left-turn lane extend to the Halsey Street intersection impacting traffic accessing/ egressing Halsey Street. Queue lengths on the southbound approach are very long during peak periods resulting in long delays and congestion within the plaza. The queue lengths on the eastbound approach often extend into the rotary.</p>

<p><i>Photo shows vehicle queues from the westbound left-turn lane extending beyond left-turn pocket.</i></p>	<p>- Optimize traffic signal timings to minimize queues.</p>			<p>- Consider extension of westbound left-turn lane onto Pell Bridge On-Ramp at the intersection to increase capacity and optimize traffic signal timings to minimize queues.</p>	<p>- Consider construction of alternate routes such as the Halsey Street extension to increase capacity in the area and redistribute traffic.</p> <p>- Eliminate left-turns with the conversion of the intersection to a modern roundabout as part of the Admiral Kalbfus Road roundabout corridor.</p>

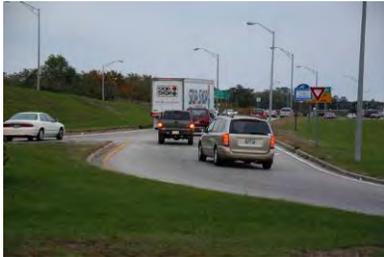
SPECIFIC NEAR TERM IMPROVEMENTS			POTENTIAL INTERMEDIATE IMPROVEMENTS	POTENTIAL LONG TERM IMPROVEMENTS
			(1-6 MONTHS)			(6 MONTHS - 2 YEARS)	(2 OR MORE YEARS)
NO.	ISSUES/CONCERNS	EXAMPLE OF ISSUES	ENGINEERING	ENFORCEMENT	EDUCATION & ENCOURAGEMENT	ENGINEERING	ENGINEERING
2	<p>Queue lengths and rear-end crashes at the merge onto the Pell Bridge On-Ramp</p> <p>-The queue lengths on the eastbound approach often extend into the rotary primarily as a result of the congestion at the merge onto the Pell Bridge On-Ramp. Eastbound vehicles turning right onto the Pell Bridge On-Ramp are required to yield to vehicles entering the On-Ramp from Admiral Kalbfus Road westbound and RK Towne Center approaches. There are some crashes resulting from vehicles not yielding at this location.</p>

<p><i>Photo shows the merge between westbound and eastbound traffic destined to the Pell Bridge.</i></p>	<p>- Consider restriping the merge as two lanes with a lane drop tapering down to one lane.</p>			<p>- Consider widening the Pell Bridge On-Ramp to accommodate two lanes.</p>	<p>- Eliminate the movement with the conversion of the intersection to a modern roundabout as part of the Admiral Kalbfus Road roundabout corridor.</p>

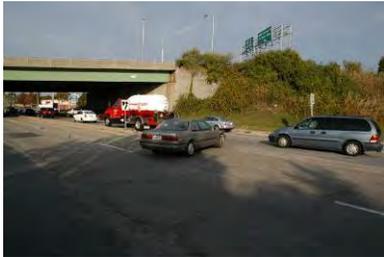
SPECIFIC NEAR TERM IMPROVEMENTS			POTENTIAL INTERMEDIATE IMPROVEMENTS	POTENTIAL LONG TERM IMPROVEMENTS
			(1-6 MONTHS)			(6 MONTHS - 2 YEARS)	(2 OR MORE YEARS)
NO.	ISSUES/CONCERNS	EXAMPLE OF ISSUES	ENGINEERING	ENFORCEMENT	EDUCATION & ENCOURAGEMENT	ENGINEERING	ENGINEERING
3	<p>Westbound left-turn lane at the Pell Bridge On-Ramp extends through the Halsey Street intersection</p> <p>- The westbound left-turn lane is often used by vehicles that are turning left onto the Pell Bridge On-Ramp which can result in crashes if vehicles turning left out of Halsey Street attempt to turn in front of them. There are also periods when the westbound left-turn queues at the RK Towne Center/Pell Bridge traffic signal extend to the Halsey Street intersection impacting access/egress.</p>

<p><i>Photo shows vehicle queues from the westbound left-turn lane extending into the Halsey Street intersection, causing conflicts for exiting vehicles.</i></p>	<p>- Optimize the signal timings at the RK Towne Center/Pell Bridge traffic signal.</p> <p>- Install a DO NOT BLOCK INTERSECTION sign along Admiral Kalbfus Road to provide left-turning vehicles from Halsey Street a gap in traffic.</p>			<p>- Convert intersection to right-in/right-out. This will have impacts to the properties along Halsey Street and coordination is necessary to determine if feasible.</p> <p>- Modify island on westbound approach to extend the length of the left turn lane.</p>	<p>- Convert the intersection to a modern roundabout as part of the Admiral Kalbfus Road roundabout corridor.</p>

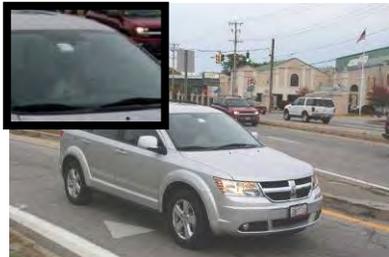
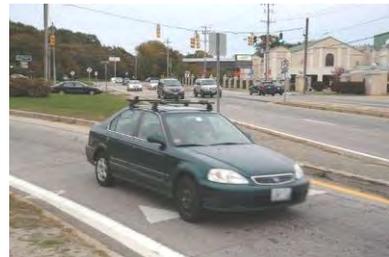
SPECIFIC NEAR TERM IMPROVEMENTS			POTENTIAL INTERMEDIATE IMPROVEMENTS	POTENTIAL LONG TERM IMPROVEMENTS
			(1-6 MONTHS)			(6 MONTHS - 2 YEARS)	(2 OR MORE YEARS)
NO.	ISSUES/CONCERNS	EXAMPLE OF ISSUES	ENGINEERING	ENFORCEMENT	EDUCATION & ENCOURAGEMENT	ENGINEERING	ENGINEERING
1	<p>Angled geometry of Pell Bridge Off-Ramp right-turn yield</p> <p>- The geometry of the Pell Bridge Off-Ramp right-turn is a large radius loop-ramp intersecting westbound Admiral Kalbfus Road at an acute angle with no merge area. This results in a variety of driver behaviors ranging from speeding up to stopping to merge with the westbound traffic. Numerous rear-end collisions occur on this ramp because the geometry and signing elicits non-uniform responses from motorists.</p>

<p><i>Top photo shows a motorist looking "hard" left for a gap in traffic, while the bottom photo shows a motorist looking straight on the Pell Bridge Off-Ramp to Admiral Kalbfus Road westbound. These varying behaviors contribute to rear-end crashes on this approach</i></p>	<p>- Add pavement markings (No Merge Area), advance yield signs on both sides of the road, and a redundant yield sign across from the existing yield signs.</p>			<p>- Realign the Pell Bridge Off-Ramp right-turn to provide a smaller radius and bring it in closer to the signalized intersection and determine if dual right-turns are needed.</p>	<p>- Eliminate the movement with the conversion of the intersection to a modern roundabout as part of the Admiral Kalbfus Road roundabout corridor.</p>

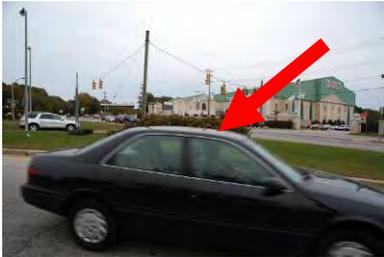
SPECIFIC NEAR TERM IMPROVEMENTS			POTENTIAL INTERMEDIATE IMPROVEMENTS	POTENTIAL LONG TERM IMPROVEMENTS
			(1-6 MONTHS)			(6 MONTHS - 2 YEARS)	(2 OR MORE YEARS)
NO.	ISSUES/CONCERNS	EXAMPLE OF ISSUES	ENGINEERING	ENFORCEMENT	EDUCATION & ENCOURAGEMENT	ENGINEERING	ENGINEERING
2	<p>Bushes in island obstruct sight distance of Pell Bridge Off-Ramp right-turning vehicles</p> <p>- There are bushes in the median that obstruct the sight distance of vehicles heading westbound from the Pell Bridge Off-Ramp.</p>

<p><i>Photo shows the bushes limiting the sight distance for vehicles looking left on the Pell Bridge Off-Ramp to Admiral Kalbfus Road westbound.</i></p>	<ul style="list-style-type: none"> - Trim bushes to improve sight distance - Consider retrofitting the existing rotary with modern roundabout features using striping and signage. 			<ul style="list-style-type: none"> - Realign the Pell Bridge Off-Ramp right-turn to provide a smaller radius and bring it in closer to the signalized intersection.

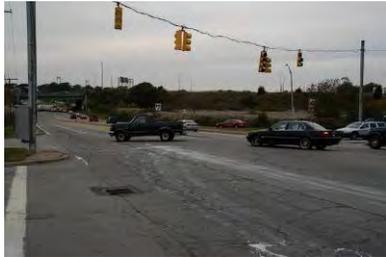
SPECIFIC NEAR TERM IMPROVEMENTS			POTENTIAL INTERMEDIATE IMPROVEMENTS	POTENTIAL LONG TERM IMPROVEMENTS
			(1-6 MONTHS)			(6 MONTHS - 2 YEARS)	(2 OR MORE YEARS)
NO.	ISSUES/CONCERNS	EXAMPLE OF ISSUES	ENGINEERING	ENFORCEMENT	EDUCATION & ENCOURAGEMENT	ENGINEERING	ENGINEERING
3	<p>Lack of left-turn storage lane on westbound approach</p> <p>- Left-turning vehicles from westbound Admiral Kalbfus Road into Newport Grand may block westbound through vehicles because there is not a left-turn pocket. This is likely to occur at critical peak traffic periods when left-turning vehicles are blocked by opposing eastbound traffic and westbound traffic is also its heaviest.</p>

<p><i>Photo illustrates the left-turn movement into Newport Grand. The absence of a left-turn pocket may cause left-turning vehicles to delay westbound vehicles seeking to continue through the intersection.</i></p>	<p>- Consider programming a Time Of Day pattern to allow additional time to Newport Grand related movements during its peak period. Verification of the controller capabilities needs to be address to determine if this is possible.</p>			<p>- Remove island and install westbound left-turn lane. This may require new signal equipment.</p>	<p>- With the conversion of the intersection to a modern roundabout as part of the Admiral Kalbfus Road roundabout corridor, all left-turn will be made at the roundabout, so no left-turn pocket will be required.</p>

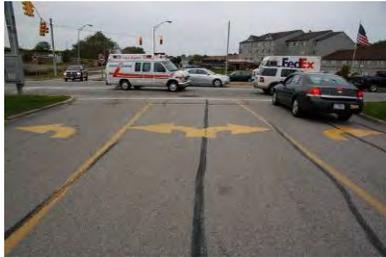
SPECIFIC NEAR TERM IMPROVEMENTS			POTENTIAL INTERMEDIATE IMPROVEMENTS	POTENTIAL LONG TERM IMPROVEMENTS
			(1-6 MONTHS)			(6 MONTHS - 2 YEARS)	(2 OR MORE YEARS)
NO.	ISSUES/CONCERNS	EXAMPLE OF ISSUES	ENGINEERING	ENFORCEMENT	EDUCATION & ENCOURAGEMENT	ENGINEERING	ENGINEERING
4	<p>Northbound Lane use out of Newport Grand</p> <p>- The center lane on the northbound approach out of the Newport Grand driveway is delineated as a shared left-turn/right-turn lane; however it is difficult for two vehicles to make right turns simultaneously. Also, the northbound departure is a dead end road and no vehicles are allowed, but there are no signs or barrier restricting this movement.</p>

<p><i>Photo shows the Newport Grand northbound approach, with the dual left-turn/right-turn movements.</i></p>	<p>- Restripe Newport Grand Driveway with white lane lines and pavement markings consisting of two left-turn lanes and a right-turn lane. Add guide stripes ("Cat tracks") to delineate the dual left turn movement out of Newport Grand.</p> <p>- Install object markers and concrete barrier to help identify the restricted movement and restrict access to the dead-end road.</p>				<p>- Remove pavement and landscape dead-end road.</p>

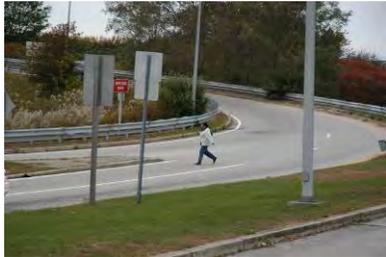
SPECIFIC NEAR TERM IMPROVEMENTS			POTENTIAL INTERMEDIATE IMPROVEMENTS	POTENTIAL LONG TERM IMPROVEMENTS
			(1-6 MONTHS)			(6 MONTHS - 2 YEARS)	(2 OR MORE YEARS)
NO.	ISSUES/CONCERNS	EXAMPLE OF ISSUES	ENGINEERING	ENFORCEMENT	EDUCATION & ENCOURAGEMENT	ENGINEERING	ENGINEERING
5	<p>Lack of marked crosswalks and ADA compliant ramps</p> <p>- Marked crosswalks and ADA compliant ramps are missing at this intersection. There are also pedestrians that walk down Halsey Street where there are no sidewalks.</p>

<p><i>Photo illustrates a pedestrian walking along the north side of Admiral Kalbfus. The pedestrian was observed to walk up the Pell Bridge off-ramp to find a suitable location to cross the ramp.</i></p>	<p>- The context of the road is one which supports several modes due to the surrounding land uses. Emphasis of this environment through the use of pavement markings may enhance the safety and comfort of pedestrians. Consider marking crosswalks and installing ADA compliant ramps for pedestrians walking parallel to Admiral Kalbfus.</p>				<p>- Create pedestrian crossings as part of the conversion of the intersection to a modern roundabout as part of the Admiral Kalbfus Road roundabout corridor.</p>

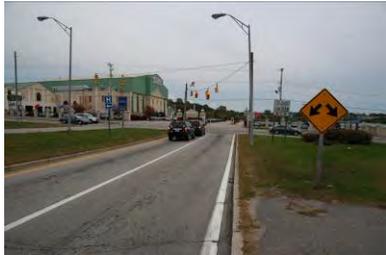
SPECIFIC NEAR TERM IMPROVEMENTS			POTENTIAL INTERMEDIATE IMPROVEMENTS	POTENTIAL LONG TERM IMPROVEMENTS
			(1-6 MONTHS)			(6 MONTHS - 2 YEARS)	(2 OR MORE YEARS)
NO.	ISSUES/CONCERNS	EXAMPLE OF ISSUES	ENGINEERING	ENFORCEMENT	EDUCATION & ENCOURAGEMENT	ENGINEERING	ENGINEERING
6	<p>There is a lack of delineation for the dual-left movement onto Admiral Kalbfus Road</p> <p>- There are insufficient pavement markings and signage to notify and guide the driver for the dual left-turn.</p>

<p><i>Photo shows the Pell-Bridge Off-Ramp approach. There is a lack of adequate markings and signage for the dual-left-turn movement.</i></p>	<ul style="list-style-type: none"> - Install supplemental lane use signs for the off-ramp approach - Install pavement parking that delineate the dual left-turn movement. 				<ul style="list-style-type: none"> - Eliminate the movement with the conversion of the intersection to a modern roundabout as part of the Admiral Kalbfus Road roundabout corridor.

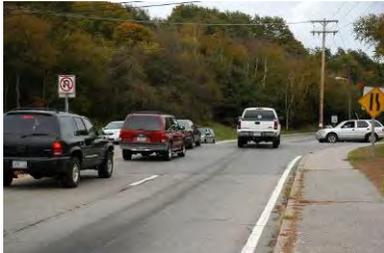
SPECIFIC NEAR TERM IMPROVEMENTS			POTENTIAL INTERMEDIATE IMPROVEMENTS	POTENTIAL LONG TERM IMPROVEMENTS
			(1-6 MONTHS)			(6 MONTHS - 2 YEARS)	(2 OR MORE YEARS)
NO.	ISSUES/CONCERNS	EXAMPLE OF ISSUES	ENGINEERING	ENFORCEMENT	EDUCATION & ENCOURAGEMENT	ENGINEERING	ENGINEERING
1	<p>Heavy traffic volumes and turning movements to/from Malbone Road/Girard Avenue</p> <p>- The traffic entering/exiting Malbone Road/Girard Avenue experience delays during peak periods.</p>

<p><i>Photo illustrates the heavy traffic volumes experienced at the intersection, looking eastbound toward the intersection</i></p>	<p>- Perform turning movement counts during the summer months and perform capacity analysis.</p>				<p>- Perform a traffic signal warrant analysis to determine if installation of a traffic signal can be justified or if installation of a roundabout would be beneficial.</p>
2	<p>Eastbound two lane approach tapers to one lane through the intersection</p> <p>- The roadway traveling eastbound tapers through the intersection from two lanes to one lane increasing the number of conflict points at the intersection.</p>

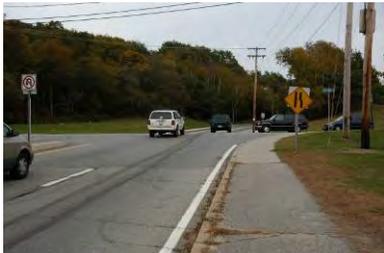
<p><i>Photo shows the taper along Admiral Kalbfus Road from 2 lanes to 1 lane through the Malbone Road/Girard Road intersection.</i></p>					<p>- Consider reconstructing the eastbound departure to accommodate two lanes that taper to one lane.</p> <p>- Convert the intersection to a modern roundabout as part of the Admiral Kalbfus Road roundabout corridor.</p>

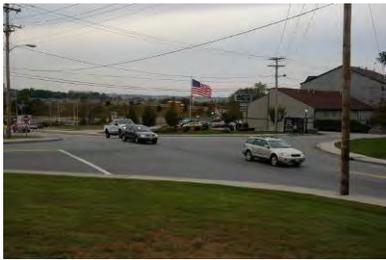
SPECIFIC NEAR TERM IMPROVEMENTS			POTENTIAL INTERMEDIATE IMPROVEMENTS	POTENTIAL LONG TERM IMPROVEMENTS
			(1-6 MONTHS)			(6 MONTHS - 2 YEARS)	(2 OR MORE YEARS)
NO.	ISSUES/CONCERNS	EXAMPLE OF ISSUES	ENGINEERING	ENFORCEMENT	EDUCATION & ENCOURAGEMENT	ENGINEERING	ENGINEERING
3	<p>Large radii on all corners</p> <p>- There are large radii on all corners creating a wide open intersection. This makes it difficult for pedestrians and motorists to cross the intersection. Motorists were observed to wait far in advance of the stop bar on the minor street approaches to squeeze through a gap in traffic. The large radii also results in high turning speeds which may increase risk to pedestrians crossing.</p>

<p><i>Photo shows the large radius along all four corners of the intersection, leading to high turning speeds and longer pedestrian crossings.</i></p>				<p>- Reconstruct small corner radii.</p>	<p>- Convert the intersection to a modern roundabout as part of the Admiral Kalbfus Road roundabout corridor.</p>

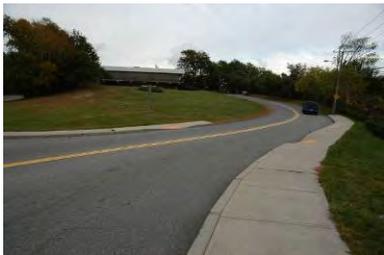
SPECIFIC NEAR TERM IMPROVEMENTS			POTENTIAL INTERMEDIATE IMPROVEMENTS	POTENTIAL LONG TERM IMPROVEMENTS
			(1-6 MONTHS)			(6 MONTHS - 2 YEARS)	(2 OR MORE YEARS)
NO.	ISSUES/CONCERNS	EXAMPLE OF ISSUES	ENGINEERING	ENFORCEMENT	EDUCATION & ENCOURAGEMENT	ENGINEERING	ENGINEERING
4	<p>ADA ramps are located around the corners on Malbone Road and Girard Avenue</p> <p>- The ADA ramps on the northbound and southbound approaches are set back from the intersection at locations motorists may not be expecting to find pedestrians crossing. Furthermore, the locations of the ramps are at locations where turning vehicles are typically accelerating, thus, potentially reducing motorist yielding to pedestrians.</p>

<p><i>Photo illustrates the existing ADA ramps located south of the intersection, along Malbone Road, which are designed to serve pedestrians walking along Admiral Kalbfus Road.</i></p>	<p>- Install TURNING VEHICLES YIELD TO PEDESTRIANS on the Admiral Kalbfus Road approaches to the intersection to warn drivers of the crossings beyond the immediate intersection.</p>			<p>- Reduce turning radii, which will shorten the pedestrian crossings and relocate the ADA ramps and pedestrian crossings at the intersection.</p>

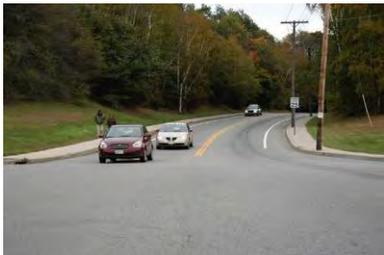
SPECIFIC NEAR TERM IMPROVEMENTS			POTENTIAL INTERMEDIATE IMPROVEMENTS	POTENTIAL LONG TERM IMPROVEMENTS
			(1-6 MONTHS)			(6 MONTHS - 2 YEARS)	(2 OR MORE YEARS)
NO.	ISSUES/CONCERNS	EXAMPLE OF ISSUES	ENGINEERING	ENFORCEMENT	EDUCATION & ENCOURAGEMENT	ENGINEERING	ENGINEERING
5	<p>High travel speeds on the eastbound and westbound approaches</p> <p>- Travel speeds on the eastbound approach are higher than the 25 mph posted speed limit due to vehicles racing from the Pell Bridge Off-Ramp/Newport Grand to the merge through the Girard Avenue/Malbone Road intersection. On the westbound approach, there is a significant down slope resulting in vehicles traveling higher than the 25 mph legal speed limit.</p>

<p><i>Photo illustrates the down slope on westbound Admiral Kalbfus Road, leading to high speeds.</i></p>	<p>- Install 25 MPH speed limit signs on the eastbound and westbound approaches. Use portable speed feedback signs to alert motorists of their speeds.</p>	<p>- Increase police enforcement of speed limit. The only posted speed limits are located on the intersection departures.</p>			<p>- Convert the intersection to a modern roundabout as part of the Admiral Kalbfus Road roundabout corridor.</p>

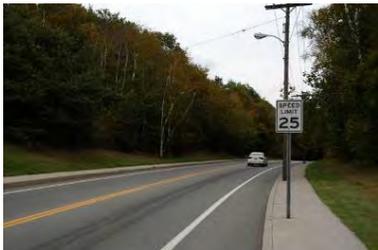
SPECIFIC NEAR TERM IMPROVEMENTS			POTENTIAL INTERMEDIATE IMPROVEMENTS	POTENTIAL LONG TERM IMPROVEMENTS
			(1-6 MONTHS)			(6 MONTHS - 2 YEARS)	(2 OR MORE YEARS)
NO.	ISSUES/CONCERNS	EXAMPLE OF ISSUES	ENGINEERING	ENFORCEMENT	EDUCATION & ENCOURAGEMENT	ENGINEERING	ENGINEERING
6	<p>Restricted sight distance on side streets</p> <p>- In addition to the horizontal curvature, there is also a vertical upgrade on the east side of the intersection that impacts the sight distance of vehicles particularly on the northbound approach.</p>

<p><i>Photo illustrates the restricted sight distance for vehicles exiting Malbone Road looking east.</i></p>					<p>- Consider geometric improvements and/or consider installation of a traffic signal or roundabout.</p>
7	<p>Heavy vehicle restriction sign poorly located</p> <p>- There is a sign restricting heavy vehicles from traveling south on Malbone Street that is located too far around the corner and south of the intersection to notify heavy vehicles before they turn.</p>

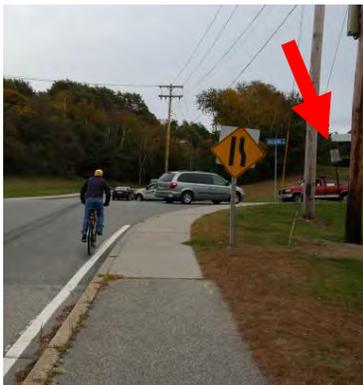
<p><i>Photo illustrates the location of the heavy vehicle restriction sign on Malbone Street.</i></p>	<p>- Consider relocating the signs restricting heavy vehicles from traveling south on Malbone Street.</p>

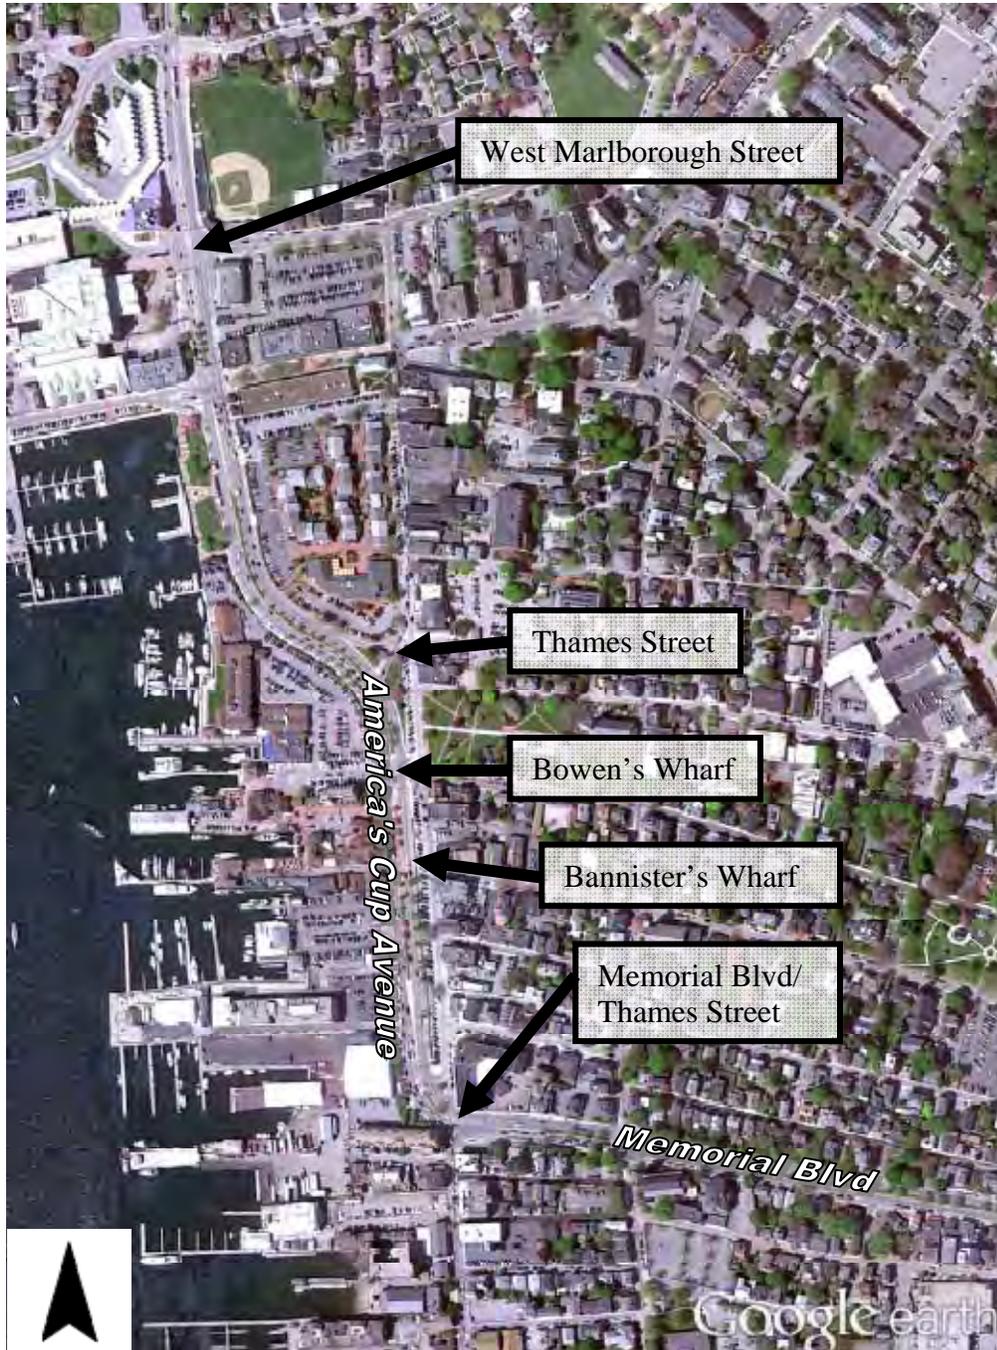
Figure 2-13 America's Cup Avenue Study Area Corridor and Intersections

America's Cup Avenue is a primary route for tourists, providing access to hotels, restaurants, shops and Newport Harbor. Vehicular, pedestrian, and bicyclist traffic volumes in this corridor are seasonal with the highest volumes occurring during the summer months due to tourism. The sidewalk is generally in good condition consisting of a wide concrete walkway lined with a brick walk located between the curb and the concrete walk. The RSAs were performed at the intersections as shown in **Figure 2-13** and as discussed in the following section.

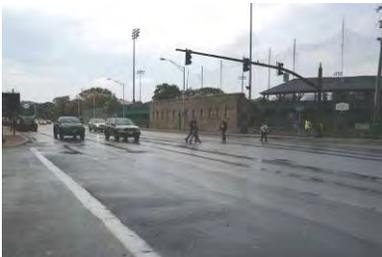
SPECIFIC NEAR TERM IMPROVEMENTS			POTENTIAL INTERMEDIATE IMPROVEMENTS	POTENTIAL LONG TERM IMPROVEMENTS
			(1-6 MONTHS)			(6 MONTHS - 2 YEARS)	(2 OR MORE YEARS)
NO.	ISSUES/CONCERNS	EXAMPLE OF ISSUES	ENGINEERING	ENFORCEMENT	EDUCATION & ENCOURAGEMENT	ENGINEERING	ENGINEERING
1	<p>Long pedestrian crossings and pedestrian clearance times appear to be too short</p> <ul style="list-style-type: none"> - Crosswalks are skewed, increasing the crossing distance. As a result, pedestrian clearance times appear to be too short.

<p><i>Photo depicts the long pedestrian crossing on the north side of the intersection.</i></p>	<ul style="list-style-type: none"> - Check pedestrian clearance timings and change programmed timings to meet required minimum clearance times per MUTCD standards. - Perform capacity analysis to determine if the number of lanes at this intersection can be reduced. 			<ul style="list-style-type: none"> - Install new wheelchair ramps on the northeast corner and restripe crosswalks to reduce the crossing lengths. - Consider reducing the radii on all corners and bumping out the curb line on the southeast corner. 	<ul style="list-style-type: none"> - Reduce the number of lanes at the intersection if warranted.

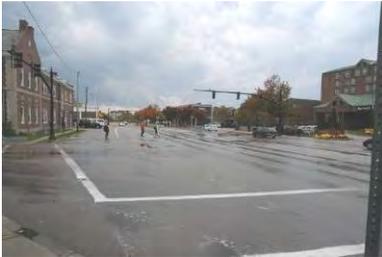
SPECIFIC NEAR TERM IMPROVEMENTS			POTENTIAL INTERMEDIATE IMPROVEMENTS	POTENTIAL LONG TERM IMPROVEMENTS
			(1-6 MONTHS)			(6 MONTHS - 2 YEARS)	(2 OR MORE YEARS)
NO.	ISSUES/CONCERNS	EXAMPLE OF ISSUES	ENGINEERING	ENFORCEMENT	EDUCATION & ENCOURAGEMENT	ENGINEERING	ENGINEERING
2	<p>Minimal pedestrian refuge area on the southeast corner and no crosswalk on south leg of intersection</p> <p>- There is little refuge area for pedestrians on the southeast corner of the intersection adjacent to the fire station and there is no marked crosswalk on the south leg of the intersection.</p>

<p><i>Photo shows pedestrians crossing the south leg of the intersection, where no marked crosswalk exists.</i></p>	<p>- Perform capacity analysis to determine of the number of lanes at this intersection can be reduced.</p>			<p>- Consider bumping out the curb line on the southeast corner.</p>	<p>- Reduce the number of lanes at the intersection if warranted.</p>

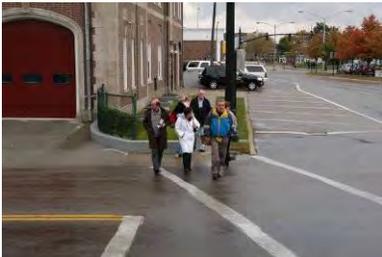
3	<p>No pedestrian pushbuttons or pedestrian signal heads on the West Marlborough Street leg</p> <p>- No pedestrian pushbuttons or pedestrian signal heads currently exist on the West Marlborough Street east leg of the intersection.</p>

<p><i>Photo illustrates the lack of pedestrian signal heads on the West Marlborough Street leg of the intersection.</i></p>				<p>- Install new pedestrian pushbuttons and pedestrian signal heads with countdown timers on the West .Marlborough Street east leg of the intersection.</p>

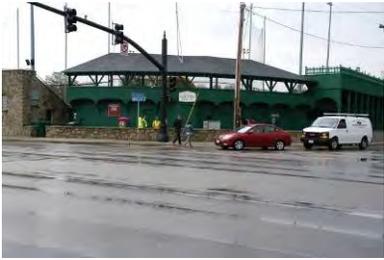
SPECIFIC NEAR TERM IMPROVEMENTS			POTENTIAL INTERMEDIATE IMPROVEMENTS	POTENTIAL LONG TERM IMPROVEMENTS
			(1-6 MONTHS)			(6 MONTHS - 2 YEARS)	(2 OR MORE YEARS)
NO.	ISSUES/CONCERNS	EXAMPLE OF ISSUES	ENGINEERING	ENFORCEMENT	EDUCATION & ENCOURAGEMENT	ENGINEERING	ENGINEERING
4	<p>Foul balls from baseball field sometimes strike vehicles</p> <p>- Based on the crash data and discussions with the fire department, foul balls from the baseball field sometimes hit vehicles parked near and traveling through the intersection.</p>

<p><i>Photo shows the Cardines Memorial Field, where foul balls sometimes strike vehicles.</i></p>				Intermediate – Install a better backstop/netting that is possibly curved to prevent foul balls from leaving the park.	
5	<p>Narrow (3 foot wide) sidewalk adjacent to the fire station</p> <p>- There is only a 3 foot wide sidewalk in front of the fire station adjacent to the northbound approach.</p>

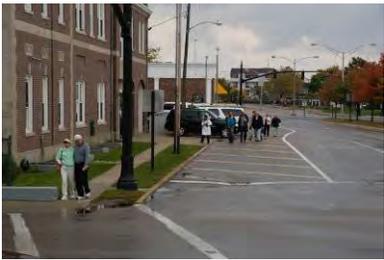
<p><i>Photo shows the narrow sidewalk adjacent to the fire station, with pedestrian activity in this area.</i></p>	– Delineate crosswalks on all approaches including the installation of ADA compliant ramps.			– Consider widening sidewalk adjacent to the fire station to at least 5 feet.

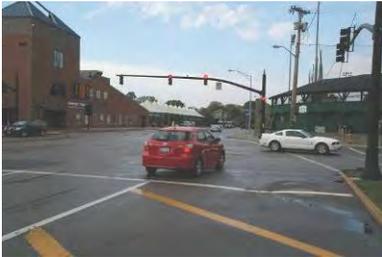
SPECIFIC NEAR TERM IMPROVEMENTS			POTENTIAL INTERMEDIATE IMPROVEMENTS	POTENTIAL LONG TERM IMPROVEMENTS
			(1-6 MONTHS)			(6 MONTHS - 2 YEARS)	(2 OR MORE YEARS)
NO.	ISSUES/CONCERNS	EXAMPLE OF ISSUES	ENGINEERING	ENFORCEMENT	EDUCATION & ENCOURAGEMENT	ENGINEERING	ENGINEERING
6	<p>Lack of compliance to “NO RIGHT TURN ON RED” sign on northbound approach</p> <p>- Although the northbound right-turn is signed “No Right Turn on Red” many vehicles continue to turn on red.</p>

<p><i>Photo shows vehicles from West Marlborough Street turning right on red onto America’s Cup Avenue. There is a “NO RIGHT TURN ON RED” posted on this approach.</i></p>		<p>– Increase police enforcement of no right-turn on red.</p>		<p>– Consider bumping out the curb line on the southeast corner.</p>	
7	<p>Fire pre-emption doesn’t meet needs of fire department</p> <p>– Based on conversations with the fire department, a new fire pre-empt is needed.</p>

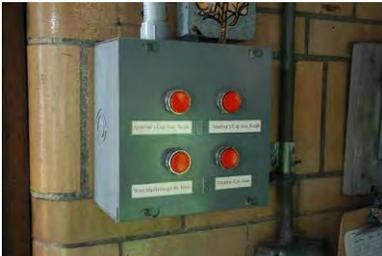
<p><i>Photo shows the existing pre-empt unit in the fire station.</i></p>				<p>– Consider installing a new fire pre-emption.</p>

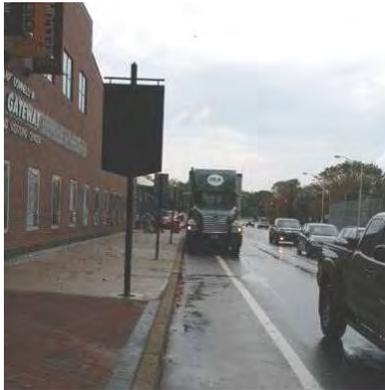
SPECIFIC NEAR TERM IMPROVEMENTS			POTENTIAL INTERMEDIATE IMPROVEMENTS	POTENTIAL LONG TERM IMPROVEMENTS
			(1-6 MONTHS)			(6 MONTHS - 2 YEARS)	(2 OR MORE YEARS)
NO.	ISSUES/CONCERNS	EXAMPLE OF ISSUES	ENGINEERING	ENFORCEMENT	EDUCATION & ENCOURAGEMENT	ENGINEERING	ENGINEERING
8	<p>Trucks park on southbound approach</p> <p>-Based on conversations with the City and observations in the field, there are trucks that park on the southbound approach blocking the right lane.</p>

<p><i>Photo illustrates heavy vehicles parking along America's Cup Avenue, partially blocking the right travel lane.</i></p>	<p>- Consider replacing existing signs with new signs that include fines. This would require an ordinance.</p>	<p>- If new signs are installed, enforcement of No Parking restrictions will be important.</p>

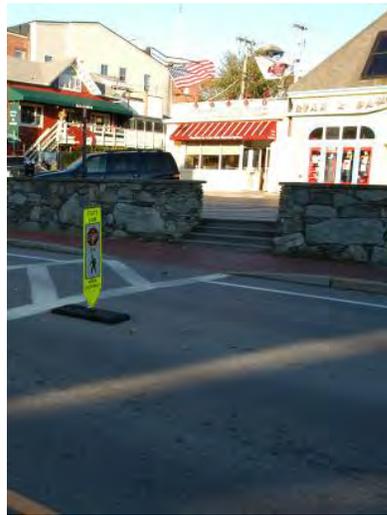
SPECIFIC NEAR TERM IMPROVEMENTS			POTENTIAL INTERMEDIATE IMPROVEMENTS	POTENTIAL LONG TERM IMPROVEMENTS
			(1-6 MONTHS)			(6 MONTHS - 2 YEARS)	(2 OR MORE YEARS)
NO.	ISSUES/CONCERNS	EXAMPLE OF ISSUES	ENGINEERING	ENFORCEMENT	EDUCATION & ENCOURAGEMENT	ENGINEERING	ENGINEERING
1	<p>ADA issues</p> <p>- There are ADA issues along this corridor that restrict access for pedestrians with mobility limitations.</p>

<p><i>Photo shows the stairs on the east side of the pedestrian crosswalk. There are other features along this corridor that are not ADA accessible</i></p>				<p>- Consider installing ADA-compliant ramps with detectable warning systems and marked crosswalks at all pedestrian crossings.</p>	<p>- Consider installing ADA-compliant ramps where stairs currently exist at locations along the corridor.</p>

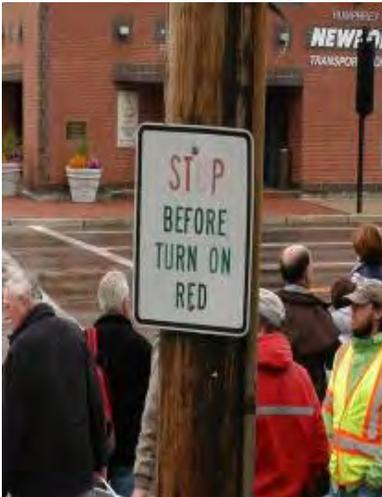
SPECIFIC NEAR TERM IMPROVEMENTS			POTENTIAL INTERMEDIATE IMPROVEMENTS	POTENTIAL LONG TERM IMPROVEMENTS
			(1-6 MONTHS)			(6 MONTHS - 2 YEARS)	(2 OR MORE YEARS)
NO.	ISSUES/CONCERNS	EXAMPLE OF ISSUES	ENGINEERING	ENFORCEMENT	EDUCATION & ENCOURAGEMENT	ENGINEERING	ENGINEERING
2	<p>Outdated signs that do not meet MUTCD standards and small text on way-finding signs</p> <p>- There are outdated signs along the corridor that do not meet current MUTCD standards. The existing way-finding signs have small text sizes and are difficult to read.</p>

<p><i>Photo shows sample of outdated signage along the corridor, which is not in compliance with MUTCD standards.</i></p>	<p>- Consider removing and replacing outdated signs along the corridor that do not meet current MUTCD standards.</p>			<p>- Consider installing new way-finding signs with larger text size that are easier to read.</p>

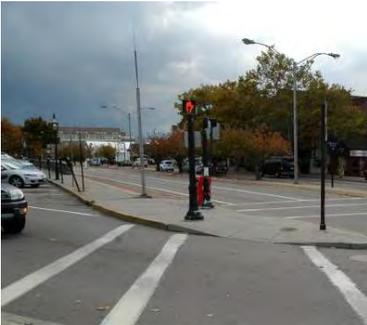
SPECIFIC NEAR TERM IMPROVEMENTS			POTENTIAL INTERMEDIATE IMPROVEMENTS	POTENTIAL LONG TERM IMPROVEMENTS
			(1-6 MONTHS)			(6 MONTHS - 2 YEARS)	(2 OR MORE YEARS)
NO.	ISSUES/CONCERNS	EXAMPLE OF ISSUES	ENGINEERING	ENFORCEMENT	EDUCATION & ENCOURAGEMENT	ENGINEERING	ENGINEERING
3	<p>Pedestrian countdown timers</p> <p>- There are no pedestrian countdown timers along the corridor.</p>

<p><i>Photo shows typical pedestrian signal head along America's Cup Avenue corridor.</i></p>				<p>- Consider installing new countdown timers along the entire corridor as required by RIDOT policy and MUTCD standards.</p>	
4	<p>Trucks park on southbound lanes</p> <p>-Based on conversations with the City, there are trucks that park along America's Cup Avenue southbound.</p>

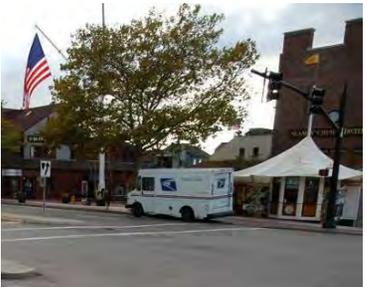
<p><i>Photo illustrates delivery vehicles parking along America's Cup Avenue, partially blocking the right travel lane.</i></p>	<p>- Consider replacing existing signs with new signs that include fines. This may require an ordinance.</p>	<p>- If new signs are installed, enforcement of No Parking restrictions will be important.</p>

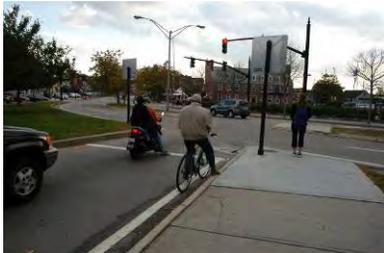
SPECIFIC NEAR TERM IMPROVEMENTS (1-6 MONTHS)			POTENTIAL INTERMEDIATE IMPROVEMENTS (6 MONTHS - 2 YEARS)	POTENTIAL LONG TERM IMPROVEMENTS (2 OR MORE YEARS)
NO.	ISSUES/CONCERNS	EXAMPLE OF ISSUES	ENGINEERING	ENFORCEMENT	EDUCATION & ENCOURAGEMENT	ENGINEERING	ENGINEERING
1	<p>No crosswalks or ADA ramps</p> <p>- There are no crosswalks across America's Cup Avenue between Market Square and Long Warf (approximately ¼ mile); therefore many pedestrians were observed crossing at the Thames Street southbound intersection (80 feet wide) where there are currently no pedestrian accommodations.</p>

<p><i>Photo depicts a heavily used pedestrian crossing with no marked crosswalks, ADA compliant ramps, or pedestrian signal heads</i></p>	<p>- Install marked crosswalks with pedestrian signal heads and ADA ramps on the north leg of the intersection.</p>			<p>- Consider installing marked crosswalks and ADA ramps on the east leg and channelized right turn movement.</p>

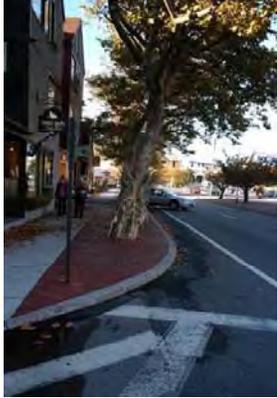
SPECIFIC NEAR TERM IMPROVEMENTS			POTENTIAL INTERMEDIATE IMPROVEMENTS	POTENTIAL LONG TERM IMPROVEMENTS
			(1-6 MONTHS)			(6 MONTHS - 2 YEARS)	(2 OR MORE YEARS)
NO.	ISSUES/CONCERNS	EXAMPLE OF ISSUES	ENGINEERING	ENFORCEMENT	EDUCATION & ENCOURAGEMENT	ENGINEERING	ENGINEERING
1	<p>Poor sight distance on west side of road at crosswalk due to trees lining the roadway</p> <p>- There are trees along the west side of America's Cup Avenue that obstruct the sight distance of pedestrians attempting to cross the roadway.</p>

<p><i>Photo illustrates the view of vehicles/pedestrian looking north out of Bannister's Wharf. There is limited sight distance due to the row of trees in the sidewalk</i></p>				<p>- Consider relocating the crosswalk to the south leg of the West Pelham Street intersection. This would improve the sight distance looking north at the crosswalk. The crosswalk would not line up with the stairs on the east side of the road; therefore, some type of channelization should be considered.</p>

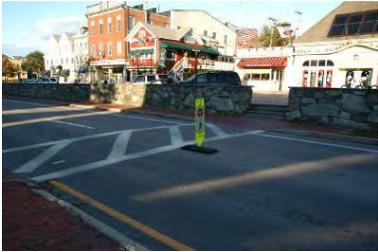
SPECIFIC NEAR TERM IMPROVEMENTS			POTENTIAL INTERMEDIATE IMPROVEMENTS	POTENTIAL LONG TERM IMPROVEMENTS
			(1-6 MONTHS)			(6 MONTHS - 2 YEARS)	(2 OR MORE YEARS)
NO.	ISSUES/CONCERNS	EXAMPLE OF ISSUES	ENGINEERING	ENFORCEMENT	EDUCATION & ENCOURAGEMENT	ENGINEERING	ENGINEERING
2	<p>Stairs on east side of pedestrian crosswalk are not handicap accessible</p> <p>- There are ADA issues on the east side of the road where there are currently stairs leading to Thames Street.</p>

<p><i>Photo shows the stairs on the east side of the pedestrian crosswalk. The stairs are not ADA accessible.</i></p>					<p>- Consider installing a ramp that is ADA compliant on the east side of the roadway.</p>
3	<p>Continuity of pedestrian zones</p> <p>- The waiting area for pedestrians on the southwest corner is not clearly defined which could contribute to conflicts between pedestrians and vehicles. This condition is exacerbated by the limited sight distance around the building corner and the trees to the north that are in the sight triangle for vehicles exiting the side street.</p>

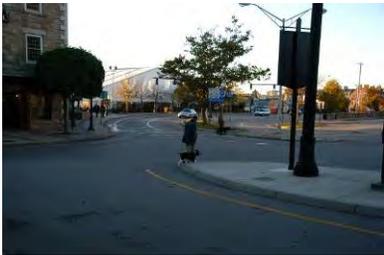
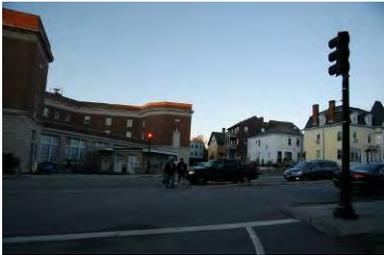
SPECIFIC NEAR TERM IMPROVEMENTS			POTENTIAL INTERMEDIATE IMPROVEMENTS	POTENTIAL LONG TERM IMPROVEMENTS
			(1-6 MONTHS)			(6 MONTHS - 2 YEARS)	(2 OR MORE YEARS)
NO.	ISSUES/CONCERNS	EXAMPLE OF ISSUES	ENGINEERING	ENFORCEMENT	EDUCATION & ENCOURAGEMENT	ENGINEERING	ENGINEERING
1	<p>Lack of pedestrian crosswalks</p> <p>- There is only one delineated crosswalk on the west leg of the wide intersection. This intersection is one of the busiest for both vehicles AND pedestrians</p>

<p><i>Photos show pedestrians crossing where no crosswalks exist.</i></p>				<ul style="list-style-type: none"> - Stripe crosswalks and install pedestrian signal heads with countdown timers. - Install landscaping/hardscaping to deter pedestrian from crossing at unauthorized areas. - Add pedestrian signal heads and exclusive pedestrian phase. 	<ul style="list-style-type: none"> - Remove the "Jug-Handle" and convert to a pedestrian refuge area. This will shorten pedestrian crossings, and extend the left-turn lane storage from Memorial Boulevard onto Thames Street southbound. However, this concept would restrict access to the Post-Office to right-in/right-out. Coordination will be necessary to determine if this concept is feasible.

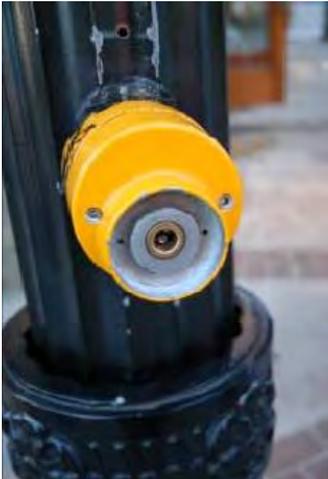
SPECIFIC NEAR TERM IMPROVEMENTS			POTENTIAL INTERMEDIATE IMPROVEMENTS	POTENTIAL LONG TERM IMPROVEMENTS
			(1-6 MONTHS)			(6 MONTHS - 2 YEARS)	(2 OR MORE YEARS)
NO.	ISSUES/CONCERNS	EXAMPLE OF ISSUES	ENGINEERING	ENFORCEMENT	EDUCATION & ENCOURAGEMENT	ENGINEERING	ENGINEERING
2	<p>Broken pedestrian equipment</p> <p>- The pedestrian pushbutton on the southwest corner is broken</p>

<p><i>Photo shows a broken pedestrian push button located on the southwest corner of the intersection.</i></p>	- Replace the pedestrian pushbutton on the southwest corner.

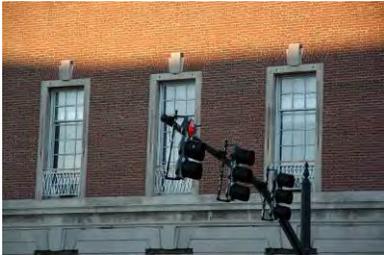
SPECIFIC NEAR TERM IMPROVEMENTS			POTENTIAL INTERMEDIATE IMPROVEMENTS	POTENTIAL LONG TERM IMPROVEMENTS
			(1-6 MONTHS)			(6 MONTHS - 2 YEARS)	(2 OR MORE YEARS)
NO.	ISSUES/CONCERNS	EXAMPLE OF ISSUES	ENGINEERING	ENFORCEMENT	EDUCATION & ENCOURAGEMENT	ENGINEERING	ENGINEERING
3	<p>Missing hoods on traffic signal heads</p> <p>- There are no hoods on the traffic signal heads on America's Cup Avenue at the U-turn.</p>

<p><i>Photo shows the existing traffic signal heads with missing hoods</i></p>	<p>- Replace missing hoods or replace entire signal heads.</p>				
4	<p>Signs poorly located resulting in driver confusion</p> <p>- The "DO NOT ENTER" sign located at the entrance to the Thames Street northbound from the southbound America's Cup Avenue U-turn movement was observed to cause some confusion with motorists.</p>

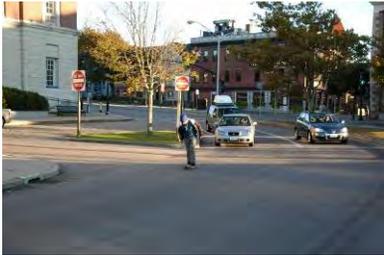
<p><i>Photo shows the "DO NOT ENTER" signs located at the Thames Street northbound entrance from America's Cup Avenue southbound. This can cause confusion for vehicles making this movement.</i></p>	<p>- Improve signage to help guide vehicles through one-way Thames Street. See Figure 3-7 for details on sign type and location.</p>

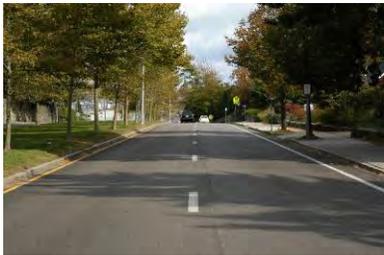
SPECIFIC NEAR TERM IMPROVEMENTS			POTENTIAL INTERMEDIATE IMPROVEMENTS	POTENTIAL LONG TERM IMPROVEMENTS
			(1-6 MONTHS)			(6 MONTHS - 2 YEARS)	(2 OR MORE YEARS)
NO.	ISSUES/CONCERNS	EXAMPLE OF ISSUES	ENGINEERING	ENFORCEMENT	EDUCATION & ENCOURAGEMENT	ENGINEERING	ENGINEERING
1	<p>High travel speeds along Memorial Boulevard</p> <p>- The Memorial Blvd eastbound and westbound approaches are approximately 28 feet wide. This wide width and straight alignment results in vehicles traveling at 40 to 45 mph. The speed limit is not posted; therefore the legal speed limit in Newport is 25 mph. There is also a large speed differential between vehicles traveling through the intersection and turning vehicles which was identified as a safety concern in the field.</p>

<p><i>Photo depicts the wide travel lanes along Memorial Boulevard.</i></p>	<ul style="list-style-type: none"> - Consider installing speed limit signs. - Consider restriping Memorial Boulevard as the following cross-section: a one foot offset from the median, two 11 foot travel lanes and a 5 foot shoulder. The narrower travel lanes may help reduce speeds and the 5 foot shoulder will provide better accommodations for bicycles. 	<ul style="list-style-type: none"> - Increase police patrols and enforcement of speed limit.

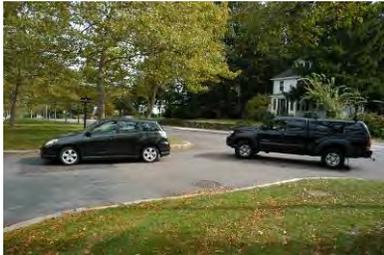
SPECIFIC NEAR TERM IMPROVEMENTS			POTENTIAL INTERMEDIATE IMPROVEMENTS	POTENTIAL LONG TERM IMPROVEMENTS
			(1-6 MONTHS)			(6 MONTHS - 2 YEARS)	(2 OR MORE YEARS)
NO.	ISSUES/CONCERNS	EXAMPLE OF ISSUES	ENGINEERING	ENFORCEMENT	EDUCATION & ENCOURAGEMENT	ENGINEERING	ENGINEERING
2	<p>Queue spill back in median blocks other movements</p> <p>- Vehicles queued in the median often extend into and block the eastbound/westbound through lanes. These queues also block vehicles traveling in the other direction crossing the median.</p>

<p><i>Photo illustrates vehicle queues from the median extending into the Memorial Boulevard travel lane.</i></p>	<p>- Consider installing intersection warning signs in advance of the intersection.</p>				<p>- Consider removing a few trees on each of the approaches to develop a short left turn pocket on the eastbound/westbound approaches.</p>
3	<p>Narrow width of median opening</p> <p>- The width of the opening in the median is only 25± feet wide..</p>
