Rhode Island Strategically Targeted Affordable Roadway Solutions

Aquidneck Island 2010-2011

Aquidneck Island
Transportation Study
On the move...connecting our communities

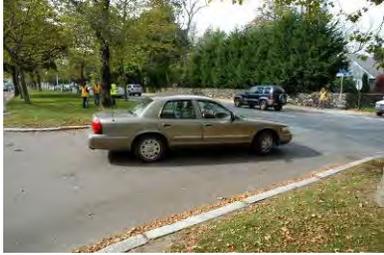
<p><i>Photo illustrates vehicle queues from the median extending into the Memorial Boulevard travel lane.</i></p>	<p>- Consider installing intersection warning signs in advance of the intersection.</p>				<p>- Consider removing a few trees on each of the approaches to develop a short left turn pocket on the eastbound/westbound approaches.</p>
3	<p>Narrow width of median opening</p> <p>- The width of the opening in the median is only 25± feet wide..</p>

<p><i>Photo illustrates vehicle taking up the entire median opening.</i></p>				<p>- Consider widening the median opening.</p>

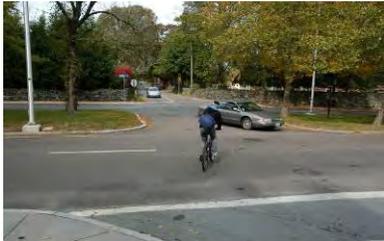
SPECIFIC NEAR TERM IMPROVEMENTS			POTENTIAL INTERMEDIATE IMPROVEMENTS	POTENTIAL LONG TERM IMPROVEMENTS
			(1-6 MONTHS)			(6 MONTHS - 2 YEARS)	(2 OR MORE YEARS)
NO.	ISSUES/CONCERNS	EXAMPLE OF ISSUES	ENGINEERING	ENFORCEMENT	EDUCATION & ENCOURAGEMENT	ENGINEERING	ENGINEERING
4	<p>U-turns traveling on wrong side of roadway</p> <p>- Some U-turning traffic was observed traveling on the left side of the roadway as they passed through the opening in the median which is undelineated. This resulted in vehicle conflicts and queues.</p>

<p><i>Photo shows a vehicle on the wrong side of the median opening while making a turn onto Memorial Boulevard southbound.</i></p>	<p>- Consider striping a double yellow centerline in the median and stop bar.</p>				
5	<p>Sight distance of vehicles in median obstructed by eastbound/westbound vehicles slowing to make left-turns</p> <p>- The sight distance of vehicles in the median is also obstructed by eastbound/westbound vehicles that are slowing to turn left.</p>

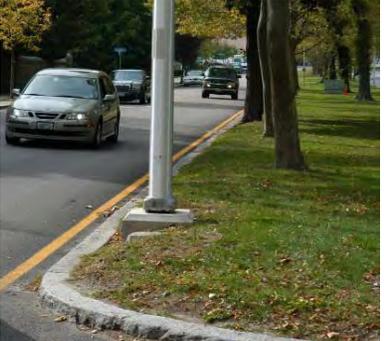
<p><i>Photo shows the limited sight distance vehicles making a turn into Rhode Island Avenue from Memorial Boulevard southbound have.</i></p>	<p>- Consider installing intersection ahead signs on Memorial Boulevard eastbound/westbound approaches to alert motorists of entering traffic.</p>

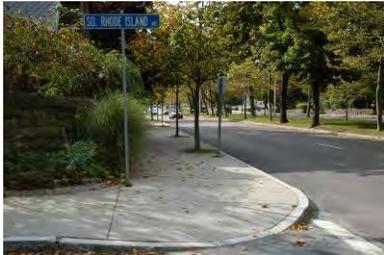
SPECIFIC NEAR TERM IMPROVEMENTS			POTENTIAL INTERMEDIATE IMPROVEMENTS	POTENTIAL LONG TERM IMPROVEMENTS
			(1-6 MONTHS)			(6 MONTHS - 2 YEARS)	(2 OR MORE YEARS)
NO.	ISSUES/CONCERNS	EXAMPLE OF ISSUES	ENGINEERING	ENFORCEMENT	EDUCATION & ENCOURAGEMENT	ENGINEERING	ENGINEERING
6	<p>Drivers' attention diverted</p> <p>- Drivers on the Rhode Island Avenue northbound and southbound approaches looking left for a gap in traffic sometimes do not see pedestrians crossing from the right.</p>

<p><i>Photo shows the direction a driver would be looking when looking for a gap in the Memorial Boulevard traffic. The drivers sometimes don't look for pedestrians attempting to cross from their right.</i></p>	<p>- Consider adding signs on the Rhode Island Avenue approaches alerting drivers to look both ways for pedestrians crossing.</p>

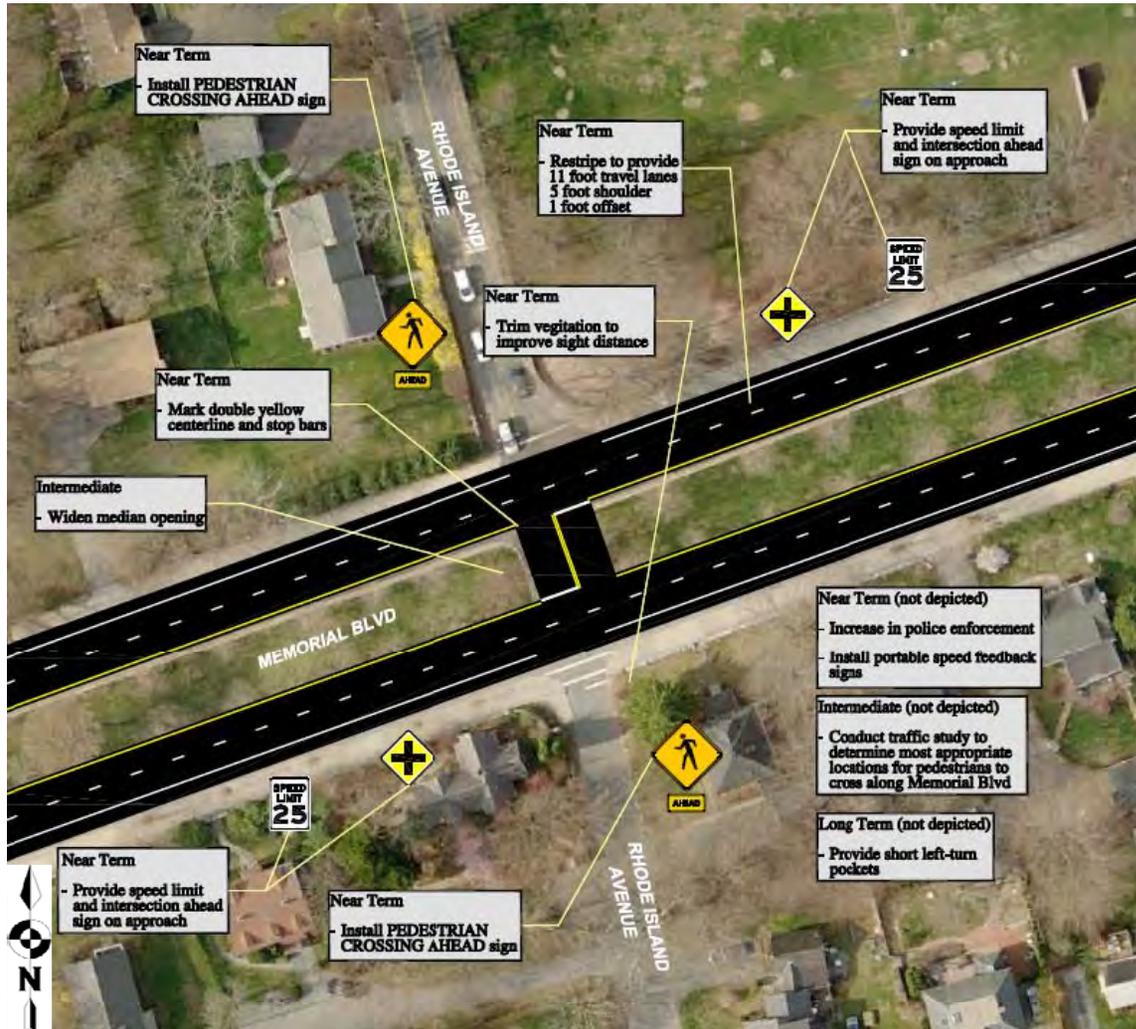
Figure 2-23 Memorial Blvd at Rhode Island Avenue Conceptual Improvements/Recommendations

The RSA Team identified several safety issues within the study area. The Team prioritized these issues in order of perceived importance and developed suggestions to mitigate the safety concerns. The RSA team noted that some of the issues and suggestions for improvements at this intersection may be applicable to other unsignalized intersections along Memorial Boulevard. The existing safety issues are summarized in **Table 2-17** and **Figure 2-23**.

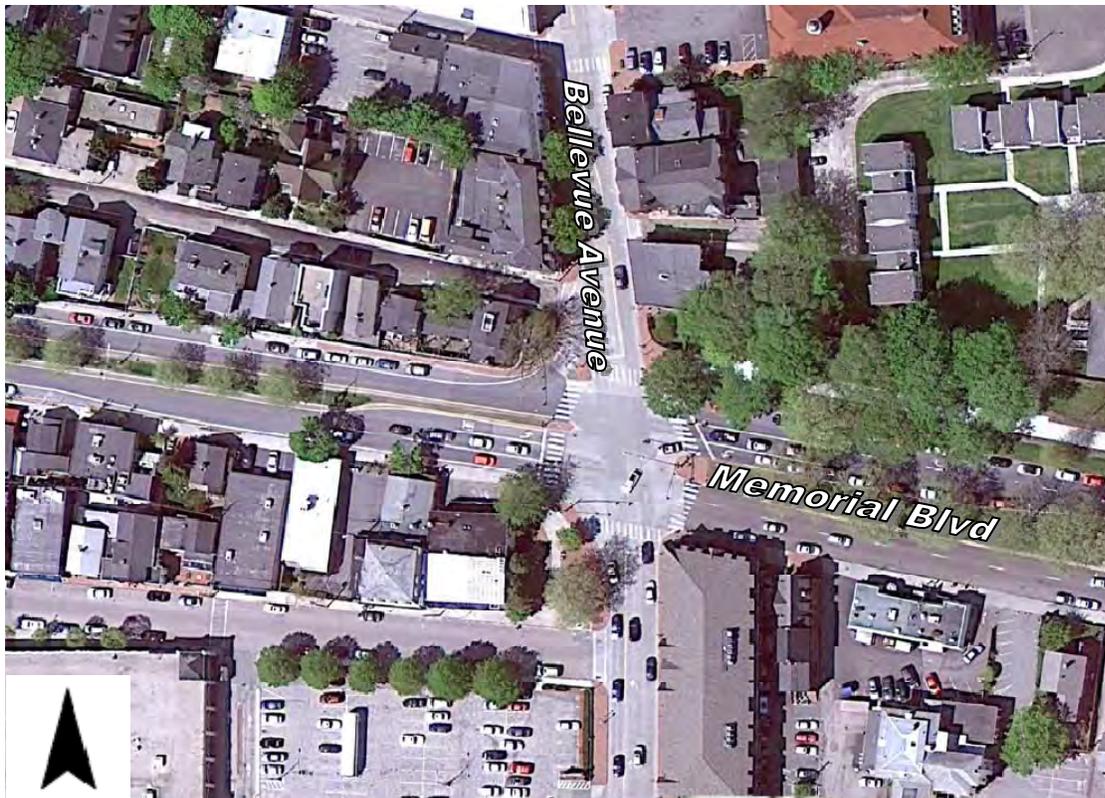
Figure 2-24 Memorial Boulevard at Bellevue Avenue Intersection

Memorial Boulevard is a primary route connecting Downtown Newport to Newport's Mansions and Easton's Beach. The roadway consists of two lanes in each direction for most of its length with some areas consisting of one travel lane with on-street parking. The pavement width on Memorial Boulevard within the study area is approximately 28 feet wide. This wide roadway width and straight alignment results in vehicles traveling at 40 to 45 mph. The speed limit is not posted; therefore the legal speed limit on roadways that are not posted in Newport is 25 mph. There is a median along most of the roadway ranging from a few feet to 40 feet wide. An RSA was performed at the intersections as shown in **Figure 2-24** and as discussed in the following section.

Memorial Boulevard at Bellevue Avenue is a signalized intersection consisting of a left-turn lane, one through lane and a shared through/right-turn lane on the eastbound approach; a left-turn lane, one through lane and an exclusive right-turn lane on the westbound approach; a left-turn lane and a shared through/right-turn lane on the northbound approach; and a left-turn lane and a shared through lane with a channelized right-turn on the southbound approach. The pavement markings are faded and generally in poor condition and the street name signs are not visible.

The northbound and southbound left-turn movements are permissive movements (not protected with a left-turn arrows and phases). Bicycles were observed traveling through the intersection randomly and in unexpected locations both on street and on the sidewalk.

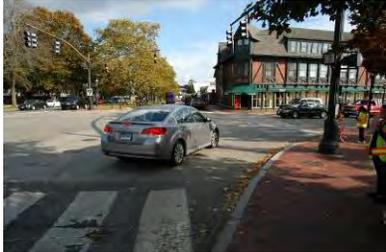
SPECIFIC NEAR TERM IMPROVEMENTS			POTENTIAL INTERMEDIATE IMPROVEMENTS	POTENTIAL LONG TERM IMPROVEMENTS
			(1-6 MONTHS)			(6 MONTHS - 2 YEARS)	(2 OR MORE YEARS)
NO.	ISSUES/CONCERNS	EXAMPLE OF ISSUES	ENGINEERING	ENFORCEMENT	EDUCATION & ENCOURAGEMENT	ENGINEERING	ENGINEERING
1	<p>Large corner radii</p> <p>- There are large radii on the northwest and southwest corners resulting in high turning speeds.</p>

<p><i>Photo illustrates the large radii on the southwest corner of the intersection, causing turning vehicles to make high speed turns.</i></p>	<p>- Restripe around curves and consider installing textured pavement to reduce curve radii as a temporary solution.</p>			<p>- Revise curb line to reduce the radii and consider installing bump-outs to reduce pedestrian crossing widths. Consider eliminating the island on the northwest corner and reducing the corner radius.</p>	
2	<p>Existing pedestrian clearance times are too short</p> <p>- There are also long skewed crosswalks and the pedestrian clearance times appear to be too short.</p>

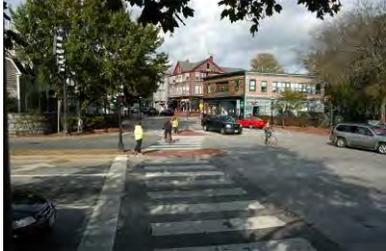
<p><i>Photo illustrates the long crosswalk on the west leg of the intersection. The center refuge island is small and can't accommodate many pedestrians at one time.</i></p>	<p>- Recalculate and revise the pedestrian clearance times in the controller.</p>

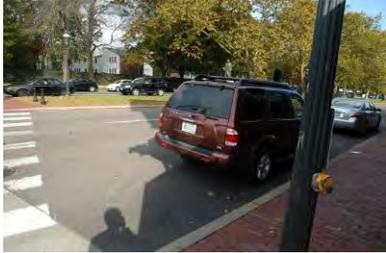
SPECIFIC NEAR TERM IMPROVEMENTS			POTENTIAL INTERMEDIATE IMPROVEMENTS	POTENTIAL LONG TERM IMPROVEMENTS
			(1-6 MONTHS)			(6 MONTHS - 2 YEARS)	(2 OR MORE YEARS)
NO.	ISSUES/CONCERNS	EXAMPLE OF ISSUES	ENGINEERING	ENFORCEMENT	EDUCATION & ENCOURAGEMENT	ENGINEERING	ENGINEERING
3	<p>Pedestrian buttons are broken and poorly located</p> <p>- The pedestrian pushbuttons are poorly located; for example, the button on the southeast corner is located on the wrong side of the pole. The pedestrian pushbutton on the island located on the northwest corner is broken.</p>

<p><i>Photo shows a pedestrian push button located on the opposite side from the wheelchair ramp.</i></p>	<p>- Replace broken pedestrian buttons and relocate pedestrian buttons that are poorly located.</p>

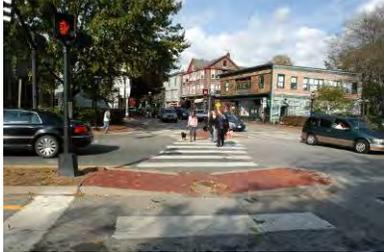
SPECIFIC NEAR TERM IMPROVEMENTS			POTENTIAL INTERMEDIATE IMPROVEMENTS	POTENTIAL LONG TERM IMPROVEMENTS
			(1-6 MONTHS)			(6 MONTHS - 2 YEARS)	(2 OR MORE YEARS)
NO.	ISSUES/CONCERNS	EXAMPLE OF ISSUES	ENGINEERING	ENFORCEMENT	EDUCATION & ENCOURAGEMENT	ENGINEERING	ENGINEERING
4	<p>Pedestrians cross outside of crosswalks/against signal and bicycles travel at unexpected locations</p> <p>- The crosswalks are skewed increasing the pedestrian crossing distance. Pedestrians were observed crossing outside of the crosswalks and against the traffic signal. Bicycles were observed traveling through the intersection randomly and in unexpected locations both on street and on the sidewalk.</p>

<p><i>Photo shows pedestrians crossing against the traffic signal, in which the walking is not allowed.</i></p>	<p>- Restripe the crosswalks and consider adding signage or landscaping features to corral pedestrians to designated crossing locations. Consider implementing designated bike accommodation.</p>			<p>- Revise curb line to reduce the radii and consider installing bump-outs to reduce pedestrian crossing widths. Consider eliminating the island on the northwest corner and reducing the corner radius.</p>

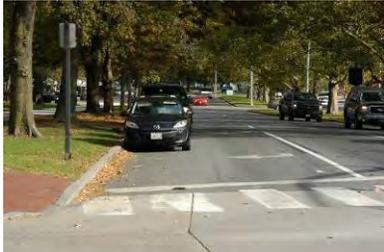
5	<p>Vehicles parked too close to intersection</p> <p>- Vehicles were observed parking too close to the intersection blocking the right lane and blocking sight distance. Some</p>

<p>- Consider installing additional No Parking signs.</p>			<p>- Consider installing bump-outs that would clearly define where parking is allowed. Consider widening the roadway to provide adequate room for</p>

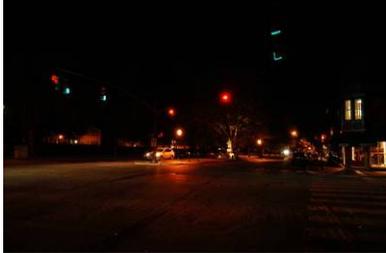
SPECIFIC NEAR TERM IMPROVEMENTS			POTENTIAL INTERMEDIATE IMPROVEMENTS	POTENTIAL LONG TERM IMPROVEMENTS
			(1-6 MONTHS)			(6 MONTHS - 2 YEARS)	(2 OR MORE YEARS)
NO.	ISSUES/CONCERNS	EXAMPLE OF ISSUES	ENGINEERING	ENFORCEMENT	EDUCATION & ENCOURAGEMENT	ENGINEERING	ENGINEERING
	vehicles blocked crosswalks and access close to the intersections. It was also noted that several of the crashes at this intersection involved sideswipes to parked vehicles.	<i>Photo shows vehicles parking along Memorial Boulevard, in close proximity to the intersection.</i>				through vehicles to get around parked vehicles.	
6	Poorly lighted intersection - At night the intersection is dimly lighted, especially on the east side of the intersection..

<i>Photo shows the intersection during the night, in which there is a lack of lighting.</i>	- Replace old guardrail with guardrail that meets current standards.			- Install additional street lighting. Any new street lighting must conform to the existing decorative lighting in the neighborhood.

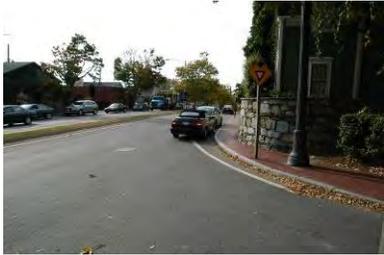
SPECIFIC NEAR TERM IMPROVEMENTS			POTENTIAL INTERMEDIATE IMPROVEMENTS	POTENTIAL LONG TERM IMPROVEMENTS
			(1-6 MONTHS)			(6 MONTHS - 2 YEARS)	(2 OR MORE YEARS)
NO.	ISSUES/CONCERNS	EXAMPLE OF ISSUES	ENGINEERING	ENFORCEMENT	EDUCATION & ENCOURAGEMENT	ENGINEERING	ENGINEERING
	visible. There is a jog in the eastbound through traffic and there is a history of vehicles ending up in the median	<i>delineation within the intersection. The Bellevue Avenue northbound through movement also experiences a slight jog on the northbound departure.</i>	the intersection.				
8	Yield Ahead sign inappropriate and in a poor location - There is a Yield Ahead sign located on the northwest corner of the intersection. This is not the correct location or the appropriate sign type.

<i>Photo depicts poorly located "YIELD AHEAD" sign, which is not the appropriate sign for this location.</i>	- Remove Yield Ahead sign and install a new Yield sign adjacent to the yield line.

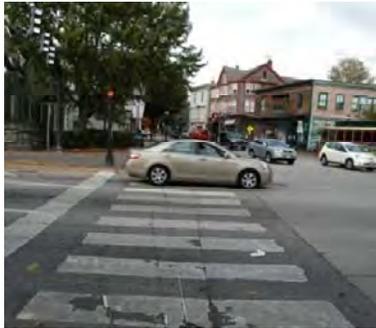
9	Vehicles stop in crosswalks - Vehicles were observed stopping in the crosswalks.

- Consider installing Stop Here on Red signs.

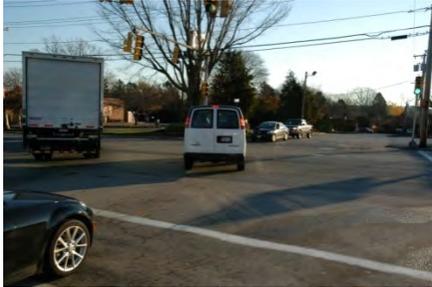
SPECIFIC NEAR TERM IMPROVEMENTS			POTENTIAL INTERMEDIATE IMPROVEMENTS	POTENTIAL LONG TERM IMPROVEMENTS
			(1-6 MONTHS)			(6 MONTHS - 2 YEARS)	(2 OR MORE YEARS)
NO.	ISSUES/CONCERNS	EXAMPLE OF ISSUES	ENGINEERING	ENFORCEMENT	EDUCATION & ENCOURAGEMENT	ENGINEERING	ENGINEERING
2	<p>Poor delineation of vehicle paths</p> <ul style="list-style-type: none"> - The dual left-turn movement from Coddington Highway to West Main Road is not delineated. - The dual left-turn movement from East Main Road onto West Main Road is not delineated. - There is no delineation on side street approaches. The side streets were observed to be mistaken for one-way streets due to the lack of a centerline.

<p><i>There is a lack of delineation for vehicles making the dual left-turning movement from Coddington Highway onto West Main Road.</i></p>	<ul style="list-style-type: none"> - Mark the dual left-turning movement with dashed white pavement markings (cat tracks). - Mark white edge lines and yellow center lines on all side street approaches for 100 feet from the intersection, at a minimum.

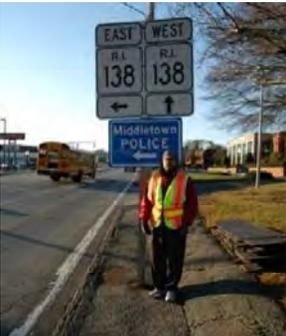
SPECIFIC NEAR TERM IMPROVEMENTS			POTENTIAL INTERMEDIATE IMPROVEMENTS	POTENTIAL LONG TERM IMPROVEMENTS
			(1-6 MONTHS)			(6 MONTHS - 2 YEARS)	(2 OR MORE YEARS)
NO.	ISSUES/CONCERNS	EXAMPLE OF ISSUES	ENGINEERING	ENFORCEMENT	EDUCATION & ENCOURAGEMENT	ENGINEERING	ENGINEERING
3	<p>Sidewalk obstructions</p> <ul style="list-style-type: none"> – Some of the existing sidewalks are not ADA compliant, including narrow width, ramp slope exceeding minimums, and missing detectable warning systems. – There are numerous objects located in the sidewalks, forming obstructions that provide less than the ADA minimum width. – There are signs in the sidewalk that do not meet minimum installation heights.

<p><i>This sign, located within the sidewalk, does not have the minimum height clearance from the ground.</i></p>	<ul style="list-style-type: none"> – Relocate signs, guy wires, etc to maintain minimum widths along the sidewalk. – Modify signs to meet minimum height clearances. 			<ul style="list-style-type: none"> – Relocate ADA ramp on southeast corner of the West Main Road/Smythe Street intersection. 	<ul style="list-style-type: none"> – Provide new sidewalks and ADA ramps as part of the “Reconstruction of Two-Mile Corner” project (either the signalized or roundabout design concept)

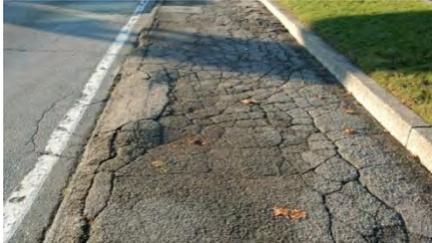
SPECIFIC NEAR TERM IMPROVEMENTS			POTENTIAL INTERMEDIATE IMPROVEMENTS	POTENTIAL LONG TERM IMPROVEMENTS
			(1-6 MONTHS)			(6 MONTHS - 2 YEARS)	(2 OR MORE YEARS)
NO.	ISSUES/CONCERNS	EXAMPLE OF ISSUES	ENGINEERING	ENFORCEMENT	EDUCATION & ENCOURAGEMENT	ENGINEERING	ENGINEERING
4	<p>Lack of delineation between sidewalk, driveways, and the roadway</p> <ul style="list-style-type: none"> - The curbing along the west side of West Main Rd, adjacent to Bank Newport, is broken and missing in some places. Sidewalks are not smooth and are not visually delineated from roadway, which may present issues to pedestrians with low-visibility. - There are wide open access points with little to no delineation. - Vehicles were observed cutting through driveways to access side streets. Examples include Commercial Street onto West Main Road and West Main Road onto Hart Street.

<p><i>The sidewalk adjacent to Bank Newport has broken and missing curb.</i></p>

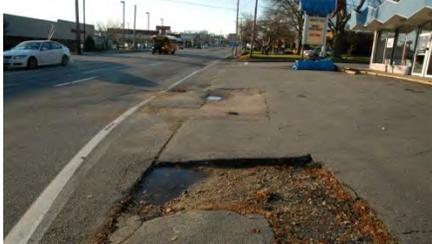
<p><i>Access point, such as the one on the southwest corner of Coddington Highway and West Main Road, lack and pavement marking or curbing delineation. This created no indication or buffer for pedestrians walking along this area.</i></p>				<ul style="list-style-type: none"> - Repave sidewalks with smooth material to differentiate sidewalk from roadway - Install new curbing along the sidewalks. - Provide minimum driveway openings by installing curbing.

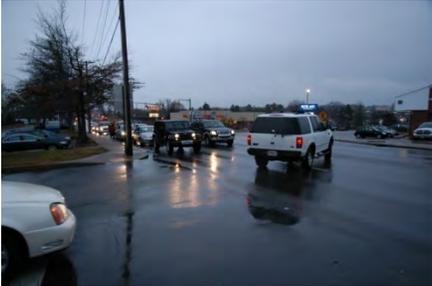
<p><i>There is a steep drop-off along the east side of West Main Road.</i></p>				<p>– Provide a railing, fence, barrier, etc to protect pedestrians from falling down the drop-off.</p>	
6	<p>Left-turns from Maple Avenue onto West Main Road conflict with through movements</p> <p>– Vehicles along West Main Rd in right lane stop to let left-turning vehicles from Maple Avenue go, and then vehicles in left lane have limited sight distance to see this vehicle crossing. This also created additional delay along West Main Rd..</p>

<p><i>Maple Avenue is a highly used cut-through roadway, connecting to JT Connell Highway.</i></p>	<p>– Perform analysis to determine if a restriction for left-turning movements is feasible.</p> <p>– Limit eastbound Maple Ave vehicles to right-turns only. Install NO LEFT TURN signs.</p> <p>– Consider applying times to restrict left-turns.</p>	<p>– Enforce the NO LEFT TURN restriction.</p>			<p>– Convert intersection to right-in/right-out through installation channelization.</p>

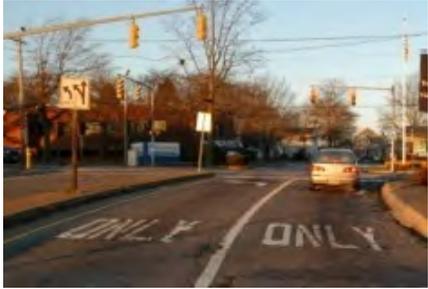
SPECIFIC NEAR TERM IMPROVEMENTS			POTENTIAL INTERMEDIATE IMPROVEMENTS	POTENTIAL LONG TERM IMPROVEMENTS
			(1-6 MONTHS)			(6 MONTHS - 2 YEARS)	(2 OR MORE YEARS)
NO.	ISSUES/CONCERNS	EXAMPLE OF ISSUES	ENGINEERING	ENFORCEMENT	EDUCATION & ENCOURAGEMENT	ENGINEERING	ENGINEERING
7	<p>Lack of clear lane use</p> <ul style="list-style-type: none"> - The signage/stripping that denotes the lane usage at intersection is inconsistent. Two examples are East Main Road approach to West Main Road and Coddington Highway approach to West Main Road. - There are no speed limit signs in the area

<p><i>The lane use signage (left side) and pavement markings conflict with each other.</i></p>	<ul style="list-style-type: none"> - Install consistent lane use signing and pavement markings - Install speed limit signage

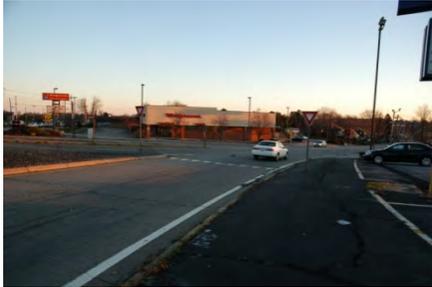
SPECIFIC NEAR TERM IMPROVEMENTS			POTENTIAL INTERMEDIATE IMPROVEMENTS	POTENTIAL LONG TERM IMPROVEMENTS
			(1-6 MONTHS)			(6 MONTHS - 2 YEARS)	(2 OR MORE YEARS)
NO.	ISSUES/CONCERNS	EXAMPLE OF ISSUES	ENGINEERING	ENFORCEMENT	EDUCATION & ENCOURAGEMENT	ENGINEERING	ENGINEERING
8	<p>High speeds along channelized right-turns</p> <ul style="list-style-type: none"> – Vehicles travel at high speeds along the channelized right-turn from West Main Road onto East Main Road. This channel has a wide radius that likely encourages higher speeds. – Typically motorists traveling at high speeds are less likely to yield. Motorists were observed not yielding at the merge with East Main Road. – There is a pedestrian crossing along this ramp. There has been a reported pedestrian crash that has occurred at this location. – The shrubs located on the island limit sight distance between merging vehicles from West Main Road north and south onto East Main Road.

<p><i>Vehicles fail to yield and travel at high speeds around the channelized right-turn ramp from West Main Road onto East Main Road.</i></p>	<ul style="list-style-type: none"> – Install larger, florescent yellow YIELD signs and pavement markings at the crosswalk to enhance visibility. – Stripe the channelized ramp/install delineators to reduce the lane width – Trim shrubs to increase sight distance. 	<ul style="list-style-type: none"> – Monitor and enforce the YIELD condition. 			<ul style="list-style-type: none"> – Reconstruct channelized right-turn ramp to provide smaller radius with correlating slower speeds OR – Convert signalized intersections to roundabout.

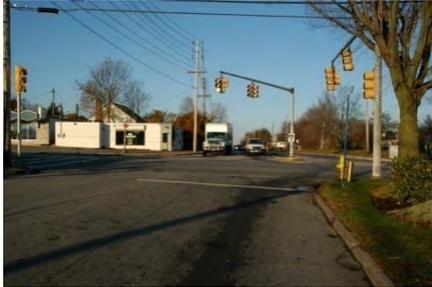
SPECIFIC NEAR TERM IMPROVEMENTS			POTENTIAL INTERMEDIATE IMPROVEMENTS	POTENTIAL LONG TERM IMPROVEMENTS
			(1-6 MONTHS)			(6 MONTHS - 2 YEARS)	(2 OR MORE YEARS)
NO.	ISSUES/CONCERNS	EXAMPLE OF ISSUES	ENGINEERING	ENFORCEMENT	EDUCATION & ENCOURAGEMENT	ENGINEERING	ENGINEERING
9	<p>Potentially confusing alignment for Rockwood Road approach to West Main Road</p> <ul style="list-style-type: none"> – Vehicles exiting Rockwood Avenue are aligned across from Coddington Highway eastbound vehicles. – The signal phase in which the Rockwood Road approach is green runs concurrent with the Coddington Highway green signal phase. Vehicles on the Rockwood Road approach were observed to wait on green until the Coddington Highway approach cleared the vehicle queue.

<p><i>Vehicles on the Rockwood Rd westbound approach are aligned directly across the Coddington Hwy eastbound approaching traffic.</i></p>

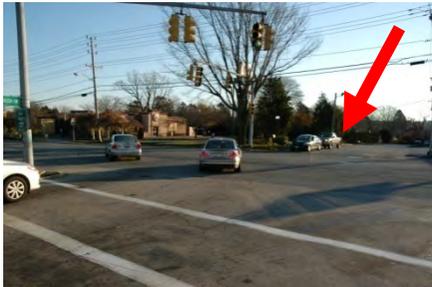
<p><i>Some vehicles on the Rockwood Rd approach wait until the Coddington Hwy vehicles clear, causing frustration for other vehicles, such as this truck</i></p>	<ul style="list-style-type: none"> – Consider revising signal phasing to provide the Coddington Highway eastbound approach and the Rockwood Road westbound approach with separate phases or implement lead/lag in the phasing to provide the Coddington Highway approach with the advance. – Install enhanced signage and pavement markings that help guide Rockwood Road vehicles to the Coddington Highway departure lanes. 				<ul style="list-style-type: none"> – If feasible, realign the Rockwood Road westbound approach OR – Convert signalized intersections to roundabout.

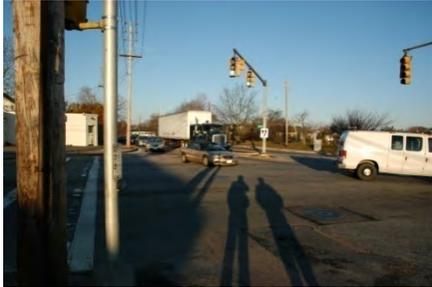
SPECIFIC NEAR TERM IMPROVEMENTS			POTENTIAL INTERMEDIATE IMPROVEMENTS	POTENTIAL LONG TERM IMPROVEMENTS
			(1-6 MONTHS)			(6 MONTHS - 2 YEARS)	(2 OR MORE YEARS)
NO.	ISSUES/CONCERNS	EXAMPLE OF ISSUES	ENGINEERING	ENFORCEMENT	EDUCATION & ENCOURAGEMENT	ENGINEERING	ENGINEERING
10	<p>Outdated traffic signal equipment</p> <ul style="list-style-type: none"> - The LEFT-TURN arrow signal heads are not bright enough to see during certain times of the day. - The traffic signal pole equipment is located in undesirable locations. -Some of the pedestrian signal equipment is not working properly. - The traffic signal heads on east and west approaches may be difficult for motorists to see due to the effects of backlighting and sun glare.

<p><i>Some vehicles on the Rockwood Road approach wait</i></p>	<ul style="list-style-type: none"> - Replace traffic signal heads as necessary with visible LED illuminations. 			<ul style="list-style-type: none"> - Replace pedestrian signal head as necessary, including countdown timers. 	<ul style="list-style-type: none"> - Replace traffic signal equipment OR - Convert signalized intersections to roundabout.

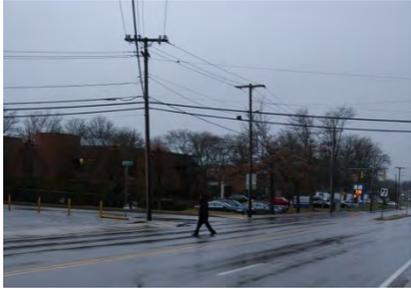
SPECIFIC NEAR TERM IMPROVEMENTS			POTENTIAL INTERMEDIATE IMPROVEMENTS	POTENTIAL LONG TERM IMPROVEMENTS
			(1-6 MONTHS)			(6 MONTHS - 2 YEARS)	(2 OR MORE YEARS)
NO.	ISSUES/CONCERNS	EXAMPLE OF ISSUES	ENGINEERING	ENFORCEMENT	EDUCATION & ENCOURAGEMENT	ENGINEERING	ENGINEERING
11	<p>Lack of delineated paths serving pedestrian desire lines.</p> <ul style="list-style-type: none"> The following West Main Road intersections legs are lacking pedestrian signal equipment and/or marked crossings: Coddington Highway north leg, East Main Road north leg, and Smythe Street north leg. The accessible ramp on Smythe Street south leg (east side) is located adjacent to the signal cabinet, leaving no room for a level landing area.

<p><i>Pedestrian crossing West Main Road, north of Smythe Street intersection.</i></p>	<ul style="list-style-type: none"> Mark and install pedestrian signal equipment at all crosswalks on all approaches to signalized intersections, as appropriate. 				<ul style="list-style-type: none"> Convert signalized intersections to roundabout. Relocate accessible ramp on Smythe Street south leg (east side)

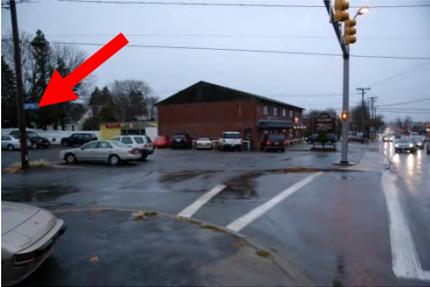
SPECIFIC NEAR TERM IMPROVEMENTS			POTENTIAL INTERMEDIATE IMPROVEMENTS	POTENTIAL LONG TERM IMPROVEMENTS
			(1-6 MONTHS)			(6 MONTHS - 2 YEARS)	(2 OR MORE YEARS)
NO.	ISSUES/CONCERNS	EXAMPLE OF ISSUES	ENGINEERING	ENFORCEMENT	EDUCATION & ENCOURAGEMENT	ENGINEERING	ENGINEERING
12	Lack of sign conspicuity – The “Smythe Street” street name sign is located too far from the intersection to be effective.

<p><i>Street name sign is located too far from the intersection.</i></p>	– Relocate sign to mast arm.

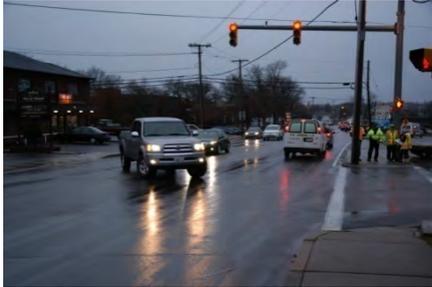
SPECIFIC NEAR TERM IMPROVEMENTS			POTENTIAL INTERMEDIATE IMPROVEMENTS	POTENTIAL LONG TERM IMPROVEMENTS
			(1-6 MONTHS)			(6 MONTHS - 2 YEARS)	(2 OR MORE YEARS)
NO.	ISSUES/CONCERNS	EXAMPLE OF ISSUES	ENGINEERING	ENFORCEMENT	EDUCATION & ENCOURAGEMENT	ENGINEERING	ENGINEERING
13	<p>Lack of left-turn lanes & exclusive left-turn phasing</p> <ul style="list-style-type: none"> – Left-turning vehicles “sneak” during red interval – Motorists wishing to take a left-turn on Commercial Street from West Main Road have a difficult time making the movement due to the lack of gaps in the heavy northbound movement. – Motorists wishing to make a left-turn block the through movement along West Main Road. – The lack of protected left-turn phasing cause additional conflicts as vehicles must make a left-turn against two lanes of opposing through traffic.

<p><i>A vehicle turning left onto Commercial Street finds a gap in traffic only after West Main Road corridor has the red light. This movement conflicts with side street traffic that has the green light.</i></p>				<ul style="list-style-type: none"> – Consider providing advance northbound left-turn movement onto Commercial Street from West Main Road. 	<ul style="list-style-type: none"> – Replace traffic signal equipment to include left-turn phasing and widen roadway to provide left-turn lanes at the East Main Road and Coddington Highway intersections with West Main Road OR – Convert signalized intersections to roundabouts. This will eliminate the left-turn/through vehicle conflict.

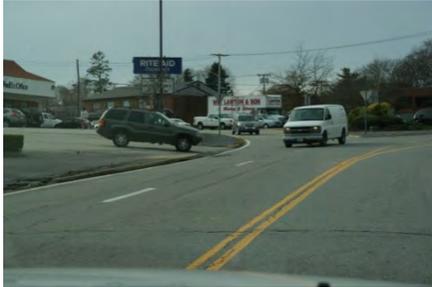
SPECIFIC NEAR TERM IMPROVEMENTS			POTENTIAL INTERMEDIATE IMPROVEMENTS	POTENTIAL LONG TERM IMPROVEMENTS
			(1-6 MONTHS)			(6 MONTHS - 2 YEARS)	(2 OR MORE YEARS)
NO.	ISSUES/CONCERNS	EXAMPLE OF ISSUES	ENGINEERING	ENFORCEMENT	EDUCATION & ENCOURAGEMENT	ENGINEERING	ENGINEERING
14	<p>Vehicle conflicts at access points close to intersection</p> <ul style="list-style-type: none"> – Access points are located too close to the intersection, creating conflicts with vehicles exiting the intersection at high speeds. – Motorists traveling on the right-turn channelized ramp to East Main Road are looking left to merge. They may not see vehicles trying to exit this driveway.

<p><i>Vehicles exiting the Rite-Aid driveway located close to the East Main/West Main Road intersection conflicted with vehicles turning from West Main Road, including the channelized right-turn lane.</i></p>					<ul style="list-style-type: none"> – Consider closing/relocating this access point. This should be done under either proposed design concept; signalized intersections or roundabouts.

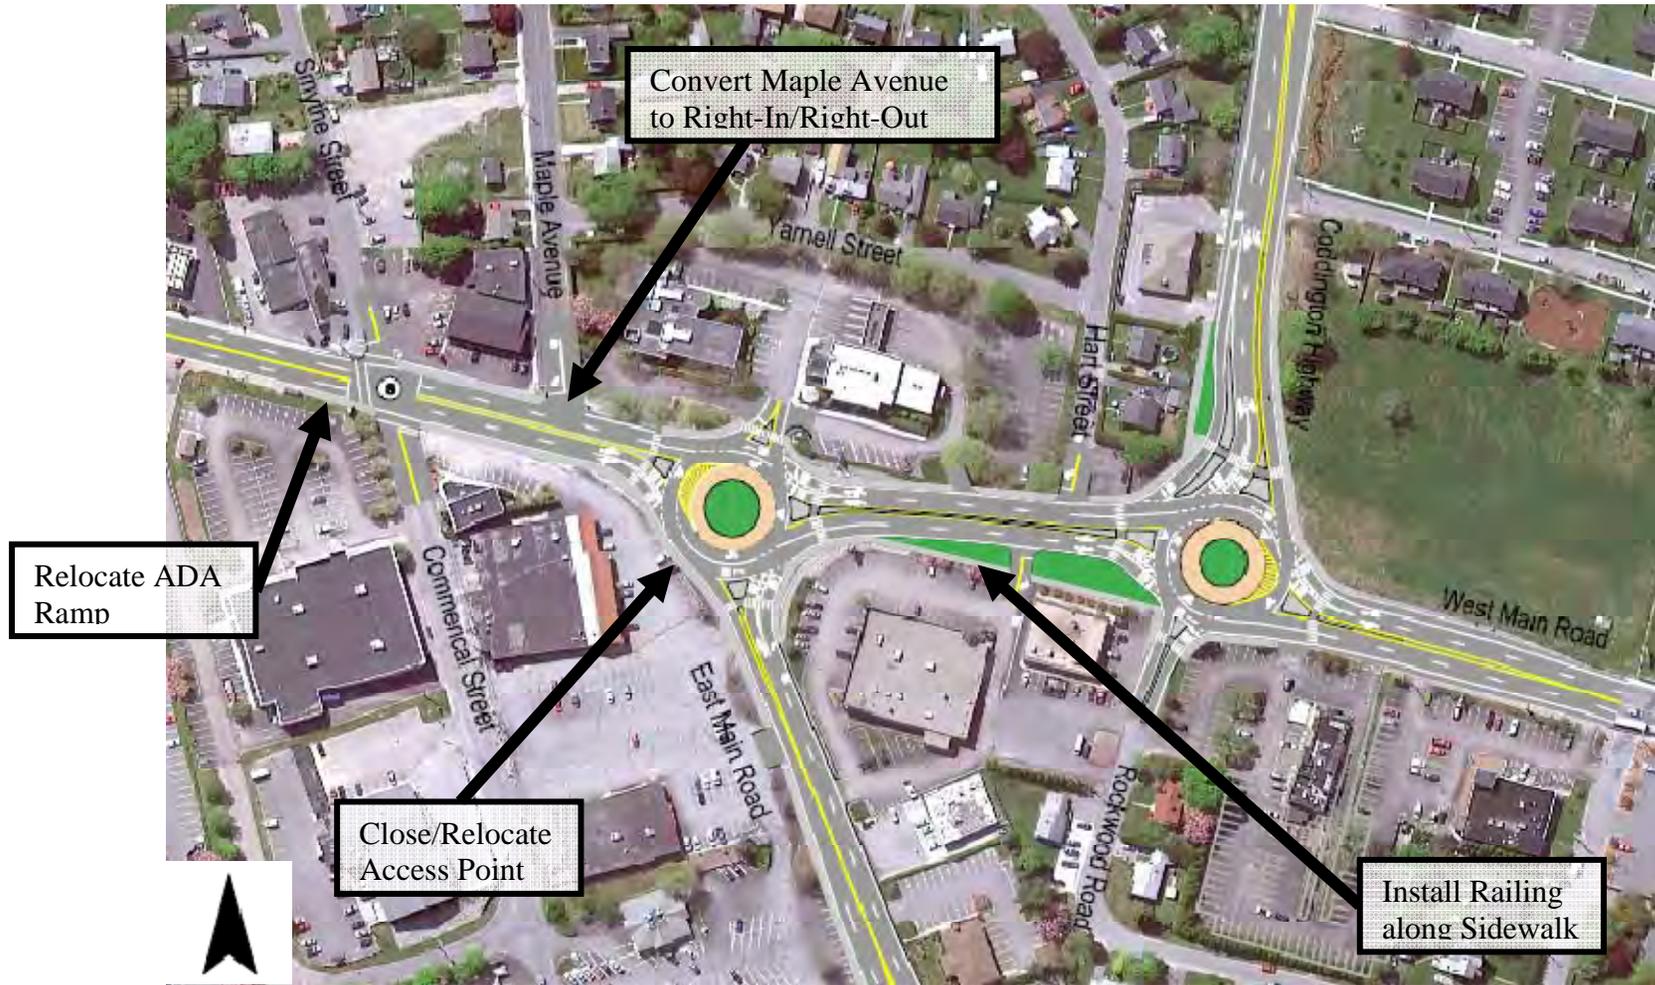
Figure 3-5 Suggested Recommendations to the Proposed Two-Mile Corner Roundabout Design Concept

As part of the Aquidneck Island Transportation Study (AITS), an alternative concept has been developed, replacing the 4-way signalized intersections with two lane roundabouts. The two roundabouts alternative would improve access management, as left-turns would be restricted on the side streets/driveways between the two intersections. Left-turns would be made by making a right-turn out of the driveway and using the roundabout to execute a u-turn. RIDOT and the Town of Middletown evaluated the roundabout alternative to determine its feasibility and potential impacts. It was determined that due to public input and potential impacts, the roundabout alternative would not be carried forward. The Roundabout and Signalized Concepts are illustrated in **Figures 3-5 and 3-6**, respectively.

The RSA Team identified several safety issues within the study area. The Team prioritized these issues in order of perceived importance and developed suggestions to correct or mitigate the safety concerns. The existing safety issues and suggestions are summarized in **Table 3-3** while **Figures 3-5 and 3-6** lists the suggestions on the preliminary conceptual designs. Because the Reconstruction of Two-Mile Corner RIDOT project is currently at the 75% design stage and is schedule to be complete

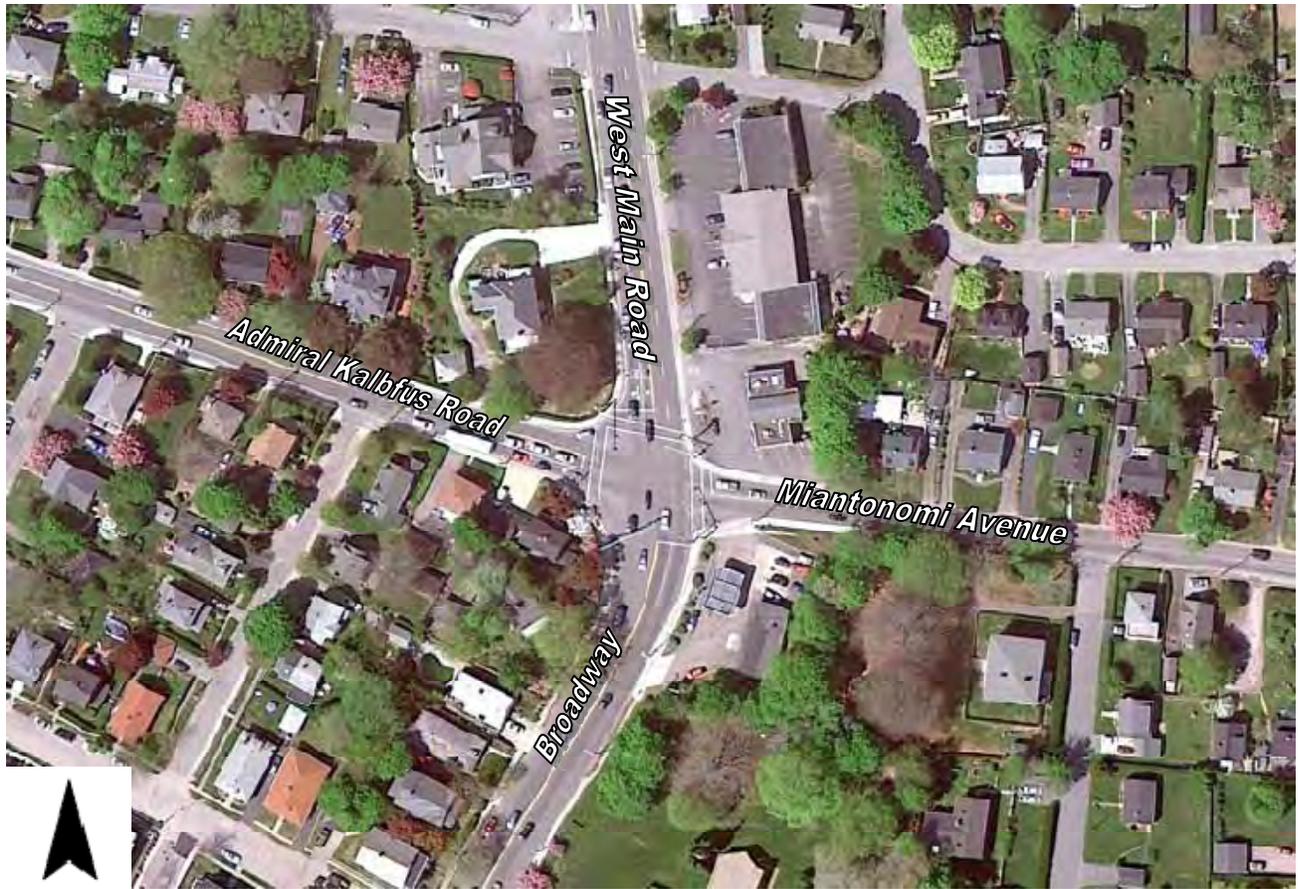
Figure 3-9 One Mile Corner Study Area Intersection

The intersection is positioned on a horizontal curve and consists of a shared left-turn/through lane and a shared through/right-turn lane on the Broadway northbound approach, a shared left-turn/through lane and a shared through/right-turn lane on the West Main Road southbound approach; a left-turn lane and a shared through/right-turn lane on the Admiral Kalbfus Road eastbound approach, and one multipurpose (left-turn/through/right-turn) lane on the Miantonomi Avenue westbound approach. The southbound receiving lanes change from two lanes to one lane immediately departing from the intersection. There are sidewalks on all approaching roadway to the intersection and there are marked crosswalks on the north, east, and west legs of the intersection marked with standard pavement markings. There are wide, undelimited access driveways on the east corners. Some vehicles were observed to use these wide driveways to by-pass the traffic signal during congested times. The RSAs was performed at the intersection as shown in **Figure 3-9** and as discussed in the following section.

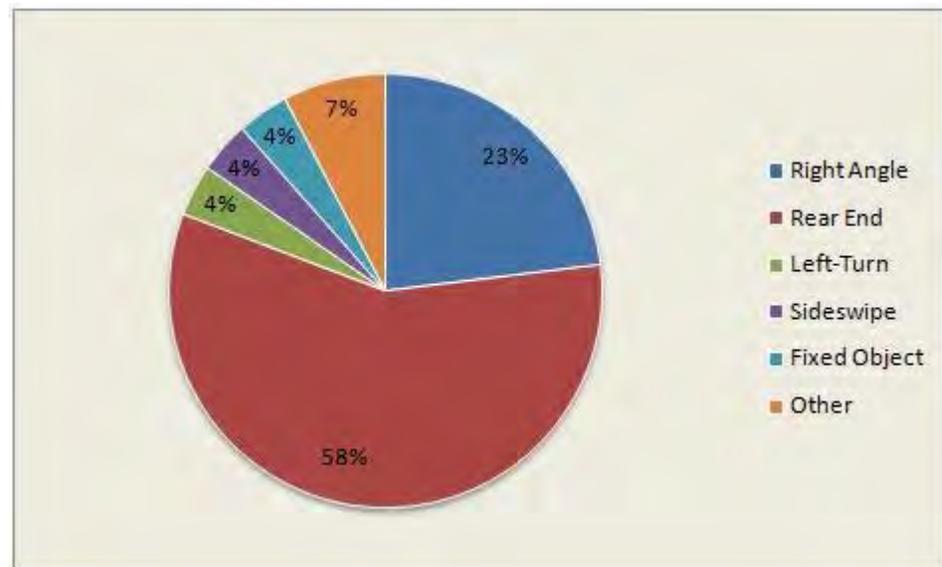
The majority (85%) of the crashes occurred in daylight conditions. Also, the second highest crash type is right angle (23%)

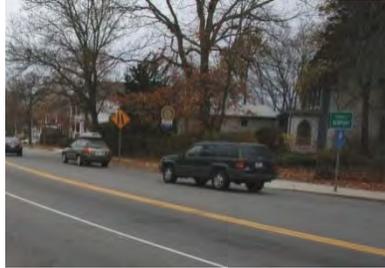
SPECIFIC NEAR TERM IMPROVEMENTS			POTENTIAL INTERMEDIATE IMPROVEMENTS	POTENTIAL LONG TERM IMPROVEMENTS
			(1-6 MONTHS)			(6 MONTHS - 2 YEARS)	(2 OR MORE YEARS)
NO.	ISSUES/CONCERNS	EXAMPLE OF ISSUES	ENGINEERING	ENFORCEMENT	EDUCATION & ENCOURAGEMENT	ENGINEERING	ENGINEERING
1	<p>Southbound right lane merges immediately after the intersection.</p> <ul style="list-style-type: none"> - There is a lack of pavement markings to delineate the two through lanes on the Broadway southbound departure. - The Lane Ends sign is located within the lane drop & merge area.

<p><i>The Lane Ends sign is located with the merge area.</i></p>	<ul style="list-style-type: none"> - Install pavement markings to delineate the two through lanes and the taper from two lanes to one lane. - Relocate the Lane Ends sign (W4-2R) to the beginning of the lane drop. 				
2	<p>Lack of lighting on the west leg of the intersection.</p> <ul style="list-style-type: none"> - There is inadequate lighting on the north and southwest corners of the intersection.

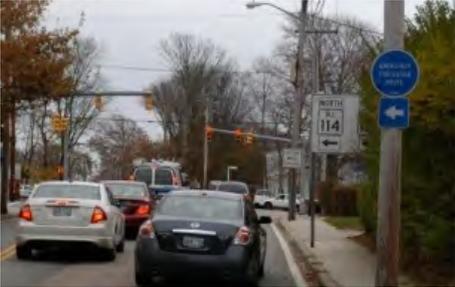
<p><i>The trailblazing signage on the eastbound approach from Pell Bridge is partially obstructed by vegetation. There is also a lack of adequate wayfinding signage on the approach.</i></p>	<ul style="list-style-type: none"> - Install wayfinding signage for this area. - Trim vegetation that blocks signage OR - Relocate signage - Install street name signage on mast arms (if structural feasible) - Provide consistent signing for Route 138. - Install supplemental LEFT LANE MUST TURN LEFT sign on eastbound approach to intersection.

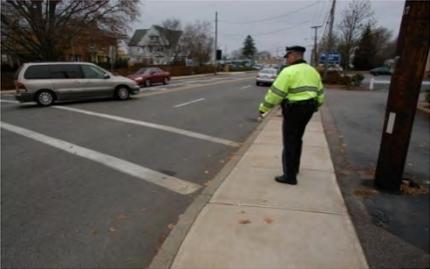
SPECIFIC NEAR TERM IMPROVEMENTS			POTENTIAL INTERMEDIATE IMPROVEMENTS	POTENTIAL LONG TERM IMPROVEMENTS
			(1-6 MONTHS)			(6 MONTHS - 2 YEARS)	(2 OR MORE YEARS)
NO.	ISSUES/CONCERNS	EXAMPLE OF ISSUES	ENGINEERING	ENFORCEMENT	EDUCATION & ENCOURAGEMENT	ENGINEERING	ENGINEERING
4	<p>Inadequate ADA facilities</p> <ul style="list-style-type: none"> - The northeast corner of the intersection is missing an ADA ramp for the pedestrian crossing West Main Road. - The ADA ramp on the northwest corner is missing a detectable warning system.

<p><i>The crosswalk along the north leg of the intersection is missing an ADA ramp.</i></p>	<ul style="list-style-type: none"> - Install detectable warning systems where missing/upgrade needed. 			<ul style="list-style-type: none"> - Construct ADA ramp. 	
5	<p>Eastbound left-turns extend beyond storage bay</p> <ul style="list-style-type: none"> - The Admiral Kalbfus Road eastbound approach left-turn queues often extend beyond the storage lane, blocking access to the through/right-turn lane.

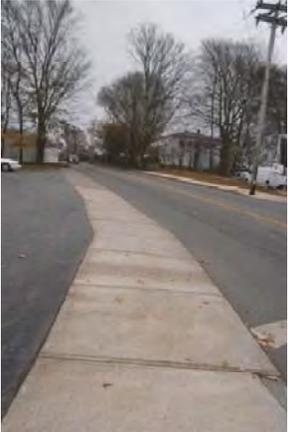
<p><i>The driveway along Miantonomi Avenue near the intersection with West Main Road is wide open and poorly delineated.</i></p>		<ul style="list-style-type: none"> - Work with the business on the corner to discourage cut-through vehicles. 			<ul style="list-style-type: none"> - Provide curbing to delineate driveway and provide smaller, more manageable access point.

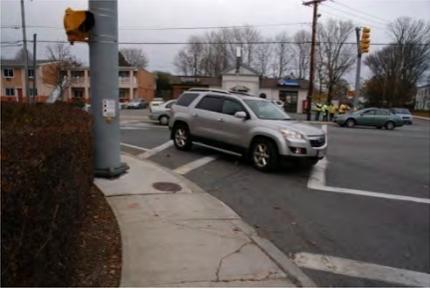
SPECIFIC NEAR TERM IMPROVEMENTS			POTENTIAL INTERMEDIATE IMPROVEMENTS	POTENTIAL LONG TERM IMPROVEMENTS
			(1-6 MONTHS)			(6 MONTHS - 2 YEARS)	(2 OR MORE YEARS)
NO.	ISSUES/CONCERNS	EXAMPLE OF ISSUES	ENGINEERING	ENFORCEMENT	EDUCATION & ENCOURAGEMENT	ENGINEERING	ENGINEERING
7	<p>High speeds right-turn movements</p> <ul style="list-style-type: none"> – The large radii on the northwest and southwest corners of the intersection allow vehicles to make high-speed right-turns. These higher speed turns may not be appropriate for the context as a pedestrian/bicycle friendly tourist destination. – The large corner radius accommodates large trucks. However, the ADA ramp and sidewalk is cracked and appears to be driven over numerous times.

<p><i>Vehicles making high-speed right-turn movements. There is limited sight-distance for pedestrian crossing the east leg of the intersection.</i></p>	<ul style="list-style-type: none"> – Provide a smaller radius on the northwest corner through cross hatch striping. This will delineate a slower path for most vehicles while providing an apron for large trucks. – Install TURNING TRAFFIC YIELD TO PEDESTRIANS signs on the southbound approach. – Move STOP BAR on the eastbound approach back to provide a clear movement for large trucks without encroaching on ADA ramp. 				<ul style="list-style-type: none"> – Provide a tighter radius through curbing on the southwest corner. This should be design to accommodate large trucks marking the right-turn movement onto Broadway southbound.

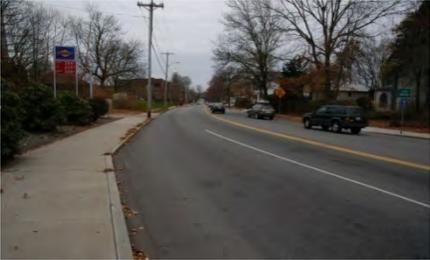
SPECIFIC NEAR TERM IMPROVEMENTS			POTENTIAL INTERMEDIATE IMPROVEMENTS	POTENTIAL LONG TERM IMPROVEMENTS
			(1-6 MONTHS)			(6 MONTHS - 2 YEARS)	(2 OR MORE YEARS)
NO.	ISSUES/CONCERNS	EXAMPLE OF ISSUES	ENGINEERING	ENFORCEMENT	EDUCATION & ENCOURAGEMENT	ENGINEERING	ENGINEERING
8	<p>Northbound approach queues extend beyond two lane storage</p> <p>– The Broadway northbound approach is often congested in the evening peak period. The two lanes on storage are insufficient during this period.</p>

<p><i>The two northbound lanes at the Broadway northbound approach to the intersection provides insufficient storage during the evening peak period.</i></p>	<p>– Restripe the Broadway northbound approach to extend the two northbound lanes for a longer distance. This may require elimination of some on-street parking on Broadway.</p>				
9	<p>Pedestrian push-button signage confusing</p> <p>– Some of the signage for instructions on how to cross is confusing as the direction they are installed does not coincide with the crossing the button responds to.</p>

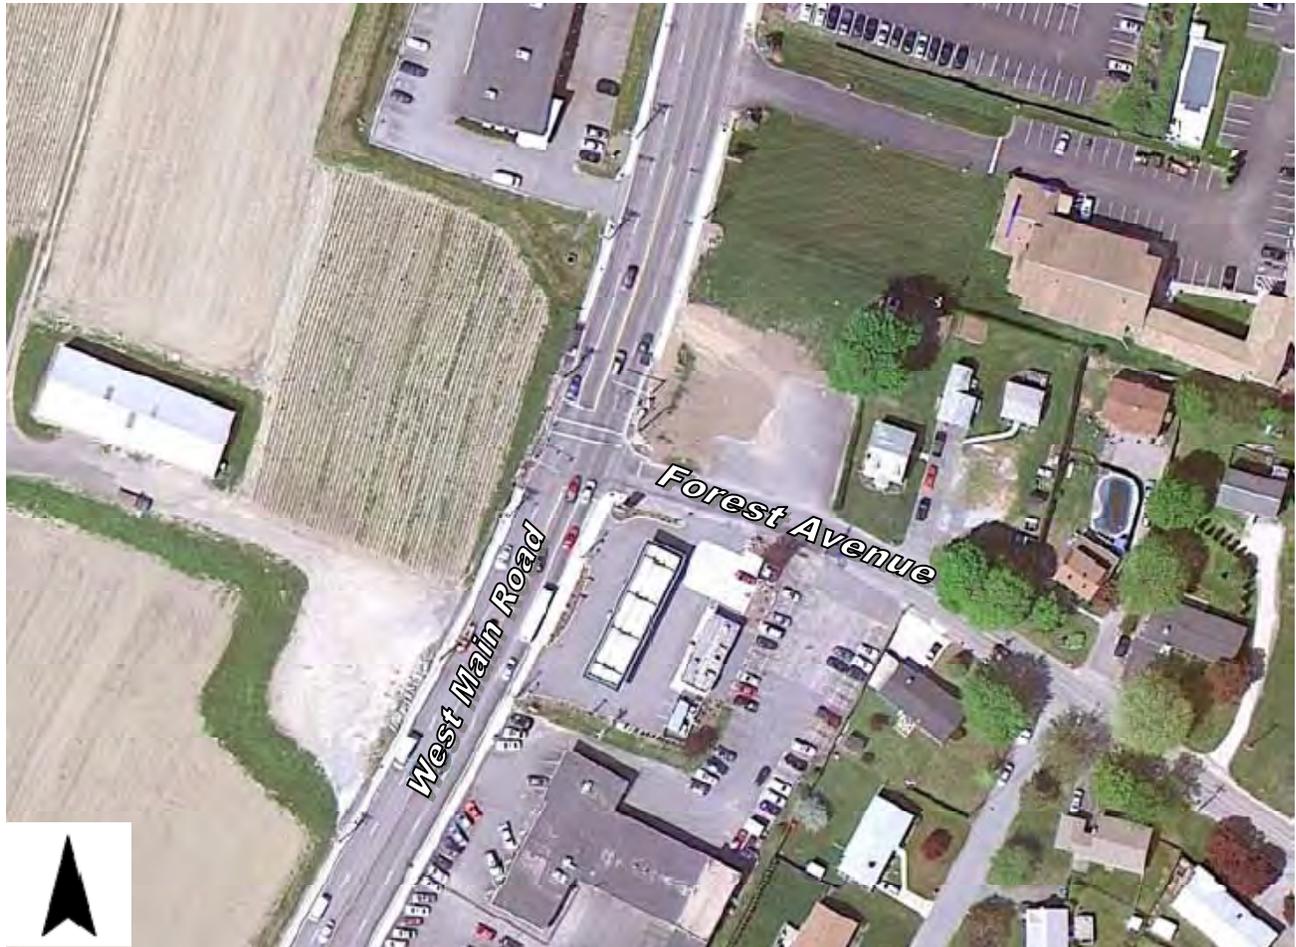
Figure 3-12 West Main Road/Forest Avenue Intersection

The intersection consists of a through lane and a shared through/right-turn lane on the West Main Road northbound approach, a shared left-turn/through lane and a through lane on the West Main Road southbound approach and one multipurpose (left-turn/through/right-turn) lane on the Forest Avenue westbound approach. There are sidewalks along West Main Road and there are marked crosswalks with pedestrian signal countdown timers on the north and west legs of the intersection. There is a service station in the southeast quadrant with 2 access points. The RSAs was performed at the intersection as shown in **Figure 3-12** and as discussed in the following section.

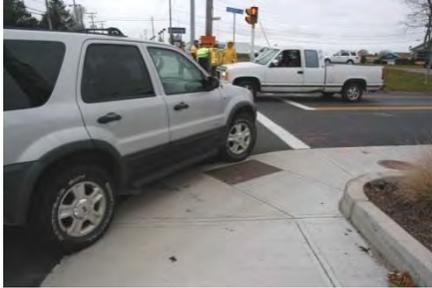
SPECIFIC NEAR TERM IMPROVEMENTS			POTENTIAL INTERMEDIATE IMPROVEMENTS	POTENTIAL LONG TERM IMPROVEMENTS
			(1-6 MONTHS)			(6 MONTHS - 2 YEARS)	(2 OR MORE YEARS)
NO.	ISSUES/CONCERNS	EXAMPLE OF ISSUES	ENGINEERING	ENFORCEMENT	EDUCATION & ENCOURAGEMENT	ENGINEERING	ENGINEERING
1	<p>Sidewalk in southwest corner flush with roadway</p> <ul style="list-style-type: none"> - The ADA ramp and sidewalk on the southeast corner of the intersection is flush with the roadway. - Right-turning vehicles encroach on the sidewalk. - Gas station driveway close to signal

<p><i>Right-turning vehicles encroaching on the ADA ramp.</i></p>

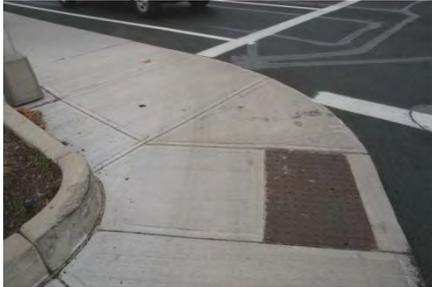
<p><i>The ADA ramp and sidewalk have numerous tire marks from being run over by right-turning vehicles.</i></p>	<ul style="list-style-type: none"> - Install raised pedestrian refuge area on southeast corner. - Move Forest Avenue STOP BAR back to provide sufficient room for vehicle to make right-turning movement without encroaching onto sidewalk. - Install TURNING TRAFFIC YIELD TO PEDESTRIANS" signs on the southbound approach. - Restrict left-turn in/out at the driveway on the southeast corner. 			<ul style="list-style-type: none"> - Increase curve radius to move back curb to provide additional waiting space for pedestrians. This may require minor ROW takings.

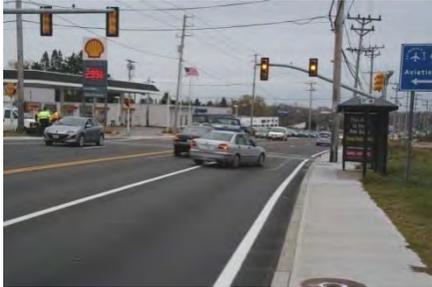
SPECIFIC NEAR TERM IMPROVEMENTS			POTENTIAL INTERMEDIATE IMPROVEMENTS	POTENTIAL LONG TERM IMPROVEMENTS
			(1-6 MONTHS)			(6 MONTHS - 2 YEARS)	(2 OR MORE YEARS)
NO.	ISSUES/CONCERNS	EXAMPLE OF ISSUES	ENGINEERING	ENFORCEMENT	EDUCATION & ENCOURAGEMENT	ENGINEERING	ENGINEERING
2	<p>Lack of left-turn lanes & exclusive left-turn phasing</p> <ul style="list-style-type: none"> – Motorists wishing to make a left-turn block the through movement along West Main Road. – The lack of protected left-turn phasing may cause additional conflicts as vehicles must make a left-turn against two lanes of opposing through traffic.

<p><i>Vehicle waiting in left-lane swerving into the right-lane to go around vehicle waiting to make left-turn movement. The high number of sideswipes at this intersection may be caused by maneuvers like the one shown.</i></p>	<ul style="list-style-type: none"> – Install advance lane use signage for southbound traffic and supplement with pavement markings. – Install street name signs and lane use signage on mast arm, if feasible. 				<ul style="list-style-type: none"> – Install exclusive left-turn lane on West Main Road southbound approach.

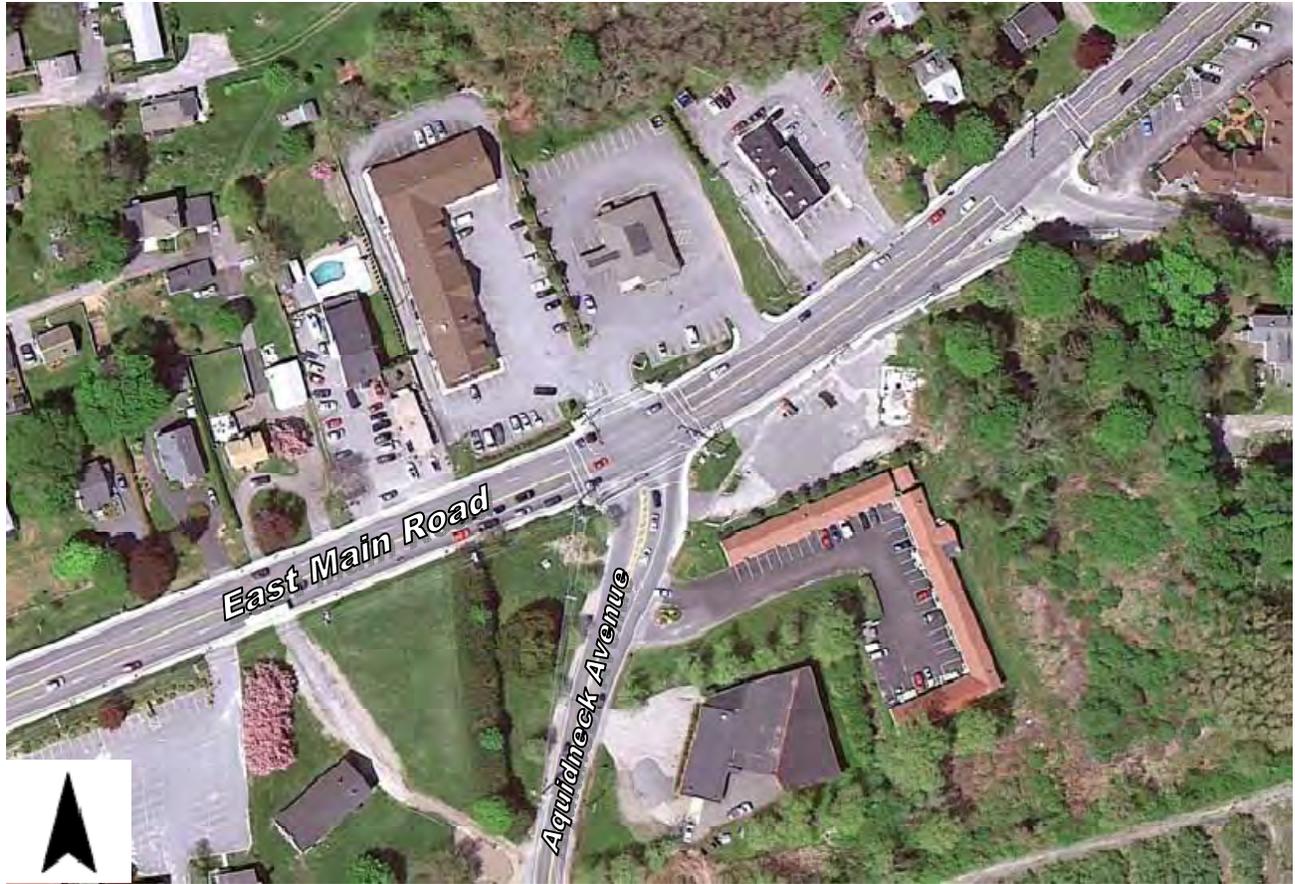
Figure 3-15 East Main Road/Aquidneck Avenue Intersection

The four-way, signalized intersection consists of a shared left-turn/through lane and a shared through/right-turn lane on the East Main Road eastbound and westbound approaches. The Aquidneck Avenue northbound approach consists of a left-turn lane and a shared through/right-turn lane and approaches the intersection on a horizontal curve and intersects at a slight skew. The southbound driveway approach consists of a shared left-turn/through lane and a right-turn lane. Four other heavily used driveways are located in the vicinity of the intersection. The posted speed limit is 25 mph. The RSAs were performed at the intersections as shown in **Figure 3-15** and as discussed in the following section.
