Rhode Island Strategically Targeted Affordable Roadway Solutions

Aquidneck Island 2010-2011

Aquidneck Island
Transportation Study
On the move...connecting our communities

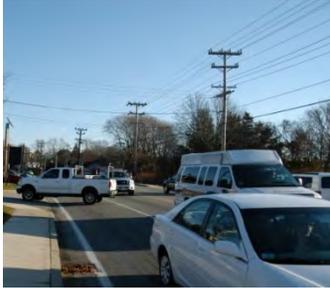
SPECIFIC NEAR TERM IMPROVEMENTS			POTENTIAL INTERMEDIATE IMPROVEMENTS	POTENTIAL LONG TERM IMPROVEMENTS
			(1-6 MONTHS)			(6 MONTHS - 2 YEARS)	(2 OR MORE YEARS)
NO.	ISSUES/CONCERNS	EXAMPLE OF ISSUES	ENGINEERING	ENFORCEMENT	EDUCATION & ENCOURAGEMENT	ENGINEERING	ENGINEERING
1	<p>Multiple access points near intersection.</p> <ul style="list-style-type: none"> – On the westbound approach, there are multiple access points close to each other and near the intersection. – Left-turning vehicles waiting to access driveways along East Main Road cause delay for through vehicles. – Vehicles along East Main Road in left lane stop to let left-turning vehicles from into driveway, and then vehicles in right lane have limited sight distance to see this vehicle crossing. – Eastbound vehicles pass the signalized entrance to the Bank/Shopping Center and enter via the unsignalized drive to the east.

<p><i>Vehicles turning left into bank driveway. Vehicles drive past signal and try to sneak in between the westbound queue.</i></p>	<ul style="list-style-type: none"> – Convert unsignalized Bank driveway to Right-In/Right-Out access only. 				<ul style="list-style-type: none"> – Install median along East Main Road, between Aquidneck Avenue and Wyatt Road. – Connect the driveways for Dunkin Donuts and the Bank/Plaza with frontage roads and consolidate access points along East Main Road.

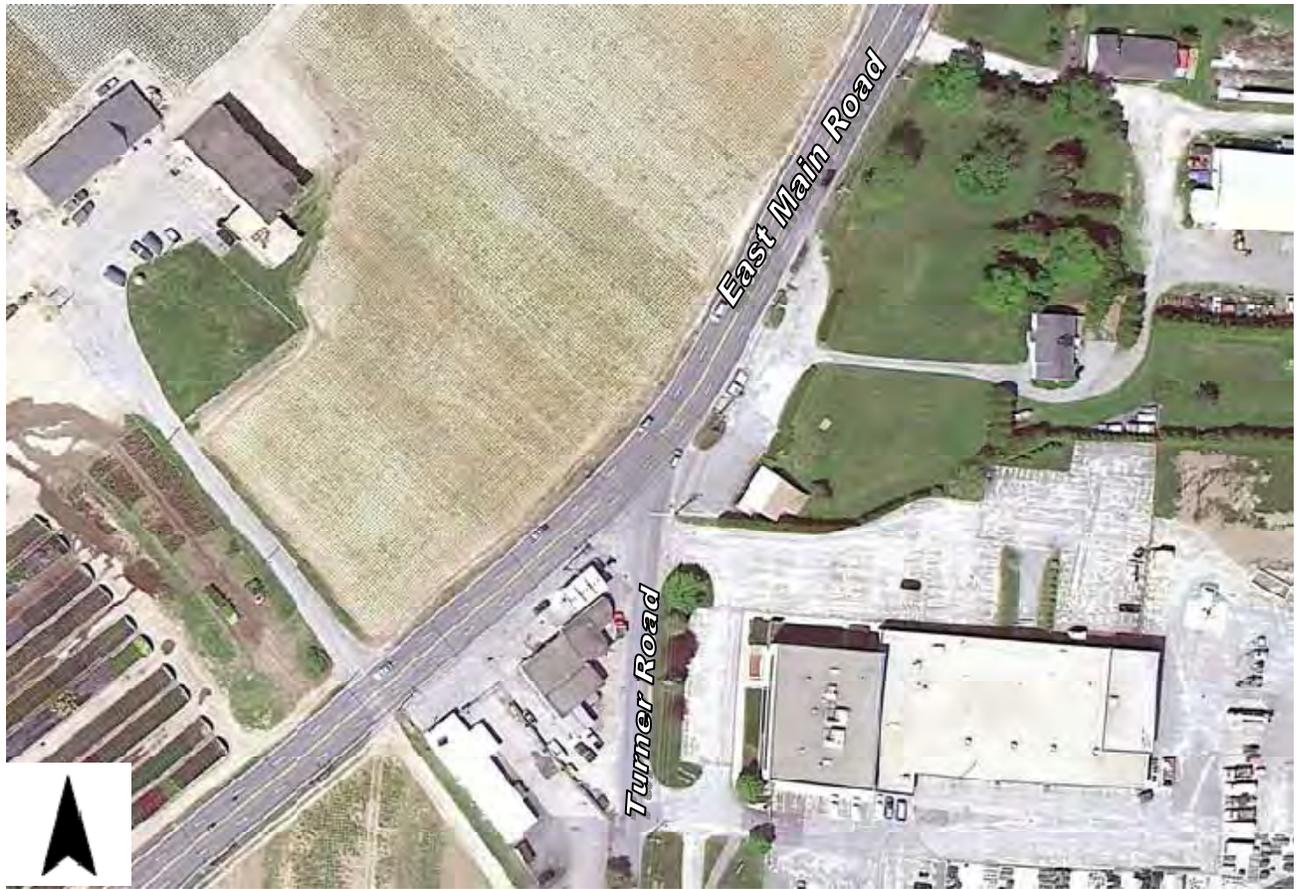
Figure 3-18 East Main Road/Turner Road Intersection

The intersection consists of a through lane and a shared through/right-turn lane on the East Main Road eastbound approach, a shared left-turn/through lane on the East Main Road southbound approach, and one multipurpose (left-turn/through/right-turn) lane on the Turner Road northbound approach. The land use in the area is mostly farm, with a small business and a gas station at the intersection corners. There is inadequate delineation for the gas station access driveways. The posted speed limit is 35 mph. The RSAs were performed at the intersections as shown in **Figure 3-18** and as discussed in the following section.

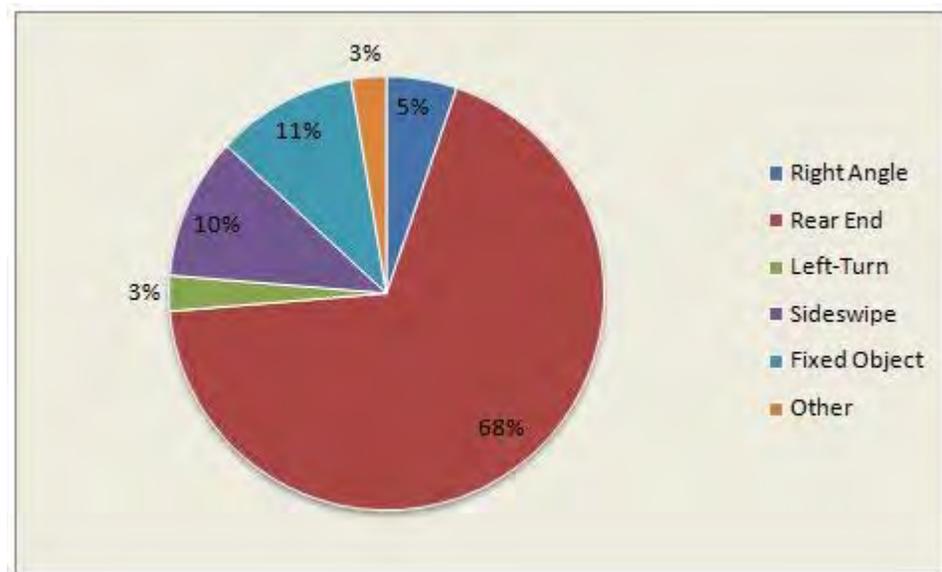
Of the 38 rear-ends crashes, 24 (63%) occurred on the Turner Road northbound approach. Also, all five crashes that involved a fixed object occurred in nighttime conditions.

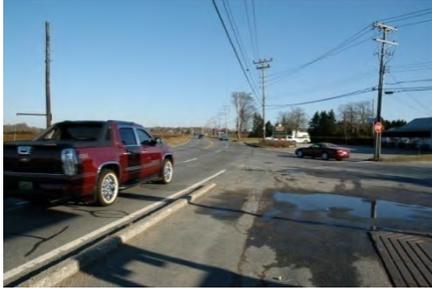
SPECIFIC NEAR TERM IMPROVEMENTS			POTENTIAL INTERMEDIATE IMPROVEMENTS	POTENTIAL LONG TERM IMPROVEMENTS
			(1-6 MONTHS)			(6 MONTHS - 2 YEARS)	(2 OR MORE YEARS)
NO.	ISSUES/CONCERNS	EXAMPLE OF ISSUES	ENGINEERING	ENFORCEMENT	EDUCATION & ENCOURAGEMENT	ENGINEERING	ENGINEERING
1	<p>The Turner Road approach to the intersection is skewed.</p> <ul style="list-style-type: none"> - The northbound approach to the intersection is at a skewed angle, requiring drivers exiting Turner Road to look "hard" left for a gap in traffic. - Because the northbound vehicles must look "hard" left, once they see a gap, they proceed without looking forward. This may have been a contributing factor in the majority of rear-end crashes at this intersection.

<p><i>Vehicles exiting Turner Road must look left at a less than desirable angle to determine a safe gap in traffic to proceed.</i></p>	<ul style="list-style-type: none"> - Restripe to realign northbound approach to create an intersection closer to a 90 degree angle. - Restrict intersection to rights-out only, if feasible. Conduct traffic counts to determine if lefts are low enough to be rerouted via another route. 			<ul style="list-style-type: none"> - Install curbing to realign northbound approach to create an intersection closer to a 90 degree angle.

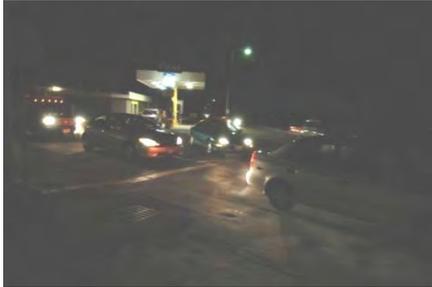
<p><i>Photo illustrated the lack of delineation between Turner Road and the property to the east.</i></p>

<p><i>Photo shows a vehicle exiting the gas station and waiting in the queue on wrong side of road.</i></p>	<ul style="list-style-type: none"> – Install tubular delineators to help define access points 			<ul style="list-style-type: none"> – Install curbing delineators to help define access points and roadway edge.

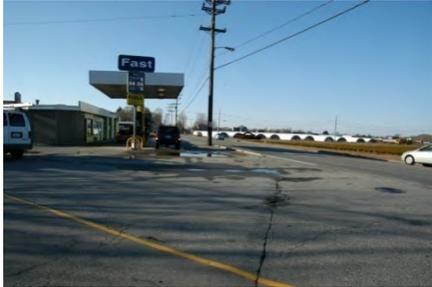
SPECIFIC NEAR TERM IMPROVEMENTS			POTENTIAL INTERMEDIATE IMPROVEMENTS	POTENTIAL LONG TERM IMPROVEMENTS
			(1-6 MONTHS)			(6 MONTHS - 2 YEARS)	(2 OR MORE YEARS)
NO.	ISSUES/CONCERNS	EXAMPLE OF ISSUES	ENGINEERING	ENFORCEMENT	EDUCATION & ENCOURAGEMENT	ENGINEERING	ENGINEERING
3	<p>Stop Bar on Turner Road northbound approach too far back from intersection.</p> <p>– The STOP BAR is located too far back and is not adhered to.</p>

<p><i>Photo illustrates view from vehicle when stopped at STOP BAR.</i></p>	<p>– Move STOP BAR closer to East Main Road.</p>				
4	<p>Horizontal curve on major arterial</p> <p>– East Main Road changes direction in this area, going from a north-south corridor to an east-west corridor.</p> <p>– There is a lack of signage warning drivers of this change in direction.</p>

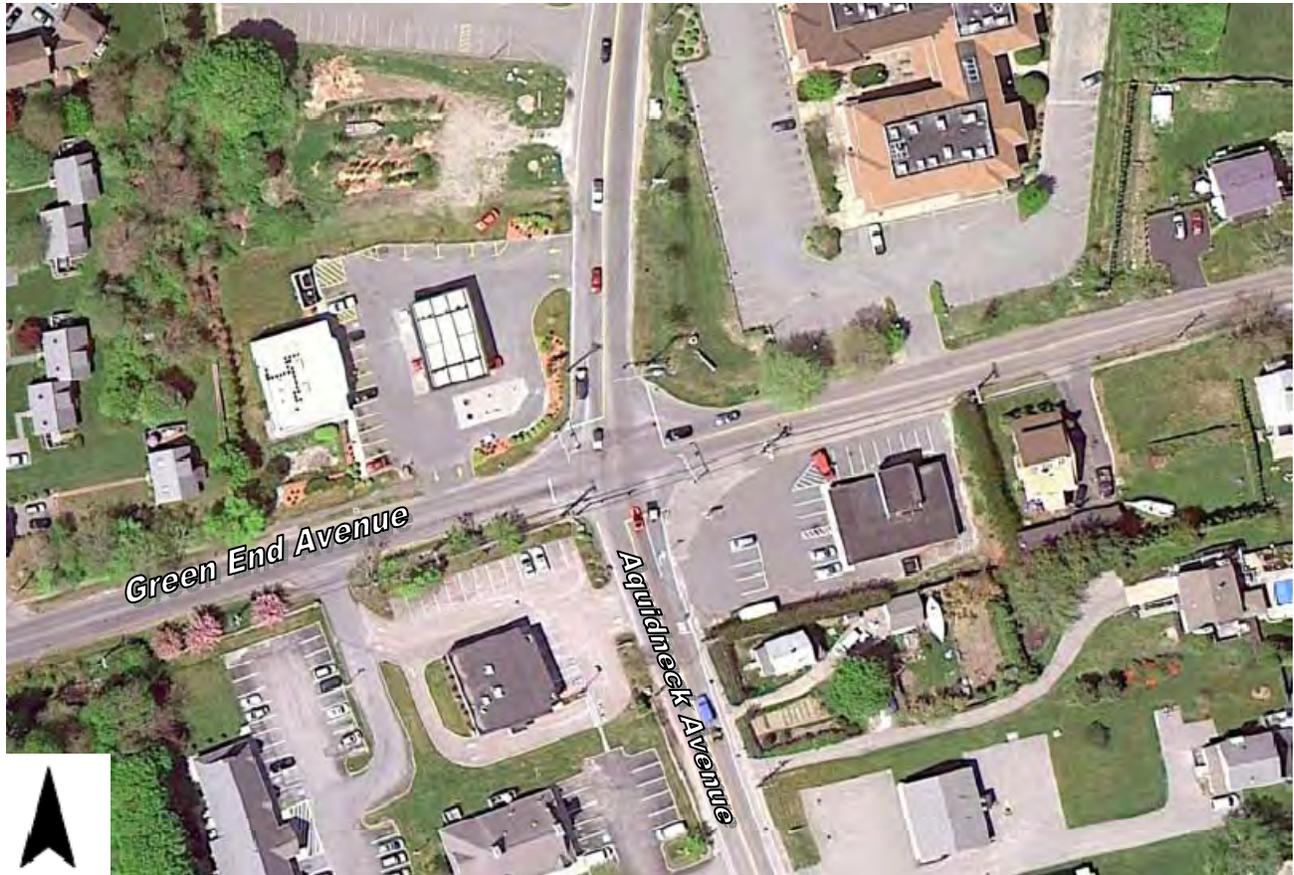
Figure 3-21 Aquidneck Avenue at Green End Avenue Intersection

The intersection of Aquidneck Avenue and Green End Avenue is identified as a High-hazard intersection based on RIDOT. It has been investigated as part of the RIDOT High-Hazard program and a proposed design has been developed.

The four-way, skewed signalized intersection consists of a shared left-turn/through lane and a right-turn lane on the Aquidneck Avenue northbound approach, a shared left-turn/through lane and a shared through/right-turn lane on the Aquidneck Avenue southbound approach, and one multipurpose (left-turn/through/right-turn) lane on the Green End Avenue eastbound and westbound approaches. The posted speed limit is 25 mph. The RSAs were performed at the intersections as shown in **Figure 3-21** and as discussed in the following section.

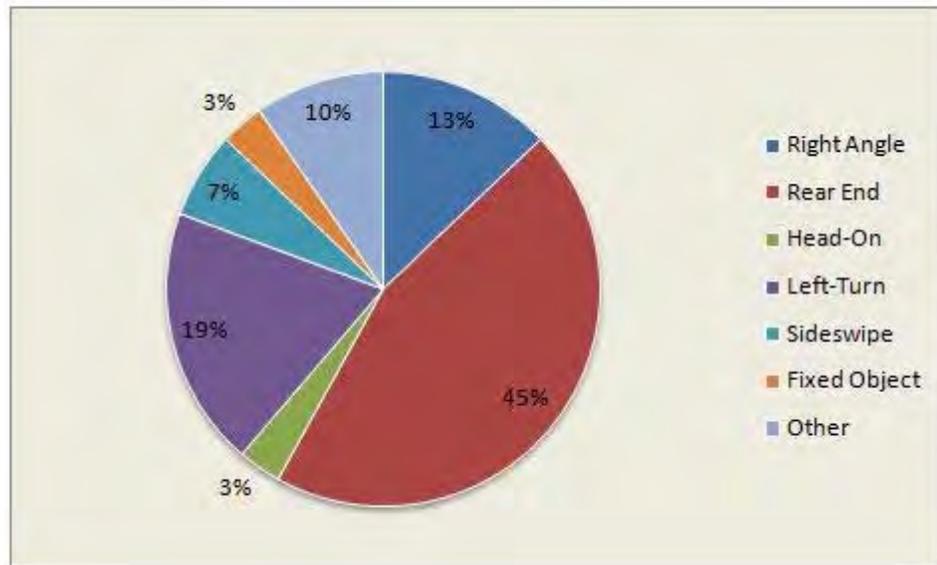
Six (20%) of the total number of crashes occurred at the 7-11 driveway, north of the intersection. Supplemental crash data was available from the RIDOT High-Hazard project. From this report, it was determined that 88 crashes occurred between 2003-2005.

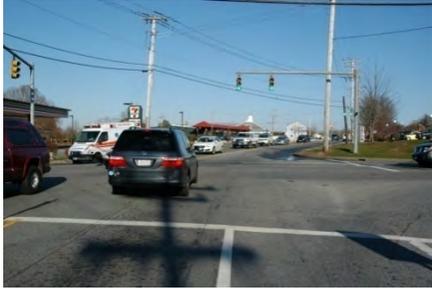
SPECIFIC NEAR TERM IMPROVEMENTS			POTENTIAL INTERMEDIATE IMPROVEMENTS	POTENTIAL LONG TERM IMPROVEMENTS
			(1-6 MONTHS)			(6 MONTHS - 2 YEARS)	(2 OR MORE YEARS)
NO.	ISSUES/CONCERNS	EXAMPLE OF ISSUES	ENGINEERING	ENFORCEMENT	EDUCATION & ENCOURAGEMENT	ENGINEERING	ENGINEERING
1	<p>The Aquidneck Avenue approaches are skewed.</p> <ul style="list-style-type: none"> The southbound approach to the intersection is at a skewed angle, causing the left-most lane, consisting of a shared left-thru lane, to line up with the opposing southbound approach.

<p><i>The southbound approach to the intersection /through lane lines up across from the southbound approach.</i></p>	<ul style="list-style-type: none"> Reconfigure northbound approach to consist of a left-turn lane and a shared thru/right-turn lane. 				<ul style="list-style-type: none"> Construct proposed design concept from High-Hazard report, which better aligns the Aquidneck Avenue northbound and southbound approaches.

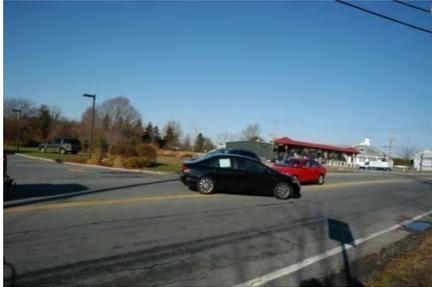
SPECIFIC NEAR TERM IMPROVEMENTS			POTENTIAL INTERMEDIATE IMPROVEMENTS	POTENTIAL LONG TERM IMPROVEMENTS
			(1-6 MONTHS)			(6 MONTHS - 2 YEARS)	(2 OR MORE YEARS)
NO.	ISSUES/CONCERNS	EXAMPLE OF ISSUES	ENGINEERING	ENFORCEMENT	EDUCATION & ENCOURAGEMENT	ENGINEERING	ENGINEERING
3	<p>High number of crashes at the 7-11 north driveway.</p> <p>– There were several crashes that involved vehicles entering/exiting 7-11 driveway off Aquidneck Avenue.</p>

<p><i>Left-turning accepts small gap in traffic to enter Aquidneck Avenue.</i></p>	<p>– Sign driveway as right-in/right-out only OR</p> <p>– Restrict lefts-in from Aquidneck Avenue northbound.</p> <p>– Consider left-turn restrictions at other driveways near the intersection.</p>	<p>– Enforce driveway restrictions</p>		<p>– Convert driveway to right-in/right-out only by constructing island/curbing.</p>

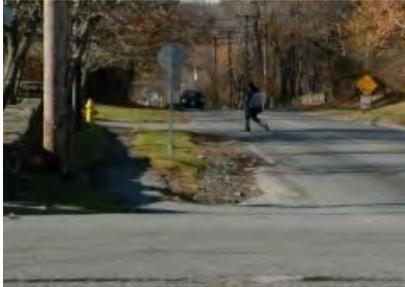
<p><i>The sidewalk on the Green End Avenue eastbound approach is narrow and in poor condition.</i></p>

<p><i>Several pedestrians were observed crossing Green End Avenue west leg, from the 7-11 store to the Polo Center.</i></p>			<p>– Encourage employees/visitors of the Polo Center to cross at the intersection, once crosswalks and pedestrian signal heads are installed.</p>	<p>– Upgrade existing sidewalks to ADA standards.</p> <p>– Connect sidewalks on all approaches to the intersection.</p>	<p>– Incorporate pedestrian signal heads with countdown timers and ADA ramps as part of the proposed design concept from High-Hazard report.</p>

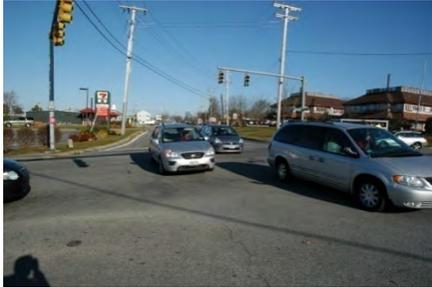
SPECIFIC NEAR TERM IMPROVEMENTS			POTENTIAL INTERMEDIATE IMPROVEMENTS	POTENTIAL LONG TERM IMPROVEMENTS
			(1-6 MONTHS)			(6 MONTHS - 2 YEARS)	(2 OR MORE YEARS)
NO.	ISSUES/CONCERNS	EXAMPLE OF ISSUES	ENGINEERING	ENFORCEMENT	EDUCATION & ENCOURAGEMENT	ENGINEERING	ENGINEERING
5	<p>Lack of lane use signage on Aquidneck Avenue southbound approach.</p> <ul style="list-style-type: none"> - The lack of any lane use signage/markings on southbound approach cause vehicles in both through lanes to continue through intersection. - There is only one receiving lane on southbound departure, causing vehicles to merge in the intersection.

<p><i>Vehicles from both southbound lanes continue through the intersection, causing vehicles in right lane to merge in the intersection.</i></p>	<ul style="list-style-type: none"> - Install lane use signage/markings to indicate left-turn lane and shared through/right-turn lane. 				<ul style="list-style-type: none"> - Incorporate lane usage as proposed design concept from High-Hazard report.

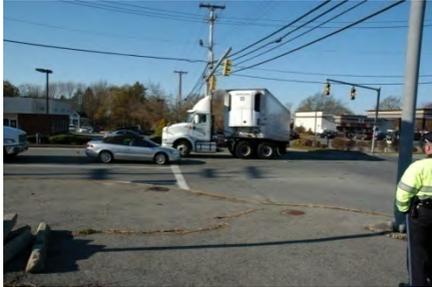
SPECIFIC NEAR TERM IMPROVEMENTS			POTENTIAL INTERMEDIATE IMPROVEMENTS	POTENTIAL LONG TERM IMPROVEMENTS
			(1-6 MONTHS)			(6 MONTHS - 2 YEARS)	(2 OR MORE YEARS)
NO.	ISSUES/CONCERNS	EXAMPLE OF ISSUES	ENGINEERING	ENFORCEMENT	EDUCATION & ENCOURAGEMENT	ENGINEERING	ENGINEERING
6	<p>Eastbound right-turn difficult for heavy vehicles to make.</p> <ul style="list-style-type: none"> - The tight radius on the southwest corner of the intersection causes heavy vehicles to encroach onto oncoming lanes.

<p><i>Heavy vehicles marking right-turn movement from Green End Avenue onto Aquidneck Avenue southbound causes conflicts through intersection.</i></p>	<ul style="list-style-type: none"> - Relocate northbound STOP BAR back to allow right-turn movement. - Restrict trucks from making this movement. Create a truck route via Valley Road. 	<ul style="list-style-type: none"> - Enforce the heavy vehicle restriction at this intersection. 			<ul style="list-style-type: none"> - Incorporate wider radius as part of the proposed design concept from High-Hazard report. This should be done only if heavy vehicle movement restriction is not feasible.

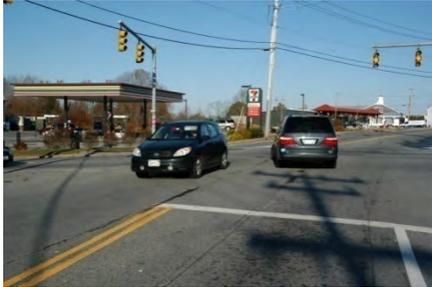
SPECIFIC NEAR TERM IMPROVEMENTS			POTENTIAL INTERMEDIATE IMPROVEMENTS	POTENTIAL LONG TERM IMPROVEMENTS
			(1-6 MONTHS)			(6 MONTHS - 2 YEARS)	(2 OR MORE YEARS)
NO.	ISSUES/CONCERNS	EXAMPLE OF ISSUES	ENGINEERING	ENFORCEMENT	EDUCATION & ENCOURAGEMENT	ENGINEERING	ENGINEERING
9	<p>Lack of left-turn lanes.</p> <ul style="list-style-type: none"> – There are no exclusive left-turn lanes or phasing at this intersection. – Six (19%) of the crashes were left-turn crashes.

<p><i>Vehicles often make left-turn movements during the yellow and red phases due to the lack of an acceptable gap in opposing traffic.</i></p>	<ul style="list-style-type: none"> – Restripe/resign the northbound approach to provide an exclusive left-turn lane. – Sign the southbound approach to provide an exclusive left-turn lane. 			<ul style="list-style-type: none"> – Incorporate exclusive left-turn phasing through existing traffic signal upgrades. 	<ul style="list-style-type: none"> – Incorporate exclusive left-turn lanes and phasing as part of the proposed design concept from High-Hazard report.

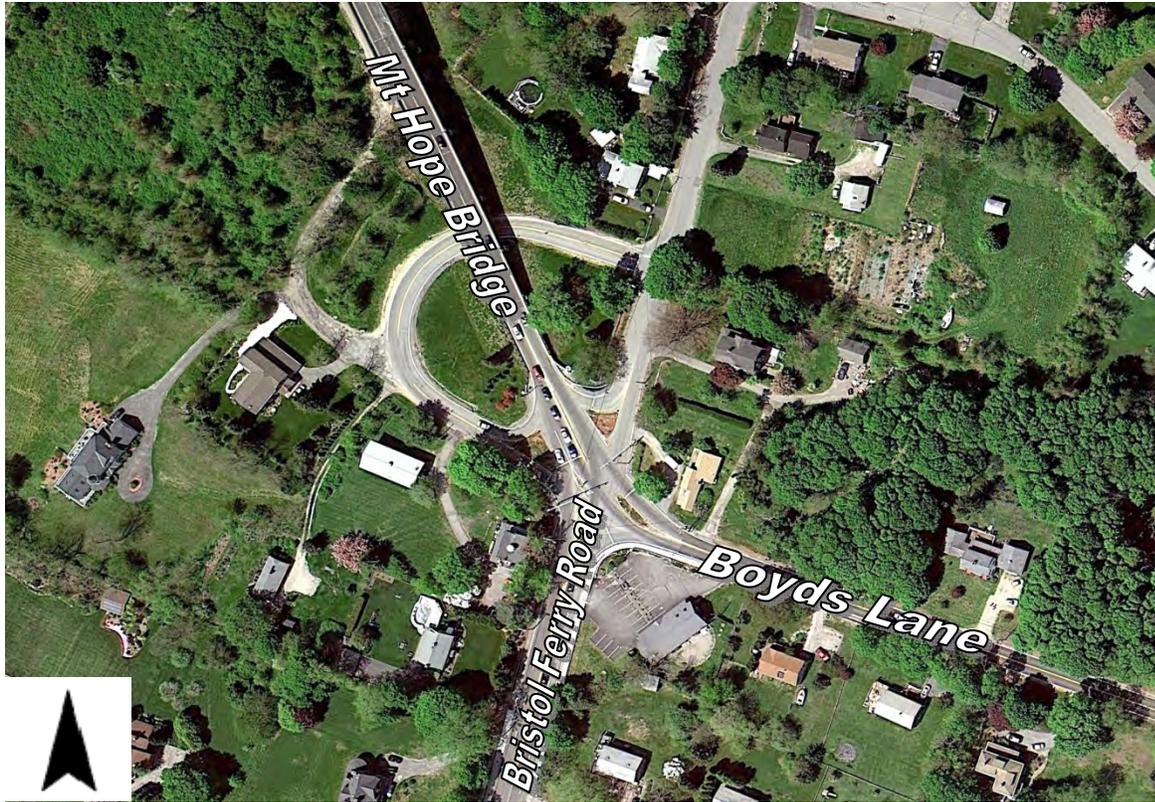
Figure 4-2 Mount Hope Bridge at Boyds Lane/Bristol Ferry Road Study Area Intersection

There are median islands on the Bristol Ferry Road northbound, Mount Hope Bridge south/west, and Boyd's Lane westbound approaches to the intersection. There are sidewalks on the Bristol Ferry Road approach and there are no marked crosswalks at the intersection. The posted speed limit is between 25-35 mph on the intersection roadways. The RSAs were performed at the intersections as shown in **Figure 4-2** and as discussed in the following section.

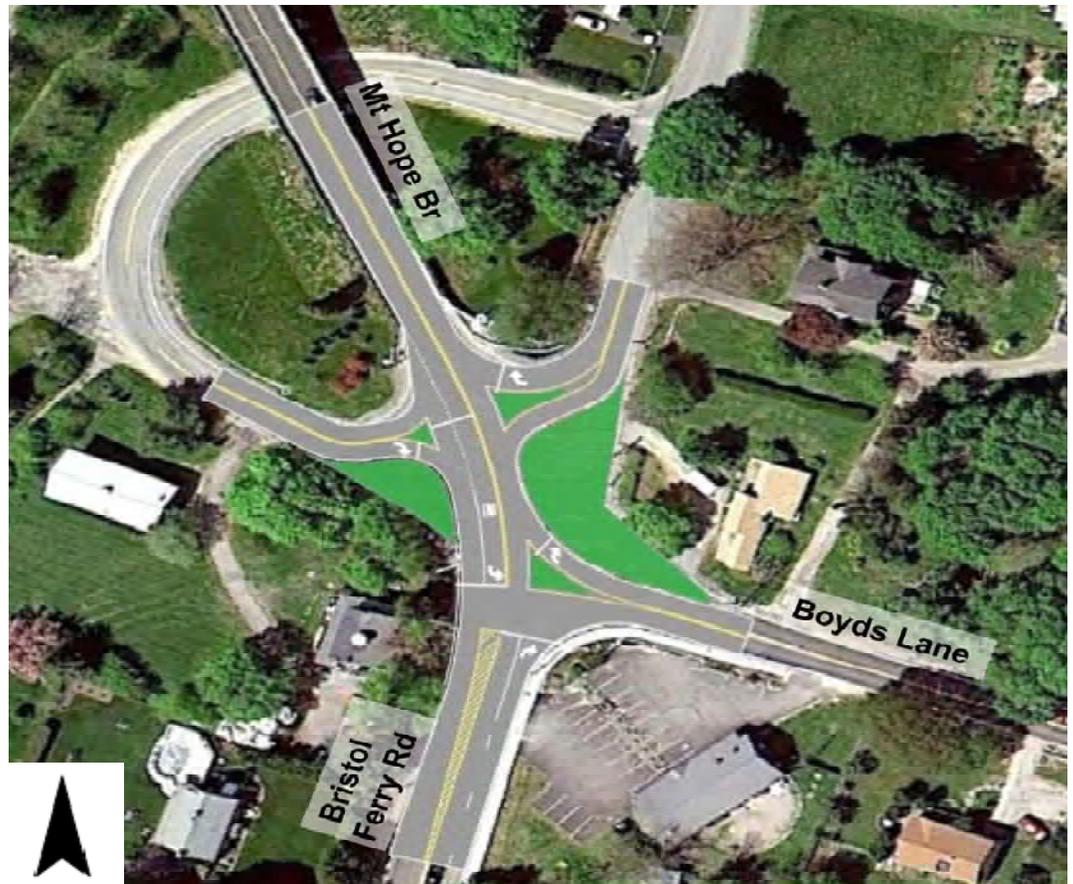
Figure 4-4 Alternative Signalized Concept

As part of the Aquidneck Island Transportation Study (AITS), an alternative concept has been developed, reconfiguring the existing intersection with a smaller intersection footprint, and changing the through movement from Mount Hope Bridge to Boyds Lane to a left-turn movement. This Alternative Signalized Concept is illustrated in **Figure 4-4**.

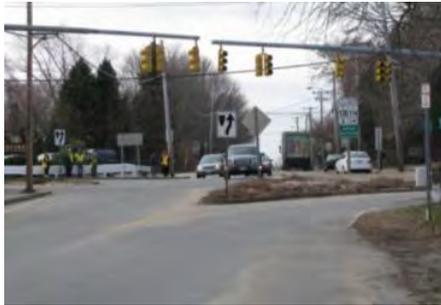
<p><i>Photo shows the southbound approach. Thru movements are not permitted from this approach. Instead, drivers must turn right prior to the intersection, go under the bridge, and then make a right back onto 114 south.</i></p>

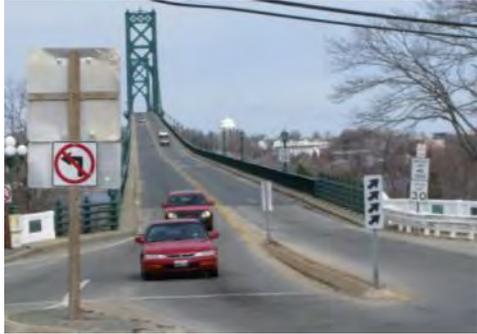
<p><i>Photo shows the downgrade from the bridge.</i></p>	<ul style="list-style-type: none"> – Consider speed feedback signs on the Mount Hope Bridge in the eastbound direction. This may be an intermediate measure for permanent signs. – Consider installing a 'signal ahead' sign/flasher on the Mount Hope Bridge in the eastbound direction. – Consider installing transverse speed bars (pavement markings) on the Mount Hope Bridge in the eastbound direction. 	<ul style="list-style-type: none"> – Target speeding in conjunction with education. There is also potential for DUI checkpoints. 	<ul style="list-style-type: none"> – Target speeding and DUI in conjunction with enforcement campaign. Specifically, there is the potential to work with bars and restaurants (maybe the university) in Bristol.

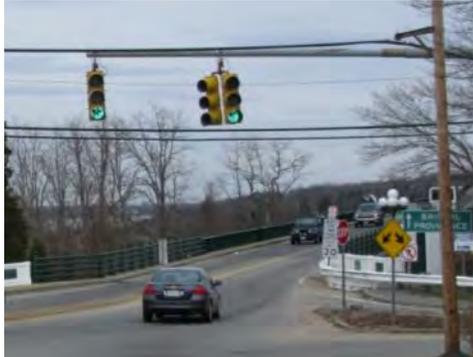
SPECIFIC NEAR TERM IMPROVEMENTS			POTENTIAL INTERMEDIATE IMPROVEMENTS	POTENTIAL LONG TERM IMPROVEMENTS
			(1-6 MONTHS)			(6 MONTHS - 2 YEARS)	(2 OR MORE YEARS)
NO.	ISSUES/CONCERNS	EXAMPLE OF ISSUES	ENGINEERING	ENFORCEMENT	EDUCATION & ENCOURAGEMENT	ENGINEERING	ENGINEERING
3	<p>Unsecured signal heads.</p> <ul style="list-style-type: none"> - The signal heads twist when the wind blows, making it difficult to determine whether the light is green or red.

<p><i>Photo shows the unsecured signal heads, which are starting to twist from the wind.</i></p>	<ul style="list-style-type: none"> - Tighten or secure signal heads to prevent twisting in the wind. - Add backplates to signals. 				
4	<p>Sight distance issues.</p> <ul style="list-style-type: none"> - There is poor sight distance to the signal on the westbound approach (Boyd's Lane). Signs and a tree obstruct drivers' view to the signal. A supplemental signal has been installed, but is not

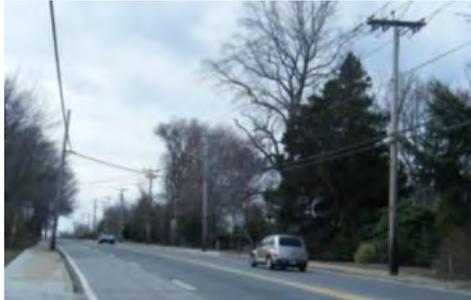
<i>Photo shows several utility poles in close proximity to the roadway.</i>	– There is the potential to relocate utility lines and eliminate at least three utility poles.			– There are plans to eliminate redundant utility poles as part of an upcoming project (Kate Wilson).

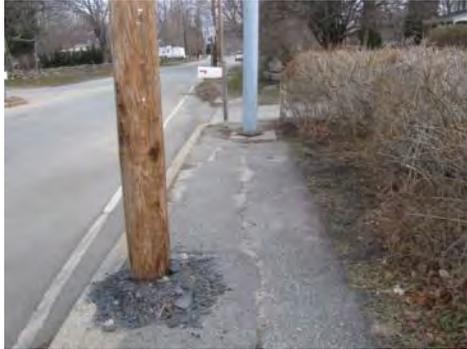
SPECIFIC NEAR TERM IMPROVEMENTS			POTENTIAL INTERMEDIATE IMPROVEMENTS	POTENTIAL LONG TERM IMPROVEMENTS
			(1-6 MONTHS)			(6 MONTHS - 2 YEARS)	(2 OR MORE YEARS)
NO.	ISSUES/CONCERNS	EXAMPLE OF ISSUES	ENGINEERING	ENFORCEMENT	EDUCATION & ENCOURAGEMENT	ENGINEERING	ENGINEERING
6	<p>Pedestrian and ADA issues.</p> <ul style="list-style-type: none"> – There are no pedestrian crossings on any of the intersection approaches and there are also obstructions along the sidewalk. – The location of the planned crosswalk on the southern leg is a concern due to high speeds from right-turn vehicles and limited sight distance. – No refuge islands.

<p><i>Photo shows several fixed objects obstructing the sidewalk.</i></p>	<ul style="list-style-type: none"> – Consider revising the plans to move the crosswalk on the southern leg and/or improve sight distance. – Reduce vehicle speeds through engineering, education, and enforcement strategies described previously. 			<ul style="list-style-type: none"> – There are plans to install pedestrian refuge islands on Bristol Ferry Road, new pedestrian heads and push-buttons, and reinforce/improve the sidewalk through an upcoming project (Kate Wilson).

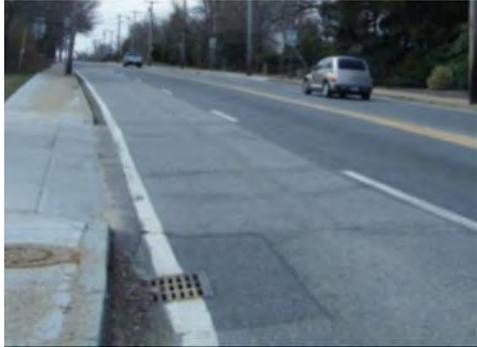
SPECIFIC NEAR TERM IMPROVEMENTS			POTENTIAL INTERMEDIATE IMPROVEMENTS	POTENTIAL LONG TERM IMPROVEMENTS
			(1-6 MONTHS)			(6 MONTHS - 2 YEARS)	(2 OR MORE YEARS)
NO.	ISSUES/CONCERNS	EXAMPLE OF ISSUES	ENGINEERING	ENFORCEMENT	EDUCATION & ENCOURAGEMENT	ENGINEERING	ENGINEERING
7	<p>Pavement issues.</p> <ul style="list-style-type: none"> – The pavement is “shoving” on the northbound approach. <p>There were also several wet-weather crashes.</p>

<p><i>Photo shows pavement shoving on the northbound approach.</i></p>				<ul style="list-style-type: none"> – There are plans to improve the pavement by white topping to address shoving (Kate Wilson) 	<ul style="list-style-type: none"> – Consider improving pavement friction.
8	<p>Capacity issues.</p> <p>The RSA team identified several capacity-related issues including:</p> <ul style="list-style-type: none"> – Eastbound vehicles queue and block the right-turn lane (AM and PM peak). – The green phase for the northbound approach

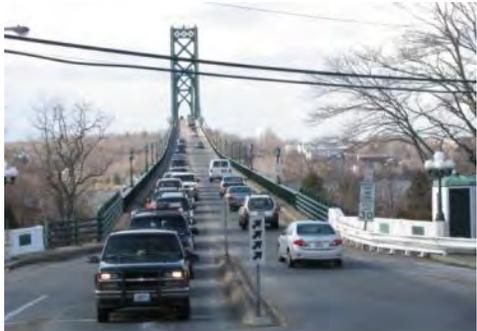
<p><i>Photo shows the queues in the PM peak along the eastbound approach.</i></p>	<ul style="list-style-type: none"> – Replace the controller in cabinet to allow more efficient timing at different peaks. 			<ul style="list-style-type: none"> – Consider impacts of tolling on safety and capacity. – There are plans to improve the northbound right-turn storage lane by roadway widening and tightening the radius for

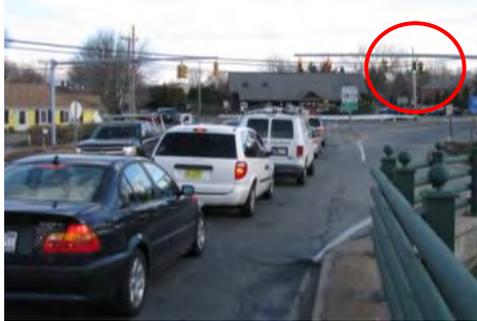
SPECIFIC NEAR TERM IMPROVEMENTS			POTENTIAL INTERMEDIATE IMPROVEMENTS	POTENTIAL LONG TERM IMPROVEMENTS
			(1-6 MONTHS)			(6 MONTHS - 2 YEARS)	(2 OR MORE YEARS)
NO.	ISSUES/CONCERNS	EXAMPLE OF ISSUES	ENGINEERING	ENFORCEMENT	EDUCATION & ENCOURAGEMENT	ENGINEERING	ENGINEERING
	<p>seemed too long for the demand in the AM peak.</p> <ul style="list-style-type: none"> - Older style controller that is not capable of different timing plans by time-of-day. - There are no apparent issues on Boyds Lane and Bristol Ferry Road (queues cleared during each cycle).

<p><i>Photo shows how the eastbound queue blocks the right-turn lane to 114 south. Note the right-turn arrow is green, but cannot be used.</i></p>				northbound right-turns as part of an upcoming project (Kate Wilson).

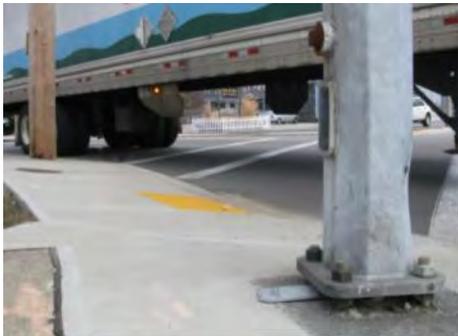
<p><i>Photo shows the relatively steep ramp and obstructions on the sidewalk.</i></p>

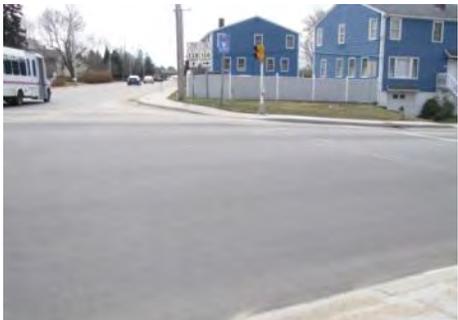
<p><i>Photo shows the lack of a crosswalk on West Main Road.</i></p>	<ul style="list-style-type: none"> – Address ADA concerns. – Consider enhancing visibility of crosswalks (piano key style).

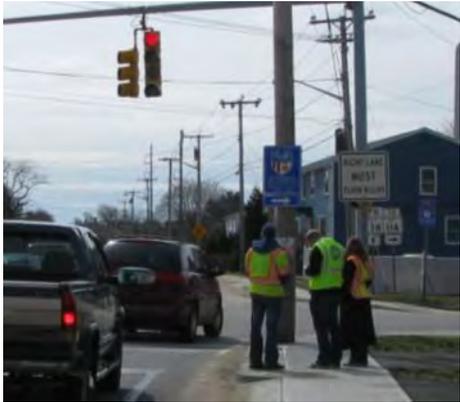
<p><i>Photo shows a vehicle stopped in the crosswalk to turn right on red.</i></p>	<ul style="list-style-type: none"> – Consider implementing a leading pedestrian interval. 				
3	<p>Maintenance issues.</p> <ul style="list-style-type: none"> – A signal head is missing a louver. – Door to signal pole is missing.

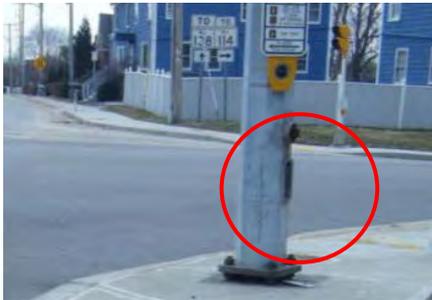
<p><i>Photo shows the missing door on the signal pole.</i></p>	<ul style="list-style-type: none"> – Replace louver on signal head. – Replace door on signal pole.

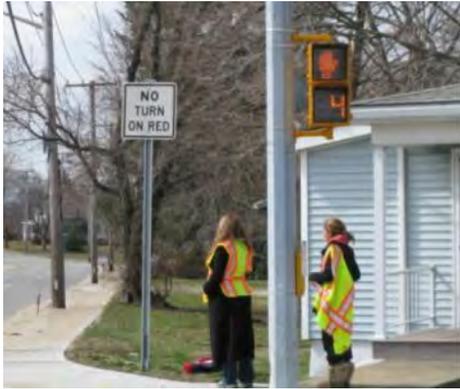
SPECIFIC NEAR TERM IMPROVEMENTS			POTENTIAL INTERMEDIATE IMPROVEMENTS	POTENTIAL LONG TERM IMPROVEMENTS
			(1-6 MONTHS)			(6 MONTHS - 2 YEARS)	(2 OR MORE YEARS)
NO.	ISSUES/CONCERNS	EXAMPLE OF ISSUES	ENGINEERING	ENFORCEMENT	EDUCATION & ENCOURAGEMENT	ENGINEERING	ENGINEERING
4	<p>Signing issues.</p> <ul style="list-style-type: none"> – A guide sign to 114 north is placed in the northwest quadrant (facing south). There is not a similar guide sign in the northeast quadrant. – There is a need for better destination signs to bridges on the northbound approach. – The “To 114” sign on the southeast corner should read “114 south”. – There is a need for a ‘No Turn on Red’ sign on Bristol Ferry Road. – The existing ‘No Turn on Red’ sign on the northwest corner is not MUTCD compliant.

<p><i>Photo shows the noncompliant NO TURN ON RED sign on the northwest corner.</i></p>	<ul style="list-style-type: none"> – Improve way-finding signs. Specifically, install guide sign to 114 north in northeast quadrant, install destination signs to bridges on northbound approach, and change “To 114” sign to “114 south” on southeast corner. – Install street name signs on mast arms (if feasible). – Install a ‘No Turn on Red’ sign on Bristol Ferry Road. – Upgrade ‘No Turn on Red’ sign to comply with MUTCD.

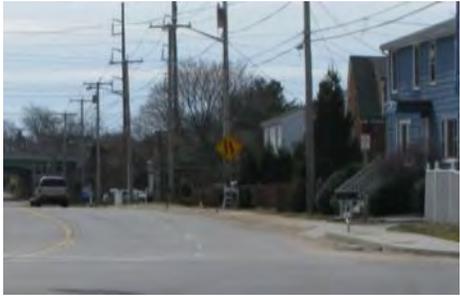
SPECIFIC NEAR TERM IMPROVEMENTS			POTENTIAL INTERMEDIATE IMPROVEMENTS	POTENTIAL LONG TERM IMPROVEMENTS
			(1-6 MONTHS)			(6 MONTHS - 2 YEARS)	(2 OR MORE YEARS)
NO.	ISSUES/CONCERNS	EXAMPLE OF ISSUES	ENGINEERING	ENFORCEMENT	EDUCATION & ENCOURAGEMENT	ENGINEERING	ENGINEERING
5	<p>Operational issues.</p> <ul style="list-style-type: none"> – There are two receiving lanes on Turnpike Avenue. This is an unnecessary configuration and creates the potential for merging issues. – The split phase provides a protected left-turn for the northbound approach, but the left-turn lane only receives a green ball (not left arrow). This is confusing to unfamiliar drivers (may not know that they have a protected phase). – Some signals do not have backplates.

<p><i>Photo shows the two receiving lanes on Turnpike Avenue and immediate merge down to one lane.</i></p>	<ul style="list-style-type: none"> – Consider restriping receiving lanes on Turnpike Avenue as one receiving lane. – Potential to add signal head with left-turn arrow (or additional bulb with arrow on existing signal head) to better communicate protected left. Check shop drawings for load capacity. – Consider signing dual left to let drivers know there is a protected left on green ball. – Potential to retime as protected only (remove split phasing). Note that changing the phasing to protected-

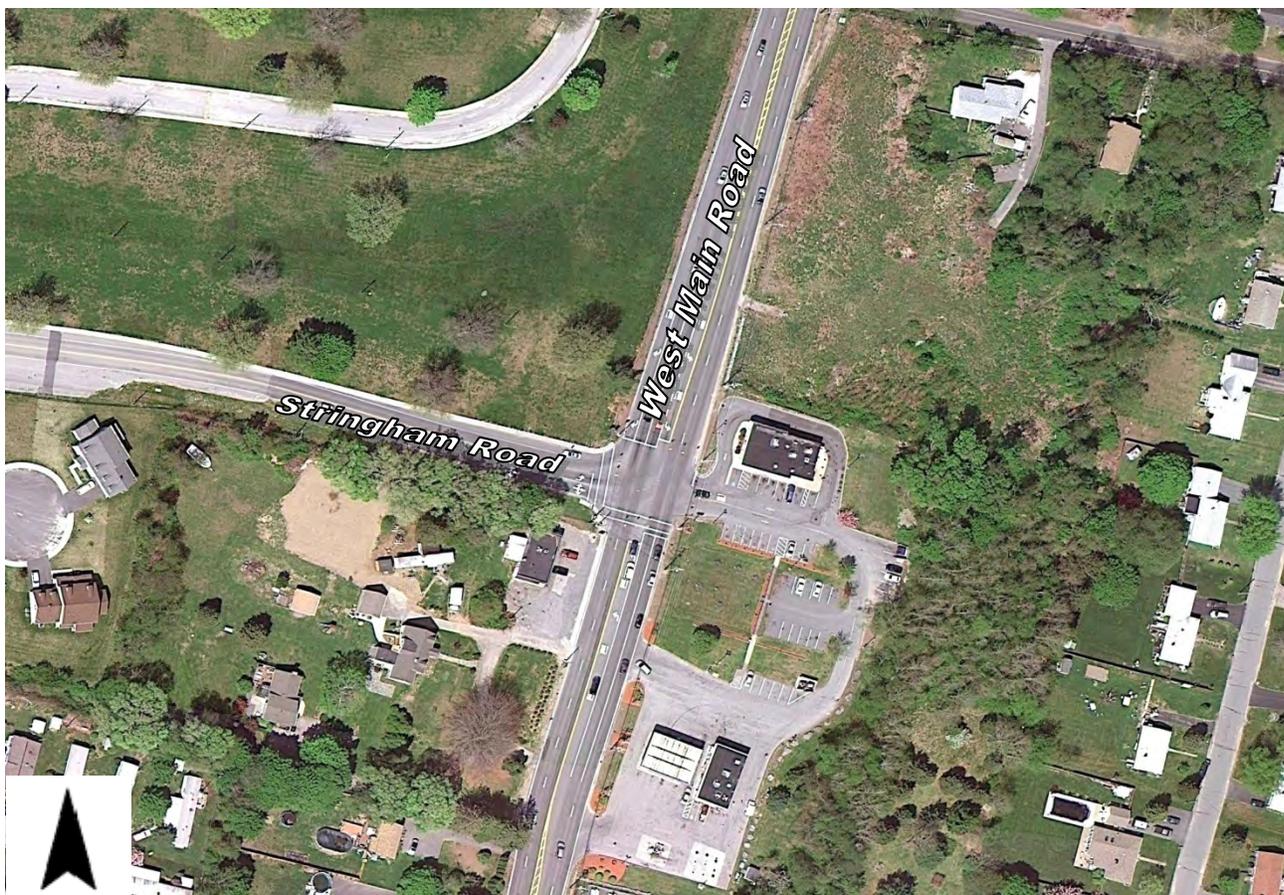
Figure 4-9 West Main Road at Stringham Road/Dunkin Donuts Intersection

The RSAs was performed at the intersection as shown in **Figure 4-9** and as discussed in the following section.

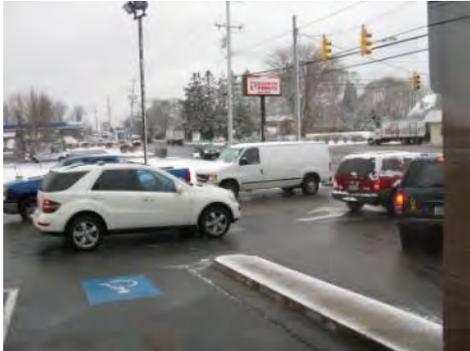
SPECIFIC NEAR TERM IMPROVEMENTS			POTENTIAL INTERMEDIATE IMPROVEMENTS	POTENTIAL LONG TERM IMPROVEMENTS
			(1-6 MONTHS)			(6 MONTHS - 2 YEARS)	(2 OR MORE YEARS)
NO.	ISSUES/CONCERNS	EXAMPLE OF ISSUES	ENGINEERING	ENFORCEMENT	EDUCATION & ENCOURAGEMENT	ENGINEERING	ENGINEERING
1	<p>Operational issues.</p> <ul style="list-style-type: none"> - Dunkin Donuts indicated the detector loop is not being tripped unless vehicles pull beyond the stop bar. The RSA team verified that the loop works correctly if vehicles are aligned properly, but the loop could be extended further back into the parking lot to ensure proper detection. - Internal conflicts create a trap in the Dunkin Donuts parking lot. The queue spills out onto West Main Road. - There is a concentrated peak in the PM from Stringham Road. The RSA team observed several long queues, which occasionally led to double cycling. There is the potential for a large development in the vicinity and capacity concerns would need to be addressed if this occurs.

<p><i>Photo shows the internal conflicts in the Dunkin Donuts parking lot.</i></p>

<p><i>Photo shows the lengthy queues that build-up in the PM peak along Stringham Road.</i></p>	<ul style="list-style-type: none"> - Potential to extend loop (back into parking lot) for Dunkin Donuts parking lot to improve detection. - Potential to eliminate southern parking spaces in Dunkin Donuts parking lot and have patrons park in back lot and use sidewalk. 				<ul style="list-style-type: none"> - Potential to extend dual lefts from Stringham Road. Could make developers improve this in the future.

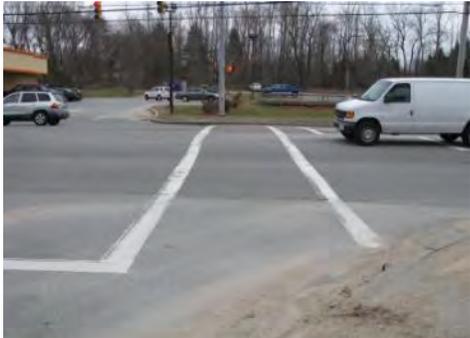
<p><i>Photo shows the crosswalk across the north leg of West Main Road and the lack of a receiving ramp.</i></p>				<ul style="list-style-type: none"> – Pedestrian heads will be addressed in Phase 3. – Consider adding pedestrian ramp on southeast corner in Phase 3 (currently does not show in the plans).

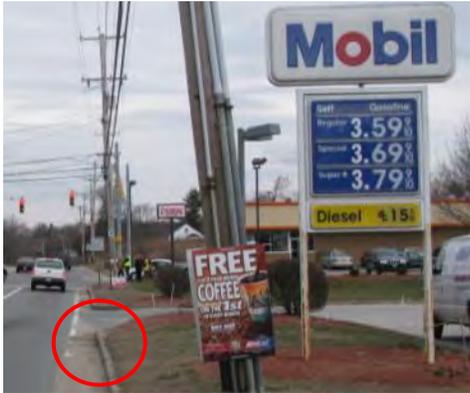
3	<p>Access management issues.</p> <ul style="list-style-type: none"> – The northern-most access to the Mobil station is in close proximity to the intersection. Southbound vehicles turning left into the Mobil station travel the wrong way in the left-turn lane for the intersection. – The left-turn lane on the northbound approach is too long. There is the potential to use the additional space for a southbound left-turn lane into the southern-most driveway of the gas station.

<p><i>Photo shows the close proximity of the gas station driveway to the intersection.</i></p>	<ul style="list-style-type: none"> – Potential to make northern-most driveway from gas station a right-out only. Work with owner of gas station to incorporate right-turn arrow from driveway, no left-turn sign from driveway, and 'No Left-Turn' sign/'Do Not Enter' sign facing East Main Road. 			<ul style="list-style-type: none"> – In Phase 3, create southbound left-turn lane into Mobil station. This may require some space from the shoulder.

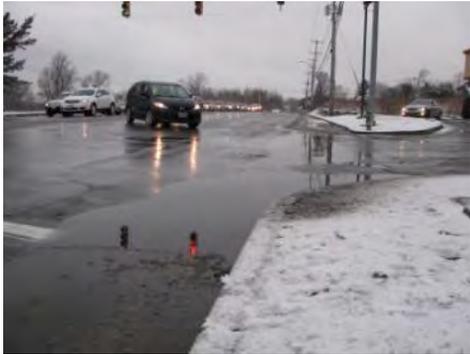
<p><i>Photo shows the drainage issue along the southeast corner where water is covering a portion of the travel lane.</i></p>				– Potential to address drainage issues through upcoming project (Phase 3).	
5	Limited guidance. – There is a lack of street name signs at the intersection.

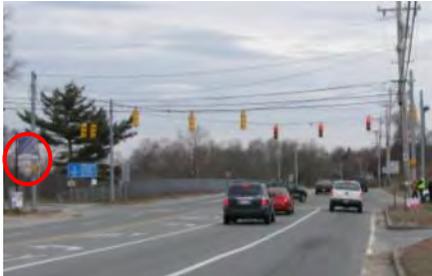
<p><i>Photo shows the lack of overhead street name signs. The only sign is circled in red on the left side of the photo.</i></p>	– Check shop drawings to determine potential to add street name signs on span wire.				– Install street name signs on mast arms.

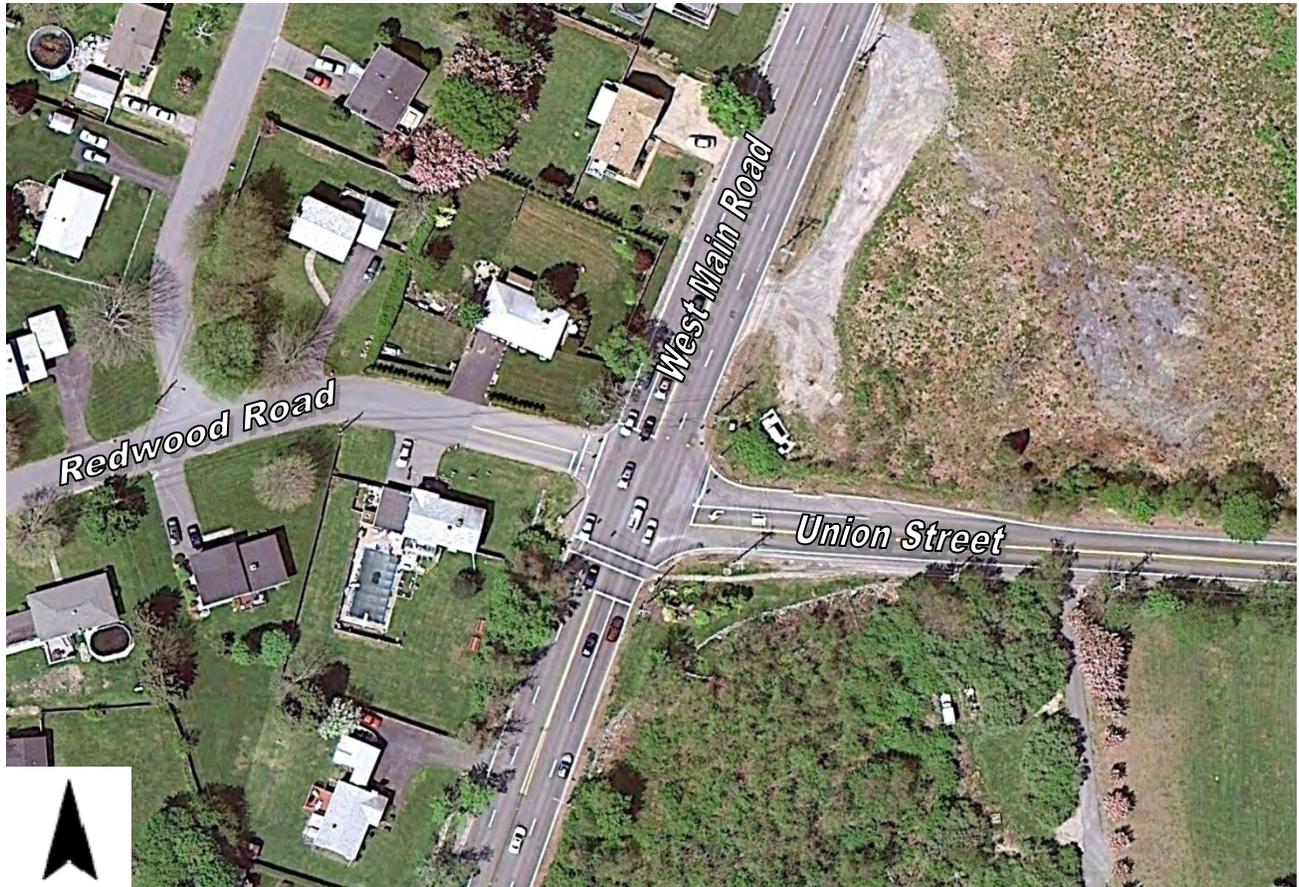
Figure 4-12 West Main Road at Union Street/Redwood Road Intersection

The RSAs was performed at the intersection as shown in **Figure 4-12** and as discussed in the following section.

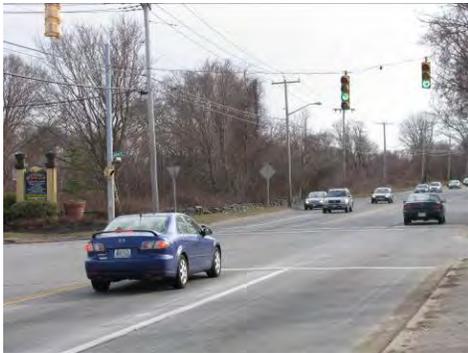
<p><i>Photo shows the lack of left-turn lanes on West Main Road and a vehicle stopped in the thru lane waiting to turn left.</i></p>

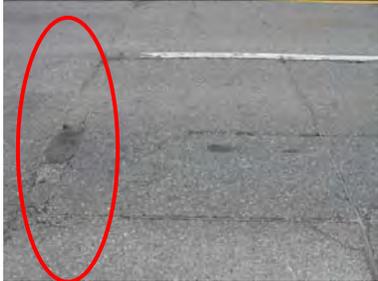
<p><i>Photo shows the potentially broken dilemma zone detector loops on the northbound approach of West Main Road.</i></p>	<ul style="list-style-type: none"> – Check functionality of dilemma zone loops. Properly functioning loops will help address red light running. 				<ul style="list-style-type: none"> – Left-turn lanes will be added on both major approaches.

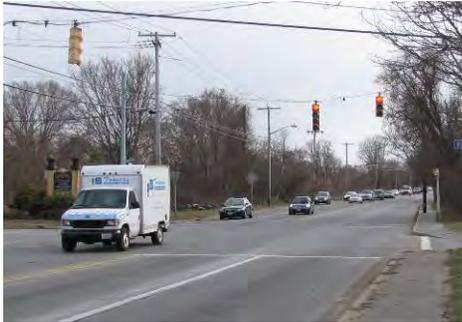
SPECIFIC NEAR TERM IMPROVEMENTS			POTENTIAL INTERMEDIATE IMPROVEMENTS	POTENTIAL LONG TERM IMPROVEMENTS
			(1-6 MONTHS)			(6 MONTHS - 2 YEARS)	(2 OR MORE YEARS)
NO.	ISSUES/CONCERNS	EXAMPLE OF ISSUES	ENGINEERING	ENFORCEMENT	EDUCATION & ENCOURAGEMENT	ENGINEERING	ENGINEERING
2	<p>Driver behavior issues.</p> <ul style="list-style-type: none"> – The law enforcement team member indicated red light running is an issue on the northbound approach. This was confirmed during the PM peak field review. – There was also an indication of speeding in the northbound direction. This was confirmed by car following during the field review. The high speeds along West Main Road create a concern for vehicles turning right-on-red from Union Street.

<p><i>Photo shows a vehicle running the red light traveling northbound.</i></p>	<ul style="list-style-type: none"> – Perform a speed study to determine the adequacy of the yellow and all red time (currently 4 sec yellow and 1.5 sec all red). Also confirm or reject speeding issue. – Consider speed feedback signs (mobile unit). – Potential to add 'No Right on Red' sign for Union Street. 	<ul style="list-style-type: none"> – Consider localized enforcement to address speeding issues if speeding is confirmed. 			<ul style="list-style-type: none"> – Consider intersection as candidate for red light running camera.

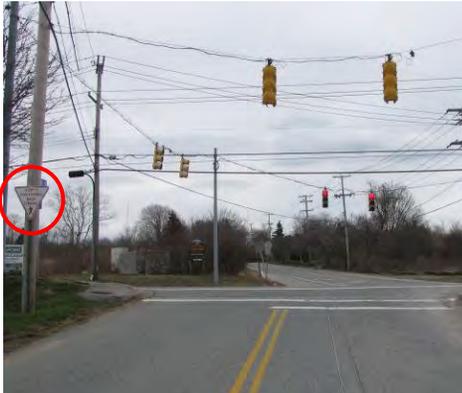
3	<p>Signage issues.</p> <ul style="list-style-type: none"> – The 'Yield to Pedestrian' signs at the intersection are not MUTCD compliant. The sign on Redwood Avenue is not located in a good place to be visible. – The street name signs are too small for the relatively high posted speed on West Main Road. – There are unnecessary pedestrian warning signs on West Main Road (not necessary at a signalized intersection). These signs increase visual clutter.

<p><i>Photo shows the non-compliant and inconspicuous 'Yield to Pedestrian' sign on Redwood Avenue.</i></p>	<ul style="list-style-type: none"> – Increase size of street name signs. – Relocate 'Yield to Pedestrian' sign on Redwood to be more conspicuous. – Remove unnecessary pedestrian warning sign.

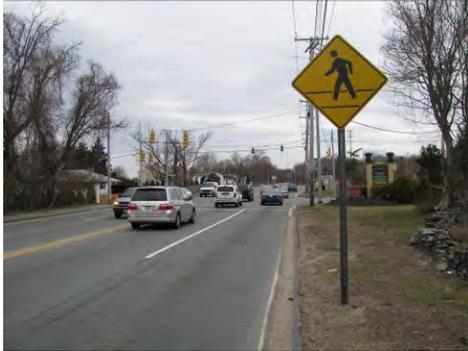
<p><i>Photo shows the unnecessary pedestrian warning sign on the northbound approach on West Main Road.</i></p>					
4	<p>Pedestrian and ADA issues.</p> <p>The RSA team noted pedestrian and ADA-related issues, including:</p> <ul style="list-style-type: none"> - The sidewalk on the southeast corner is insufficient. - The southeast corner lacks a pedestrian ramp. - There is a non-compliant pedestrian ramp on the southwest corner.

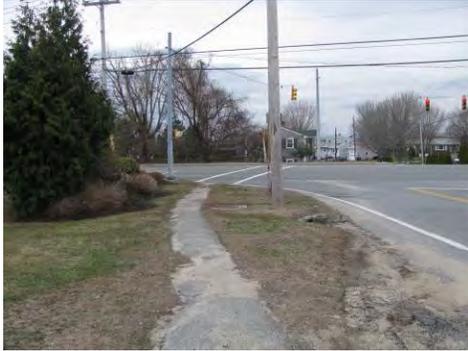
<p><i>Photo shows the sidewalk on the southeast corner. The sidewalk is insufficient.</i></p>					<ul style="list-style-type: none"> - Crosswalk should be shown on the plans for the southern leg. - Update pedestrian equipment and pedestrian heads. Relocate equipment behind sidewalk. - Install accessible ramps

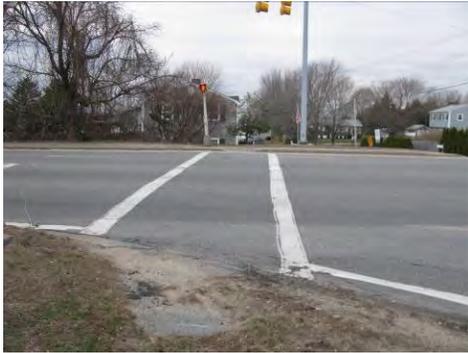
<p><i>Photo shows the lack of a pedestrian ramp on the southeast corner.</i></p>					
5	<p>Geometric issues.</p> <ul style="list-style-type: none"> - The alignment of Union Street is skewed and the signal heads are not aligned with the left-turn lane.

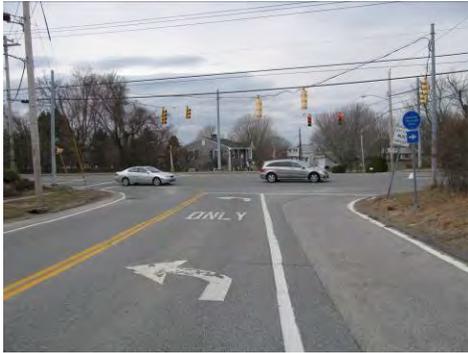
<p><i>Photo shows the westbound approach on Union Street. The signal heads are not aligned properly, particularly with the left-turn lane.</i></p>					<ul style="list-style-type: none"> - Consider realigning Union Street to better align with Redwood Avenue, particularly if the northeast quadrant is developed in the future. - Need to update plans to show the westbound left-turn lane and shared thru-right lane. - Add supplemental head on signal pole in southwest quadrant facing Union Street.

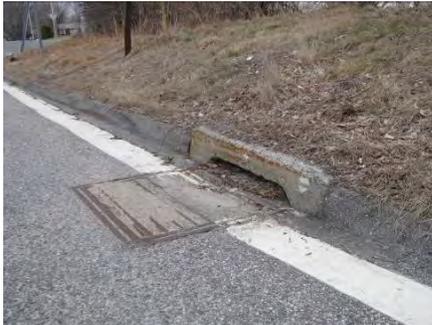
SPECIFIC NEAR TERM IMPROVEMENTS			POTENTIAL INTERMEDIATE IMPROVEMENTS	POTENTIAL LONG TERM IMPROVEMENTS
			(1-6 MONTHS)			(6 MONTHS - 2 YEARS)	(2 OR MORE YEARS)
NO.	ISSUES/CONCERNS	EXAMPLE OF ISSUES	ENGINEERING	ENFORCEMENT	EDUCATION & ENCOURAGEMENT	ENGINEERING	ENGINEERING
6	<p>Drainage issues.</p> <ul style="list-style-type: none"> – There is a plugged catch basin along Union Street.

<p><i>Photo shows the plugged catch basin along Union Street.</i></p>	<ul style="list-style-type: none"> – Notify maintenance to clean catch basin on Union Street. 				
7	<p>Delineation issues.</p> <ul style="list-style-type: none"> – There is a lack of lighting on the north side of West Main Road. There is some lighting at the intersection, but the northeast corner of the intersection is poorly lit. – The edge of the roadway is not well delineated along West Main Road. Reflectors are installed on utility poles, but consider installing other reflectors along edgeline or in between utility poles to enhance guidance.

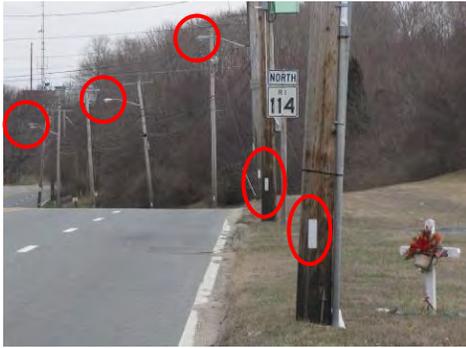
<p><i>Photo shows the continuous lighting further north of the intersection and the delineators on the utility poles.</i></p>	<ul style="list-style-type: none"> – Consider adding lighting along the north side of West Main Road to fill-in gap. – Consider focusing one of the lights in the northeast corner of intersection. – Consider installing reflectors along the edgeline or in between utility poles on the roadside.

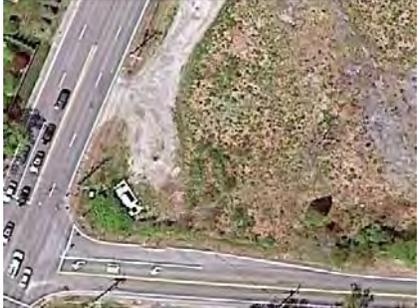
SPECIFIC NEAR TERM IMPROVEMENTS			POTENTIAL INTERMEDIATE IMPROVEMENTS	POTENTIAL LONG TERM IMPROVEMENTS
			(1-6 MONTHS)			(6 MONTHS - 2 YEARS)	(2 OR MORE YEARS)
NO.	ISSUES/CONCERNS	EXAMPLE OF ISSUES	ENGINEERING	ENFORCEMENT	EDUCATION & ENCOURAGEMENT	ENGINEERING	ENGINEERING
8	<p>Access management issues.</p> <ul style="list-style-type: none"> – There is the potential to develop the northeast quadrant of the intersection in the future.

<p><i>Aerial shows the undeveloped northeast corner.</i></p>					<ul style="list-style-type: none"> – Need to consider management of access and secure freeway line. – Try to prohibit curb cuts along West Main Road.
