Rhode Island Strategically Targeted Affordable Roadway Solutions

Aquidneck Island 2010-2011

Aquidneck Island
Transportation Study
On the move...connecting our communities

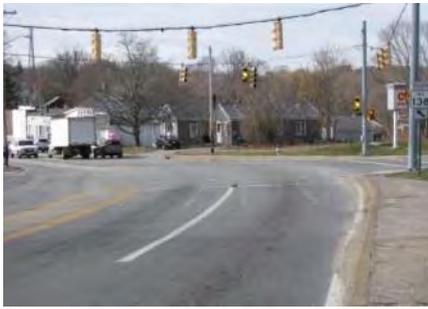
<p><i>Photo shows the general lack of guidance (no lane designation signs or pavement markings) at the intersection.</i></p>	<ul style="list-style-type: none"> – Restripe pavement markings and make sure they comply with MUTCD. – Add pavement arrows to designate lane use. 				
2	<p>Driver behavior issues.</p> <p>The RSA team noted several safety concerns related to driver behavior, including the following:</p> <ul style="list-style-type: none"> – Northbound drivers are making a left-turn from the right lane, which is a shared through-right. – Northbound left-turning drivers cut the turn and drive in southbound receiving lane. – Lanes on northbound approaches are narrow, between 9 and 10 feet wide.

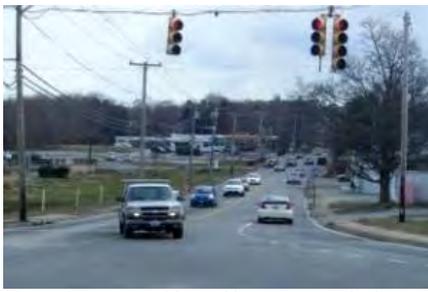
<p><i>Photo shows a northbound left-turning vehicle cutting the turn and encroaching on the southbound receiving lane.</i></p>	<ul style="list-style-type: none"> – Designate lane use by adding pavement arrows. – Add skip marks to provide better guidance for dual turning vehicles.

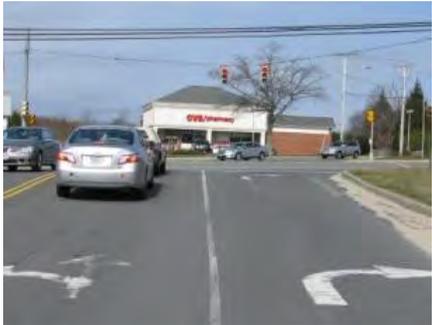
<p>Photo shows the drivers view looking from Clement's Market toward Turnpike Avenue. It is difficult to determine if the vehicles are in the near or far lane of the opposing approach.</p>	<ul style="list-style-type: none"> – Pull northbound left-turn lane back (allow more room for westbound left-turns and eastbound right-turns).

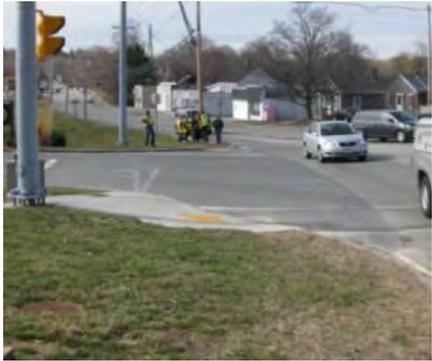
<p><i>Photo shows the gaps in the sidewalk and lack of crosswalk at the entrance to Clement's Market.</i></p>	<ul style="list-style-type: none"> – Potential to add crosswalk across Clement's Market driveway (would also require pedestrian signal head). – Fix deficient wheelchair ramp. – Make call to Lamar to install bus shelter. 			<ul style="list-style-type: none"> – Wheelchair ramps will be improved under upcoming project. 	<ul style="list-style-type: none"> – Future plans for a roundabout at this location. There is the potential to extend the sidewalk along East Main Road (from north down to Clement's Market and from bus shelter to corner of intersection) as part of this project.

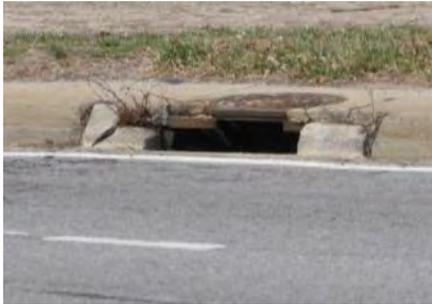
<p><i>Photo shows the unprotected catch basin and deteriorating curb.</i></p>				<p>– Catch basins will be improved under upcoming project.</p>	
7	<p>Narrow lanes.</p> <p>– The receiving lanes for left-turns from Clement's Market and dual right-turns from Turnpike Avenue are relatively tight. This issue is accentuated by the placement of the northbound stop bar, which is relatively close to the intersection.</p> <p>– There are also several fixed objects and a steep embankment in the southeast quadrant that are in close proximity to the roadway. Narrow lanes don't provide much room for recovery. There are post-mounted delineators to delineate the embankment in the southeast quadrant, but no protection.</p>

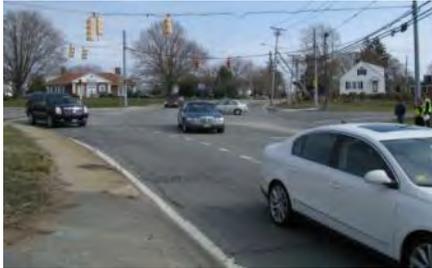
<p><i>Photo shows several vehicles turning into the southbound receiving lanes, which is a difficult maneuver with the narrow lanes.</i></p>	<p>– Pull northbound left-turn lane back (allow more room for westbound left-turns and eastbound right-turns).</p> <p>– Install context-friendly guardrail in southeast quadrant.</p>

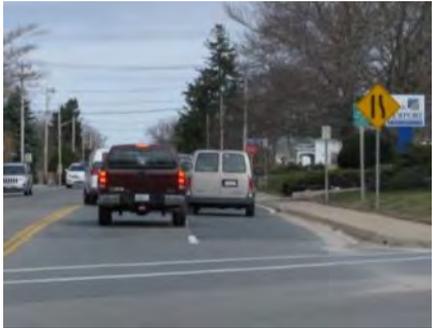
SPECIFIC NEAR TERM IMPROVEMENTS			POTENTIAL INTERMEDIATE IMPROVEMENTS	POTENTIAL LONG TERM IMPROVEMENTS
			(1-6 MONTHS)			(6 MONTHS - 2 YEARS)	(2 OR MORE YEARS)
NO.	ISSUES/CONCERNS	EXAMPLE OF ISSUES	ENGINEERING	ENFORCEMENT	EDUCATION & ENCOURAGEMENT	ENGINEERING	ENGINEERING
8	<p>Dual receiving lanes on Turnpike Avenue.</p> <p>There are two receiving lanes on Turnpike Avenue, which creates a weaving issue within a short distance.</p>

<p><i>Photo shows the dual receiving lanes on Turnpike Avenue and vehicles attempting to merge as one receiving lane is dropped.</i></p>	<p>– Restripe departure to one acceptance lane with shoulder.</p>

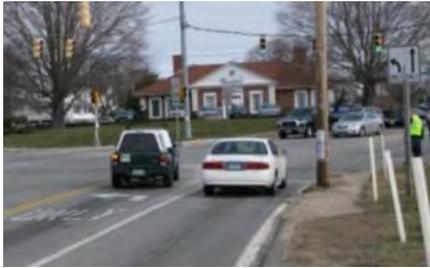
SPECIFIC NEAR TERM IMPROVEMENTS			POTENTIAL INTERMEDIATE IMPROVEMENTS	POTENTIAL LONG TERM IMPROVEMENTS
			(1-6 MONTHS)			(6 MONTHS - 2 YEARS)	(2 OR MORE YEARS)
NO.	ISSUES/CONCERNS	EXAMPLE OF ISSUES	ENGINEERING	ENFORCEMENT	EDUCATION & ENCOURAGEMENT	ENGINEERING	ENGINEERING
9	<p>Signing issues.</p> <ul style="list-style-type: none"> - The northbound lane use sign shows a left-turn and thru only. This approach functions as a left-turn and a shared thru-right. - There are multiple route options to Route 24, but limited signing.

<p><i>Photo shows the lane use sign for the northbound approach that indicates an exclusive left and thru only.</i></p>	<ul style="list-style-type: none"> - Improve signing to designate lane use. - Consider replacing existing sign with sign showing exclusive left and shared thru-right. - Could add sign to indicate 'no left from right lane' or 'left lane must turn left' or 'left from left lane only'. - Consider providing guidance to Route 24 in either direction (left or thru from northbound approach). One route would use "alternate" as the designation. Guidance should be provided prior to intersection.

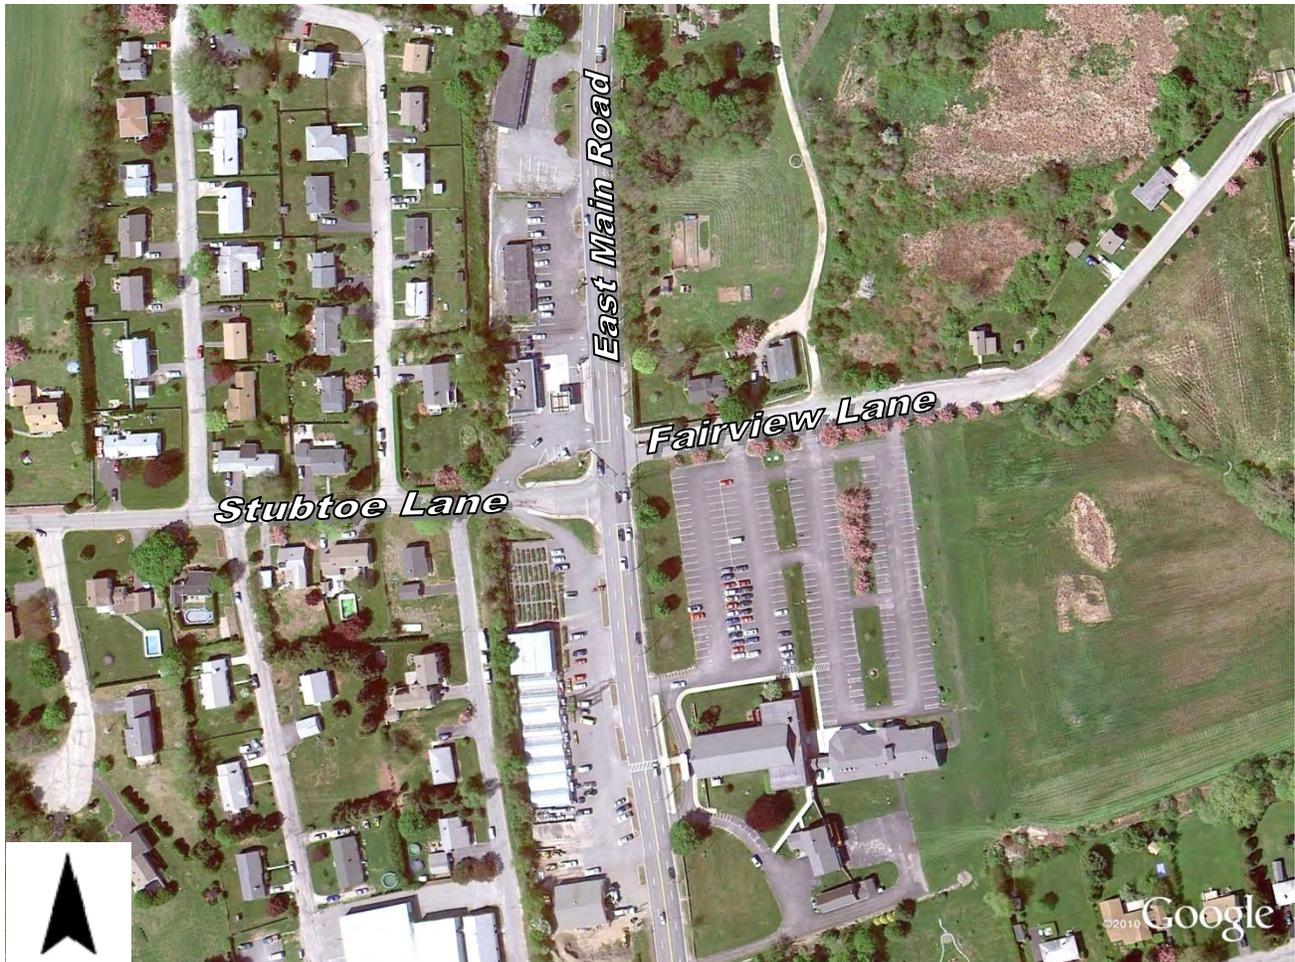
Figure 4-21 East Main Road at Stubtoe Lane/Fairview Lane Intersection

Stubtoe Lane and Fairview Lane intersect West Main Road from the west and east respectively to form a four-leg signalized intersection. Stubtoe Lane and Fairview Lane are offset from each other at the intersection with East Main Road. The intersection is part of the RIDOT's High-Hazard project. As part of this project, upgraded signal equipment, the addition of left-turn lanes, and new pavement is proposed.

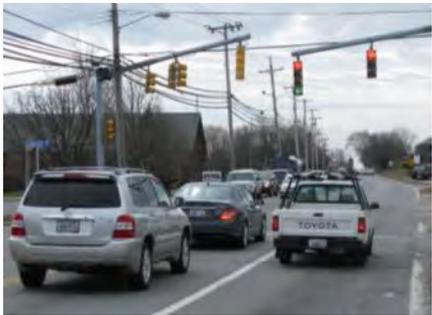
<p><i>Photo shows the protected left from the mainline and lack of left-turn lanes. The protected green arrow is on, but the first vehicle in the queue is not turning left and blocking others from making the turn.</i></p>	<ul style="list-style-type: none"> – Retime signal to gain efficiency. Specifically, address the northbound green maxing out during nighttime cycle. 			<ul style="list-style-type: none"> – Investigate the potential for permissive phasing. This may require skip marks to provide guidance. 	<ul style="list-style-type: none"> – Install left-turn lanes.

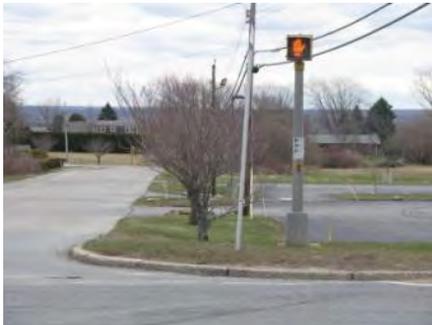
<p><i>Photo shows the pedestrian signal crossing West Main Street, but the lack of a crosswalk and pedestrian ramp.</i></p>	<p>15,000 vpd). Consider using other treatments or other crossing improvements to supplement the marked crossing if it is to remain.</p> <ul style="list-style-type: none"> – Consider realignment of midblock crosswalk near church to terminate at curb rather than the driveway. – If parking is available on the church side of the road, consider restricting parking across the road. 				<p>refuge across Stub Toe Lane as the current plans show a painted median.</p> <ul style="list-style-type: none"> – Consider lighting and other pedestrian improvements such as rapid rectangular flashing beacons (RRFB) to supplement the crosswalk near the church. Coordinate these efforts with the church.

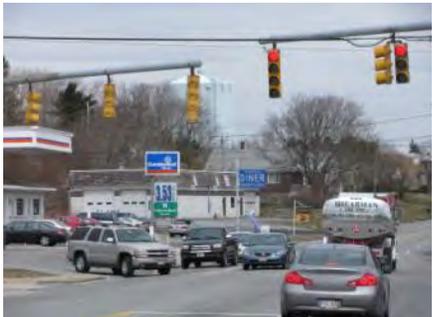
3	<p>Access management issues.</p> <ul style="list-style-type: none"> – There are three driveways to the gas station and three additional driveways to Castro's. The number of access points creates a greater opportunity for conflicts. – It is difficult to access gas station driveways for northbound drivers turning left.

<p><i>Photo shows a driveway to the gas station that is in</i></p>	<ul style="list-style-type: none"> – Potential to make driveway from gas station as right-out only (work with owner of gas station) – Incorporate right-turn arrow from gas station driveway, no left-turn sign from driveway, and no left-turn sign/do not enter sign facing East Main Road. 			<ul style="list-style-type: none"> – Consider closing one driveway as part of future project. 	<ul style="list-style-type: none"> – Consider creating a left-turn lane into the gas station for northbound drivers. This could involve shortening the southbound left-turn lane to create the necessary space.

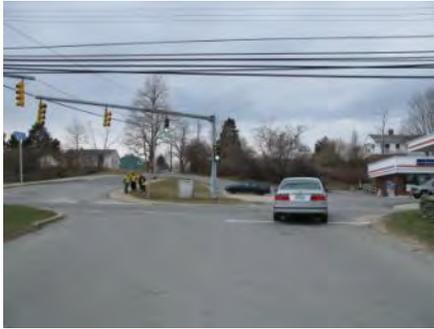
<p><i>Photo shows the offset geometry of the intersection as viewed from Fairview Lane.</i></p>					– Consider realigning the intersection.

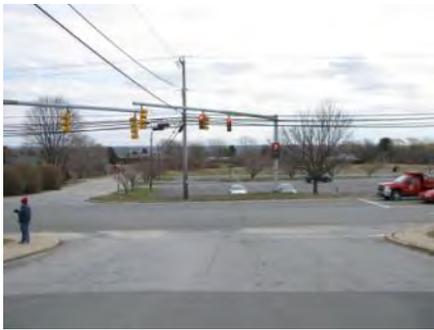
5	<p>Limited guidance at intersection.</p> <ul style="list-style-type: none"> – There is a lack of delineation on Stub Toe Lane and Fairview Lane, which may be a particular issue at night. – Segment lighting is present along West Main Road, but there is no formal intersection lighting. This issue was not apparent in the crash data, but should be monitored.

<p><i>Photo shows the lack of delineation on the side streets.</i></p>	– Define centerline on the side streets for a short distance.			– Monitor nighttime crashes and consider formal intersection lighting if nighttime crashes become an issue.

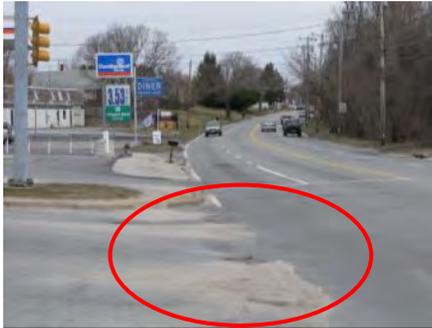
<p><i>Photo shows the accumulated debris along the west side of the intersection.</i></p>	<p>– Clear debris from the road and continue regular maintenance practices.</p>

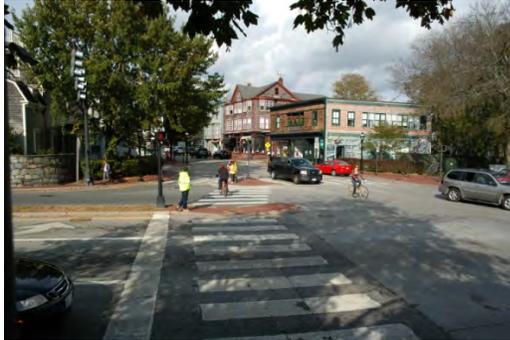
"Piano Key" style crosswalks are systemically recommended

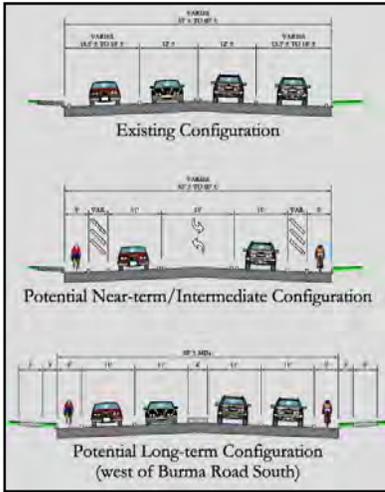
Coddington Highway proposed "Road Diet"

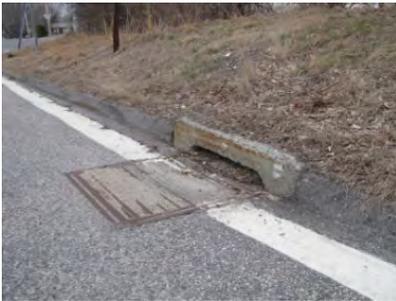
Silted catch basin, causing ponding in roadway

Some of the recommended improvements can be performed by the RIDOT maintenance section. Such improvements involve cleaning and flushing of drainage structures.

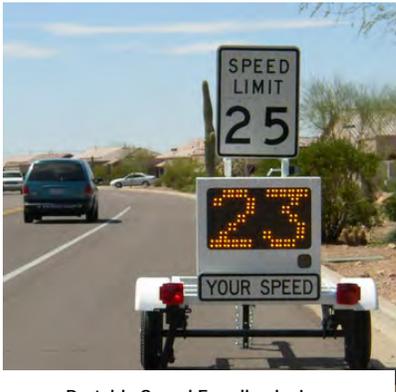
Portable Speed Feedback sign
