CABLE GUARDRAIL EVALUATION
U.S. ROUTE 1 MEDIAN
MOORESFIELD ROAD TO GOVERNMENT CENTER
SOUTH KINGSTOWN

April 2005

Cable Guardrail Installation on Route 1 Median

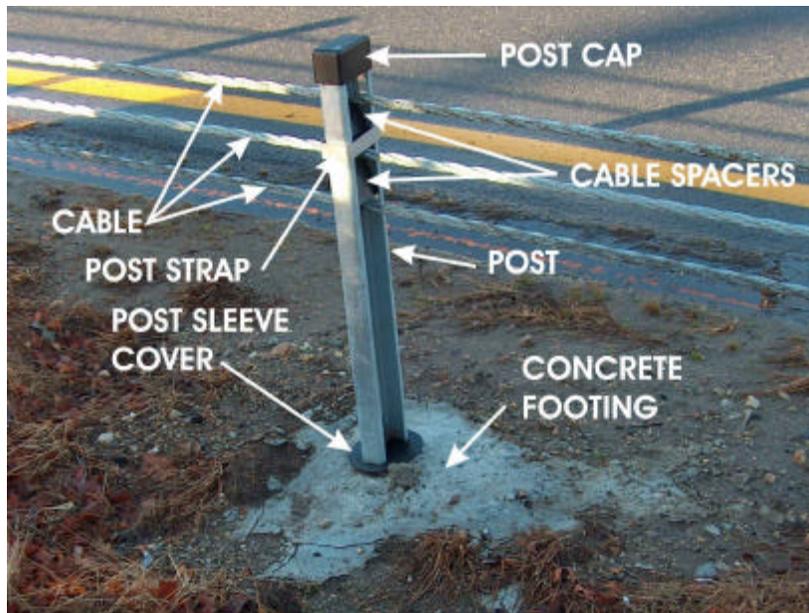
Figure 1 – Post, Installed and Complete

A high tension cable barrier system with reduced dynamic deflection was approved in 2001² for use in median applications on the National Highway System by the Federal Highway Administration. Since then, four manufacturers have received acceptance of their product as a National Cooperative Highway Research Program (NCHRP) Report 350 test level 3 (TL-3) bi-directional (median) traffic barrier. These systems utilize either 3 or 4 steel cables that are aligned by steel line posts. Post lengths are typically 4 to 5 feet, with varying cable heights set between 1.5 and 2.5 feet. NCHRP-approved post spacing varies from 6.6 feet to 16.4 feet. Posts are either driven into the ground with soil plates or are set into a socket within a concrete base (the latter was used on Route 1, see Figure 1).

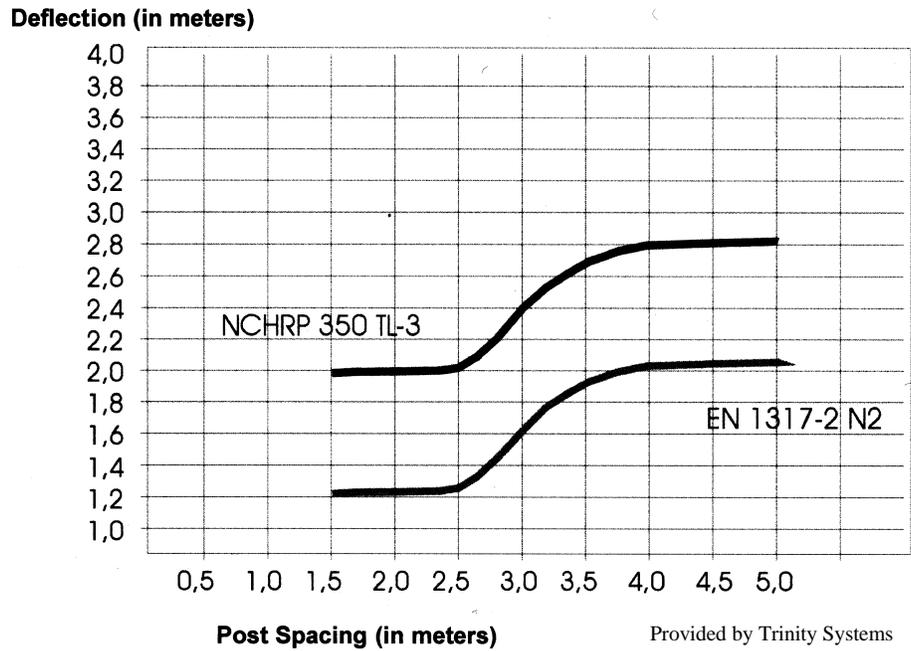
Figure 2 – Deflection vs. Post Spacing (Trinity CASS)⁵

This final design placed the barrier system 5 feet from the near-side high-speed travel lane on a slope that is generally flatter than 6:1. According to the AASHTO Roadside Design Guide Subsection 5.6.2.2, cable guardrail has performed well even on 6:1 slopes. However, an errant vehicle approaching from the side opposite the cable barrier location could produce a deflection greater than the provided 5-foot setback. Reducing the post spacing was considered, but after consulting with the manufacturers, this option was not pursued because none of the products have met NCHRP-350 criteria at that spacing (Figure 2 shows deflection vs. post spacing for the system used; EN 1317 is a European barrier standard). Two primary concerns were that the deceleration forces and the occupant impact velocities would be higher than allowed. After careful consideration, the Department sought and received design concurrence from the FHWA based upon the premise that the barrier still provides a significant safety upgrade to the corridor by reducing the potential for head-on collisions due to vehicle crossovers. A post spacing of 6.6 feet was selected for the design of the system.

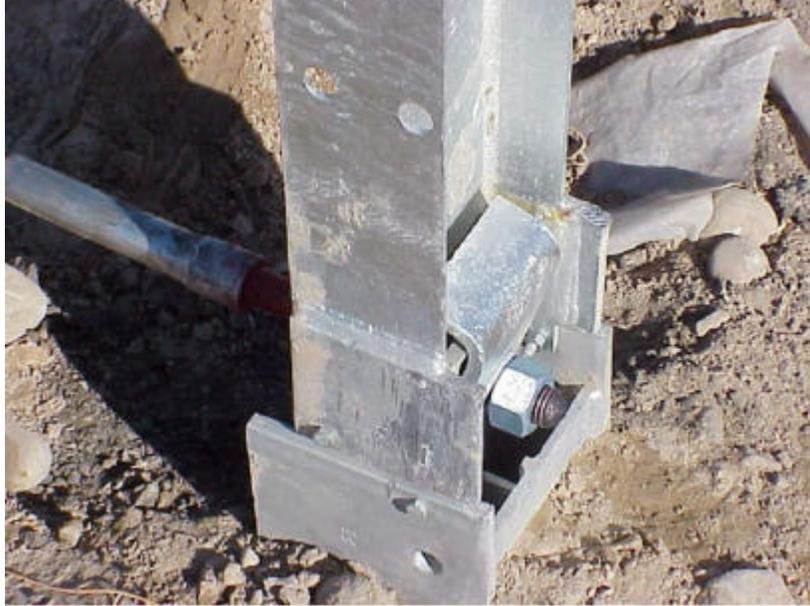
Figure 3 - Anchor Point⁶

The contractor installed the terminal end section footings first (see Figure 3). Then an auger truck was used to excavate the footing hole to a depth of thirty inches, the reinforcing steel and hardware was positioned in the hole and followed by the concrete placement. Next, the excavation of the intermediate posts using an auger truck and two man crew began. Once a sufficient number of holes were excavated another crew of 2 to 3 laborers began placement of the concrete footings for the intermediate posts. The concrete was purchased from a local RIDOT approved facility (Cardi Corporation) and delivered using a front discharge concrete truck. The concrete used was a RIDOT Class XX ¾" (4000 psi), cured for three days prior to proceeding with the installation. A plumb bob was used to set the post sleeves true into the concrete while it was in the plastic state. Once the footings were installed, the contractor began installing the posts and associated hardware (see Figures 4 & 5). The cables were strung (see Figure 6) and finally tensioned to a predetermined cable tension based on ambient temperature (see Figures 7). Tensioning was performed by using turnbuckles installed between each 1000 foot length of cable (see Figure 8). A tension meter purchased from the manufacturer was required to test the tension (see Figure 9).

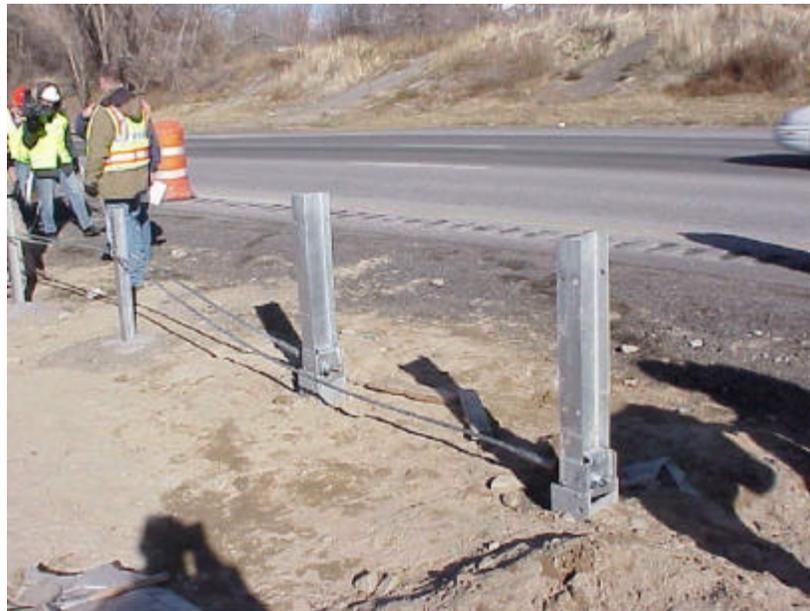
Figure 4 - Installed End Posts⁶

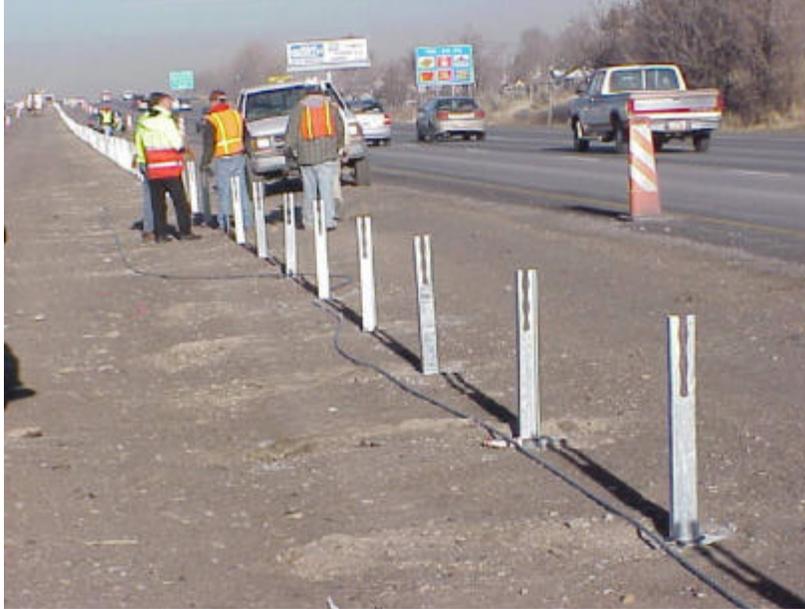
Figure 5 - Installed Standard Posts (without cable)⁶

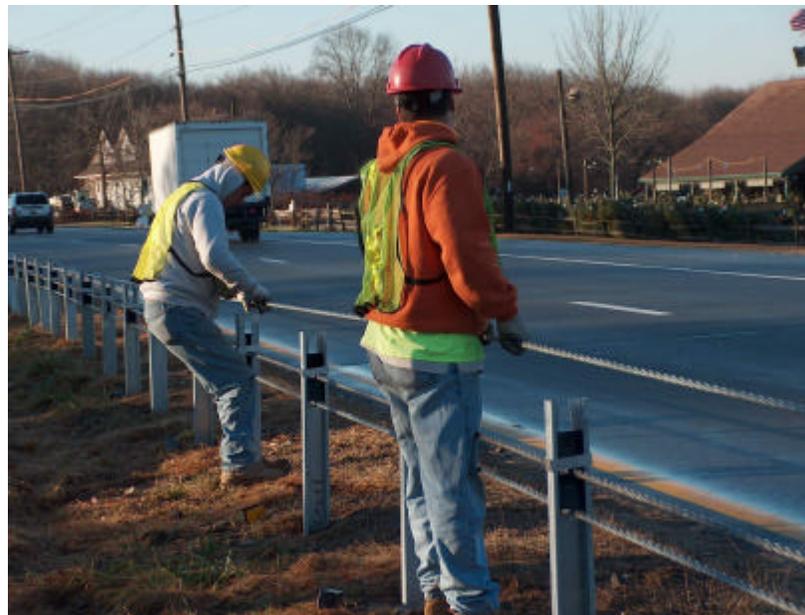
Figure 6 - Placing the Cable

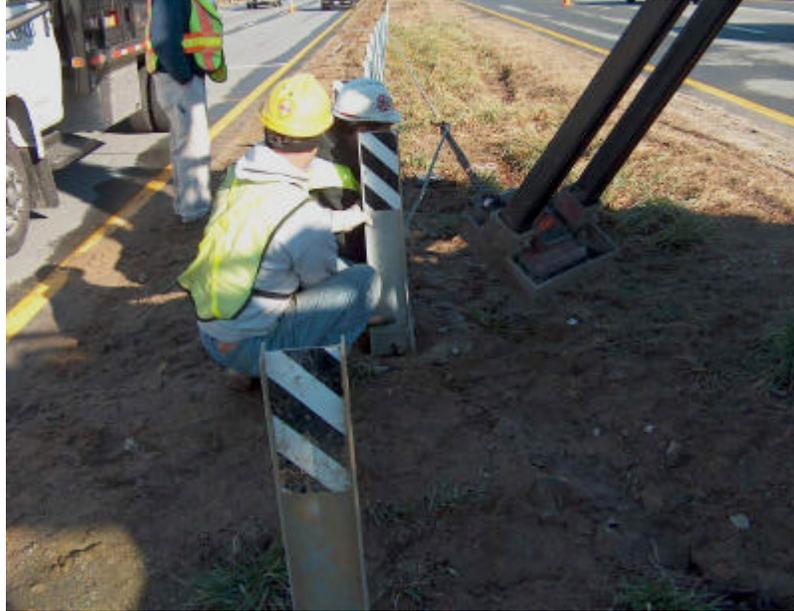
Figure 7 - Pulling the Cable

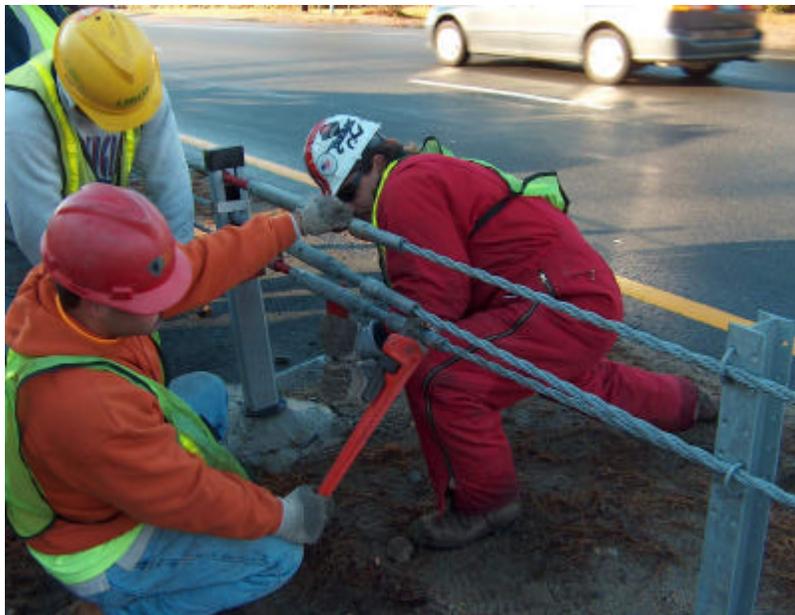
Figure 8 – Adjusting Tension with the Turnbuckles

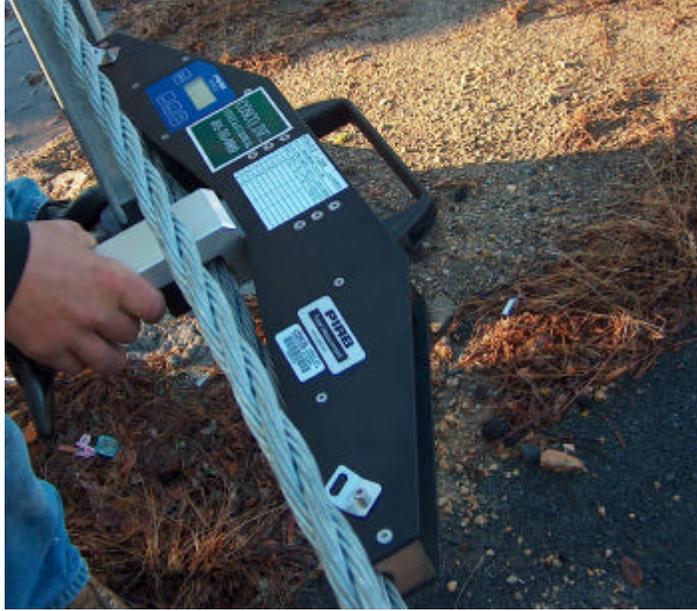
Figure 9 – Checking with the Tension Meter

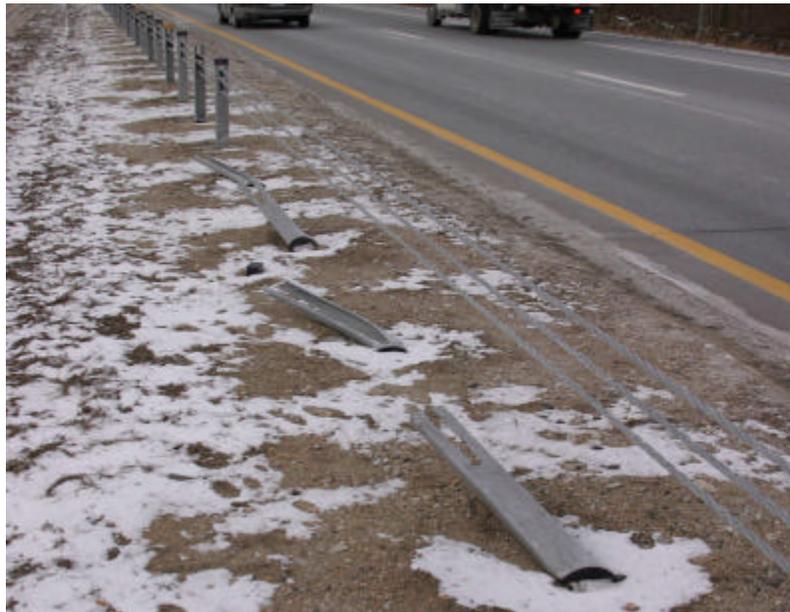
The components of the system generally appeared to function as intended (see Figures 10 and 11). Both the standard and end section posts failed as designed, with no apparent damage to the cable. As of the writing of this report, there have been no fatalities, no known serious injuries and no vehicle crossovers resulting from collisions with the system.

Figure 10 – Impacted section of Cable Guardrail

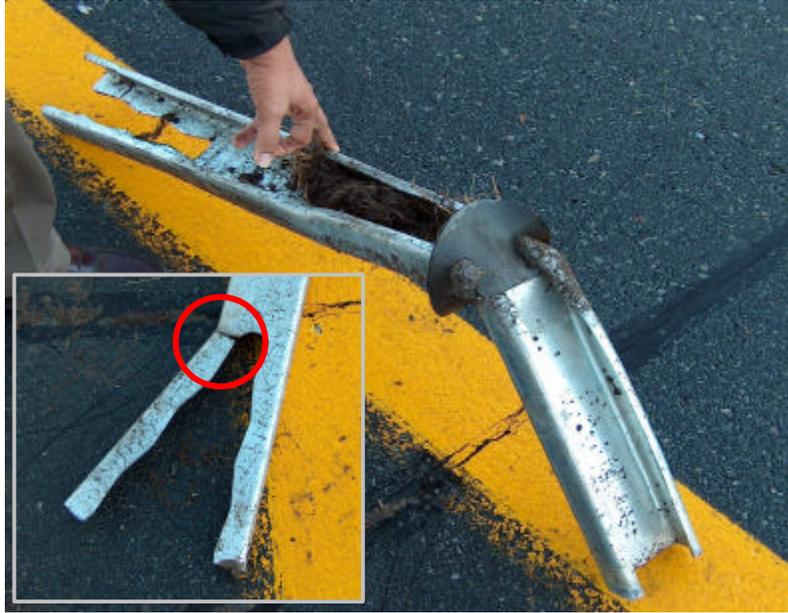
Figure 11 – Post After Impact (Inset – Crack at Bottom of the Cable Slot)

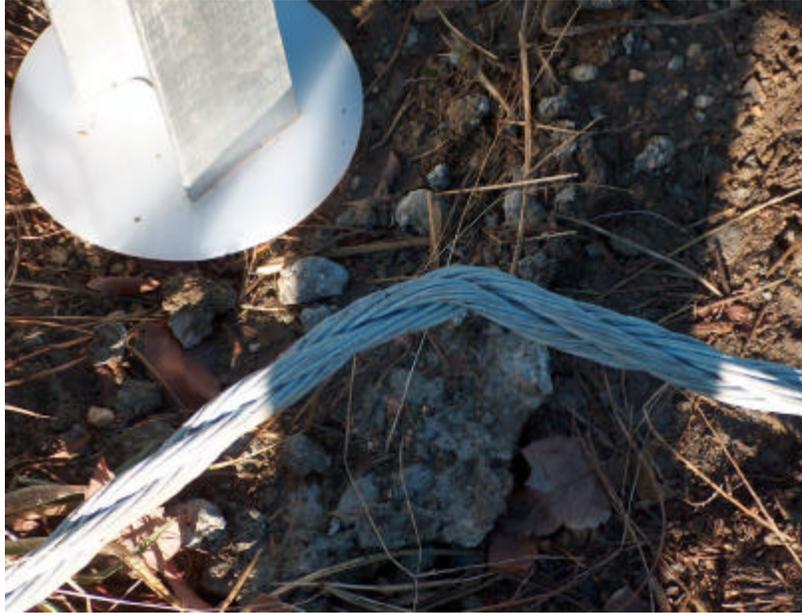
Figure 12 – Kink in Cable After Impact

If a kink or some other aberration (other than obvious fraying or other such strand separation) should show up in the cable after an impact we do not at present have any means of determining if the cable is still useful. There are a couple of methods of replacing the cable section if an area is suspect. If the kink or damage is in the end terminal cable, that section of cable has a specific part number for upper, middle, or lower and can be ordered and replaced. If a suspect area is in the CASS cable run then: (a) a new 1,000' section can be ordered and replaced, or (b) the bad area can be cut out and a new short section of cable spliced in using 2 left-handed fittings, 2 right-handed fittings, and 2 turnbuckles.

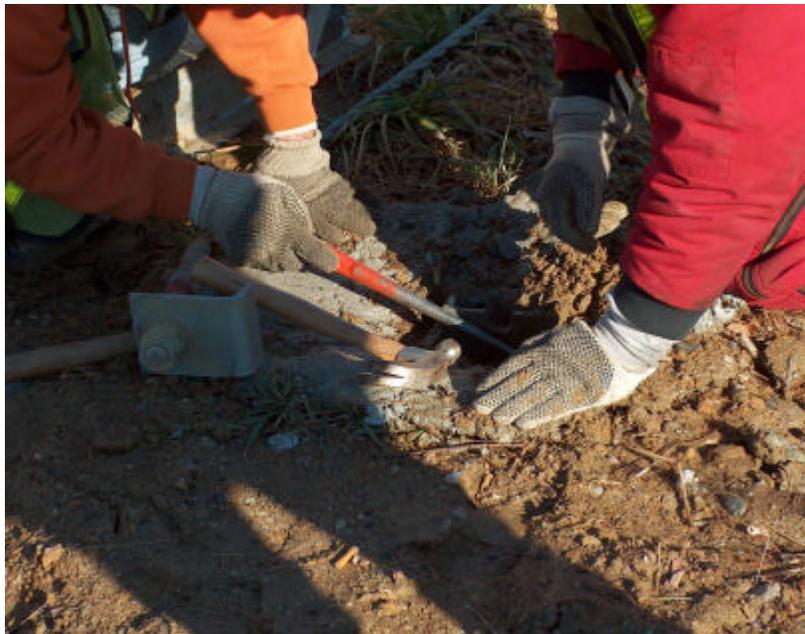
There was at least one instance where one of the concrete post foundations was shifted, apparently the result of an accident. However, one of the end section concrete anchors became dislodged (pulled out) from the ground. This is not believed to be the result of an accident. In another case, the cable was seen to have a kink in it due to an impact (see Figure 12). It is not known whether this would have any effect on the cable's mechanical properties. When repairing the end section, there was some difficulty replacing the shear bolts, due to excess concrete collected around the base anchor brackets during placement (see Figure 13). This required a laborious process to chisel away the concrete, in order to reinstall the posts and cable ends. This substantially increased the time required to make the repair.

Figure 13 – Removal of Excess Concrete from Shear Bolt Mounting Hole

- Anchor Footings: Based on the problems encountered during the repair of the end section, a detail should be developed for placement of the end section mounting brackets in the concrete anchor point to maintain clear access to shear bolt holes. It is also recommended that instead of a individual foundation for each anchor point, that a single block be cast, with the anchors connections still staggered as in the current design. This would have to be accepted by the manufacturer, to assure that the crashworthiness of the system is not negatively affected.

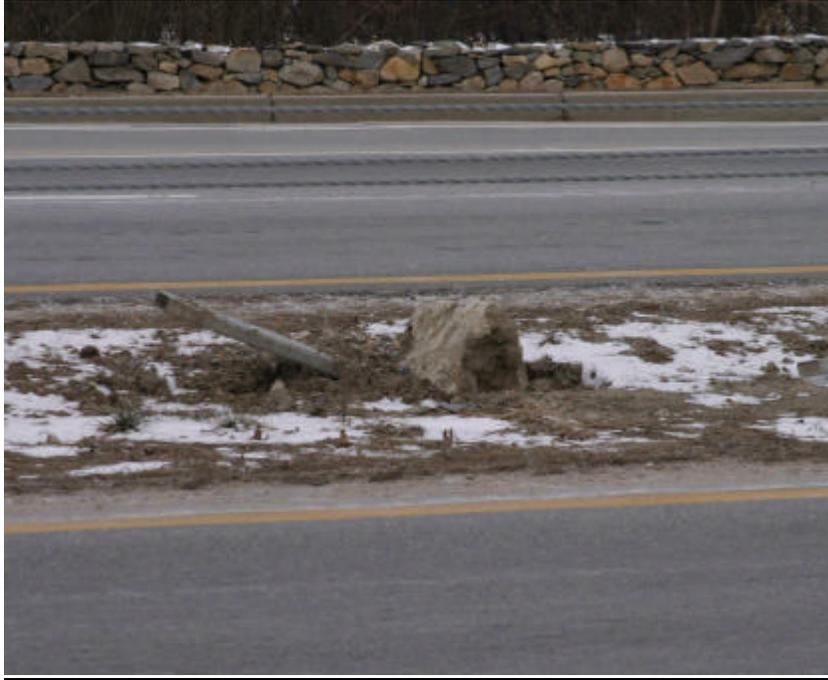
Some of the post footings were pulled out of the ground on impact (see Figure 14). While it did not happen in every accident, the purpose of using the footings is to allow the posts to fail, but still have an intact insertion point for the new posts. The intent was to make the repair process as rapid as possible.

Figure 14 – Dislodged Footing

- Geotech – Soils: There should be a geotechnical survey and analysis of the soil conditions prior to installation. While using a two foot deep concrete base may give some short term stability to the system, an impact or shifting over time may reveal problems that were not anticipated during the design and construction phase. Soil type and strata variations, potential moisture content and environmental changes can all affect the bearing capacities of the soil surrounding the footings. Guidelines should be provided by the manufacturer on how to design for varying soil conditions.

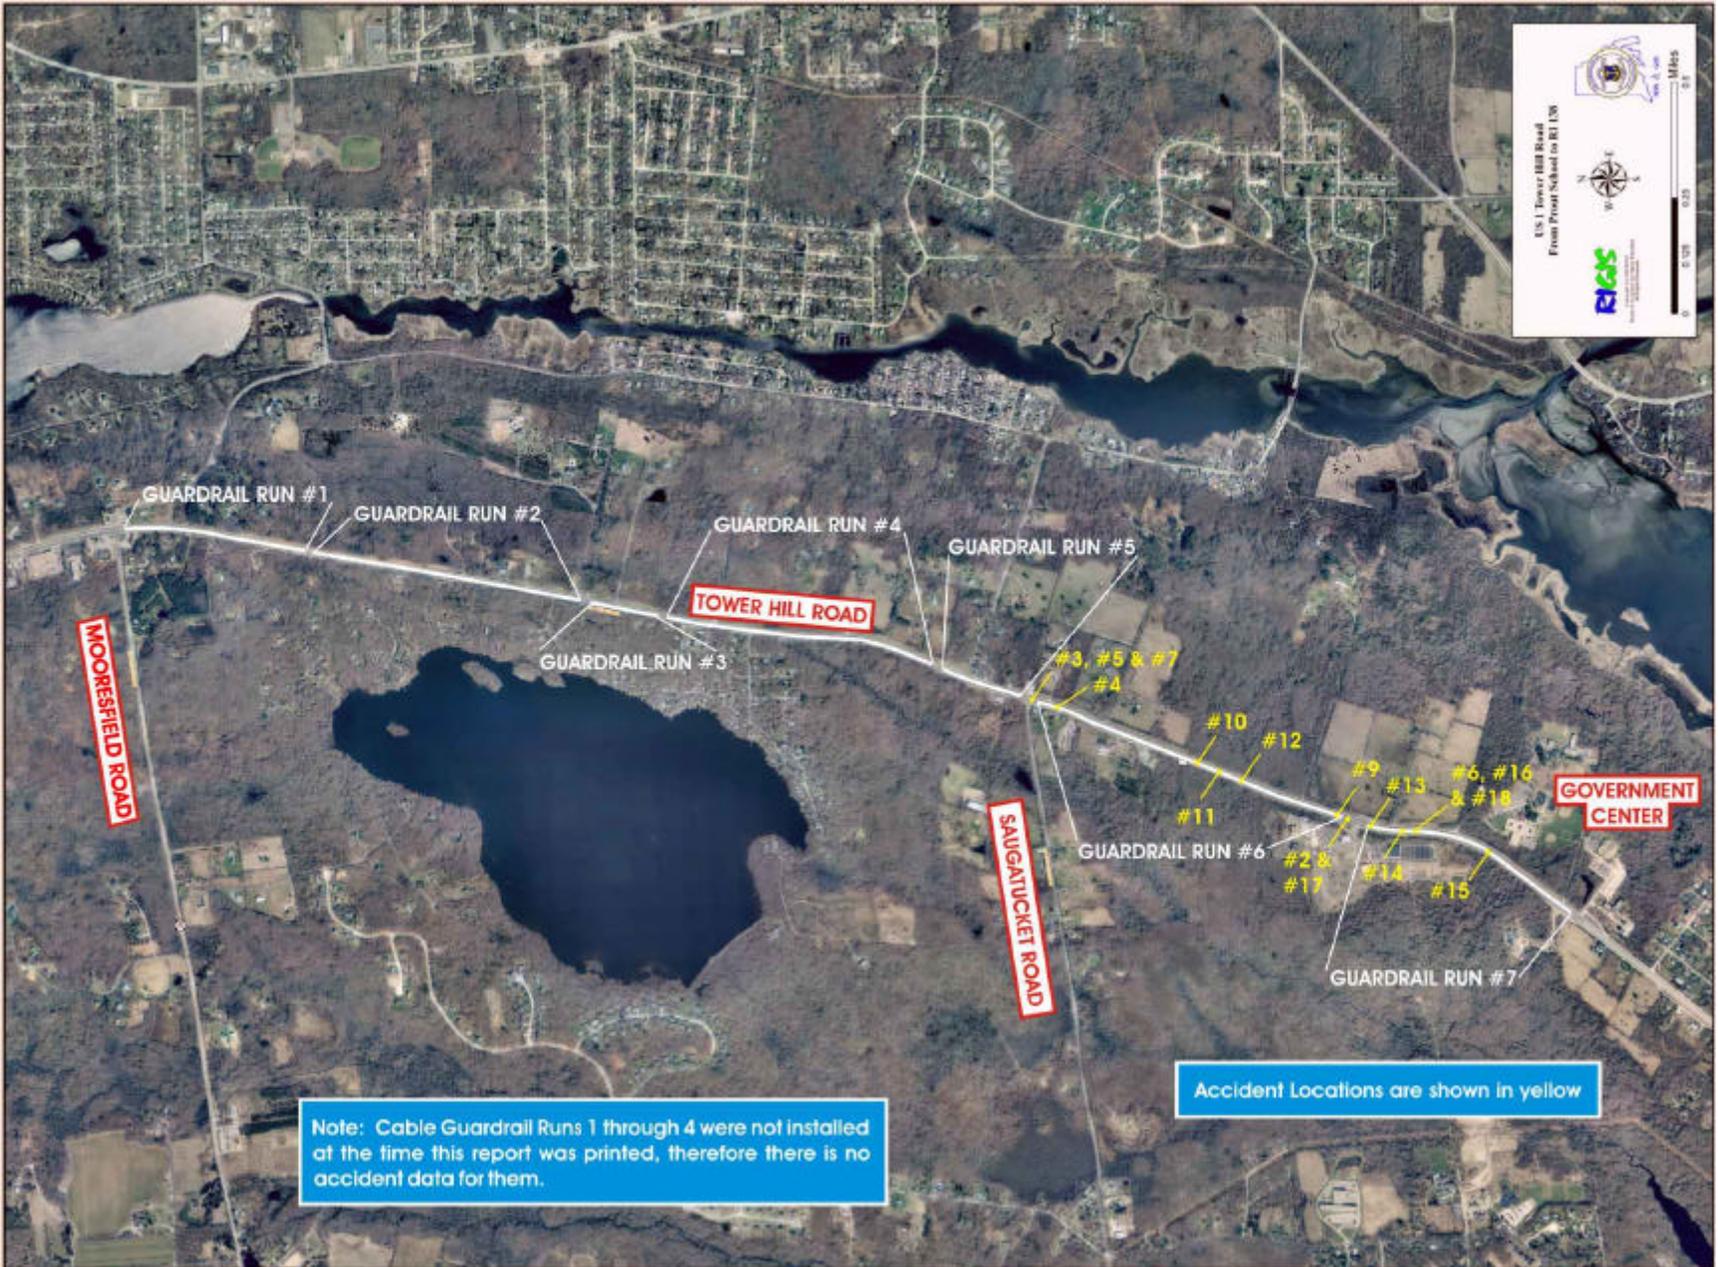
Figure B1 – Aerial View of Accident Locations

To date there have been twenty locations requiring repairs due to traffic accidents. Typically, the contractor was notified of the damage and they mobilized to make repairs. Repairs include traffic control and setup, replacement of the damaged hardware and rechecking and re-tensioning of the cables as required. Accident and available repair information, up to the time of the writing of this report are summarized in the table below. Note that these are based on the submitted costs for the repairs. This was the best data that could be compiled by the Resident Engineer, but there are some gaps as the need for some of the information was not known at the time the data was collected. Payment was made at the bid price for installation of the barrier per linear foot. In Appendix B, Figure B1 shows an aerial view of the accident locations.

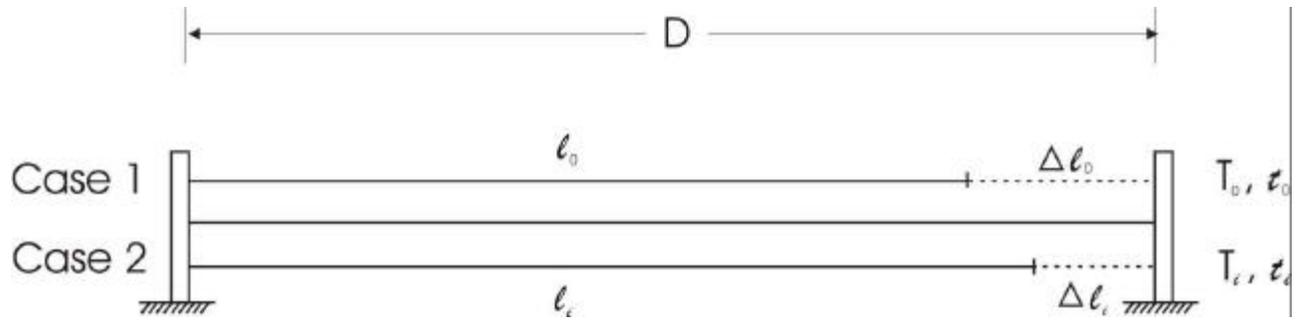
- 1] Let l_0 be the length of wire @temp t_0 @ installation
- 2] l_0 is tensioned to T_0 to span length 'D' with an elastic extension of Δl_0
- 3] Let l_i be the length of l_0 @ temp t_i , with a tension T_i and extension Δl_i
- 4] Let 'a' be the cross-sectional area of the wire; α is the temperature coefficient for the steel

More information needs to be developed on the cable displacement versus temperature. Cable that is tensioned at 80°F temperatures may shrink by as much as four inches over every 1000 feet at 40°F. For runs of several thousand feet, this may make re-tensioning the cable after repairing an end section very difficult. This was seen during the repair of guardrail in December.
