**FREEZE/THAW TEST OF GLASS FIBER-REINFORCED CONCRETE FOR THE  
WASHINGTON PEDESTRIAN BRIDGE FASCIA PANELS**

**JULY 2004**

Michael Sock  
Research and Technology  
Rhode Island Department of Transportation

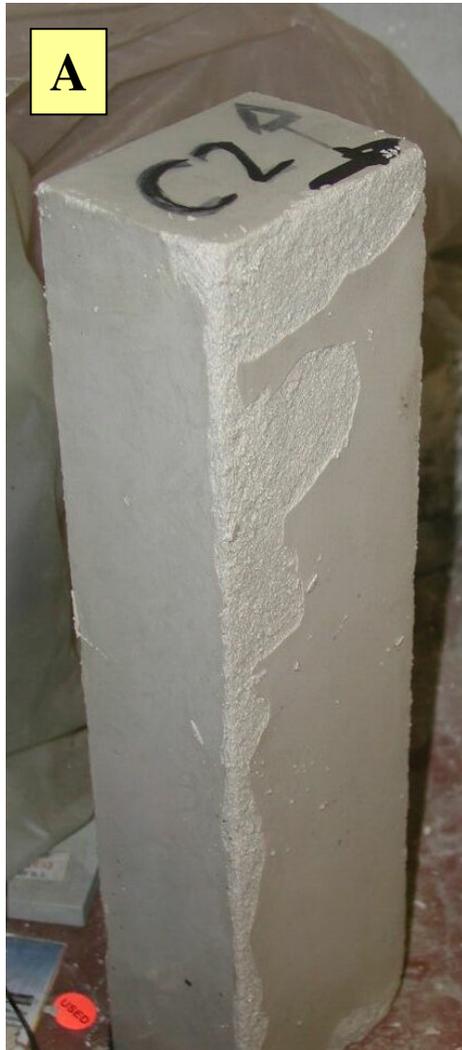
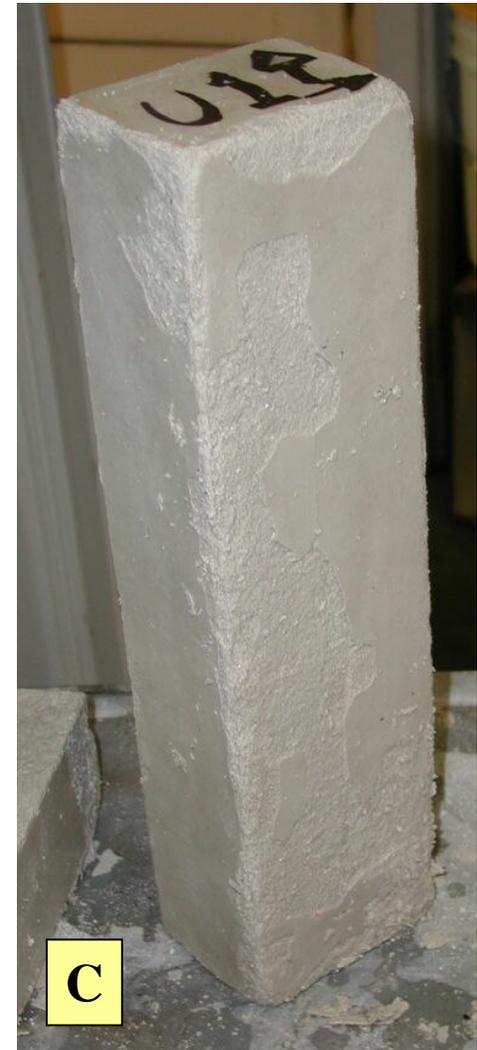
Figure 3 – A: Specimen C2 @ 160 Cycles, B: Specimen C2 @ 300 Cycles, C: Specimen U1 @ 196 Cycles,  
D: Specimen U1 @ 300 Cycles

*Visual Inspection:* Of concern was the loss of the surface paste (scaling) in the early stages of the test (see Figures 3 and 4 below). The loss of much of the face mix and some of the fine material from the matrix to the degree seen would be unusual for a standard concrete mix. But this isn't a normal mix. Freeze/thaw specimens typically don't have a face mix and consolidating the concrete with fibers into such a small mold (particularly at corners) is more difficult than even a stiff mix with a coarse aggregate. Still, this was potentially a problem, because the concrete is to be used in decorative panels and even if the structural integrity was not affected, aesthetics of the panels is important. The first specimen to experience loss was one of the coated specimens (C1 @ 36 cycles) and as none of the others exhibited this behavior at first, it was thought to be an anomaly. Then the other coated specimens started to scale and finally the uncoated ones showed loss of paste, too. Most of the material was lost in a sheeting type of failure. The scaling was severe by the end of the cycling, particularly around the edges and corners, although even in the worst cases, there was little loss in concrete containing fiber, including the troweled surface. Normally, the troweled face is the first to experience scaling, owing to the mix bleed water creating a higher water/cement ratio. This higher w/c ratio mortar is less resistant to freeze/thaw.

below 97.9% for any of the specimens, well in excess of the 80% minimum used by RIDOT for acceptance of concrete mix designs. There was also no significant loss of material from the specimens. Even the face mix showed some structural integrity in that it failed in large sections, rather than by flaking. The loss of the paste was probably caused by the intense stresses created when the water froze in the confined space between the concrete faces and the sides of the specimen compartments.

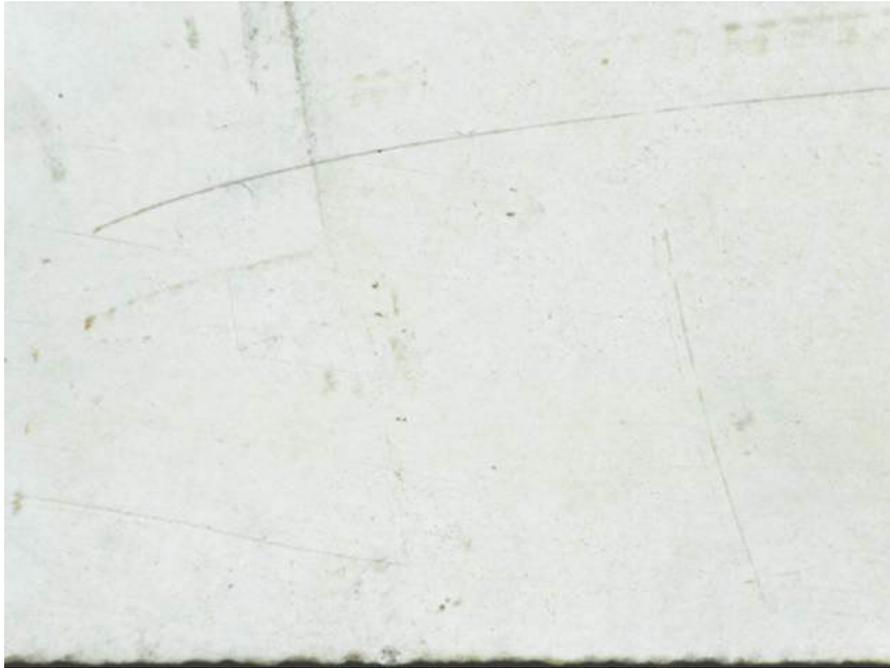
Figure 9 – Specimen Appearance with Face Mix

**PHASE II RESULTS:** In Table 3, the relative dynamic moduli are provided and in Table 4, weight changes for the specimens are given. Figures 6 and 7 display the information graphically. The “F” series had fibers visible on the surface and the “N” series did not. Figures 8 and 9 show the surface with and without the face mix. Note that both photos have been enhanced to better display detail. Figures 10, 11 and 12 show the defects in the information only specimens. The bulk specific gravities ranged from 2.292 to 2.296 and averaged 2.294. The absorptions ranged from 1.54 to 1.87%, averaging 1.70%. The compressive strengths ranged from 9,000 to 11,000 psi and averaged 10,018 psi. The flexural strengths ranged from 2,175 to 2,390 psi for three specimens, with an average of 2,250 psi. The approximate deflections at failure ranged from 0.0185 to 0.0460 inches, with an average of 0.0335 inches. Even though failed in flexure (increased displacement using the machine head did not increase the measured machine load), the cracked specimens did not separate easily and in fact were able to sustain a sharp blow at the fracture without breaking into two pieces. Figure 13 shows aspects of the tested specimens. The specimens halves shown were from prisms broken in the load frame.

*Visual Inspection:* Little deterioration was evident on both of the specimens sets (with the face mix or without), with some slight loss on the edges in a few cases. That isn't unusual in concrete subjected to freeze/thaw. In fact, these specimens have performed better visually than ones from standard silica fume-modified mixes, which generally do quite well.

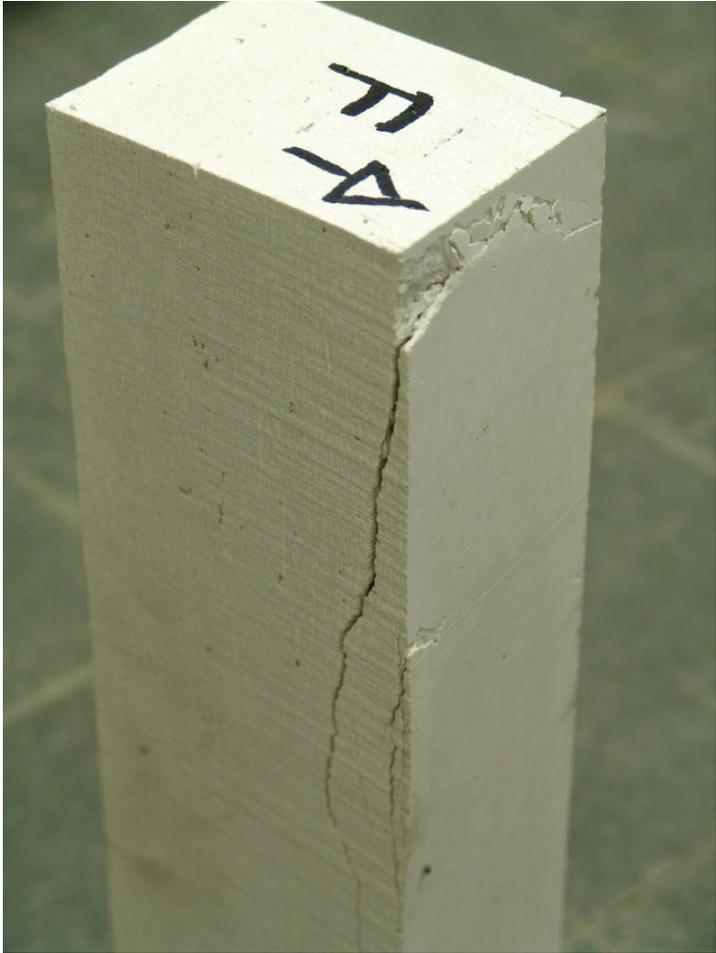
Figure 10 – Fracture in Information Only Specimen without Face Mix

Of particular interest is the behavior of the information only specimens. Normally, it would be expected that the cracks would be enlarged during freezing and eventually lead to fracturing of the prisms. That was why the second set of specimens intended for Phase II (after the ones that didn't meet the dimensional tolerances) were not tested, as stated previously. However, these did quite well, with only a small amount of loss at the very thinnest section on one specimen and a slight bulging at the fissures on another one. This indicates that the fiberglass-reinforced concrete matrix has good resistance to propagation of fractures.

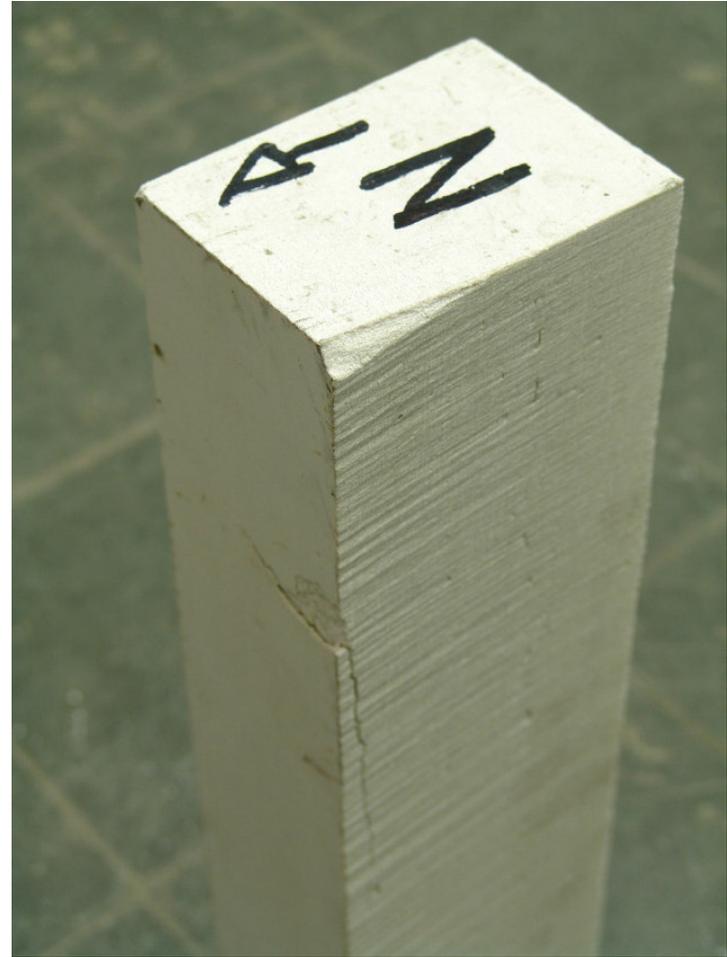
Figure 11 – Fracture in Information Only Specimen with Face Mix

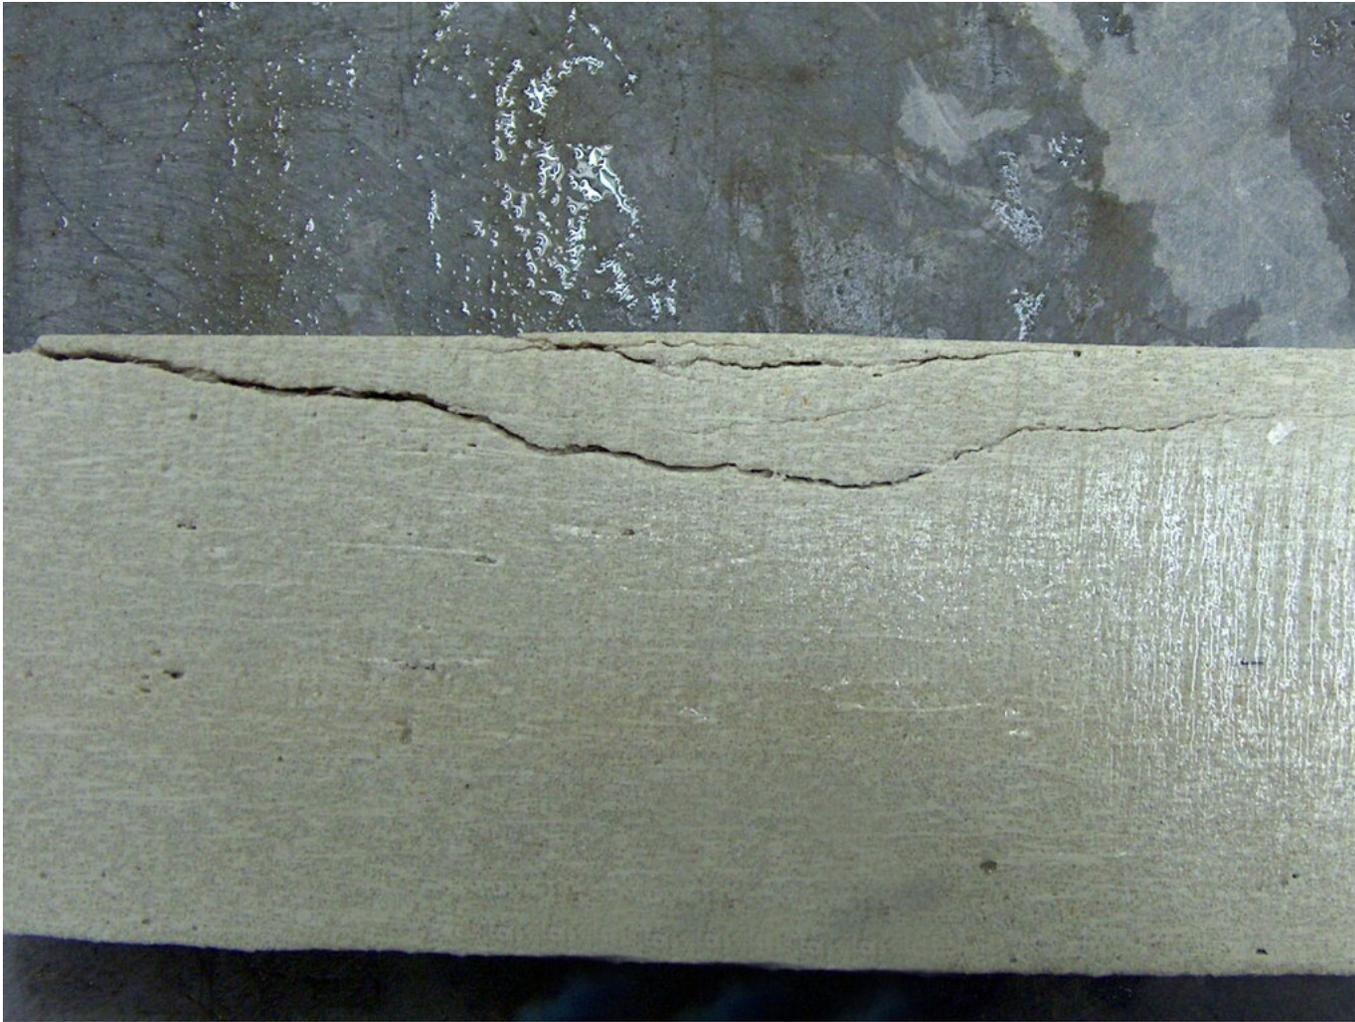
Figure 12 – Fracture in Information Only Specimen without Face Mix @ 108 Cycles (Slight Bulging Evident)

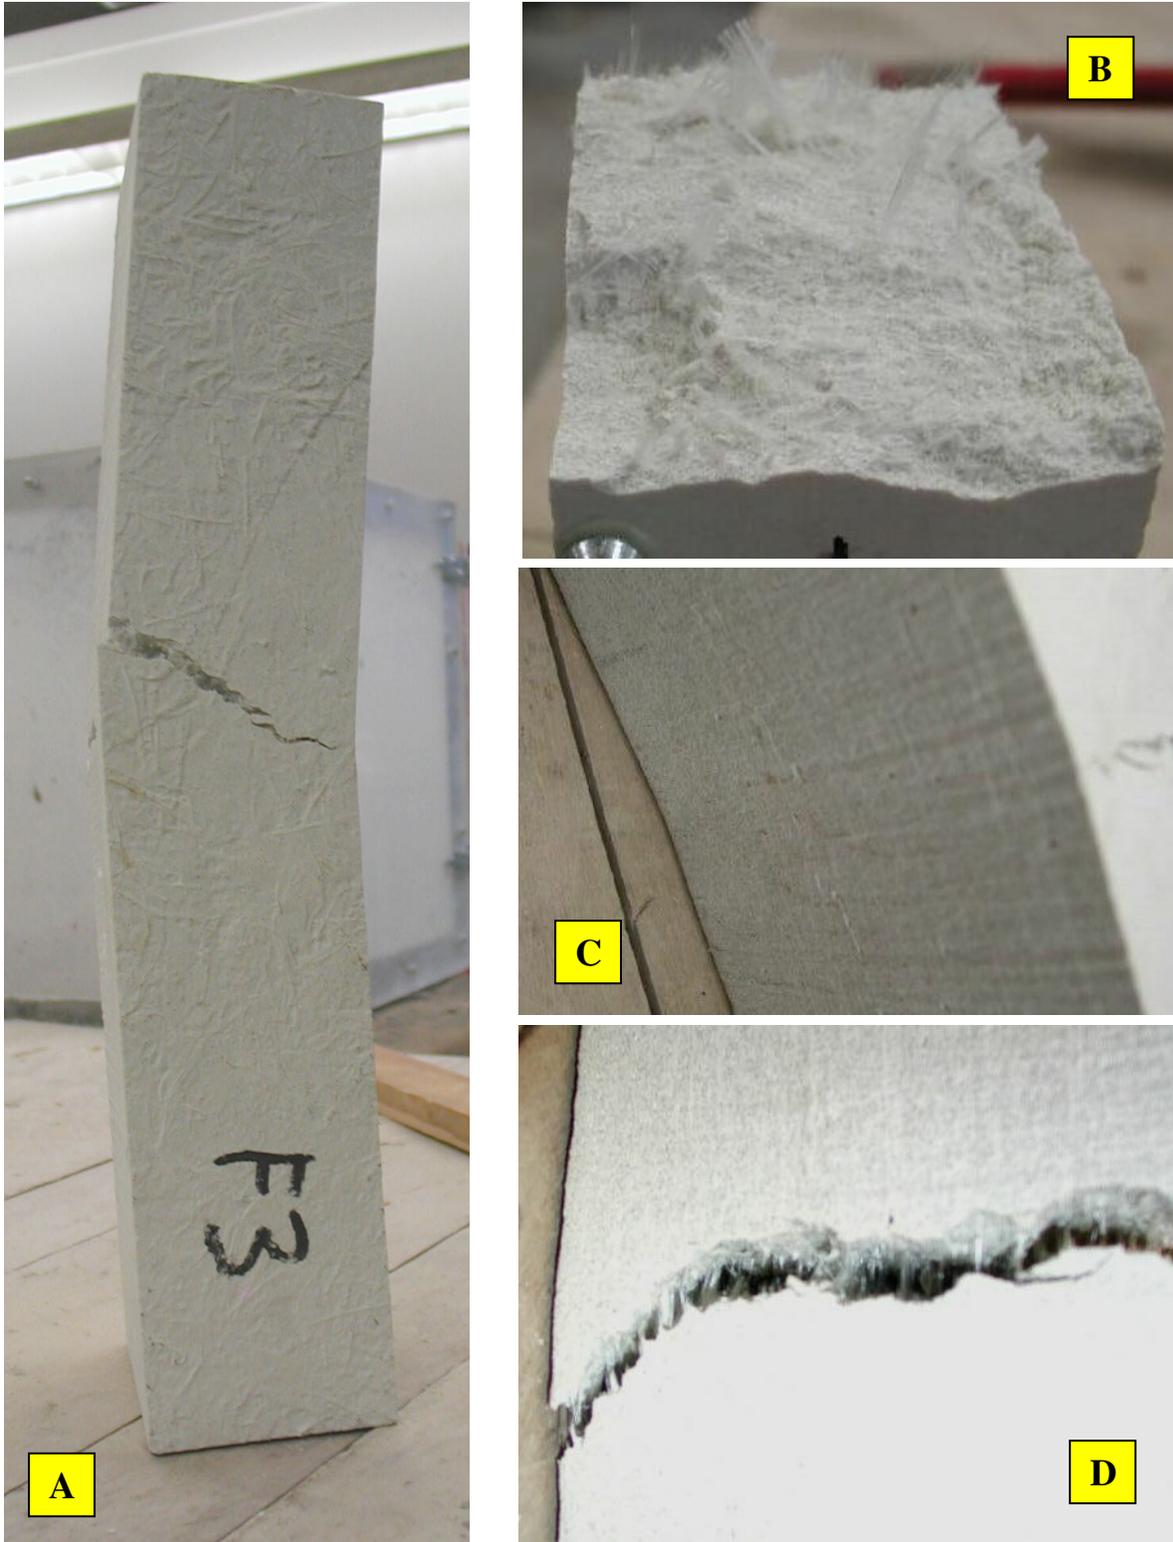
Figure 13 – A: Fractured But Intact, Even While Upright; B: Fibers at Fracture Interface; C: Fractured, But Not Separated; D: Fibers Stretched Across Fracture

*Flexural Strength:* The flexural results were higher than typical values for other mixes tested previously. The fiberglass appears to have greatly enhanced the tensile strength of the concrete, compared to concrete specimens seen before that had no structural fibers. After the specimens failed under load, the fibers still held the broken halves together. Even after the center of the prisms were deflected by nearly ½", the halves remained solidly connected by the fibers.
