Bridge: 066201
Photo: 1

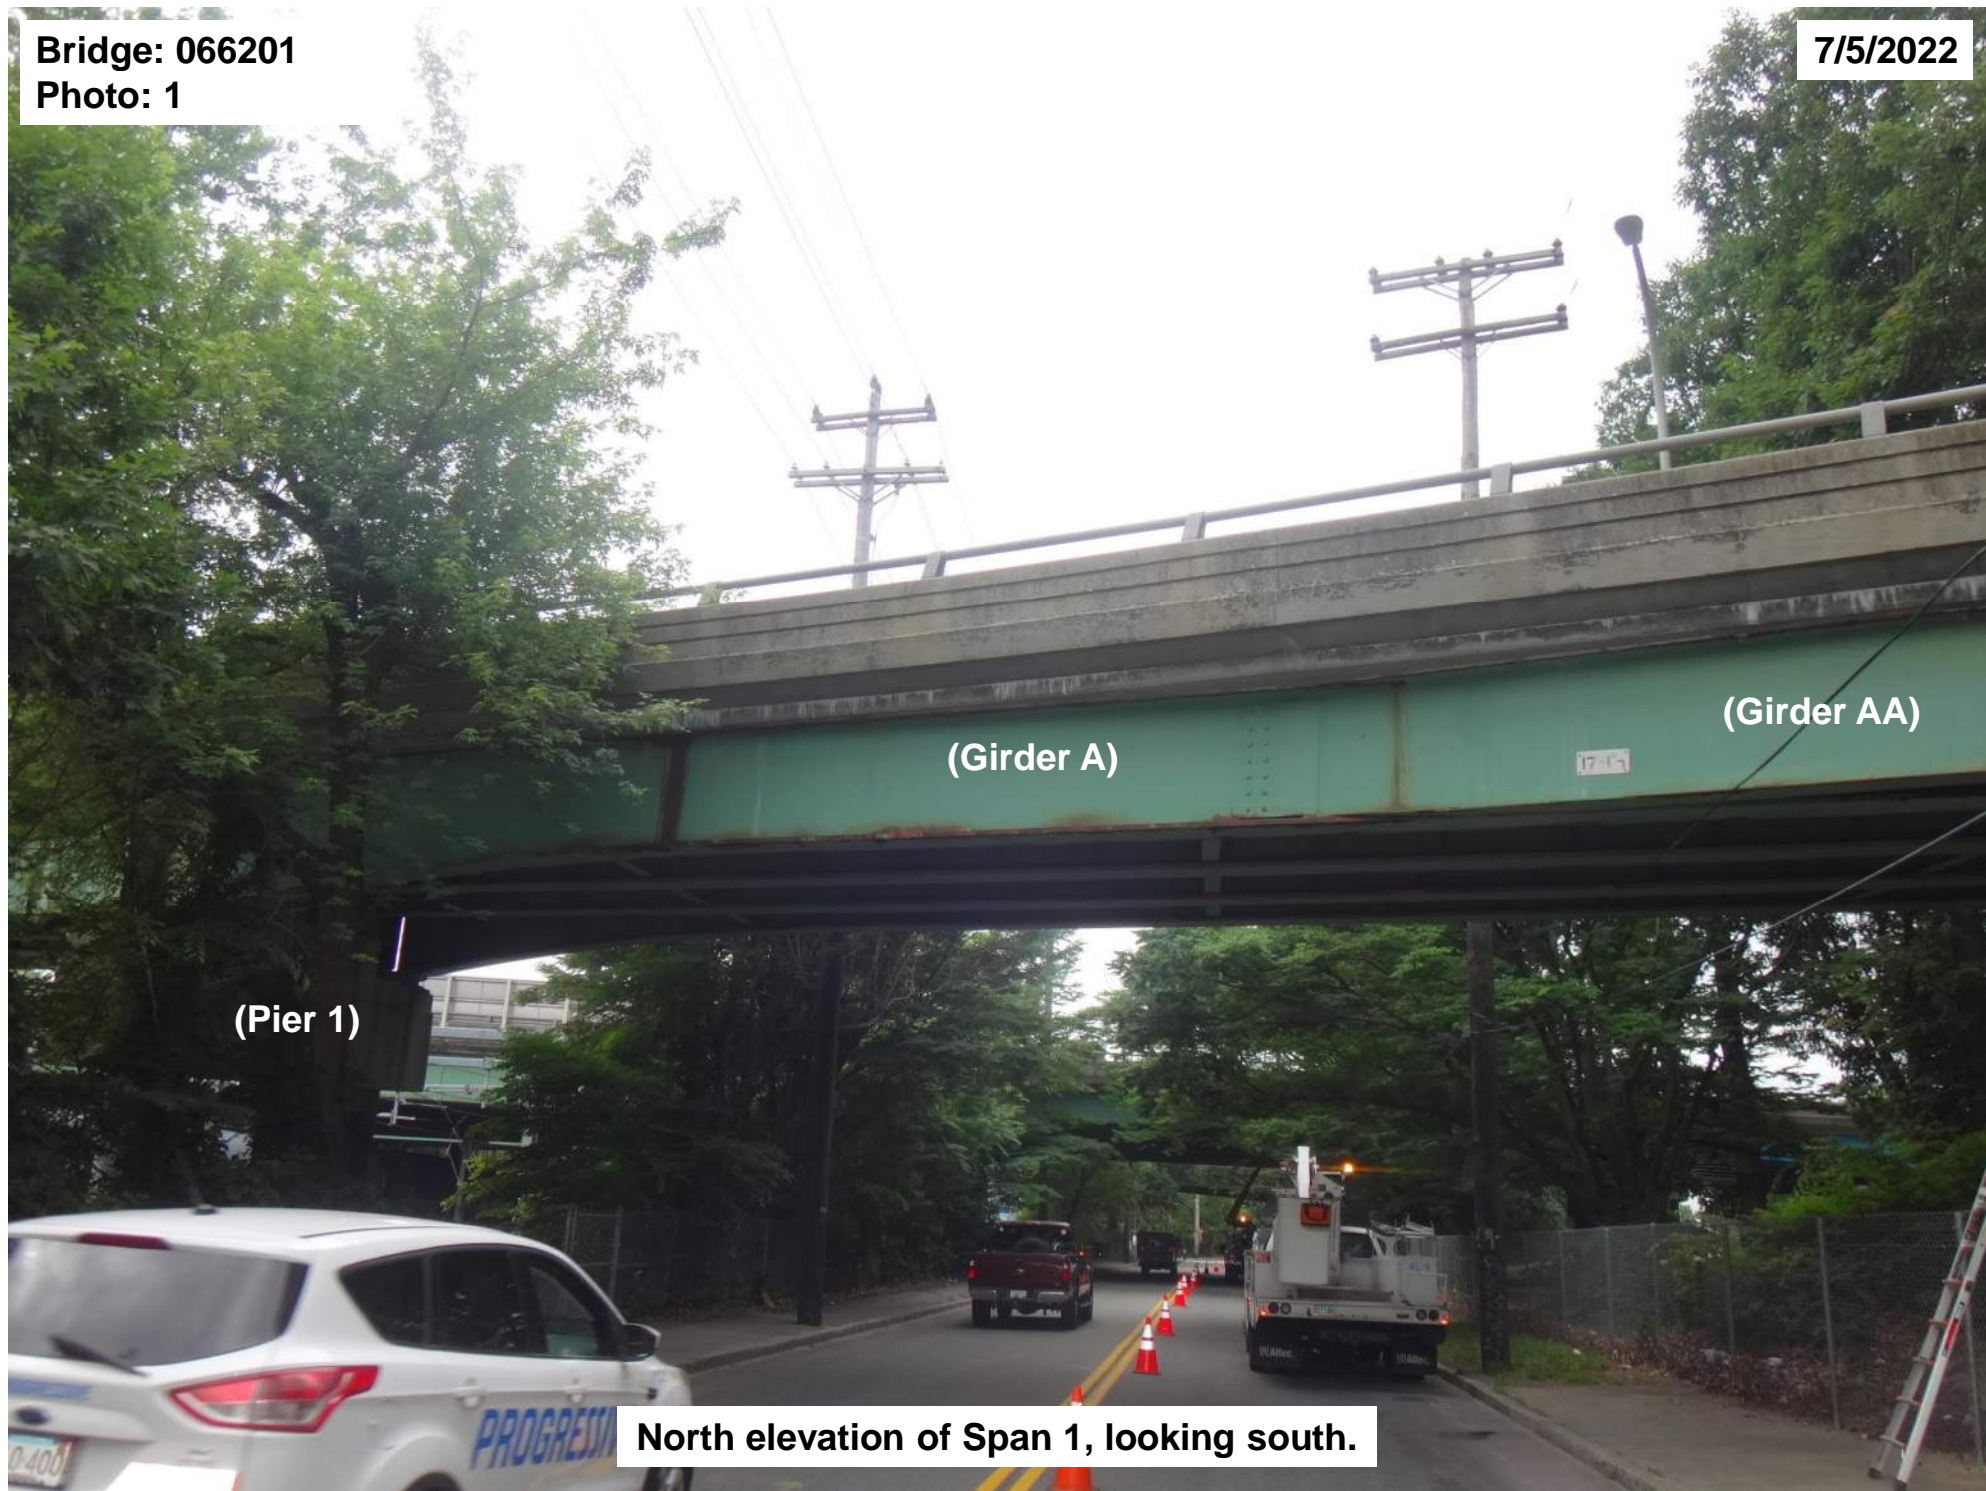
North elevation of Span 1, looking south.

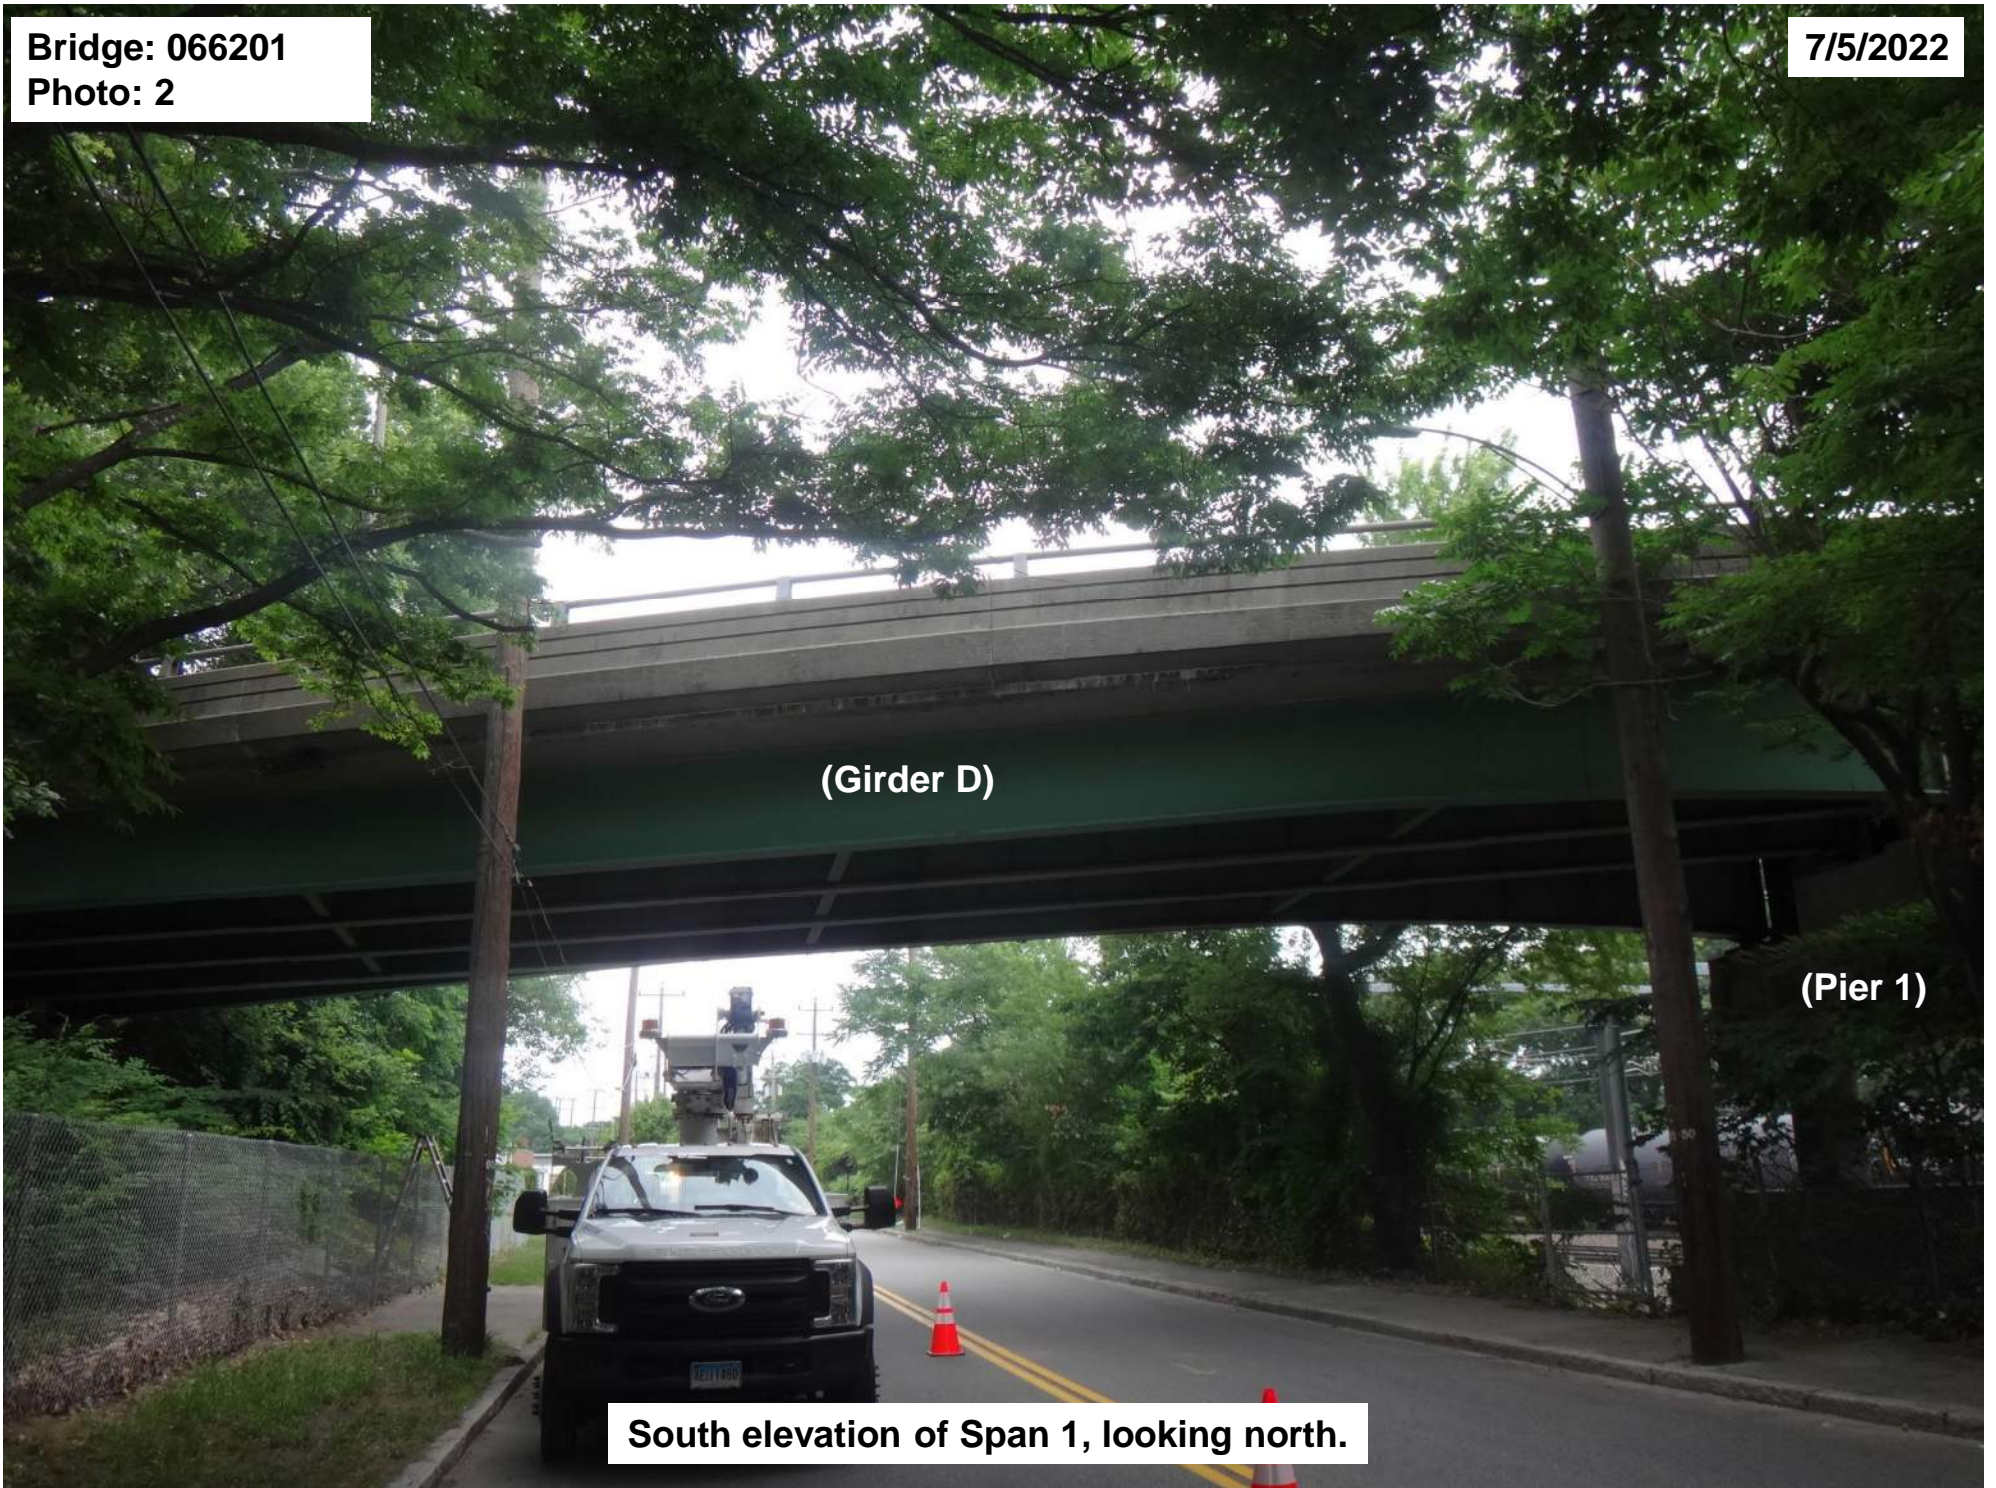
Bridge: 066201
Photo: 2

South elevation of Span 1, looking north.

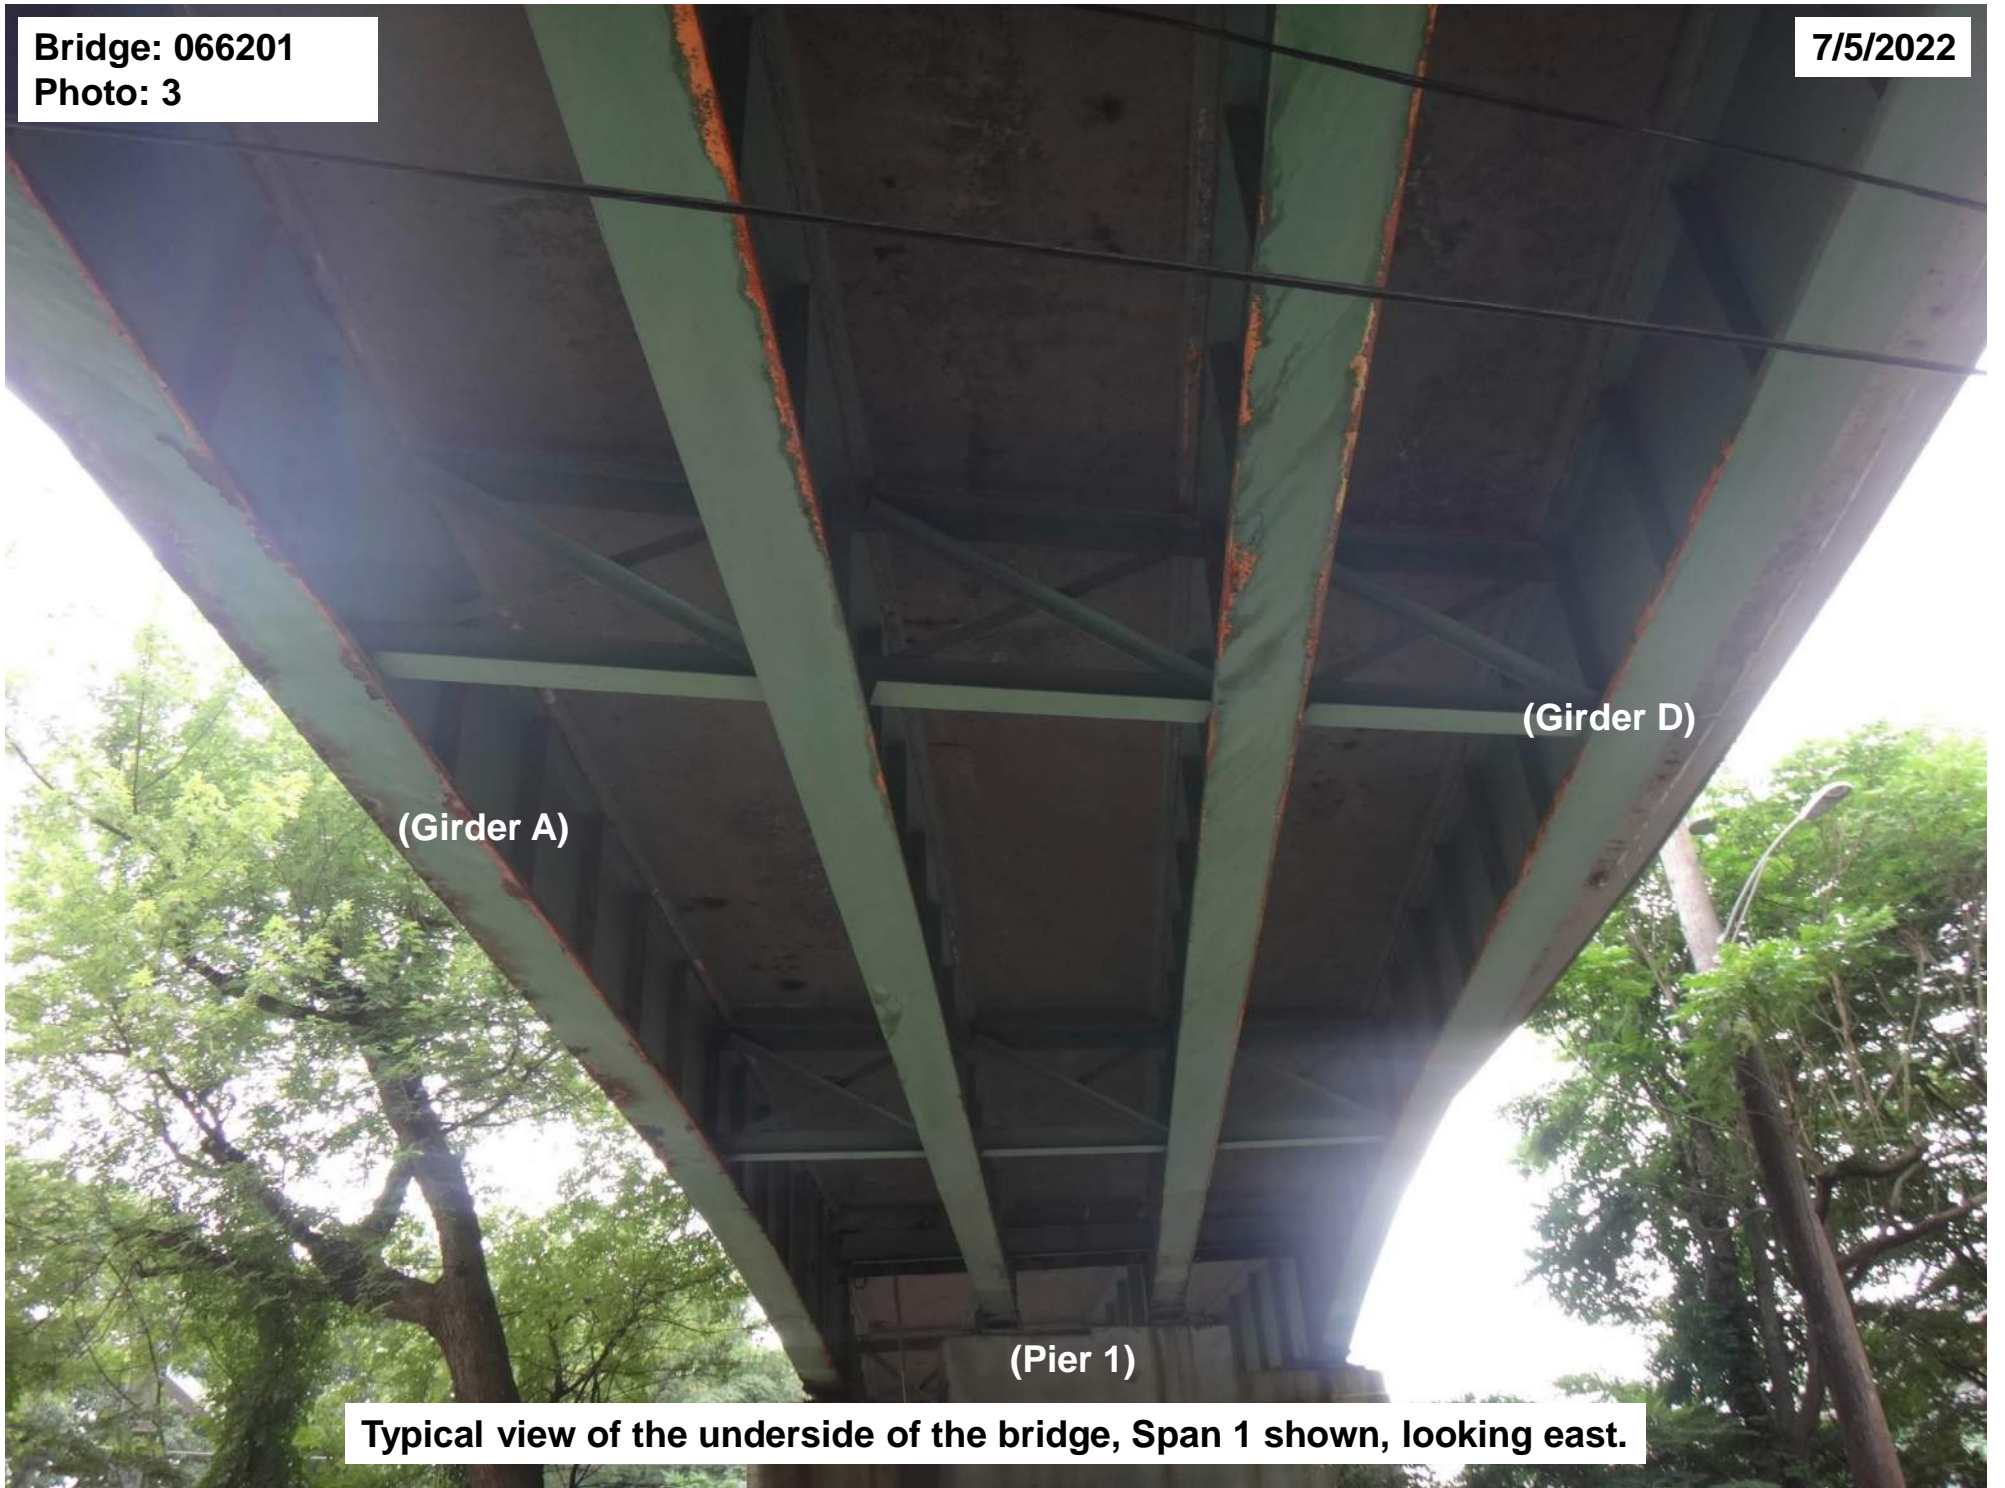
Bridge: 066201
Photo: 3

Typical view of the underside of the bridge, Span 1 shown, looking east.

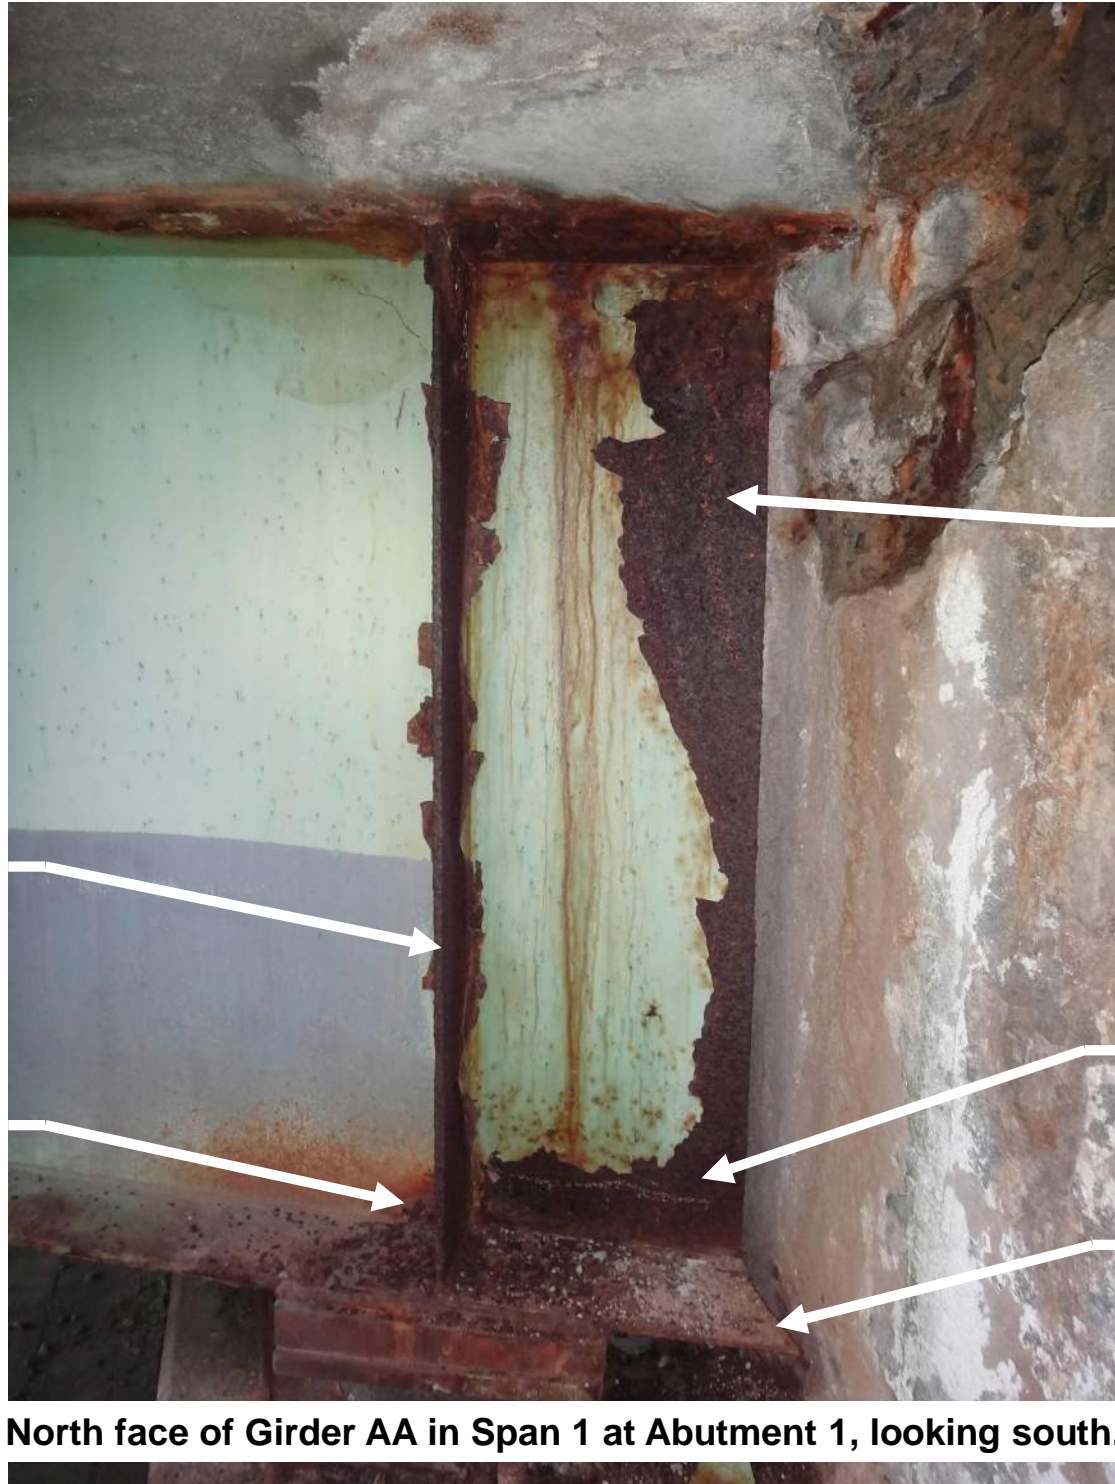
Bridge: 066201
Photo: 4

Section loss, down to 1/4" remaining x remaining height x full length.

Section loss, 3" high x full width x 1/4" to 3/8" remaining

Section loss, 1/4" to 1/8" remaining x 4" high x 13" long

Section loss, 1/8" deep x 1" high x 2" long

Bottom flange section loss, down to 1/8" remaining x full width x full length

North face of Girder AA in Span 1 at Abutment 1, looking south.

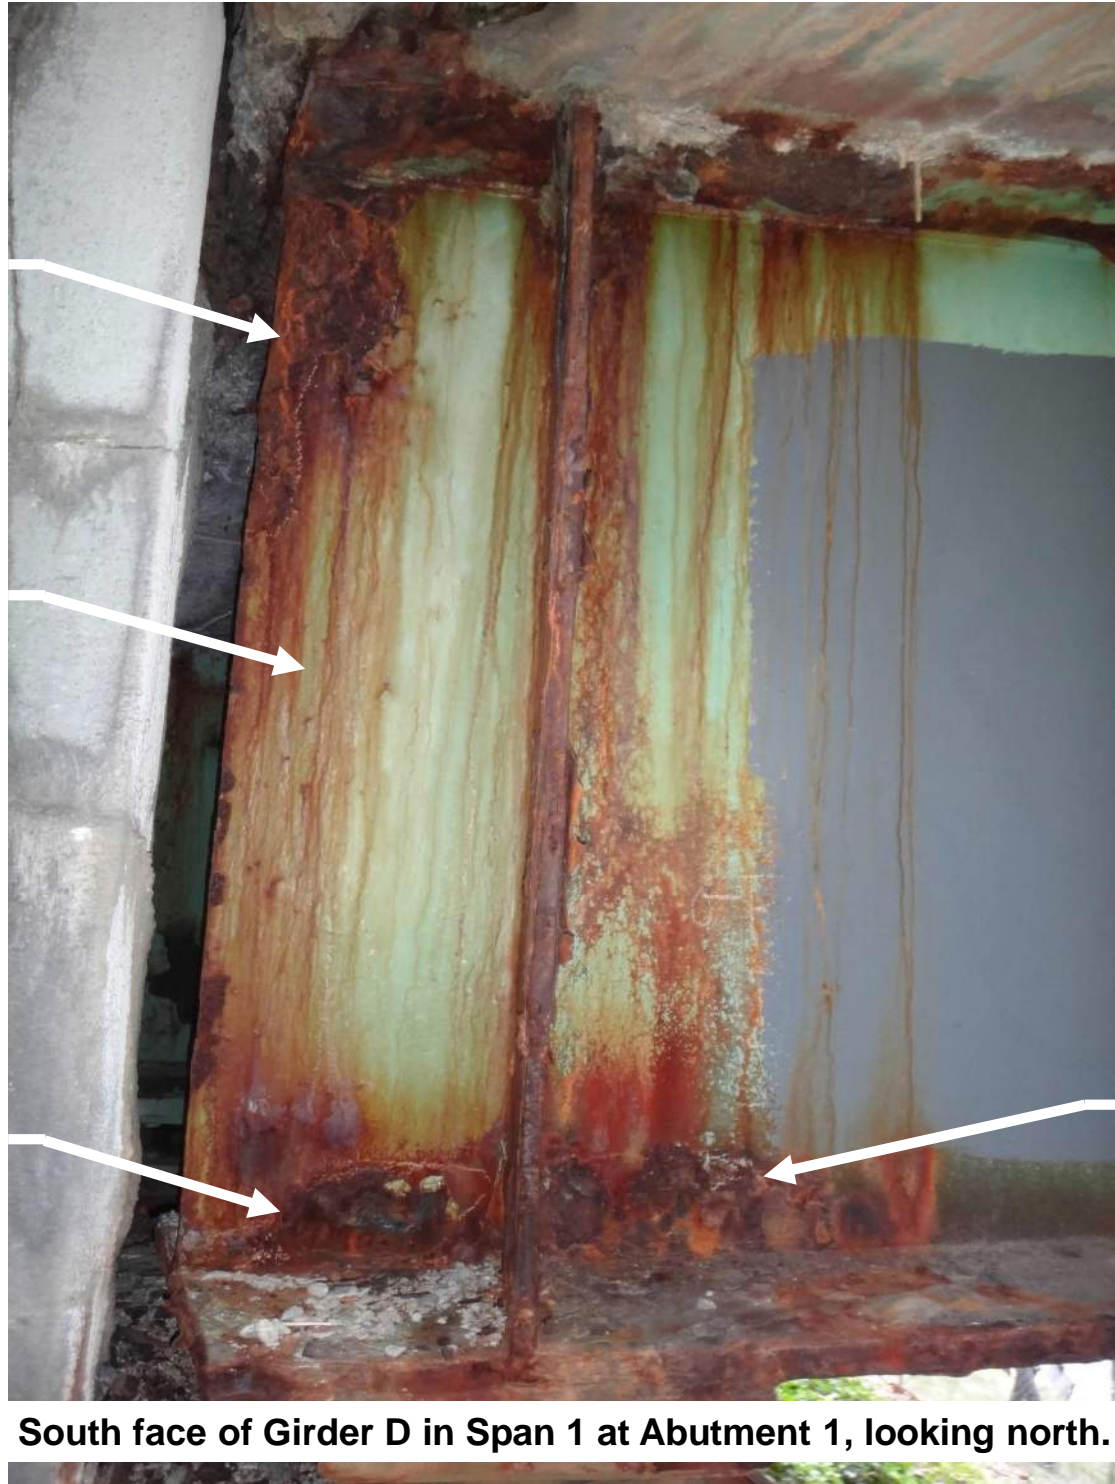
Bridge: 066201
Photo: 7

Section loss, 1/4"
remaining x 17" high x
up to 6" long

3/8" avg. remaining
thickness

Section loss, 1/8" deep x
4" high x full length

Section loss, up to 1/8"
deep x 5" high x 15" long

South face of Girder D in Span 1 at Abutment 1, looking north.

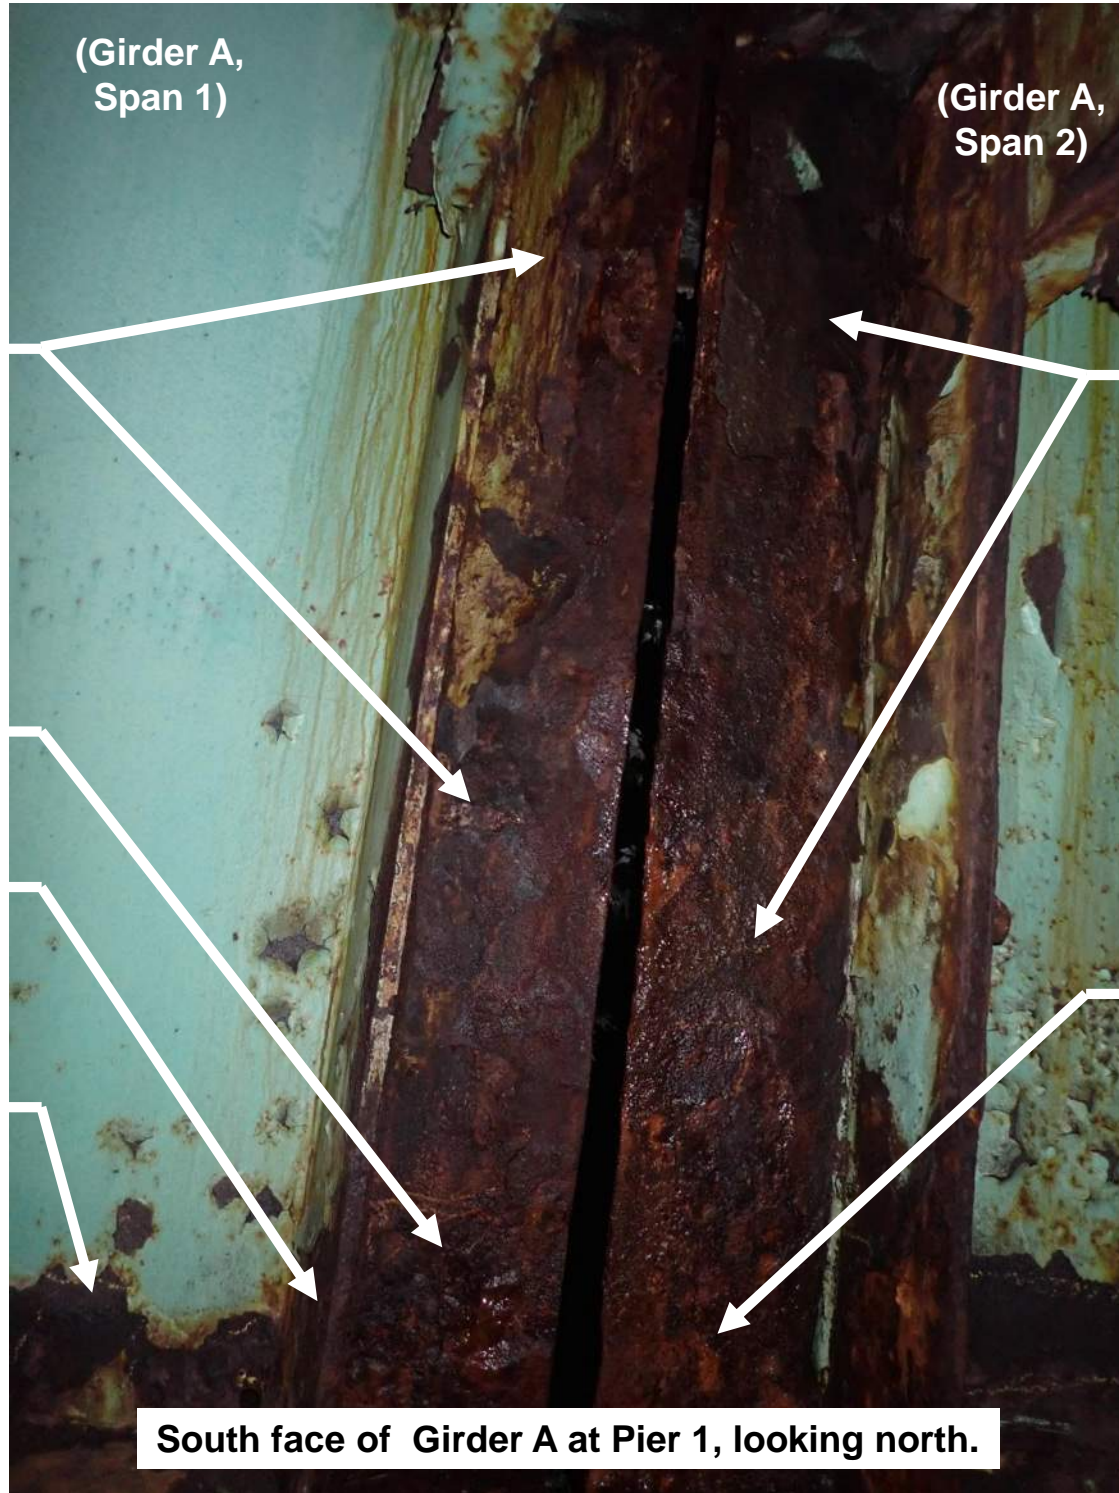
Bridge: 066201
Photo: 8

1/2" avg. remaining x
full length x full height

Web down to 5/16"
remaining x full
length x full height

1/4" remaining x full
length x 10" high

Bearing stiffener, 1/2"
remaining x up to full
width x 12" high

Base of web, 1/8"
remaining x 7"
high x 10" long

1/4" deep section loss
x 4" high x 4" long

South face of Girder A at Pier 1, looking north.

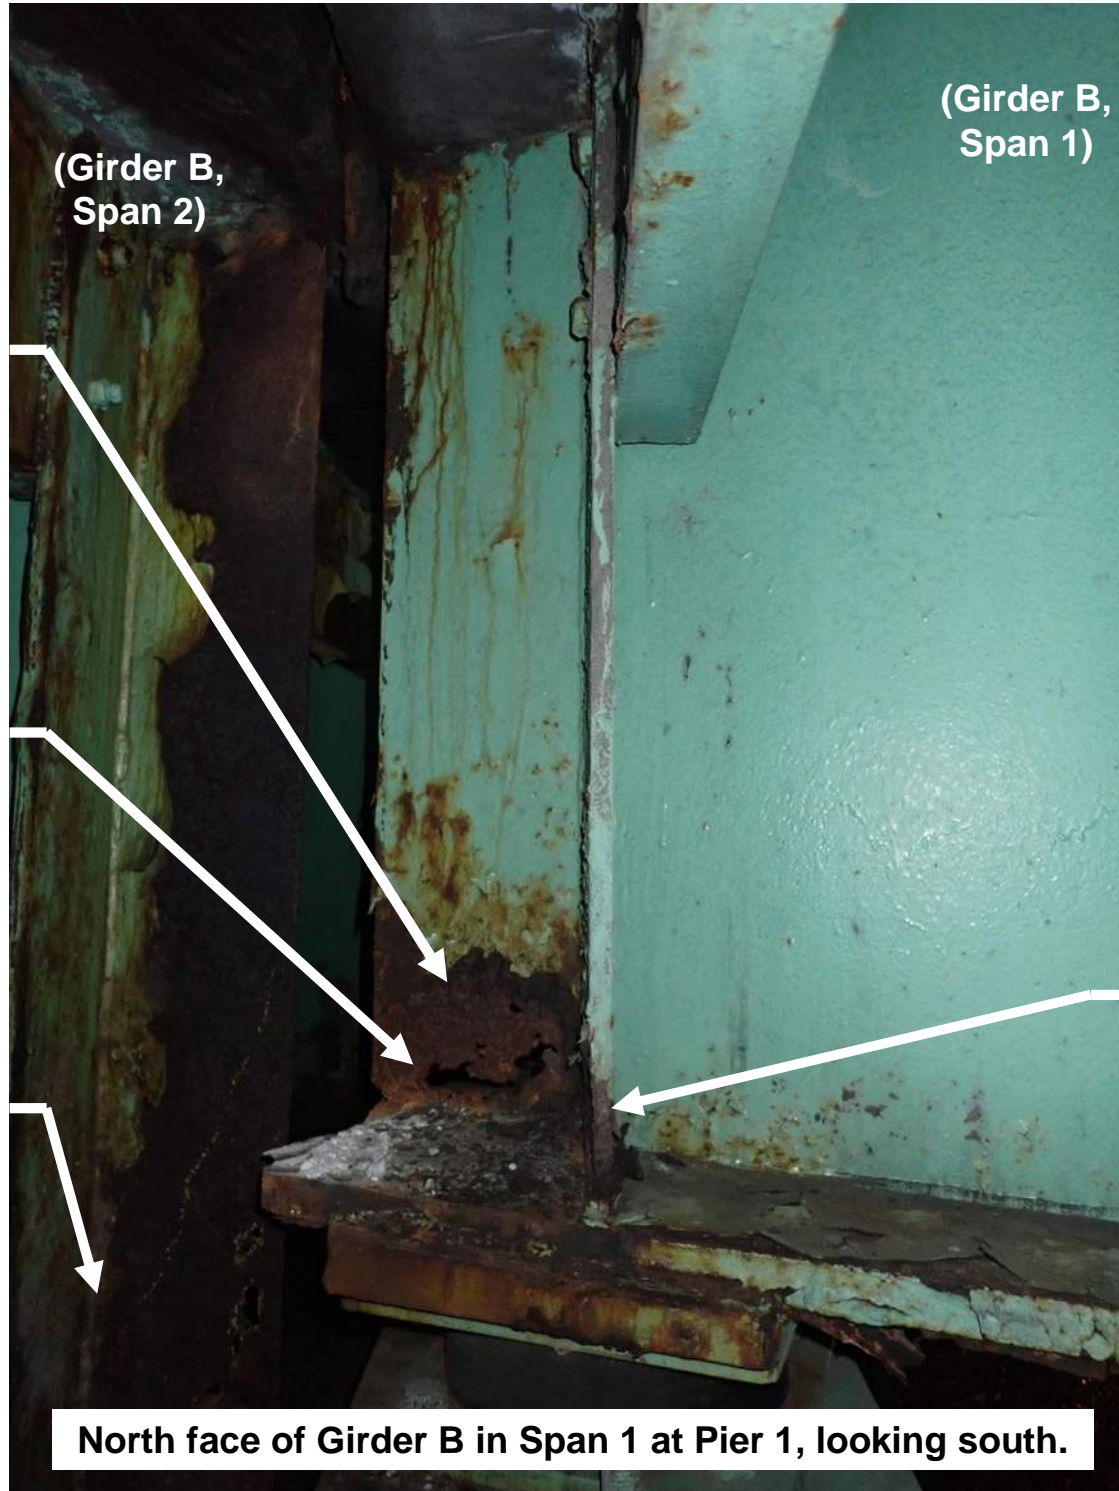
Bridge: 066201
Photo: 9

Section loss, 1/4" deep
down to 100% loss x
6" high x 8" long

Hole, 8" long x 4" high
with web crippled 1/2"
out-of-plane x 3" high
x full length

Heavy rust

Bearing stiffener,
1/2" remaining x
3" high x 3" wide.

North face of Girder B in Span 1 at Pier 1, looking south.

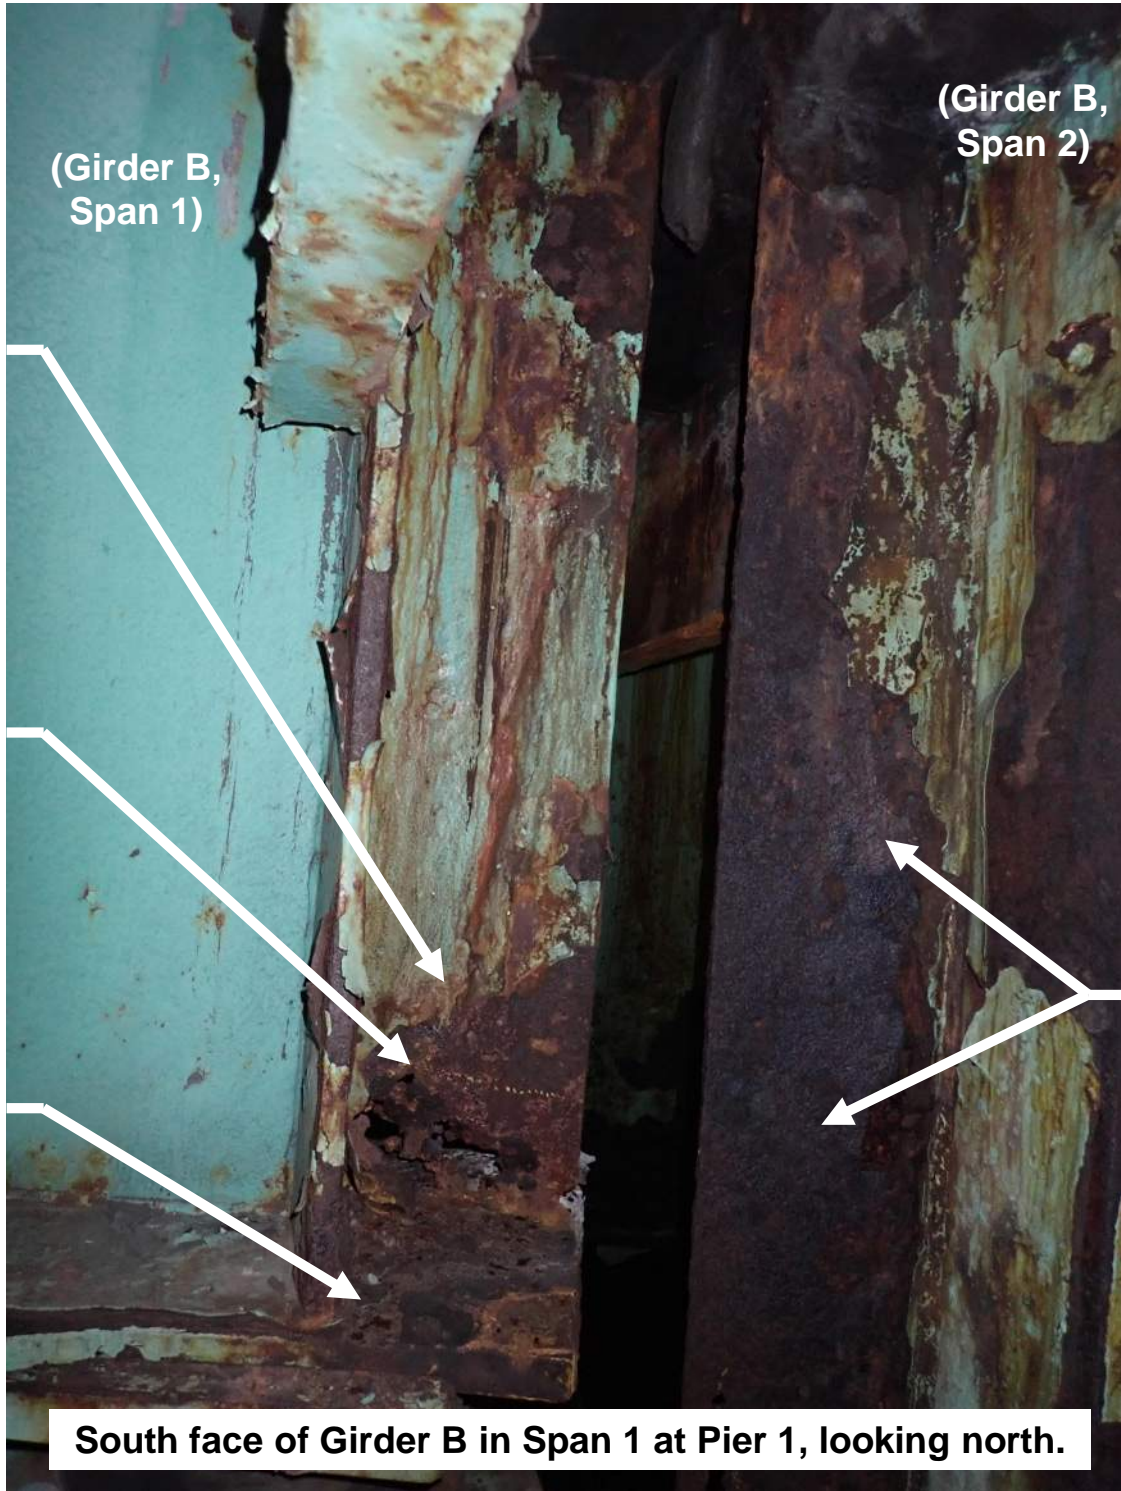
Bridge: 066201
Photo: 10

South face of Girder B in Span 1 at Pier 1, looking north.

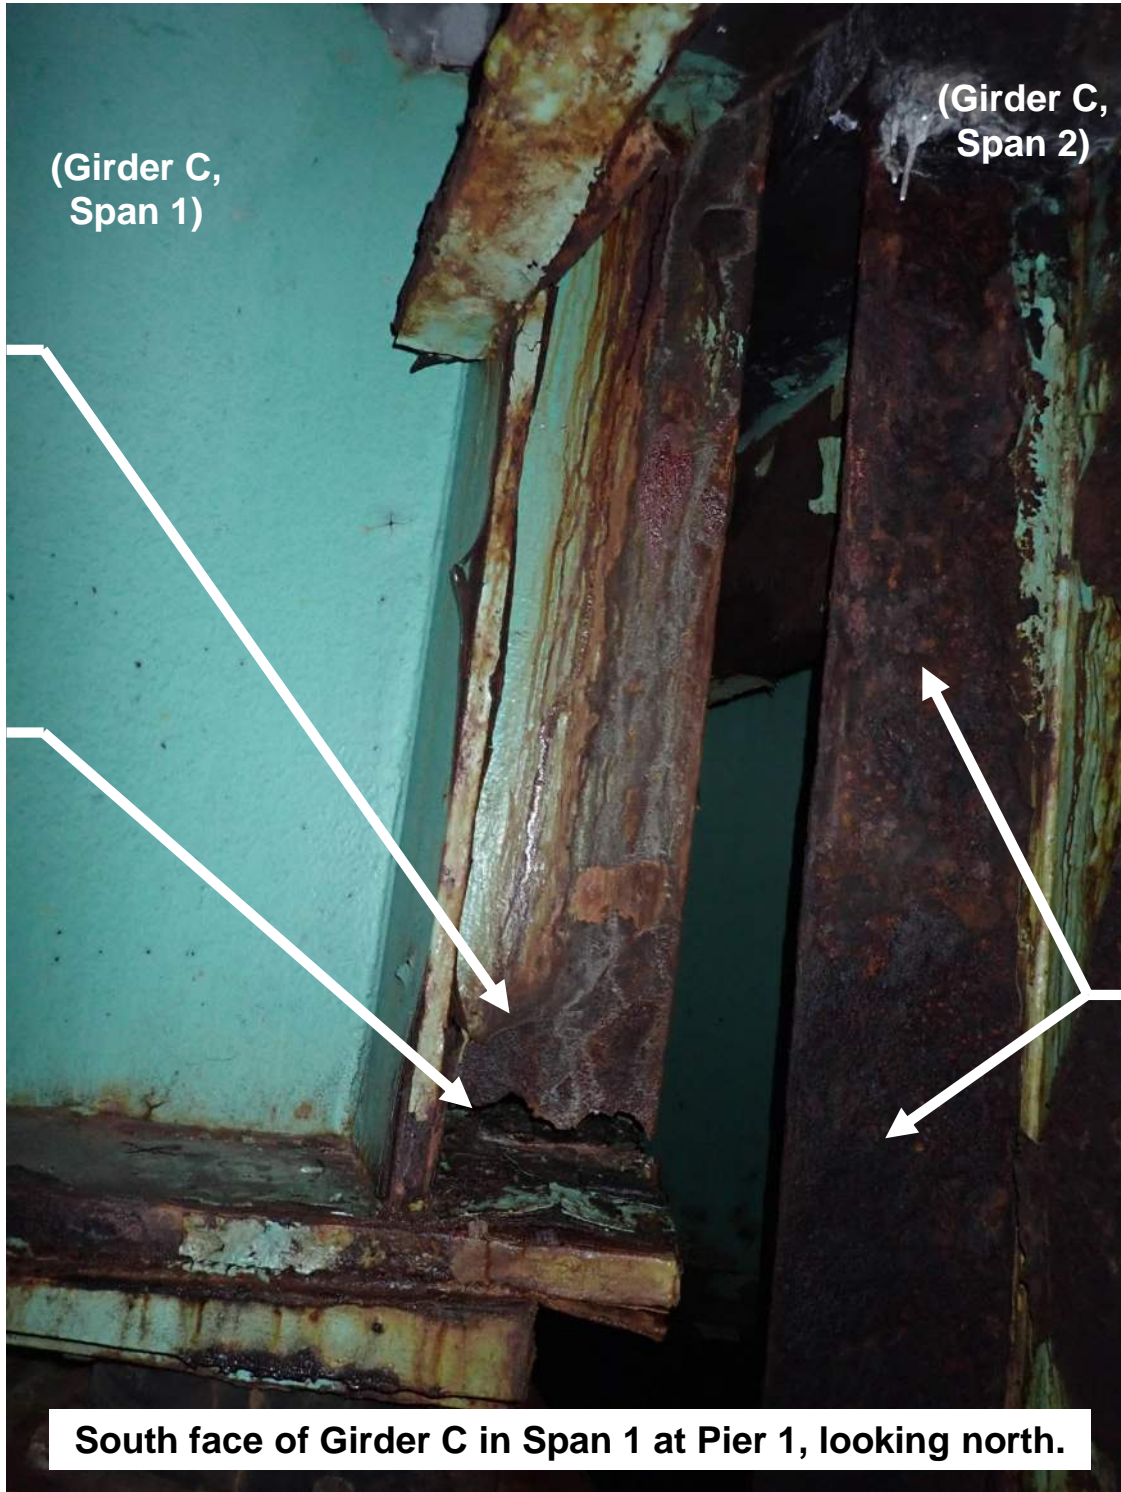
Bridge: 066201
Photo: 12

Section loss, 1/4"
remaining x 7" high x
full length

Hole, 2" high x full
length

Web down to 3/16"
remaining x full
height x full length

South face of Girder C in Span 1 at Pier 1, looking north.

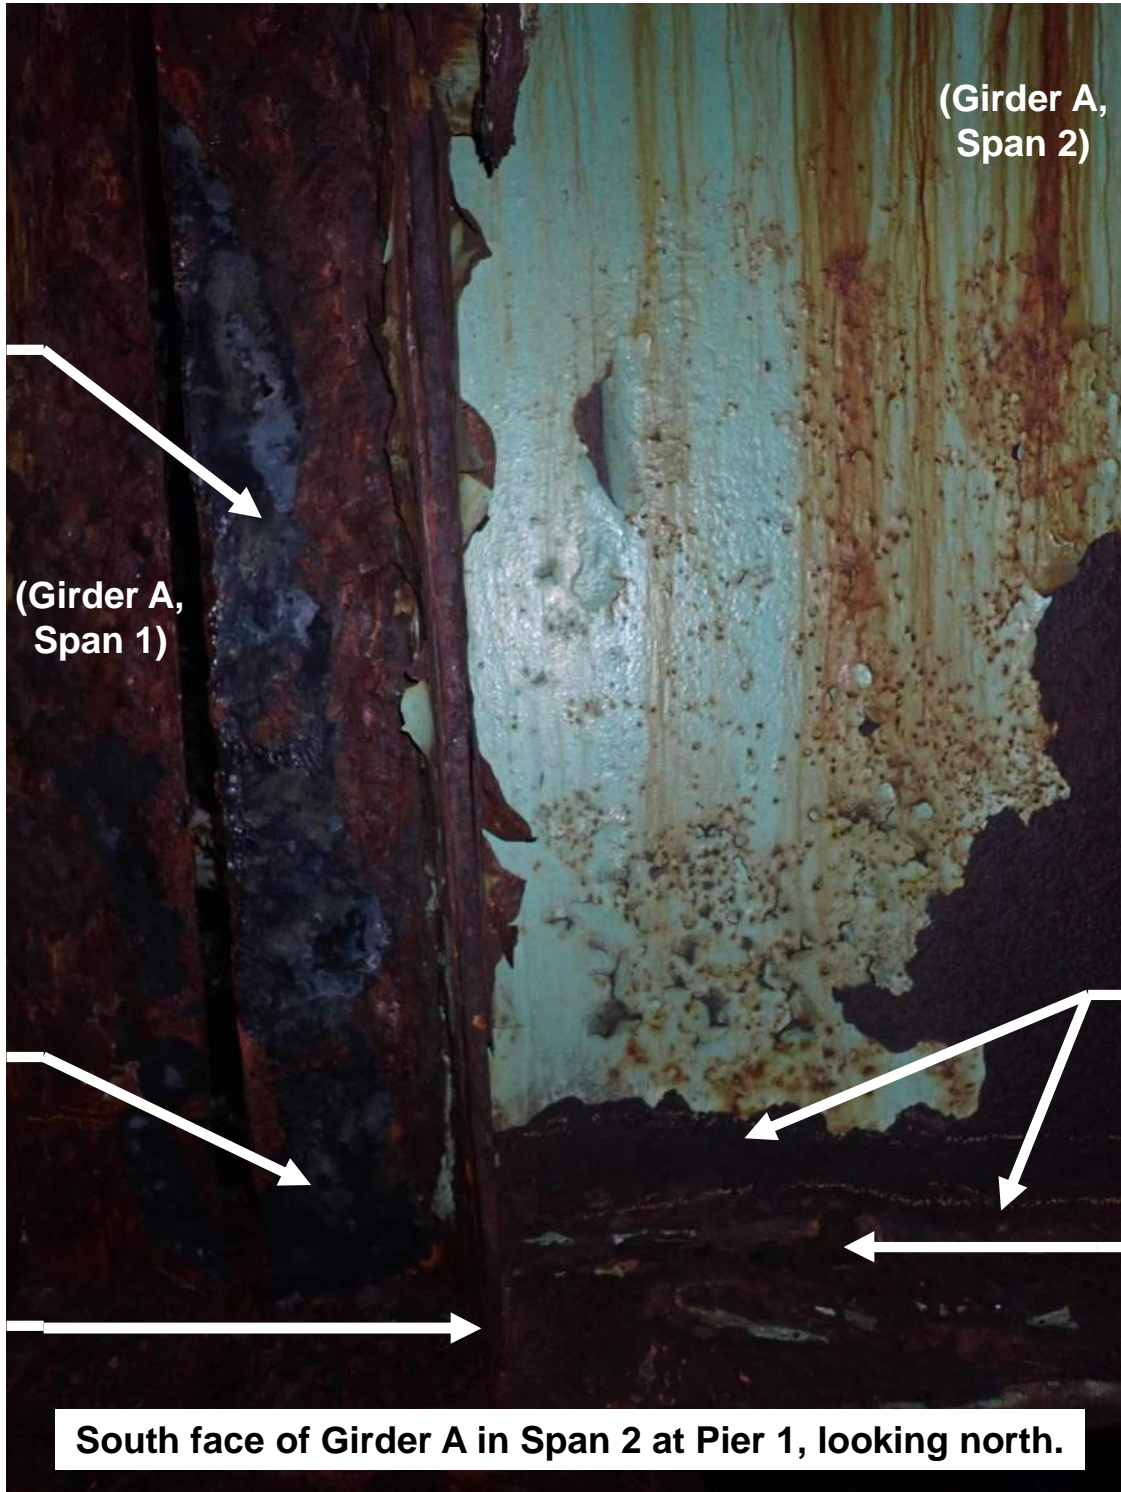
Bridge: 066201
Photo: 15

Web down to 5/16"
remaining x full length
x full height

1/8" remaining x 7"
high x 10" long

1/16" section loss x 4"
high x 4'-0" long over
1/4" section loss 3"
high x 4'-0" long

1/2" remaining x 16"
high x full width
(bearing stiffener)

100% section loss to
lateral bracing at
connection to girder

South face of Girder A in Span 2 at Pier 1, looking north.

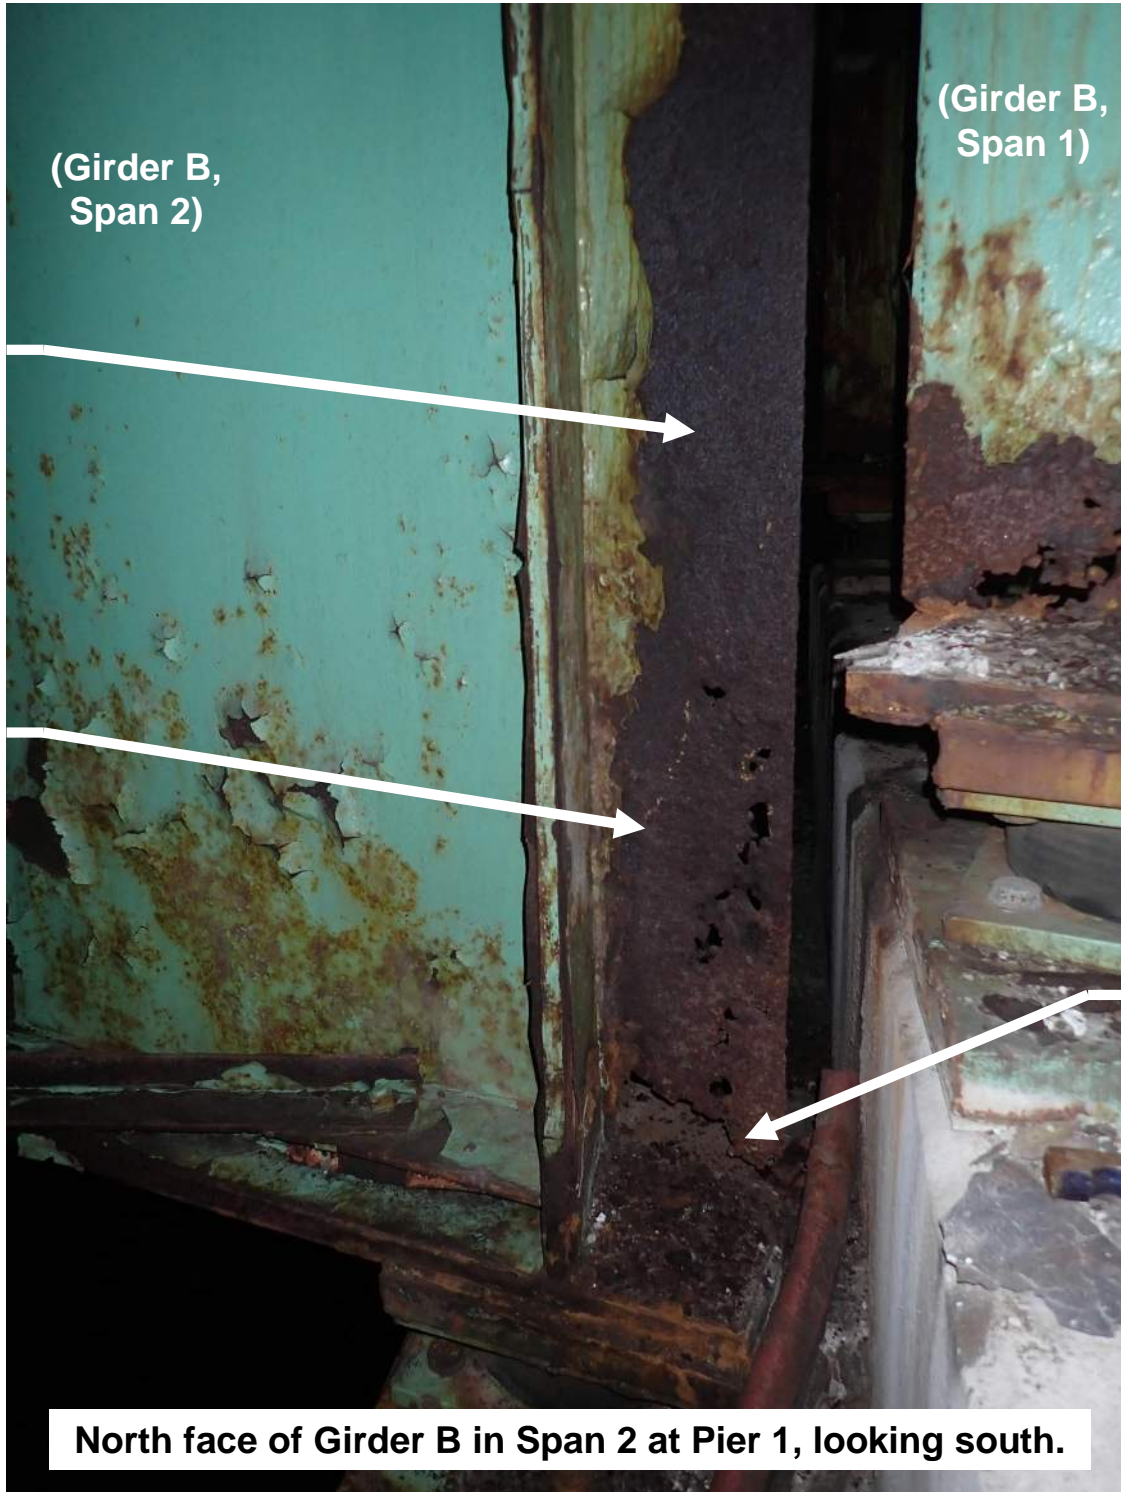
Bridge: 066201
Photo: 16

Down to 3/16"
remaining x full height
x full length

Multiple up to 2" high
x 1" long holes within
area 20" high x 5" long

Hole, 5" high x 9" long

North face of Girder B in Span 2 at Pier 1, looking south.
