Bridge: 066201
Photo: 1

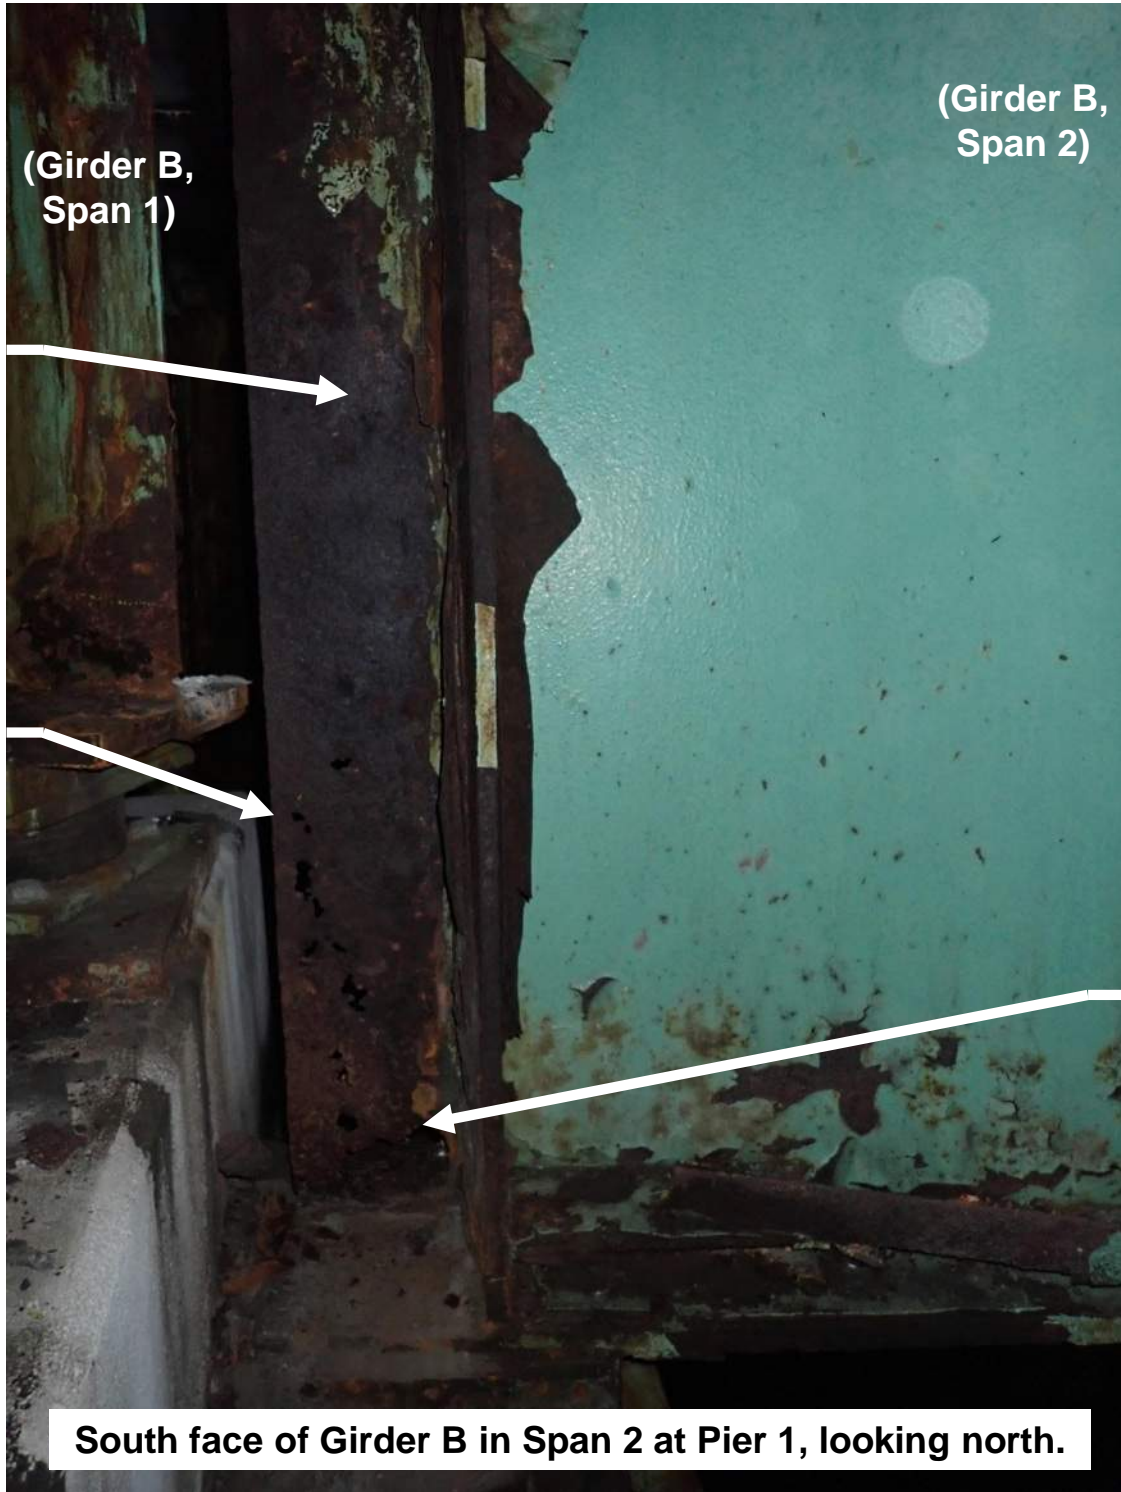
Bridge: 066201
Photo: 17

Down to 3/16"
remaining x full height
x full length

Multiple up to 2" high
x 1" long holes within
area 20" high x 5" long

Hole, 5" high x 9" long

South face of Girder B in Span 2 at Pier 1, looking north.

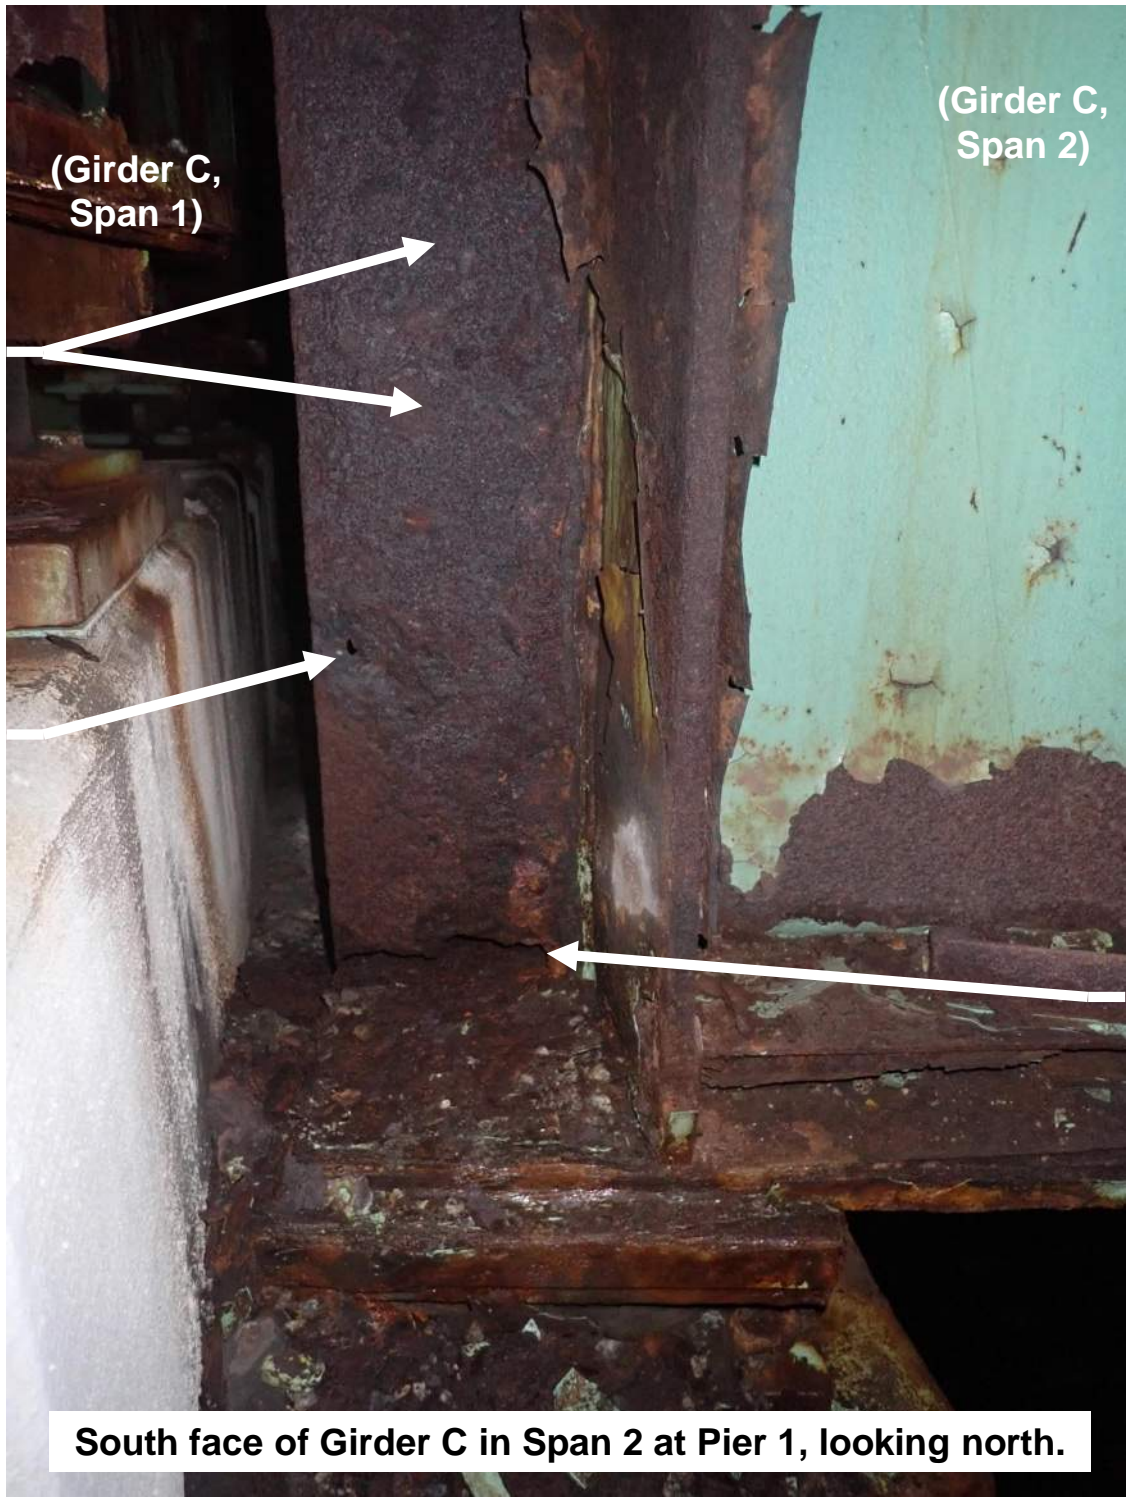
Bridge: 066201
Photo: 18

Section loss, 3/16"
remaining x full height
x full length

Hole, 1/2" Ø

Hole, 2-1/2" high
x 8" long

South face of Girder C in Span 2 at Pier 1, looking north.

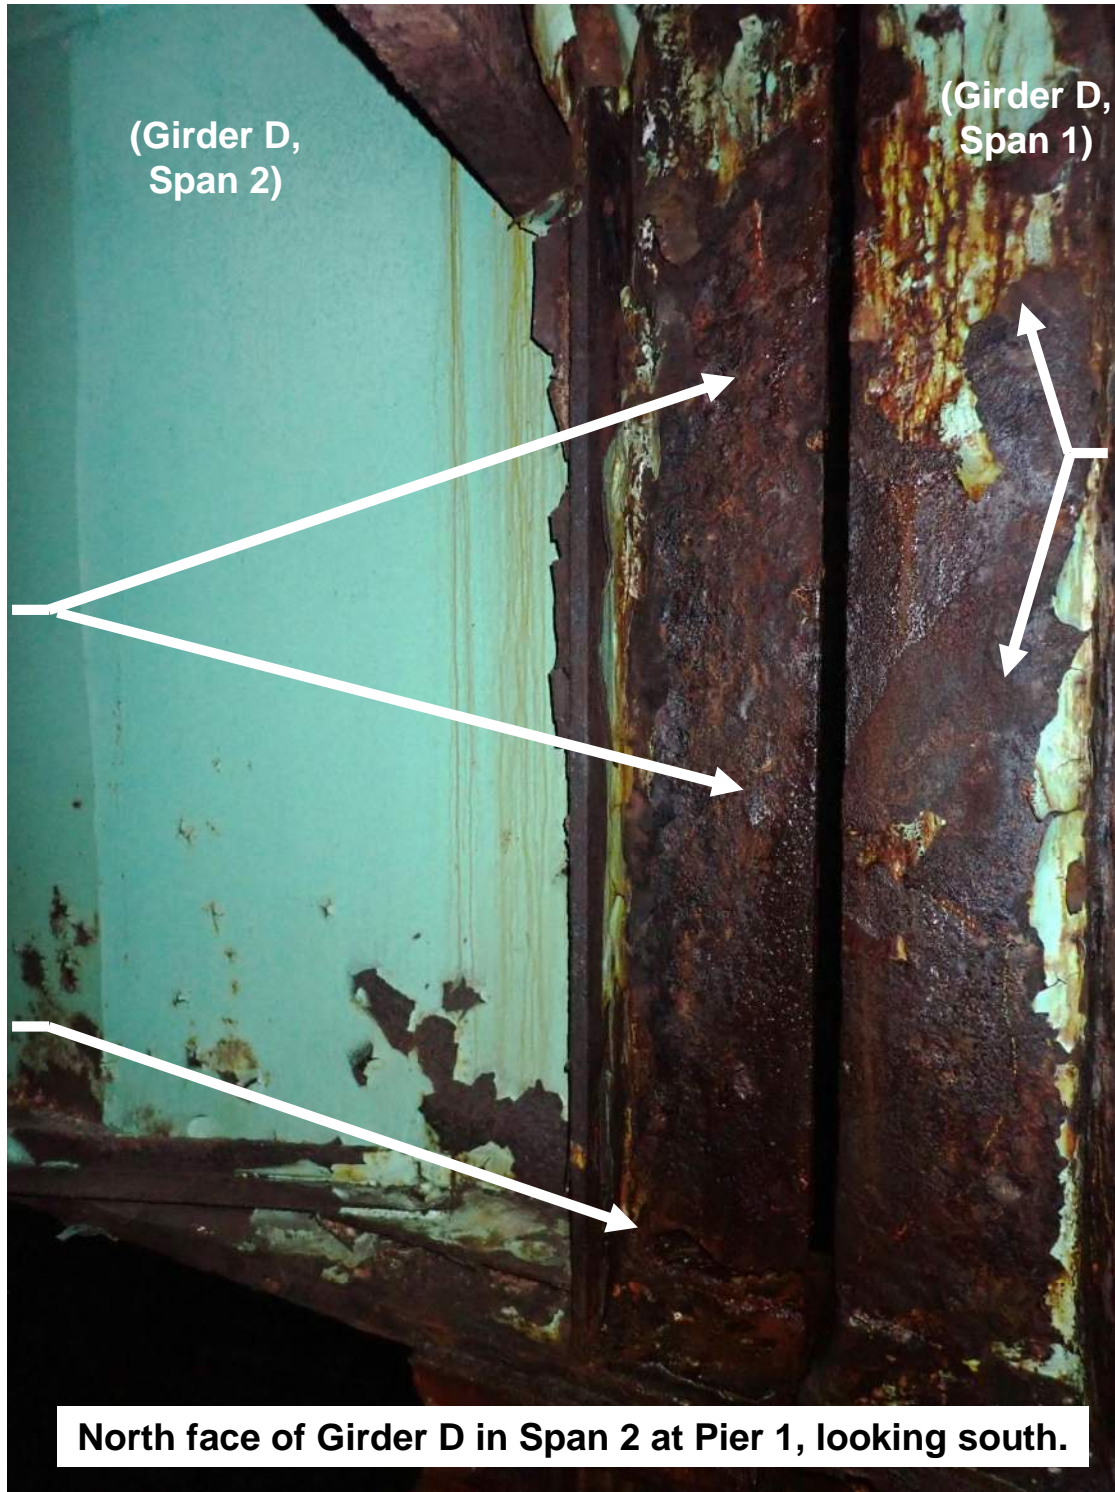
Bridge: 066201
Photo: 19

1/4" remaining x full
height x full length

Hole, 2-1/2" high
x 9" long

North face of Girder D in Span 2 at Pier 1, looking south.
