BRIDGE NO. 070001

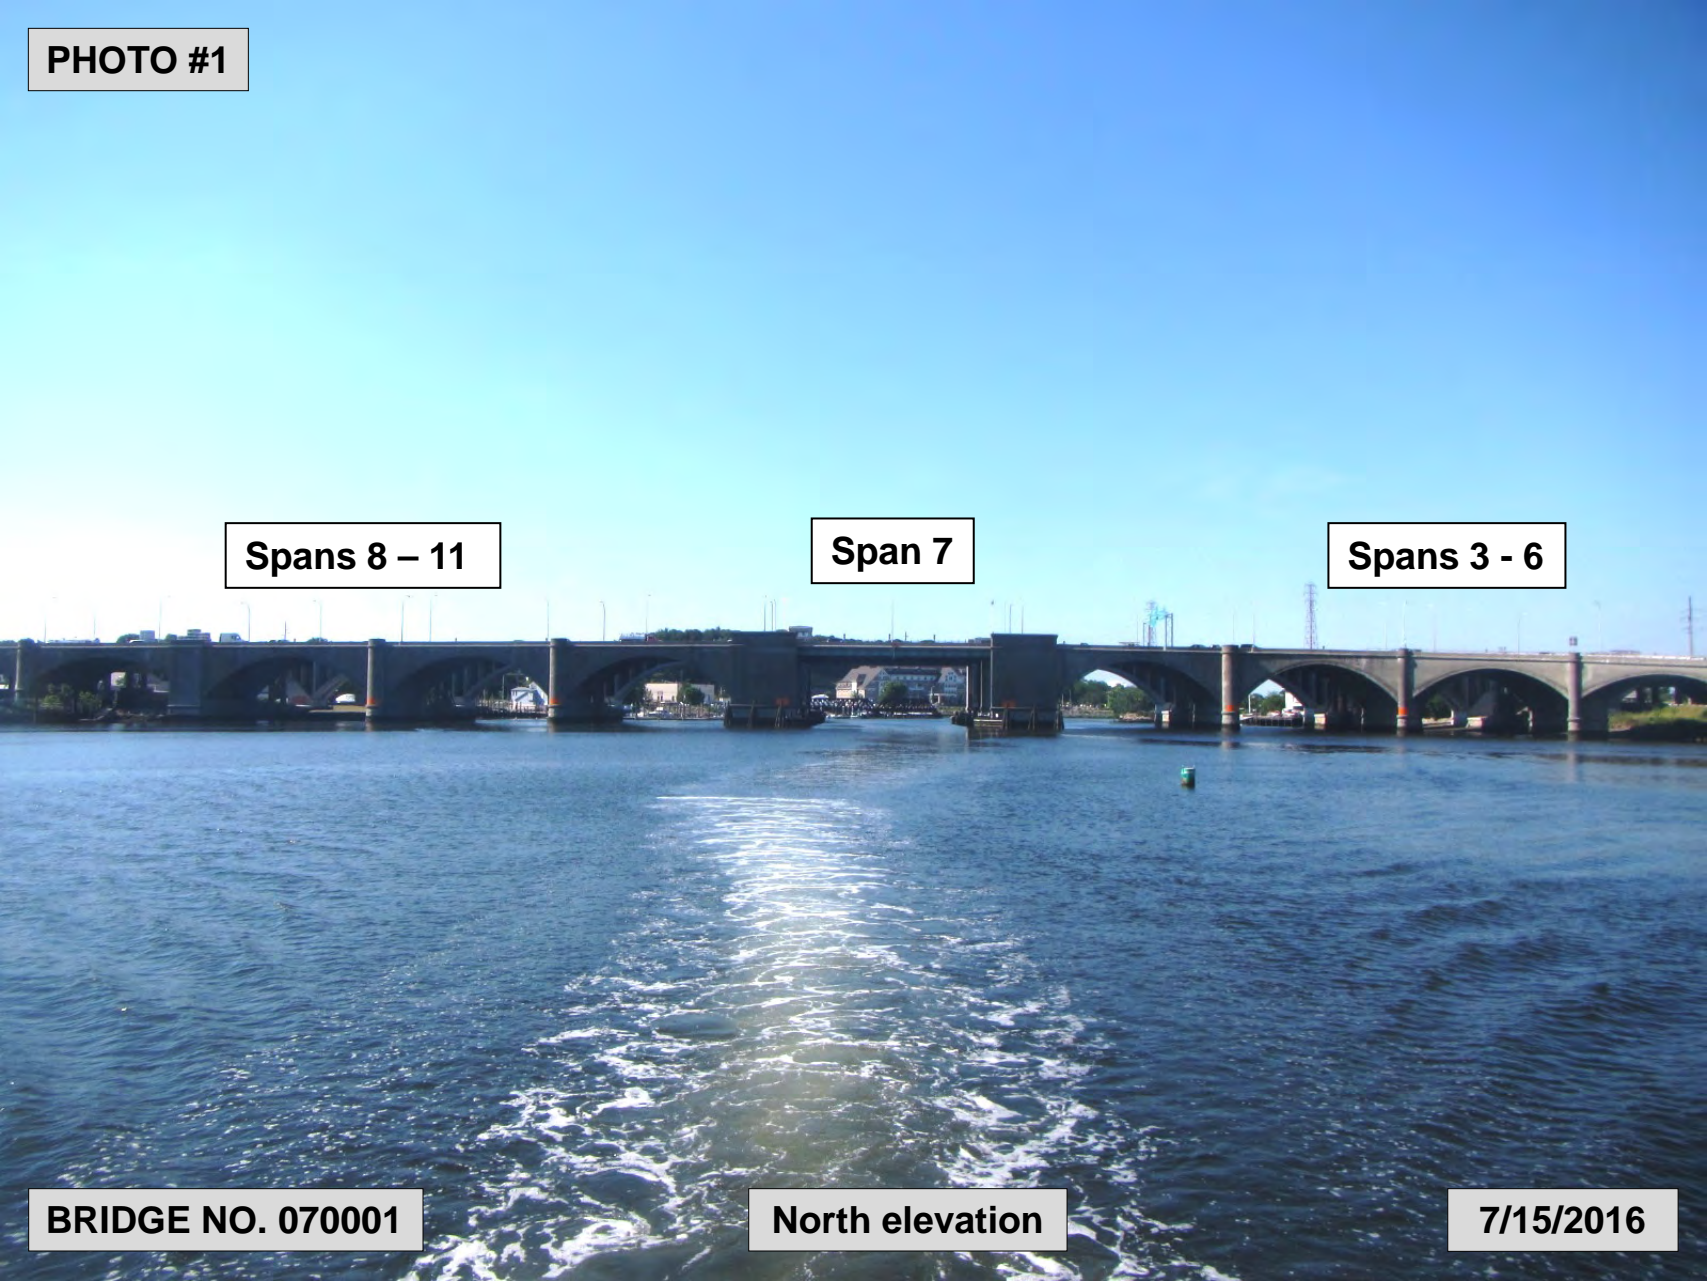
PHOTO #1

North elevation

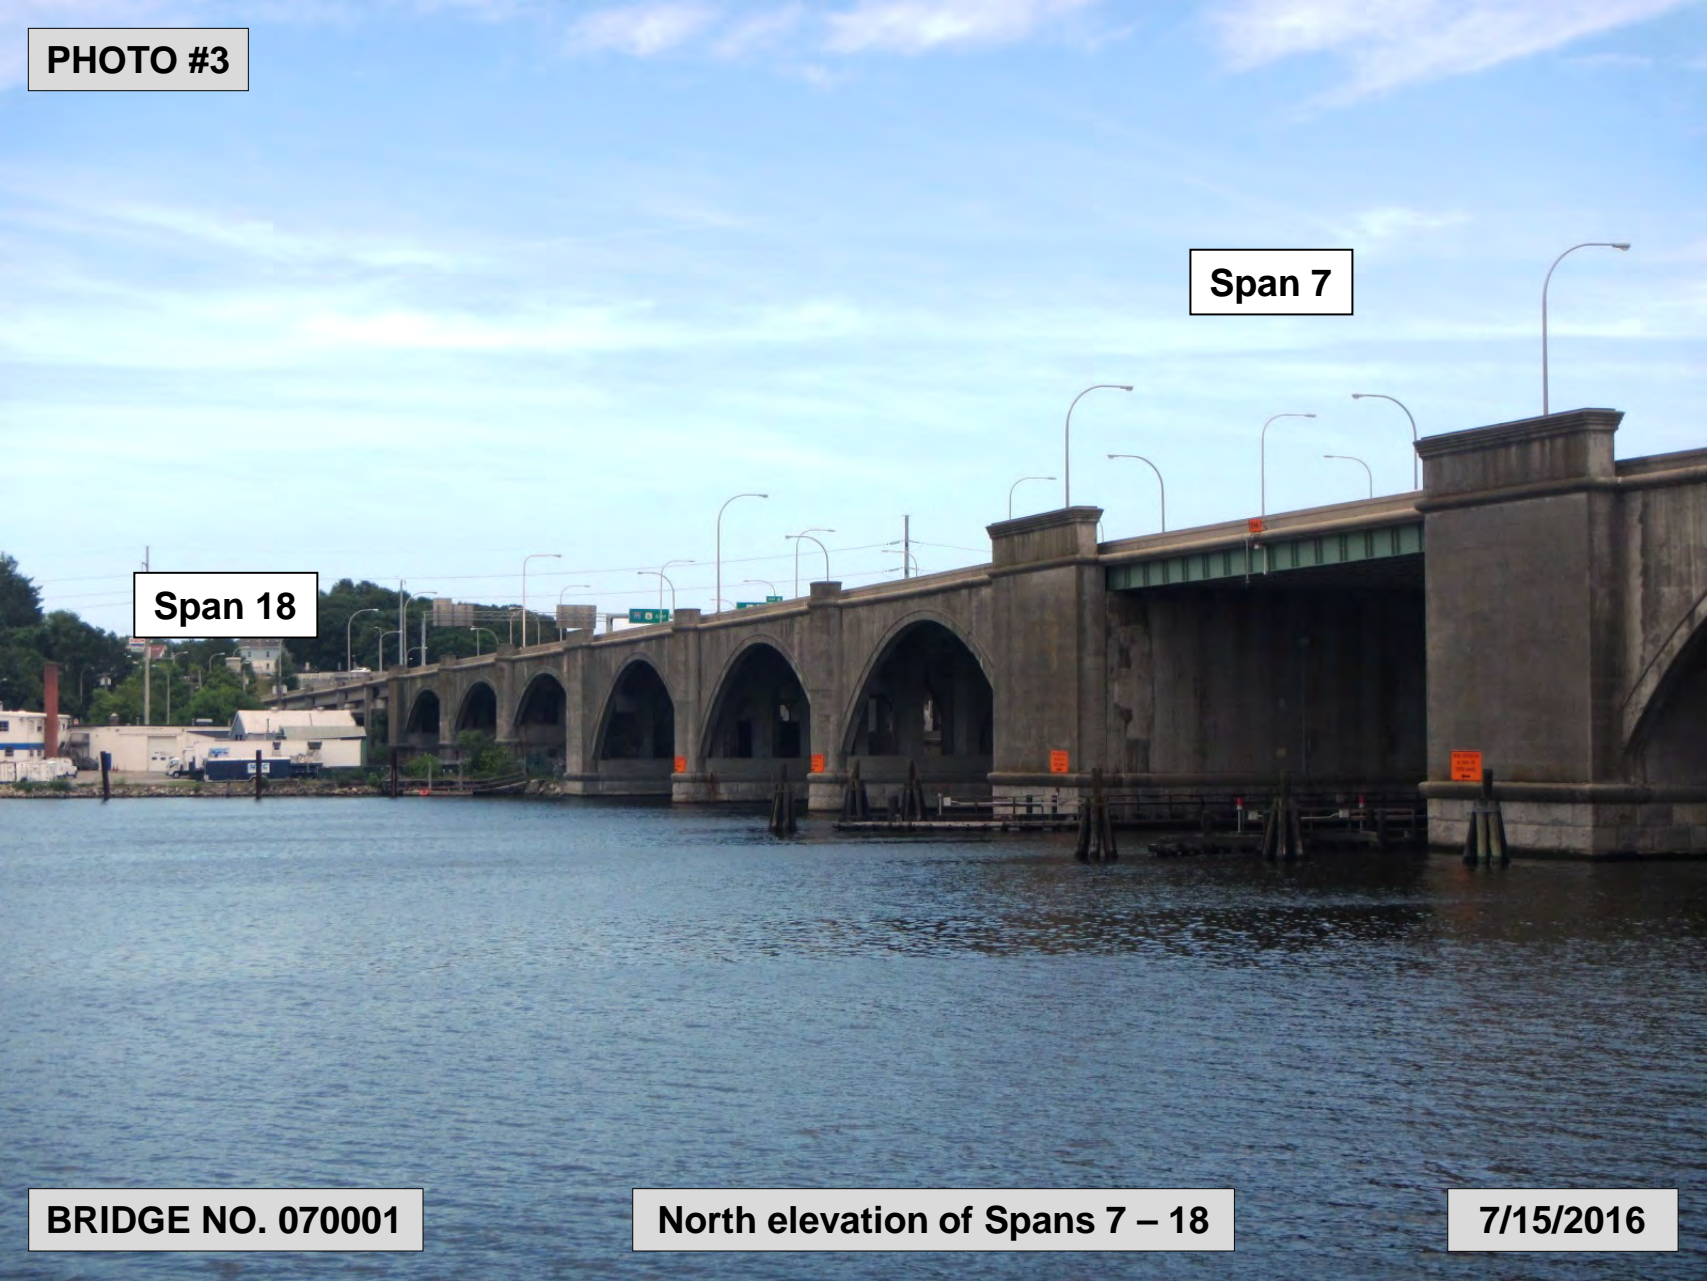
PHOTO #3

North elevation of Spans 7 – 18

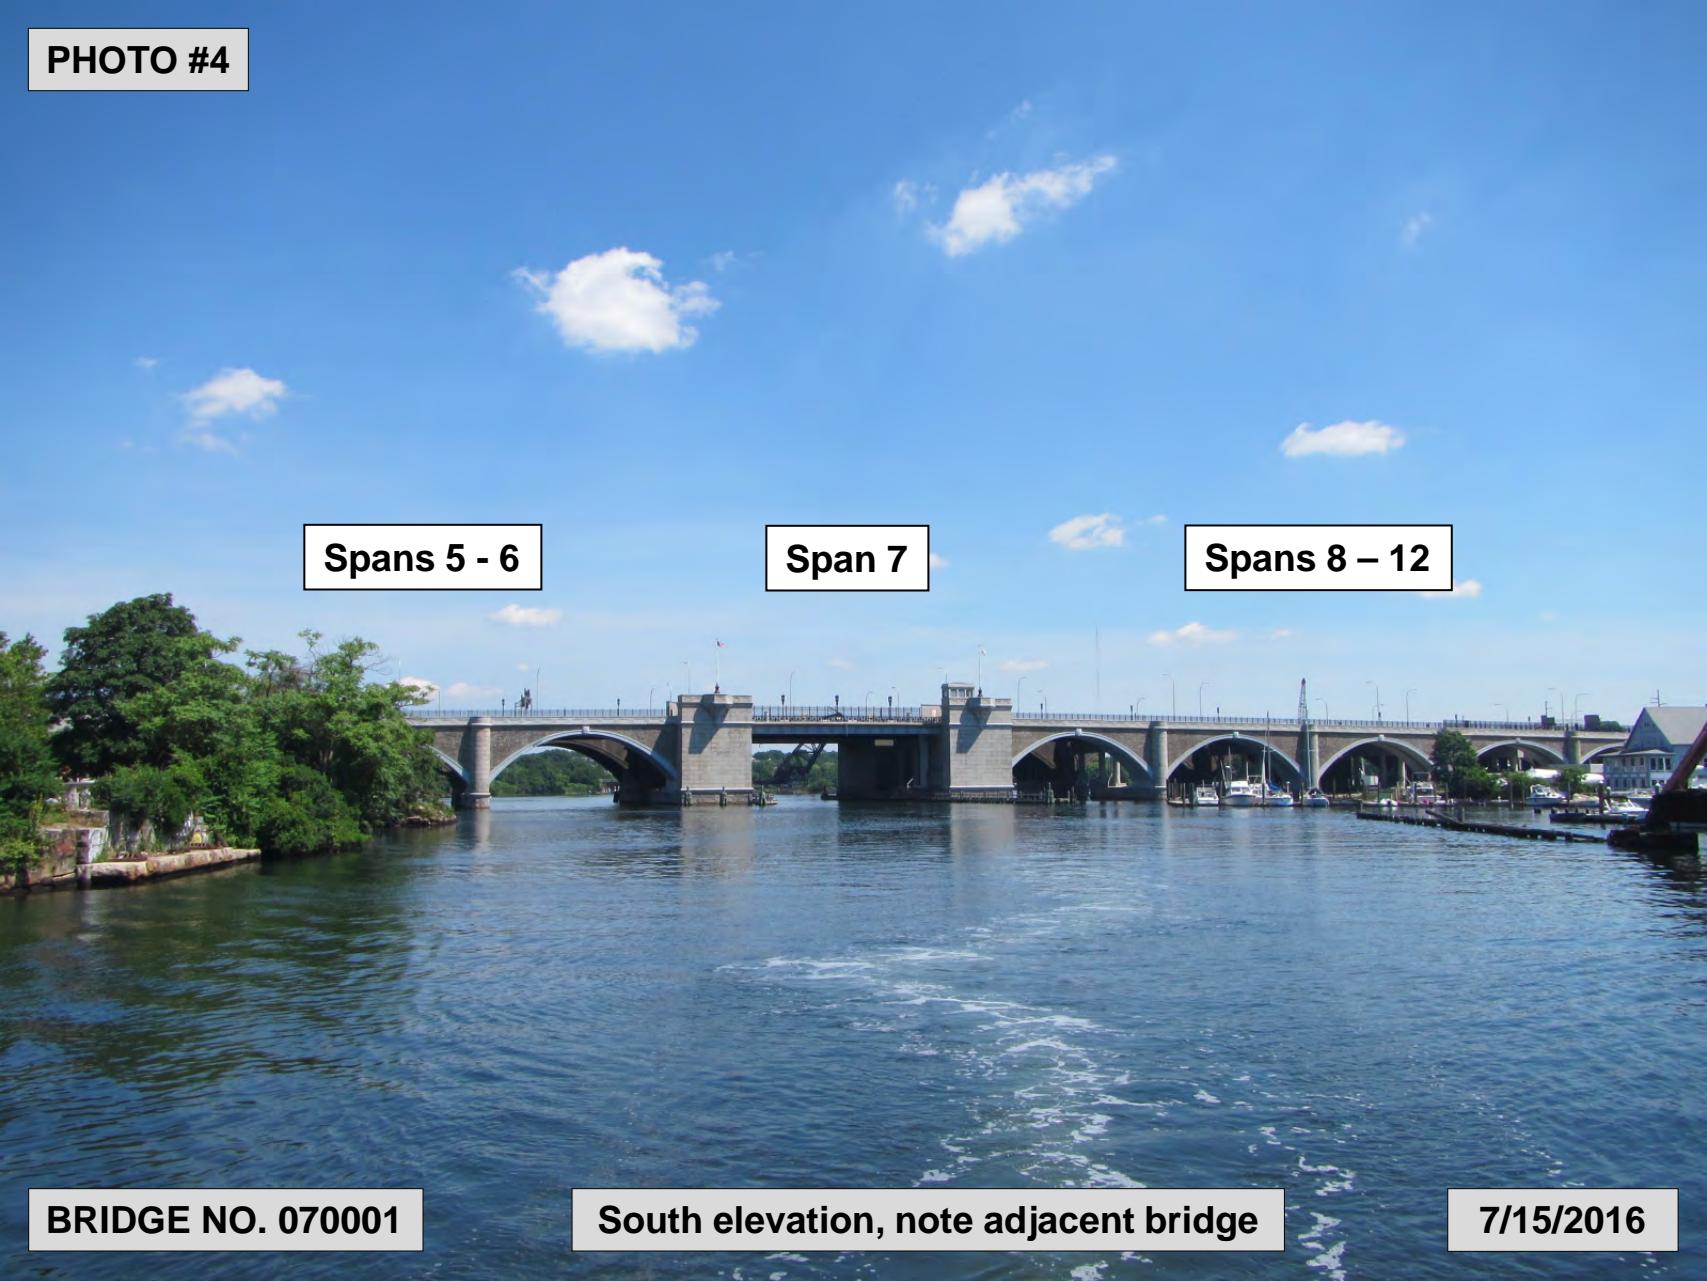
PHOTO #4

South elevation, note adjacent bridge

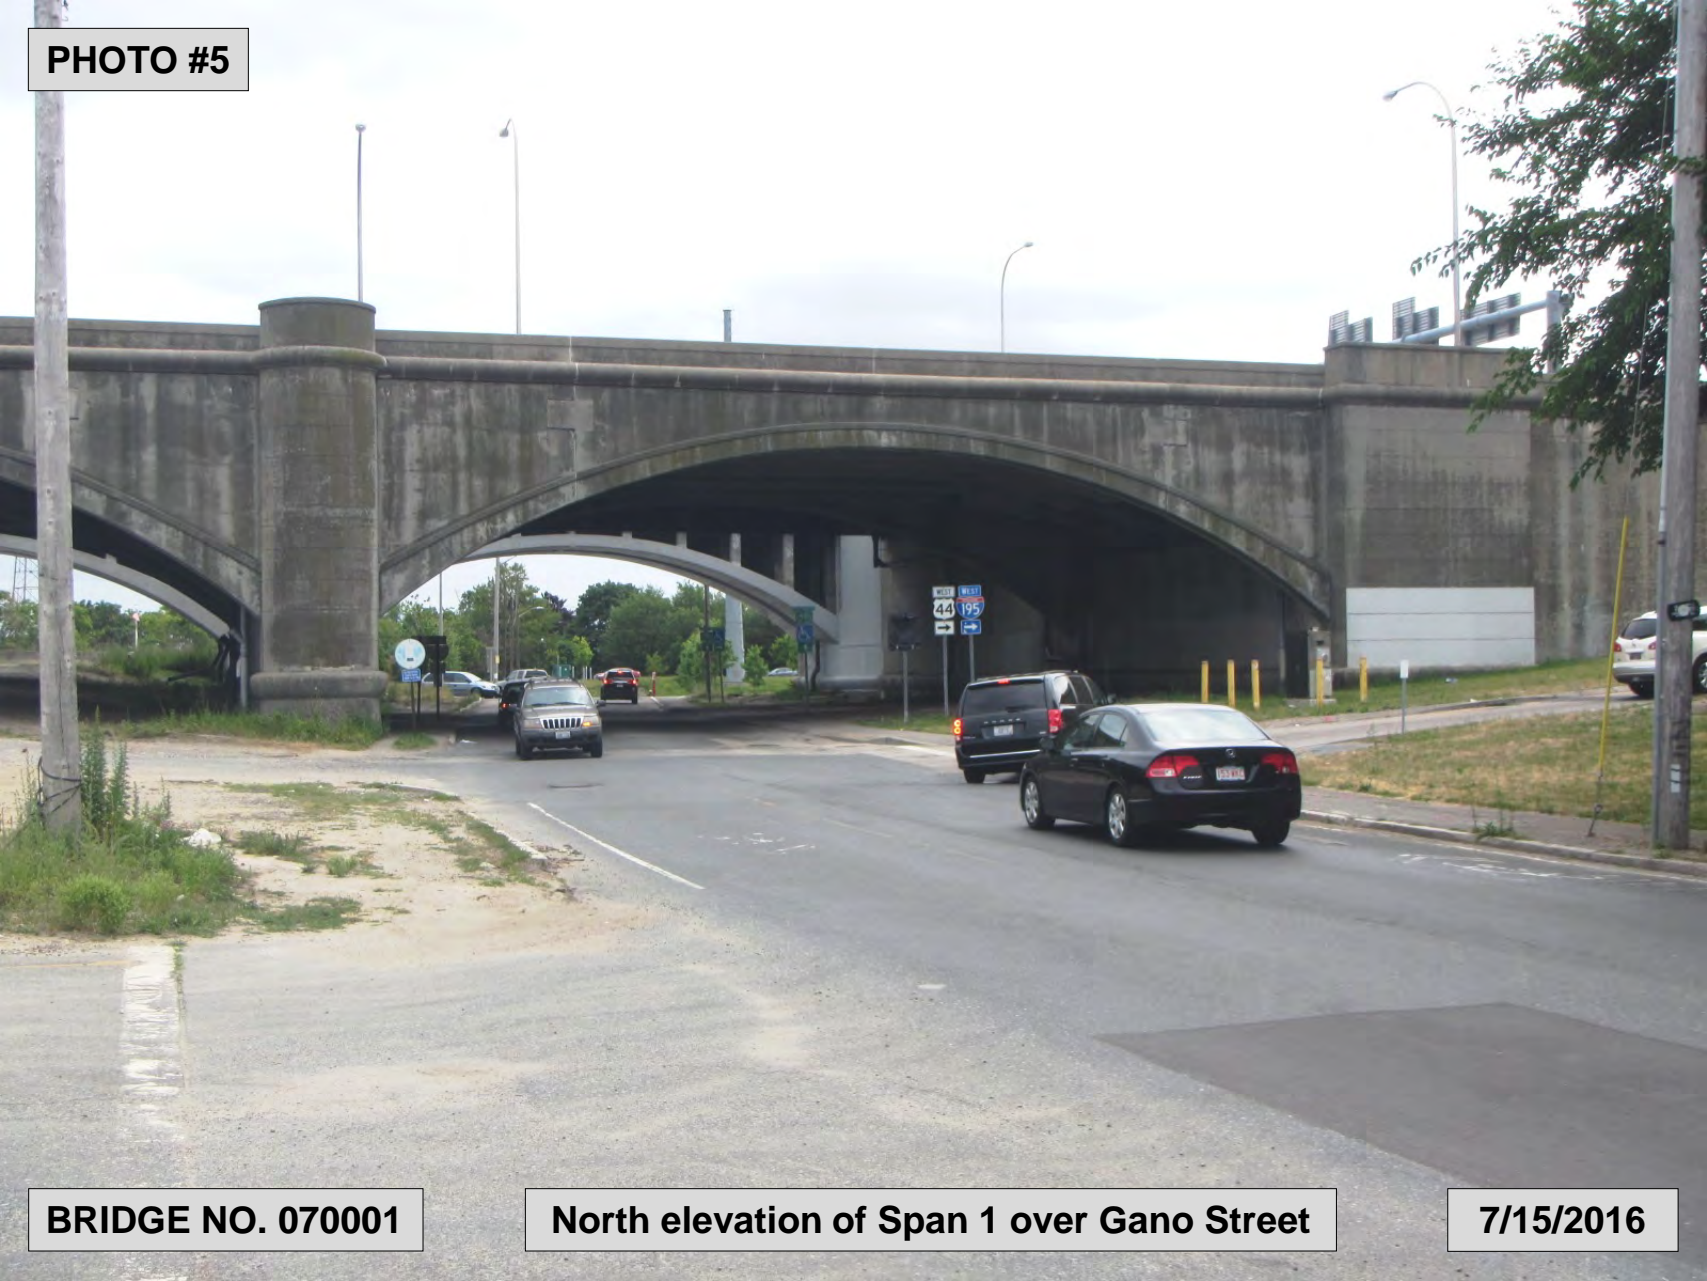
PHOTO #5

North elevation of Span 1 over Gano Street

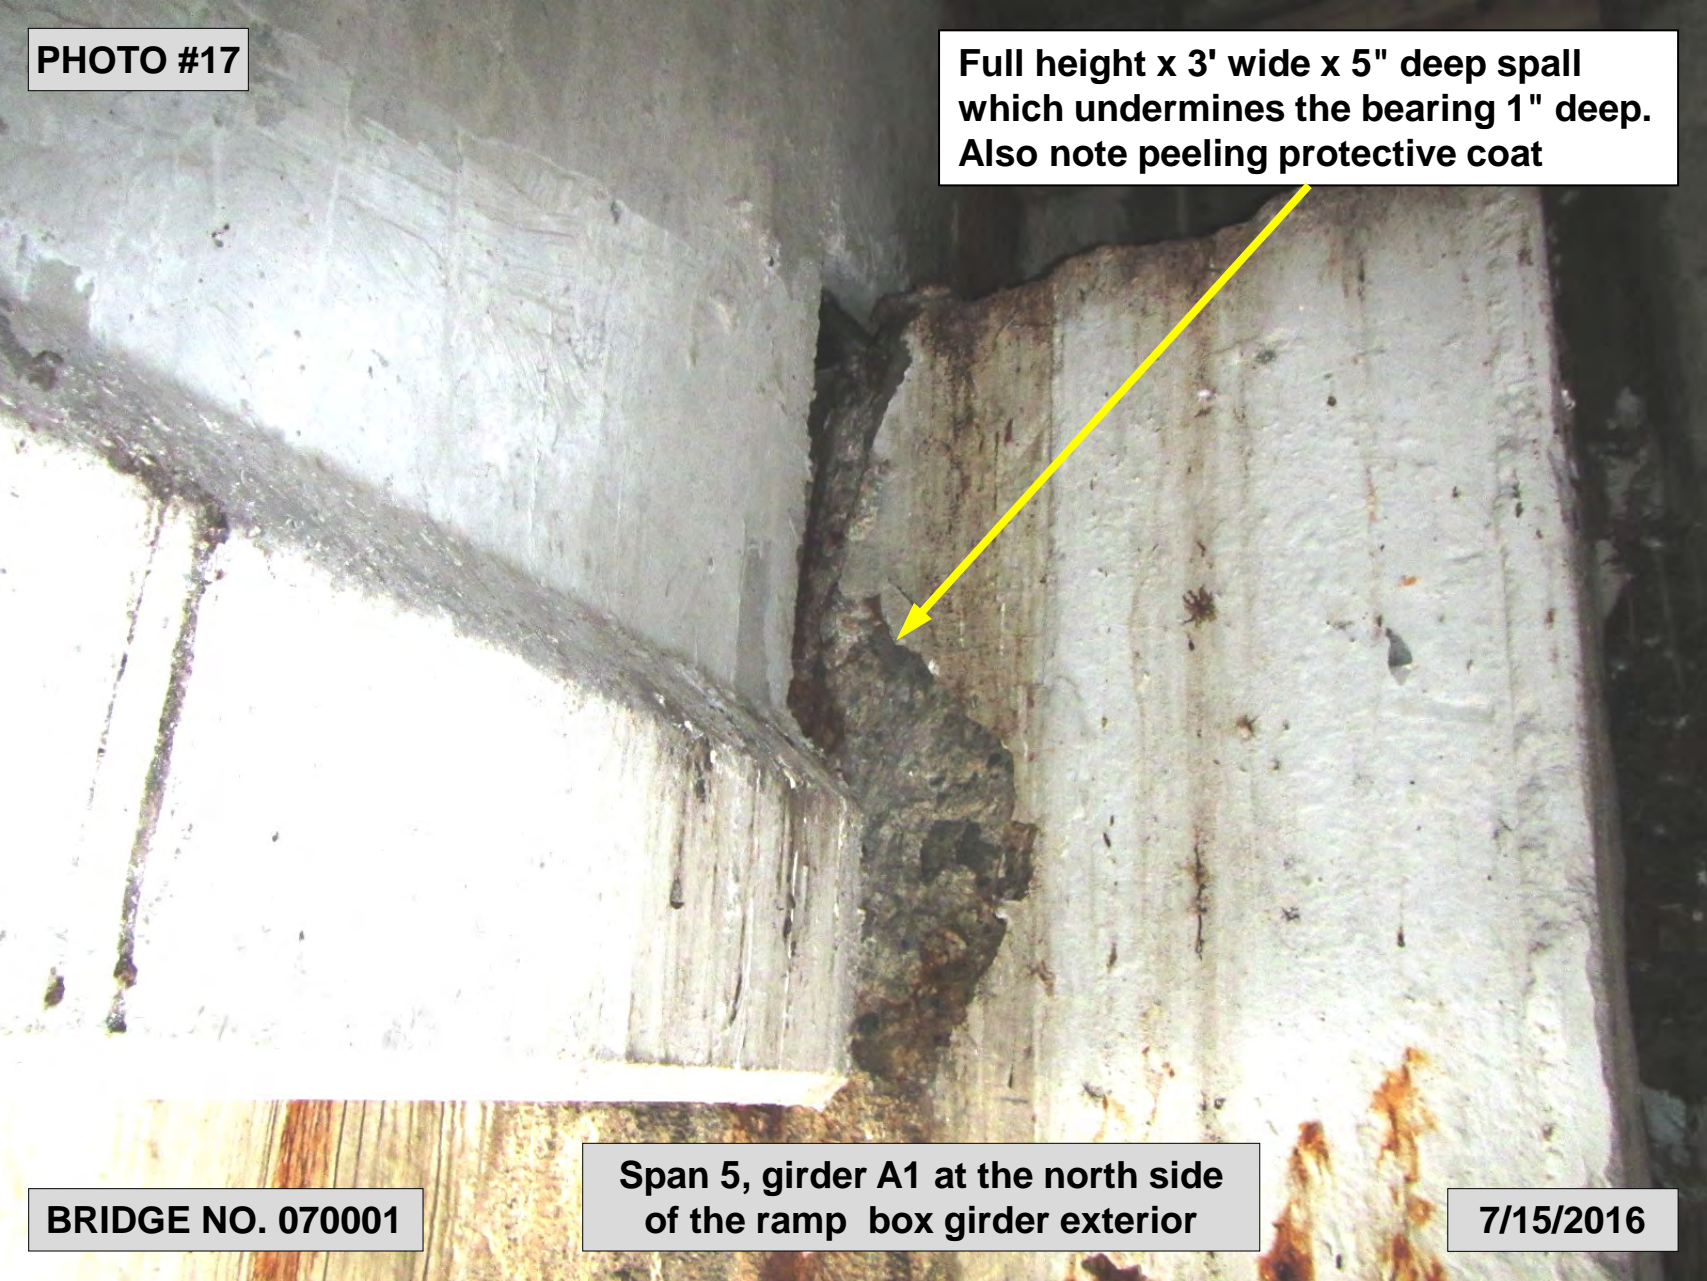
PHOTO #17

Full height x 3' wide x 5" deep spall which undermines the bearing 1" deep. Also note peeling protective coat

**Span 5, girder A1 at the north side
of the ramp box girder exterior**

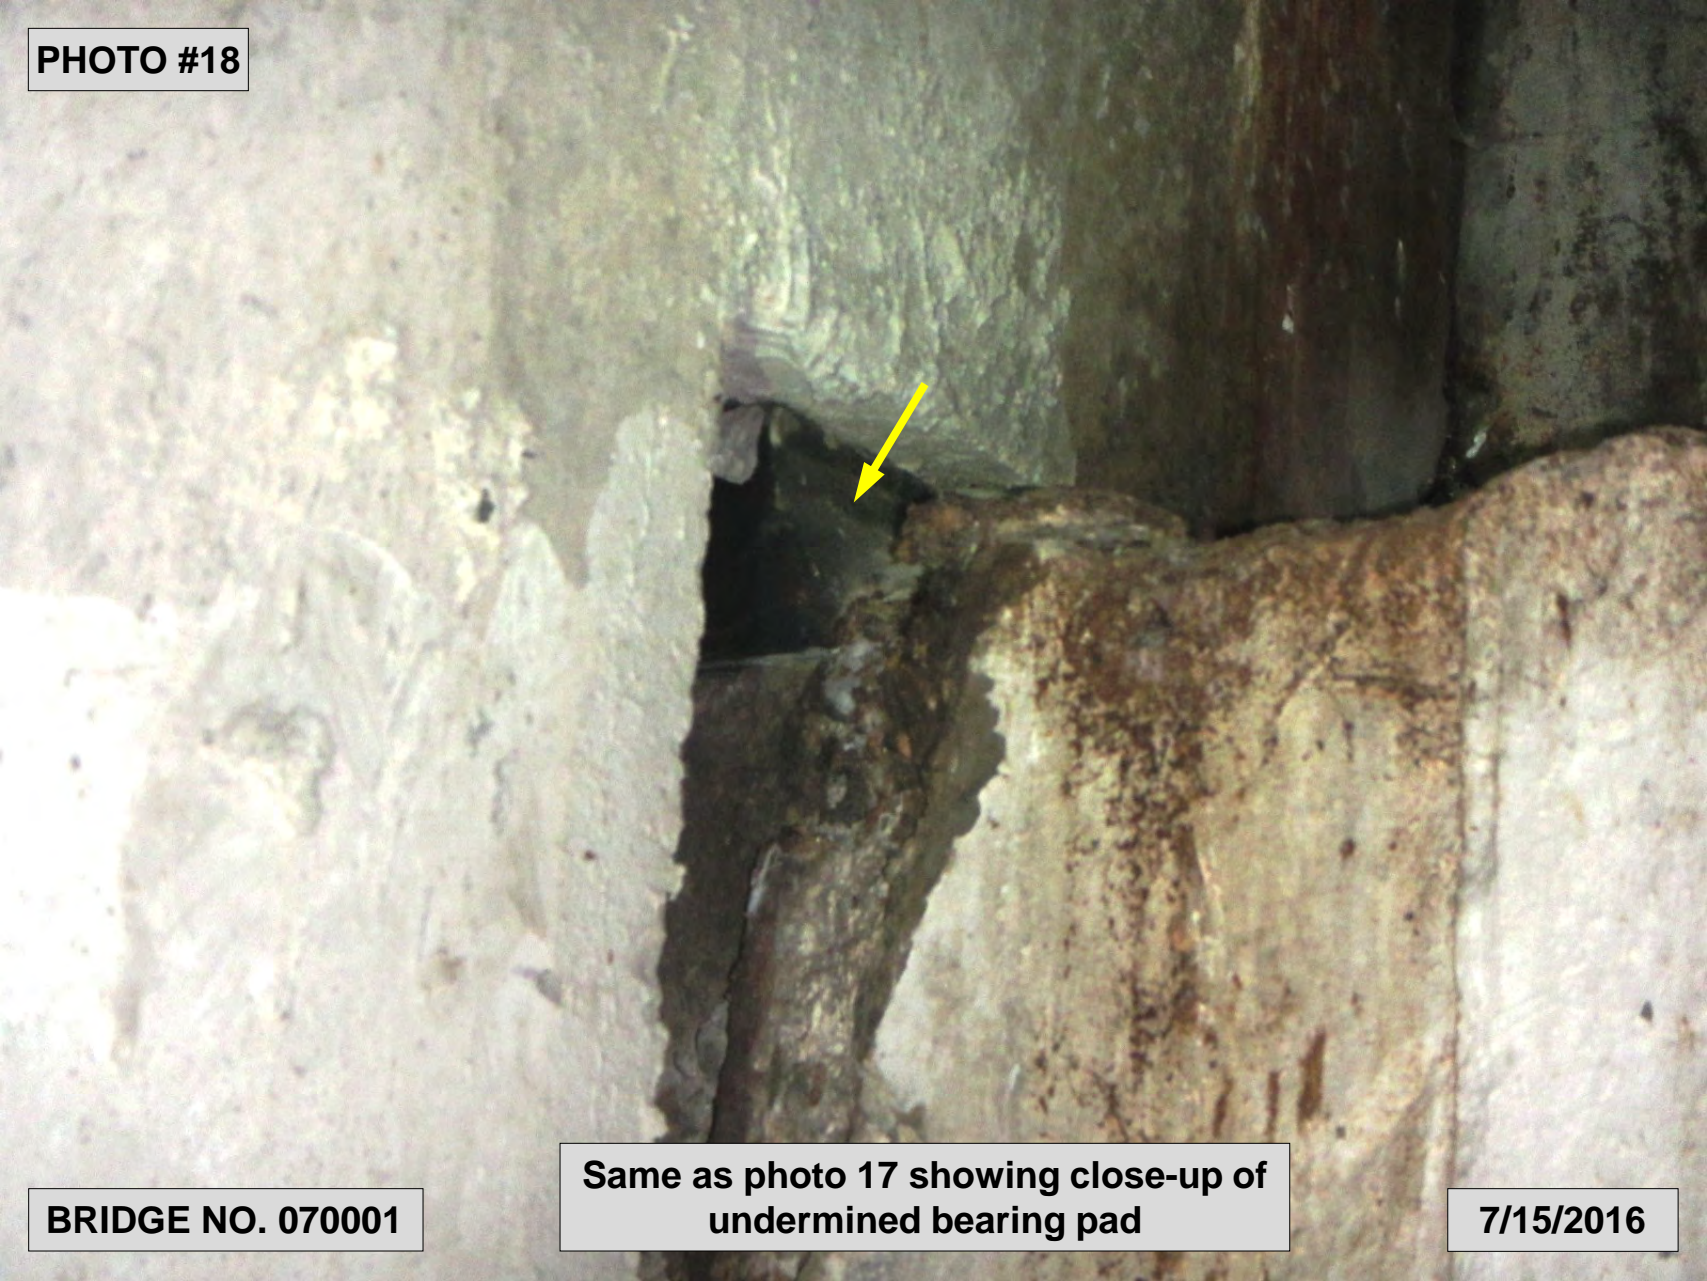
PHOTO #18

**Same as photo 17 showing close-up of
undermined bearing pad**

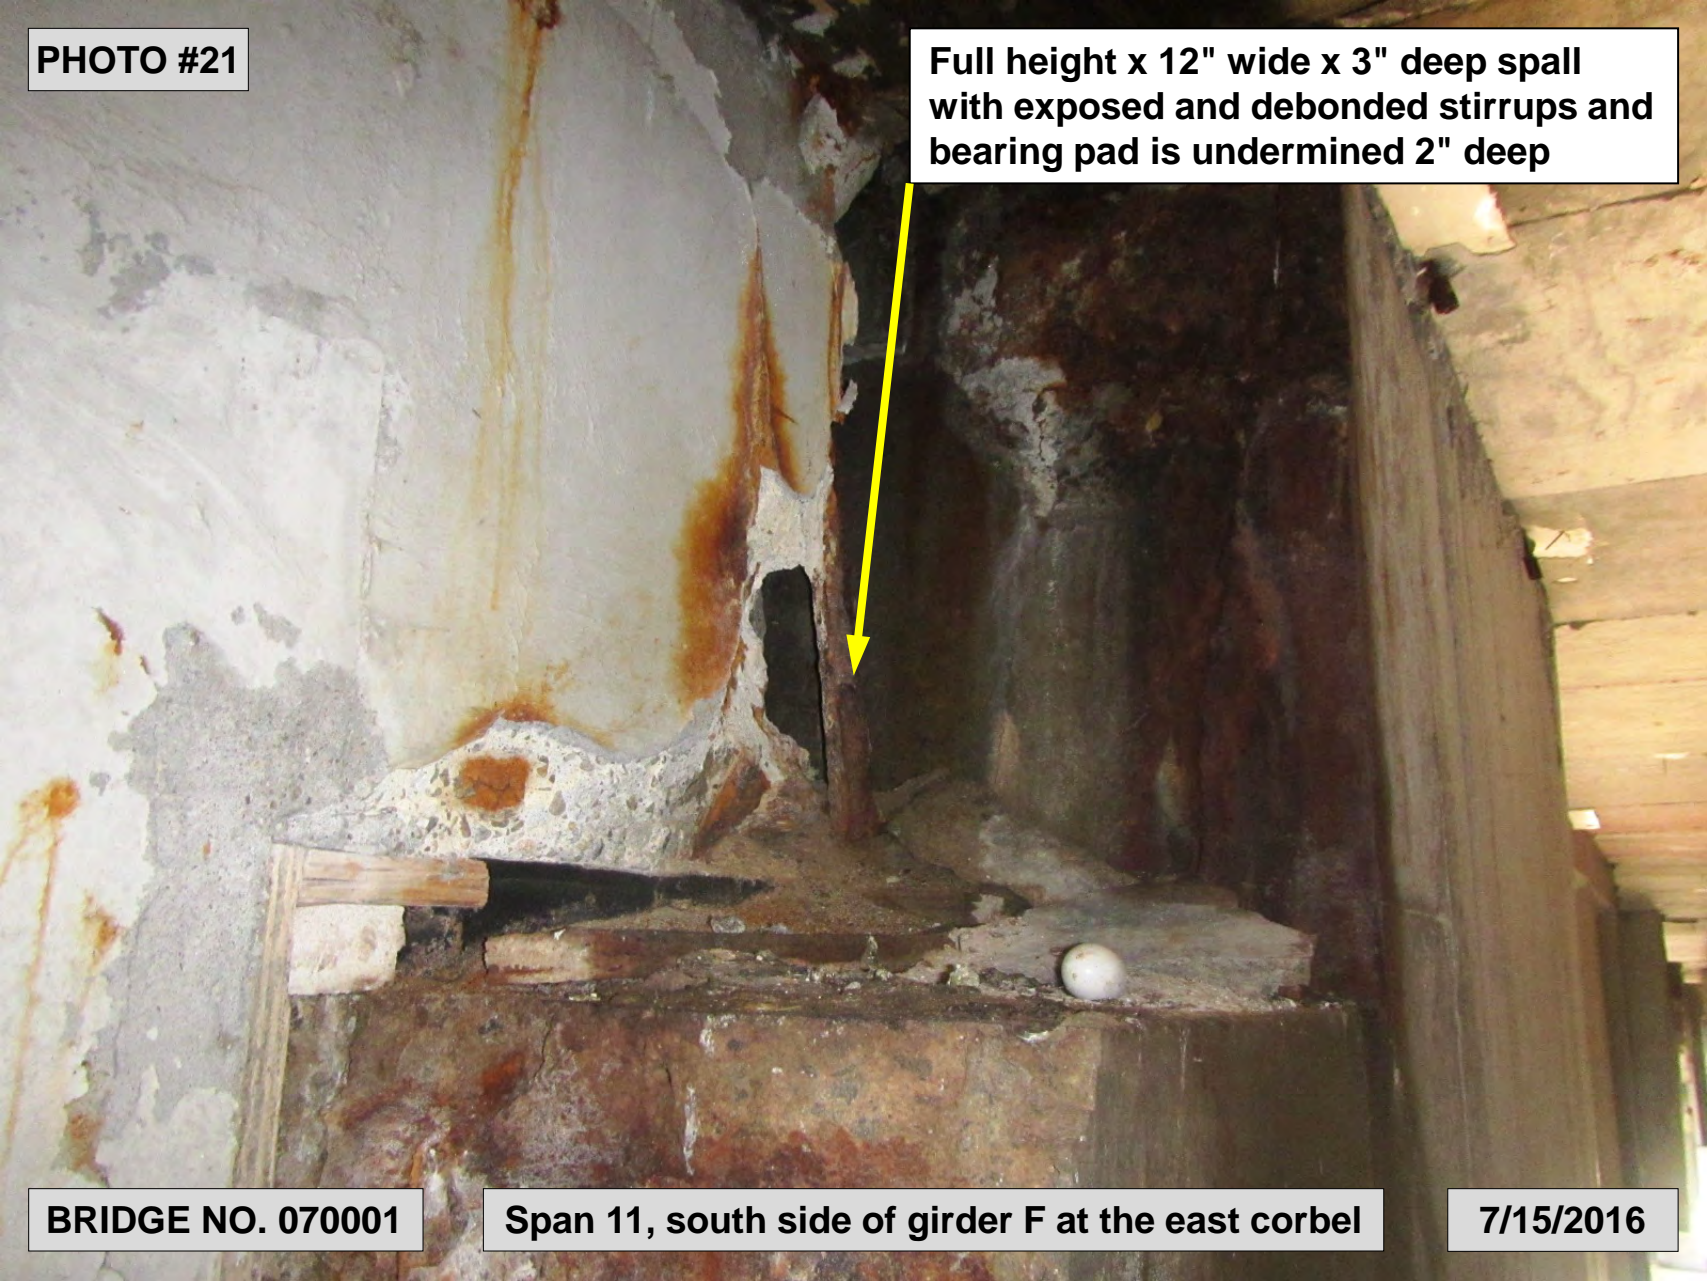
PHOTO #21

Full height x 12" wide x 3" deep spall with exposed and debonded stirrups and bearing pad is undermined 2" deep

Span 11, south side of girder F at the east corbel

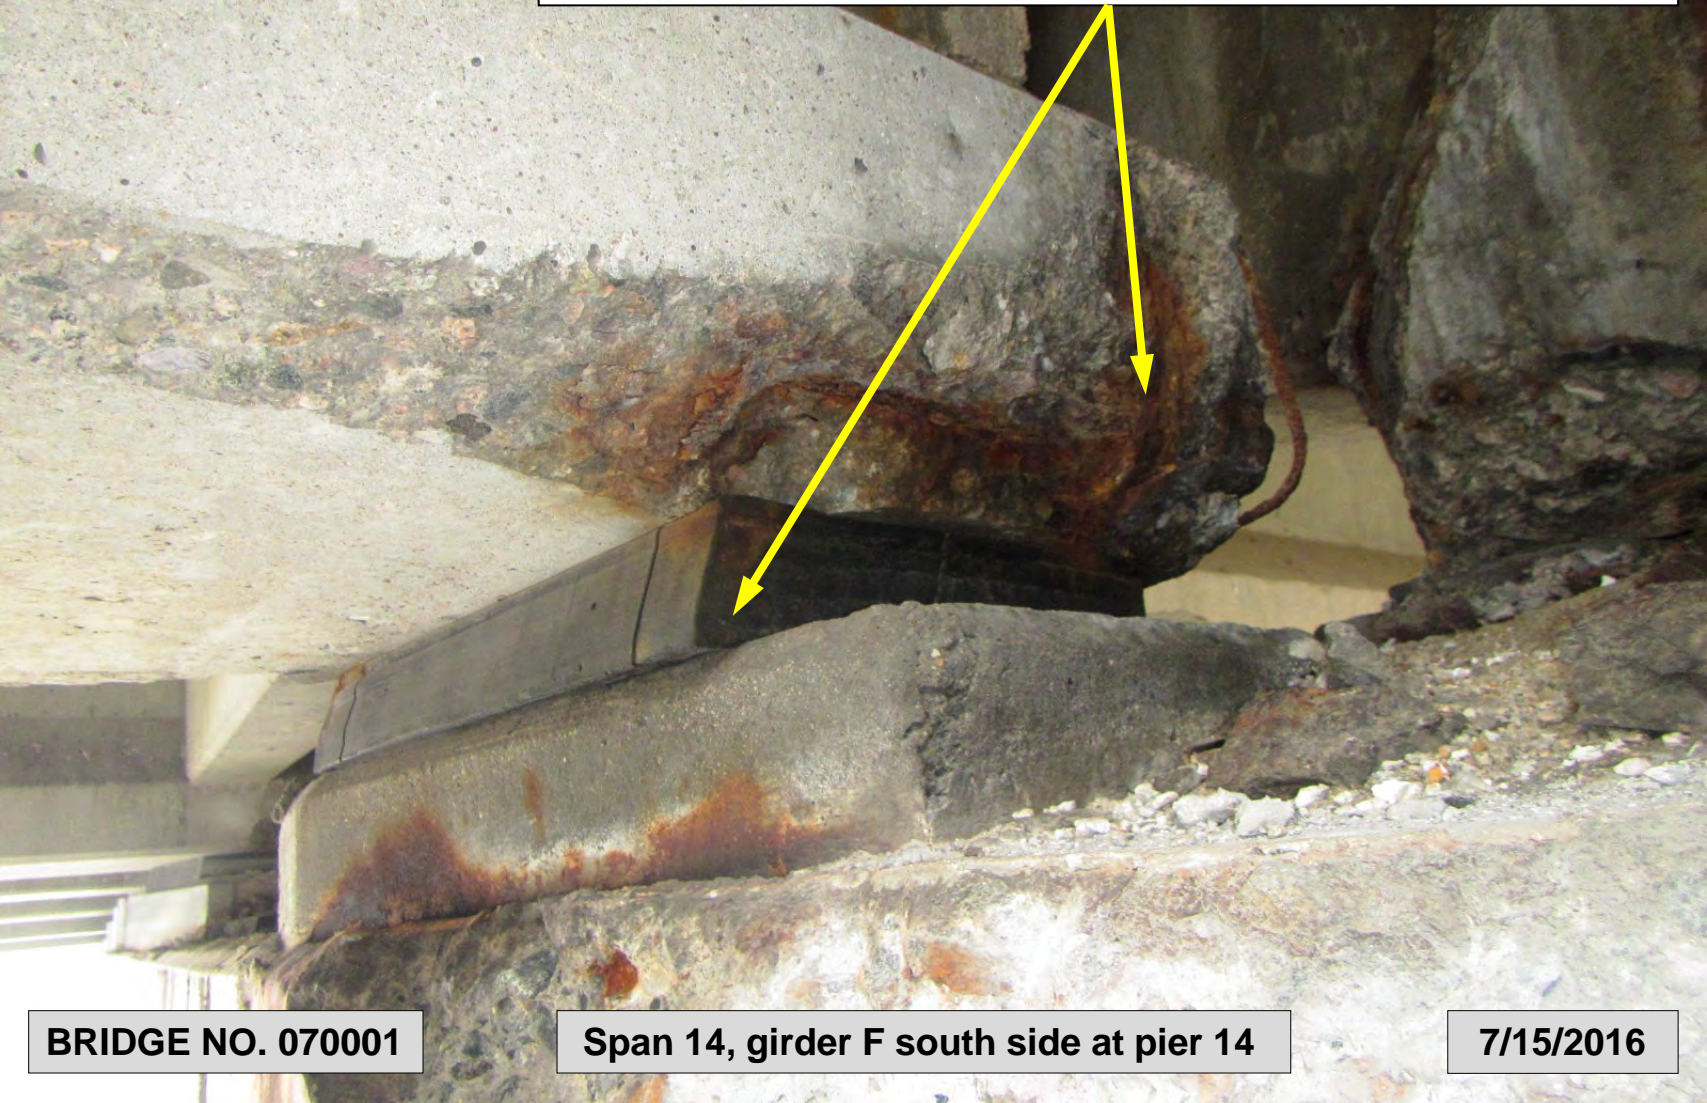
PHOTO #23

(2) Spalls up to 33" long x 10" high x 2.5" deep with exposed stirrups and bearing pad is undermined 1" deep. Also note the bearing pad has slid forward less than 1"

Span 14, girder F south side at pier 14

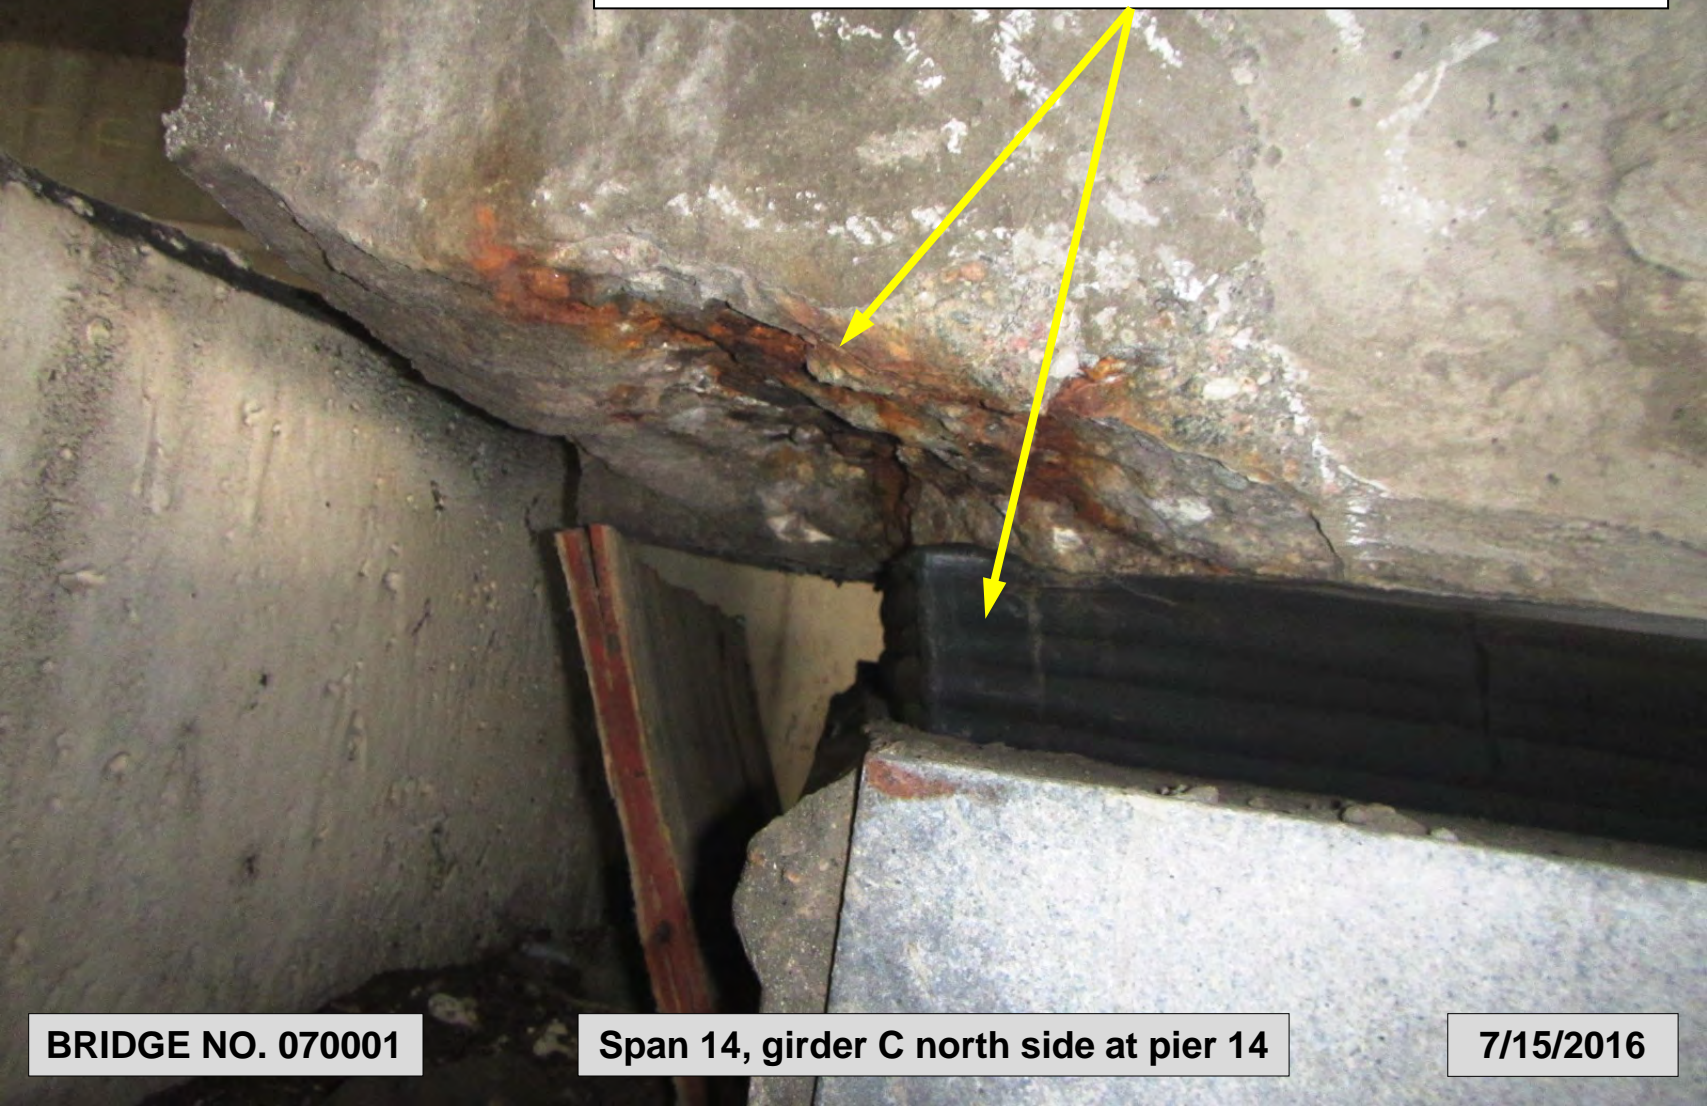
PHOTO #24

1' long x 2" high x 2" deep spall with exposed rebar which extends to the girder underside and undermines the bearing pad x 1.5" deep. Also note 1/2" bearing pad tilt

Span 14, girder C north side at pier 14

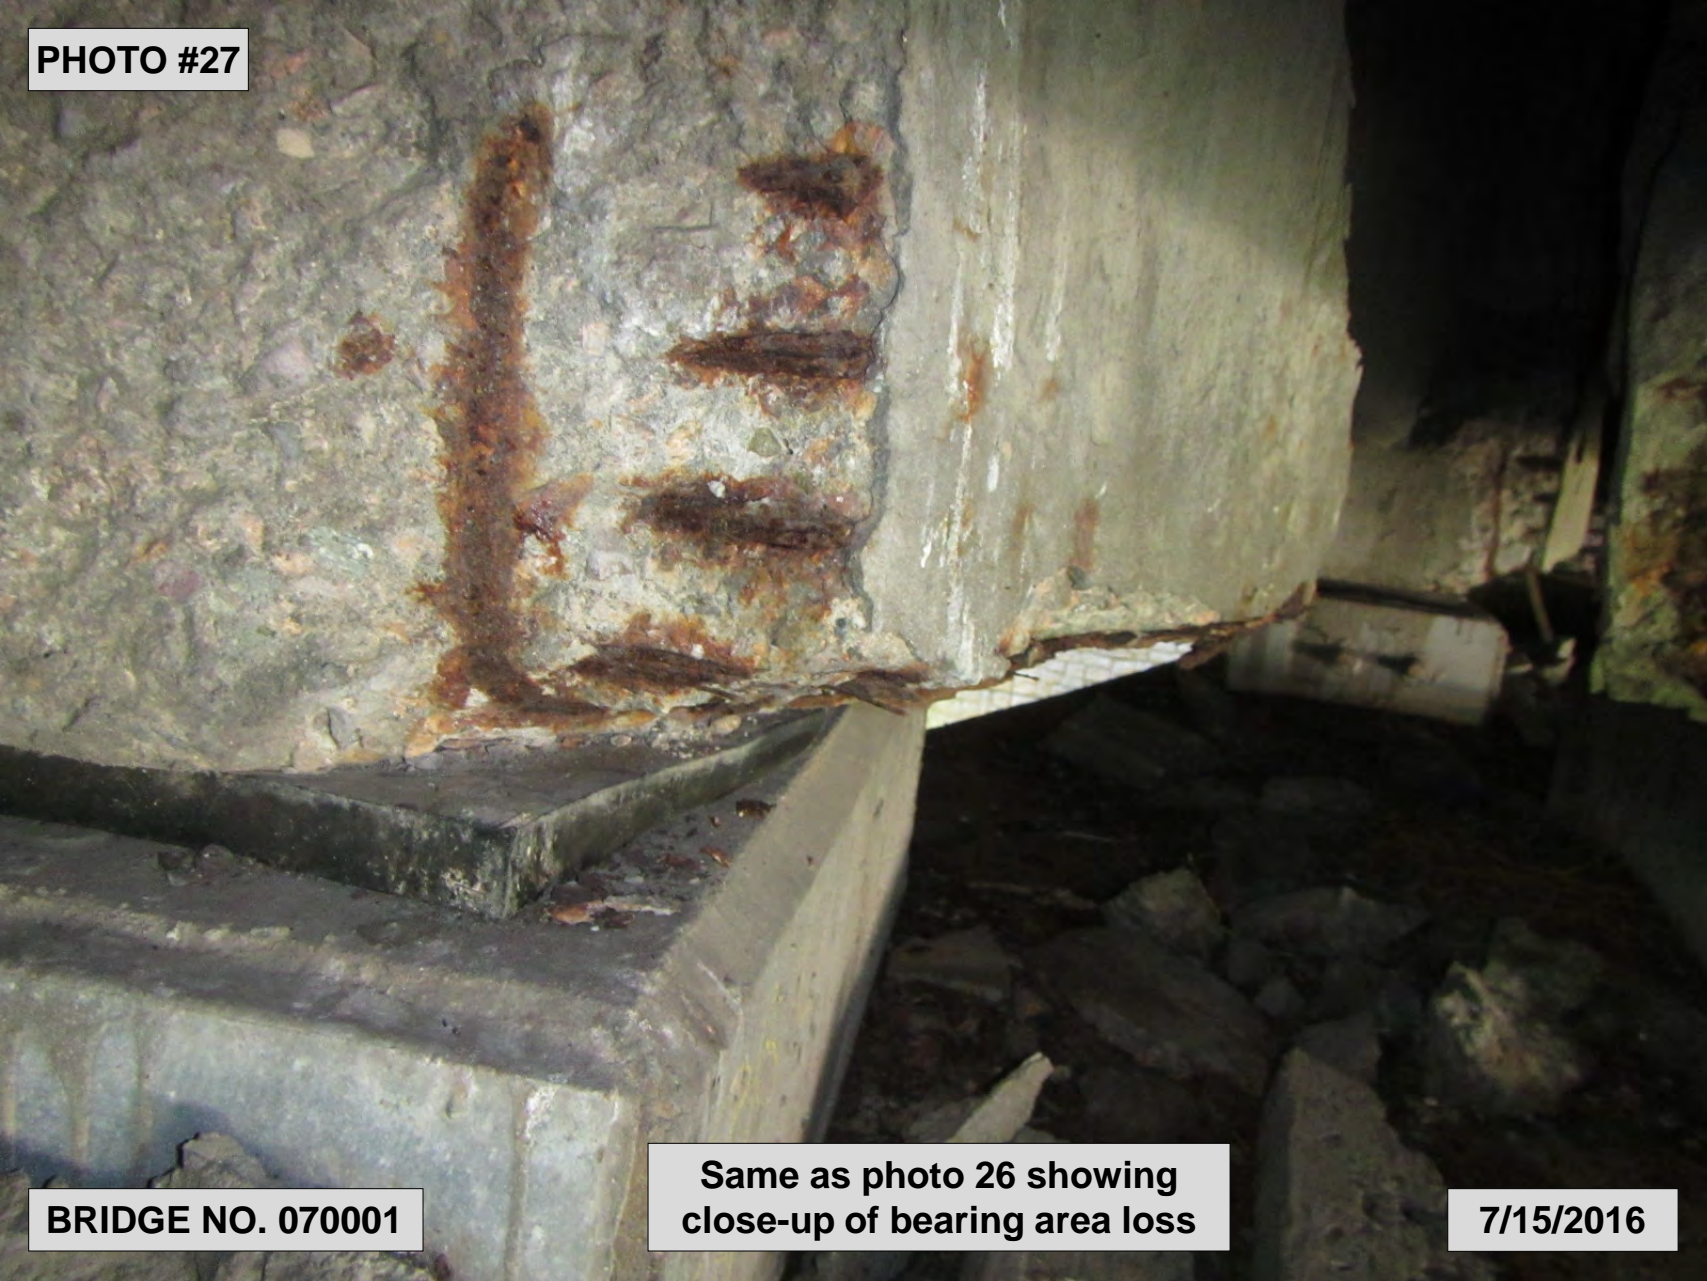
PHOTO #27

**Same as photo 26 showing
close-up of bearing area loss**
