BRIDGE NO. 070001

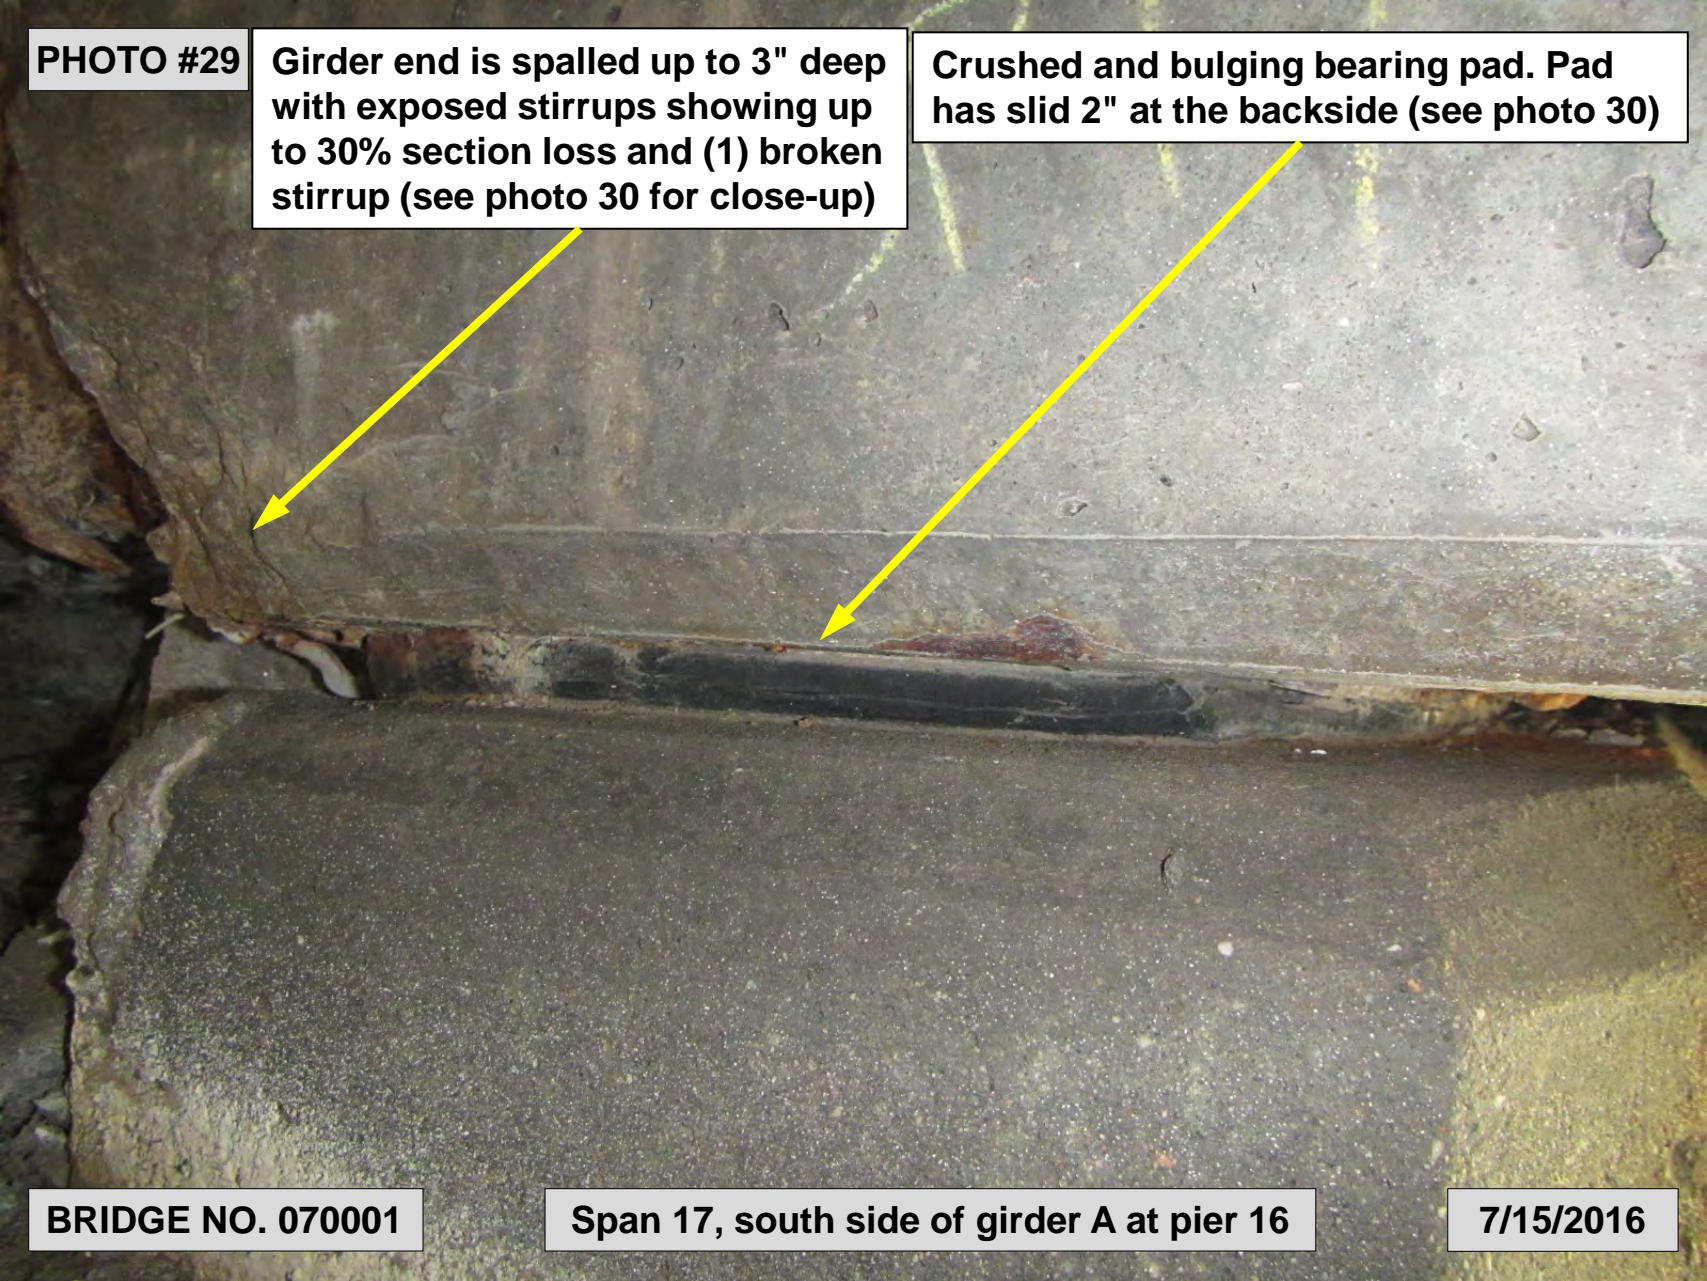
PHOTO #29

Girder end is spalled up to 3" deep with exposed stirrups showing up to 30% section loss and (1) broken stirrup (see photo 30 for close-up)

Crushed and bulging bearing pad. Pad has slid 2" at the backside (see photo 30)

Span 17, south side of girder A at pier 16

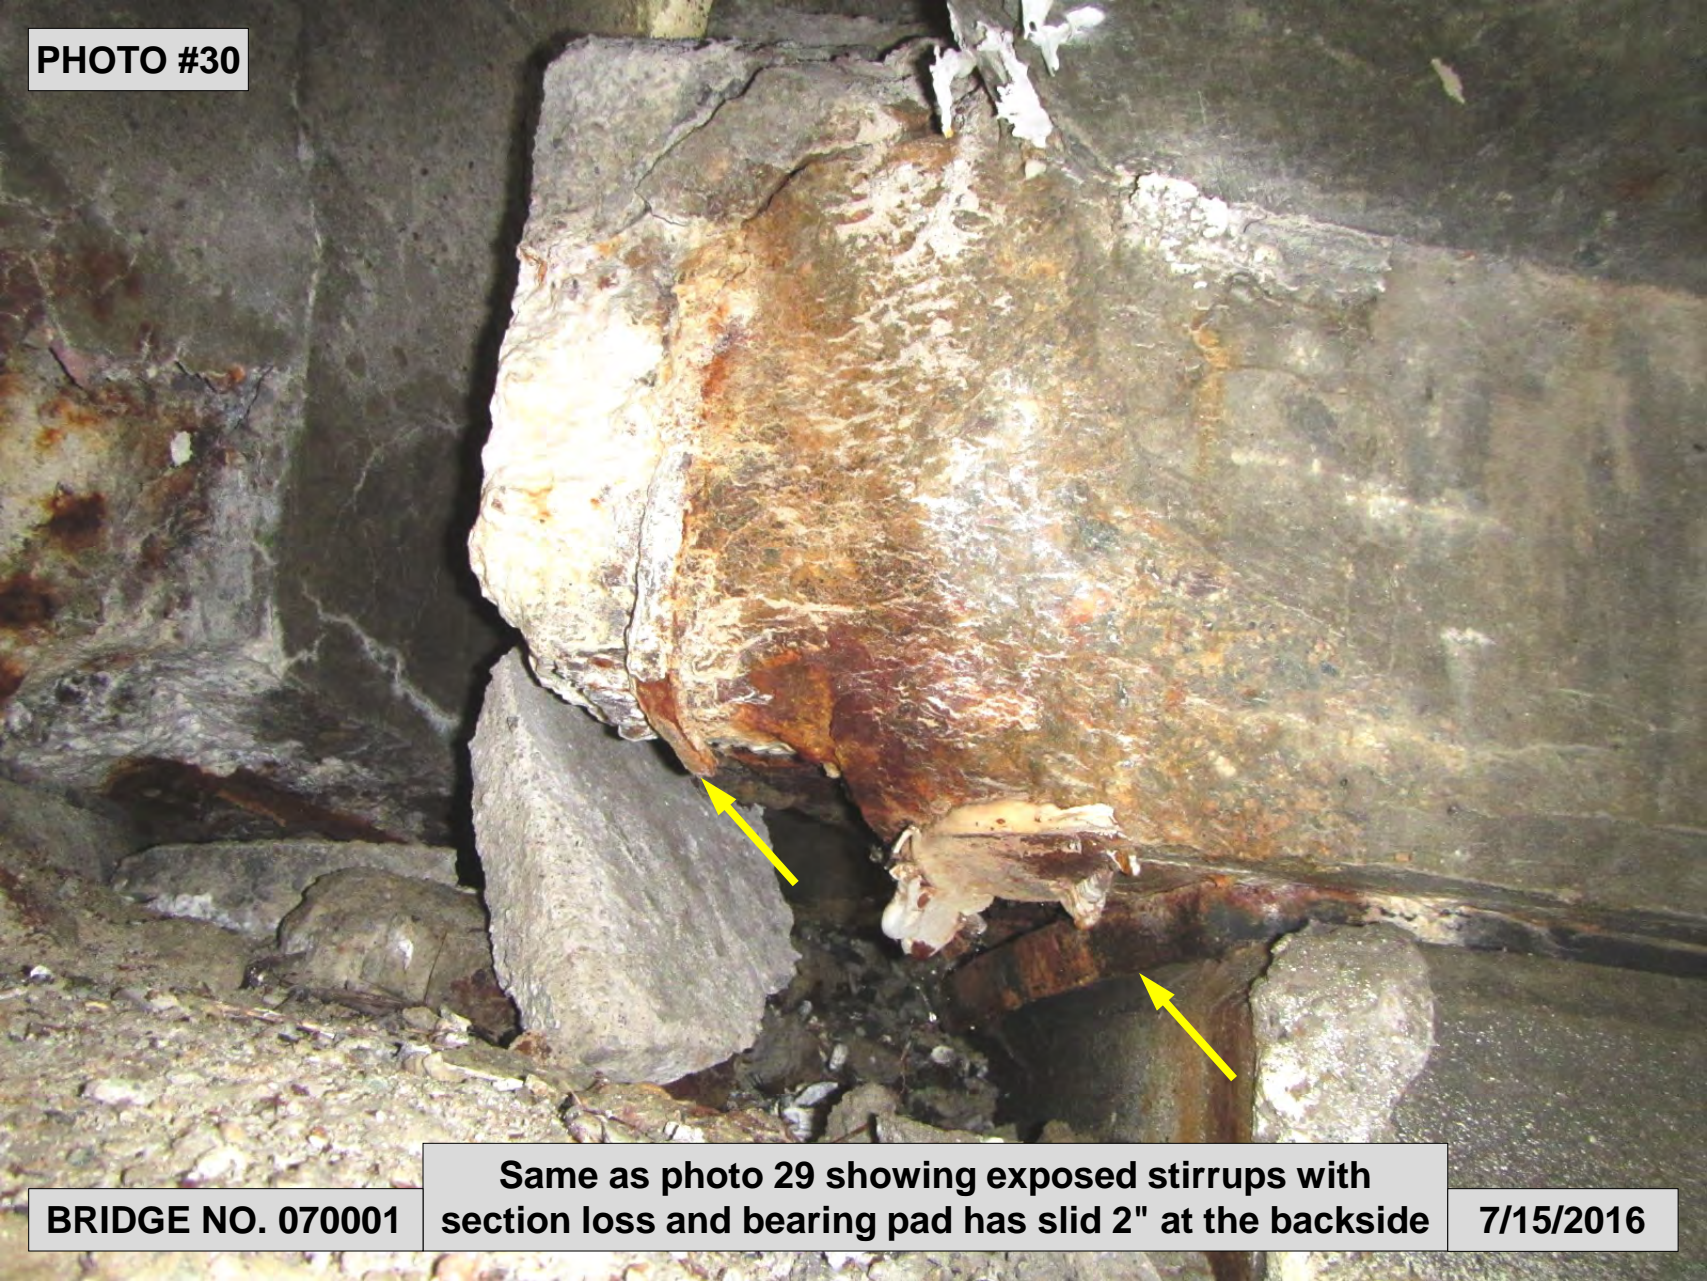
PHOTO #30

Same as photo 29 showing exposed stirrups with section loss and bearing pad has slid 2" at the backside

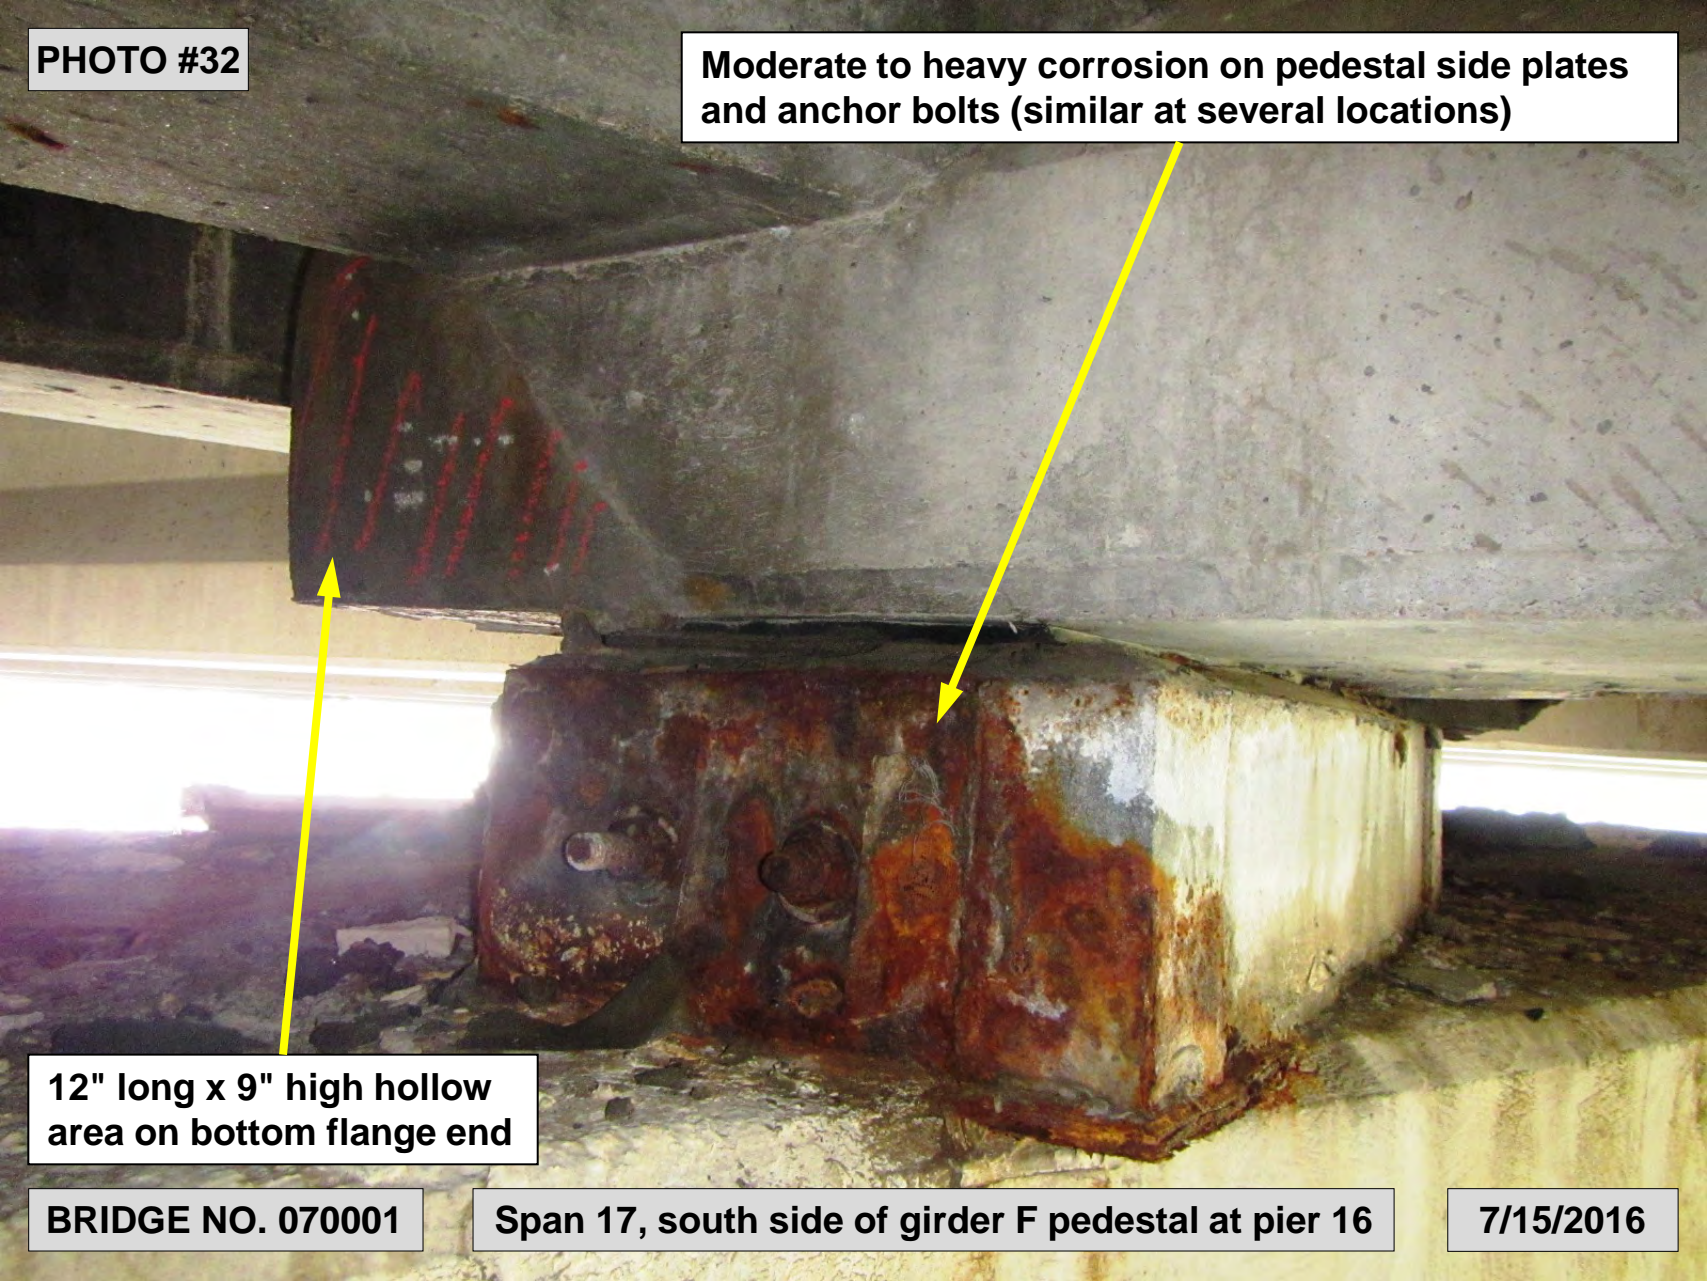
PHOTO #32

Moderate to heavy corrosion on pedestal side plates and anchor bolts (similar at several locations)

12" long x 9" high hollow area on bottom flange end

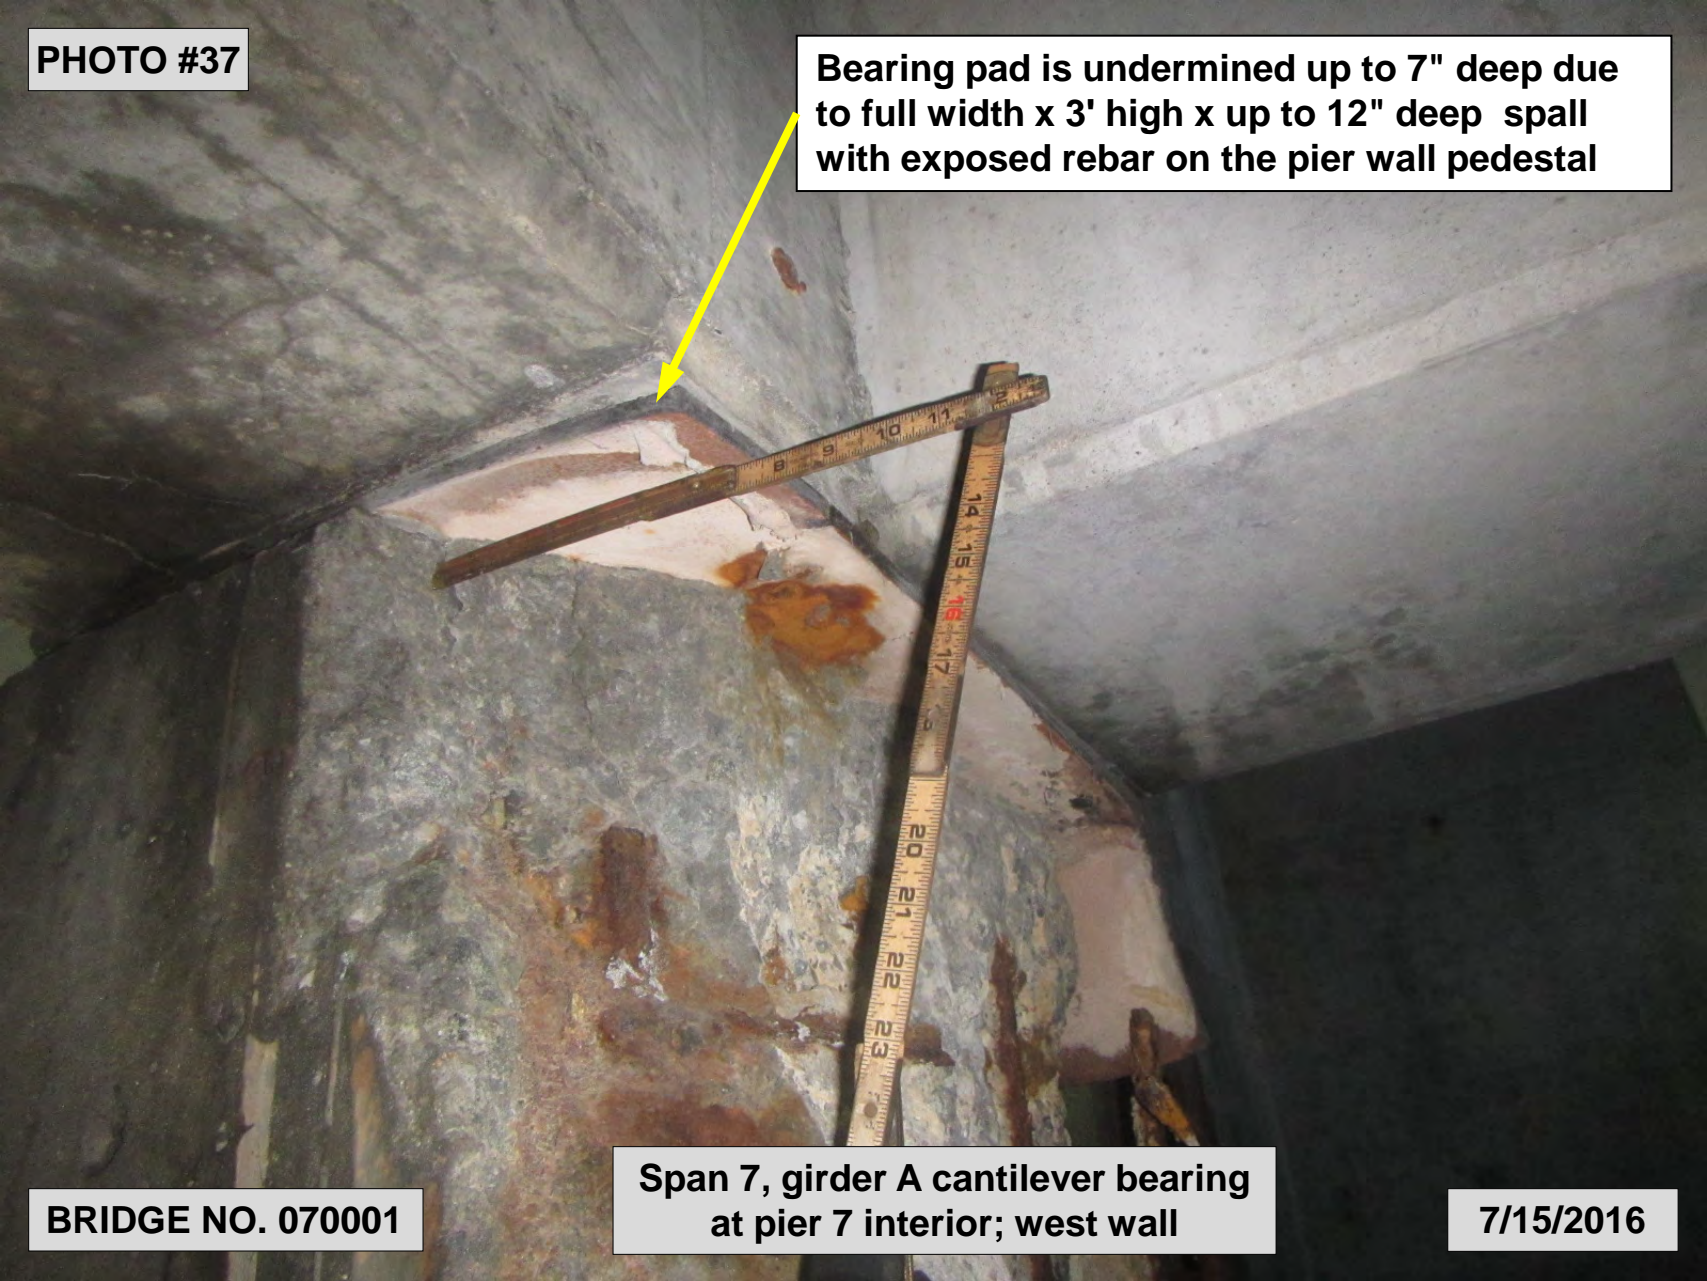
PHOTO #37

Bearing pad is undermined up to 7" deep due to full width x 3' high x up to 12" deep spall with exposed rebar on the pier wall pedestal

**Span 7, girder A cantilever bearing
at pier 7 interior; west wall**

Full width of all faces x 3' high x up to 12" deep spall with fully exposed and debonded bars and up to 10% section loss on exposed rebars. See photo 37 for undermining of cantilever bearing

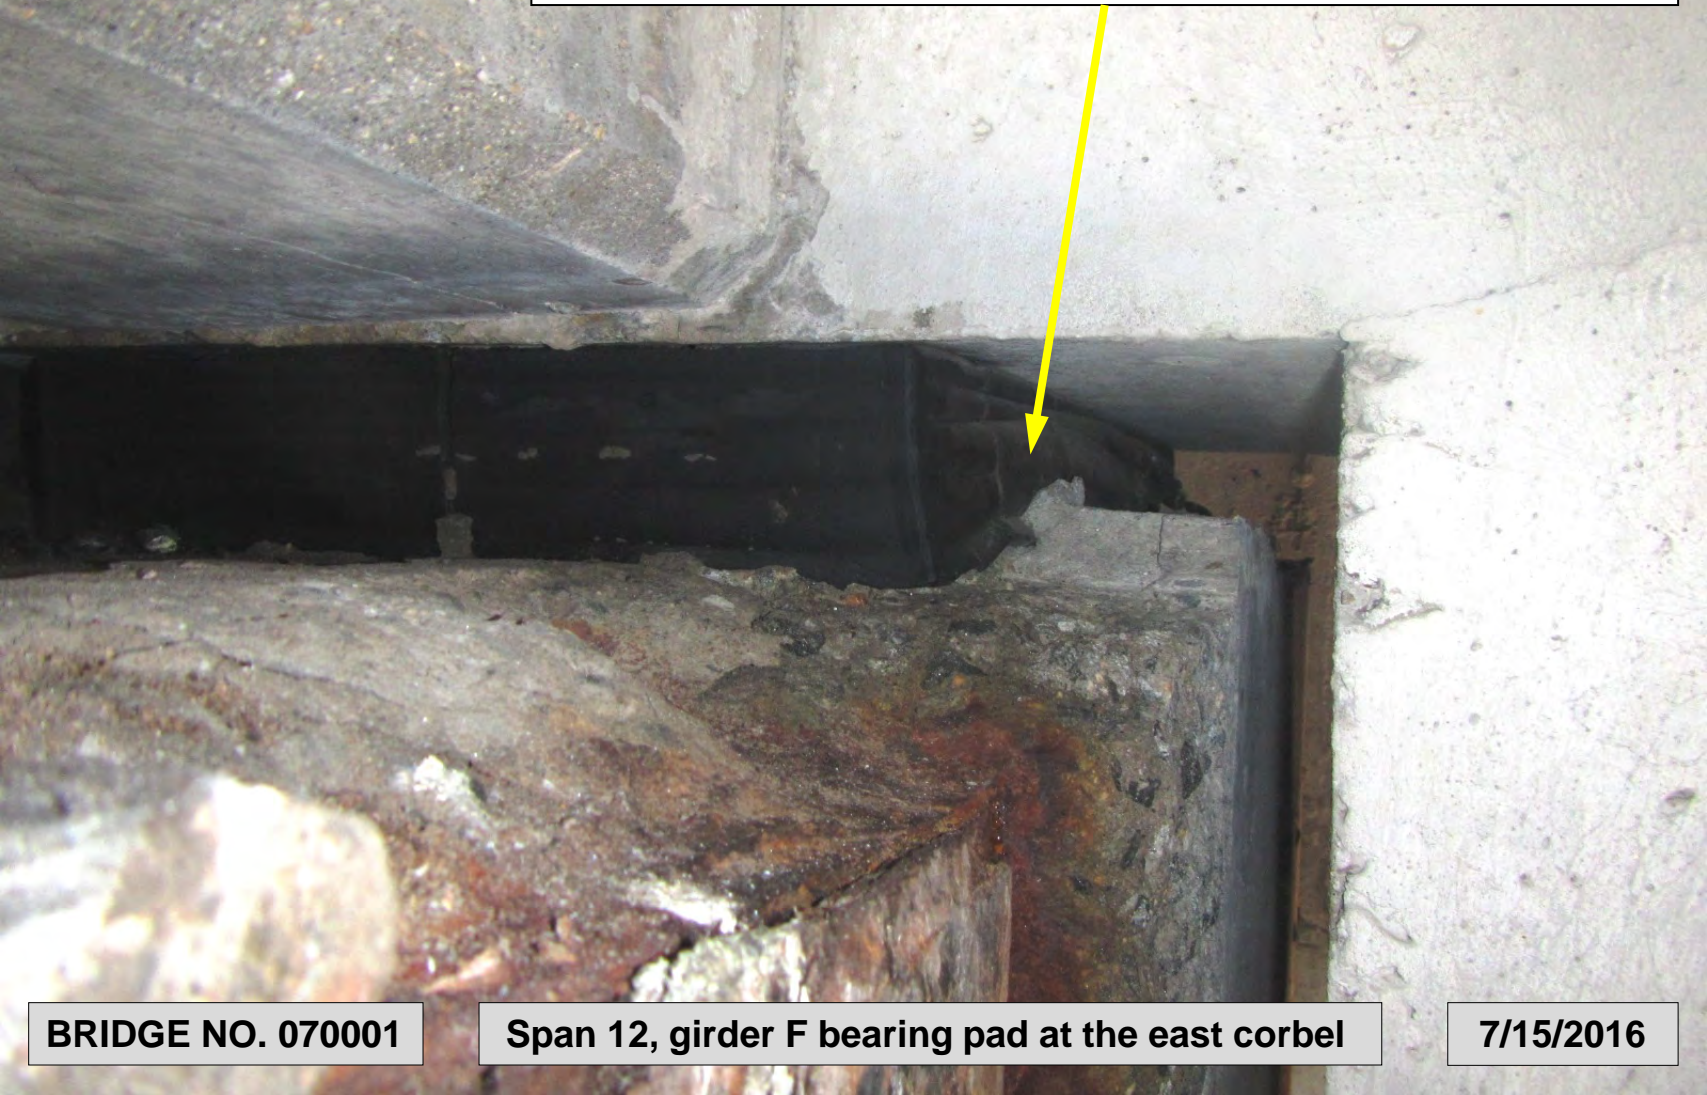
PHOTO #38

Bearing pad is undermined 1" deep due to 1' high x 1' wide x 1.5" deep spall with exposed reinforcing plate on the corbel. Also note moderate to heavy bulging on the bearing pad

Span 12, girder F bearing pad at the east corbel

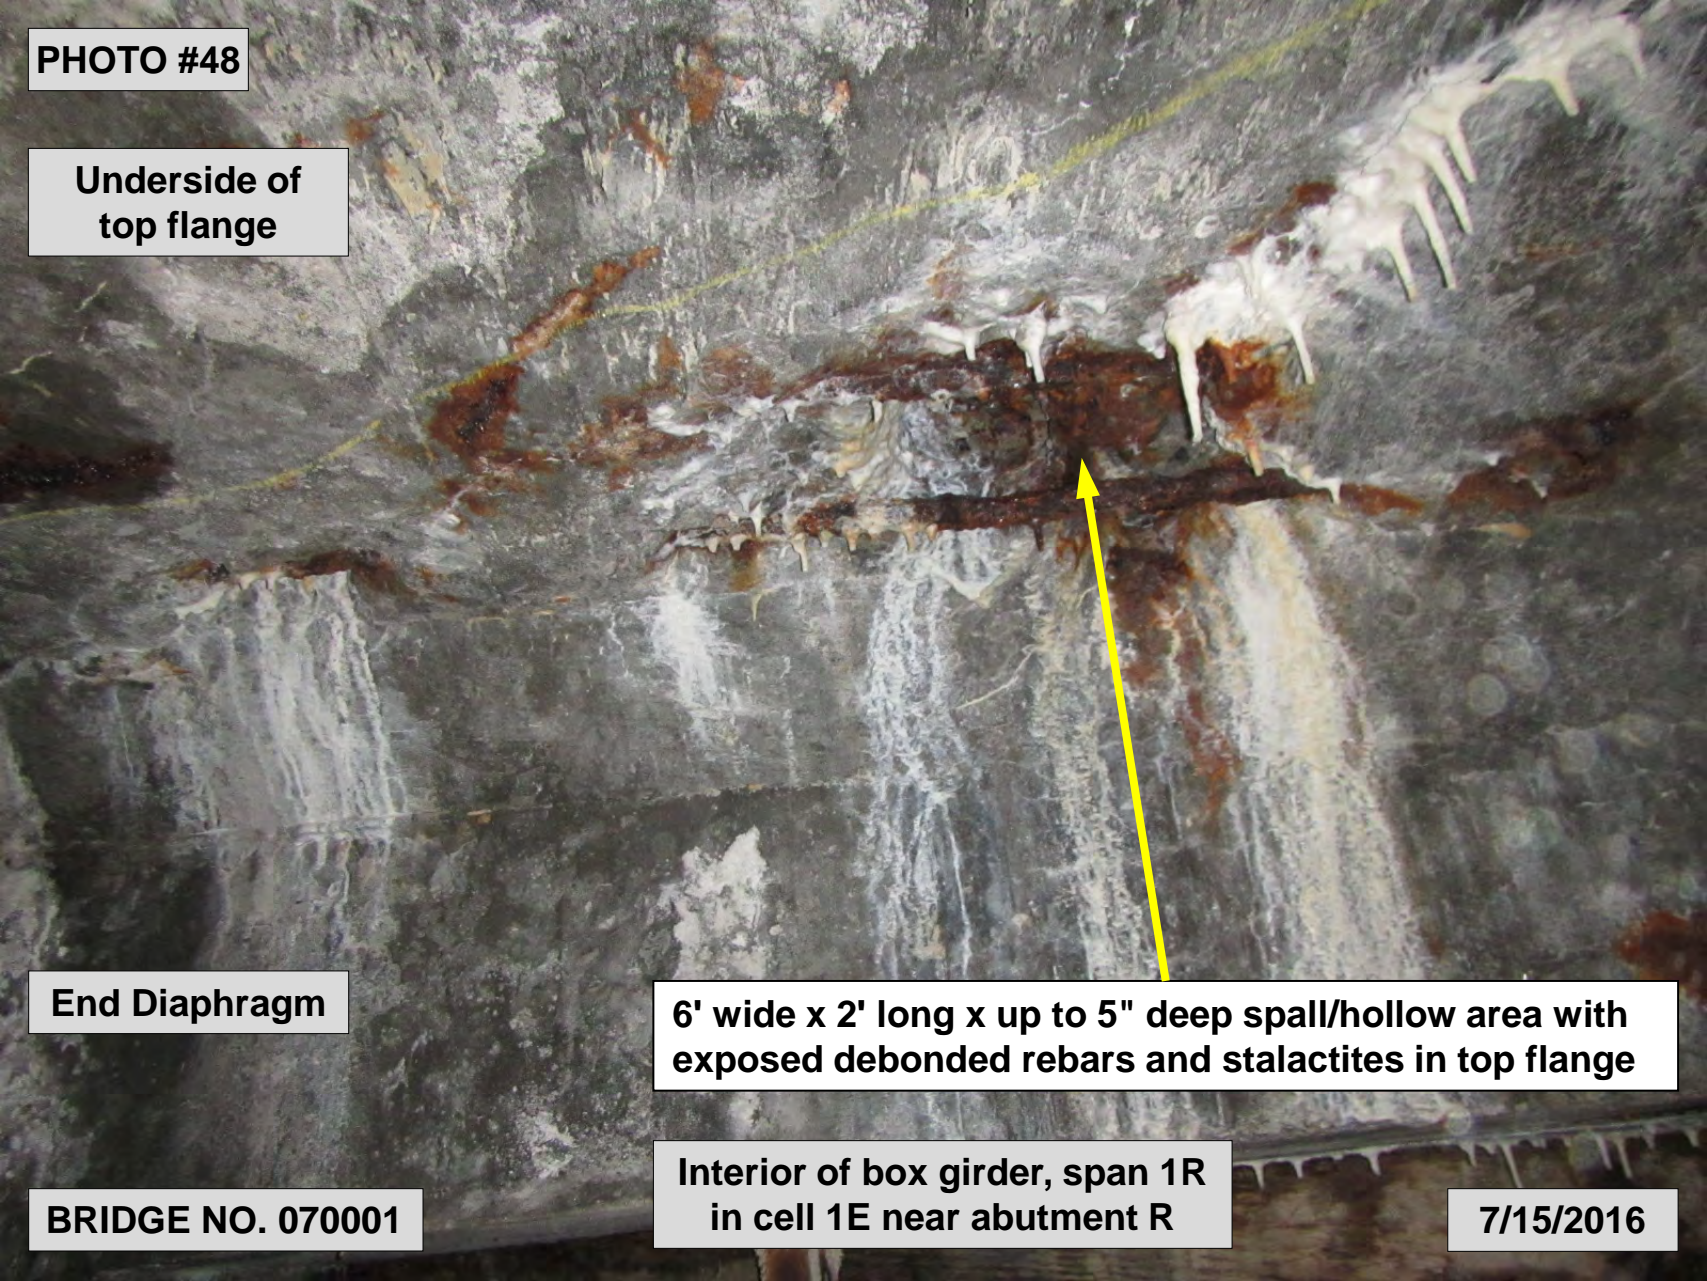
PHOTO #49

38" wide x 28" long x 2" deep spall with exposed and debonded rebar, and (1) full width transverse hairline crack in top flange

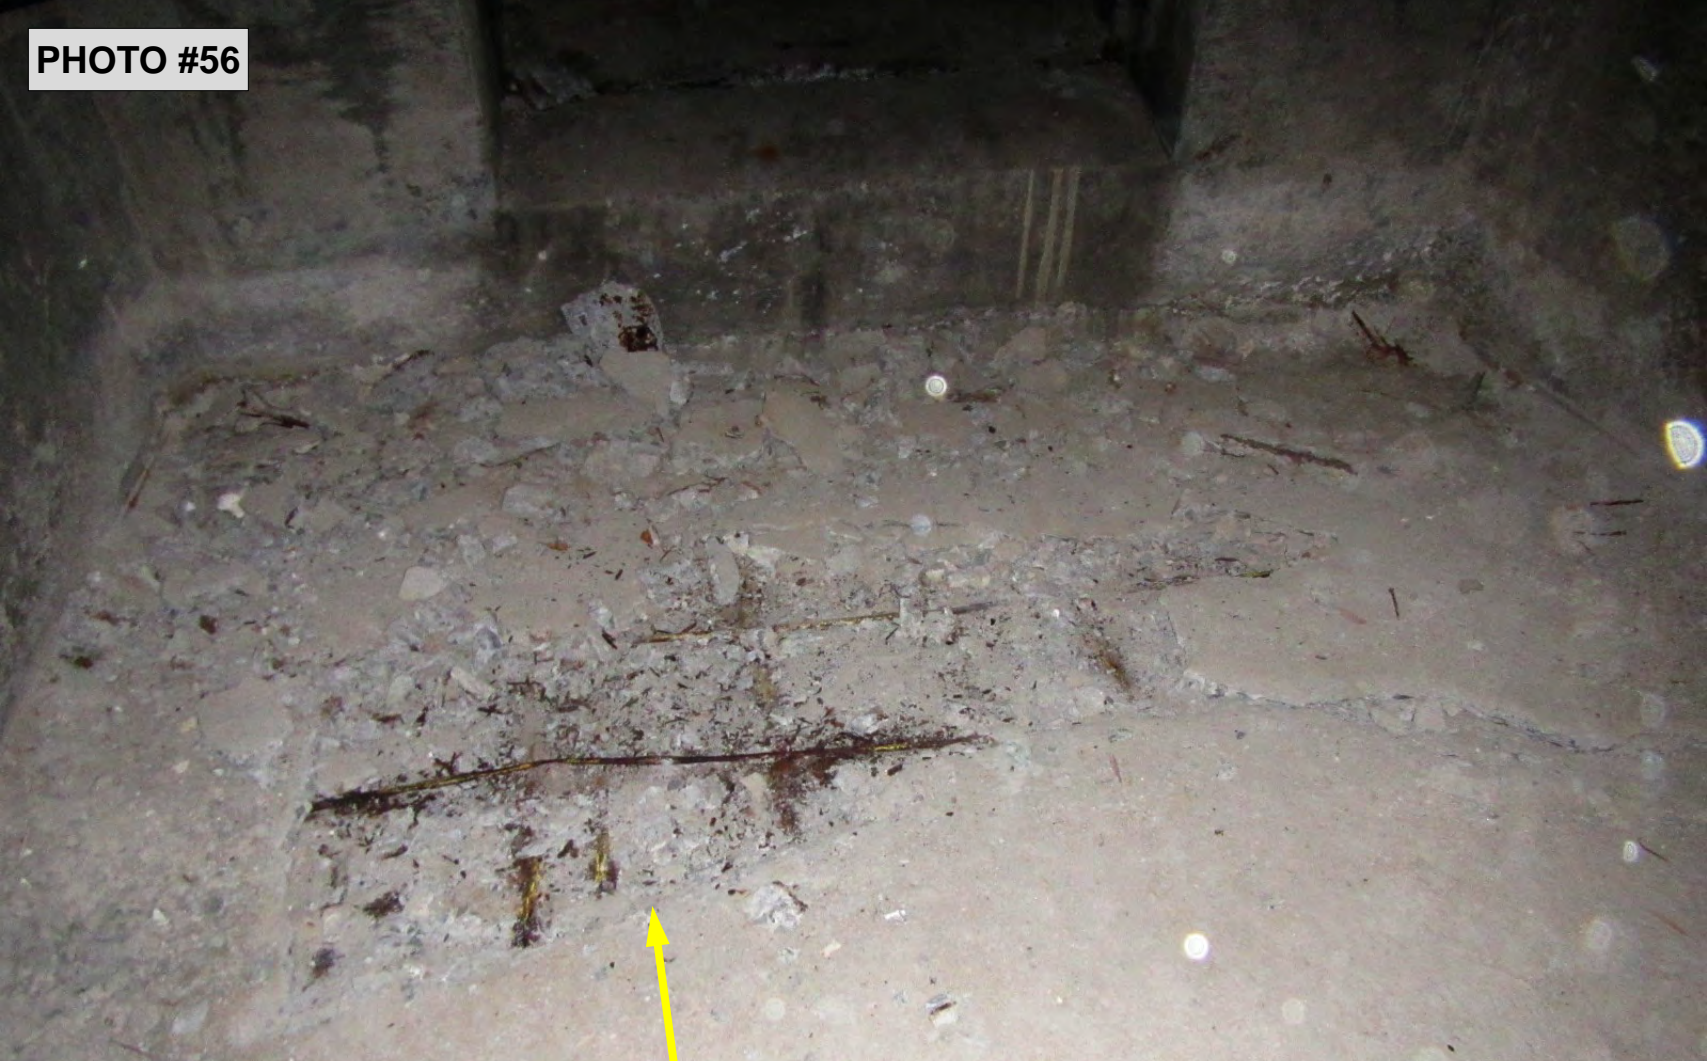
PHOTO #56

Full width x 5' long x 2" deep spall with exposed debonded rebar with up to 90% section loss in bottom flange. See photo 57 for close-up

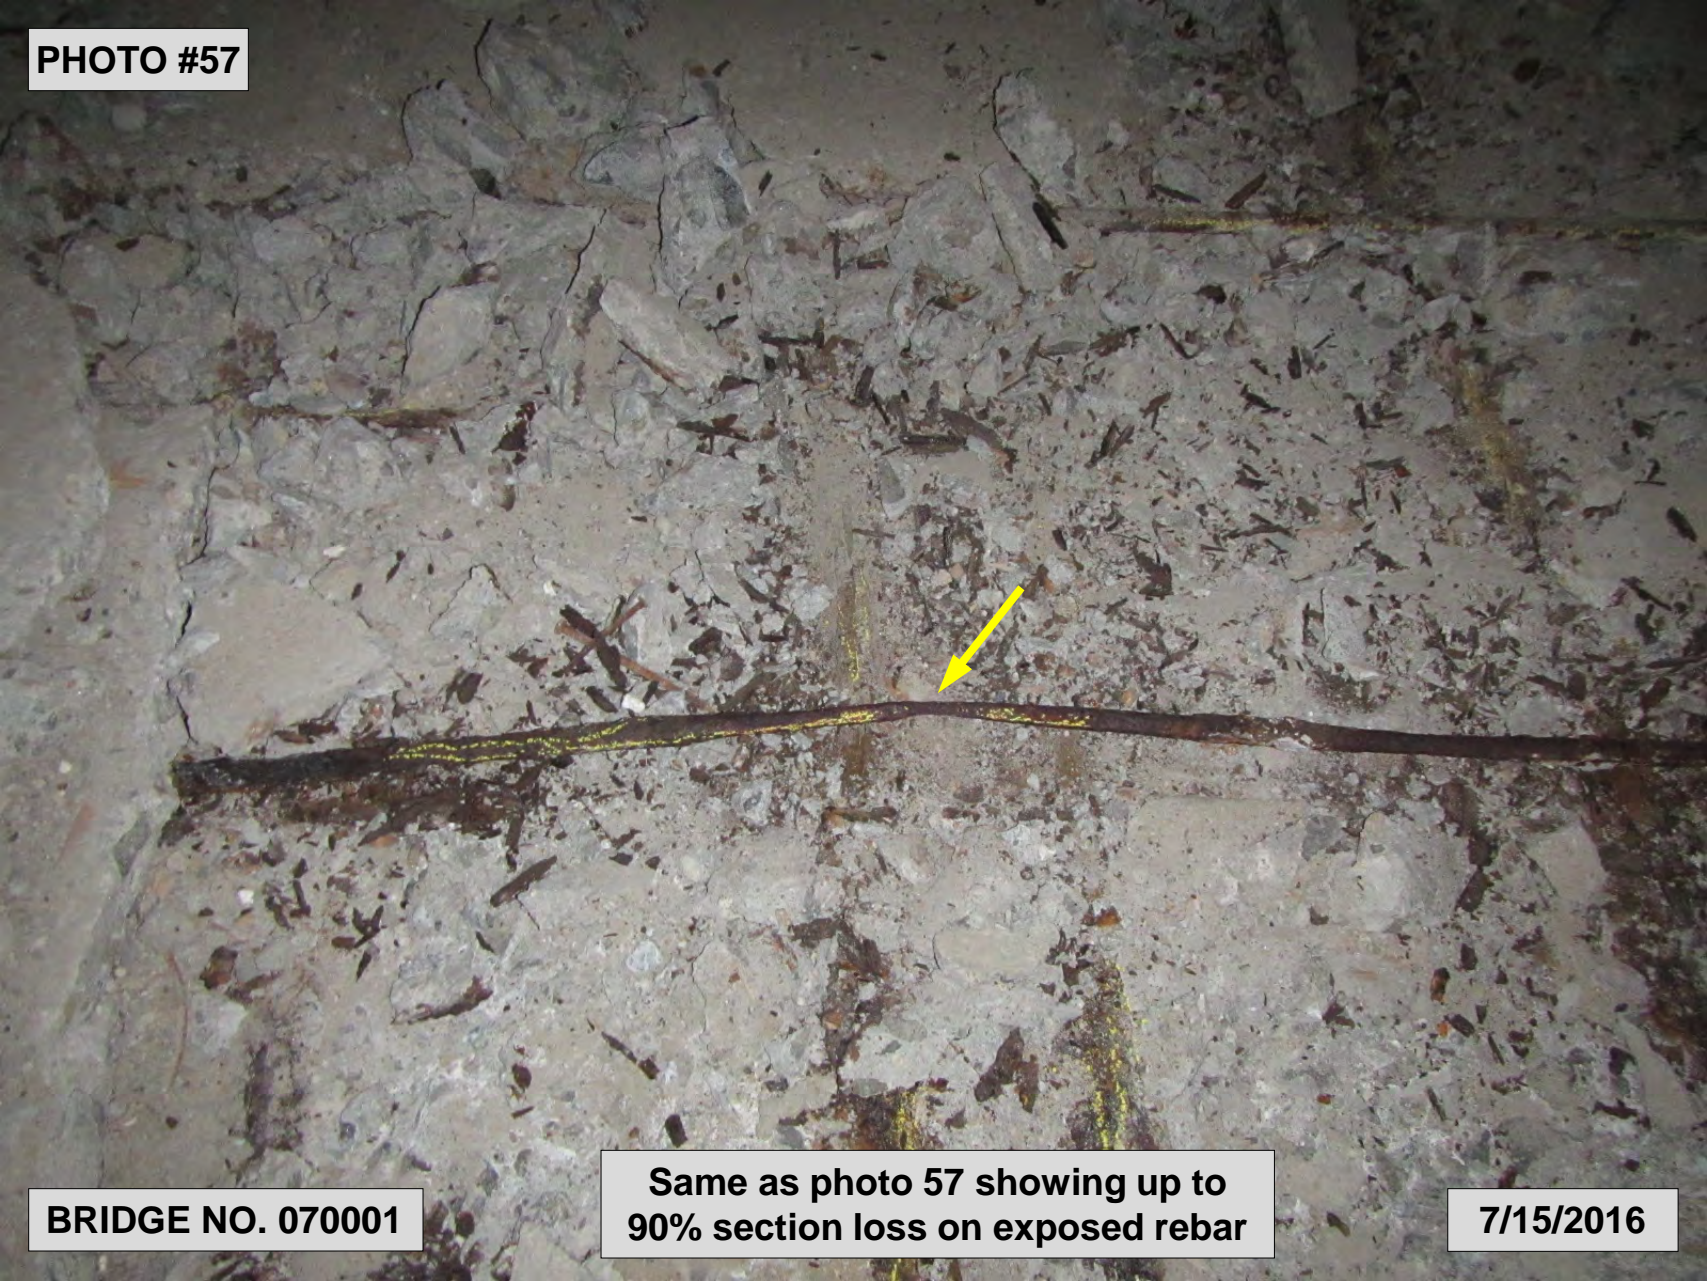
PHOTO #57

**Same as photo 57 showing up to
90% section loss on exposed rebar**

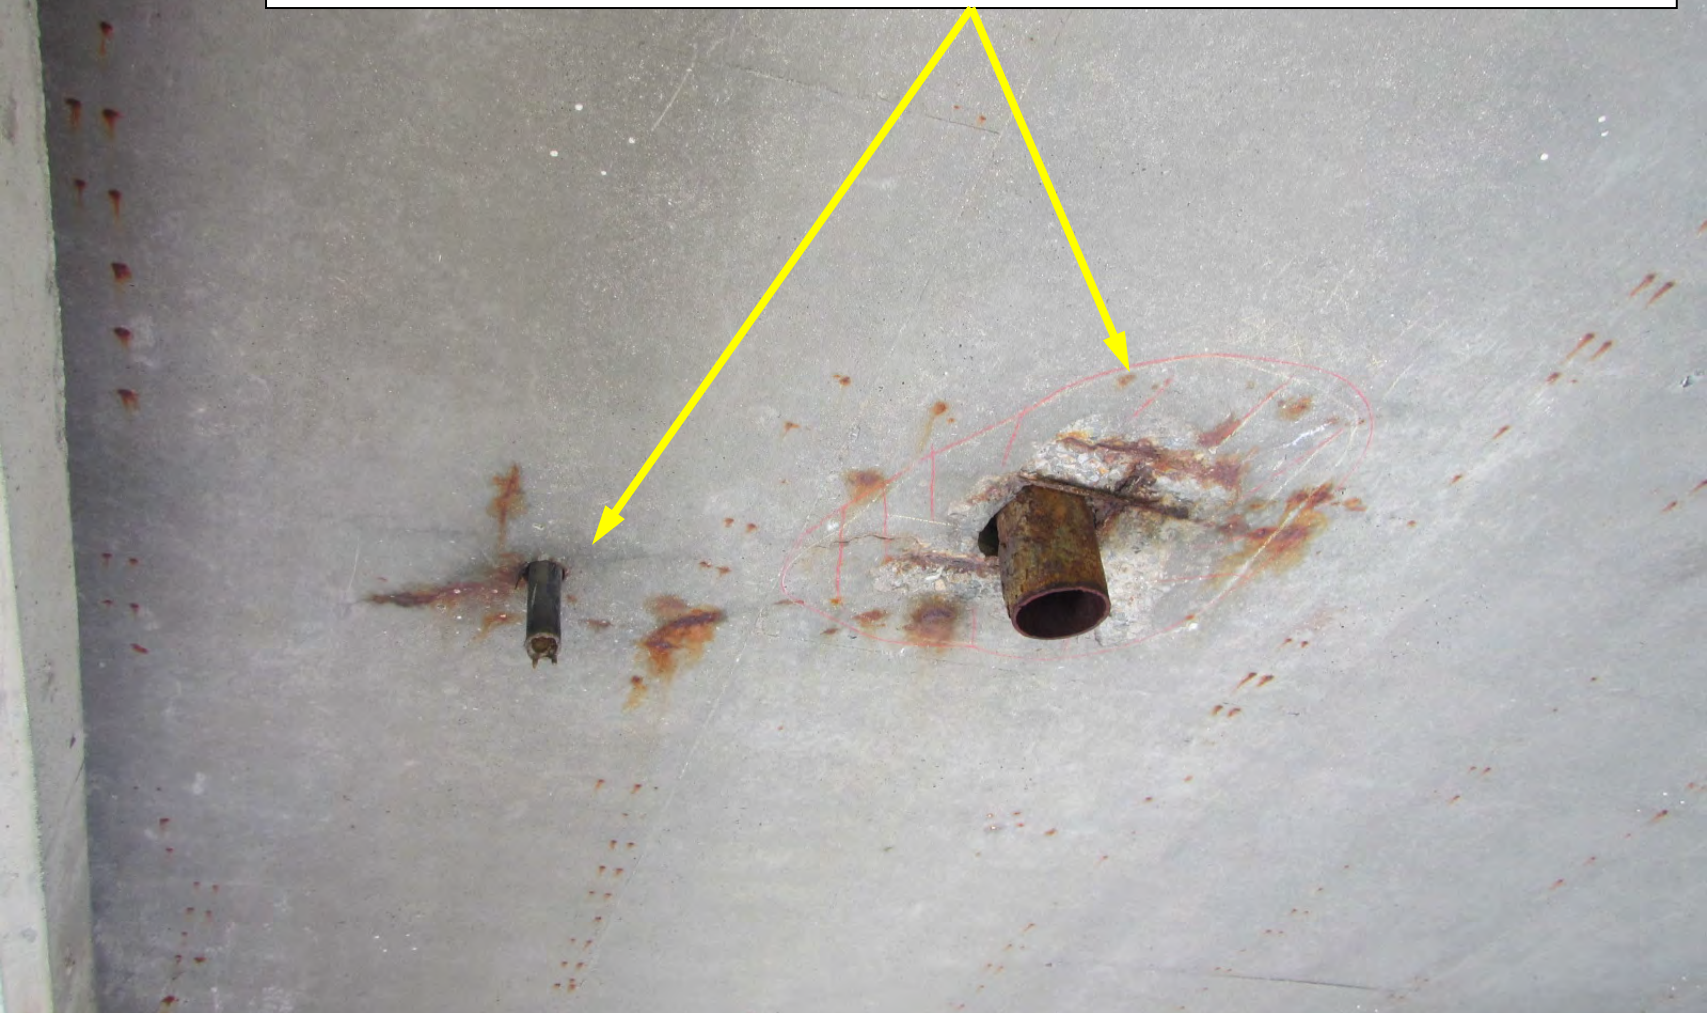
PHOTO #64

30" long x 30" wide hollow area with a 18" long x 18" wide x 2" deep spall with exposed rebar (one debonded with up to 40% section loss) at scupper pipe. Additional 12" long x 12" wide hollow area at second drainpipe

Underside of box girder, span 1R near pier 1R

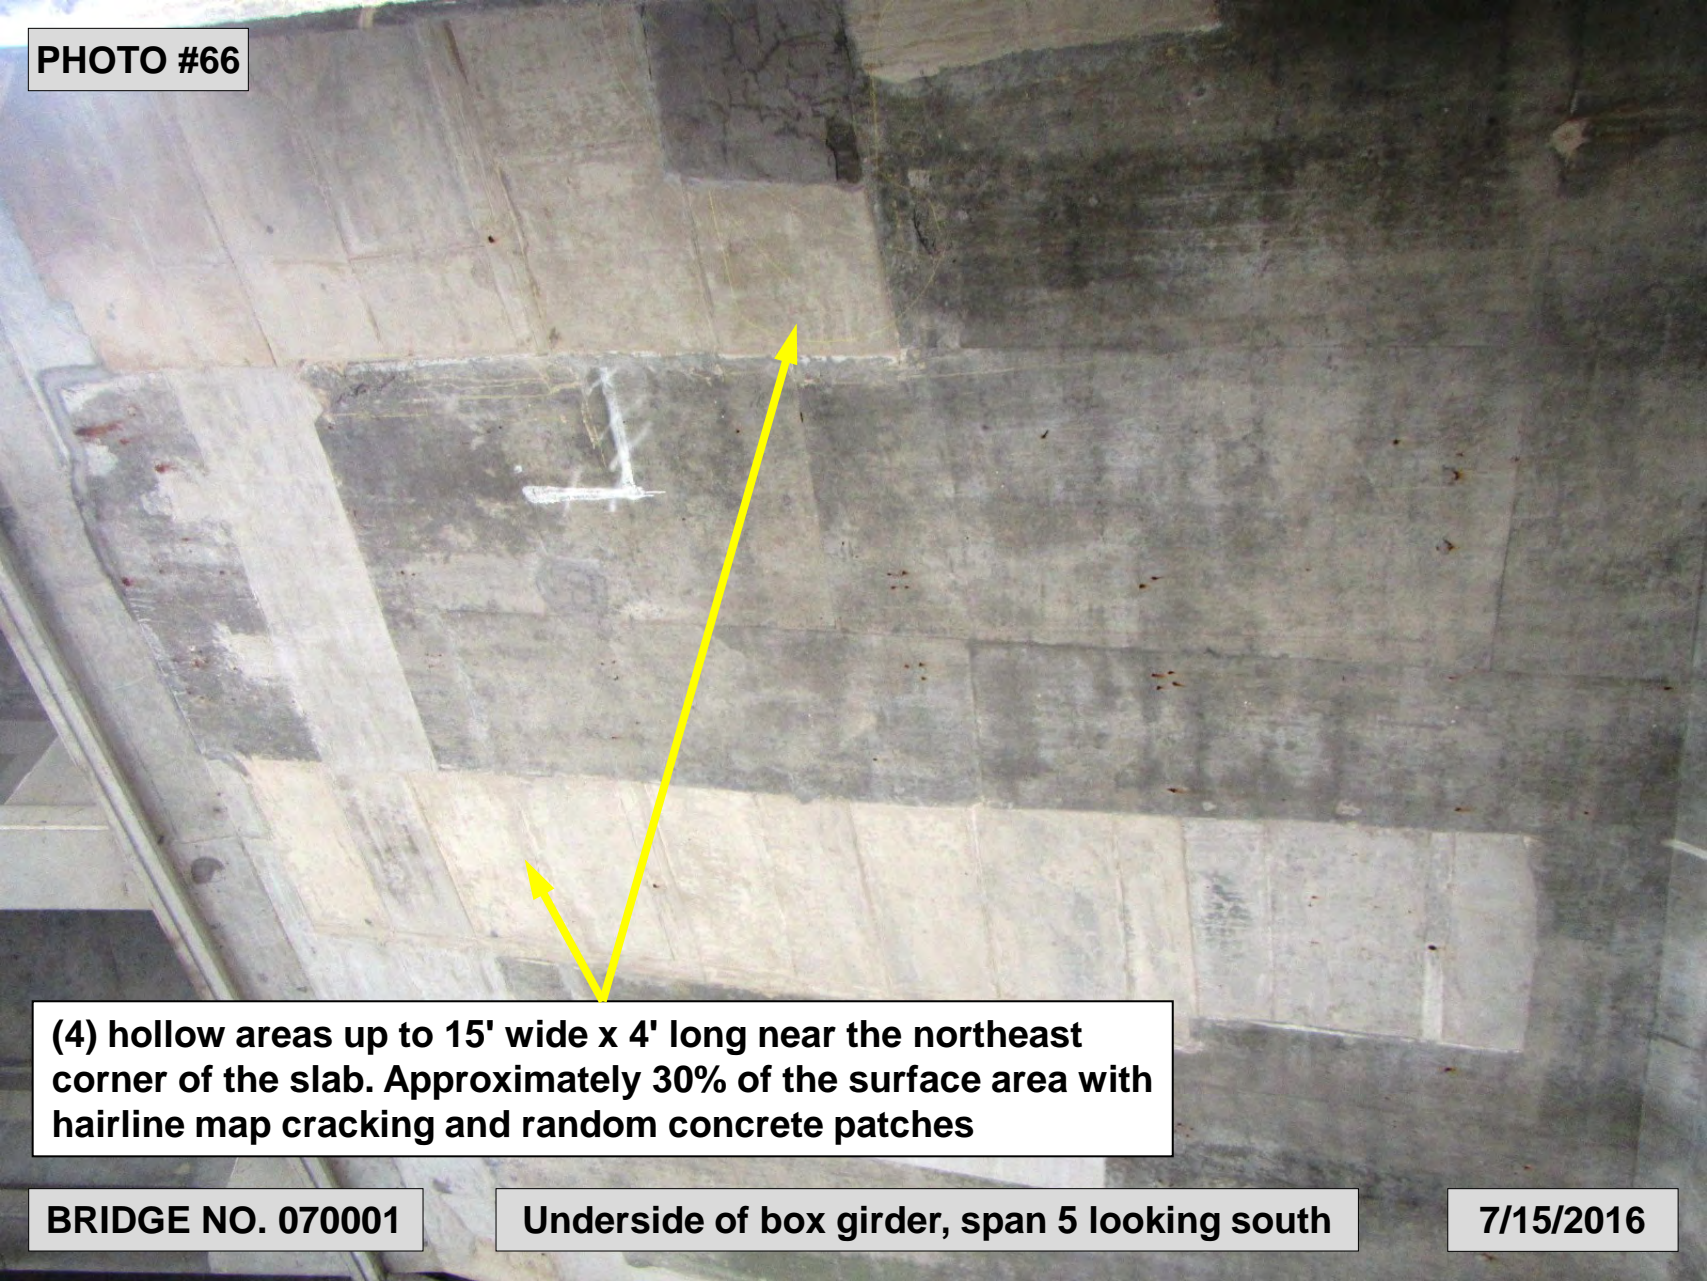
PHOTO #66

(4) hollow areas up to 15' wide x 4' long near the northeast corner of the slab. Approximately 30% of the surface area with hairline map cracking and random concrete patches

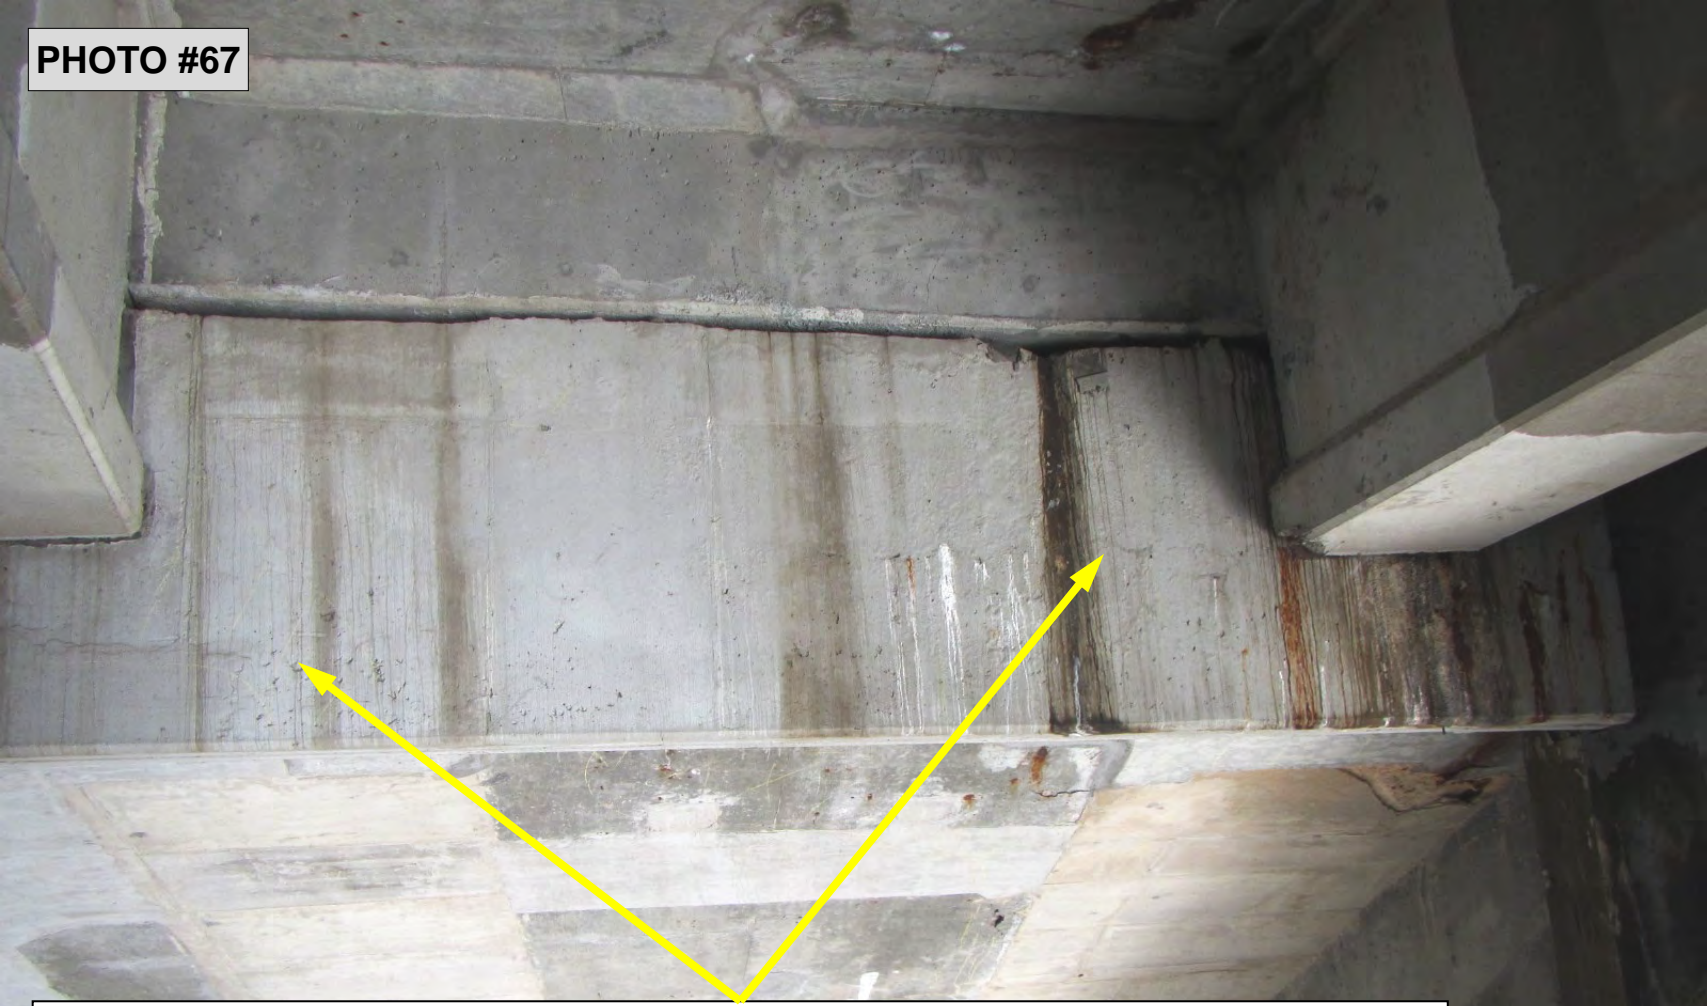
PHOTO #67

(4) hollow areas up to full height x up to 3' wide area next to Girder 'A1'; a 12" high by 12" wide area at the top of the East face, and a 3' high by 2' wide hollow area adjacent to Girder 'AA'. Note leakage stains and rust stains
