BRIDGE NO. 070001

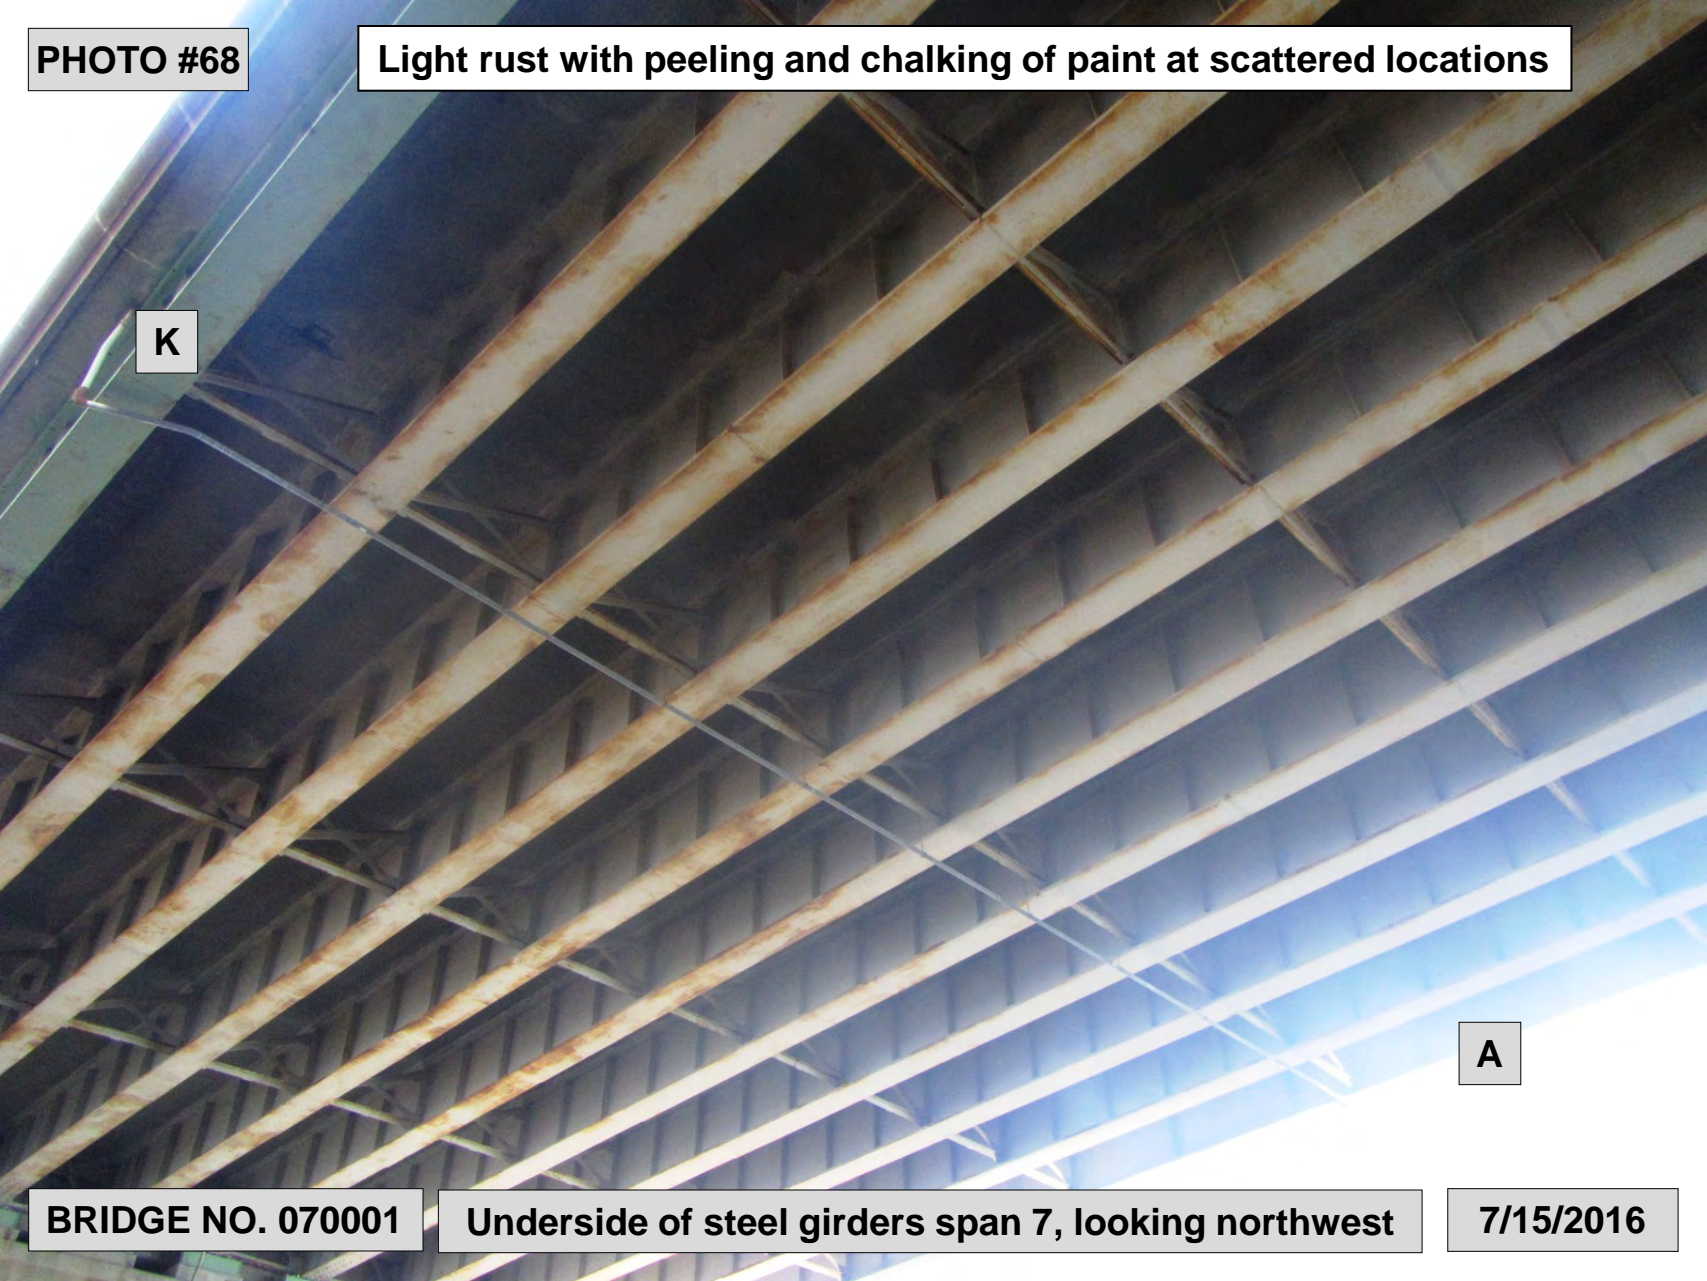
PHOTO #69

Full width x 6' long x 1/2" thick remaining on the bottom flange, up to 6" high x 1/16" deep pitting on the web and repair plates, heavy rust

**Bolted repair plates
(typical)**

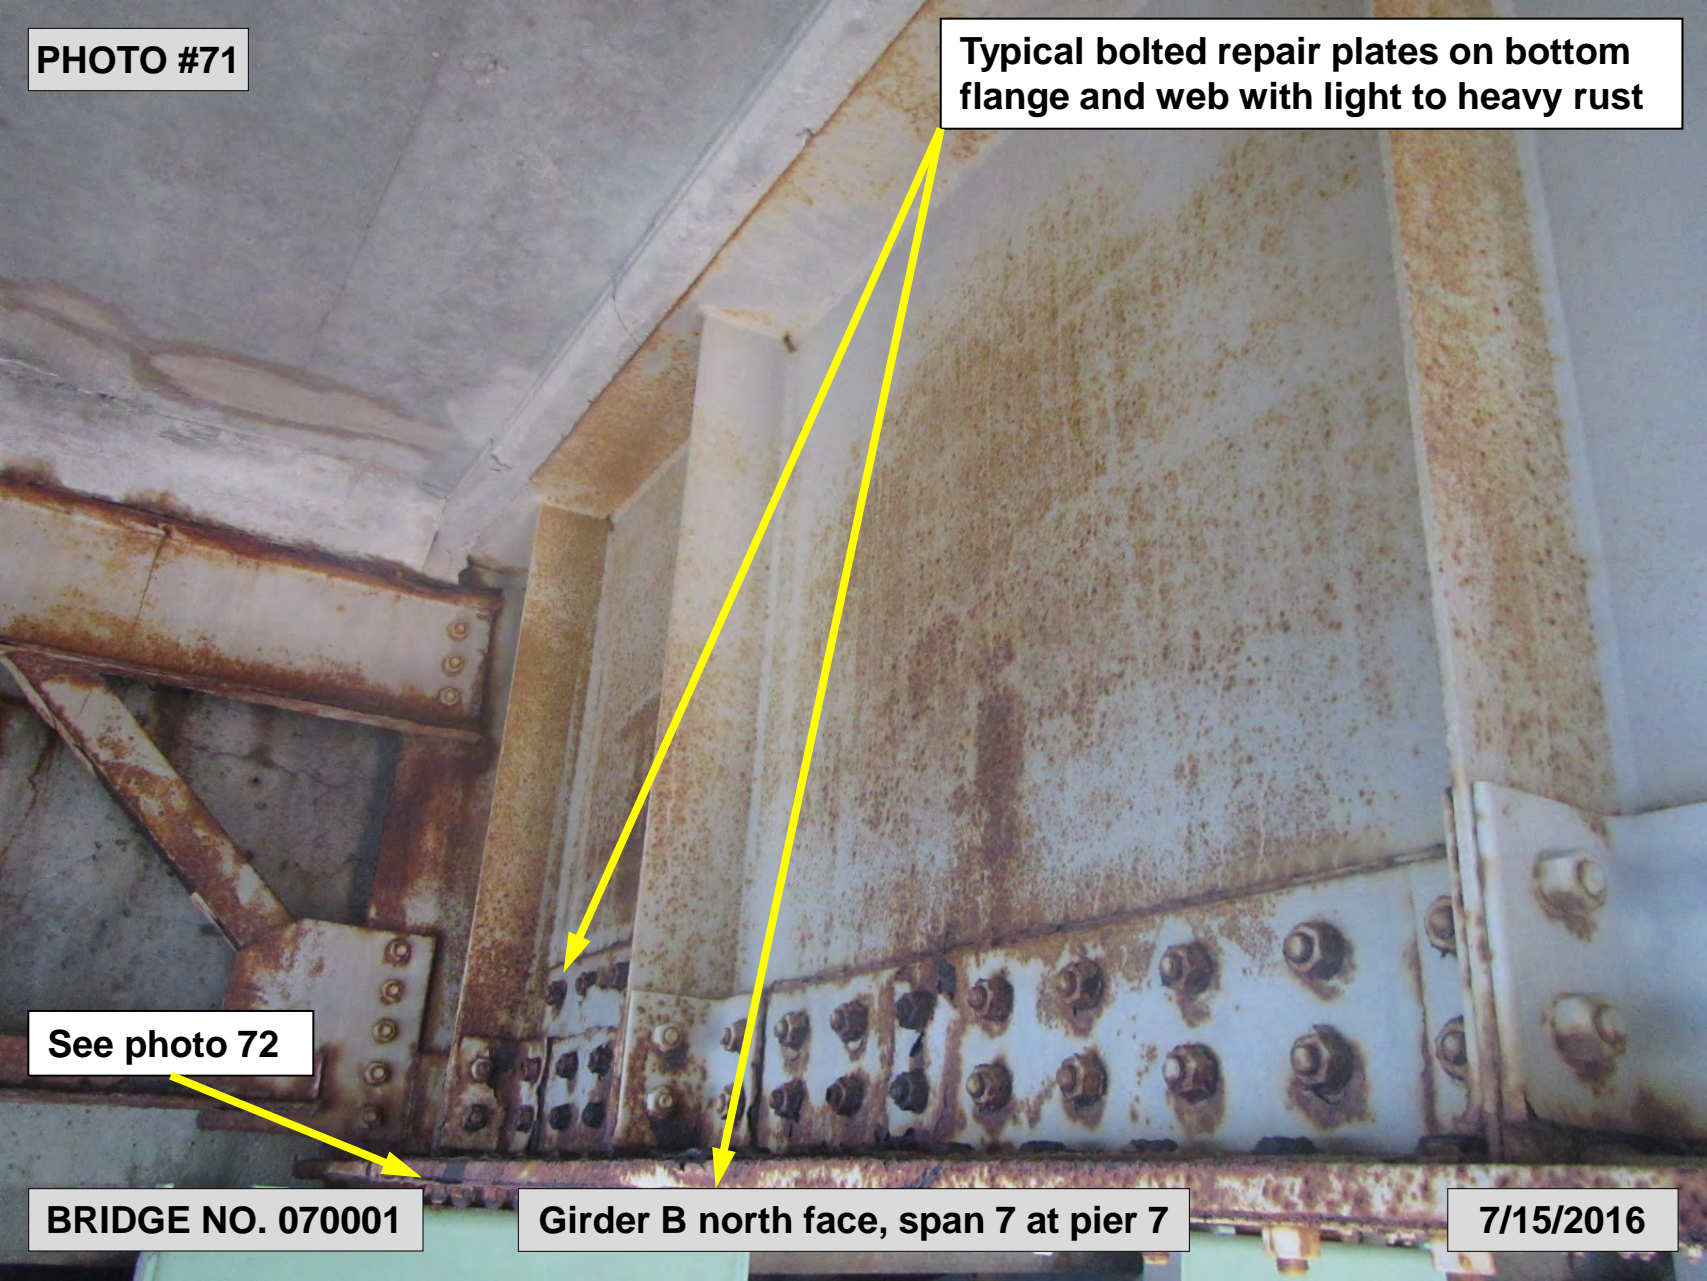
PHOTO #72

**Full width x 7' long x 1/8" deep pitting
with peeling paint and heavy rust**

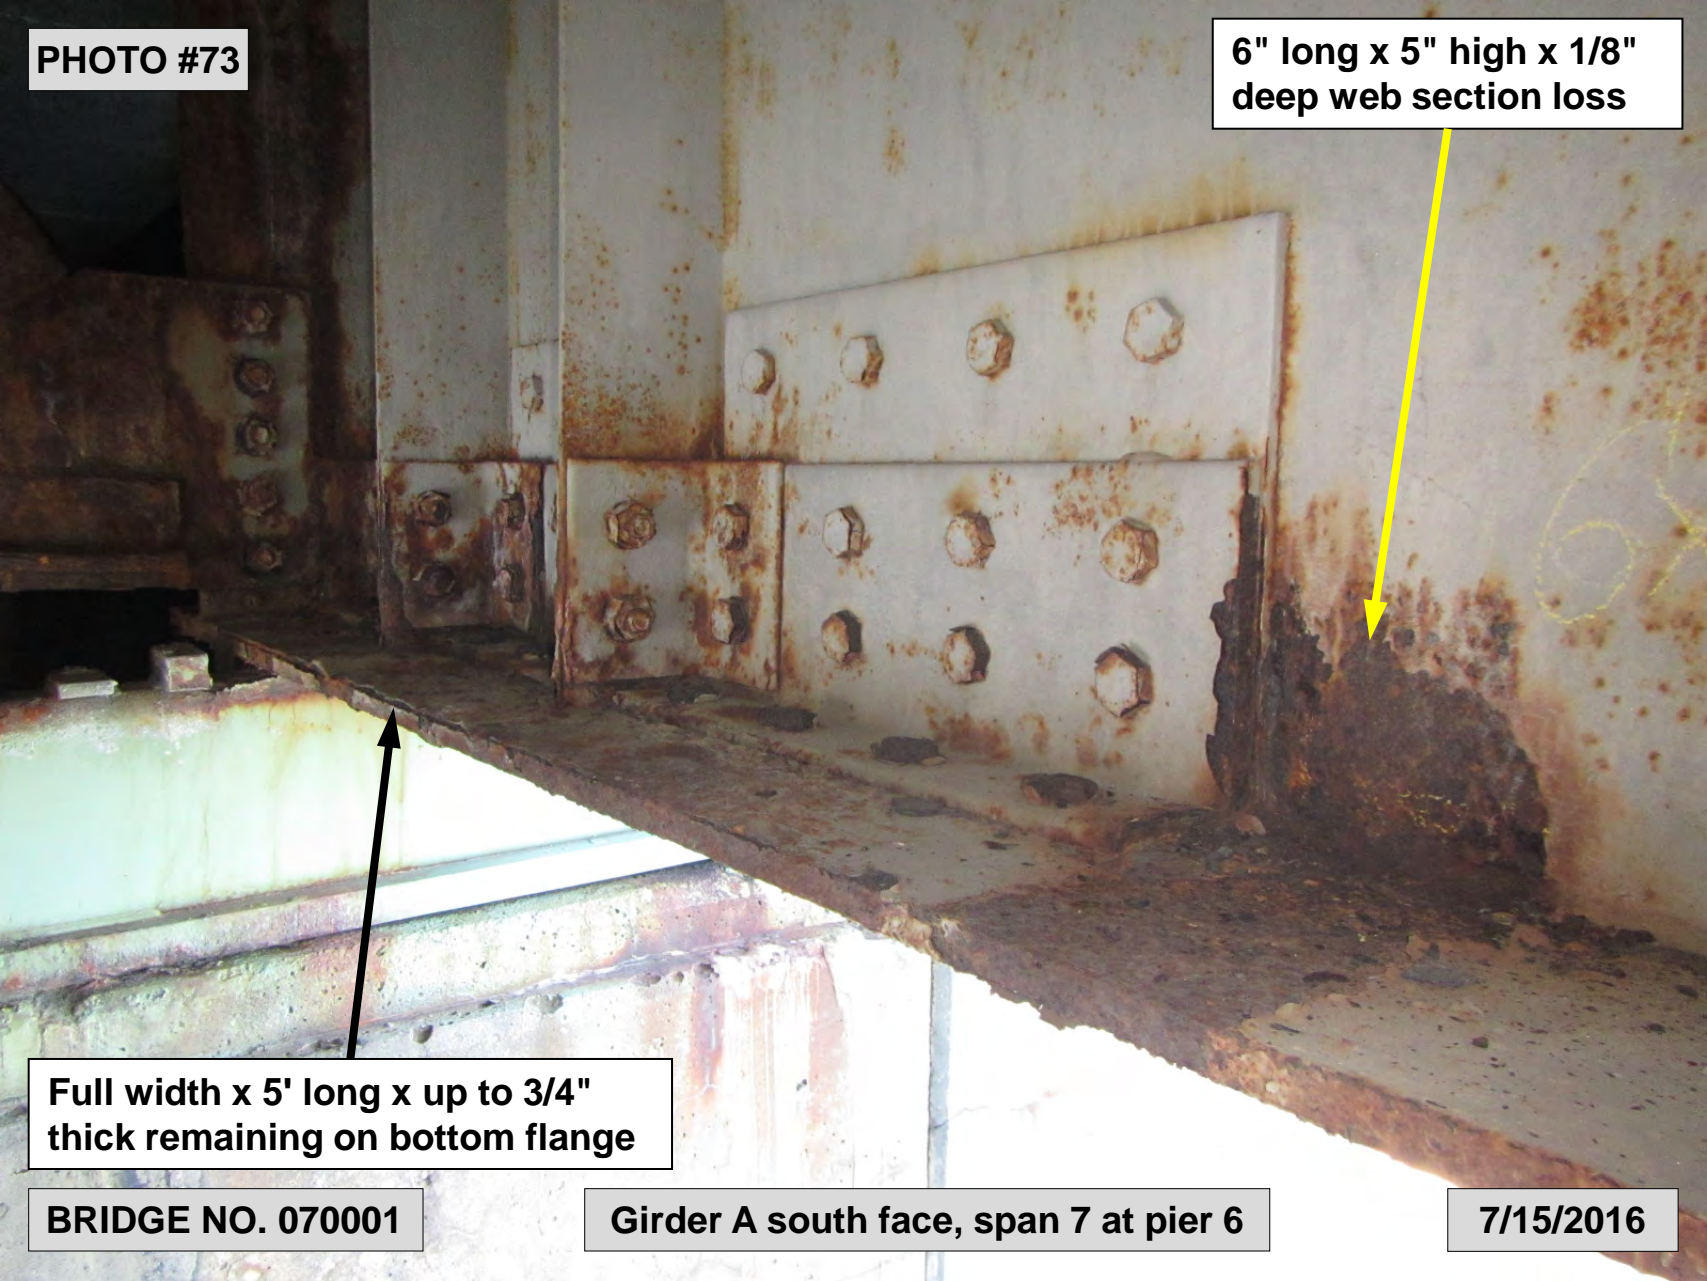
PHOTO #73

6" long x 5" high x 1/8"
deep web section loss

Full width x 5' long x up to 3/4"
thick remaining on bottom flange

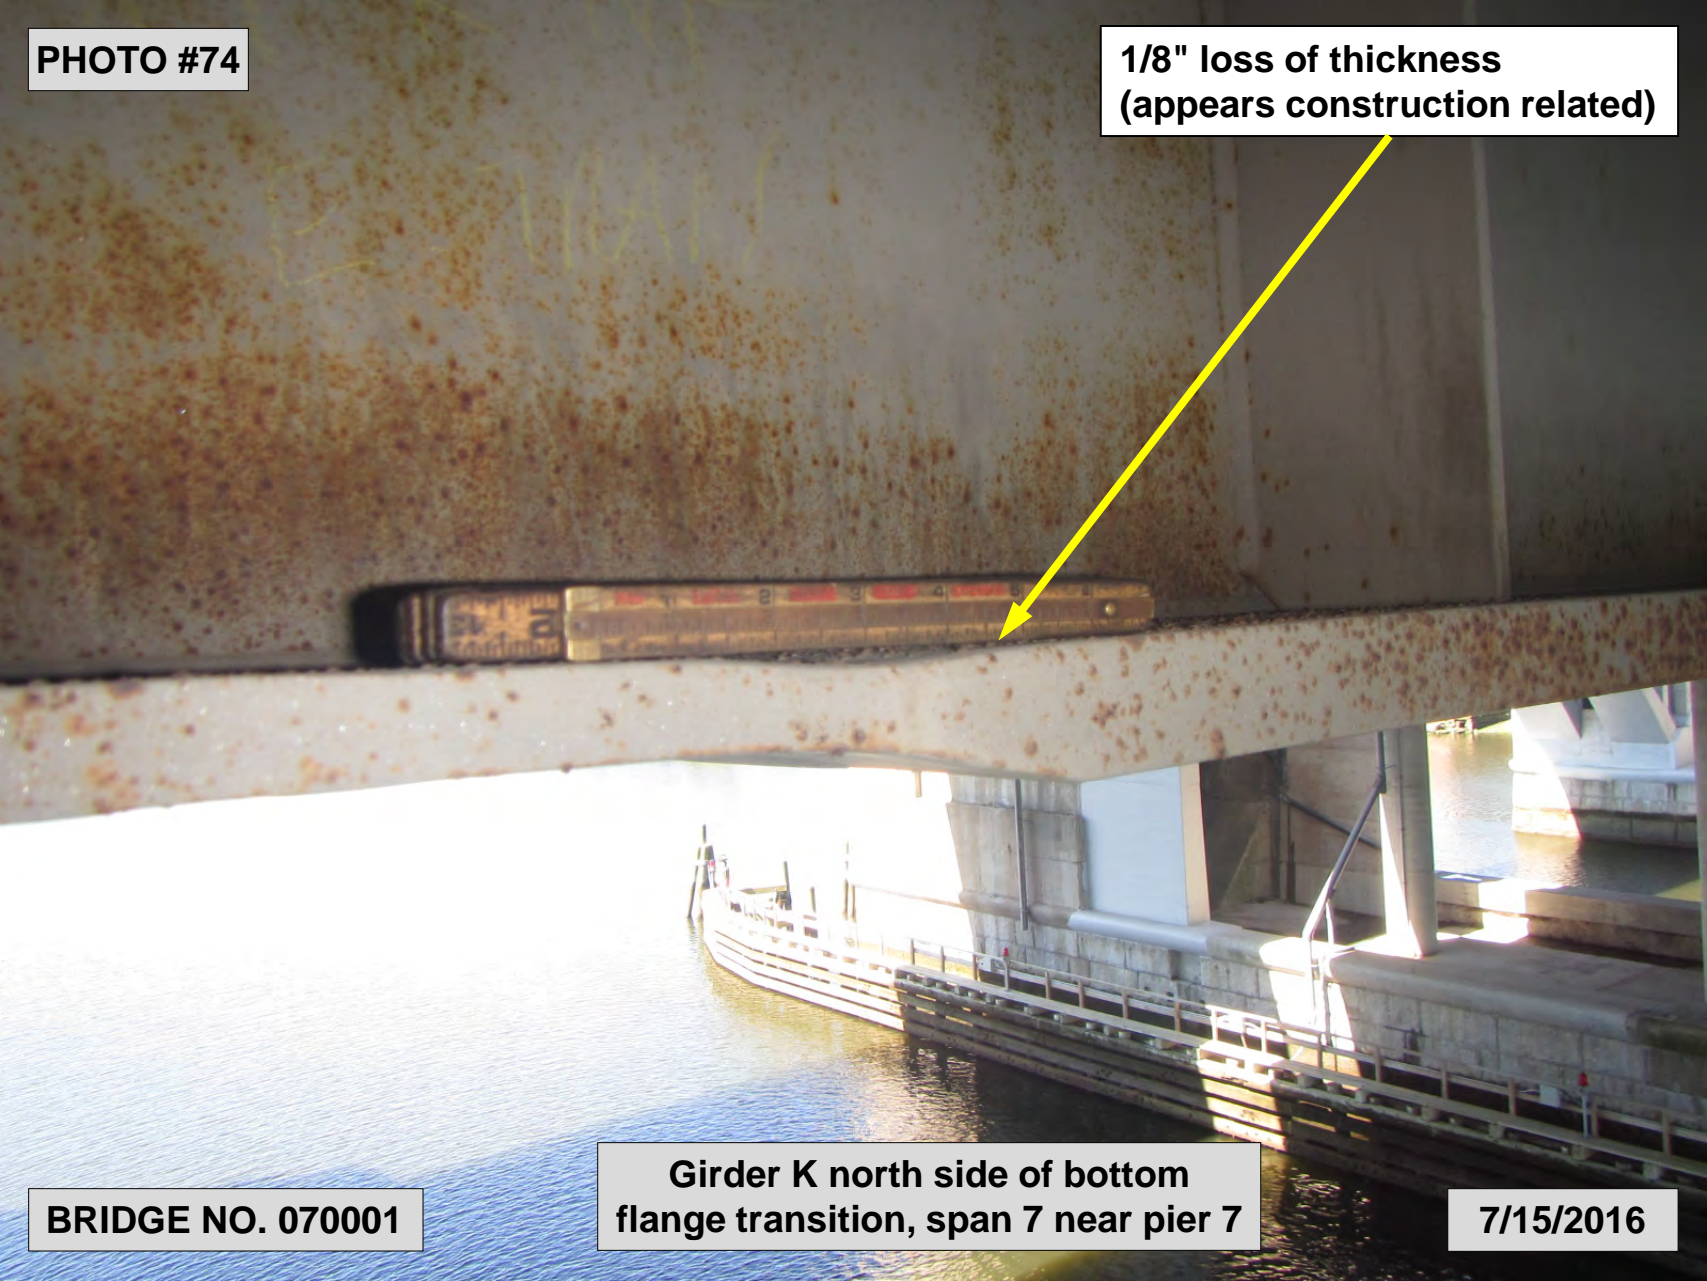
PHOTO #74

**1/8" loss of thickness
(appears construction related)**

**Girder K north side of bottom
flange transition, span 7 near pier 7**

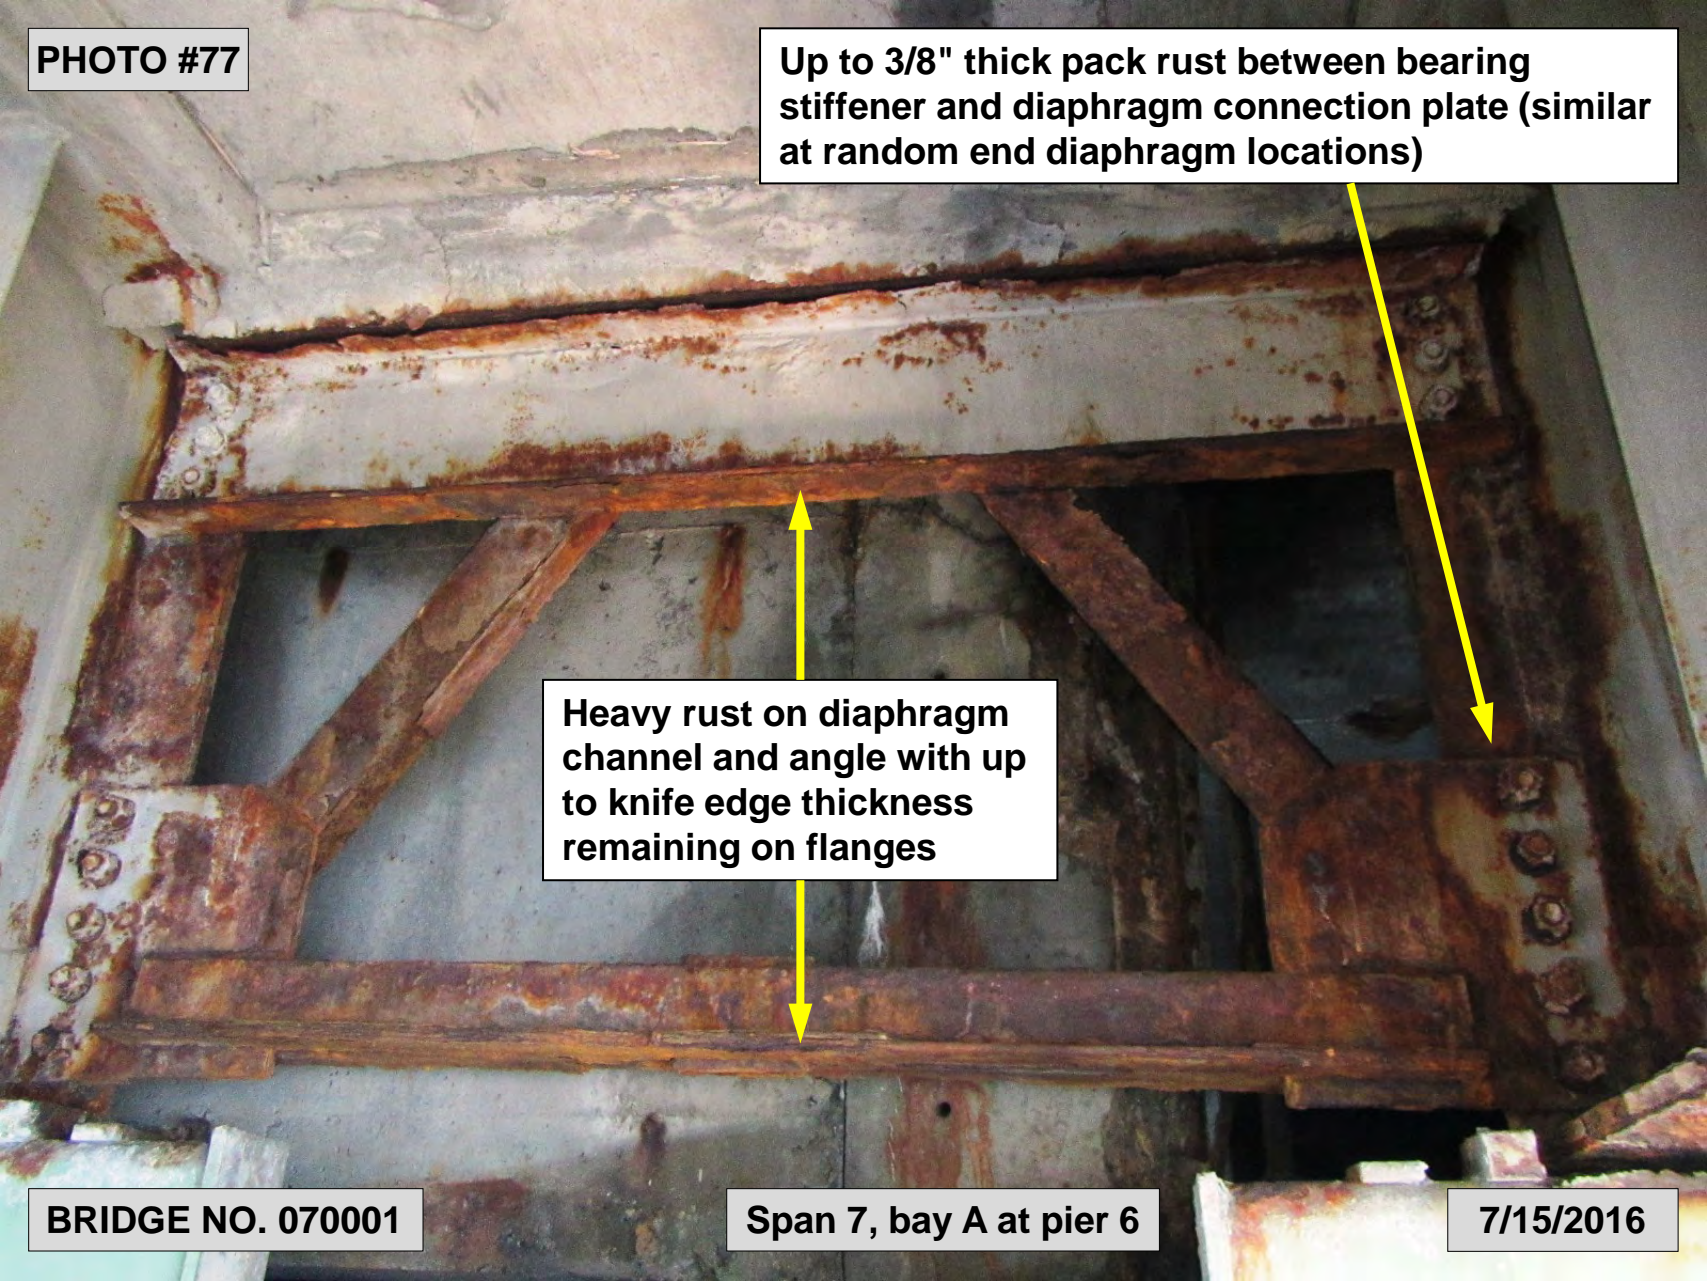
PHOTO #78

Missing connection bolt

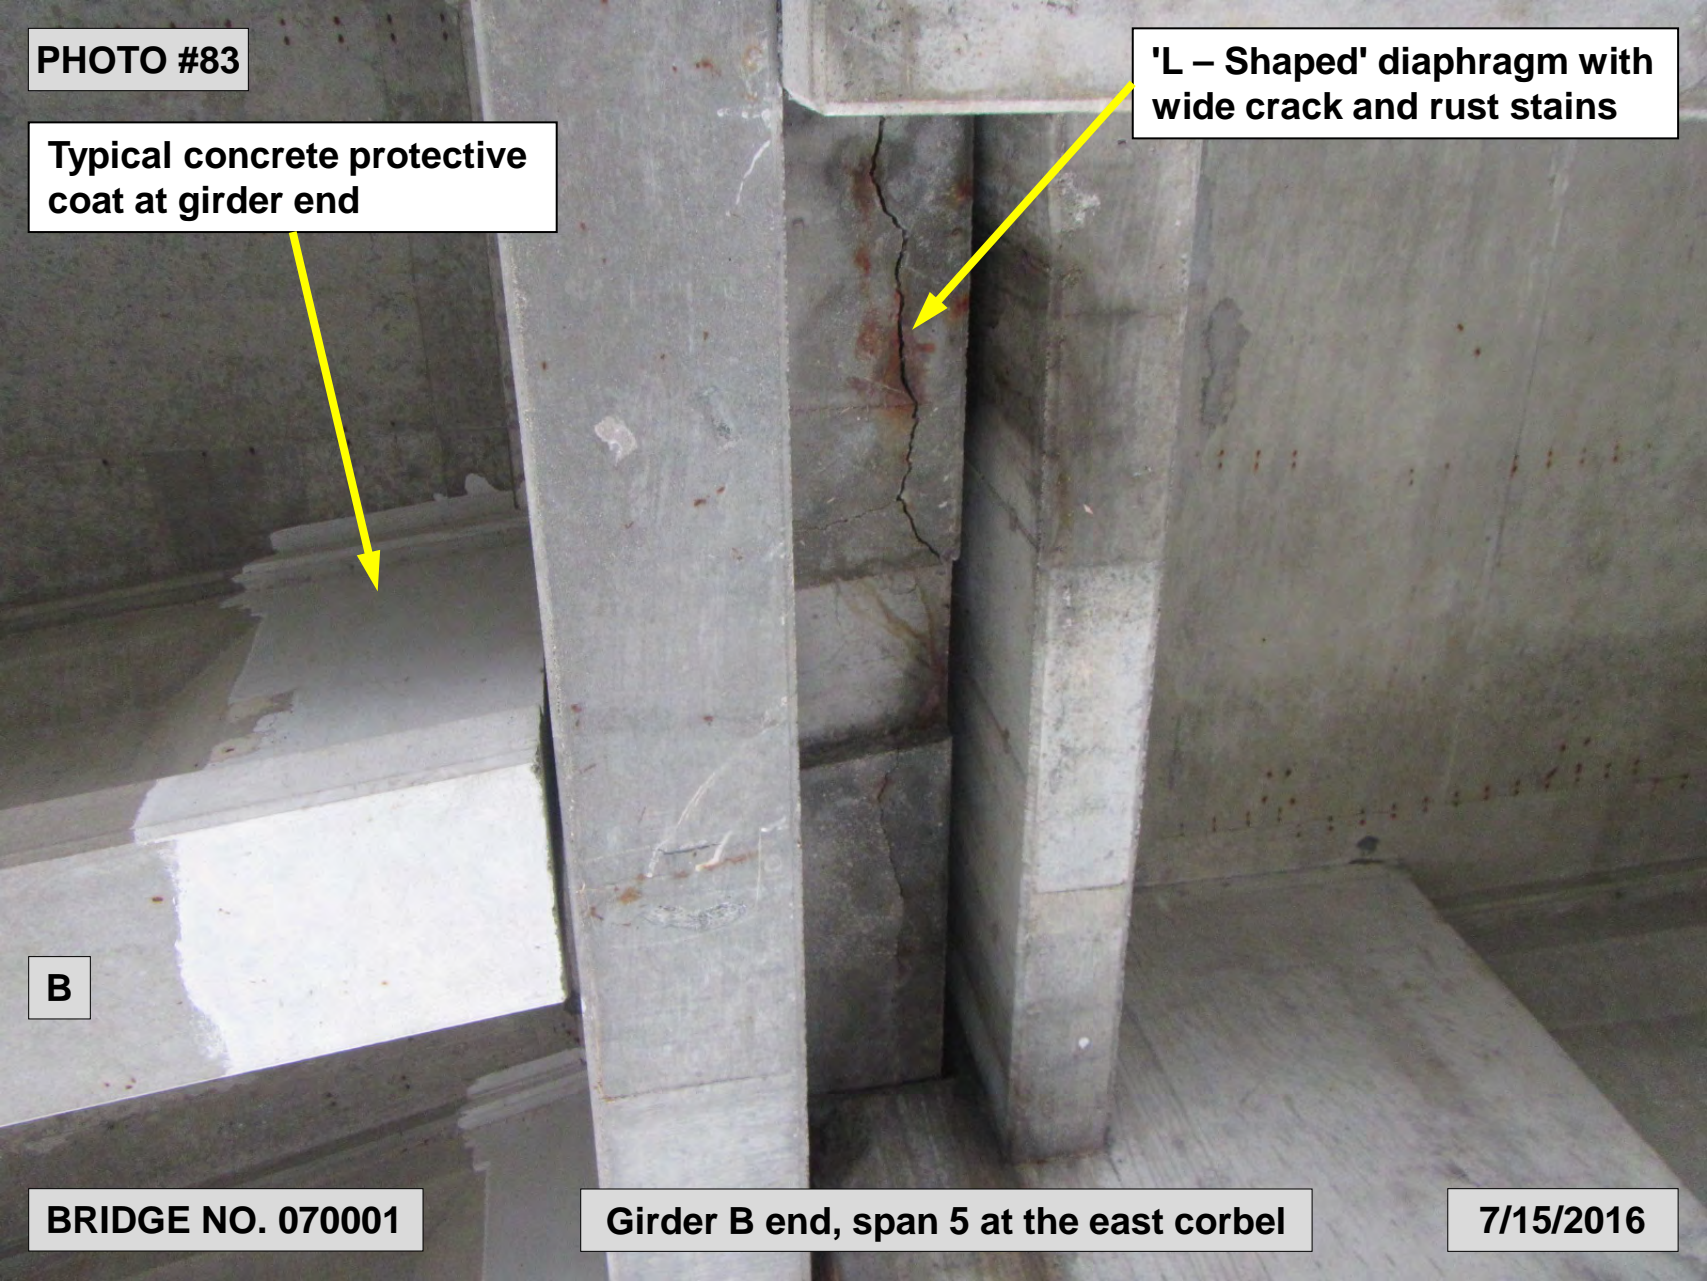
PHOTO #83

Typical concrete protective coat at girder end

'L - Shaped' diaphragm with wide crack and rust stains

Girder B end, span 5 at the east corbel

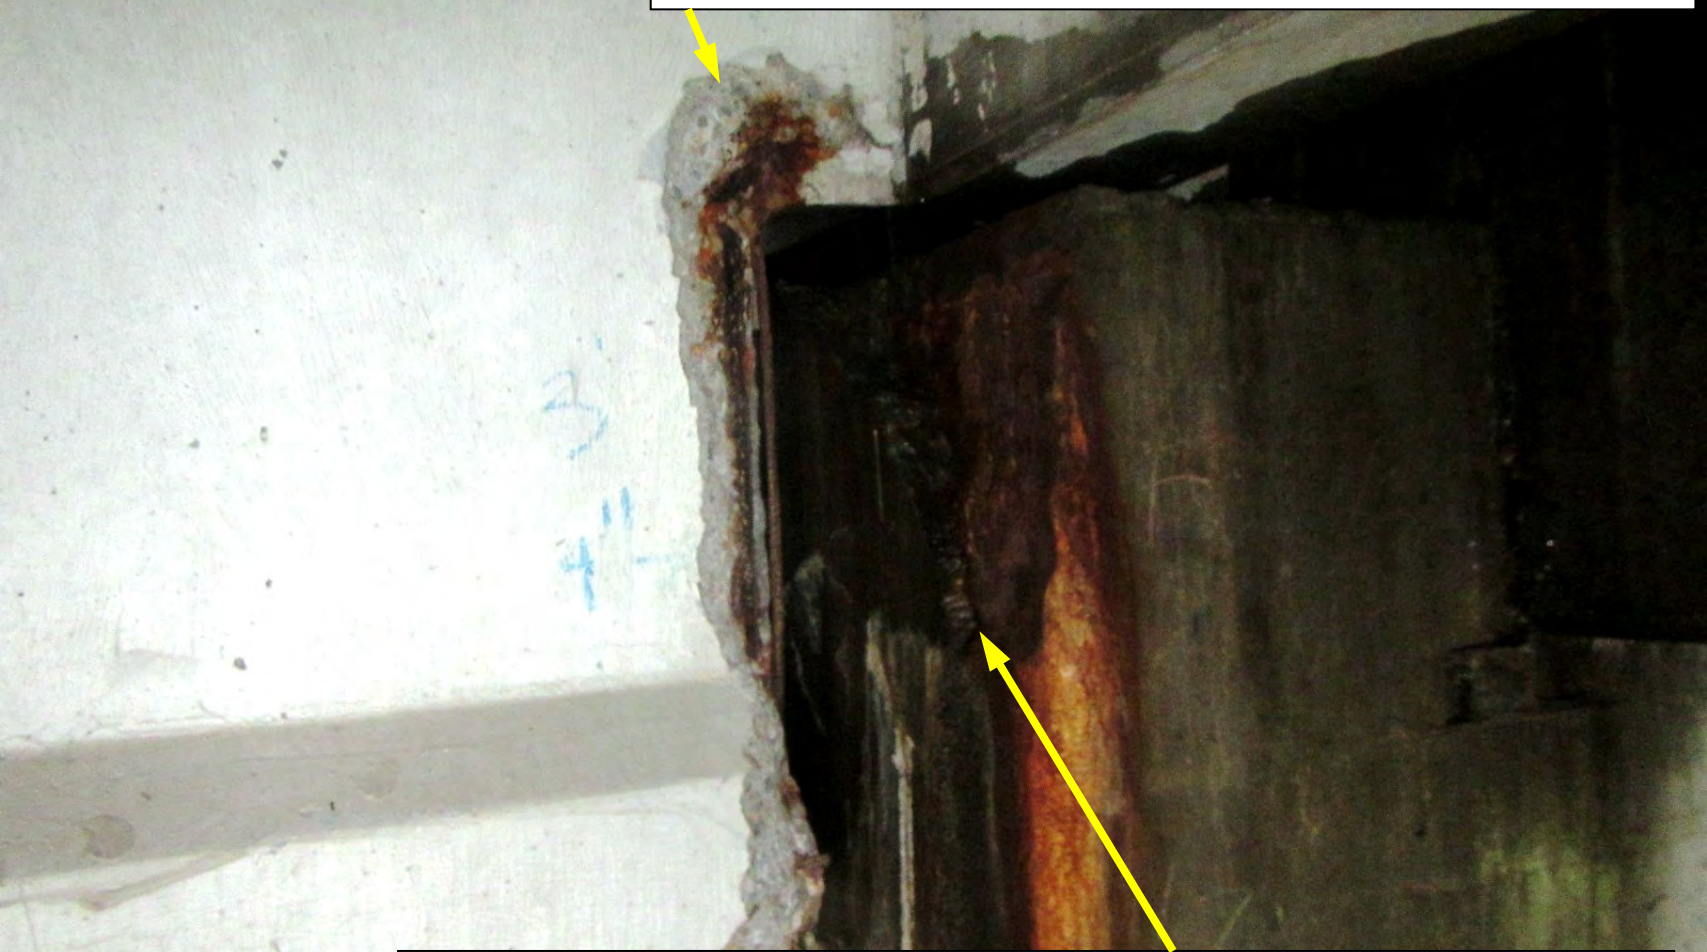
PHOTO #91

8" long x 3' high x 2.5" deep spall with exposed debonded stirrups extending to bottom flange and web

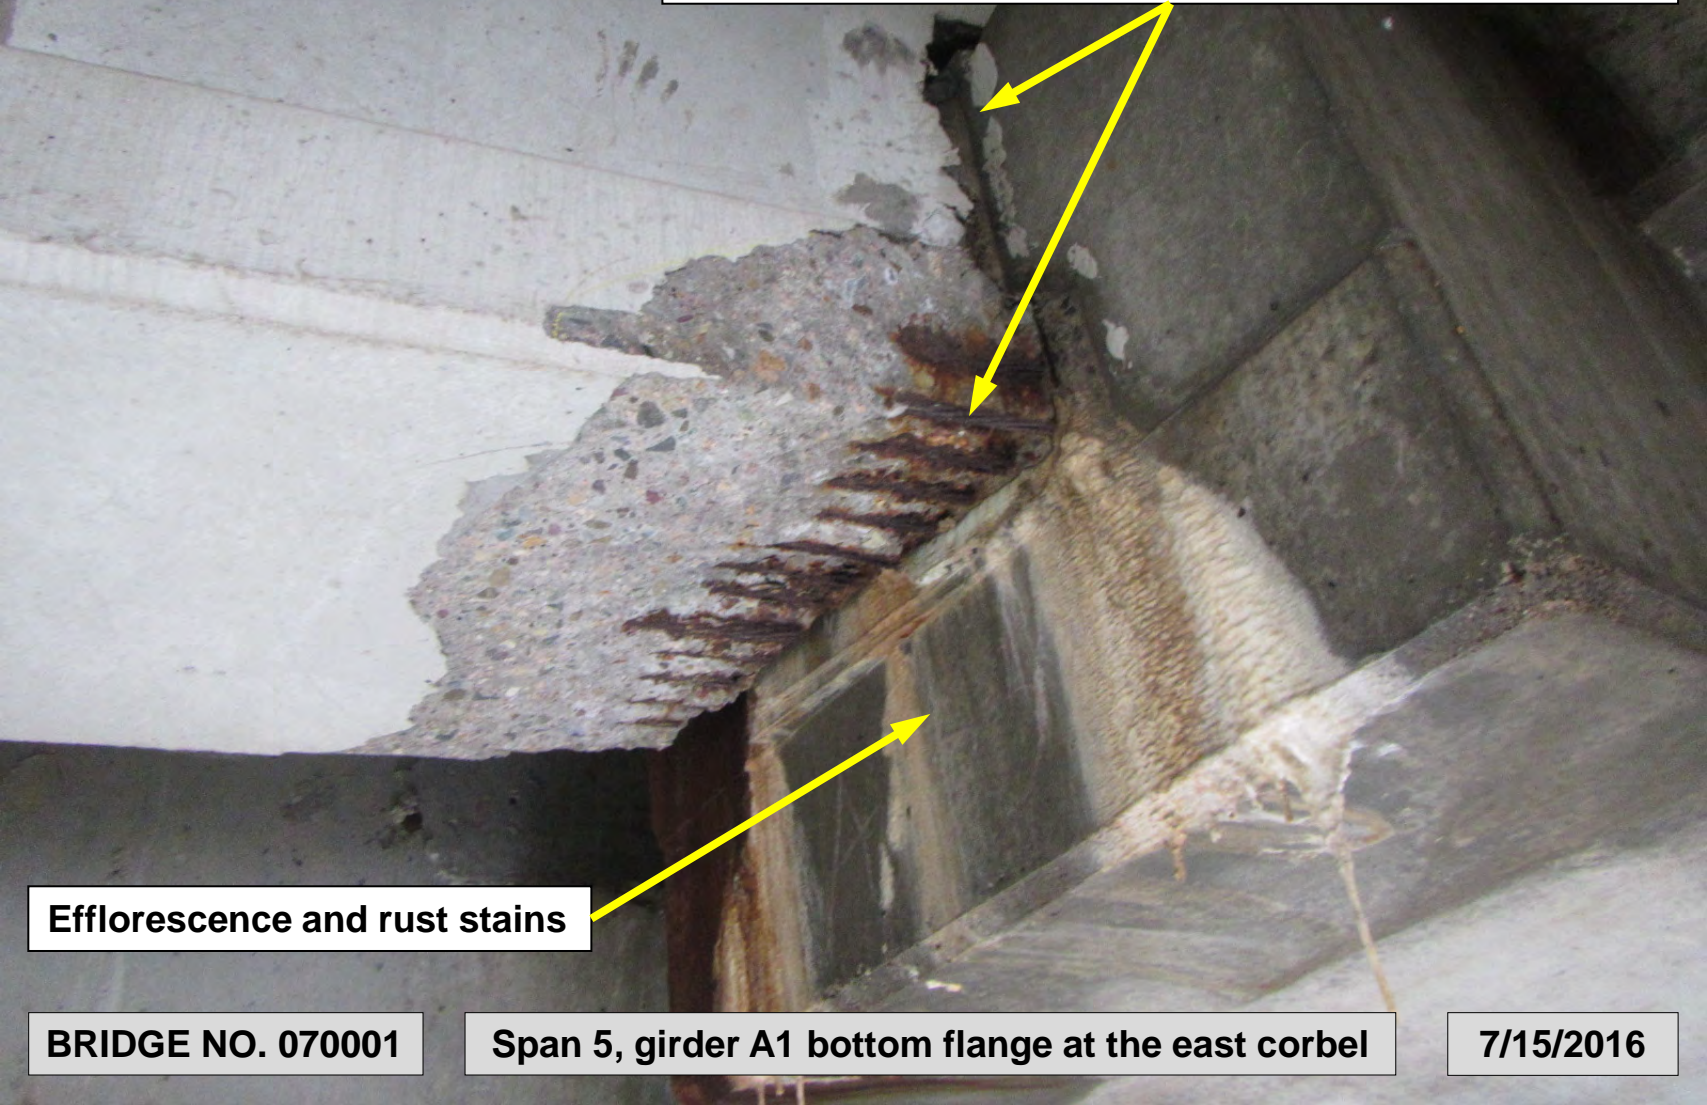
PHOTO #93

Full width x 20" long x 2" deep spall with (14) exposed and corroded strand ends; spall extends 16" high x 2" wide x 2" deep to end of web with heavy efflorescence

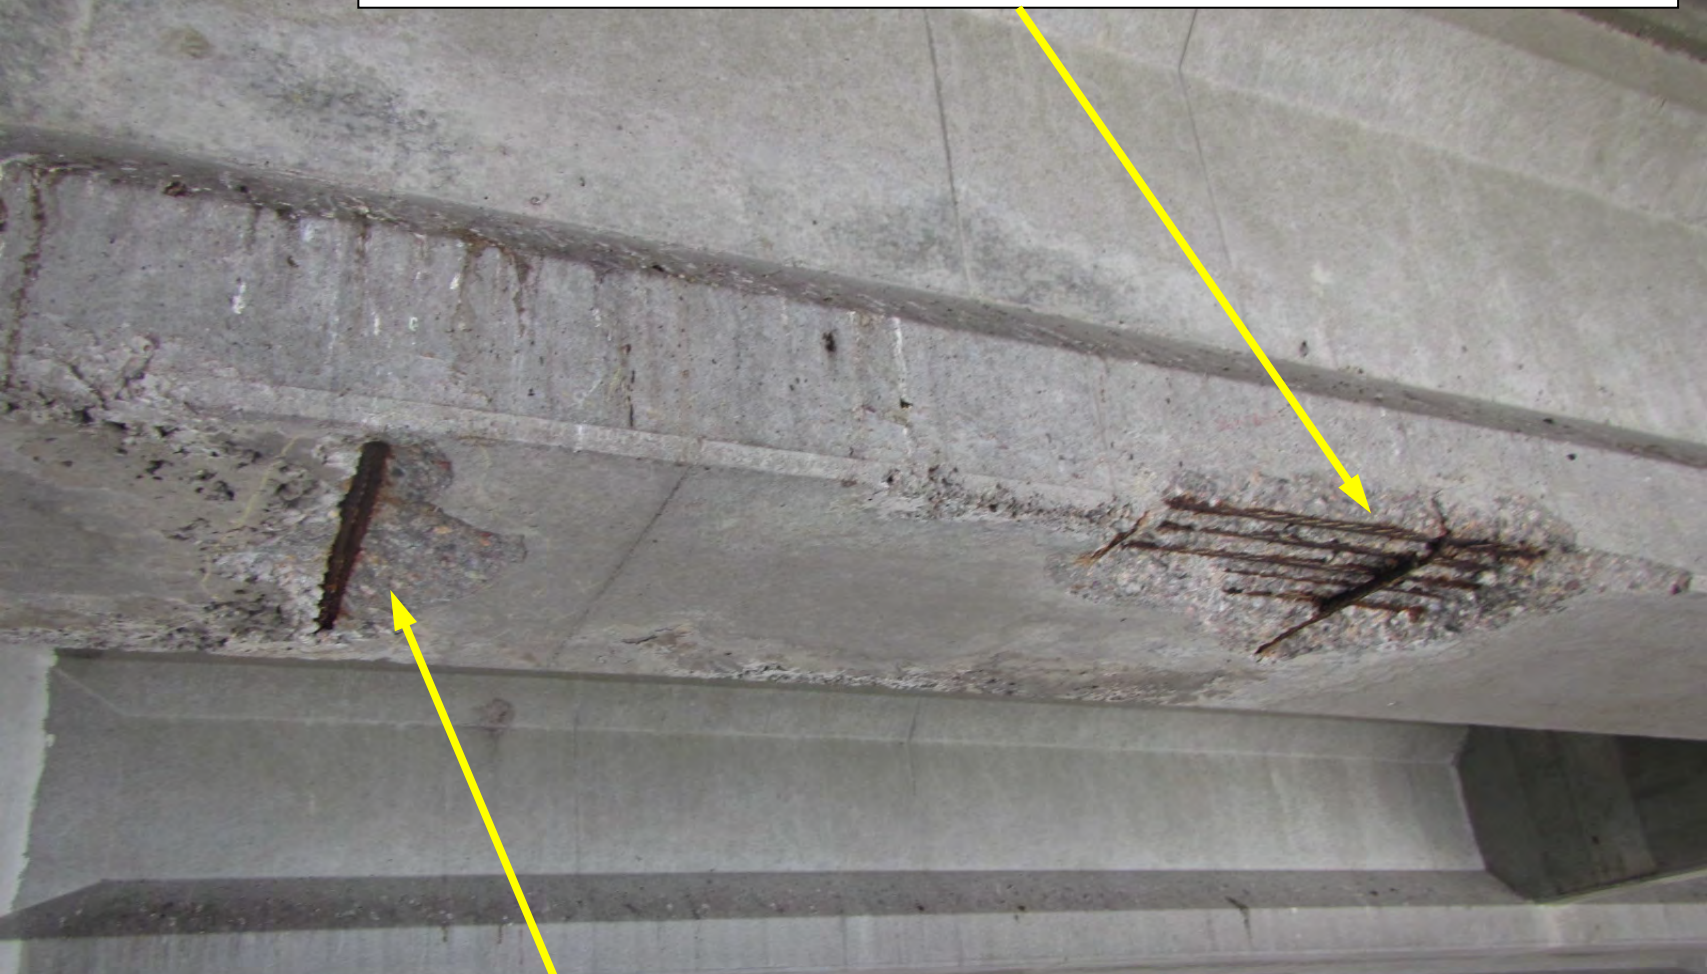
PHOTO #97

40" long x 18" wide x 2" deep spall with (5) strands exposed with broken wires and (1) exposed debonded stirrup. See photo 98 for close-up.

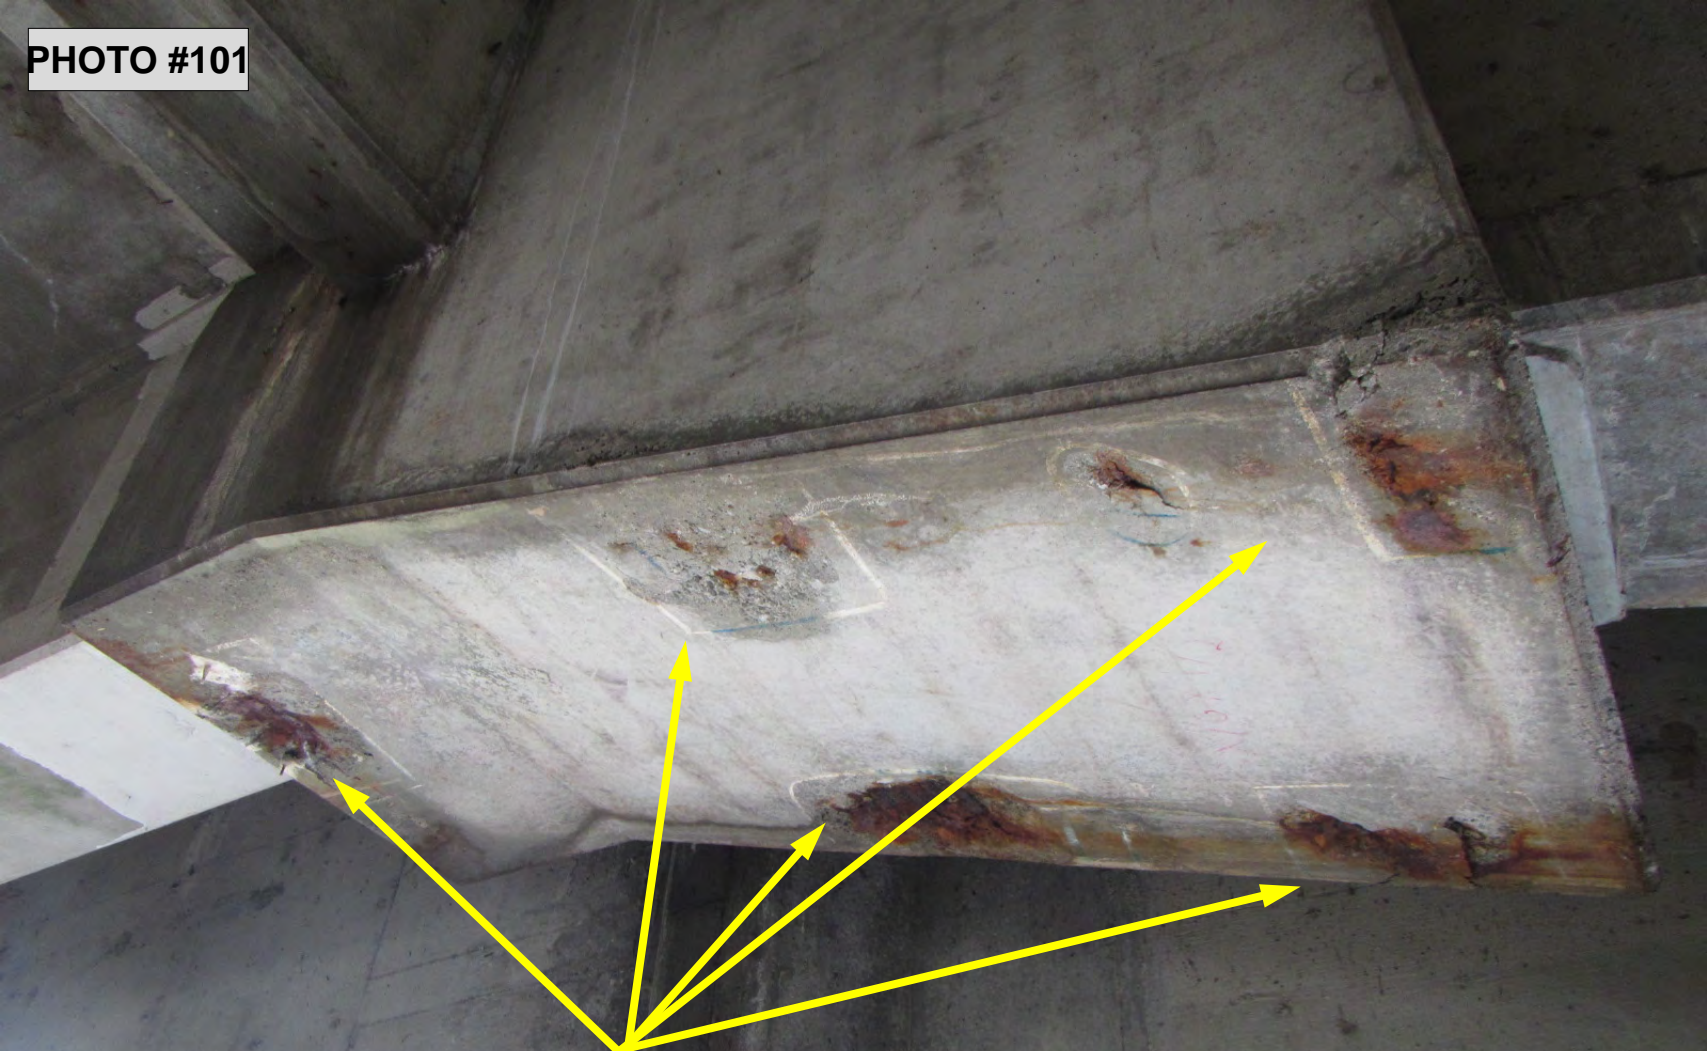
PHOTO #101

Multiple cracks, hollow areas and spalls (6 total) up to 28" wide x 12" long x 2" deep with leakage stains and exposed rebar

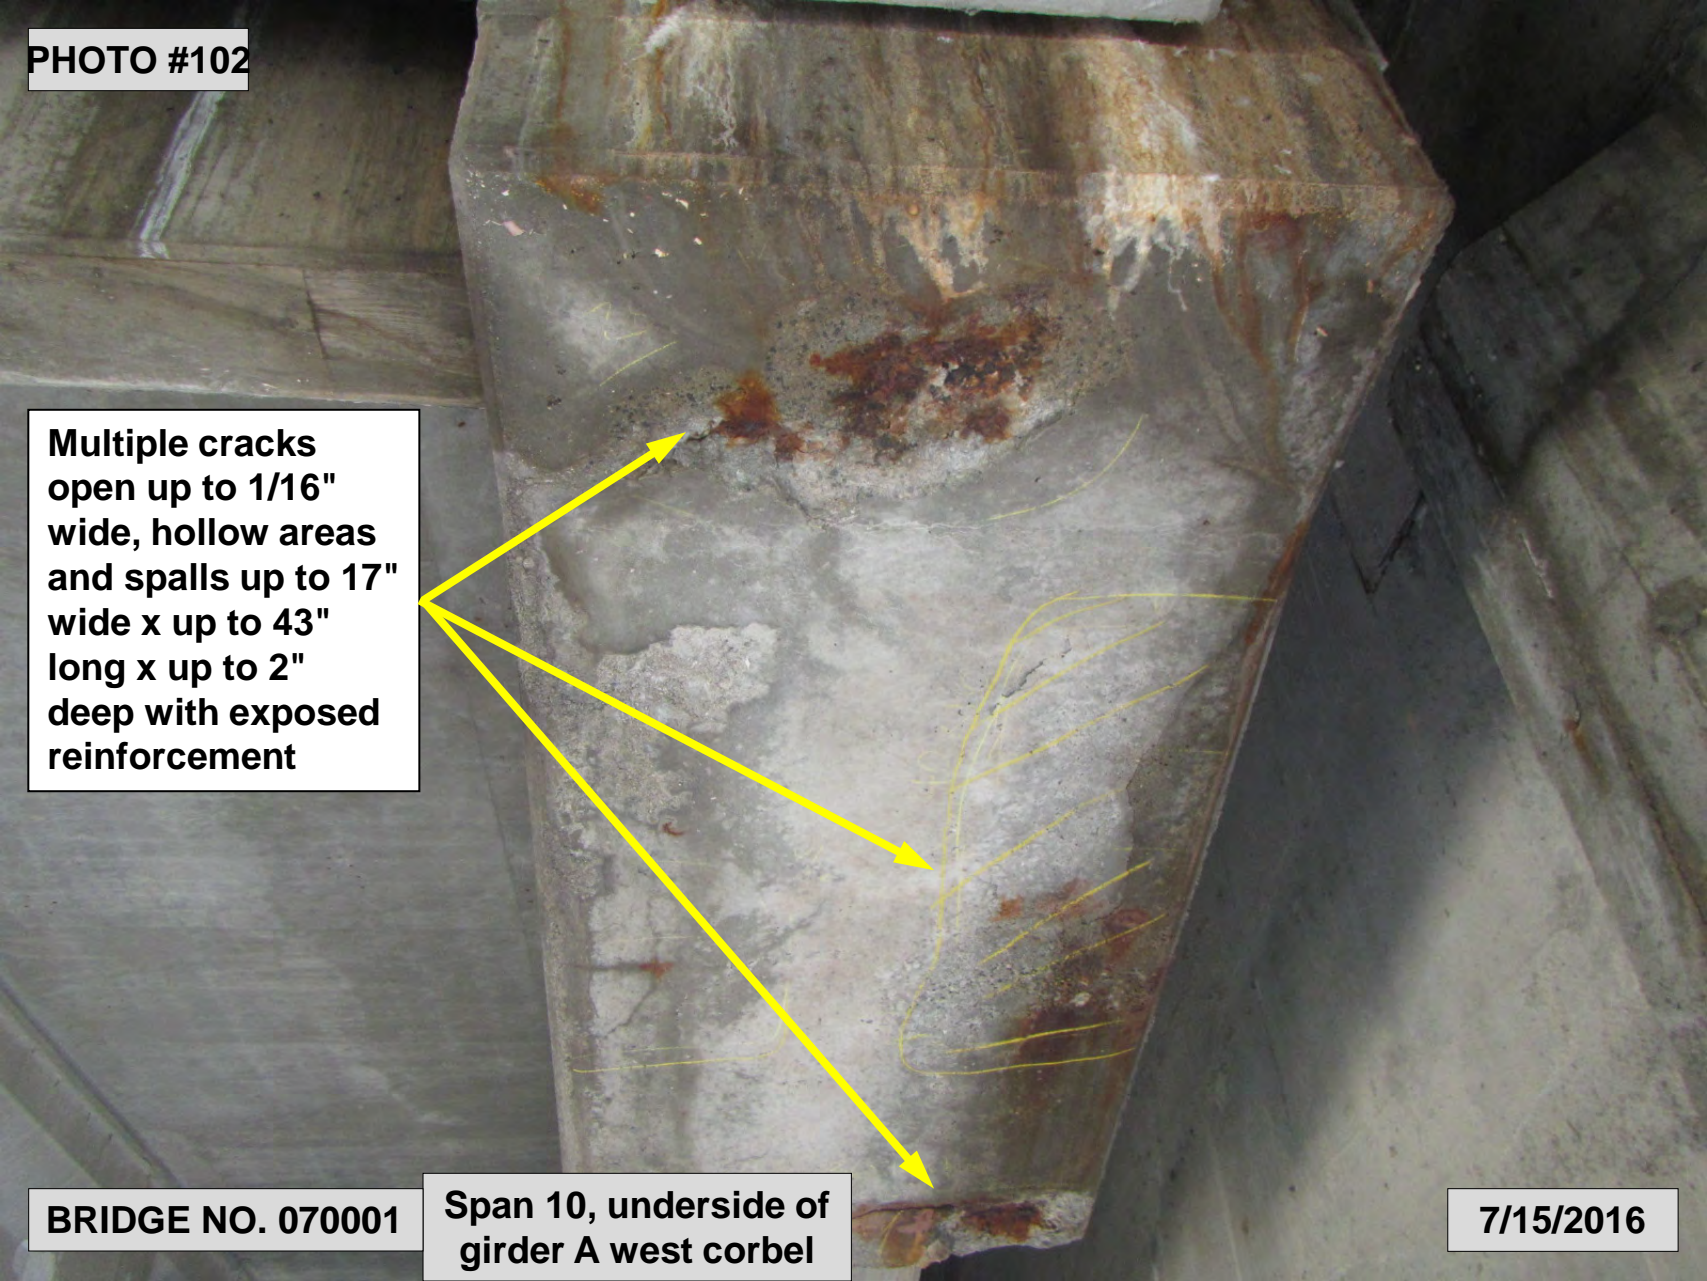
PHOTO #103

24" long x 18" wide x 3" deep spall with exposed rebar and strands exposed

Full width horizontal crack open up to 1/8"

14" long x full width hollow area at east edge and extends 8" high onto east face; with rust and efflorescence
