BRIDGE NO. 070001

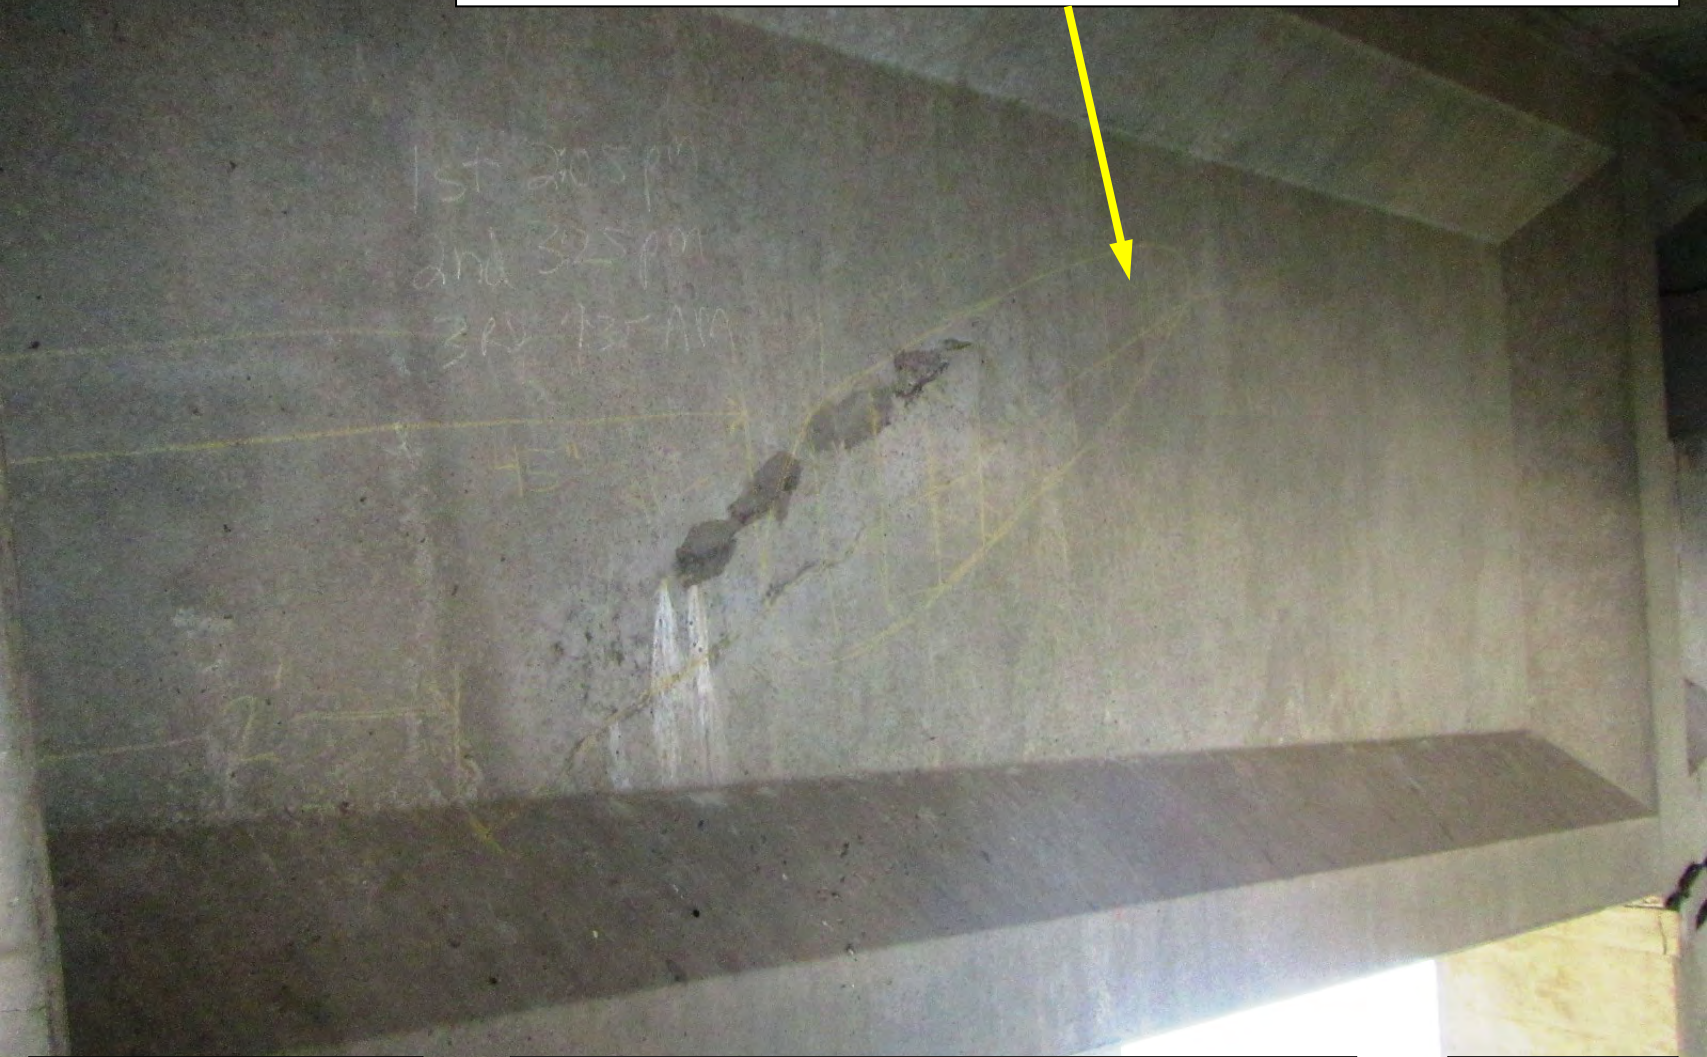
PHOTO #107

114" long diagonal hairline crack within 5' long x 15" high hollow area with edge spalling up to 1/2" deep and efflorescence

Span 4, south side of cantilever B near pier 4

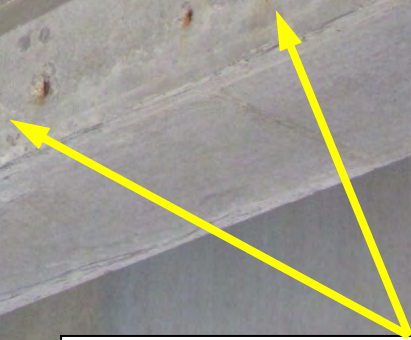
PHOTO #108

Built out web

Four popouts up to 3" high x 2" wide x 1/2" deep with exposed rebar

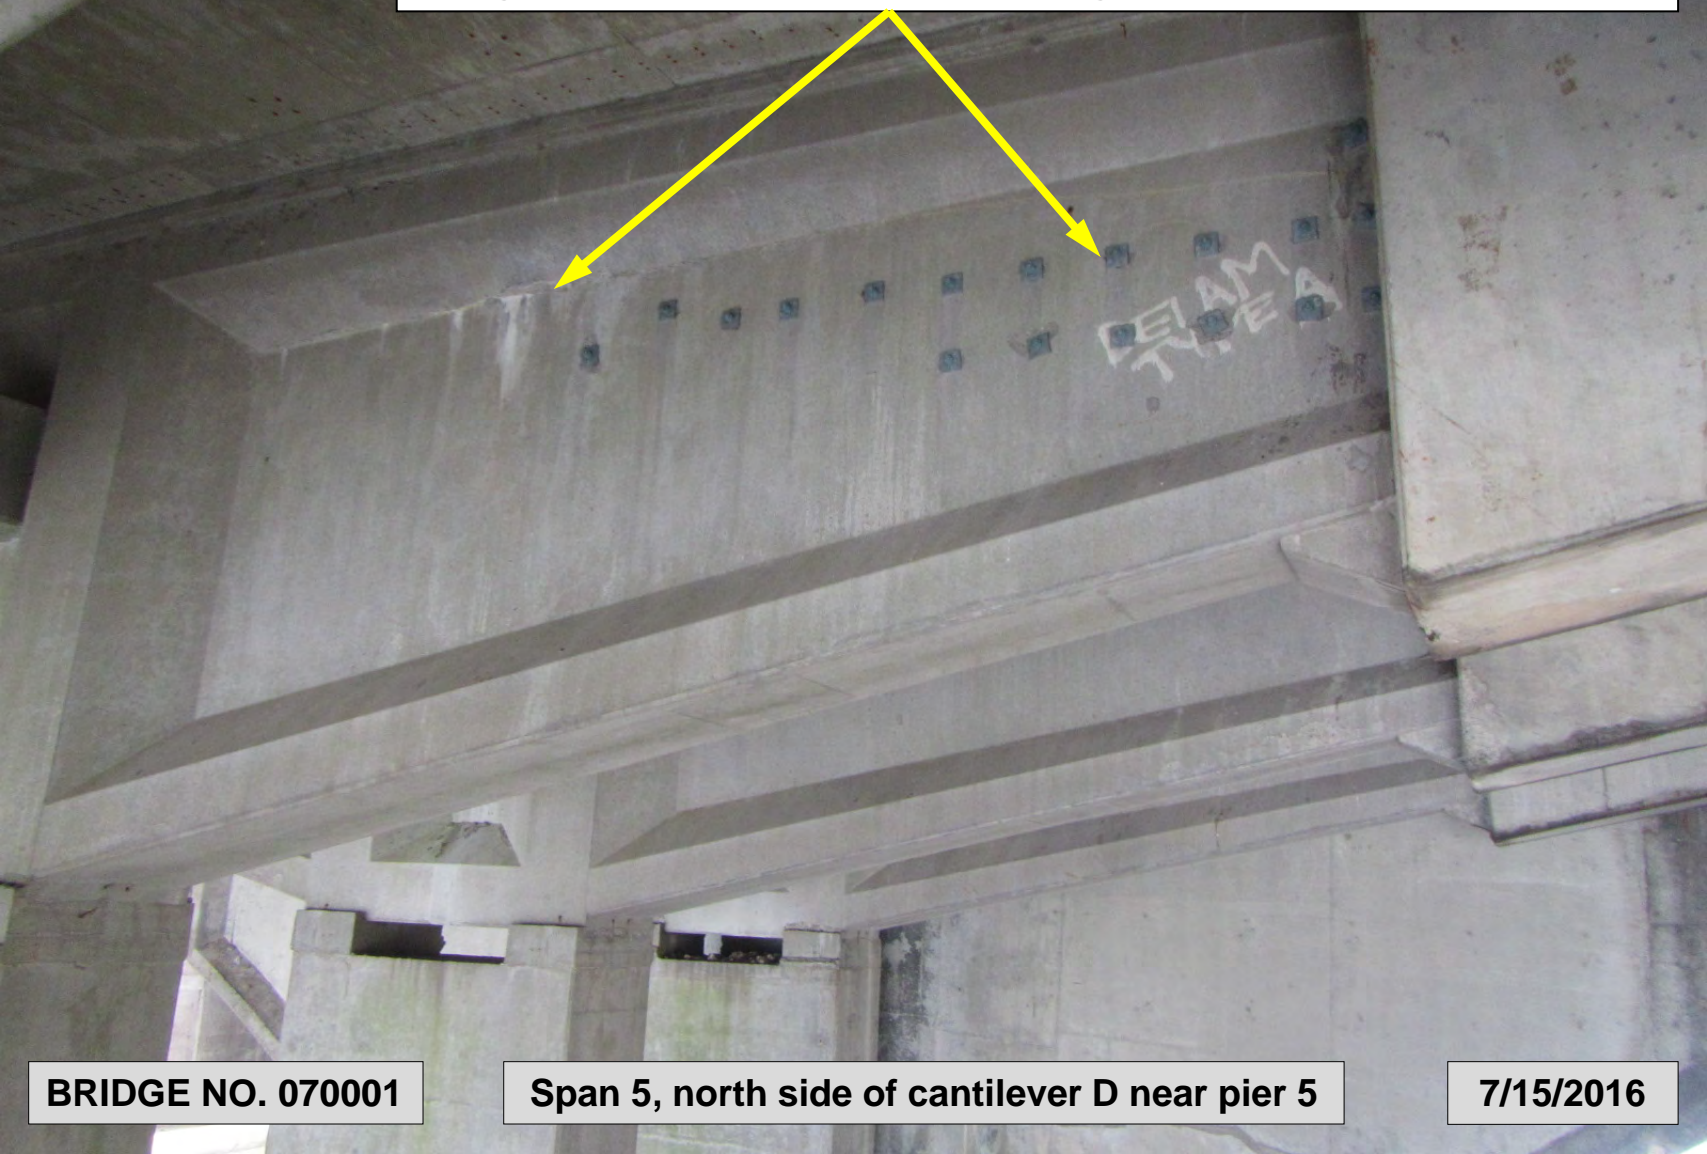
PHOTO #112

Full length x 0.025" wide horizontal hairline crack with efflorescence along top of web. (17) steel rods through bolted in the web

Span 5, north side of cantilever D near pier 5

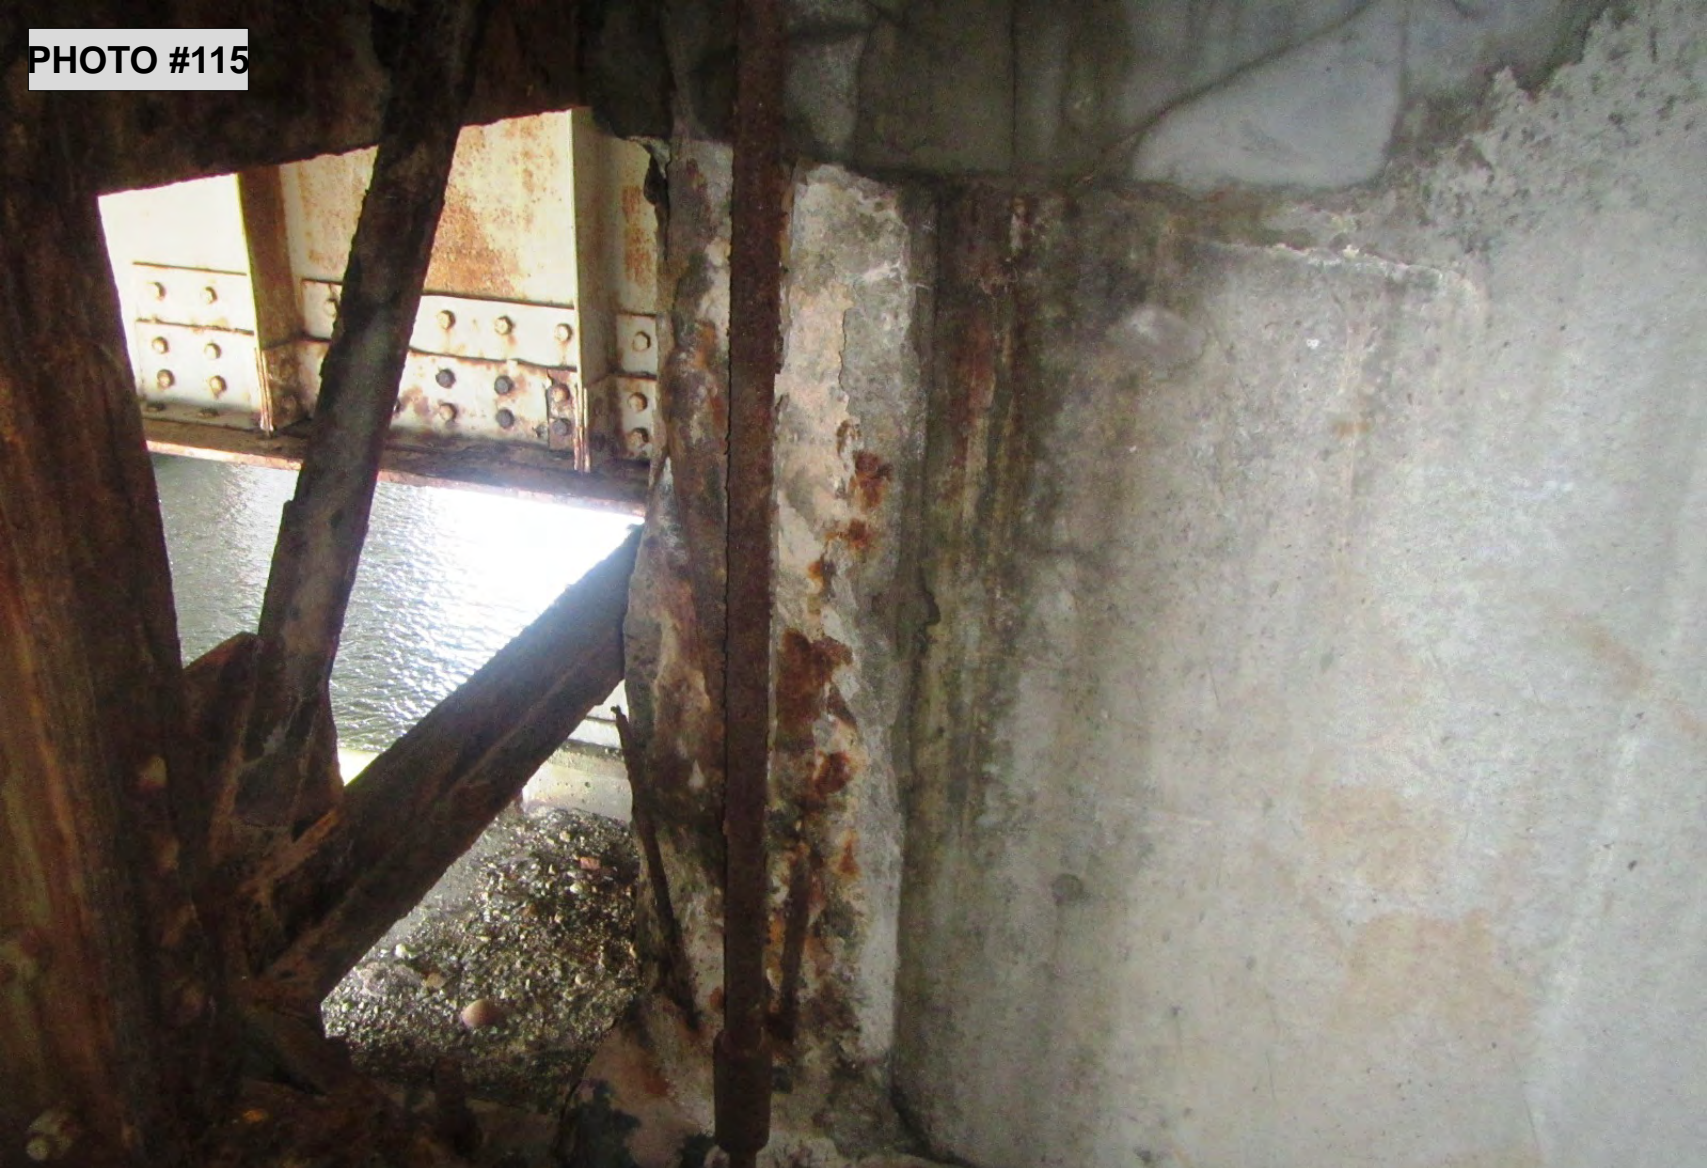
PHOTO #115

Same as photo 114 showing close-up of spall with exposed, debonded and broken rebar

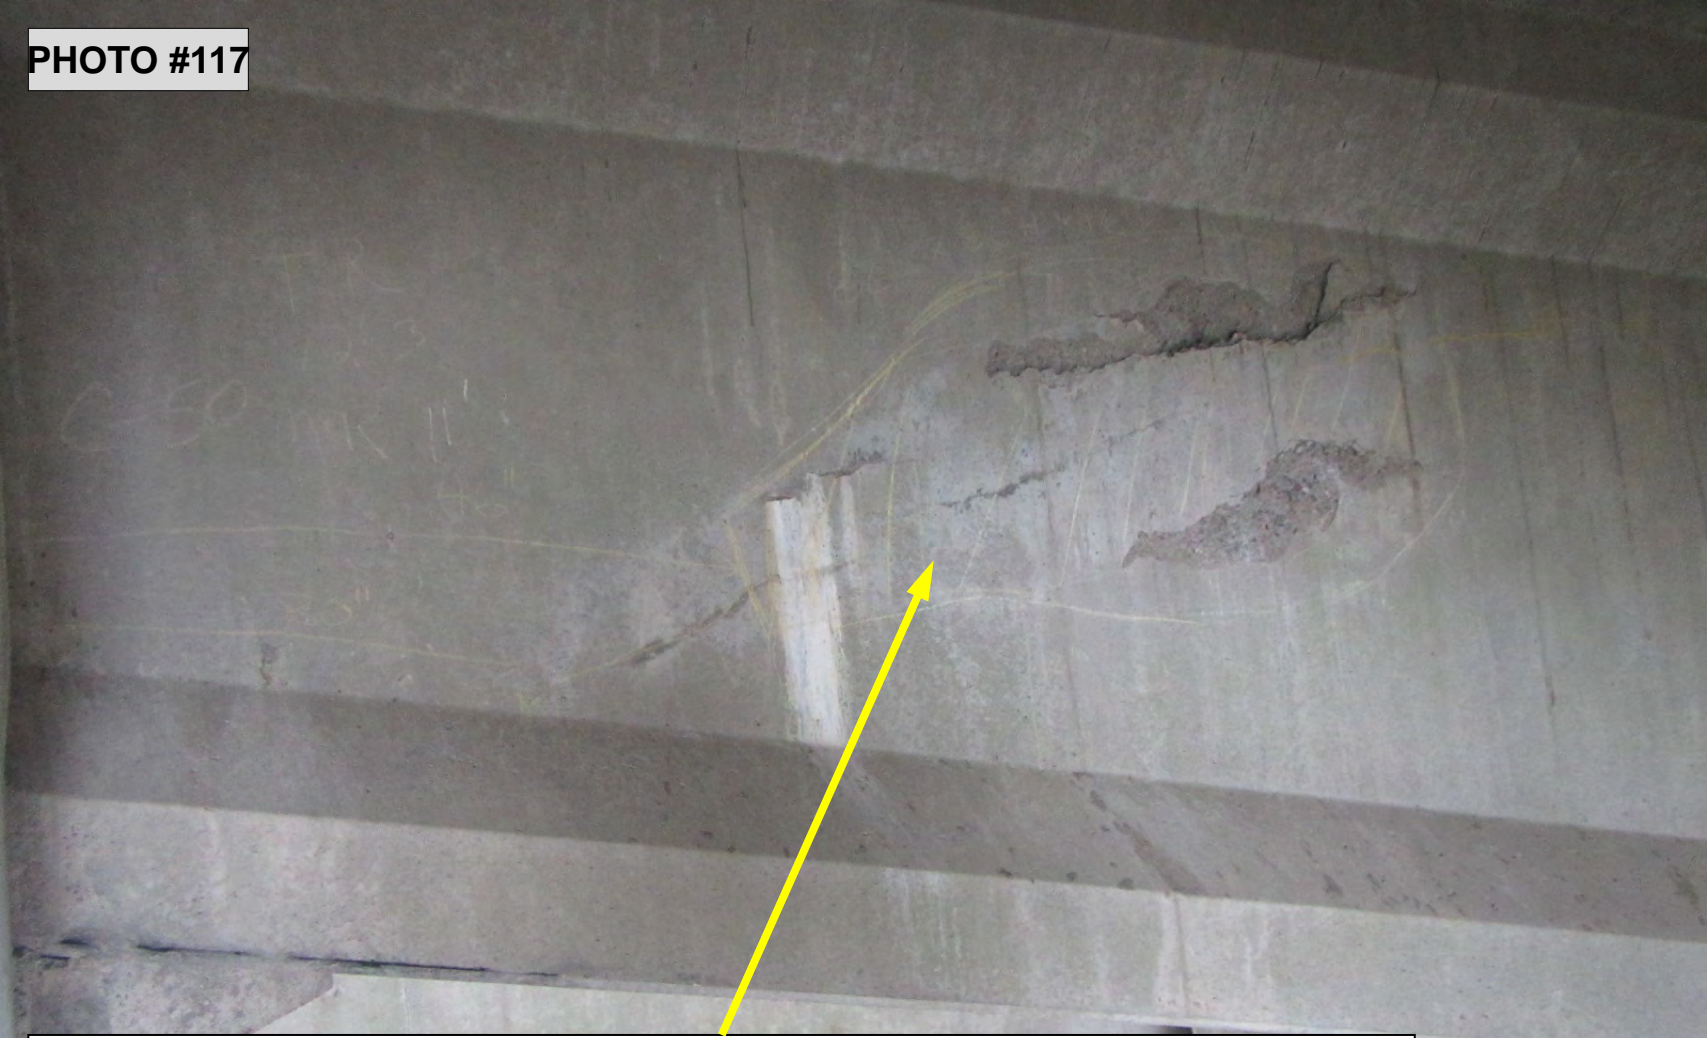
PHOTO #117

126" long diagonal hairline crack within 82"L long x 36" high hollow area with (2) spalls up to 1-1/2" deep with (2) exposed stirrups and efflorescence

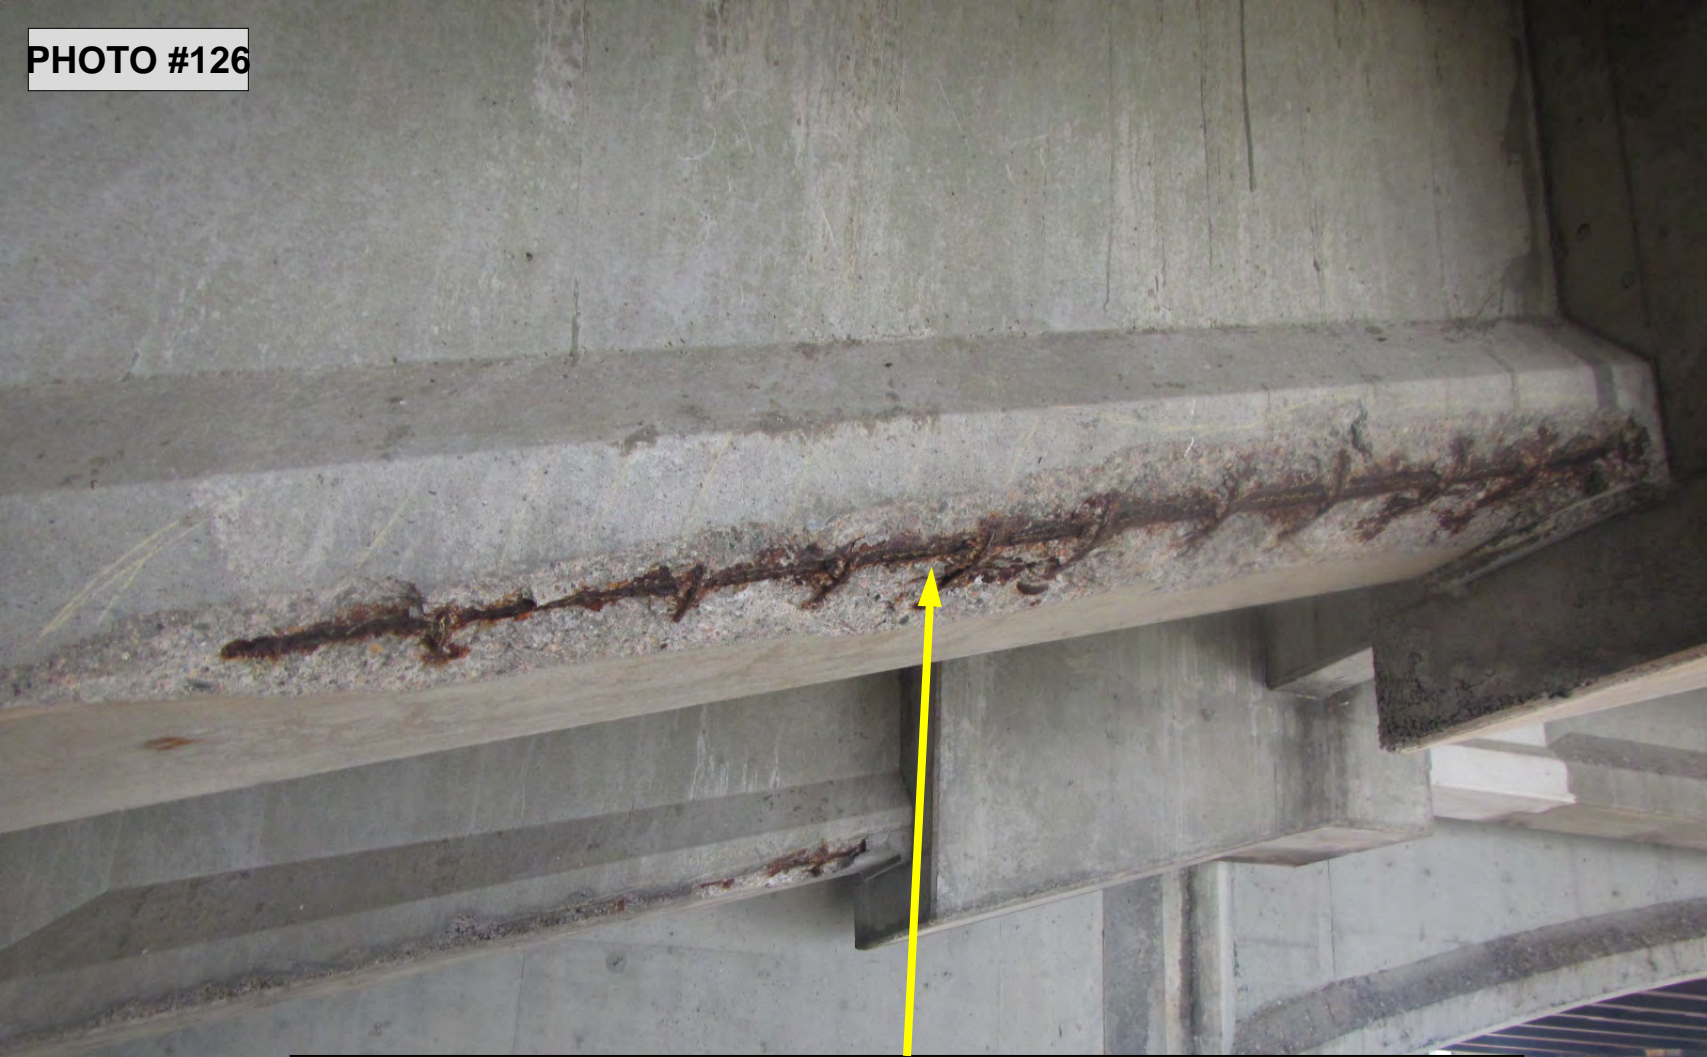
PHOTO #126

8' long x 14" wide x 2" deep spall with (2) exposed longitudinal bars, (2) snapped stirrups and a 6" diameter adjacent hollow area

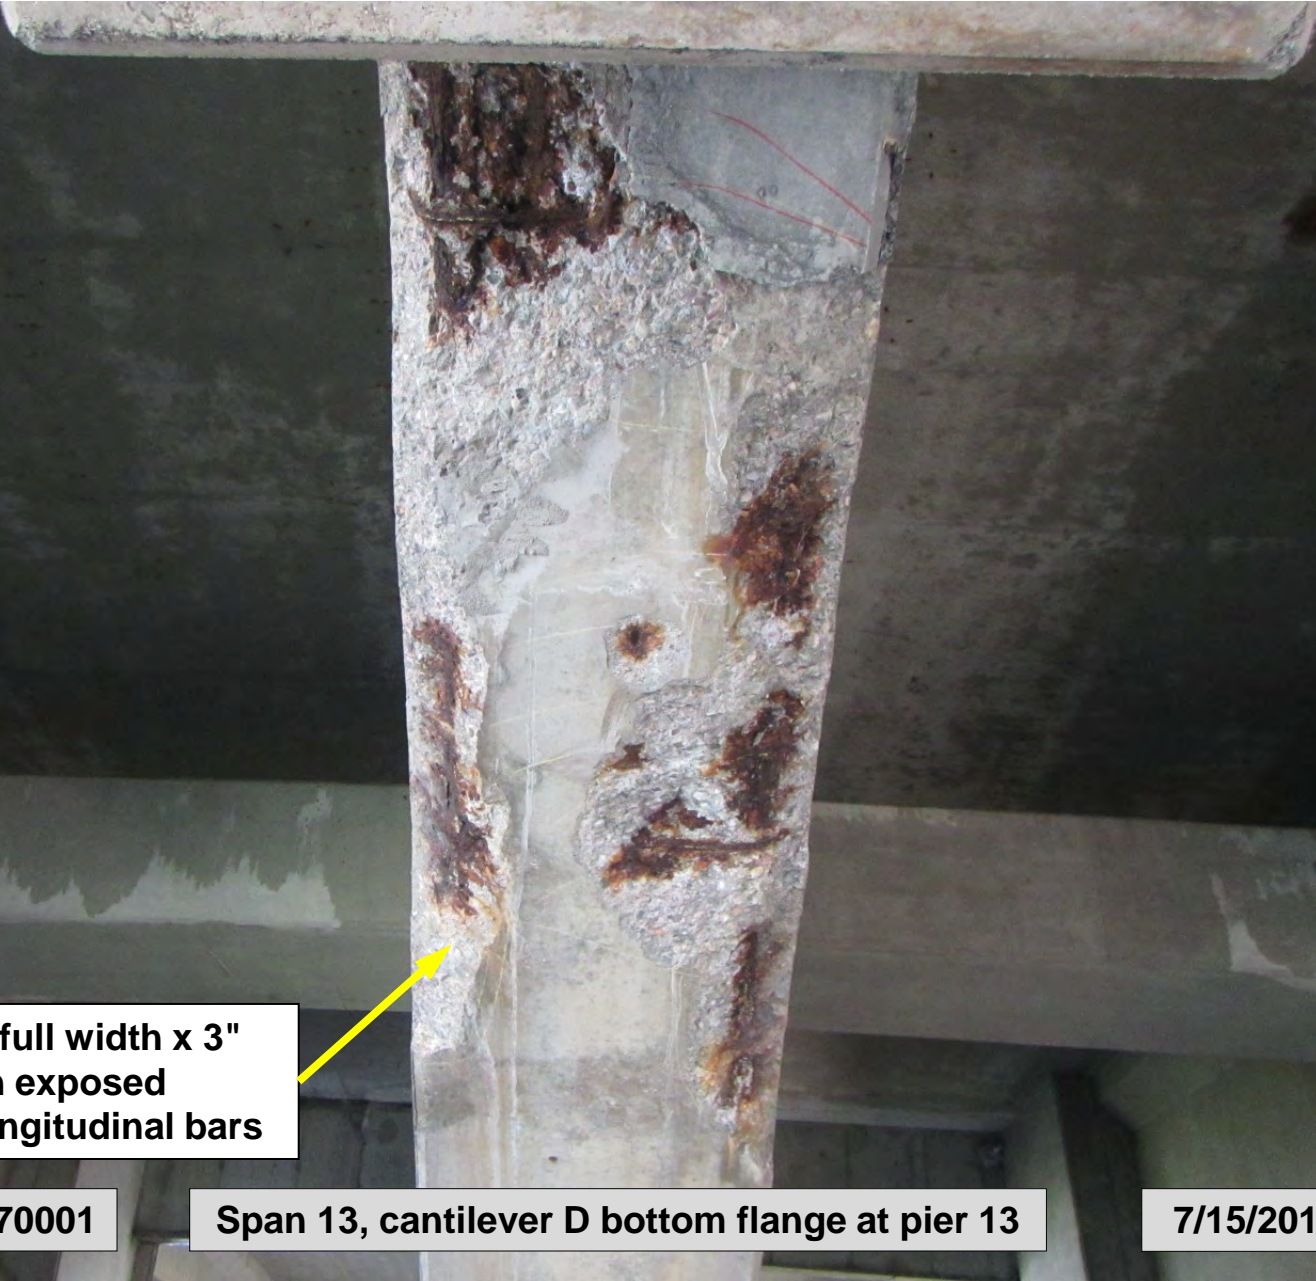
PHOTO #127

**9' long x up to full width x 3"
deep spall with exposed
stirrups and longitudinal bars**

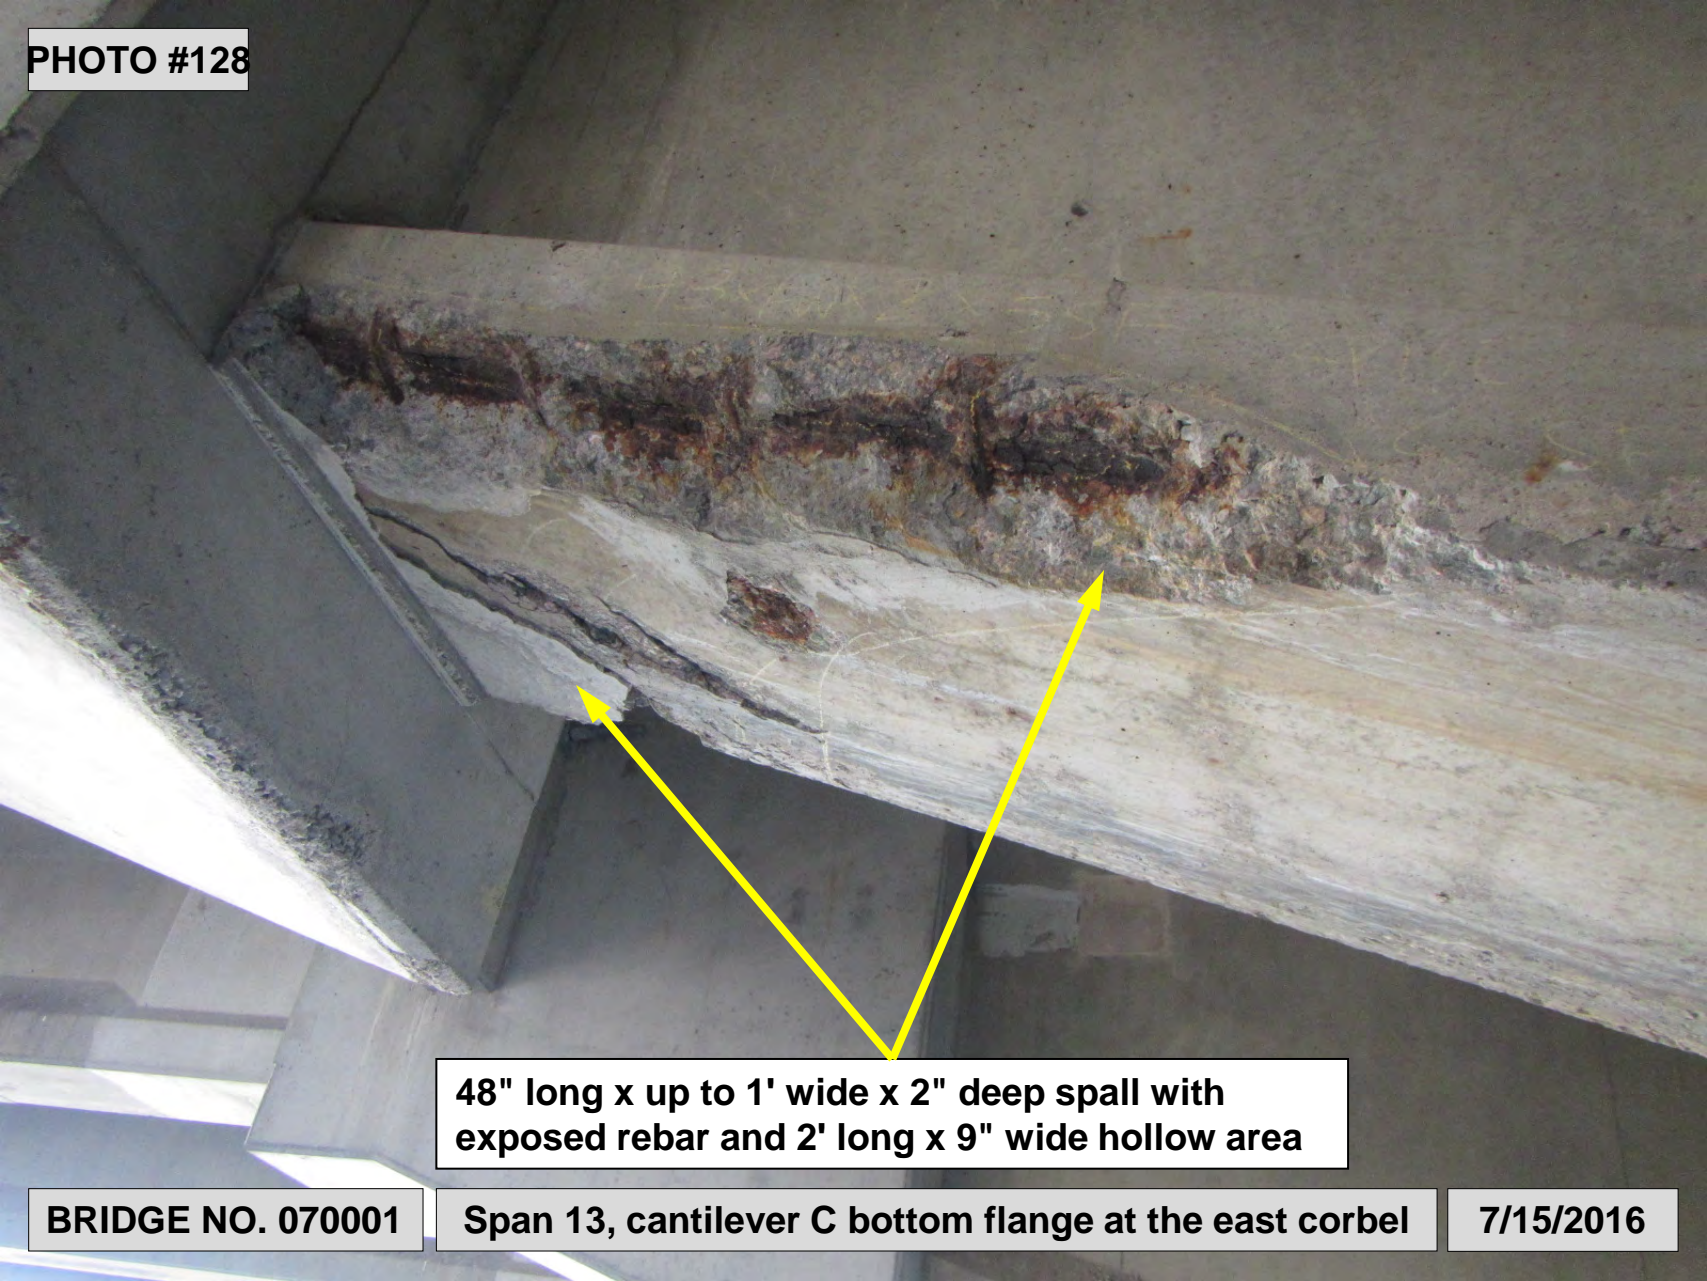
PHOTO #128

48" long x up to 1' wide x 2" deep spall with exposed rebar and 2' long x 9" wide hollow area

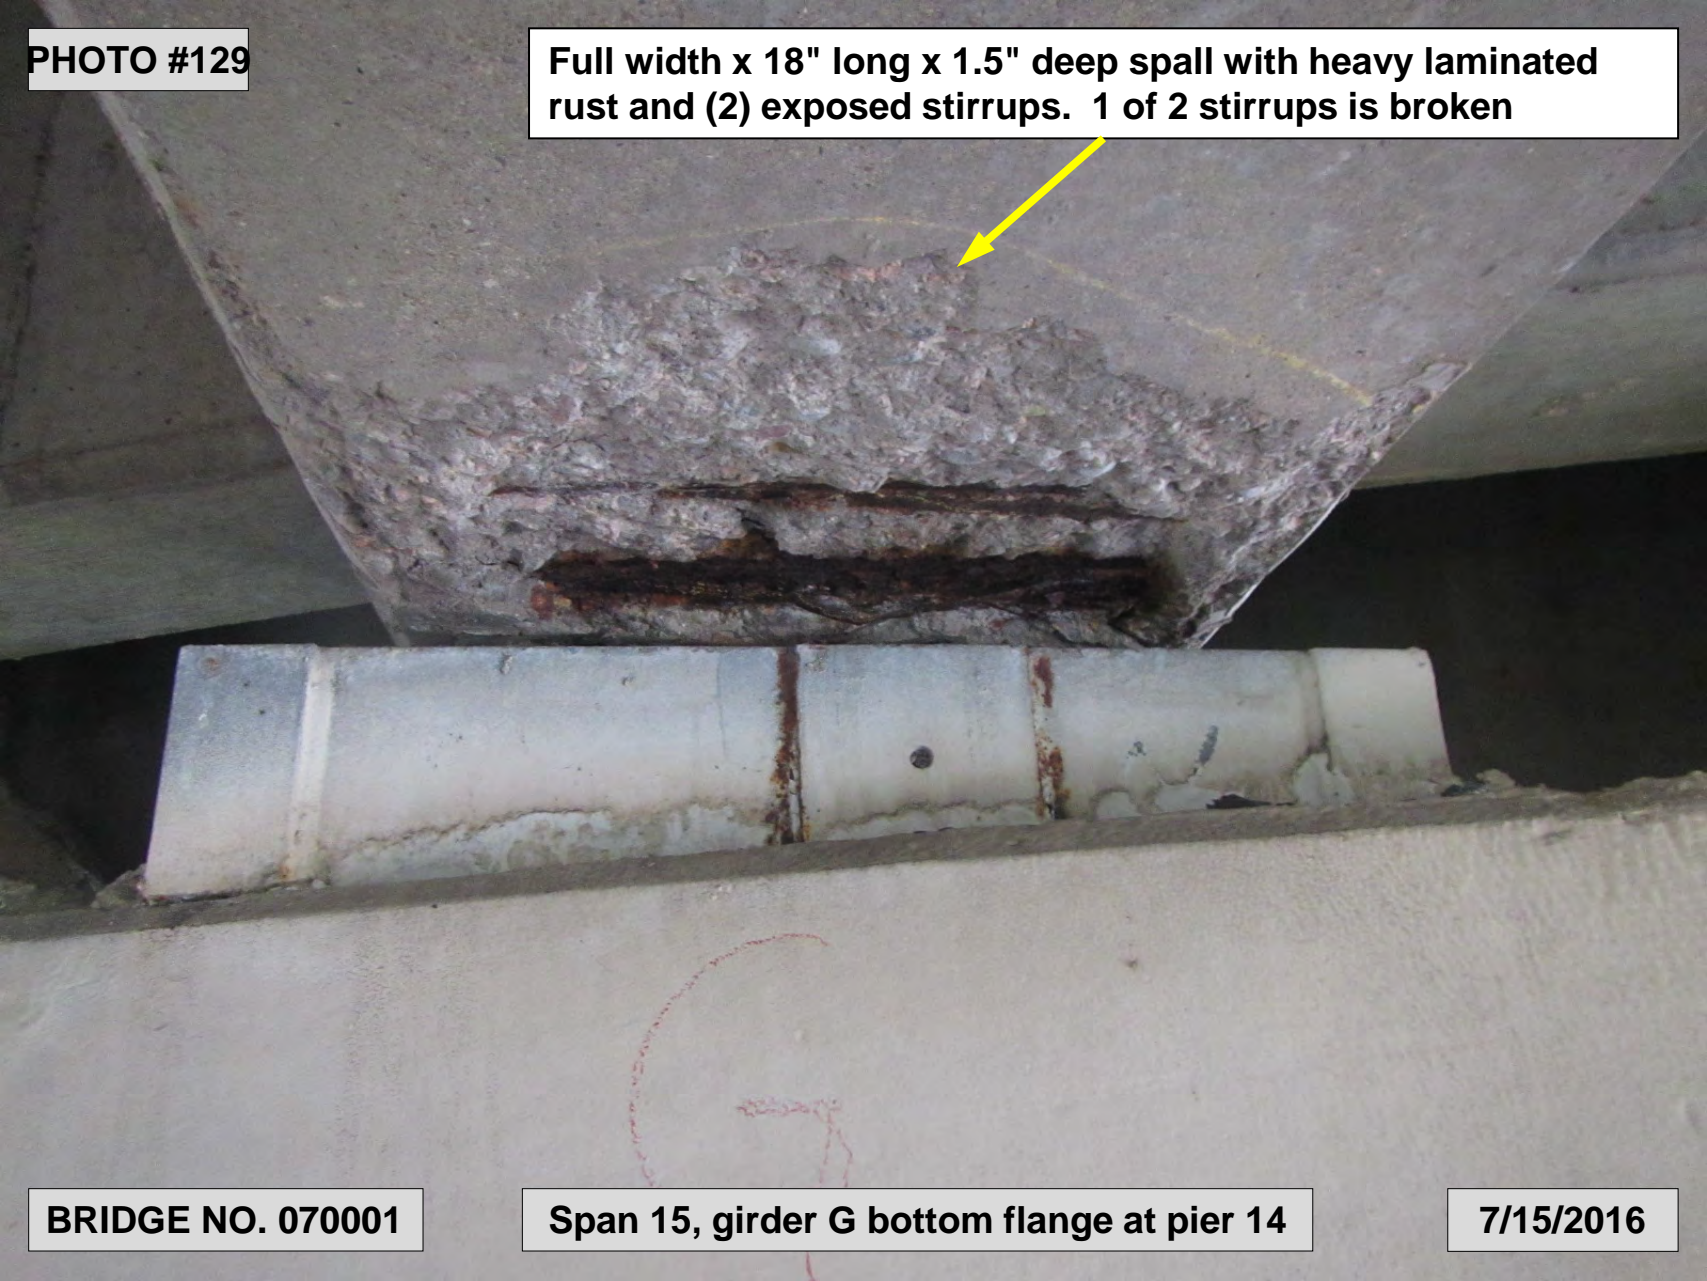
PHOTO #129

Full width x 18" long x 1.5" deep spall with heavy laminated rust and (2) exposed stirrups. 1 of 2 stirrups is broken

Span 15, girder G bottom flange at pier 14

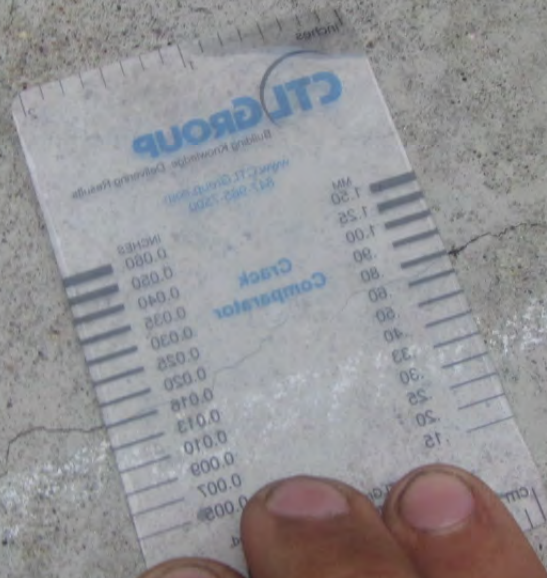
PHOTO #131

Same as photo 130 showing crack width

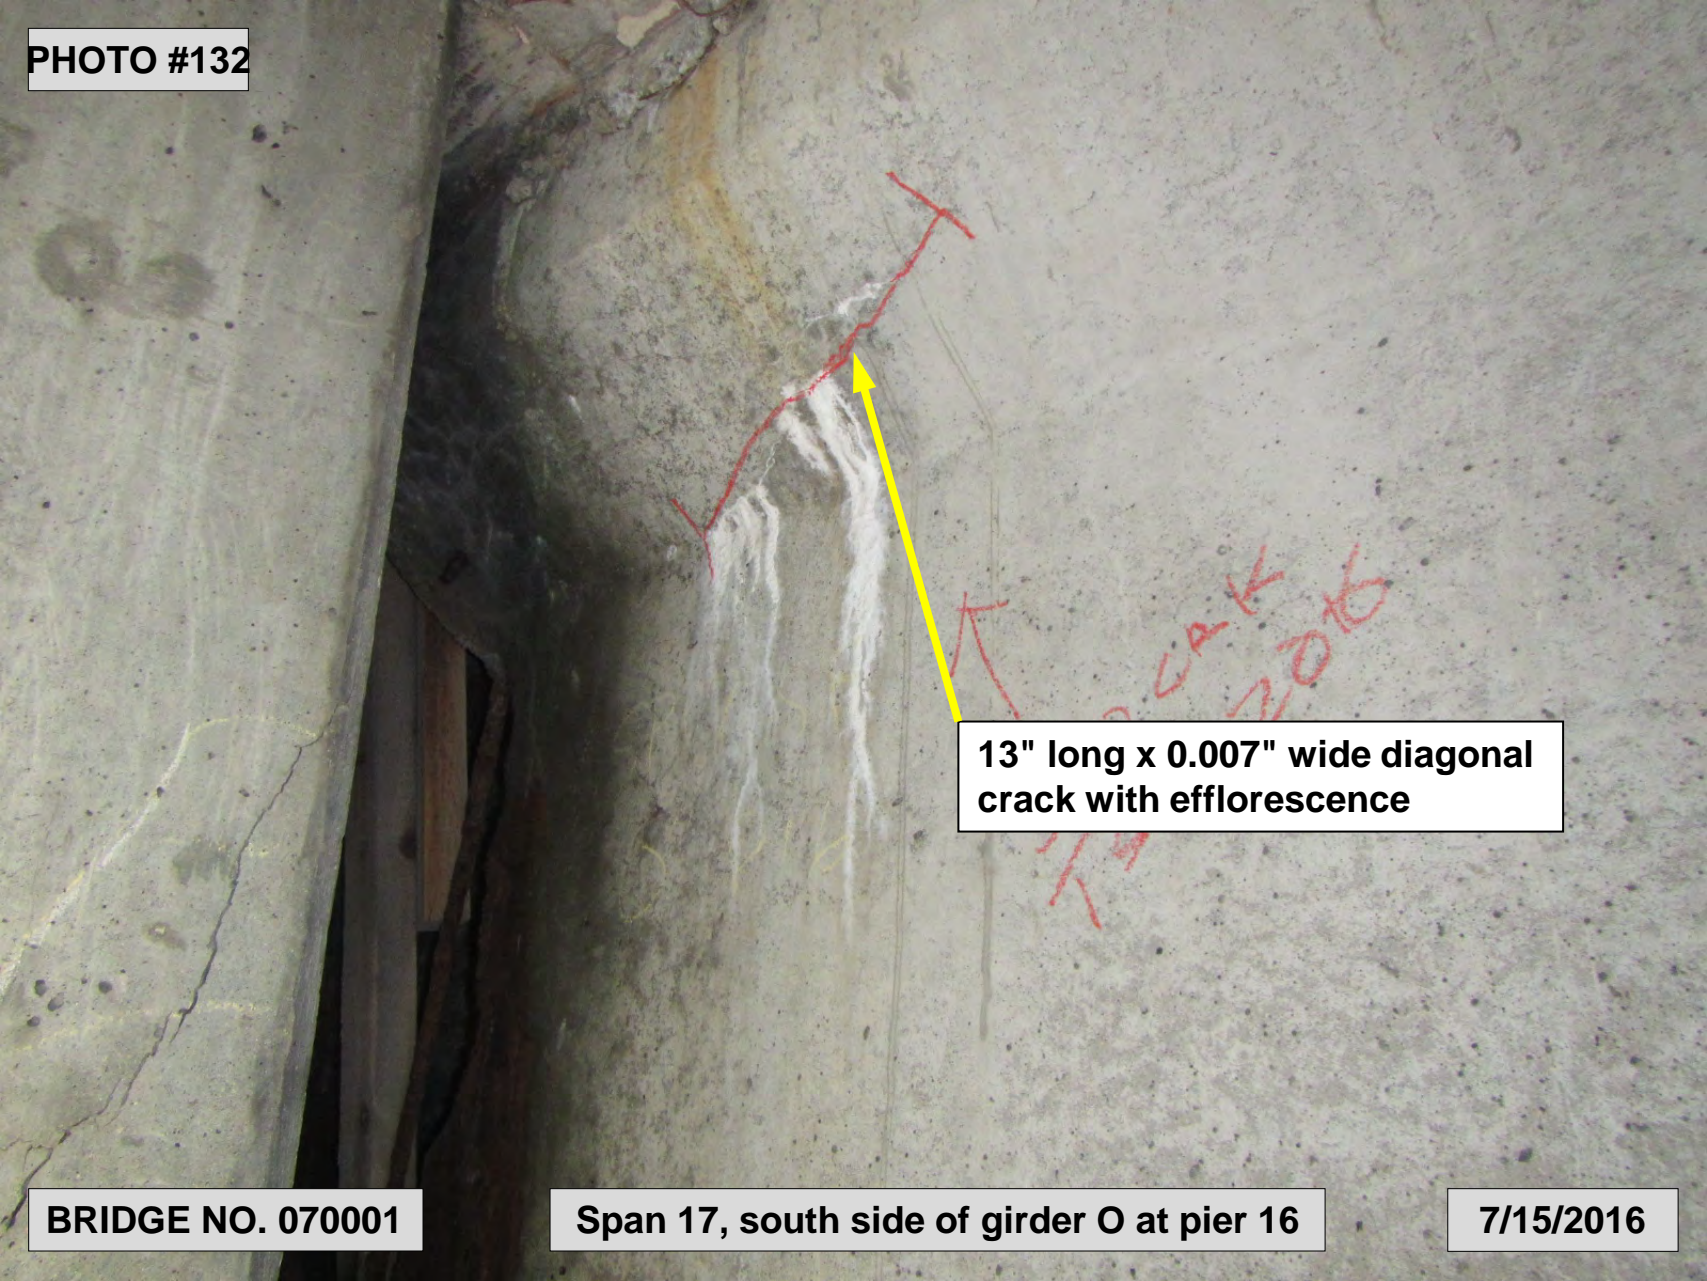
PHOTO #132

13" long x 0.007" wide diagonal crack with efflorescence

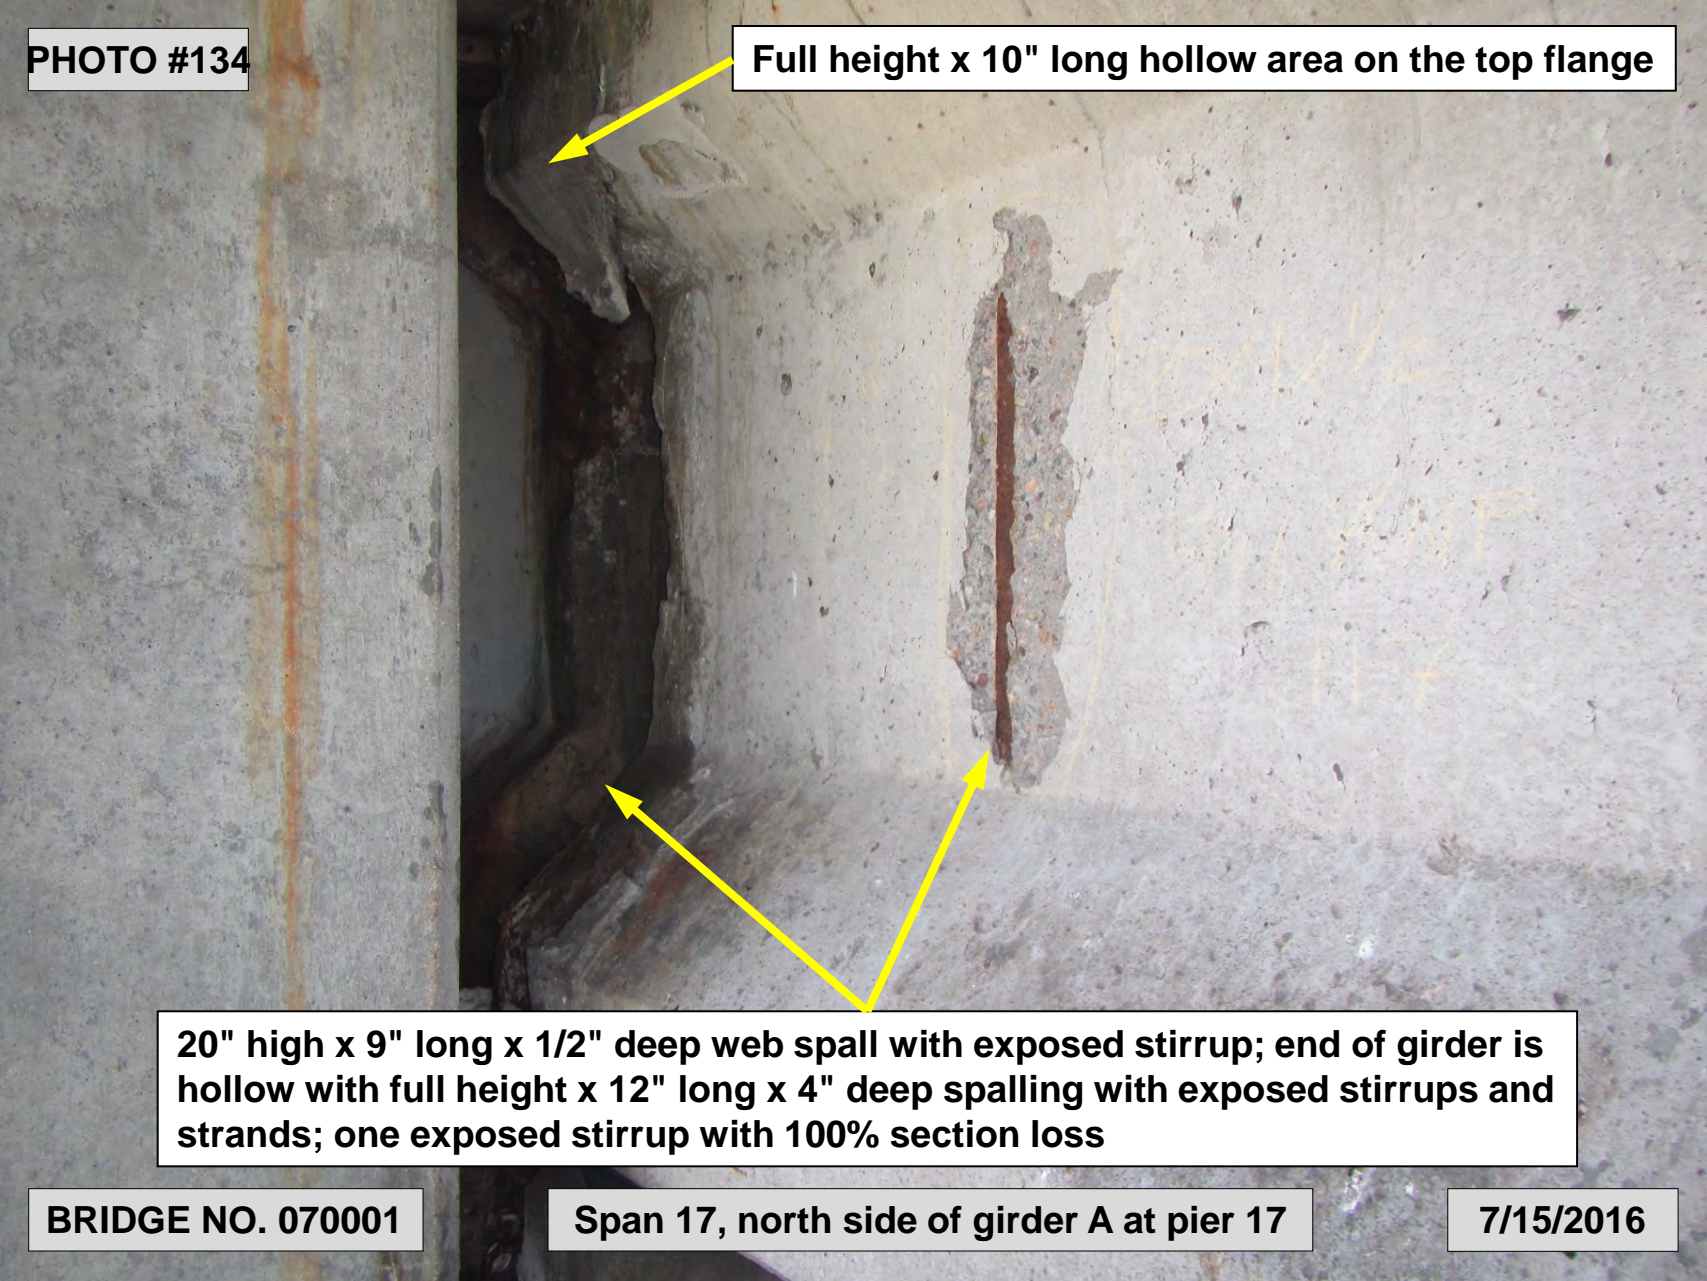
PHOTO #134

Full height x 10" long hollow area on the top flange

20" high x 9" long x 1/2" deep web spall with exposed stirrup; end of girder is hollow with full height x 12" long x 4" deep spalling with exposed stirrups and strands; one exposed stirrup with 100% section loss

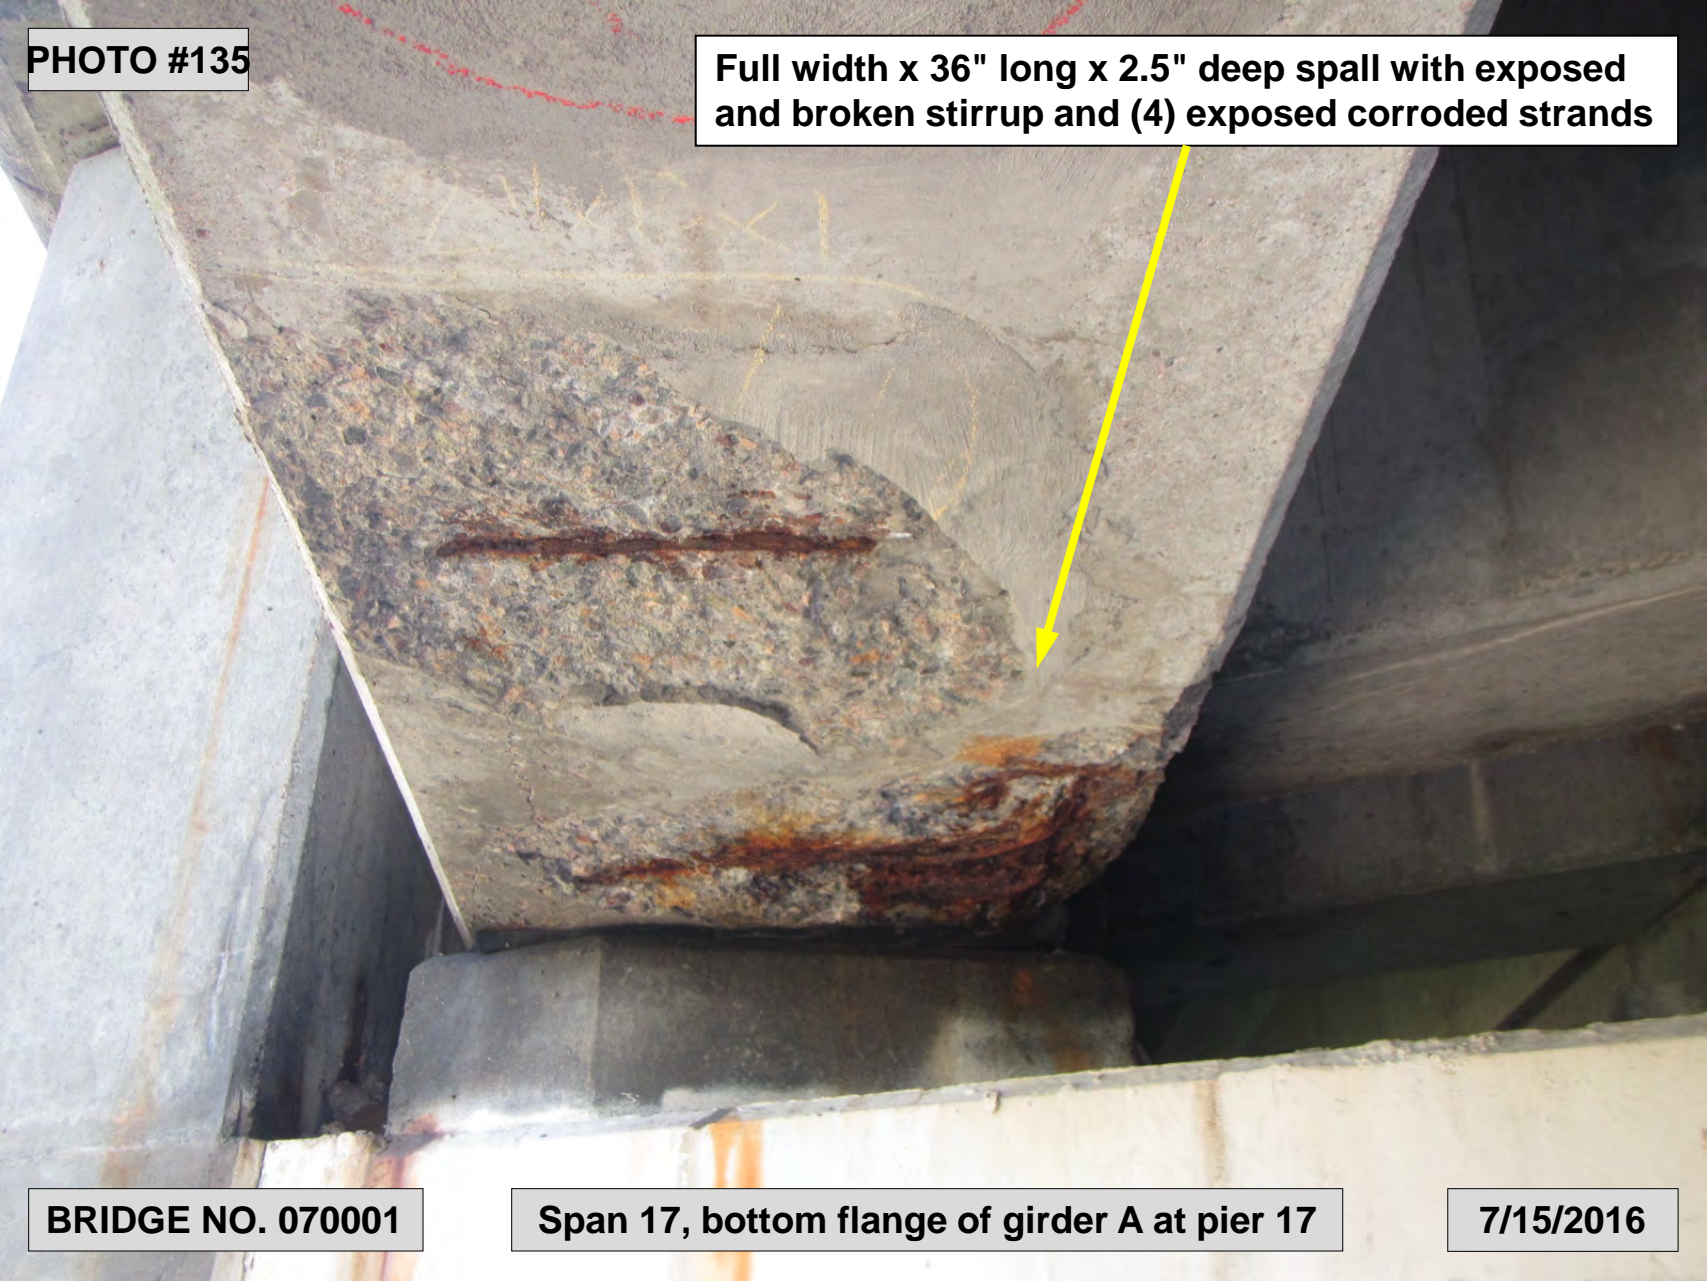
PHOTO #135

Full width x 36" long x 2.5" deep spall with exposed and broken stirrup and (4) exposed corroded strands

Span 17, bottom flange of girder A at pier 17
