BRIDGE NO. 070001

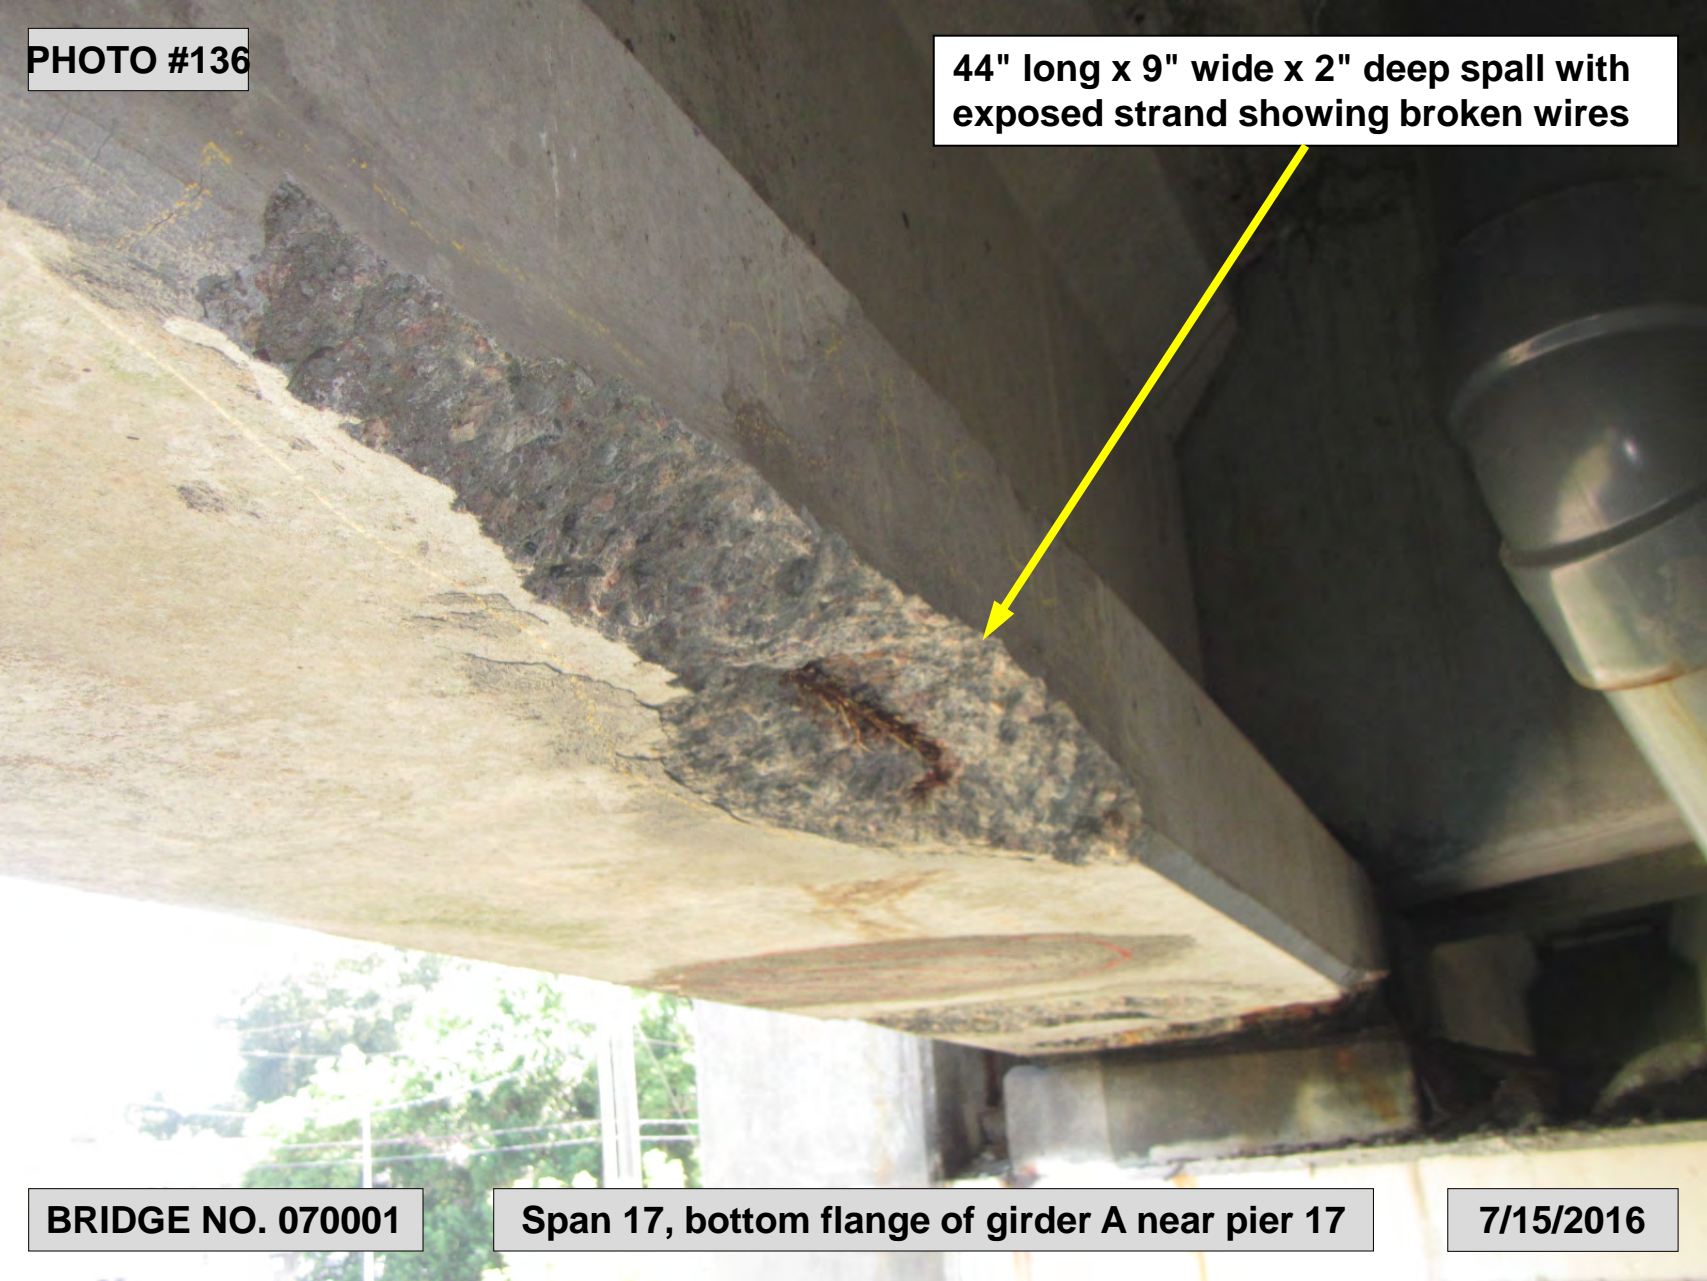
PHOTO #136

44" long x 9" wide x 2" deep spall with exposed strand showing broken wires

Span 17, bottom flange of girder A near pier 17

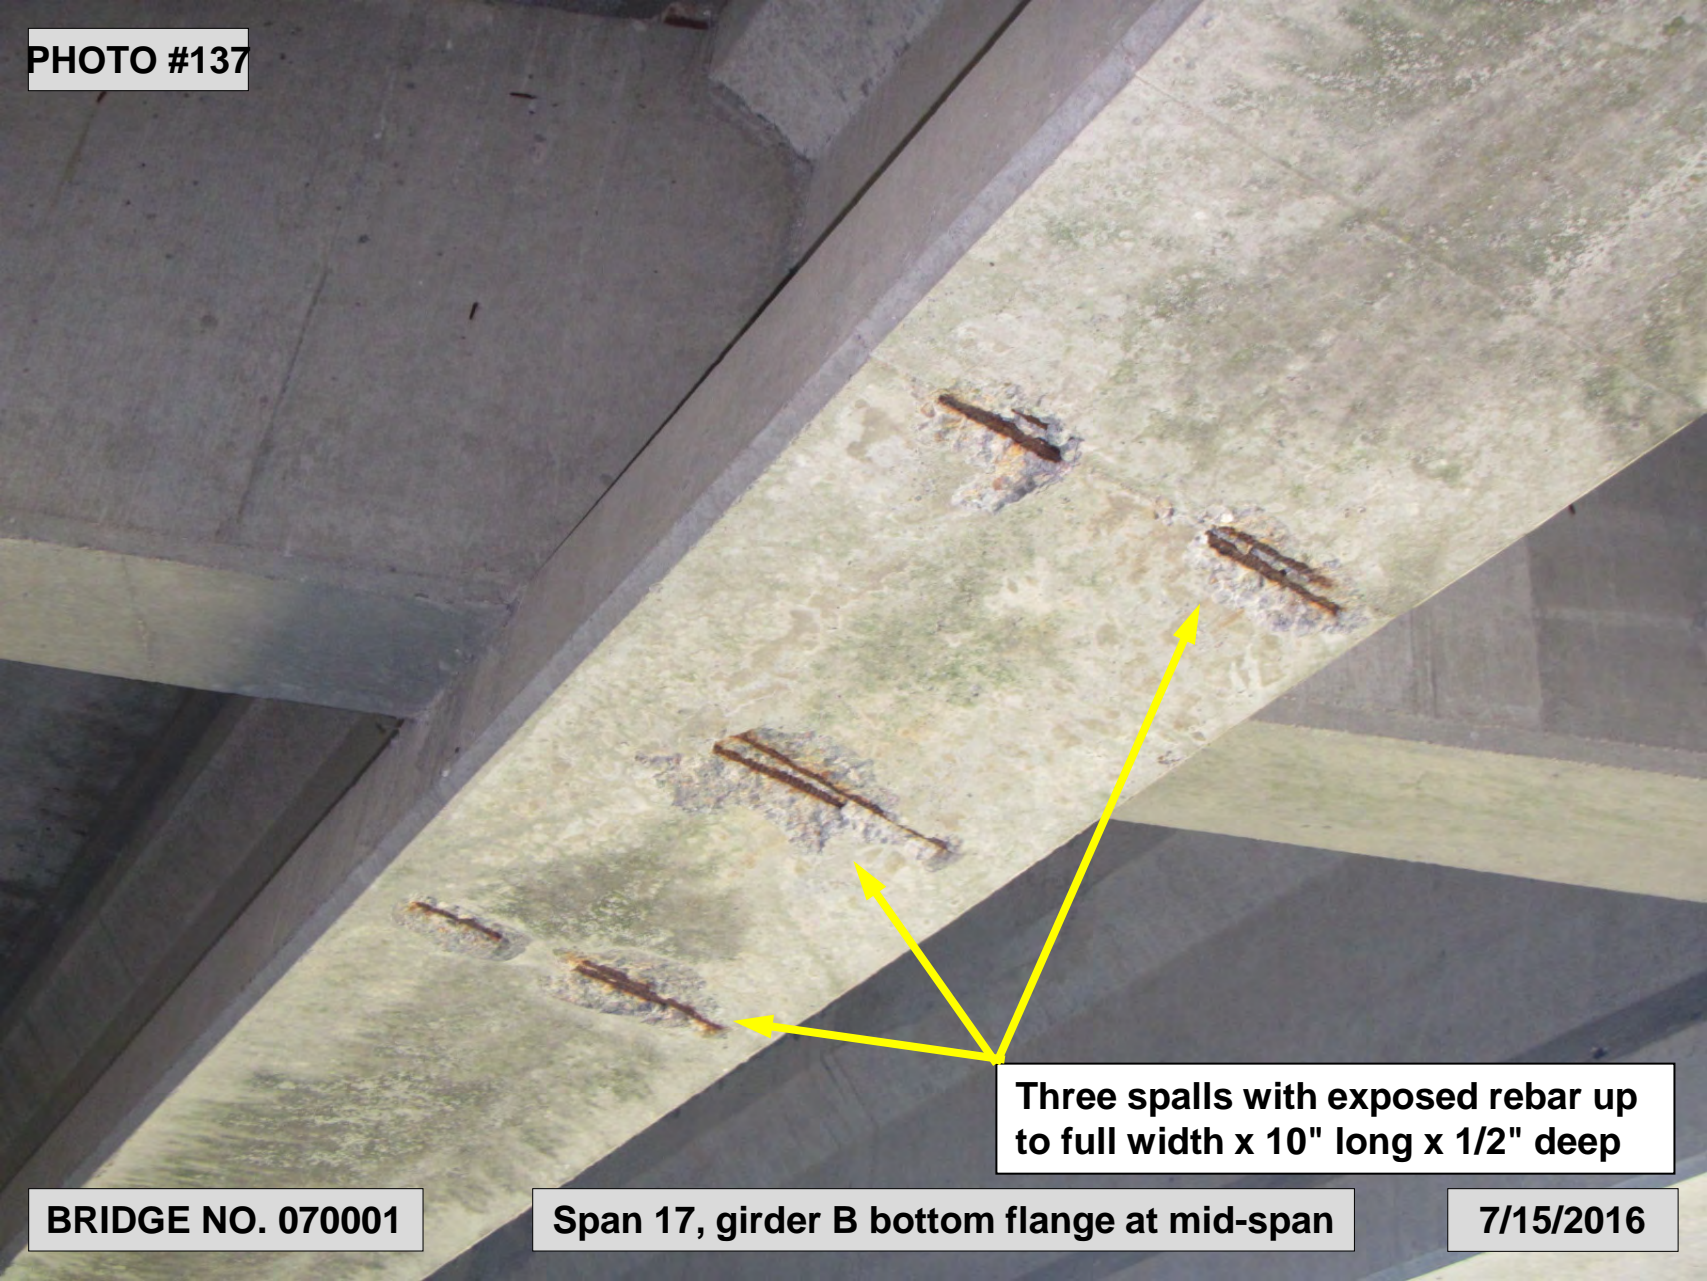
PHOTO #137

Three spalls with exposed rebar up to full width x 10" long x 1/2" deep

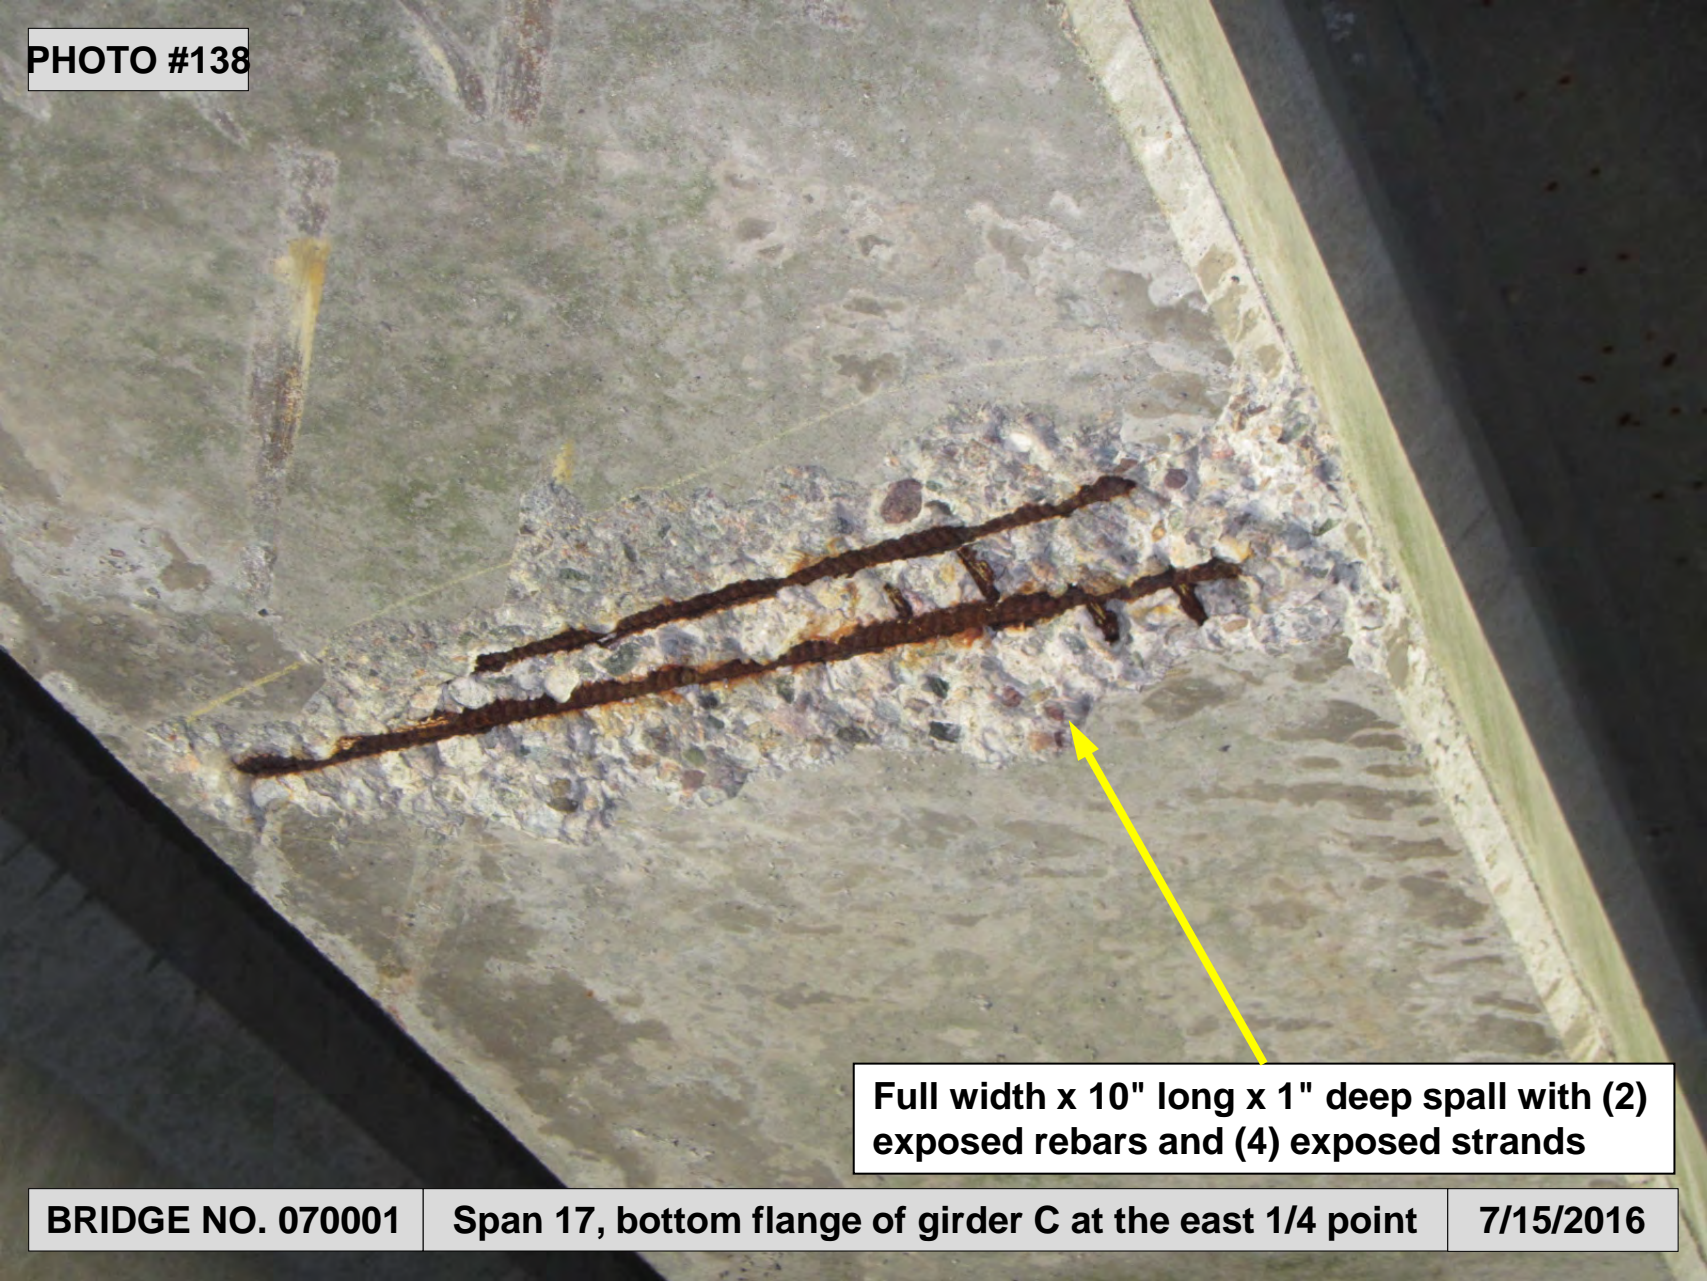
PHOTO #138

Full width x 10" long x 1" deep spall with (2) exposed rebar and (4) exposed strands

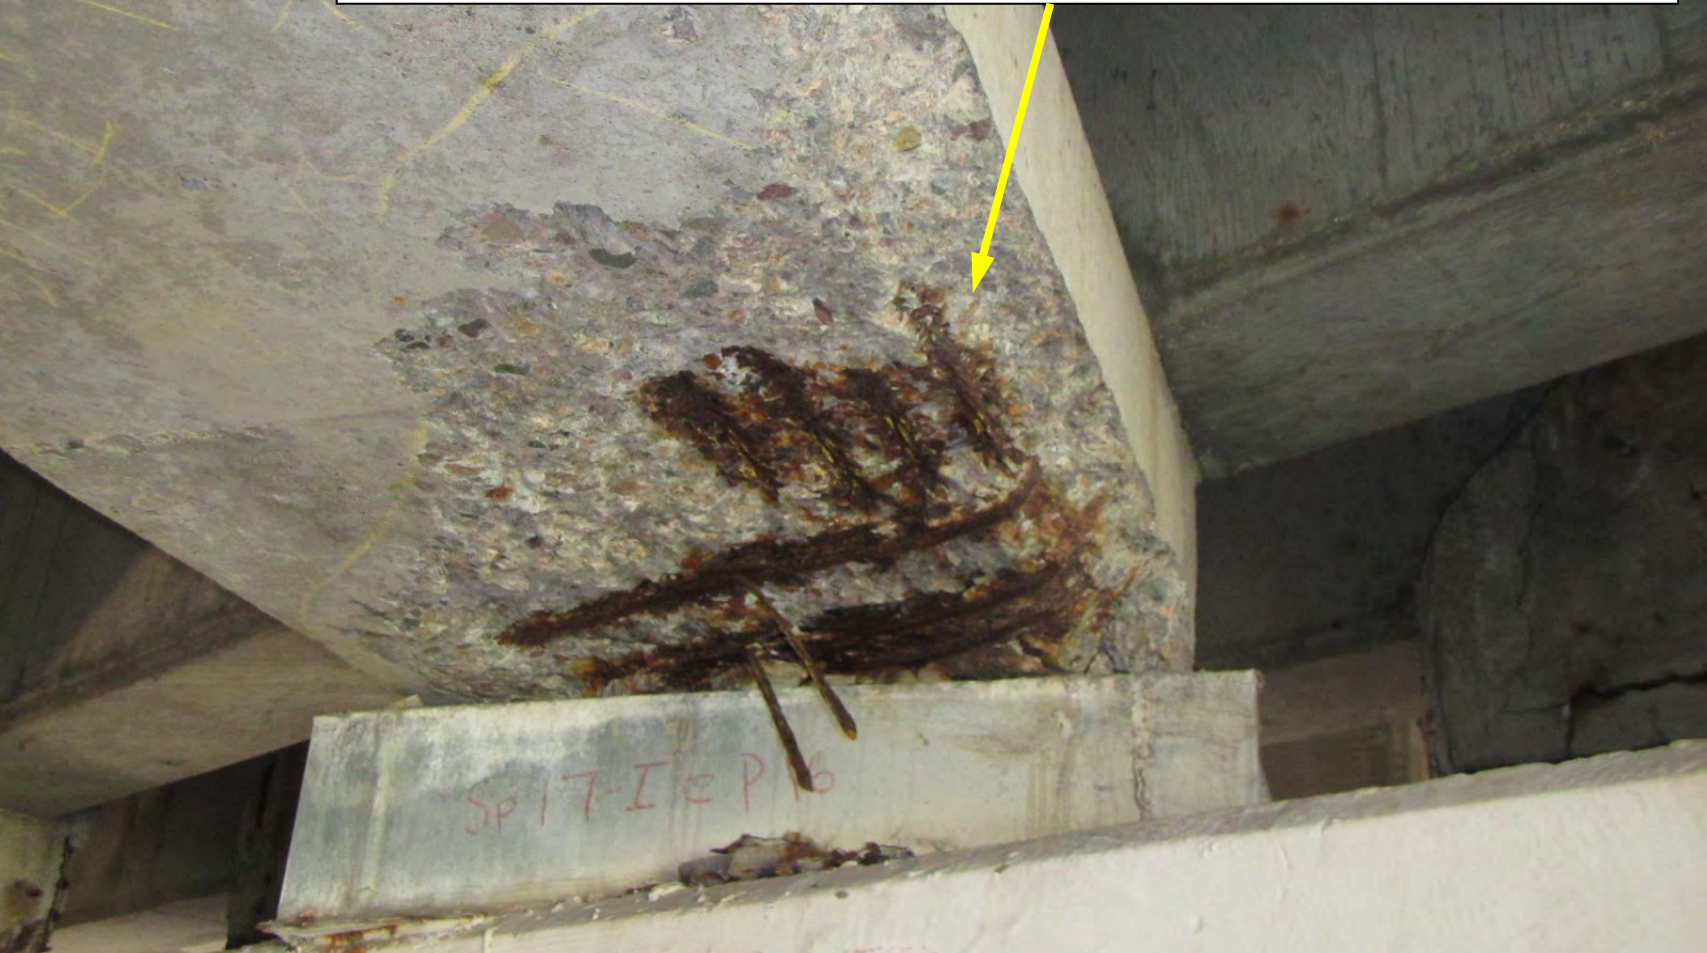
PHOTO #139

Up to full width x 42" long x 2" deep spall, with (4) exposed strands showing broken wires; adjacent 18" long x 2" wide x 2" high corner/edge spall with (2) exposed and broken stirrups; remaining exposed stirrups show up to 50%± section loss. See photo 140 for close-up

Span 17, bottom flange of girder I at pier 16

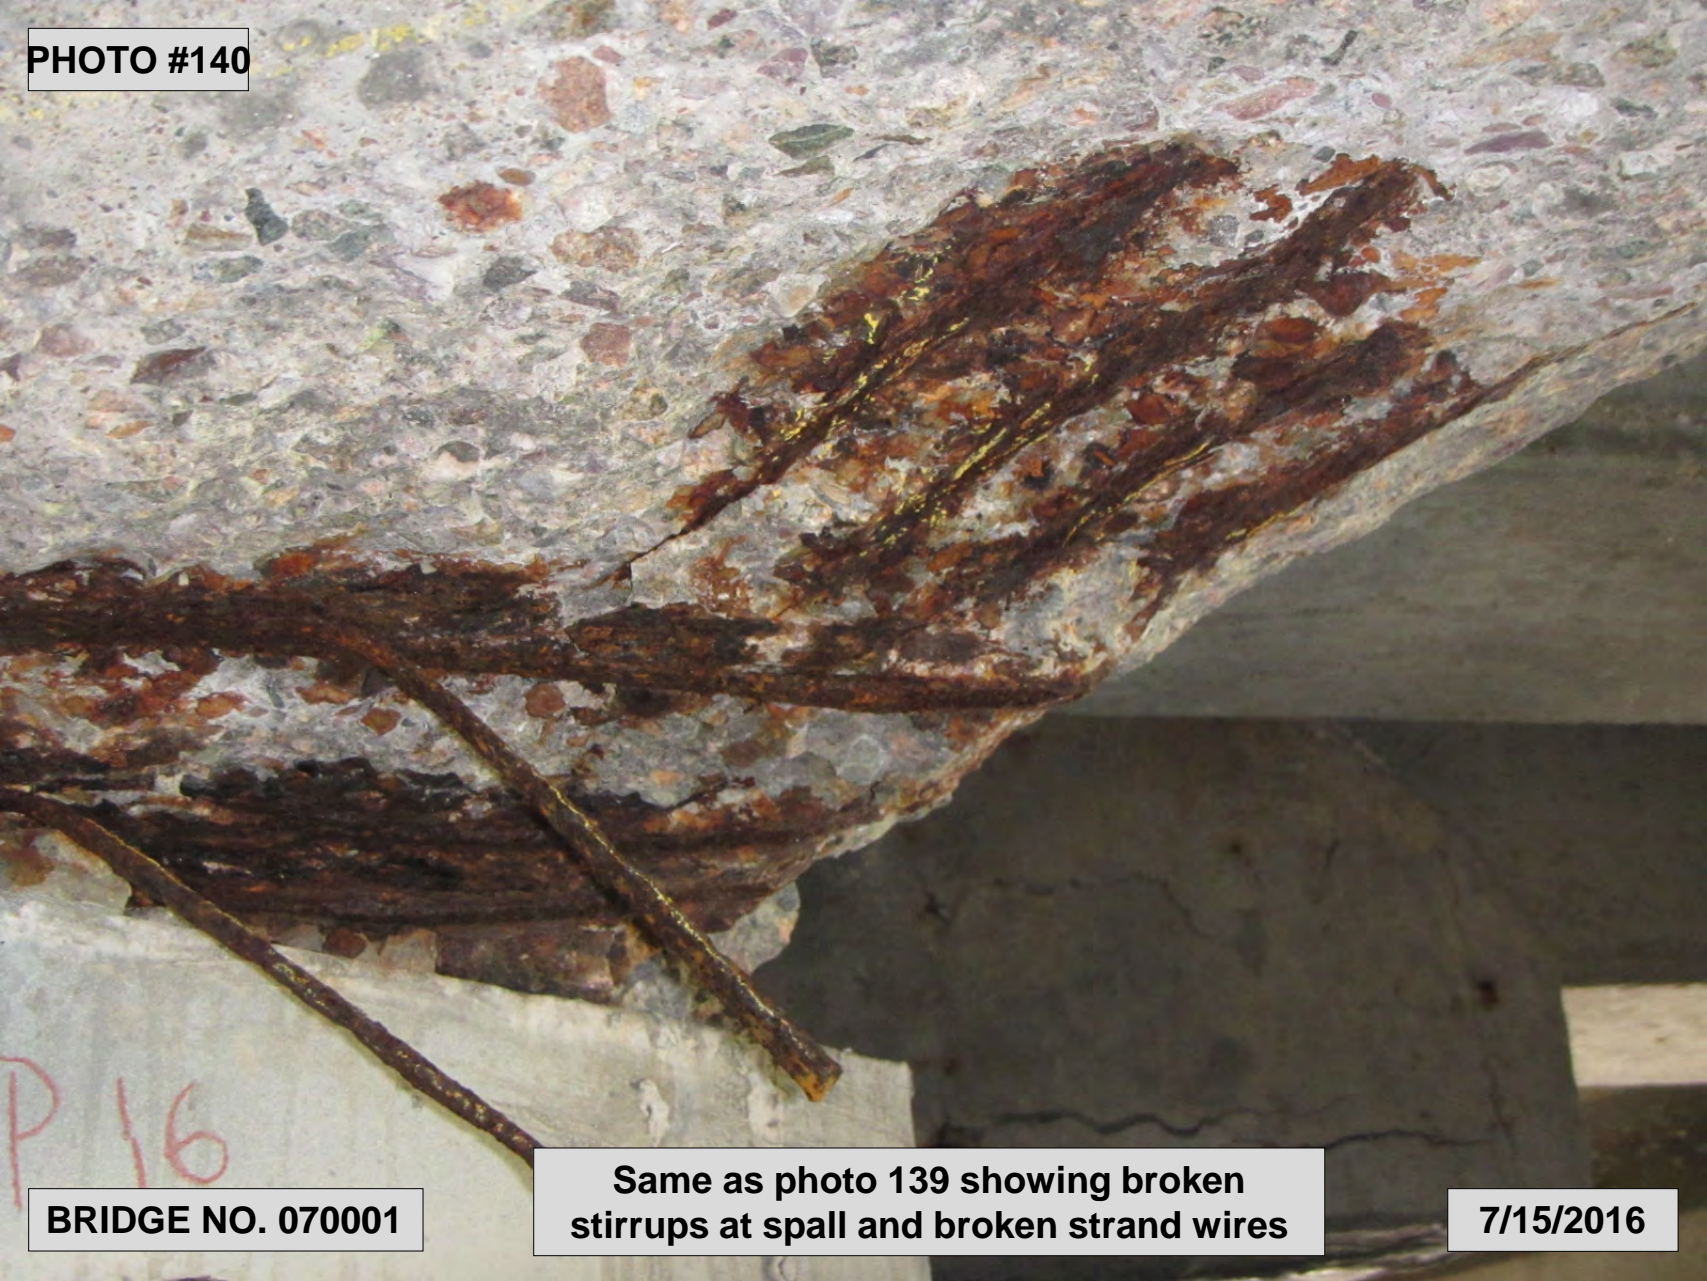
PHOTO #140

Same as photo 139 showing broken stirrups at spall and broken strand wires

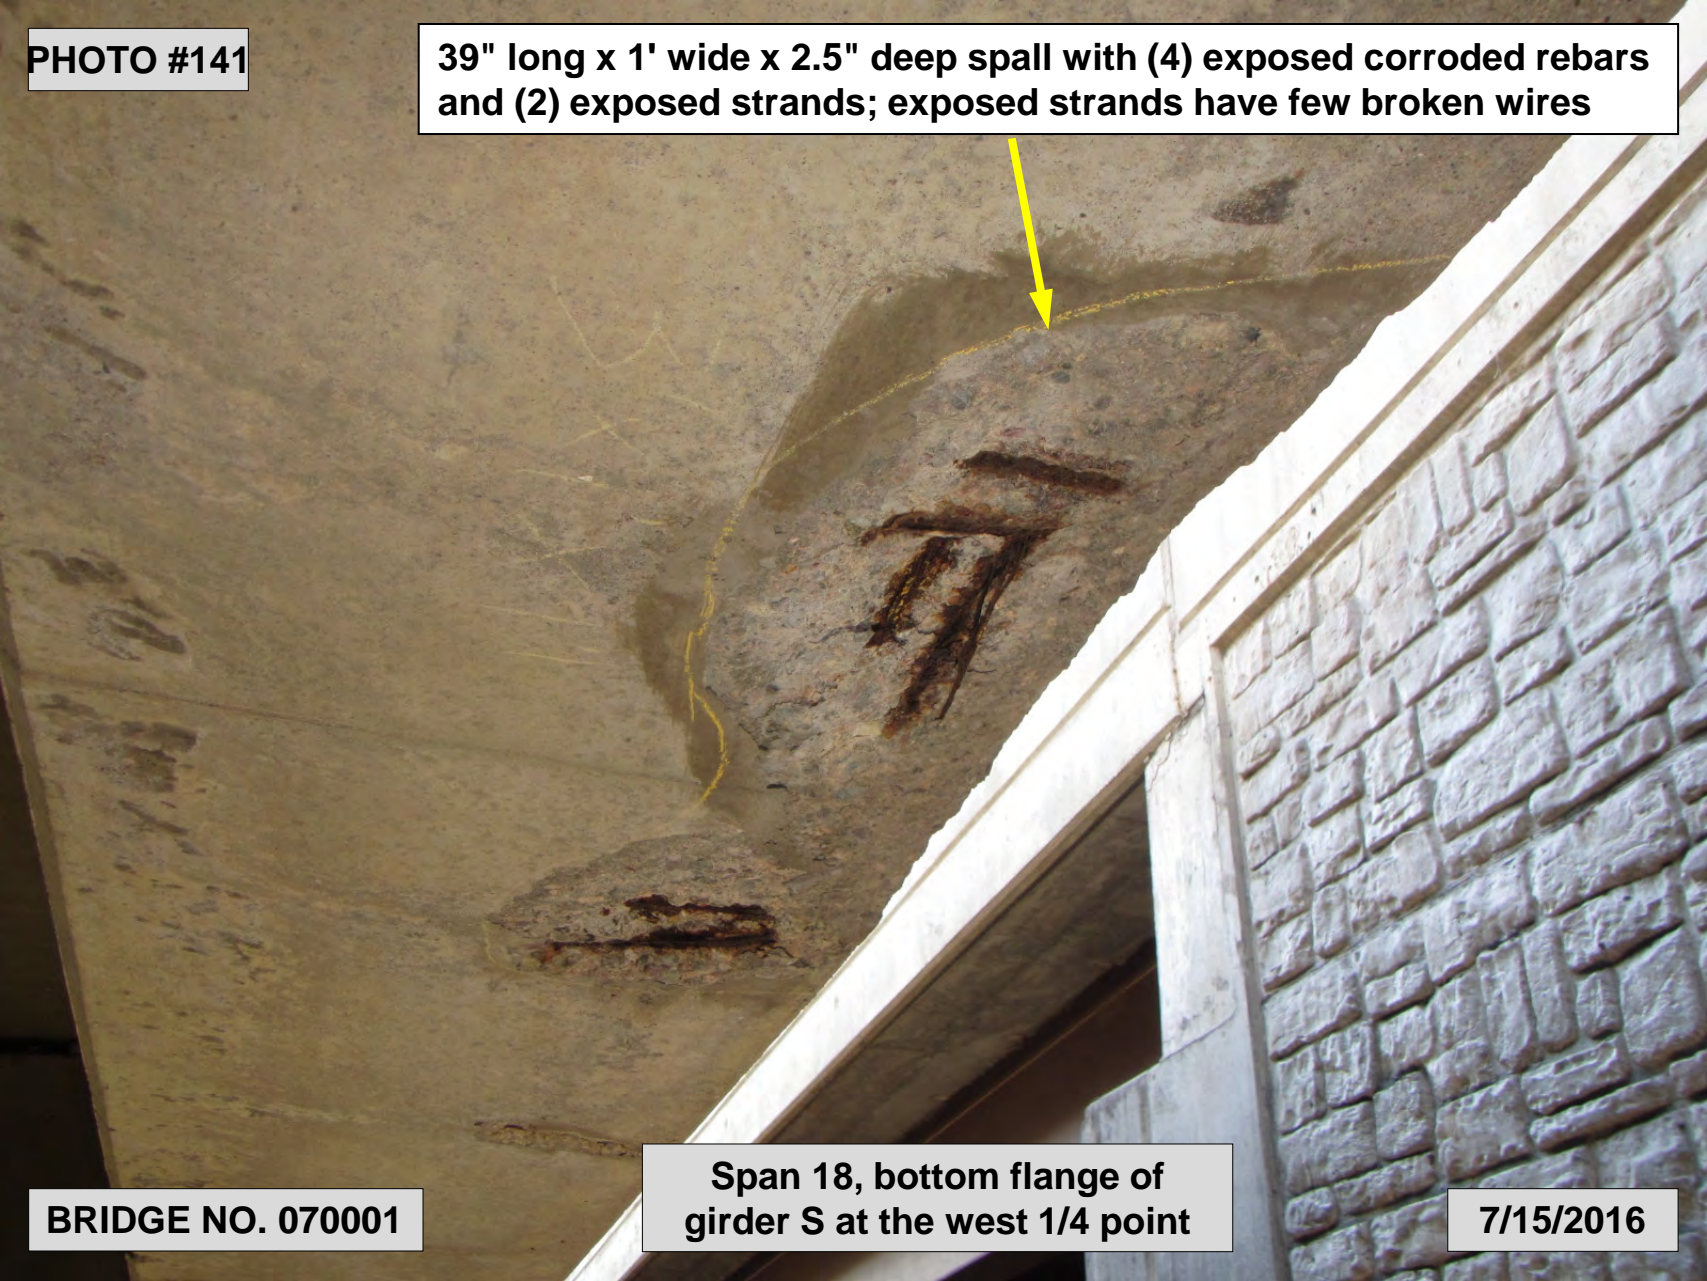
PHOTO #141

39" long x 1' wide x 2.5" deep spall with (4) exposed corroded rebars and (2) exposed strands; exposed strands have few broken wires

**Span 18, bottom flange of
girder S at the west 1/4 point**

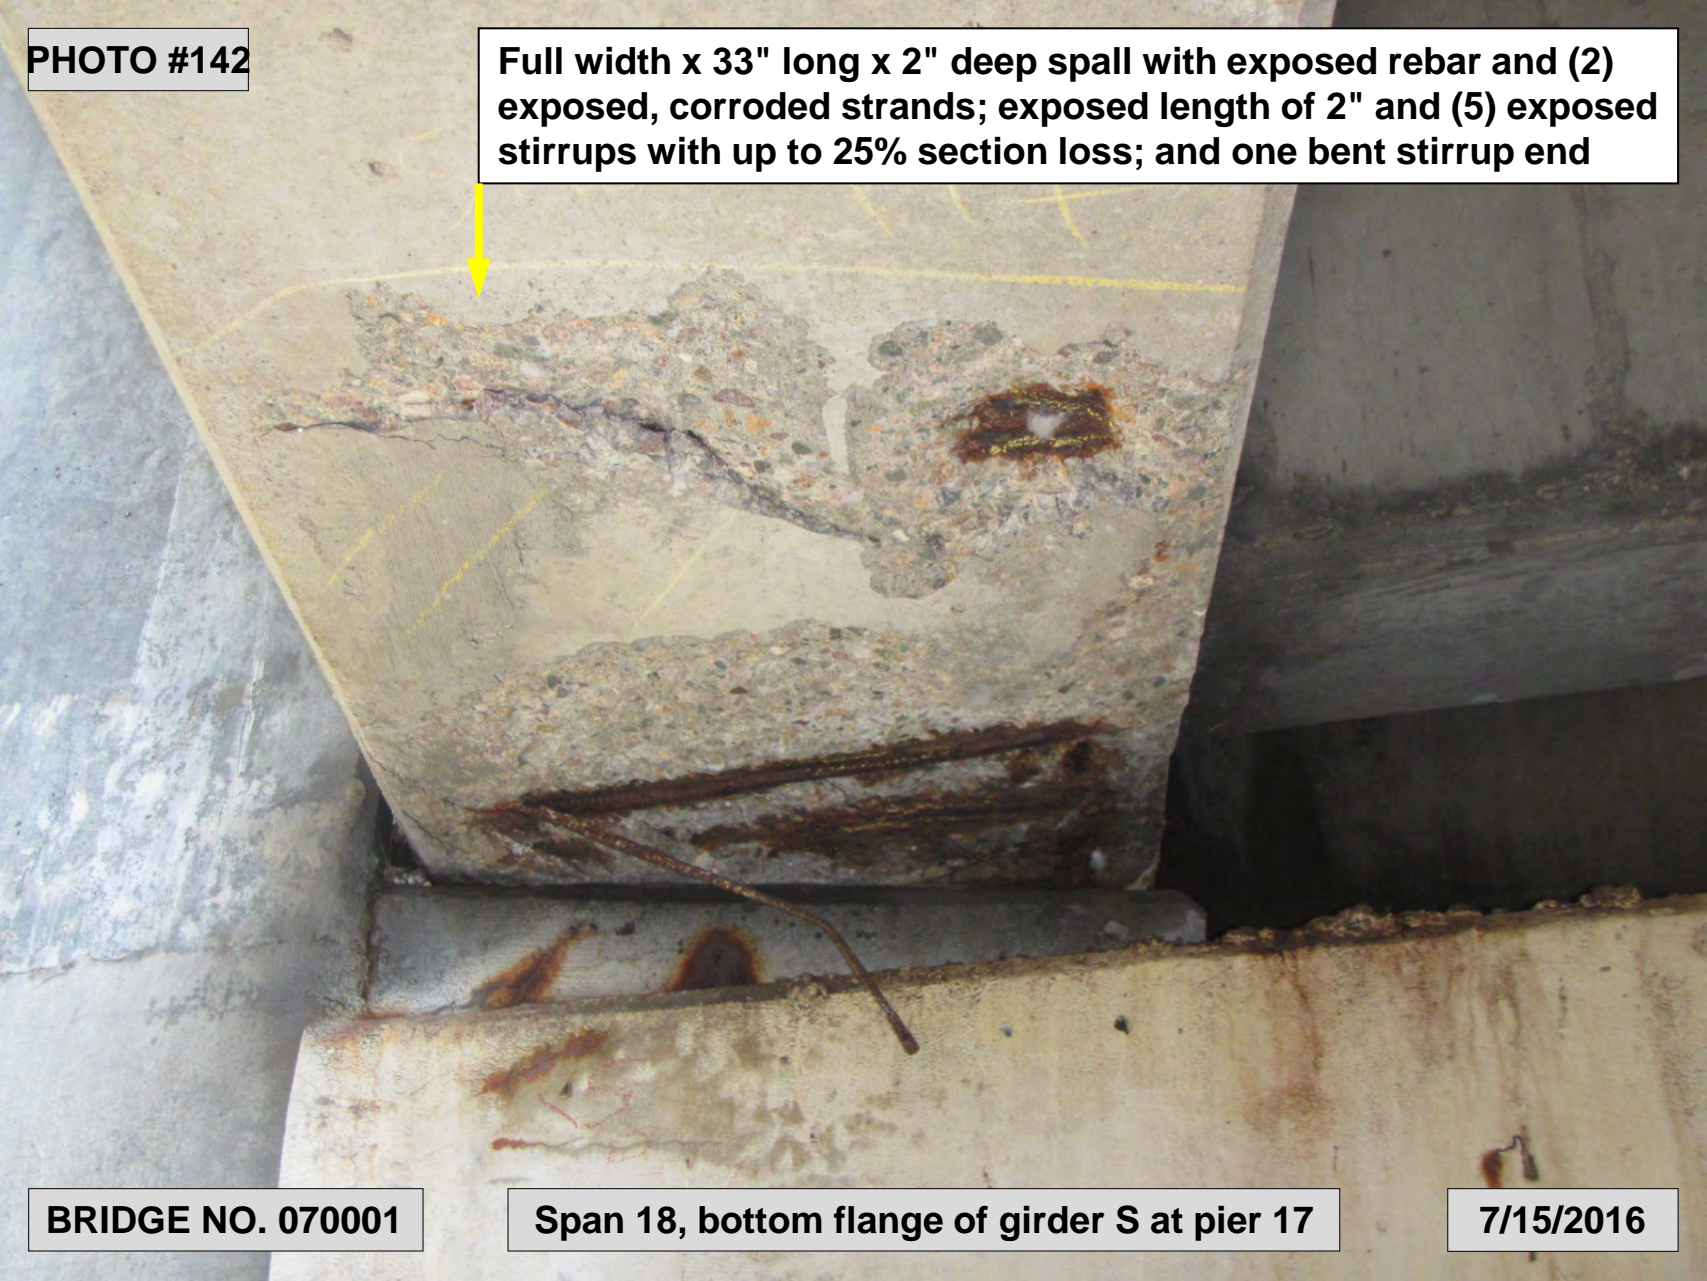
PHOTO #142

Full width x 33" long x 2" deep spall with exposed rebar and (2) exposed, corroded strands; exposed length of 2" and (5) exposed stirrups with up to 25% section loss; and one bent stirrup end

Span 18, bottom flange of girder S at pier 17

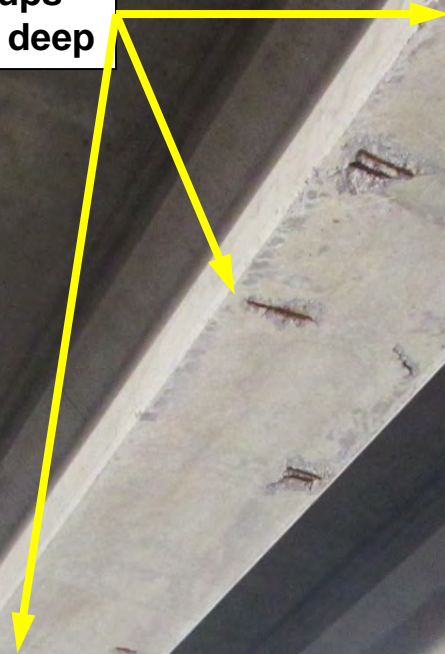
PHOTO #143

**(14) spalls with exposed stirrups
up to full width x 9" long x 1" deep**

Span 18, bottom flange of girder O west half

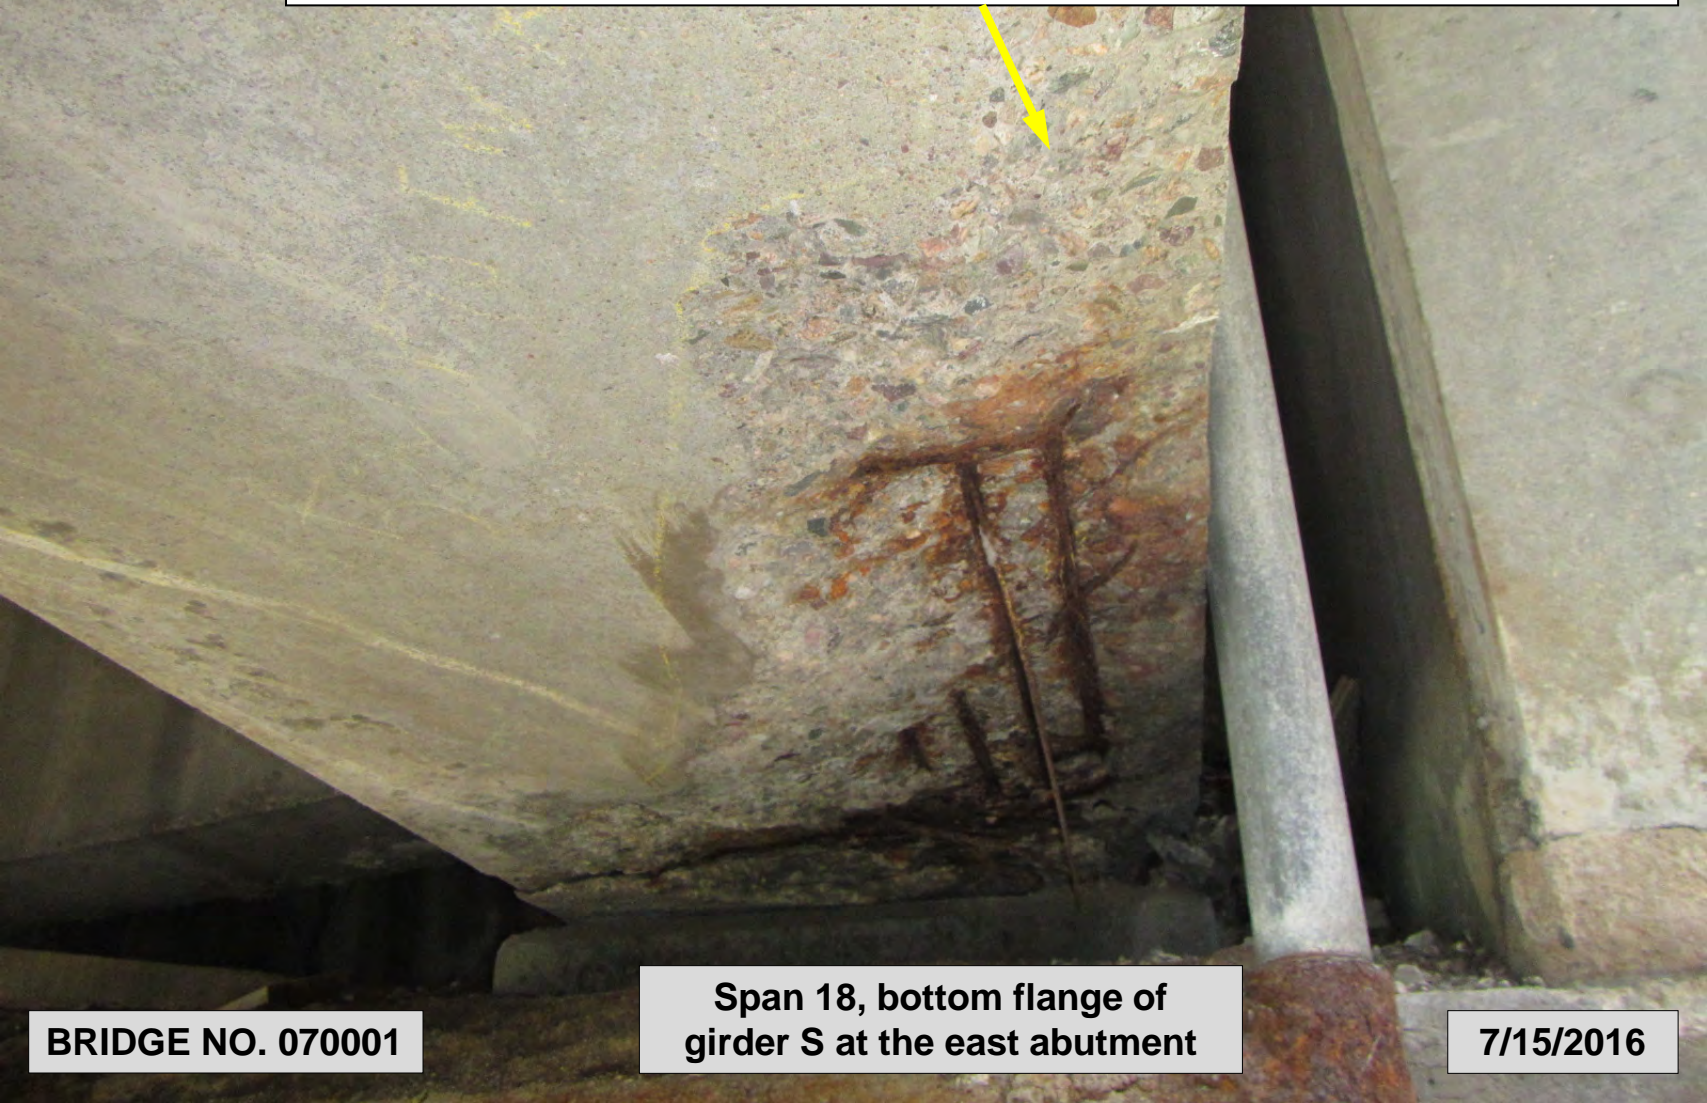
PHOTO #145

Full width x 52" long x up to 3" deep spall with exposed rebar and (4) exposed strands, continuous over the bearing. 3 of 4 strands have broken wires, (2) exposed stirrups are broken. See photo 146 for close-up

**Span 18, bottom flange of
girder S at the east abutment**

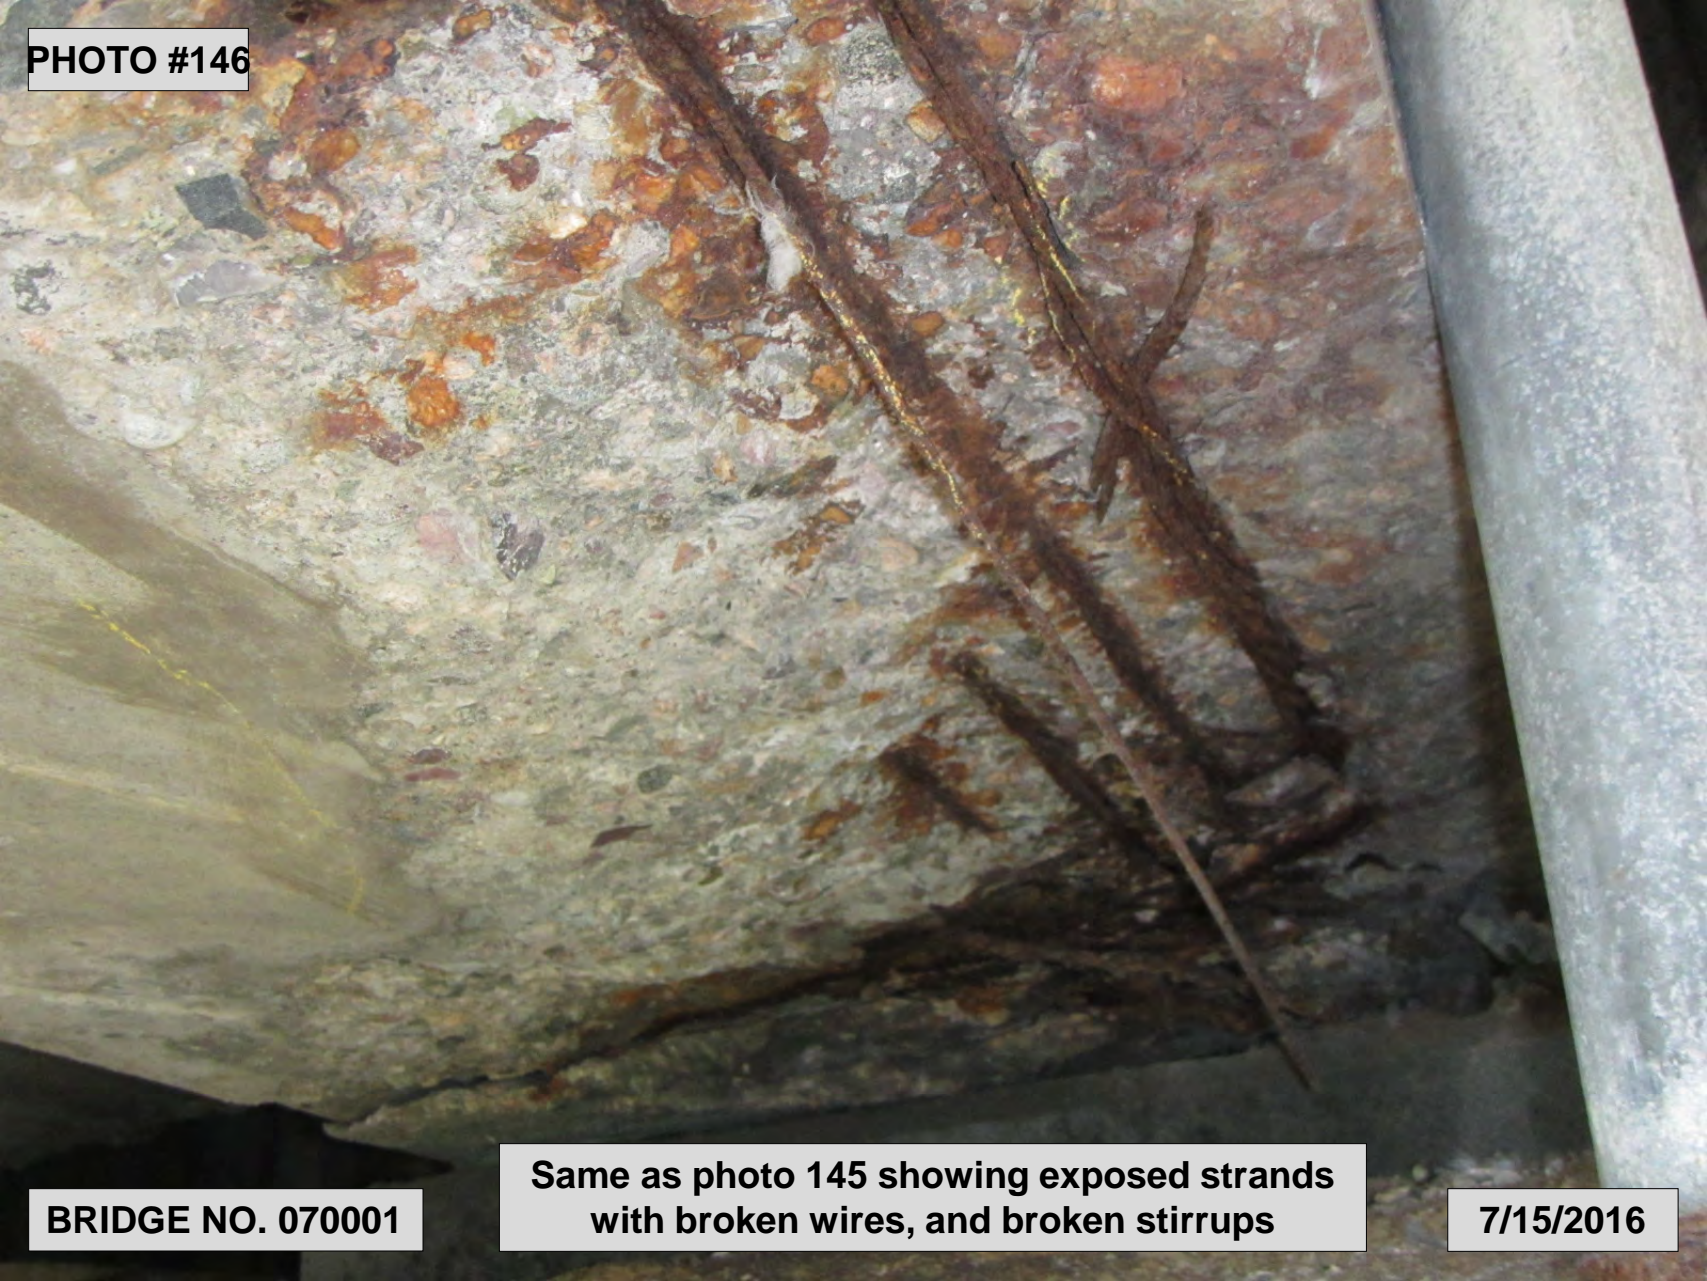
PHOTO #146

**Same as photo 145 showing exposed strands
with broken wires, and broken stirrups**

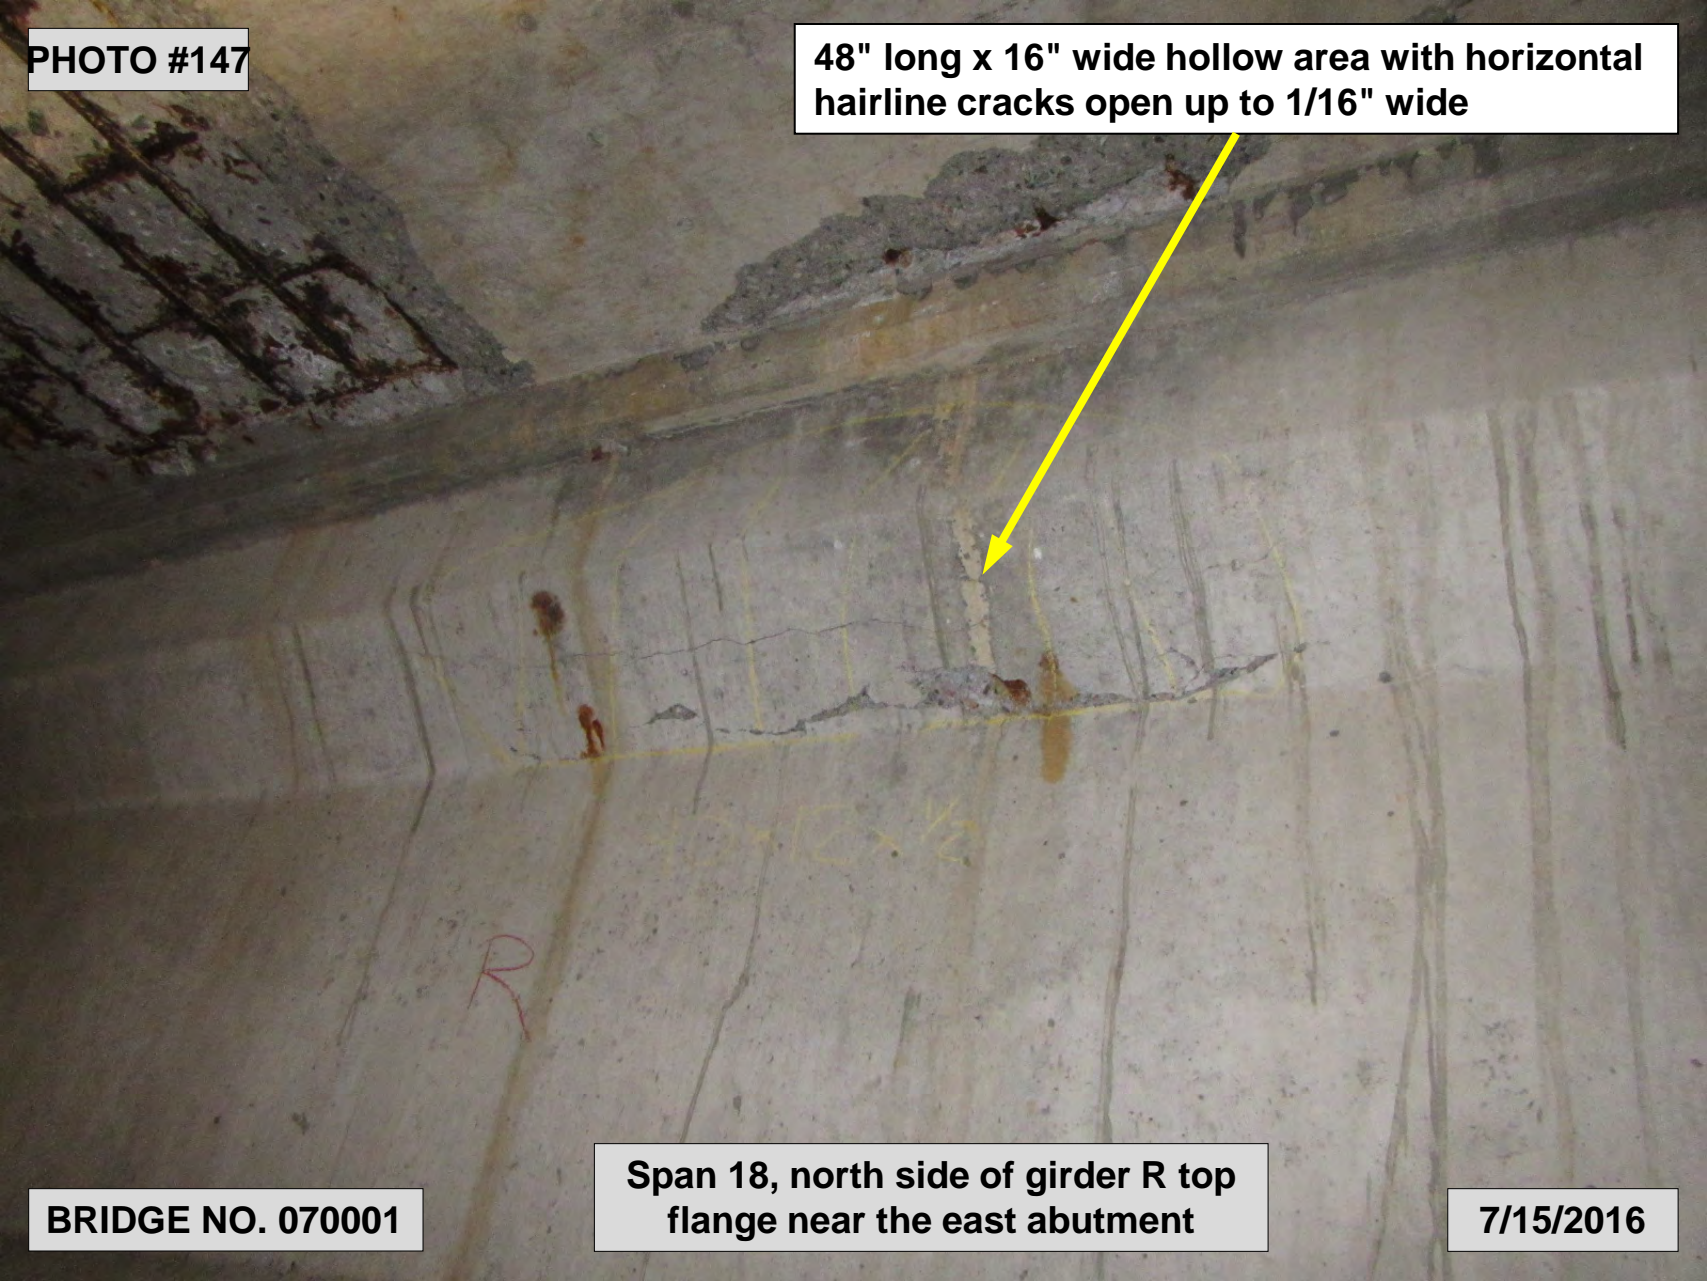
PHOTO #147

48" long x 16" wide hollow area with horizontal hairline cracks open up to 1/16" wide

Span 18, north side of girder R top flange near the east abutment
