BRIDGE NO. 070001

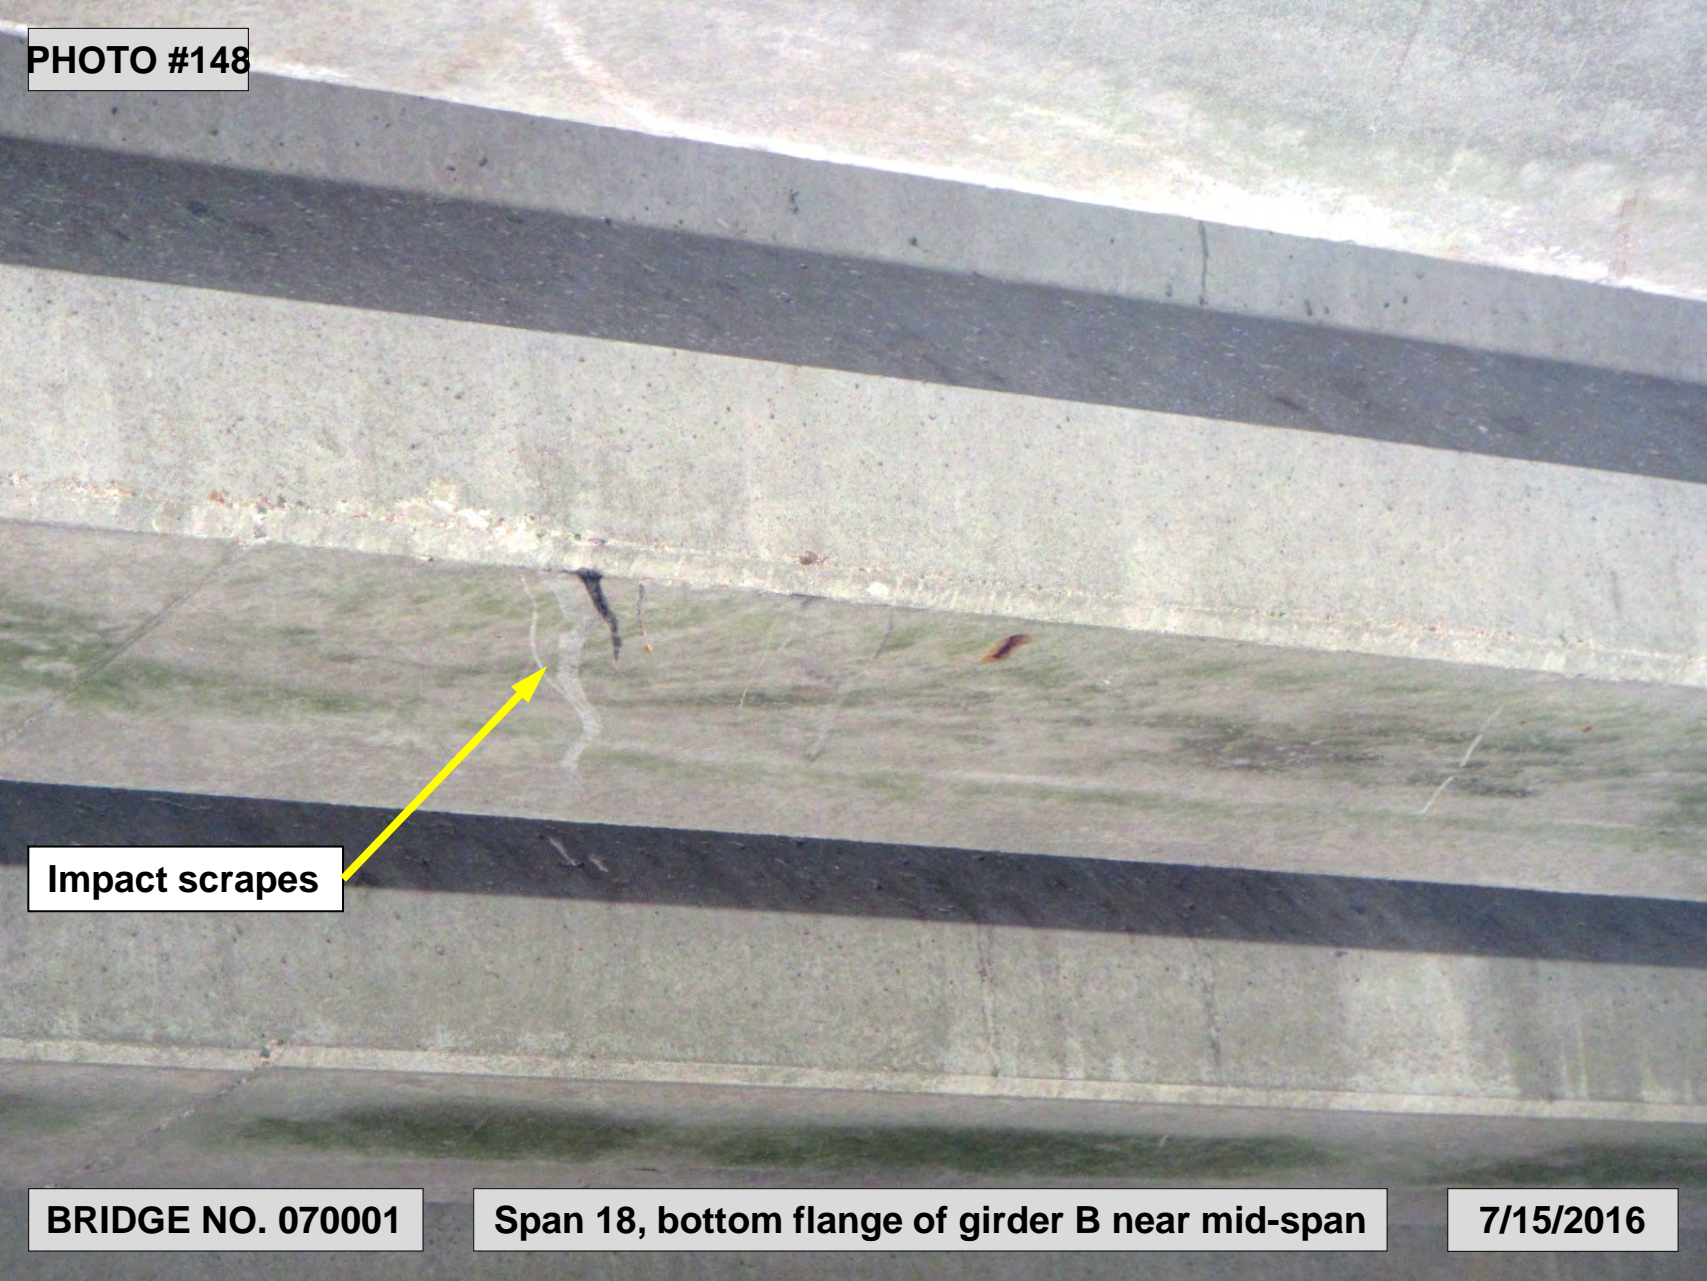
PHOTO #148

Impact scrapes

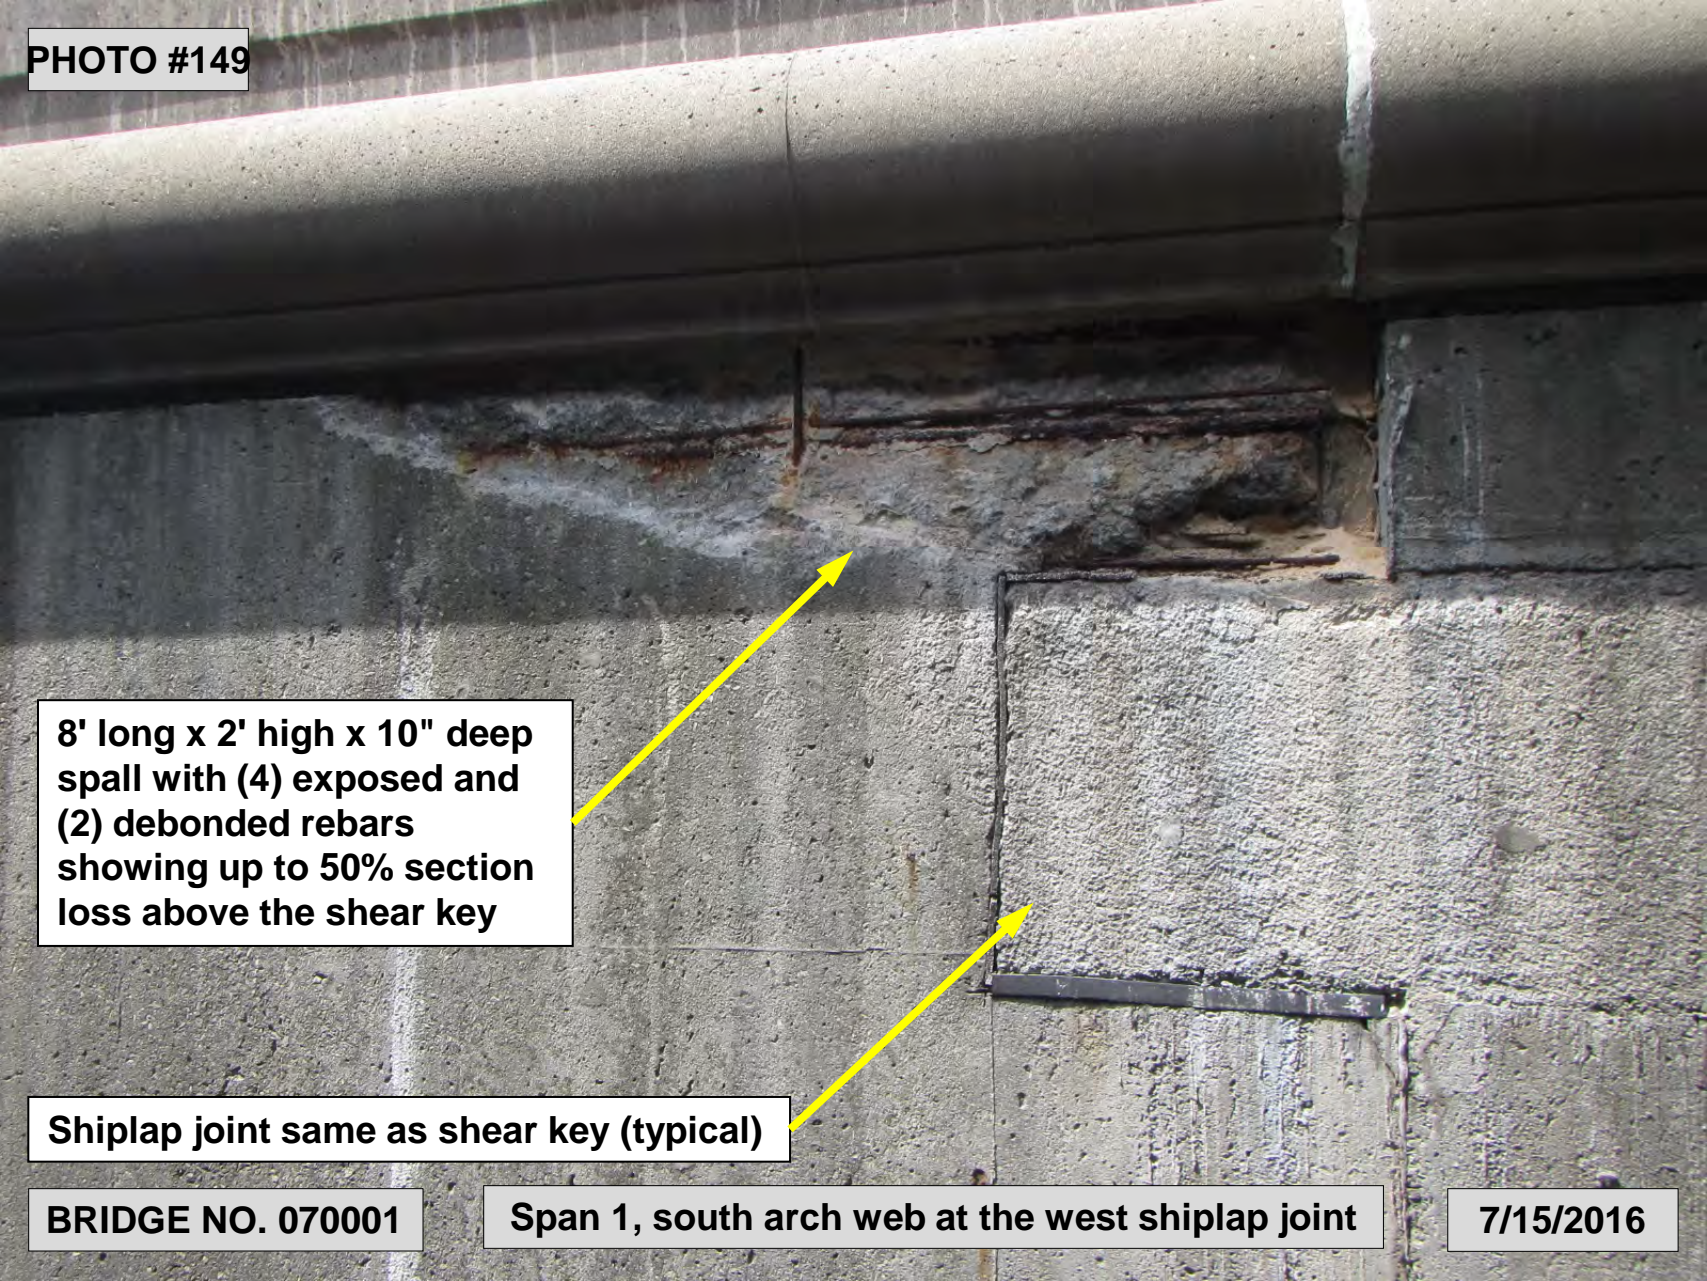
PHOTO #149

**8' long x 2' high x 10" deep
spall with (4) exposed and
(2) debonded rebar
showing up to 50% section
loss above the shear key**

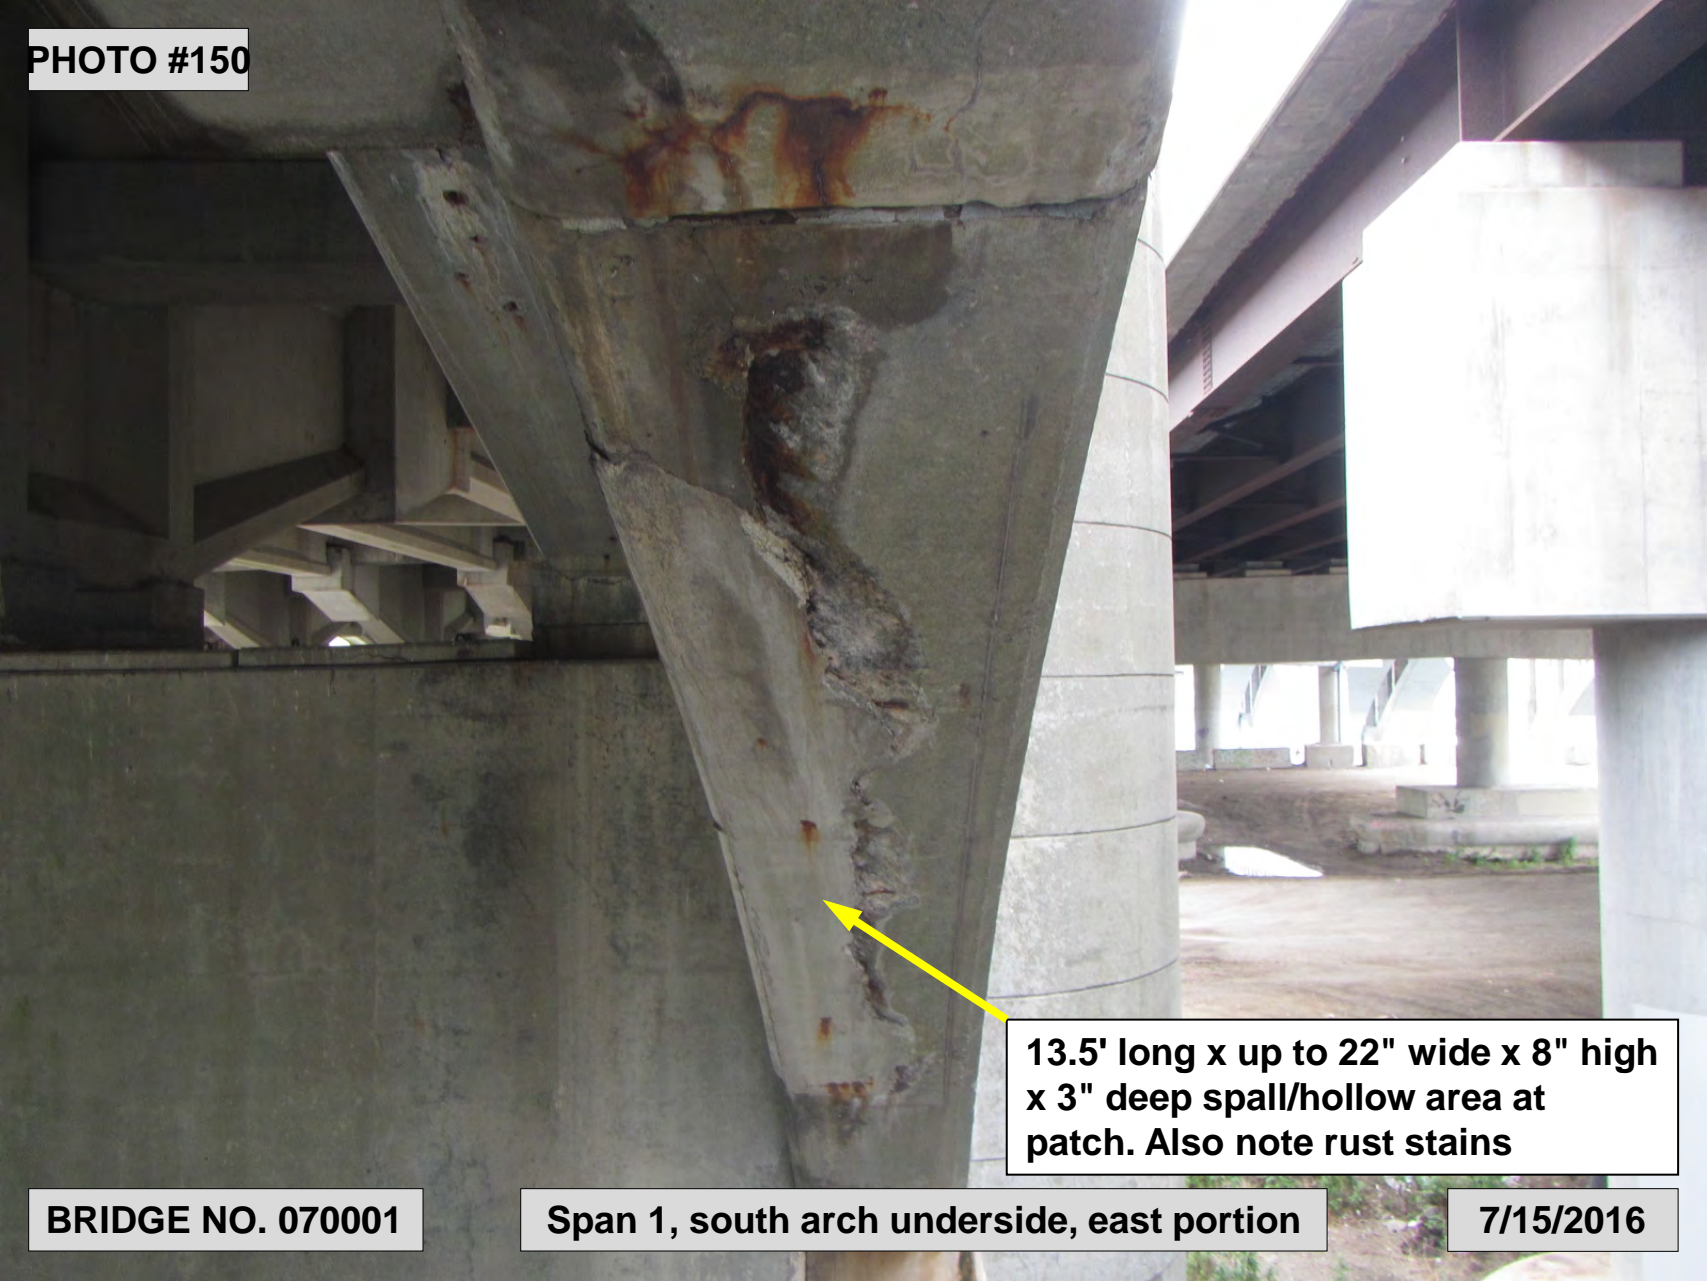
PHOTO #150

**13.5' long x up to 22" wide x 8" high
x 3" deep spall/hollow area at
patch. Also note rust stains**

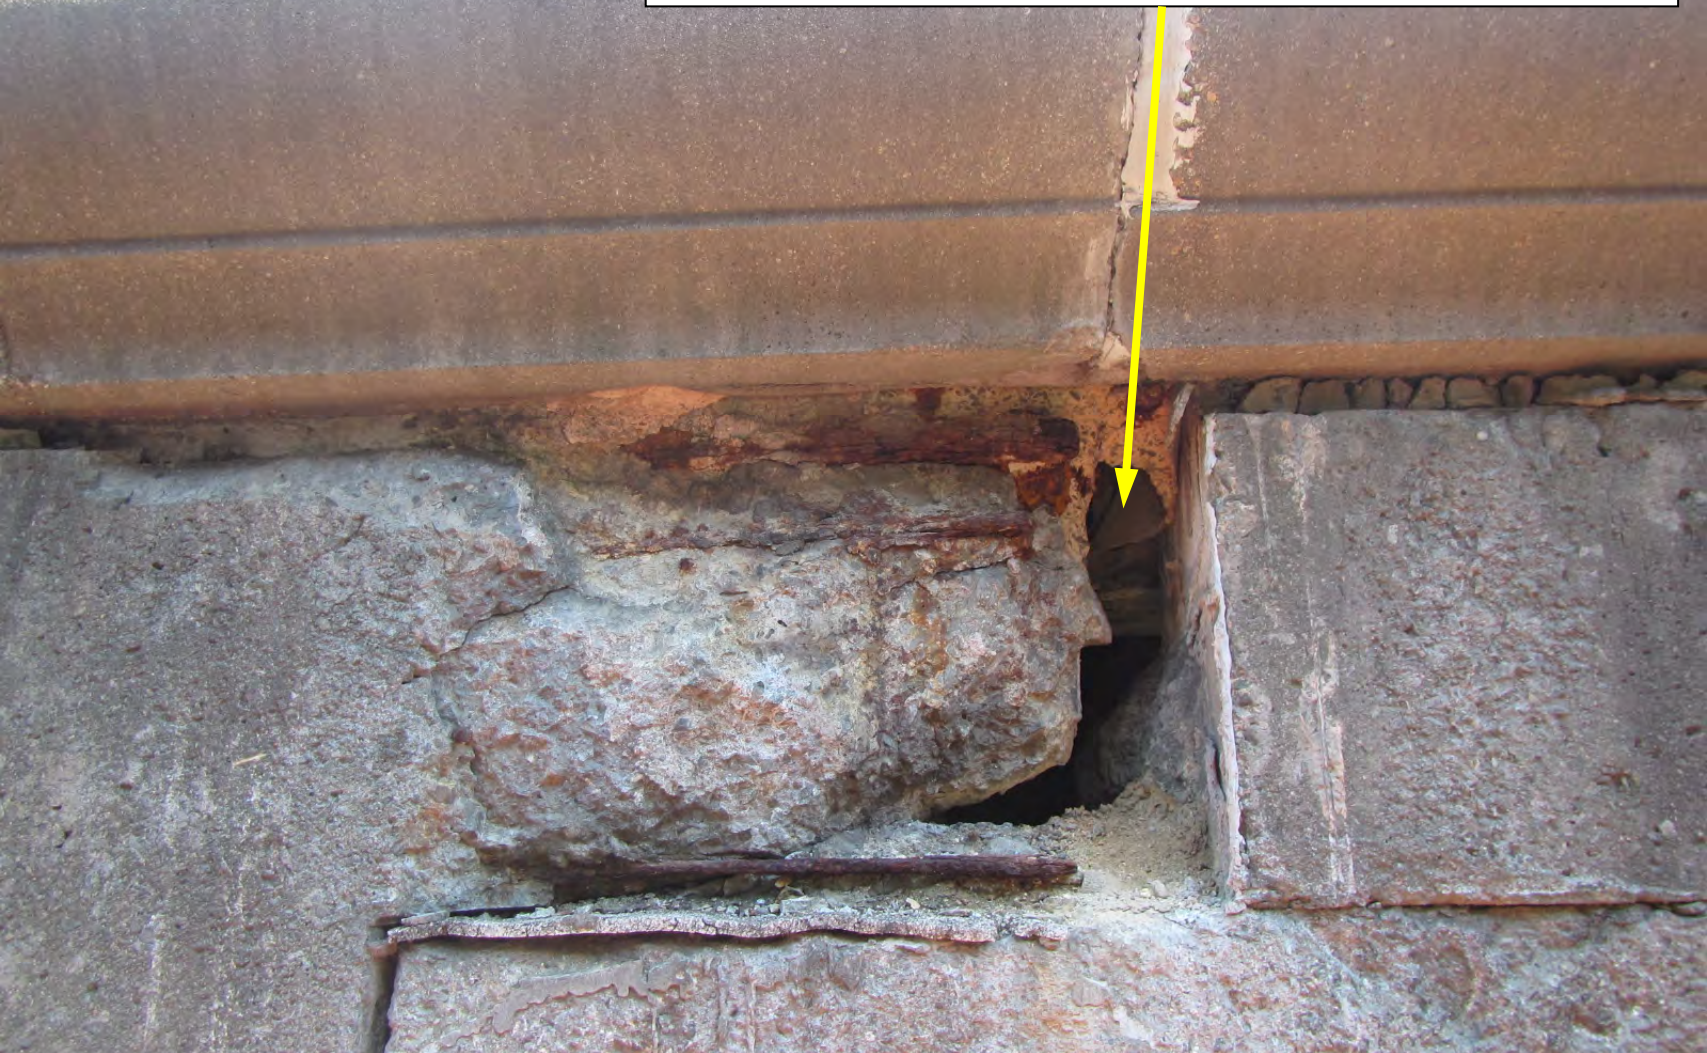
PHOTO #151

2.5' long x 22" high x up to full depth spall with exposed rebar and 14" high x 12" wide x full depth hole

Span 2, south arch web at the west shiplap joint

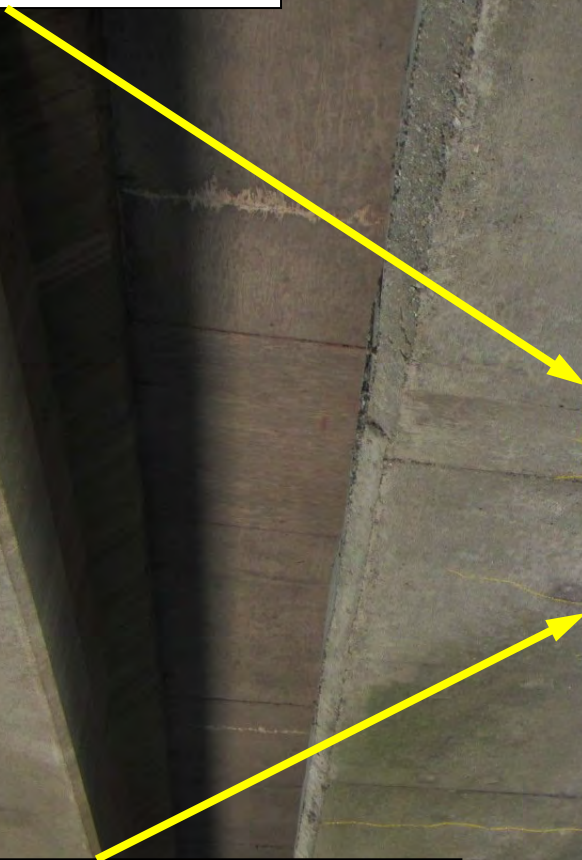
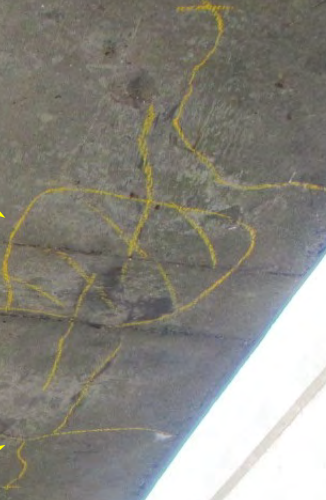
PHOTO #158

1' long x 1' wide hollow area

Longitudinal and transverse hairline cracks (similar at scattered locations)

Span 4, south arch bottom flange at crown region

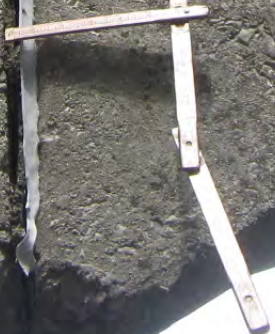
PHOTO #160

Vertical misalignment at joint between crown arch section and west arch section up to 1.5" (crown section lower), and joint open up to 1" wide. See photo 161 for close-up of vertical misalignment

Span 6, south arch bottom flange at the west shiplap joint

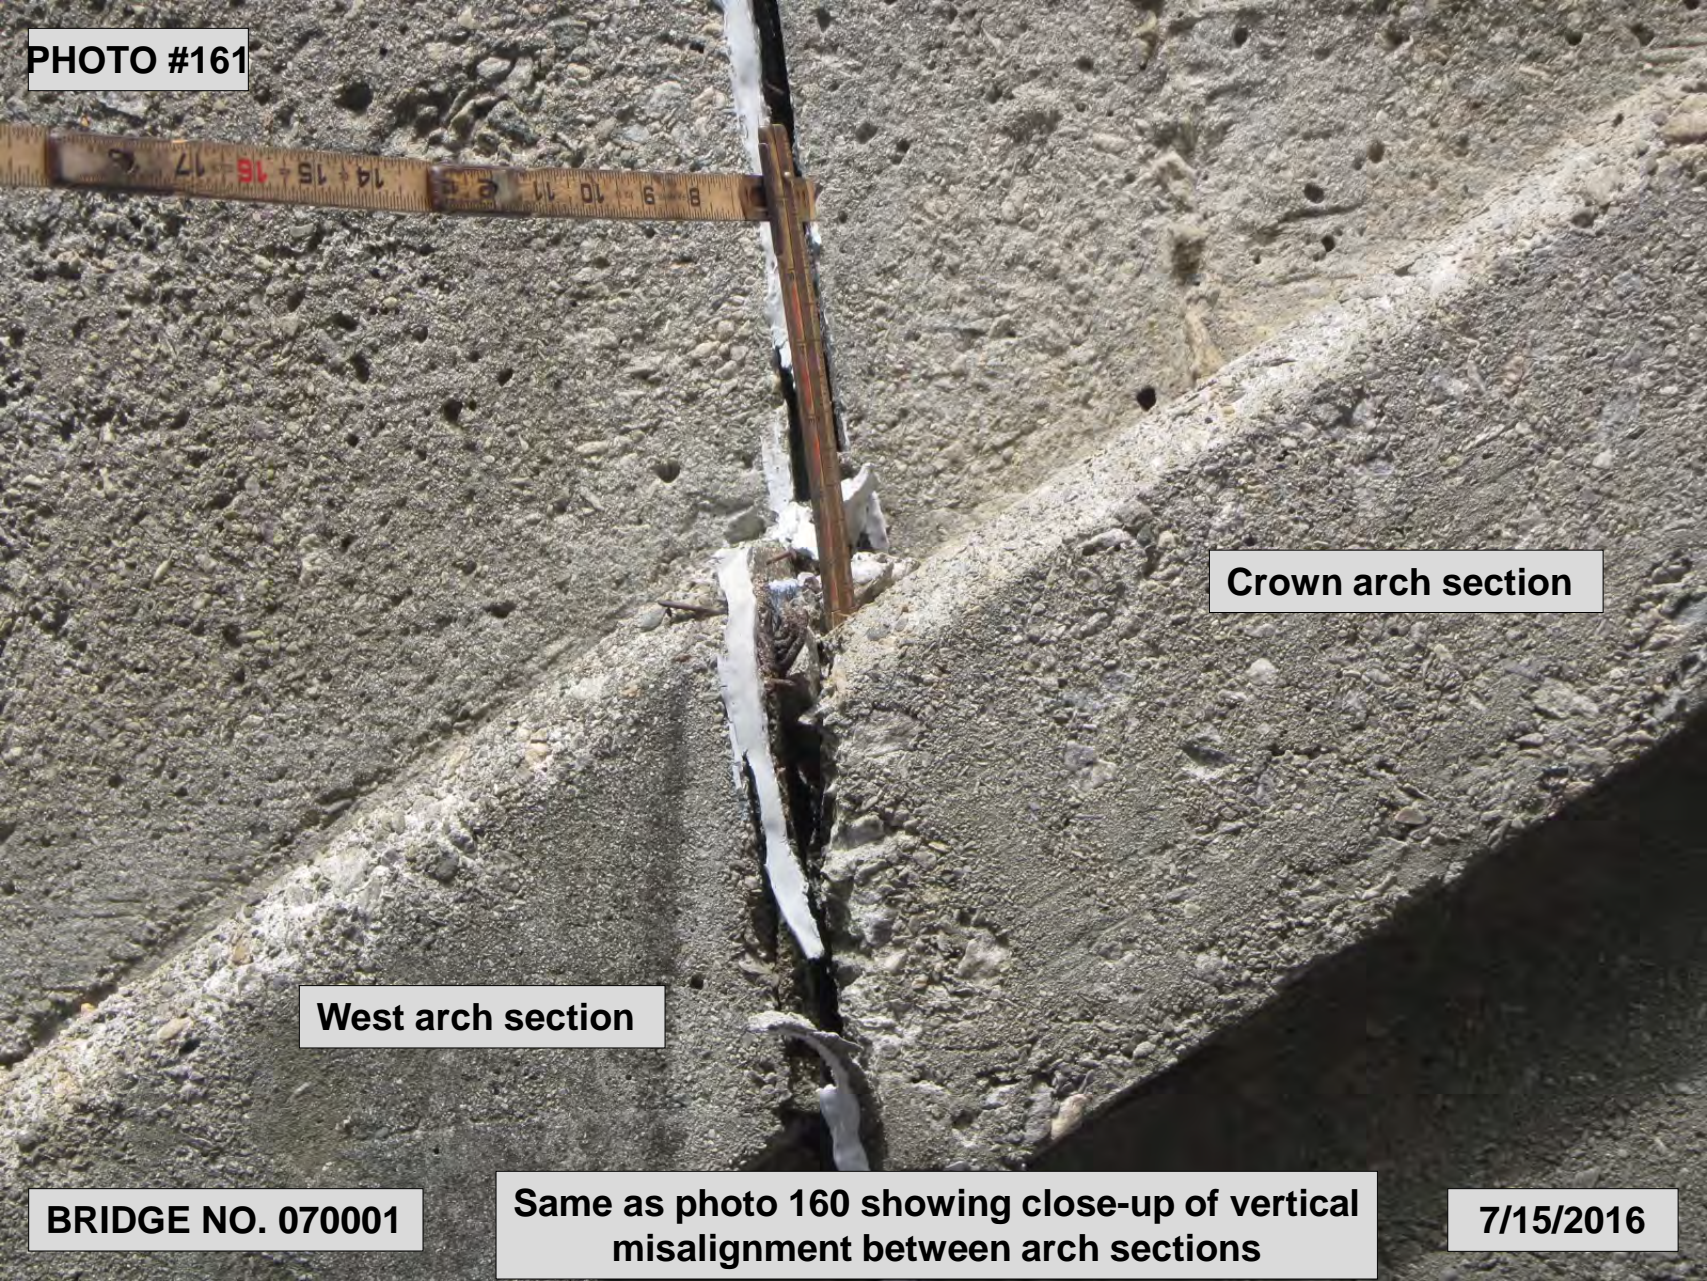
PHOTO #161

Same as photo 160 showing close-up of vertical misalignment between arch sections

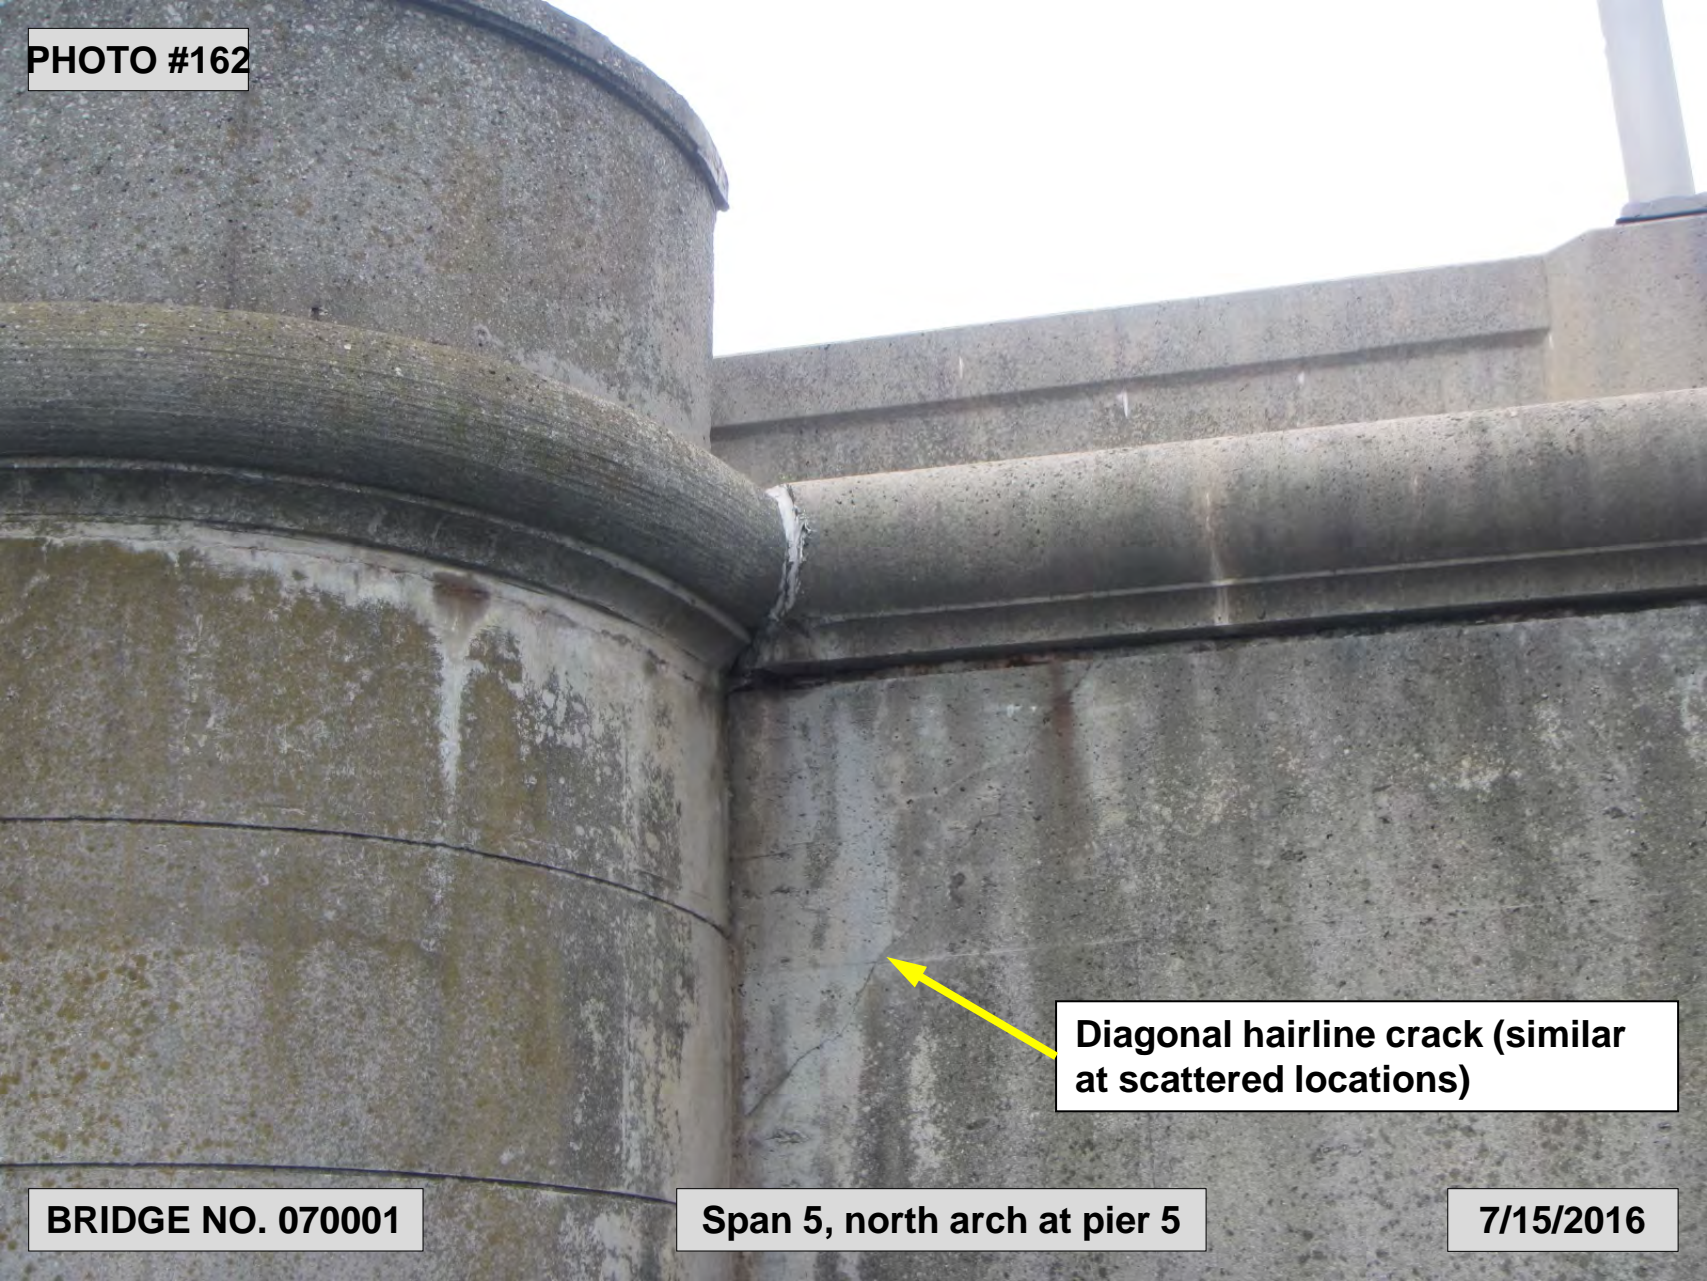
PHOTO #162

Diagonal hairline crack (similar at scattered locations)

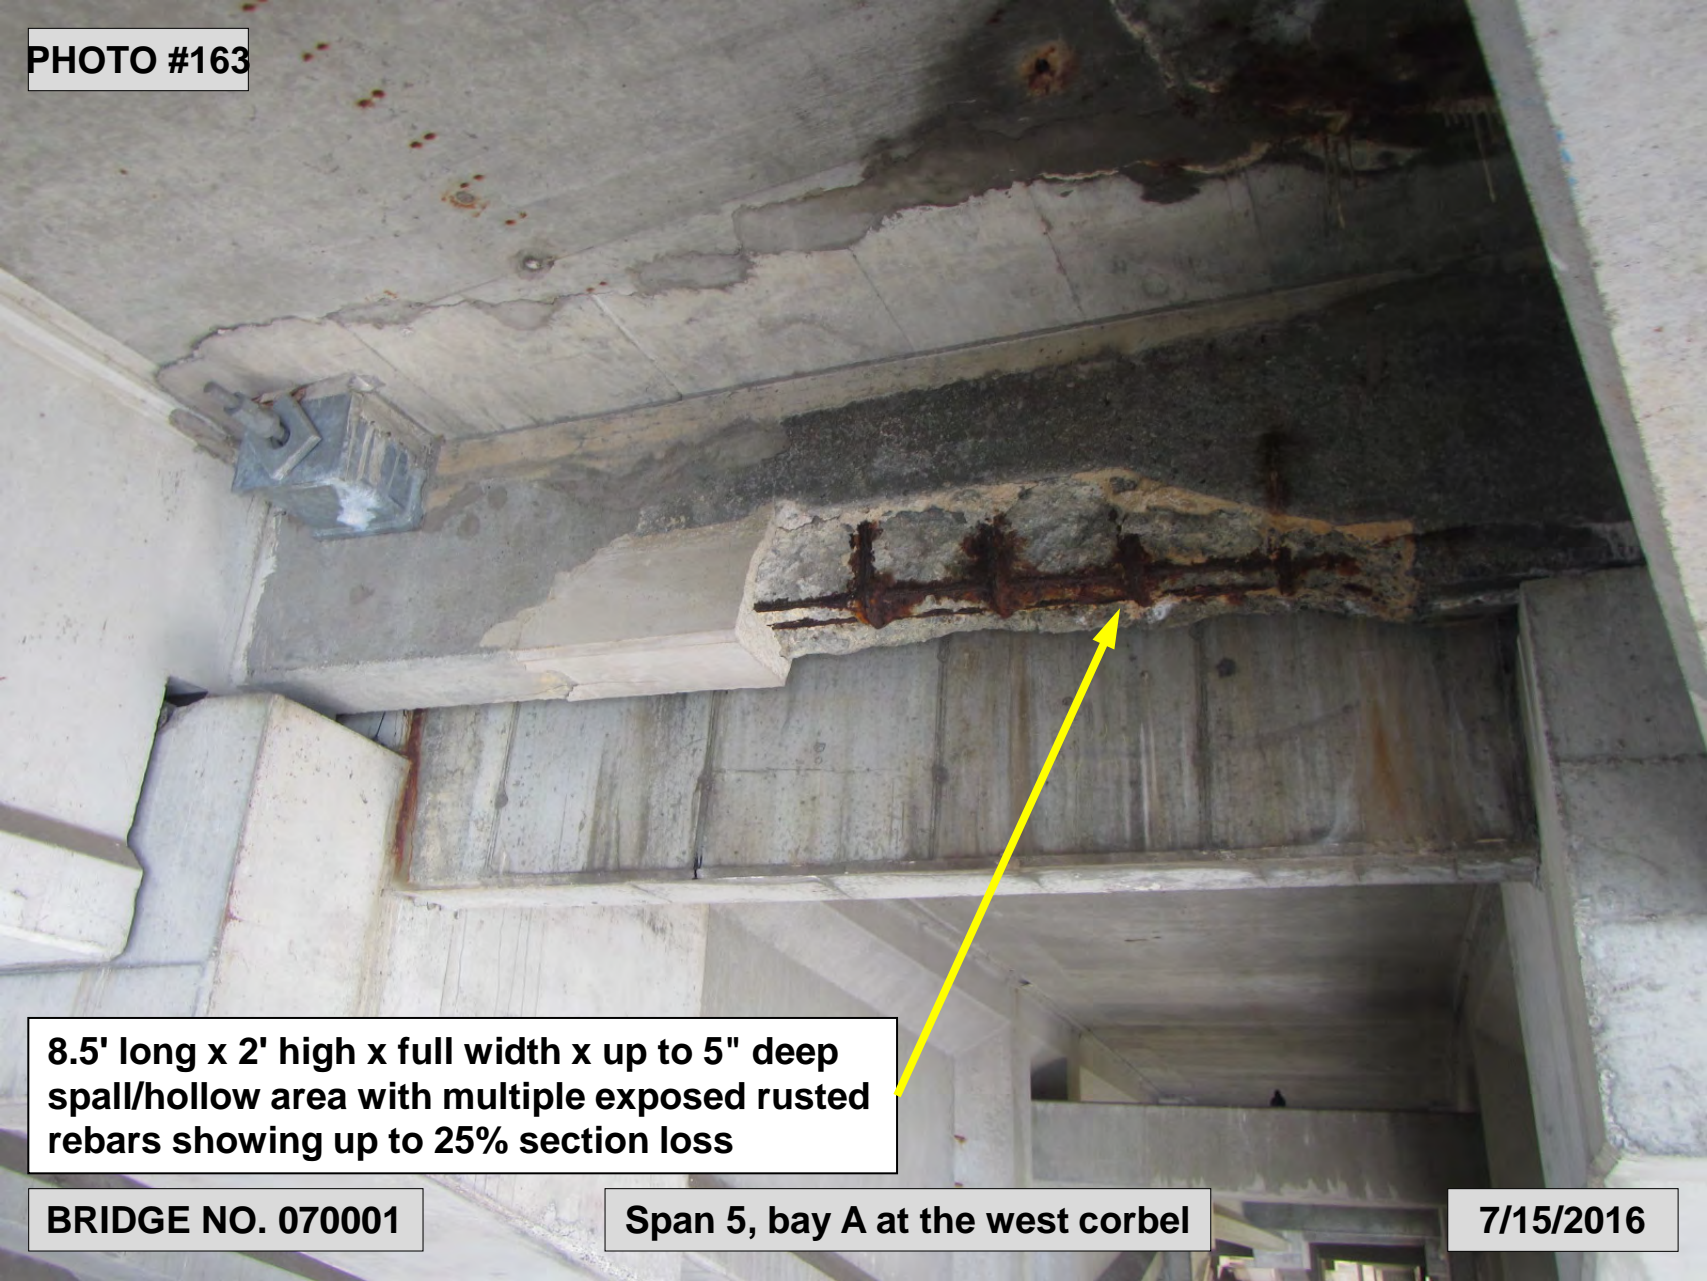
PHOTO #163

**8.5' long x 2' high x full width x up to 5" deep
spall/hollow area with multiple exposed rusted
rebars showing up to 25% section loss**

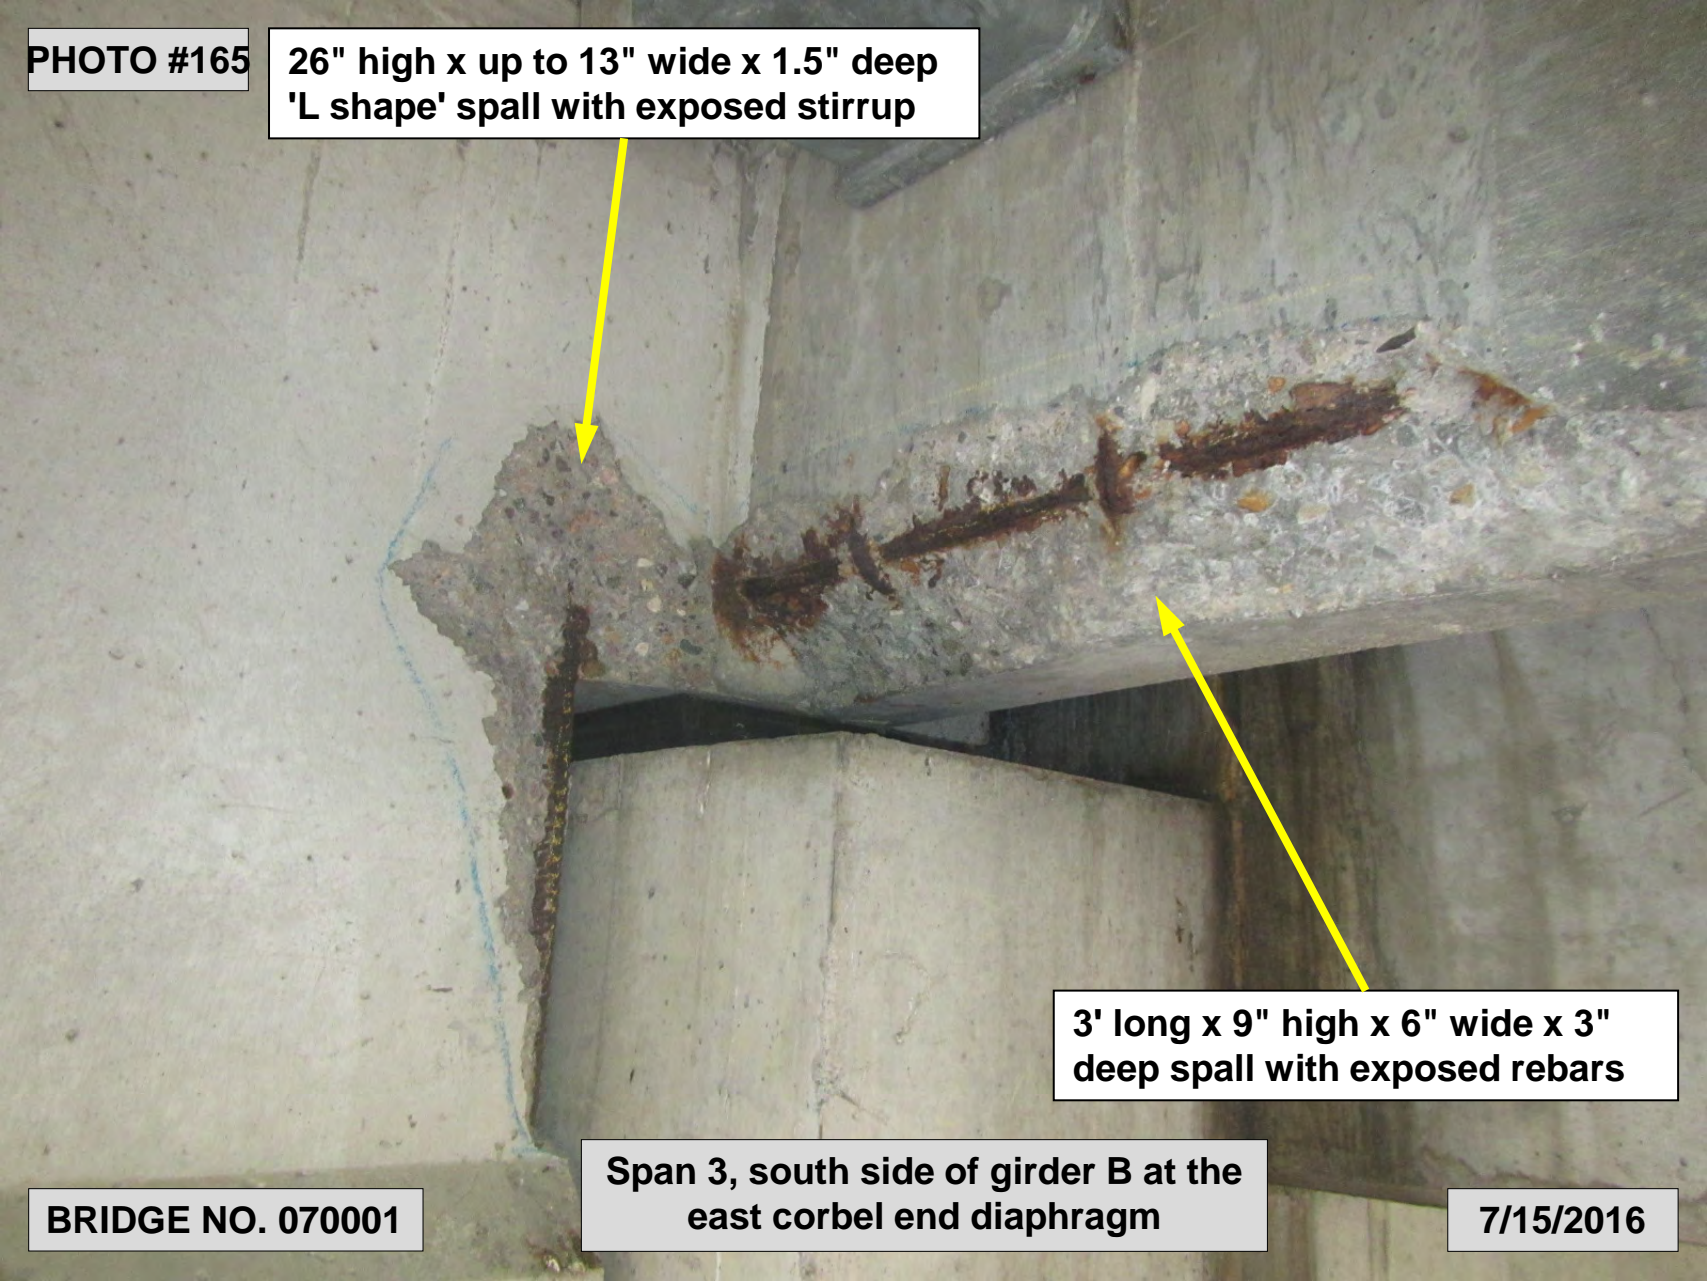
**3' long x 9" high x 6" wide x 3"
deep spall with exposed rebar**

**Span 3, south side of girder B at the
east corbel end diaphragm**

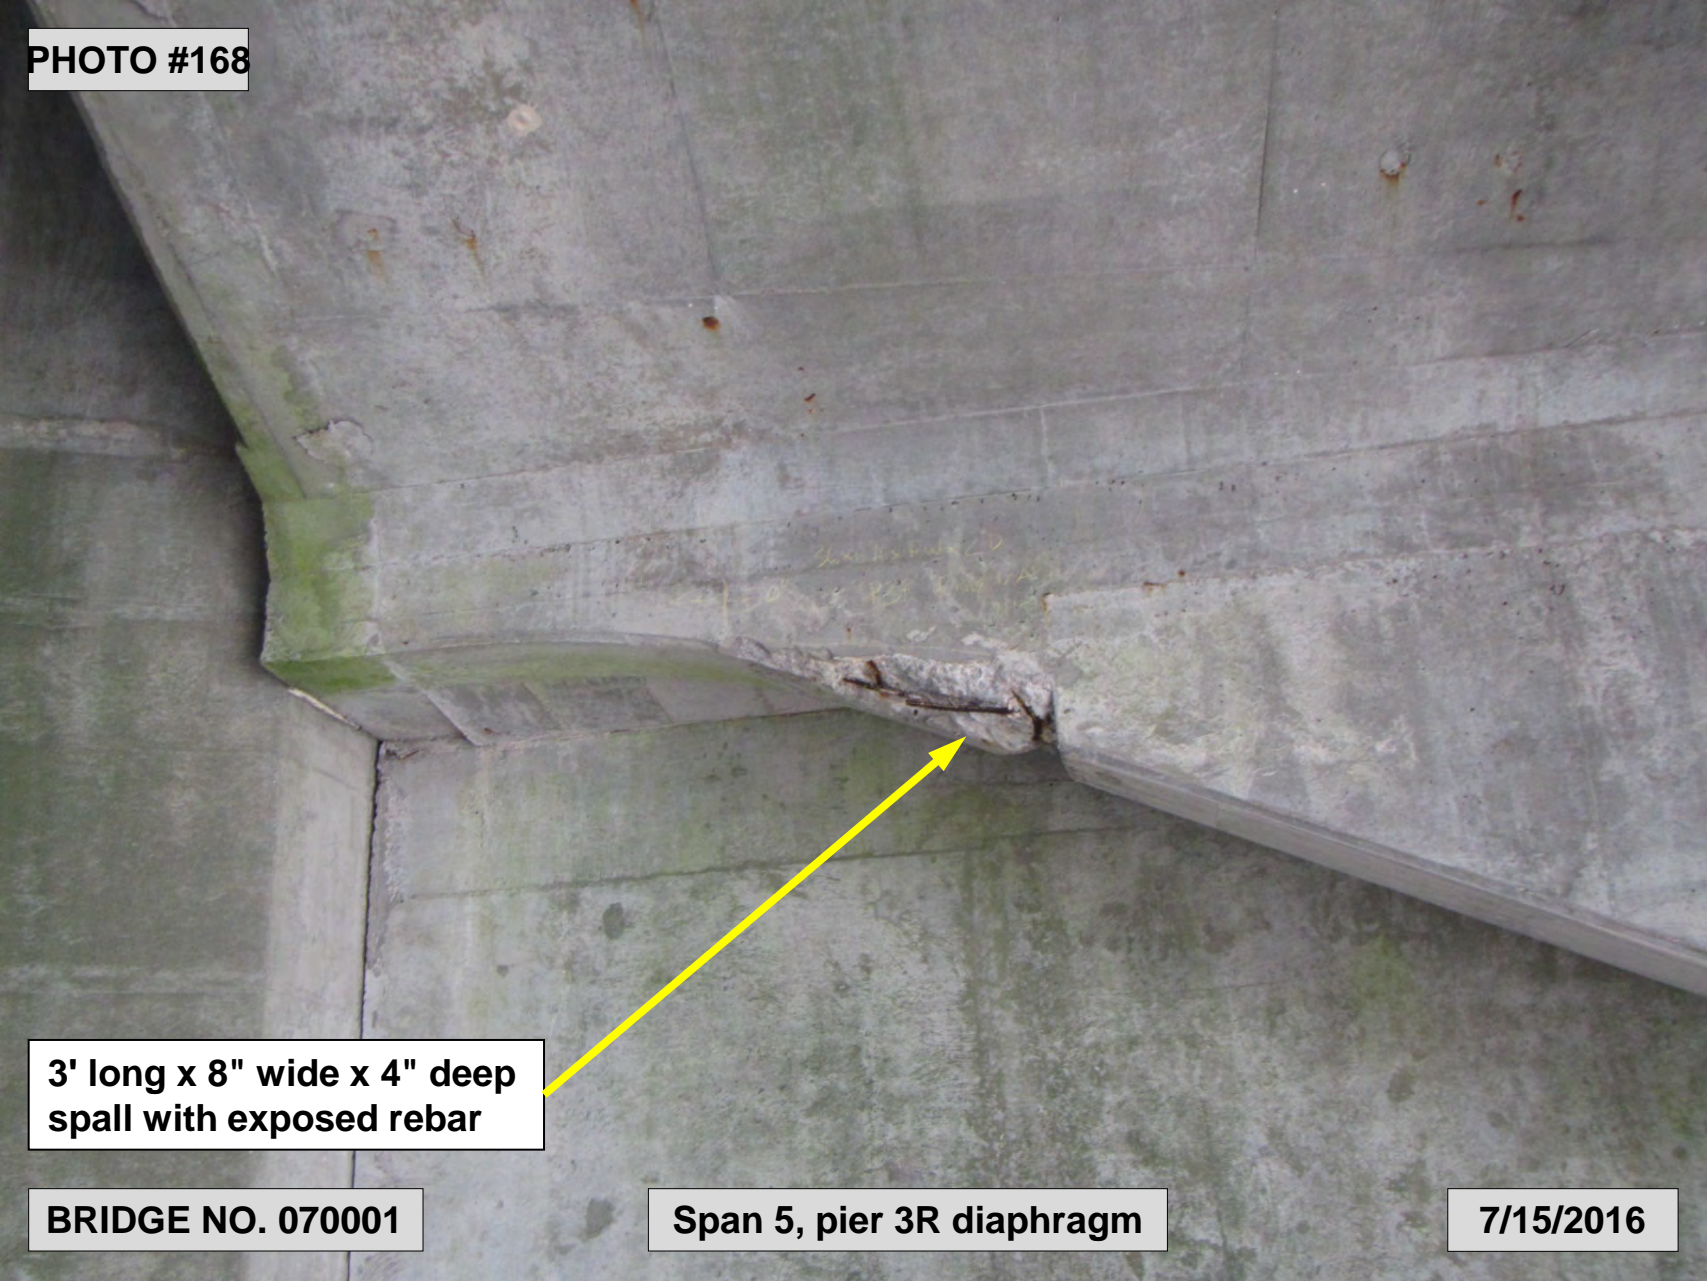
PHOTO #168

**3' long x 8" wide x 4" deep
spall with exposed rebar**

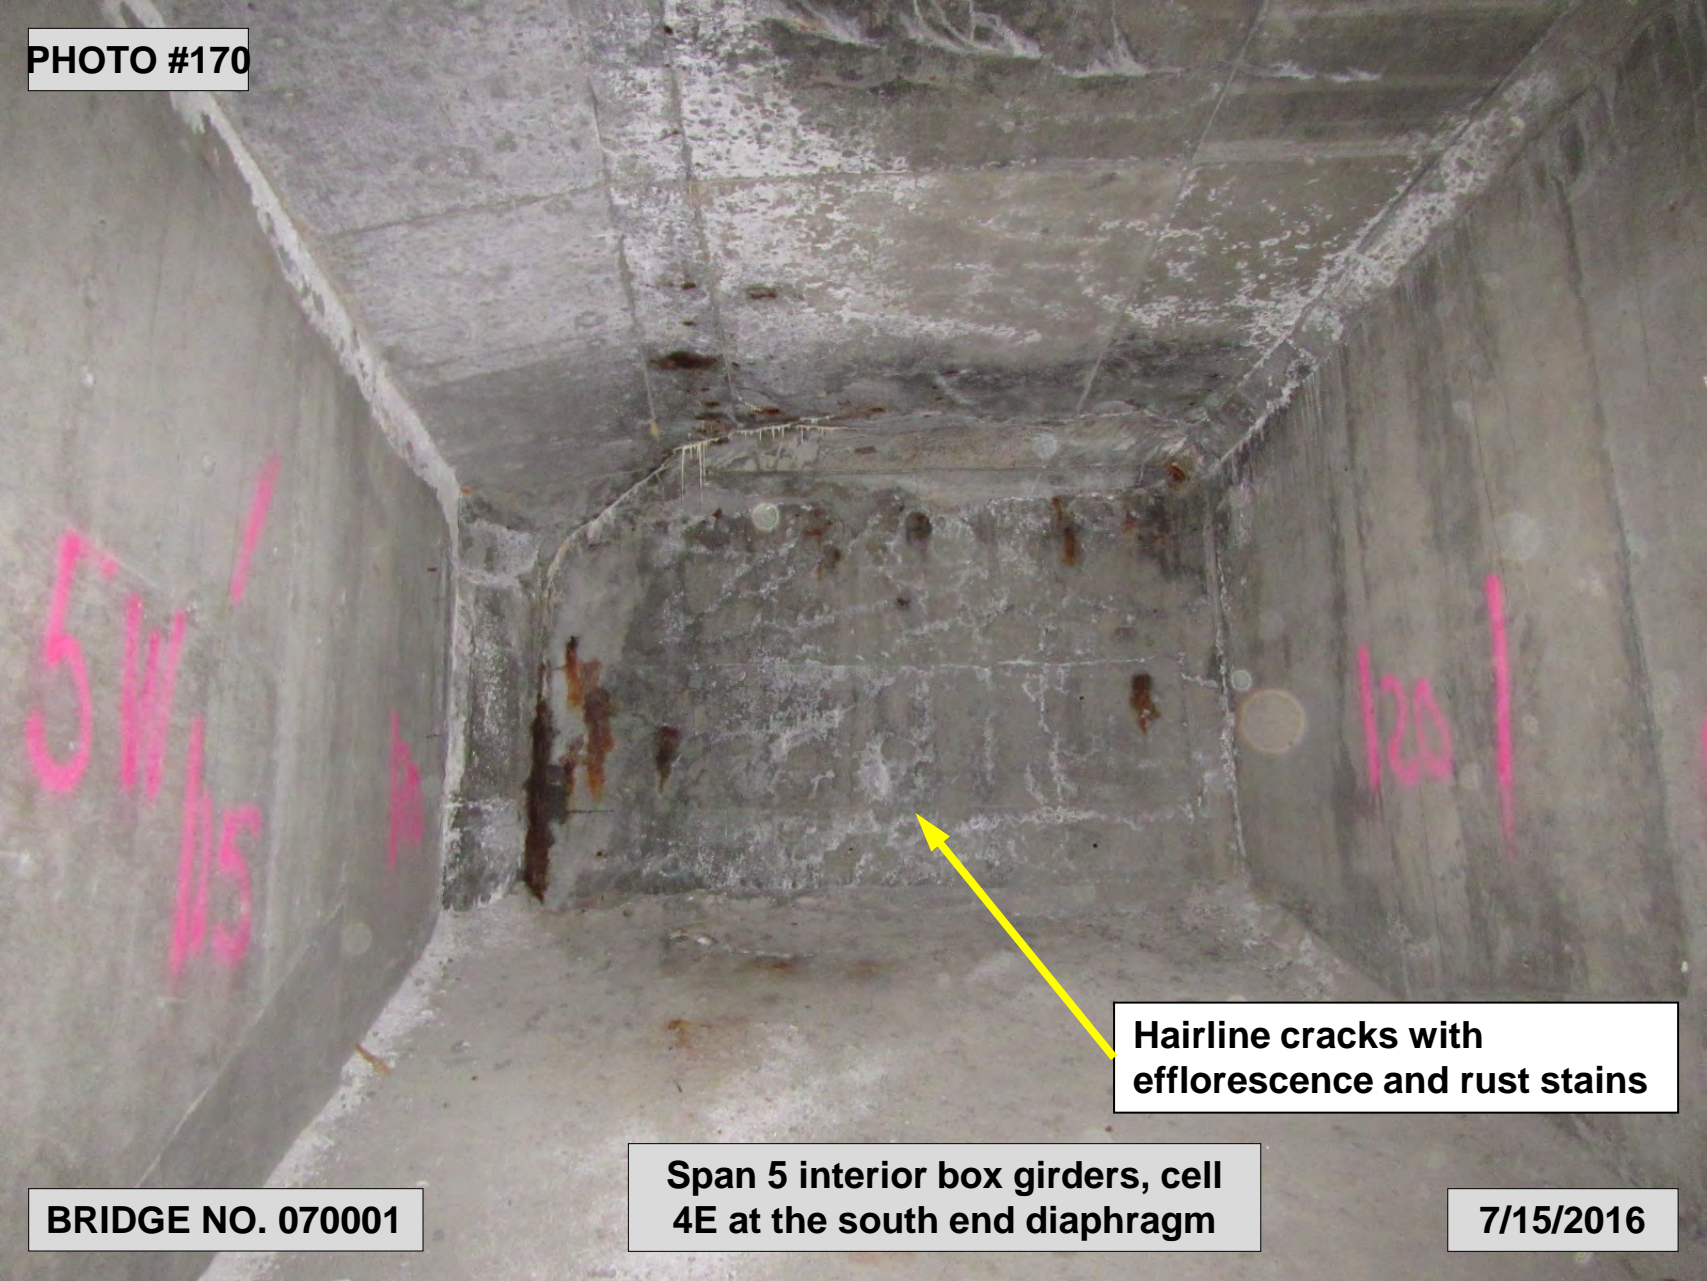
PHOTO #170

Hairline cracks with
efflorescence and rust stains

Span 5 interior box girders, cell
4E at the south end diaphragm
