BRIDGE NO. 070001

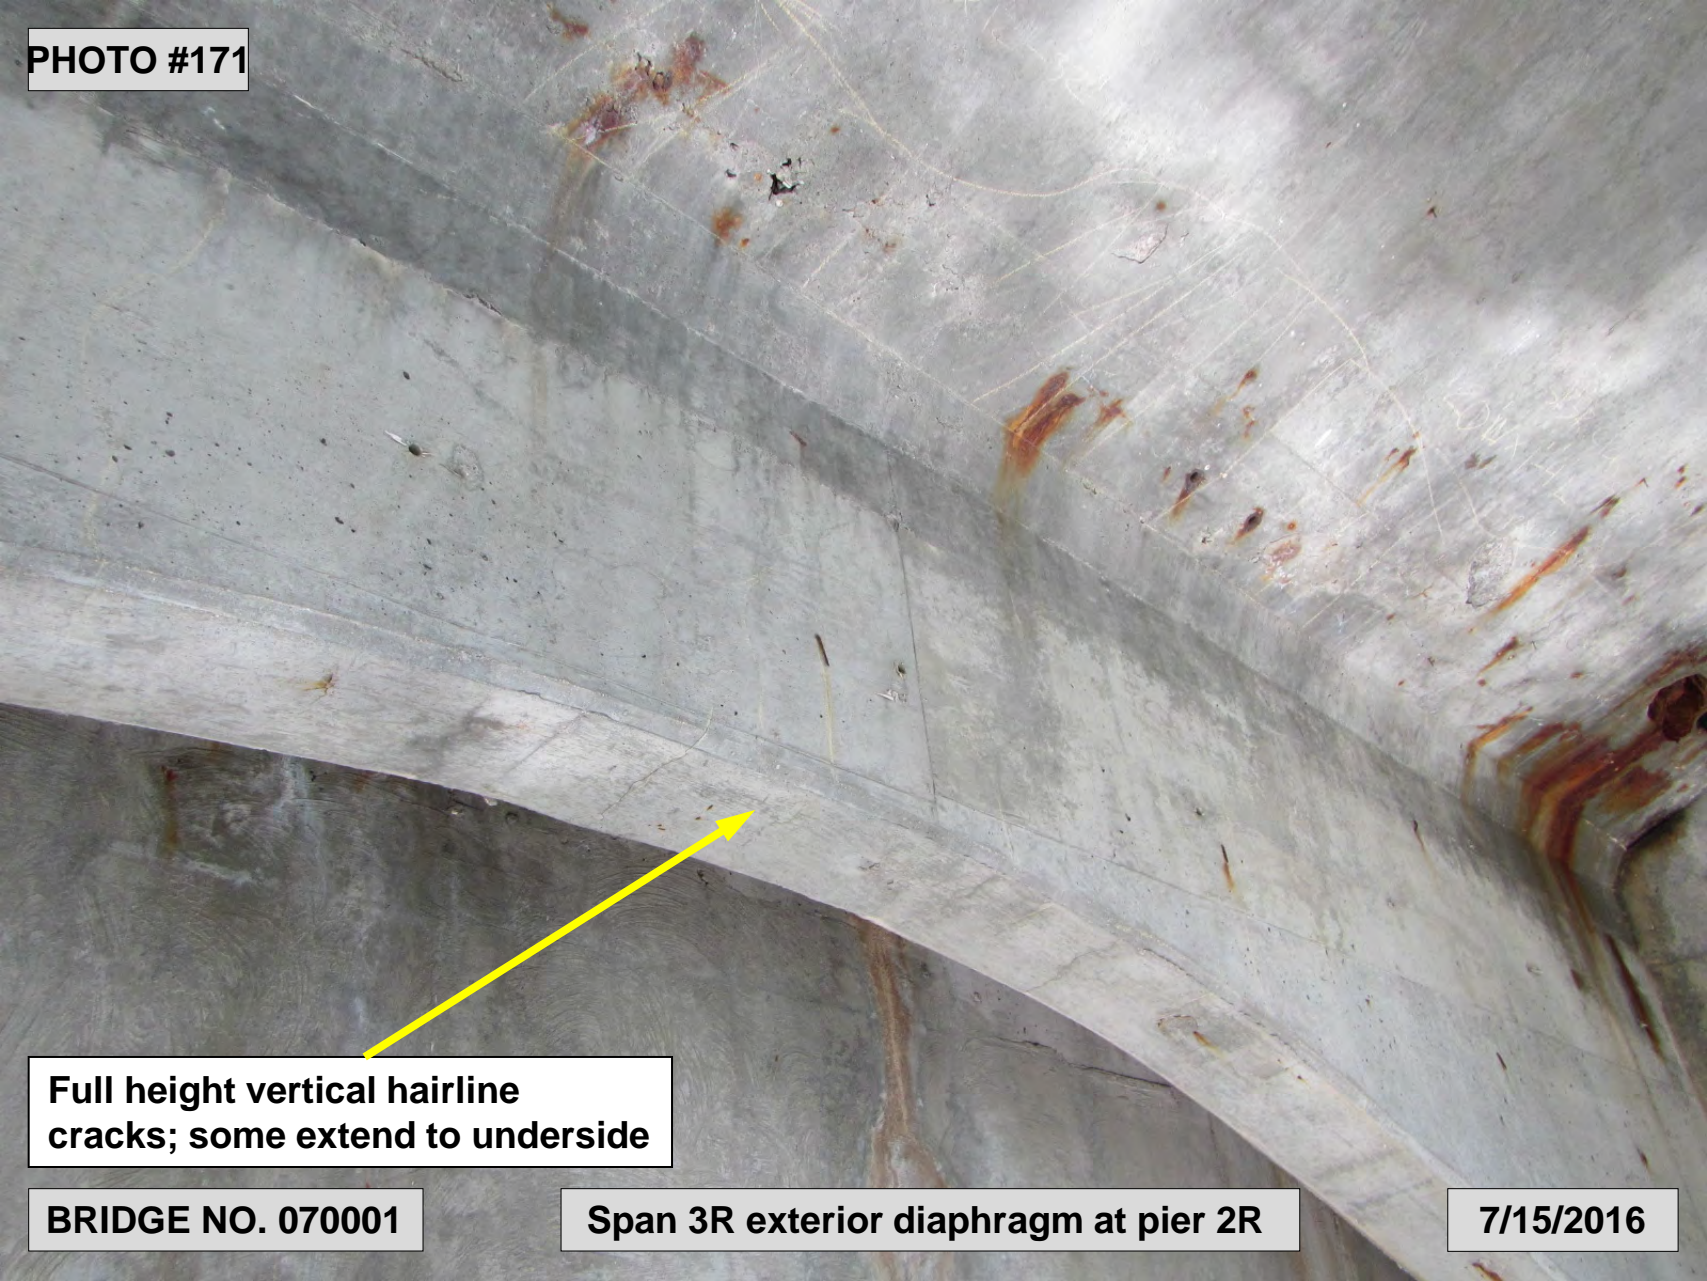
PHOTO #171

**Full height vertical hairline
cracks; some extend to underside**

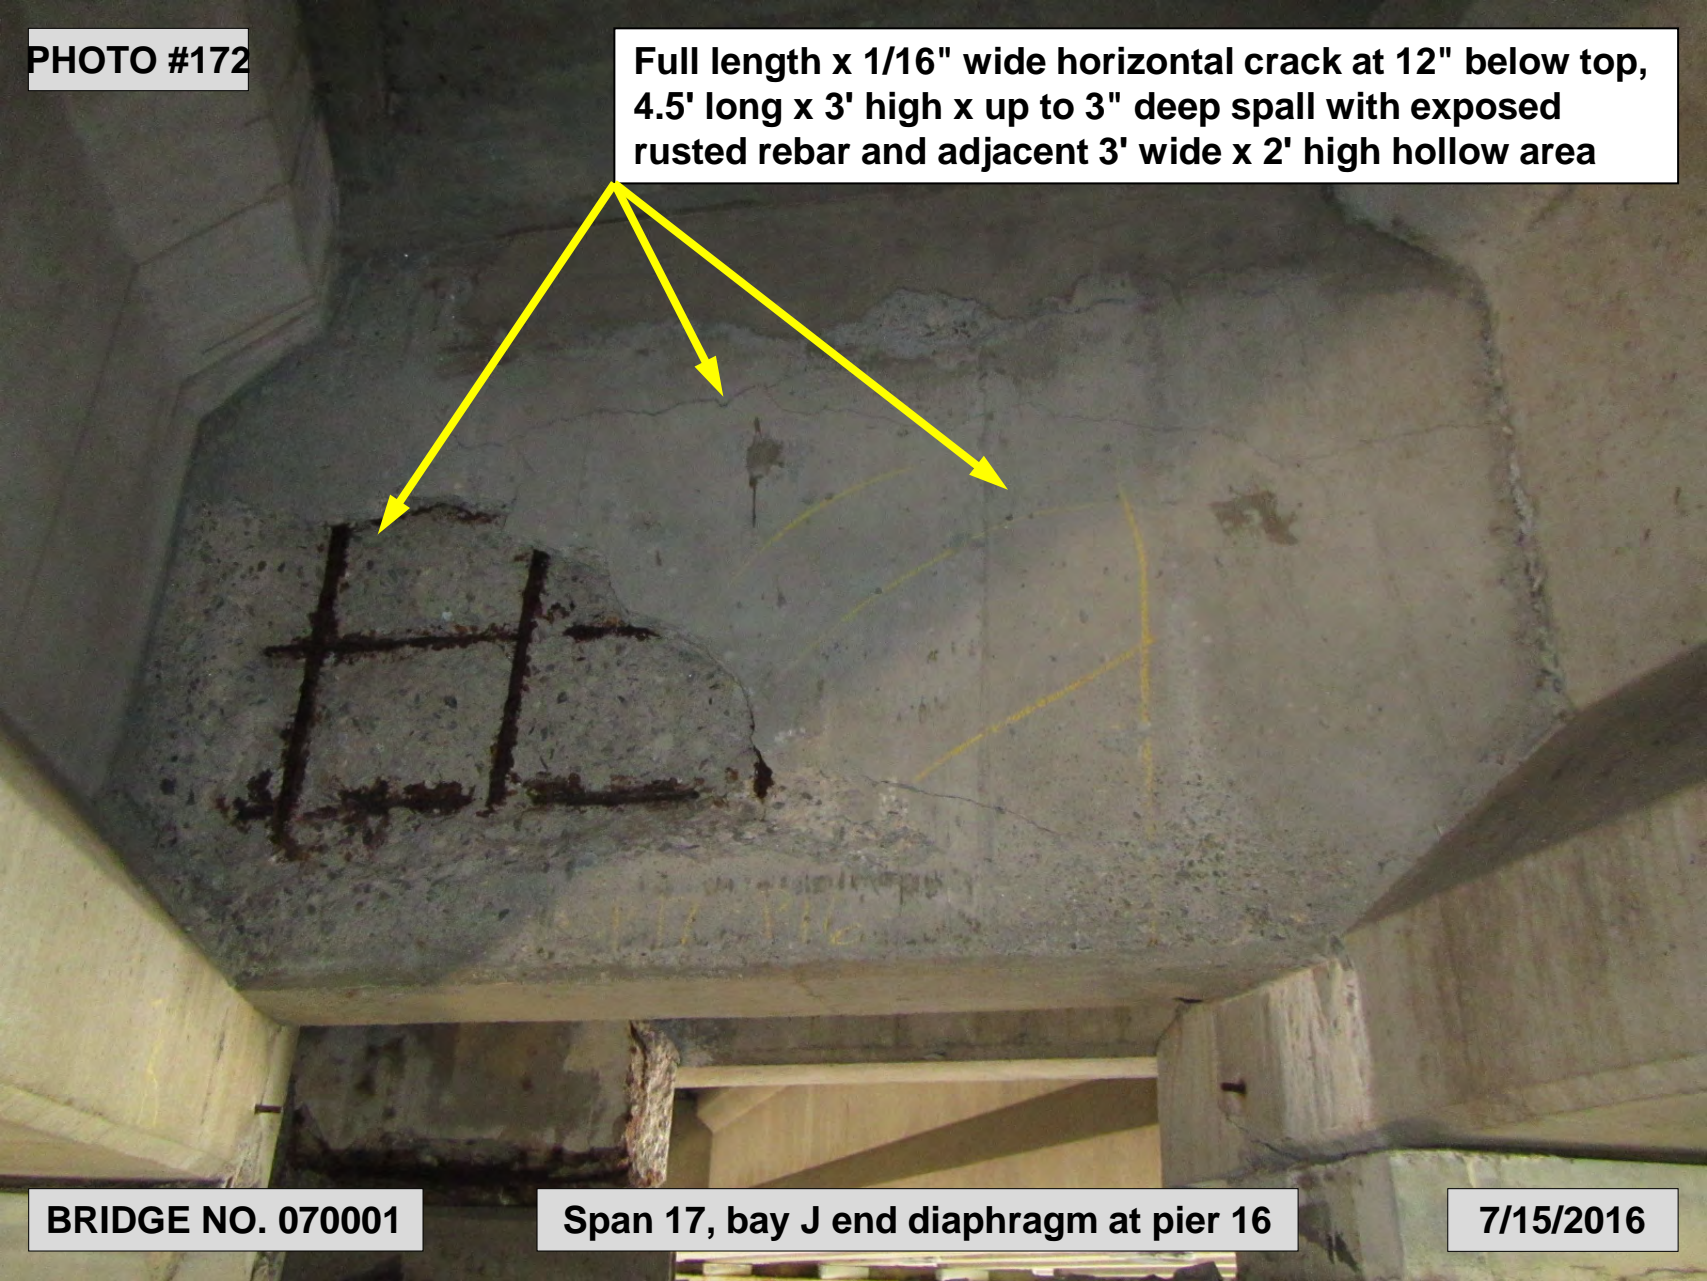
PHOTO #172

Full length x 1/16" wide horizontal crack at 12" below top, 4.5' long x 3' high x up to 3" deep spall with exposed rusted rebar and adjacent 3' wide x 2' high hollow area

Span 17, bay J end diaphragm at pier 16

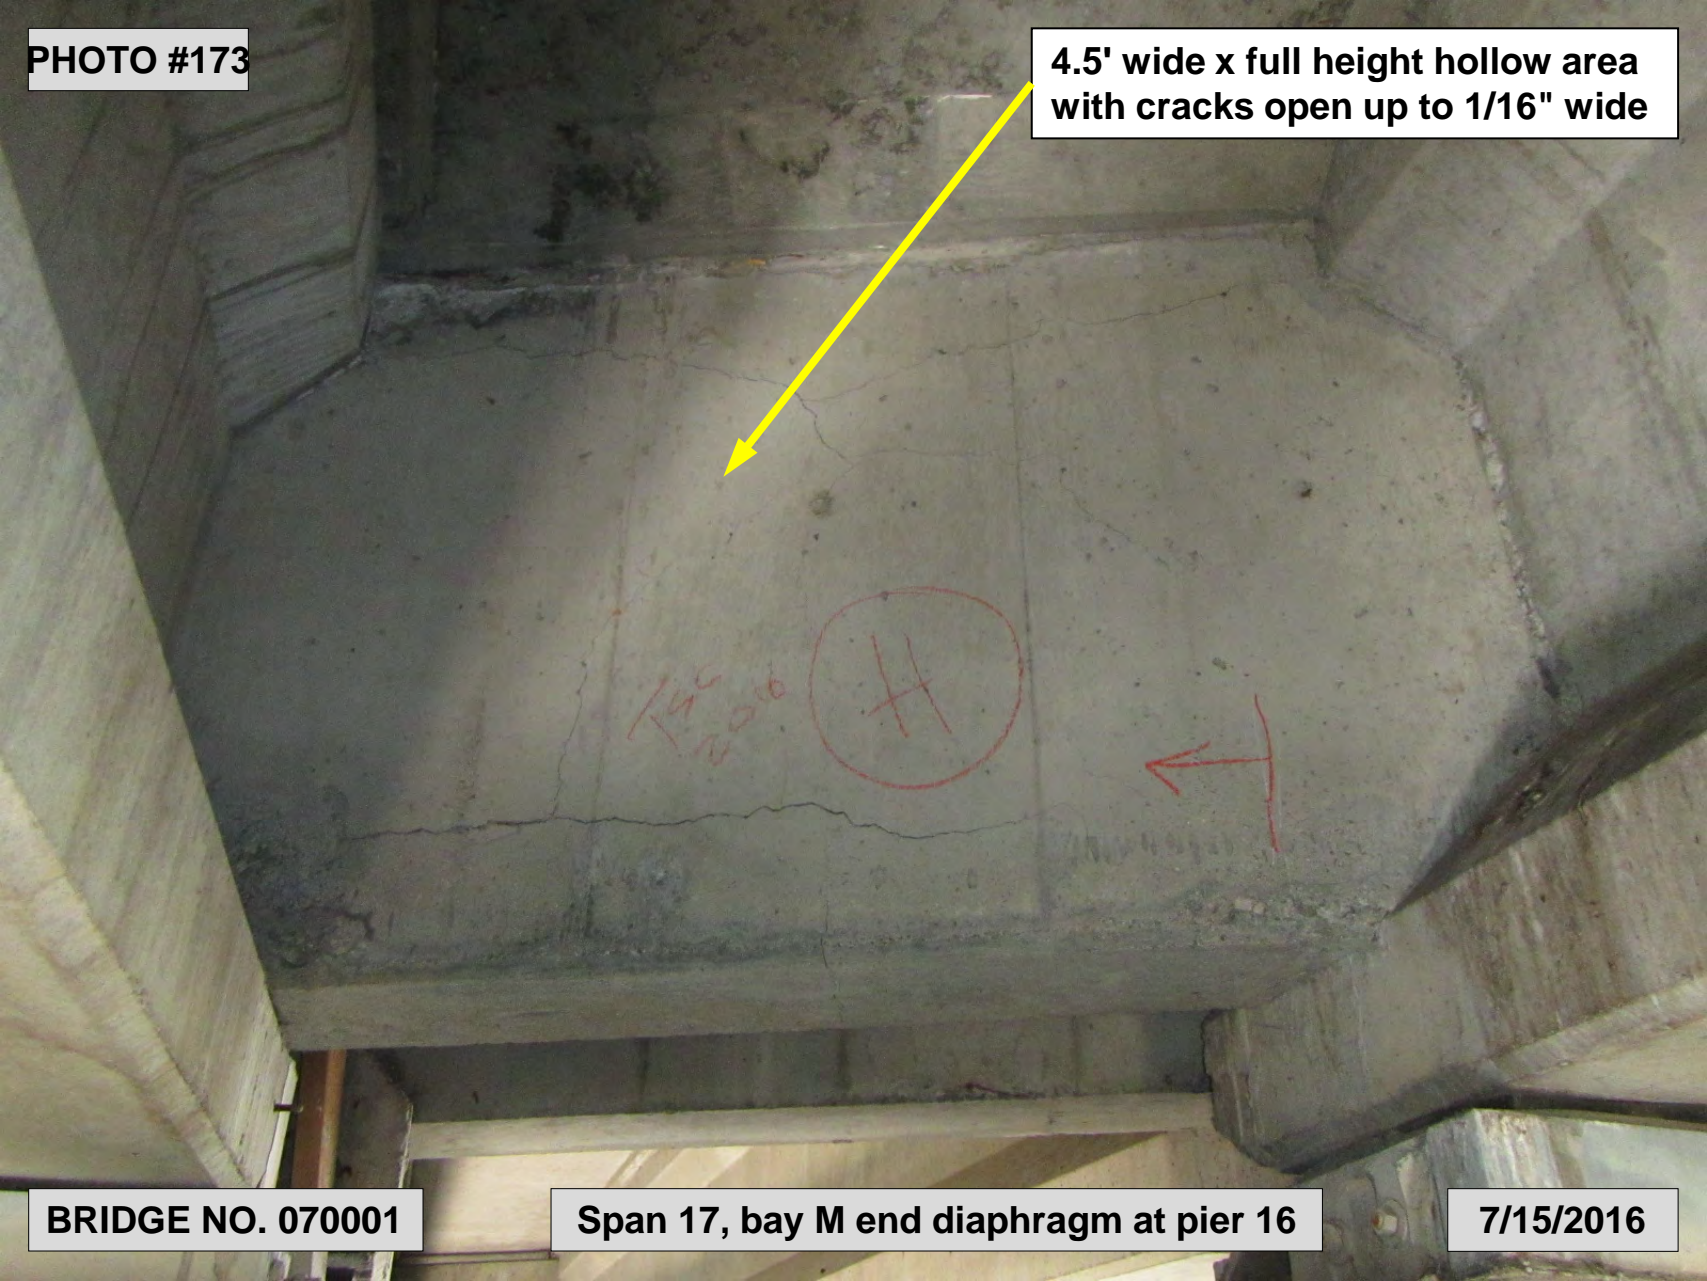
PHOTO #173

4.5' wide x full height hollow area with cracks open up to 1/16" wide

Span 17, bay M end diaphragm at pier 16

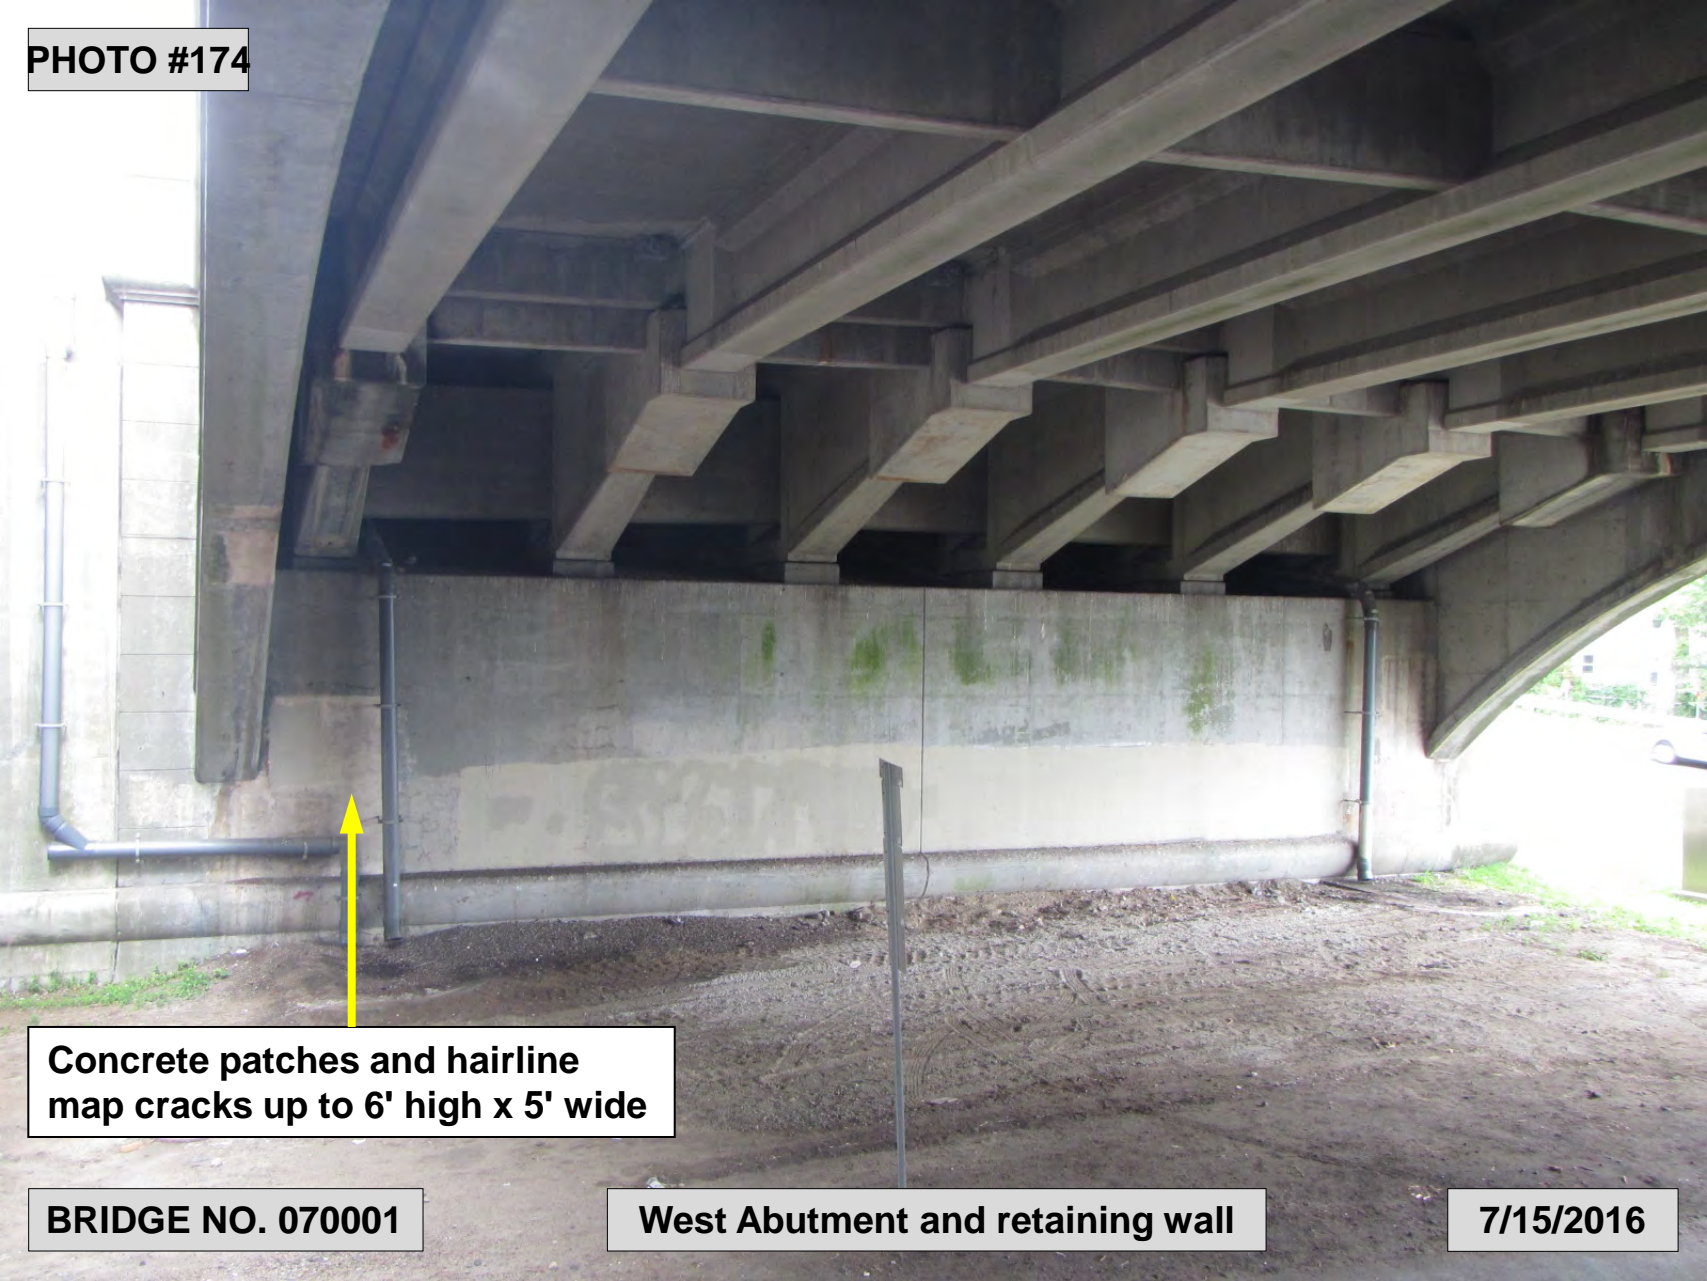
PHOTO #174

**Concrete patches and hairline
map cracks up to 6' high x 5' wide**

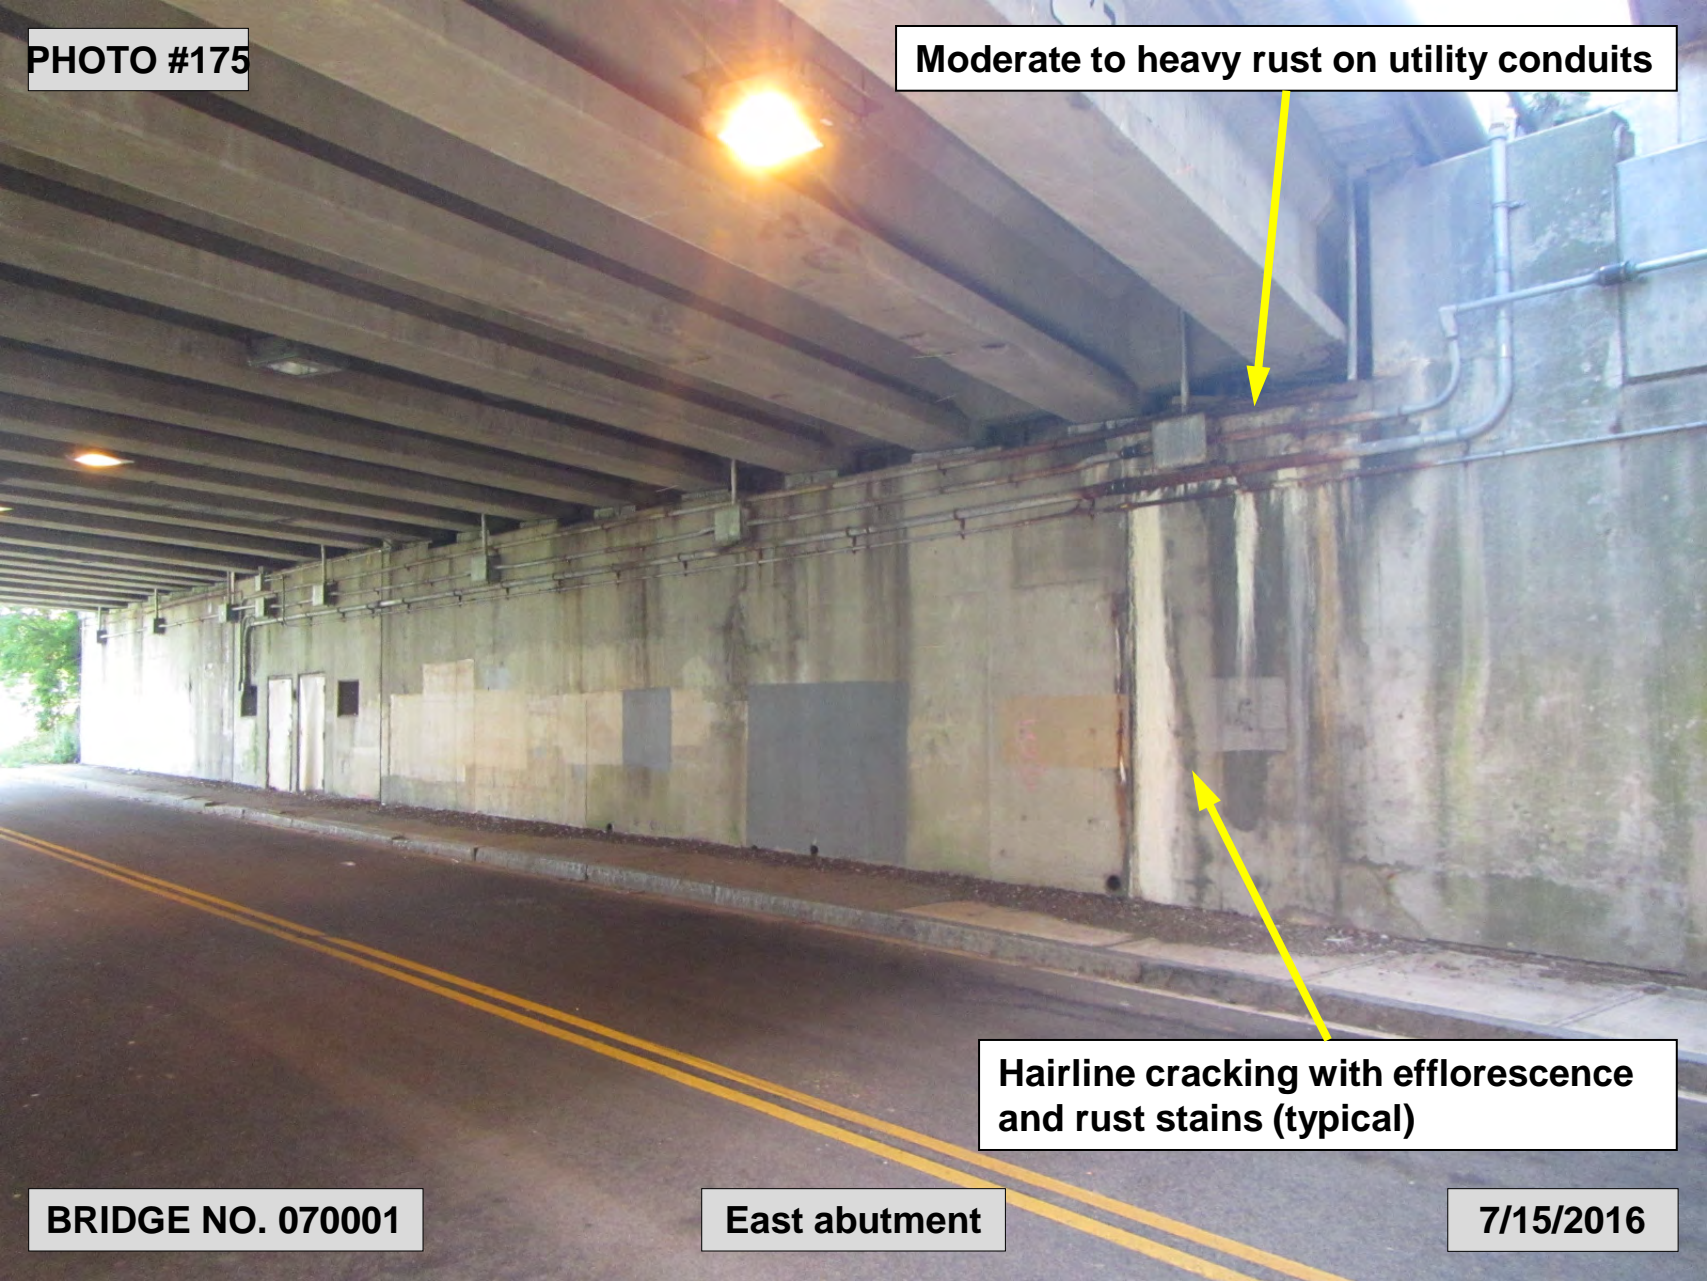
PHOTO #175

Moderate to heavy rust on utility conduits

Hairline cracking with efflorescence and rust stains (typical)

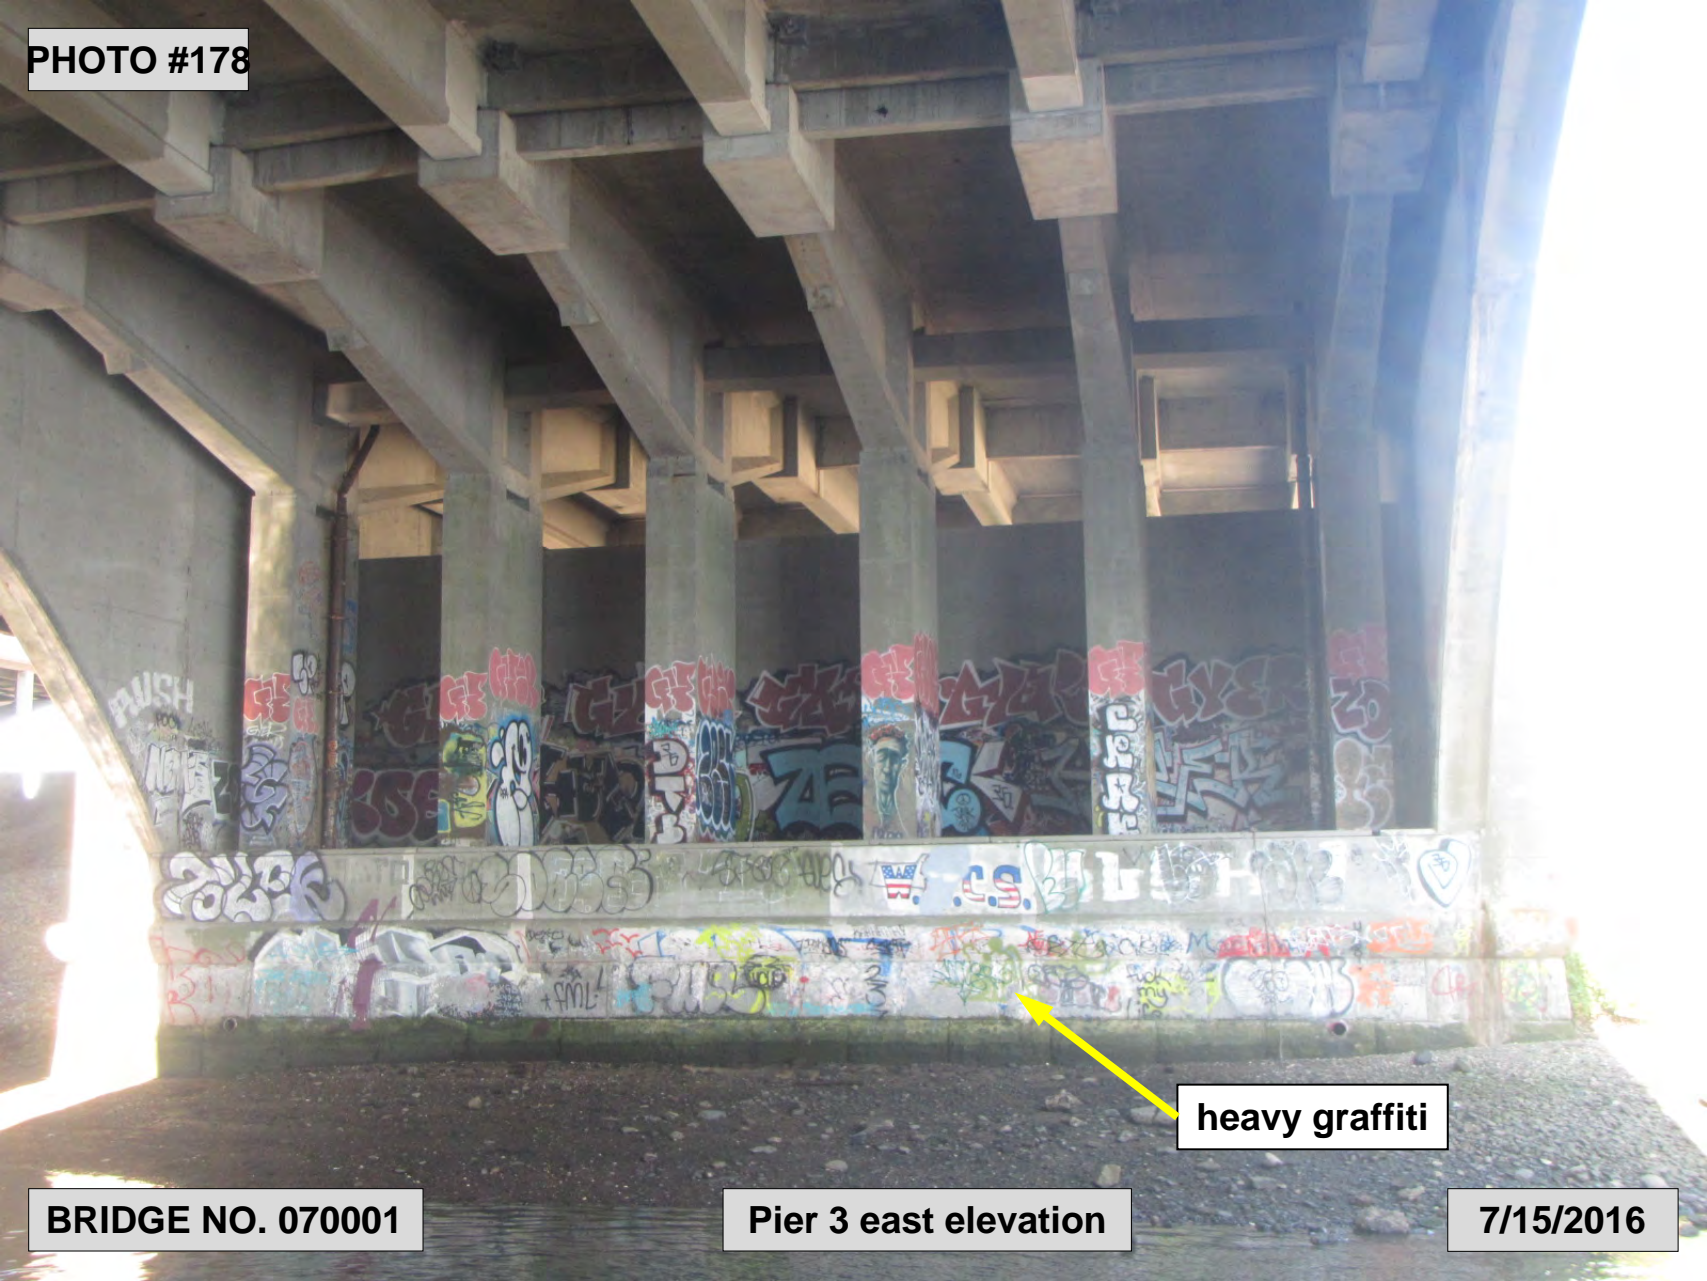
PHOTO #178

heavy graffiti

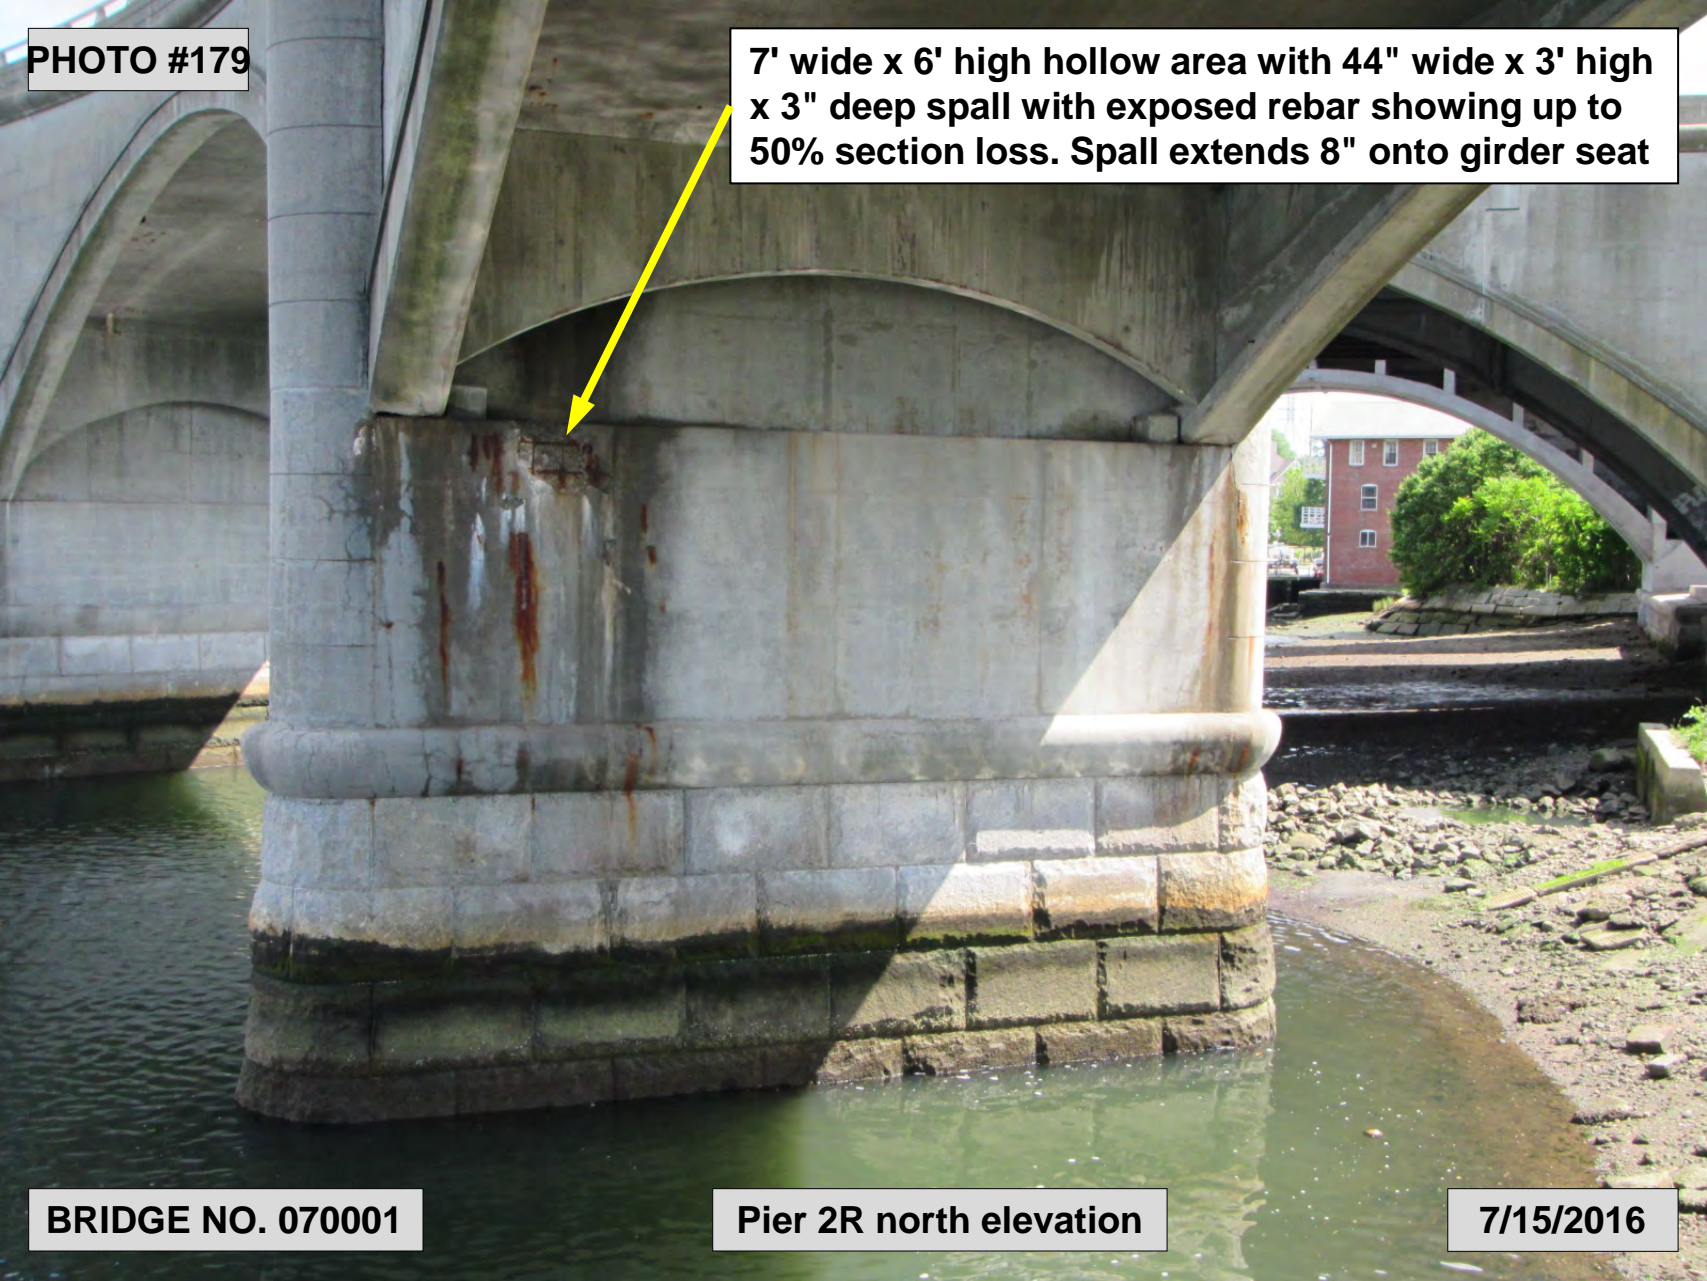
PHOTO #179

7' wide x 6' high hollow area with 44" wide x 3' high x 3" deep spall with exposed rebar showing up to 50% section loss. Spall extends 8" onto girder seat

Pier 2R north elevation

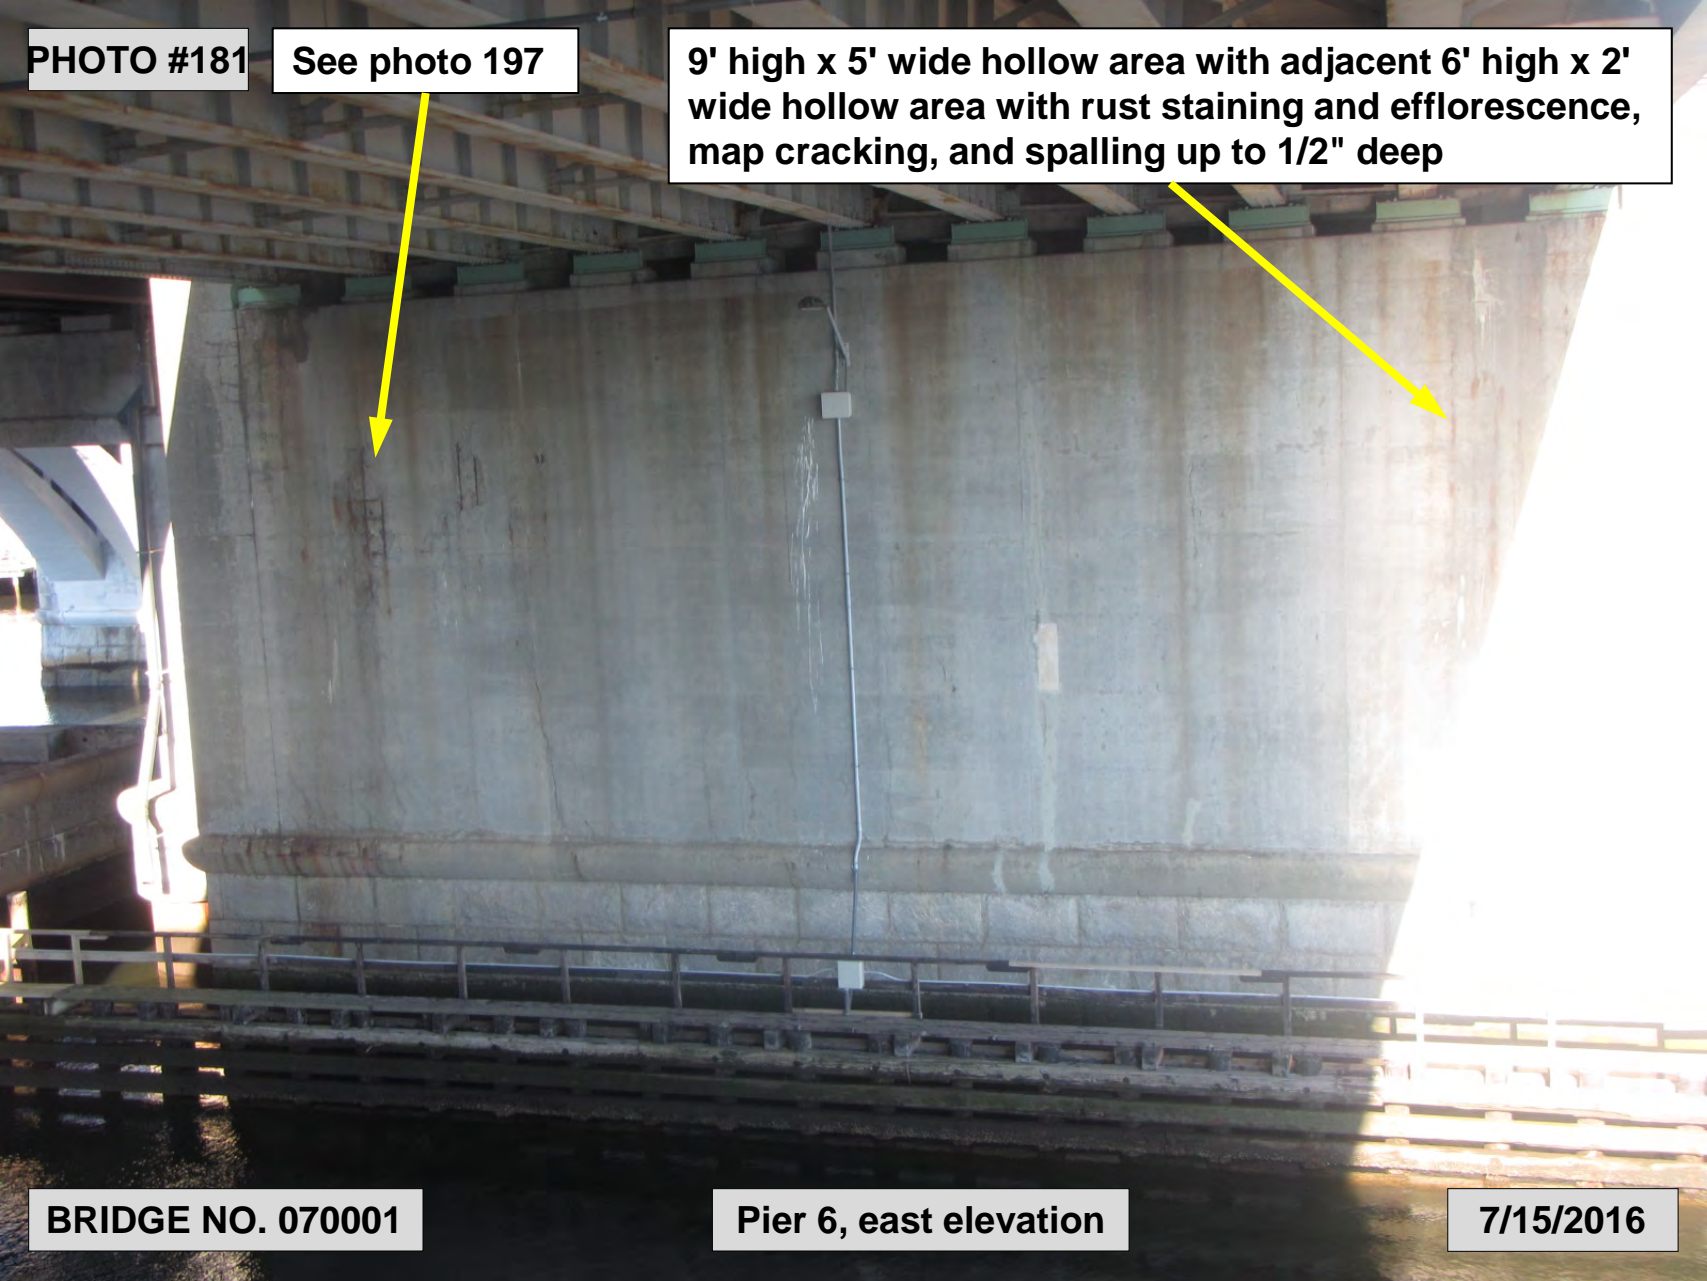
9' high x 5' wide hollow area with adjacent 6' high x 2' wide hollow area with rust staining and efflorescence, map cracking, and spalling up to 1/2" deep

Pier 6, east elevation

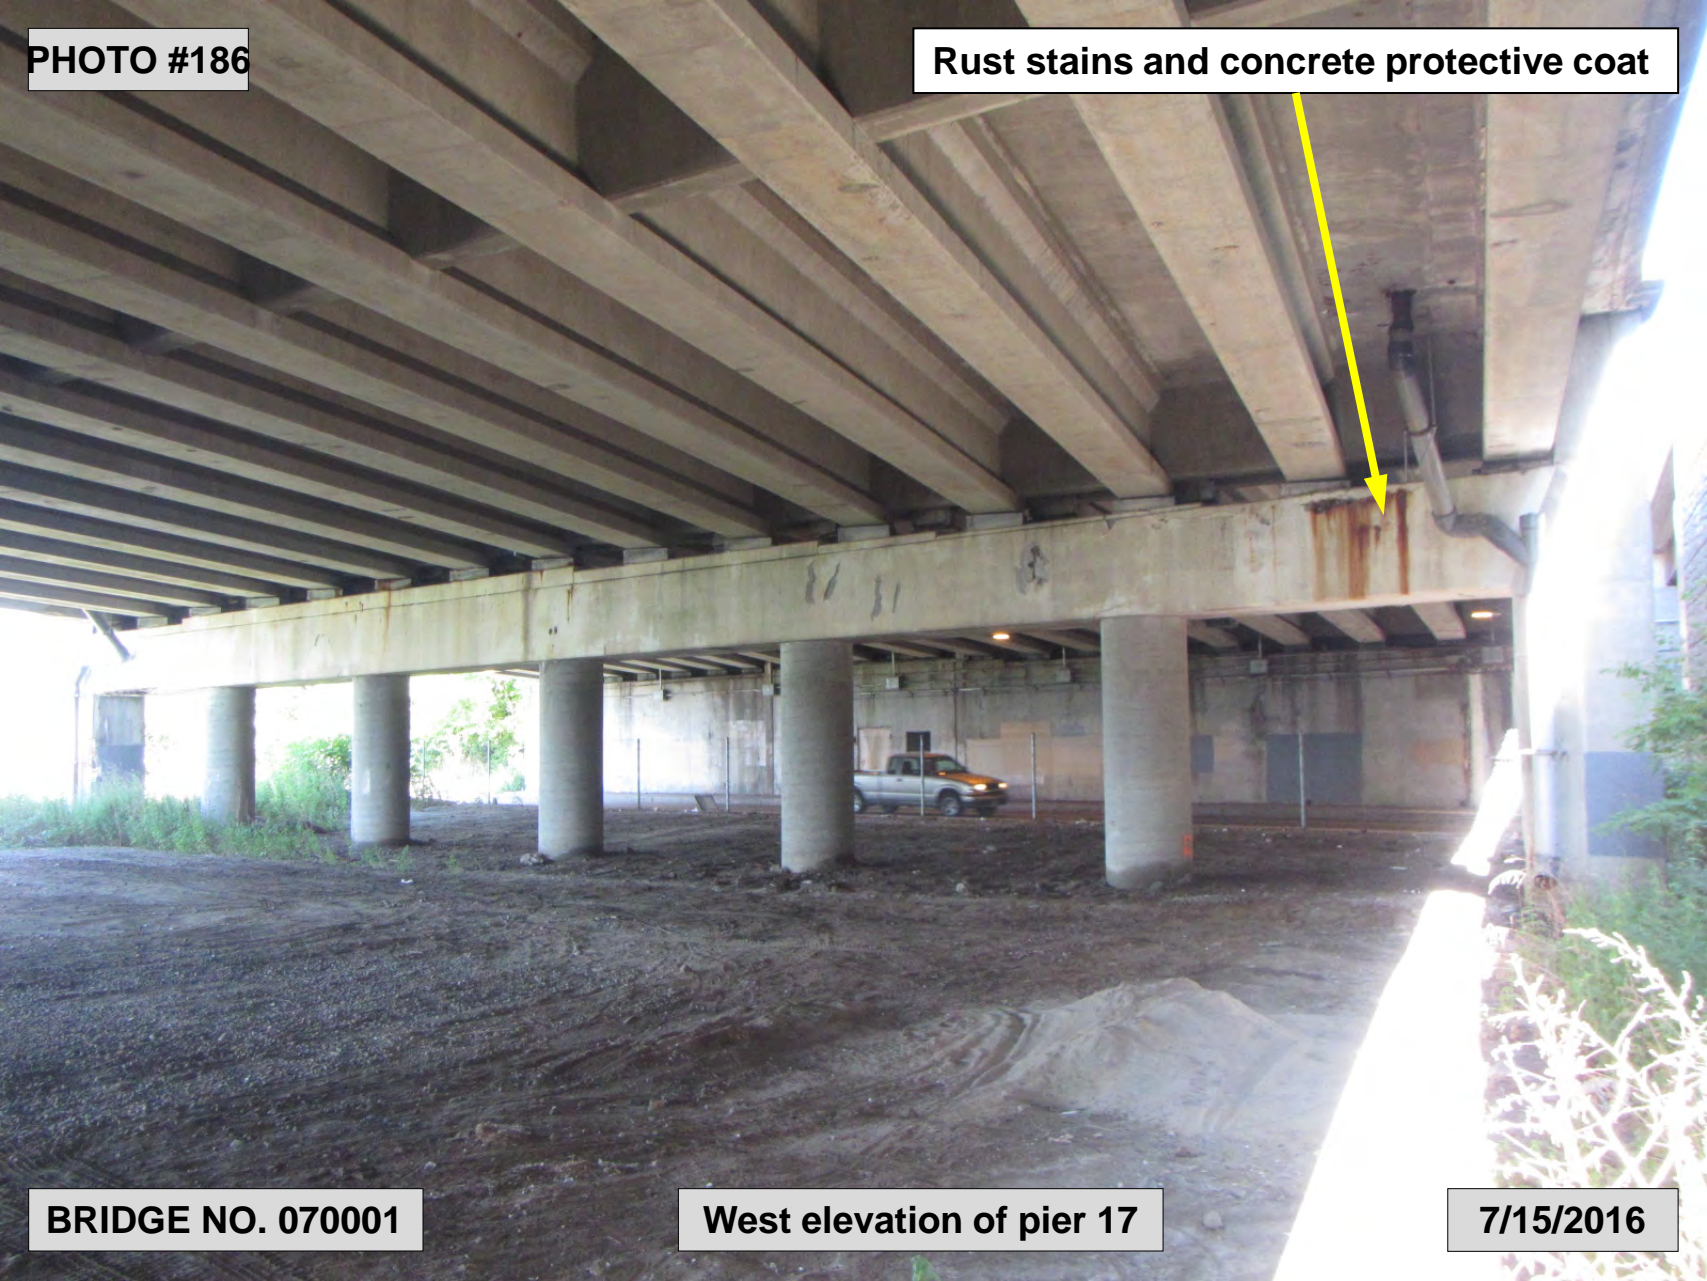
PHOTO #186

Rust stains and concrete protective coat

West elevation of pier 17

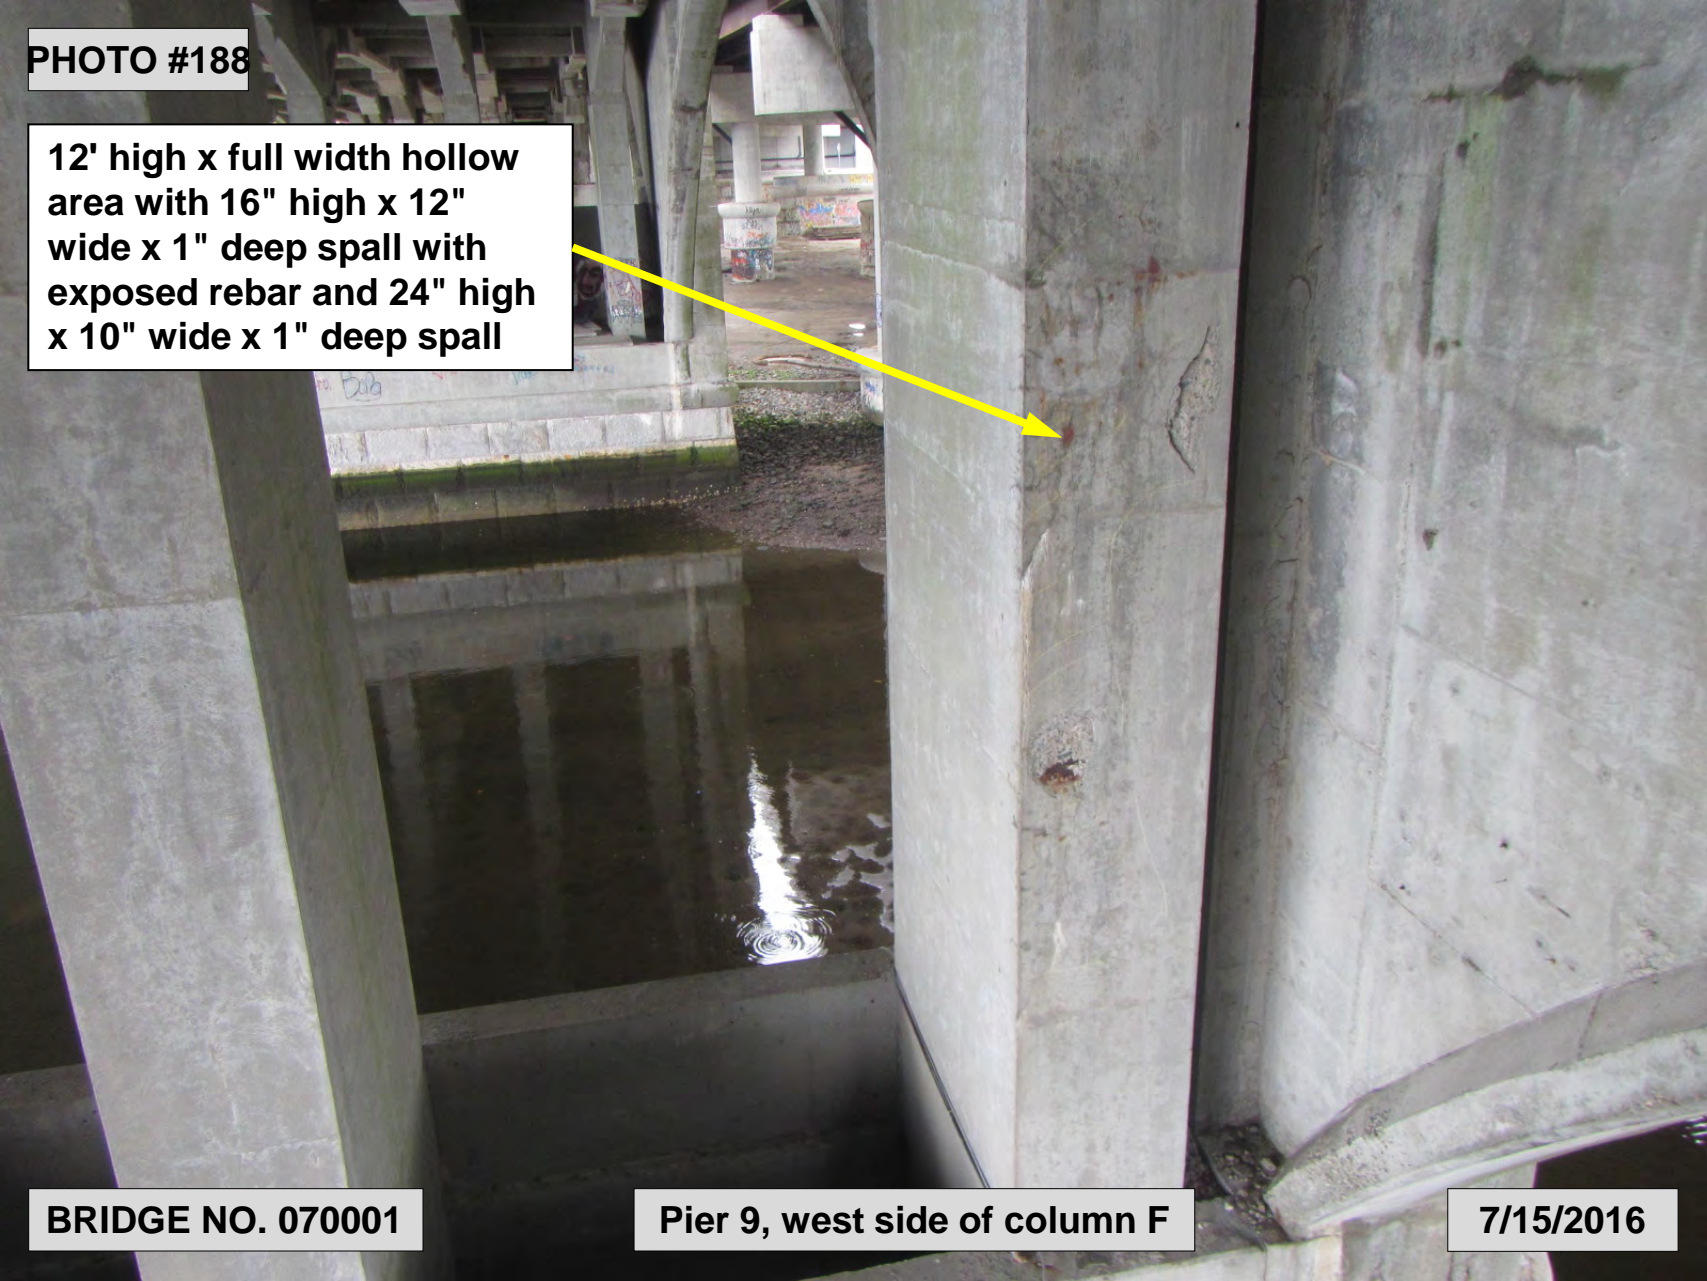
PHOTO #188

12' high x full width hollow area with 16" high x 12" wide x 1" deep spall with exposed rebar and 24" high x 10" wide x 1" deep spall

Pier 9, west side of column F
