BRIDGE NO. 070001

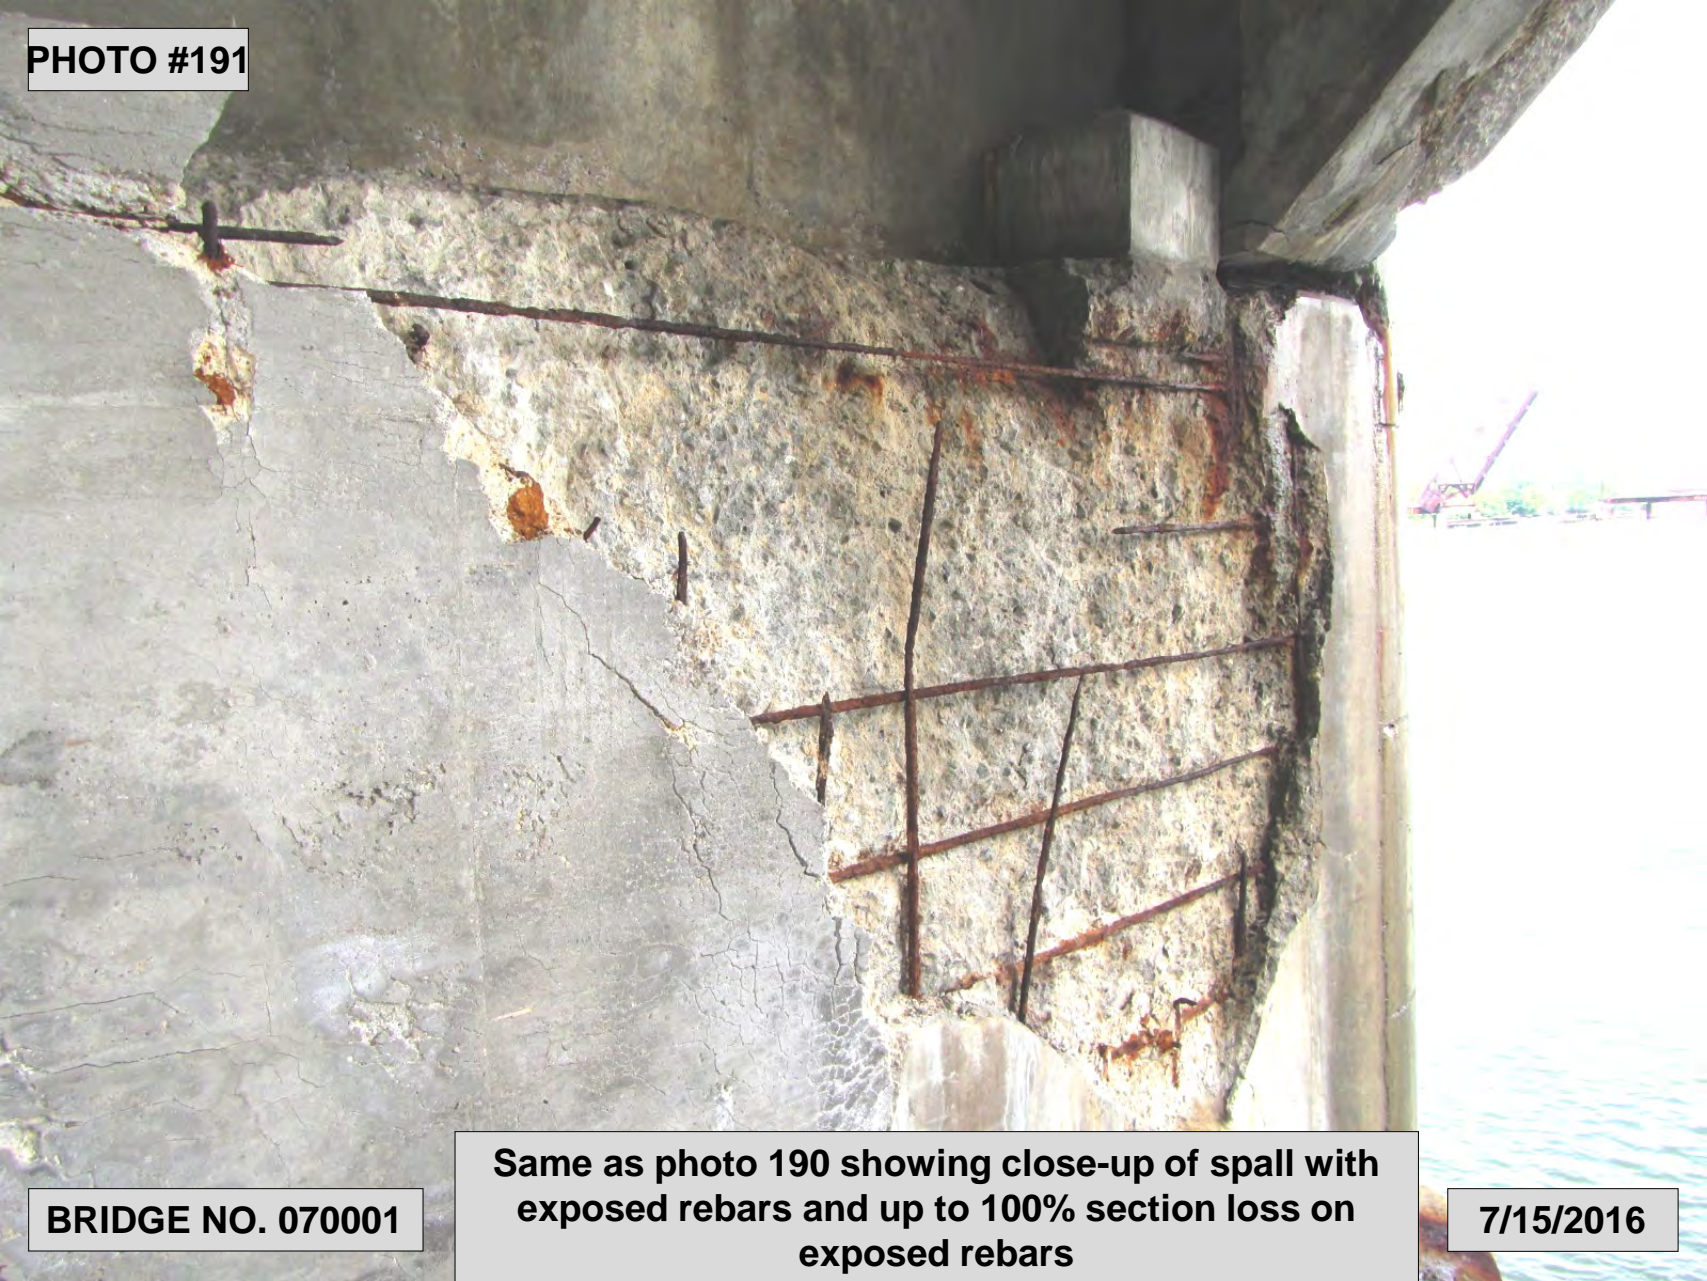
PHOTO #191

Same as photo 190 showing close-up of spall with exposed rebar and up to 100% section loss on exposed rebar

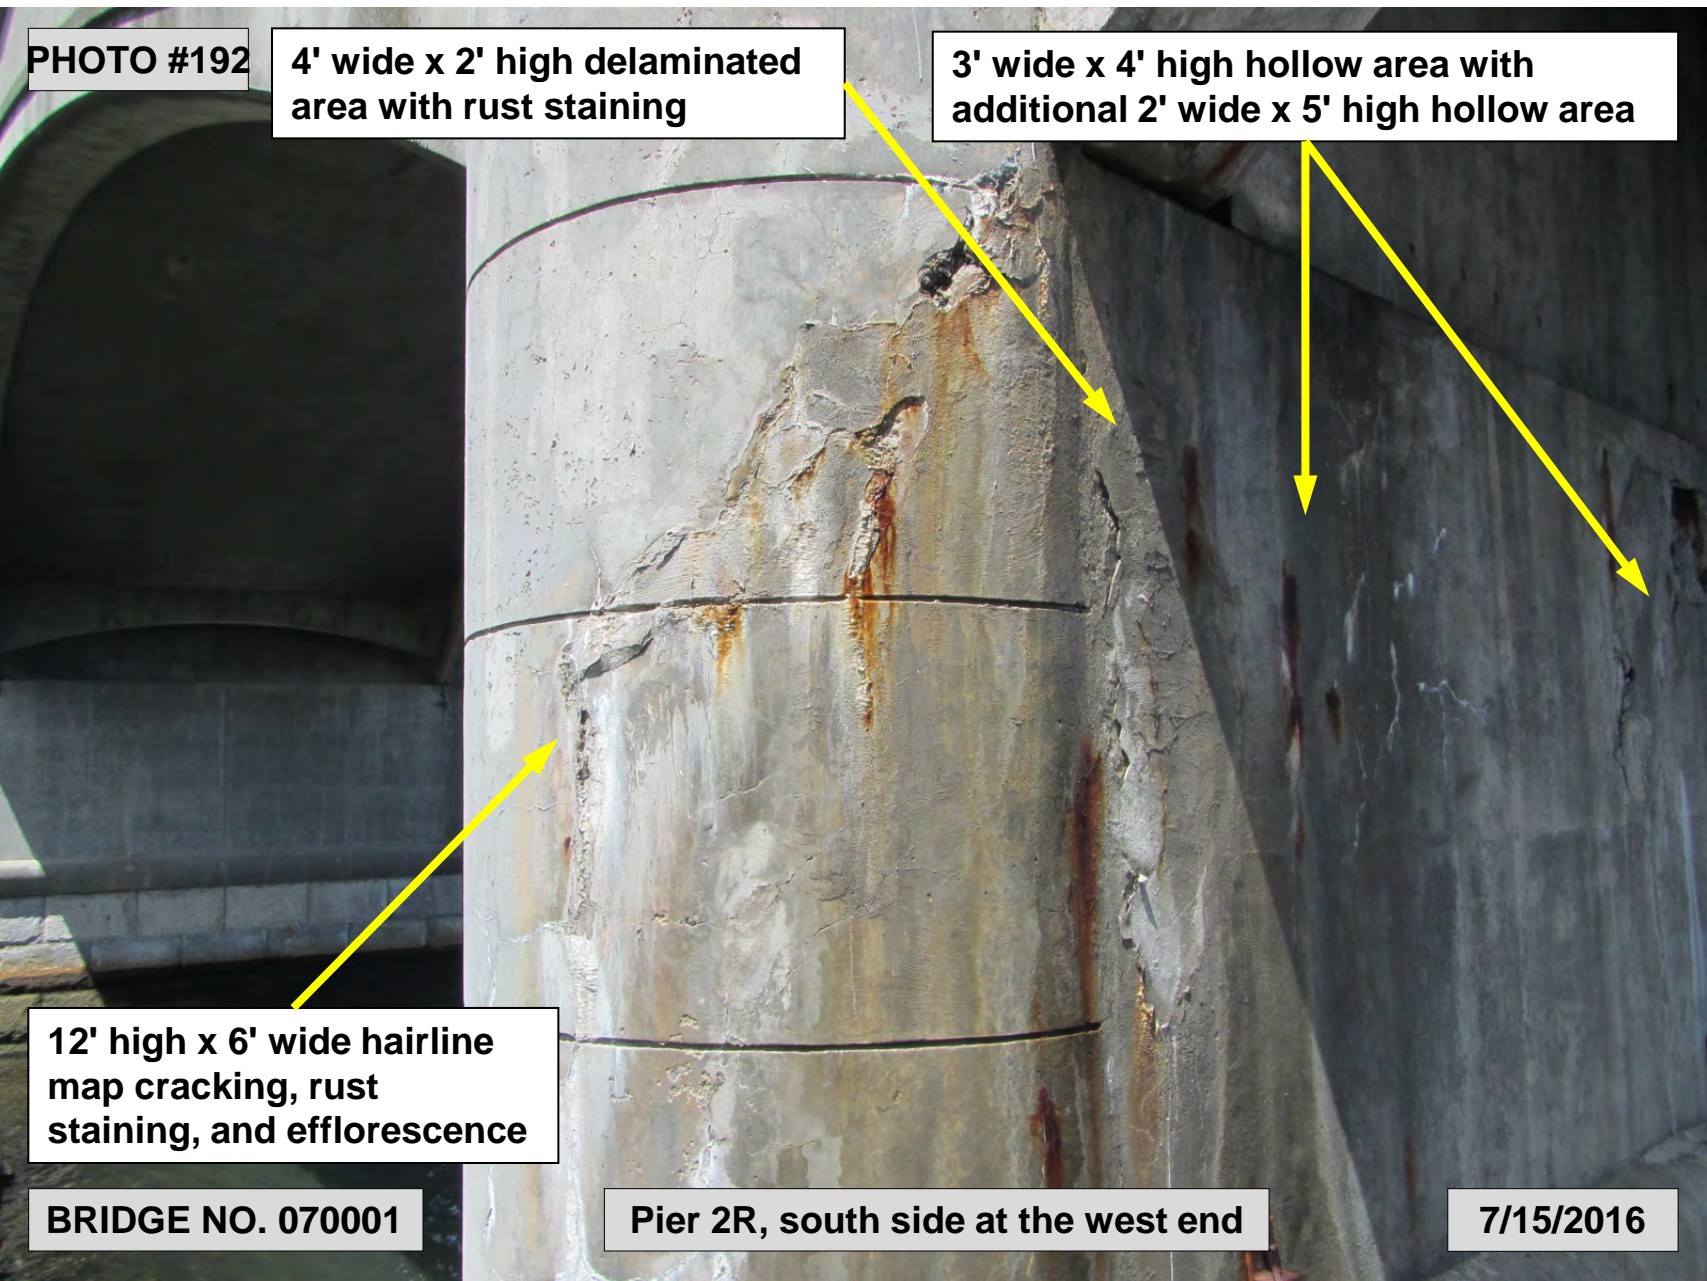
Pier 2R, south side at the west end

12' high x 6' wide hairline map cracking, rust staining, and efflorescence

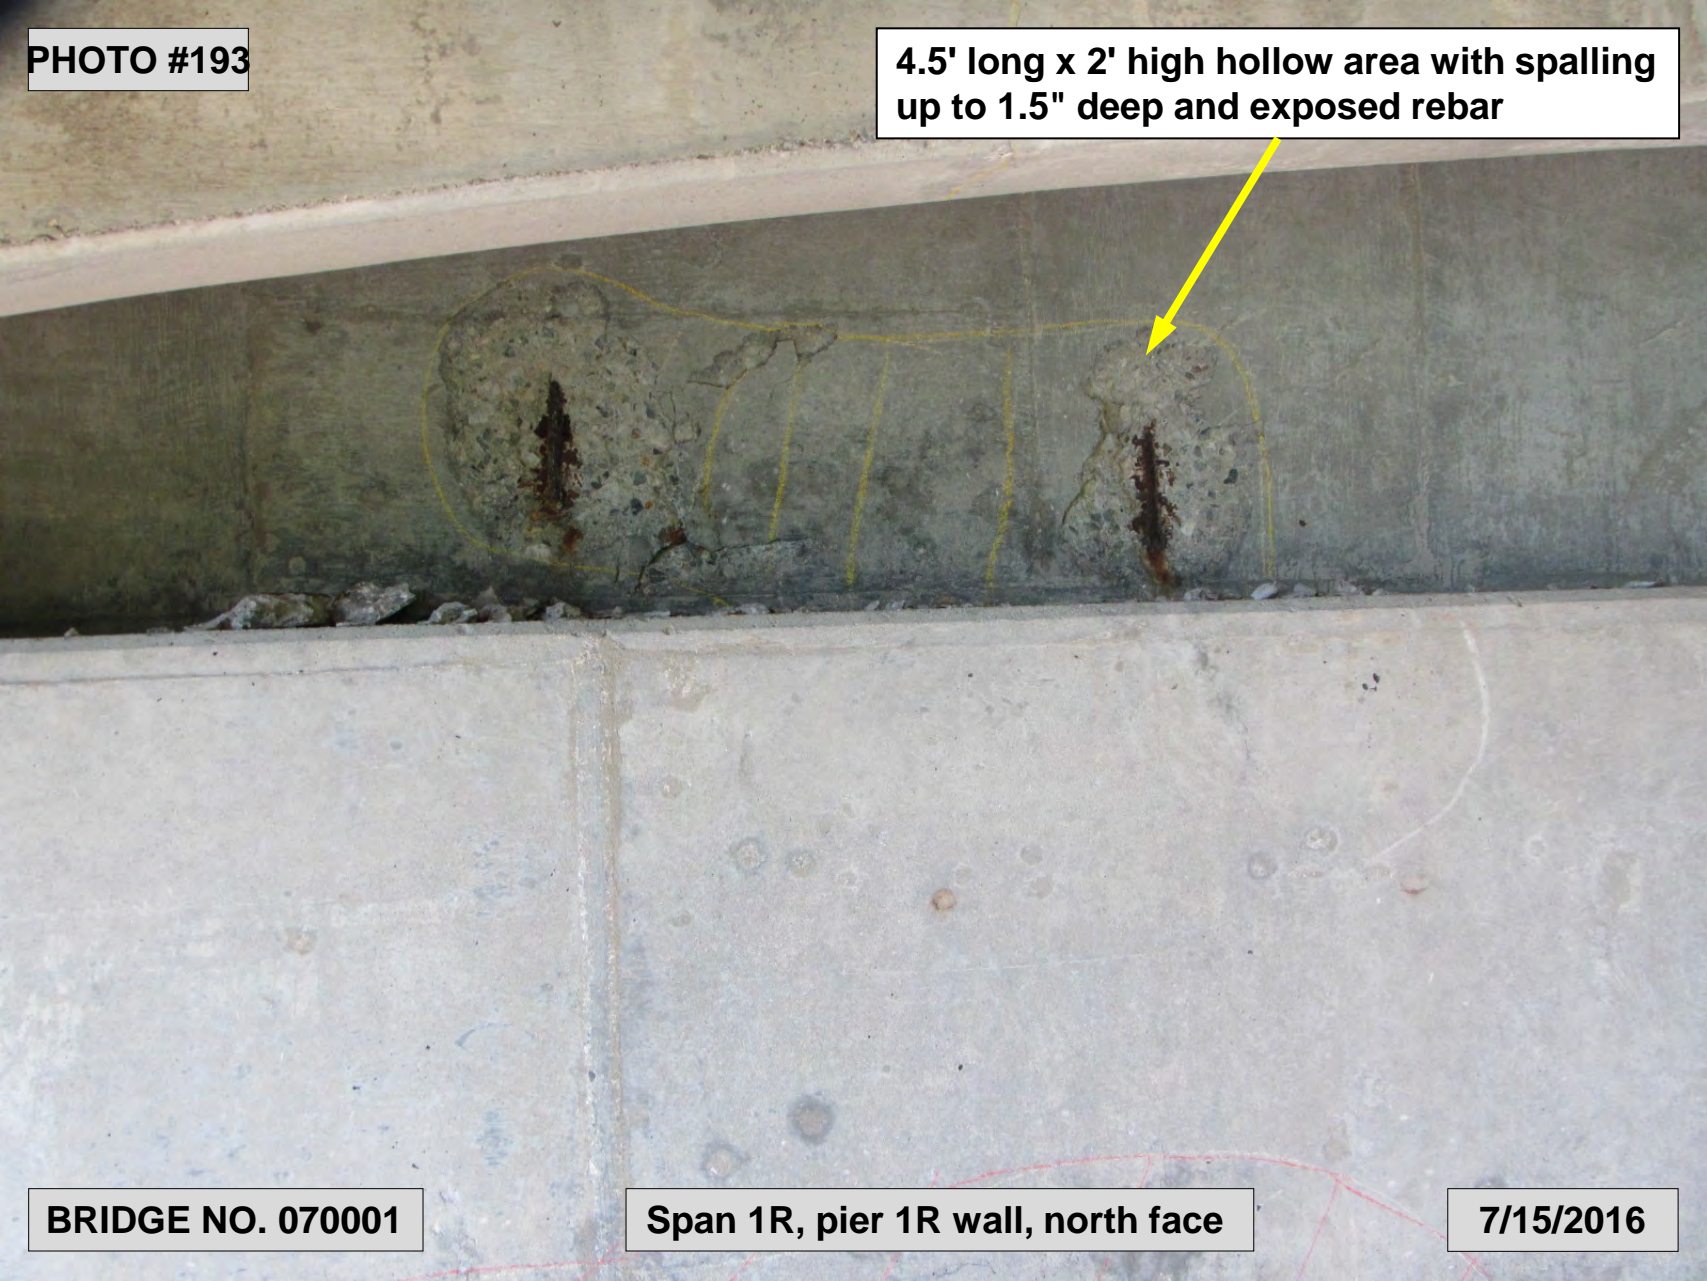
PHOTO #193

4.5' long x 2' high hollow area with spalling up to 1.5" deep and exposed rebar

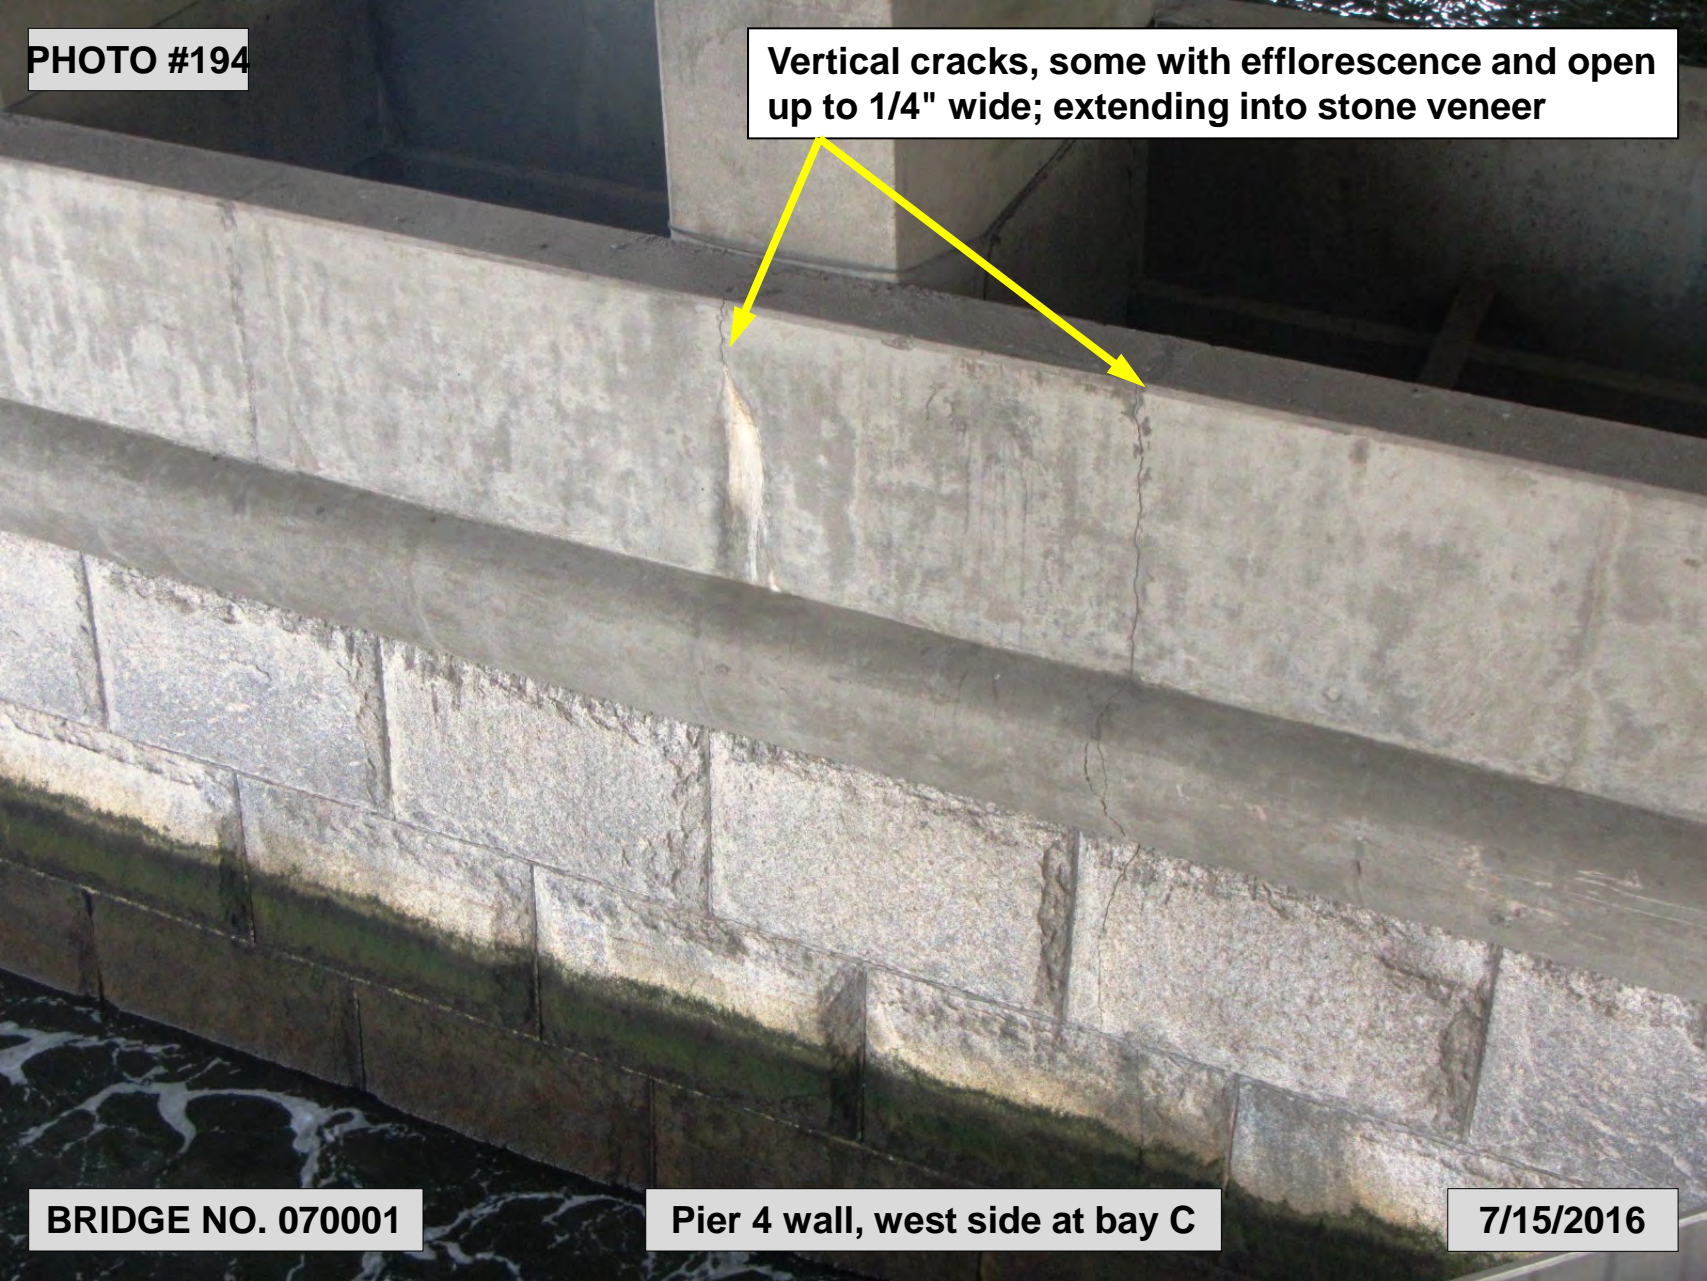
PHOTO #194

Vertical cracks, some with efflorescence and open up to 1/4" wide; extending into stone veneer

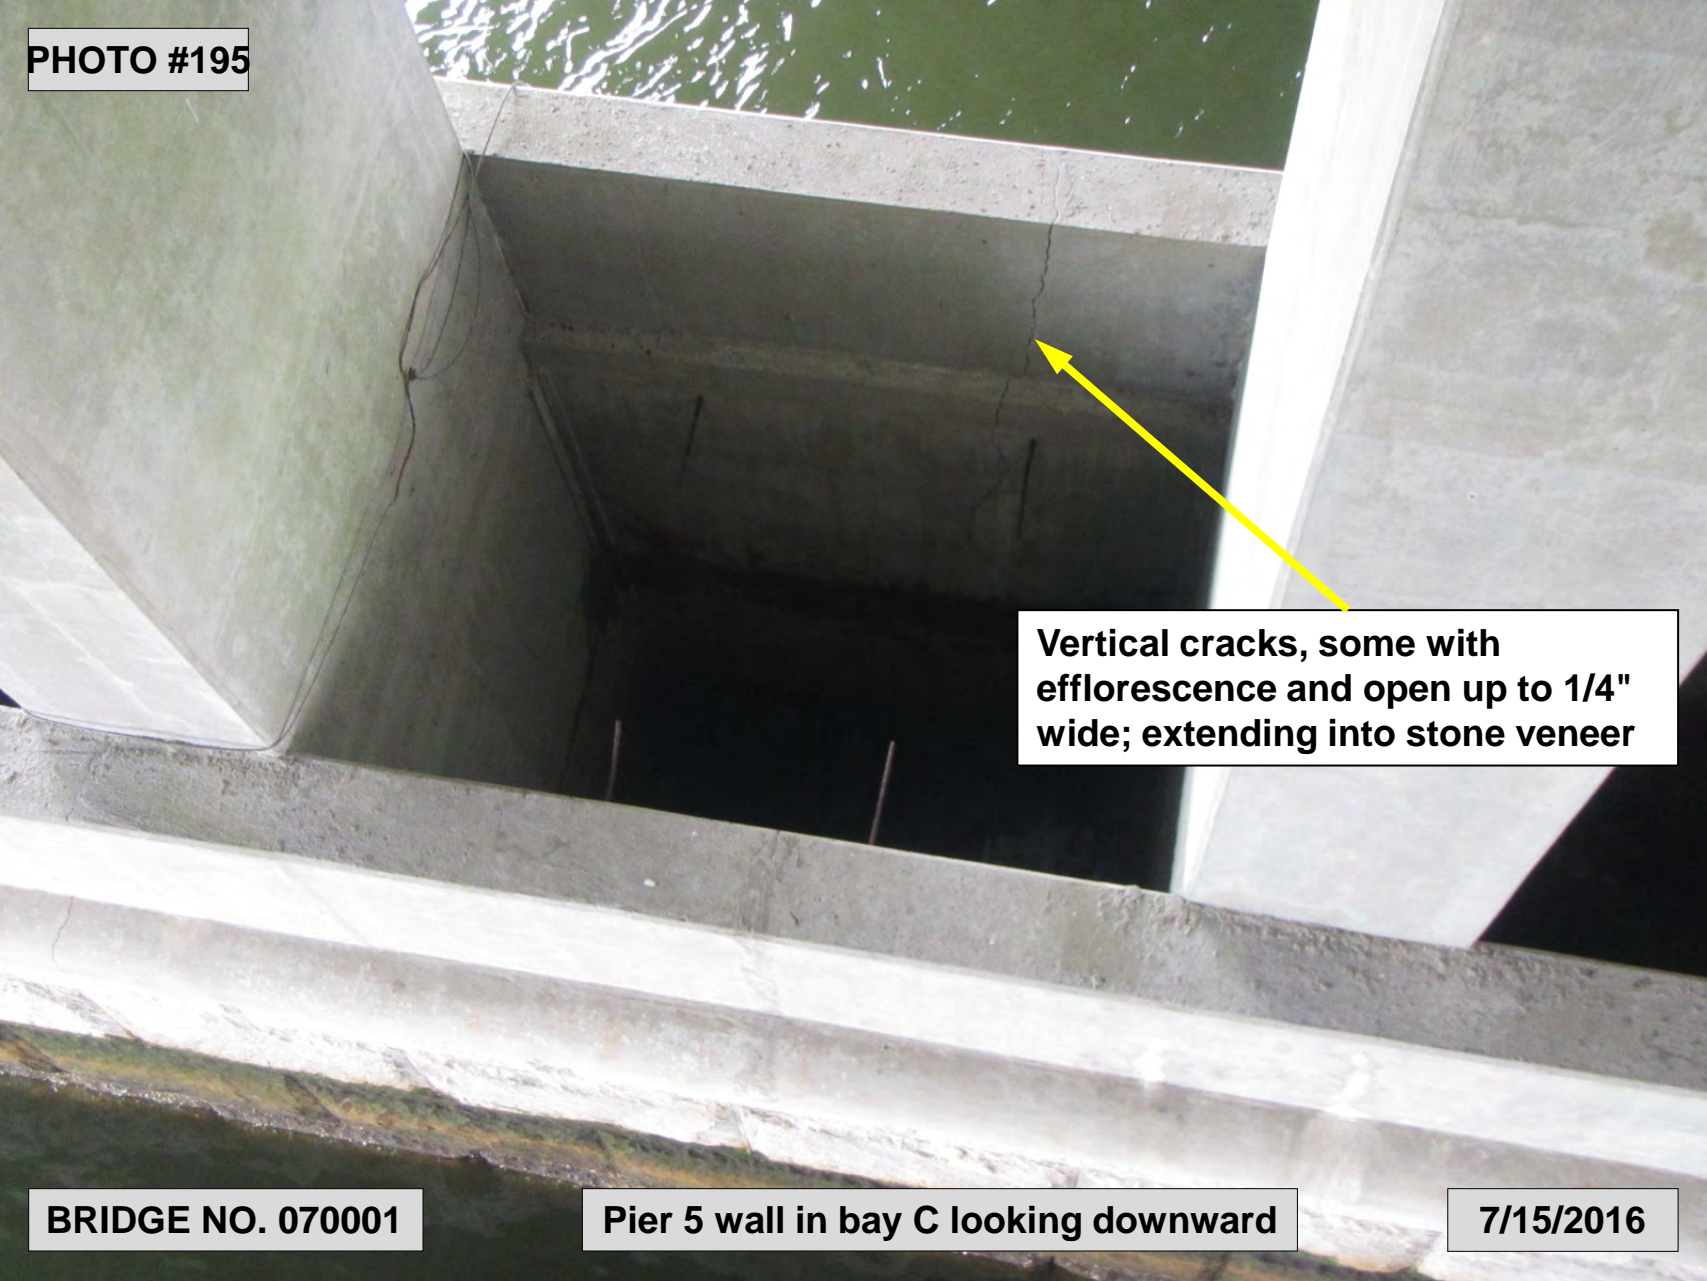
PHOTO #195

Vertical cracks, some with efflorescence and open up to 1/4" wide; extending into stone veneer

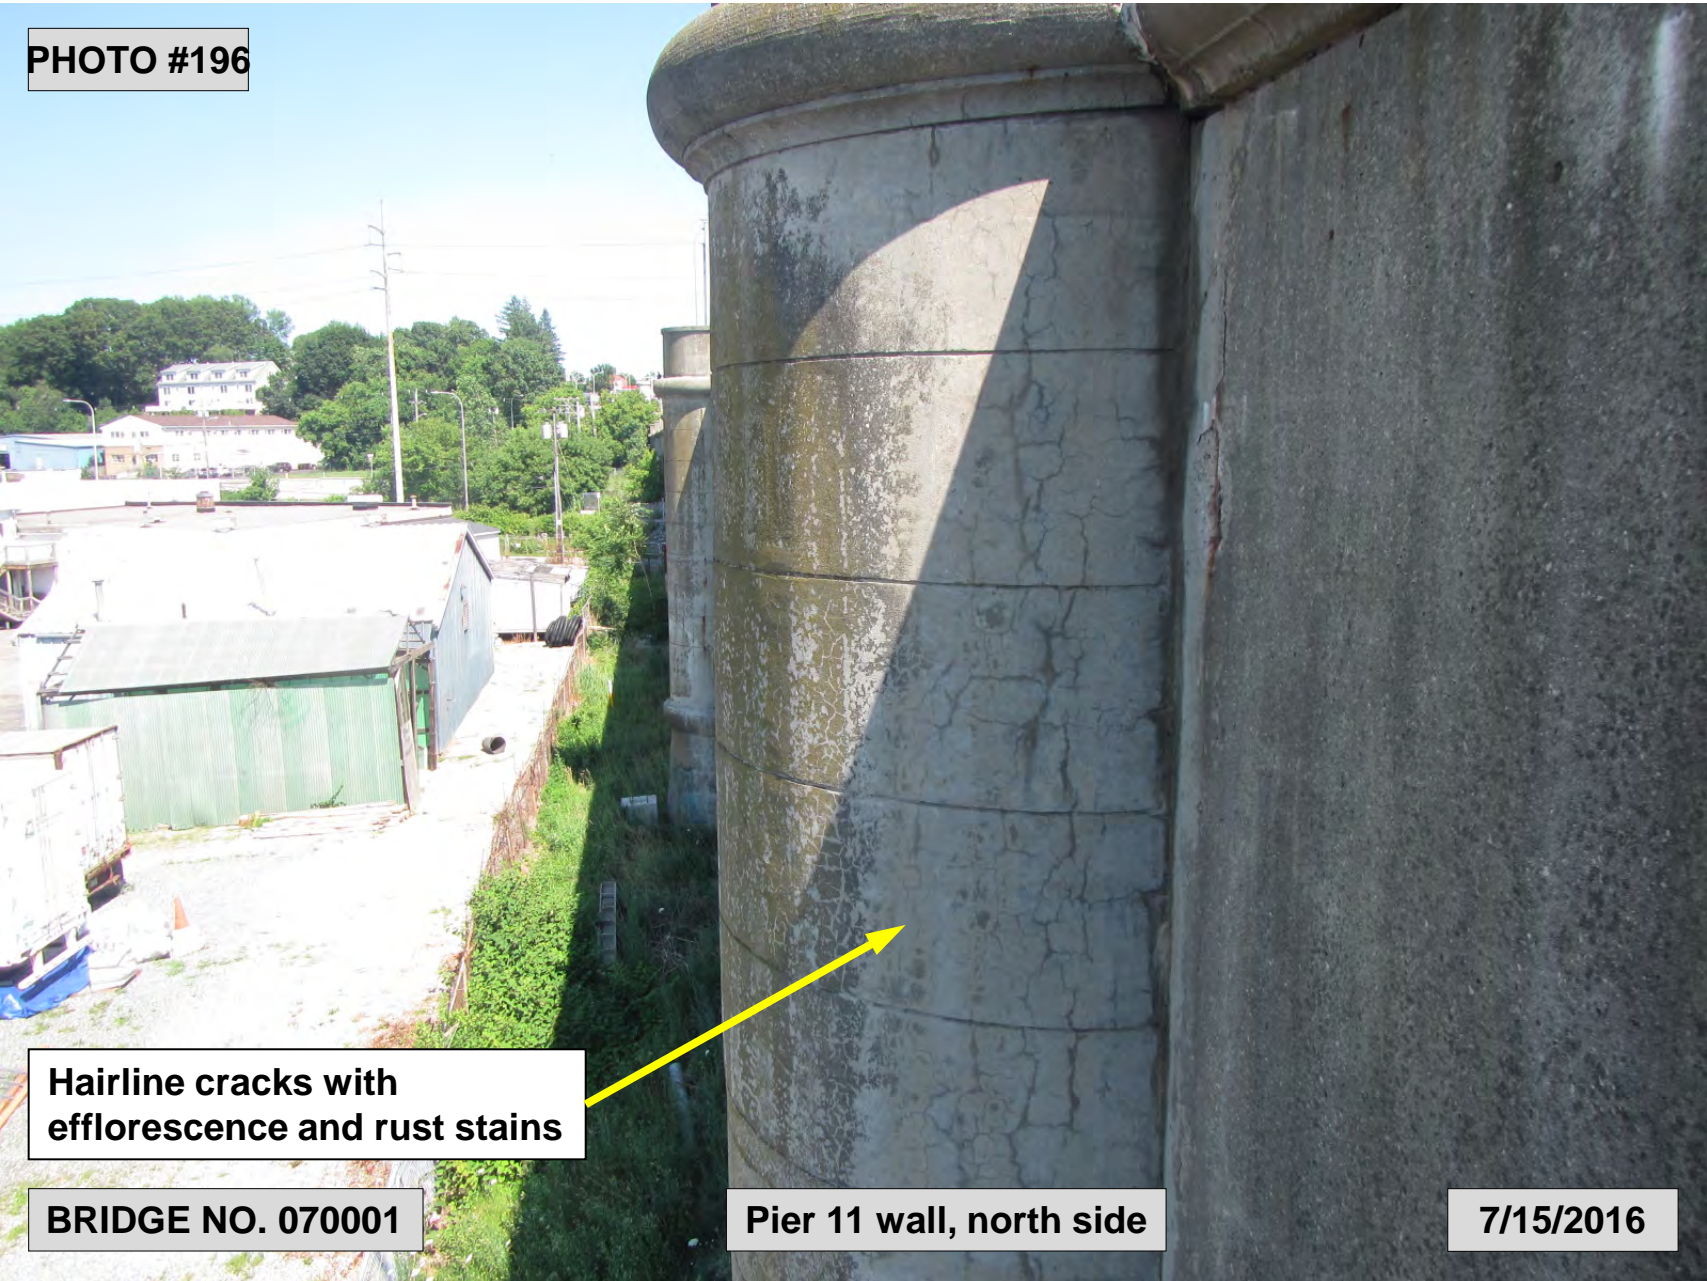
PHOTO #196

Hairline cracks with efflorescence and rust stains

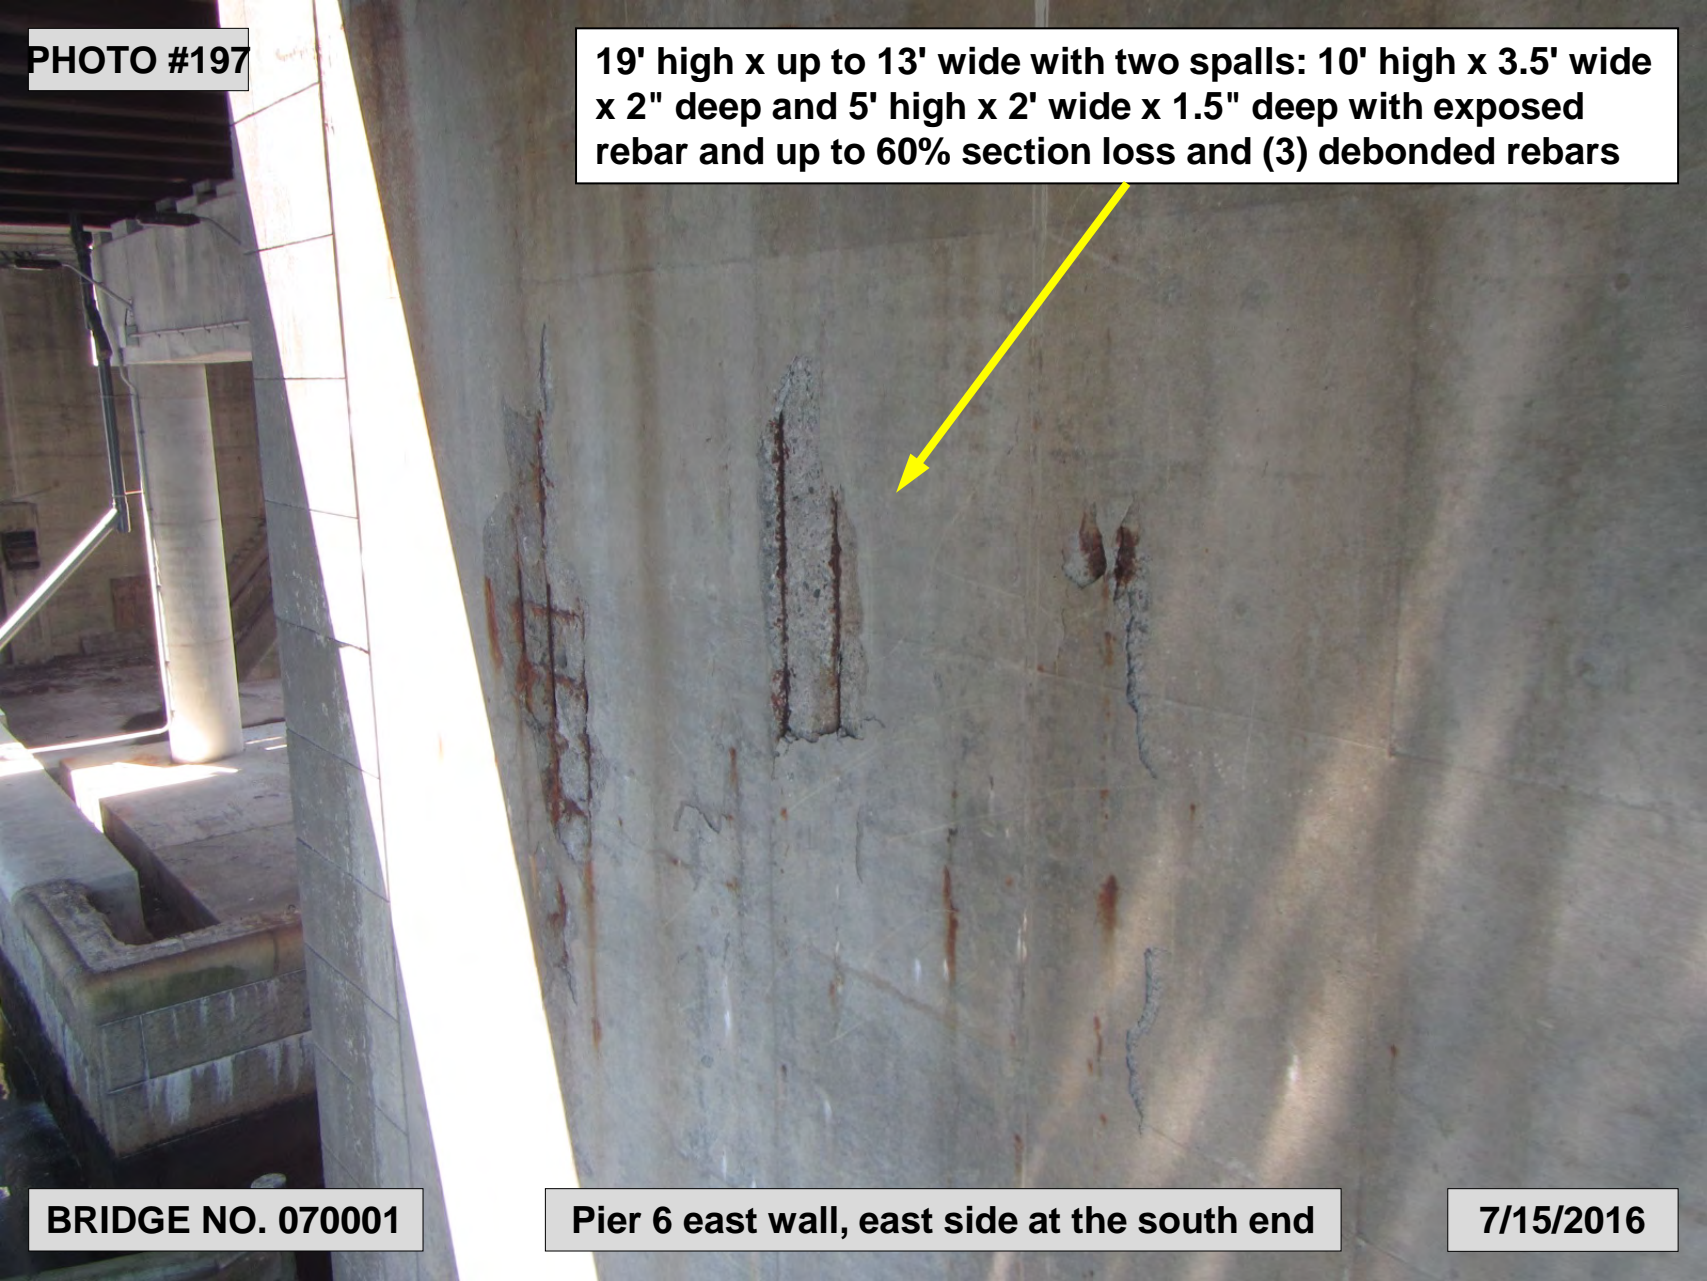
PHOTO #197

19' high x up to 13' wide with two spalls: 10' high x 3.5' wide x 2" deep and 5' high x 2' wide x 1.5" deep with exposed rebar and up to 60% section loss and (3) debonded rebars

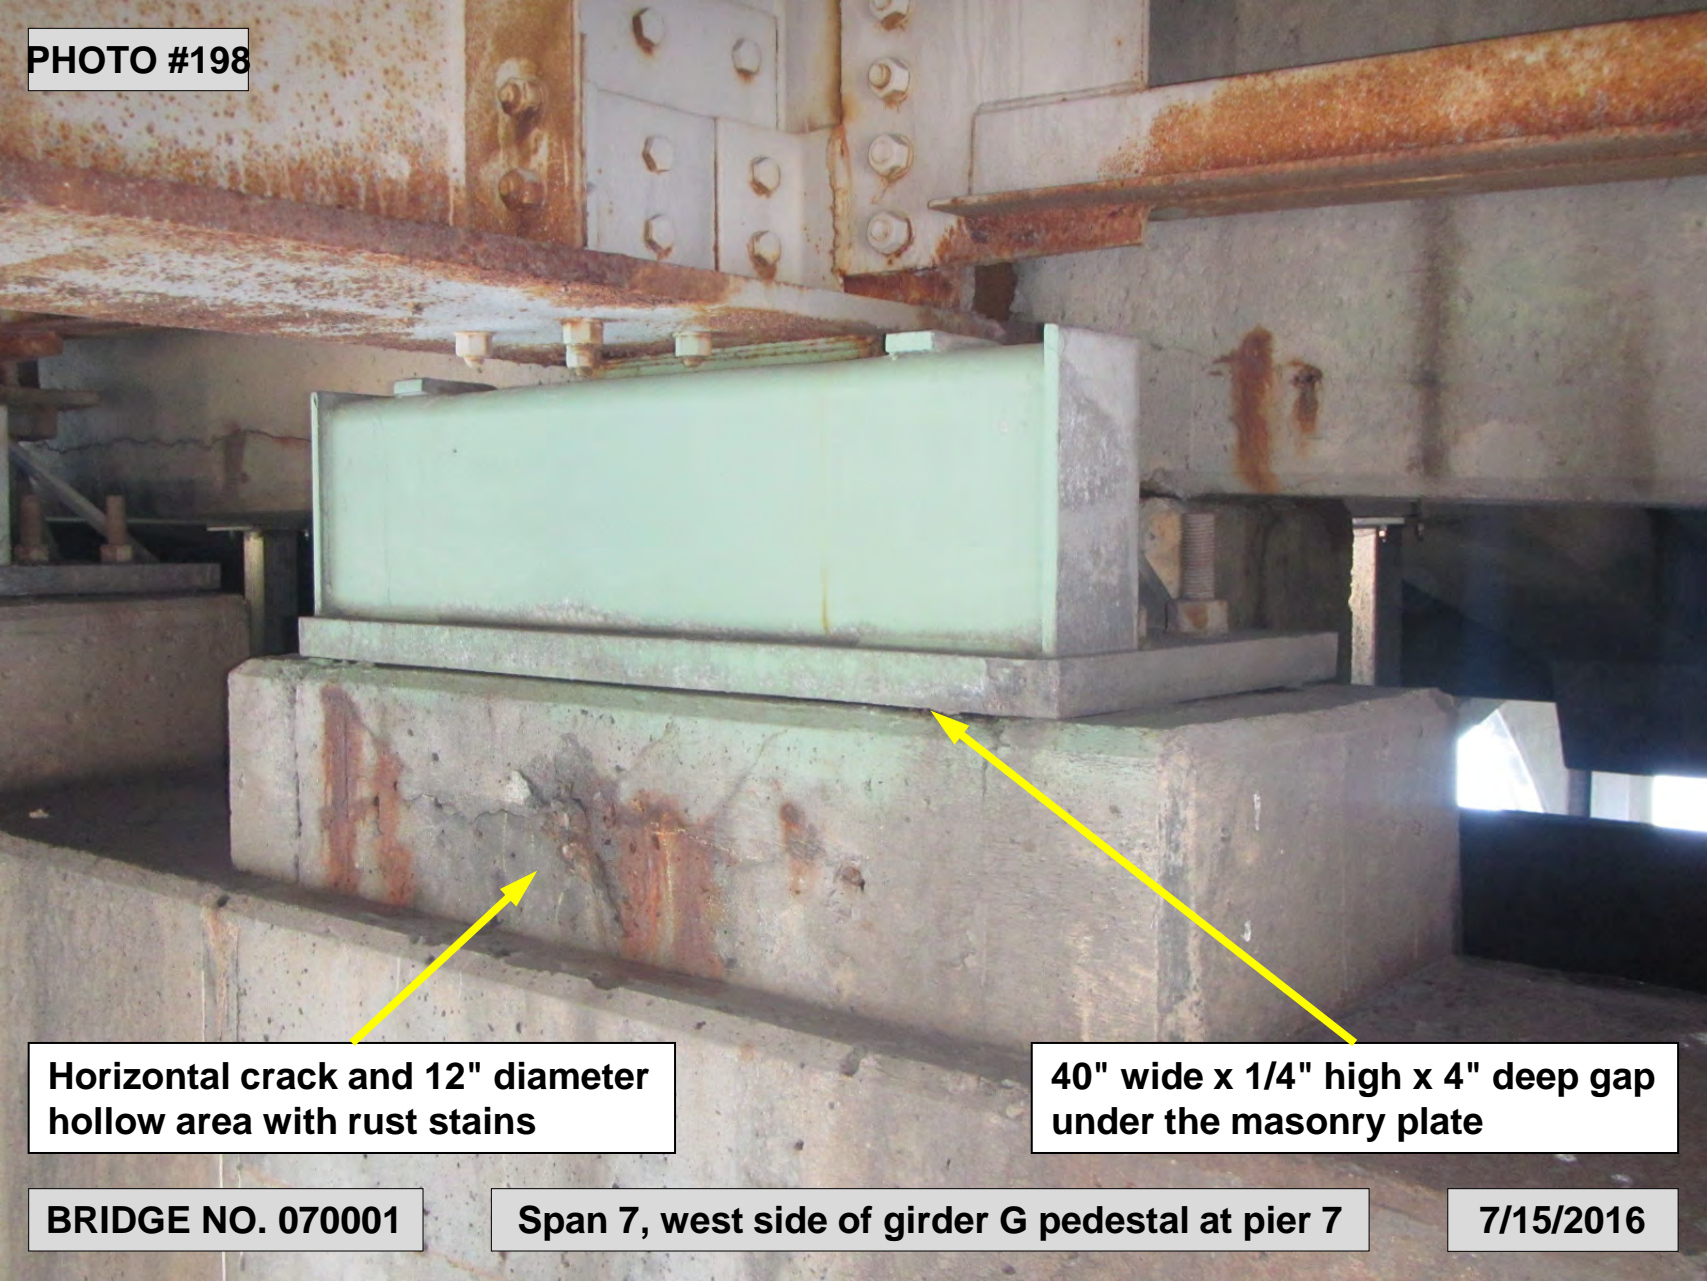
PHOTO #198

Horizontal crack and 12" diameter hollow area with rust stains

40" wide x 1/4" high x 4" deep gap under the masonry plate

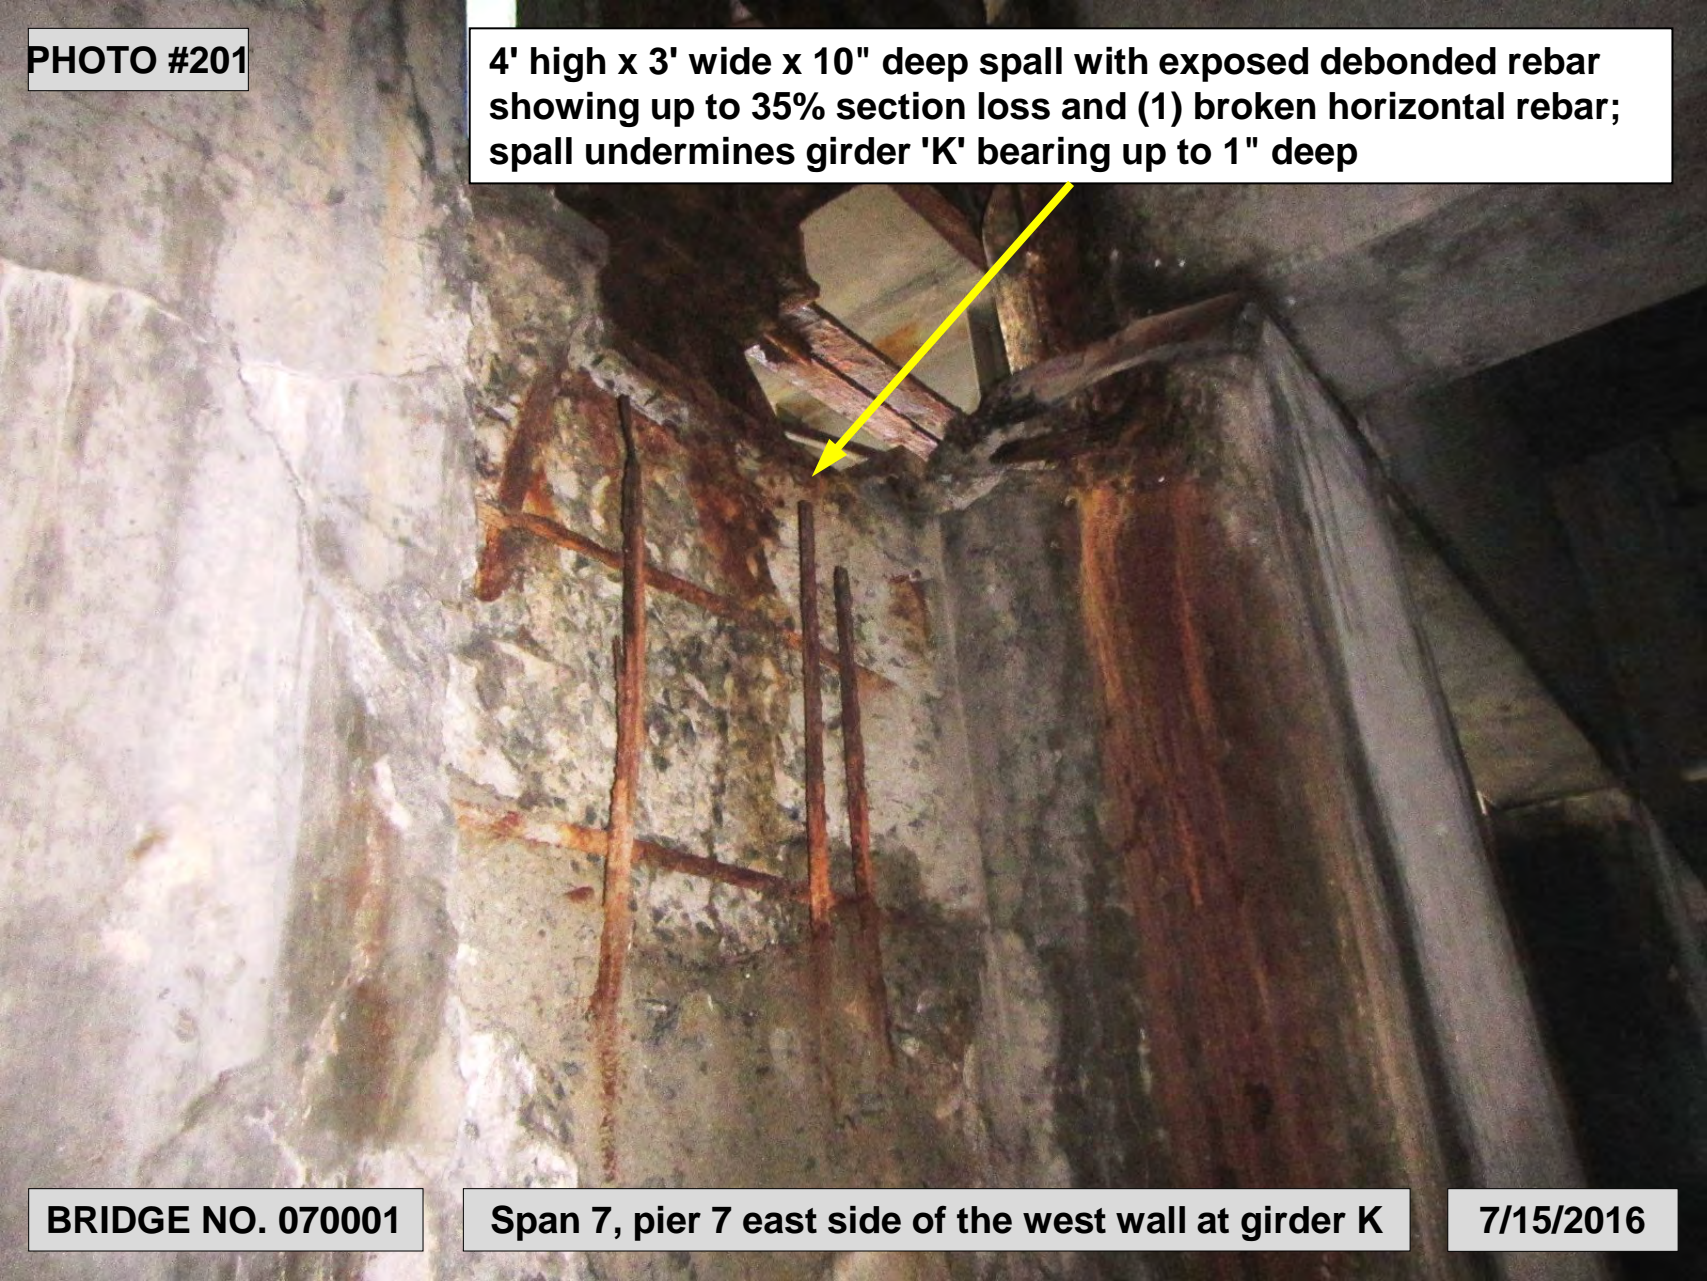
PHOTO #201

4' high x 3' wide x 10" deep spall with exposed debonded rebar showing up to 35% section loss and (1) broken horizontal rebar; spall undermines girder 'K' bearing up to 1" deep

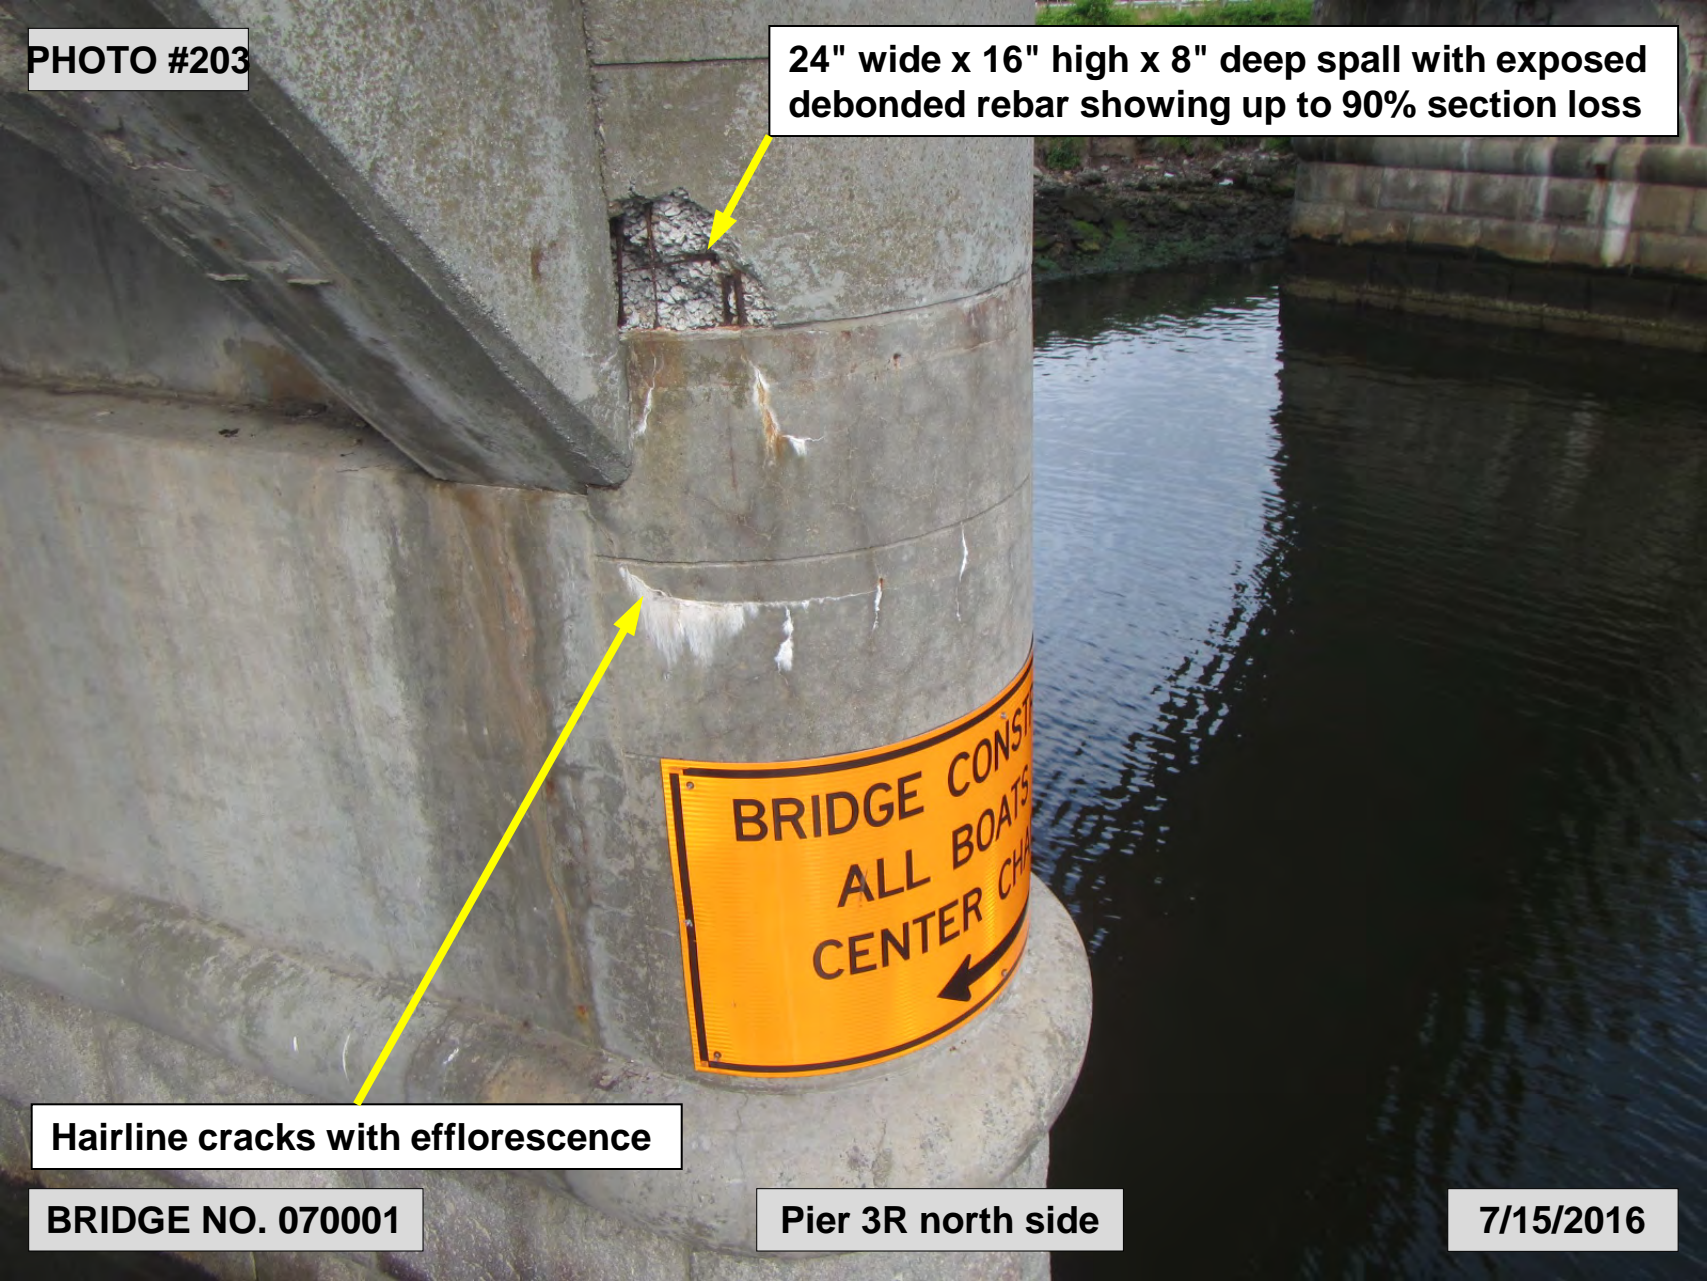
PHOTO #203

24" wide x 16" high x 8" deep spall with exposed debonded rebar showing up to 90% section loss
