BRIDGE NO. 070001

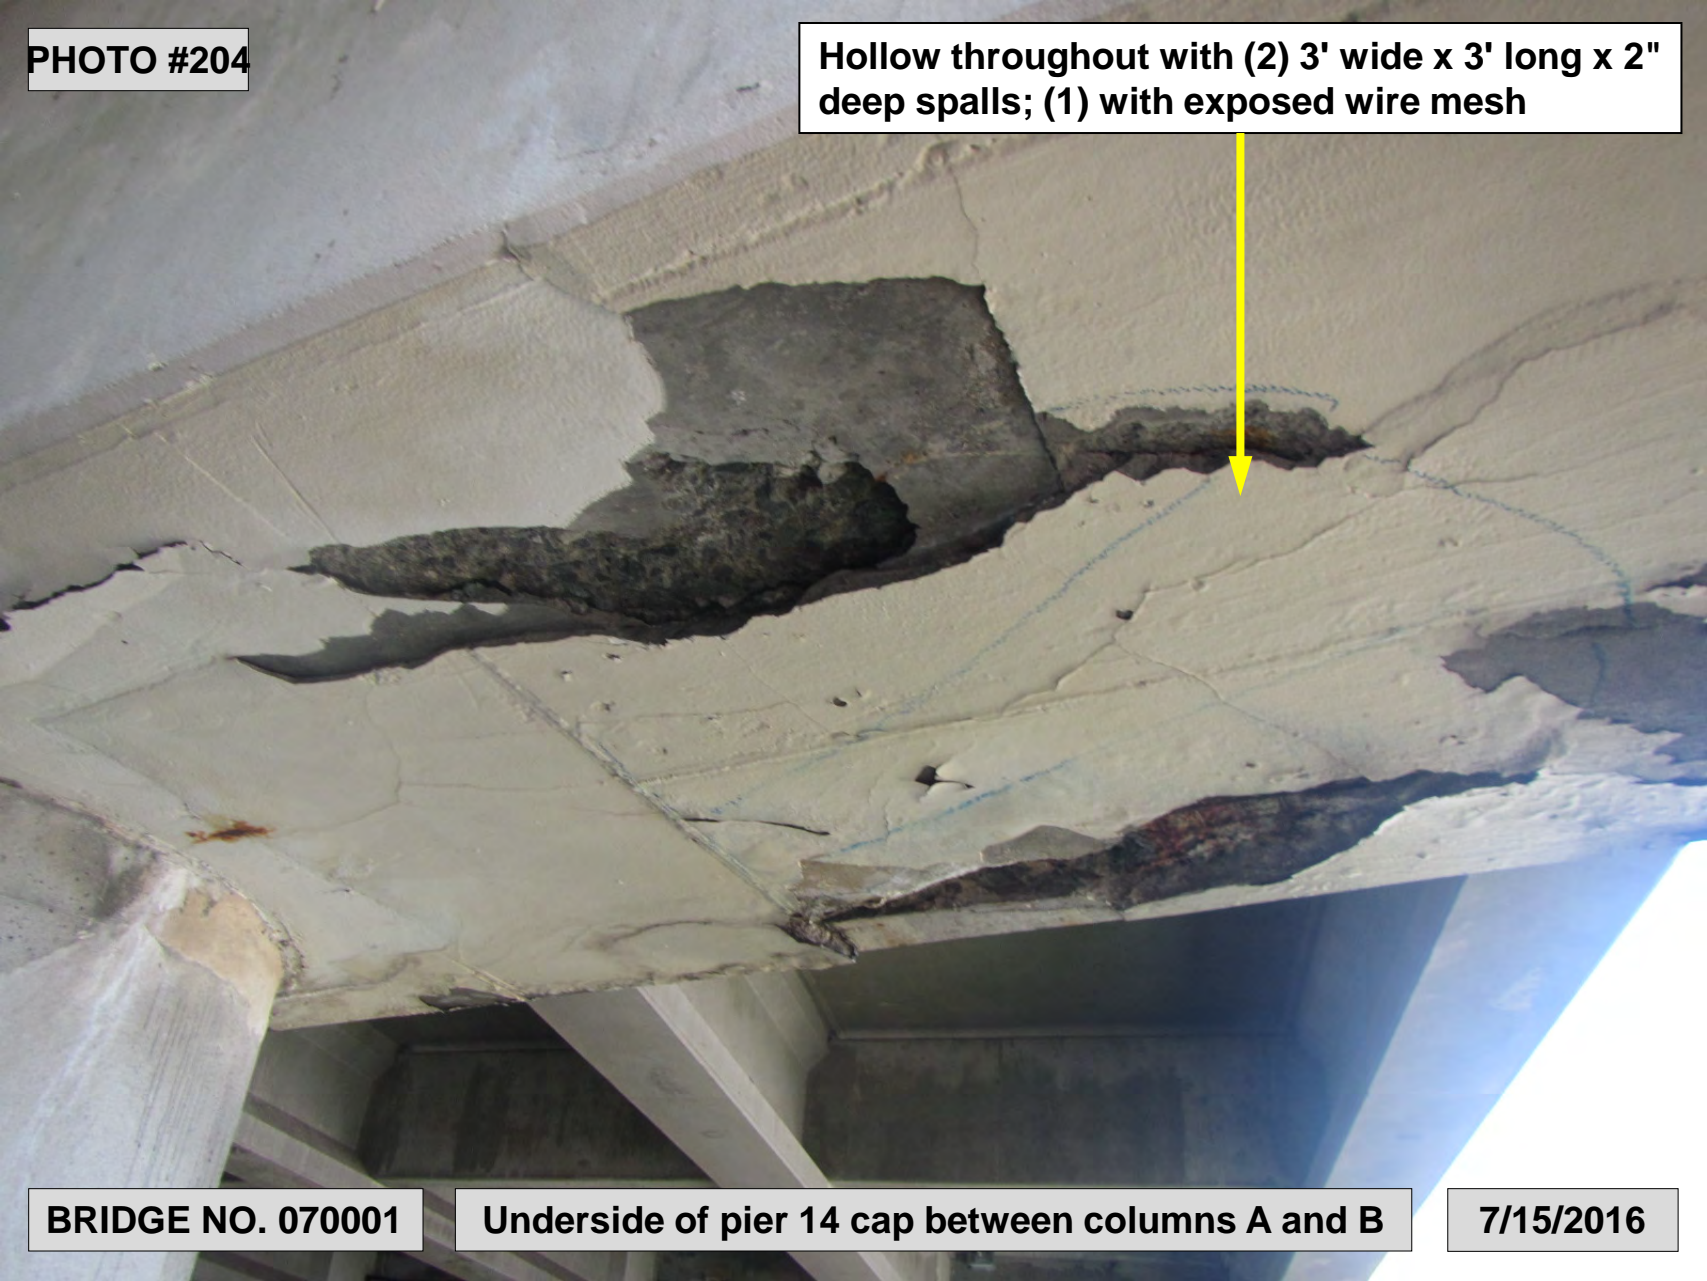
PHOTO #204

Hollow throughout with (2) 3' wide x 3' long x 2" deep spalls; (1) with exposed wire mesh

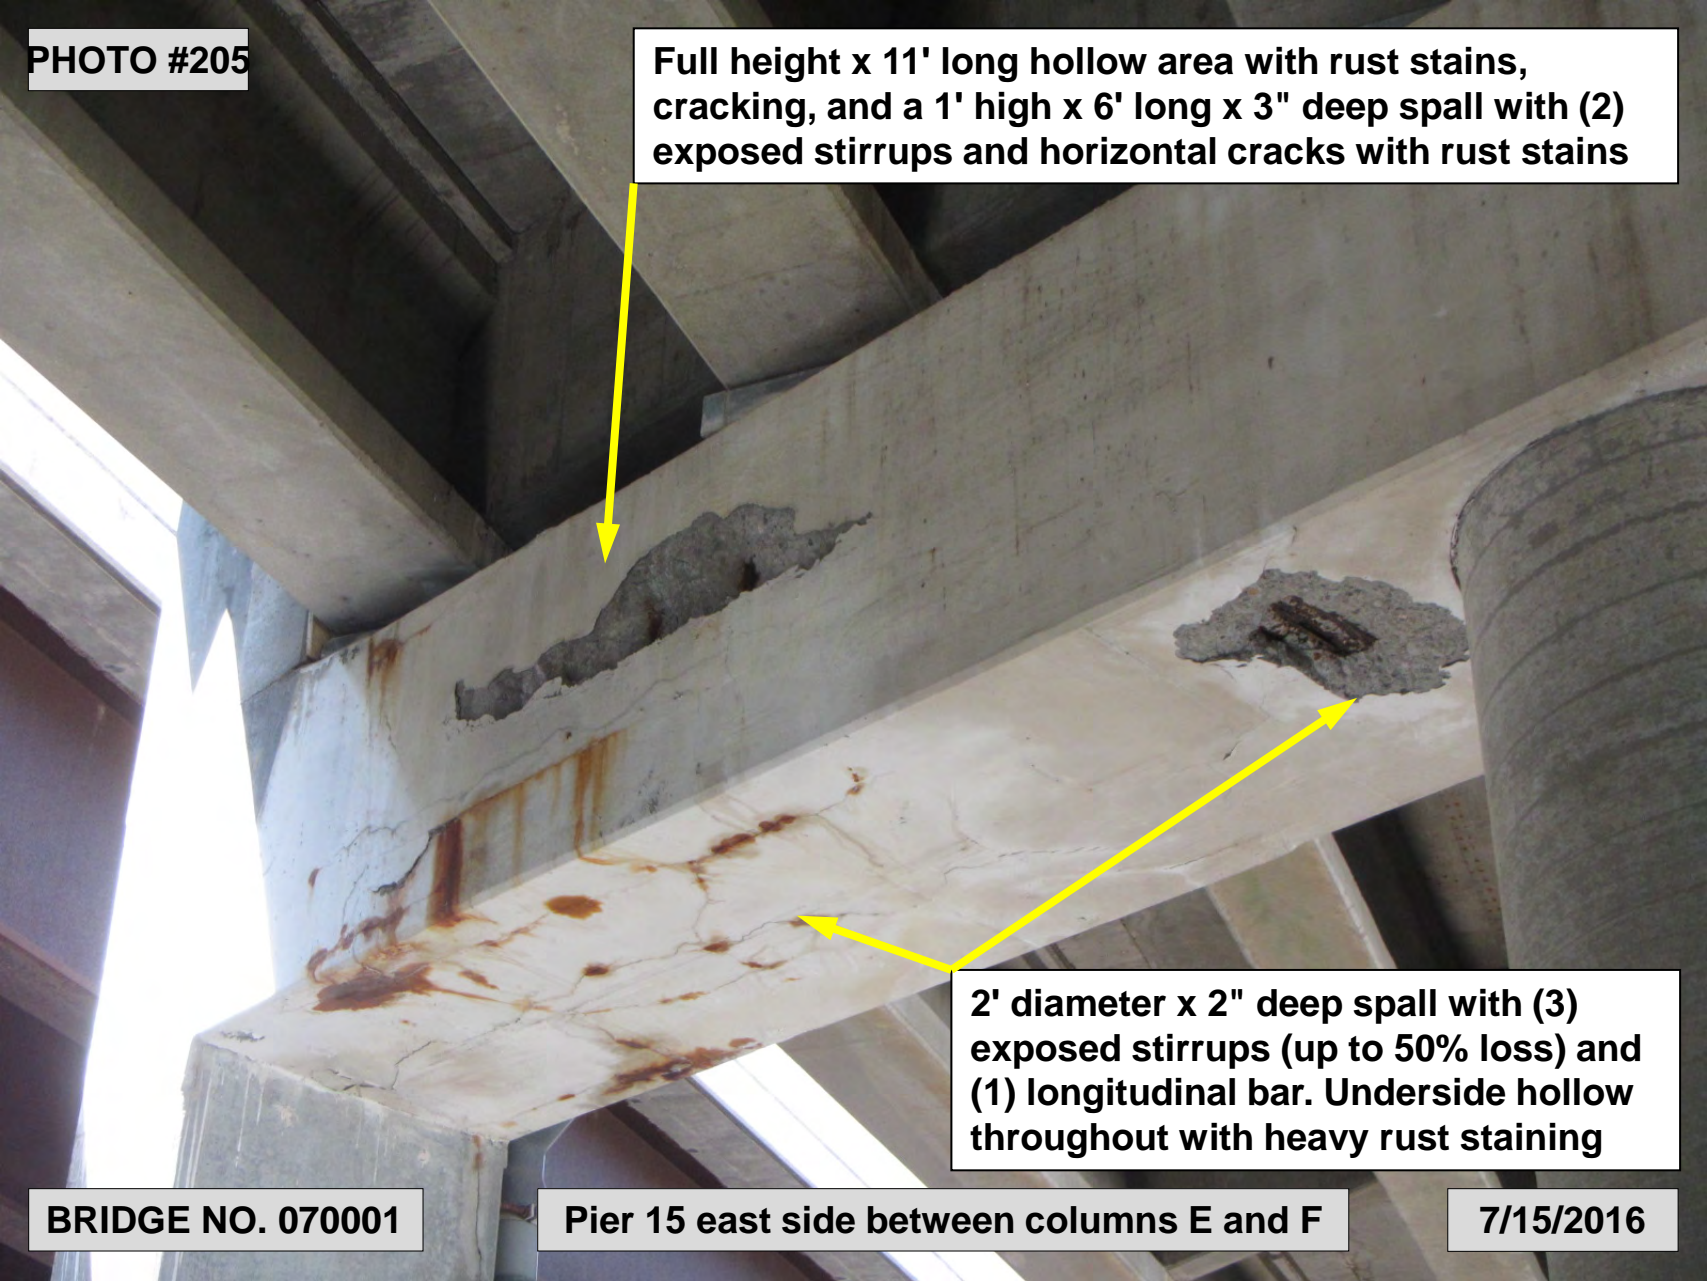
PHOTO #205

Full height x 11' long hollow area with rust stains, cracking, and a 1' high x 6' long x 3" deep spall with (2) exposed stirrups and horizontal cracks with rust stains

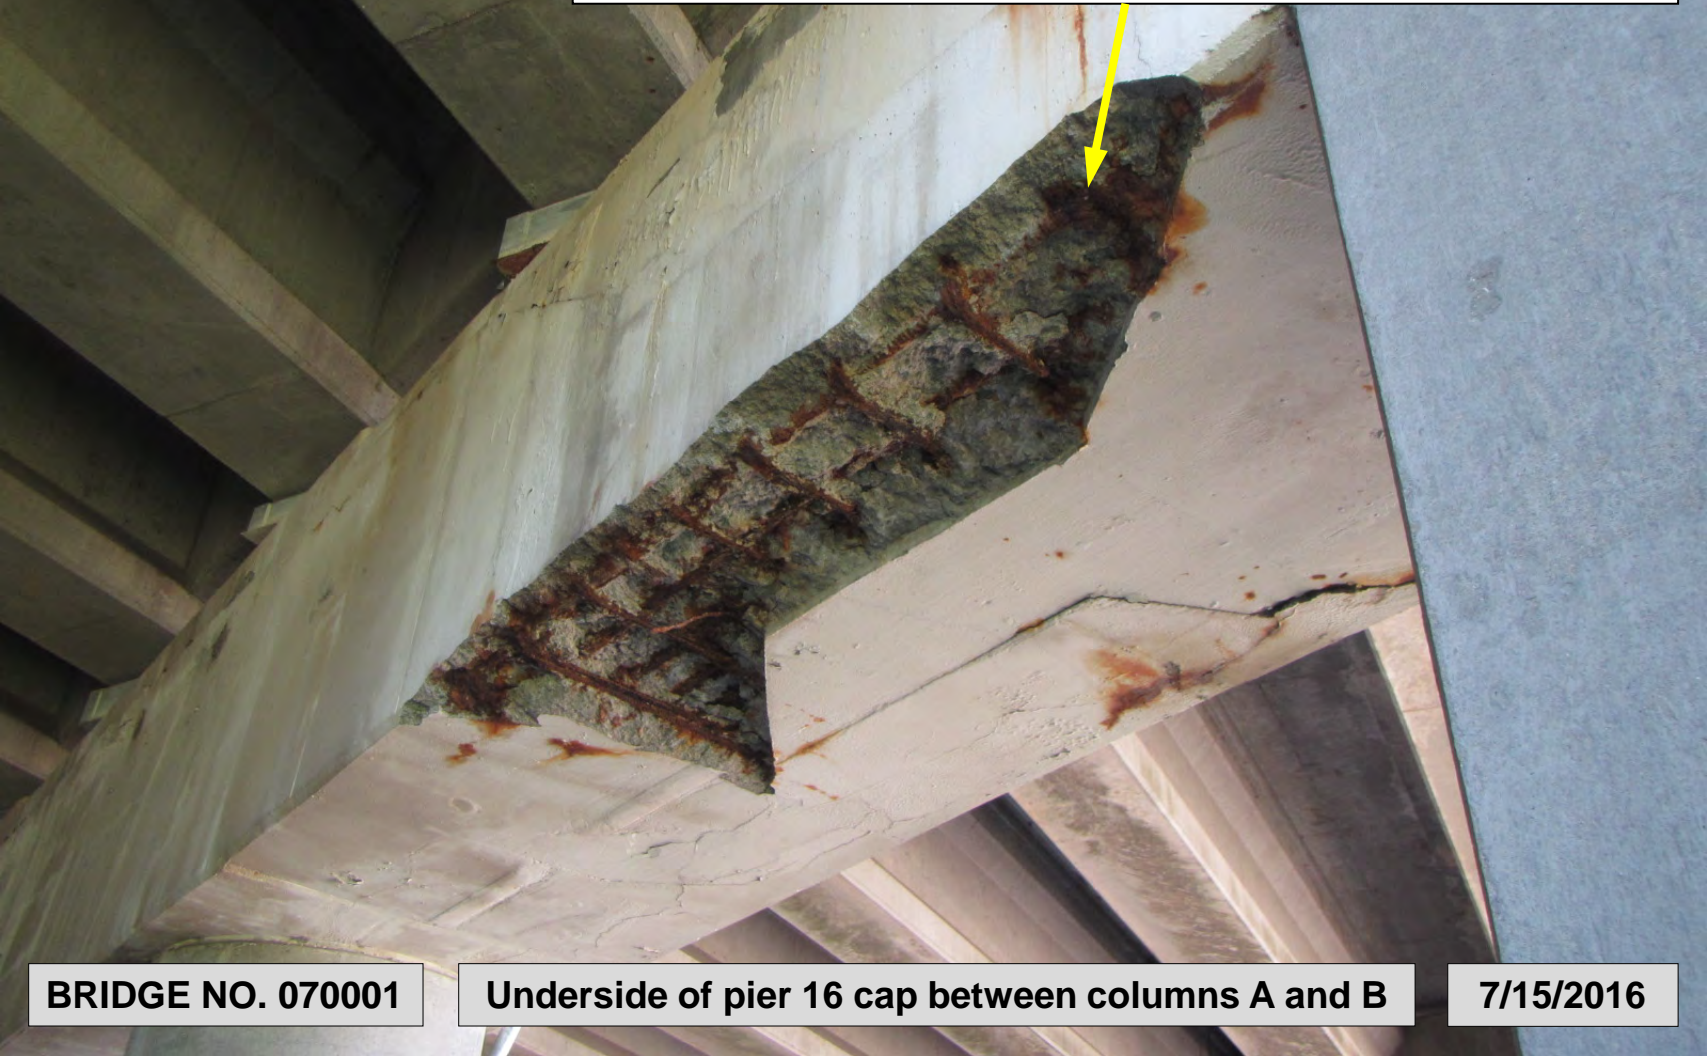
PHOTO #206

Full width x full length hollow area with 8' long x 3' wide x 4" deep spall with (9) exposed stirrups with up to 80% section loss and (5) exposed longitudinal bars with up to 25% loss. (1) Stirrup is snapped. See photo 207 for close-up

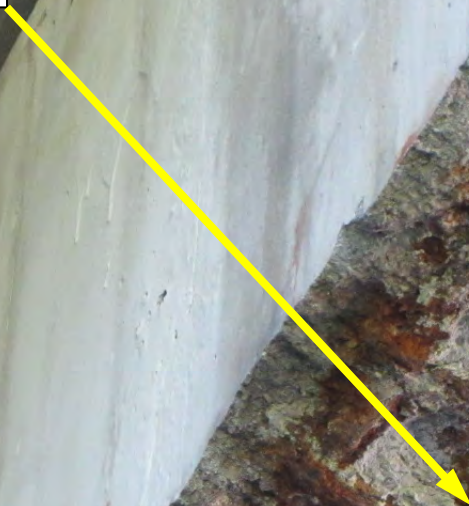
PHOTO #207

Snapped stirrup

**Same as photo 206 showing close-up
of spall with exposed rebar**

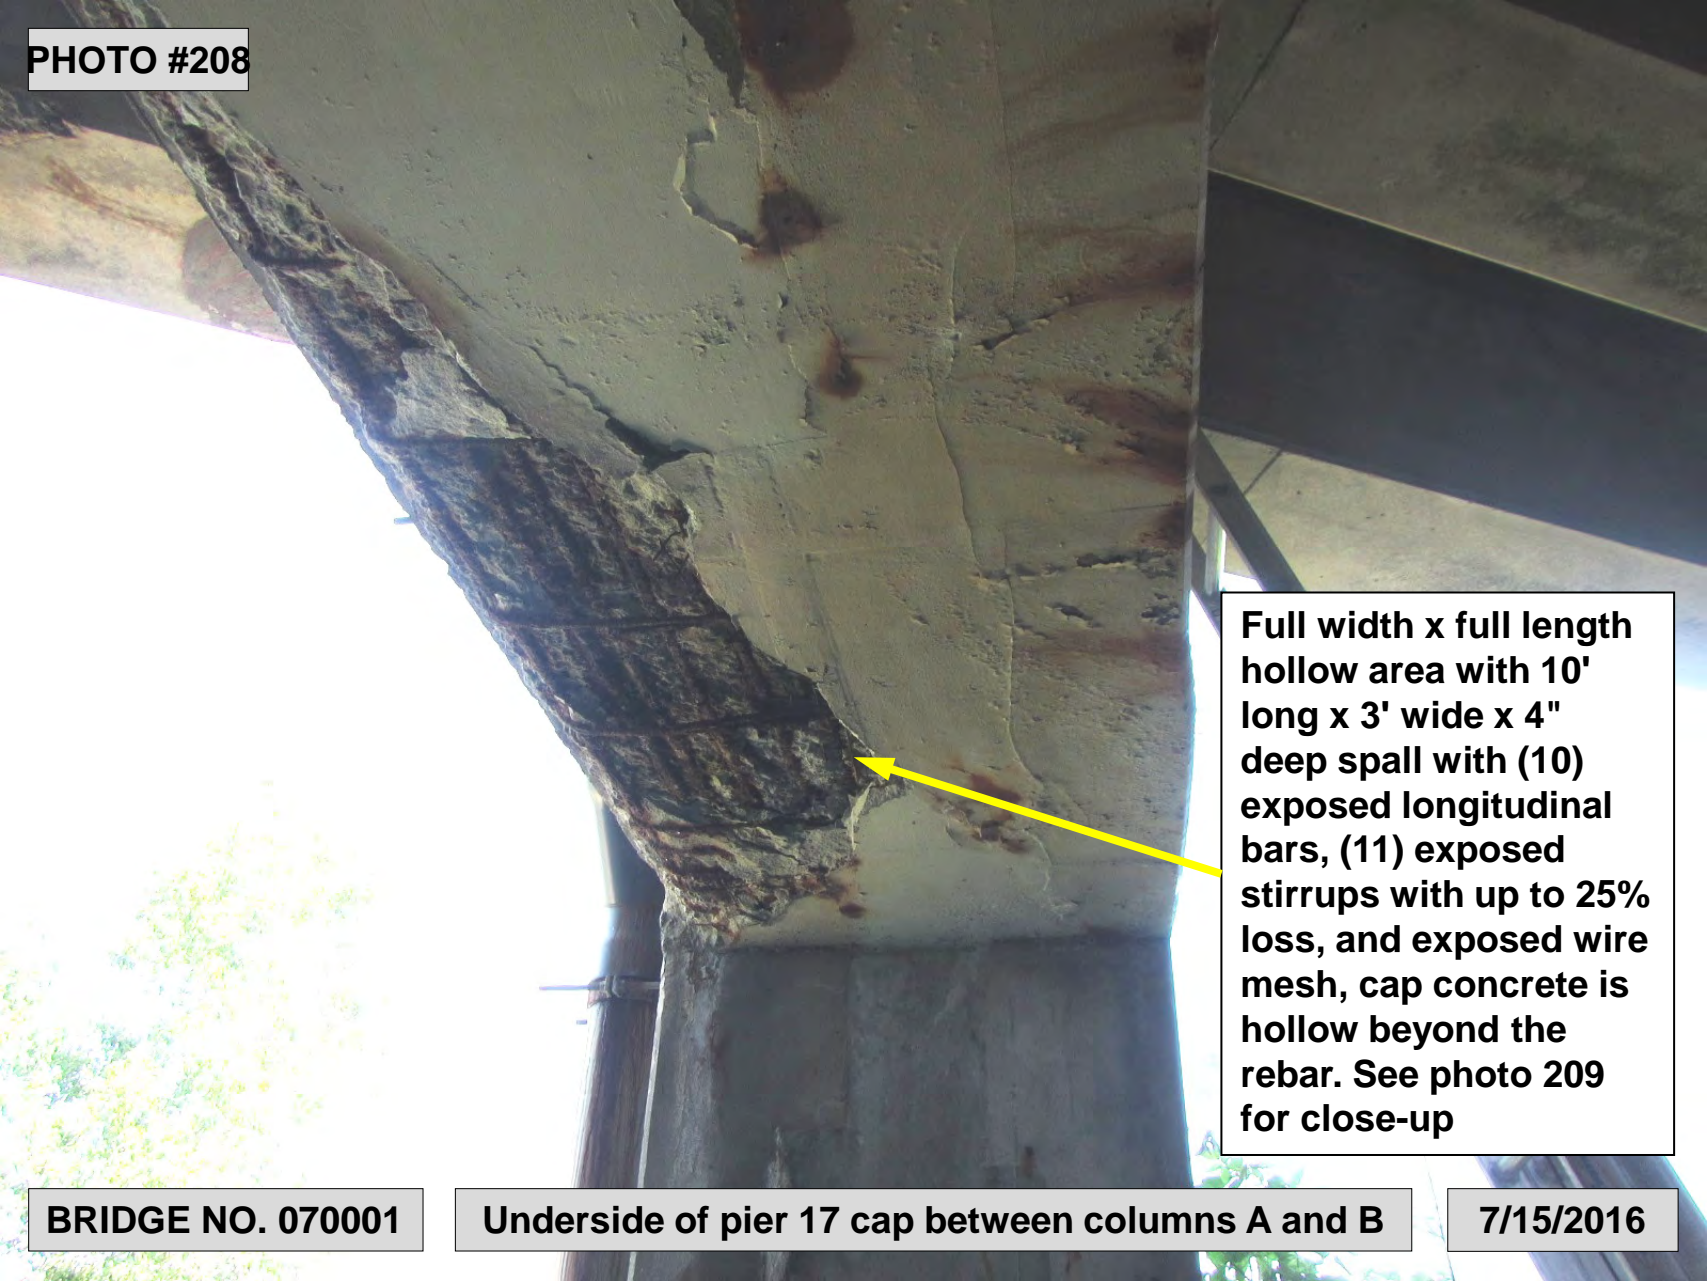
PHOTO #208

Full width x full length hollow area with 10' long x 3' wide x 4" deep spall with (10) exposed longitudinal bars, (11) exposed stirrups with up to 25% loss, and exposed wire mesh, cap concrete is hollow beyond the rebar. See photo 209 for close-up

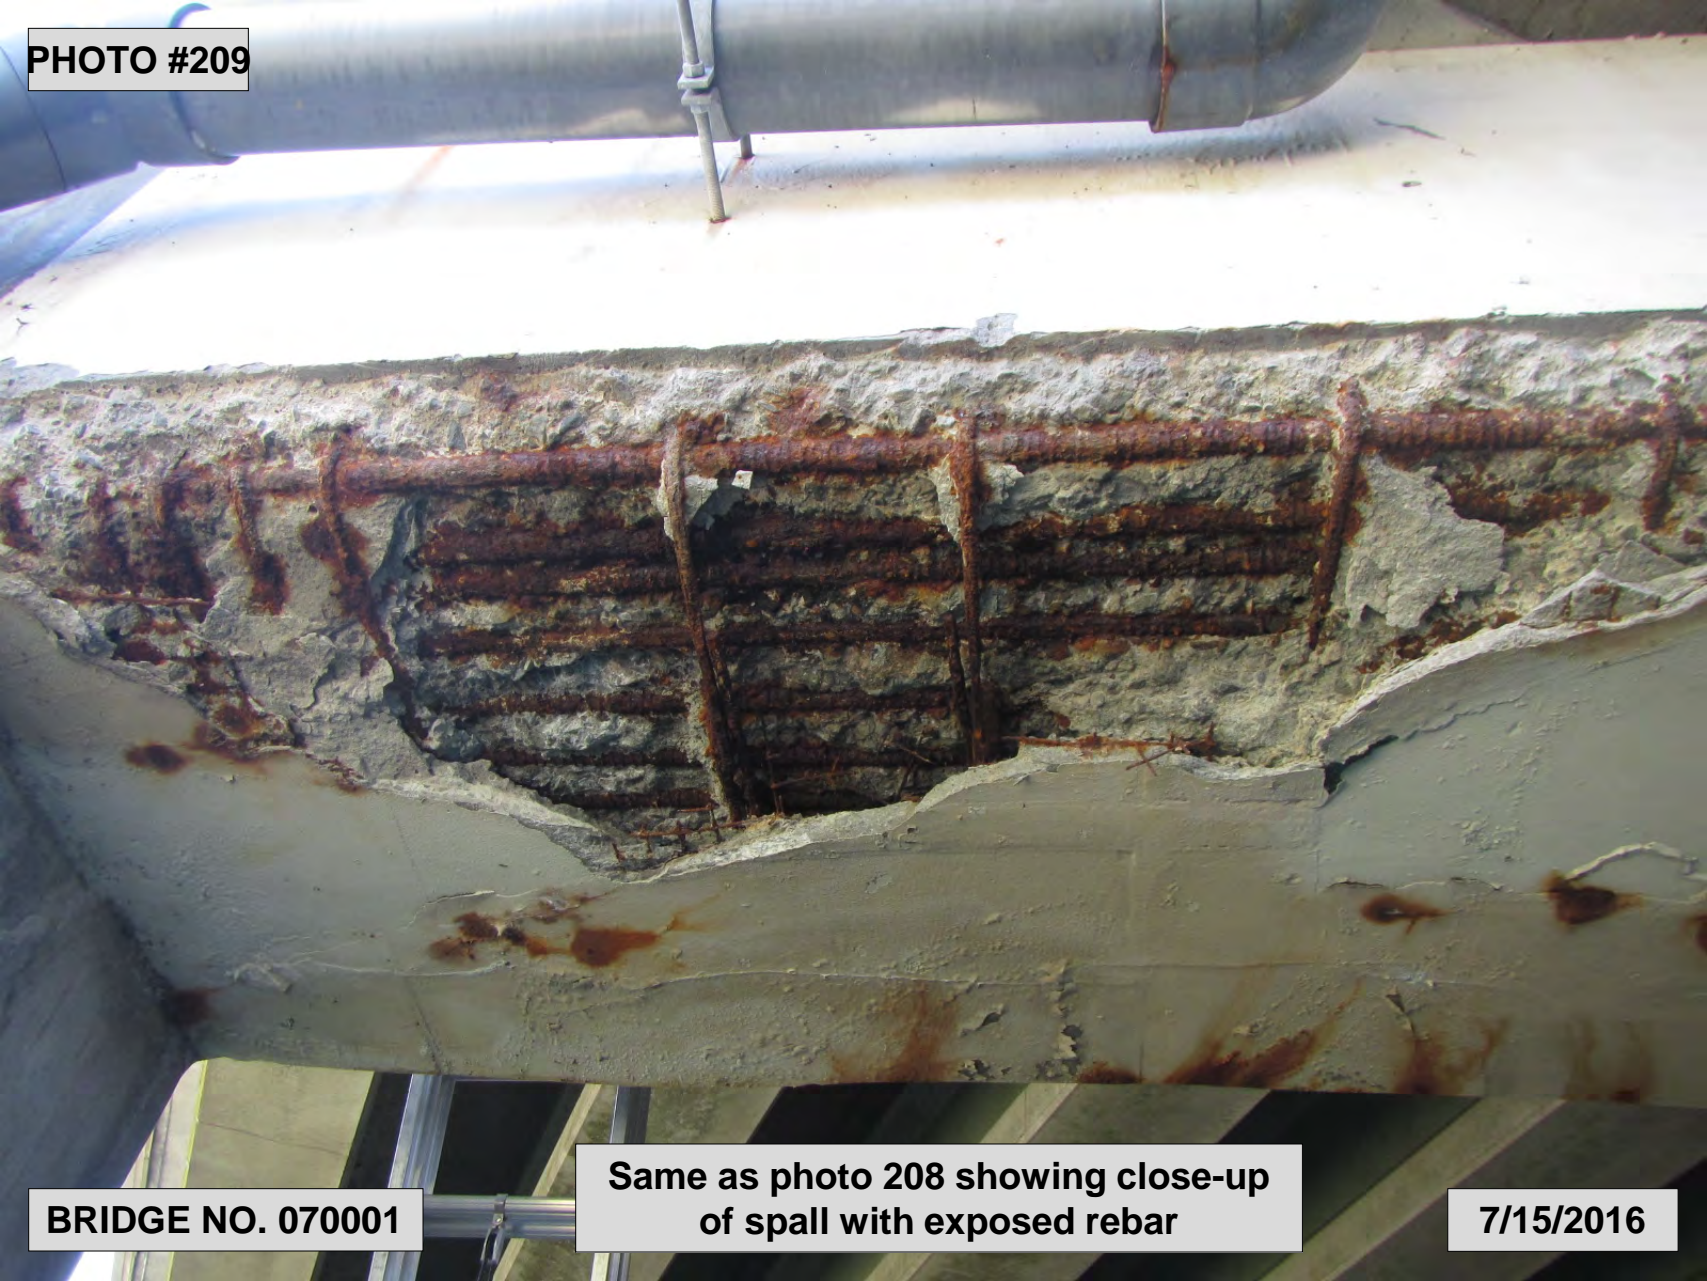
PHOTO #209

**Same as photo 208 showing close-up
of spall with exposed rebar**

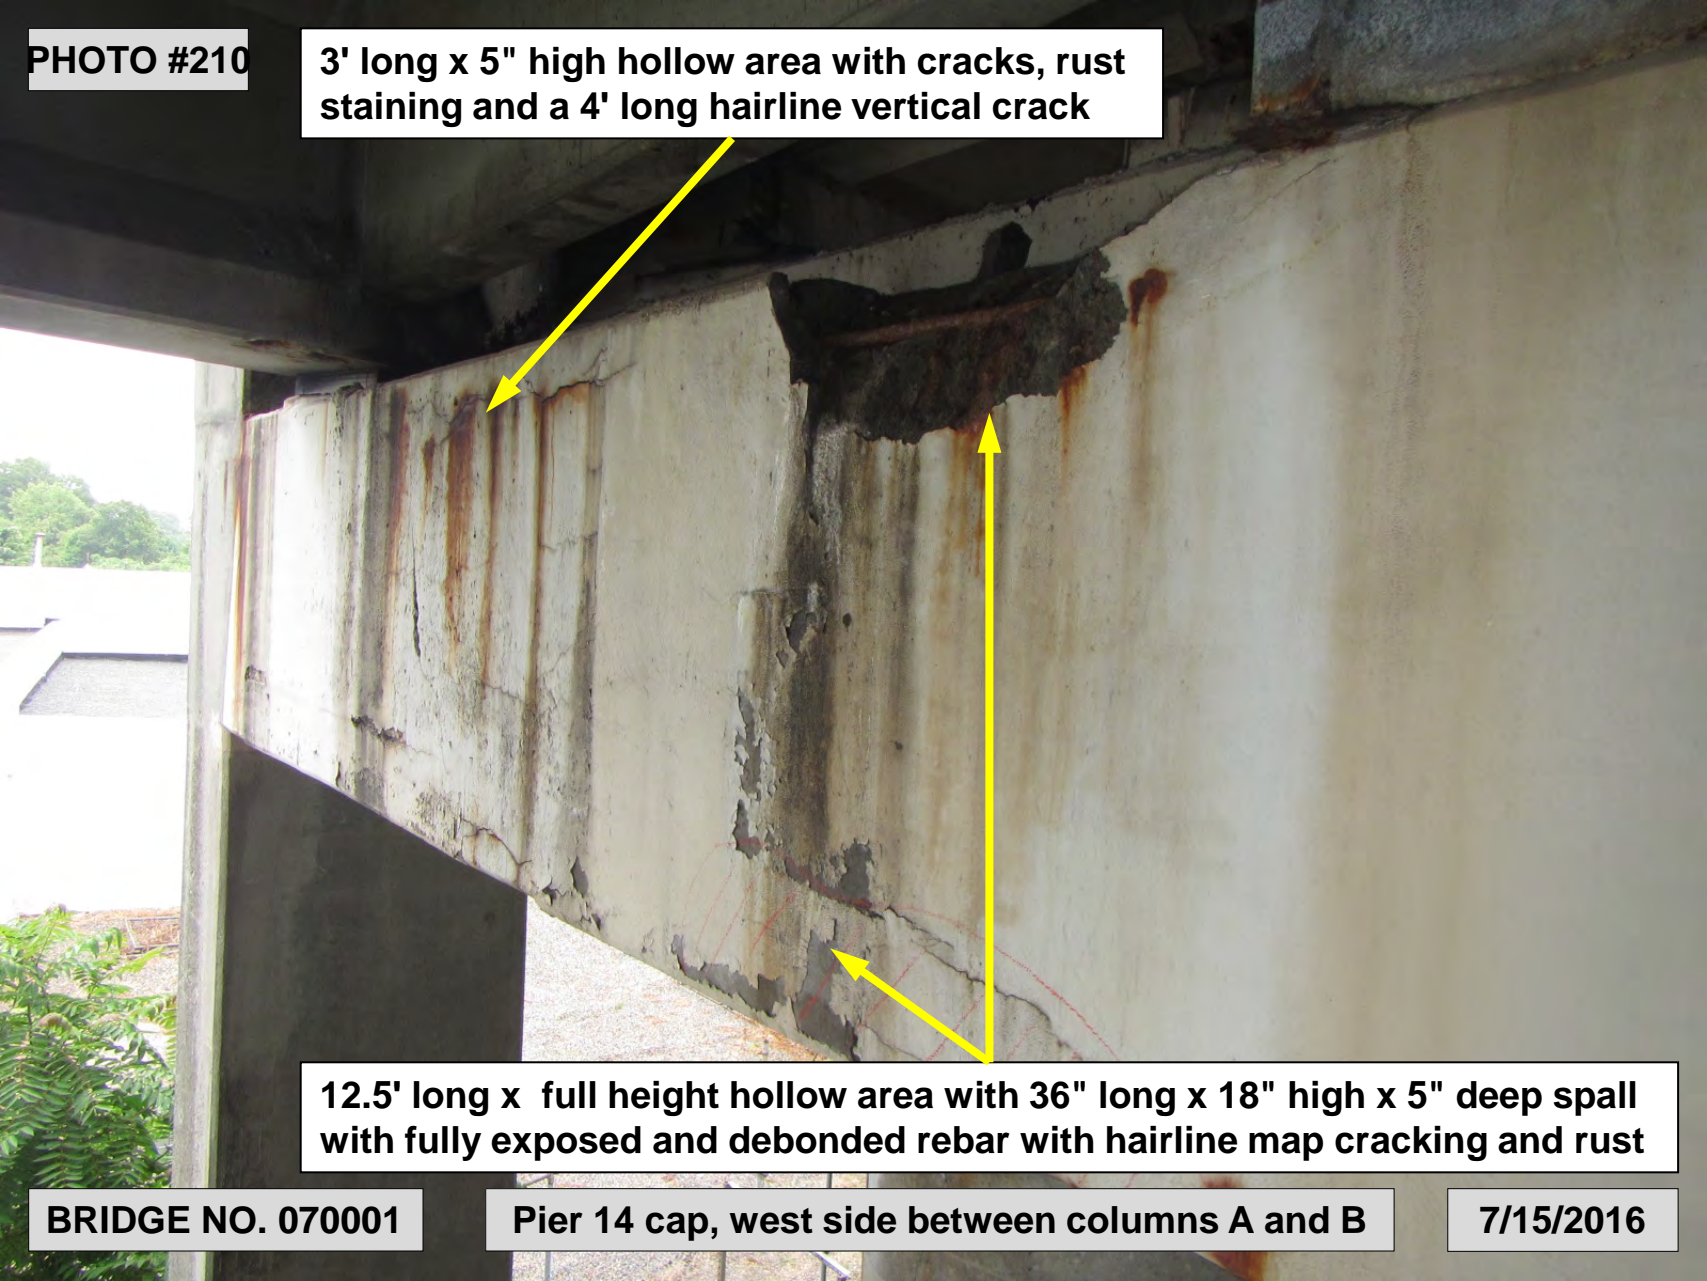
PHOTO #210

3' long x 5" high hollow area with cracks, rust staining and a 4' long hairline vertical crack

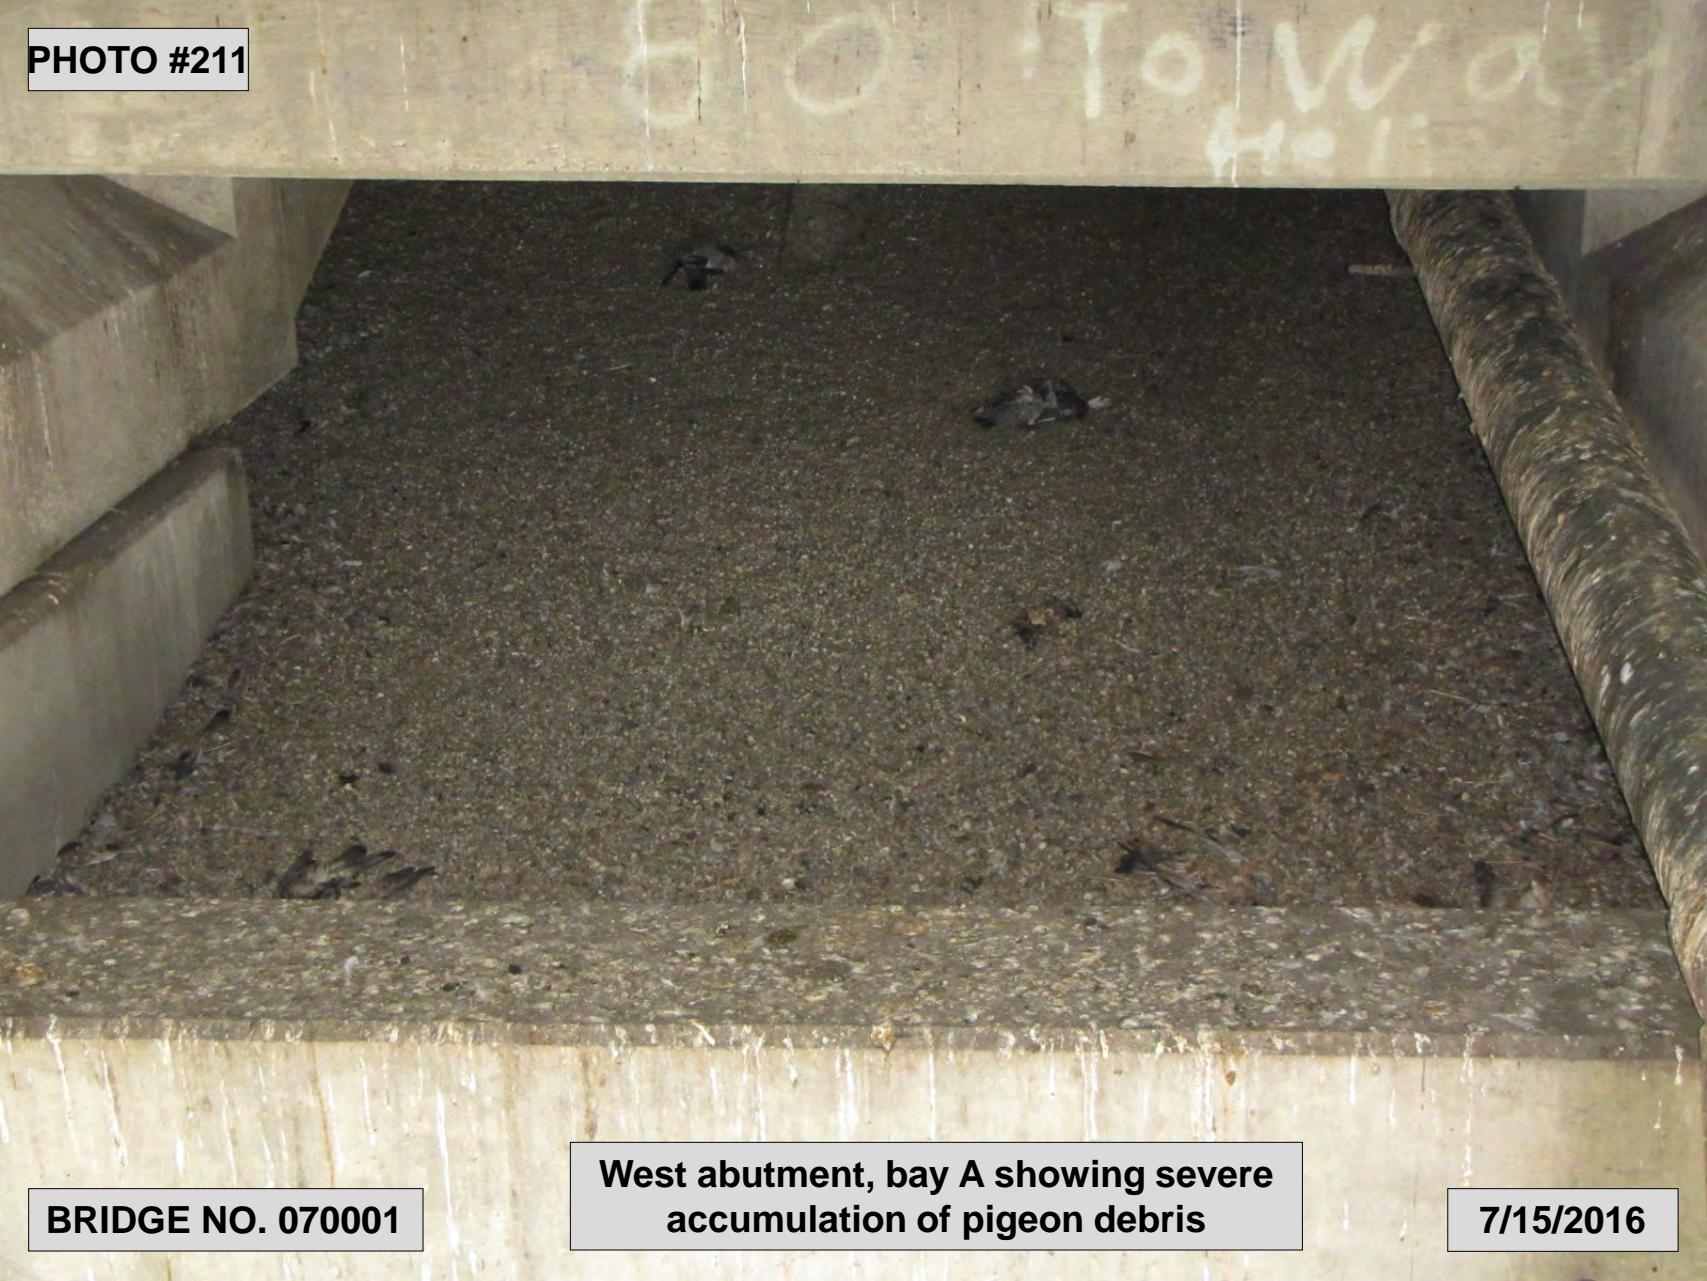
PHOTO #211

West abutment, bay A showing severe accumulation of pigeon debris

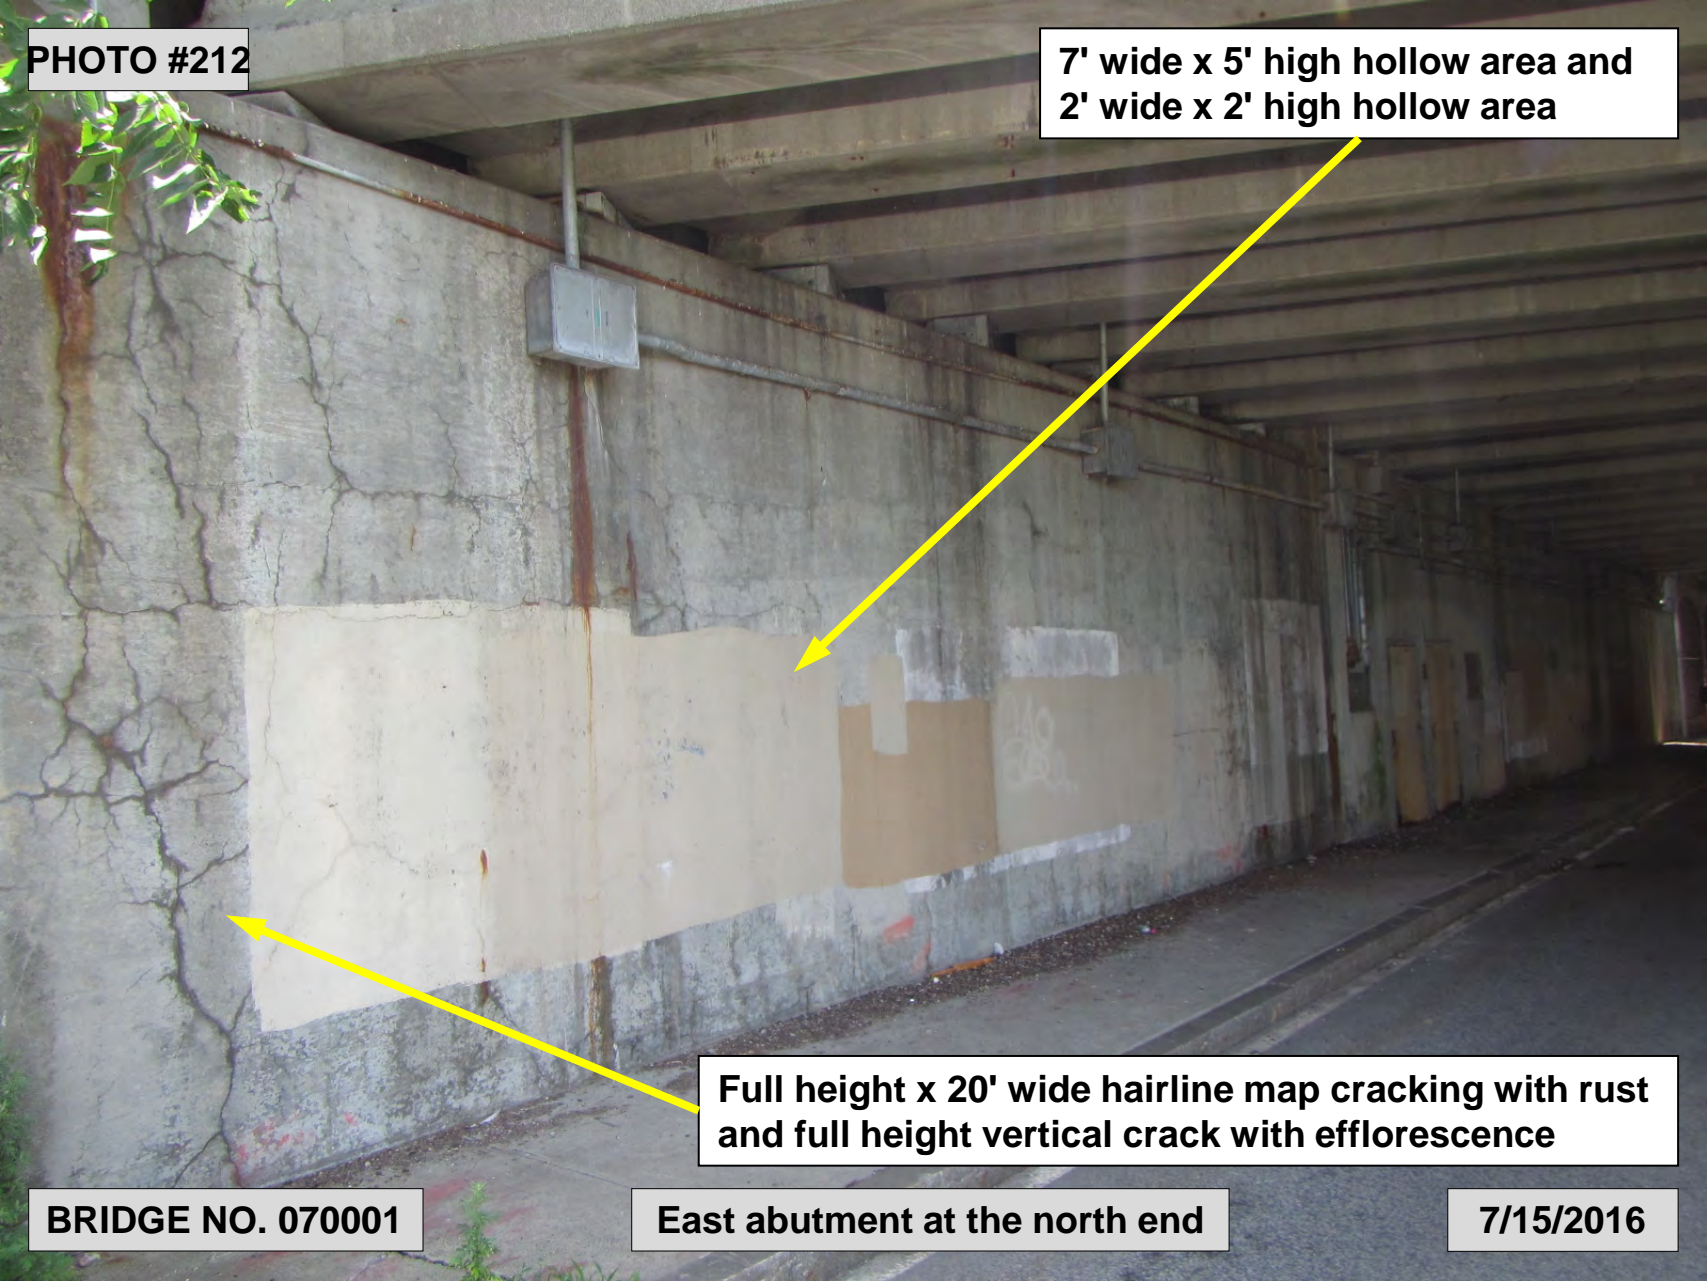
PHOTO #212

**7' wide x 5' high hollow area and
2' wide x 2' high hollow area**

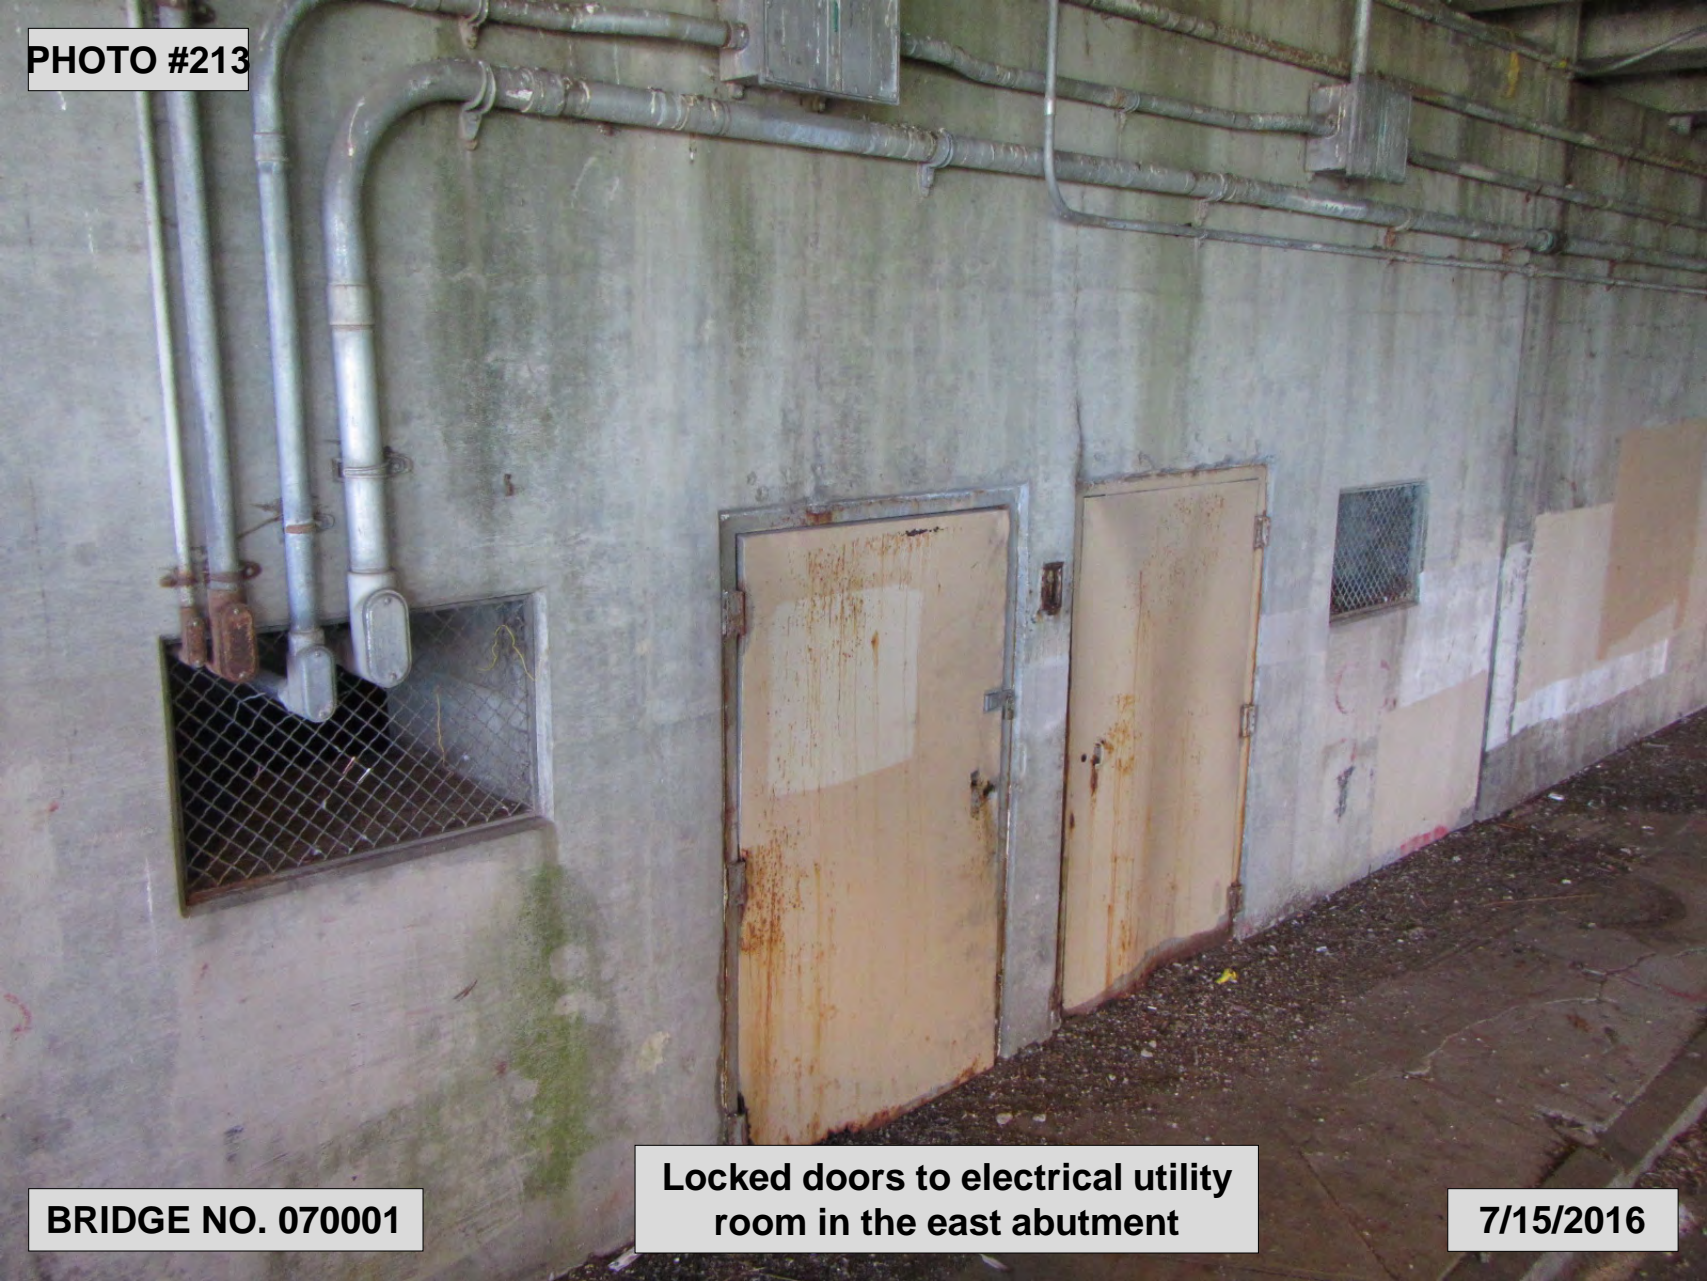
PHOTO #213

**Locked doors to electrical utility
room in the east abutment**

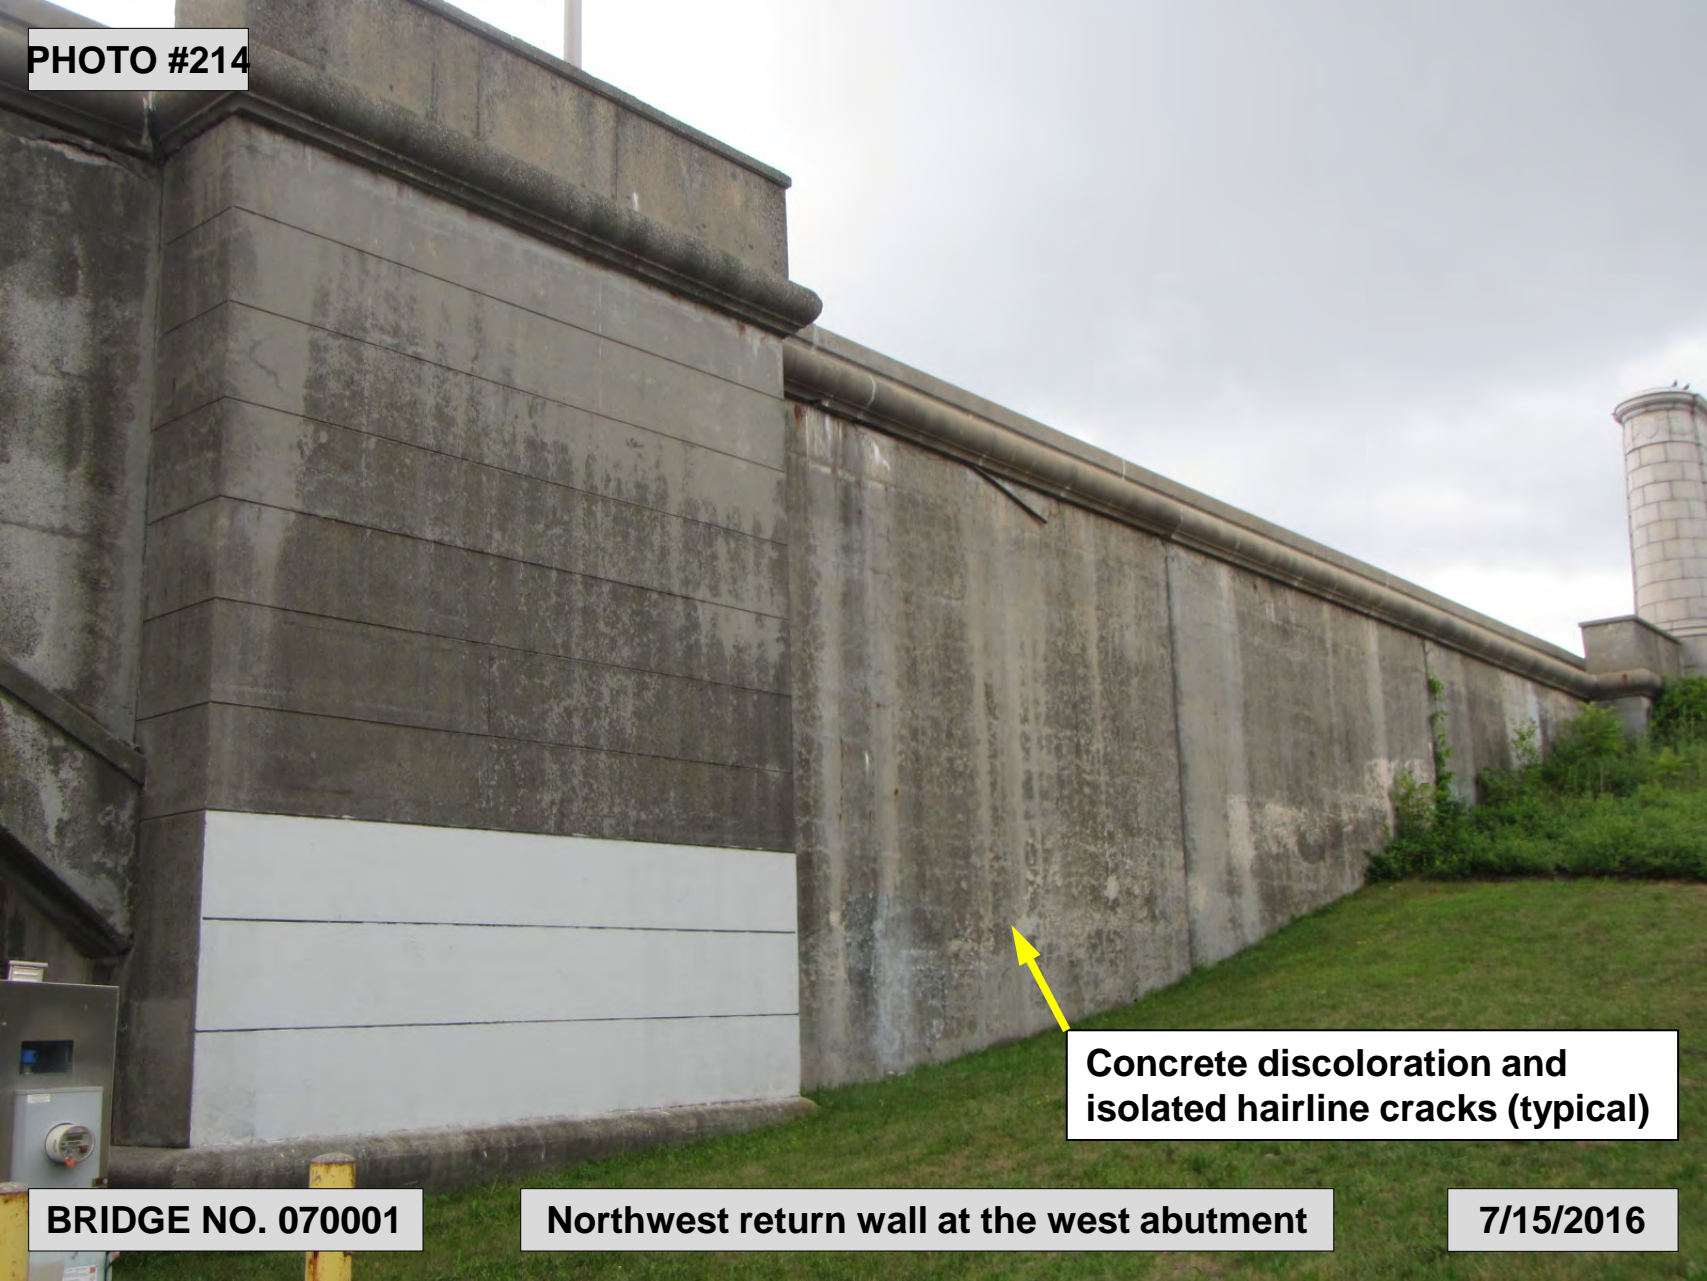
PHOTO #214

Concrete discoloration and isolated hairline cracks (typical)
