BRIDGE NO. 070001

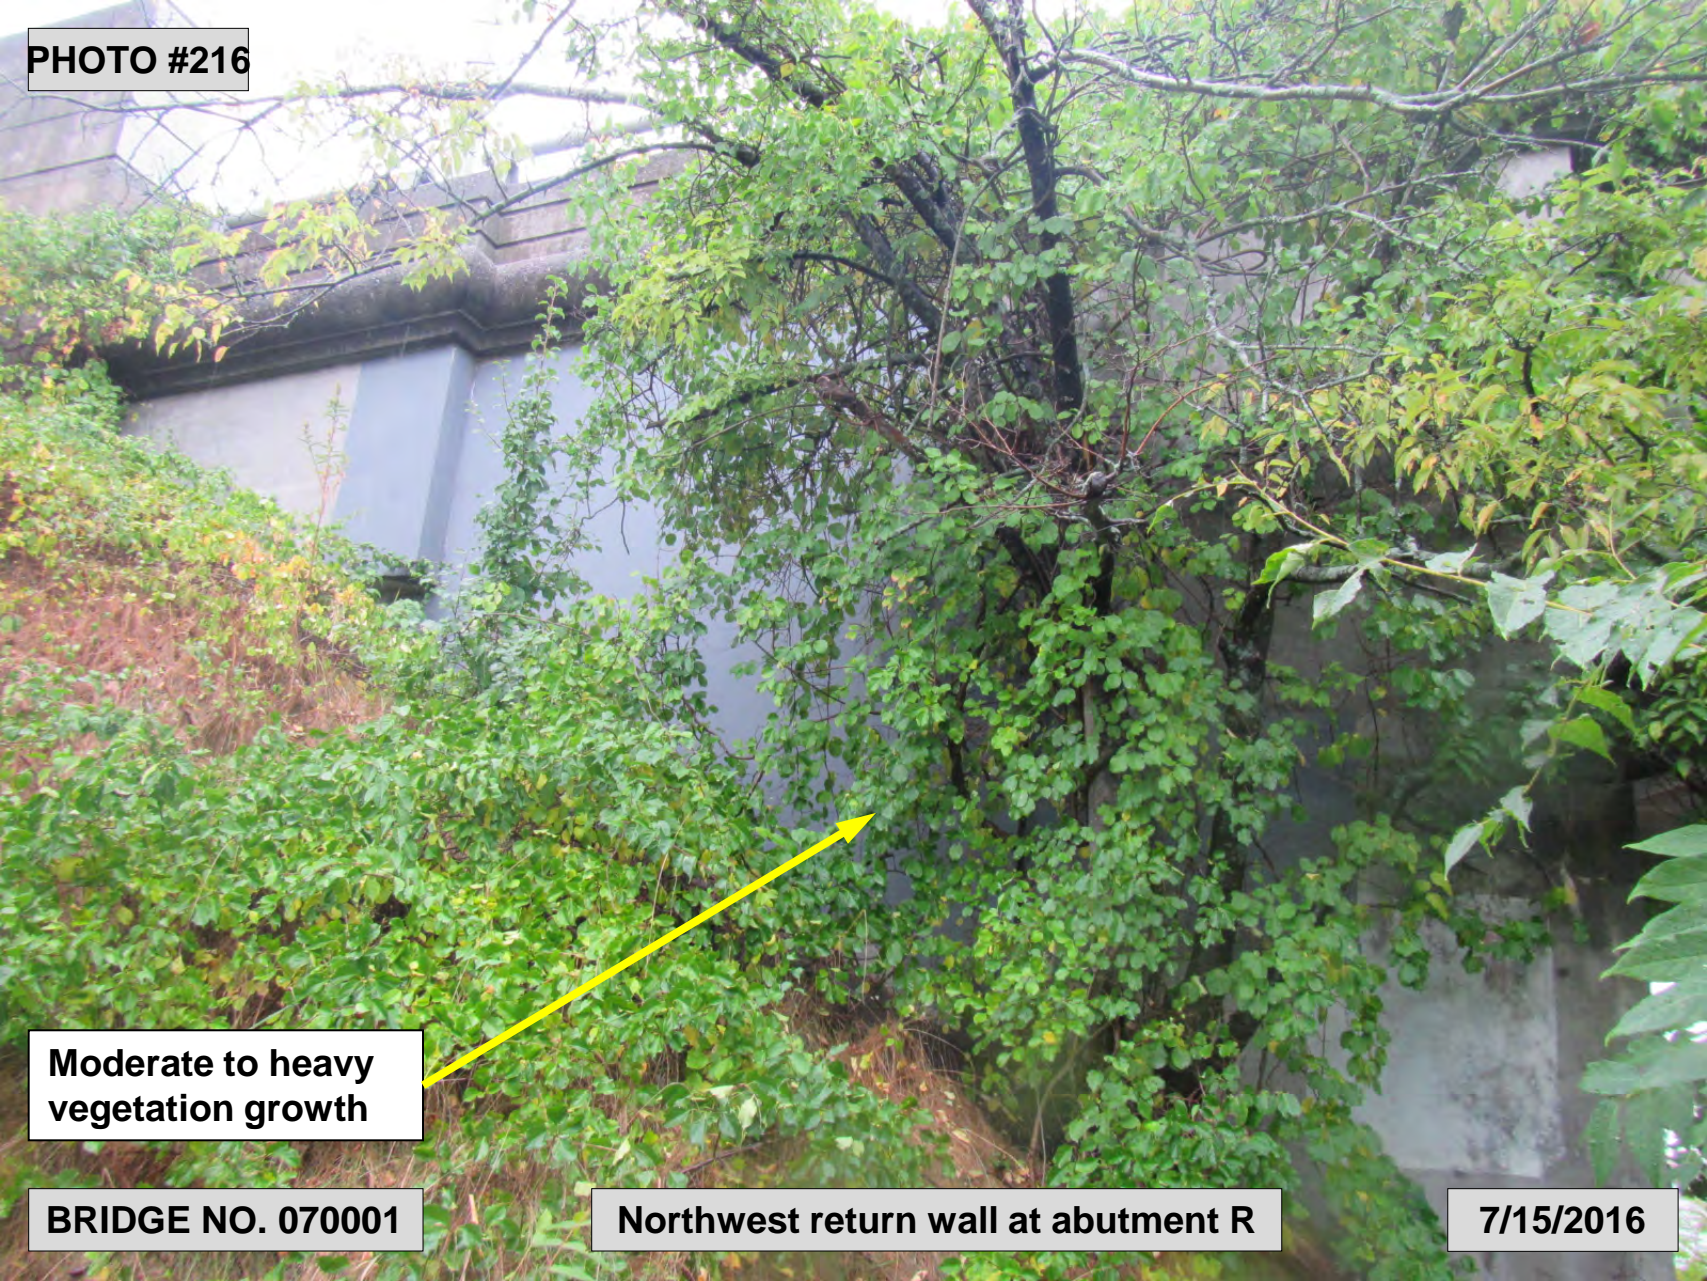
PHOTO #216

**Moderate to heavy
vegetation growth**

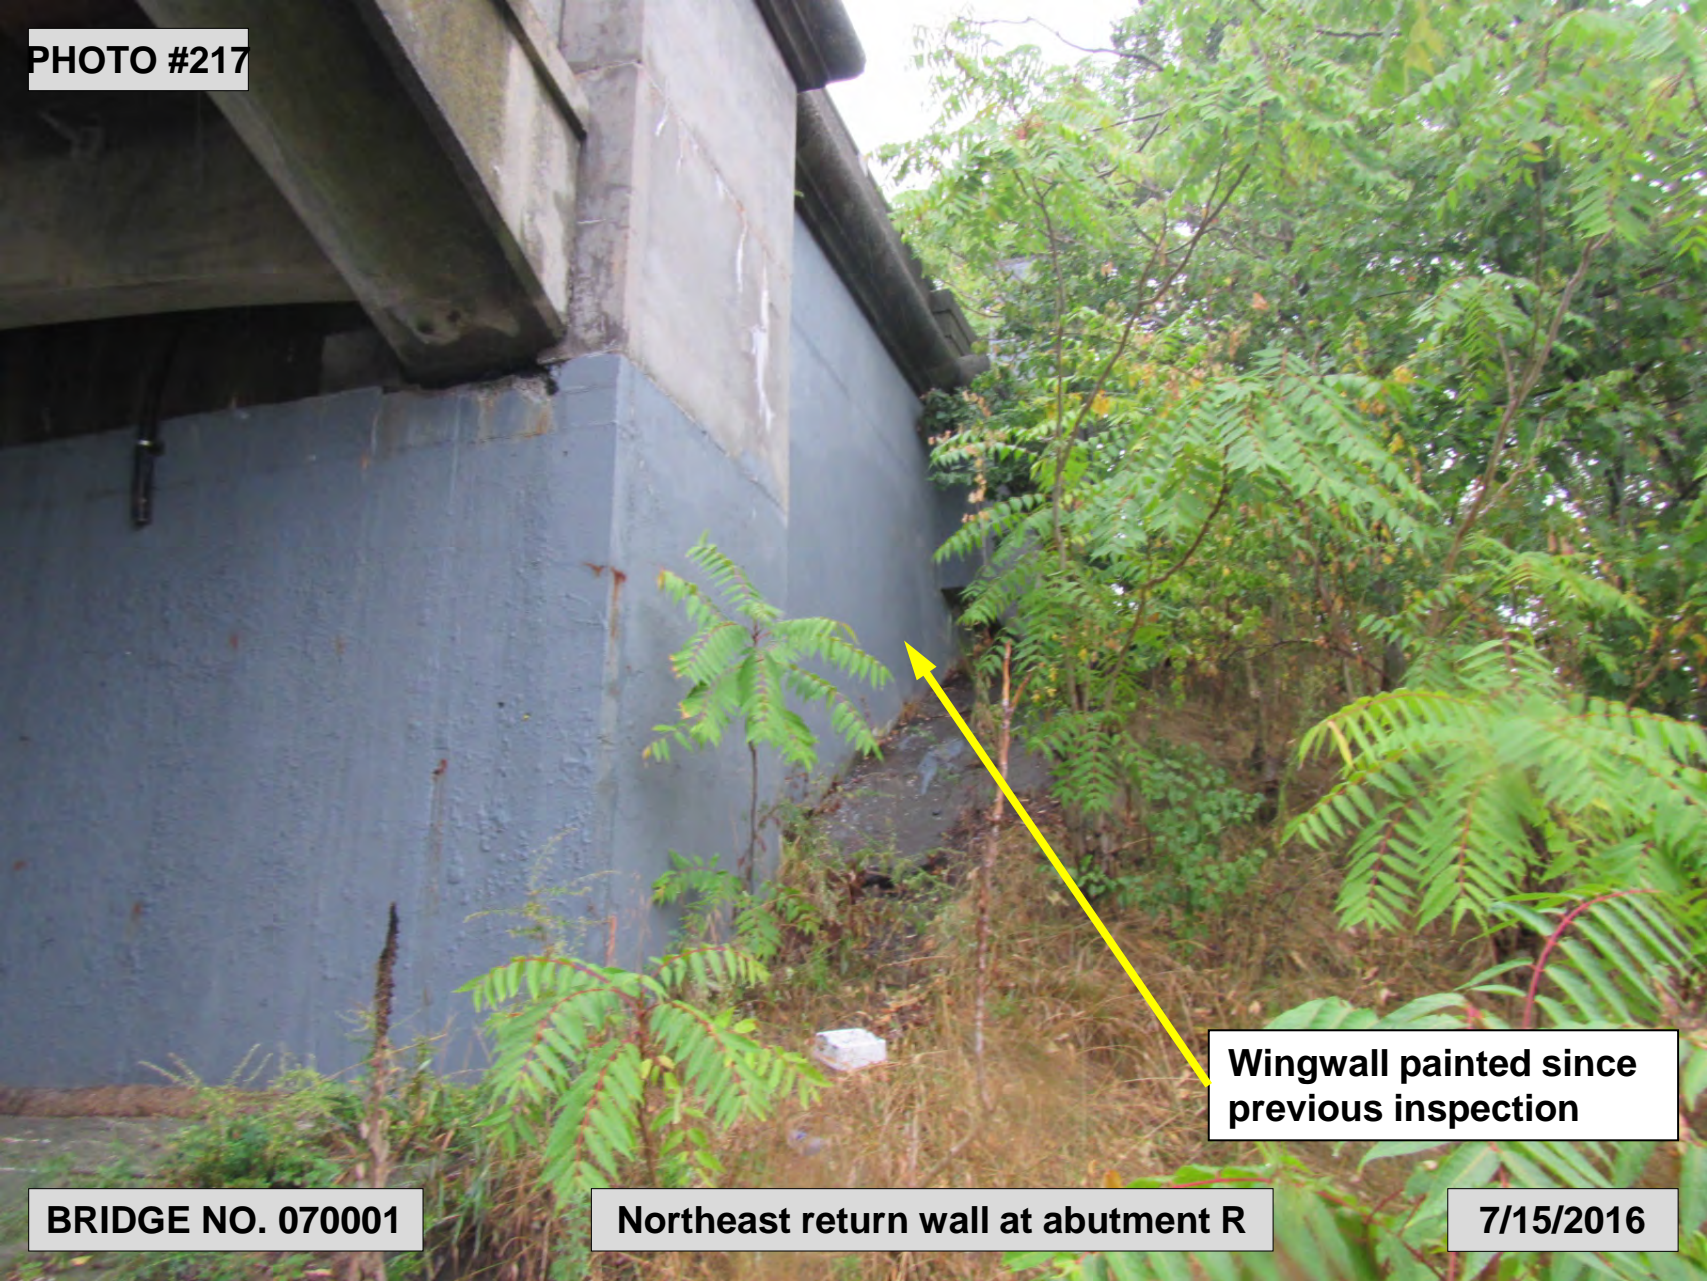
PHOTO #217

Wingwall painted since previous inspection

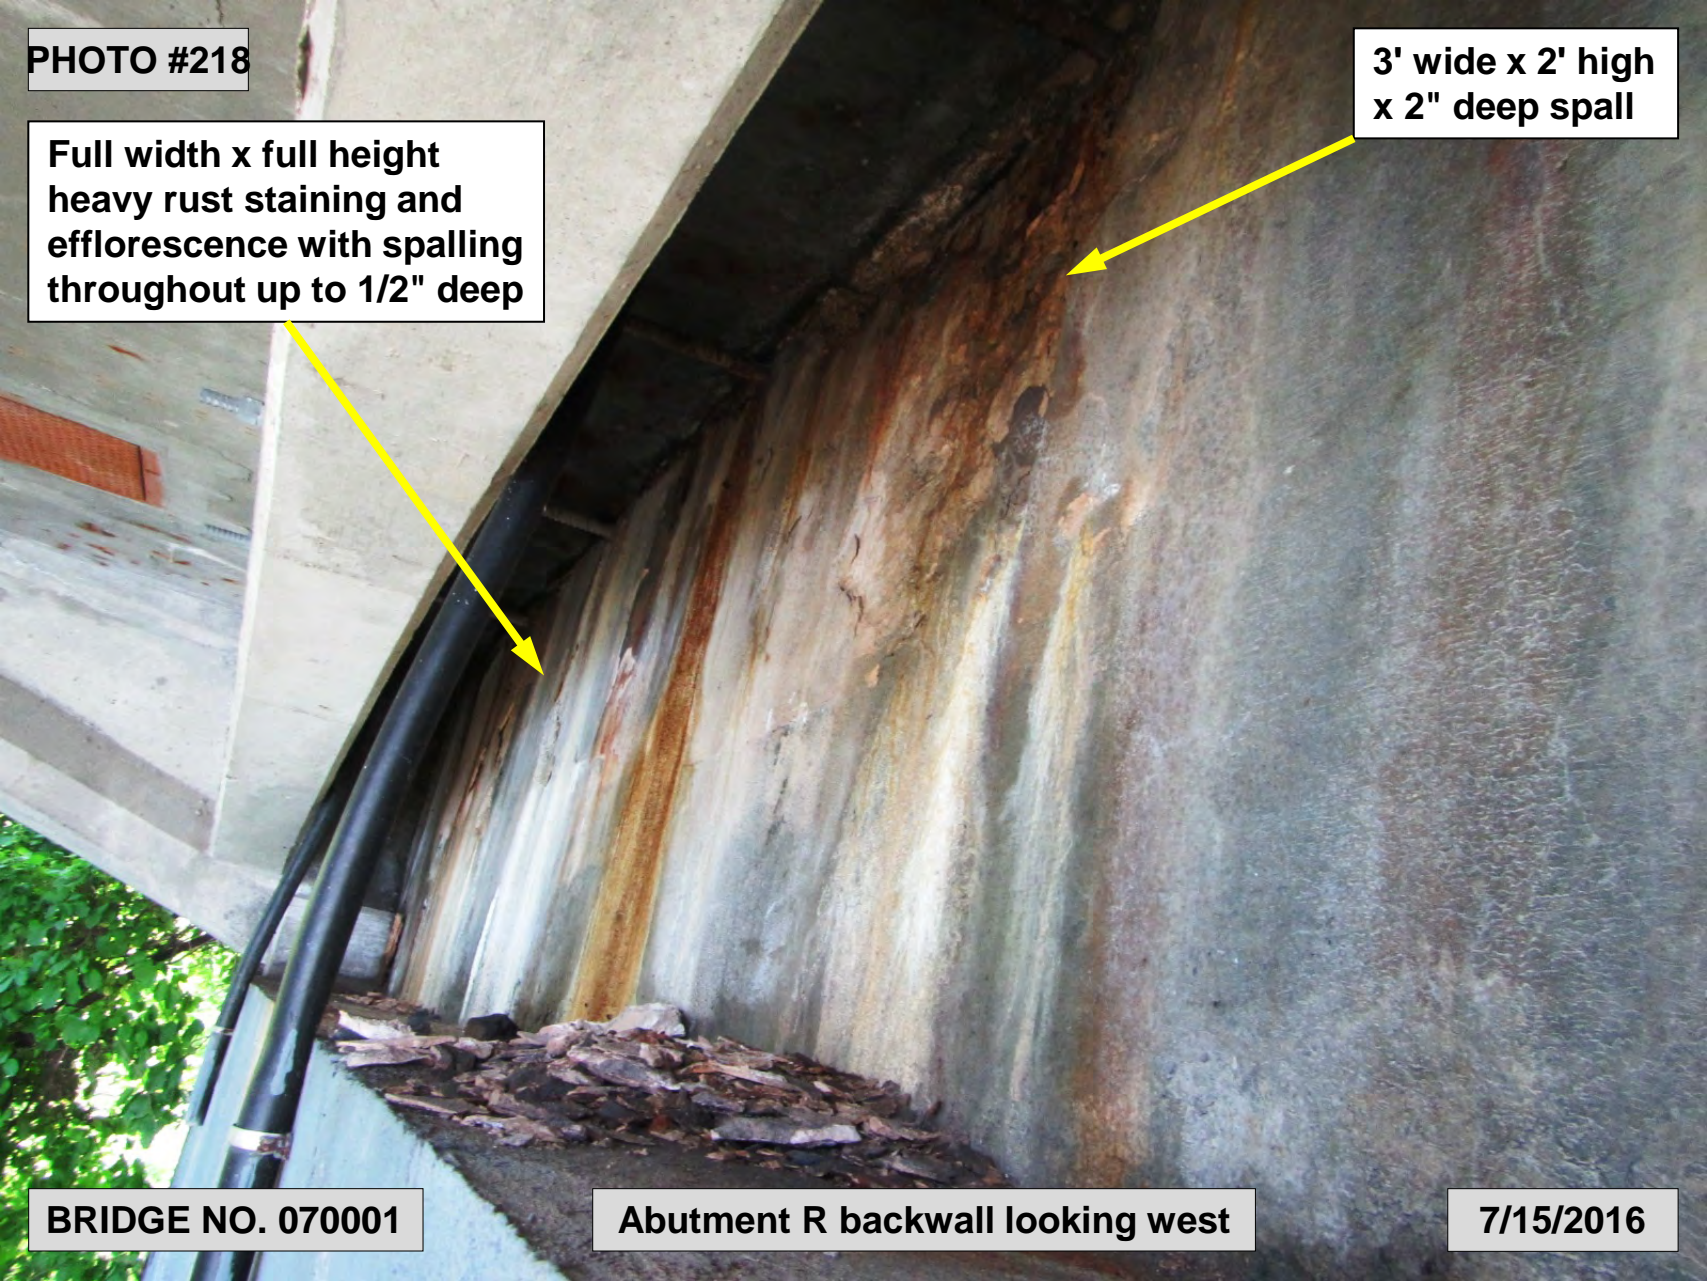
Abutment R backwall looking west

Full width x full height heavy rust staining and efflorescence with spalling throughout up to 1/2" deep

3' wide x 2' high x 2" deep spall
