12-MONTH SPECIAL INSPECTION

BRIDGE #070001

07/22/2020

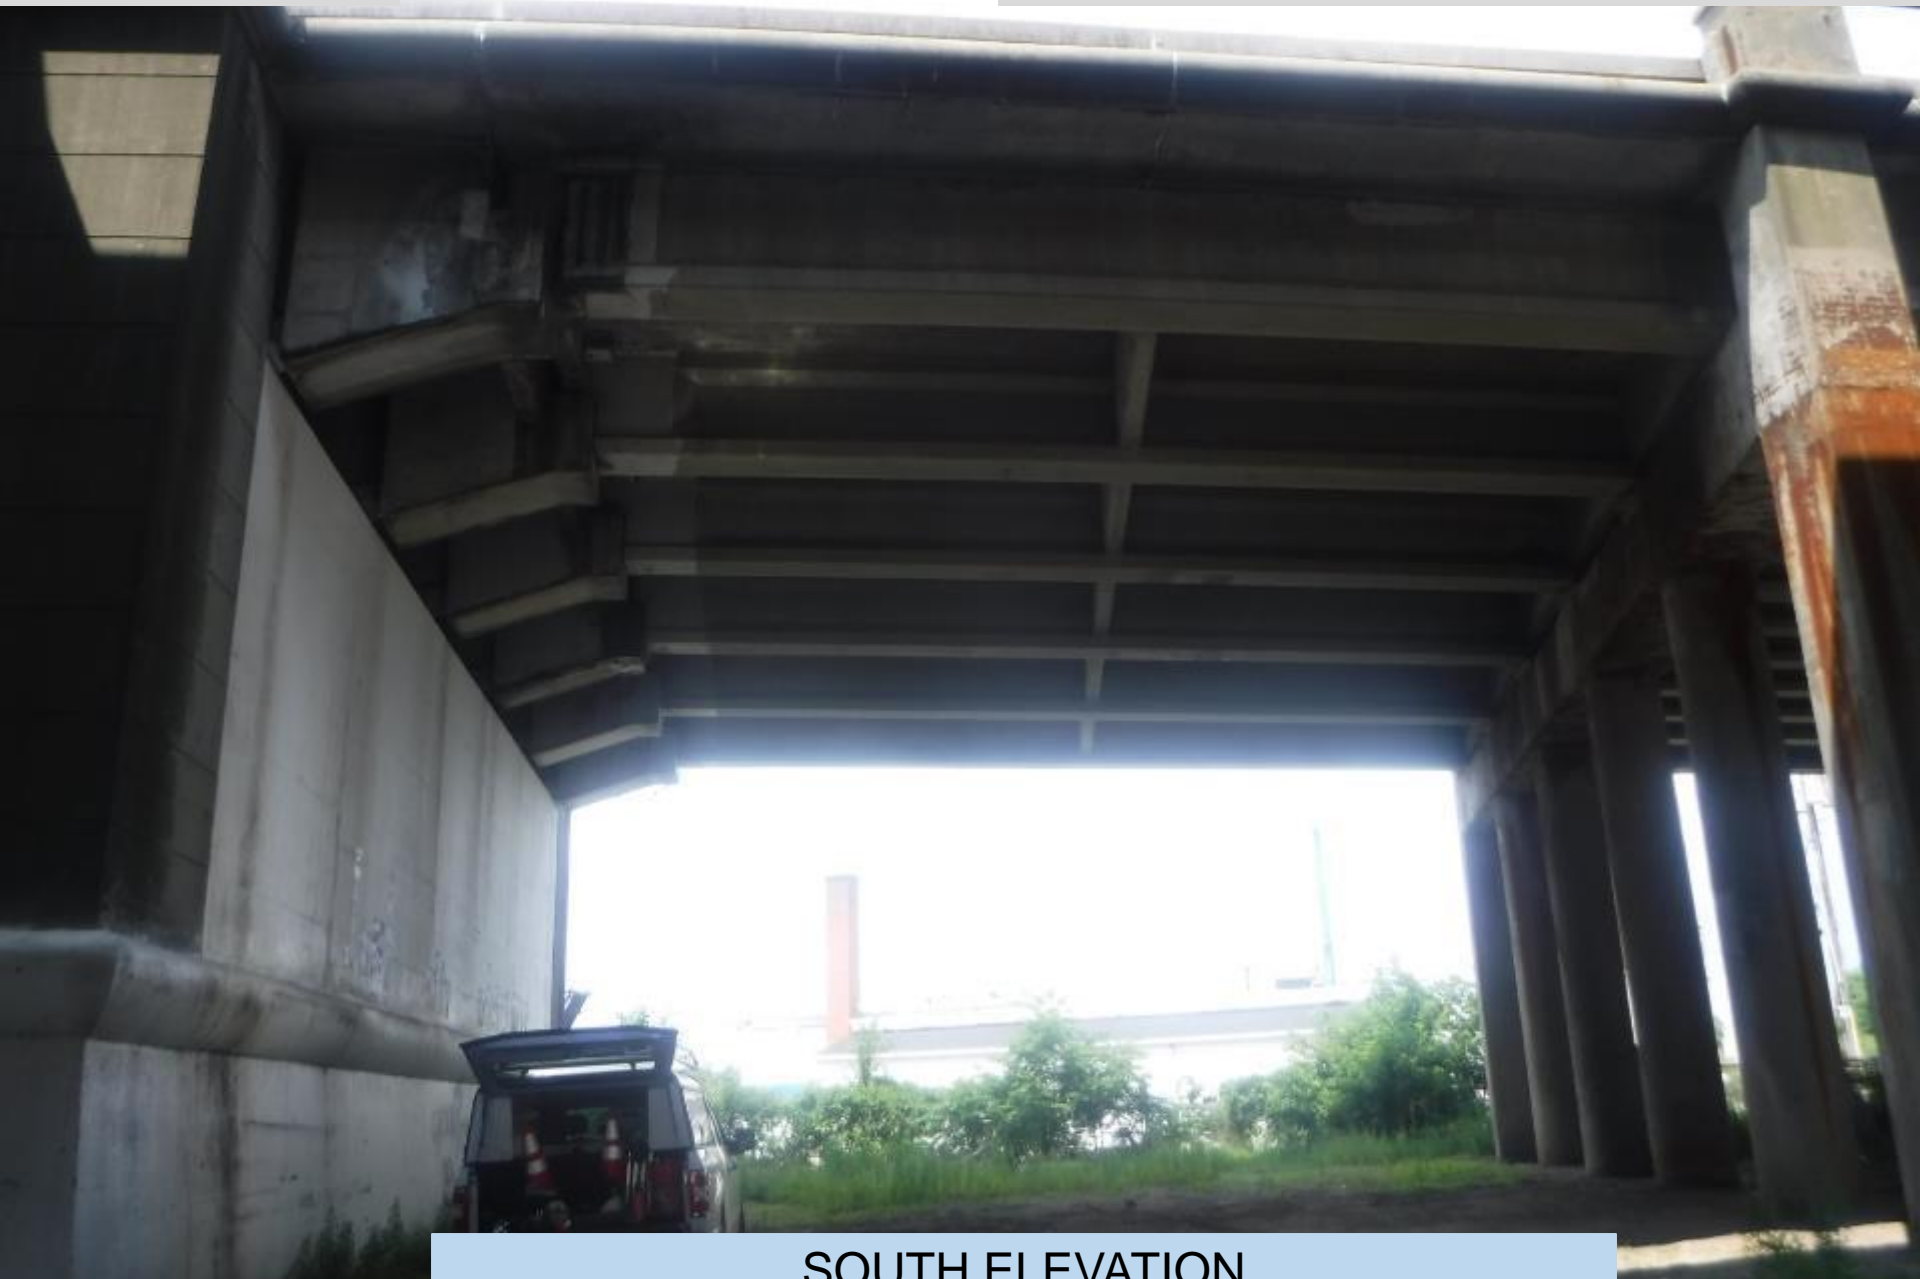
**SOUTH ELEVATION
IN SPAN #14 (LOOKING NORTH)**

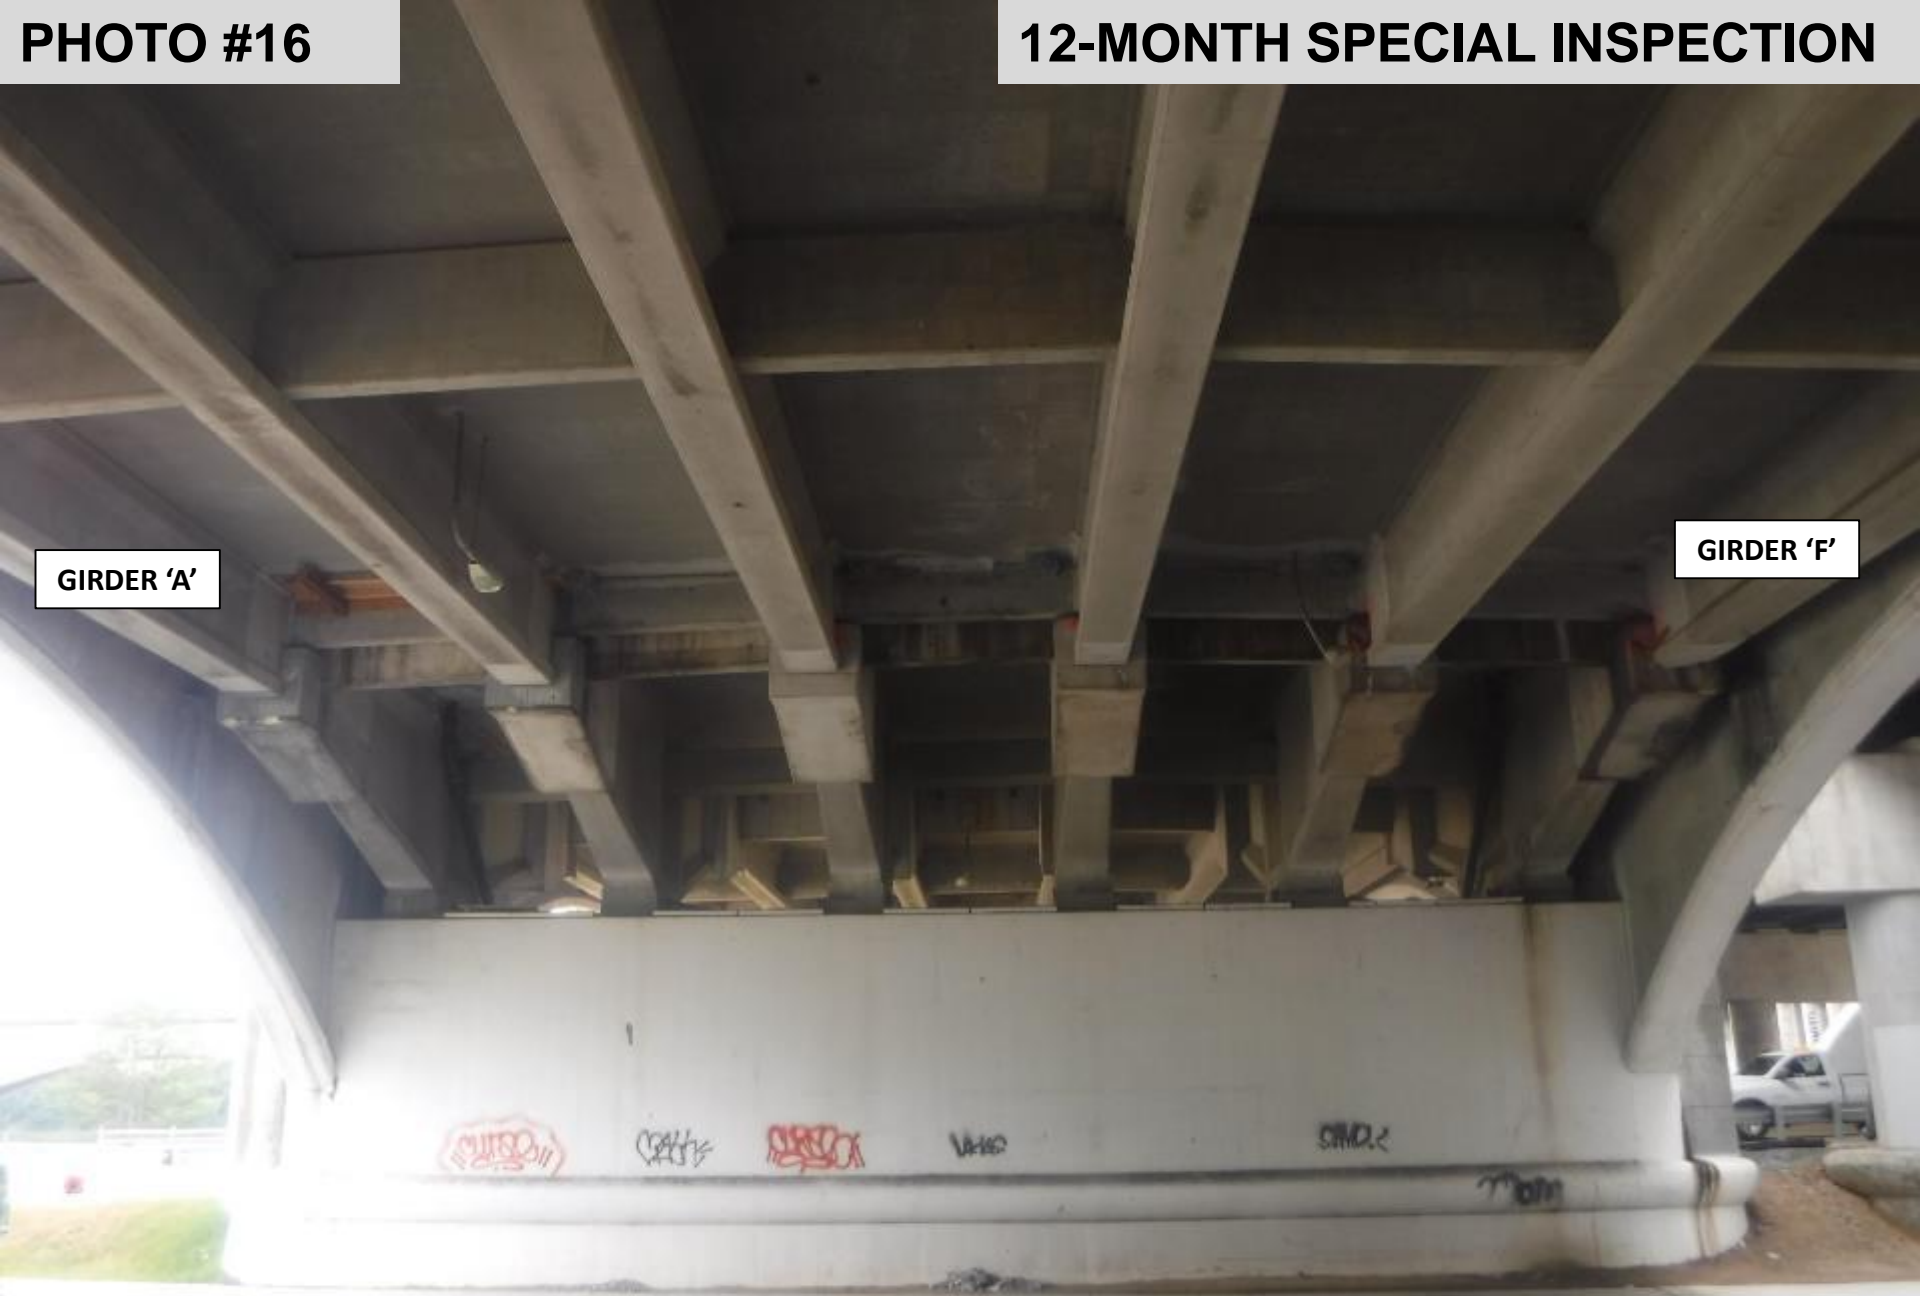
GENERAL UNDERSIDE IN SPAN #1 / PIER #1

WEST FACE (LOOKING EAST)

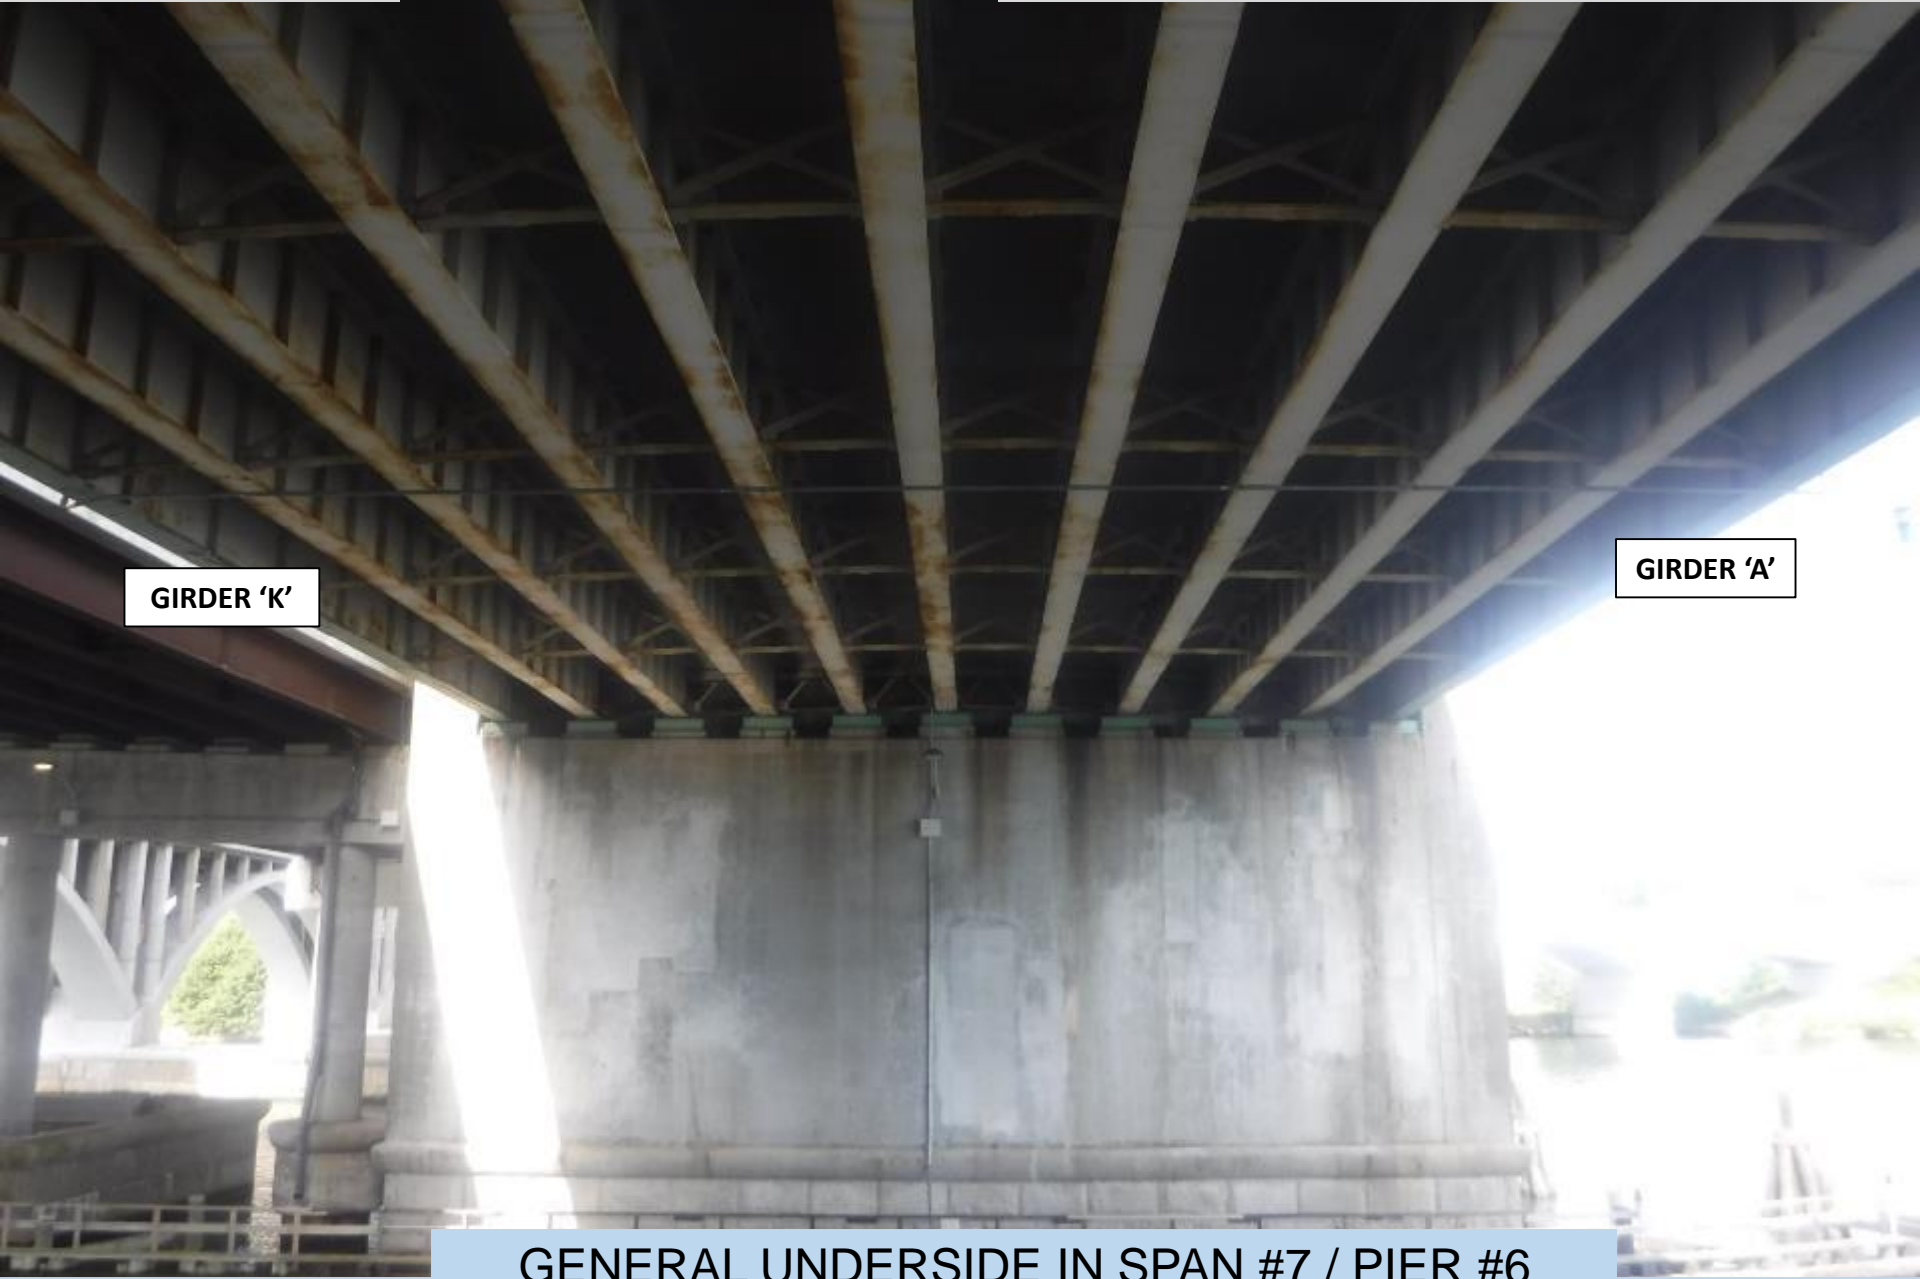
**GENERAL UNDERSIDE IN SPAN #7 / PIER #6
EAST FACE (LOOKING WEST)**

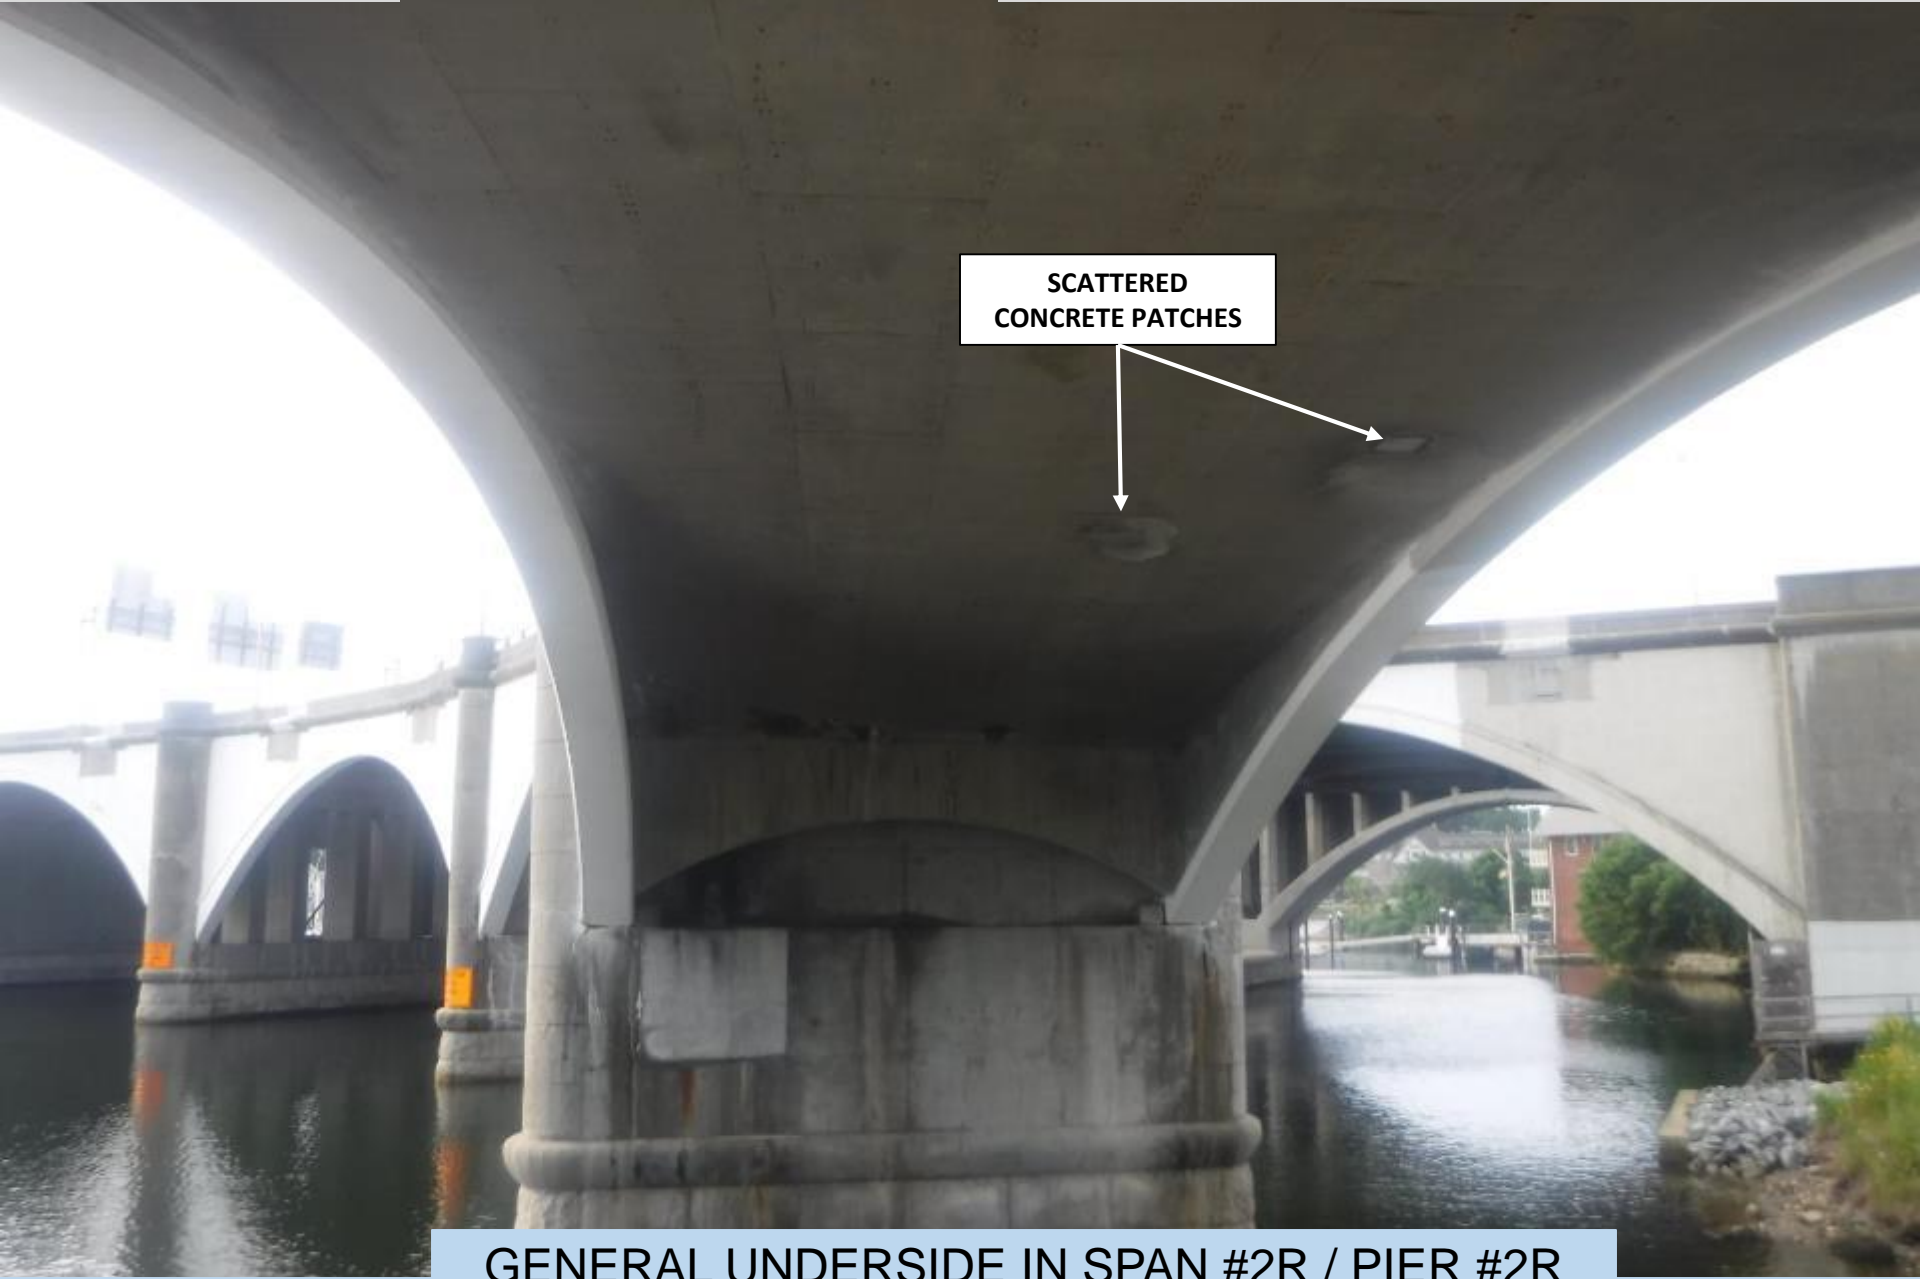
**SCATTERED
CONCRETE PATCHES**

**GENERAL UNDERSIDE IN SPAN #2R / PIER #2R
WEST FACE (LOOKING SOUTH)**

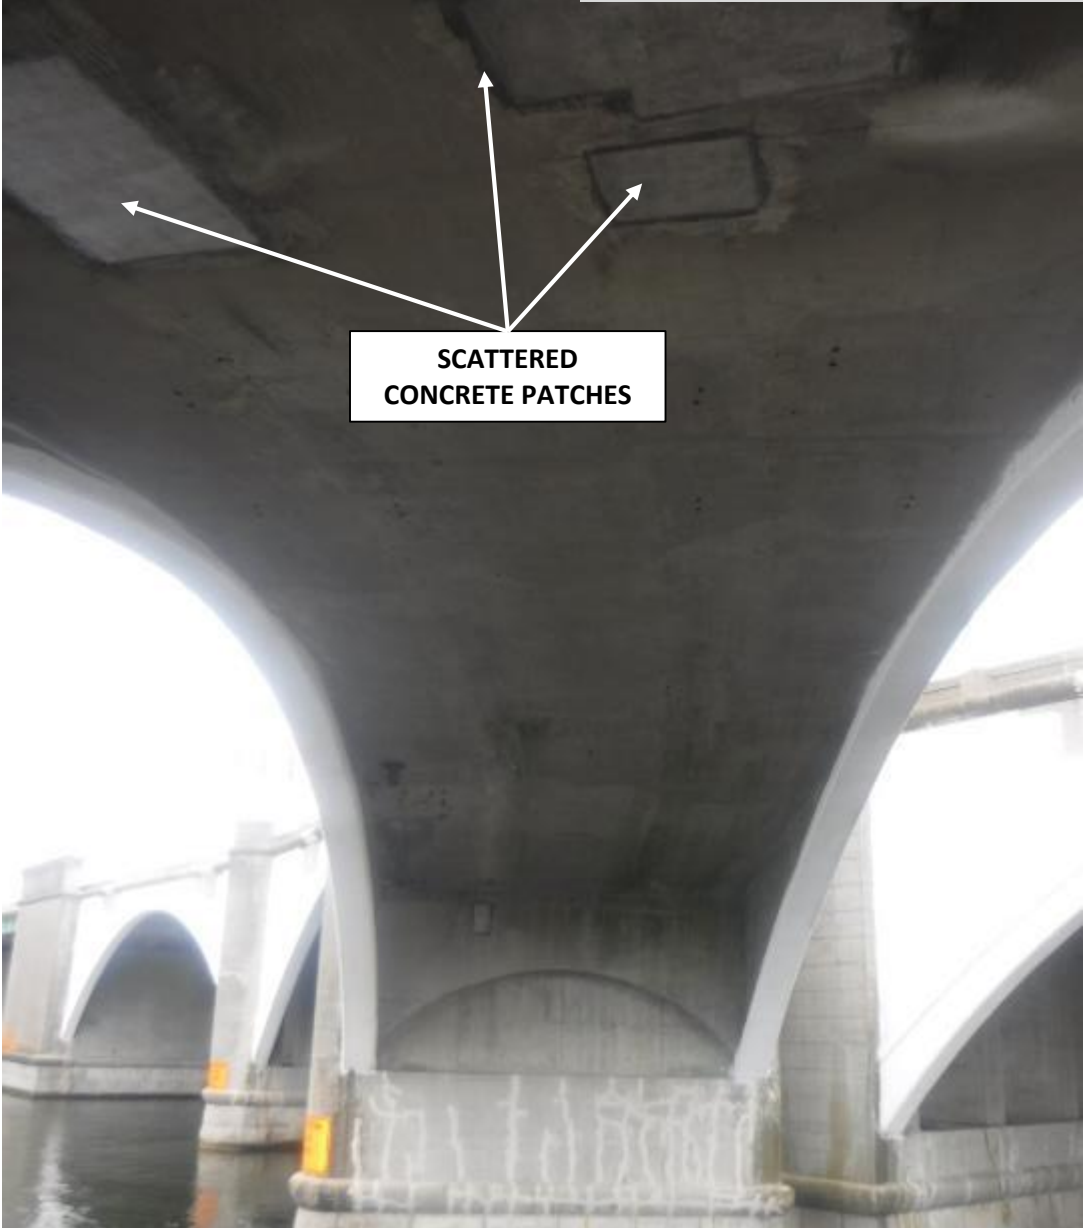
**SCATTERED
CONCRETE PATCHES**

**6" LONG HOLE IN
DECK JOINT**

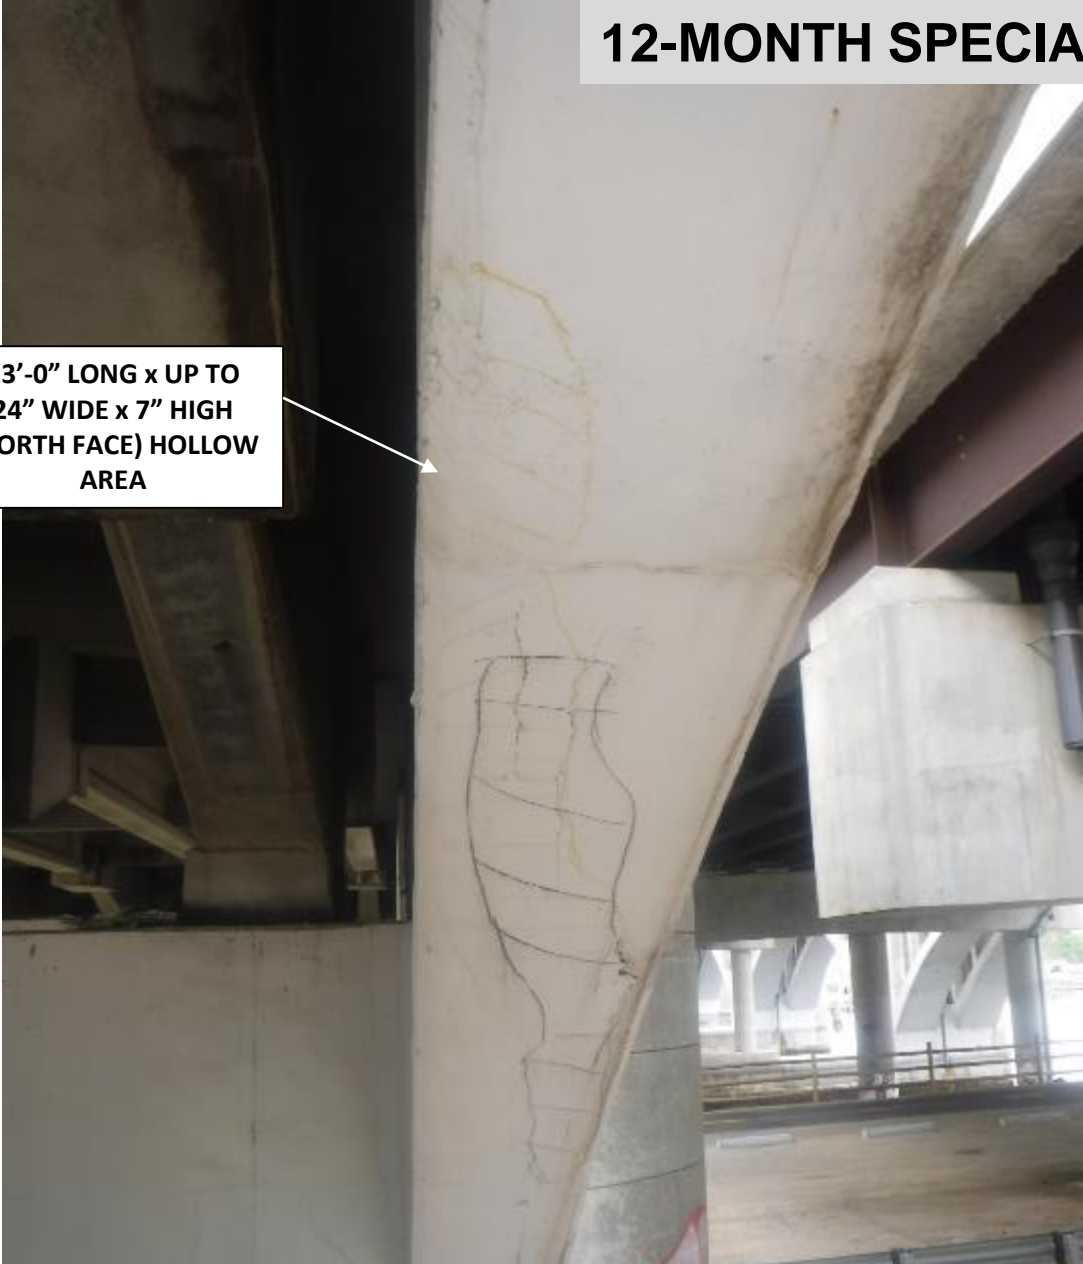
**SOUTH ARCH – UNDERSIDE
AT EAST JOINT IN SPAN #2**

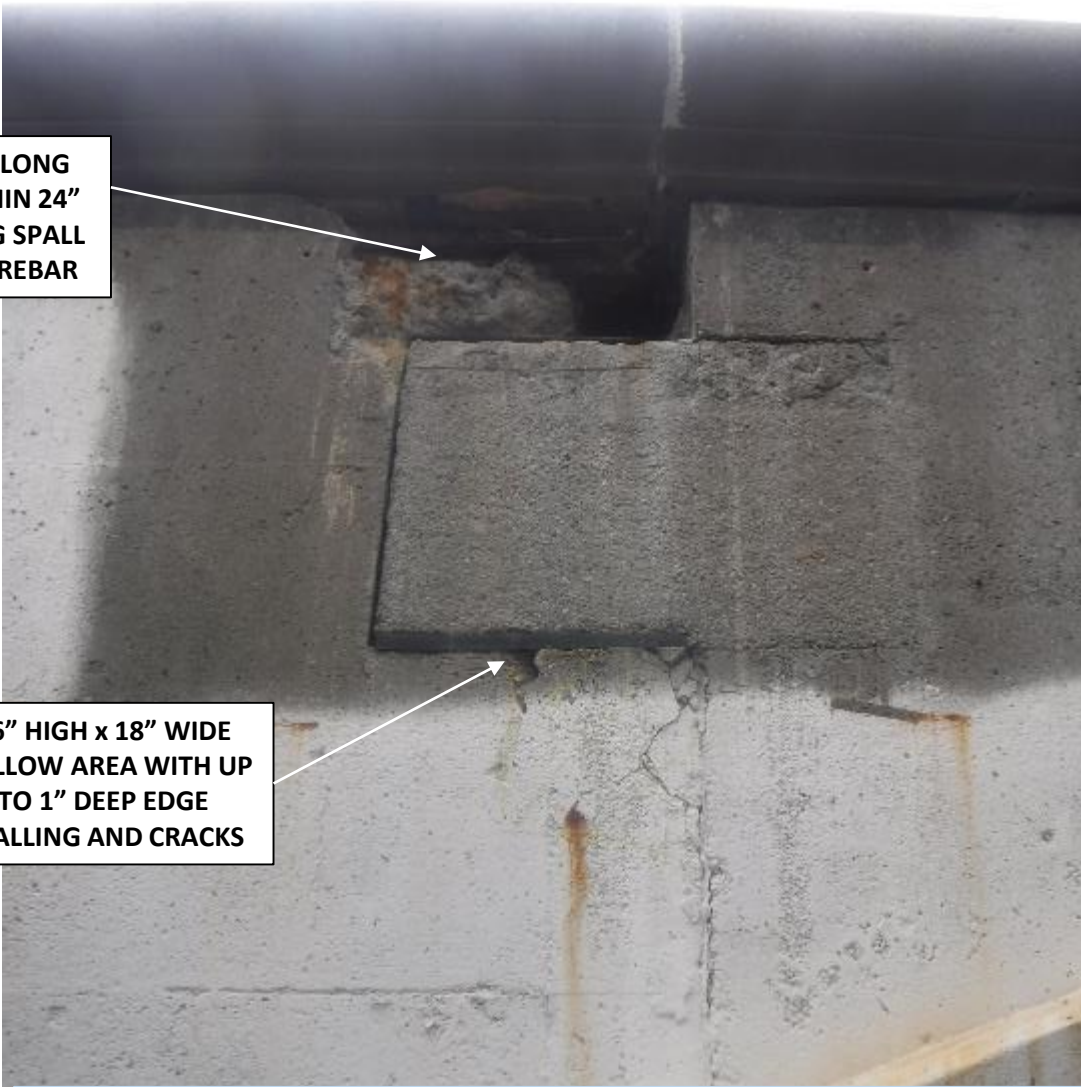
**22" HIGH x 18" LONG
WEB HOLE WITHIN 24"
HIGH x 38" LONG SPALL
WITH EXPOSED REBAR**

**16" HIGH x 18" WIDE
HOLLOW AREA WITH UP
TO 1" DEEP EDGE
SPALLING AND CRACKS**

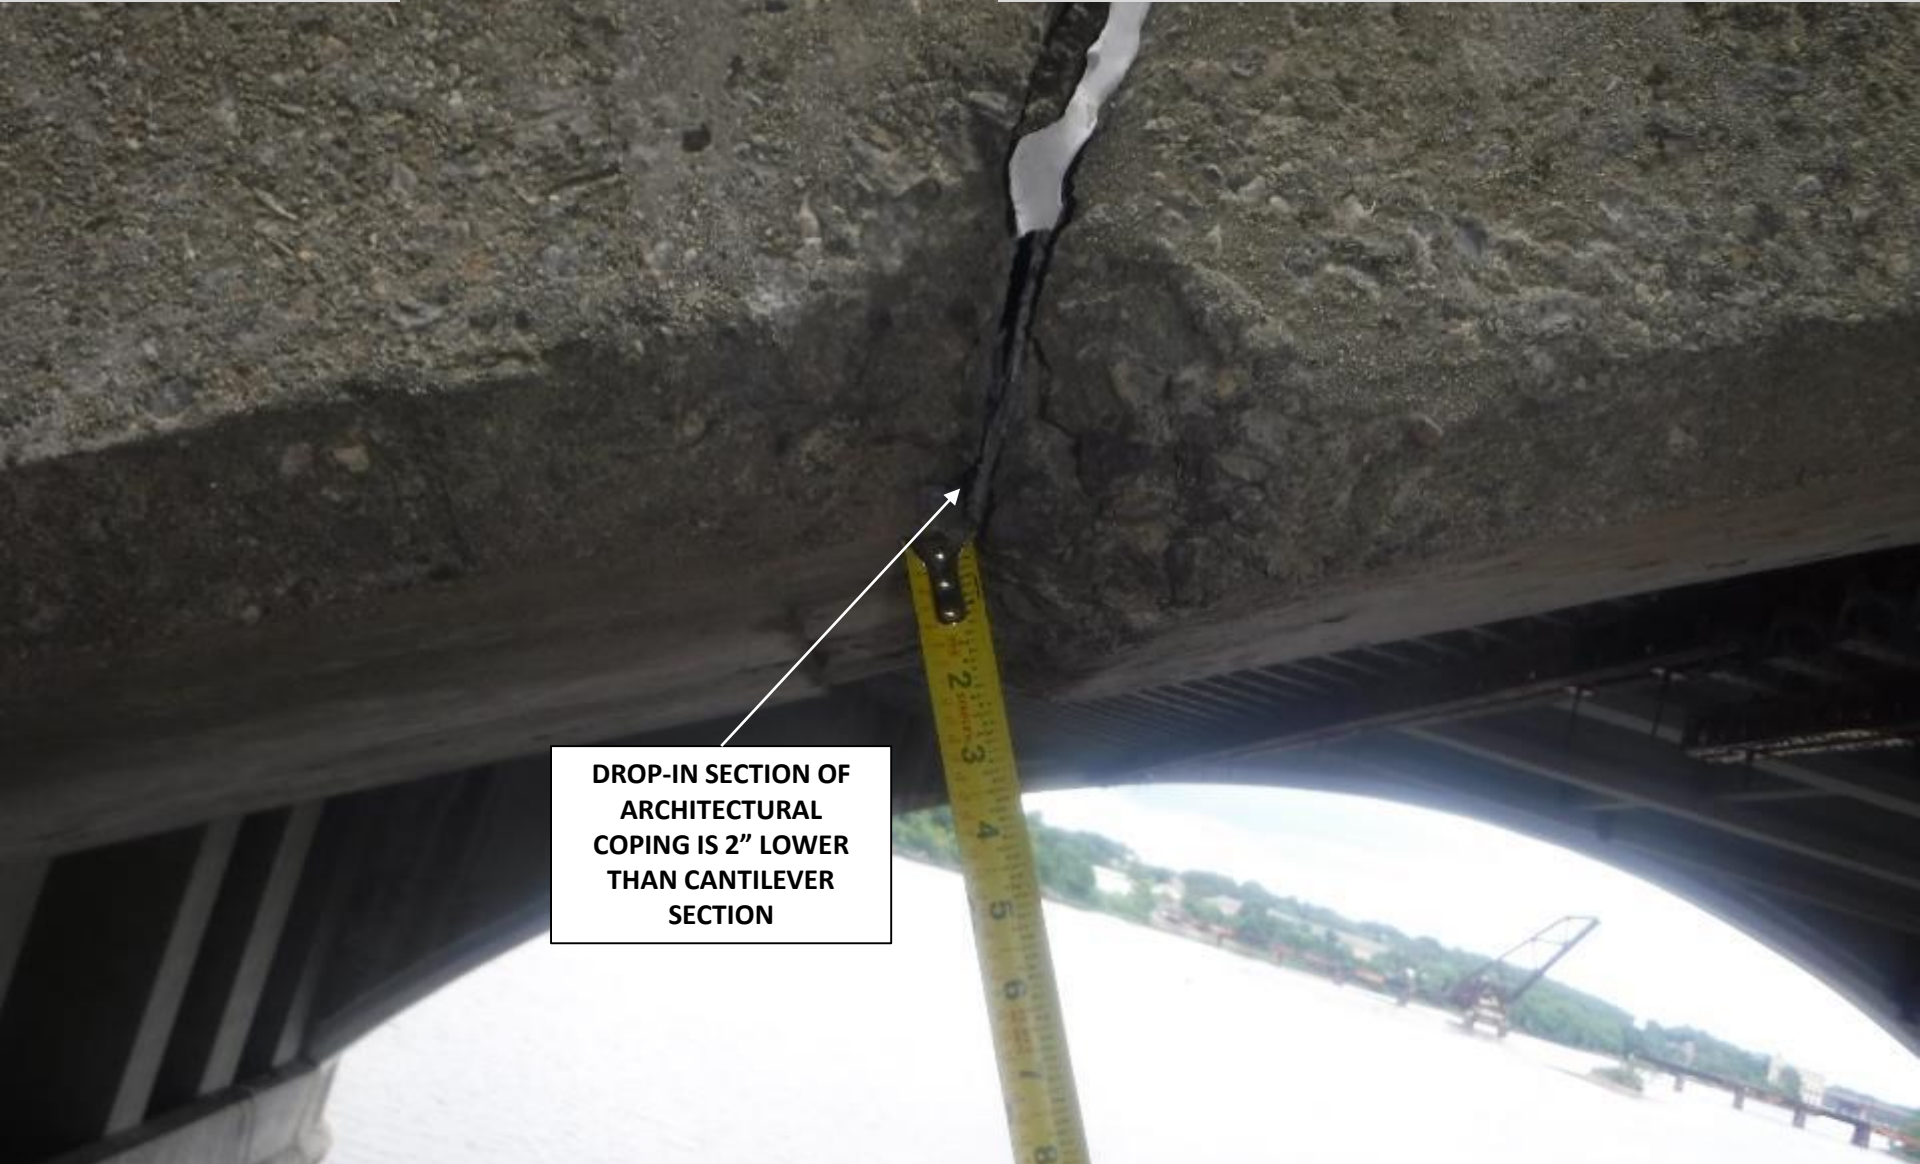
**DROP-IN SECTION OF
ARCHITECTURAL
COPING IS 2" LOWER
THAN CANTILEVER
SECTION**

**SOUTH ARCH – SOUTH FACE
AT WEST JOINT IN SPAN #6**

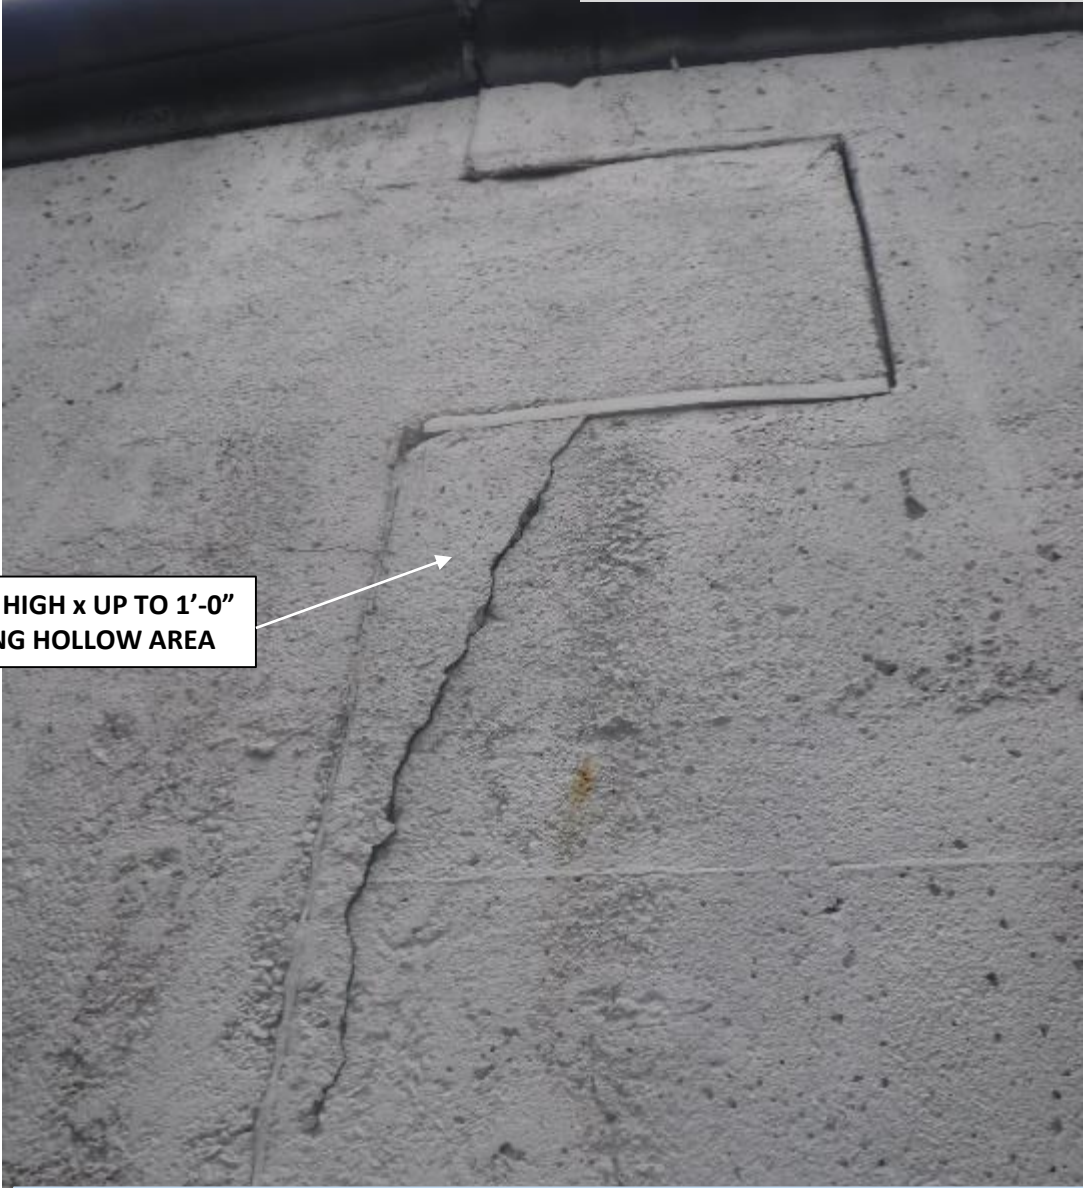
**4'-0" HIGH x UP TO 1'-0"
LONG HOLLOW AREA**

**SOUTH ARCH – SOUTH FACE
AT EAST JOINT KEY IN SPAN #8
(LOOKING NORTH)**

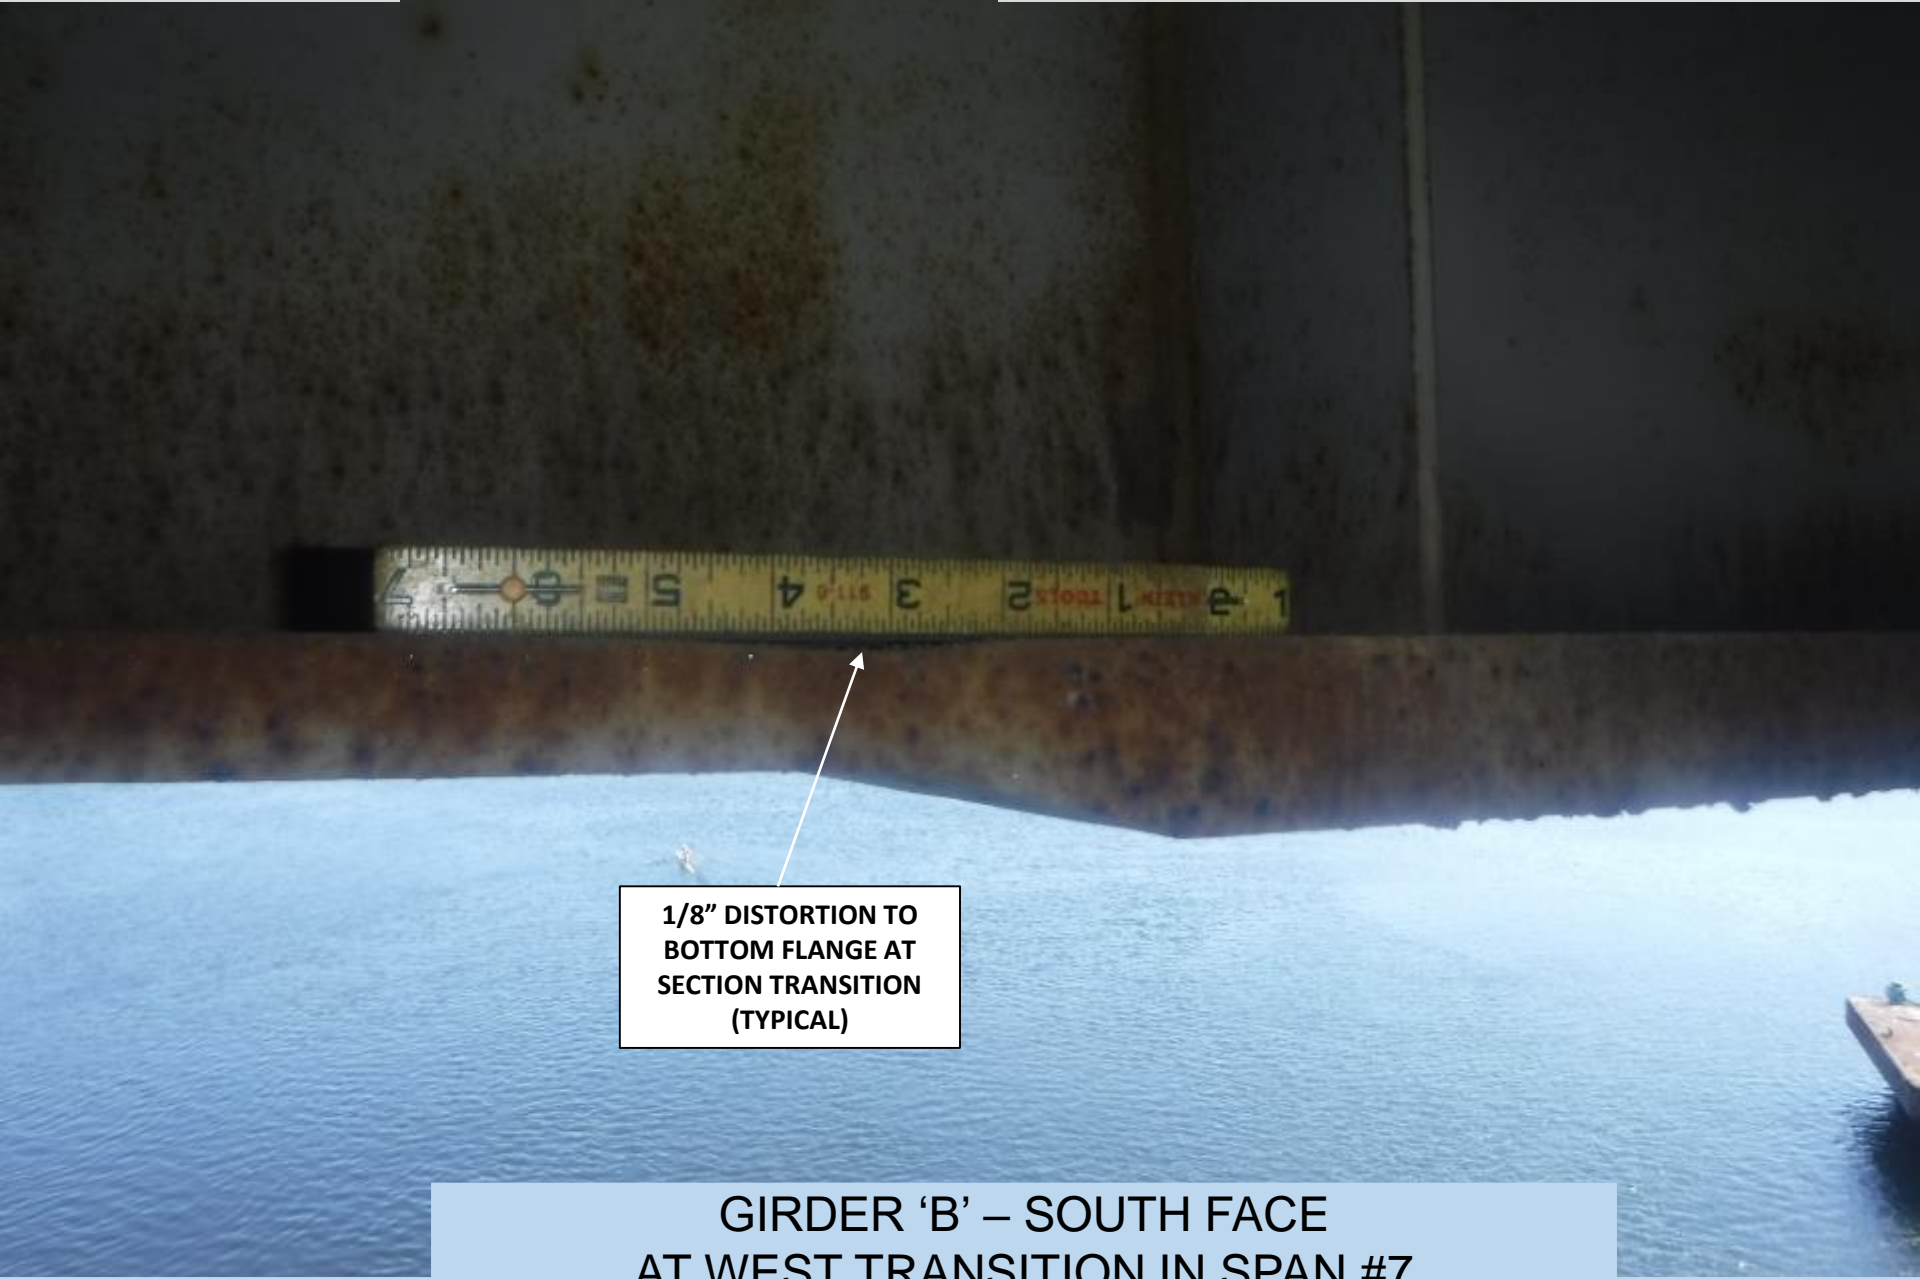
**1/8" DISTORTION TO
BOTTOM FLANGE AT
SECTION TRANSITION
(TYPICAL)**

**GIRDER 'B' – SOUTH FACE
AT WEST TRANSITION IN SPAN #7**

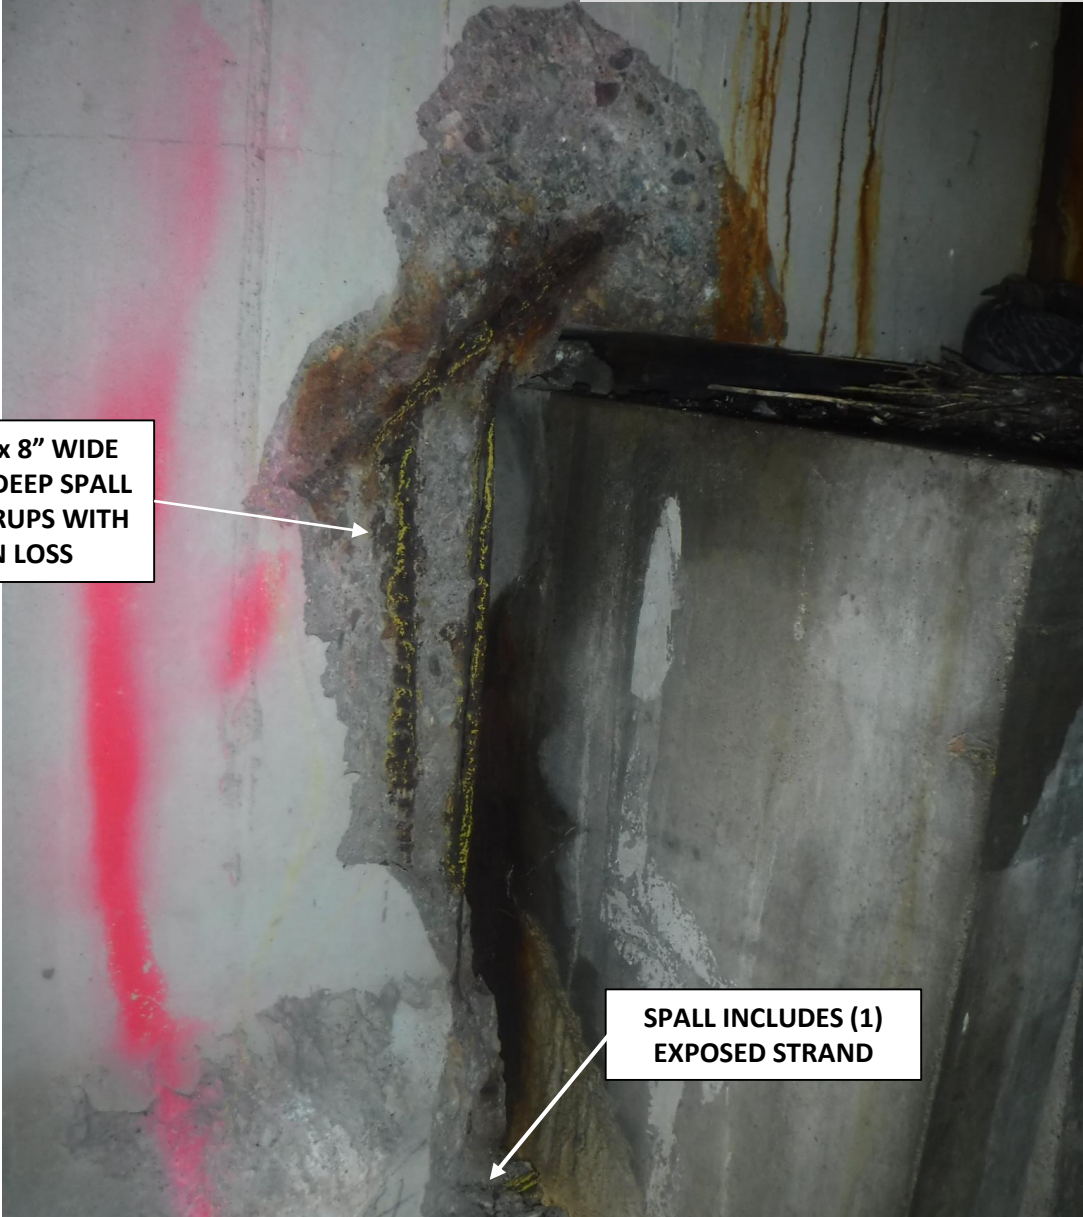
**22" LONG x 3'-0" HIGH x 8" WIDE
(EAST FACE) x UP TO 3" DEEP SPALL
WITH (3) EXPOSED STIRRUPS WITH
UP TO 75% SECTION LOSS**

**SPALL INCLUDES (1)
EXPOSED STRAND**

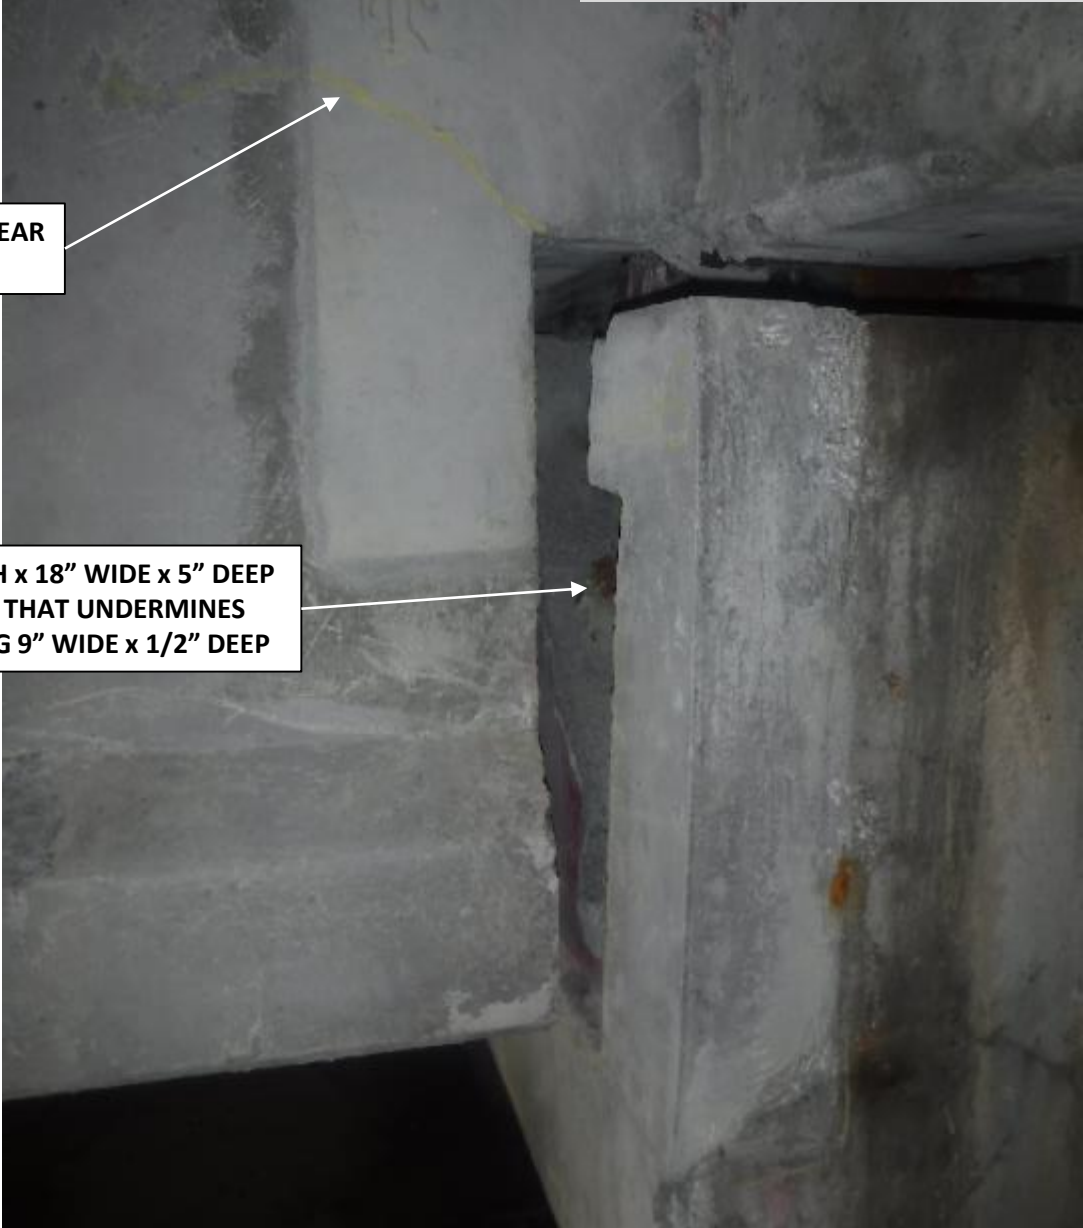
**15" LONG SHEAR
CRACK**

**26" HIGH x 18" WIDE x 5" DEEP
SPALL THAT UNDERMINES
BEARING 9" WIDE x 1/2" DEEP**
