12-MONTH SPECIAL INSPECTION

BRIDGE #070001

07/22/2020

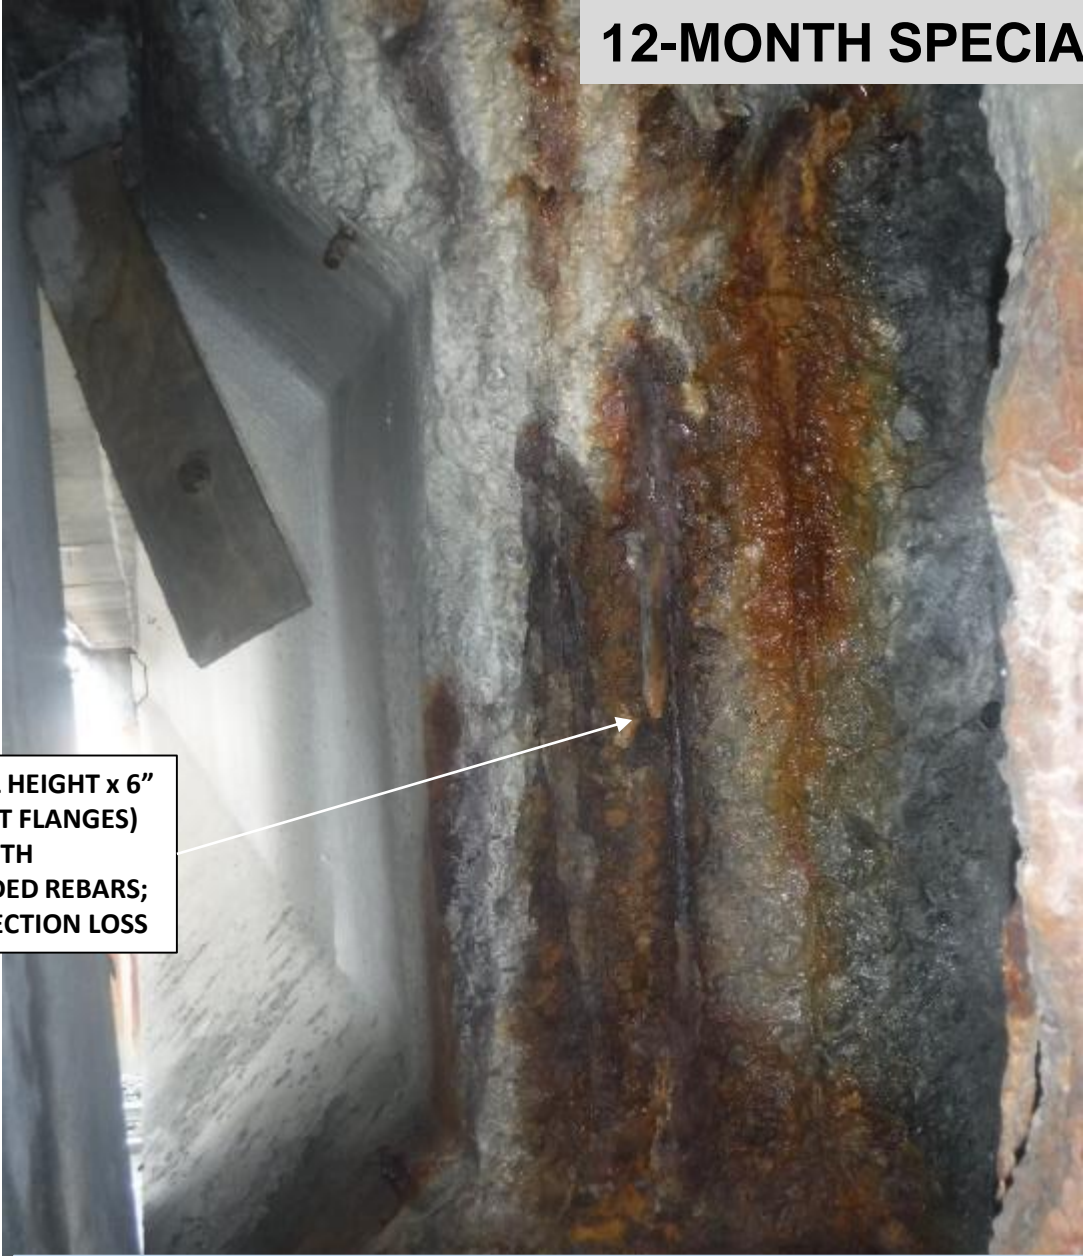
**FULL WIDTH x FULL HEIGHT x 6"
DEEP (10" DEEP AT FLANGES)
SPALL WITH
EXPOSED/DEBONDED REBARS;
AND UP TO 80% SECTION LOSS**

**AASHTO GIRDER 'N' – EAST/BACK FACE BEYOND
BEARING AT PIER #16 IN SPAN #16 (LOOKING
WEST)**

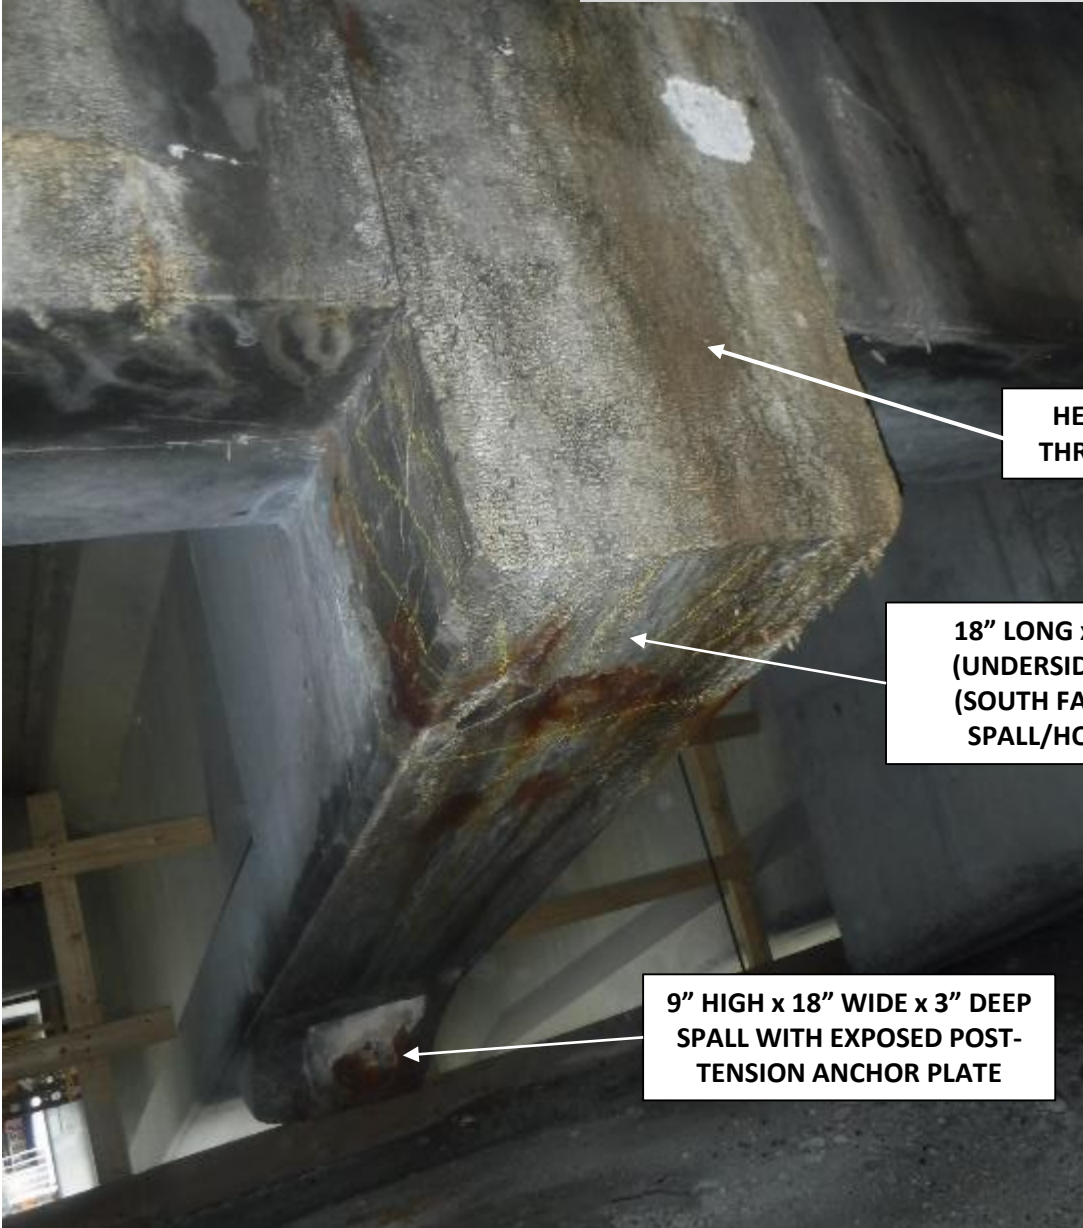
**HEAVY EFFLORESCENCE
THROUGHOUT EAST FACE**

**18" LONG x FULL WIDTH
(UNDERSIDE) x 12" HIGH
(SOUTH FACE) x 1" DEEP
SPALL/HOLLOW AREA**

**9" HIGH x 18" WIDE x 3" DEEP
SPALL WITH EXPOSED POST-
TENSION ANCHOR PLATE**

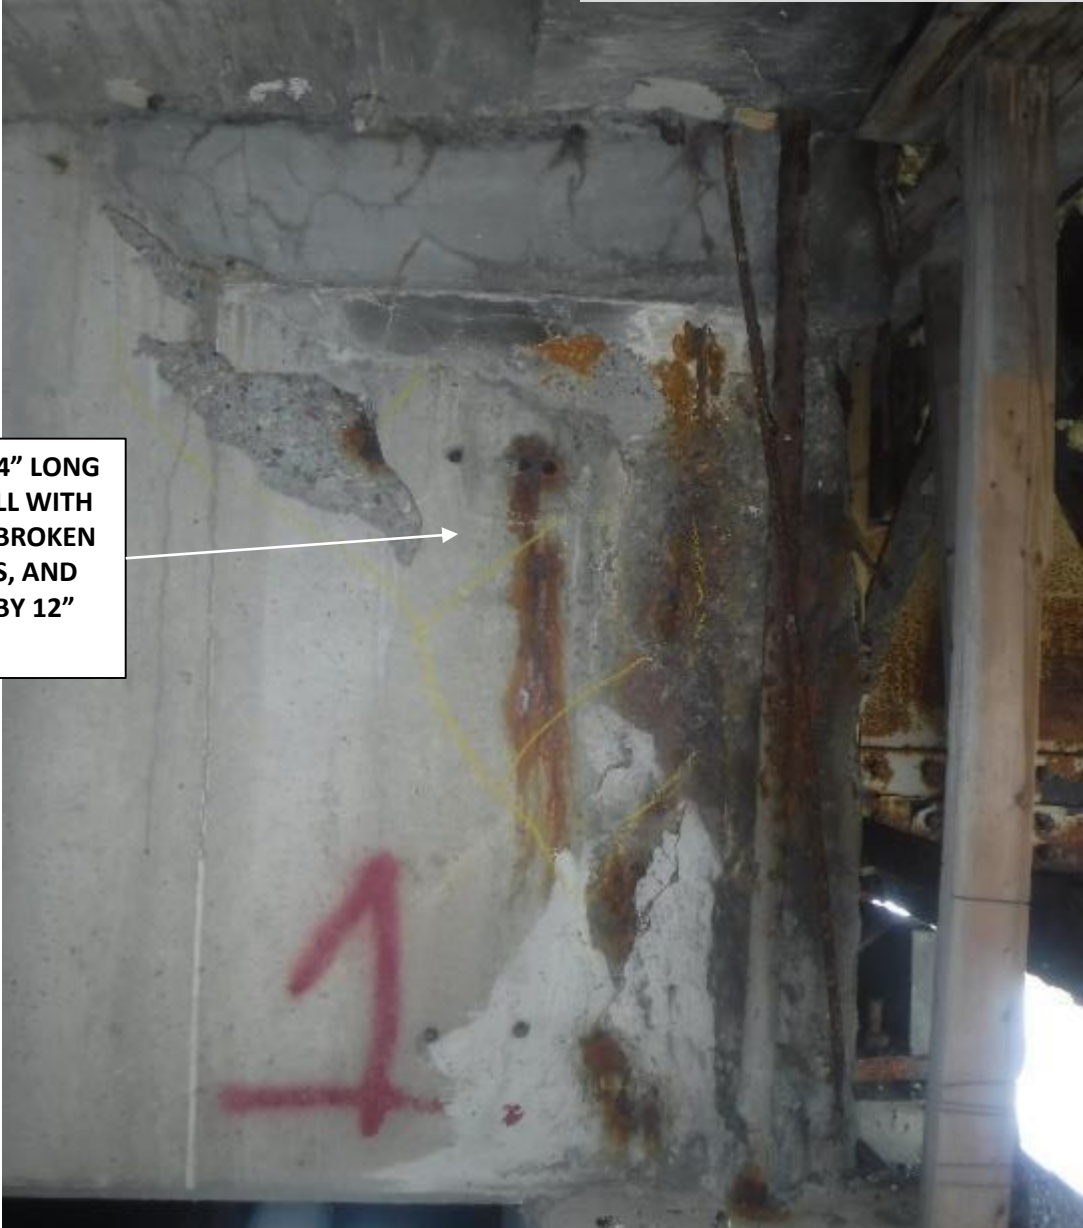
**FULL HEIGHT x 36" WIDE x 14" LONG
(WEST FACE) x 6" DEEP SPALL WITH
EXPOSED, DEBONDED AND BROKEN
REBAR; EXPOSED STRANDS, AND
REDUCED BEARING AREA BY 12"
WIDE x 7" LONG**

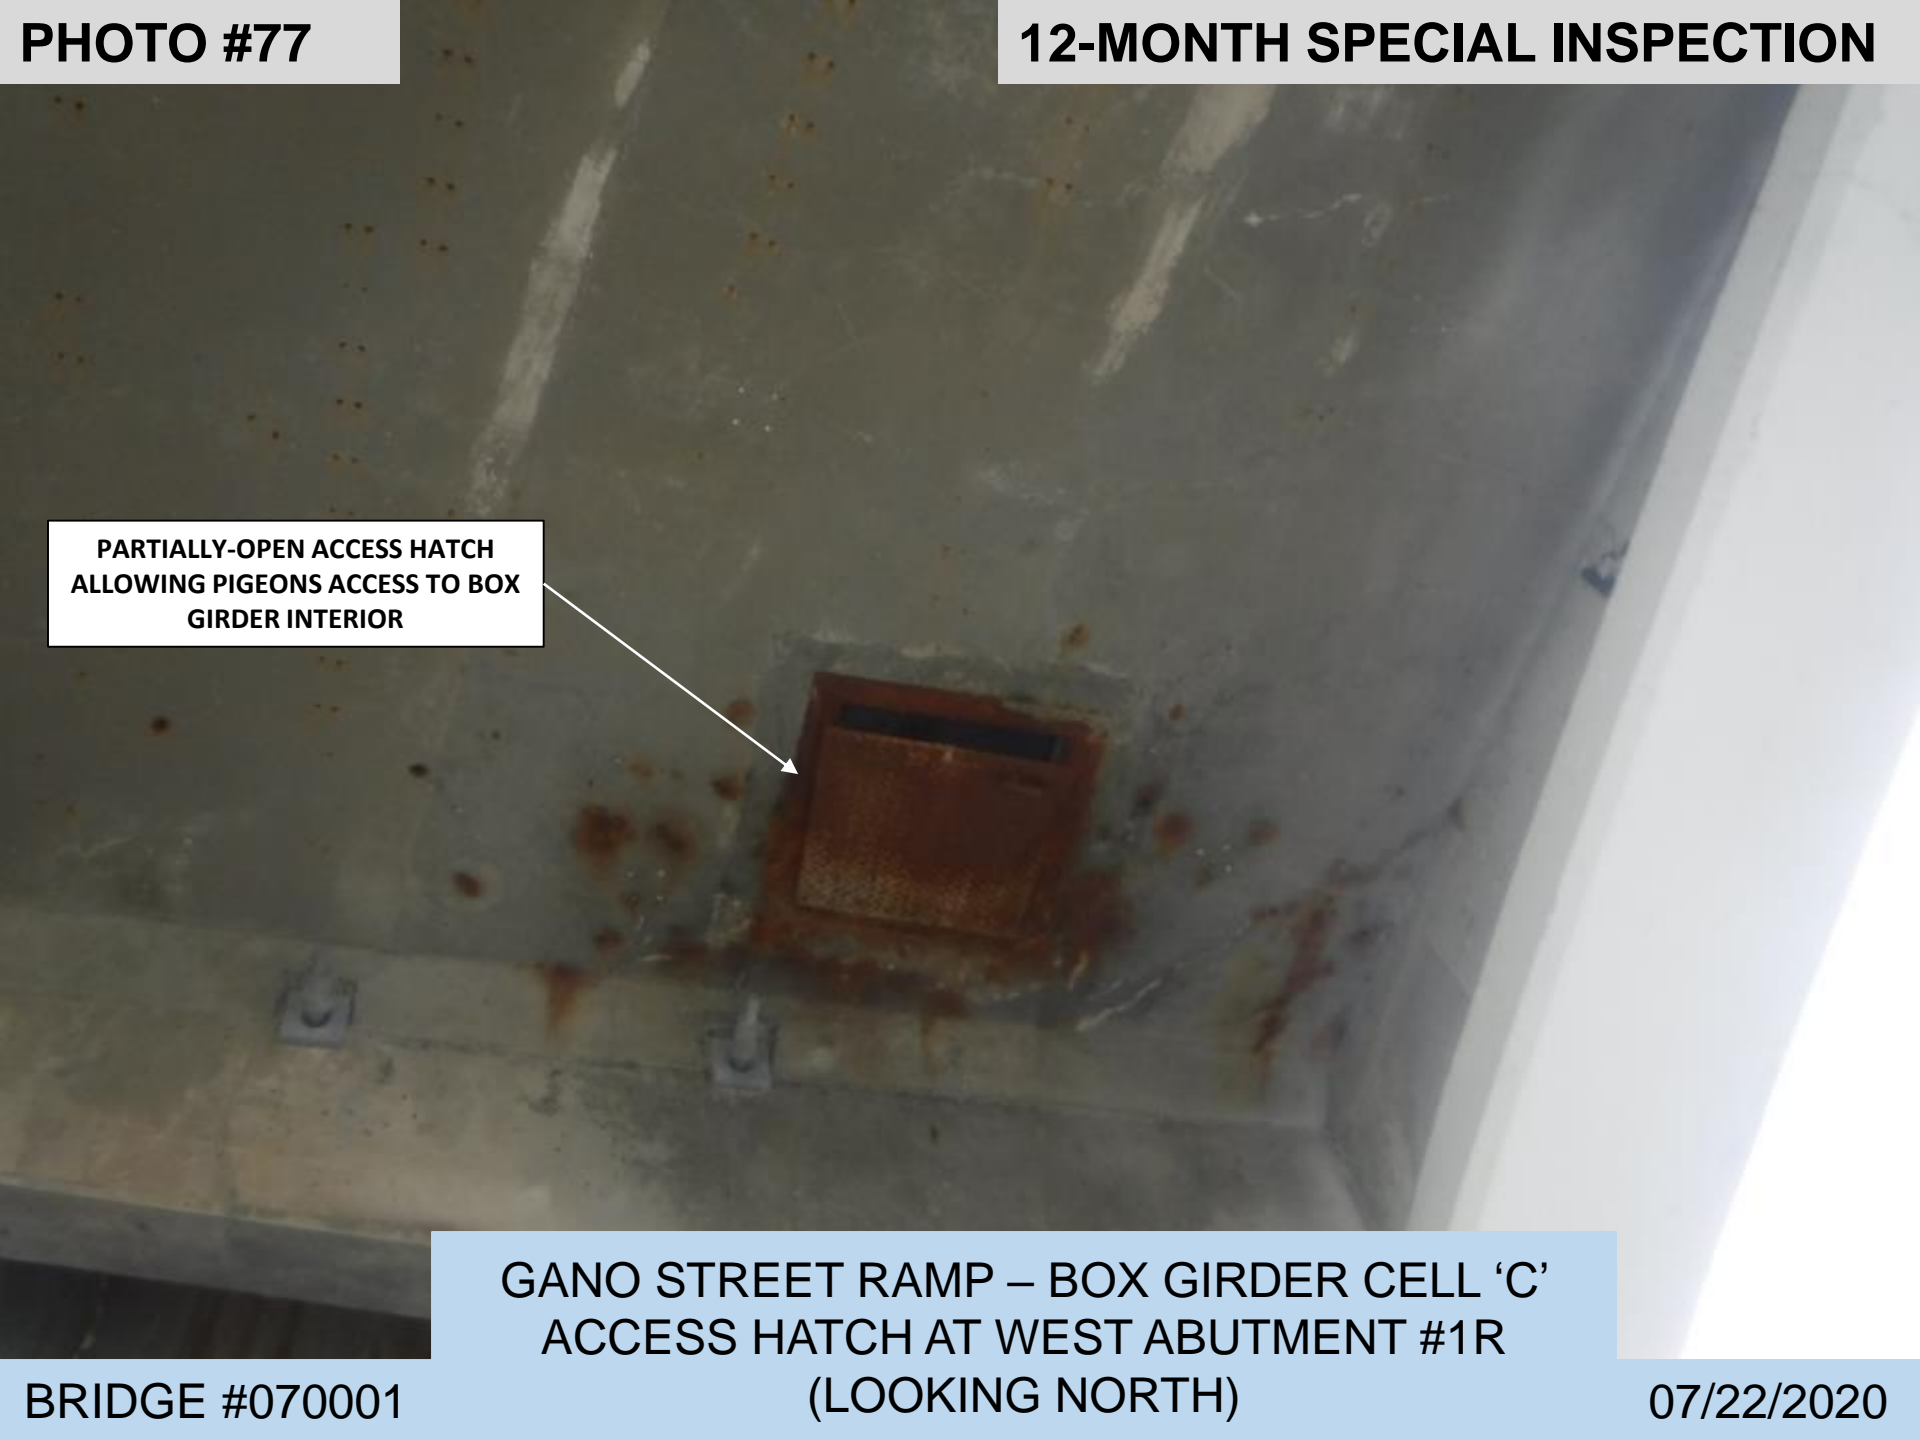
**PARTIALLY-OPEN ACCESS HATCH
ALLOWING PIGEONS ACCESS TO BOX
GIRDER INTERIOR**

**GANO STREET RAMP – BOX GIRDER CELL ‘C’
ACCESS HATCH AT WEST ABUTMENT #1R
(LOOKING NORTH)**

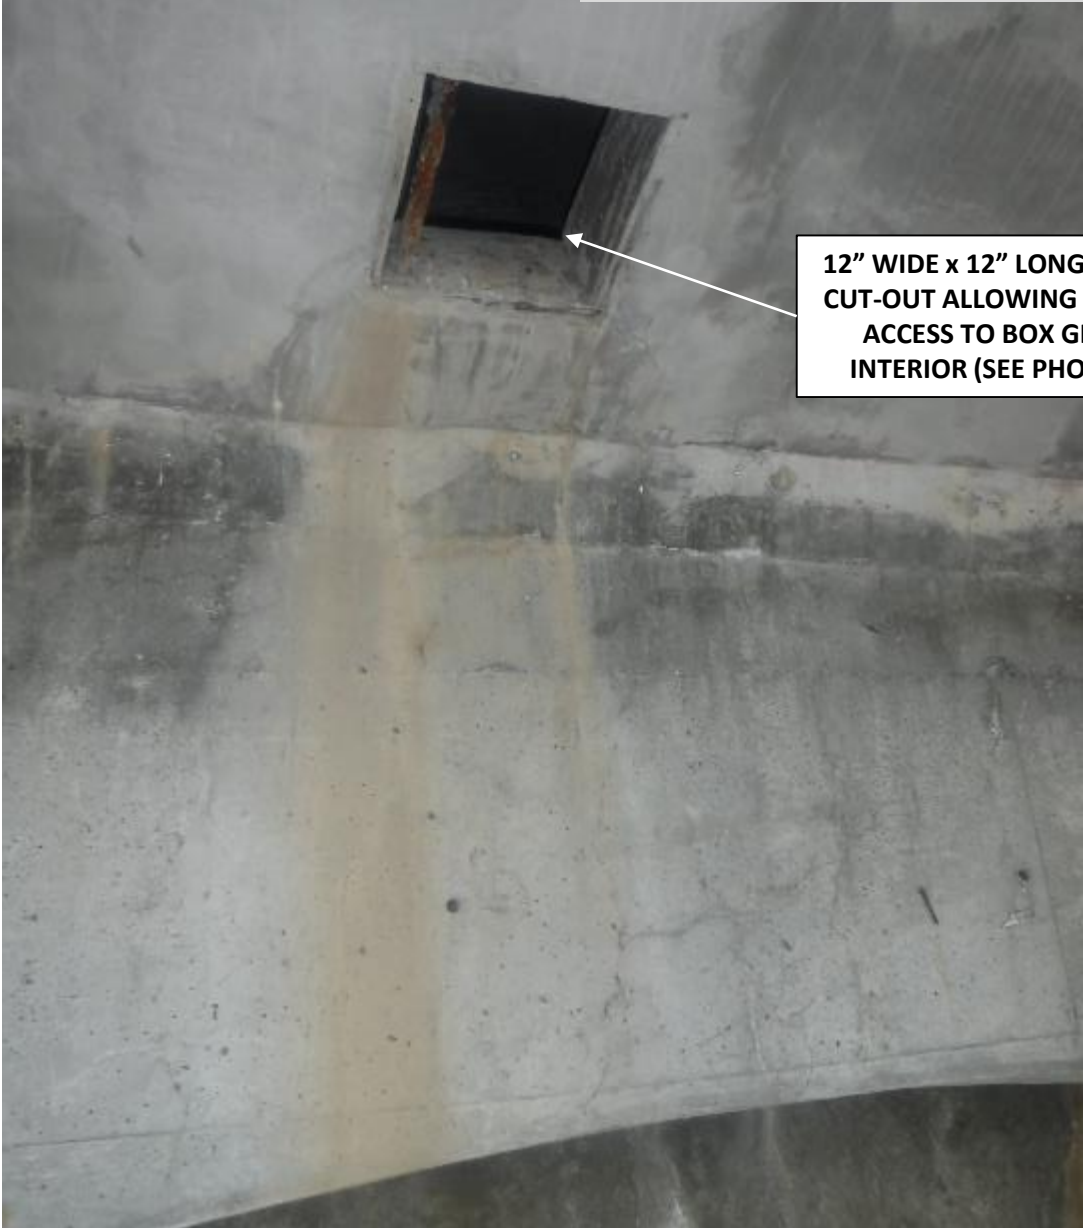
**BOX GIRDER EXTERIOR – UNDERSIDE
AT NORTH END NEAR PIER #2R IN SPAN #2R**

**12" WIDE x 12" LONG SQUARE
CUT-OUT ALLOWING PIGEONS
ACCESS TO BOX GIRDER
INTERIOR (SEE PHOTO 92)**

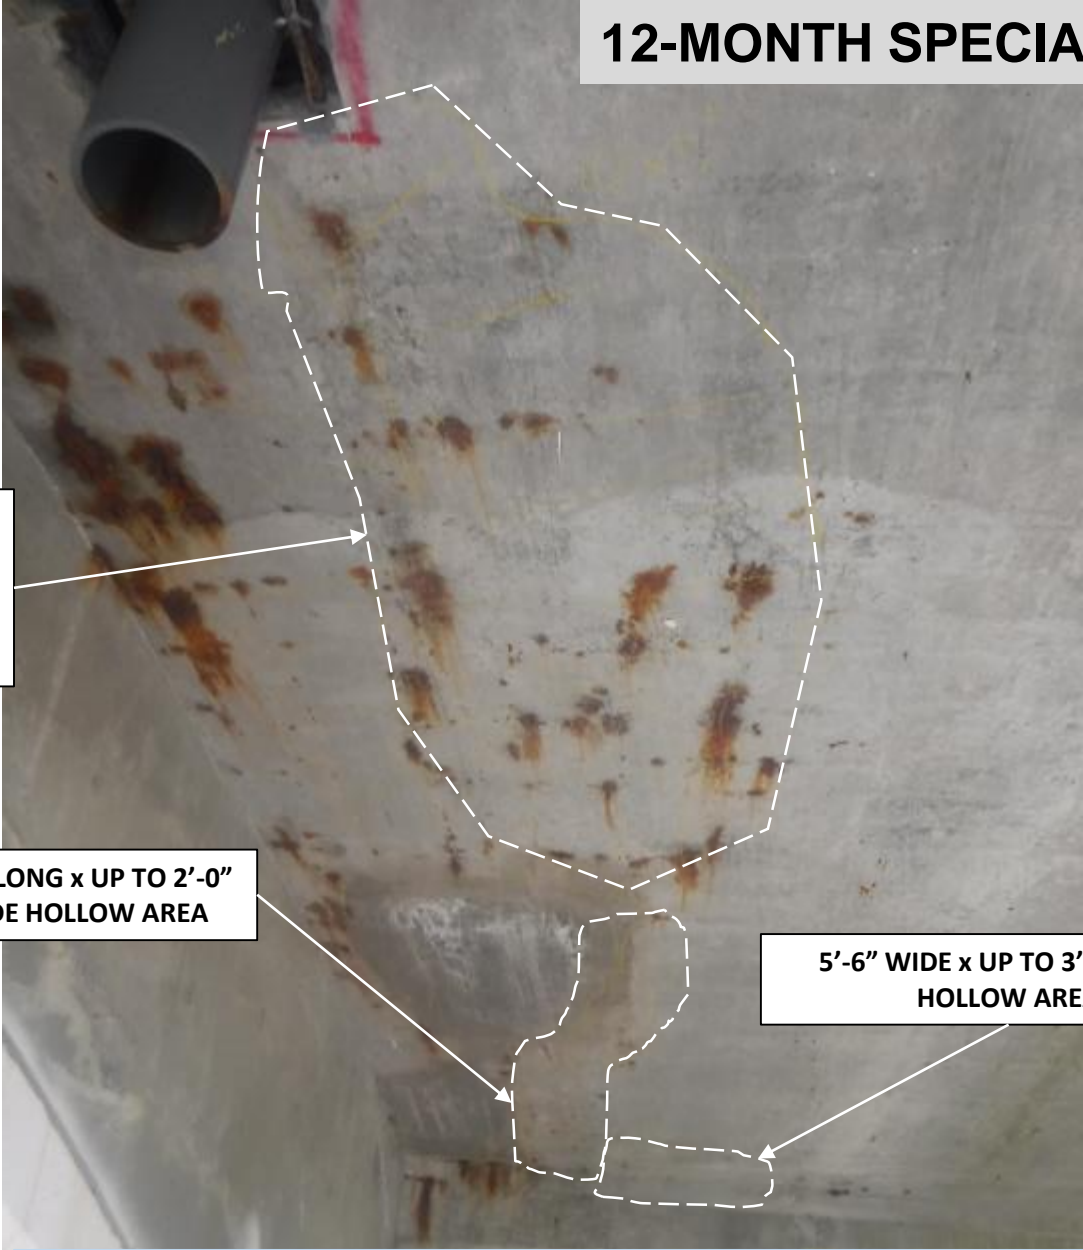
BRIDGE #070001 BOX GIRDER EXTERIOR – UNDERSIDE OF CELL 'B' AT PIER #2R IN SPAN #3R (LOOKING NORTH) 07/22/2020

**10'-0" LONG x 5'-0" WIDE
HOLLOW AREA WITHIN 6'-0"
WIDE x 15'-0" LONG AREA OF
HAIRLINE CRACKS AND RUST
STAINING**

**8'-0" LONG x UP TO 2'-0"
WIDE HOLLOW AREA**

**5'-6" WIDE x UP TO 3'-0" LONG
HOLLOW AREA**

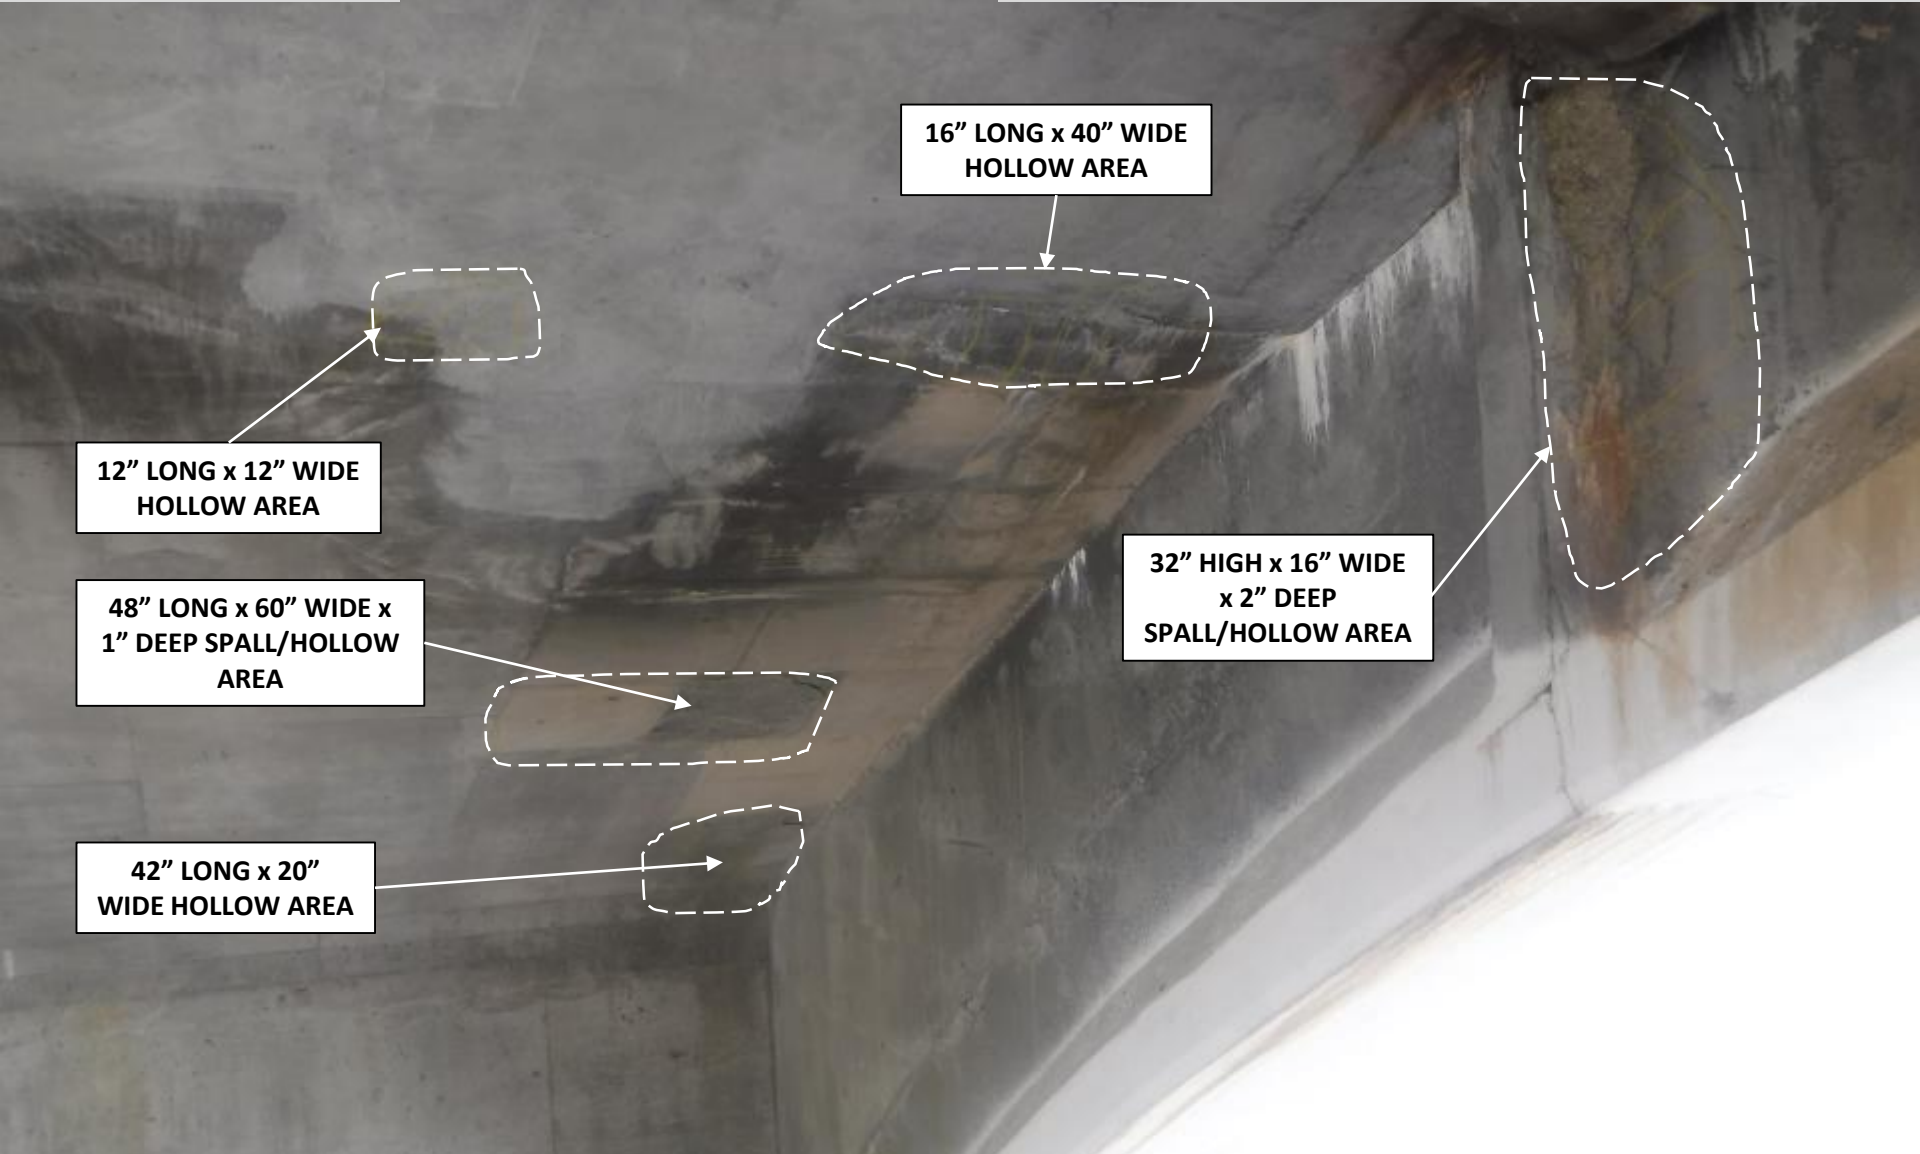
**BOX GIRDER EXTERIOR – UNDERSIDE
NORTHEAST CORNER AT PIER #3R IN SPAN #3R**

**12" LONG x 12" WIDE
HOLLOW AREA**

**16" LONG x 40" WIDE
HOLLOW AREA**

**48" LONG x 60" WIDE x
1" DEEP SPALL/HOLLOW
AREA**

**32" HIGH x 16" WIDE
x 2" DEEP
SPALL/HOLLOW AREA**

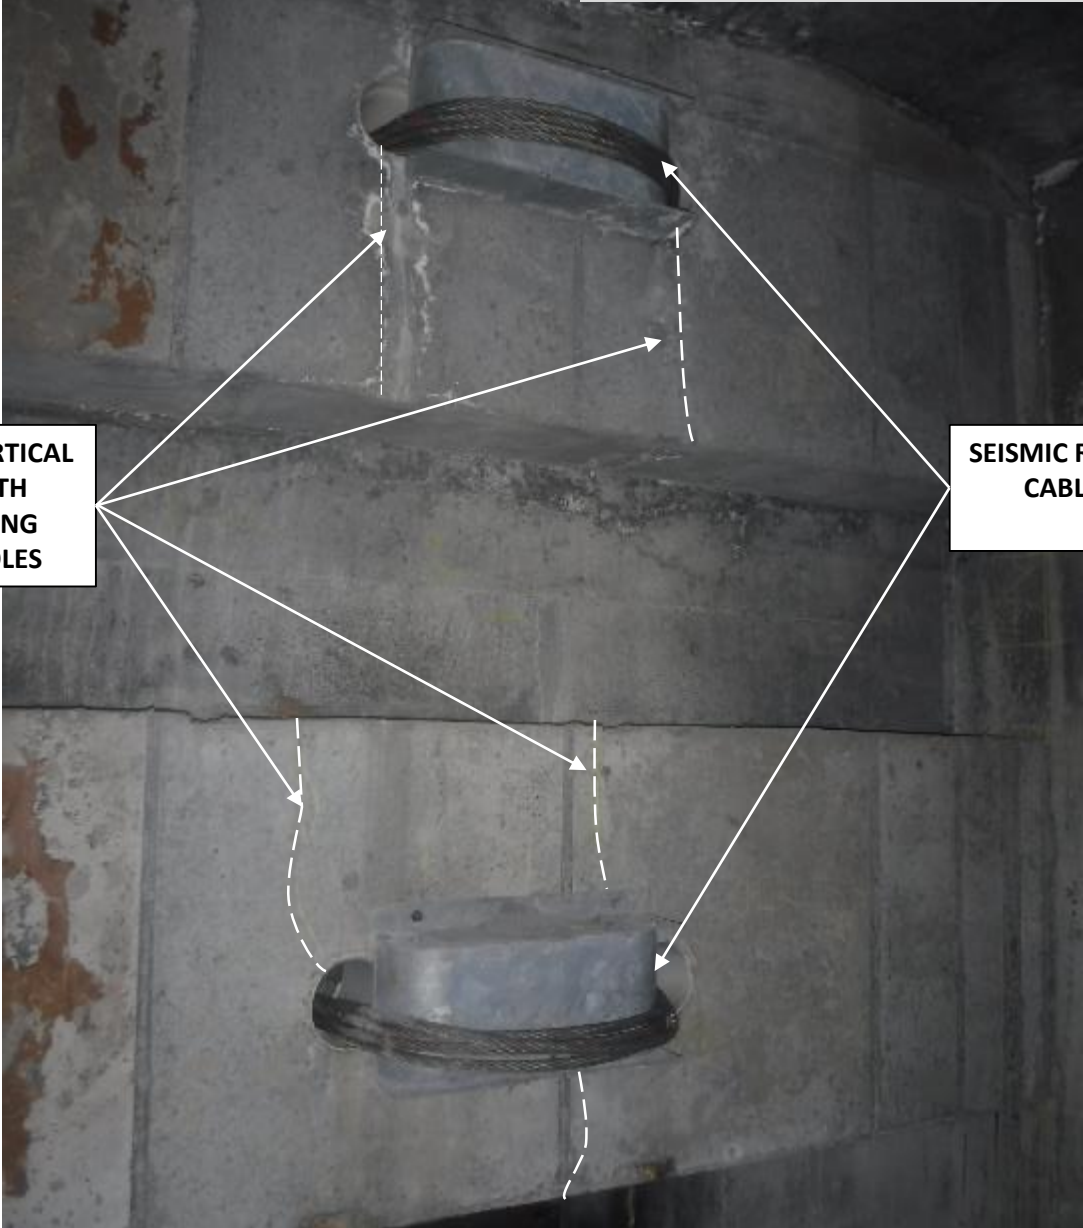
**SEISMIC RESTRAINER ASSEMBLY AND
CABLES RUSTED WITH LIGHT
CORROSION (SEE PHOTO #88)**

**(4) UP TO 3'-0" LONG VERTICAL
HAIRLINE CRACKS WITH
EFFLORESCENCE COMING
FROM RESTRAINER HOLES**

**SEISMIC RESTRAINER ASSEMBLY AND
CABLES RUSTED WITH LIGHT
CORROSION**

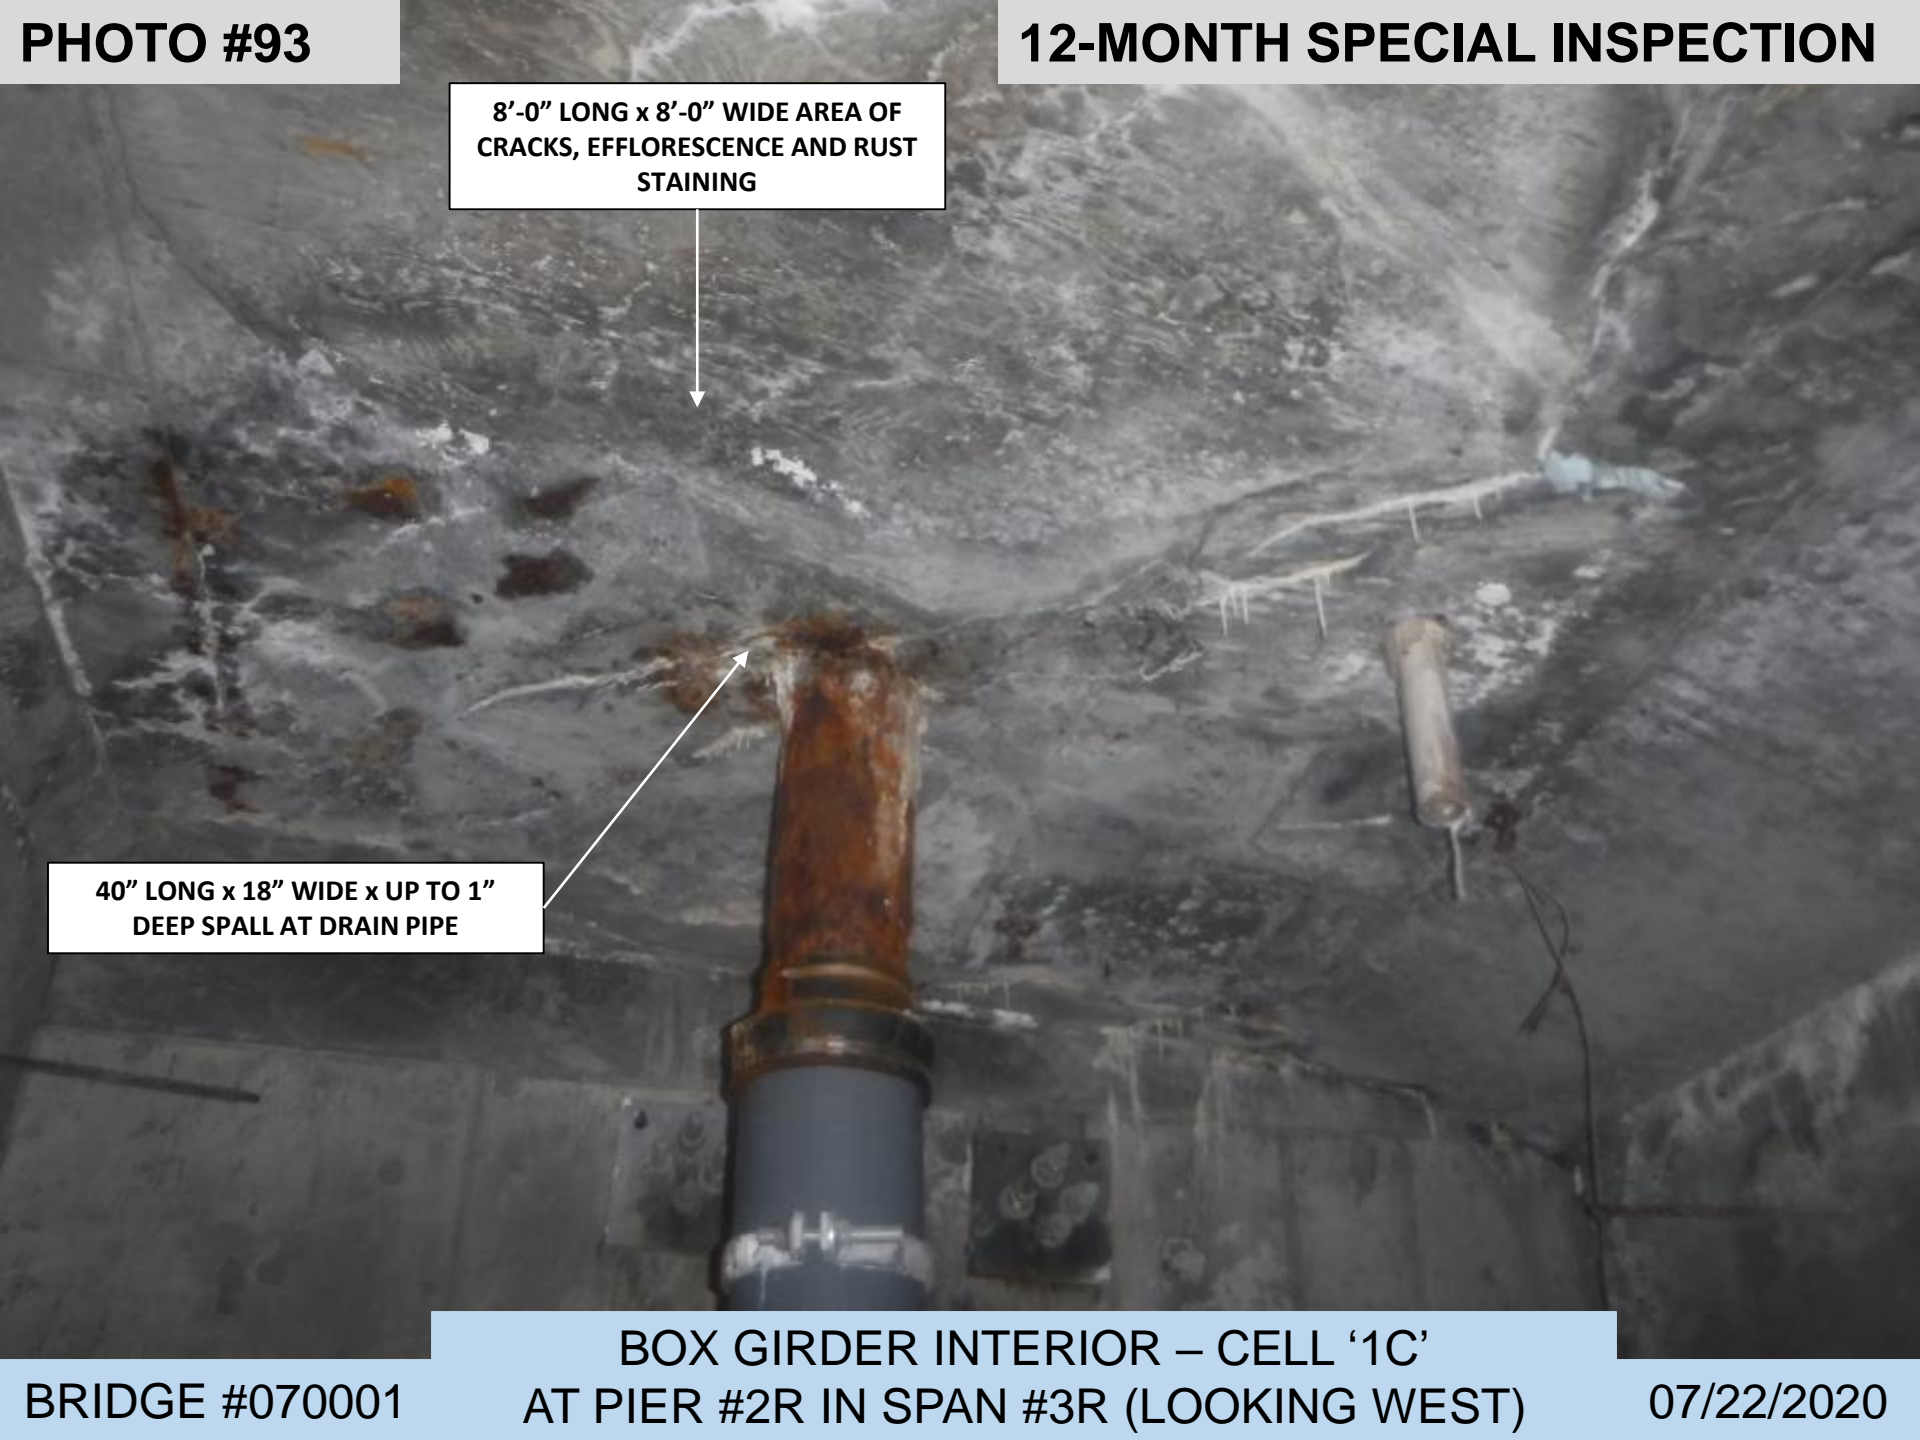
**8'-0" LONG x 8'-0" WIDE AREA OF
CRACKS, EFFLORESCENCE AND RUST
STAINING**

**40" LONG x 18" WIDE x UP TO 1"
DEEP SPALL AT DRAIN PIPE**

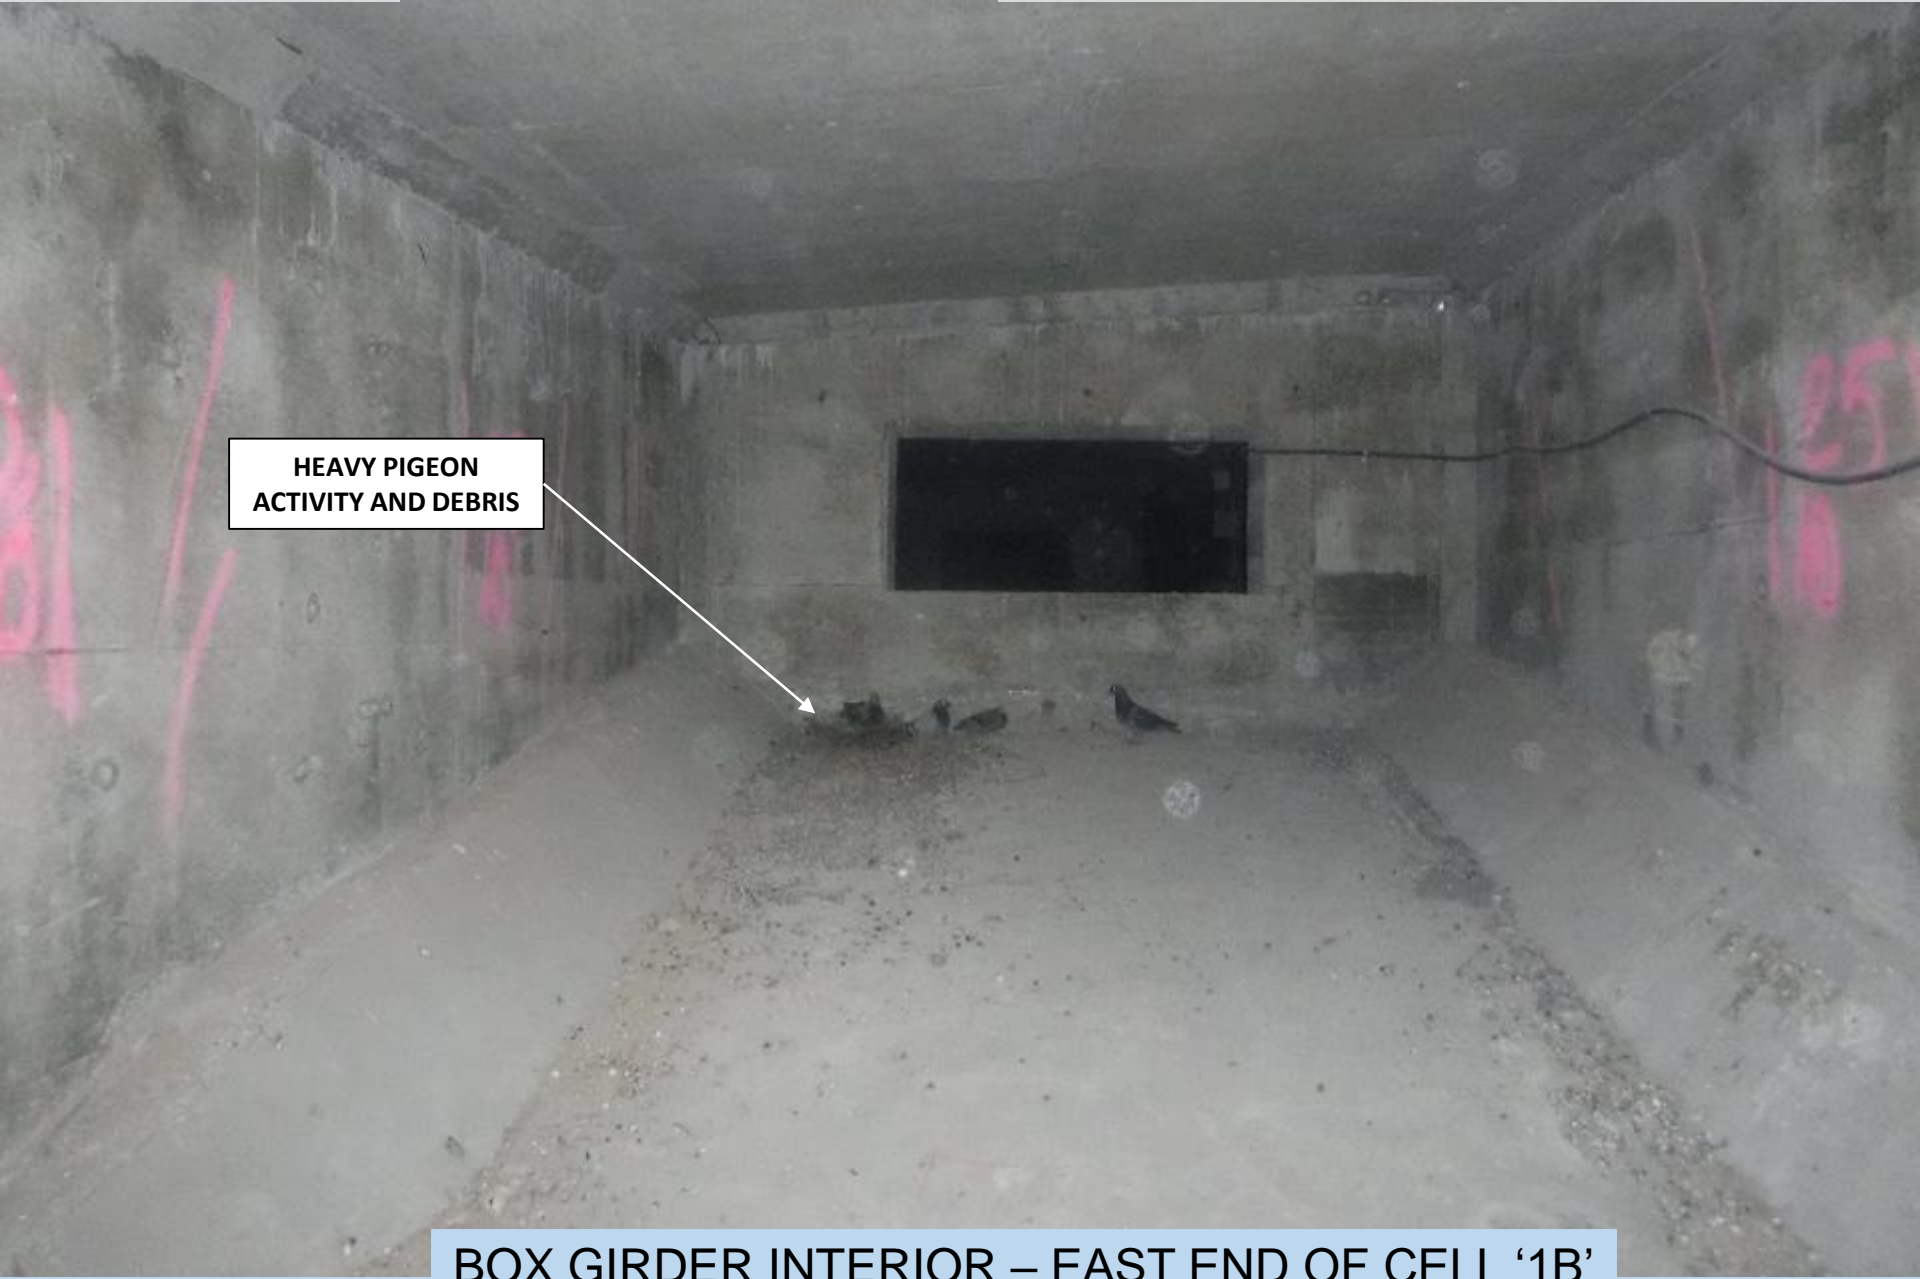
BOX GIRDER INTERIOR – EAST END OF CELL ‘1B’

**3'-0" LONG x FULL WIDTH x 4" DEEP
AREA OF PONDING WATER**

**HEAVY PIGEON
ACTIVITY AND DEBRIS**

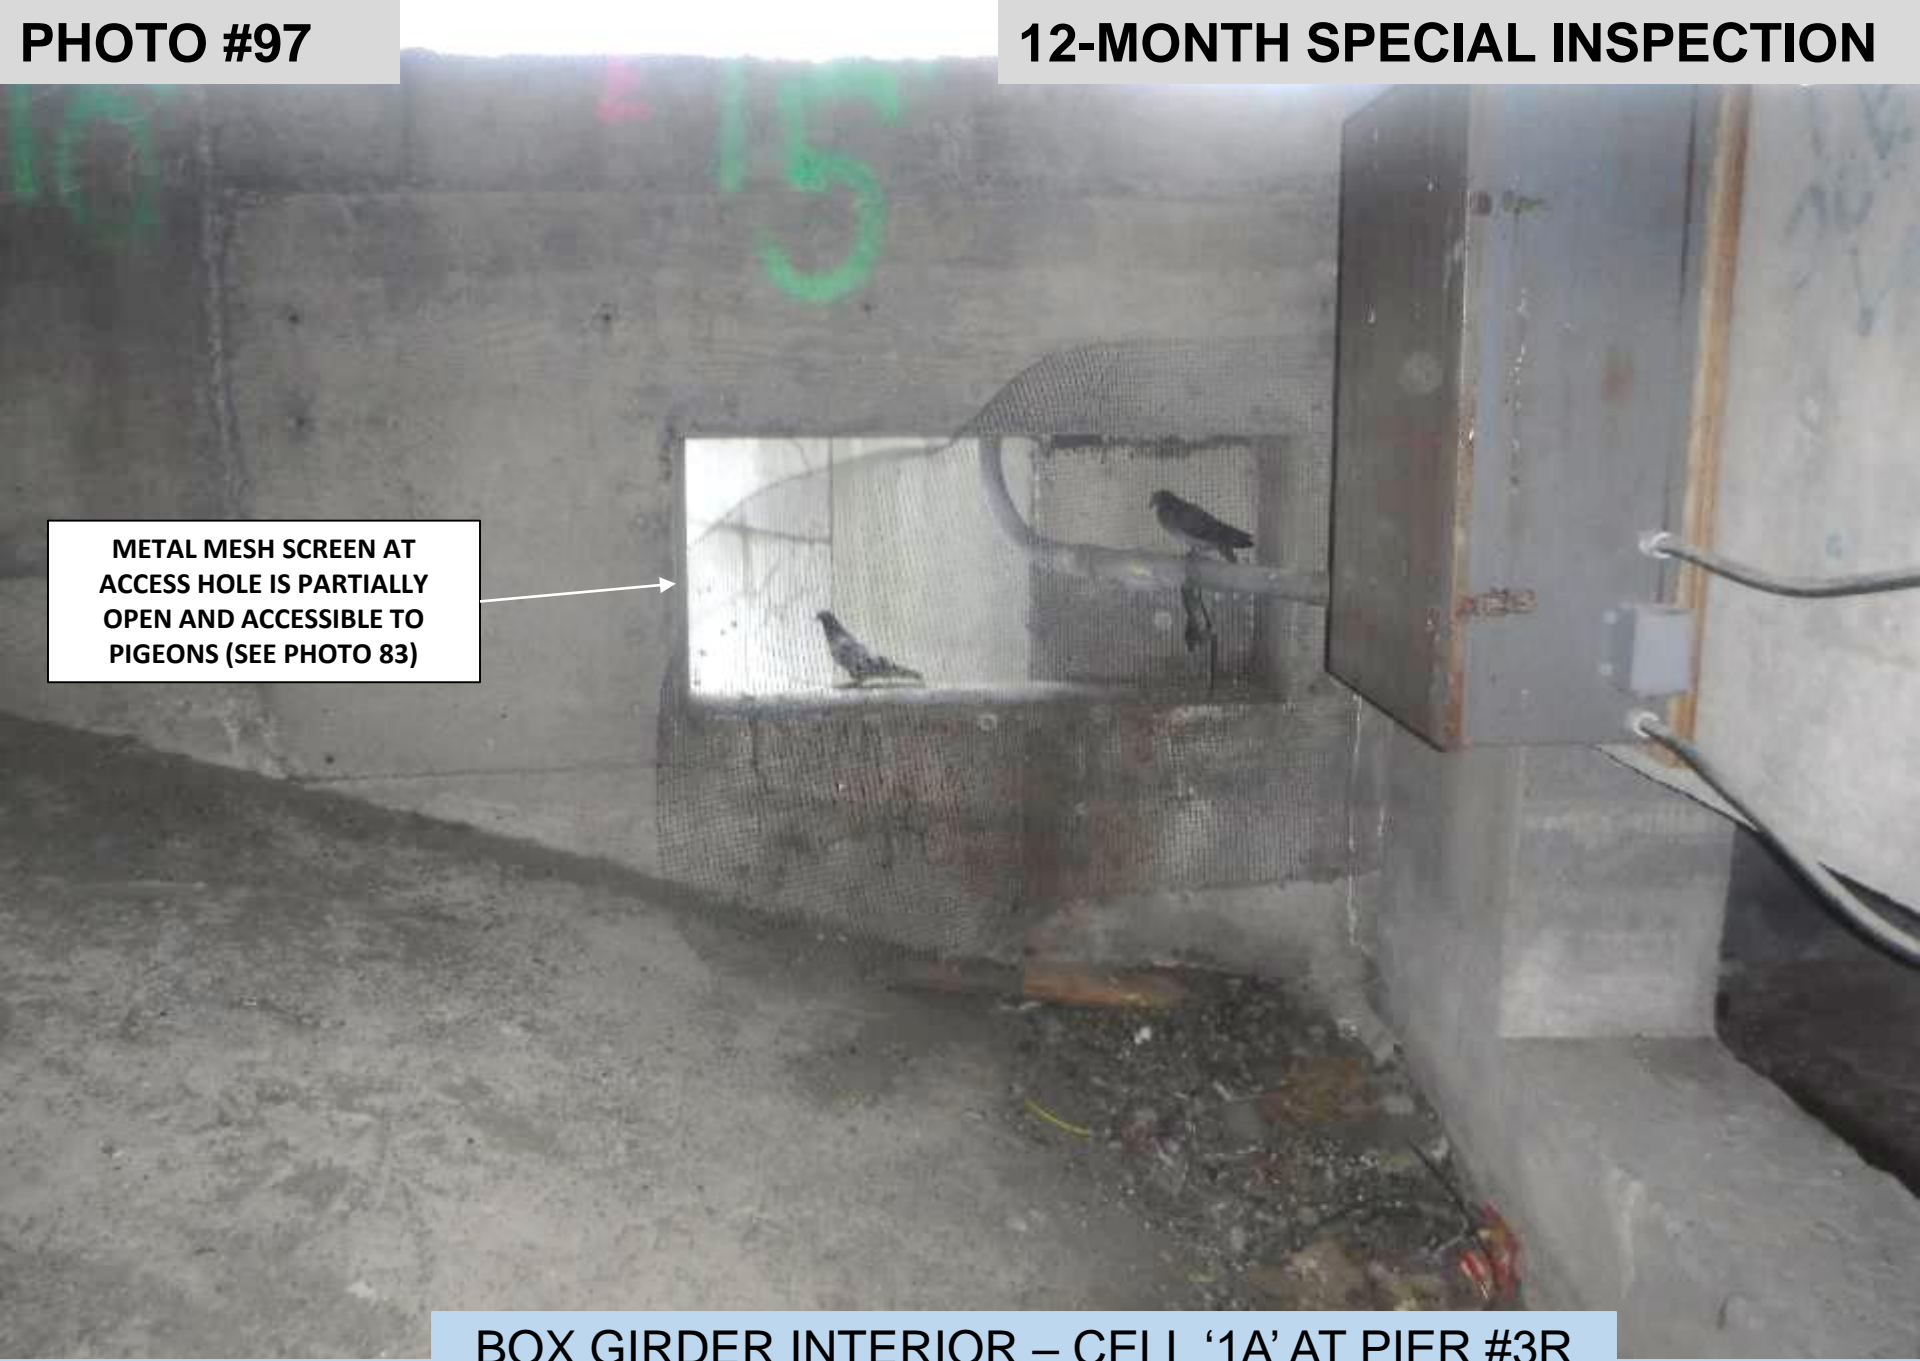
**3'-0" LONG x 1'-0" WIDE HOLLOW
AREA WITHIN AN 8'-0" LONG x 8'-0"
WIDE AREA OF CRACKS,
EFFLORESCENCE, AND RUST
STAINING**

**METAL MESH SCREEN AT
ACCESS HOLE IS PARTIALLY
OPEN AND ACCESSIBLE TO
PIGEONS (SEE PHOTO 83)**
