12-MONTH SPECIAL INSPECTION

BRIDGE #070001

07/22/2020

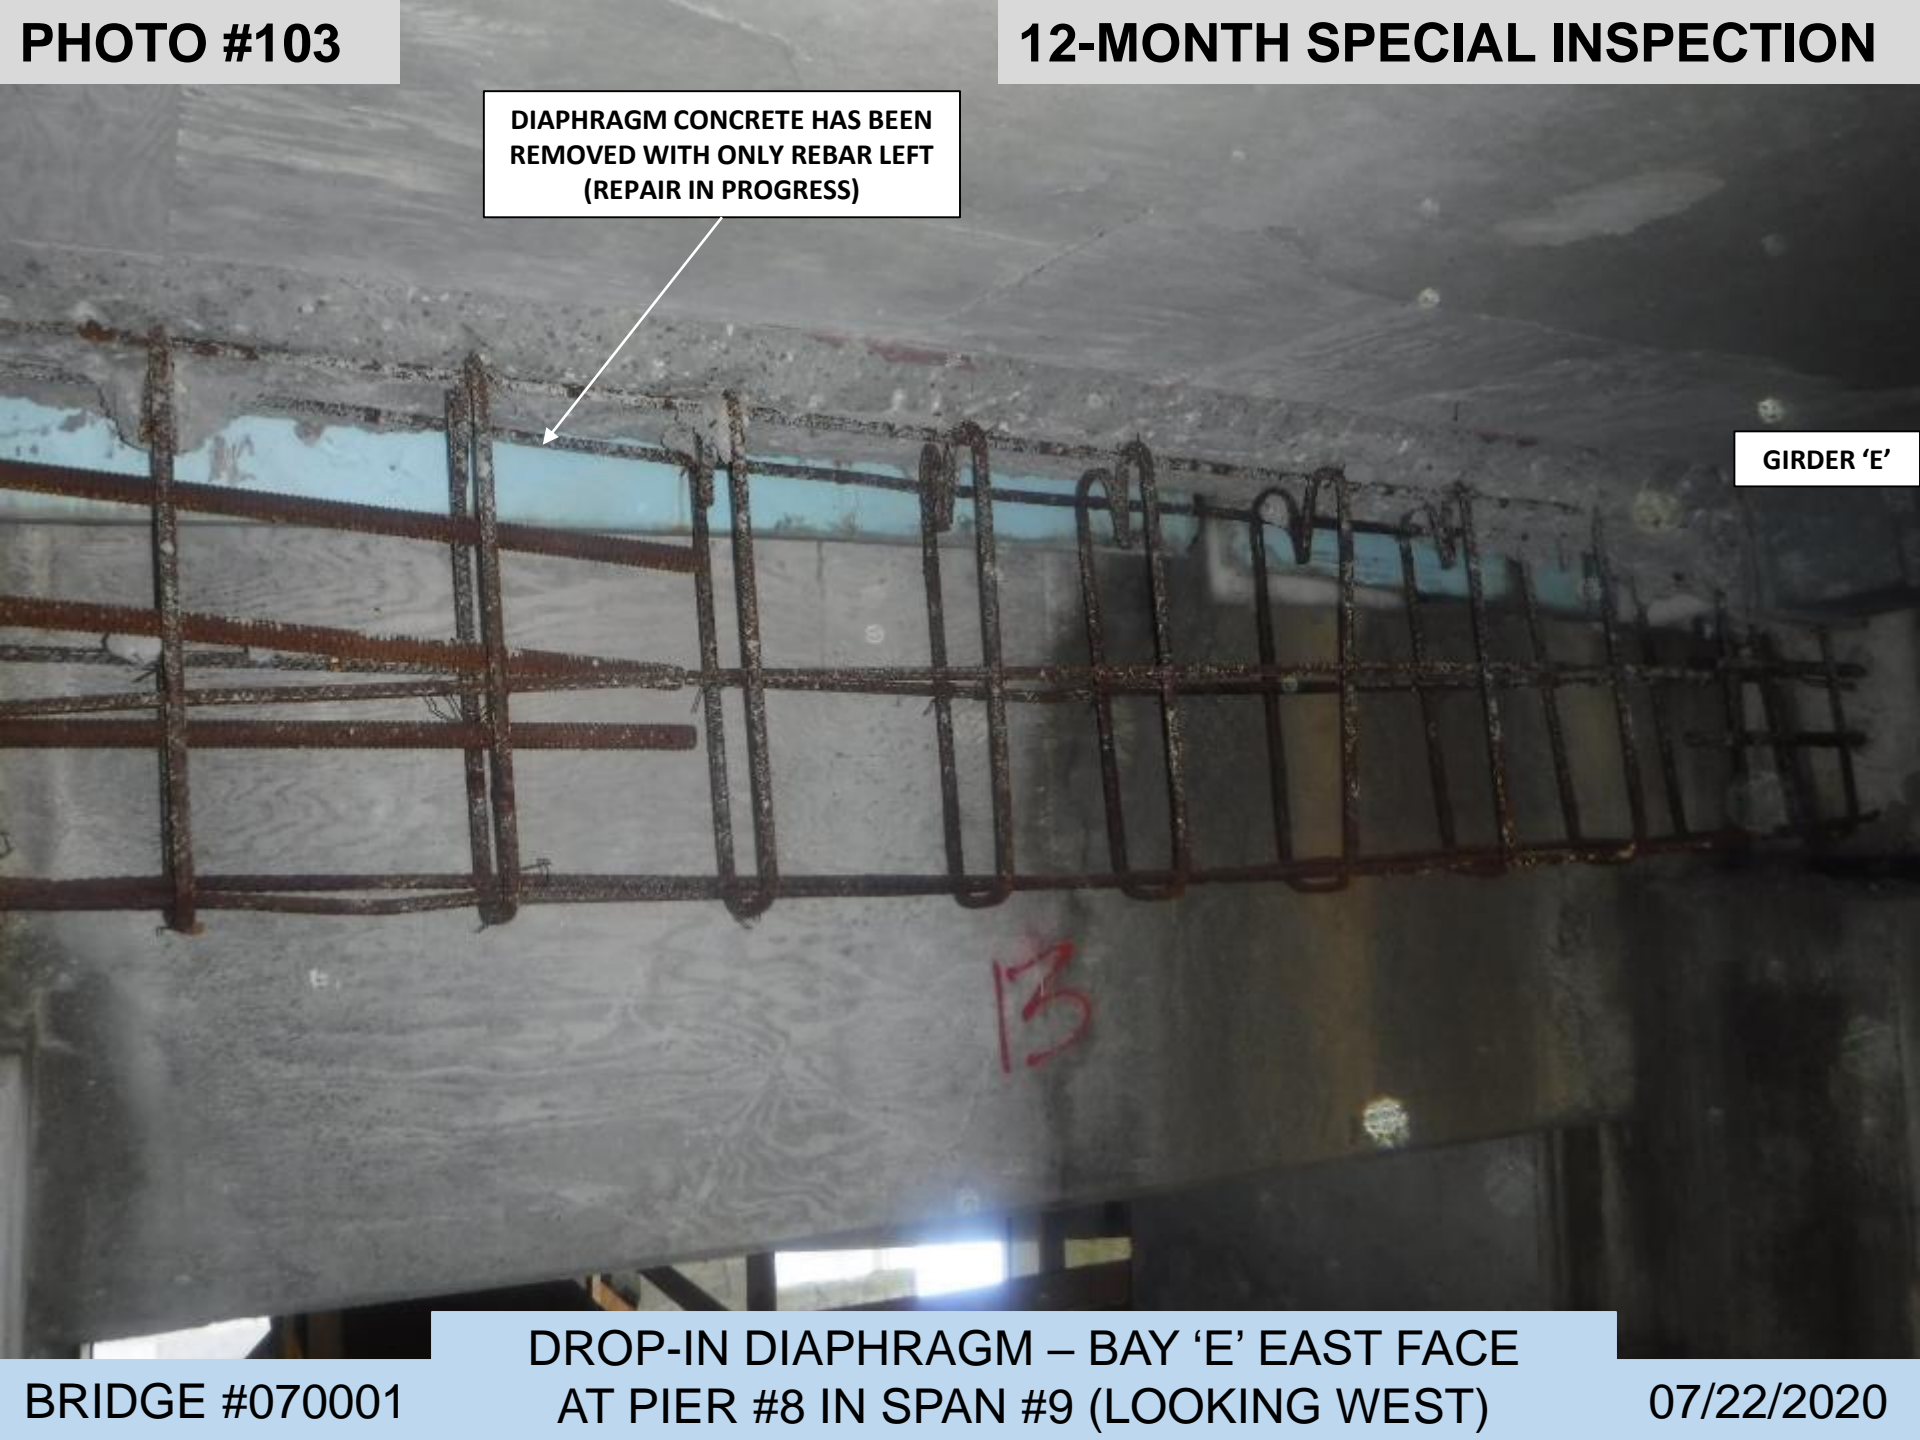
**6-1/2' LONG x UP TO 18"
HIGH x 4" DEEP
SPALL/HOLLOW AREA**

**16" LONG x FULL
WIDTH x 4" DEEP
SPALL (UNDERSIDE)**

**DIAPHRAGM CONCRETE HAS BEEN
REMOVED WITH ONLY REBAR LEFT
(REPAIR IN PROGRESS)**

**DROP-IN DIAPHRAGM – BAY 'E' EAST FACE
AT PIER #8 IN SPAN #9 (LOOKING WEST)**

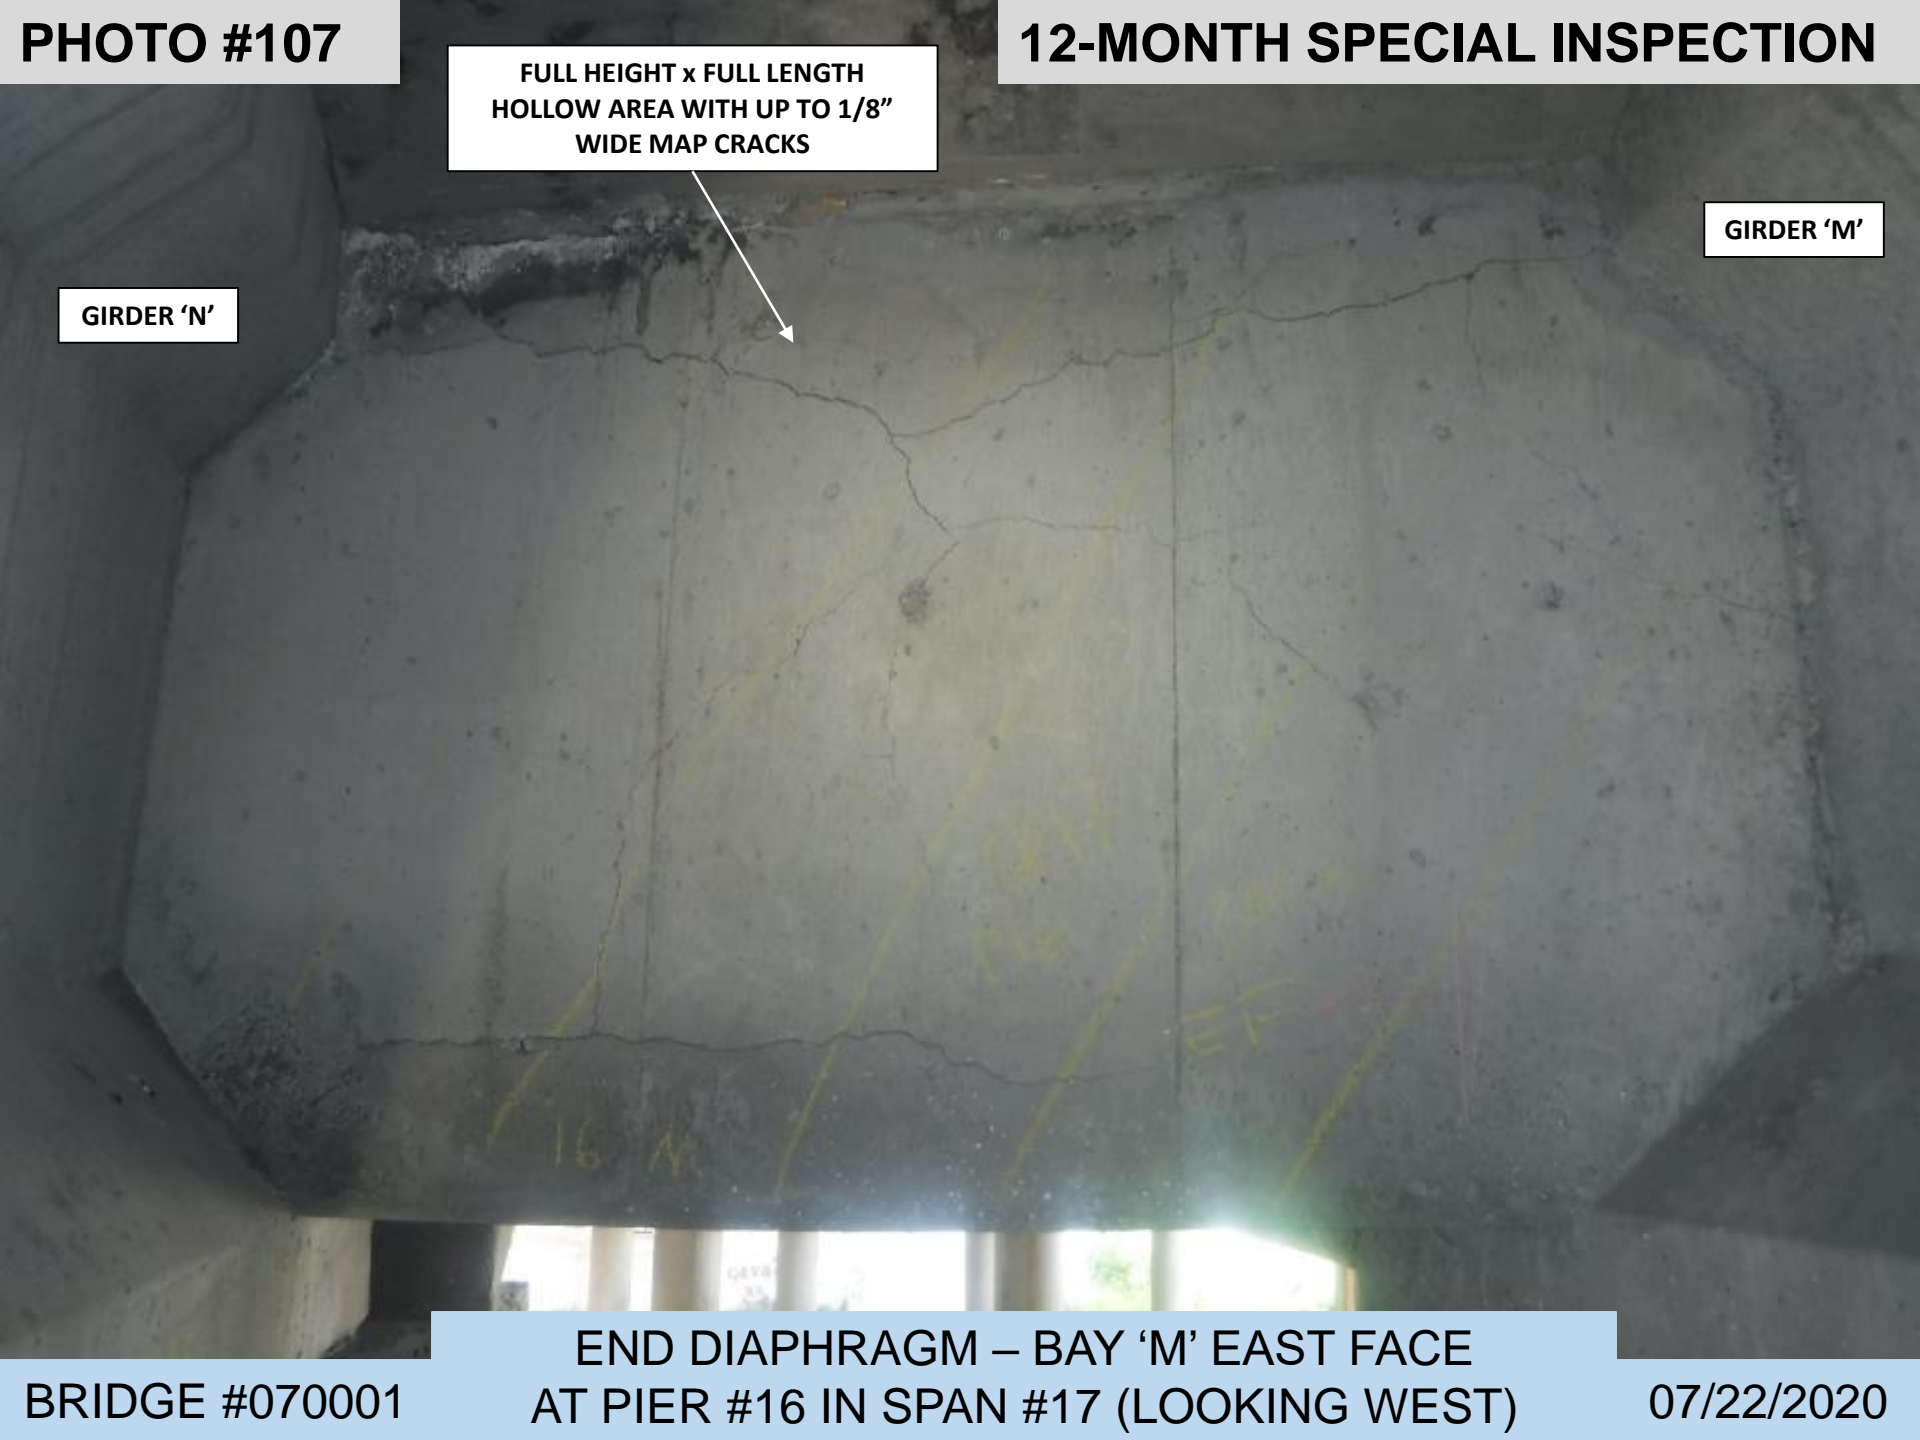
FULL HEIGHT x FULL LENGTH
HOLLOW AREA WITH UP TO 1/8"
WIDE MAP CRACKS

**END DIAPHRAGM – BAY 'M' EAST FACE
AT PIER #16 IN SPAN #17 (LOOKING WEST)**

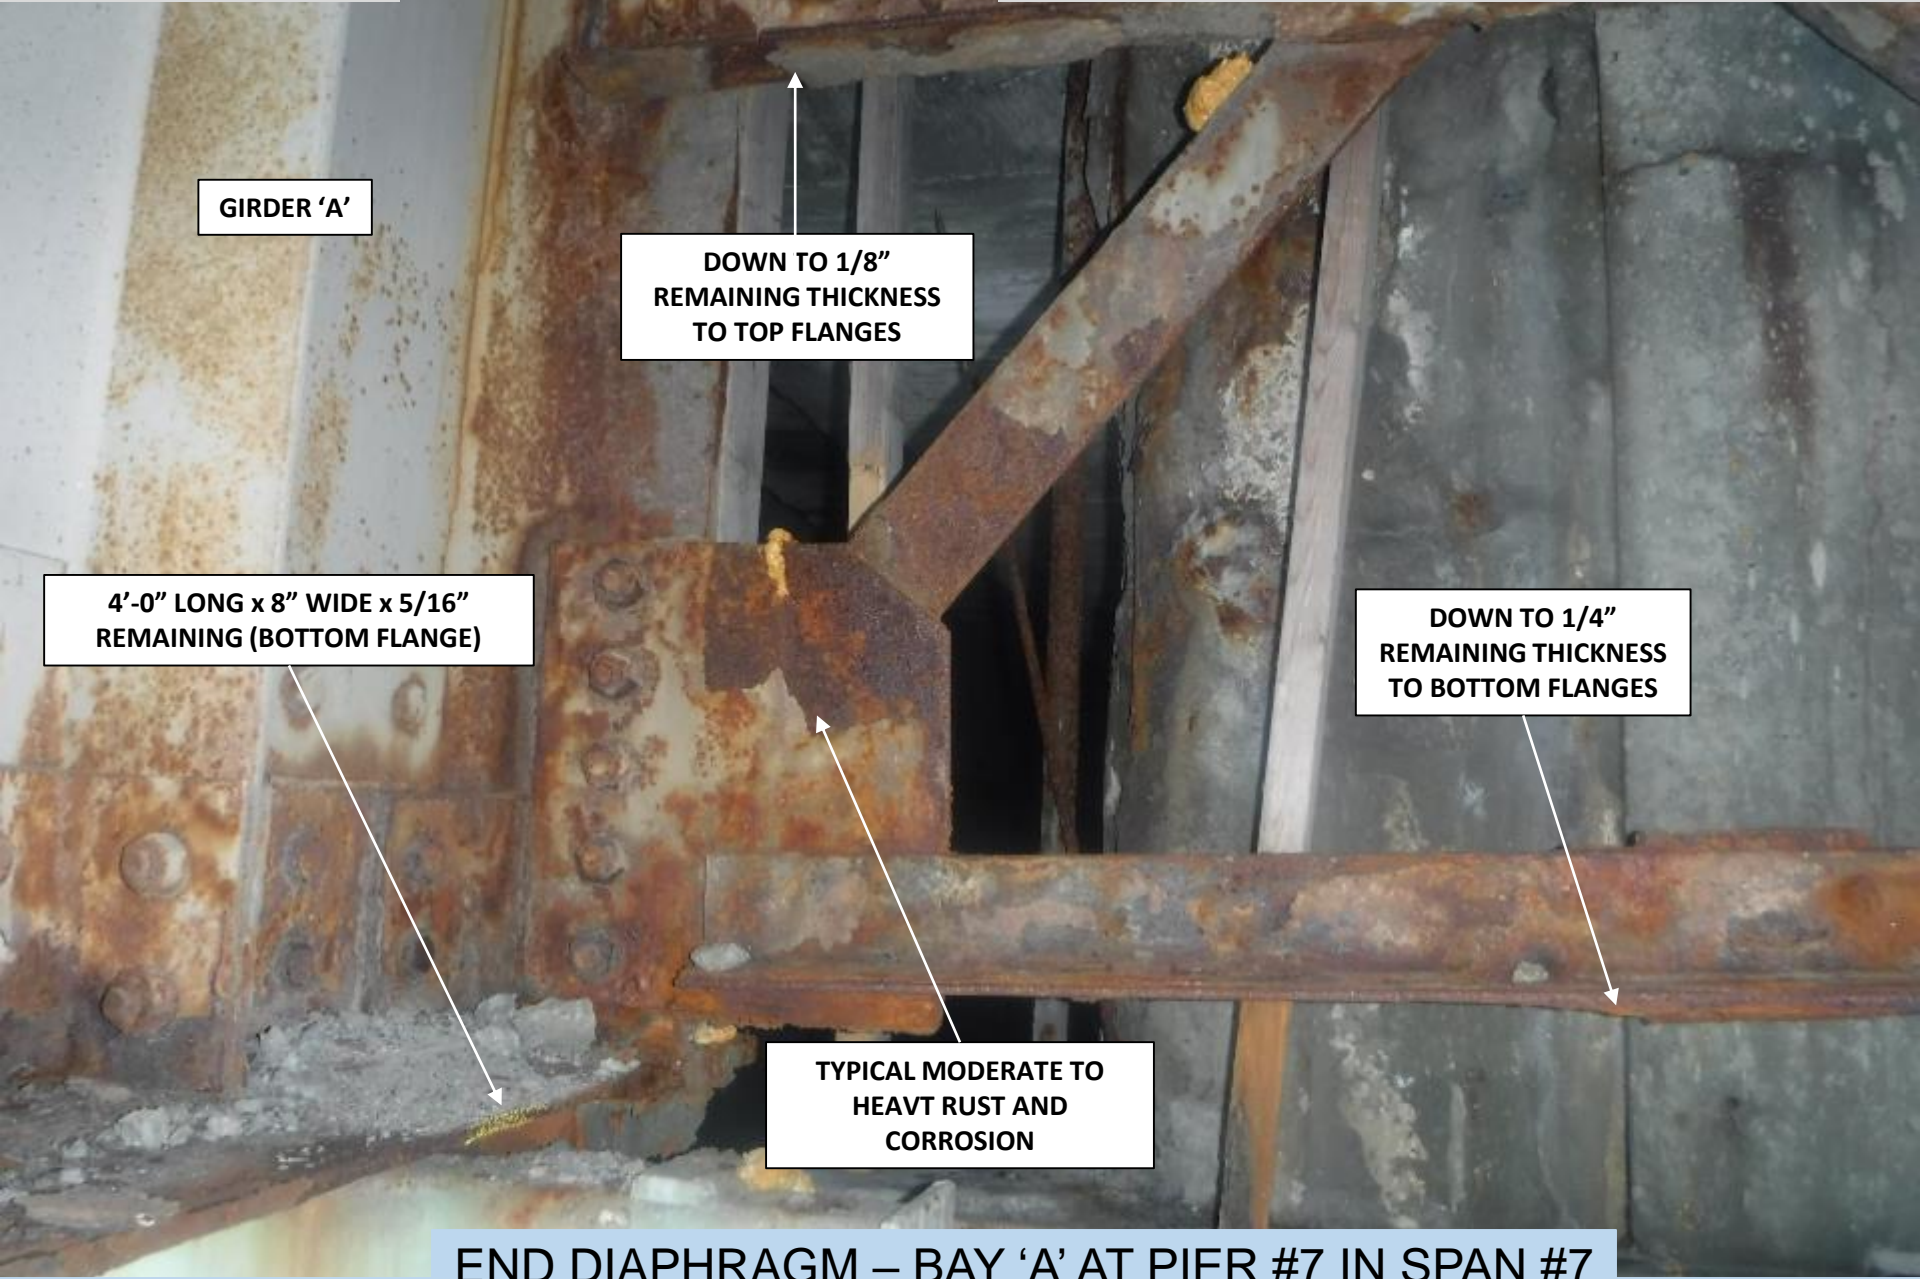
**DOWN TO 1/8"
REMAINING THICKNESS
TO TOP FLANGES**

**TYPICAL MODERATE TO
HEAVY RUST AND
CORROSION**

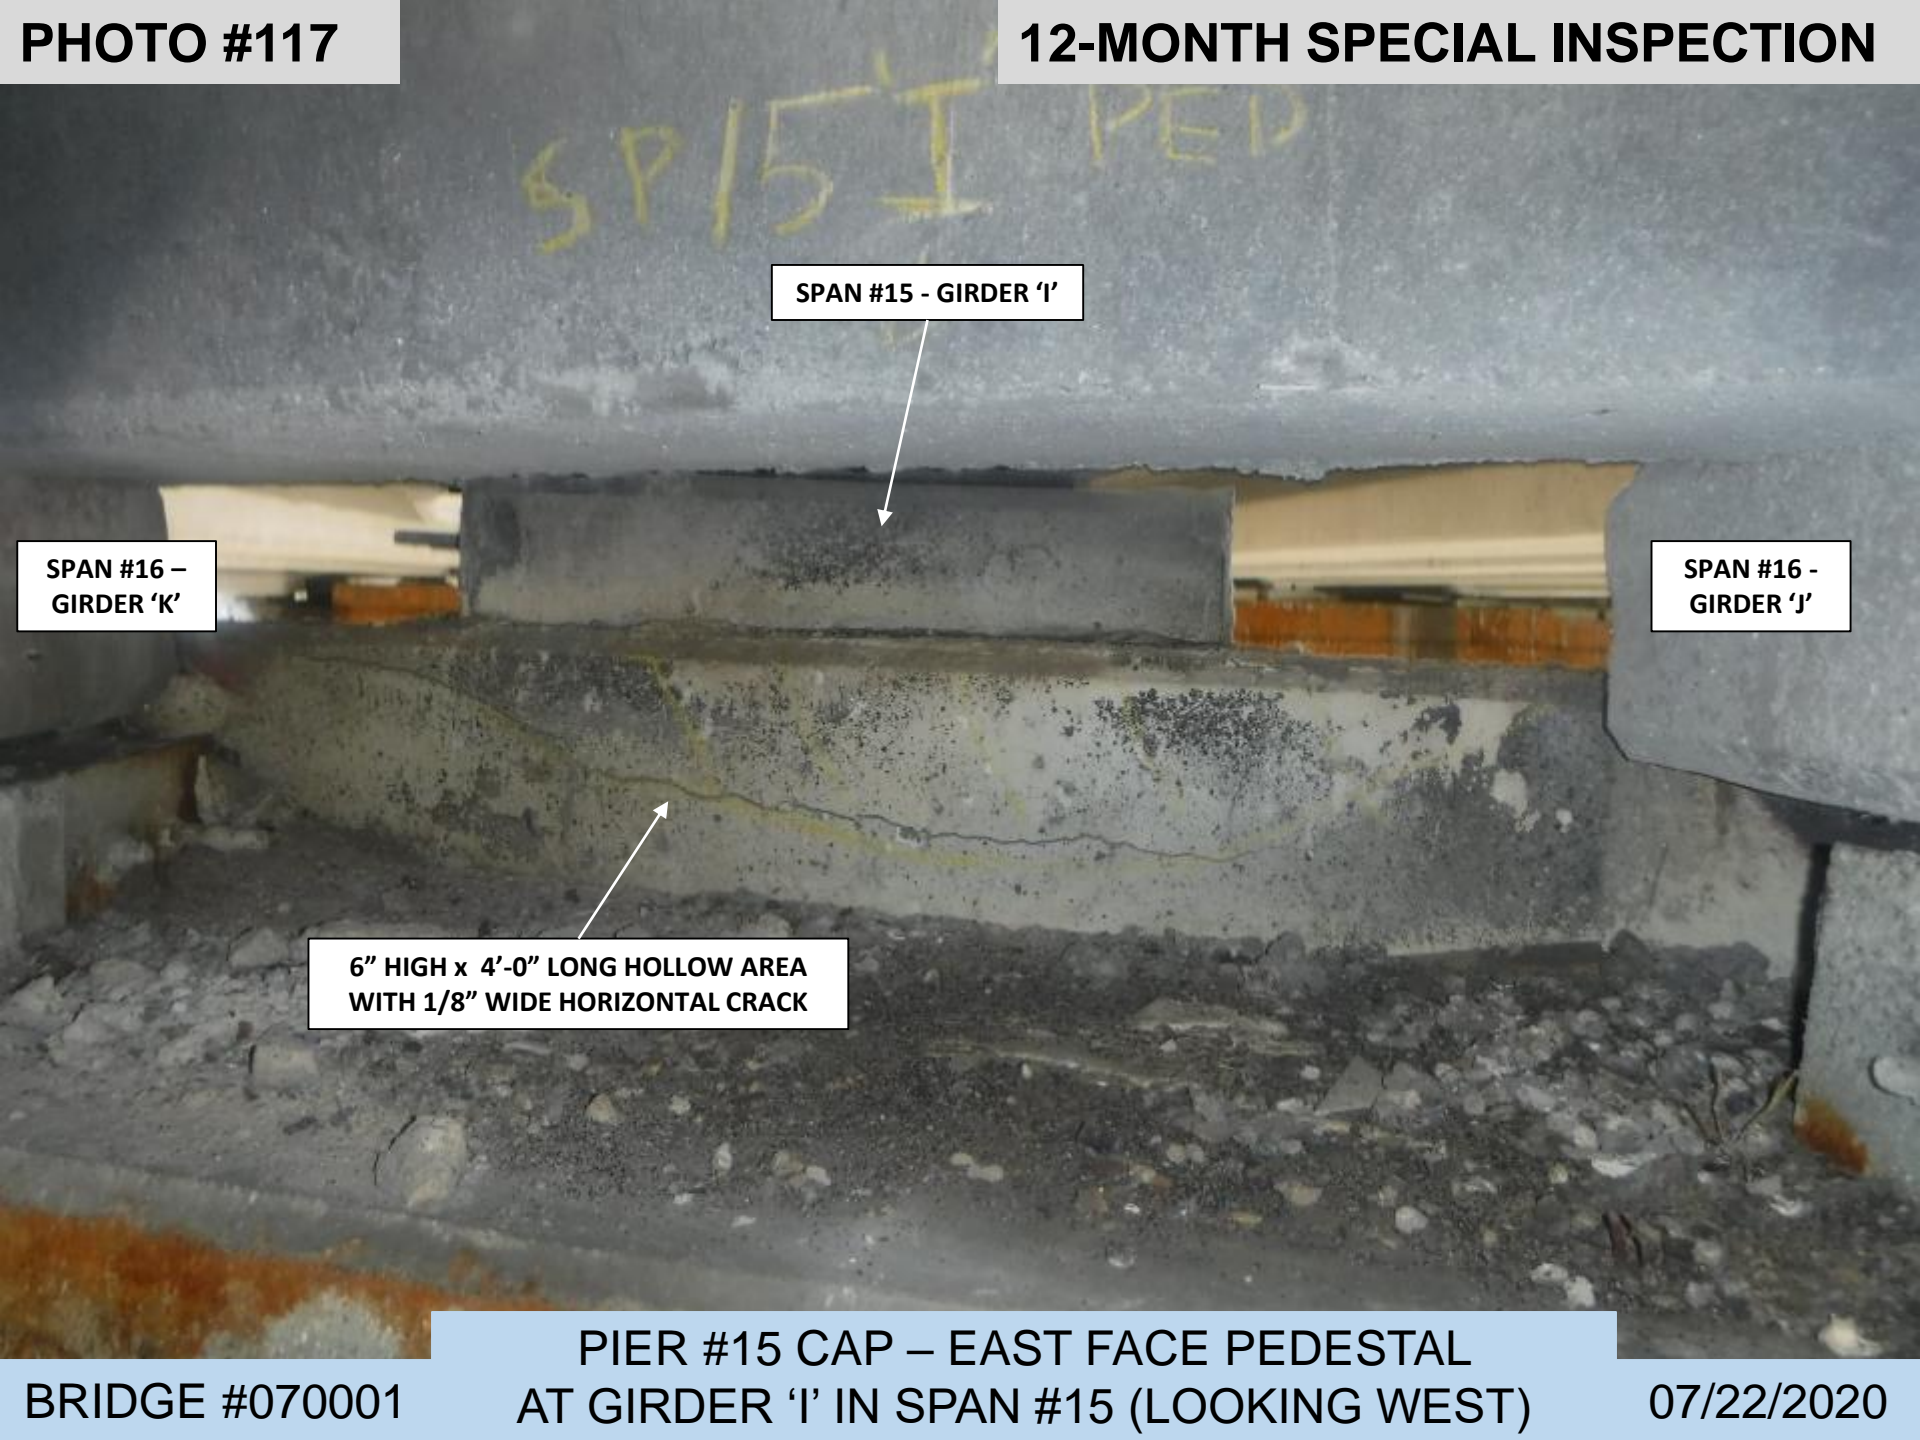
SPAN #15 - GIRDER 'I'

6" HIGH x 4'-0" LONG HOLLOW AREA WITH 1/8" WIDE HORIZONTAL CRACK

PIER #15 CAP – EAST FACE PEDESTAL AT GIRDER 'I' IN SPAN #15 (LOOKING WEST)

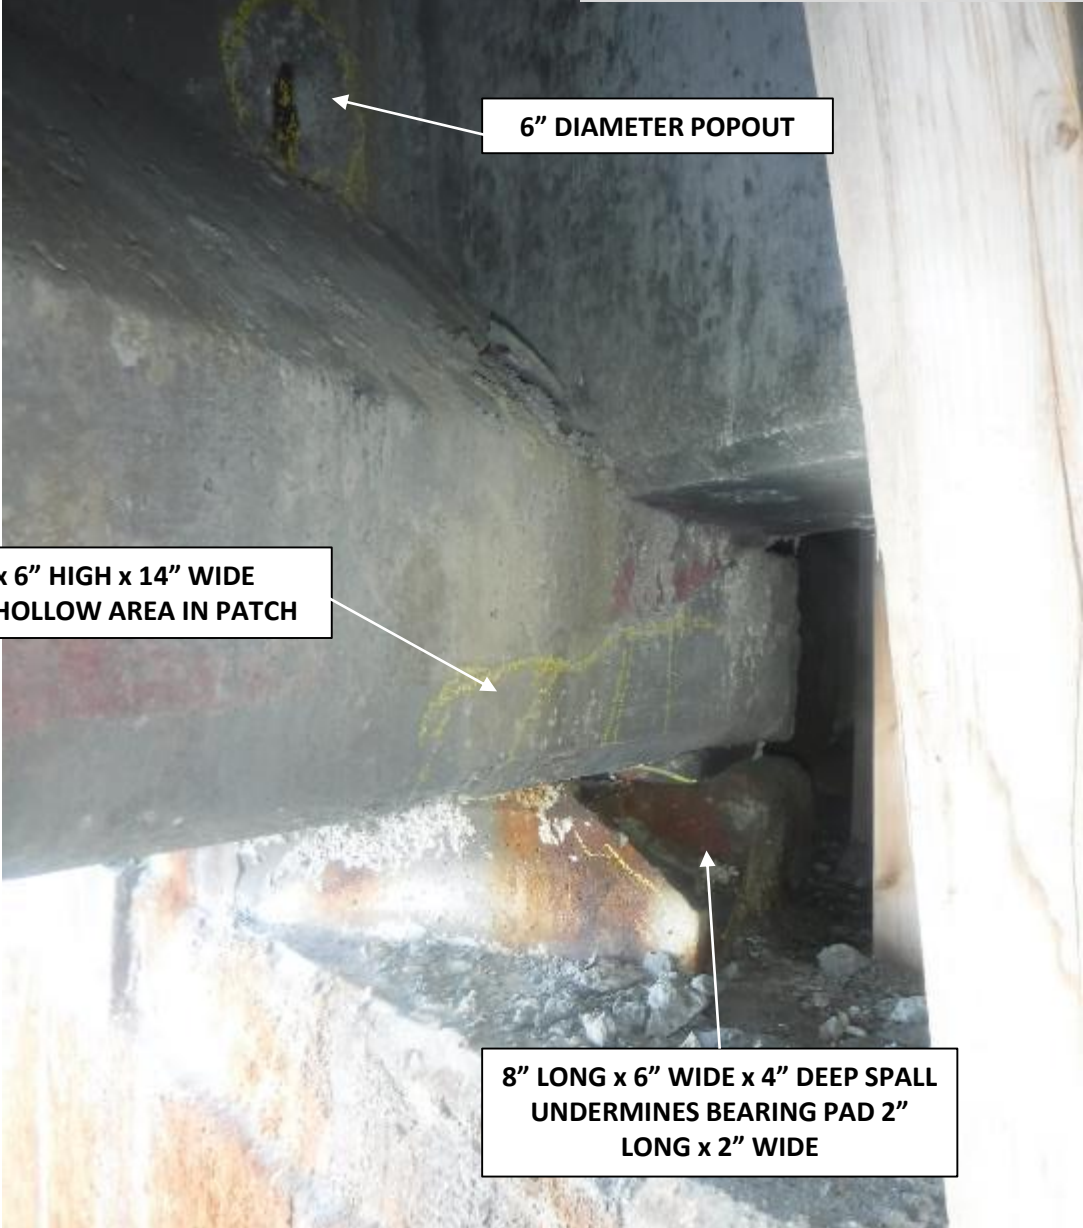
6" DIAMETER POPOUT

**28" LONG x 6" HIGH x 14" WIDE
(UNDERSIDE) HOLLOW AREA IN PATCH**

**8" LONG x 6" WIDE x 4" DEEP SPALL
UNDERMINES BEARING PAD 2"
LONG x 2" WIDE**

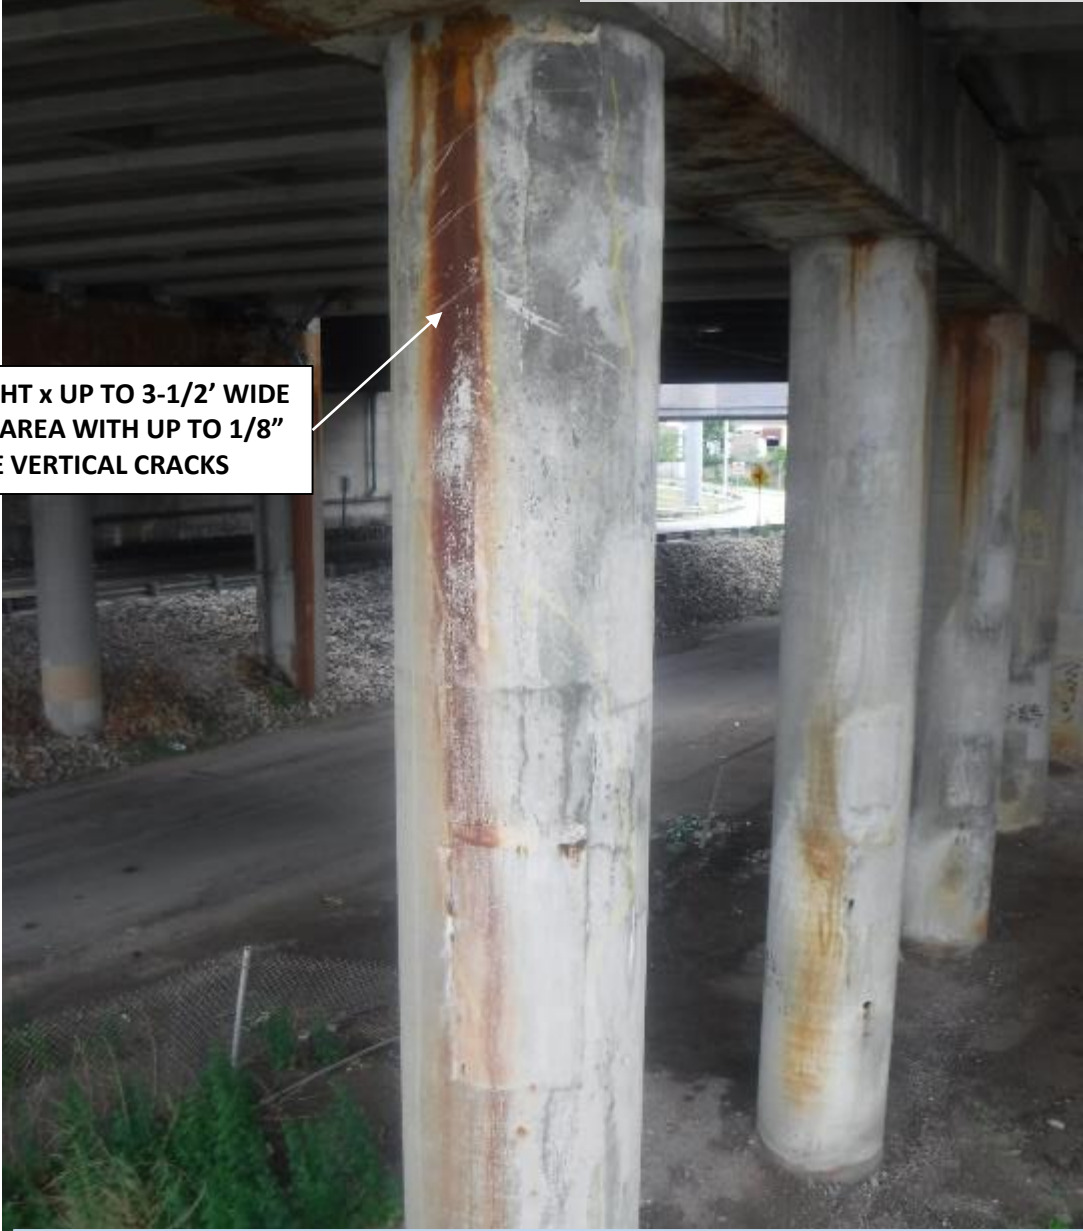
**10" LONG (WEST FACE) x 10" WIDE (SOUTH FACE)
x 8" HIGH x UP TO 4" DEEP SPALL UNDERMINES
BEARING PAD BY 1/2"**

**FULL HEIGHT x UP TO 3-1/2' WIDE
HOLLOW AREA WITH UP TO 1/8"
WIDE VERTICAL CRACKS**

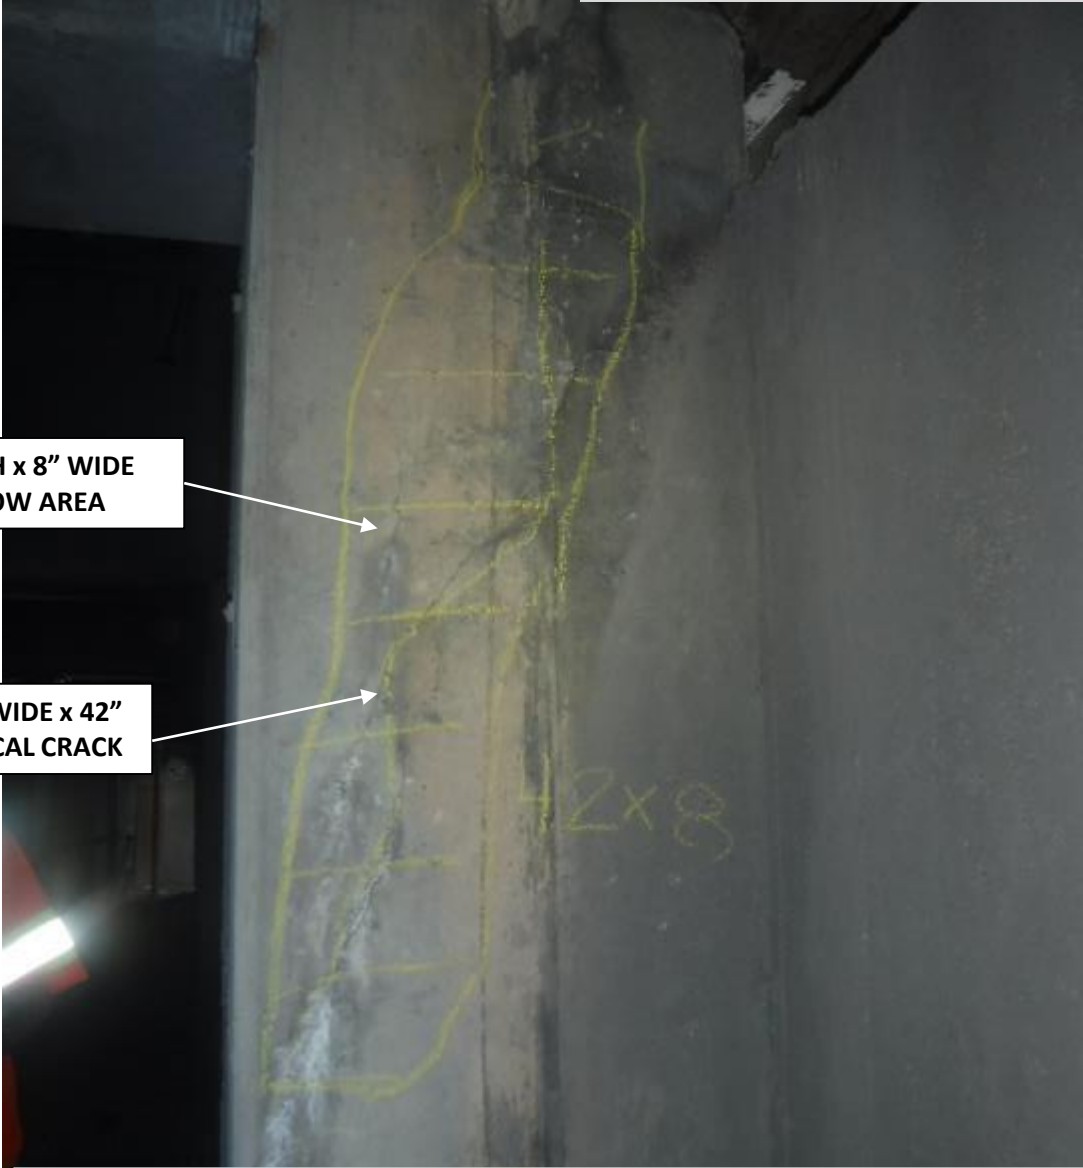
**CELLULAR WALLS AT
BASE OF PIER INTERIOR
(TYPICAL AT PIER #6
AND #7)**

**42" HIGH x 8" WIDE
HOLLOW AREA**

**UP TO 1/8" WIDE x 42"
LONG VERTICAL CRACK**

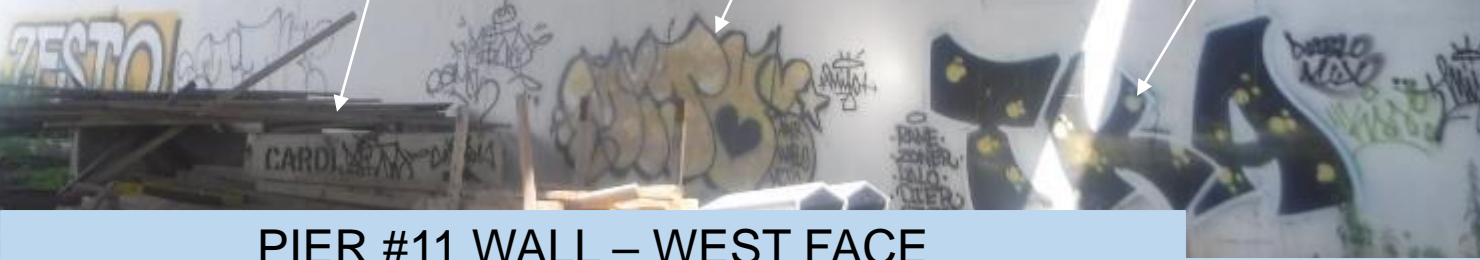
PIER #11 WALL – WEST FACE (LOOKING EAST)

**10'-0" HIGH x 5'-0" WIDE
HOLLOW AREA 1/2"
DEEP SPALLING AND
BOUNDARY CRACKS**

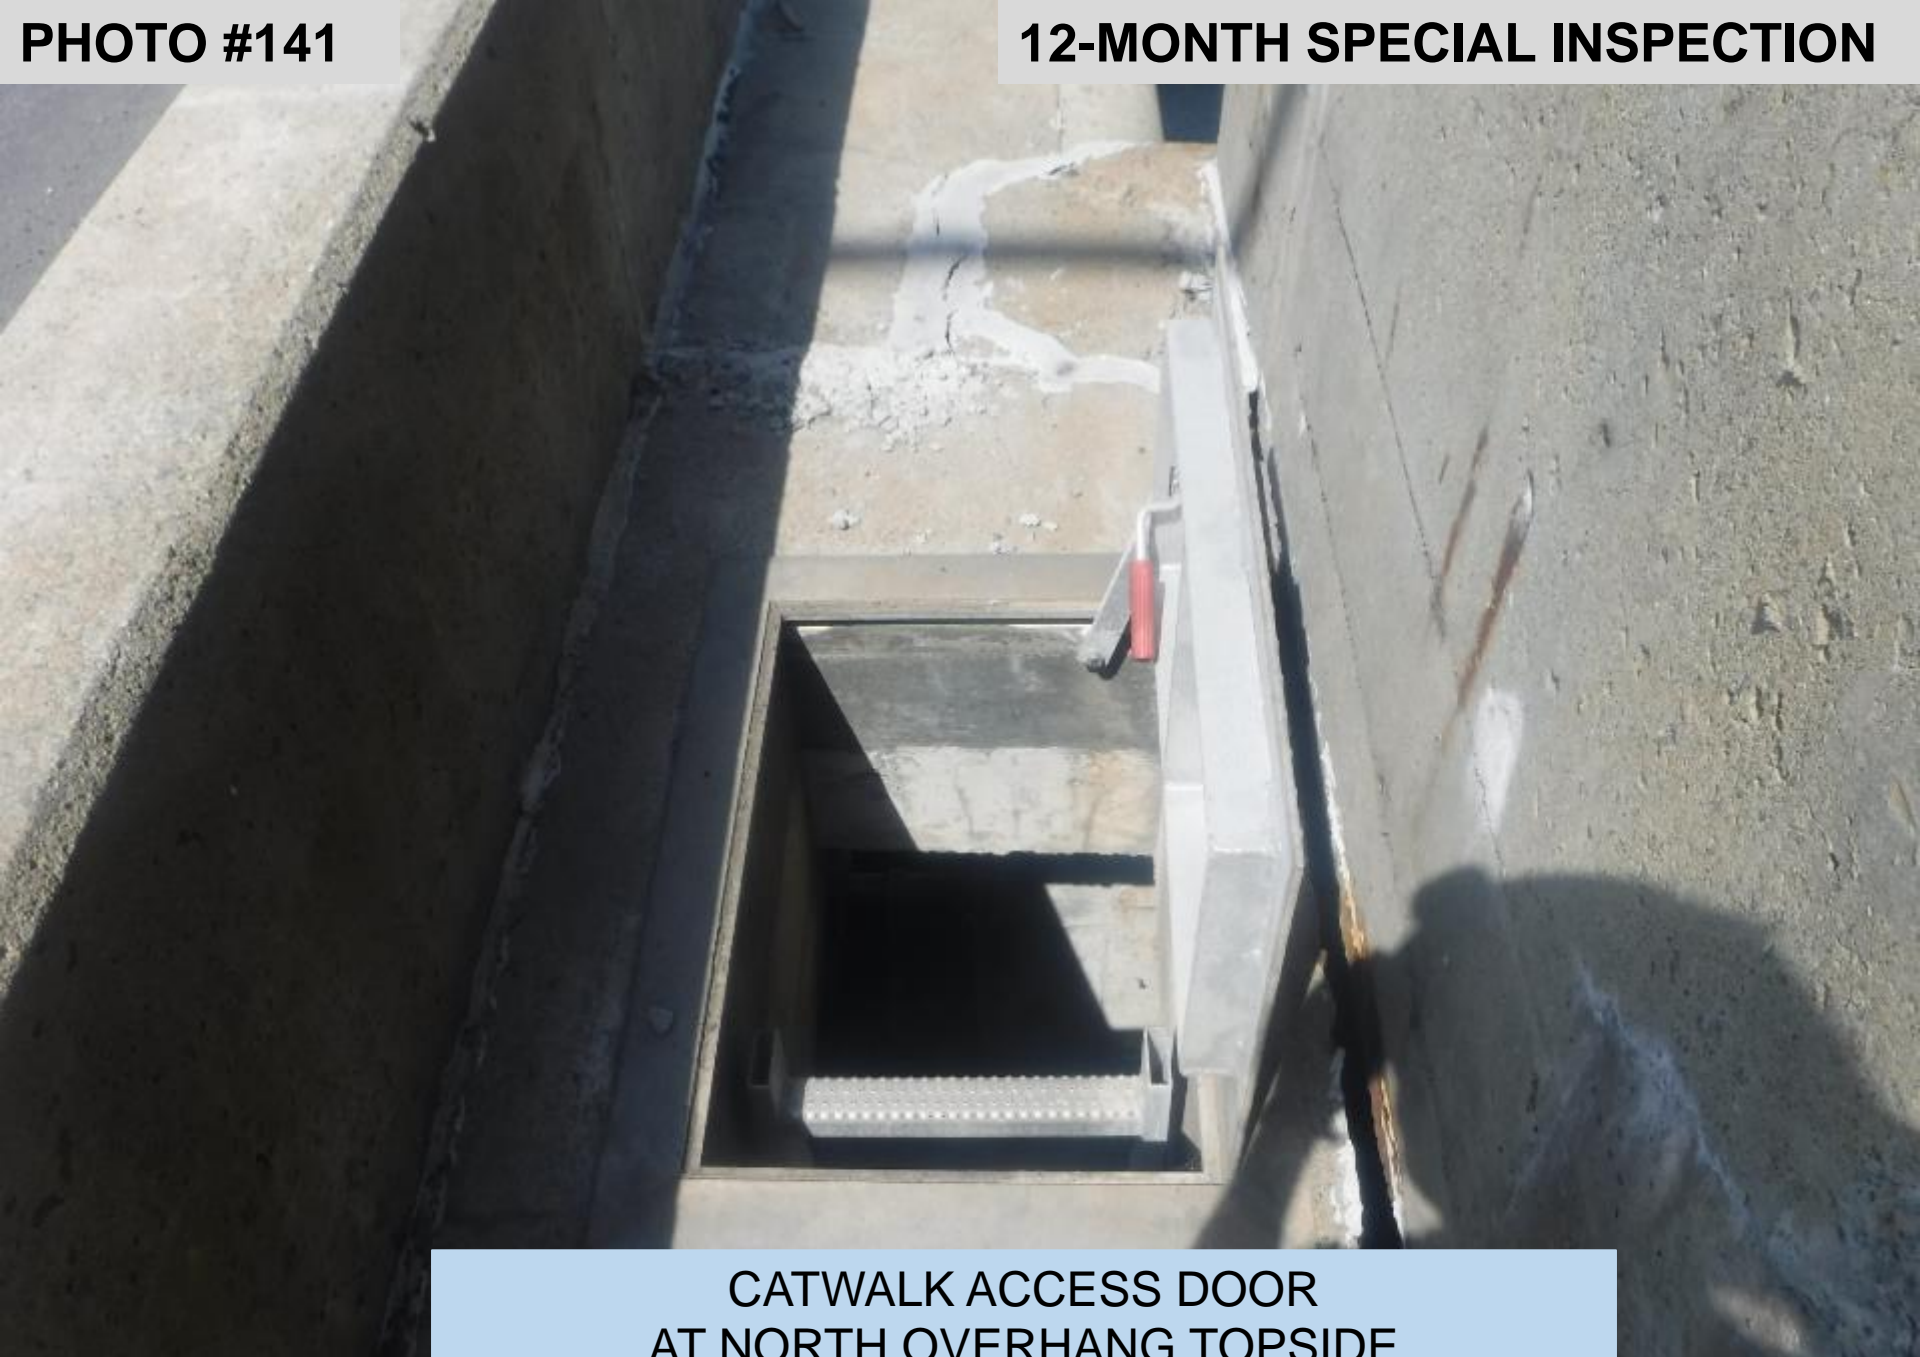
PHOTO #141

**CATWALK ACCESS DOOR
AT NORTH OVERHANG TOPSIDE
AT PIER #7 IN SPAN #6 (LOOKING WEST)**

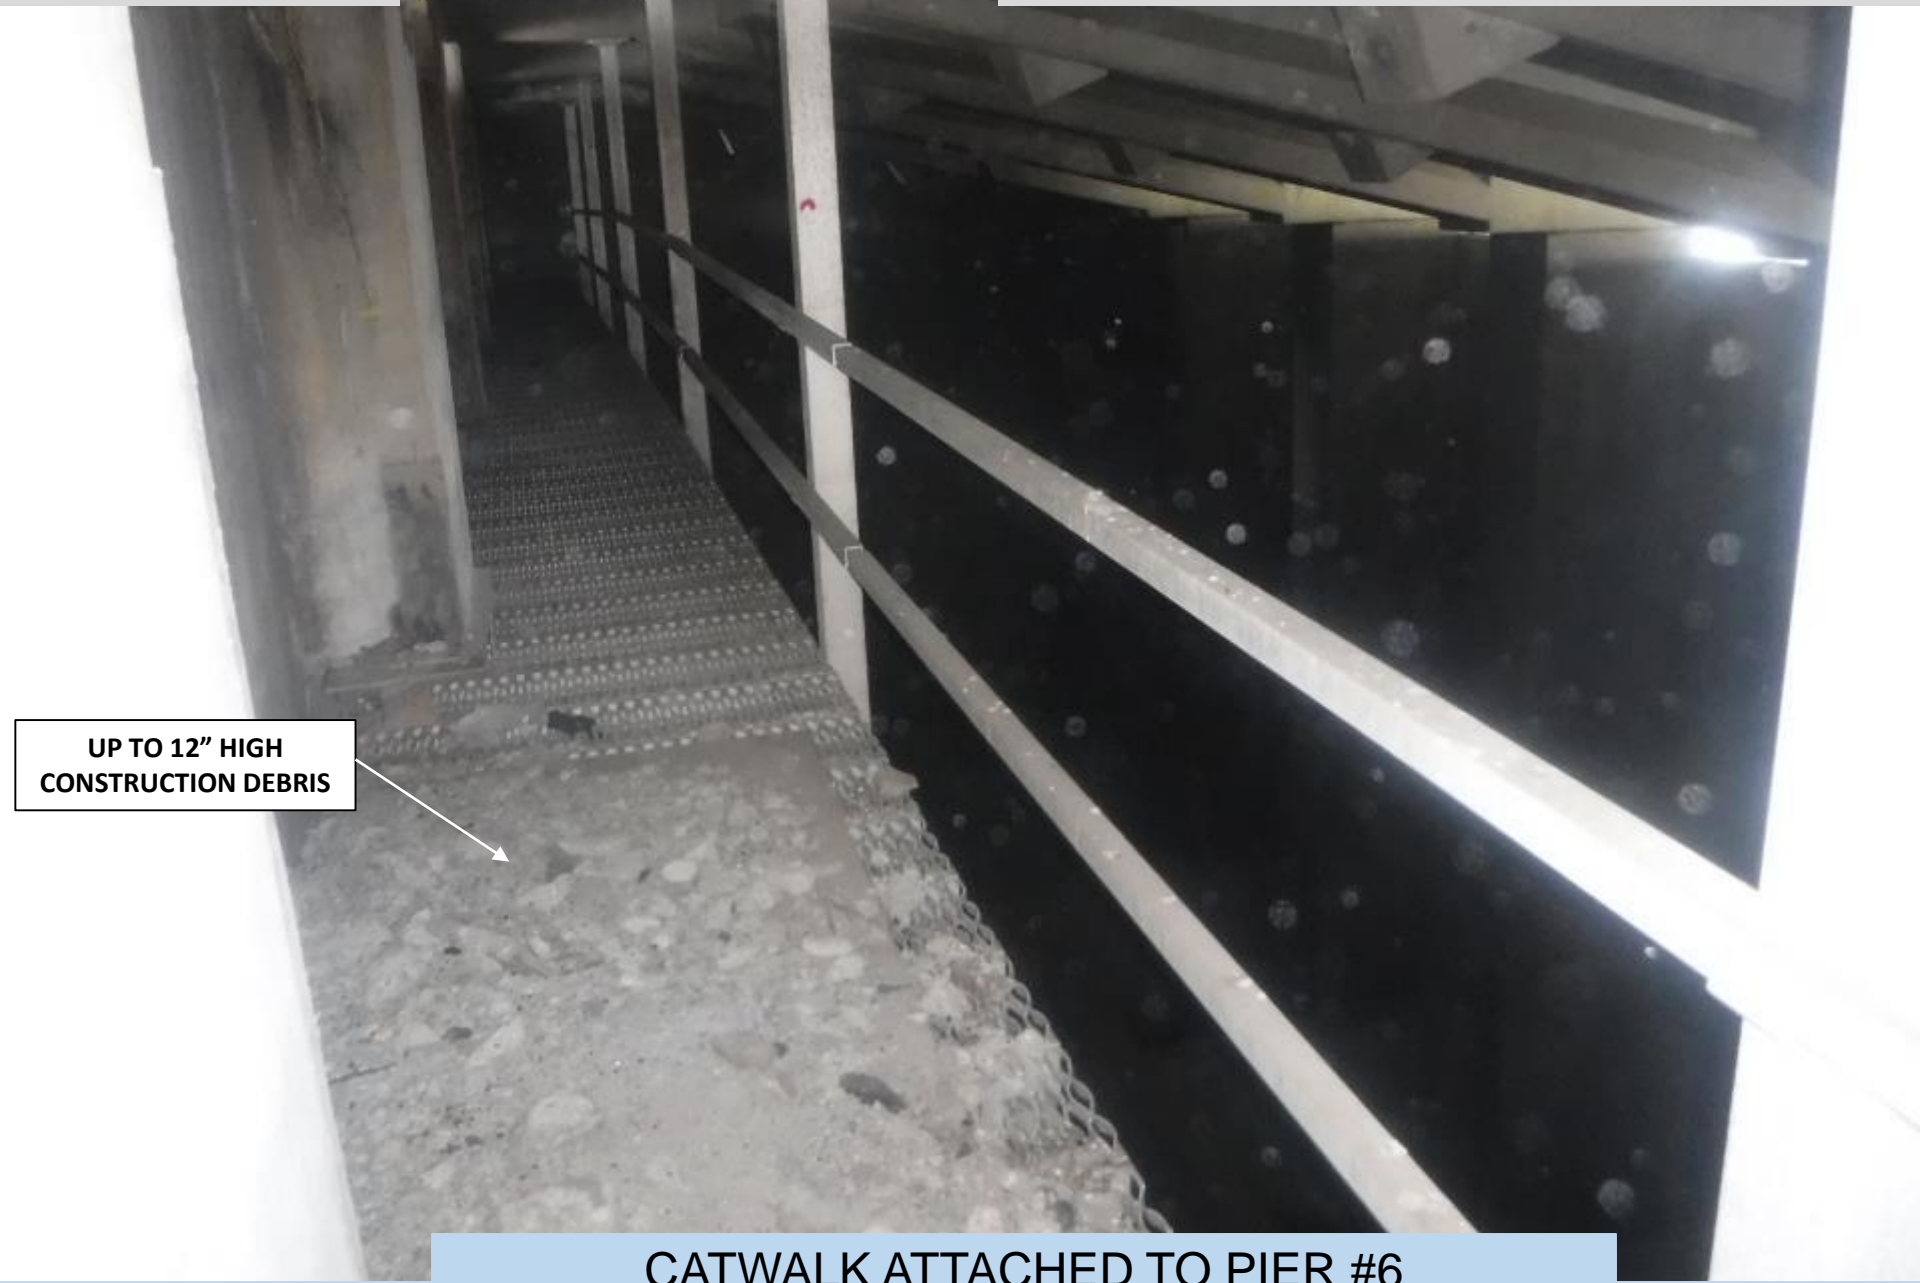
**UP TO 12" HIGH
CONSTRUCTION DEBRIS**

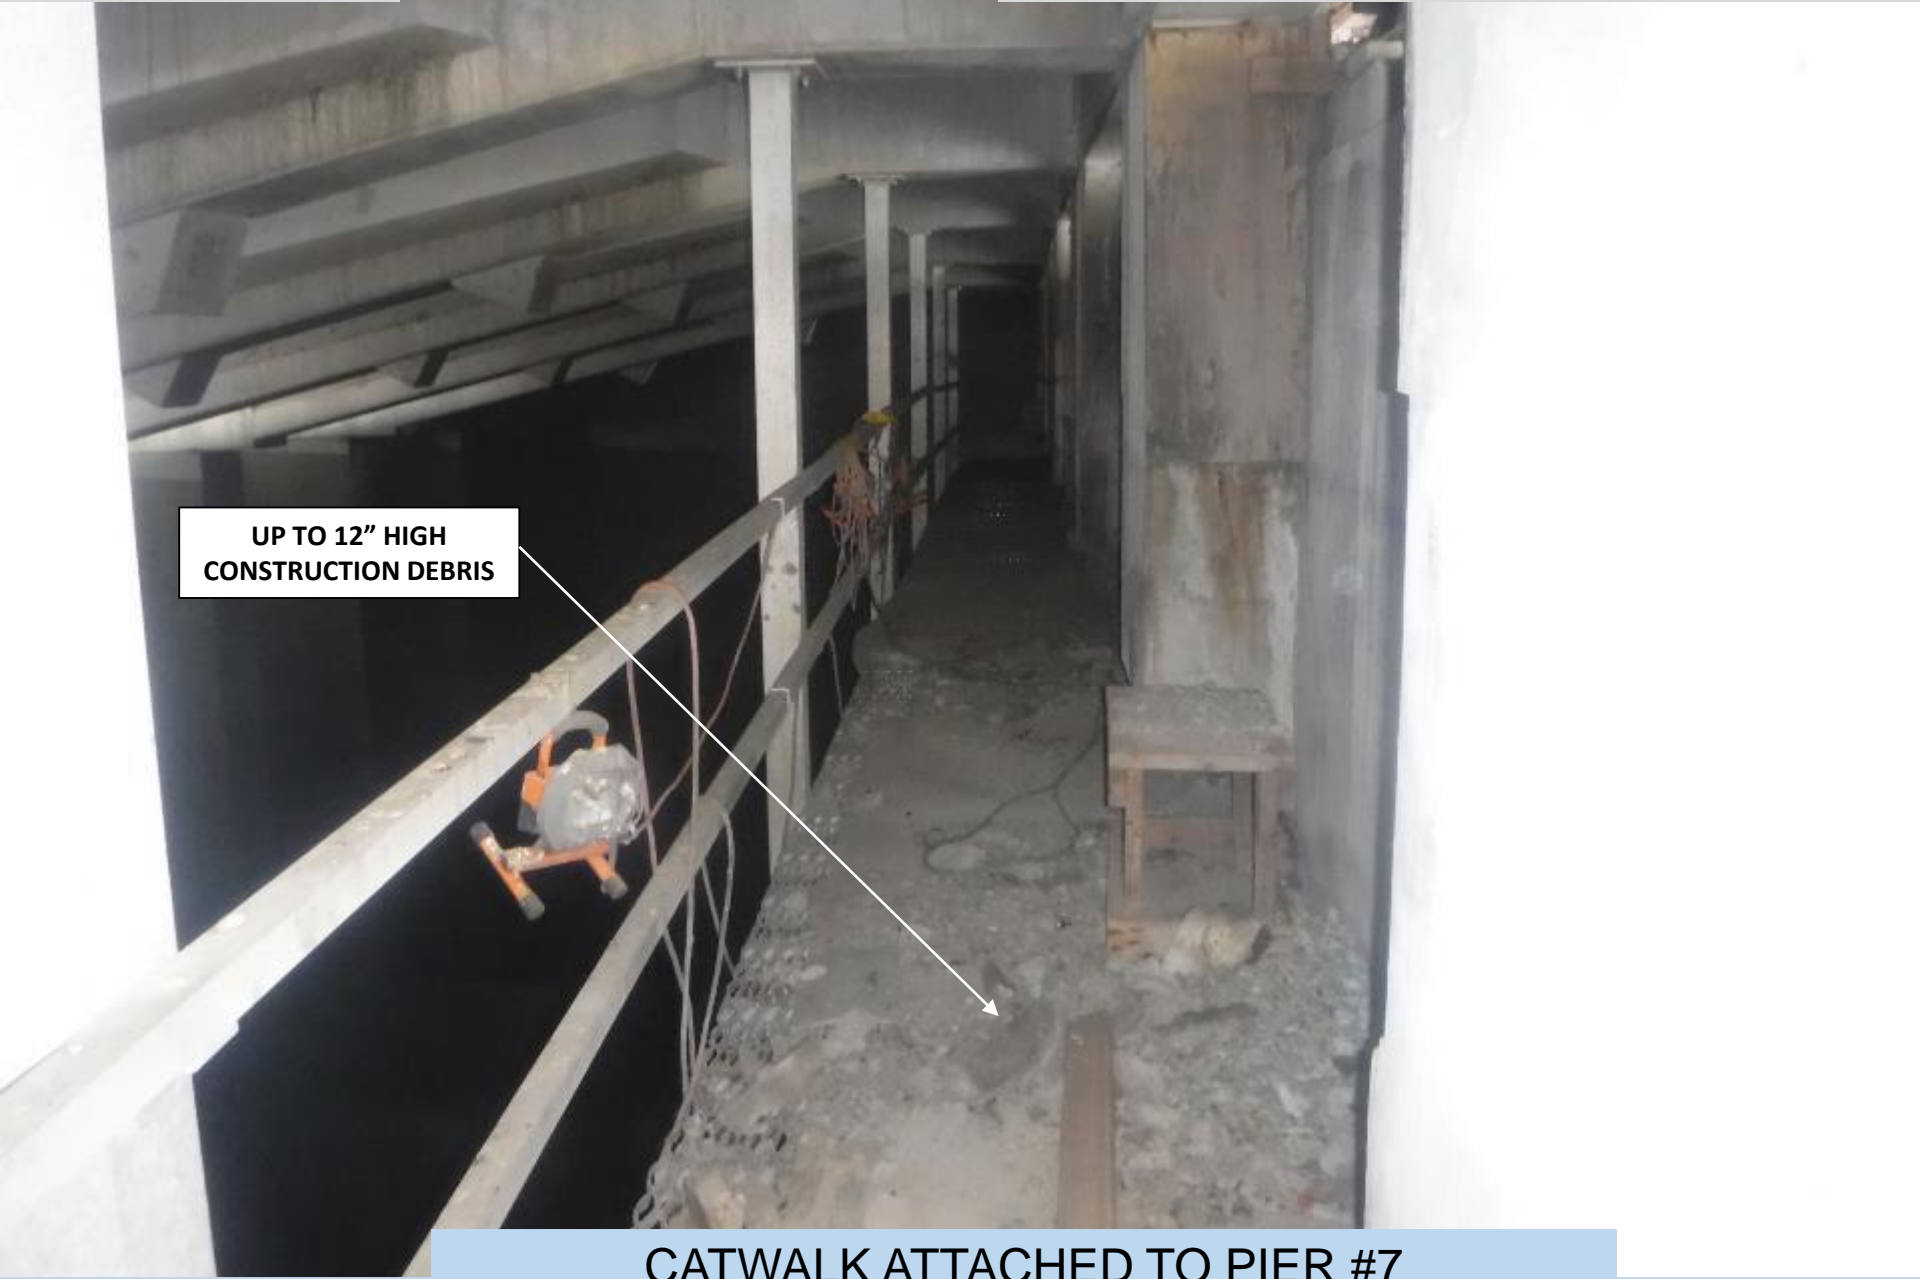
**UP TO 12" HIGH
CONSTRUCTION DEBRIS**
