12-MONTH SPECIAL INSPECTION

BRIDGE #070001

07/22/2020

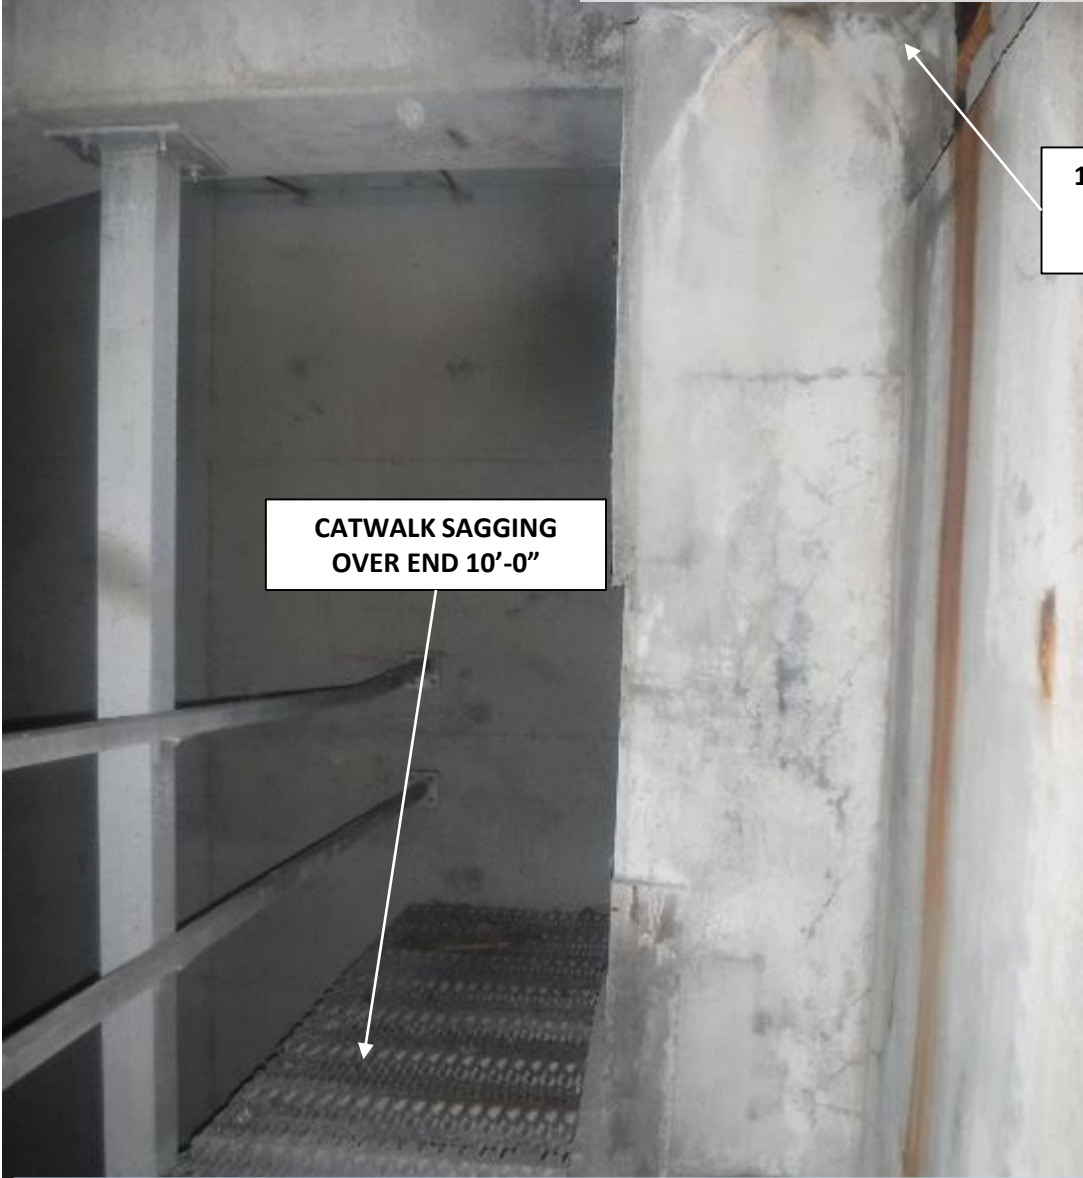
**1/4" WIDE x 12" LONG
VERTICAL CRACK IN
PEDESTAL**

**CATWALK SAGGING
OVER END 10'-0"**

**CATWALK ATTACHED TO PIER #7
WEST WALL INTERIOR FACE AT SOUTH END**

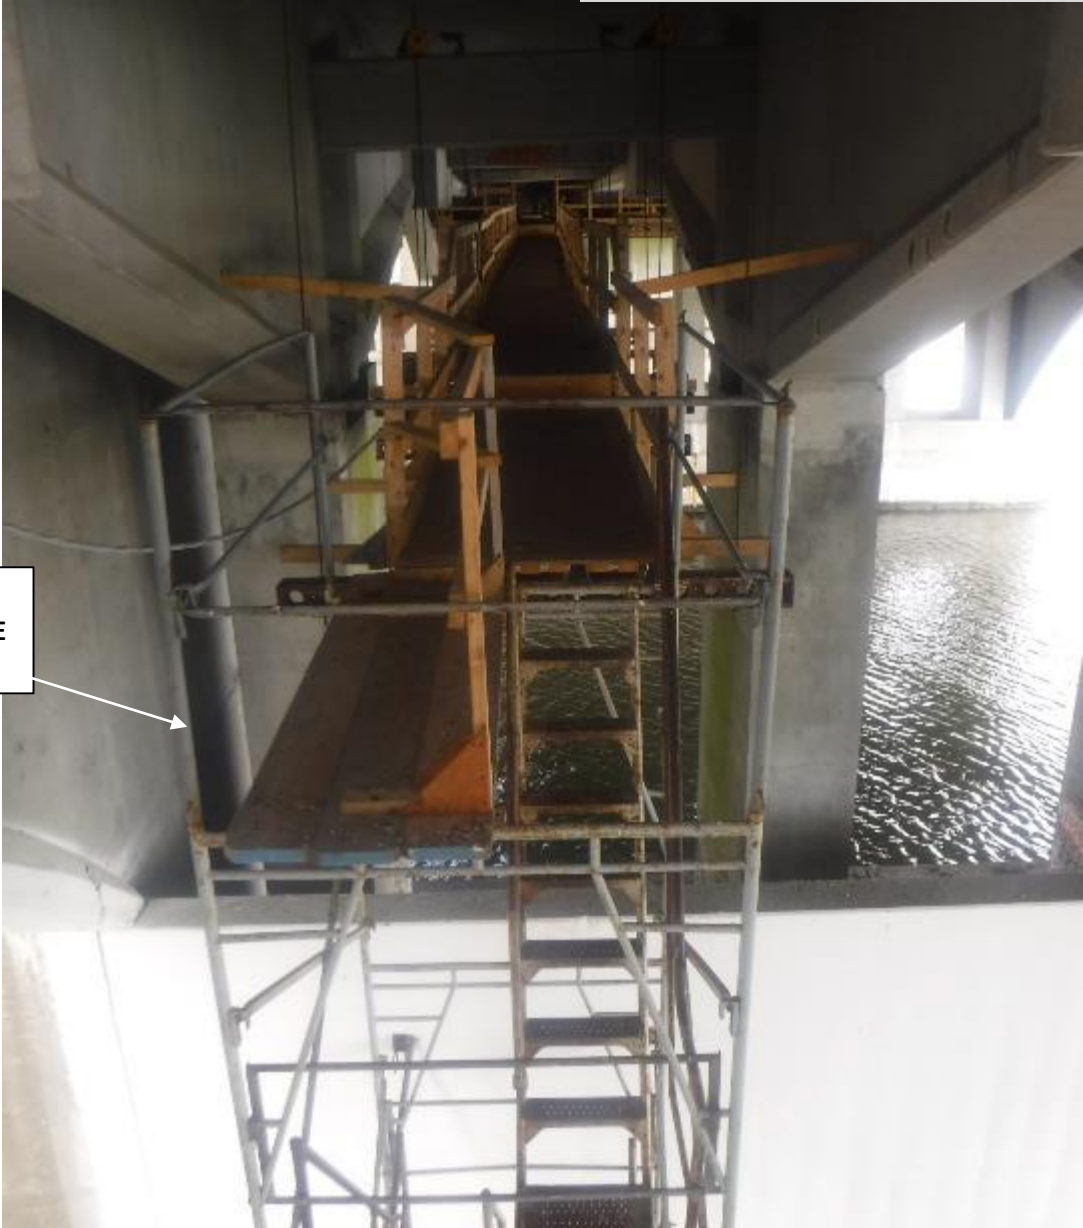
**CONSTRUCTION
SCAFFOLDING IN PLACE
(TYPICAL)**

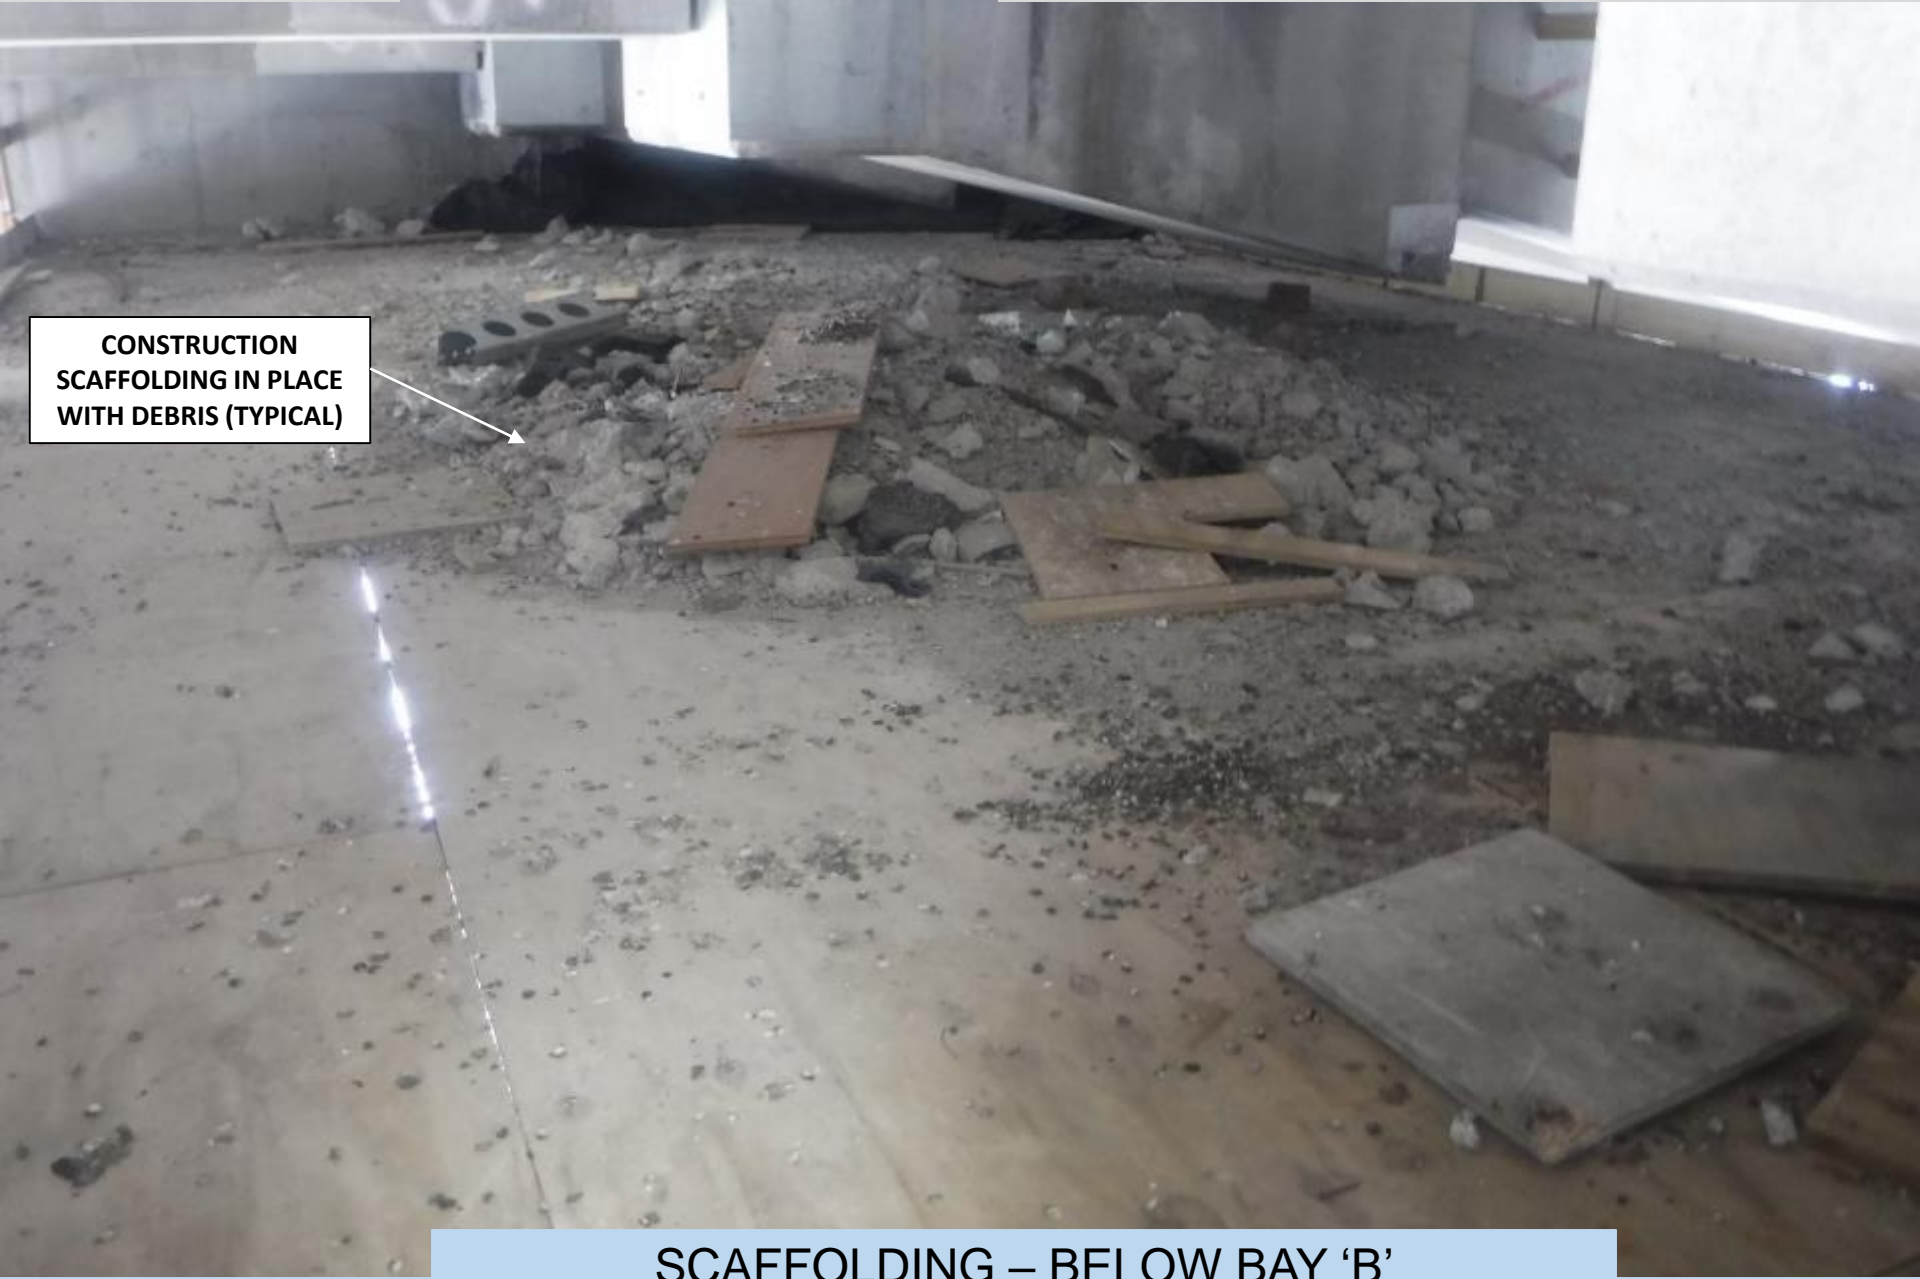
**CONSTRUCTION
SCAFFOLDING IN PLACE
WITH DEBRIS (TYPICAL)**

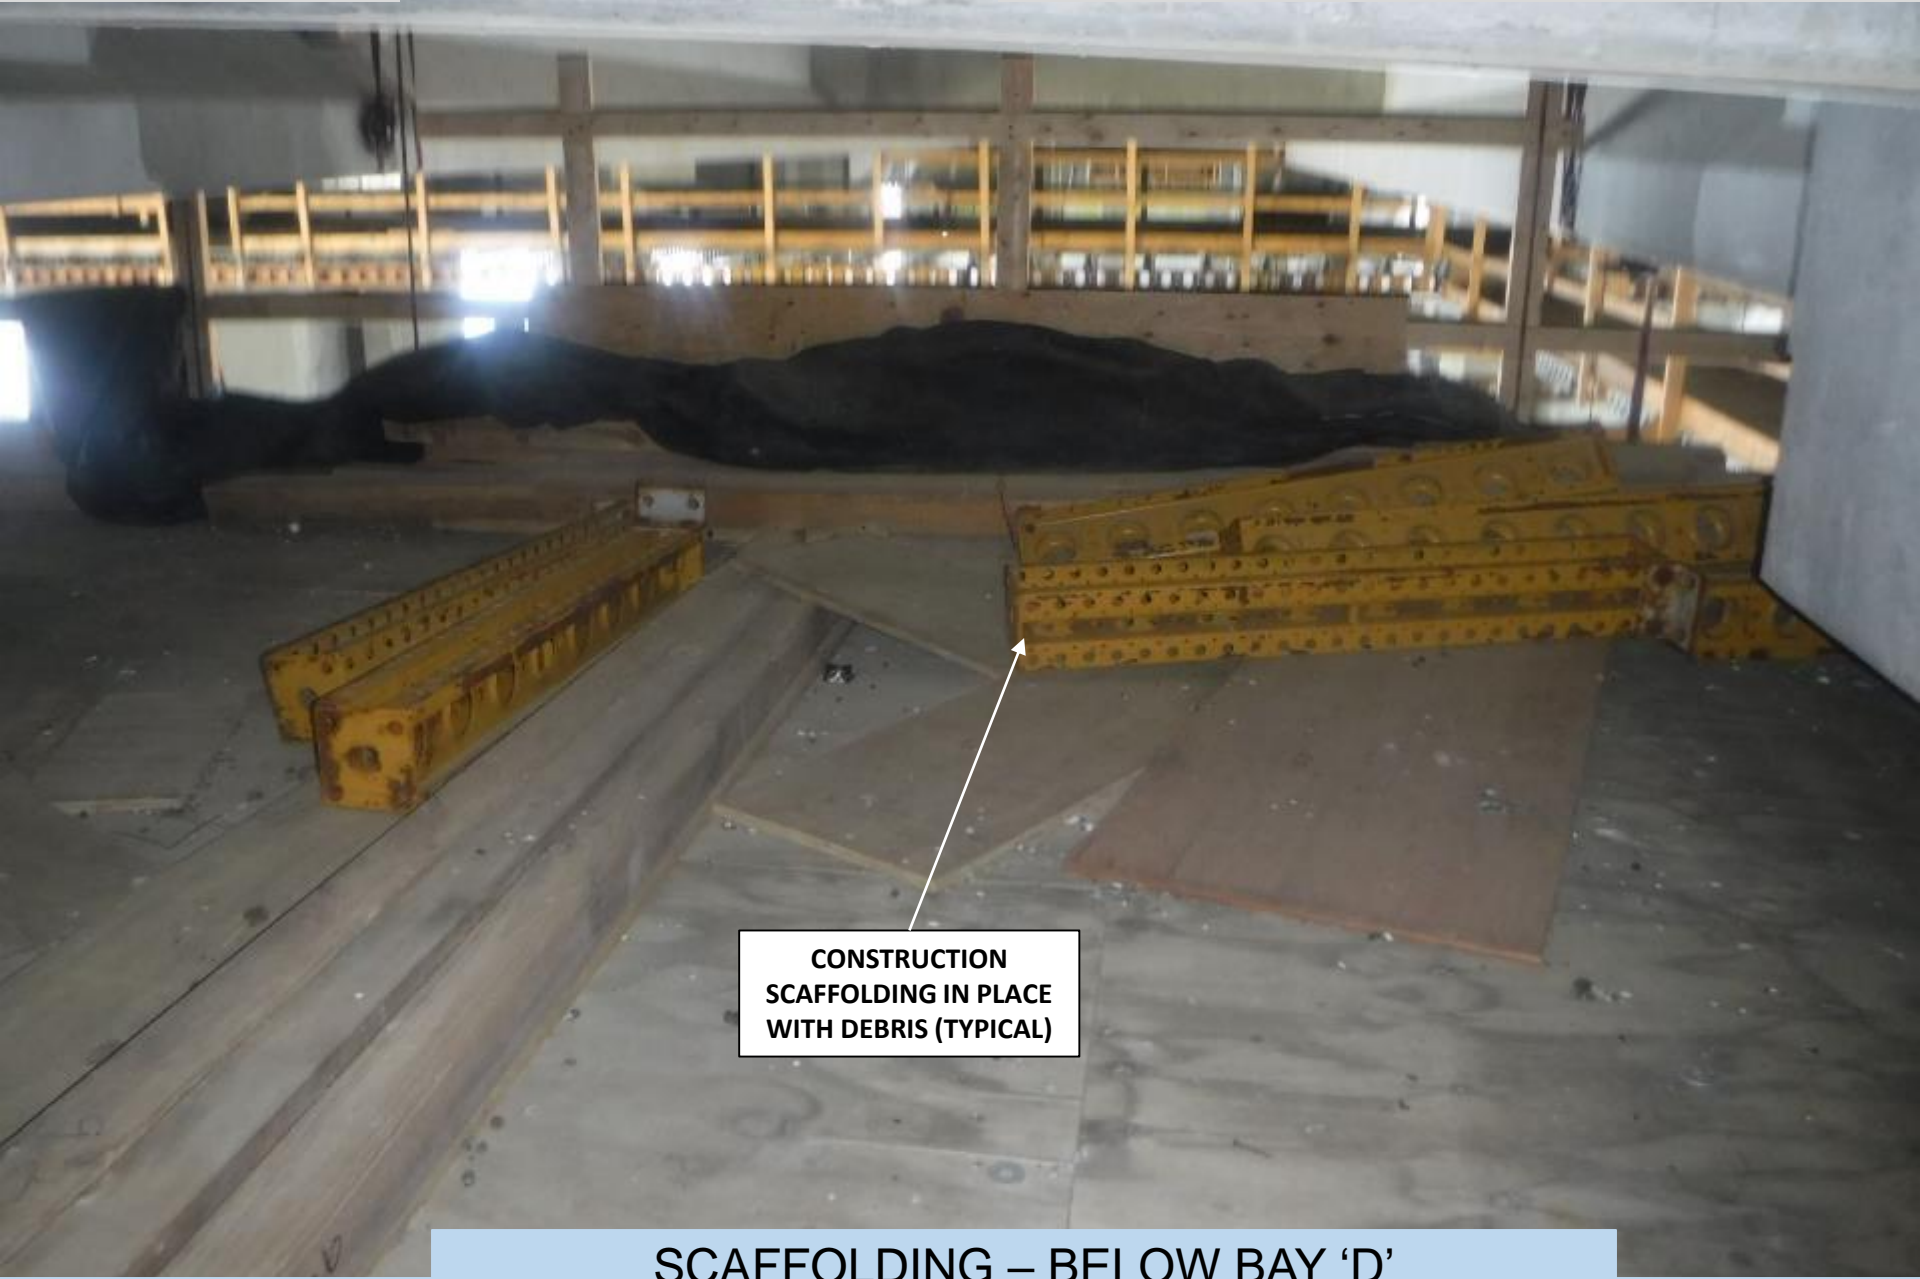
**CONSTRUCTION
SCAFFOLDING IN PLACE
WITH DEBRIS (TYPICAL)**
