RIDOT

IDDE Compliance Update Report No. 10

January 1, 2024 – June 30, 2024

**Rhode Island
National Pollutant Discharge Elimination System
Municipal Separate Storm Sewer Systems**

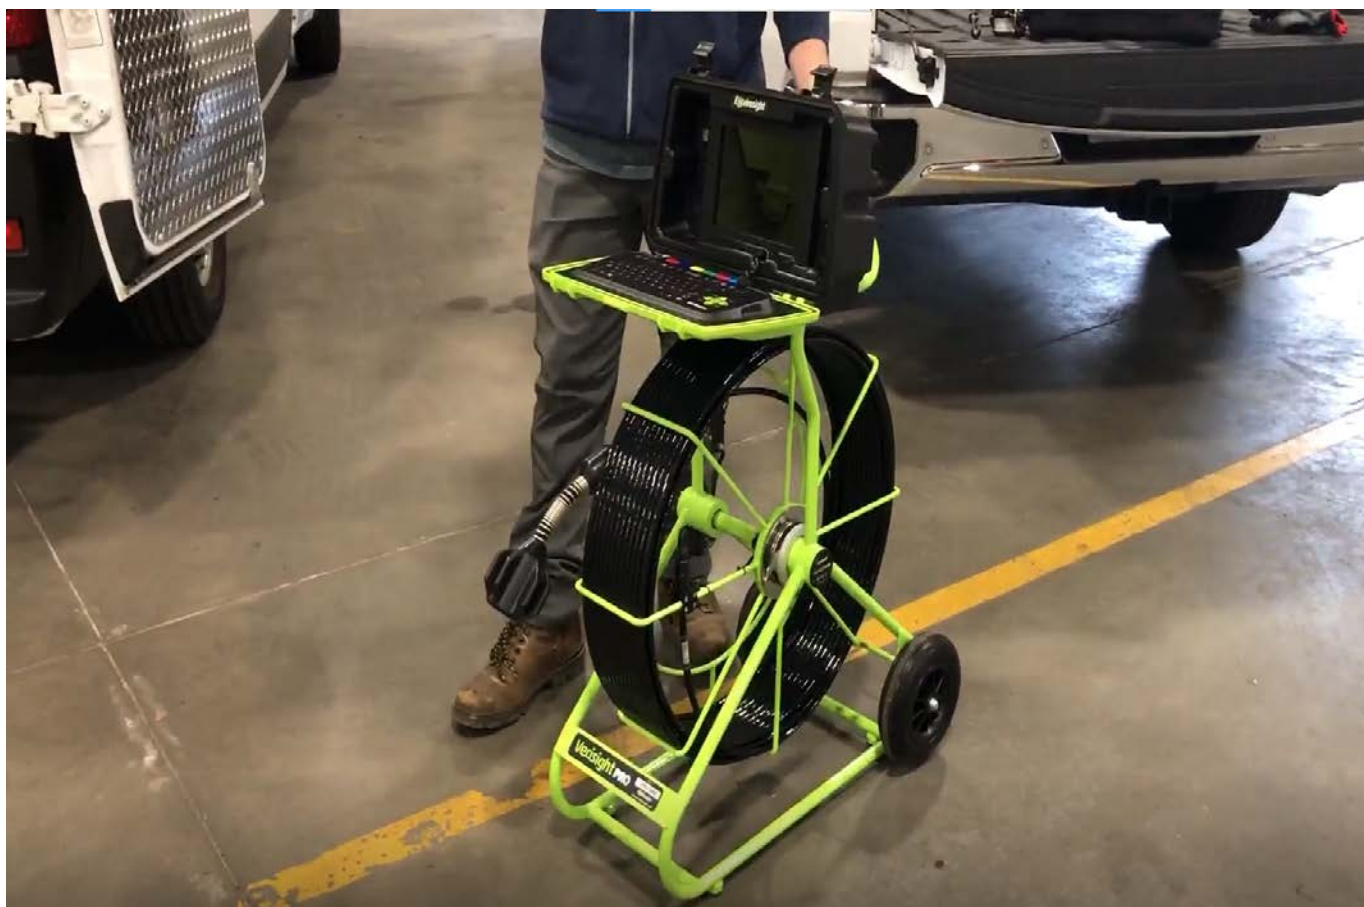
Figure 1 Photo of RIDOT CCTV push camera, new state of the art technology for inspecting small diameter pipes

- RIDOT has purchased a new push camera for inspecting small diameter pipes, this system is an upgrade with longer inspection capabilities and report generating software.
